**Cell 1 Regional Coastal Monitoring Programme
Update Report 5: 'Partial Measures' Survey 2013**

**South Tyneside Council
Final Report**

June 2013

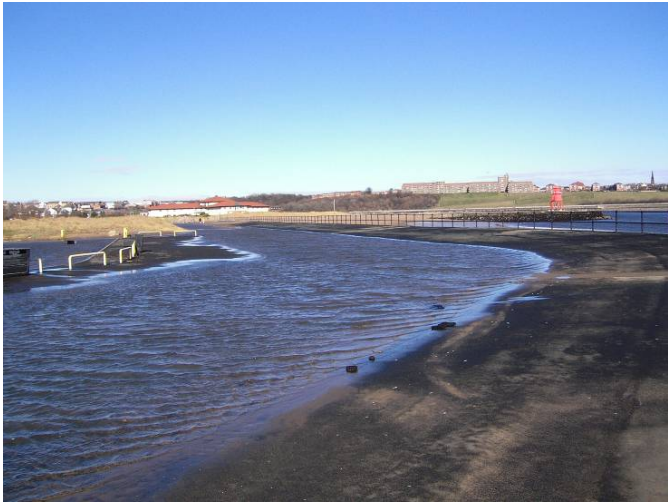
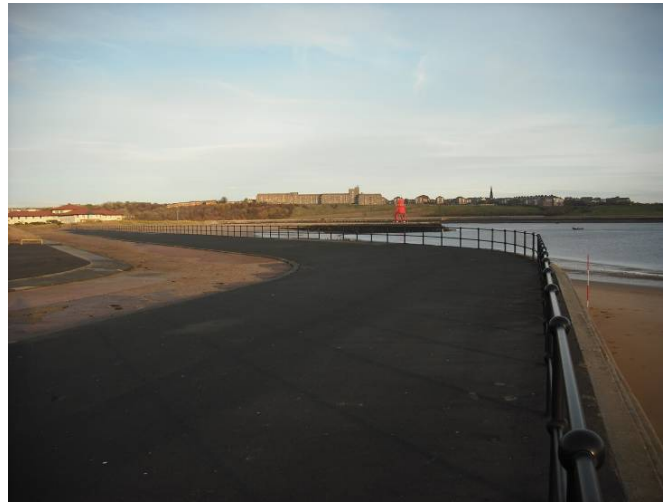
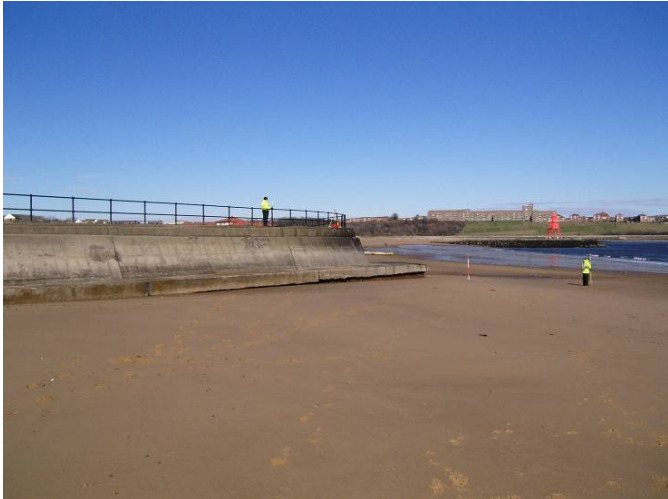
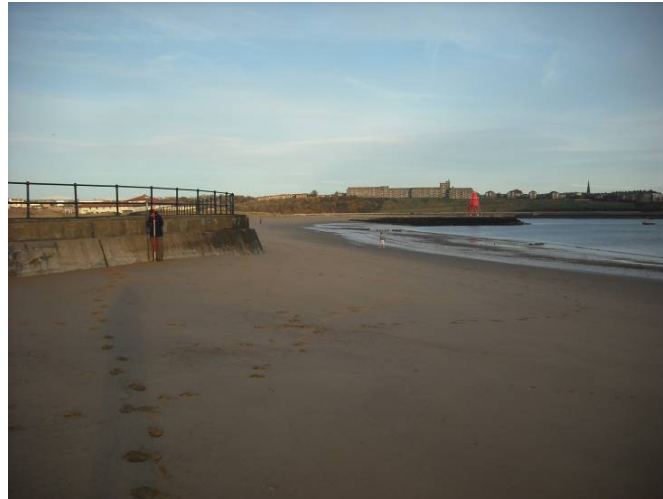
Plate 1 – Survey photograph 1bSS3_20130312_N1.JPG

Plate 2 – Survey photograph 1bSS3_20121114_N2.JPG

Plate 3 – Survey photograph 1bSS3_20130312_N3.JPG

Plate 4 – Survey photograph 1bSS3_20121114_N3.JPG

At beach profile 1bSS3, beach levels have fallen to expose the toe of the seawall apron and piling. Although, the structural integrity of the seawall is not likely to be compromised under the present beach levels, the structure should be assed regularly for a further fall in beach levels and to identify if any trigger levels have been met.

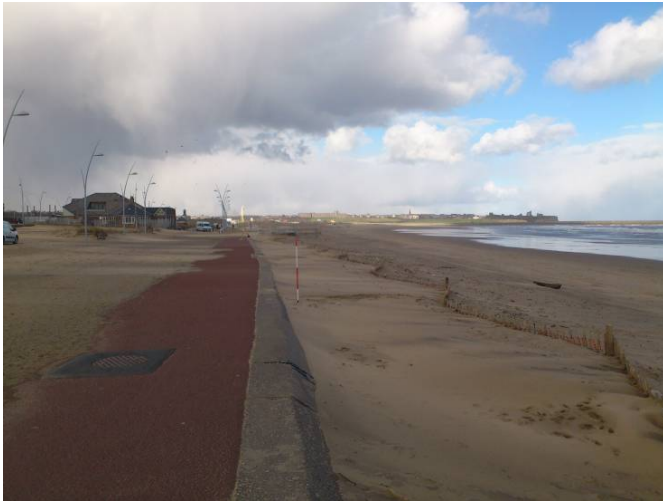
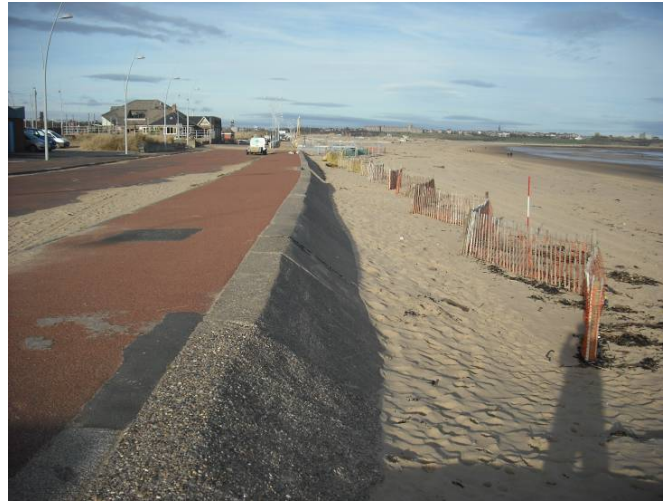
Plate 5 – Survey photograph 1bSS8_20130311_N1.jpg

Plate 6 – Survey photograph 1bSS8_20121114_N1.JPG

It is noted from the survey photograph for profile 1bSS8, that sand has been blown onto the promenade and road behind, which may create a maintenance issue. Any wind-blown sand should be returned to the beach to assist in maintaining a healthy beach.

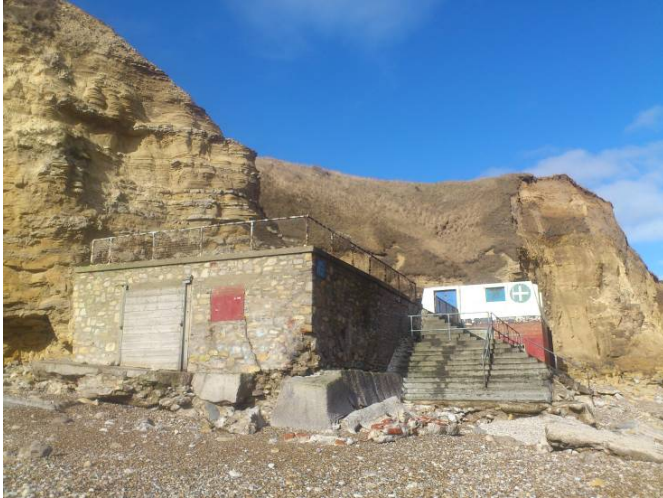
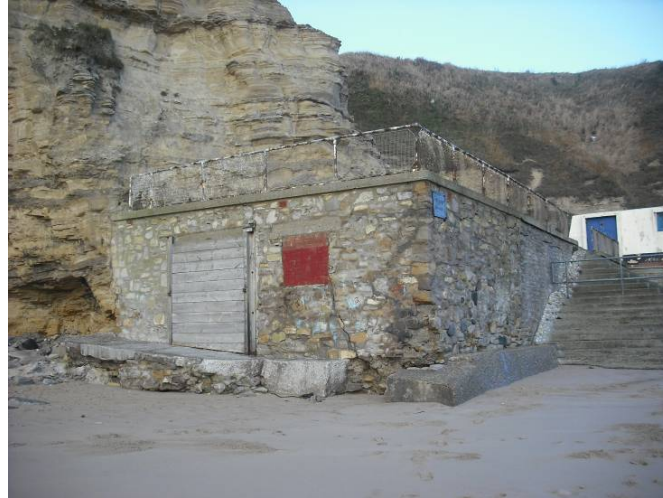
Plate 7 – Survey photograph 1bSS14_20130311_N4.jpg

Plate 8 – Survey photograph 1bSS14_20121112_N2.JPG

At beach profile 1bSS14, beach levels have fallen to expose the toe of the Redwell. Although, the structural integrity of the steps is not likely to be compromised under the present beach levels, the structure should be assed regularly for a further fall in beach levels and to identify if may trigger levels have been met.

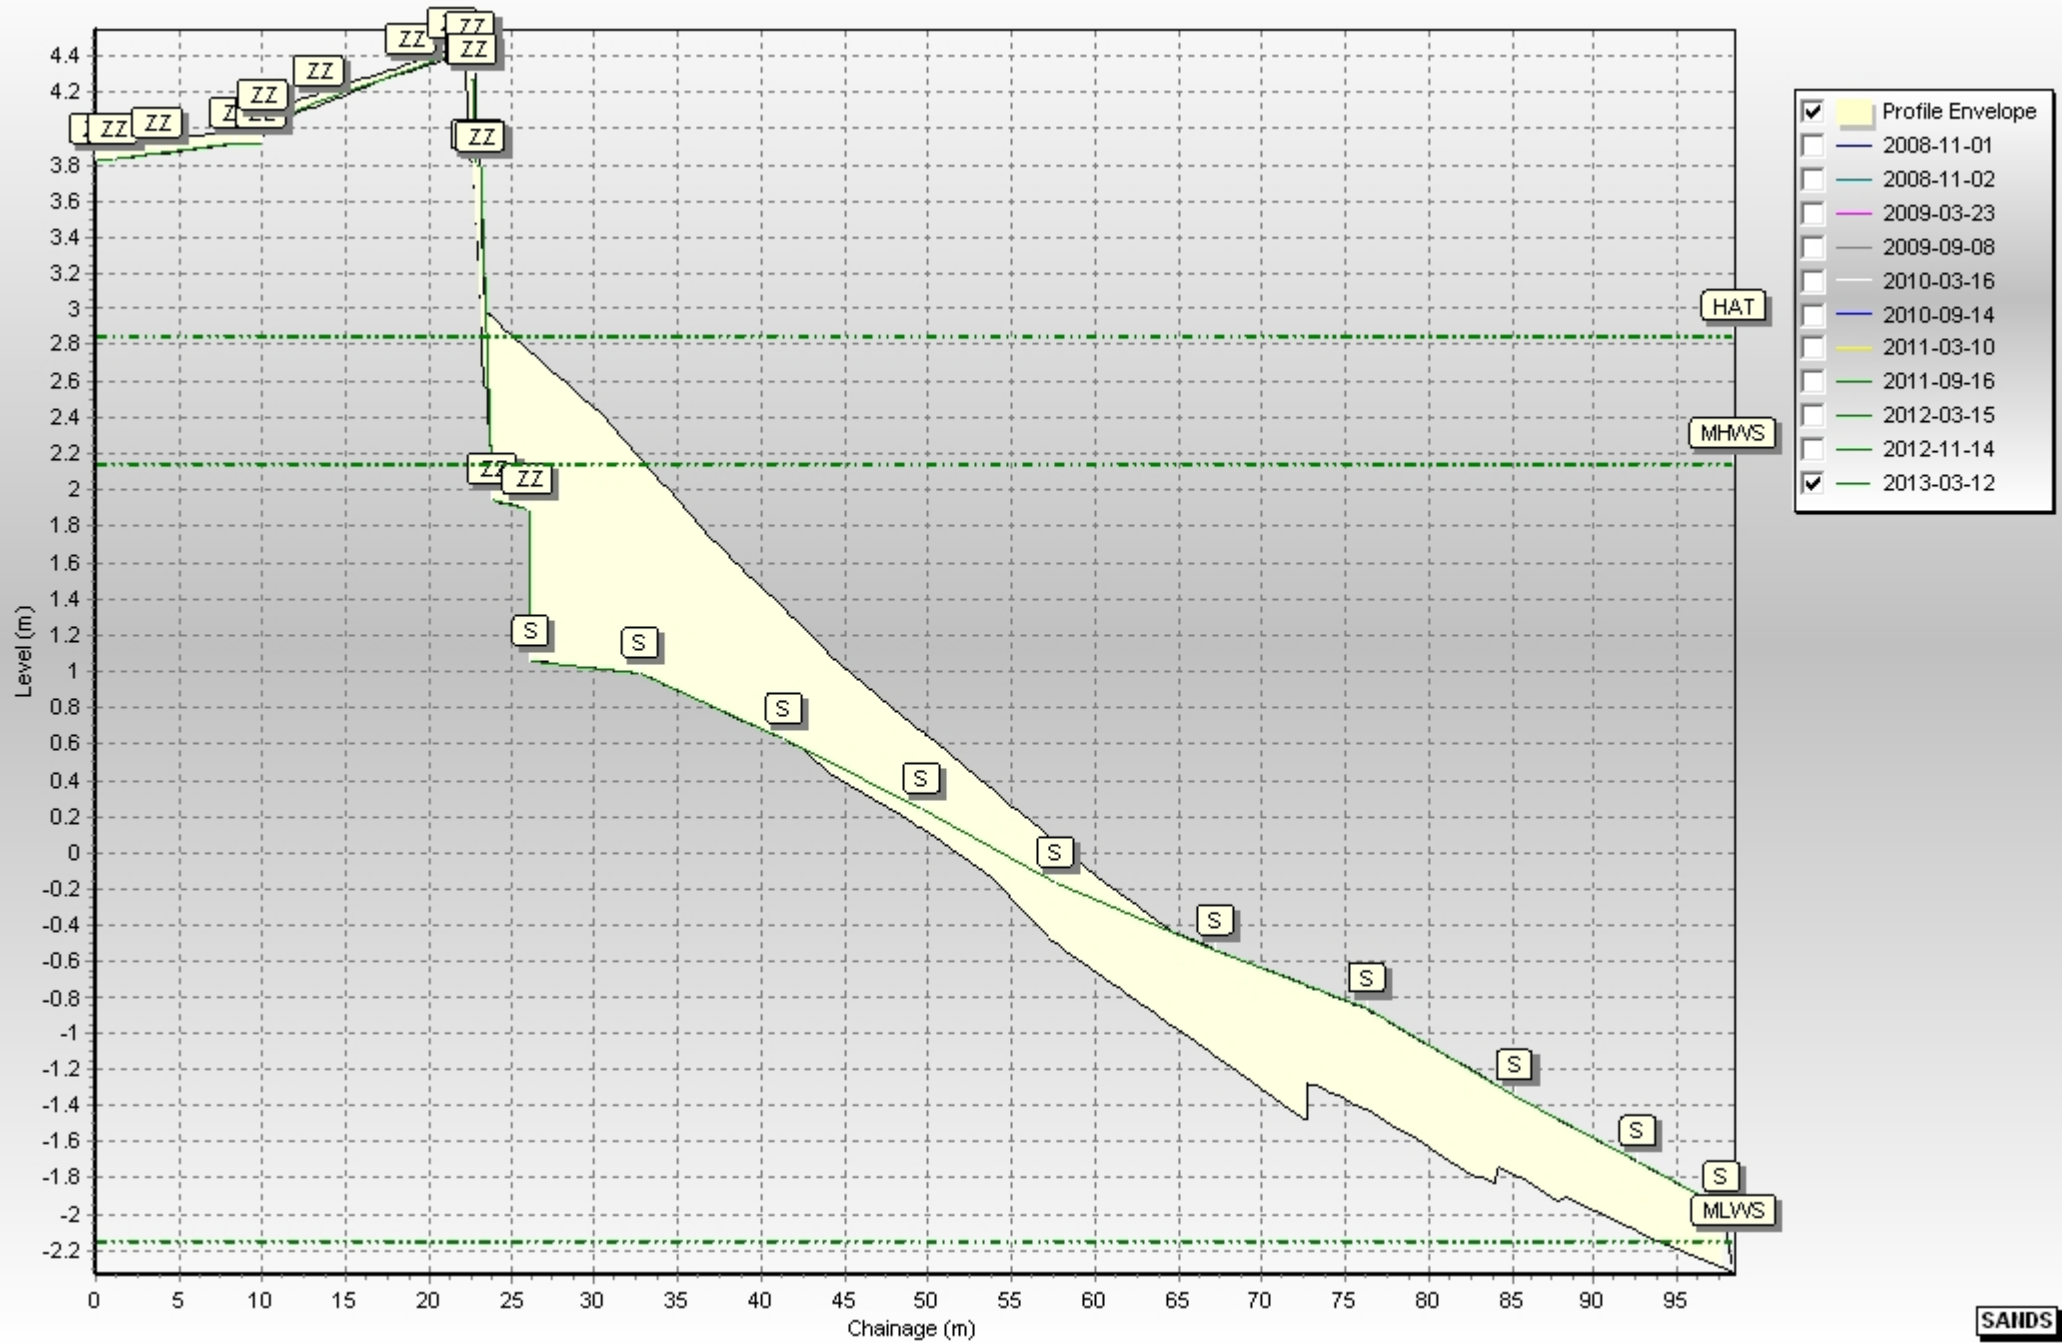
Profiles: 1bSS3

Survey Date	Description of Changes Since Last Survey	Interpretation
Mar 2013	<p>Beach Profiles:</p> <p>Littlehaven Beach is covered by two beach profile lines for the Partial Measures survey, spaced between South Groyne and South Pier (Appendix A). The previous survey was the Full Measures survey undertaken in autumn 2012.</p> <p>Profile 1aSS1 is located to the north of Littlehaven Beach, in the lee of a rocky outcrop. As with the previous Full Measures surveys (2012 and 2011), the dunes have been subject to some accretion, with a small increase on the top of the dunes and the dune face. Beach levels at the toe of the dune to a chainage of 95m have fallen by approximately 0.4m, but seaward of there, beach levels have increased by approximately the same magnitude. This suggests that material has been drawn-down from the upper beach to the middle/lower beach as a result of winter storms.</p> <p>Profile 1bSS3 extends seawards from the protruding section of Littlehaven Sea Wall. The survey photographs for the present and Full Measures 2012 survey ((refer to Plates 1 and 2), show that a large volume of water has accumulated on top of the seawall, from rainwater or wave overtopping. Beach levels have fallen considerably (up to 1.5m) between the seawall and a chainage of 55m, exposing the toe of the seawall apron and sheet piling (shown in survey photographs Plates 3 and 4). Seaward of there, beach levels have increased by approximately 0.6m to 0.8m. Together, these findings suggest the occurrence of severe storms, with overtopping and the draw-down of material from the upper beach to the middle/lower beach under storm wave action.</p>	<p>At Littlehaven Beach, the upper beach has been subject to considerable erosion, whilst the middle/lower beach has been subject to an increase in beach levels. This is evidence of beach draw-down, as material is transported across the beach by winter storms.</p> <p>At beach profile 1bSS3, beach levels have fallen to expose the toe of the seawall apron and piling. Although, the structural integrity of the seawall is not likely to be compromised under the present beach levels, the structure should be assed regularly for a further fall in beach levels and to identify if may trigger levels have been met.</p> <p>Longer term trends: When compared with previous profiles, the beach levels are the lowest observed to on the upper beach and the highest observed to date on the middle/upper beach.</p>

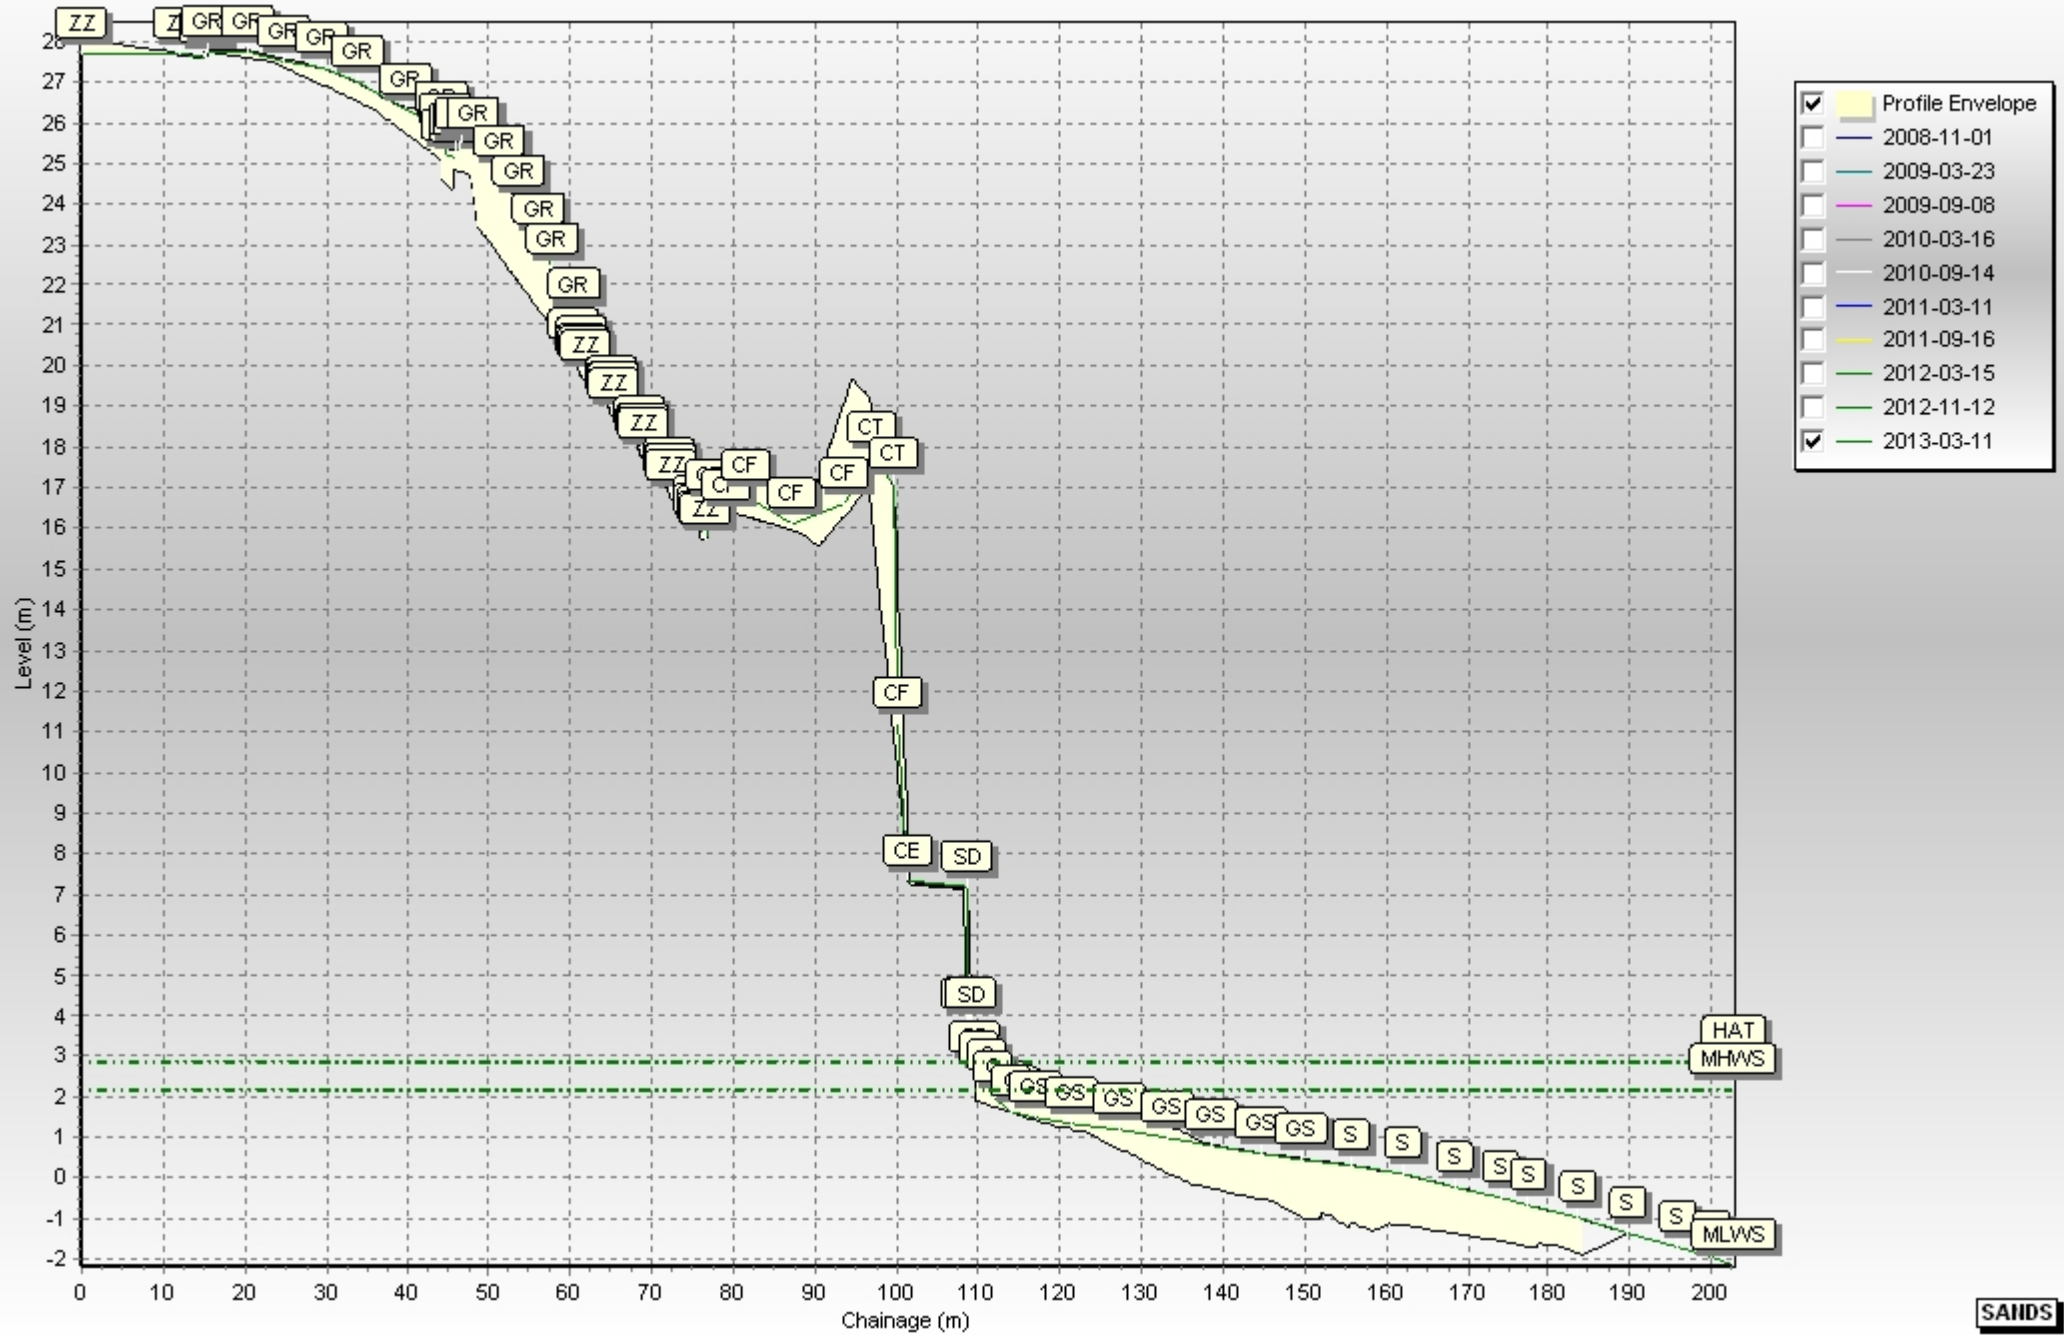
Profiles: 1bSS14

Survey Date	Description of Changes Since Last Survey	Interpretation
<p>Mar 2013</p>	<p>Beach Profiles:</p> <p>Marsden Bay is covered by two beach profile lines for the Partial Measures survey (Appendix A). The previous survey was the Full Measures survey undertaken in autumn 2012.</p> <p>Profile 1bSS14 is located to the north of the bay and covers the cliffs and former lifeguard station adjacent to the Redwell Steps. As shown in Appendix A, the cliff profile suggests that the cliff face has advanced by up to 1m. As noted in the previous Full Measures (autumn 2012) report, this is likely to reflect access difficulties to the cliff toe, but may represent accumulation of talus from cliff recession. Beach levels have dropped considerably (by over 1m) at the toe of the Redwell steps (refer to the survey photographs in Plates 9 and 10. Seaward of a chainage of 135m (level of 1m), beach levels have increased. This suggests that material has been drawn-down from the upper/middle beach to the lower beach during winter storms. The survey photographs also show a change in the beach material to shingle, which is likely to have been exposed from beneath the overlying sand that was drawn down during storm events.</p> <p>Profile 1bSS17 is located to the south of the bay. As shown in Appendix A, the cliff profile suggests that the cliff face has advanced by up to 4m at the toe. As noted above and in the previous Full Measures (autumn 2012) report, this may reflect error due to access difficulties or deposition of talus at the slope toe. Beach levels in front of the cliff have remained relatively unchanged.</p>	<p>Along the length of Marsden Bay, the cliff has retained the same form and position since the last surveys.</p> <p>To the north of Marsden Bay, the beach has undergone quite considerable change, with a fall in beach levels in the region of 1m on the upper beach but an increase of a similar magnitude on the middle/lower beach suggesting that material has been drawn-down across the beach by storm activity. The overlying sand has also been removed from the beach to expose the underlying coarse shingle/cobble material, further evidence of winter storm activity. If newly deposited, this suggests some form of sediment sorting has occurred, which is a response to storm waves. To the south of Marsden Bay, the beach has remained relatively stable. At beach profile 1bSS14, beach levels have fallen to expose the toe of the Redwell steps. Although, the structural integrity of the steps is not likely to be compromised under the present beach levels, the structure should be assessed regularly for a further fall in beach levels and to identify if any trigger levels have been met.</p> <p>Longer term trends: At profile 1bSS14, beach levels at the toe of the Redwell steps, between a chainage of 110m and 120m are the lowest observed to date (*2008, when monitoring began), whilst beach levels seaward of a chainage of 136m (level of 1m) are the highest observed to date (*).</p>

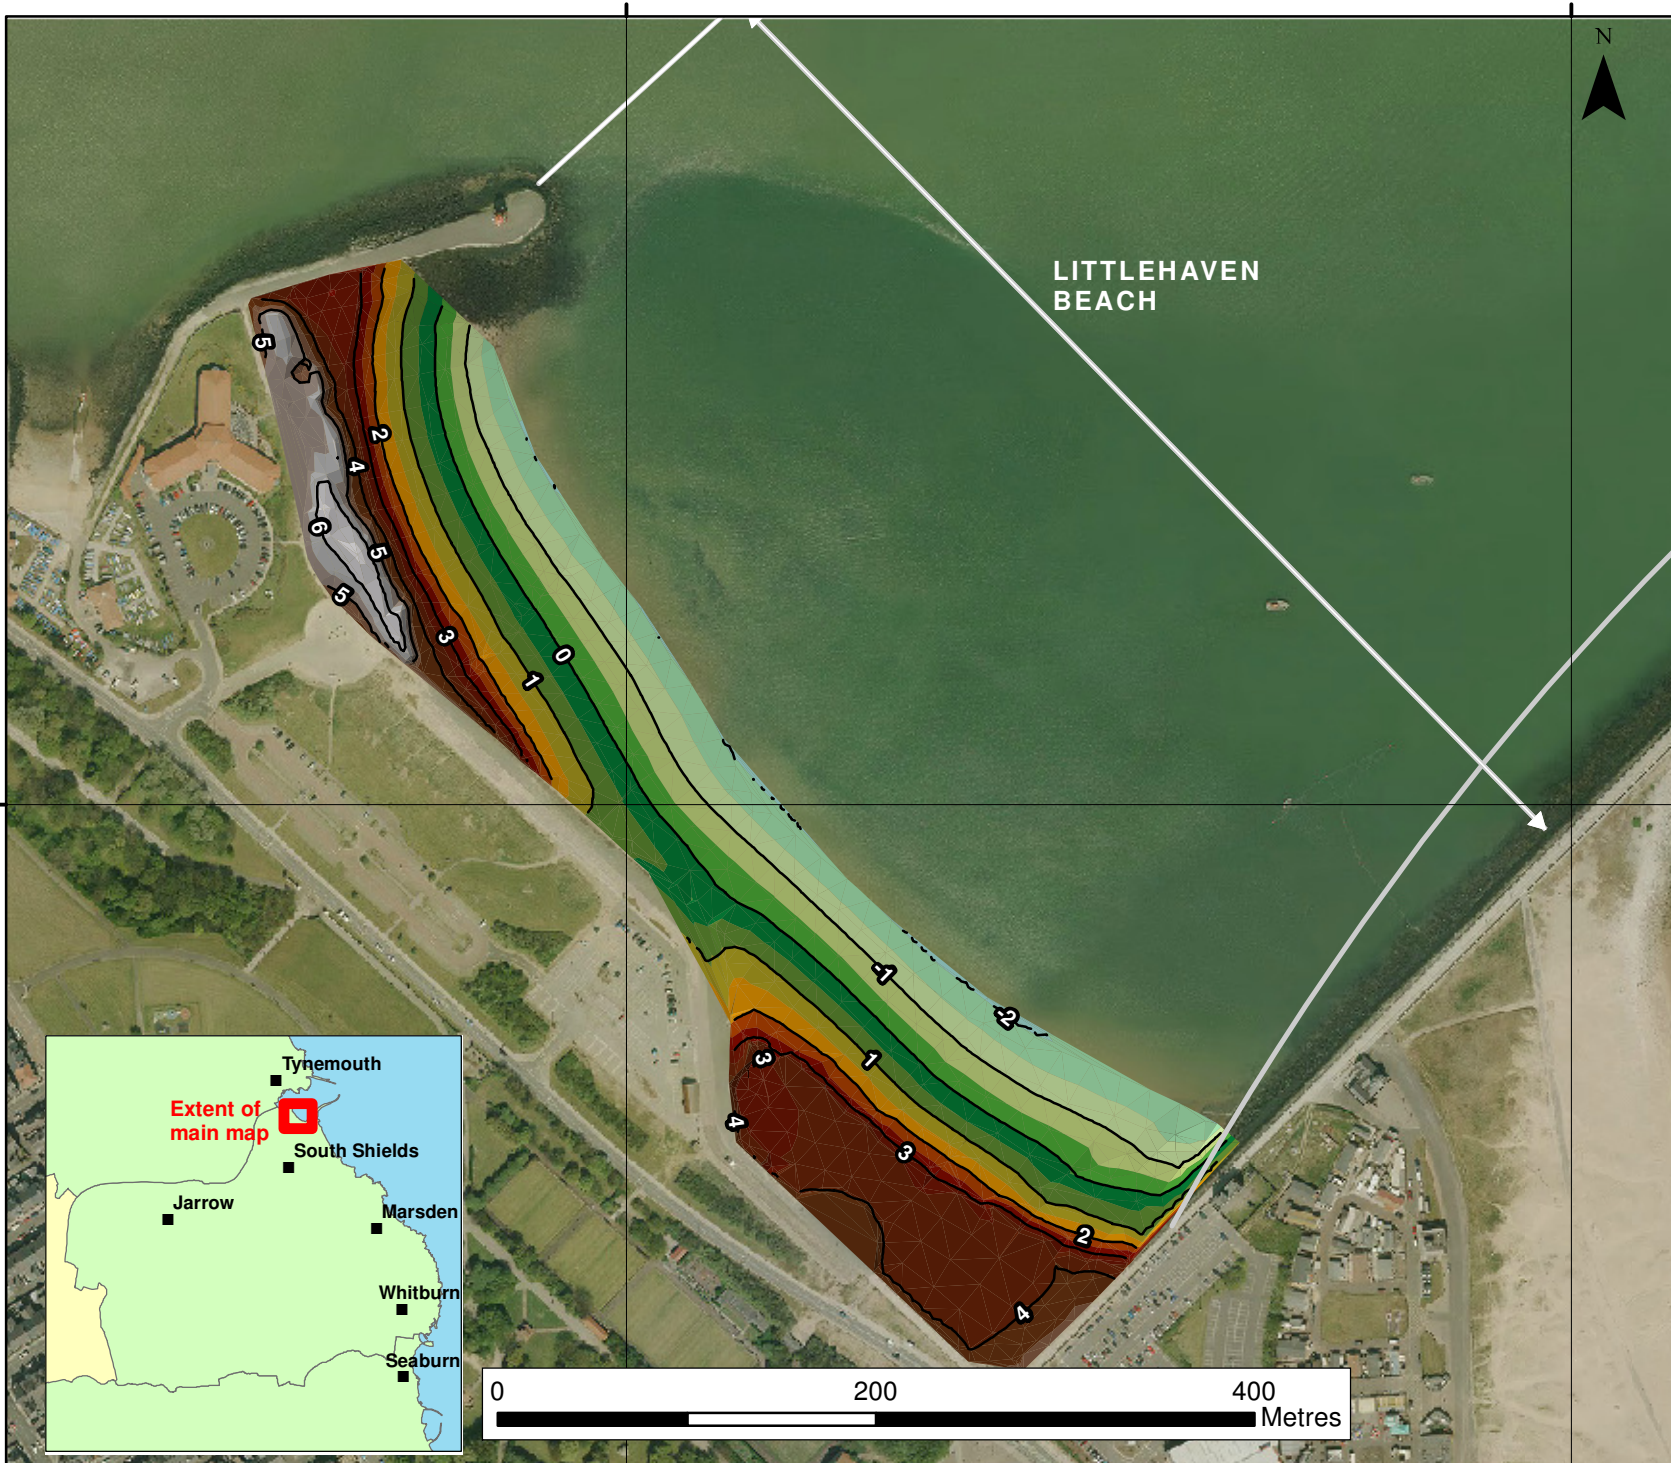
Appendix B - Map 1a
Topographic Survey
Littlehaven Beach
South Tyneside Council

Mar 2013	<p>Topographic Survey:</p> <p>Littlehaven Beach is covered by bi-annual topographic survey between the South Groyne and the South Pier, which commenced in March 2010. Data from the most recent topographic survey (Partial Measures, spring 2013) have been used to create a DGM (Appendix B – Map 1a) using a Geographical Information System (GIS). A difference plot has also been produced using the DGM (Appendix B – Map 1b) produced from the last produced topographic survey (Partial Measures, spring 2011) and the</p>	<p>Comparison of the present topographic survey with the previous Full Measures (autumn, 2012) shows that the beach in the lee of the breakwaters has remained relatively stable since the last survey. Immediately in front of the seawall, at the location of the car park, beach elevation has reduced by up to 2m. Seaward of this, there is a band of beach elevation decrease,</p>

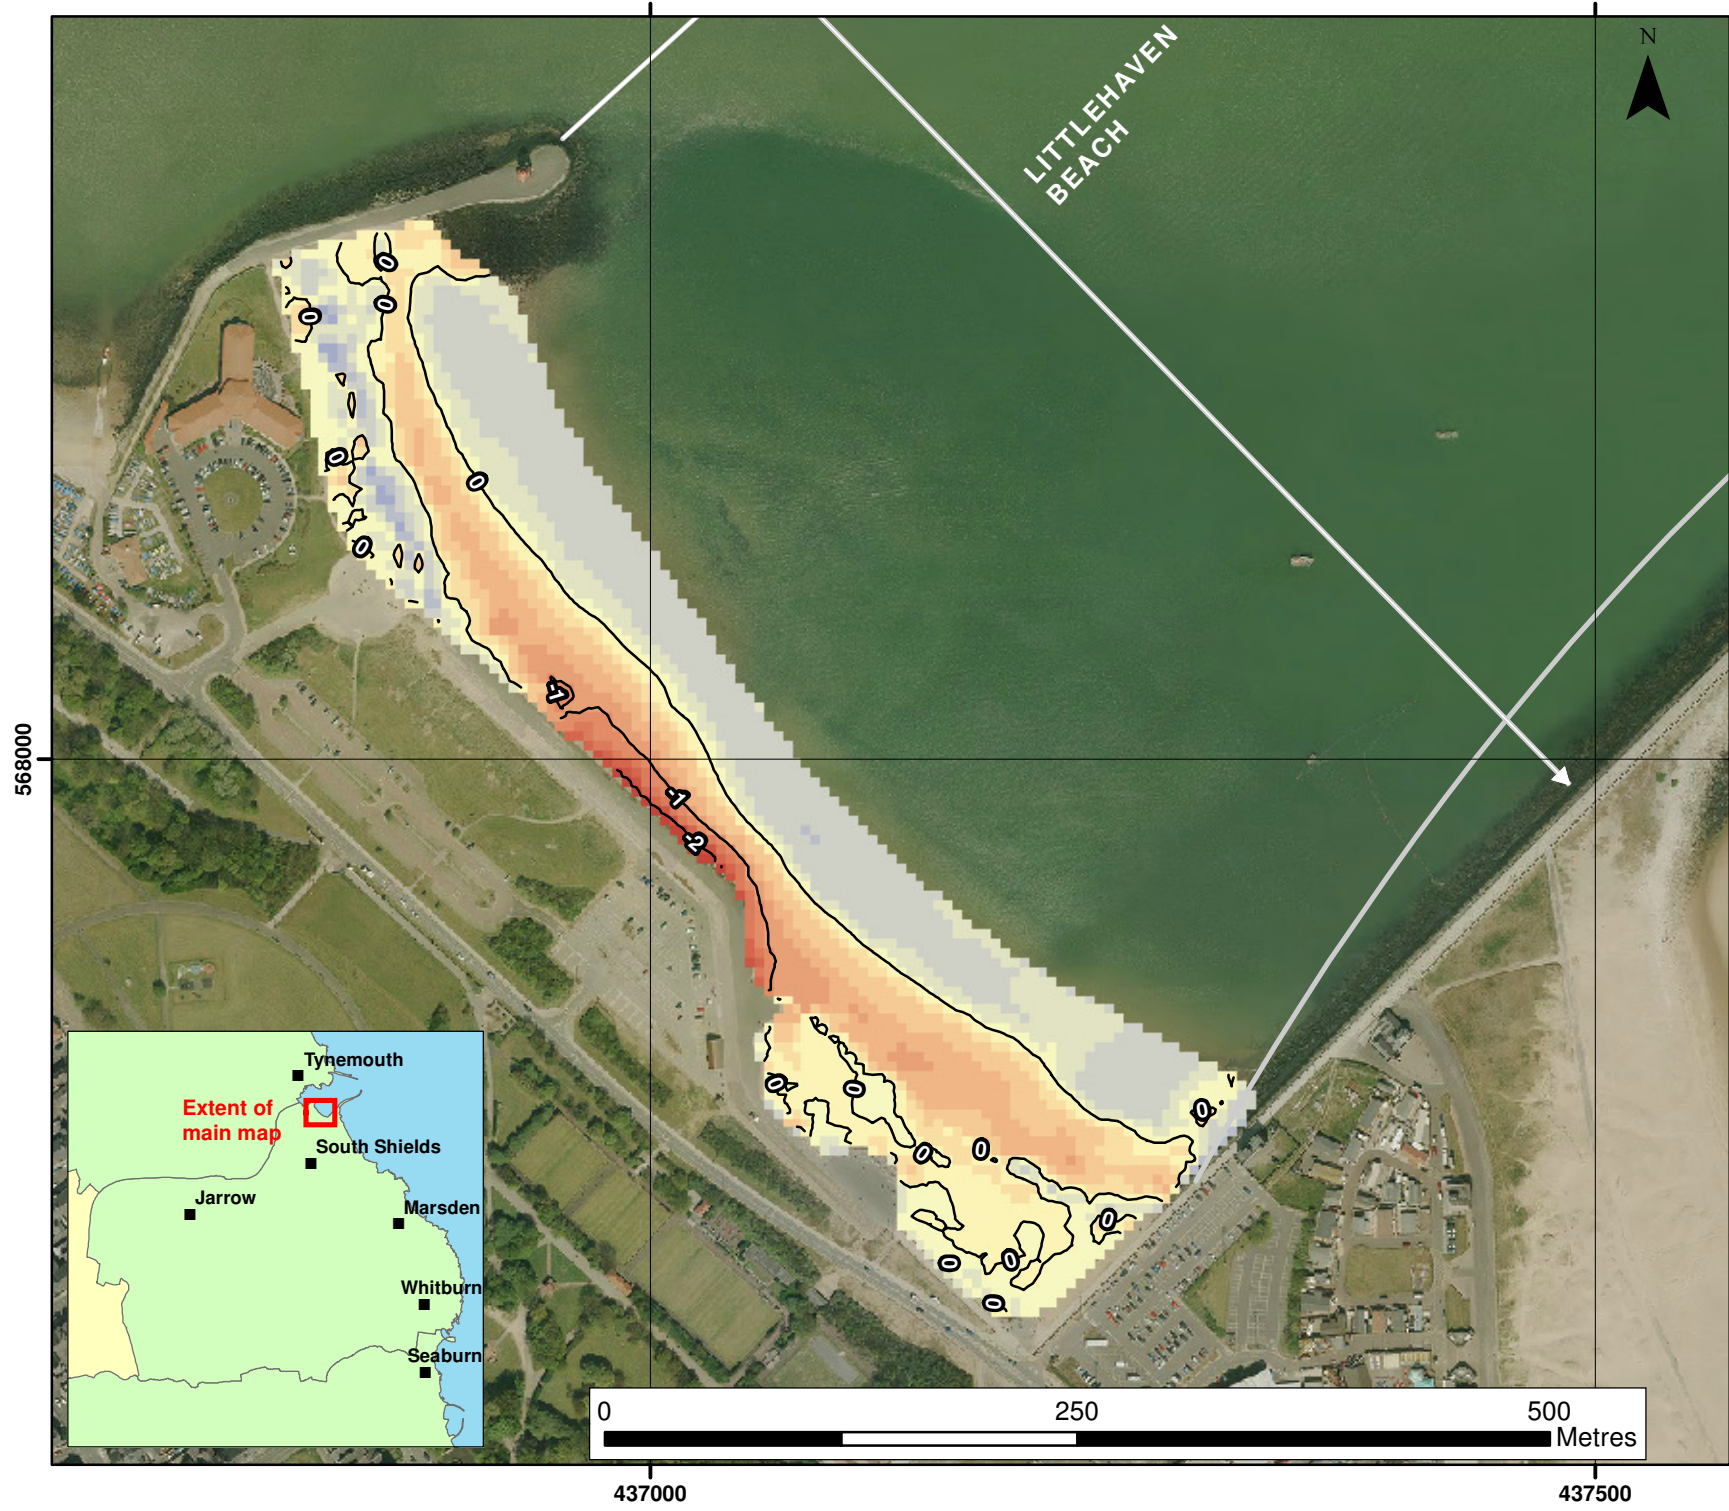
Appendix B- Map 1b
Short-term
Elevation Change
Littlehaven
SouthTyneside Council

Survey Date	Description of Changes Since Last Survey	Interpretation
	<p>present survey.</p> <p>In particular, the difference plot shows: (i) little change to beach elevation along the backshore to the north and south of Littlehaven Beach, however, towards the centre, opposite the car park, beach elevation has reduced by up to 2m; (ii) a linear band of beach elevation decrease along the upper beach, seaward of which is a linear band of beach elevation increase along the beach. These trips of change are parallel to the shoreline and indicate migration of sand bars.</p>	<p>fronted by a band of beach elevation increase. Both of which run parallel to the shoreline.</p> <p>The findings of the topographic survey reflect those of the beach profile surveys, with considerable beach elevation decrease at the toe of the seawall apron, beach elevation fall along the upper beach and beach elevation increase along the middle/lower beach. Again, this is evidence of beach draw-down, as material is transported across the beach by winter storms.</p>

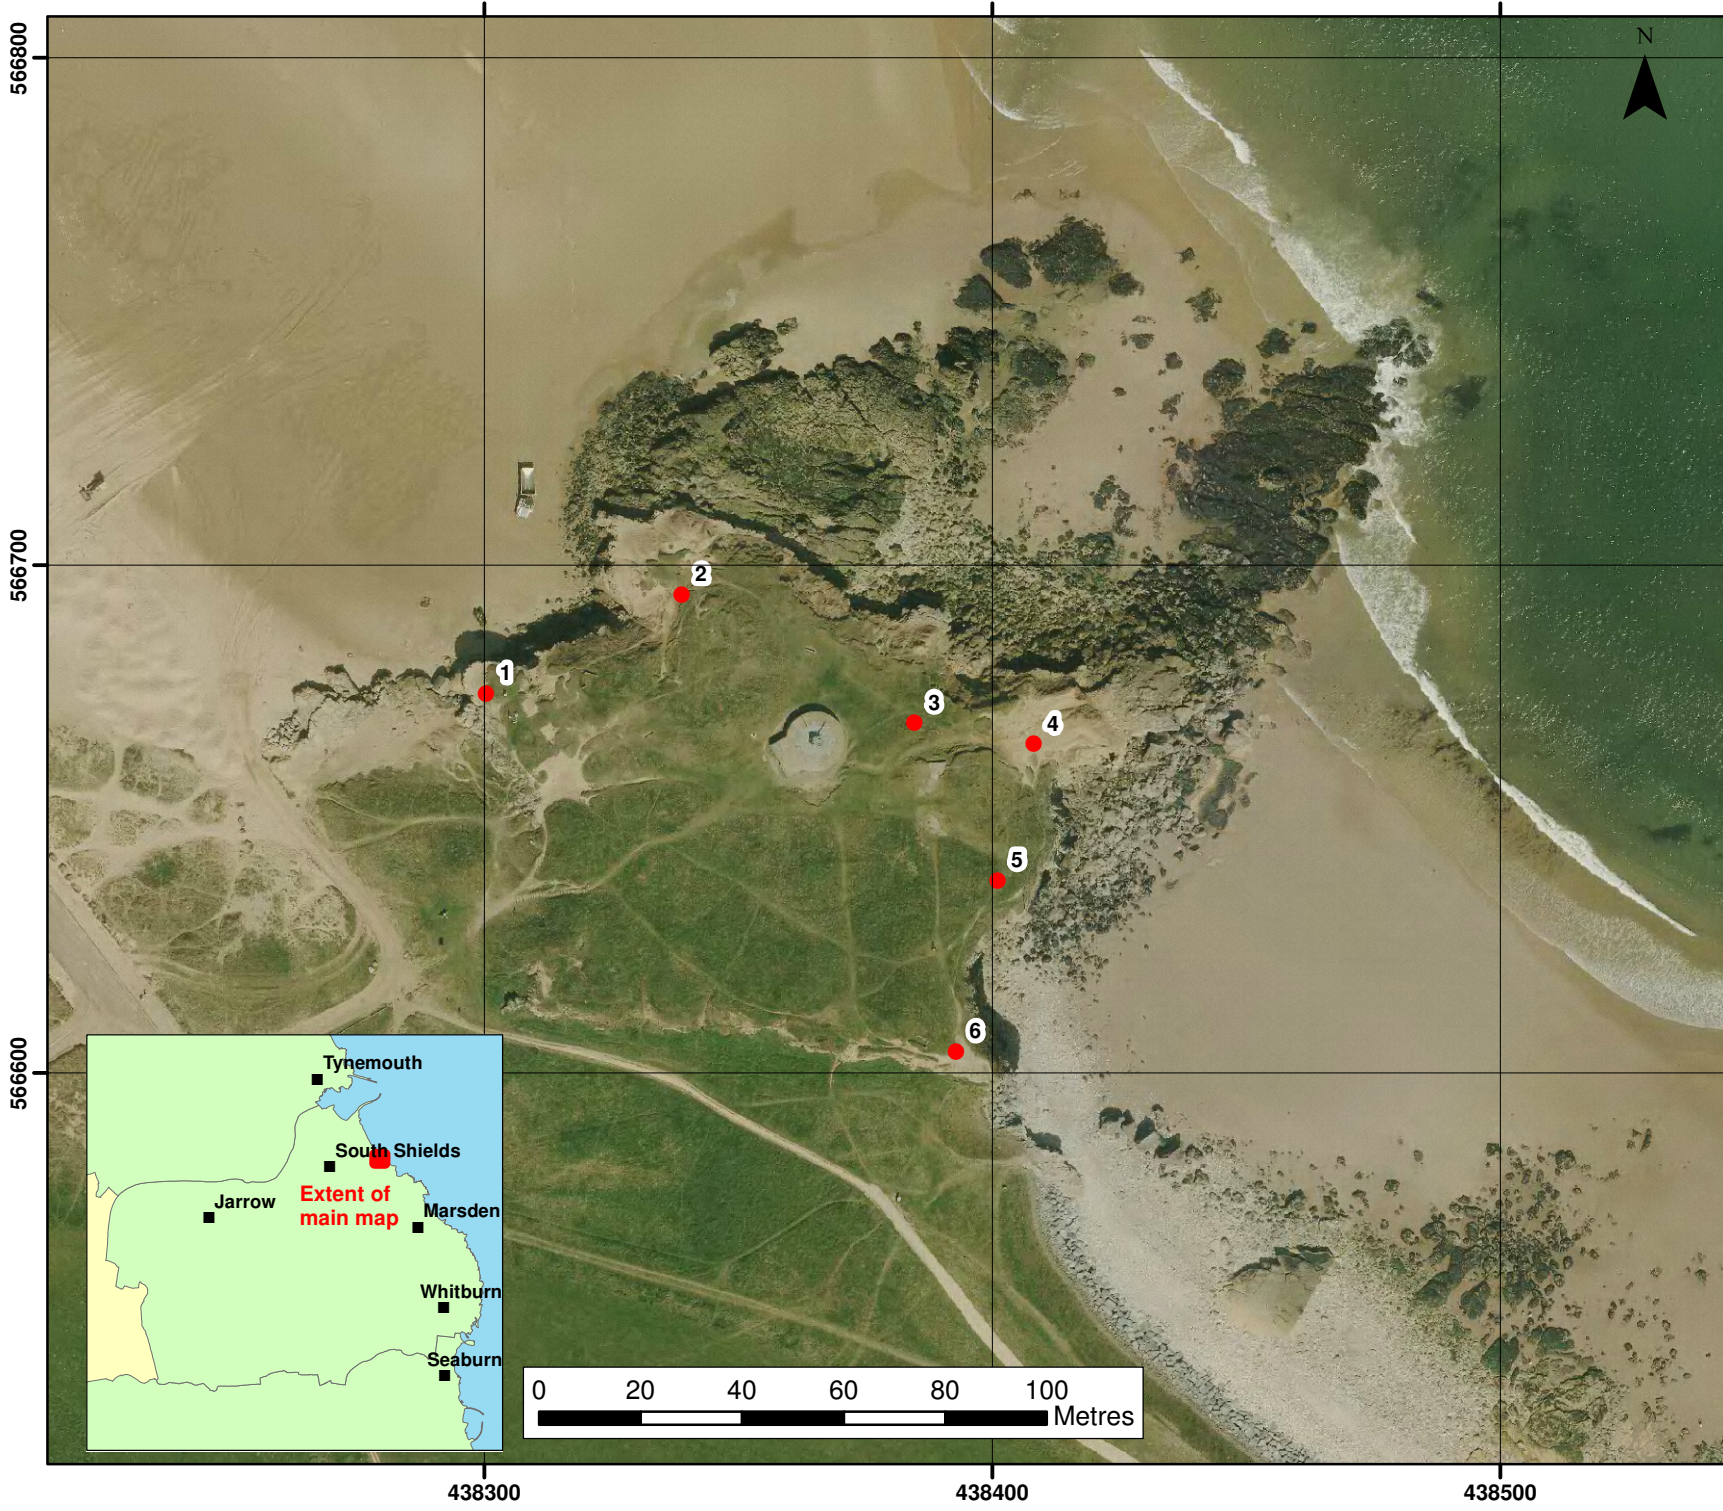
Appendix C- Map 1
Cliff Top Survey
Trow Quarry
South Tyneside Council

Survey Date	Description of Changes Since Last Survey	Interpretation
	<p>anticipated to have an accuracy of $\pm 0.2\text{m}$ due to the technique used.</p> <p>The results from the cliff top survey are presented in Appendix C – Table C1, showing the position from the ground control point to the edge of the cliff top along a defined bearing. Also shown is the change in measurement since the baseline (autumn 2011) and current (spring 2013) cliff top surveys.</p> <p>Results show that erosion or an amount of movement greater than the survey error has occurred has two ground control points since surveys began in September 2011. However, points 3 and 4 are calculated to have advanced by 0.3m and 0.7m respectively, which is interpreted as error associated with problems in precisely locating the cliff edge. All other points show no movement.</p> <p>Since the last survey in November 2012, erosion greater than the survey error has not occurred at any locations and it has not been possible to identify any trends. Review and analysis of the 2012 aerial photography will allow the nature of cliff recession to be better understood.</p>	<p>survey was completed in Sept/Oct 2012 and a second repeat survey is planned for 2014. These data will be analysed to give more accurate information on the behaviour of the cliffs in a separate report.</p>

- At Trow Quarry, the recorded profiles present no causes for concern. The cliffs to the north-west of Trow Headland are eroding, but the magnitude of change is presently small and presents no cause for concern.
