**Cell 1 Regional Coastal Monitoring Programme
Cambois Bay Post Storm Walkover Inspection
Surveys 2023**

**Northumberland County
Council**

December 2023

Cambois Bay Post Storm Walkover Inspection Surveys 2023

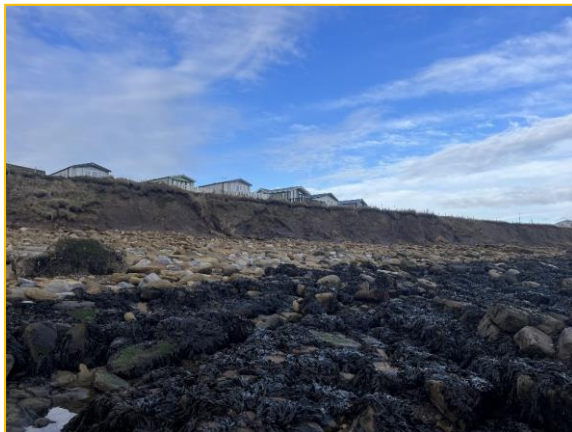
The cliffs fronting Sandy Bay Caravan Park are offered some protection by a sandstone boulder berm at their toe. To the north, additional protection is provided by a rocky outcrop on the foreshore, in this location the cliffs appear relatively stable with well vegetated seaward slope. Where the rocky outcrop tapers out, the cliffs appear more unstable and are actively eroding. The cliffs here have little to no vegetation on the seaward face and minor slumping is observed at the toe. As reported previously, in places, recession of the cliff top has occurred to within a few metres of the caravans. There are three near-shore rock breakwaters that have helped stabilise the cliffs immediately in their lee, but erosion then continues along the remaining cliff length immediately to the south to the mouth of the River Wansbeck. It appears the recent storms have only exacerbated erosion along this frontage.

Eroding cliffs fronting Sandy Bay Caravan Park (/3701C03)

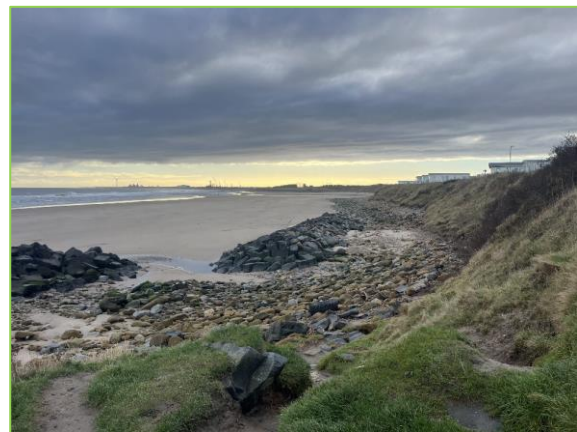
One of three near shore breakwaters offering protection to backing cliffs (/3701C03)

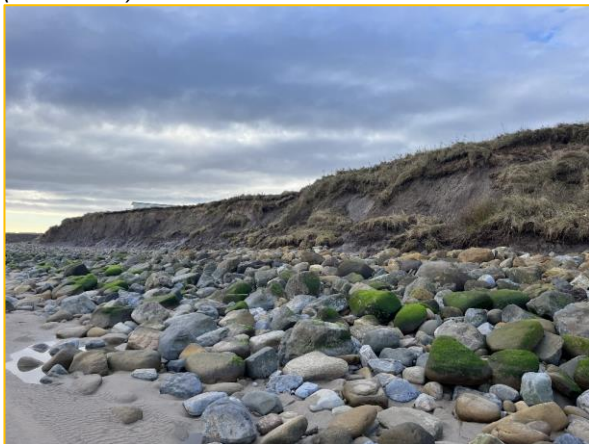
Actively eroding cliff between breakwaters and River Wansbeck (/3701C03)

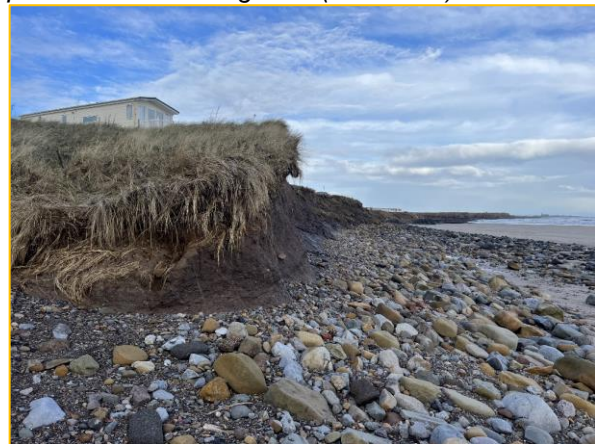
Actively eroding cliff between breakwaters and River Wansbeck (/3701C03)

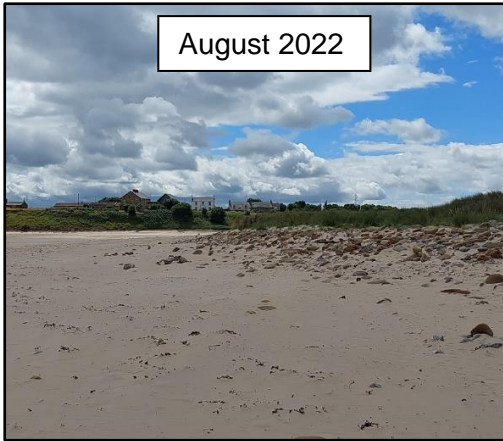
Sand accumulating at the River Wansbeck mouth embankment in 2022 (/3801C01)

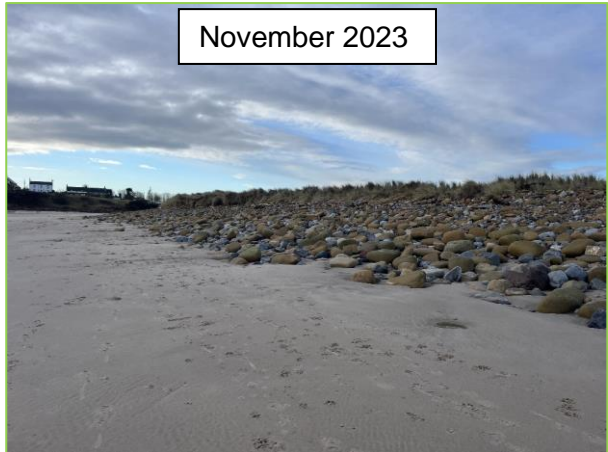
Lower beach levels at the same position post storms (/3801C01)

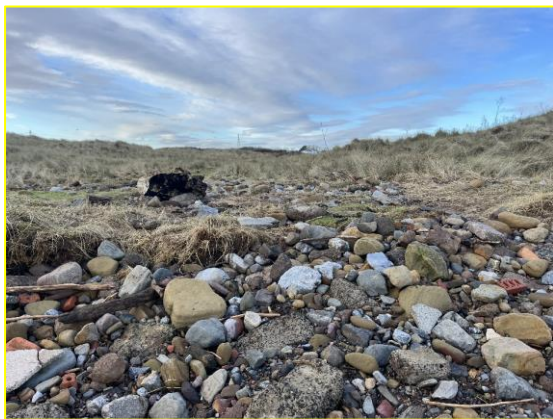
As the coastline turns west at the mouth of the River Wansbeck, there is a sandstone cobble berm which has helped stabilise the dunes on the northern bank. Although the cobble berm is still present, it is clear beach levels have dropped in this area likely as a result of the recent storms. The lower dunes in this location have been overtopped during the recent storms with debris evident past the dune crest.

Overtopping evident during recent storms (/3801C01)

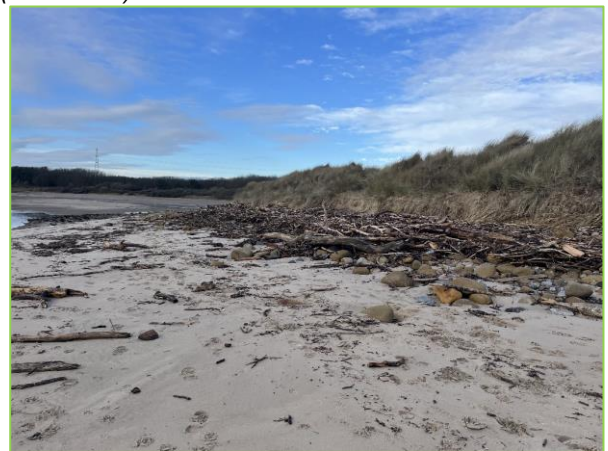
Storm debris at the River Wansbeck mouth (/3801C01)

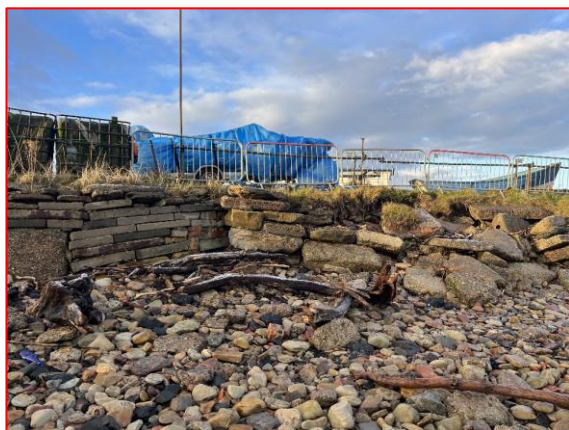
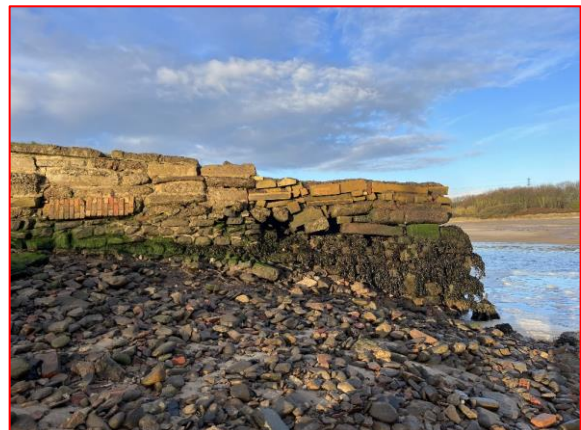
On the south bank of the River Wansbeck, the private defences of the *Wansbeck Boat Club*, remain in very poor condition with partial collapses, significant voiding, and block loss evident. Despite this they still provide shelter to the boat club and thus are not redundant.

Wansbeck Boat Club retaining wall in very poor condition (/3801C02)

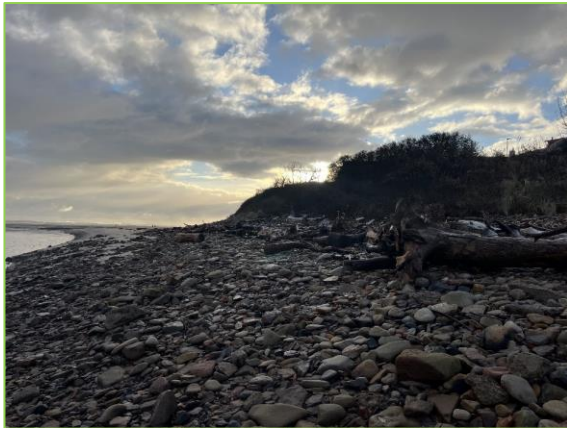
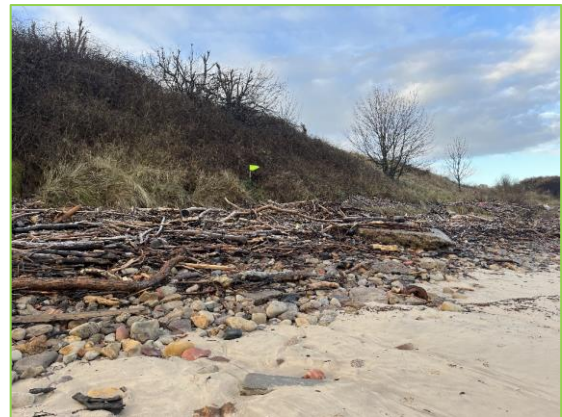
The undefended section of cliff (/3801C02) within the estuary mouth is very stable because, historically, the estuary channel is not directly at the toe of the cliff, leading to a good accumulation of sand, boulders and vegetation above the high tide mark. In the November 2023 inspection, the cliffs remain stable and

well vegetated, but the beach levels have dropped as a result of the recent storms and significant volumes of drift wood have been deposited at the toe of the cliffs.

Lower beach levels and storm deposits at the toe of the cliffs (/3801C02).

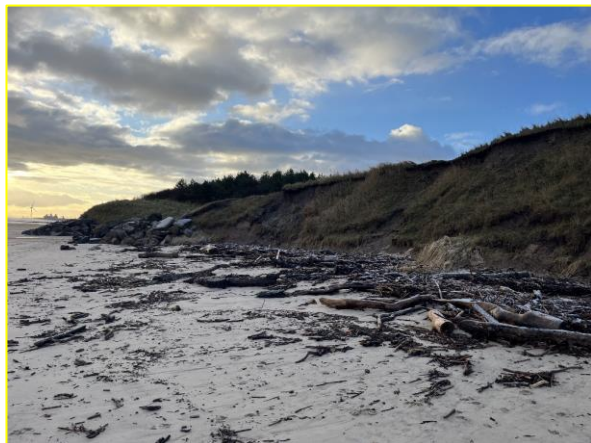
Progressing from the sheltered estuarine frontage with its stable cliffs to the more active open coastline of Cambois Bay there is a transitional section of cliff fronting Cambois House (/3801C02). The cliffs were reported previously to be recovering due to sand accumulation at the toe but it appears the recent storms have reactivated them with erosion of the toe and slipping of vegetation down the face evident. Storm deposits are again visible at the toe of the cliffs.

Waterline cut back with moderate toe erosion (/3901C01)

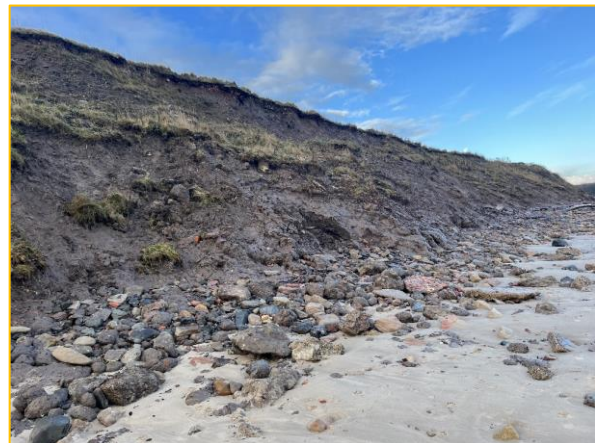
Beach levels have dropped south of Cambois House (/3901C01)

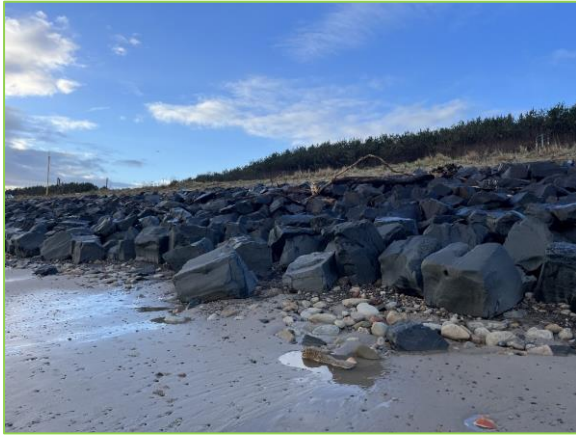
The rock revetment to the south of the Cambois Links Car Park slipway remains overall in good condition. However, the recent storms have resulted in a notable drop in beach levels against the toe of the structure, particularly to the south, where the weathered foreshore has been exposed. Notable volumes of storm deposits were also visible on the on the earth slope backing the revetment.

The drop in beach level has revealed a number of the armour stones along the structure have been locally displaced, it is unclear whether this is recent damage or were just previously concealed. The two disused, corroded and failed outfall pipes remain crossing the beach at the southern end of the revetment, the drop in beach has revealed further defects notably a supporting steel pile is at risk of imminent failure. Emergency repair works should be undertaken to make this safe. The lower concrete slab of the ramp adjacent to the outfalls has been displaced since the previous inspection and should be repaired to reinstate safe access from the car park.

Rock revetment protecting former foundry site. Displaced lower rocks and storm debris visible (/3901C05)

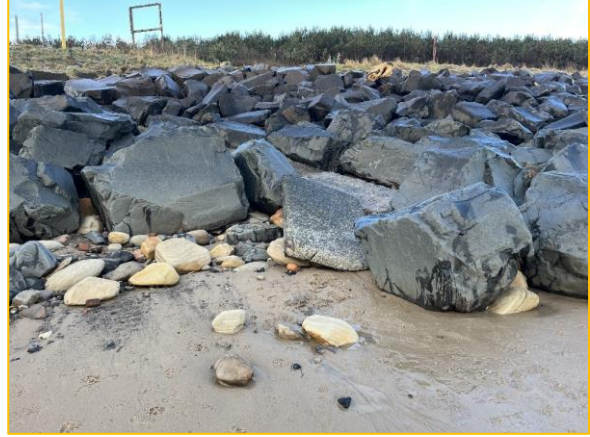
Displaced lower ramp from car park adjacent to redundant outfalls. (/3901C05)

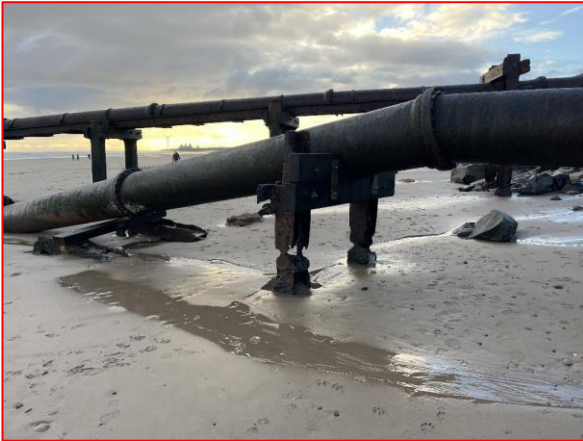
Low beach levels exposing further defects in abandoned outfalls (/3901C05)

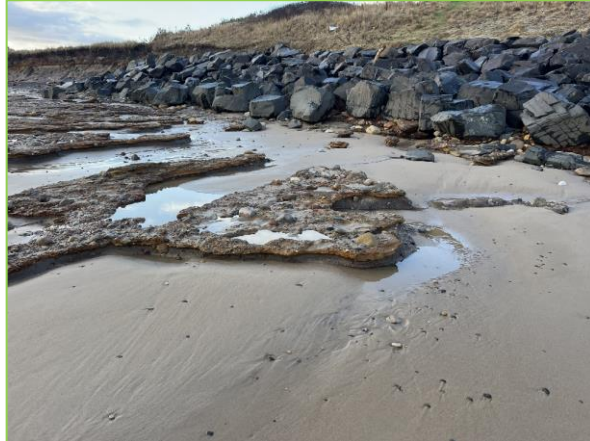
Low beach levels exposing weathered foreshore (/3901C05)

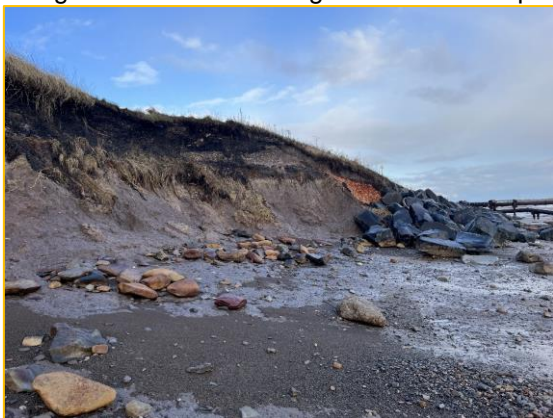
At the end of the revetment, the low earth cliffs to the immediate south (/3901C03) have experienced terminal erosion along a length of approximately 150m. It is clear the recent storms have only exacerbated the erosion with beach levels at a very low level and in places not present at all. The set of timber access steps are in fair condition, although require repairs to a lost section of handrail that make navigating the steep steps difficult. The cliffs behind the steps have continued to retreat exposing the hardcore foundation of the landing. This should be monitored closely. The soft cliffs merge almost imperceptibly into vegetated dunes which also appear to have been affected by the storms. Particularly to the south, the dunes are showing extensive loss of vegetation and collapse of the dune front face.

Outflanking at south end of the revetment (/3901C03)

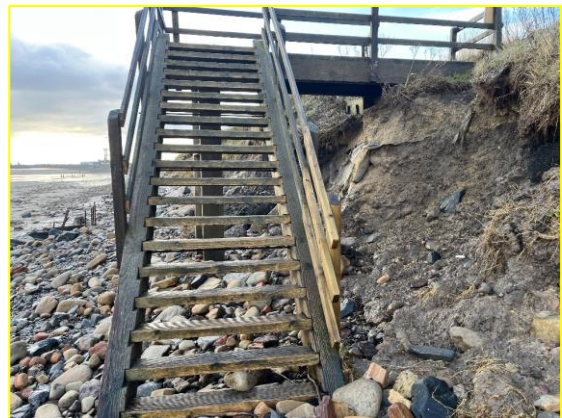
Damaged handrailing to timber access steps (/3901C03)

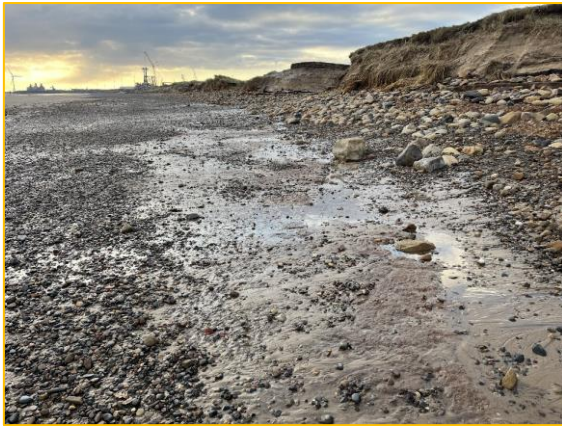
Low beach levels exposing weathered foreshore (/3901C03)

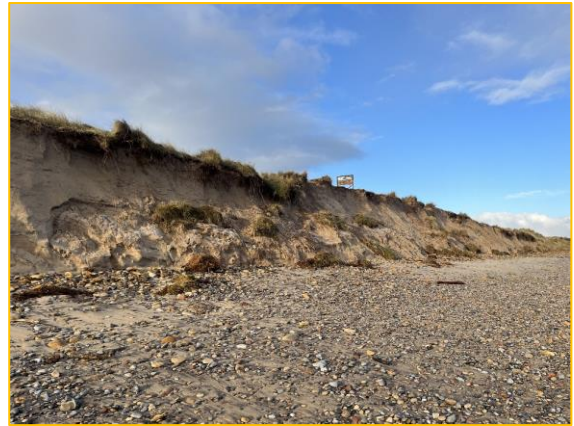
Significant erosion to dune system (/3901C03)

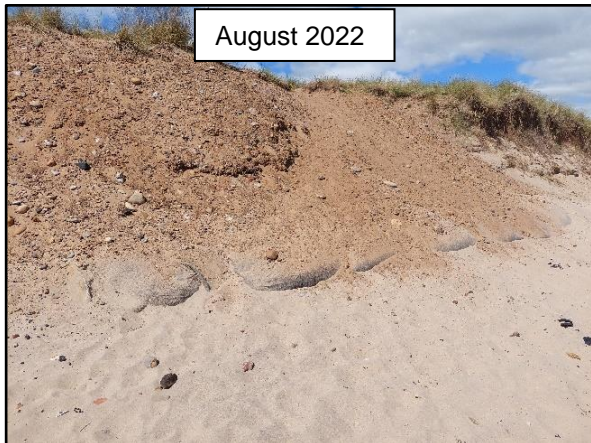
The next section of low clay cliff/dunes (/3901C04), associated with the landfall works for export cables from the Blyth Offshore Demonstrator Windfarm (BODF), is built in lee of the Rockers outcrop. Following storm damage, repair to the dunes were undertaken which included sand-filled geotextile bags and marram grass turves plantation. A combination of erosion and low beach levels have exposed the sand bag repairs in the November 2023 inspection. It is clear some of the bags have also been lost as a result. The dunes to the south of the cable landing have also experienced recent erosion with slumping of the seaward face and vegetation slips evident. At one location the cobble berm at the toe of the cliff has accreted such that its now flush with the crest. It is clear in this location overtopping has occurred with storm debris evident past the crest.

Sandbags and reinstated dunes at cable landfall layout (/3901C04)

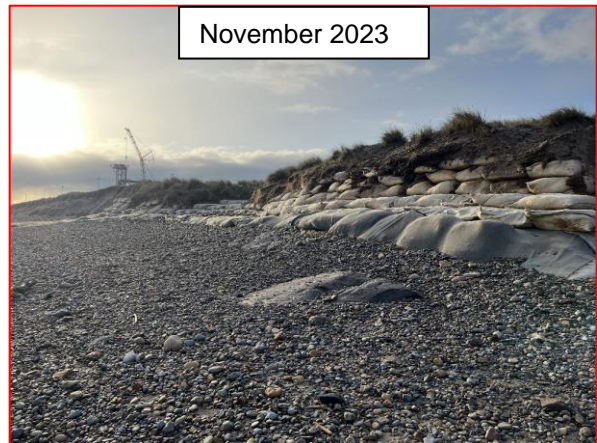
Exposed / damaged repair works (/3901C04)

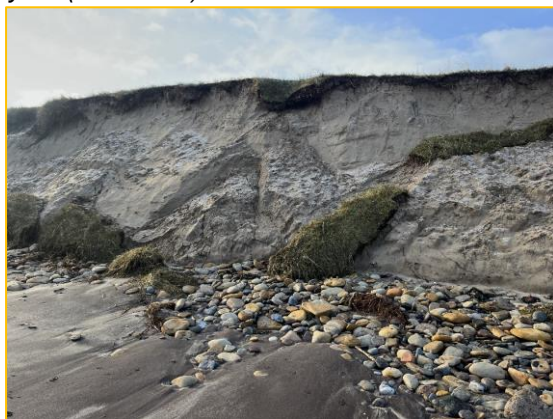
Actively eroding dunes (/3901C04)

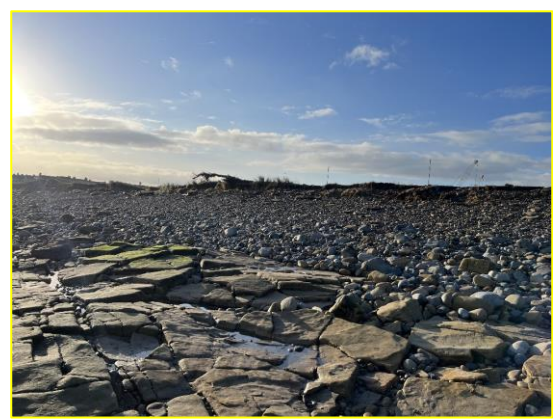
Accreted cobble berm flush with crest resulting in overtopping (/3901C04)

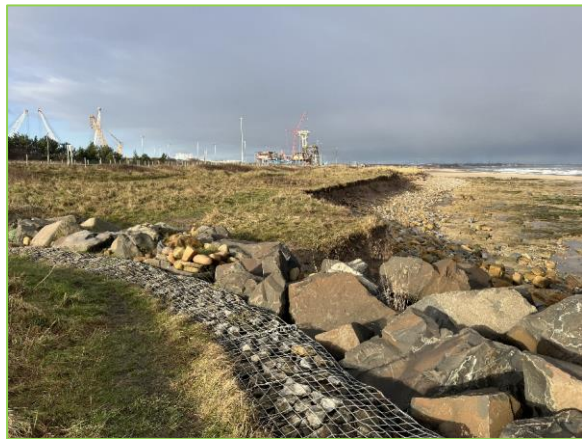
The North Blyth frontage is protected entirely by man-made defences. At the northern end, this comprises a substantial rock revetment with rock-filled gabions along the crest. The rock revetment itself appears to be unchanged since the previous survey and therefore, despite some displaced stones along the toe and areas of slight settlement of the profile, remains in good condition. As noted previously, the slope of the revetment seems to be more steep than recommended (1V:1.5H) which may have led to observed localised cliff stability failure and rotational failure of some gabions baskets. The gabions baskets adjacent to the failed section also have a rotated notably and are likely to failure in a similar manner in the future. The ramp from the beach to the car park is in fair condition however, localised rock slumping beneath has undermined the edge of the concrete slab, which will eventually fail.

Rock revetment buried northern tie in (/4001C01)

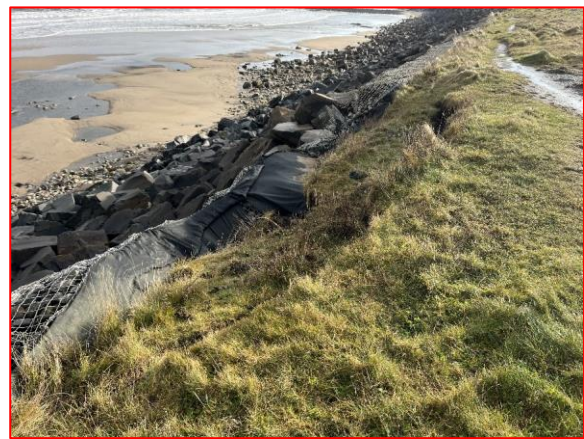
Localised cliff slide producing revetment movement and gabions failure on top of cliff (/4001C01)

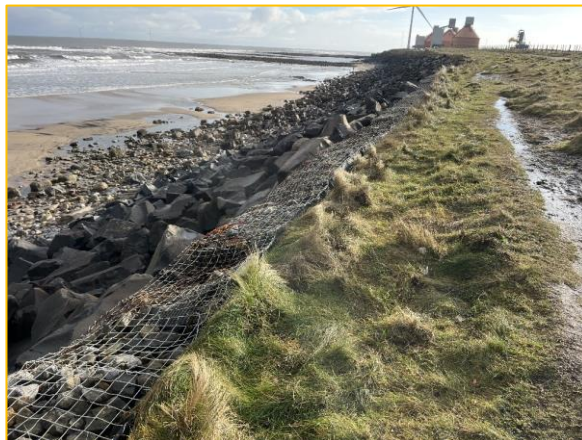
Rotated gabions adjacent to failed section (/4001C01)

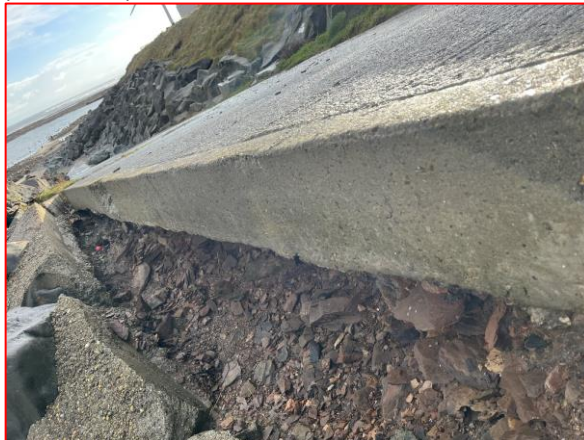
Ramp concrete slab undermining – needs to be repaired (/4001C01)

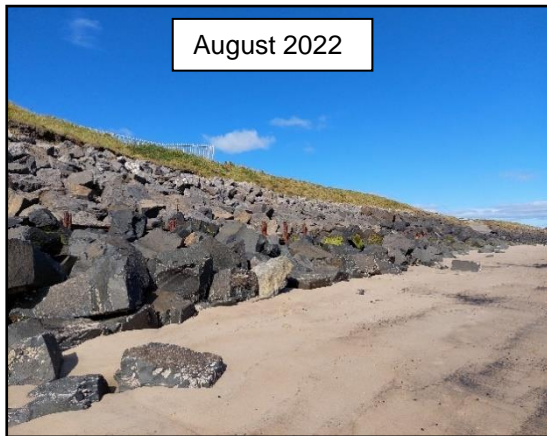
August 2022

The (/4001C02) steel breastwork is largely in a poor condition with extensive corrosion and numerous failed members. This issue is not relevant to the structural integrity of the revetment, since the upper armour rocks now rest on the newer and larger armour rocks of the toe. This interlocking process may

have produced some erosion and slumps observed in 2018 at the cliffs crest behind the revetment. These slumps do not seem to have progressed. In some areas construction waste and smaller rocks were tipped at the crest in a likely attempt to protect these sections. The structure appears largely unaffected by the recent storms, although beach levels have significantly dropped at the toe.

New rock armour placed at toe to create a stable slope, protecting the damaged steel (/4001C02)

121AA901A4001C02	Rock revetment with large units on lower slope, and smaller units on upper slope separated by steel breast work. Scree on beach fronted by rock intertidal platform.	Revetment - Shiny Gripe Lug	NZ31778209	NZ31888197	582090	167.9	29/11/2023	Royal HaskoningDHV	Steel breast has failed in some sections. Upper and lower rocks form a new continued slope, no movements since last inspection. Top of revetment is stable and well vegetated. Some sand accumulation on the toe. Access ramp concrete slab presenting localised undermining.	3	11 - 20	Monitor armour movement at toe. Monitor erosion at crest. Repair localised ramp undermining.	routine
121AA901A4001C03	Composite seawall comprising timber breastwork and concrete and rock armour apron with narrow foreshore	Sea Wall - Alcan Reclaim	NZ31888197	NZ31968188	581970	114.3	29/11/2023	Royal HaskoningDHV	Concrete wall and rock apron in fair condition. Timber screen in poor condition with some missing sections. All steel nails and bolts etc are corroded. Industrial waste is not stable behind the structure, at risk of falling down on top of timber. Rock armour looks new and is in good condition.	4	1 - 5	Repair timber breastwork and stop material migration.	urgent

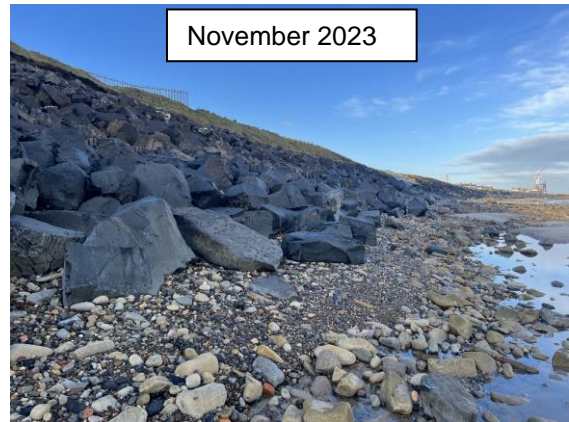
November 2023

Low beach levels as a result of recent storms (/4001C02)

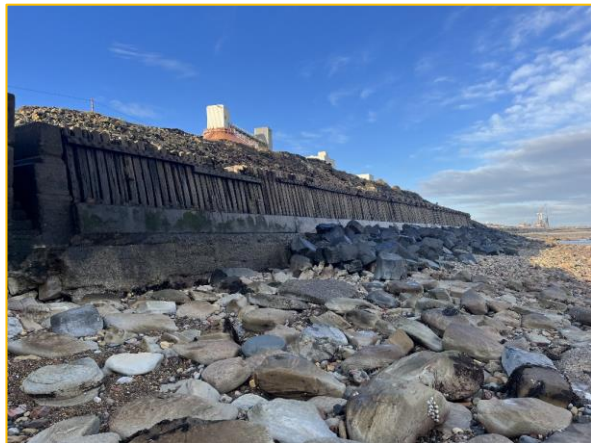
The timber breastwork of the composite structure (/4001C03), sits on a concrete apron with rock armour at the toe. The timber is in poor condition, including broken vertical timber boards and rotten horizontal wallings. The upper rubble and industrial waste slope presents significant erosion, due to material migration among the breastwork gaps and unstable slopes, exposing the timber tiebacks to corrosion. Whereas no further movement or undermining was observed there is a risk that without further maintenance the breastwork may fail, resulting in partial collapse of the access roadway above. The toe protection seems to be in good condition.

Industrial waste that looks unstable and could collapse over the structure (/4001C03)

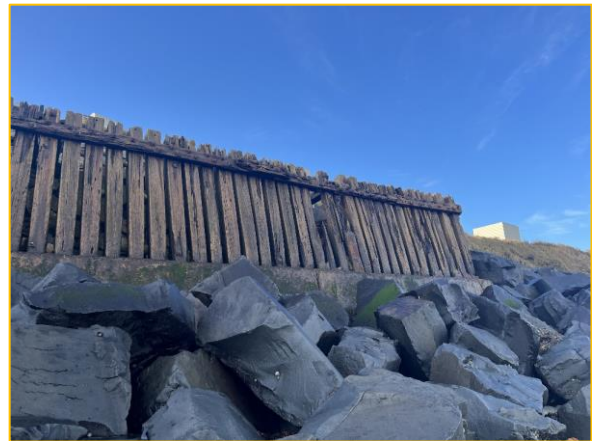
Corroded holdings and rotten timber screen – are in poor conditions and requires repairs (/4001C03)

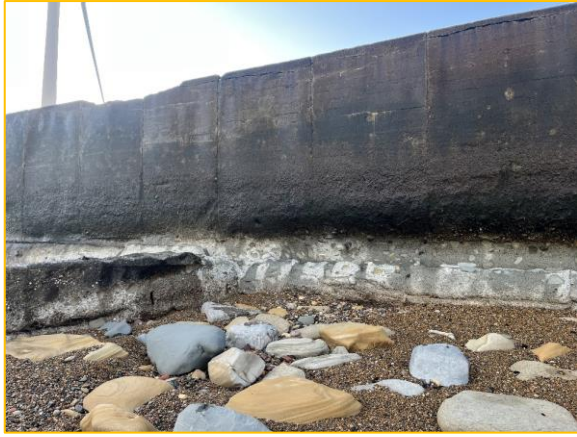
The concrete seawall (/4001C04) extending to Blyth East Pier is generally in fair structural condition, with no visible evidence of movement. However, the toe of the wall as well as the groynes of this section are showing noticeable abrasion from the shingle and cobbles present (agitated by wave action). This abrasion is most significant at the northern section of the wall where the abrasion has led to an approximately 0.5m undercut. The wall presents some vertical cracks, gaps in vertical joints between some adjacent sections and numerous horizontal cracks at the parapet level. The parapet is in very poor condition, presenting large horizontal cracks, most prevalent at access points through the wall's crest. It is at risk of collapse of localised sections and in need of urgent repair. The north end of the parapet presents massive abrasion with some loss of crest level.

Severe undercutting of concrete wall to the north (/4001C04)

121AA901A4001C04	Vertical concrete seawall and crestwall with concrete groynes on scree strewn rock foreshore forming part of the Blyth East Pier	Sea Wall - Crab Law	NZ31968188	NZ32138162	581880	322	29/11/2023	Royal HaskoningDHV	Toe presents moderate erosion, not affecting the structure. Concrete wall is in poor condition. The walls ladders are broken and failed; this area was in fair to poor condition. Groynes in poor condition with extensive erosion, still performing however. Parapet in very poor condition with failed sections and large cracks, walkway slabs have missing or broken sections. No evident damage to the area behind.	4	6 - 10	Repairs to cracks. Assessment of crest wall failure.	urgent

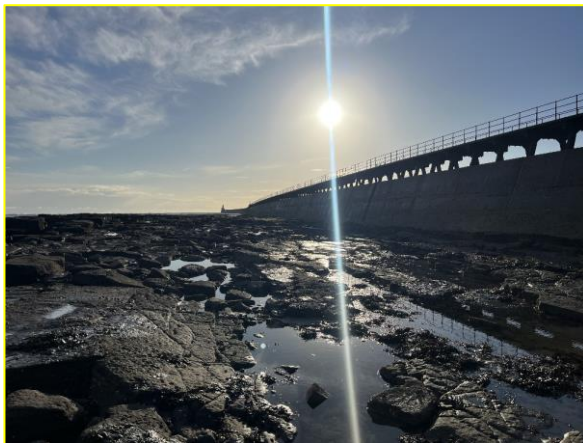
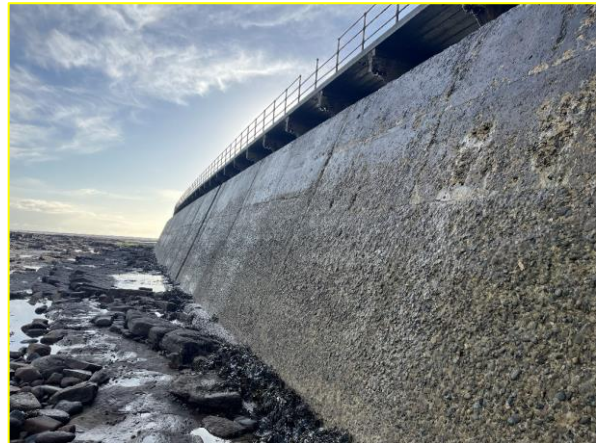
The last asset of this coastal section is the Blyth East Pier (/4001C05). This asset could only be partially inspected during the November 2023 inspection due to the particularly slippery, rocky foreshore. However it generally appeared in fair condition with no noticeable signs of undermining at the toe or movement in the sub structure or superstructure. The flood defence crest level of the structure seems unaltered. Significant issues remain on the timber trestle on top of the wall with missing sections of the deck. The first section of this deck is supported by concrete frames presenting heavy corrosion and concrete spalling. The second section of the deck, supported by long timber legs embedded within the wall, has no handrails and the concrete cover of the timber legs is missing.

Some harbour structures were only viewed from a distance (e.g. seaward end of Blyth East Pier) or from the deck. In these cases, vessel-based or underwater inspections are recommended to inform future maintenance and capital works programmes.
