**Cell 1 Regional Coastal Monitoring Programme
Coastal Walkover Inspections 2010**

**Northumberland County Council
Final Report**

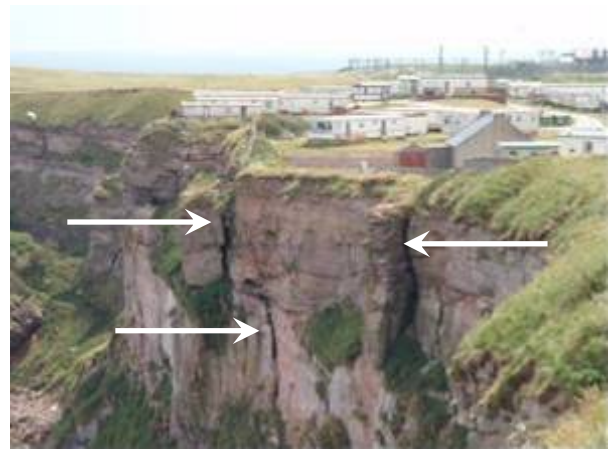
The cliffs along St. John's Haven are highly stable as they are fronted by a wide rock platform which dissipates incoming wave energy (below left). The platform reduces in width at the cliffs which front the North Road Industrial Estate and as a consequence there are caves and arches (such as Needles Eye, below right) formed at their base. The geology of the cliffs provides a strong control on recession here, with only very occasional local rock falls noted, although one of the rock stacks was visibly fractured.

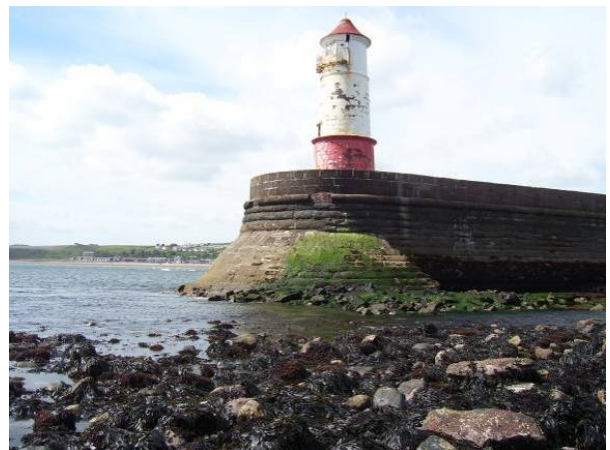
In general the deck and main inner face of the breakwater is in reasonable condition. There continues to be some spalling along the deck (below left). However, locally the inspection has identified a significant hole developing in the face of the breakwater and this requires urgent attention (below right). Reference should also be made to recommendations within the detailed inspection report under taken in 2008.

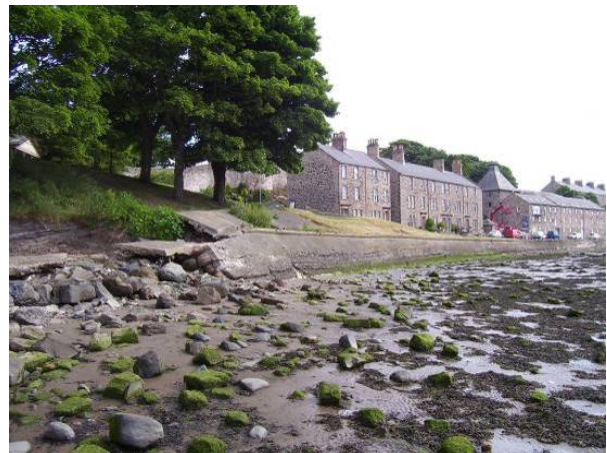
The main town walls remain in relatively good condition with no significant change over the foreshore. Monitoring of the vertical crack in the main tower (below right) shows no movement and it is concluded that this is an old feature of the wall. It is noted from the description of the history of the walls that the early extension seaward of the tower in this area was endangered by the sea. Potentially the crack is associated with the subsequent modifications.

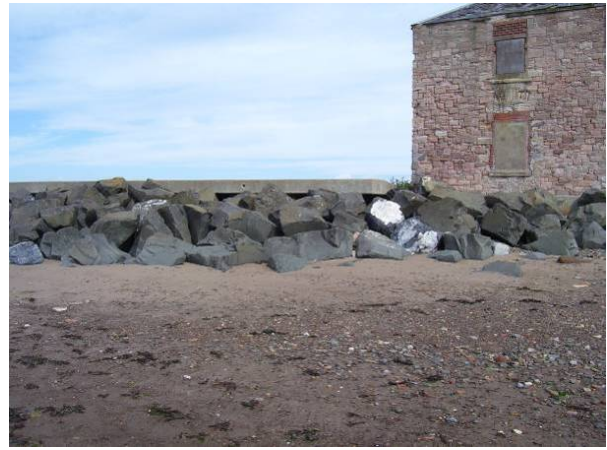
The main Berwick Quay wall appears in good condition although some of the older masonry sections will require further repointing. There some concern noted from 2008 that a local corner of the old wall showed signs of movement. The cracks in this area have not become worse (below right).

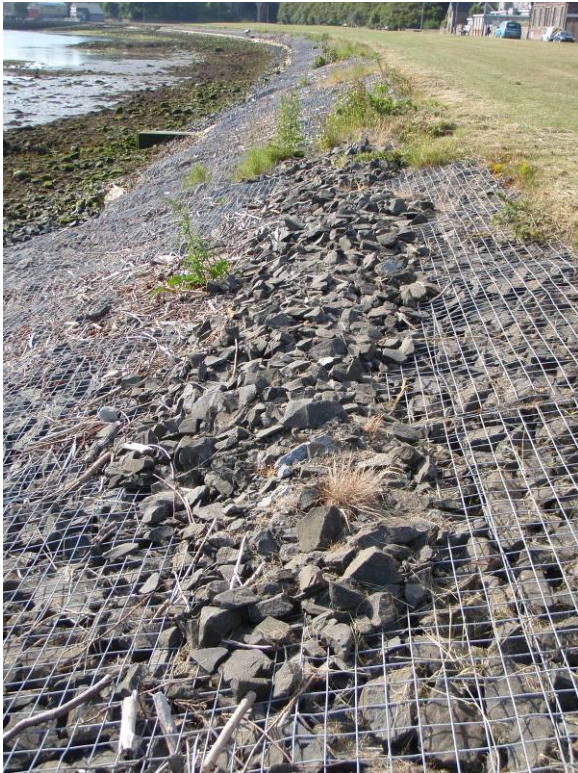
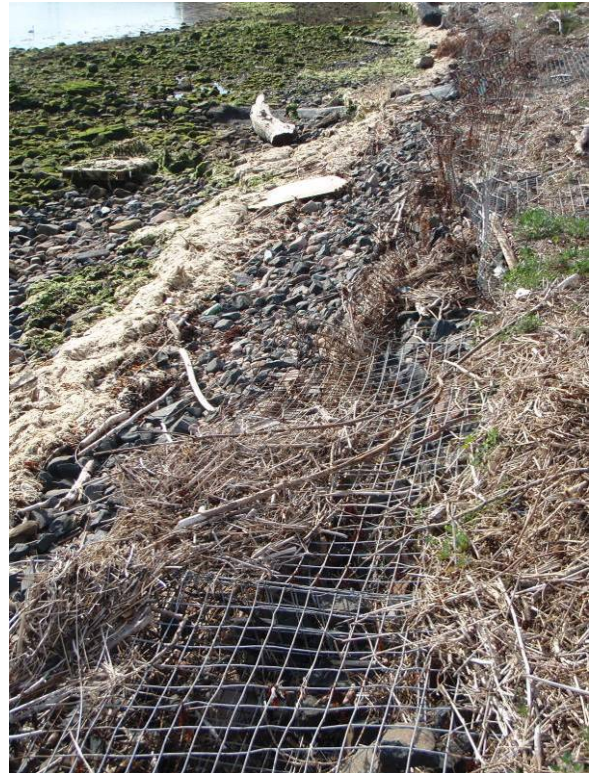
South of Tweed Dock, the gabions used to protect the grassy sloping bank along Dock Road have, in places, broken with the stone now falling out (below left). Elsewhere the gabions appear to have settled and towards the eastern end are considerably damaged at the toe (below right). At the eastern-most end newer gabions have been placed at the toe to provide further protection, but similar work needs extending slightly further west. The deterioration of the gabions has continued from damage noted in 2008 and the long term management needs to be reviewed as highlighted by the SMP2.

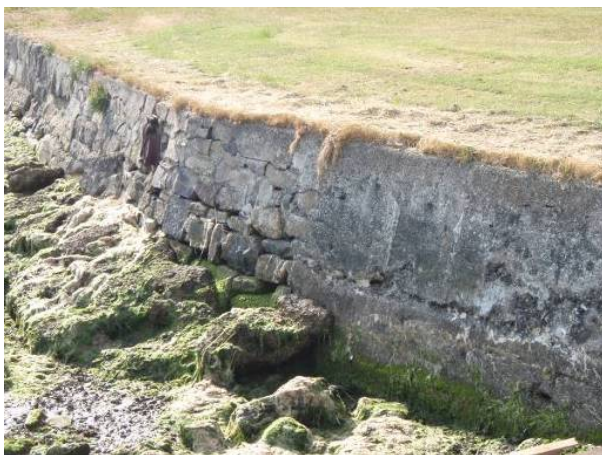
Minor routine maintenance is needed to infill gaps in the low masonry wall (below left) to the east of the gabions, and to Spittal Pier (below right).

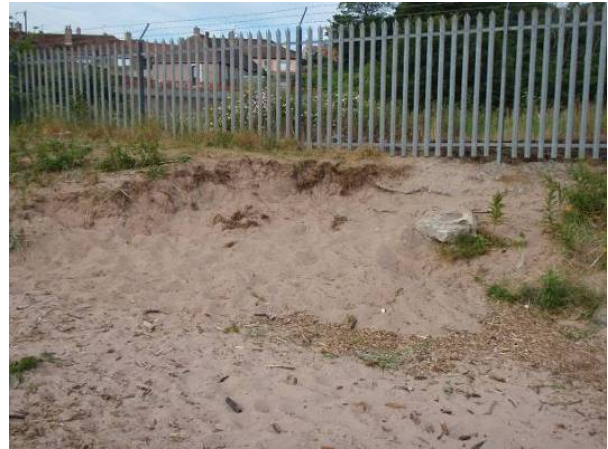
Routine maintenance would also benefit the masonry toe underneath the timber jetty at Spittal Quay, where some stones are missing (below left) and where there is some outflanking at the tie-in to the dunes (below right).

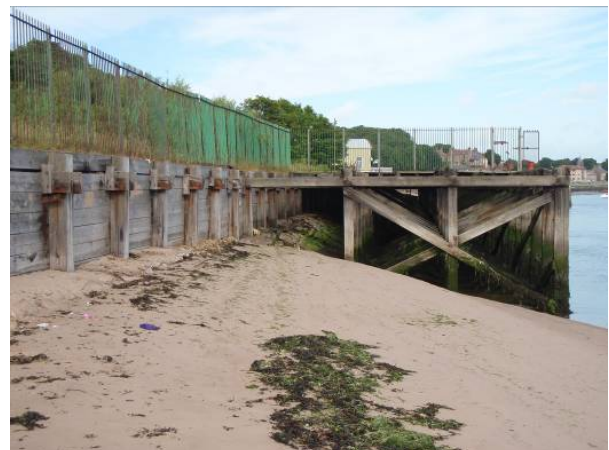
However, there has been a significant build up of sand at the downstream end (below right 2010, below left 2008). The revetment beneath the level of sand remains in a precarious state. The change along this section relates to the erosion pattern noted to the dunes further downstream and it suggests that the frontage does act as a controlling feature of this whole area. This needs to be considered as part of the current strategy being developed for the area.

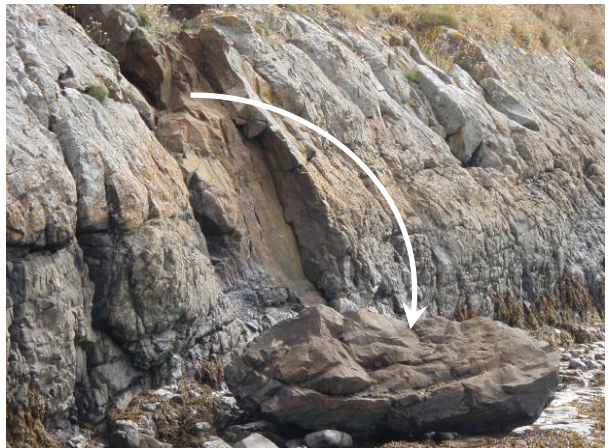
Extending from The Heugh access ramp to Steel End, at the harbour pier, the hard rock cliff is once again highly fissured. In one location a single rock has fallen (below).

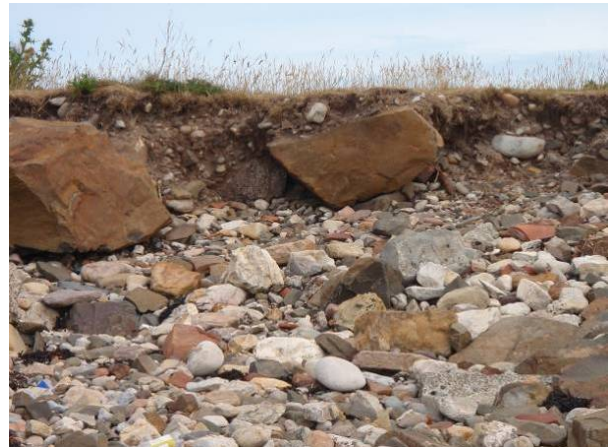
The section fronting the footpath that extends towards Lindisfarne Castle is eroding at its western end, although there remains a suitable buffer to the footpath. Some rubble has been placed to slow this process in the west (below left), but ongoing erosion here results in boulders being released onto the foreshore (below right).

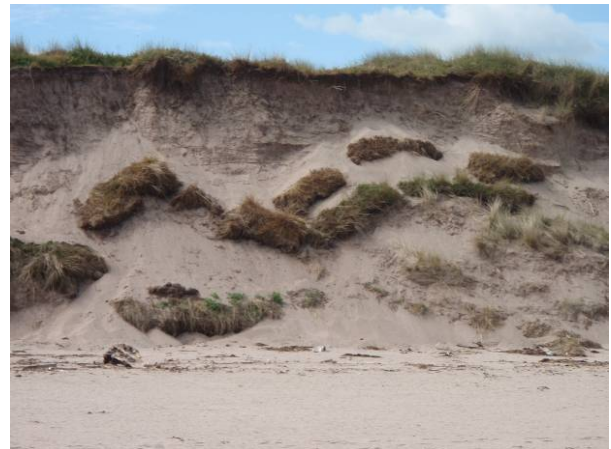
At Sanham, the dunes in the south and north of the bay are relatively stable due to the sheltering effect provided by Emmanuel Head and Castlehead Rocks, respectively (below left). In the centre of the bay, however, slumping remains active down the dune face (below right), although this is fairly modest and presents no risks to assets.

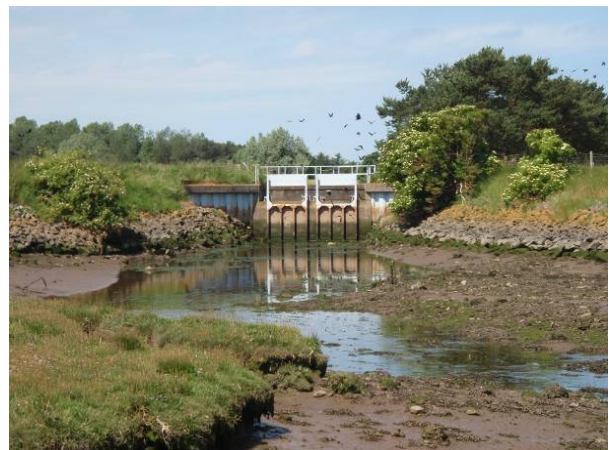
Various walls and mortared rock revetments (below left) extend around Links End towards the sluice at Ross Low (below right). These appear to remain in need of maintenance although their condition has not significantly deteriorated further since 2008.

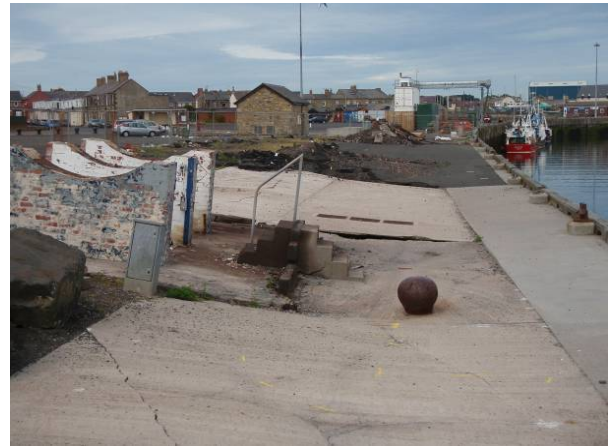
Of some concern is some apparent (presently slight) bulging in the seaward face of the quayside further upstream along the south bank (below left), between the dock and the lifeboat station, where a small hole has opened in the deck (below right). This area should be considered further from the river using a vessel-based survey at an appropriate stage of the tide.

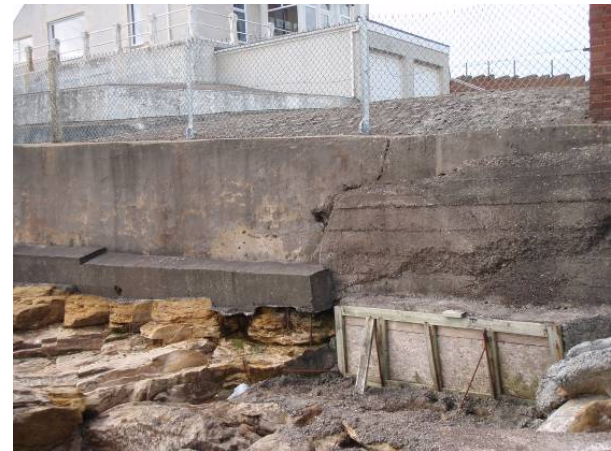
The seawall fronting the children's play area is in overall fair condition, although some minor unravelling of the tarmac on the promenade (below left) and some abrasion of the wave return wall at the southern end (below right), where previous patch repairs had been made, were noted.

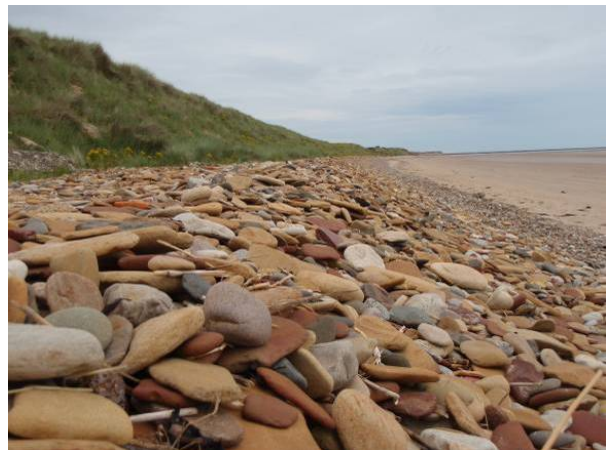
The low soft cliffs and dunes in the northern part of Druridge Bay appear to have been more actively eroding than was observed in 2008. This even has occurred in well vegetated and apparently previously stable areas, in places revealing bricks exposed in the crest (below left). It is only with southerly progression towards the Visitor Centre that the dunes become more stable, where they are backed by a substantial cobble berm at their toe (below right).

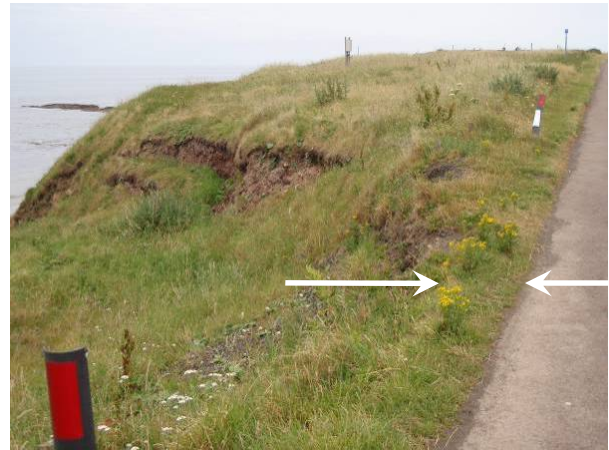
Further south, towards Snab Point, the cliffs become more active once again, where the cobble berm becomes sparser and the gabions are becoming damaged and outflanked (below left). Where the gabions have split, the cobbles have spilled out, resulting in slumping in the backing cliffs, including one area where the cliff top has now cut back to within a very short distance (a few centimetres) of the road edge (below right).

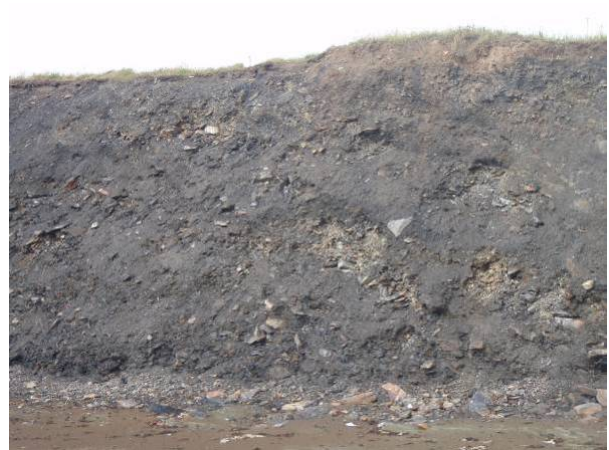
The shoreline fronting Lynn Hill is less well protected by a spoil beach. Where a narrow width of is present, it is actively eroding, resulting in cliffing on the seaward face (below left). Where there is no spoil beach present, the backing spoil cliffs are eroding, releasing debris to the foreshore. Where these cliffs contain softer soil there is evidence of soil cracking, slumping and a steep profile. Along one short length, the cliff face is entirely composed of colliery spoil in a near-vertical profile (below right).

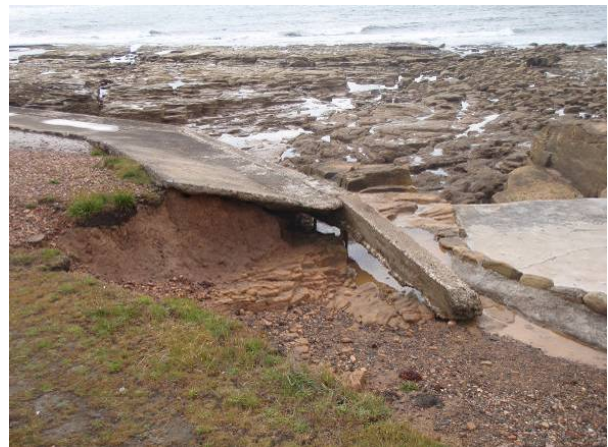
The second length of seawall is slightly further south around Newbiggin Point and remains in very poor condition. The tie-in sections remain actively breaking up, with concrete debris remaining on the rock ledge. Although the damage at the northern tie-in looks recent, this situation was also recorded in the 2008 inspections (below left). Further deterioration undoubtedly is occurring, however, at the southern tie-in where outflanking due to erosion of the soft cliff continues (below right).

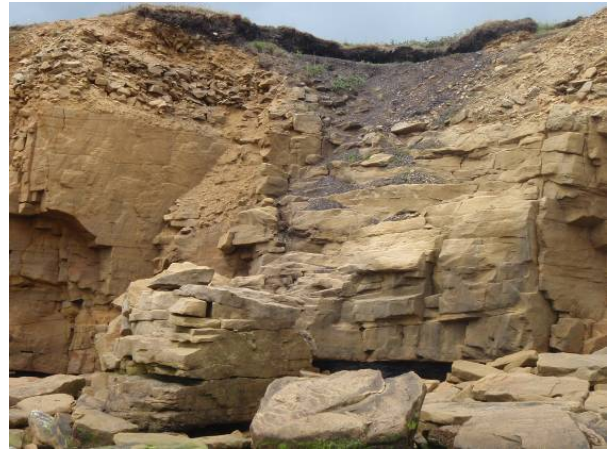
Hawks Cliff (below left) generally experiences gradual, local erosion caused by slumping in the upper soft material and occasional rock falls in the base. However, over the severe winter of 2009/2010 the whole section has been active. Tragically, there was a fatality in January 2010 when a section of cliff collapsed during severe weather (freezing temperatures, heavy rainfall and snow loading) and harsh marine conditions (high tide storm) and a sea angler standing on the cliff top fell to the foreshore. This section not only appears to have experienced a rock fall, but a slump in some of the overburdening till was also triggered by this event (below right).

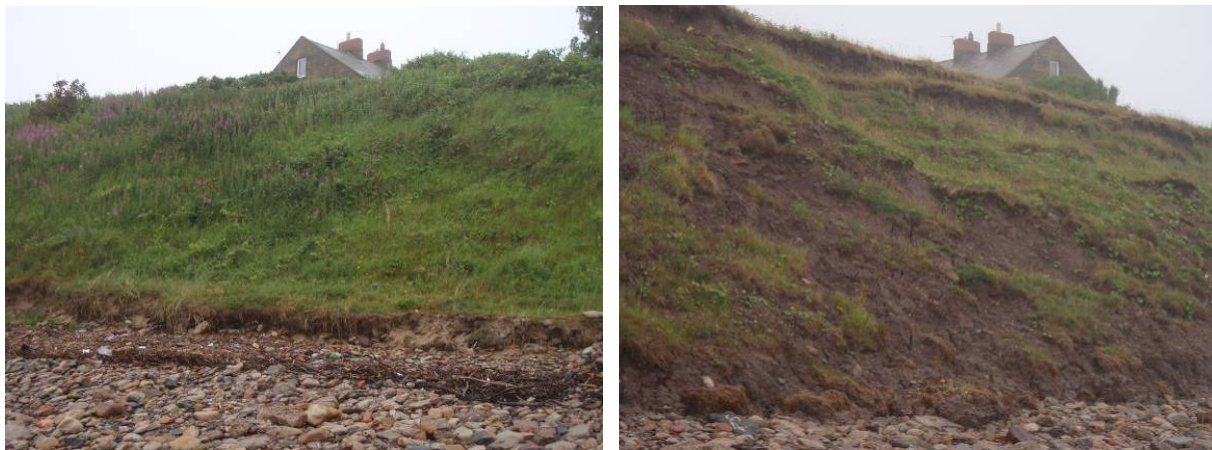
Further south along the open coast, the cliffline then has become highly active with clear evidence of recent, and ongoing, failures (below) in the industrial spoil material that was tipped over the edge of the dunes, thereby burying them and advancing the shoreline position. Given the extent and ongoing nature of the changes along this section of shoreline, it may be worth revisiting the previous Cambois Pre-feasibility Study to update consideration of management options. At the very least, warning the public against the dangers of parking their vehicles on the cliff top to view the sea should be undertaken – one local resident mentioned that 2-3 cars per day are parked up at this point, despite it being private land with no formal access tracks.

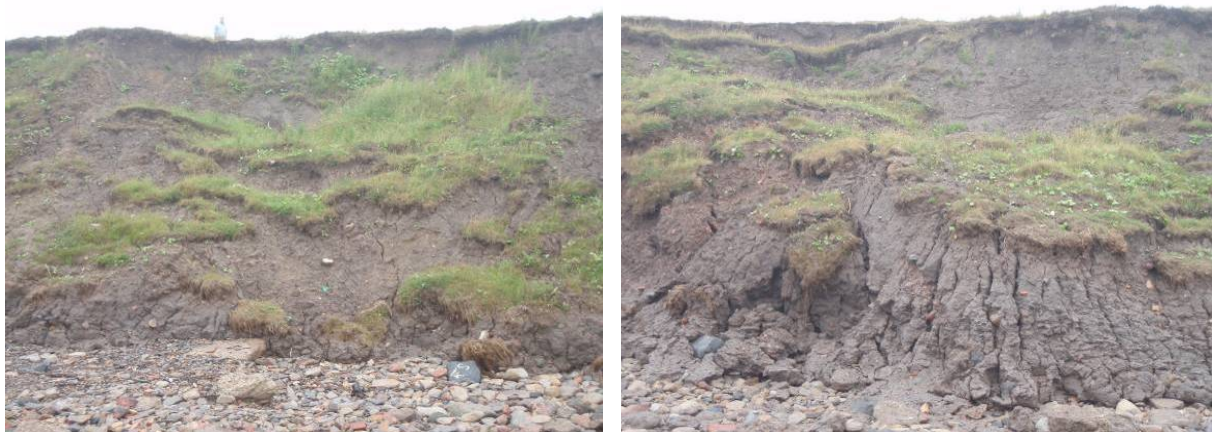
The pill box which was previously eroded out from the cliff face has started to break up on the foreshore, and although it does still act as a local hard point control, cliff slumping is continuing in its lee (below left). At the intersection of the cliffs with the access ramp from the car park, the tipped rock armourstone and large rubble is partially stabilising the outflanking problem of the ramp, although again slumps are continuing in the cliffs behind (below right).

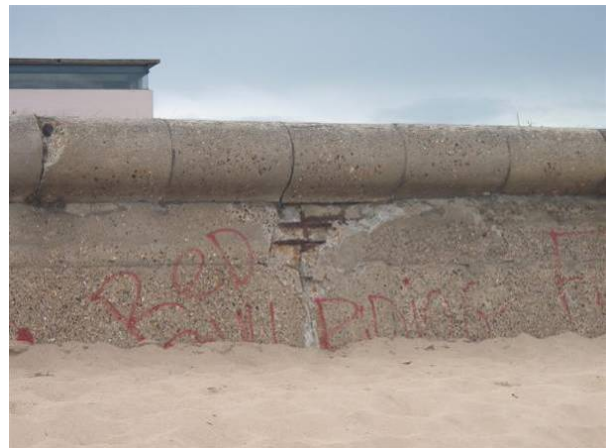
The sea wall fronting the promenade was largely buried by high beach levels at the time of the inspections, but some minor cracks and gaps at construction joints were noted in the visible sections of wall, as well as a few patchy areas of abrasion, leading to exposed and corroded reinforcement bars (below).
