## **Cell 1 Regional Coastal Monitoring Programme Walkover Inspection Surveys 2022**

**Northumberland  
County Council**

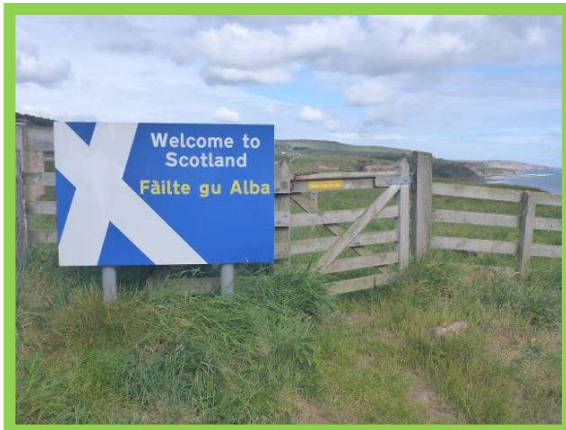
*Start of inspection at Scottish Border (/0601C01)*

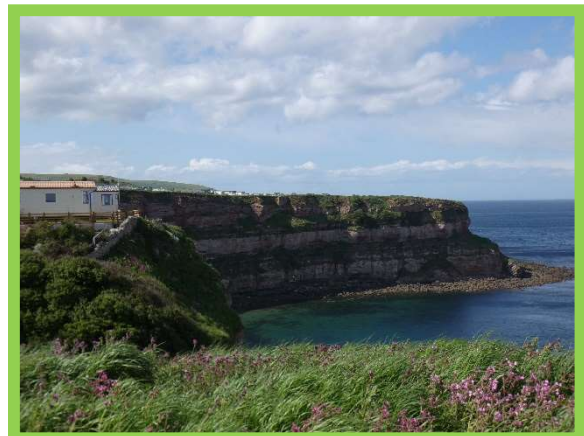
*High stable cliffs (/0601C02)*

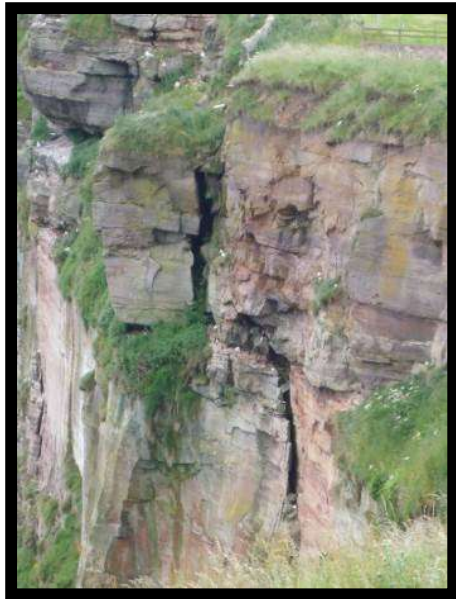
*Fractured cliffs at Marshall Meadows Bay (/0601C02) - 2016*

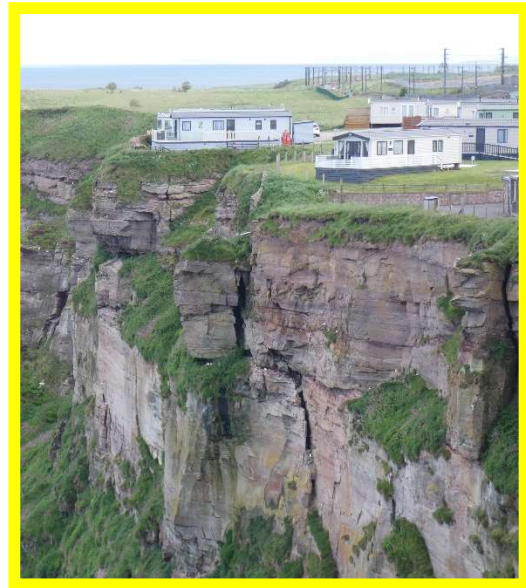
*Fractured cliffs at Marshall Meadows Bay (/0601C02) - 2022 (no change)*

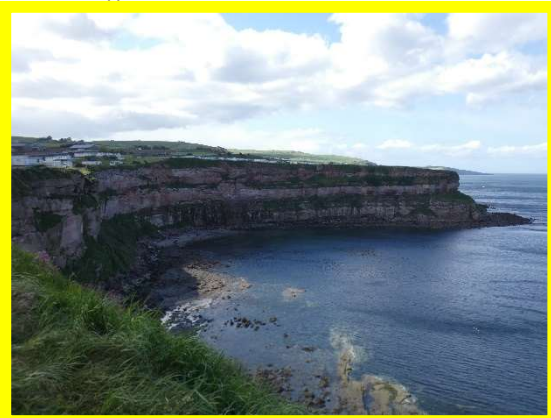
*Cliffs in front of the holiday park at Marshall Meadows Bay (/0601C02) 2022*

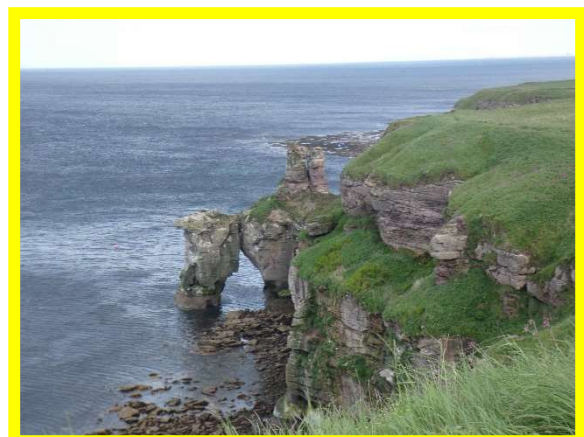
*Needle's Eye (/0601C05) 2022*

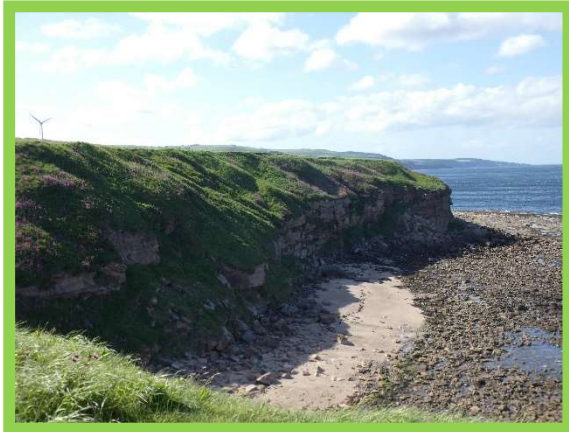
*Stable cliffs (/0601C06) 2022*

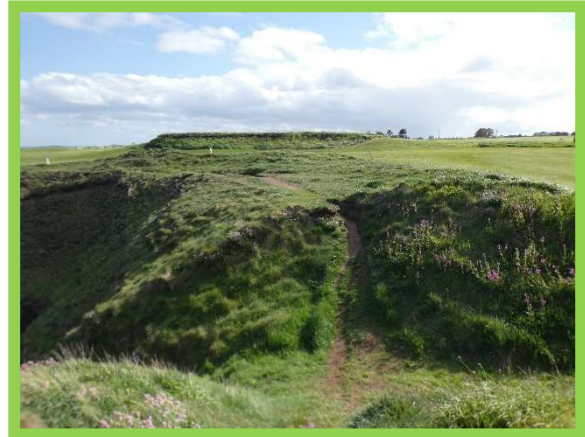
*Northern end of golf course (/0601C06) 2022*

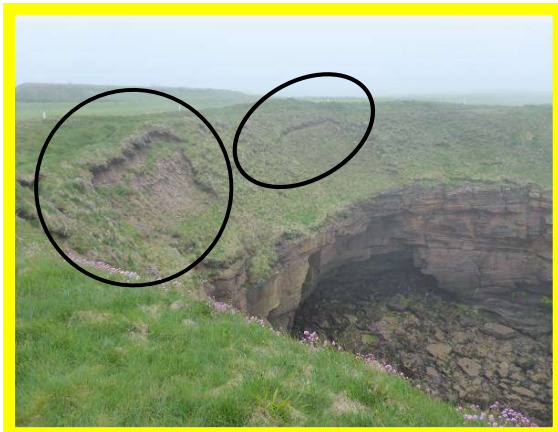
*Localised slumping at Brotherston's Hole reported in 2018 (/0701C01)*

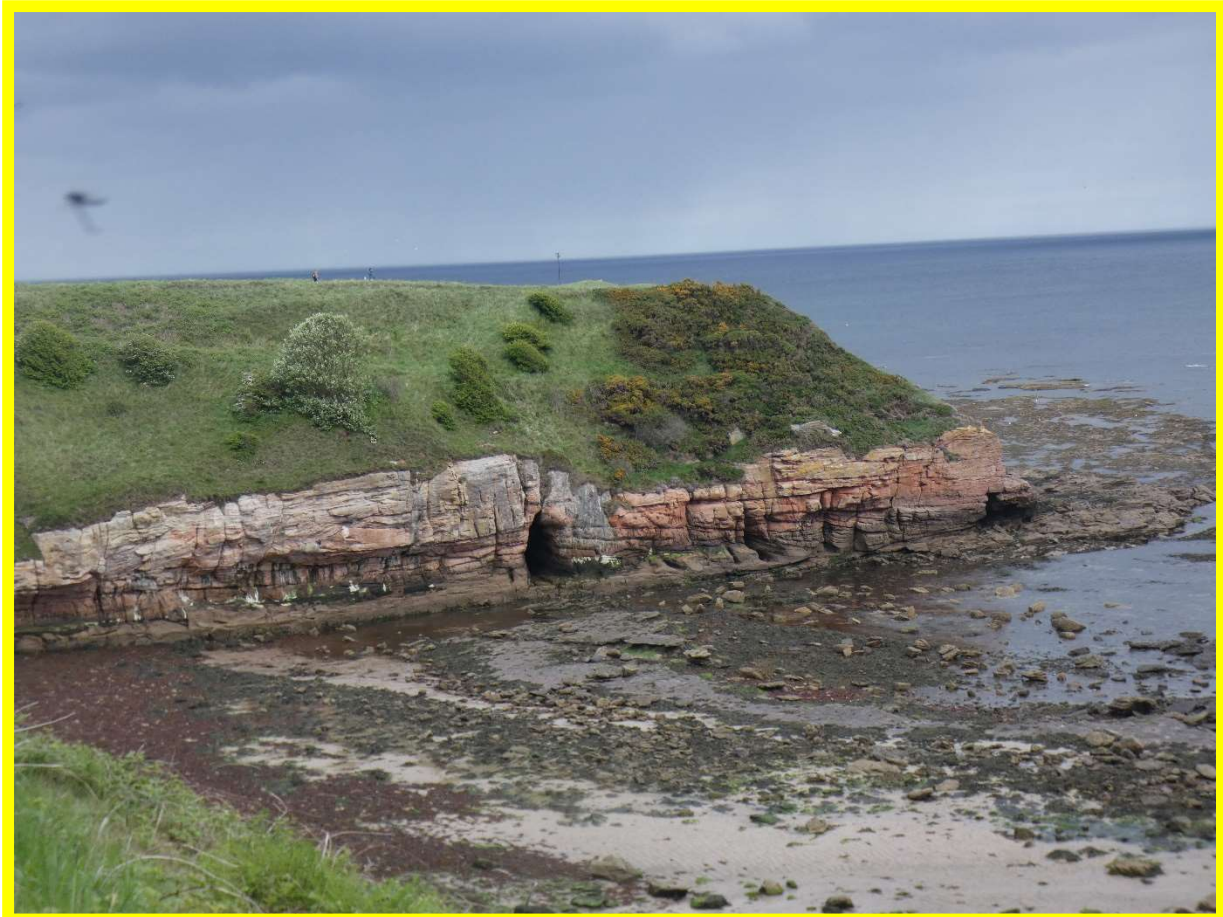
*Caves at base of cliffs (/0701C02) 2022*

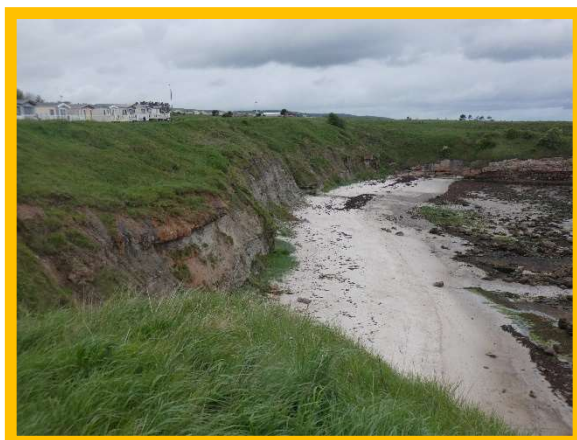
*Cliff face overhang (/0701C02)*

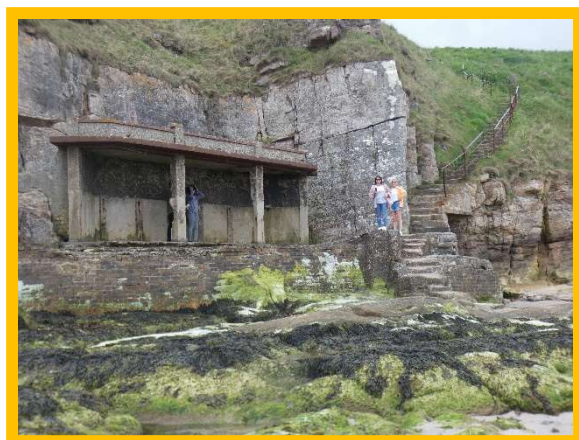
*Concrete pavilion structure in fair/poor condition, missing brickwork from fronting wall (/0701C02)*

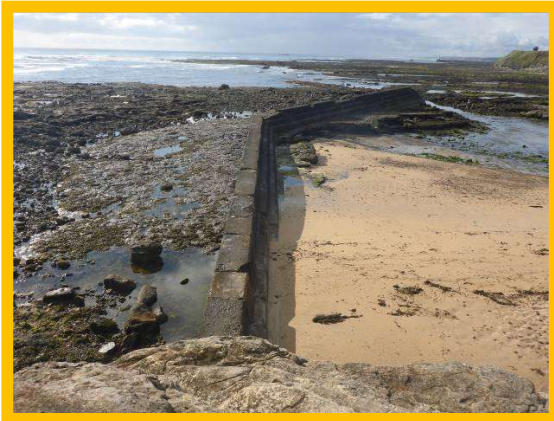
*Green's Haven Breakwater (/0701C04) 2020*

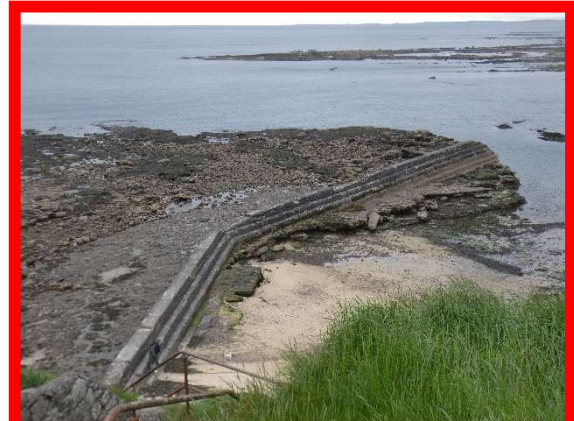
*Damaged section on breakwater crest (/0701C04) 2022. Further damage and undermining.*

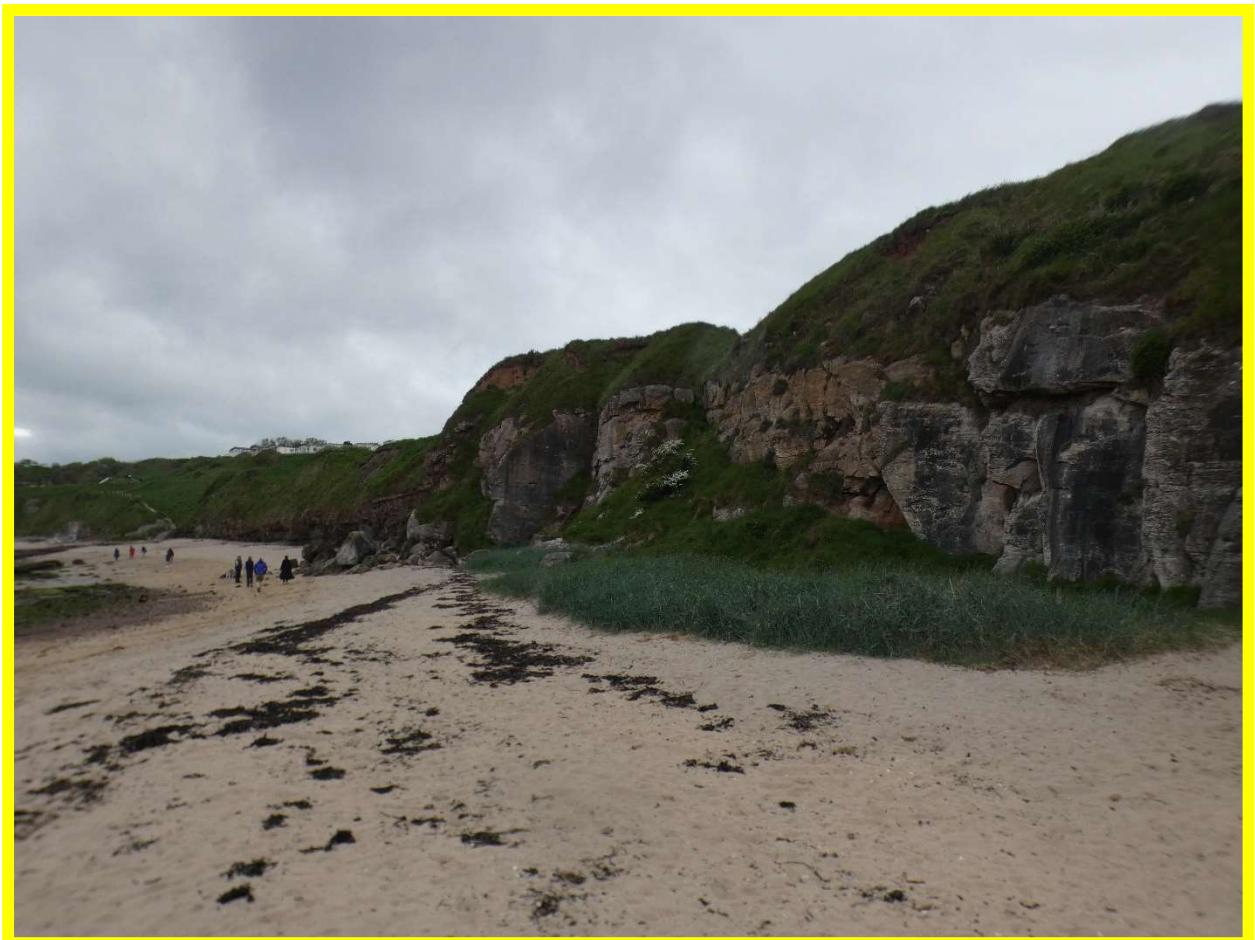
*Sand accumulation and embryo dune growth at toe of cliffs in lee of Breakwater (/0701C05)*

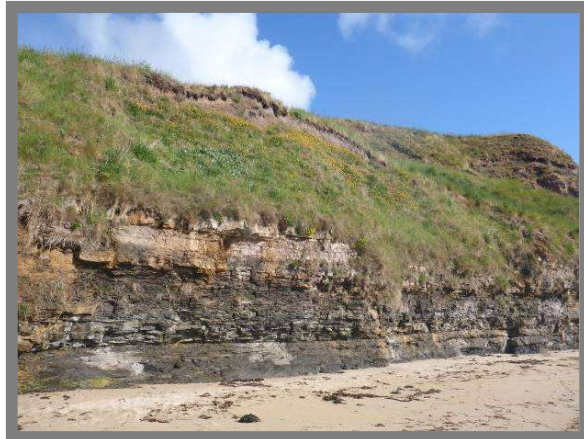
*Slumping in cliffs at Green's Haven (/0701C06) 2020*

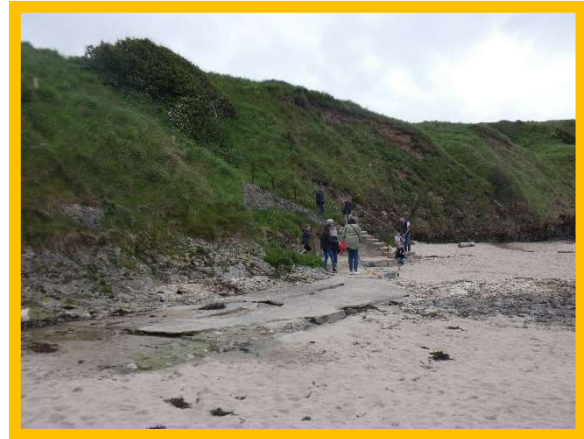
*Slumping in cliffs at Greens' Haven (/0701C06) 2022*

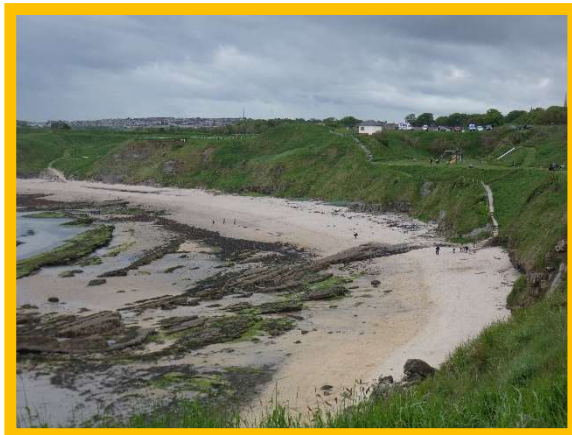
*General view of condition across bay (/0701C06 to C10) 2022*

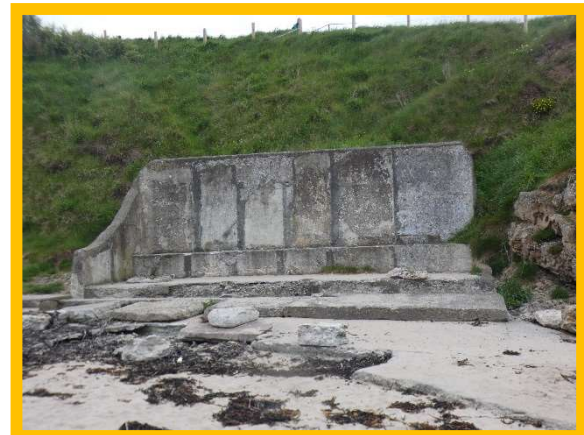
*Short seawall with active breaking-up apron (/0701C07) 2022*

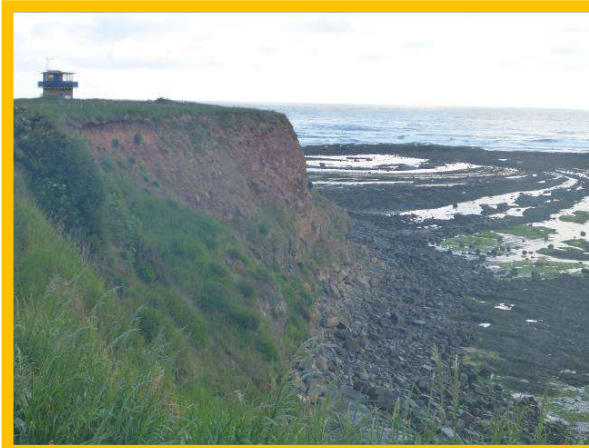
*Slumping cliffs along Magdalene Fields Golf Course (/0701C12) 2020*

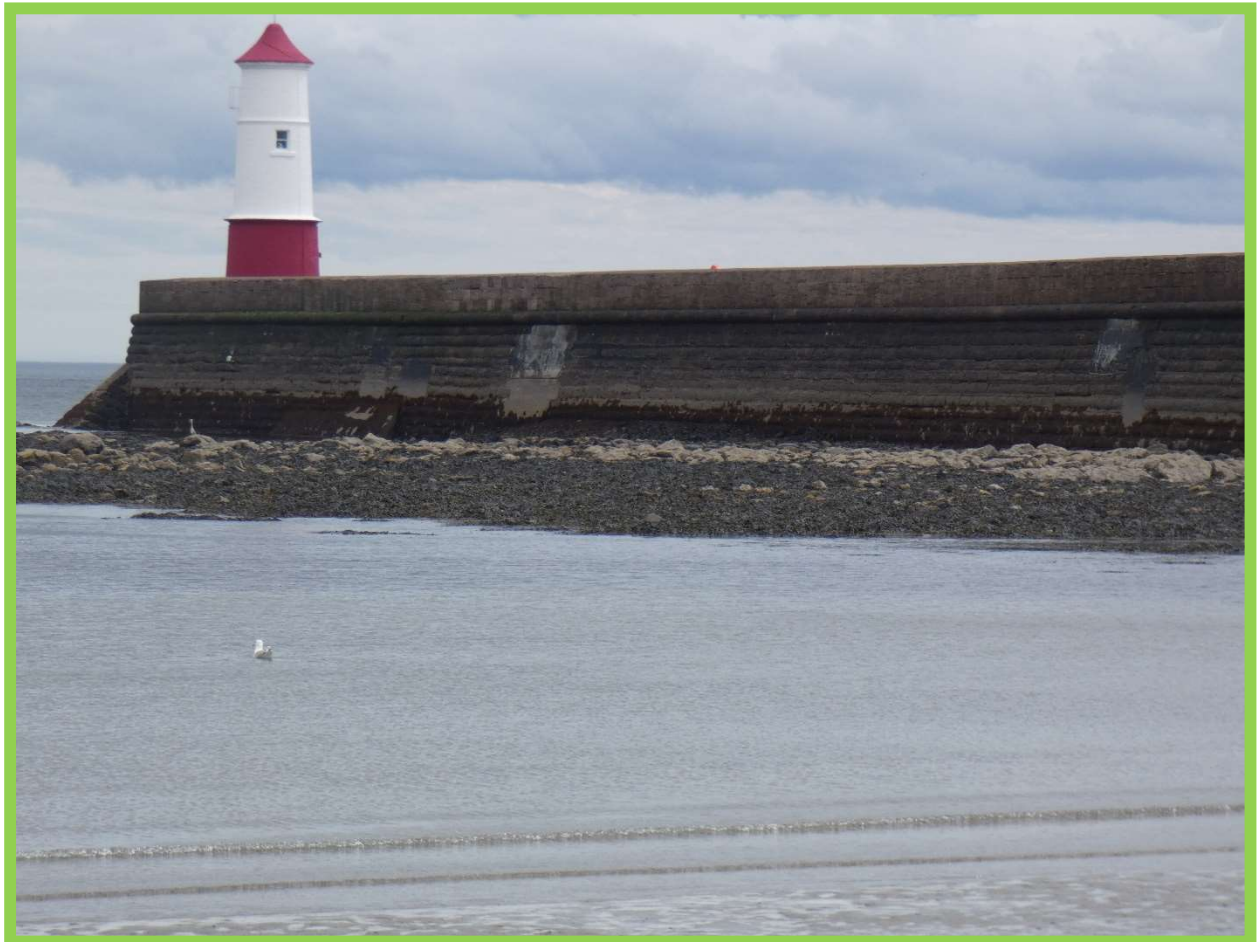
*Berwick Pier in good overall condition following refurbishment in 2012/13 (/0701C14 & C15)*

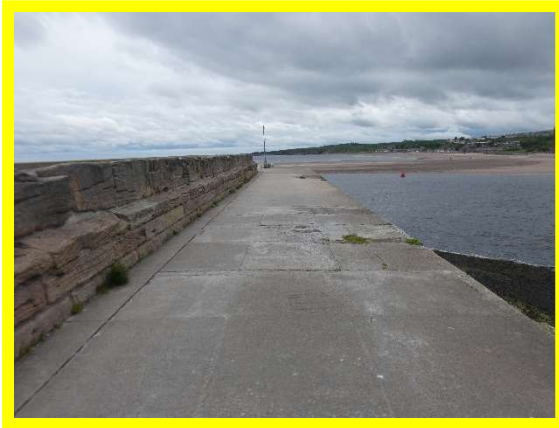
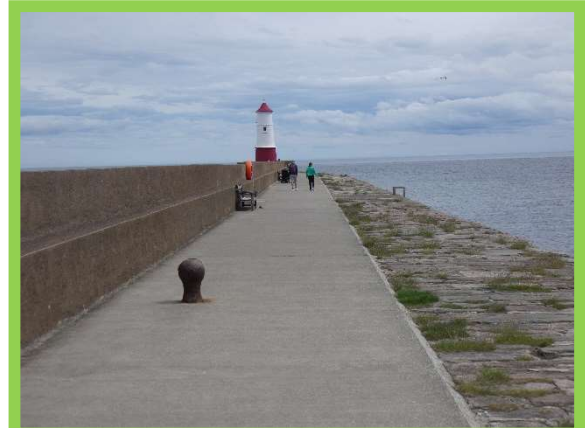
*Older (inland) sections of cracked deck and abraded wave wall on Berwick Pier (/0701C15) Repairs to deck of Berwick Pier (/0701C14/15)*

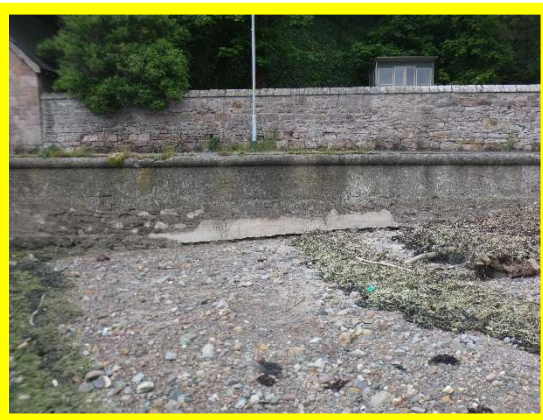
*Eastern end undermining (/0801C07)*

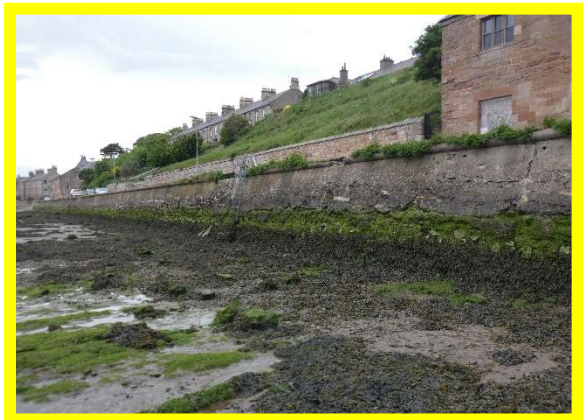
*Deterioration of the coping (/0801C07)*

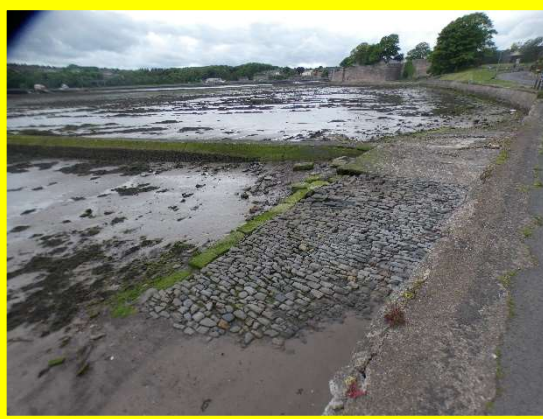
*Local failed section of slipway over foreshore outfall (/0801C07)*

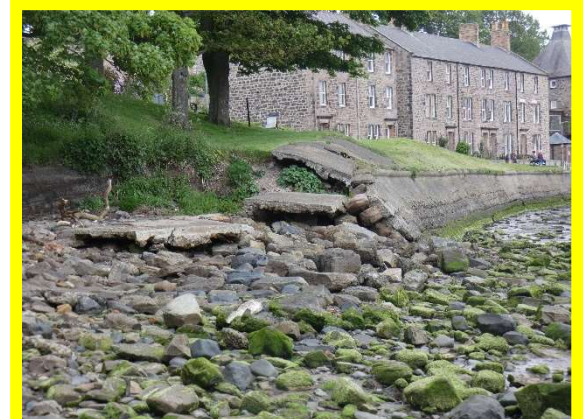
*Western end failure of wall (/0801C07)*

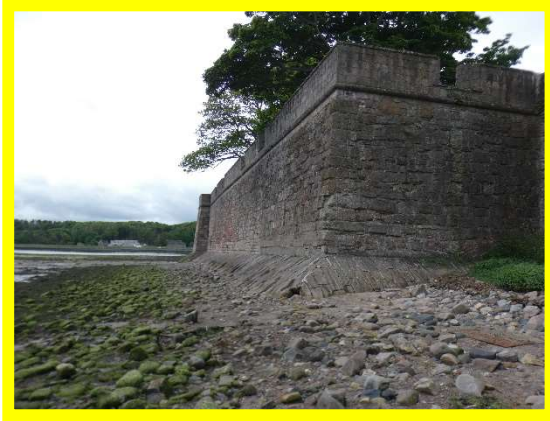
*Berwick's historic town walls in good overall condition (/0801C06)*

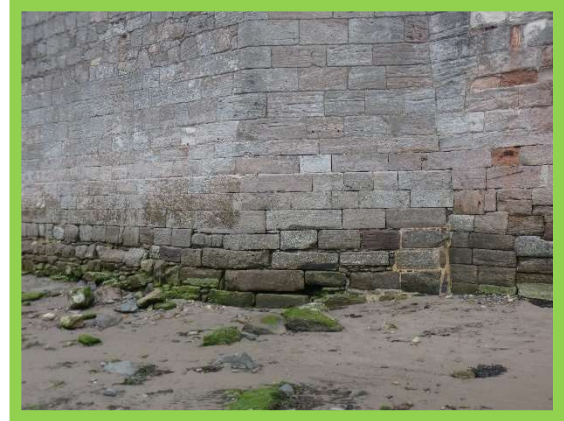
*Abrasion to toe (/0801C06)*

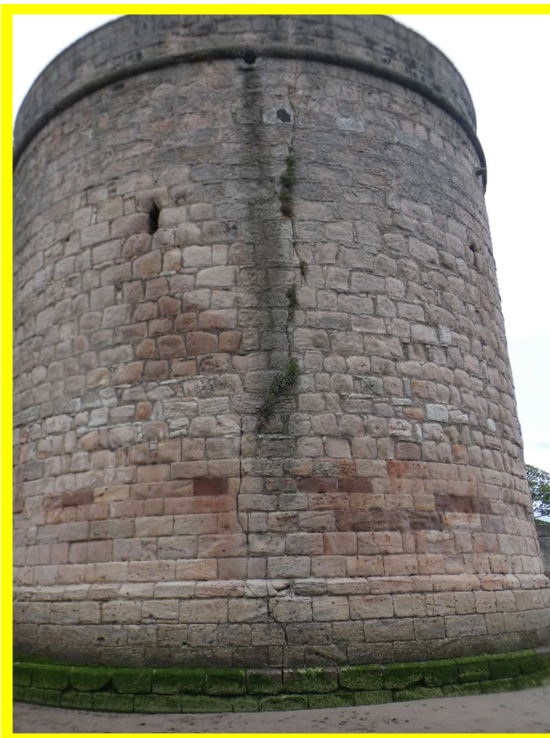
*Vertical crack in wall at roundhead (/0801C06)*

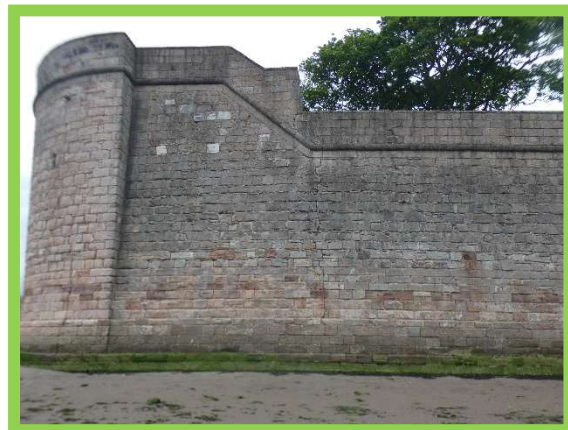
*Vertical crack in wall at roundhead (/0801C06)*

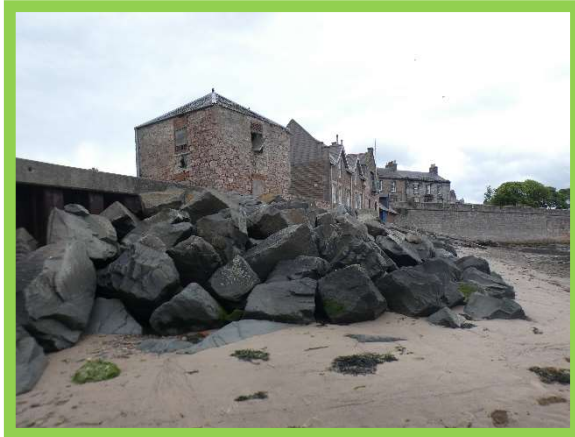
*Rock revetment in good overall condition (/0801C04)*

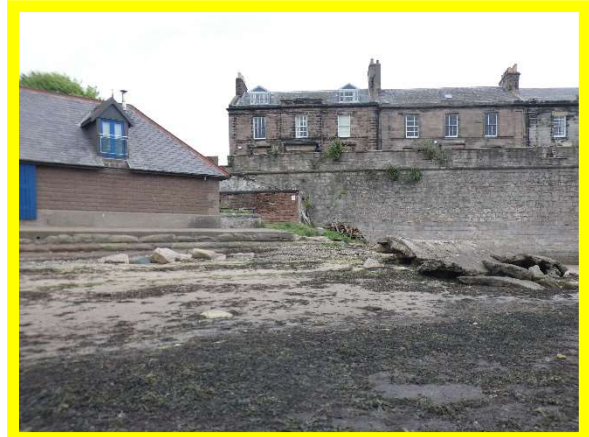
*Wall in fair overall condition (/0801C05)*

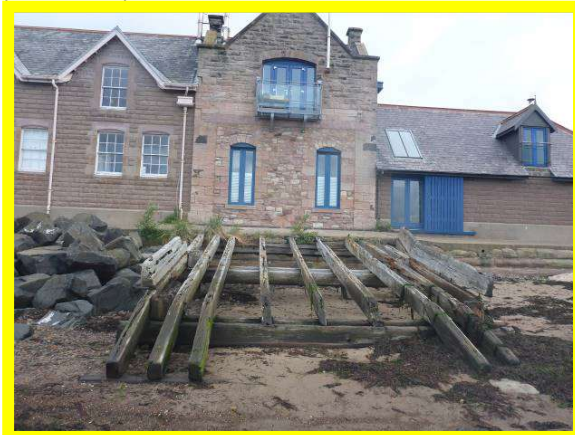
*Obsolete timber slipway (/0801C05) 2020*

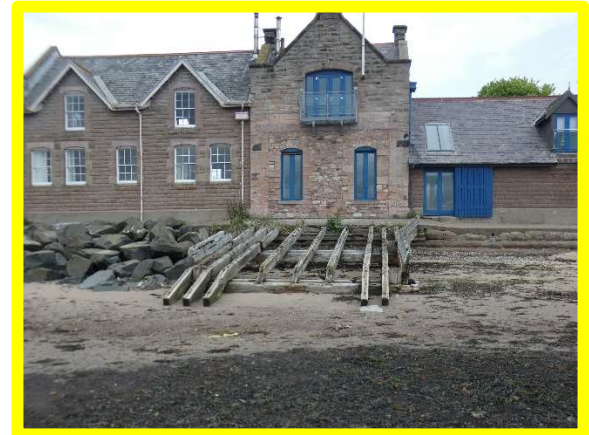
*Obsolete timber slipway (/0801C05) 2022*

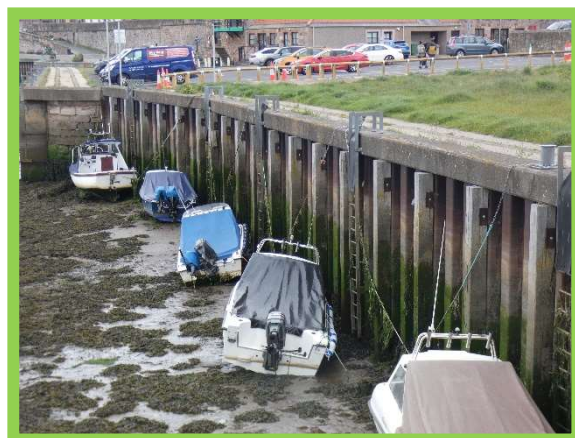
*Steel sheet piled quay walls in good overall condition (/0801C03)*

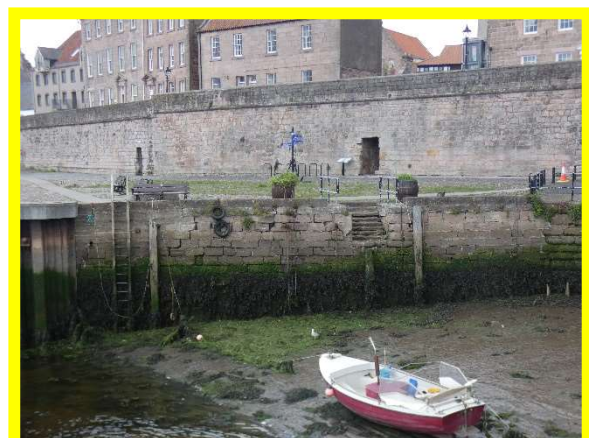
*Masonry quay walls in dock area in fair overall condition with some open joints, cracks and abrasion (/0801C03)*

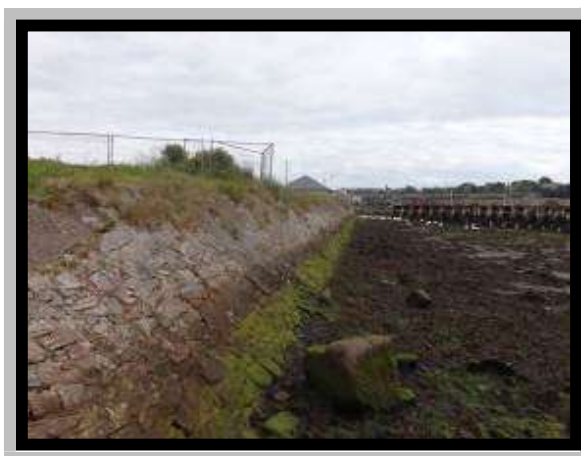
*Masonry revetment 901c04 at northern end -2016.*

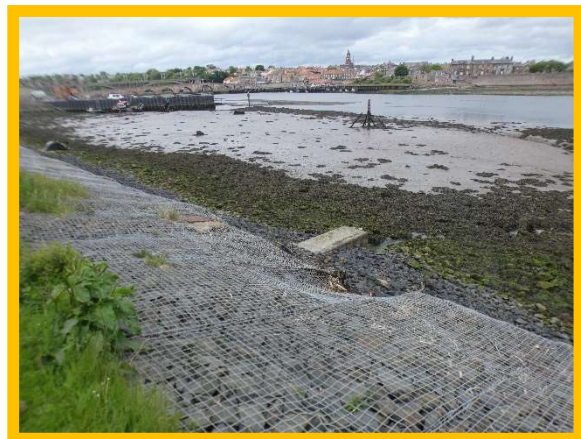
*901c04 continued damage 2022.*

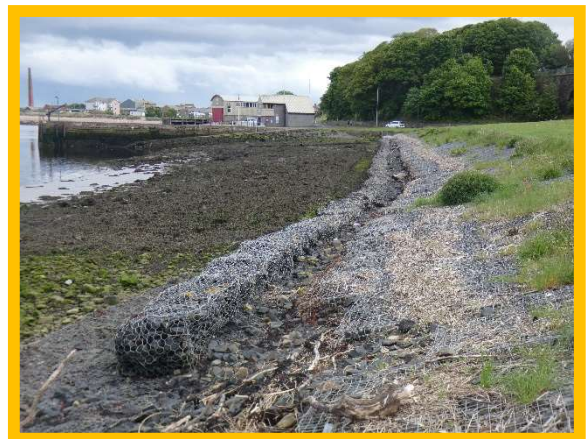
*901c04 continued damage 2022.*

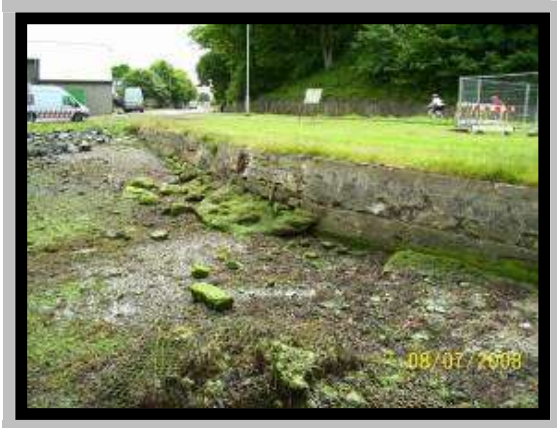
901c05/06 in 2008 showing toe level and condition of masonry.

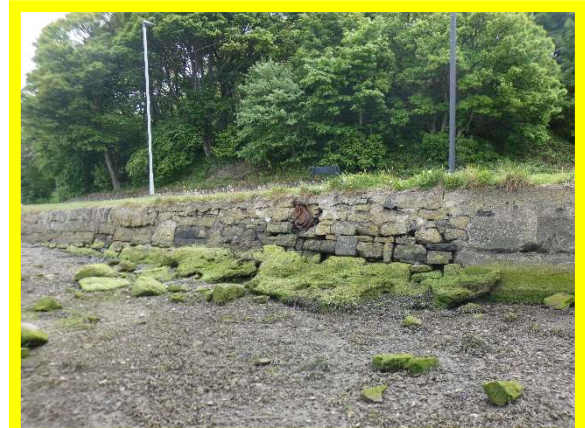
901c05/06 further cracking and loss of pointing 2022.

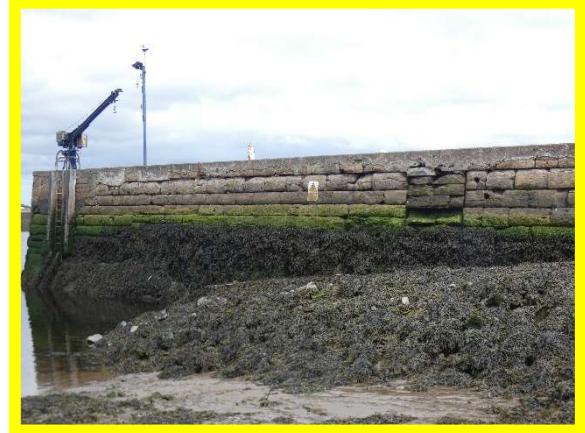
901c06 - 2022. Little change since 2008

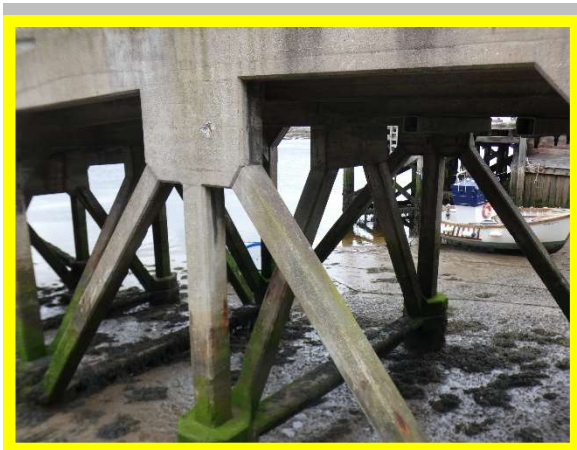
901c06 - spalling to RNLI structure.

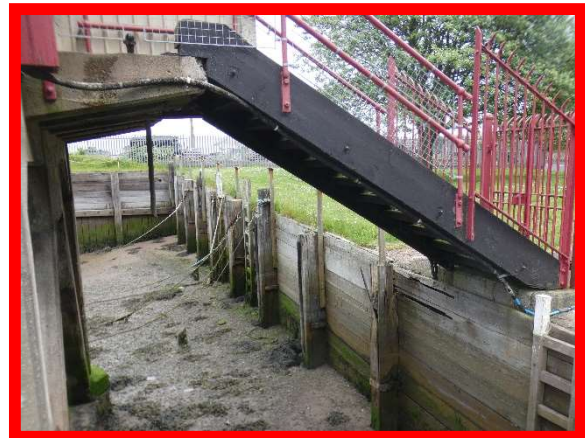
901c06 – loss of integrity of timber retaining wall.

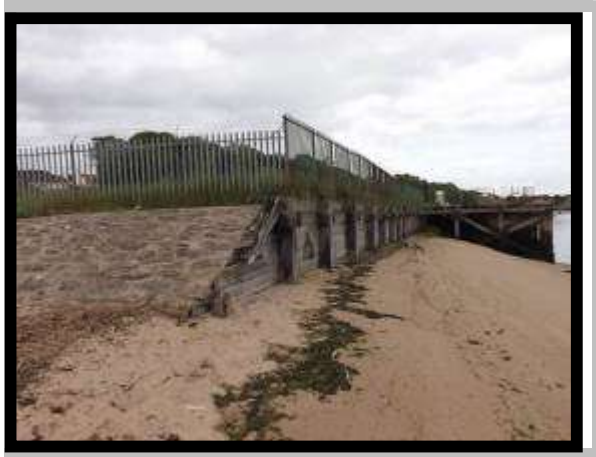
*901c07 high sand levels 2016.*

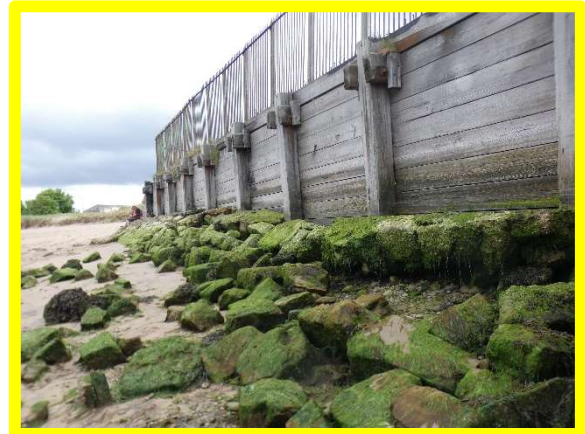
*901c07 – reduced beach levels 2022, continuing change since 2018.*

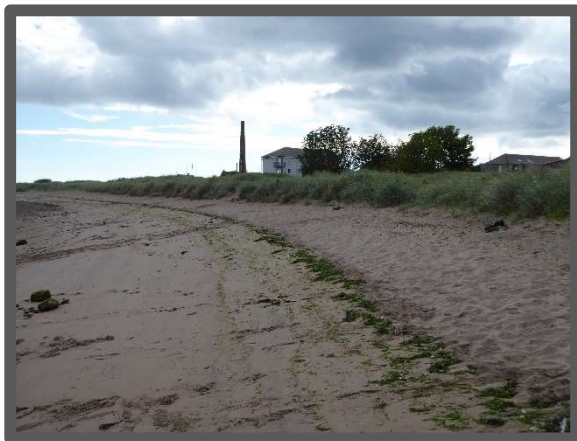
*901c08 – 2020, stable since 2017*

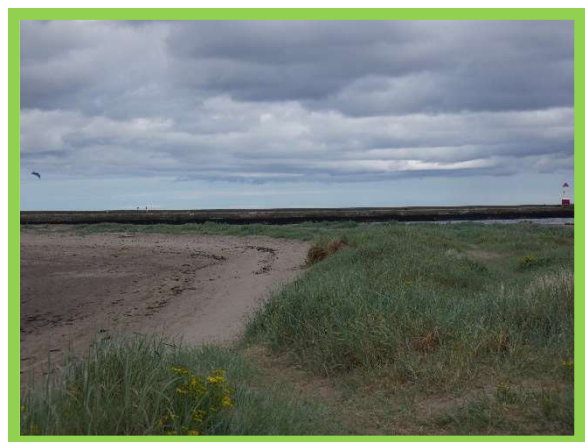
*901c08 – slight erosion since 2020 but with embryo dune growth to spit.*

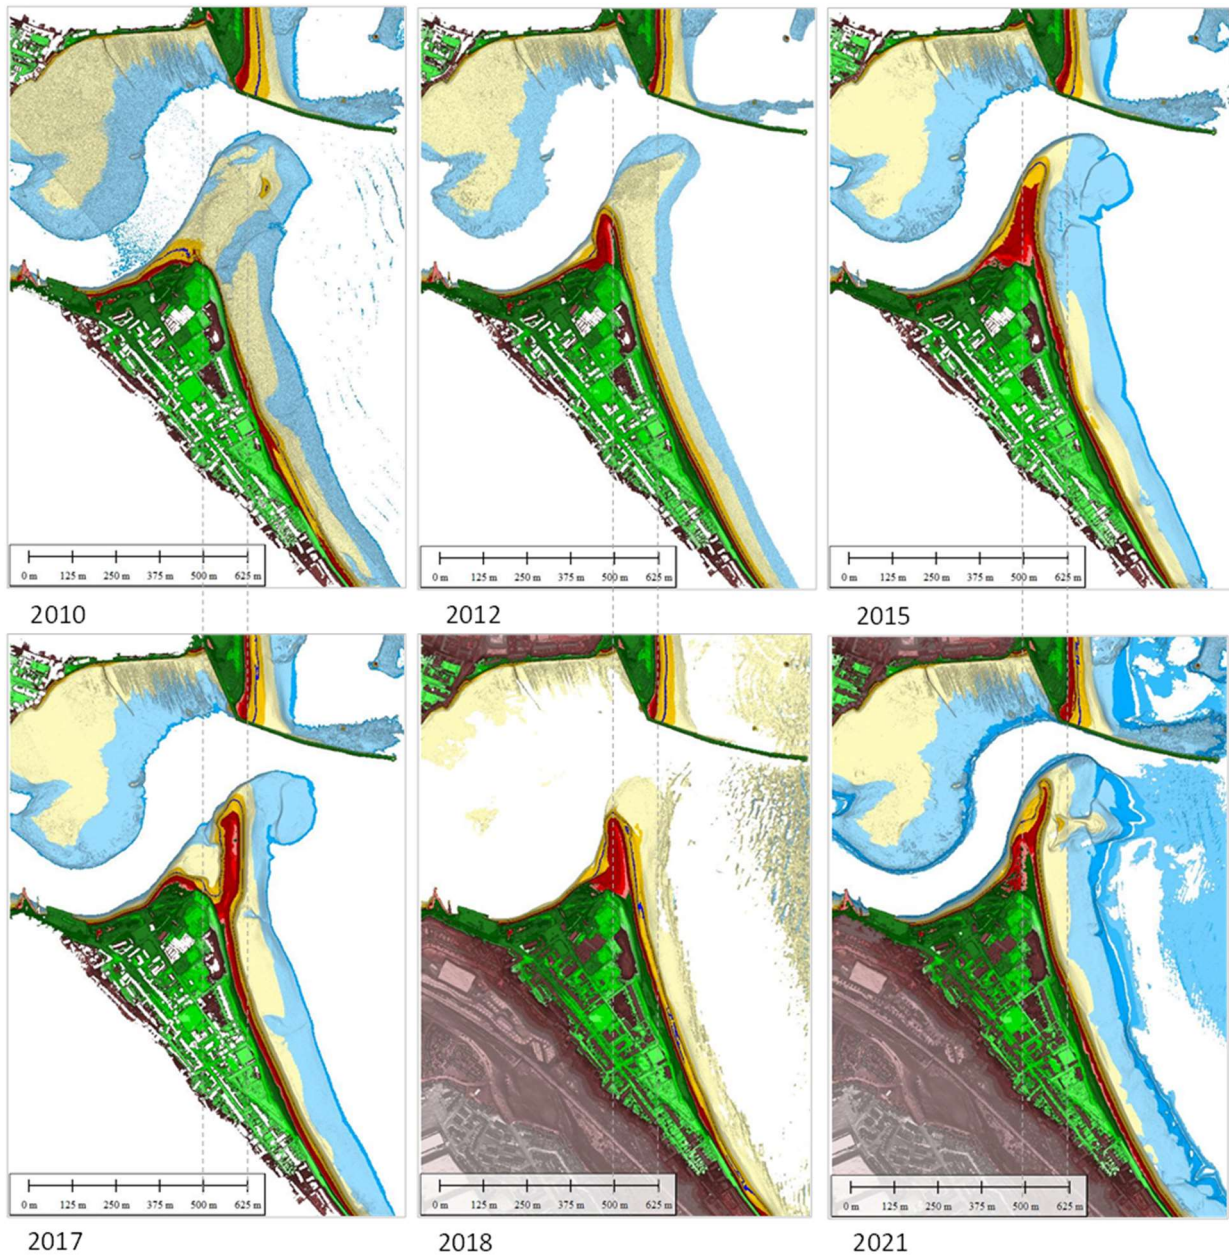
*Comparative plot of LiDAR.*

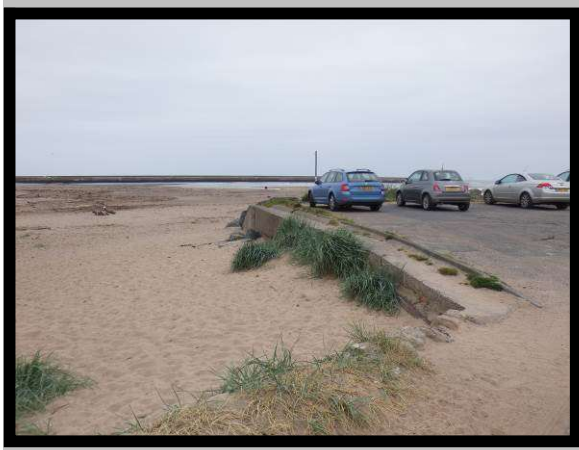
901c09 – high beach levels 2018.

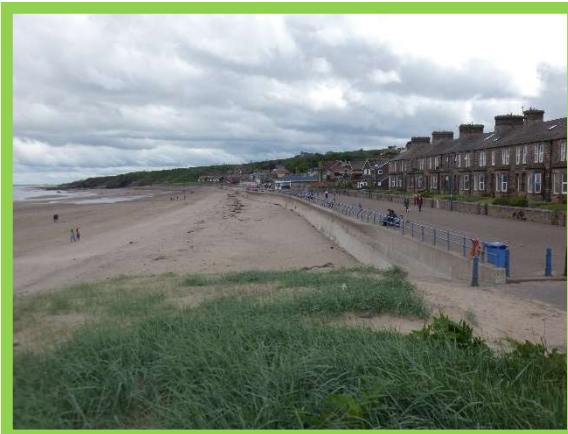
*1001 c02 – 2022 continued development of embryo dune .*

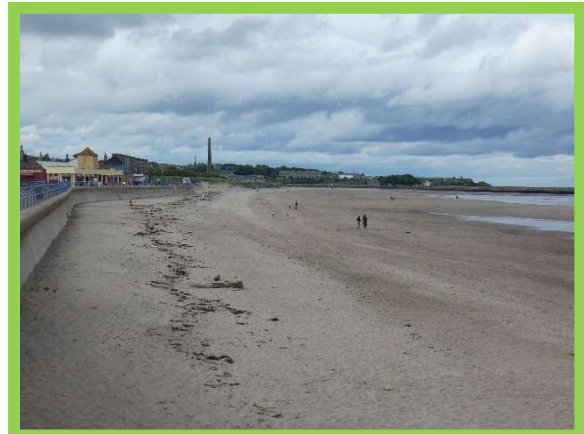
*1001 c02 – 2022 loss of embryo dune since 2020*

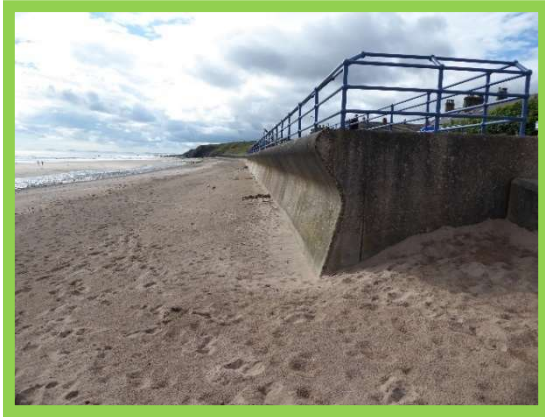
Beach levels to 121AA901A1001/ C03 have increased from 2018, to a similar level to 2016, particularly over the norther section. Since 2020 levels have fallen slightly. However, there remains a healthy beach to the defence. The crack or failed repair identified in 2014 remains in the same condition (this crack has remained the same since 2010). There is some general loss of joint sealant but this does not appear to be detrimental to the performance of the wall.

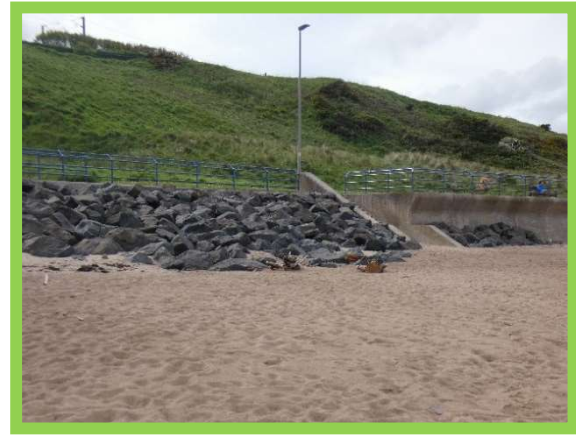
1001 c04– 2022 high beach level sustained

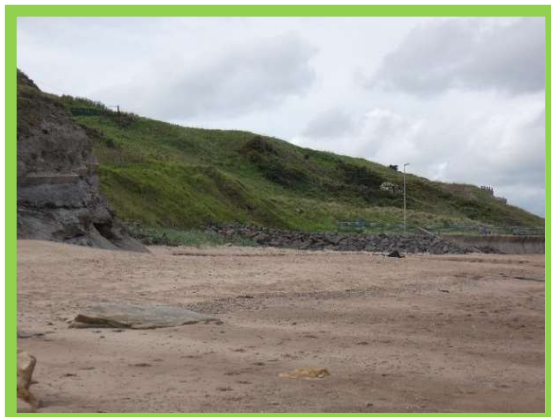
1001 c04/ 05 – 2022 no substantial change.

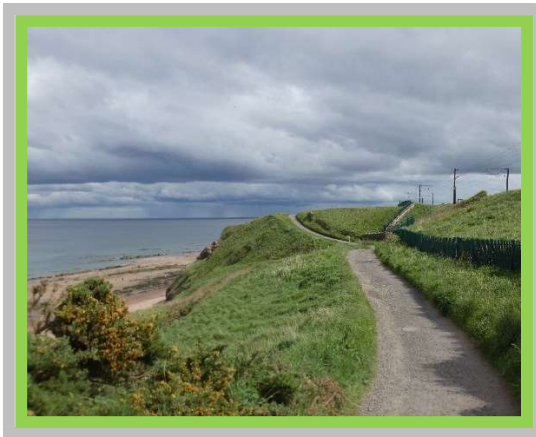
*1101/c01 general position of railway line in relation to cliff and coastal slope*

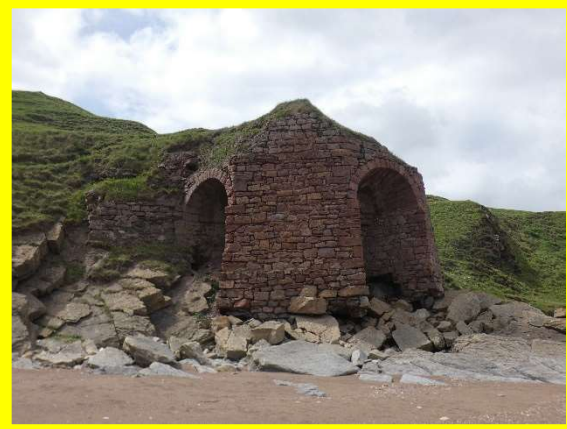
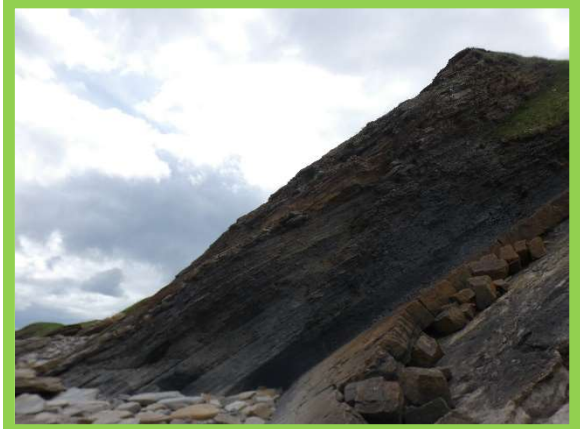
*1101/c02 2022 coastal slope and historic structure. 1101/c03 2022 coastal slope*

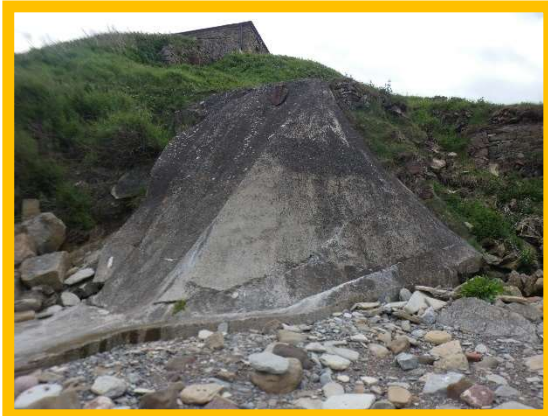
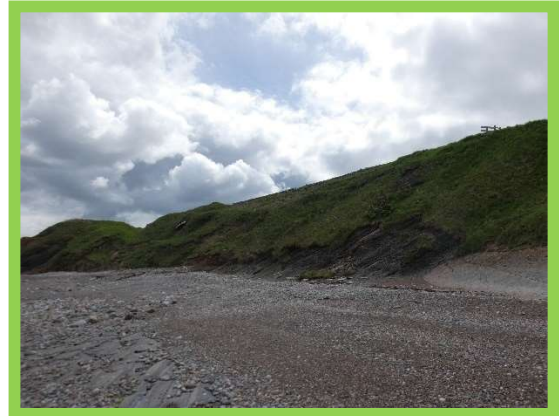
*1101/c04 2022 Outfall and concrete slope protection, cracked and minor undermining. 1101/c04 2022 general slope, no change.*

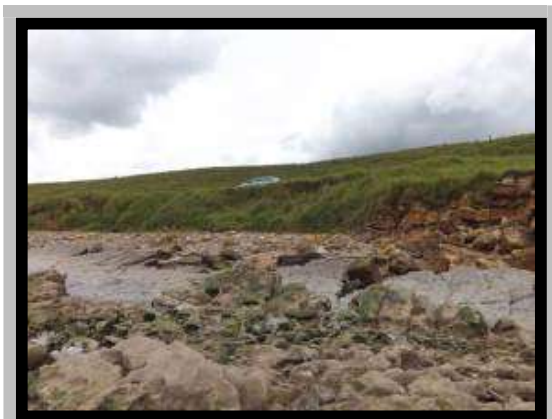
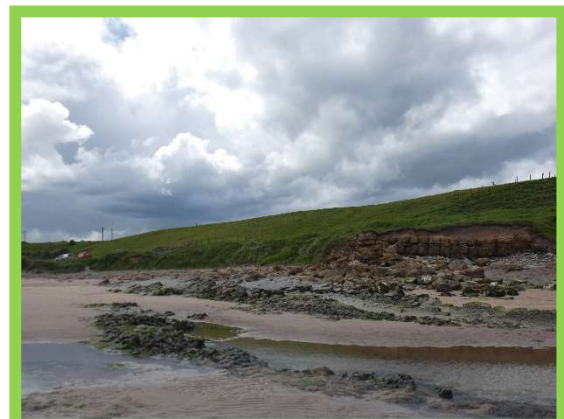
*1101/c05 Critical section of frontage closest to road 2016 1101/c05 2022 Critical section of frontage closest to road. No change.*

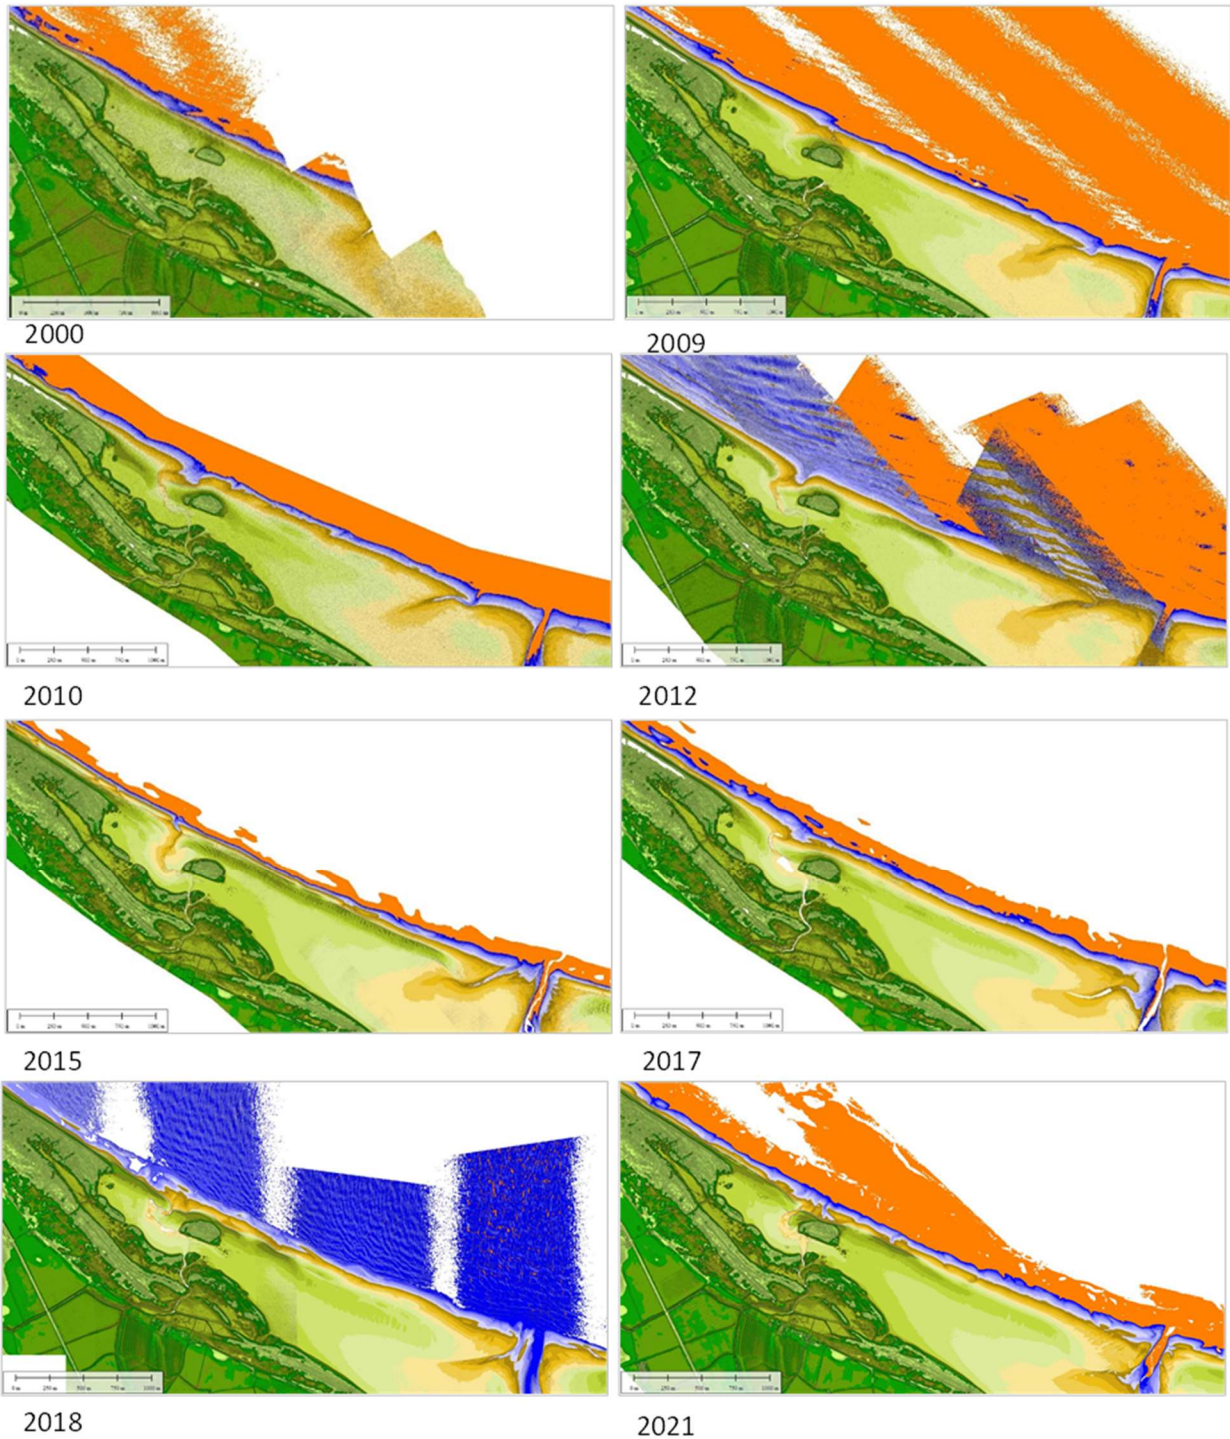
3001/C01 LiDAR plots

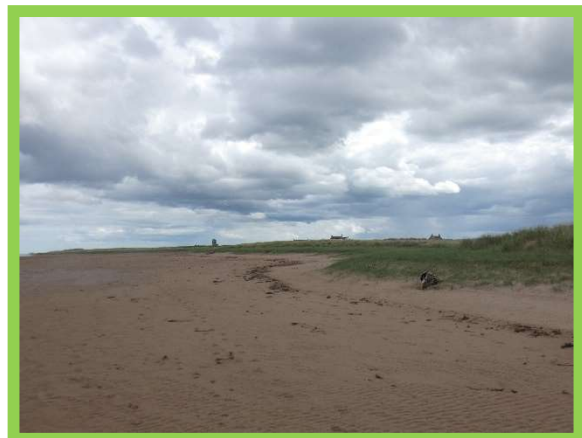
*1301/ C01, embryo dunes to southern end of the unit.*

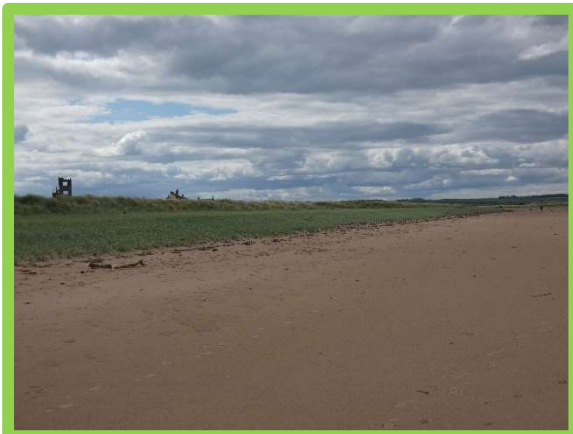
*1301/C01 – 2022 at Beachcomber access showing continued dune development.*
