## **Cell 1 Regional Coastal Monitoring Programme Walkover Inspection Surveys 2022**

**Northumberland  
County Council**

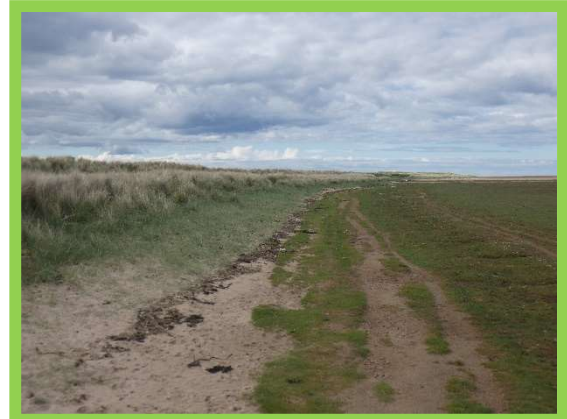
1401/ C31, 2022 back dune behind high saltmarsh.

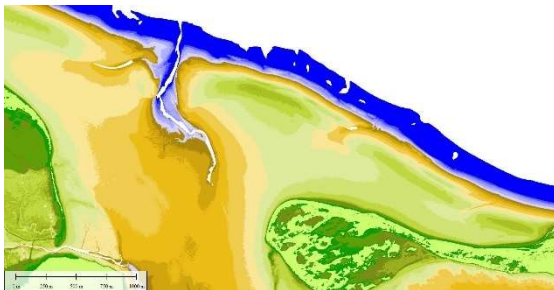
1401/C31 – 2017 LiDAR

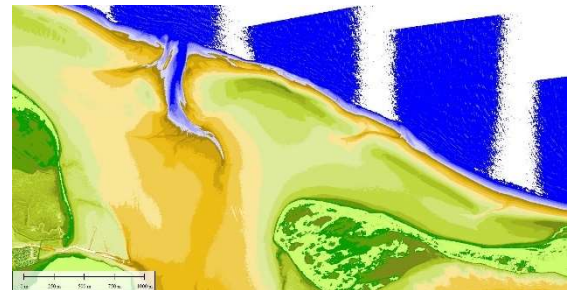
1401/ C31, 2018 LiDAR

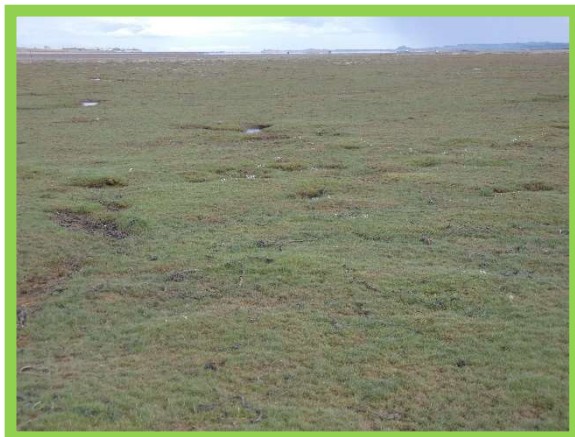
1401/C31 – 2022 developing salt marsh.

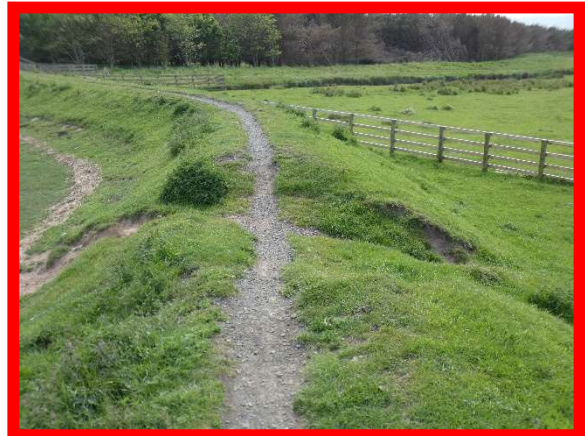
1401/ C31, 2022 no improvement to low area of the bank to area of South Low.

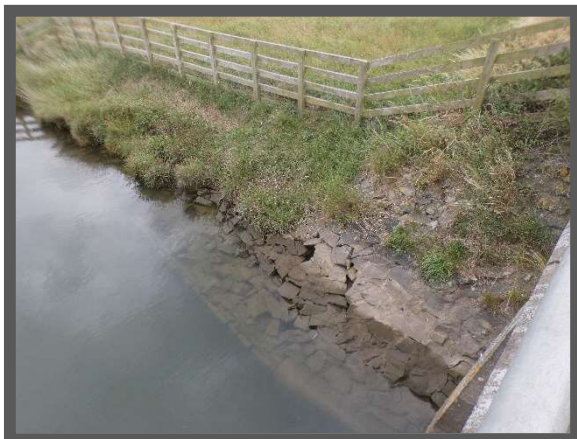
1401/C01 – 2020 undermining of edge protection.

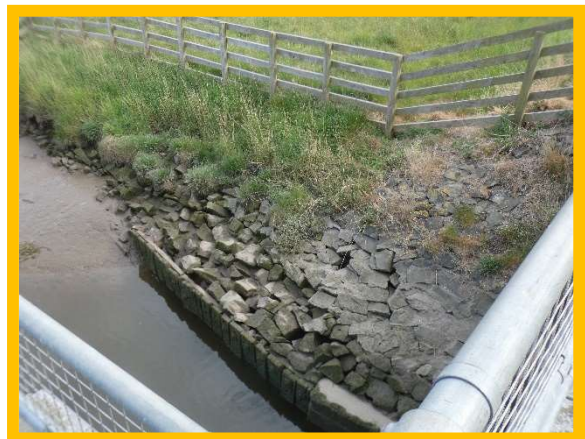
1401/ C01, 2020 view of entrance channel. .

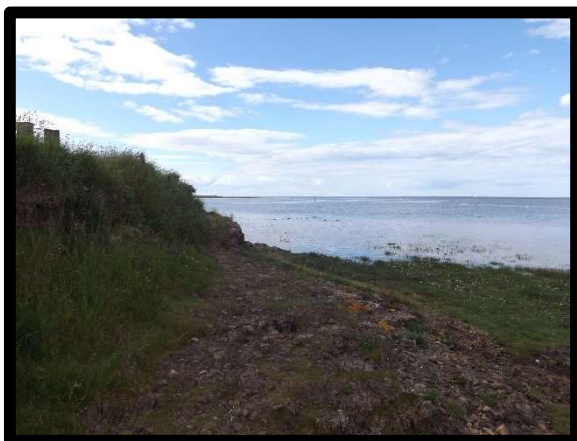
1401/C02 – 2016 at corner to South Low Channel.

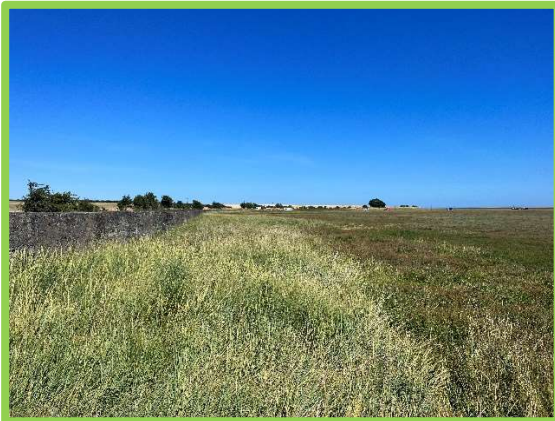
1401C23 – Wide vegetation looking north towards the causeway

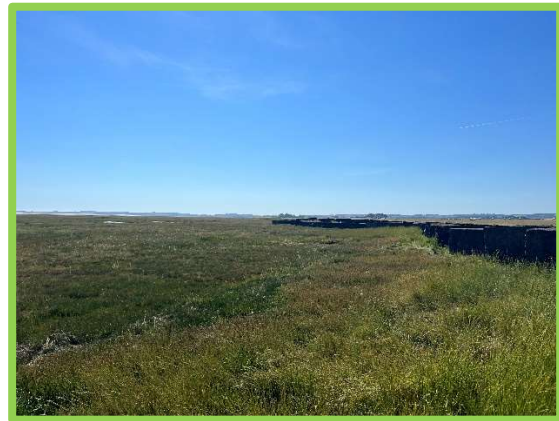
1401C23 – Wide vegetation looking south over The Swab.

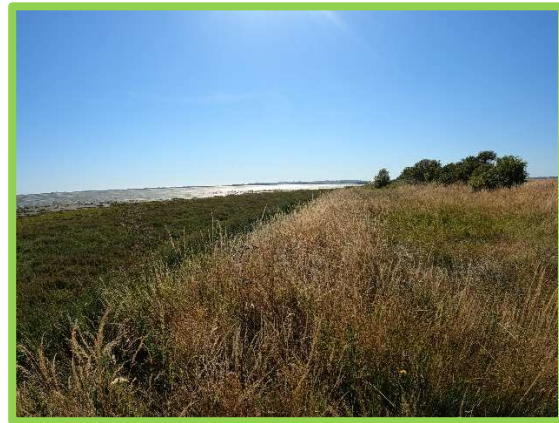
1401C23 – Looking south from Lowmoor Point

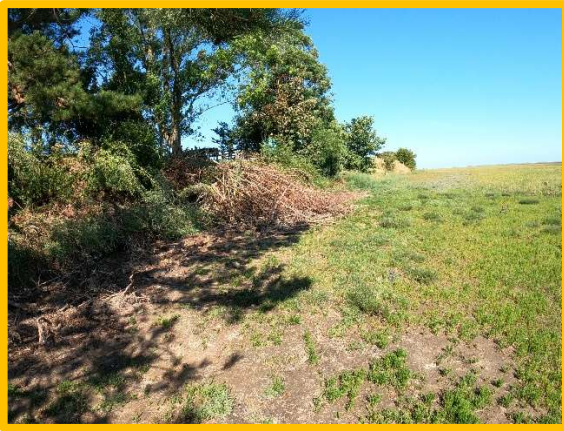
1401C23 – Informal defences adjacent Fenham Mill

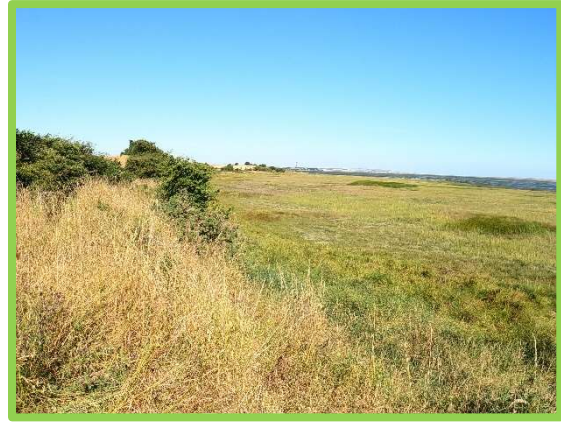
1401C24 – Healthy, but narrowing, marshland beyond Fenham burn

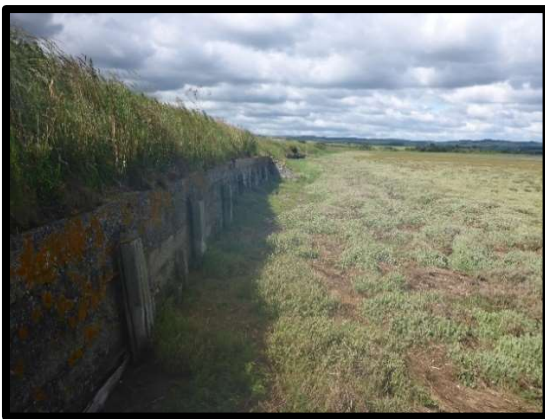
1401C98 – (Photo from 2020) retaining structure in fair condition. Rotten timber support posts and minor rotational movement.

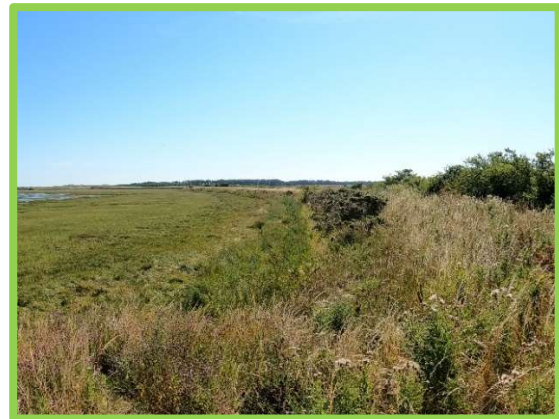
1401C98 – Densely vegetated embankment.

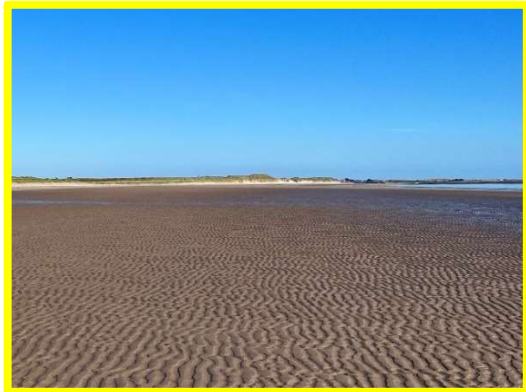
*1401C99 – some evidence of erosion to dune toe*

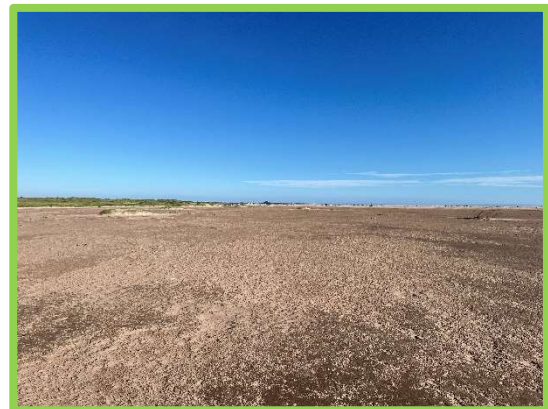
*1401C06 – Embryo dunes observed to the south of Ross Back Sands*

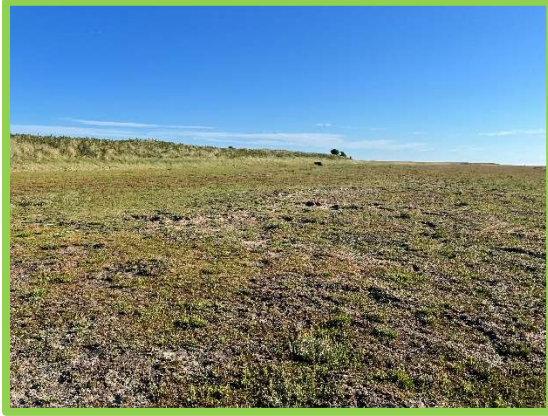
*1401C26 – Vegetated intertidal flats at transition between Budle Bay and Ross Sands.*

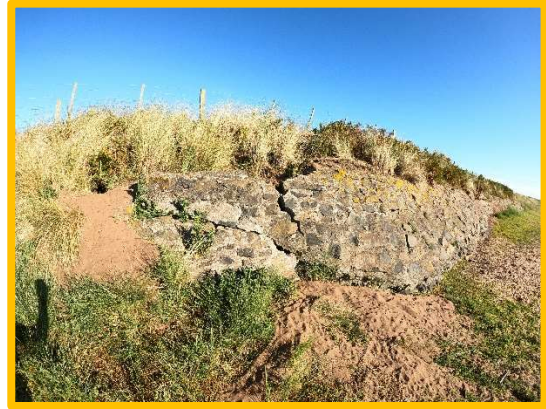
*1401C27 – Localised section to the north of mortared revetment failed. Extensive cracking and washout of material.*

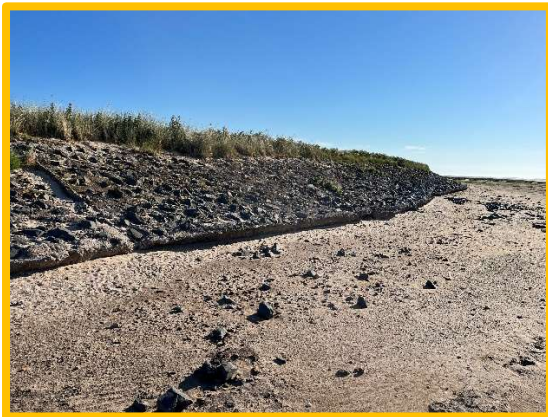
*1401C29 – Undermining of revetment as a result of lowering beach levels.*

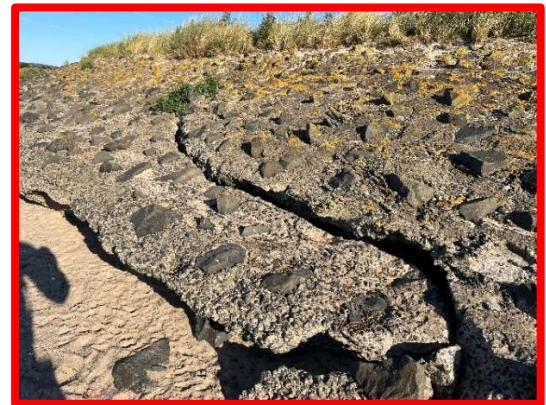
*1401C29 – Failed section of the grouted stone revetment.*

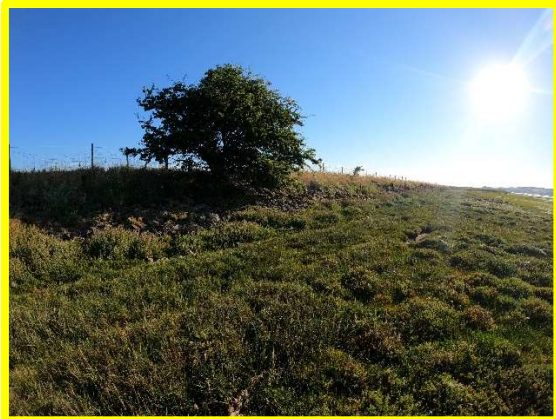
1401C27 – Mature vegetation growth through revetment.

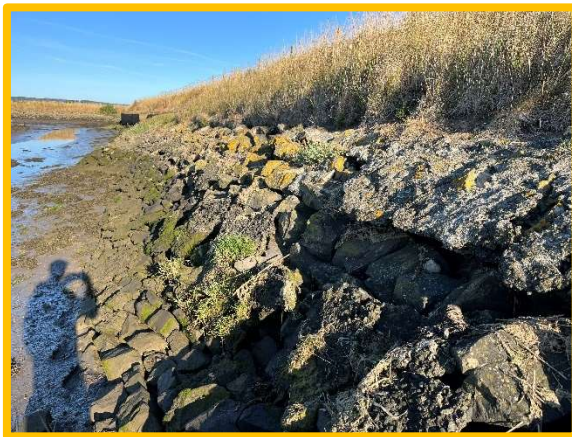
1401C14 – Grouted stone revetment in poor condition.

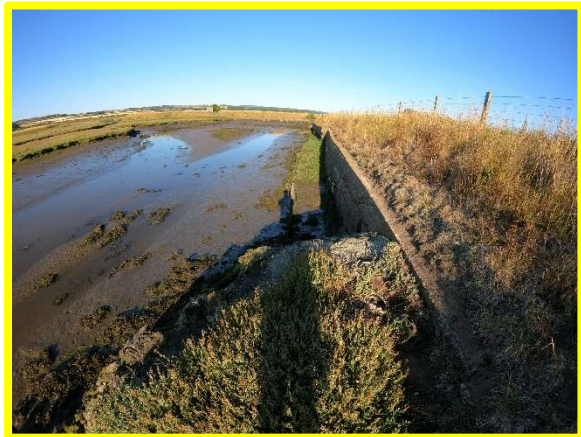
1401C15 – Concrete wall in fair condition. Timber toe erosion protection in poor condition.

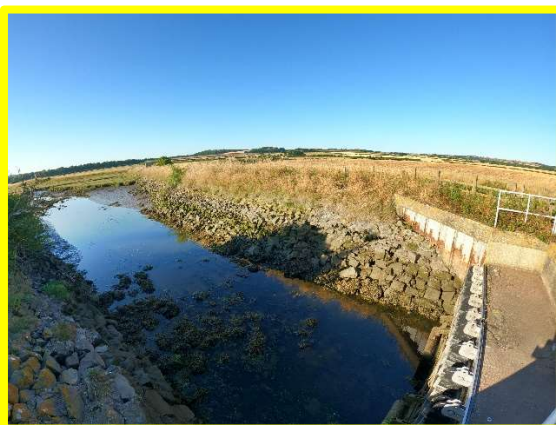
1401C17 – Uneven rock revetment profile

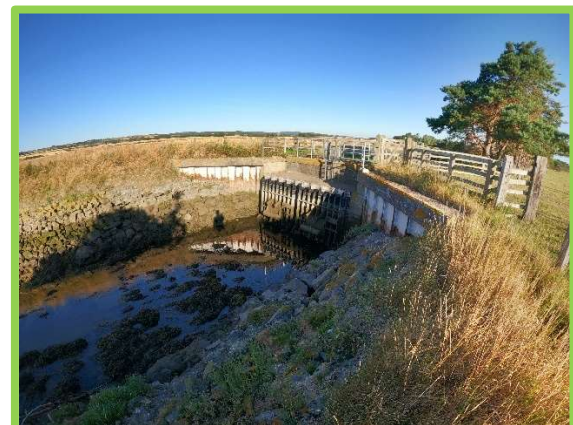
1401C18 – Good condition sluice at Ross Low channel. Corrosion on adjacent steel sheet piles.

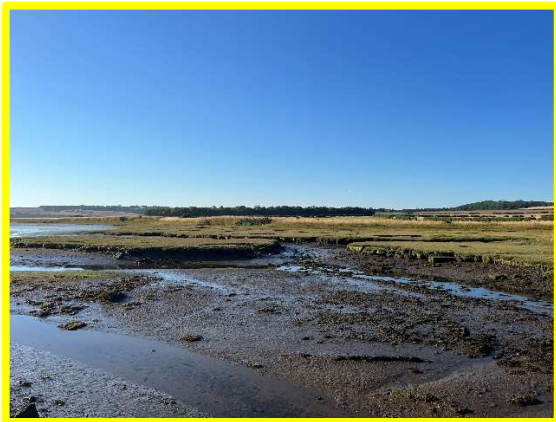
1401C21 – Looking south across Chesterhill Slakes

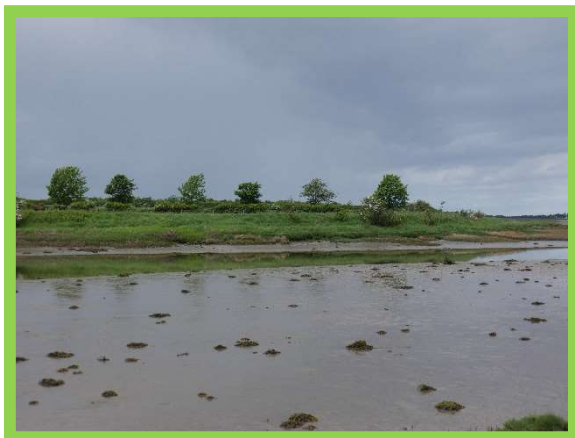
1501/C08 – lower spartina growth in front of eroding back marsh.

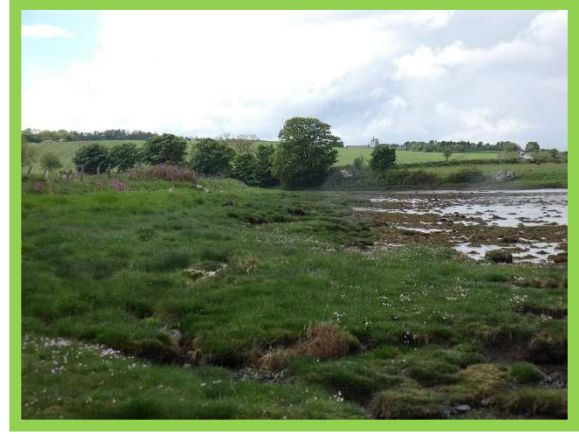
1501/C03 – formation of deep creeks within saltmarsh.

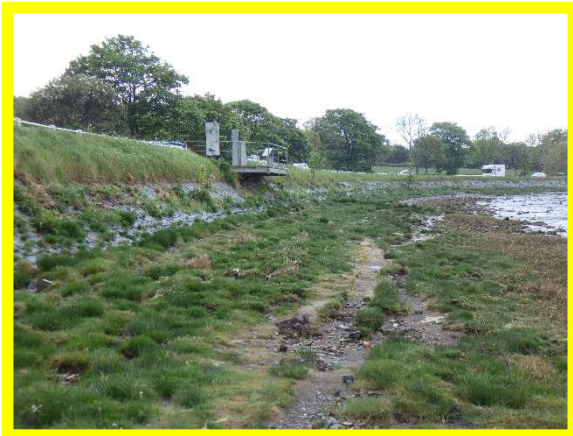
1501/C04 – heavily vegetated revetment

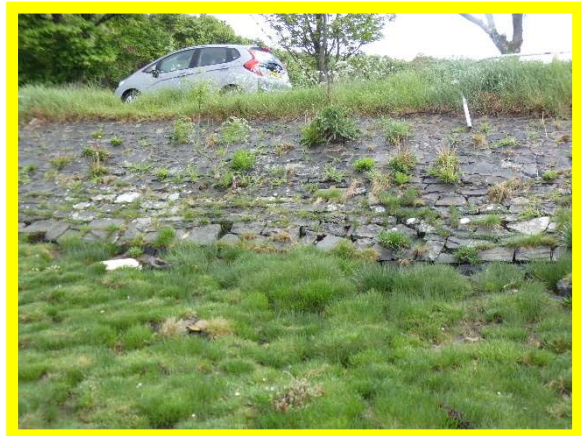
1501/C04 – very local undermining due to back creek development.

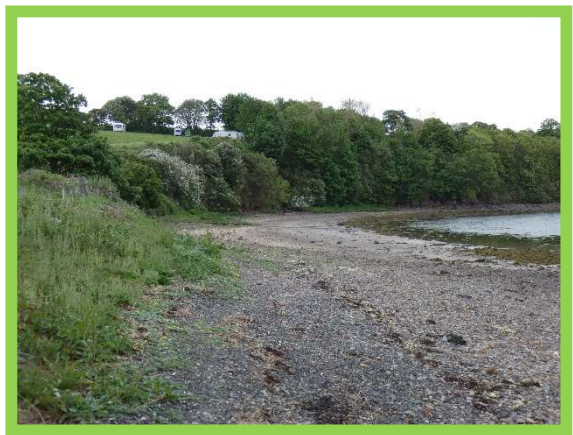
1501/C05 – natural bank running to heavily wooded section.

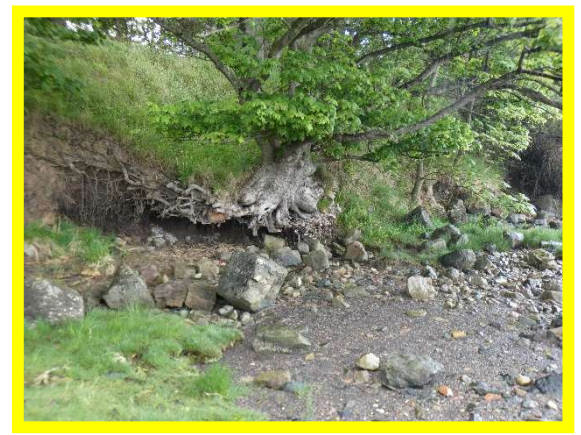
1501/C05 – local bank failure but no apparent risk to road.

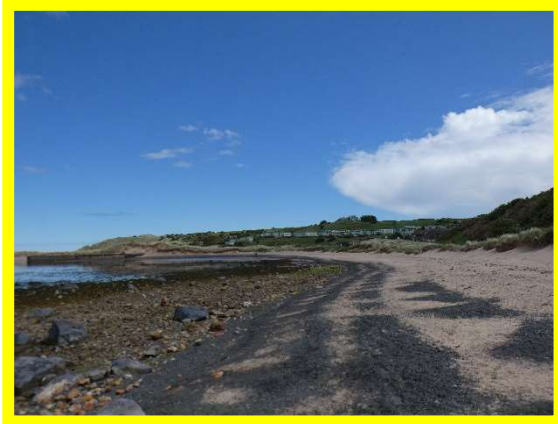
1501/C06 – erosion down to stone on foreshore south of Jetty

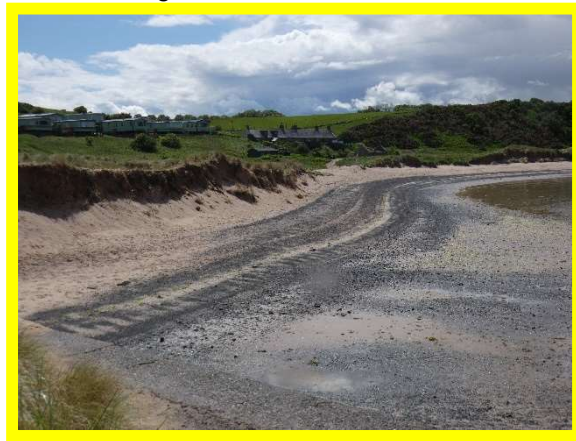
1501/C06 – continued erosion of dune 2022

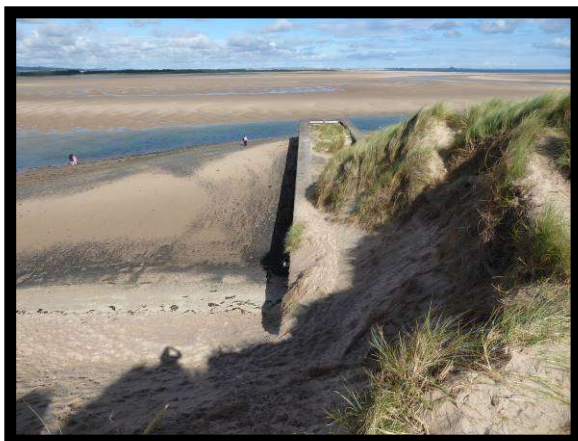
1501/C06 – South face and core of Jetty 2020

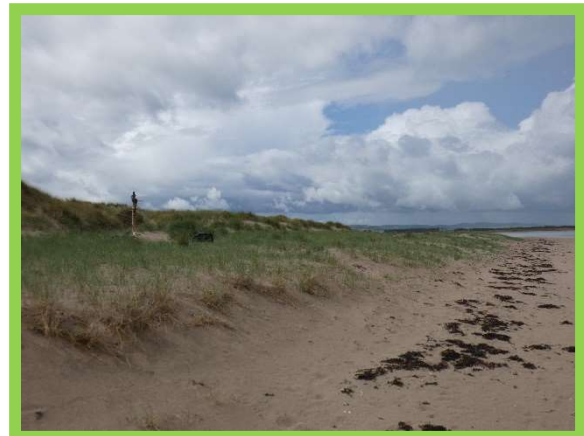
1501/C06 – Growth of embryo dunes to north face.

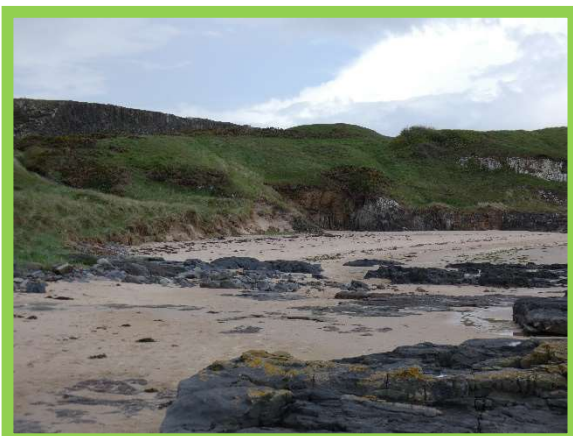
1501/C07 – areas of dune toe growth

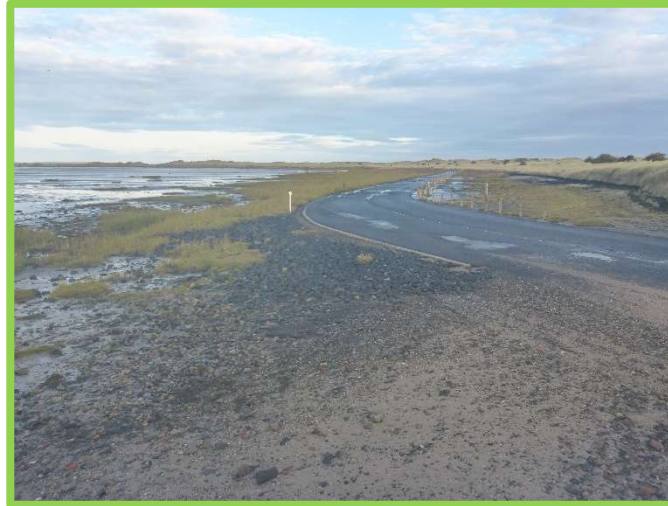
*Repaired road surface and kerb at Chare Ends in 2016 (4901c01)*

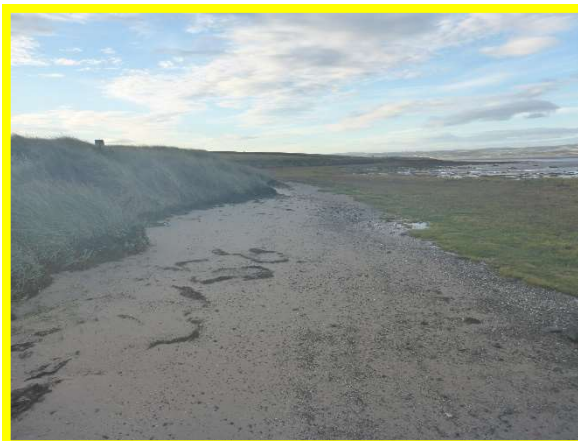
*Stable dunes approaching The Basin (/4901c02).*

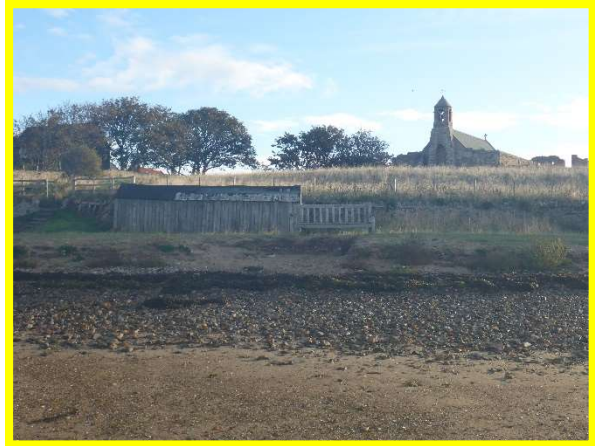
*Beach in shelter of St. Cuthbert's Isle (/4901c04).*

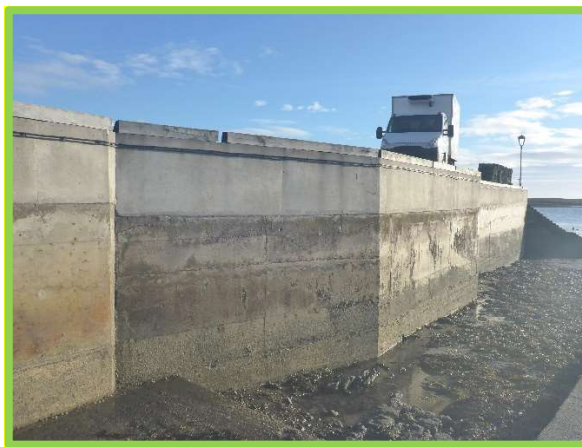
*Improvement works to harbour pier (/4901c09)*

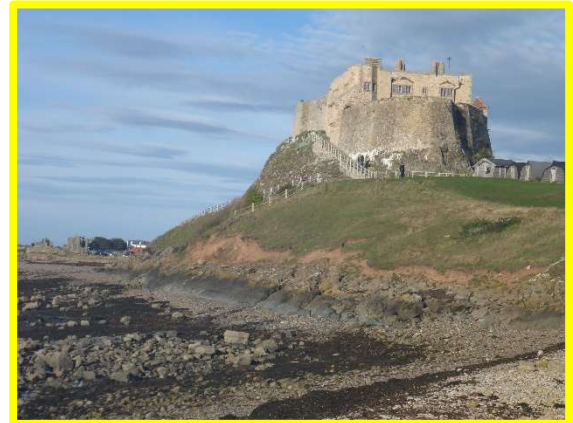
*Cliff below castle east of erosion matting (/4901c12).*

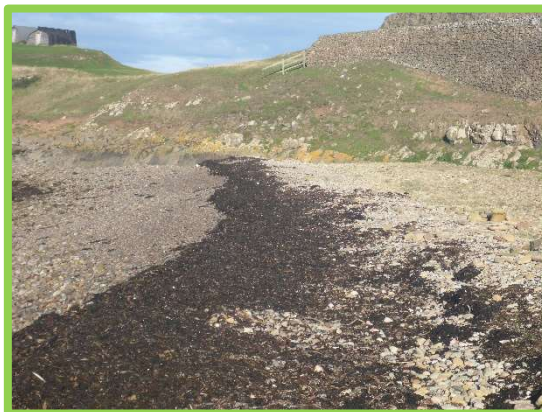
*Shingle ness at Castle Point remains in a healthy condition – south face (/4901c014)*

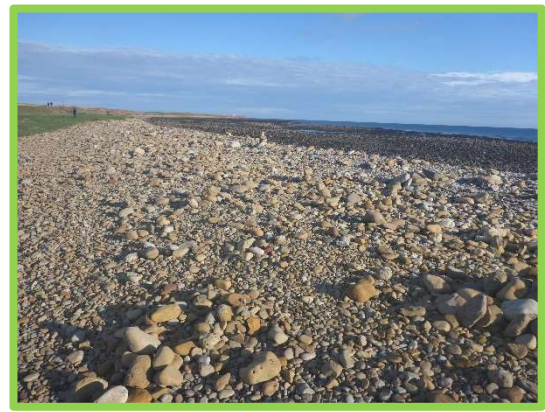
*Shingle ness at Castle Point remains in a healthy condition – north face (/4901c014)*

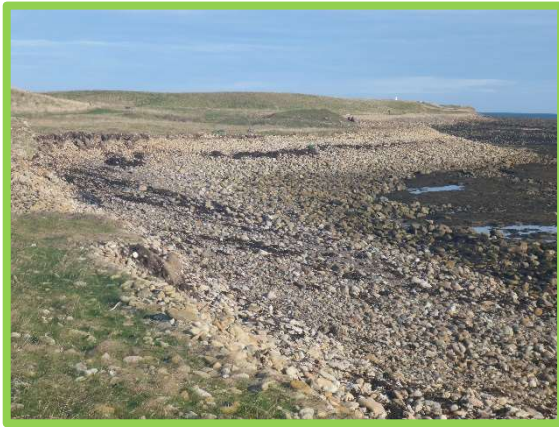
*Relatively stable shingle bay near Sheldrake Pool with washover fans (/5001c03)*

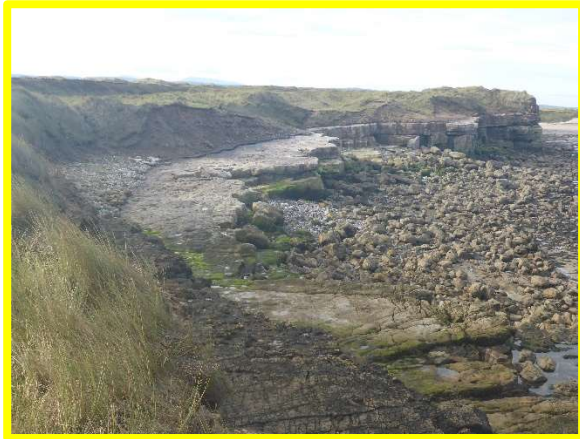
*Locally active cliffs at Nessend (/5001c07).*

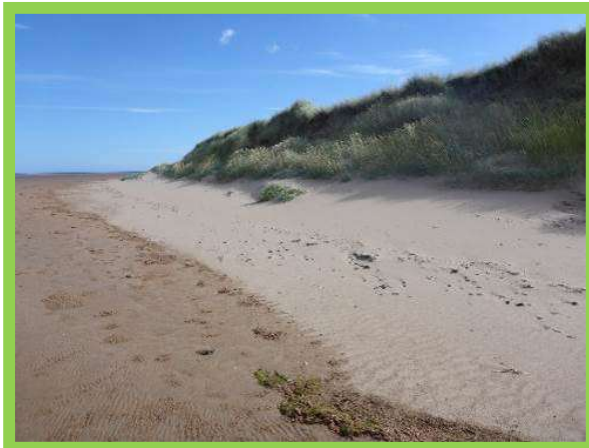
*Well vegetated dunes at Snook Point (/5001c10).*

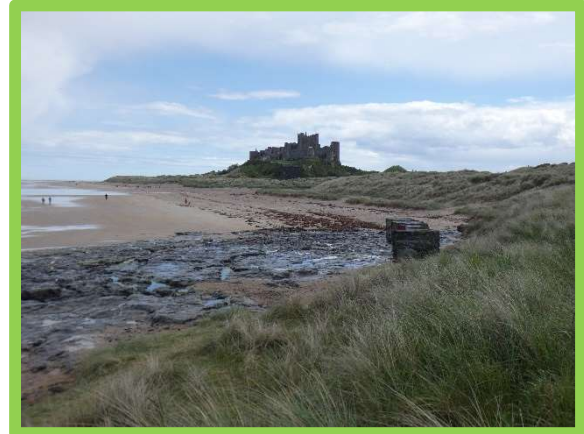
*Embryo dune growth evident just north of castle and along main dune frontage 1601/ C05. 2022*

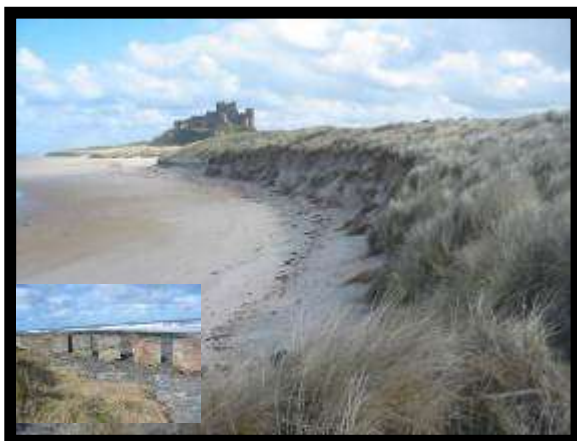
*View of the dune at “the Dice” 2006*

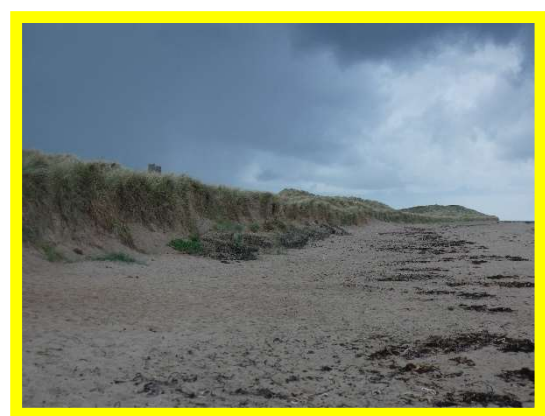
*1601/C04. 2022 showing cliffing and further erosion.*

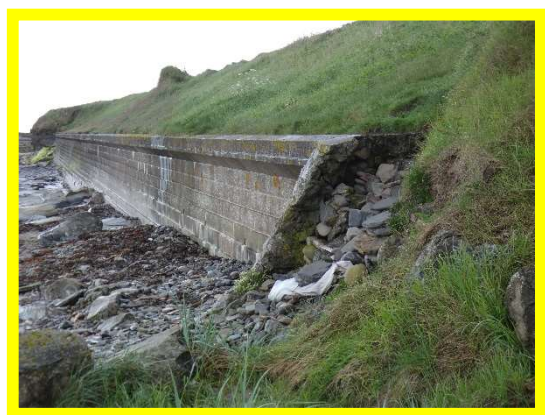
*1701/C54 – no substantial change*

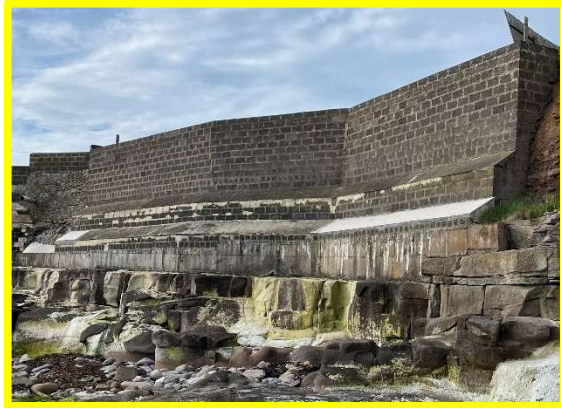
*Maintenance repair works since 2020 to concrete apron and blockwork (1701C02)*

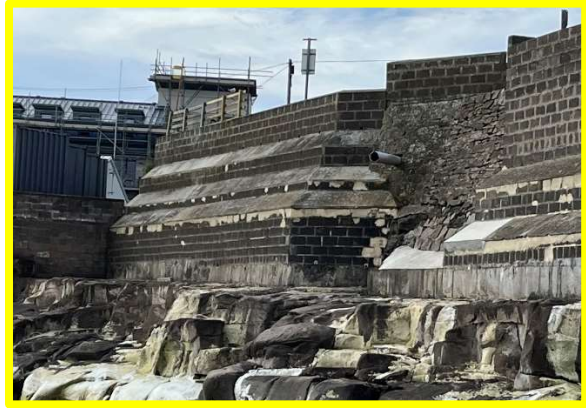
*Maintenance repair works since 2020 to concrete apron and blockwork (1701C03 and 1701C04)*

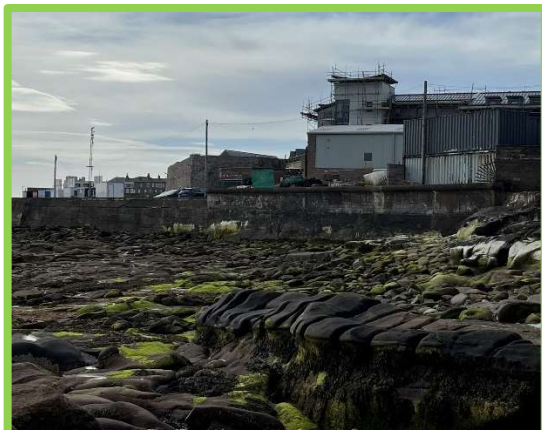
*Storage yard wall in good condition (1701C05)  
Significant cracking to parking area wall (1701C06)*

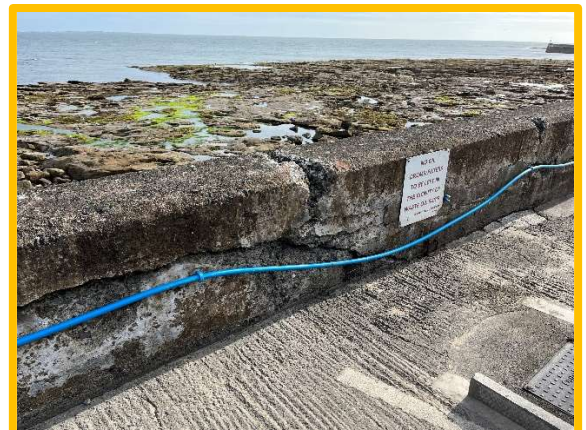
*Significant crack through parapet wall (not worsened since 2020) 1701C06*

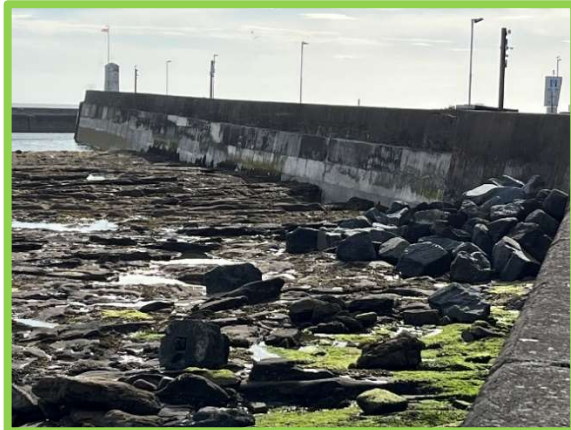
*Rock armour wave reduction and Repaired outer wall 1701C06 & 1701C07*

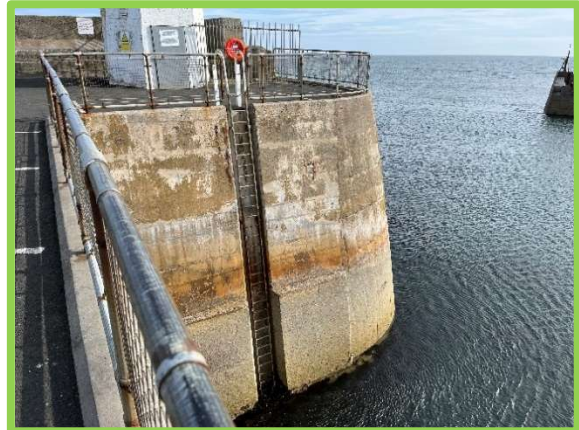
*Pier head appeared in good condition 1701C08*

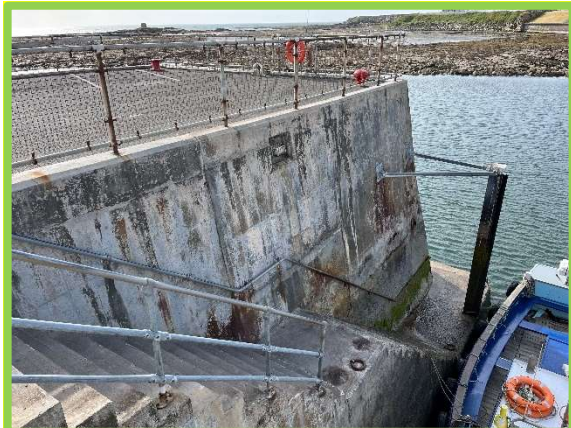
*South east corner to stub, underwater repairs not visible 1701C09*

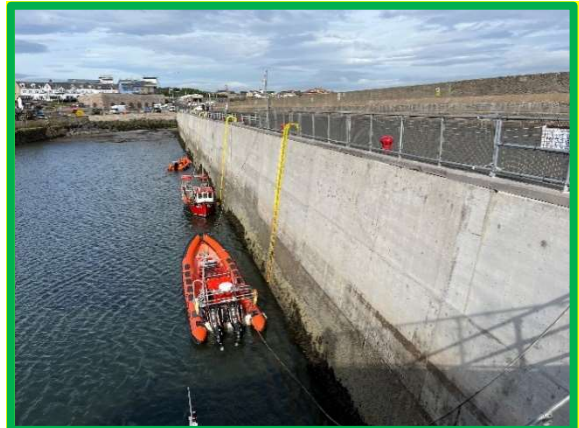
*Concrete encasement and cope repair to inner face of north breakwater. 1701C09*

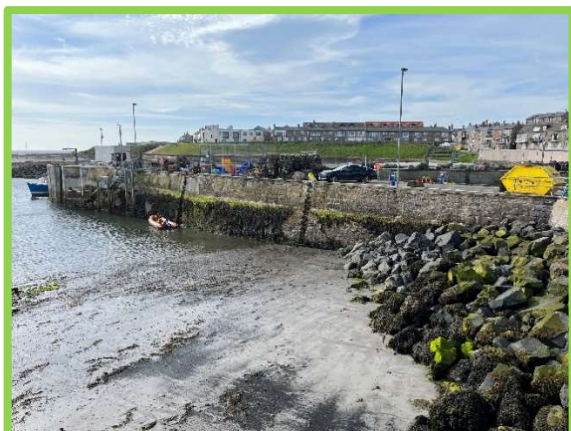
*Inner face of the Inner Pier 1701C10*

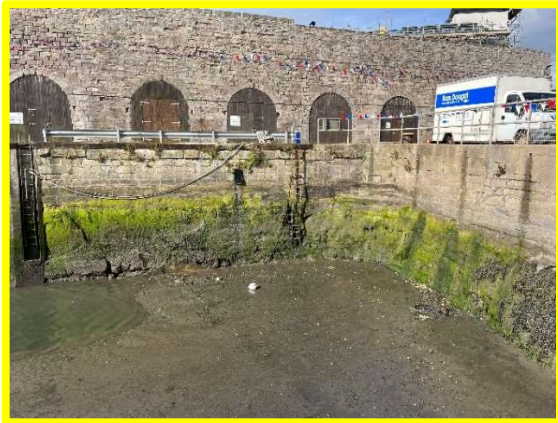
*Masonry wall in fair condition 1701C13*

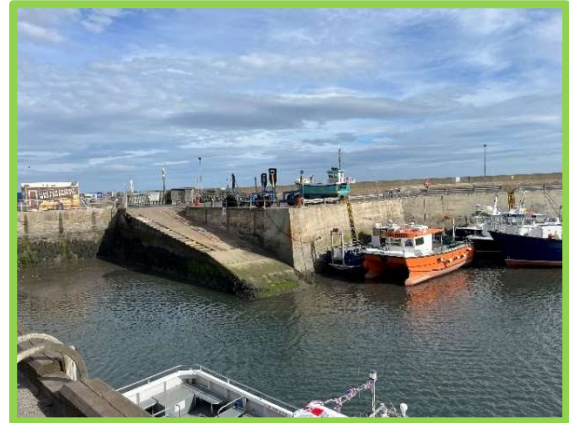
*Undercutting of slipway not visible 1701C12*

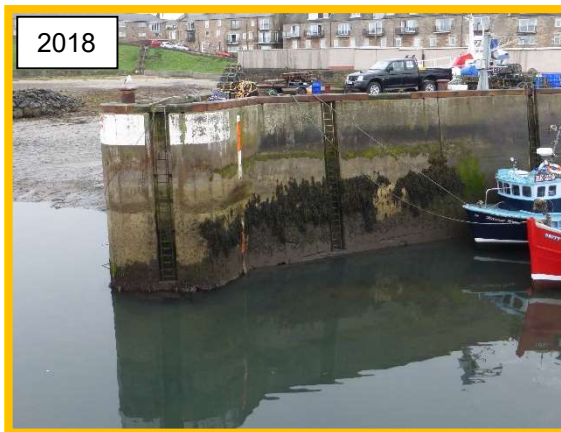
*Scour holes and possible undermining around low water mark 1701C14*

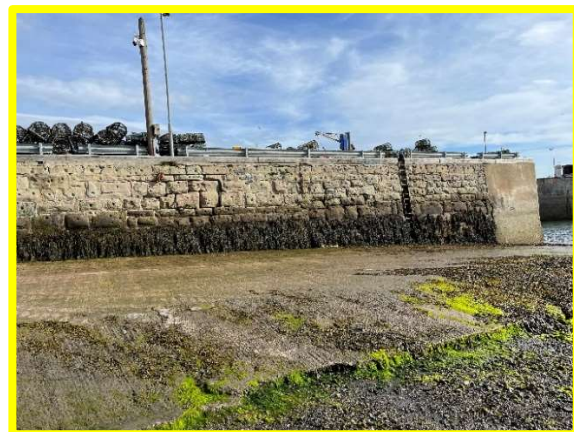
*Pock marked, abraded outer face 1701C14*

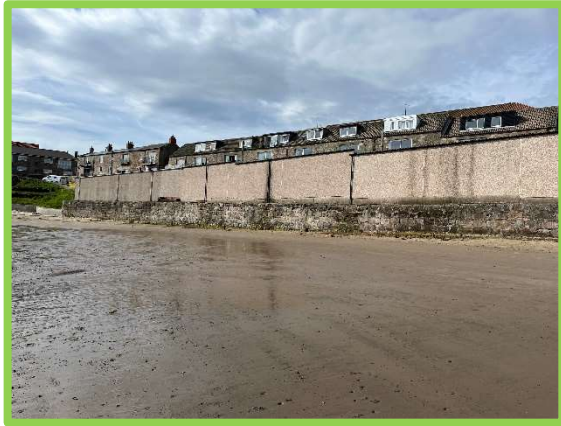
*Good condition overall – areas of fair condition where cope is breaking away with vegetation growing through (1701C15)*

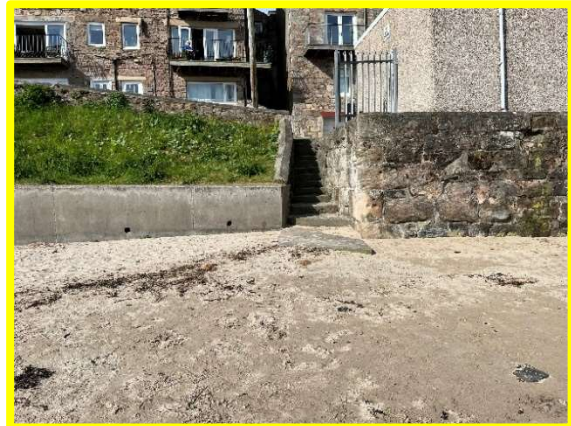
*Undercutting of toe of steps concealed (1701C16)*

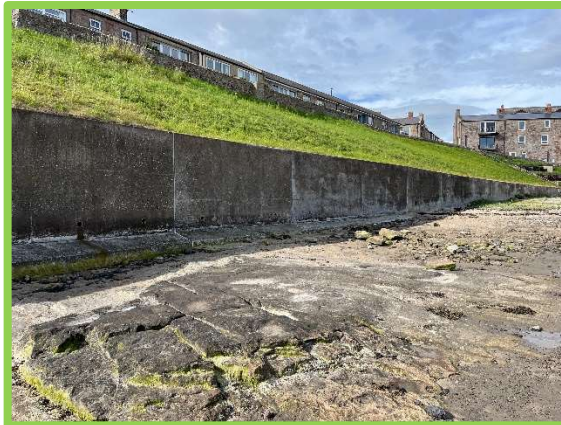
*Wall and slope in good condition (1701C17)*

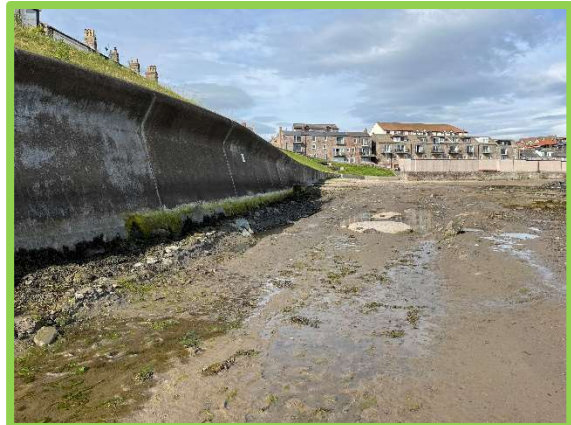
*Wall and slope in good condition (1701C18)*

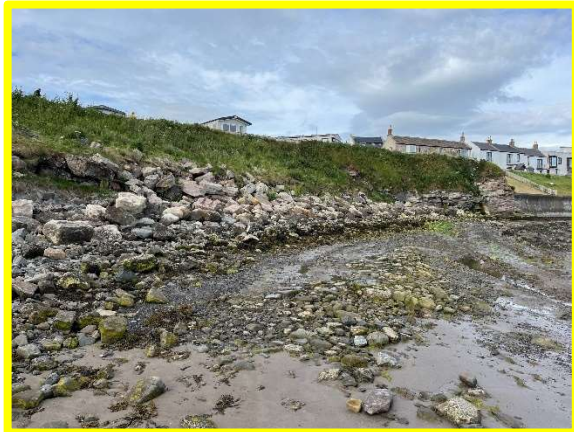
*Tipped rubble slope (1701C19)*

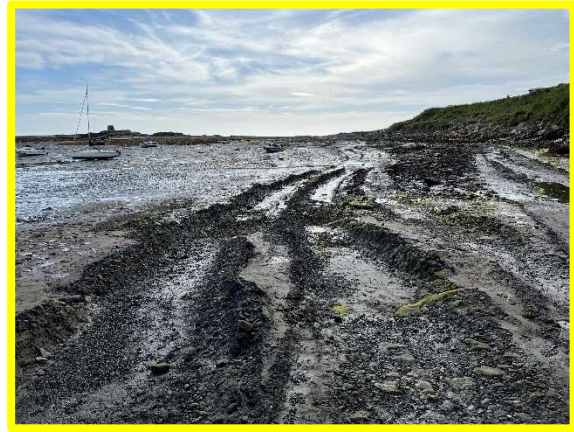
*Heavily rutted foreshore fronting rubble (1701C19)*

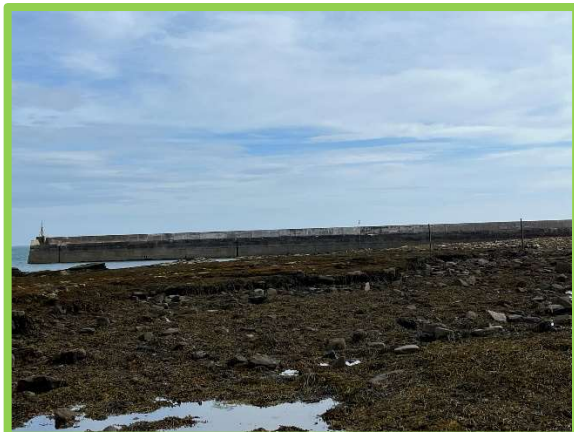
*Damage to the cope stones noted – Inspection from afar only (1701C21)*

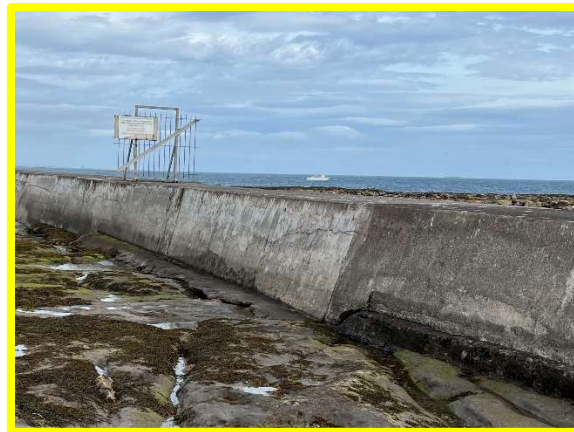
*Horizontal cracking to seaward face (1701C20)*

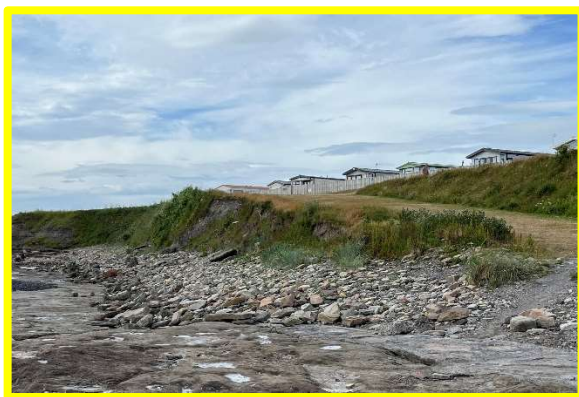
*Eroding access ramp (1701C22)*

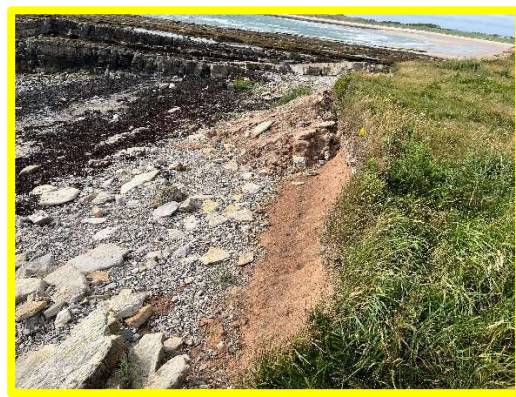
*Slumping of cliff material adjacent to Long Sea Outfall (LSO) (1701C22)*

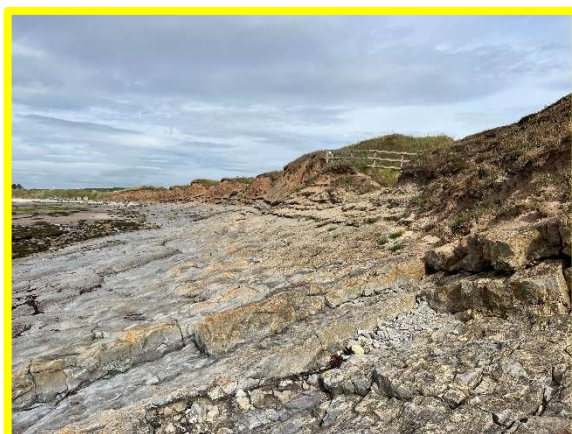
*Narrowing and retreat of ridge 1701C23*

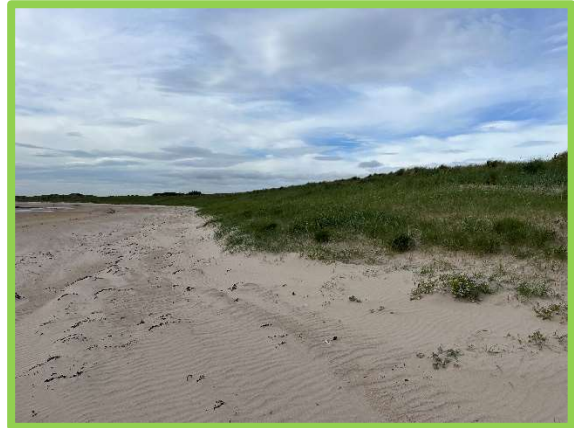
*Embryonic dune growth to the south of Annstead Burn (1701C23)*

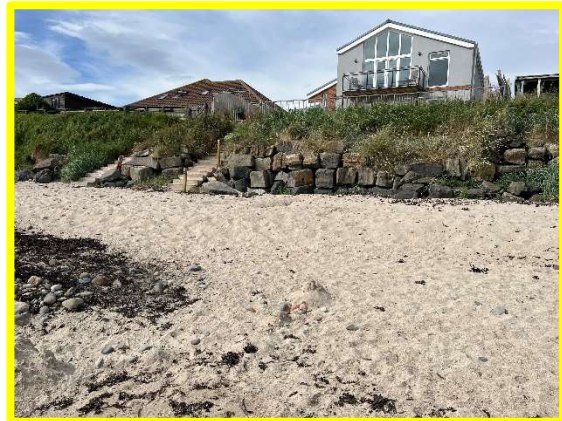
*Informal rock armour fronting properties at Beadnell Haven (1701C24)*

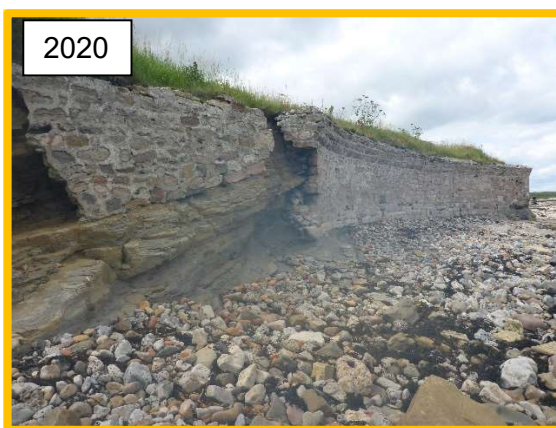
*Masonry blockwork wall in poor condition. (1701C25)*

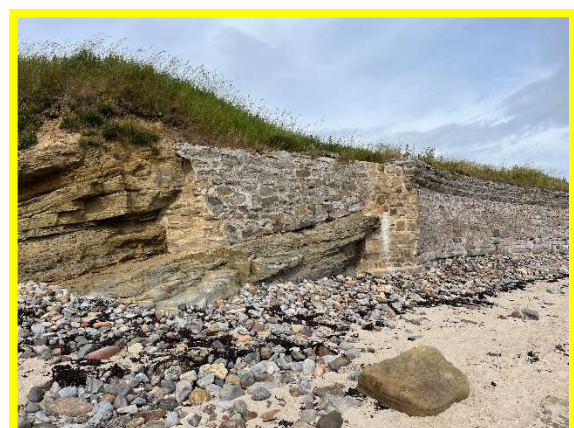
*Masonry blockwork wall repaired in 2022 (1701C25)*

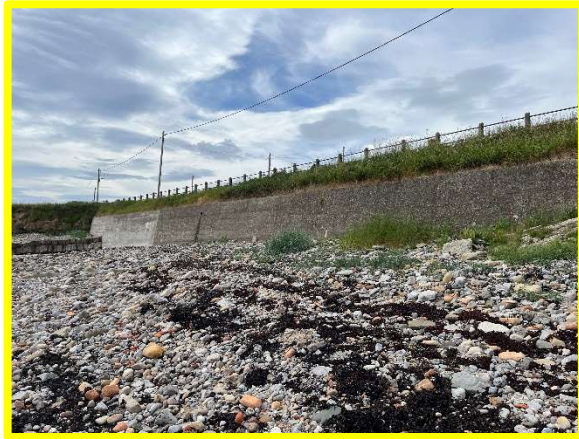
*Fair classification of wall north of Dell Point, minor outflanking at southern end (/1701C27)*

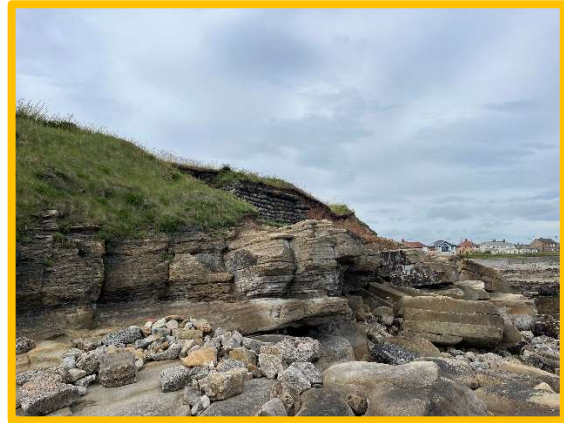
*Ongoing erosion of cliffs around Dell Point (/1701C28)*

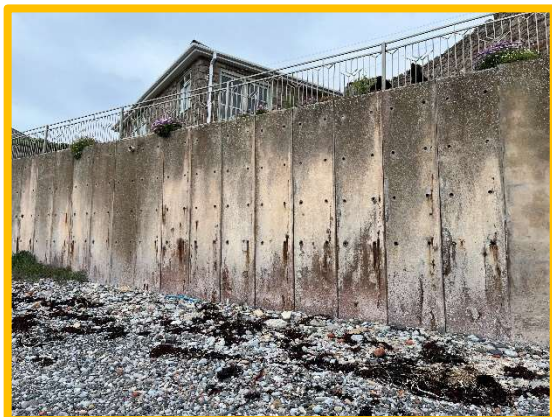
*Precast vertical seawall in poor condition locally (/1701C31)*

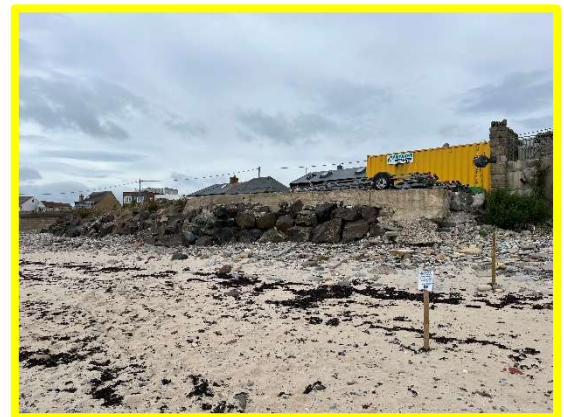
*Concrete cast onto the crest of the revetment to provide flat storage area ( /1701/C32)*

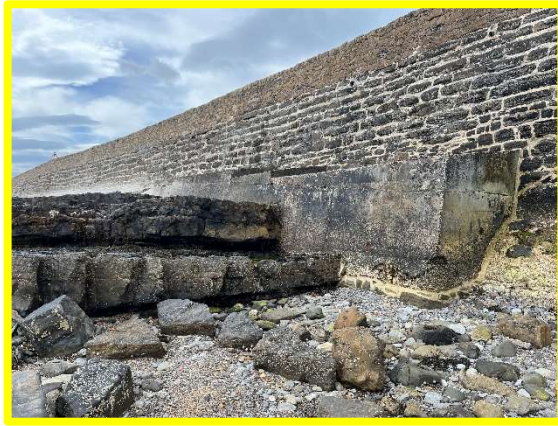
*Repaired undermining of seawall at Beadnell North (Nacker's Hole) (1701C36)*

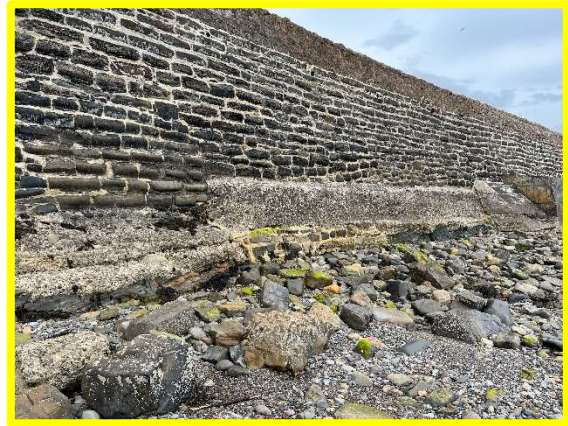
*Repaired section of abraded concrete toe at Beadnell North (Nacker's Hole) (1701C36)*

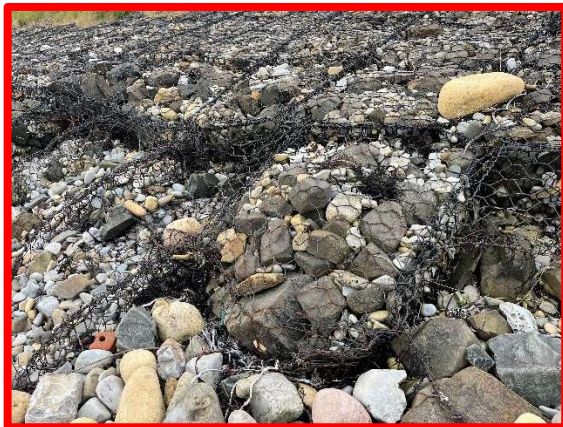
*Failed mattresses at Beadnell North (Lady's Hole) (1701C39)*

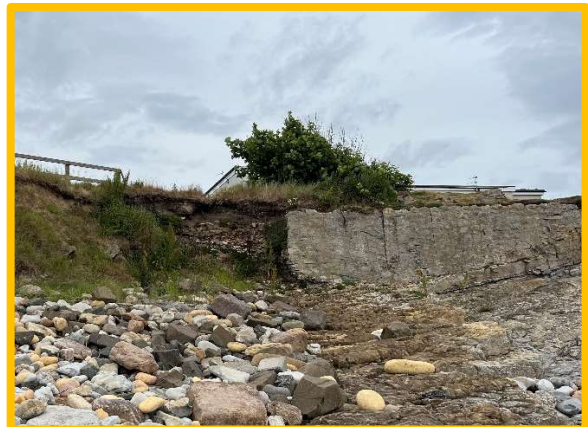
*Outflanking of wall to north of gabions (1701C38)*

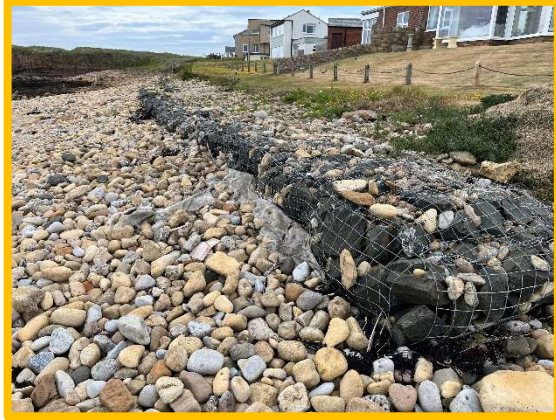
*Damage to gabion basket wall at (Lady's Hole) gabion wall – partially submerged to high sediment levels. (1701C40)*
