## **Cell 1 Regional Coastal Monitoring Programme Walkover Inspection Surveys 2022**

**Northumberland  
County Council**

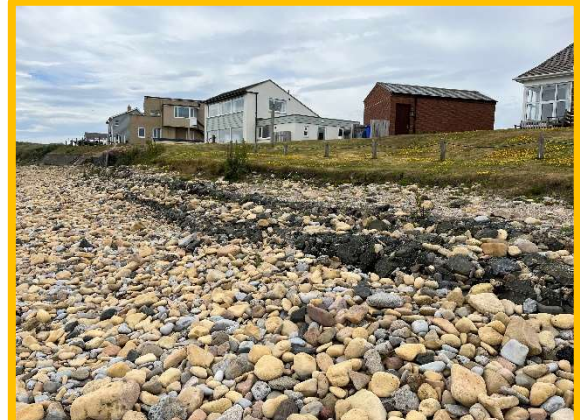
*Erosion bypassing the gabion baskets (1701C40)*

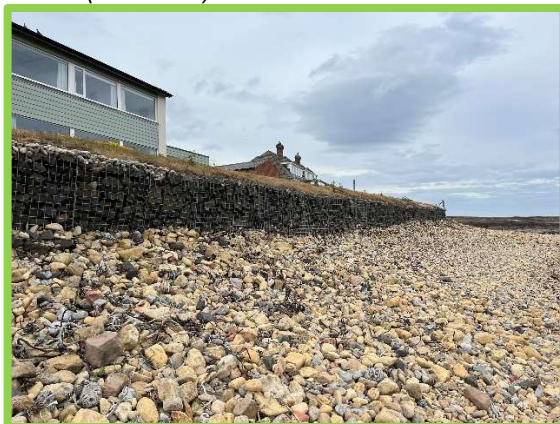
*New gabion basket wall in good condition. (1701C41)*

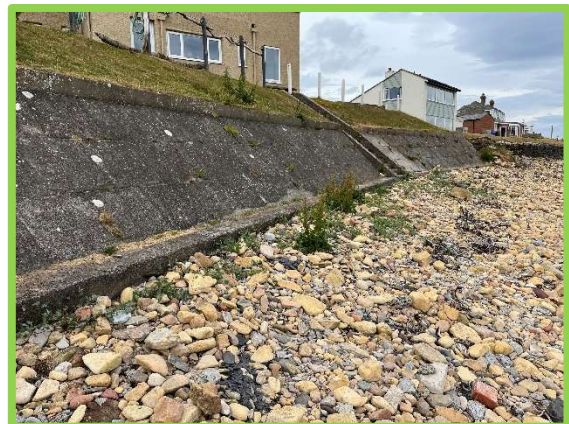
*Concrete revetment in good condition, evidence of grout repairs at southern end (1701C42)*

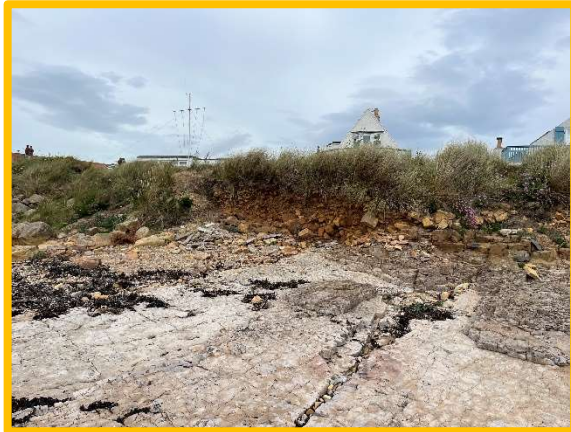
Ongoing erosion to slopes fronting properties (1701C44)

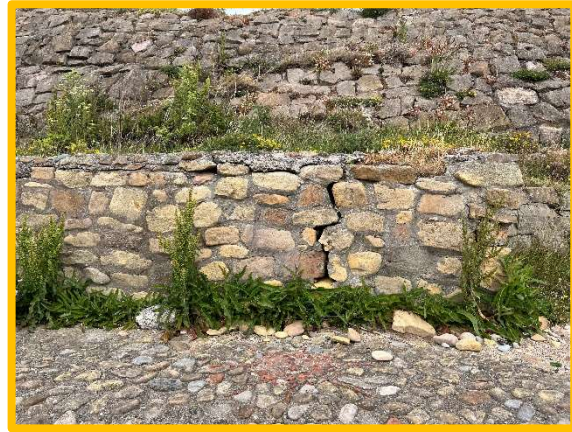
Significant cracking to the stone terraced structure (1701C45)

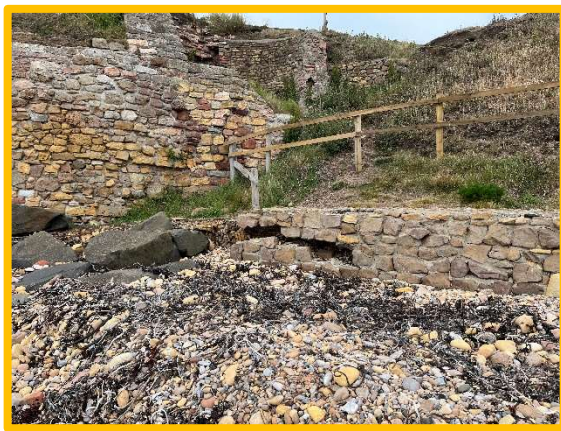
Damage to retaining wall adjacent lime kiln. (1701C45)

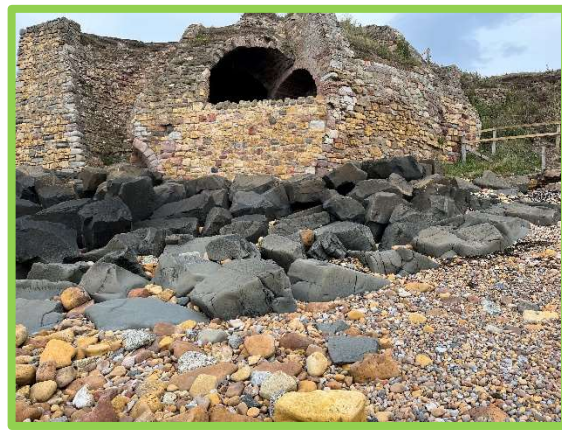
Rock revetment in good condition (1701C46)

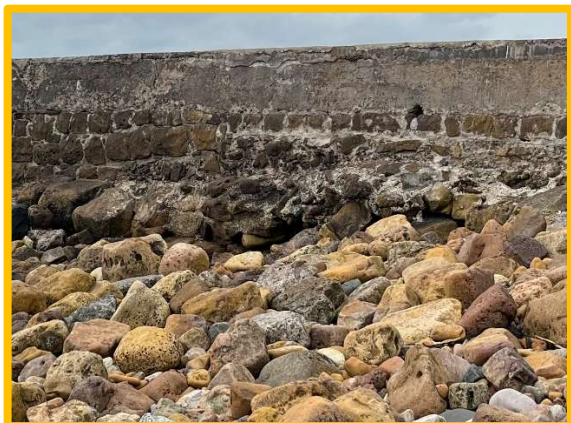
Potential voiding beneath outer face of pier adjacent to rock armour (1701C47)

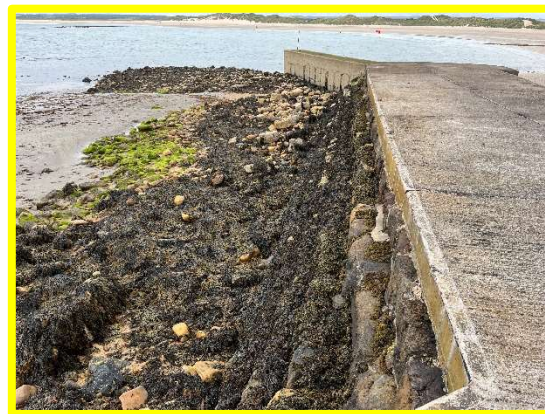
Seaward face appears in fair condition (1701C50 & 1701C51)

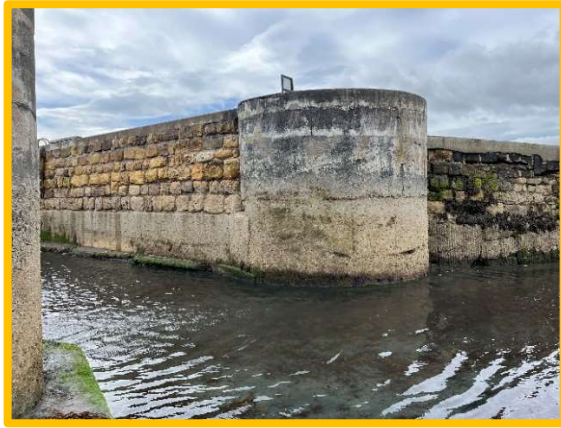
*Undermining of Beadnell Harbour wall (inner face of southern wall) (/1701C51)*

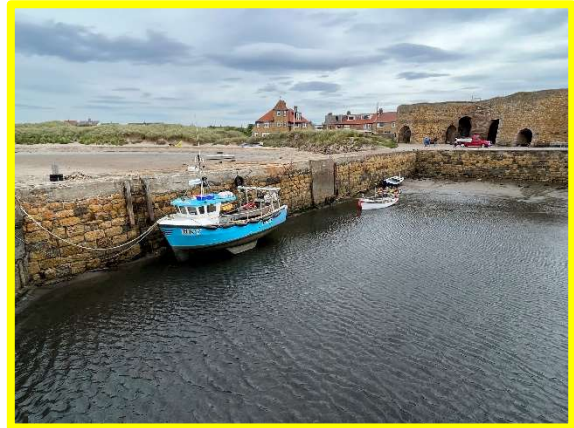
*Missing blocks at Beadnell Harbour wall (inner face of northern wall) (/1701C52)*

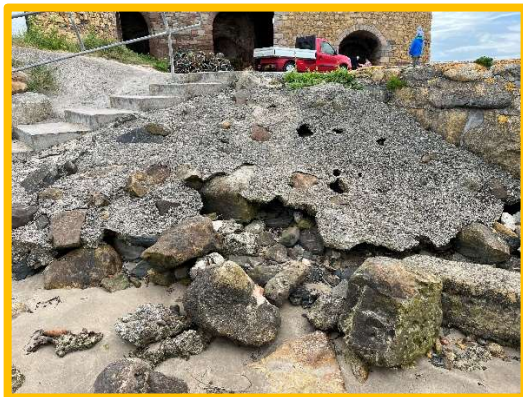
*Undermining and partial collapse of grouted stone revetment adjacent access steps. (/1701C53)*

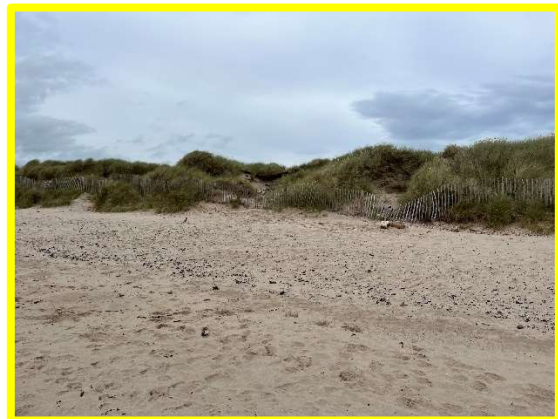
*Timber beach fence in Beadnell Bay to control access (/1701C53)*

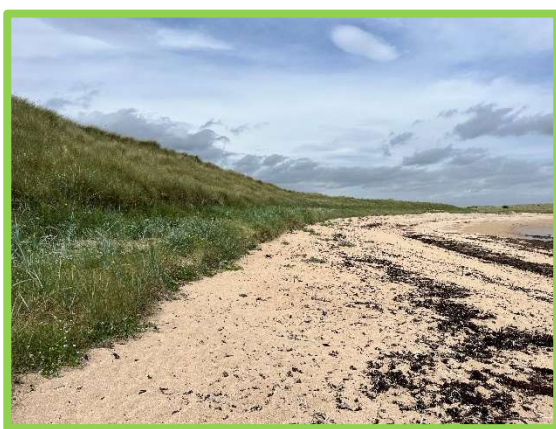
*Stable dunes in Football Hole 1901C02)*

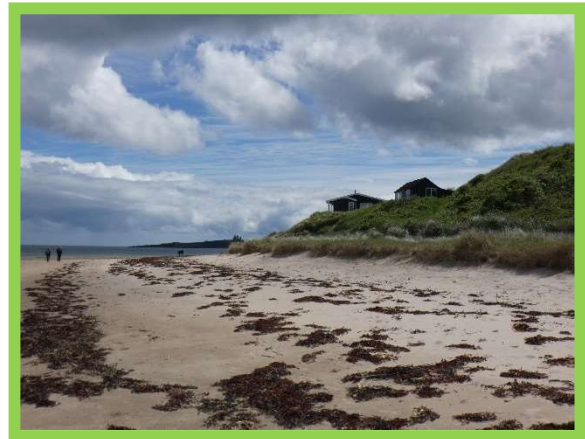
*2001/C03 stable 2022*

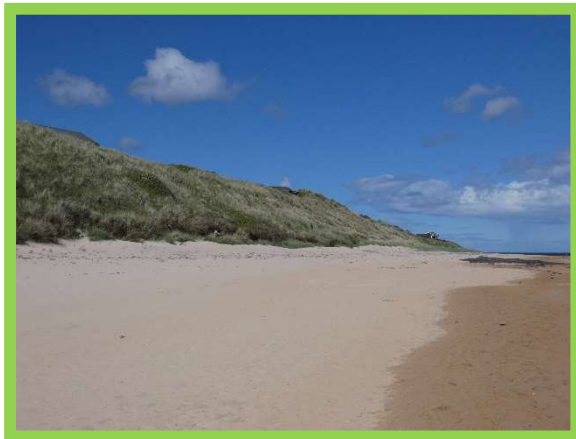
*2001C04 2022 higher upper beach*

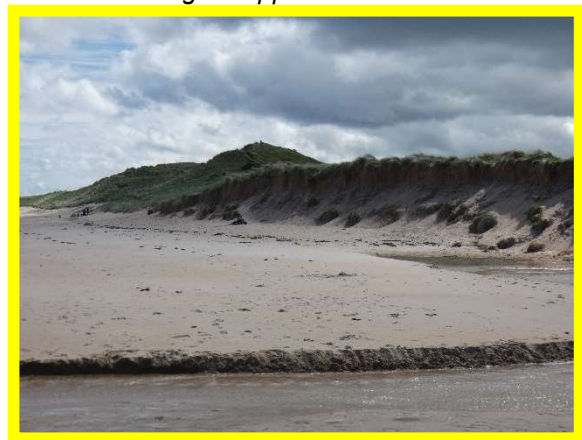
*2001C04 2022 local but significant erosion due to configuration of the outfall channel*

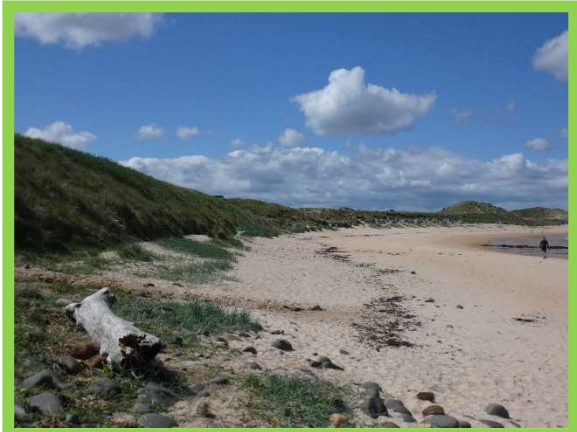
*2001/C04 embryo dune growth to southern end*

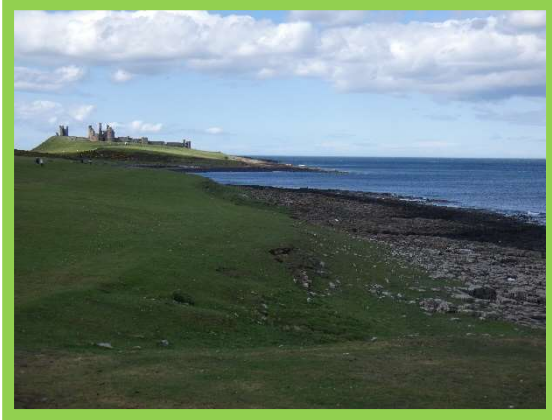
The gentle coastal slopes from Dustanburgh Castle to Craster Harbour are well protected by a shingle/ boulder/ rock outcrop foreshore and are generally in good condition.

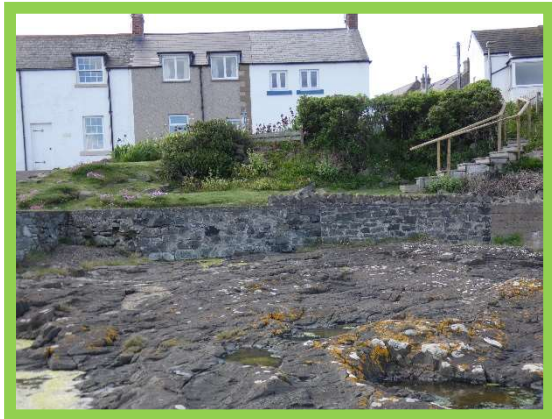
To the north of the Craster harbour, the low wall remains in fair condition and there has been no further erosion around the outfall manhole.

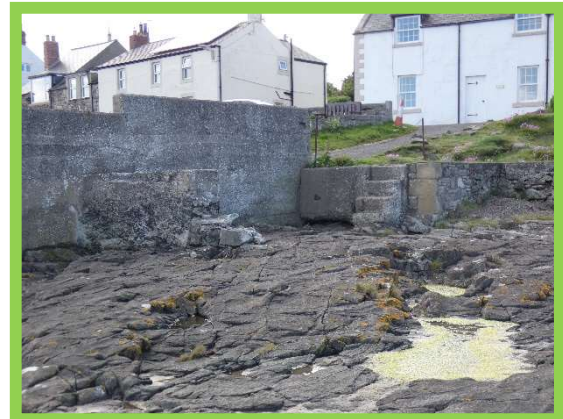
Wall and start of Pier (/2201C02 / C03)

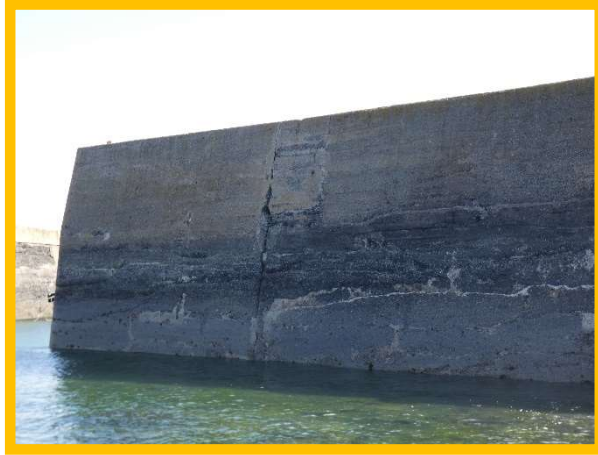
2201C03 Crack in north pier. No change

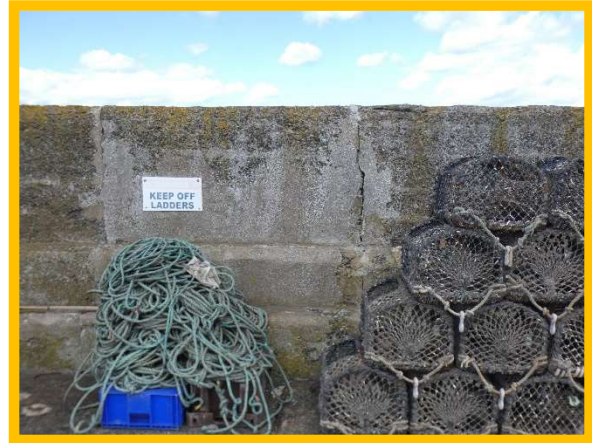
2201C03 Inside face (crest wall) at crack

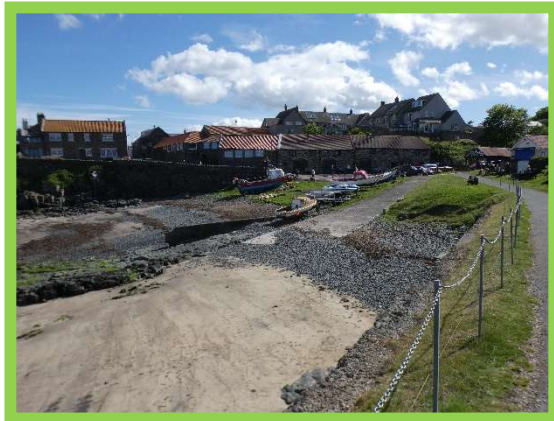
2201/C07 Slipway no change

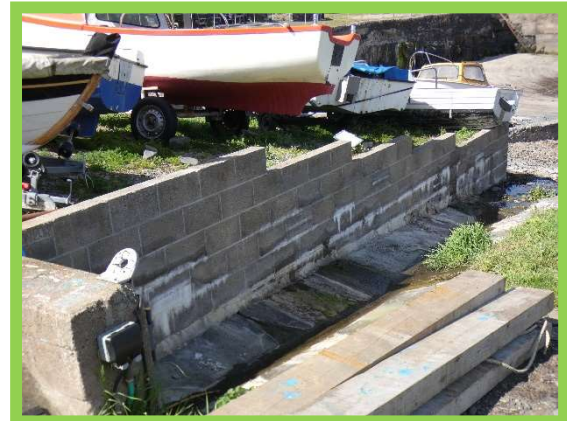
2201/C06 Blockwork wall

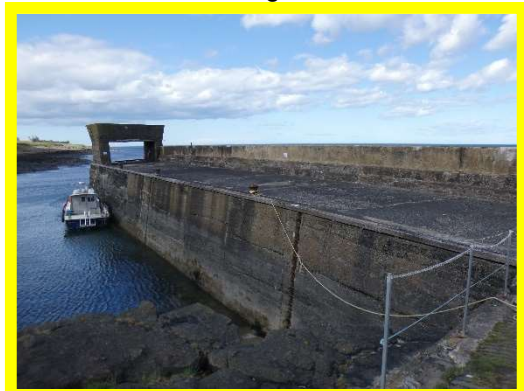
201/C10 no significant change

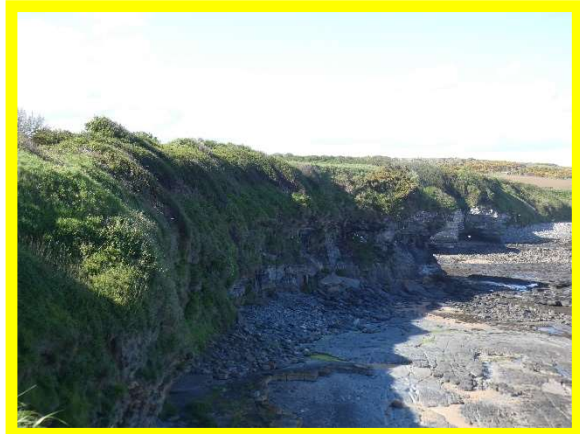
2401/C01 slow undercutting of cliff

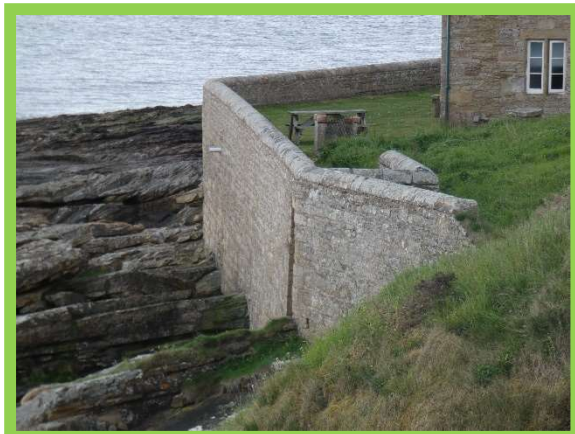
2401/C02 Bathing House wall

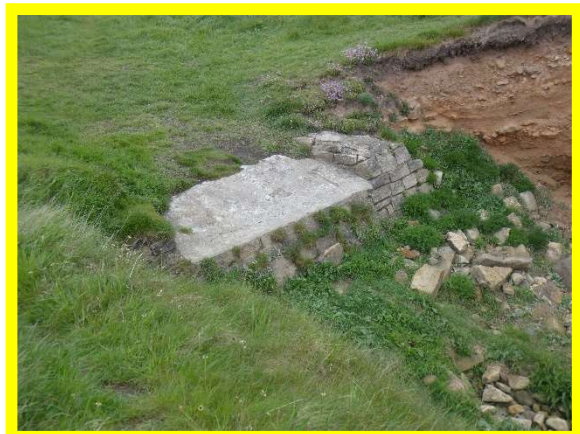
2401/C02 outflanking of local masonry wall to south of Rumbling Kern. No worse than 2020.

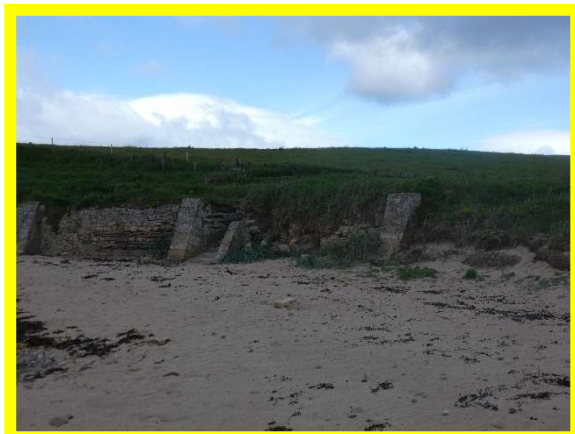
2501/C01 series of masonry walls to coastal path.

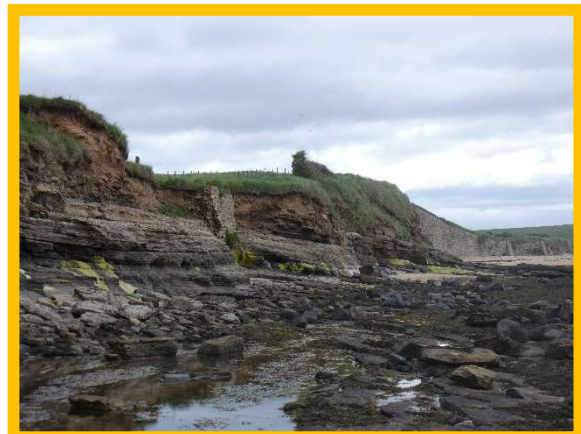
2501/C01 masonry wall in poor condition being outflanked.

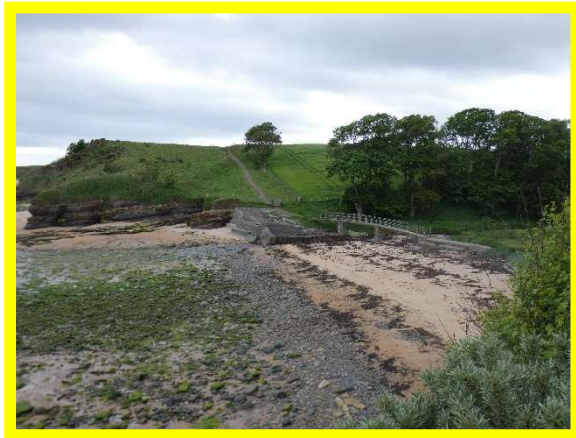
*2501/C01 Undermining of concrete at southern bridge abutment. However limited deterioration since 2020.*

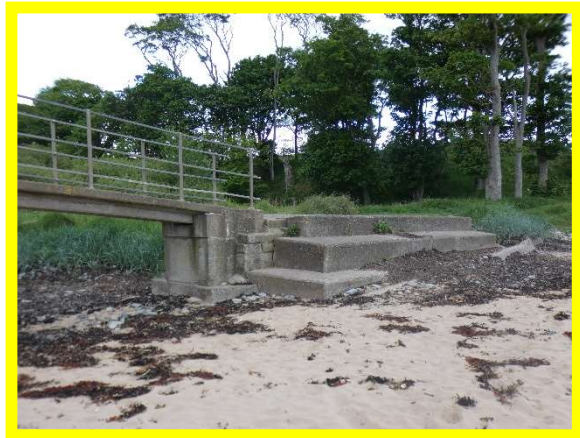
*2501/C01 lower beach levels around supports to northern side..*

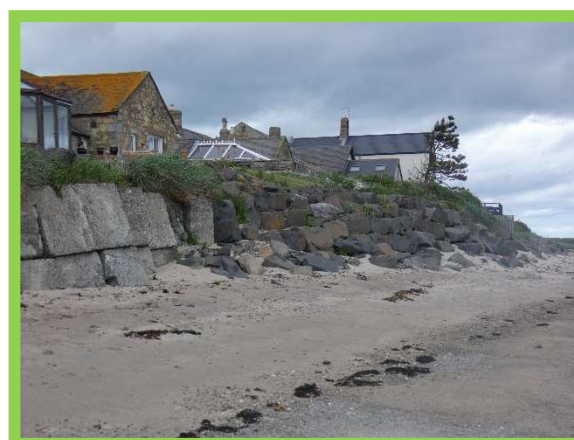
2601/C05 (blocks) and C04 (rock), no change

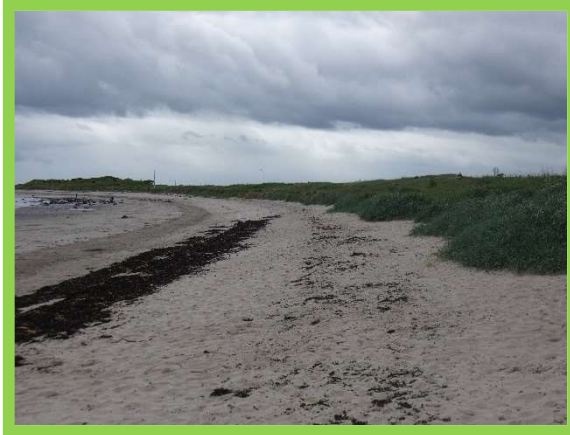
*2601/C06 dunes with toe growth since 2018*

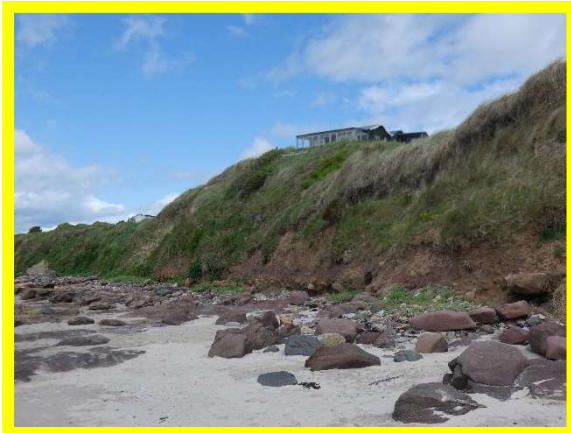
2601/C08 continuing erosion

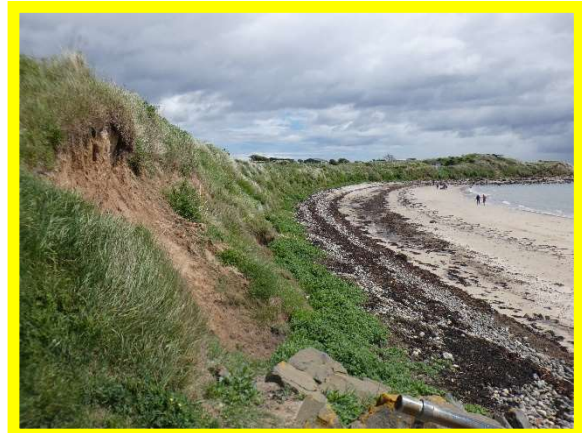
2601/C08 more substantial shingle beach

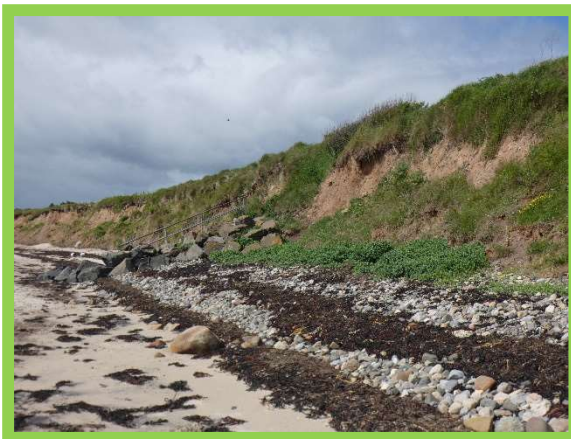
2601/C09 2022 higher shingle levels

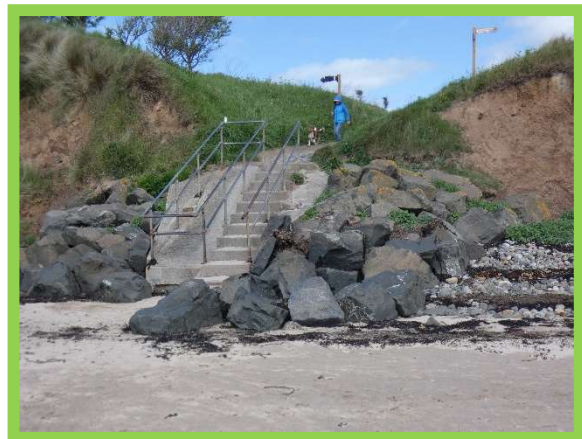
2601/c09 slightly lower sand beach to steps.

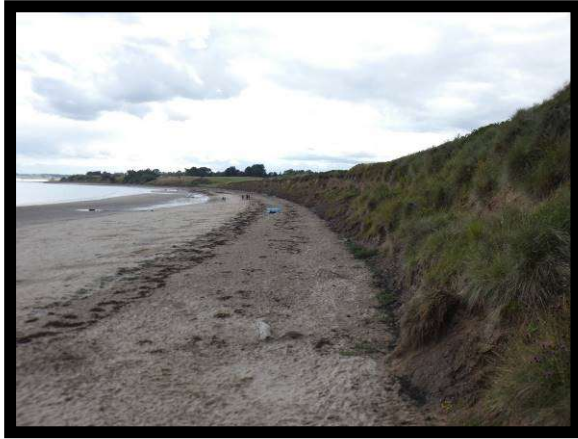
*2701/C01 Eroding cliff to golf course 2020*

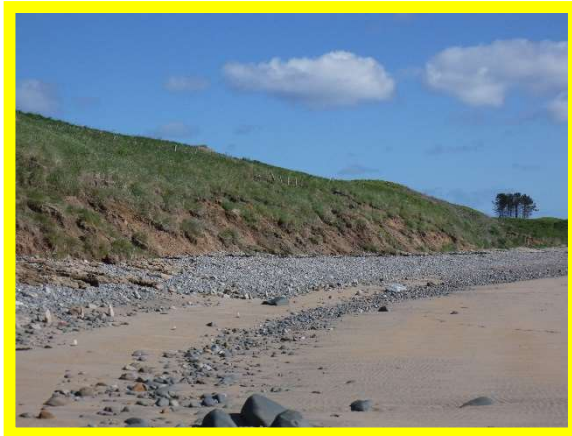
*2701/C02 some slope failure continuing since 2018*

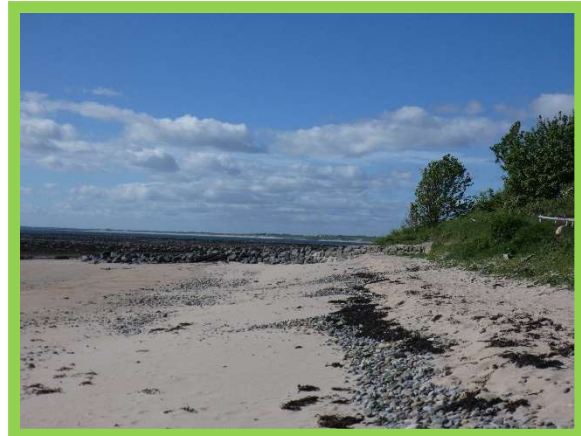
*2701/C03 Timber breastwork and low masonry wall fronting property*

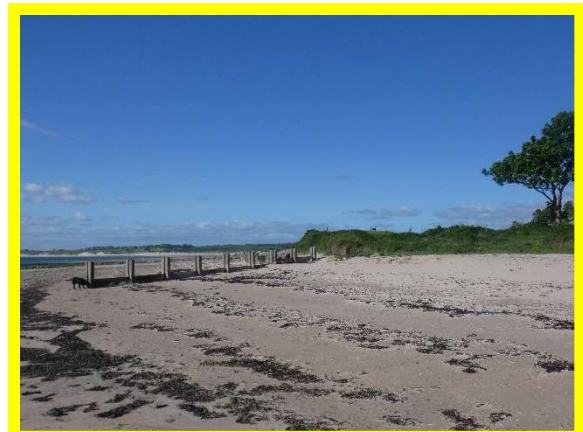
*2701/C04 Slightly higher upper beach but lower foreshore 2022.*

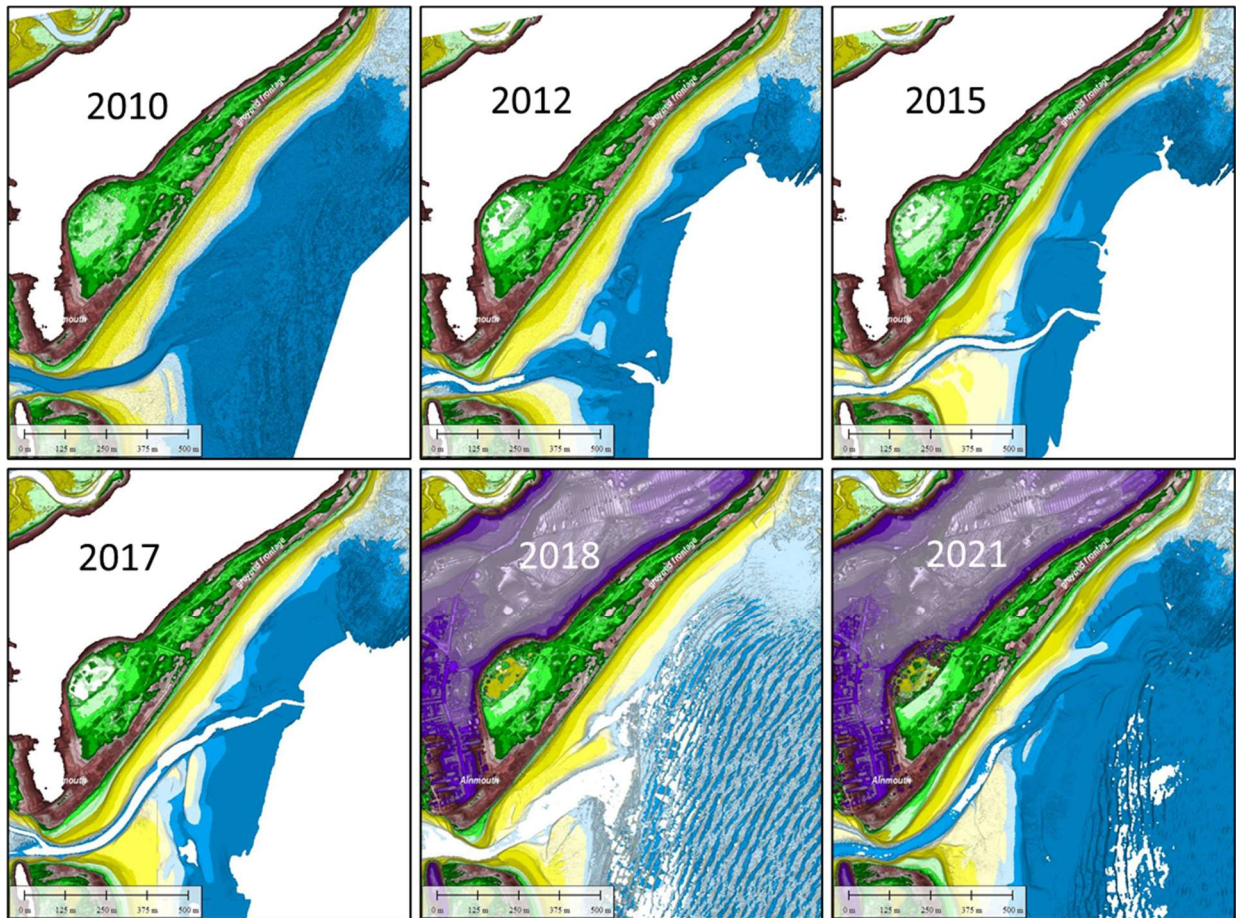
*Change in beach shape over the whole frontage.*

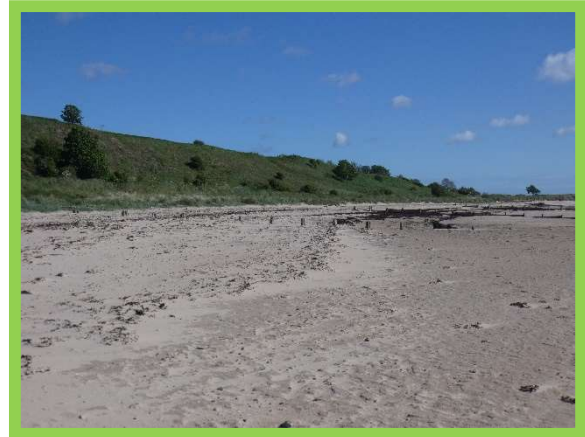
*2701/C05 slight growth in general foreshore to south.*

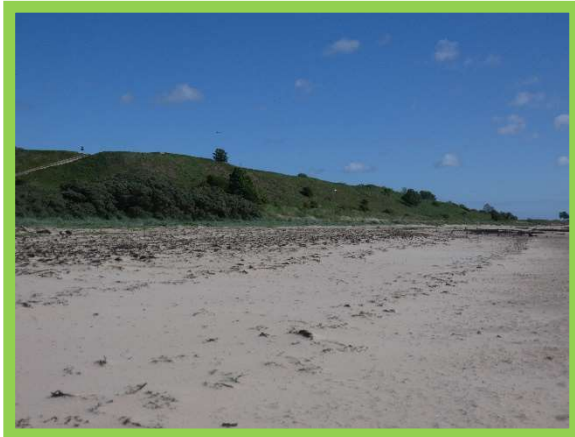
*2701/C06 northern, concrete blocks buried.*

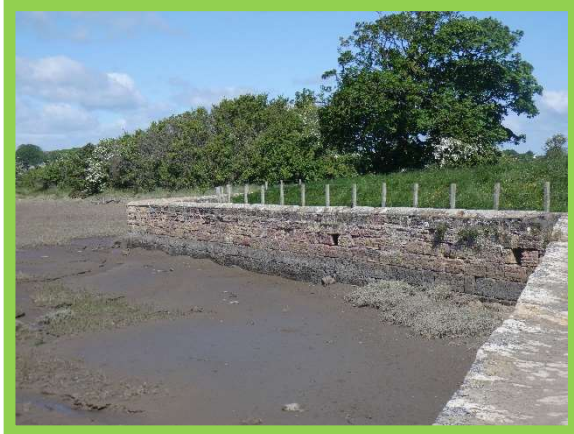
*2801/C06 Masonry wall fronted by salt marsh, no change*

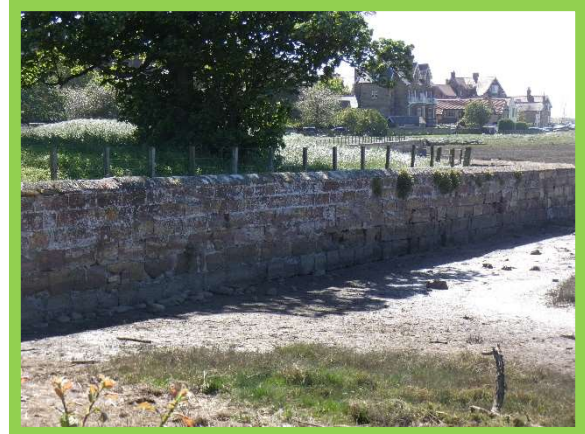
*2801/C06 Masonry wall fronted by salt marsh, no change*

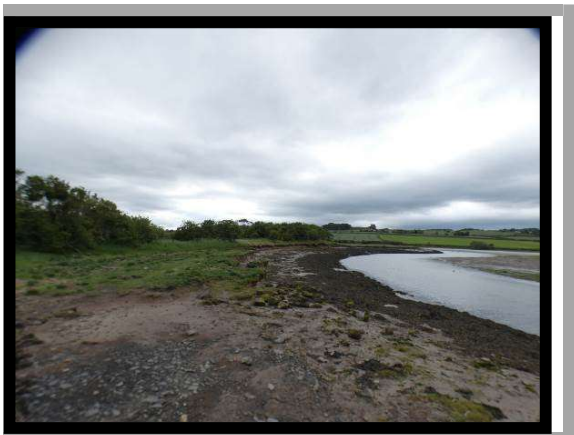
*2801/C09 Eroding face of raised area in 2018*

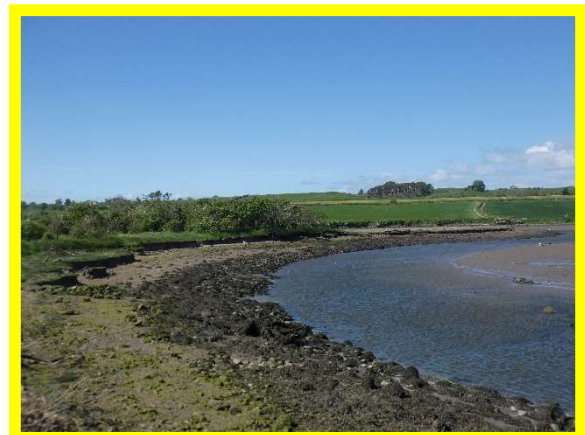
*2801/C09 increased erosion 2022*

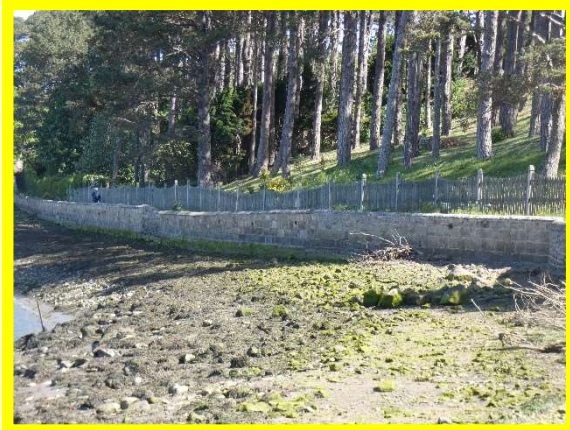
*2801/C10 Local undercutting of concrete toe to repaired section*

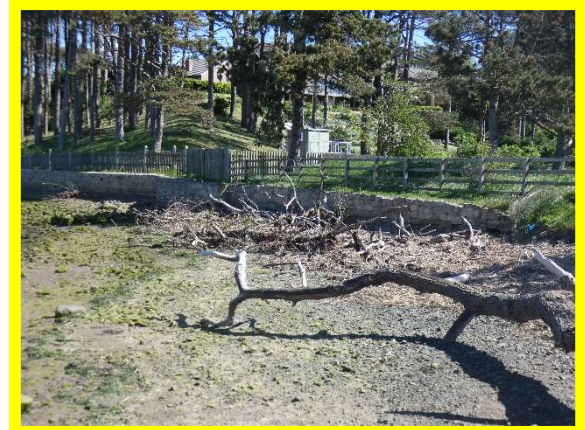
*2801/C10, slight damage to downstream end.*

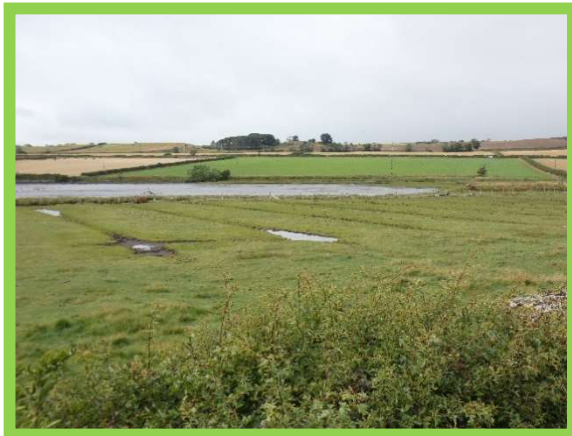
*Area of managed realignment (/2801C11)*

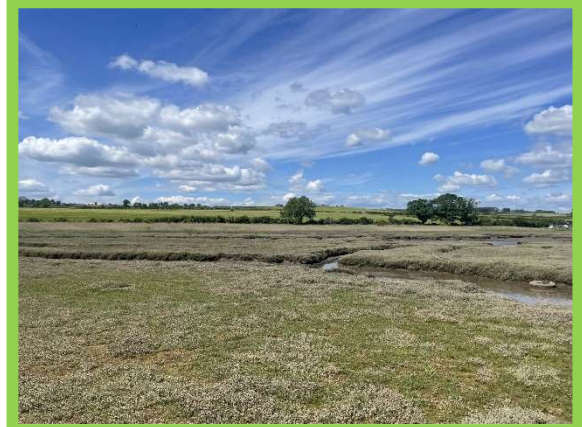
*Healthy saltmarsh (/2801C12)*

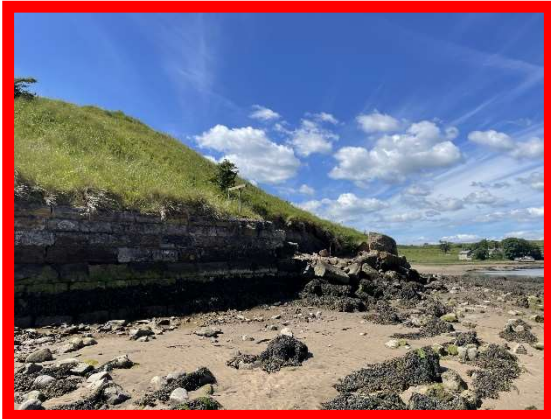
*Collapsed section of wall at Church Hill with erosion of the land behind (/2801C13)*

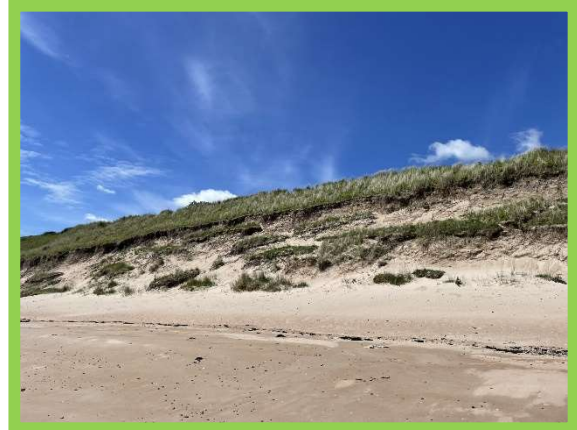
*Slumping of dunes following winter 21/22 storm damage along Alnmouth Dunes frontage (2901C01)*

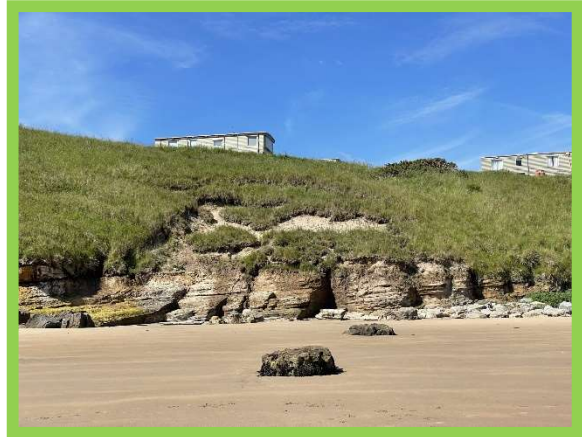
*Localised slip at Birling Carrs (2901C02)*

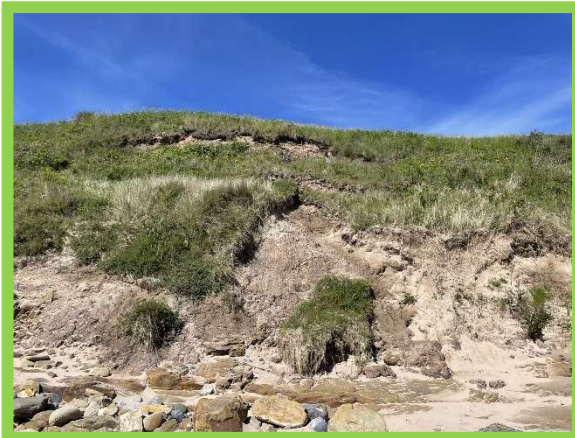
*Warkworth Dunes with some localised slumping (/2901C02)*

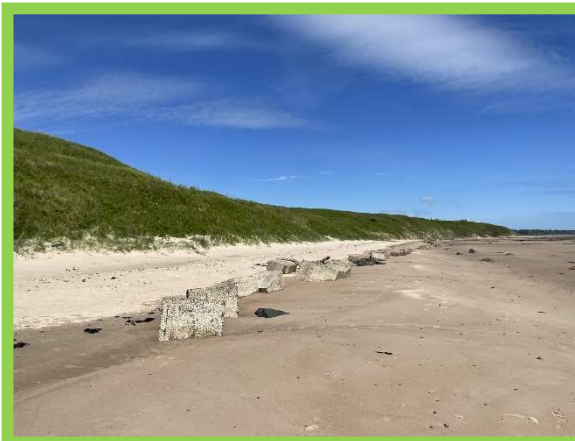
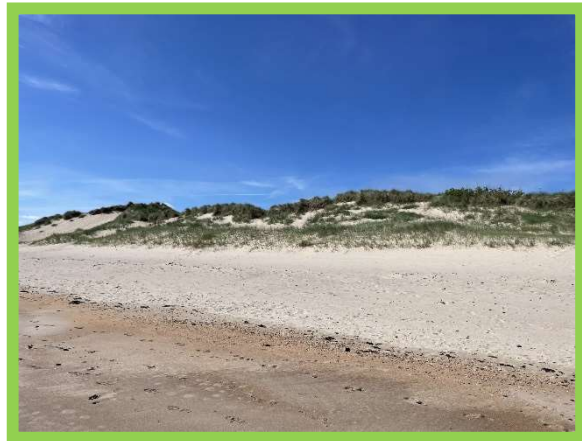
*Dunes protected by tank blocks, some recovery (/2901C02)*

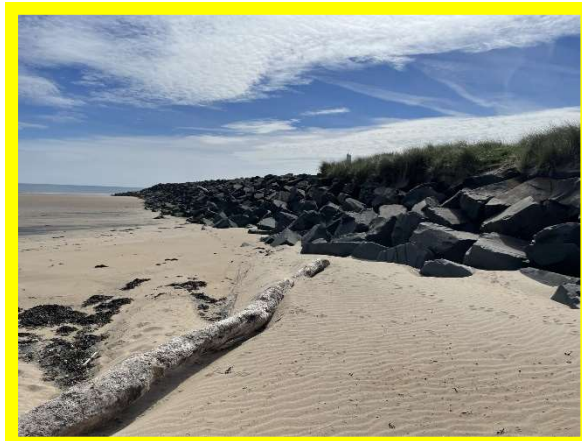
*Rock armourstones on north face of North Pier (/3001C01)*

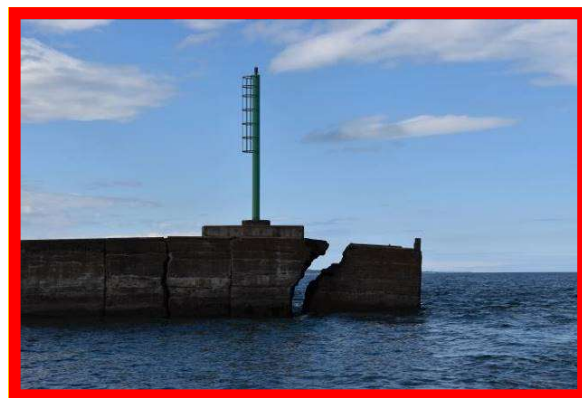
*Seaward end of North Pier in very poor condition (/3001C02)*

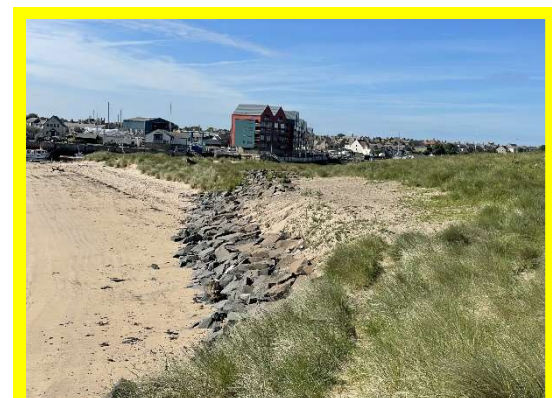
*Revetment and dunes along wide spending beach in lee of North Pier (/3001C04)*

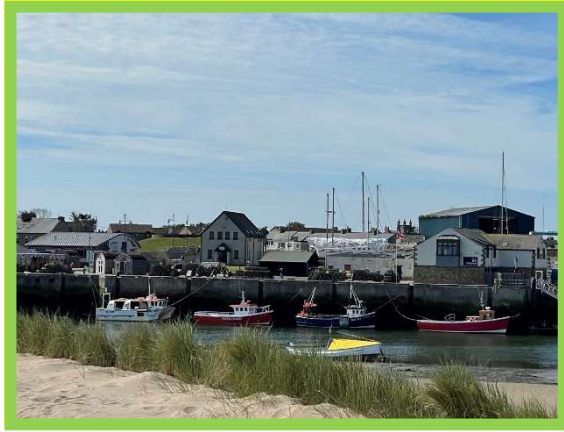
*Quay wall in good overall condition (/3001C05)*

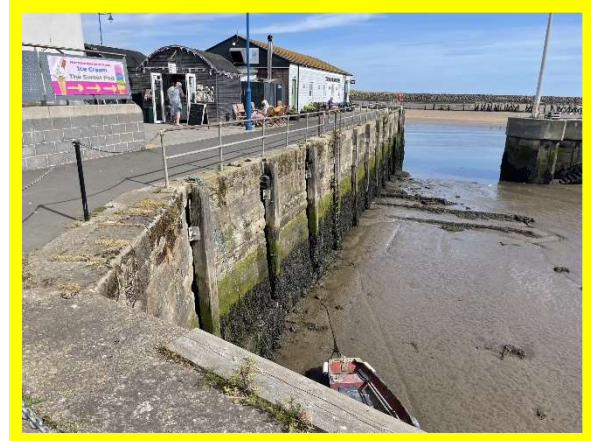
*Dock basin in fair overall condition (/3001C06)*

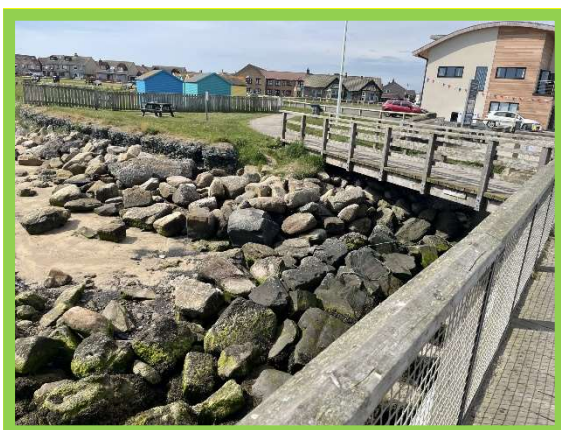
*Rock and boulders provide additional erosion protection at root of linkspan bridge (/3001C07)*

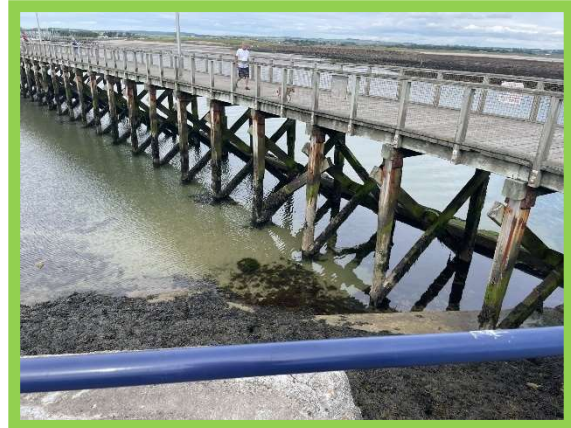
*Good condition of South Jetty (/3101C11)*

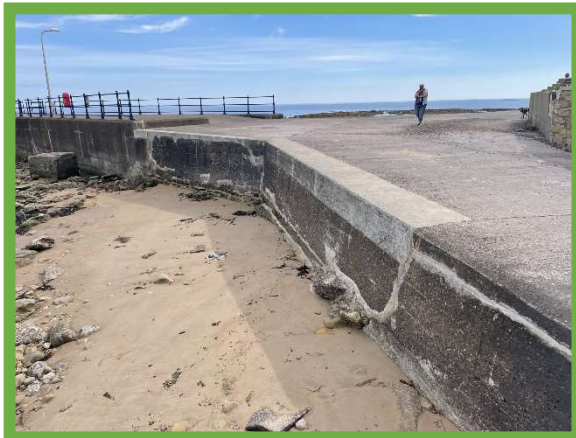
*Repairs return sea wall along Bay View to good overall condition in 2020 (/3001C10)*

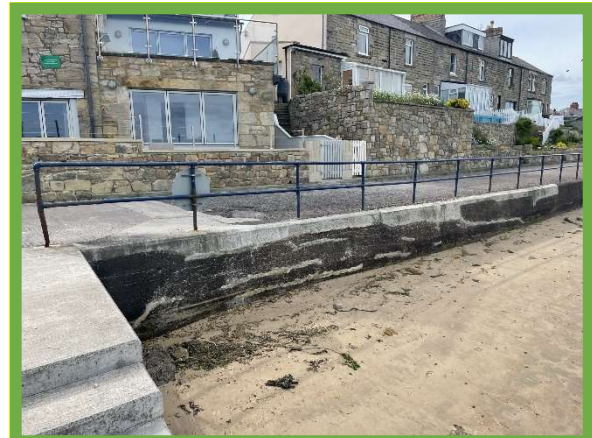
*Seawall at Little Shore Wave Basin repaired to good condition in 2020 (/3001C10)*

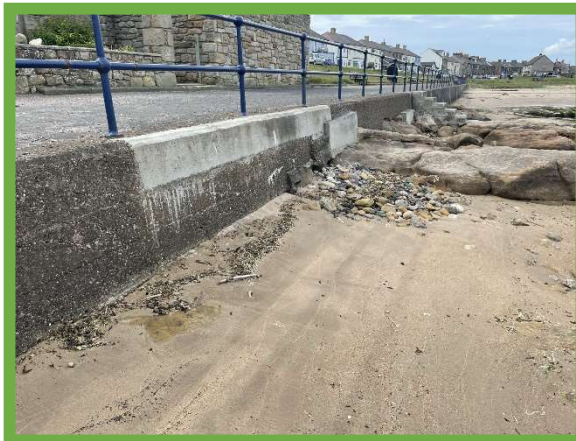
*Repairs return sea wall along Bay View to good overall condition in 2020 (/3001C10)*

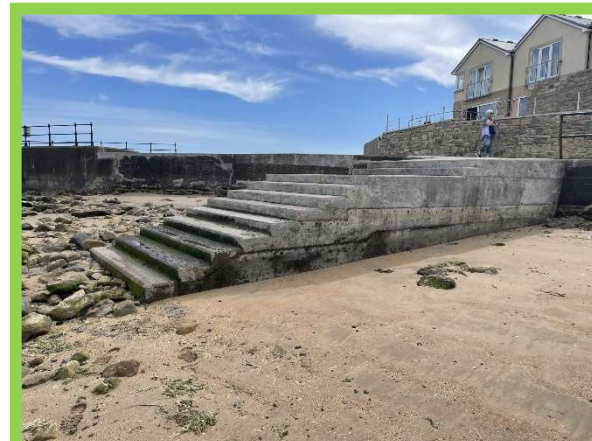
*New access steps to Little Shore Wave Basin in good condition in 2020 (/3001C10)*

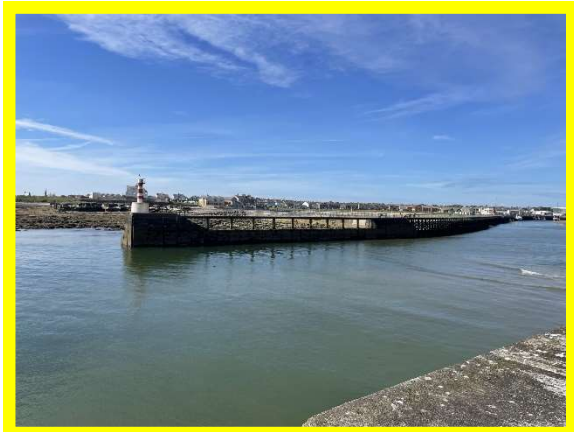
*South Pier in fair condition, possibly some voiding at base. (/3101C01)*

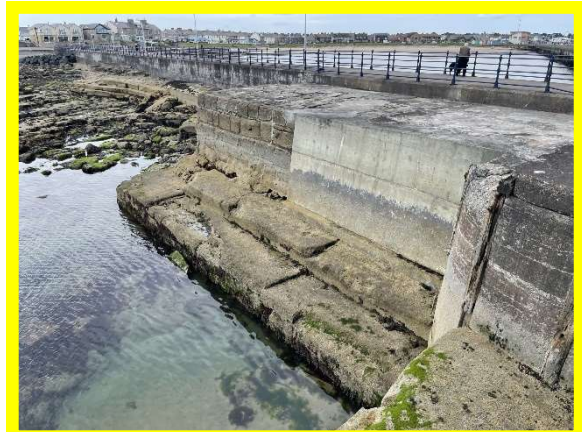
*Repairs at junction of South Pier and South Jetty (seaward face) made in 2018 (/3101C01)*

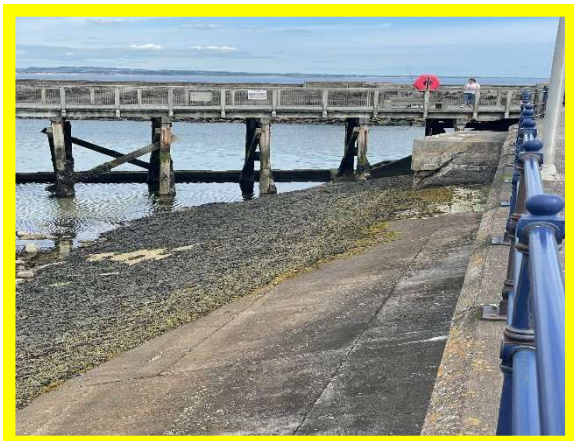
*Inner face of South Pier in fair condition (/3101C02)*

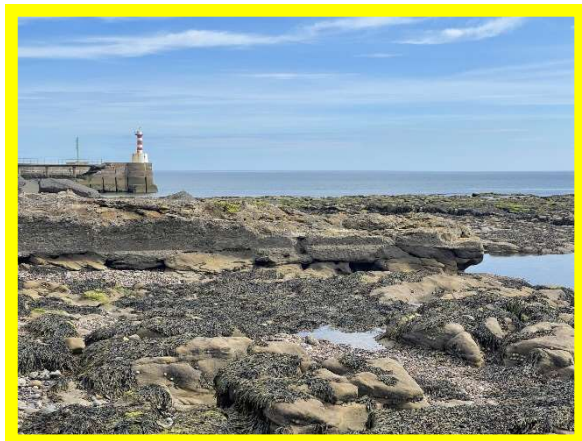
*Abraded but functional stub groyne (and rock armour) on seaward face of South Pier (/3101C02)*

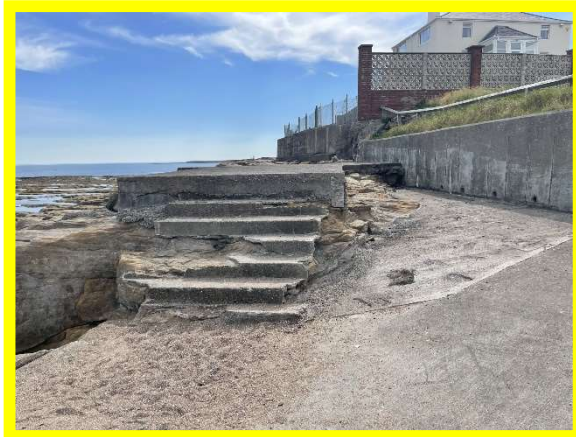
*Heavily abraded access steps to Pan Point (/3101C02)*

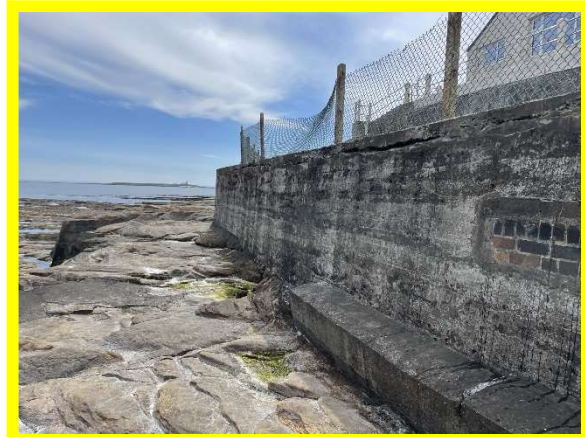
*Cracks in private seawall around Pan Point (/3101C04)*

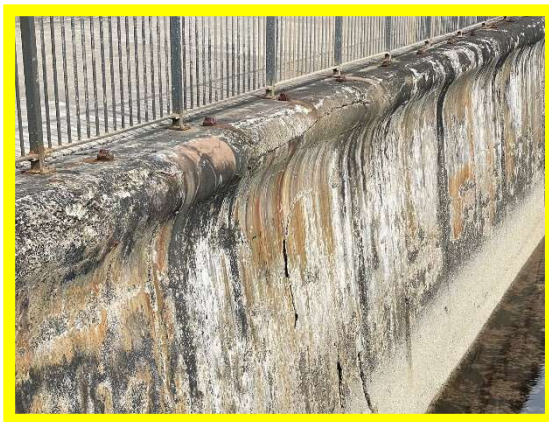
*Seawall in fair condition with corrosion, spalling and some cracking, this is typically limited to the cope (/3101C05)*

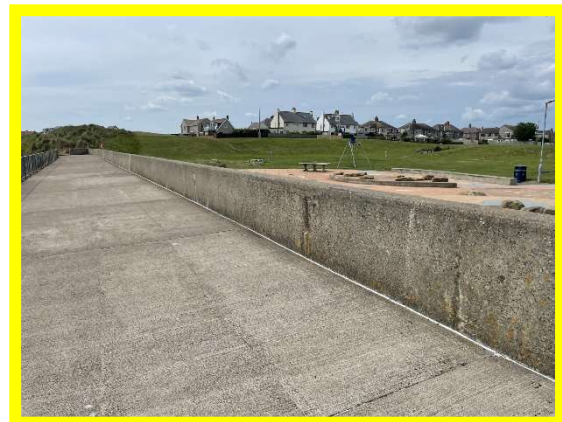
*Some staining of the back wall (/3101C05)*

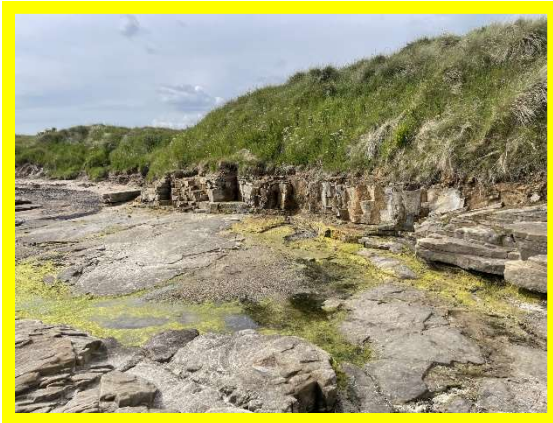
*Dunes and low slopes above rock ledge (/3101C06)*

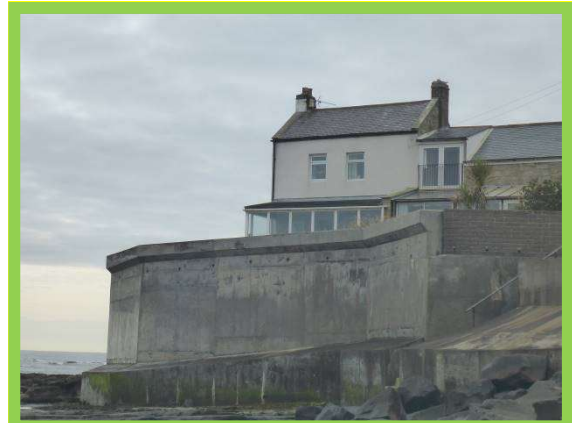
*Substantial seawall in overall good condition (/3101C07)*

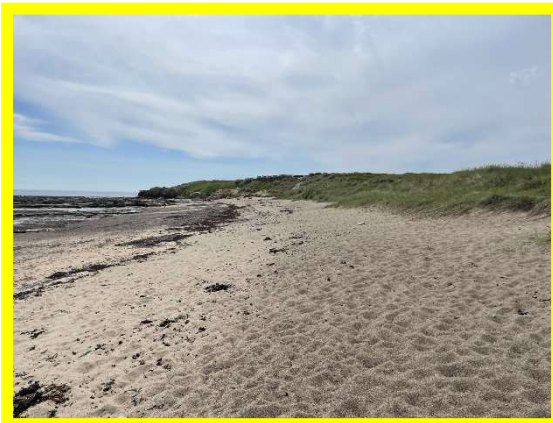
*Low dunes north of Wellhaugh Point (/3101C09)*

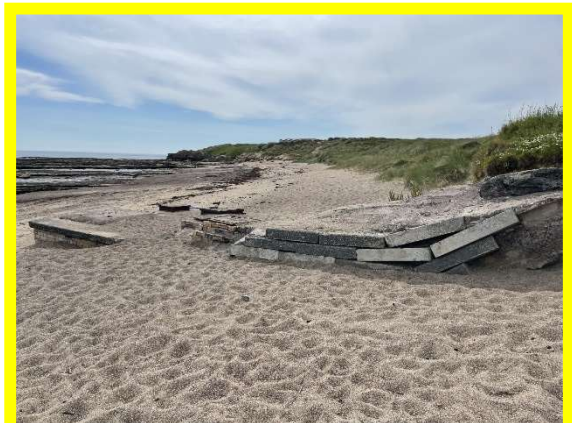
*Dilapidated but largely buried outfall (/3101C09)*

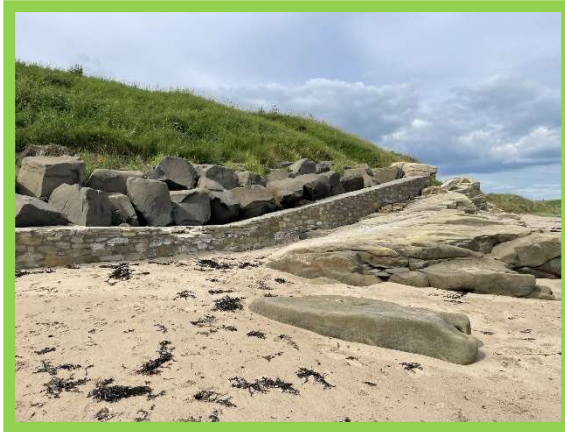
*Low dunes north of Wellhaugh Point (/3101C10)*

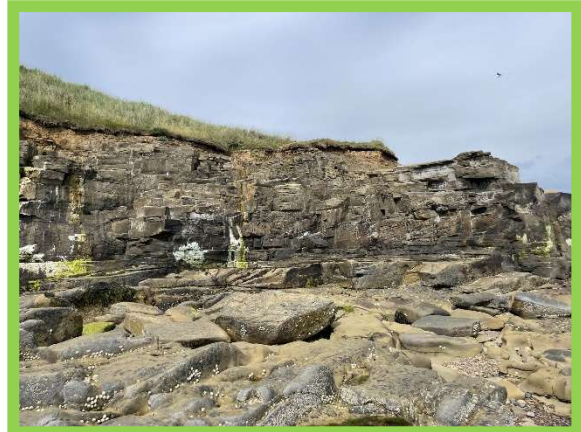
*Rock headland around Wellhaugh Point (/3101C10/11)*
