## **Cell 1 Regional Coastal Monitoring Programme Walkover Inspection Surveys 2022**

**Northumberland  
County Council**

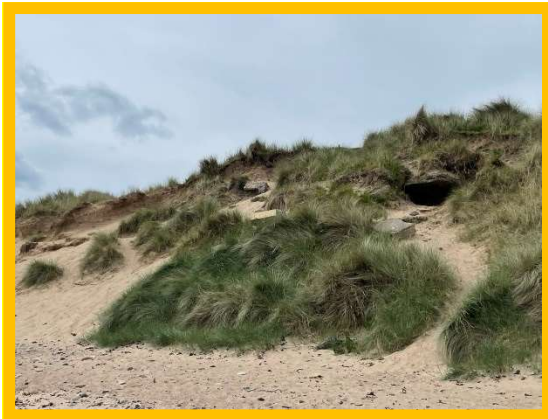
*Dunes slumping, exposing concrete rubble (/3101C12)*

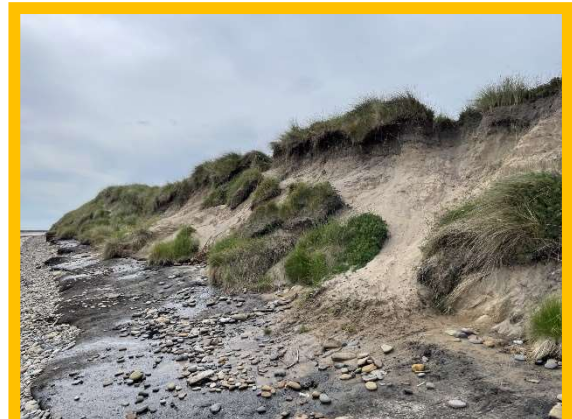
*Cobble berm fronting dunes. Petrified tree stumps at base. Dunes slumping (/3101C12)*

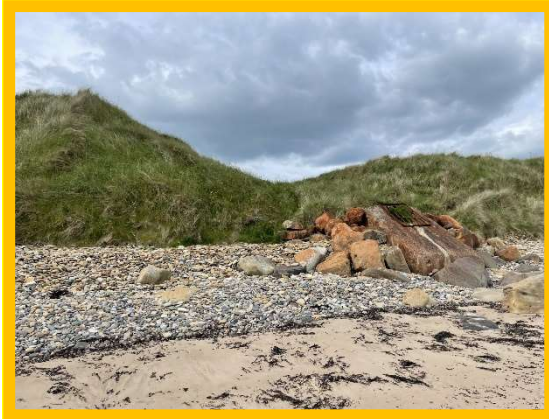
*Rust-stained outfall within generally stable dunes (/3101C12)*

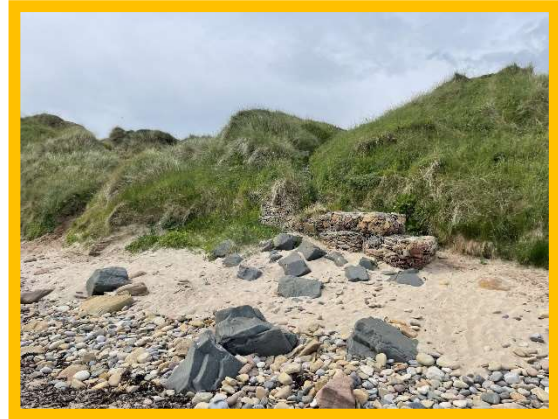
*Access steps through dunes protected at base with gabions (/3101C12)*

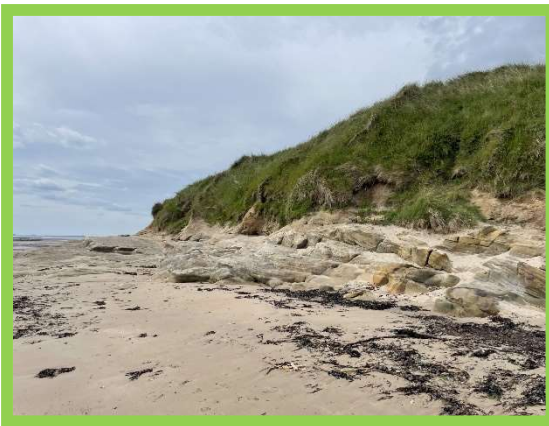
*Stable dunes on rock ledge around Beacon Hill (/3101C13)*

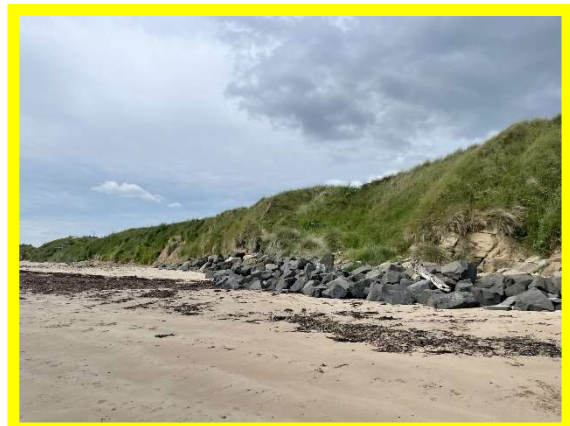
*Loosely placed rock armour at Low Hauxley (/3101C14)*

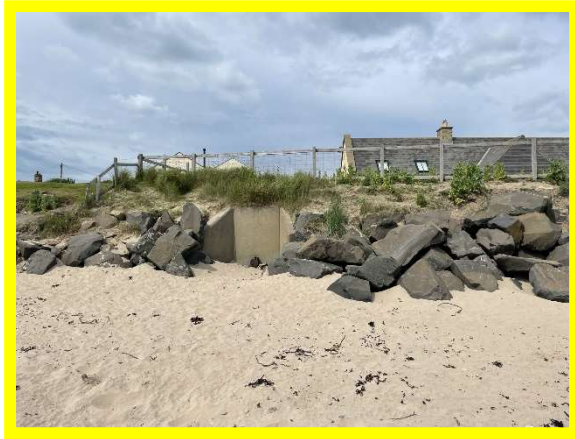
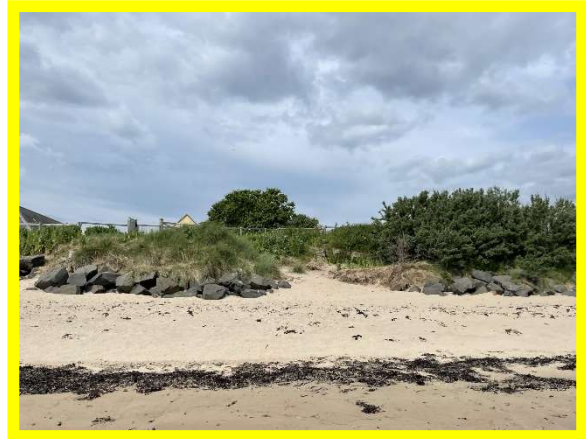
*Outfall with large headwall at Low Hauxley (/3201C02) Access through dunes at Low Hauxley (/3201C02)*

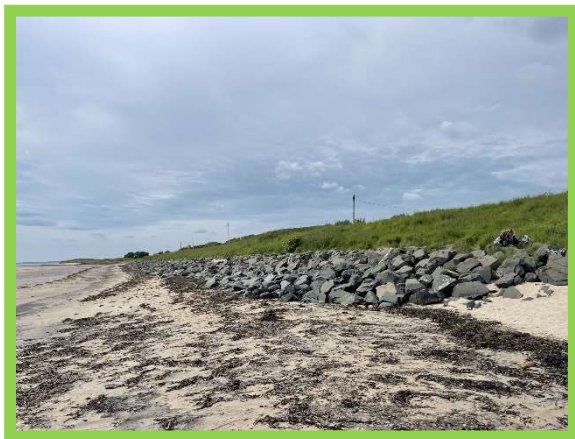
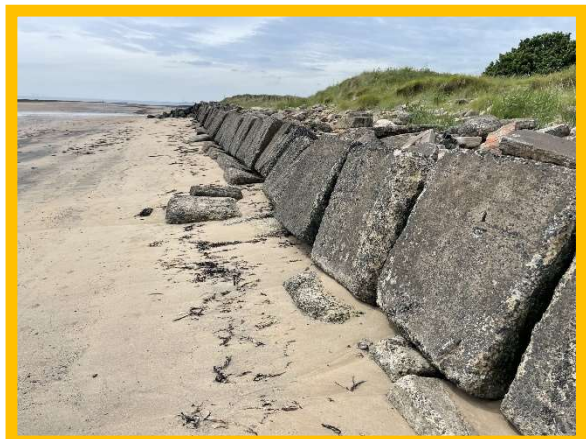
*Wide rock revetment in good condition (/3201C03) Rotational displacement at southern end of concrete block revetment (/3201C04)*

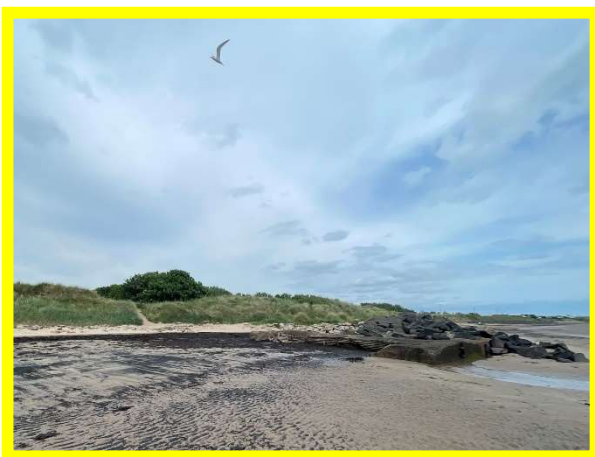
*Rock revetment in fair condition (/3201C05) around poor but functional outfall*

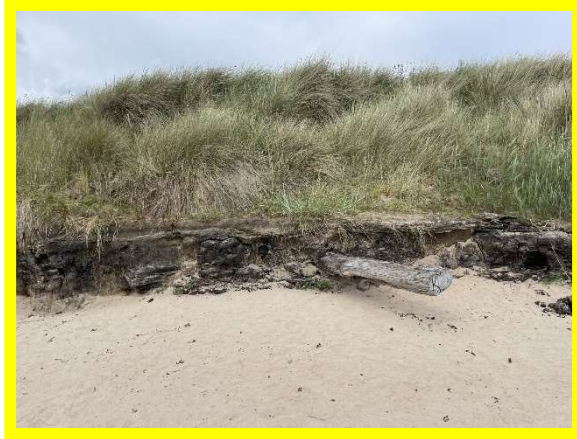
*Petrified timbers exposed in base of dunes (/3201C07)*

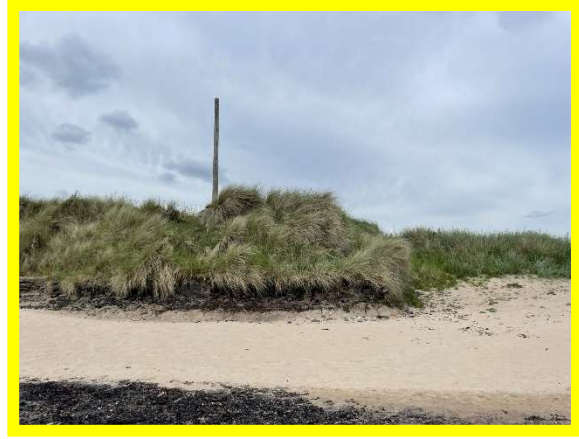
*Telegraph marker pole becoming undermined at base through erosion (/3201C07)*

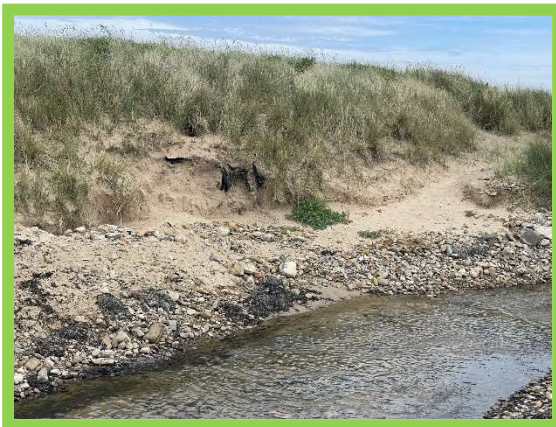
*View from landward to seaward of ‘daylighted’ open channel section of outfall from Hauxley Nature Reserve, exposed geotextile in black (/3201C09)*

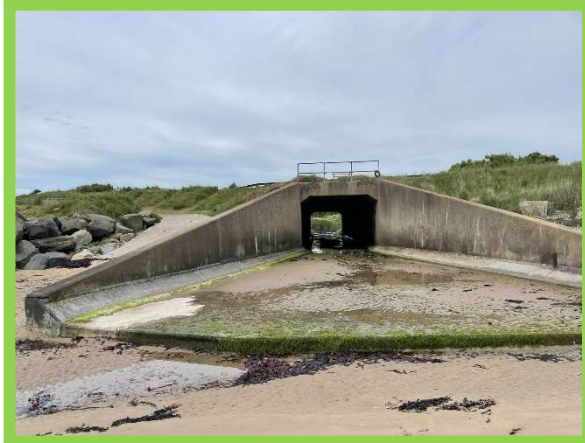
*Concrete outfall and adjacent rock revetment (/3201C12)*

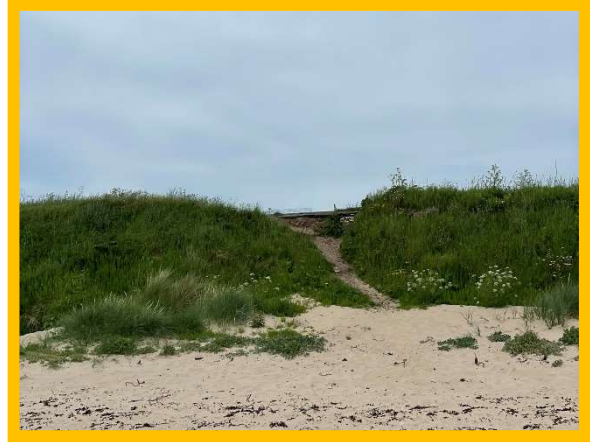
*Terminal erosion beyond end of defended section of dune resulting in cut back to road (/3201C14)*

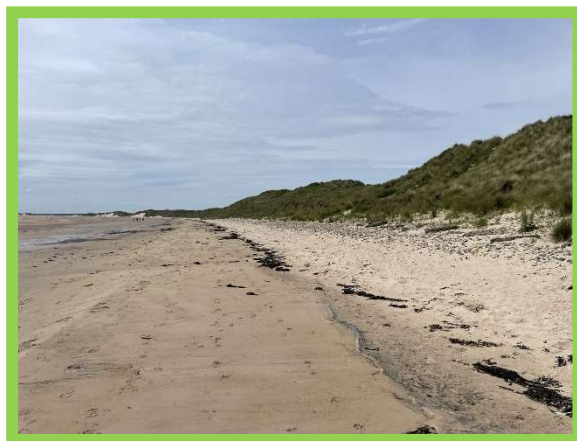
*Healthy dunes in Druridge Bay with concrete blocks over short length, note high sand levels (/3201C15)*

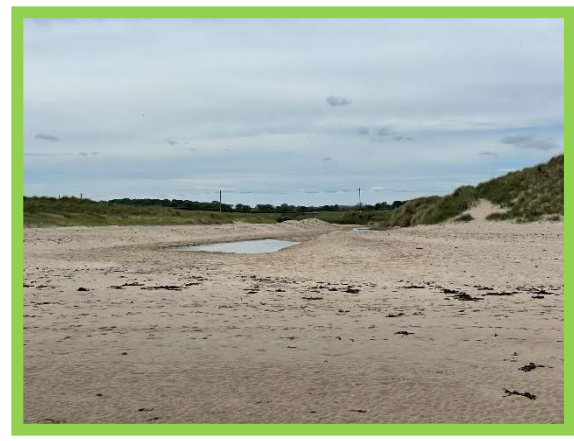
*Evidence of excavation works to maintain a channel for the Creswell Northumberland Wildlife Trust pond. (/3201C16)*

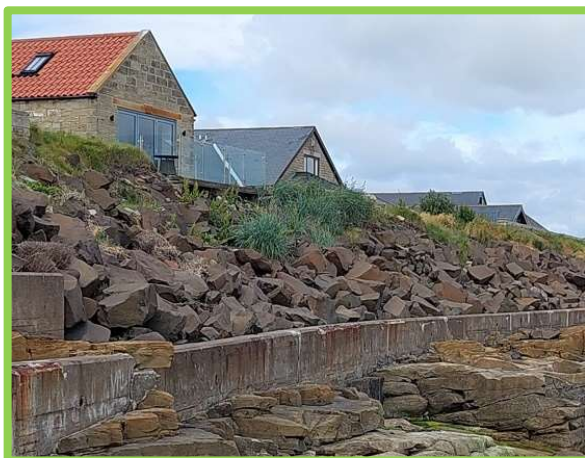
*Low concrete wall and rock revetment at Cresswell (/3201C18)*

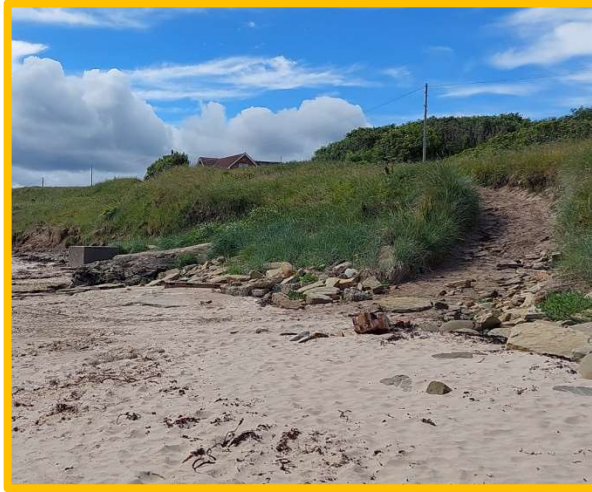
*Access to the north of the bay (/3201C21)*

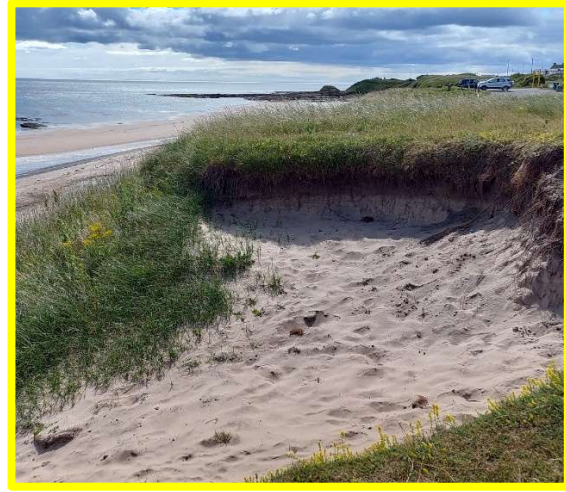
*Slippage north of the car park (/3201C21)*

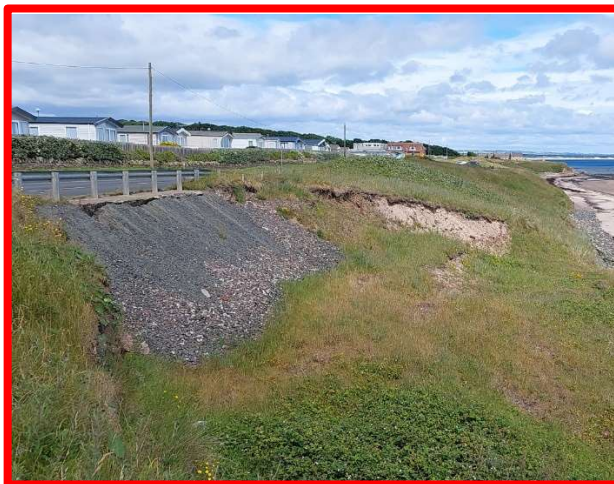
*Failed section of cliff adjacent to coast road (/3201C22)*

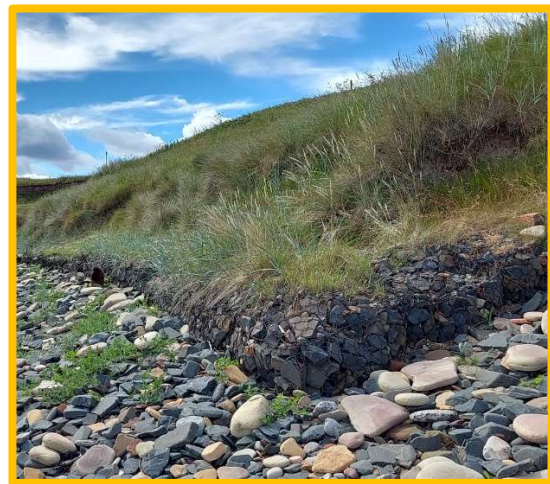
*Gabions failing and slumping cliff (/3201C22)*

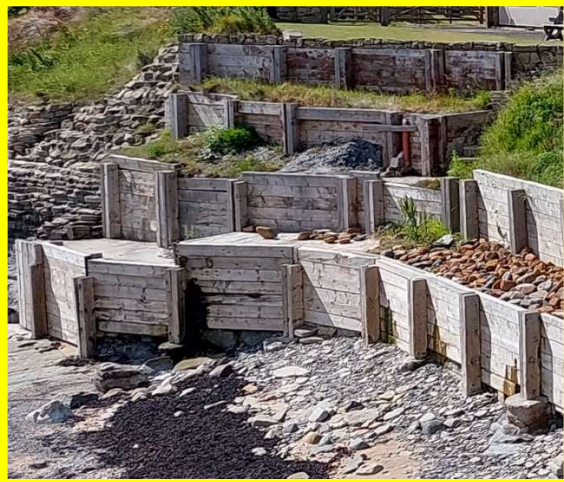
*Private timber/rubble retaining defences north of Snab Point (/3301C01)*

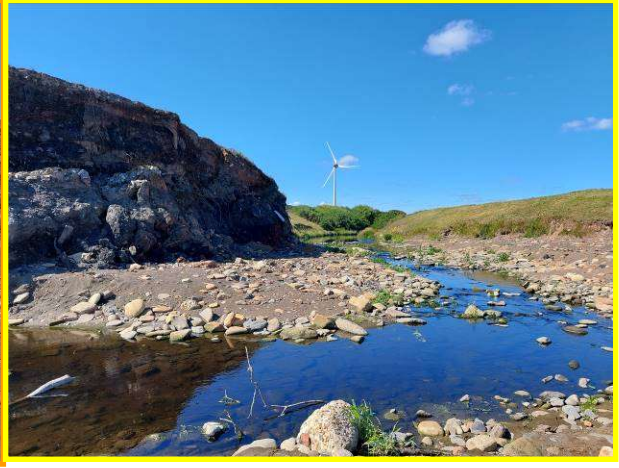
*Lyne River Mouth flanked by the colliery spoils cliff (3401C06)*

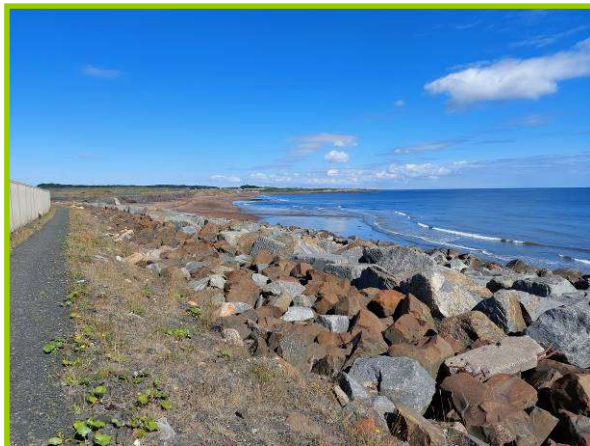
*Rock revetment north extension (/3401C07)*

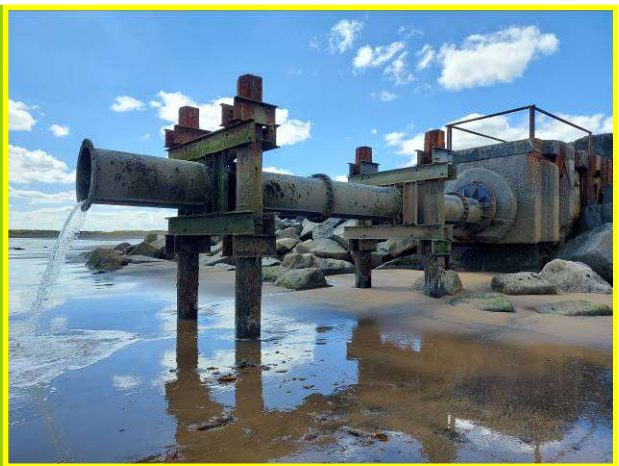
*Power Plant water outfall through the rock revetment (/3401C08)*

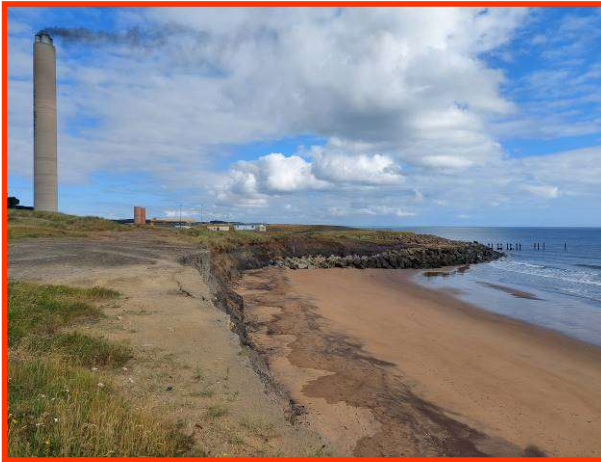
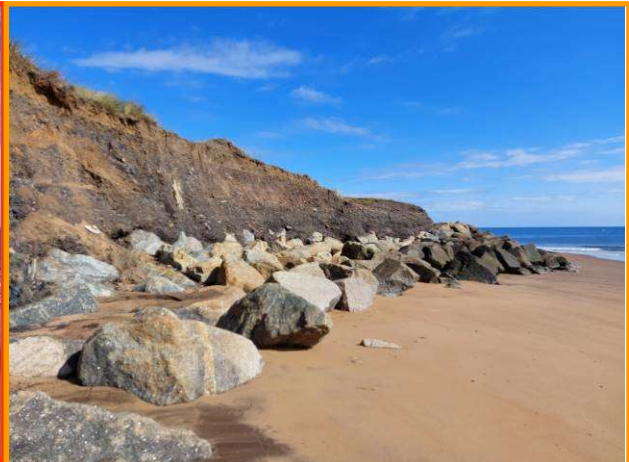
*Power station rock revetment south end and cracks in spoils cliff top (/3401C03)*

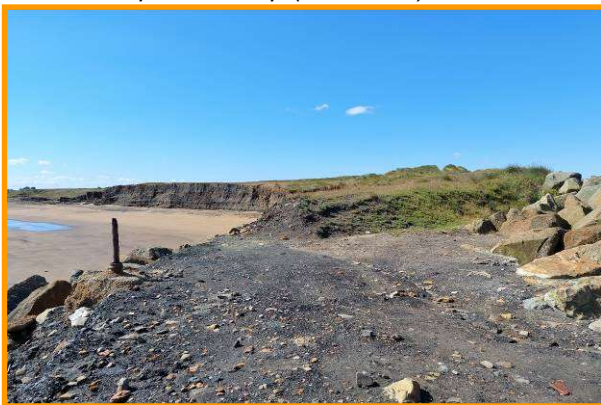
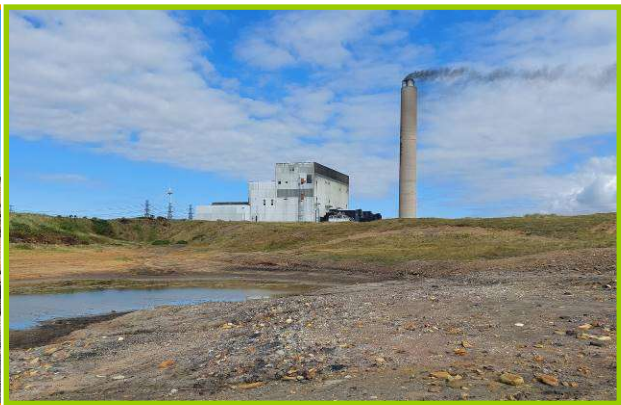
*South end of rock revetment berm covered by Spoils (/3401C03)*

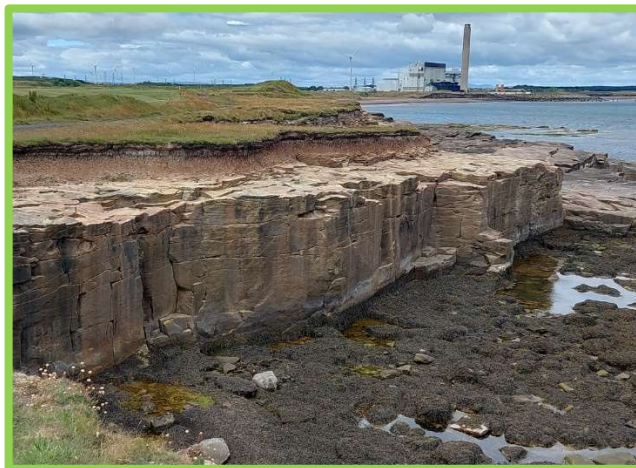
*Currently relatively stable cliffs around Beacon Point (/3501C11)*

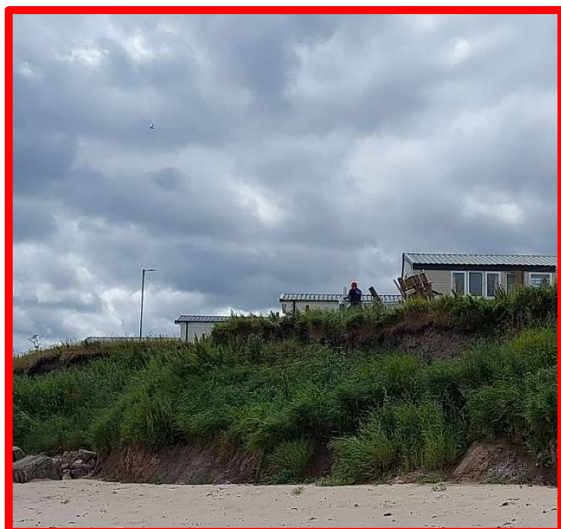
*Active slumping at northern section fronting caravan park (/3501C05)*

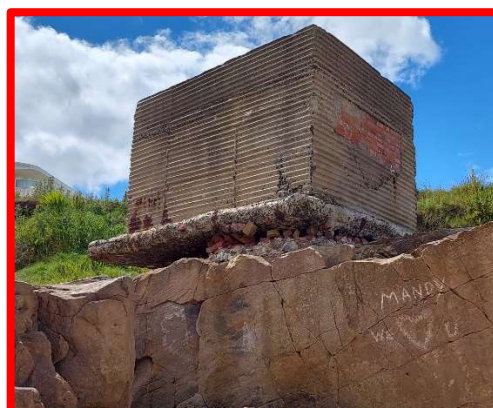
*Northern concrete pill box perched on rock ledge (/3501C07)*

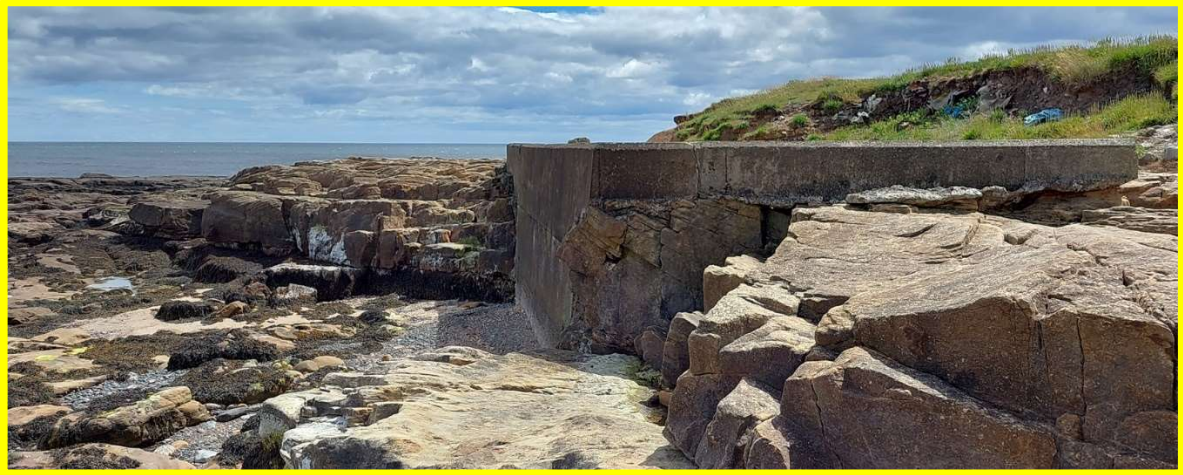
*Seawall with undermining and outflanking (/3501C08)*

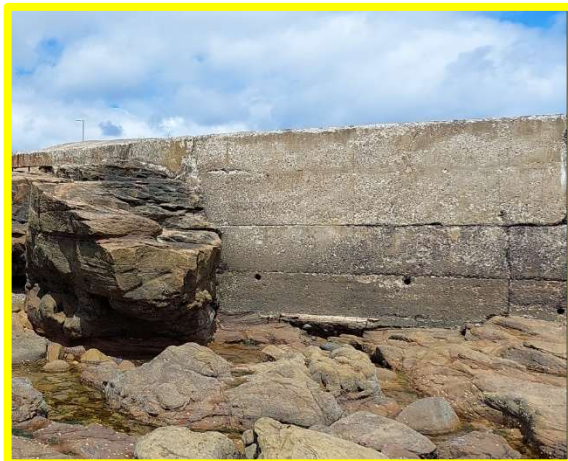
*Second length of seawall with undermining and outflanking (/3501C10)*

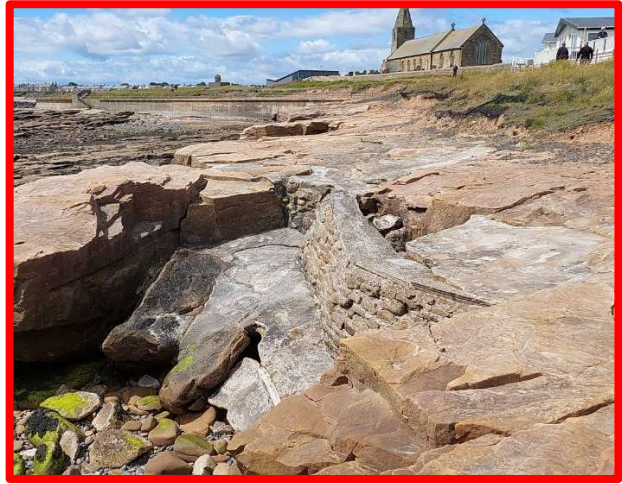
*Voiding at crest of small wall in 2020 (/3601C01)*

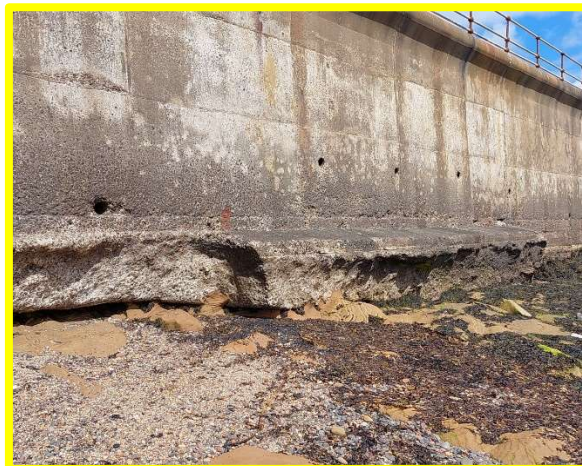
*Church Point seawall in fair overall condition with localised undermining of toe protection (/3601C12)*

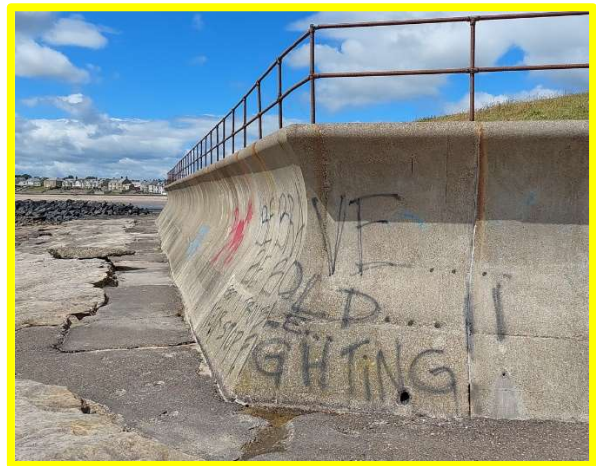
*Recurved section of Church Point seawall in good condition. Toe apron cracked. Rusty handrailing (/3601C13)*

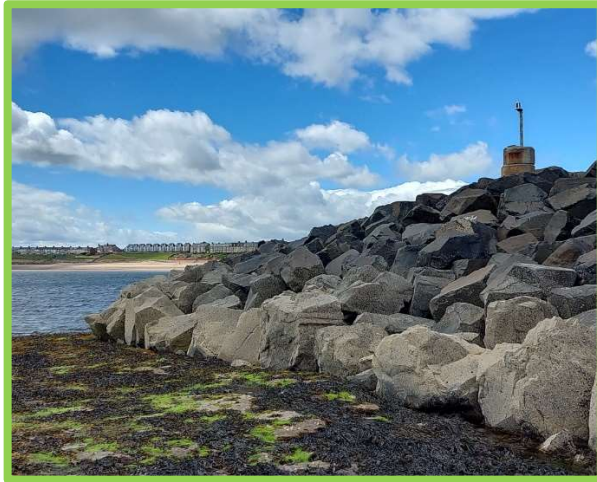
*North breakwater in Newbiggin Bay in overall good condition (/3601C14)*

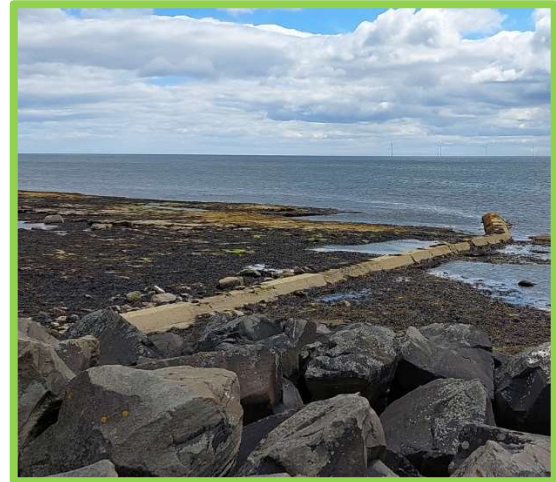
*Outfall crossing underneath the North breakwater in Newbiggin Bay in overall good condition (/3601C14)*

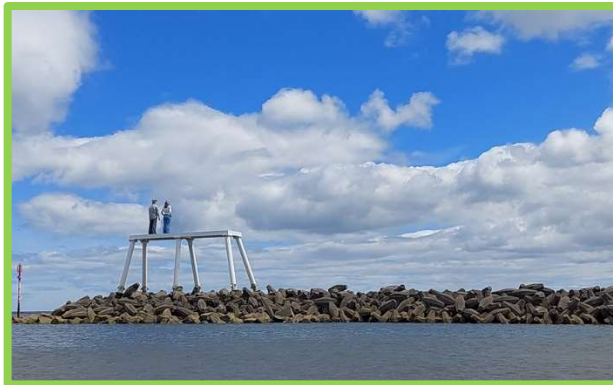
*Detached breakwater in central Newbiggin Bay remains in good condition (/3601C16)*

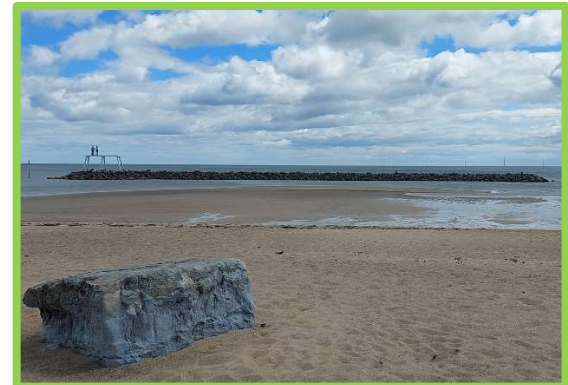
*Salient/tombolo developed in lee side of the detached breakwater (/3601C16)*

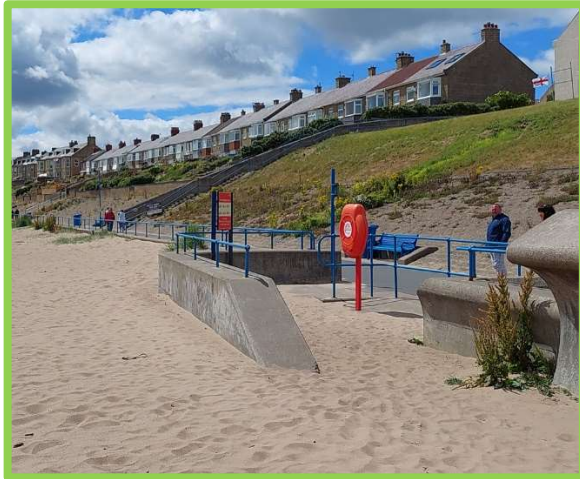
*High beach levels and wind-blown sand to rear of promenade in central sections of Newbiggin Bay (/3601C07)*

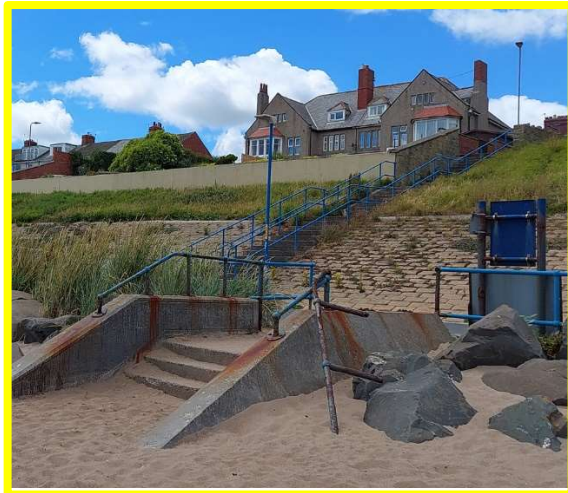
*Healthy beach levels fronting rock revetment. Corroded handrailing and posts (/3601C08)*

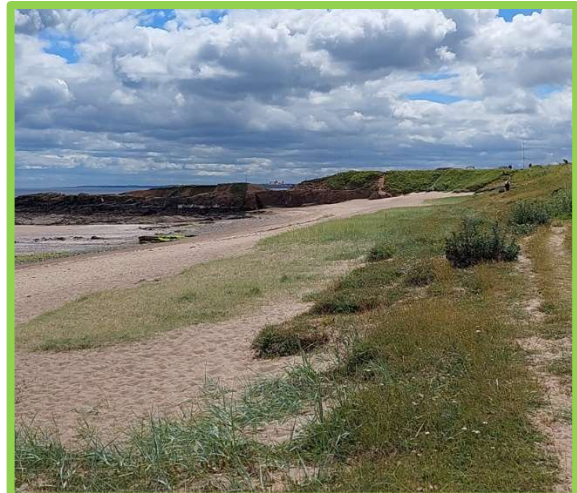
*High beach levels and embryo dune vegetation growth at southern end of Newbiggin Bay (/3601C09)*

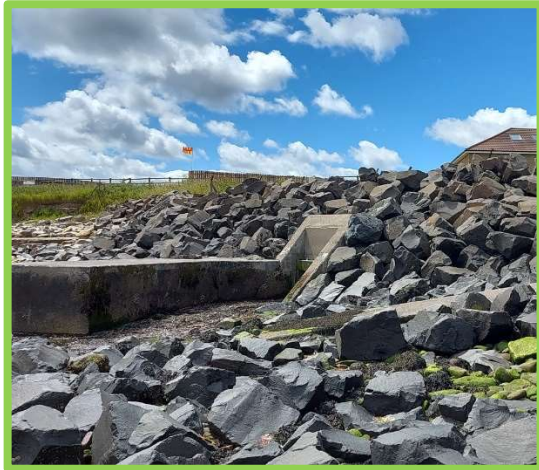
*Rock revetment around sewage outfall Outfall (/3601C11)*

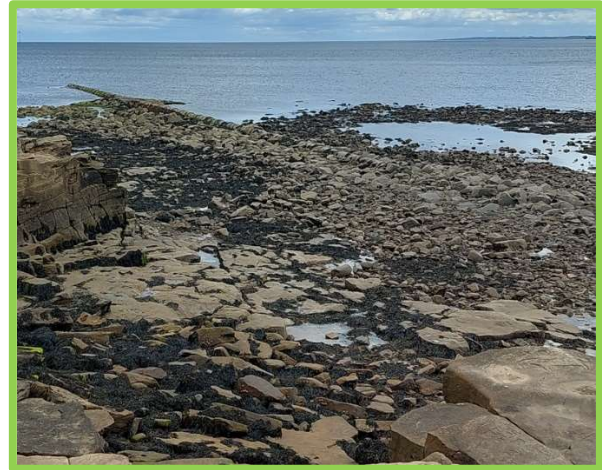
South of the outfall, there is a short section of cliffs fronting Links Quarry which are in poor condition, with significant erosion and cliffing along most of the length. Large quantities of rubble and quarry waste have been tipped down its seaward face. However, slumping in the soft material continues, releasing waste and debris onto the foreshore.

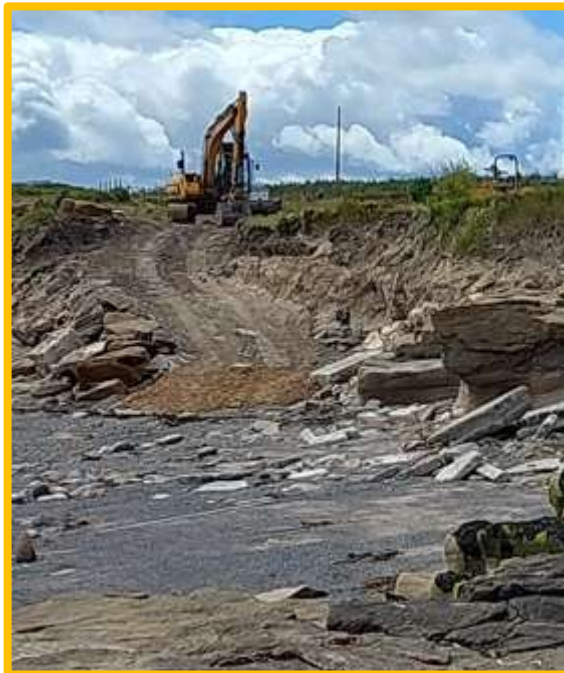
*Haul access to the rocky foreshore at the cliff toe (/3701C01)*

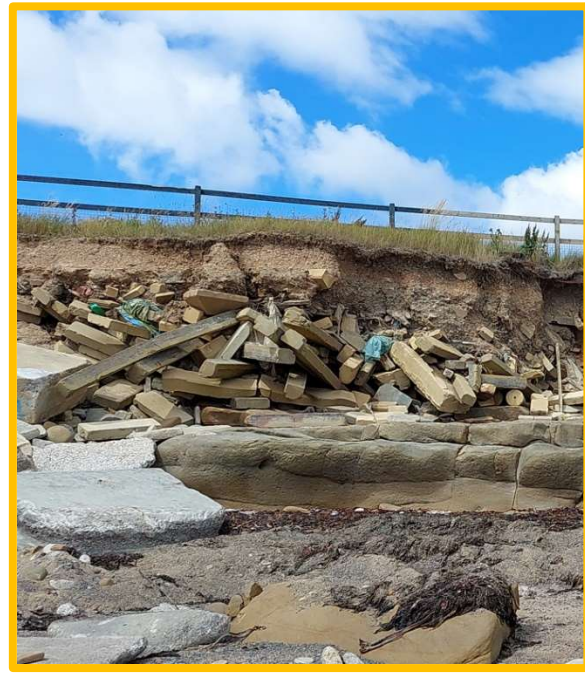
*Construction waste materials dumped at the toe of the soft cliff (/3701C01)*

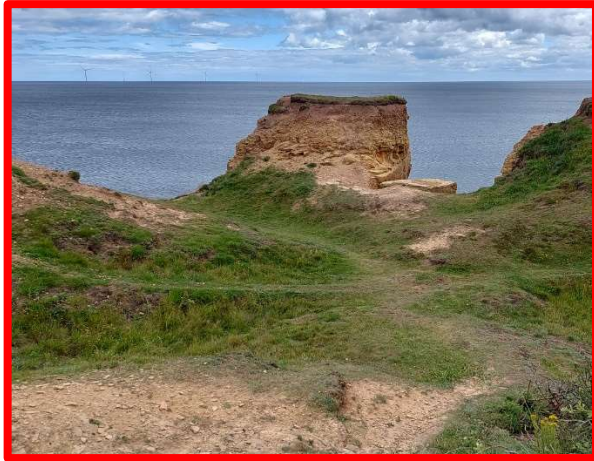
*Collapsed section of Hawks Cliff (/3701C02)*

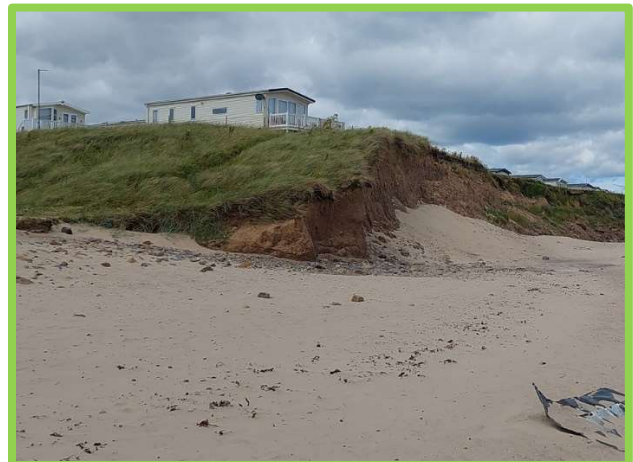
Start of embankment (/3801C01)

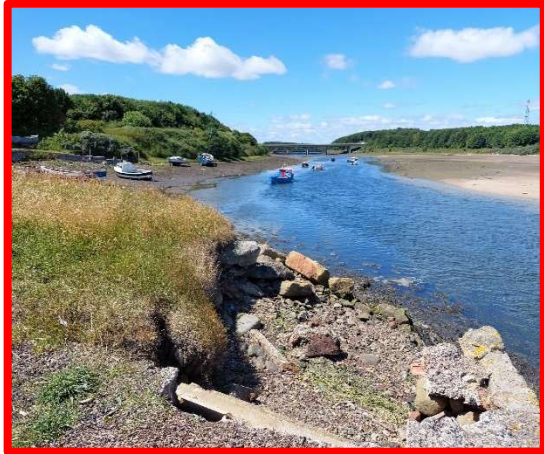
*Wansbeck Boat Club retaining wall leeward erosion – local defect (/3801C02)*

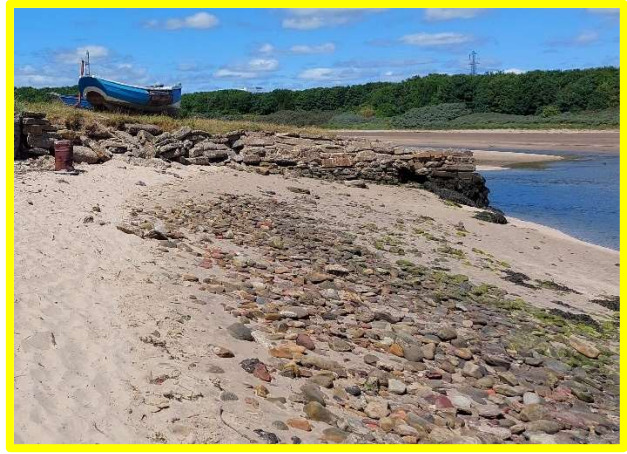
*Wansbeck Boat Club retaining wall (/3801C02)*

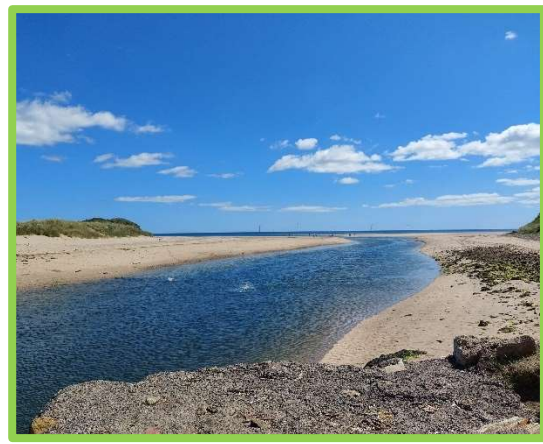
*Built up sandy beach protecting a stable cliff on the right side. (/3801C02)*

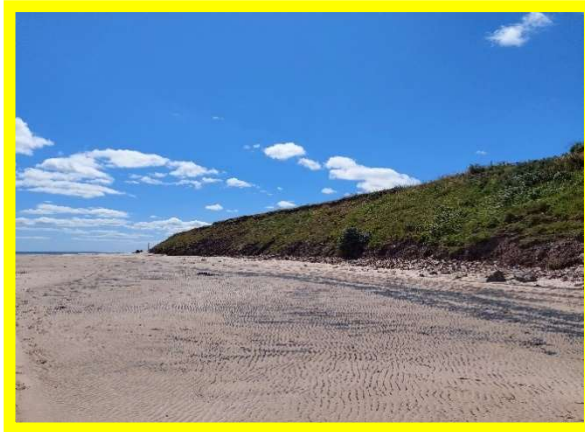
*Waterline cut back with moderate toe erosion (/3901C01)*

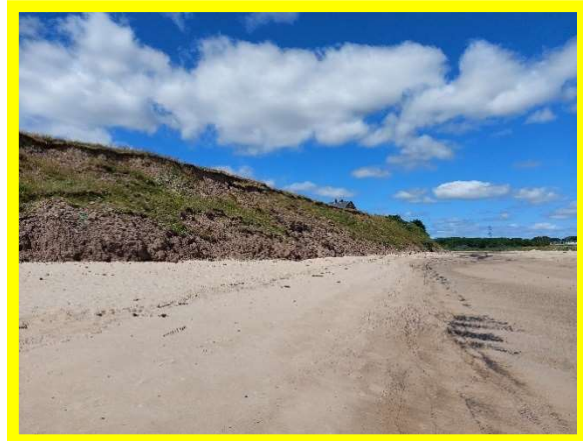
*Some sand protecting the cliffs, south of Cambois House (/3901C01)*

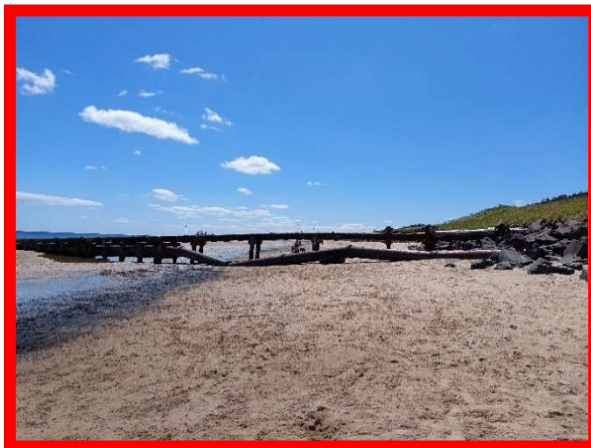
*Failed and disused outfall – H&S risk (/3901C05)*

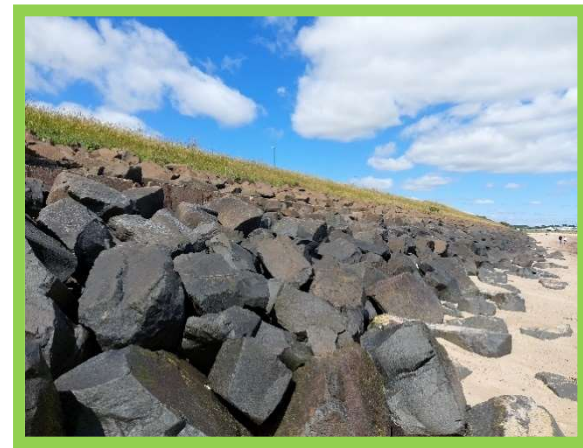
*Rock revetment protecting former foundry site (/3901C05)*

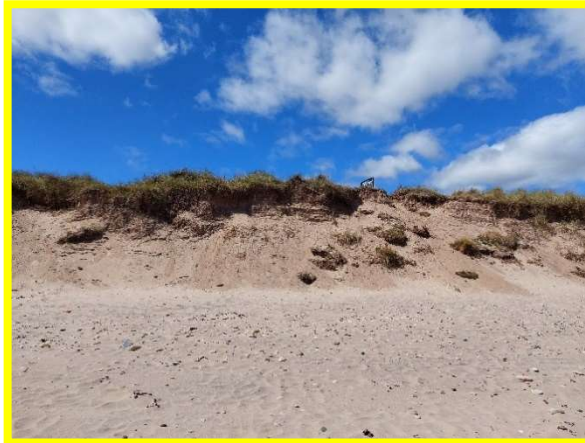
*Erosion of cliffs at south end of the section (/3901C03)*

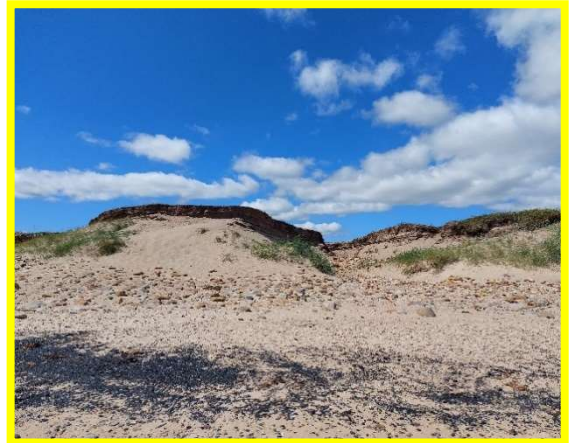
*Cliffs protected by relatively wide and high beach (/3901C03)*

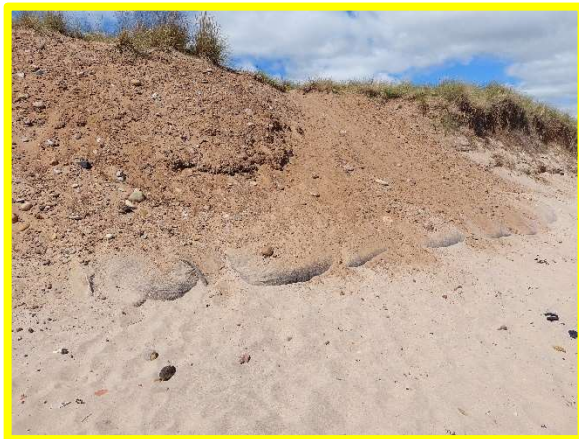
*Sandbags and reinstated dunes at cable landfall layout (/3901C04)*

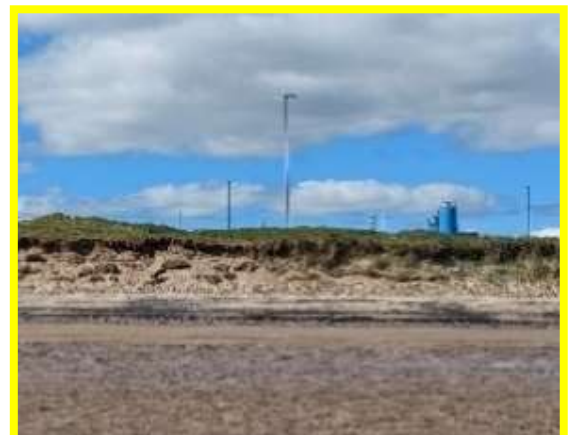
*Stable and healthy dunes with moderate toe erosion (/3901C04)*

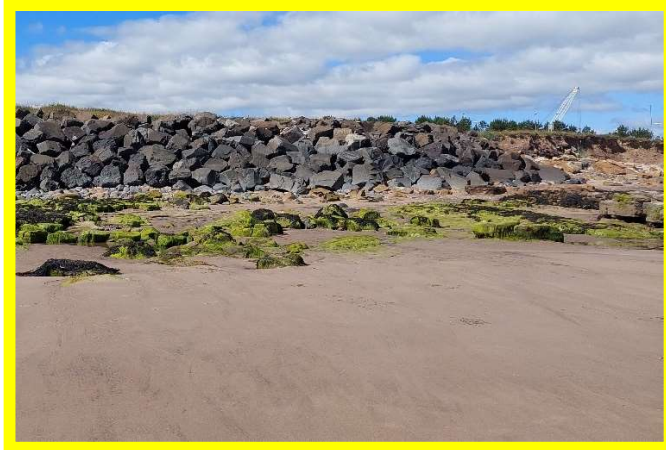
*Rock outcrops protecting the north end revetment toe (/4001C01)*

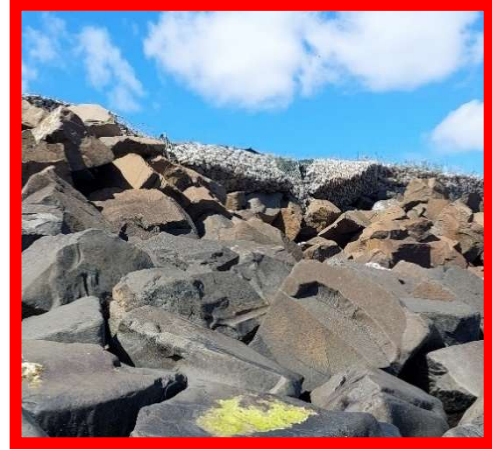
*Localised cliff slide producing revetment movement and gabions failure on top of cliff (/4001C01)*

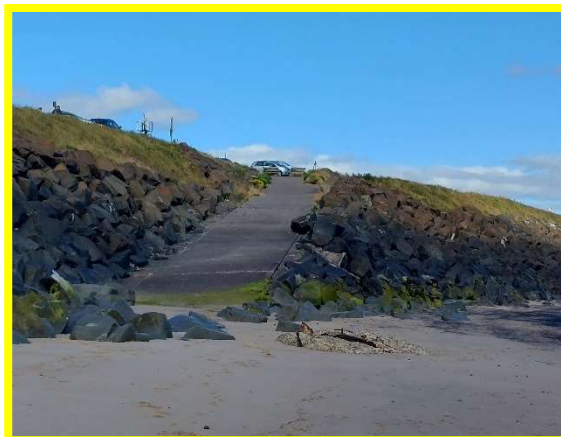
*Beach access ramp (/4001C01)*

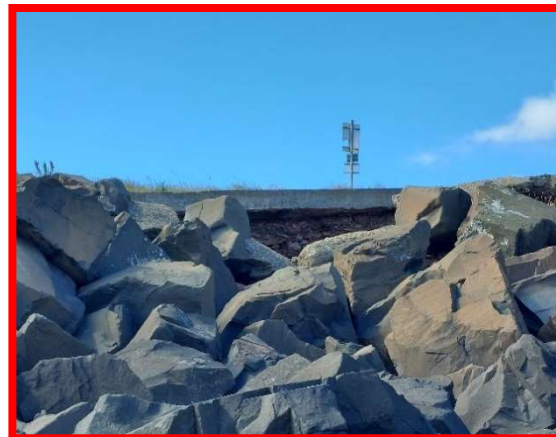
*Ramp concrete slab undermining – needs to be repaired (/4001CO1)*

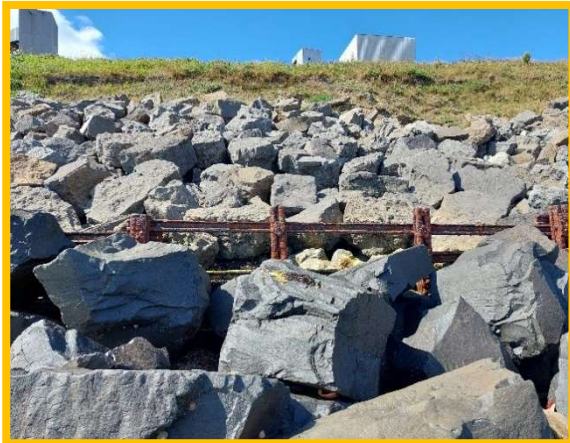
*Steel framework separating old and new rock armour – no need for repairs as it has no function due to new rock armour below (/4001C02)*

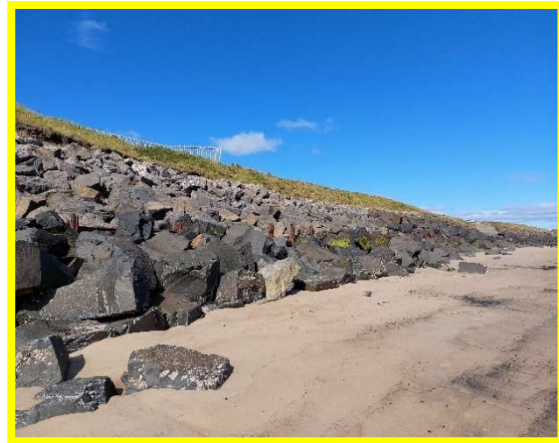
*New rock armour placed at toe to create a stable slope, protecting the damaged steel (/4001C02)*

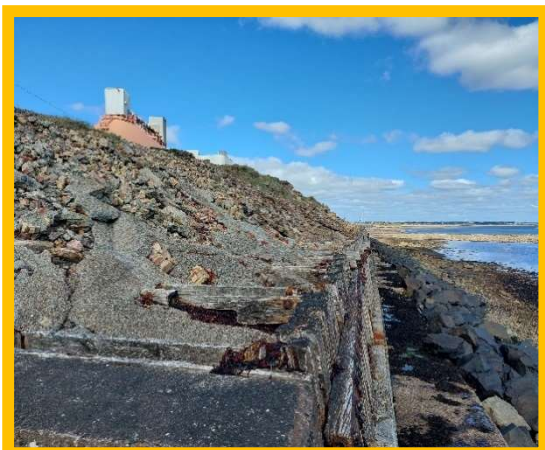
*Industrial waste that looks unstable and could collapse over the structure (/4001C03)*

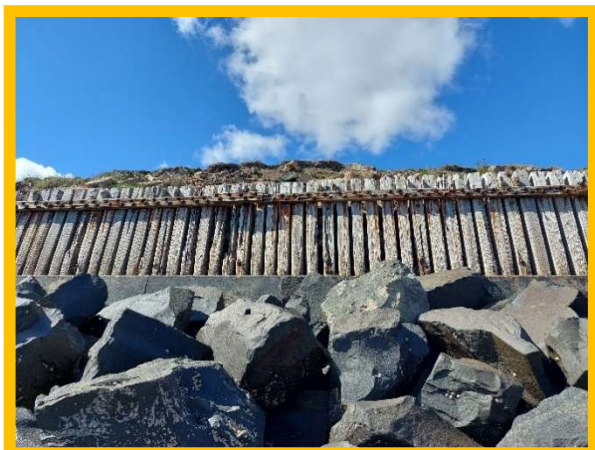
*Corroded holdings and rotten timber screen – are in poor conditions and requires repairs (/4001C03)*

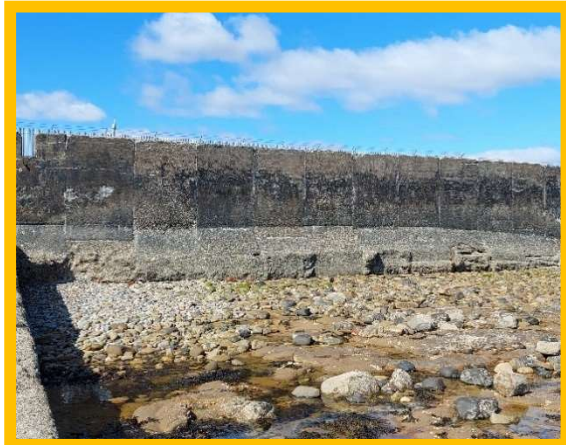
*Sea wall that has experienced moderate amount of erosion – needs to be monitored carefully or repaired (/4001C04)*

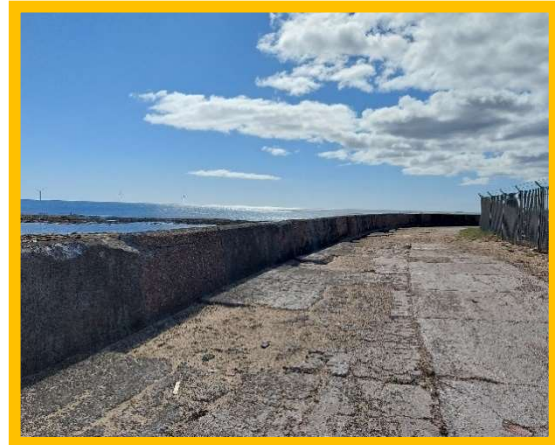
*Parapet in poor condition with missing and broken walkway slab sections – signs of undermining (/4001C04)*

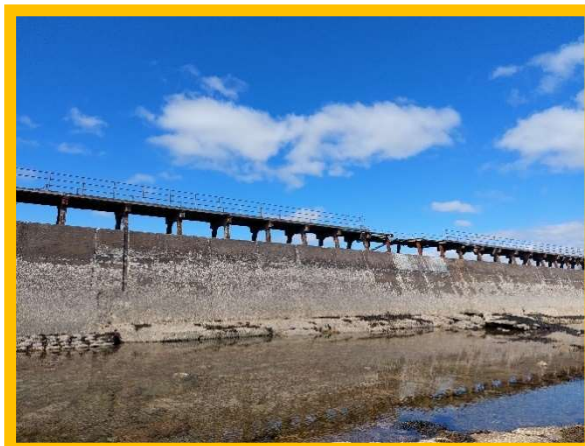
*Seawall in fair condition – missing sections of trestle deck (/4001C05)*

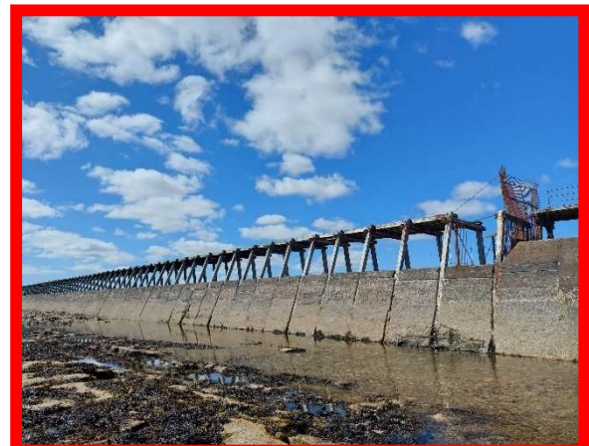
*Timber deck supported by timber legs – not accessible (/4001C05)*

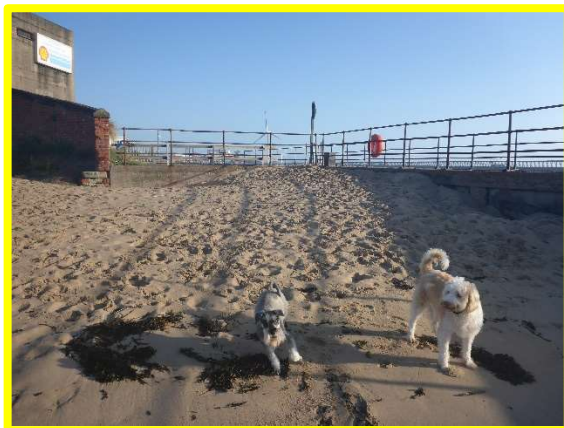
High beach levels in spending beach (/4201C10)

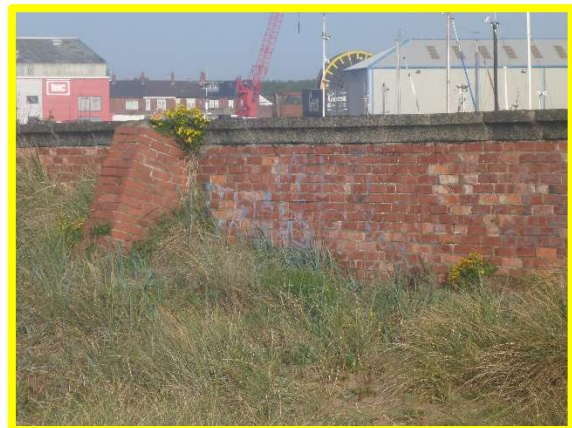
Brick boundary wall to rear of dunes (/4201C10)

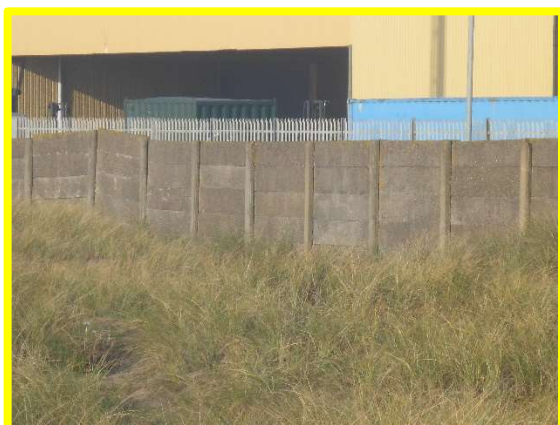
Concrete boundary wall (/4201C11)

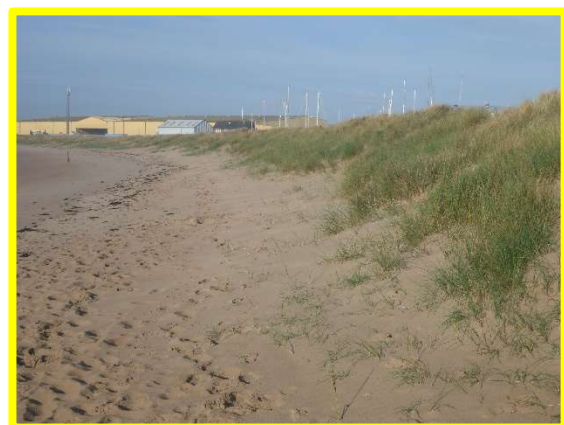
Stable dunes (/4201C11)

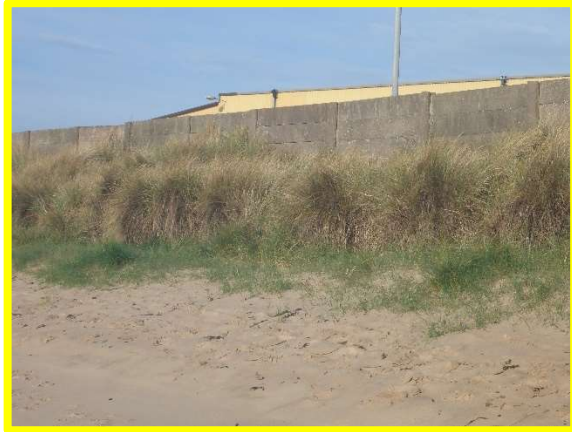
*Dunes width narrows with progression to south (/4201C11)*

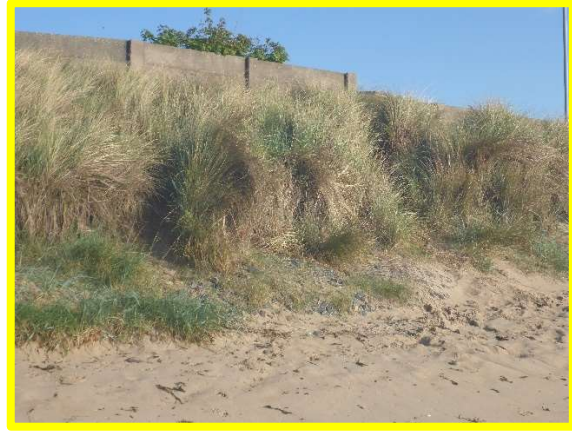
*Very narrow dunes with gabions at toe becoming exposed (/4201C11)*
