## **Cell 1 Regional Coastal Monitoring Programme Walkover Inspection Surveys 2022**

**Northumberland  
County Council**

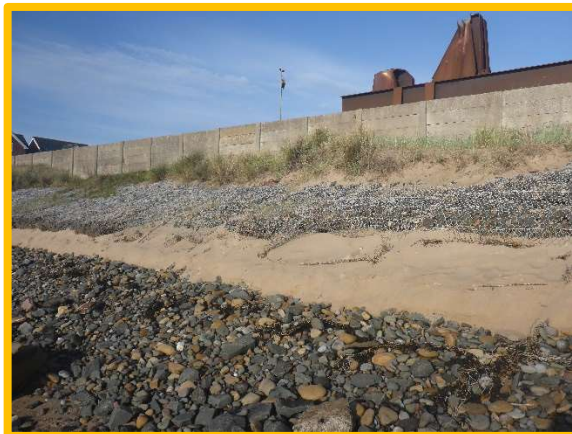
*Gabions protecting very narrow strip of dunes (/4201C03)*

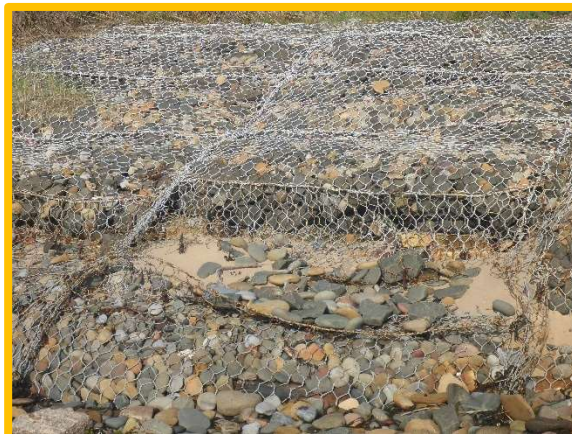
*One example of several failed gabions (/4201C03)*

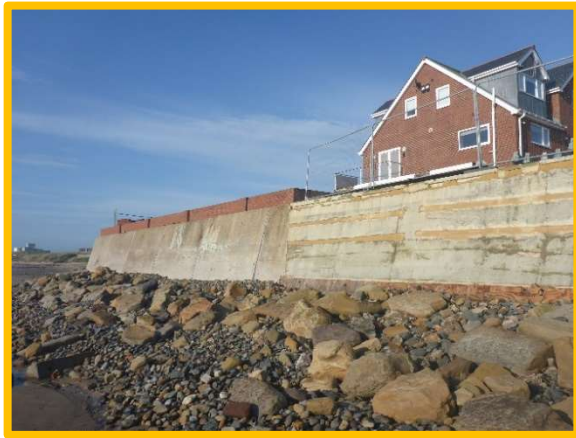
*Original and extended sea walls protecting new properties (/4201C04)*

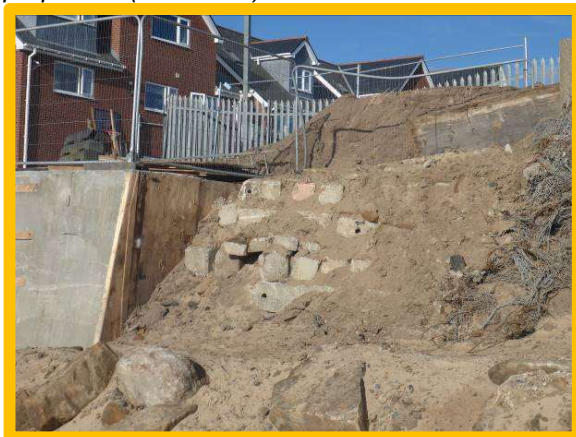
*Tie-in section of wall at failing gabions under construction in 2020 (/4201C04)*

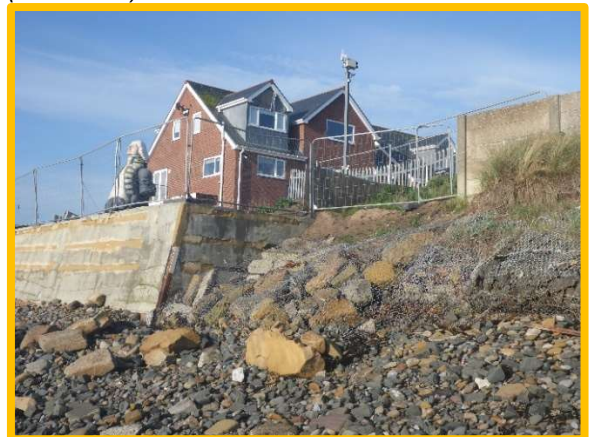
*Tie-in section of wall at failing gabions further protected by 2022 (/4201C04)*

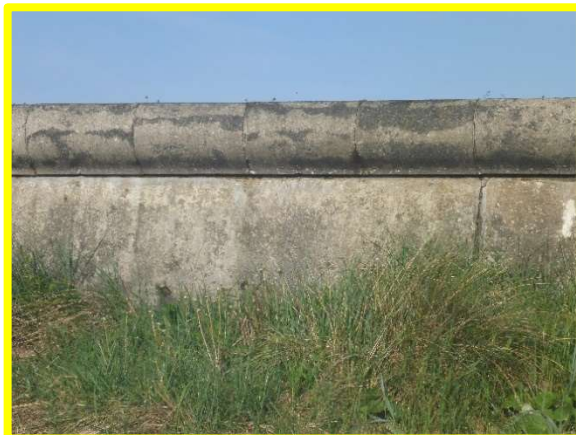
*Sea wall (/4201C05)*

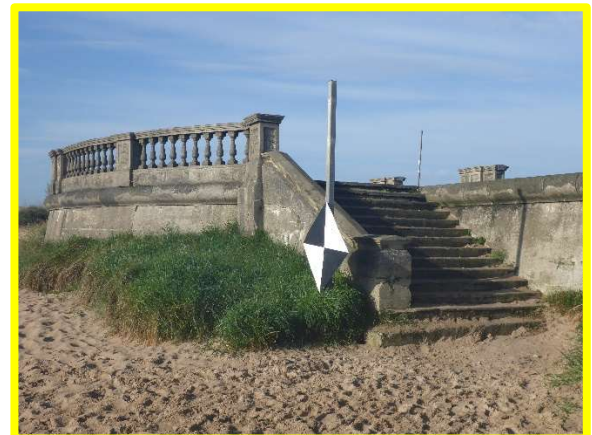
*Seawall and access steps (/4201C05)*

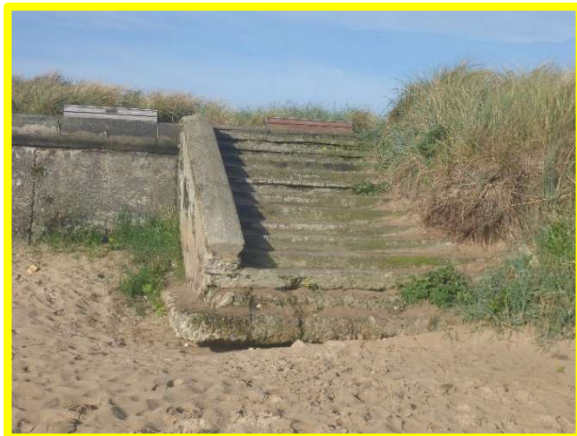
*Abrasion and undermining of access steps (northern end of sea wall) to seawall (/4201C06)*

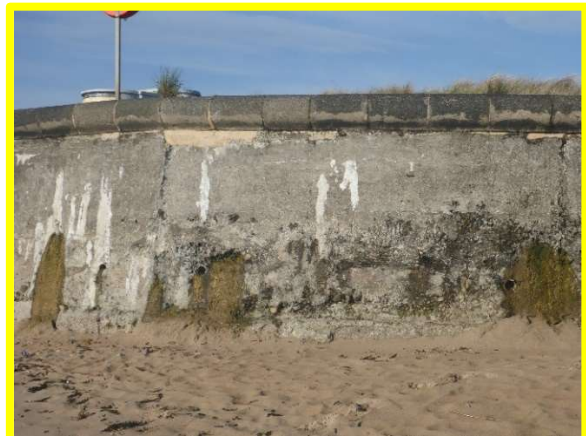
*Abrasion and staining to sea wall at its northern end (/4201C06)*

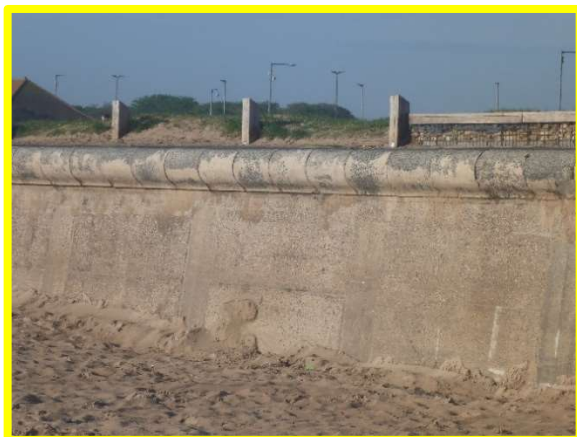
*Sea wall fronting regenerated Blyth seafront – northern end of Blyth promenade (/4201C07)*

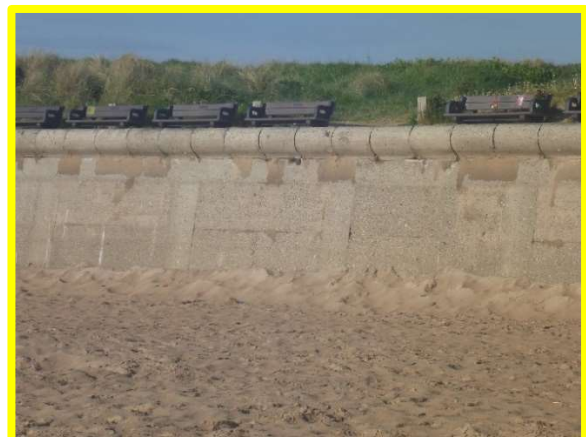
*Sea wall fronting southern end of Blyth promenade (/4201C08)*

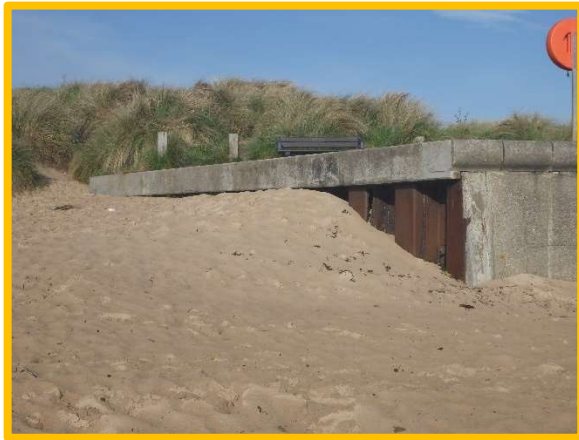
*Steel sheet pile end to promenade (/4201C08)*

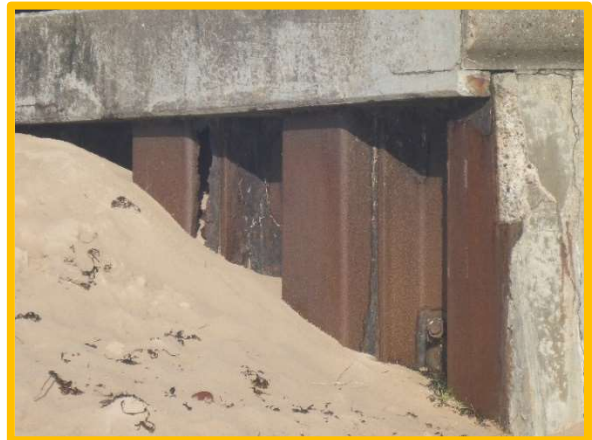
*Voids in steel sheet pile end to promenade (/4201C08)*

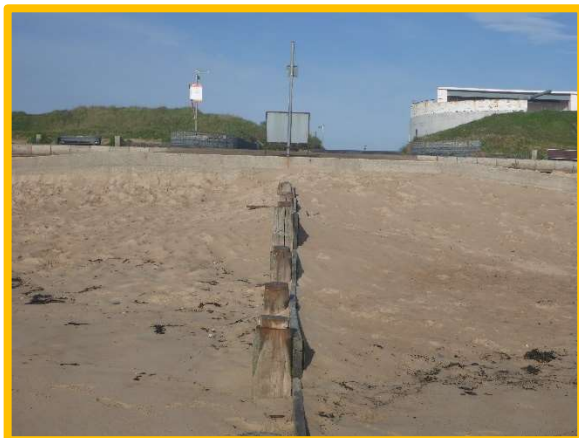
*Northern groyne (/4301C01) – generally fair condition but overall groyne field is poor*

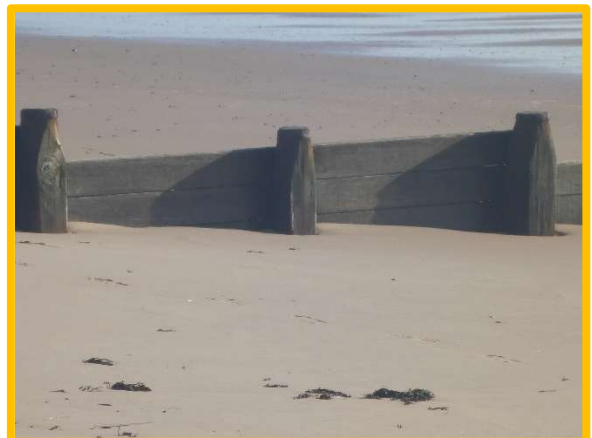
*Northern groyne (/4301C01) – generally fair condition but overall groyne field is poor*

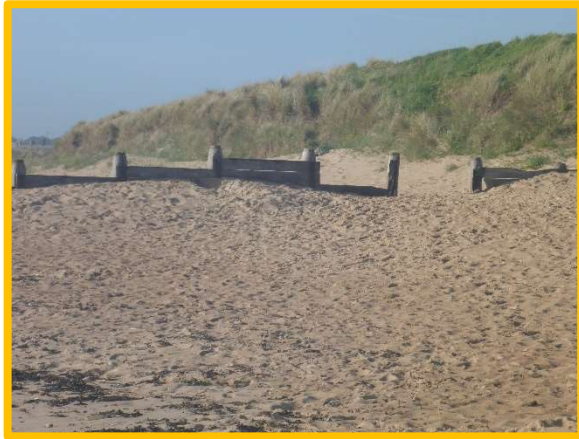
*Central groyne (/4301C01) – poor condition*

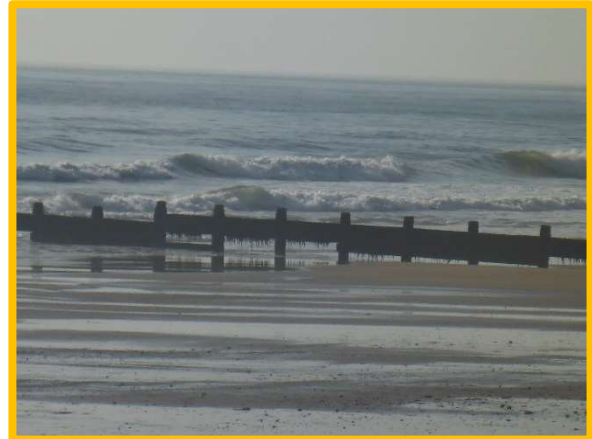
*Central groyne (/4301C01) – poor condition*

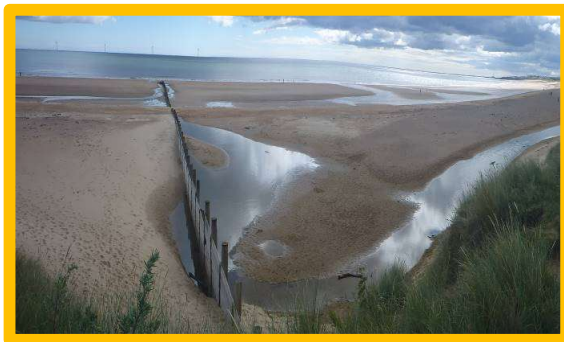
*Meggie's Burn channel undermining southern groyne in 2020 (/4301C01)*

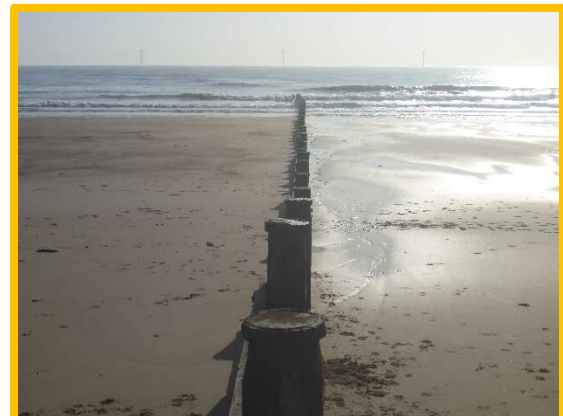
*Southern groyne in 2022 with the channel re-engineered to a different alignment (/4301C01)*

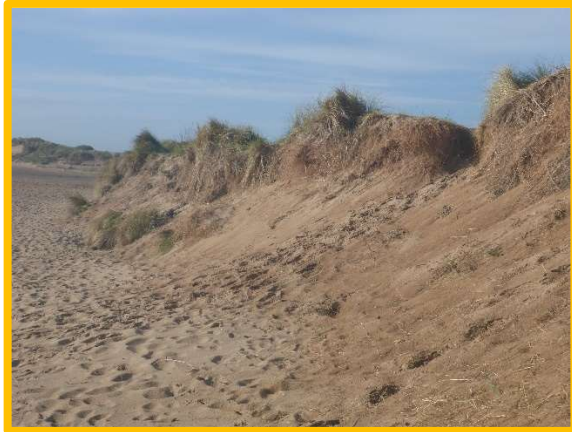
*Previous dune erosion between southern groyne and Meggies Burn (/4301C01)*

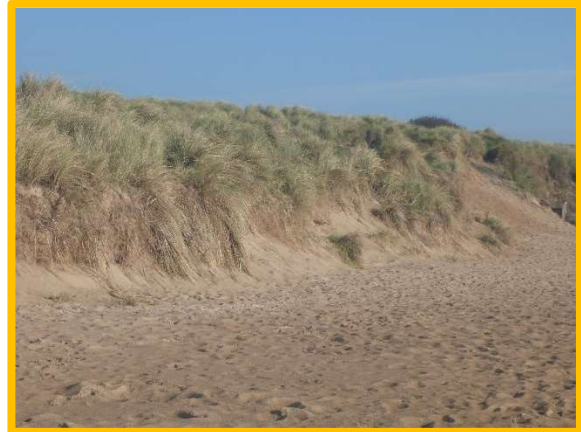
*Previous dune erosion between southern groyne and Meggies Burn (/4301C01)*

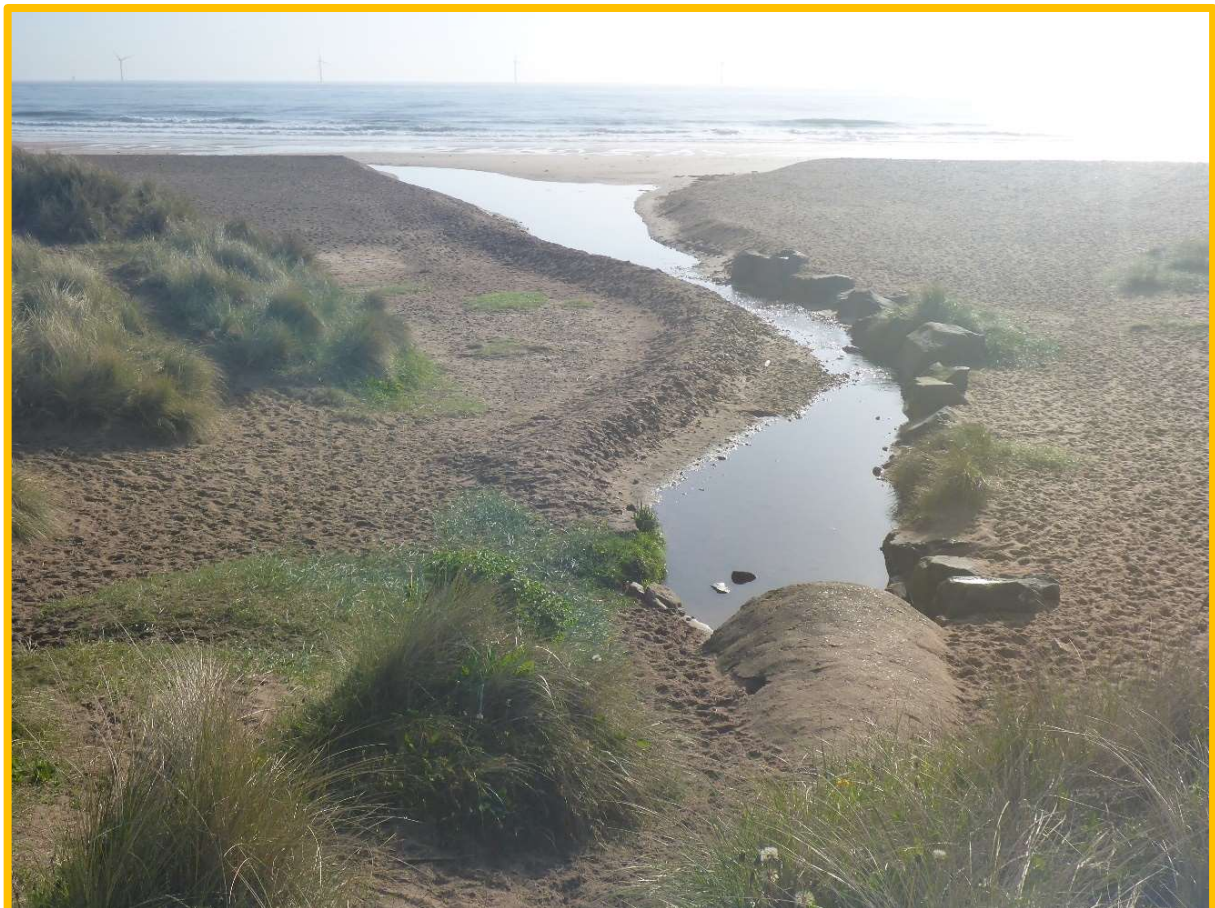
*Re-engineered channel alignment at Meggies Burn (/4301C01)*

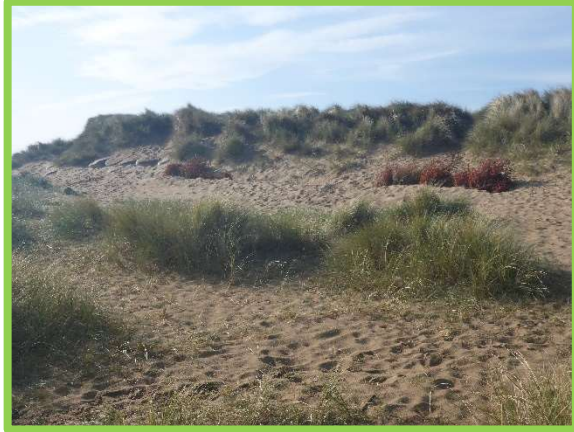
*Dune restoration to south side of Meggies Burn (/4301C02)*

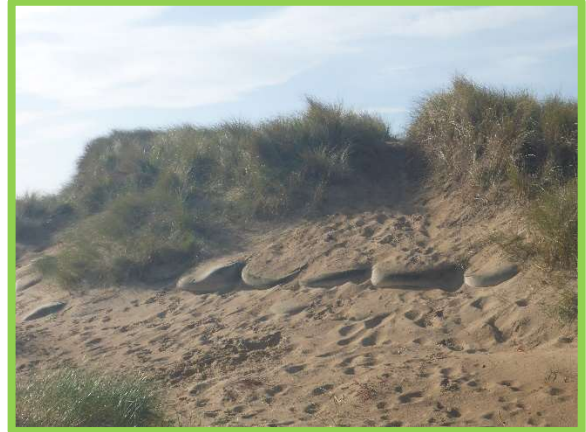
*Slight exposure of a small number of sand-filled geo-bags at Meggies Burn (/4301C02)*

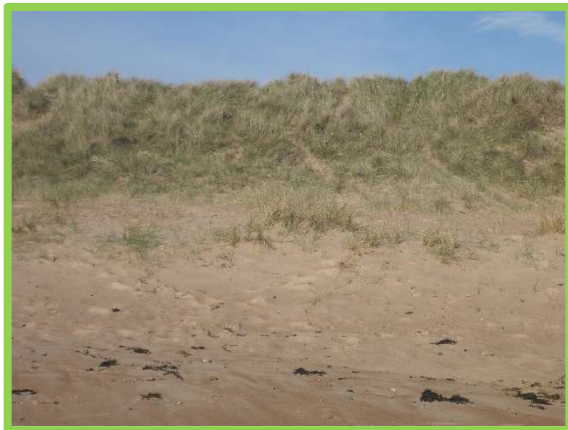
*Dunes fully recovered from 2018 erosion (/4301C02)*

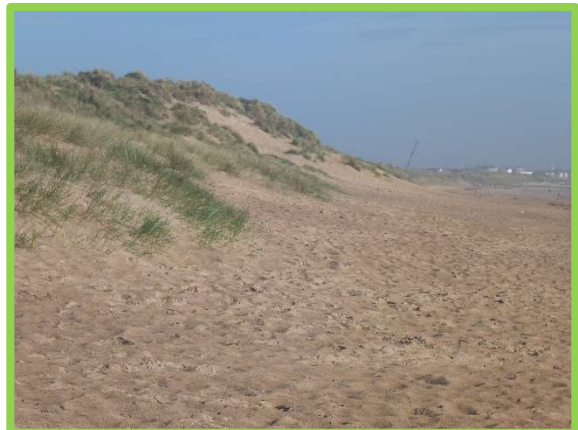
*Dunes fully recovered from 2018 erosion (/4301C02)*

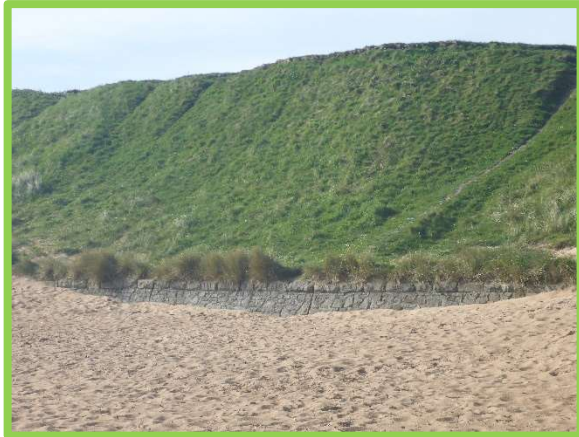
*Northern wall in good condition (/4401C01)*

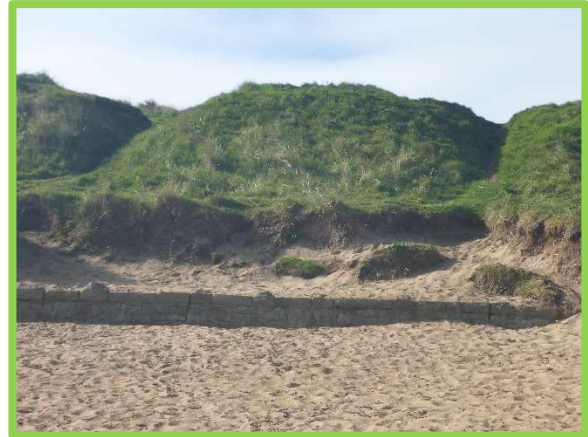
*Southern wall in fair condition with some dune erosion behind (/4301C02)*

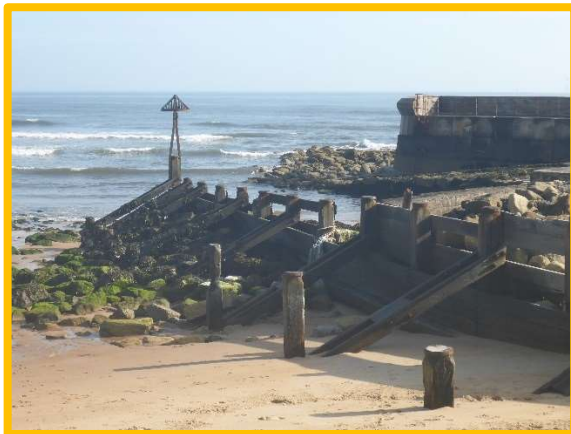
*Timber groyne at Seaton Sluice harbour (/4401C02)*

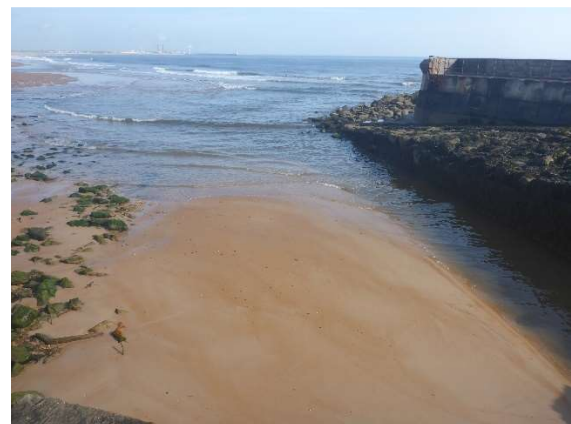
*Sand bar removed from mouth of Seaton Sluice harbour*

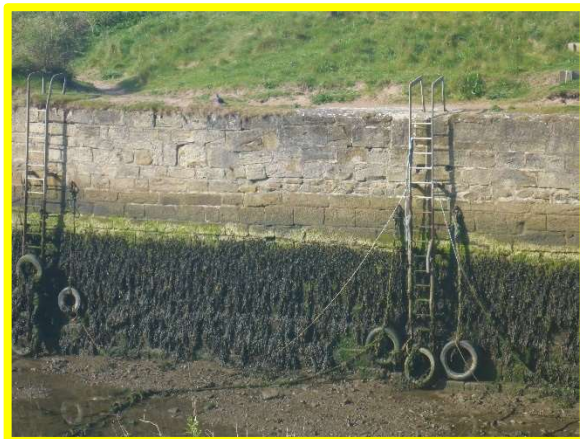
Wall on west side of harbour (/4401C04)

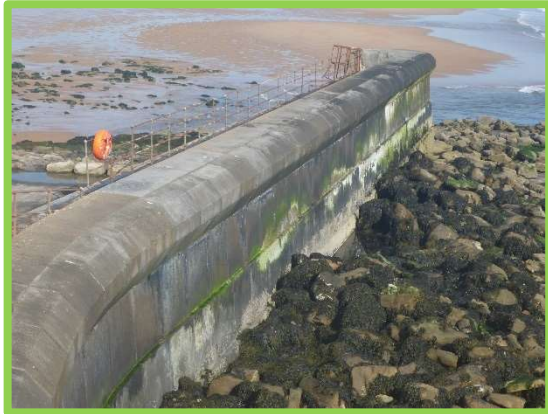
*Pier wall (/4401C10)*

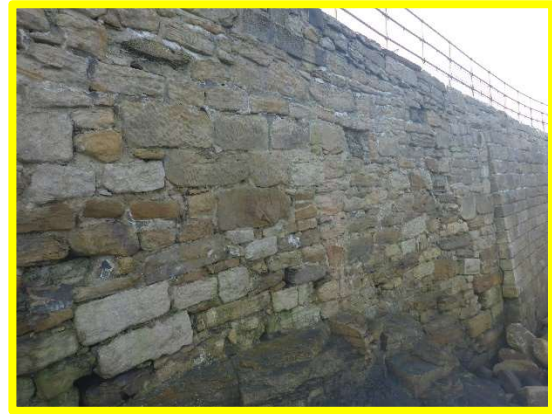
*High masonry wall (/4401C11)*

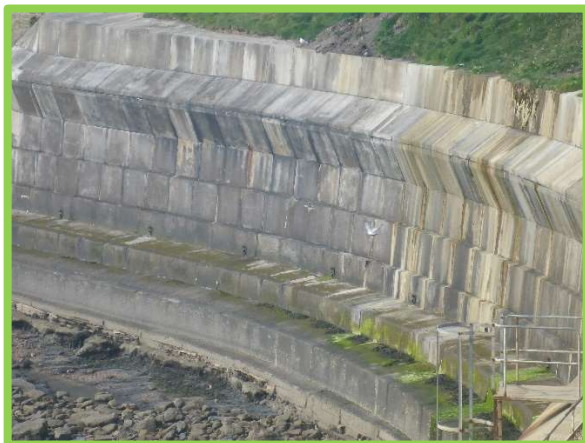
*Near-vertical seawall (/4401C14)*

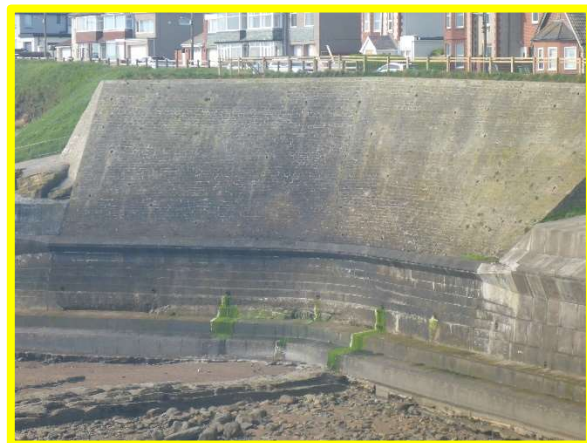
*Seawall with upper brickwork retaining wall (/4401C15)*

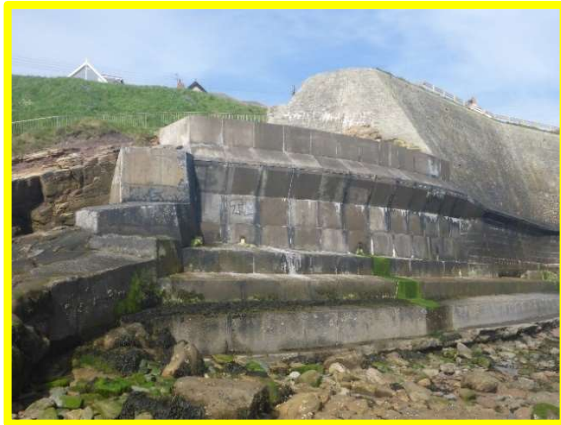
*Short length of tie-in sea wall (/4401C16)*

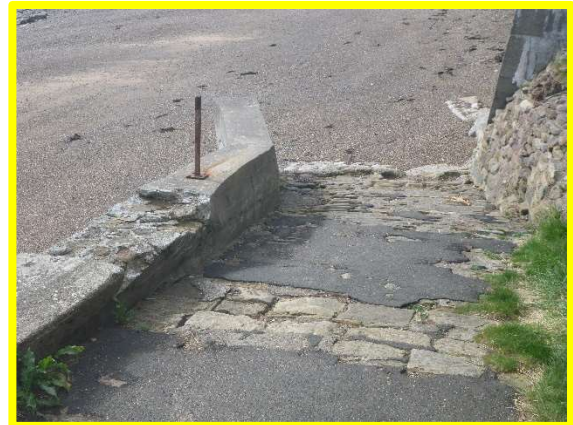
*Abraded access ramp (/4401C16)*

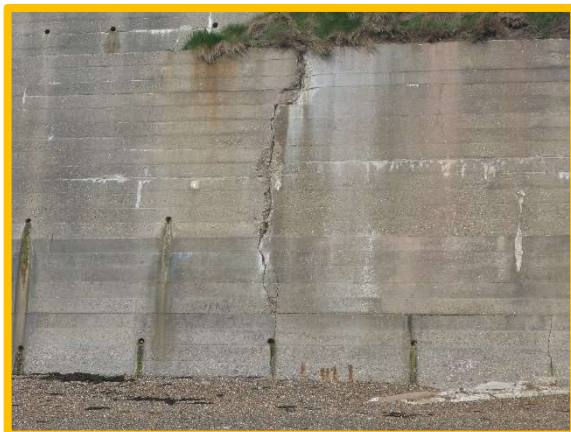
*One of three notable vertical cracks in the sea wall (/4401C17)*

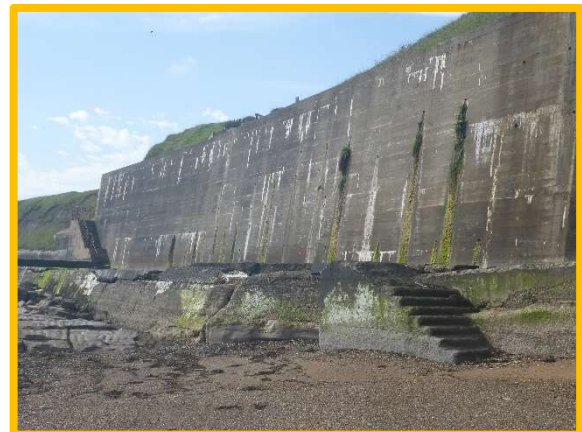
*Abraded toe apron of sea wall (/4401C17)*

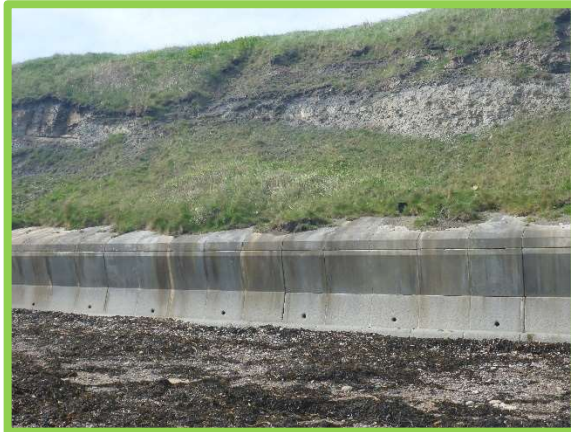
Sea wall with slumping cliffs above (/4401C18)

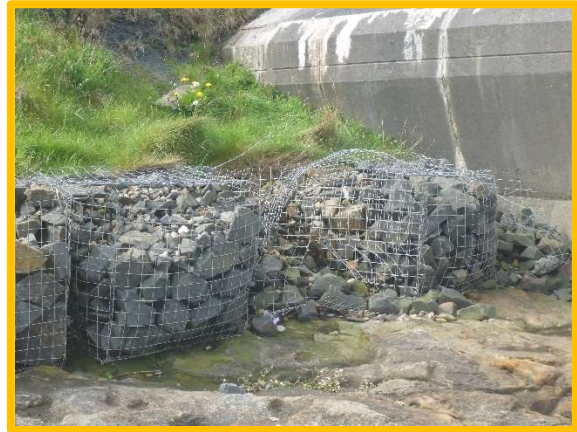
Break-up of gabion baskets (/4401C19)
