**Cell 1 Regional Coastal Monitoring Programme:  
Walk-over Visual Inspections of Assets**

**North Tyneside Council  
Final Report**

**December 2012**

## Walkover Inspection Survey

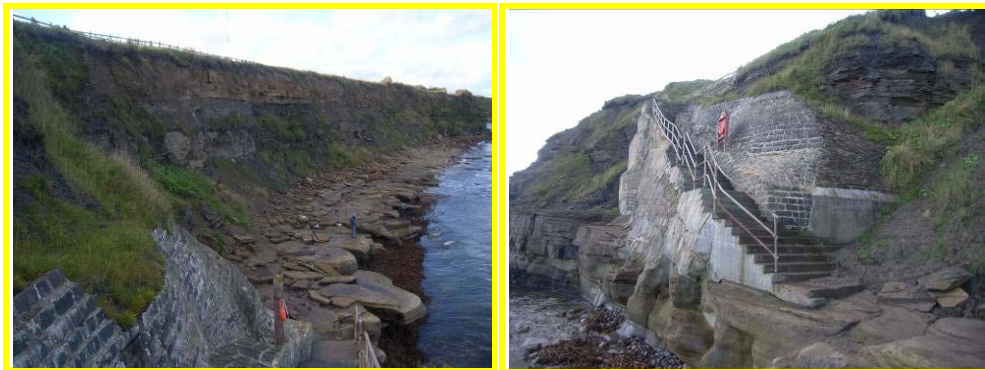
*Rock falls and cliffing along high cliff and Hartley Cove.*

*Access steps, retaining wall and hand railing in fair condition.*

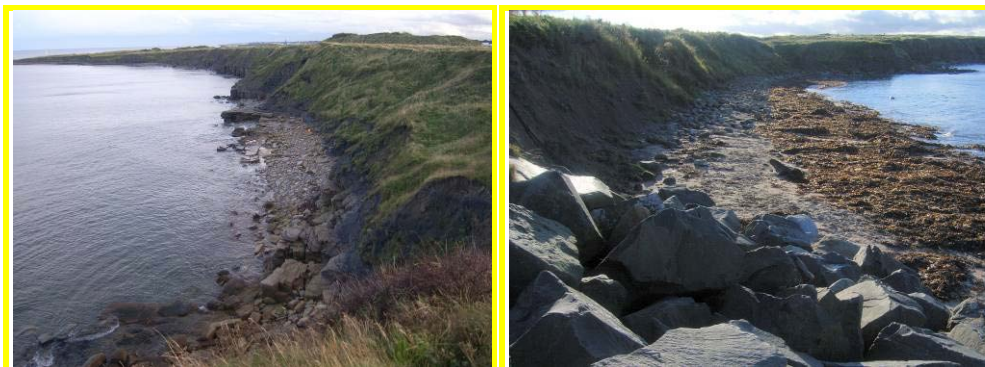
*Continued rock falls and slips in cliffs north of Curry's Point.*

*Onset of outflanking north end of revetment at Curry's Point.*

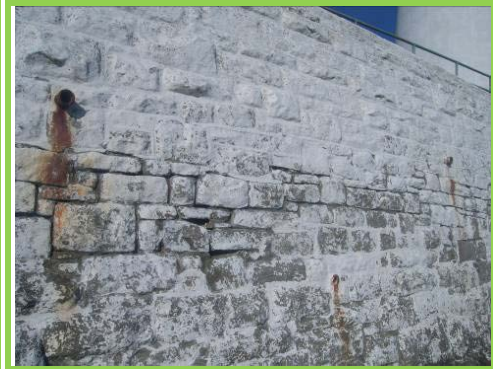
*Minor loss of mortar to high masonry wall on east side of island.*

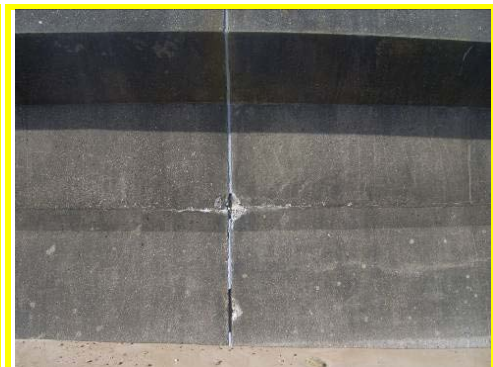
*Spalling at some concrete joints and new sealant.*

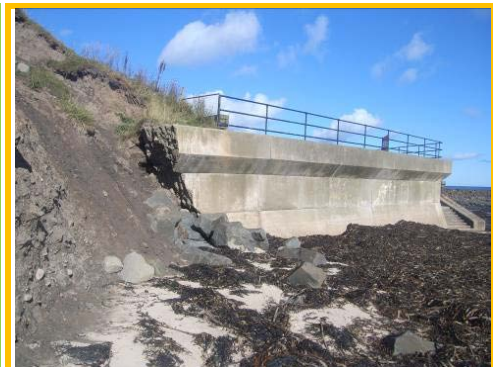
*Continued outflanking at south end of wall and displacement of armour.*

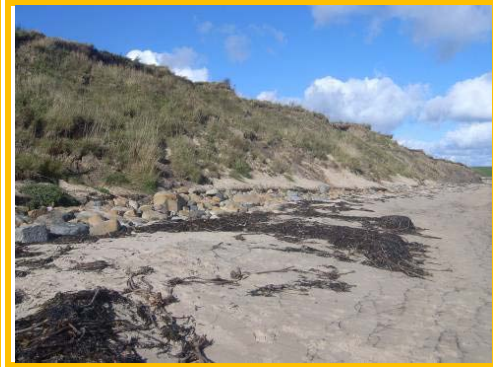
*Cliffing evident along the top of the soft earth cliffs and boulder toe.*

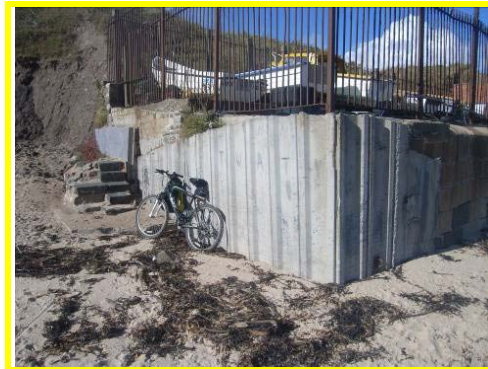
*Repairs at south end of boatyard on Whitley Sands in fair condition.*

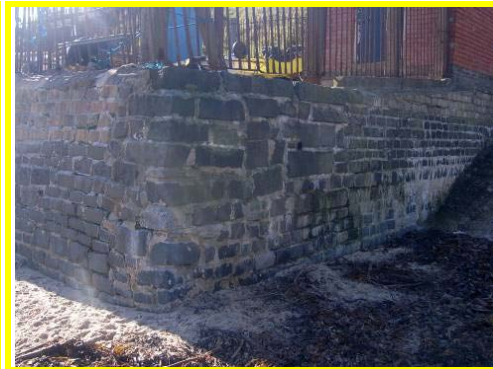
*Some gaps and missing mortar in masonry blocks at north end of boatyard.*

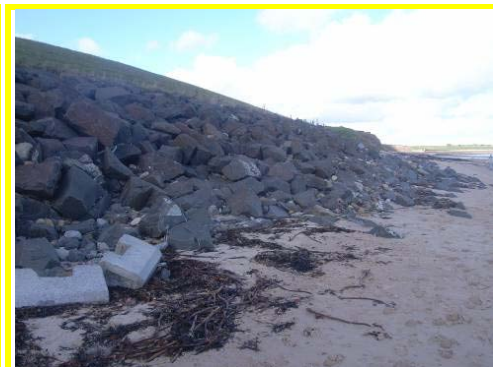
*Slight flattening of profile and displaced rocks at toe of revetment.*

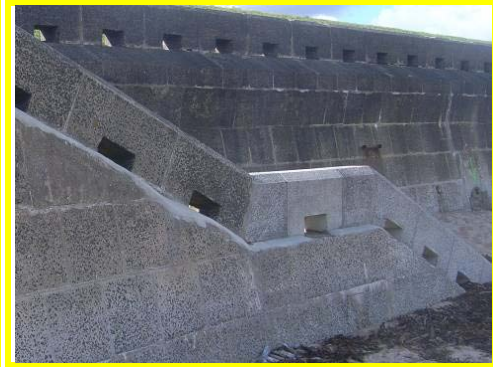
*Repairs to some cracks along in Whitley Links Sea Wall good condition.*

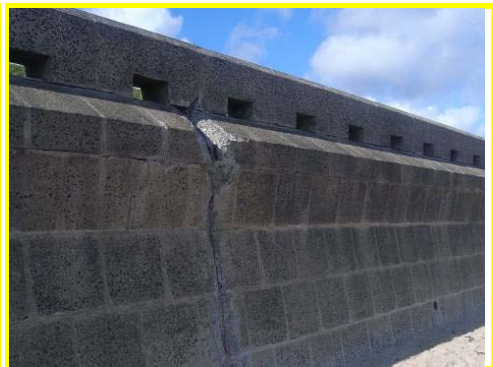
*Gaps and missing mortar along the coping.*

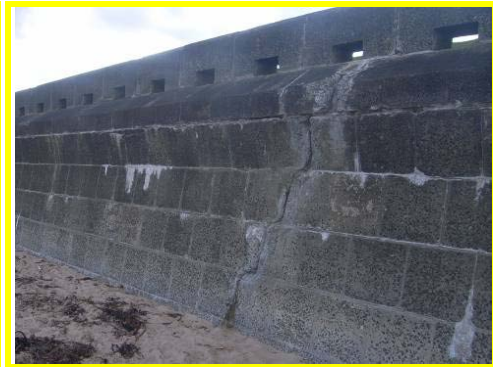
*Diagonal crack through blocks south of Rendezvous Cafe.*

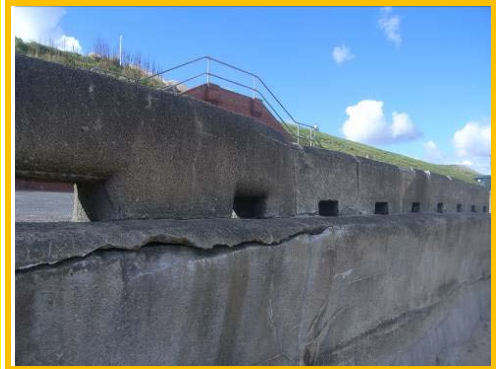
*Cracking in render along cope of seawall.*

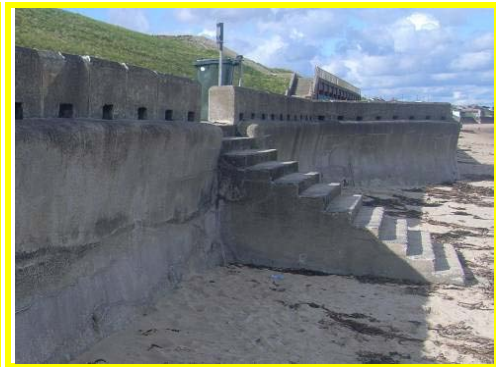
*Damage along base of concrete steps no observed due to high beach levels.*

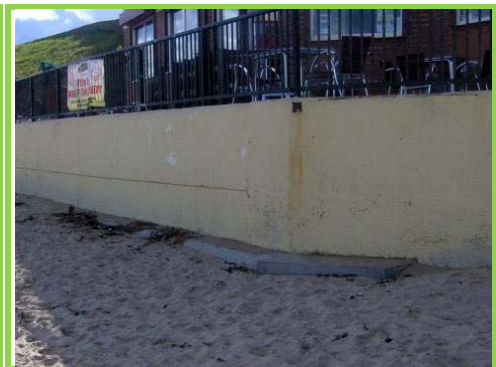
*High beach levels covering exposed timber piles and undermining of wall.*

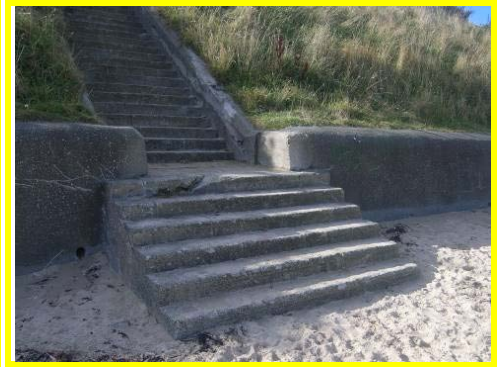
*Cracks and spalling in concrete at the steps.*

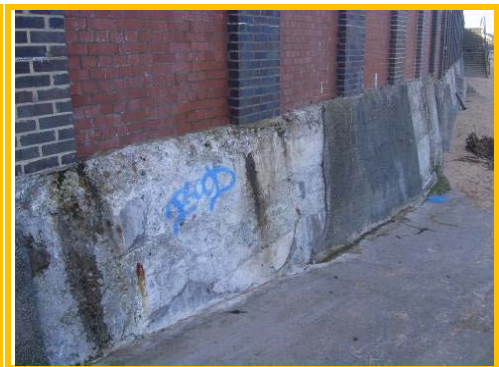
*Abrasion and spalling of concrete encasing along the toe.*

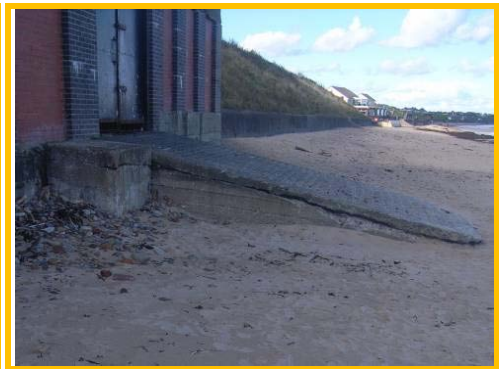
*Cracks and gaps beneath the access ramps.*

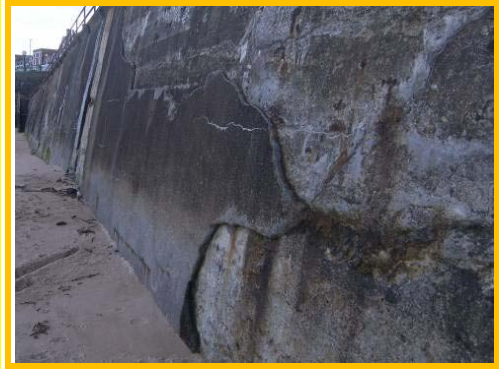
*Continued loss of concrete encasement and corrosion of reinforcement mesh.*

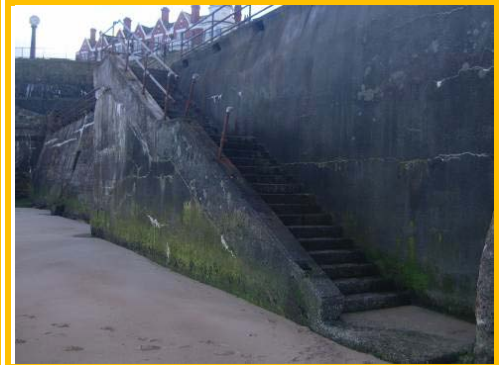
*Missing lower post and hand railing at access steps.*

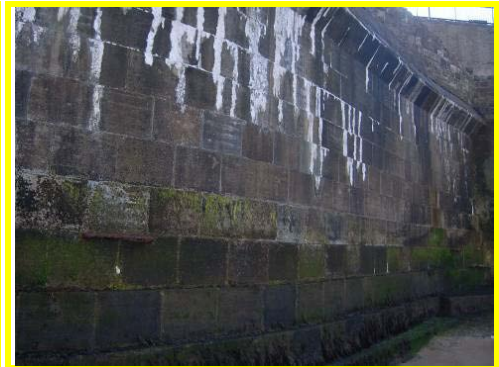
*Heavy staining down face of wall.*

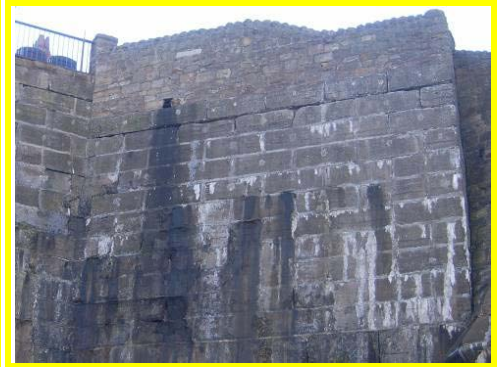
*Horizontal gap in blockwork along the crest of the upper section of wall.*

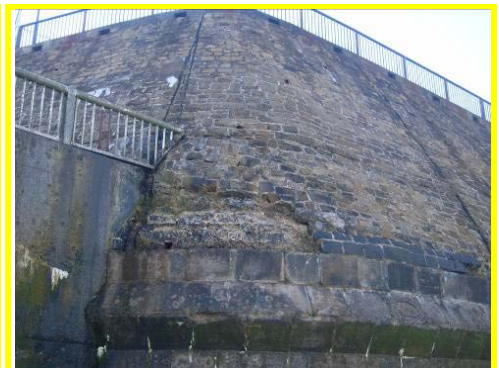
*Section of missing brickwork at south end of upper sloping masonry wall.*

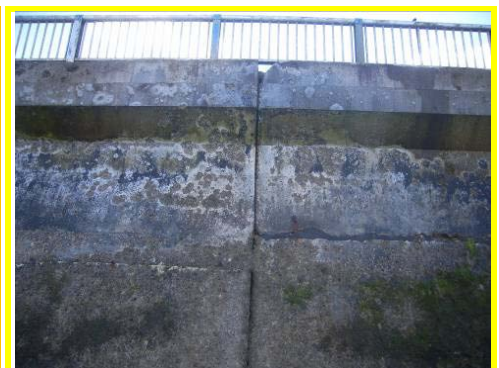
*Missing sealant from construction joints.*

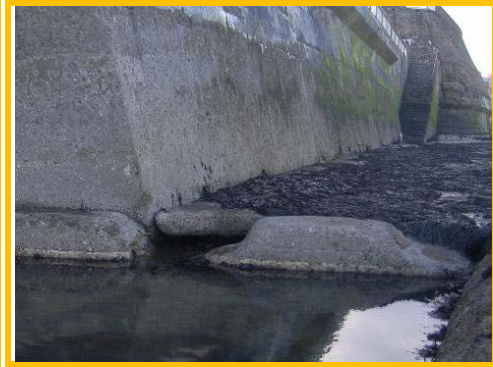
*Voiding and undermining of toe apron at south end.*

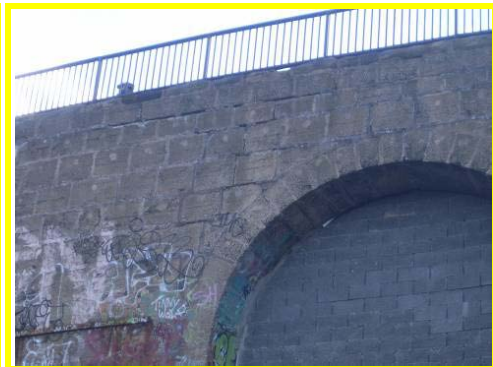
*Gaps between blocks in the upper wall.*

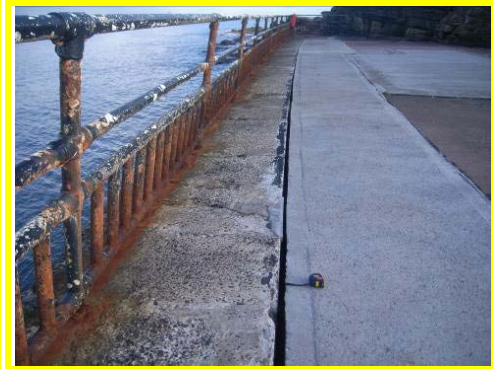
*Wide gap between coping and surfacing at south end.*

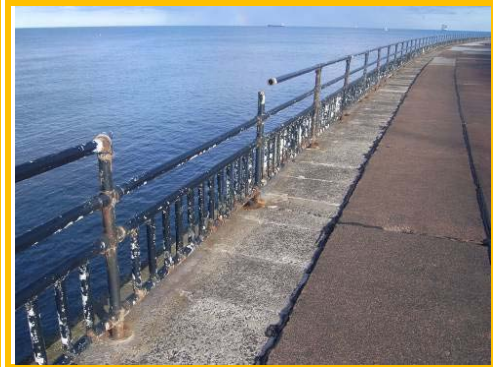
*Missing section of hand railing at central section of wall.*

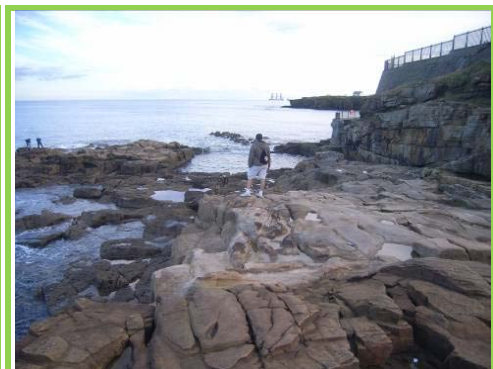
*Wide rock platform of Table Rocks providing protection to the cliffs.*

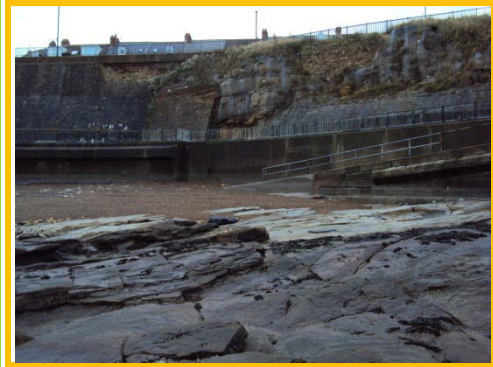
*Southern wall and access ramp is locally in poor condition.*

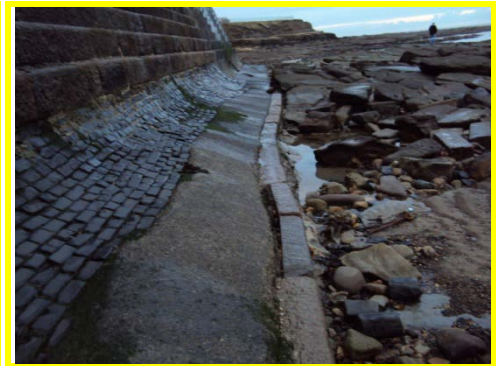
*Apron to blockwork wall with signs of movement.*

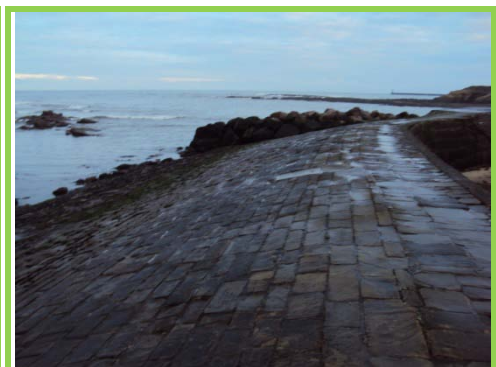
*Seaward face of north pier with improved rock armour.*

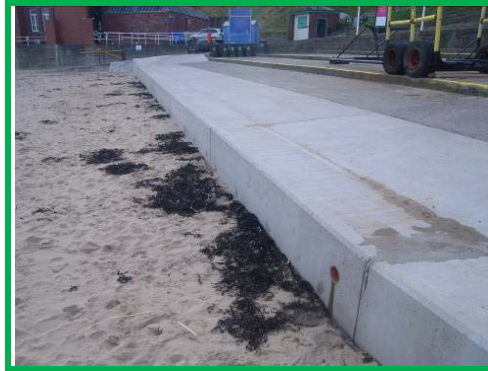
*New low concrete wall along toe of wide stepped concrete apron.*

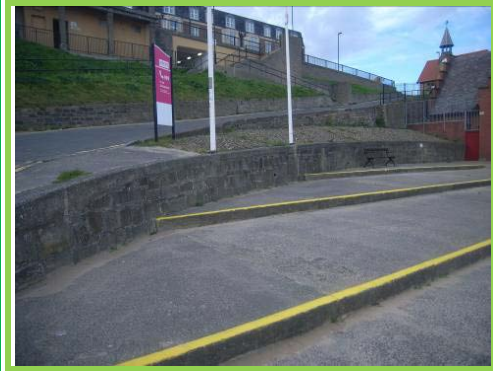
*No apparent cracks or gaps in masonry wall at back of stepped apron.*

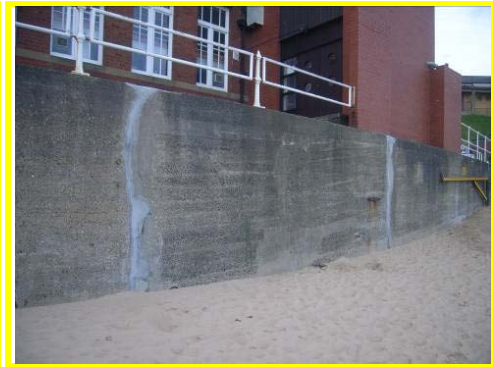
*Recently repaired cracks in concrete wall in good condition.*

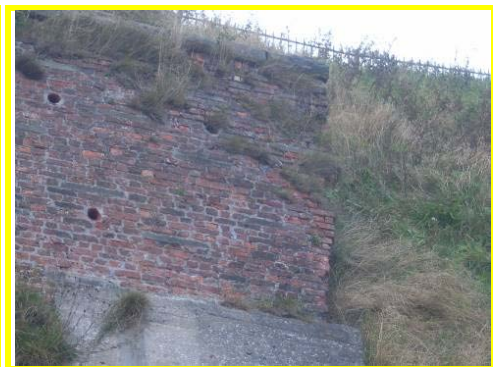
*Missing mortar and gaps between bricks in upper wall.*

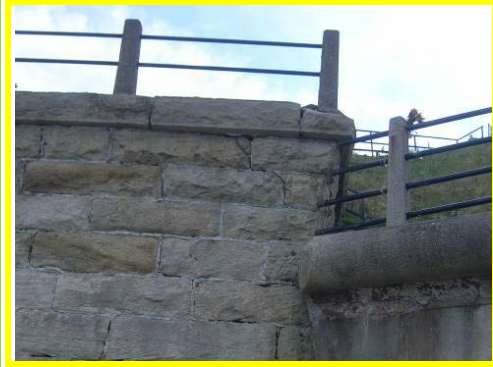
*Movement and cracking between blocks at the north end of the high wall Section.*

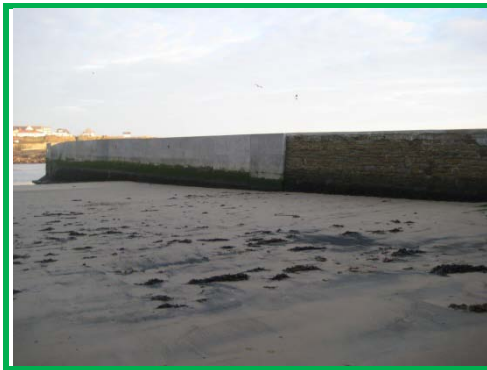
*Leeward face of Cullercoats south pier with recent concrete repairs.*

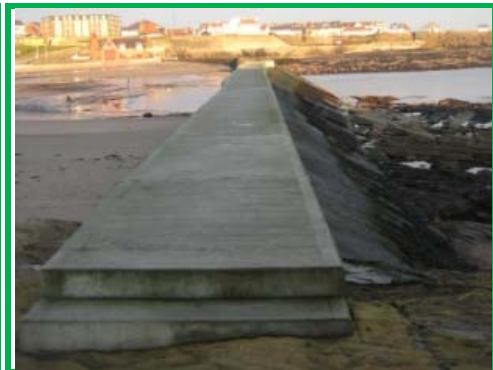
*Recently repaired pier deck*

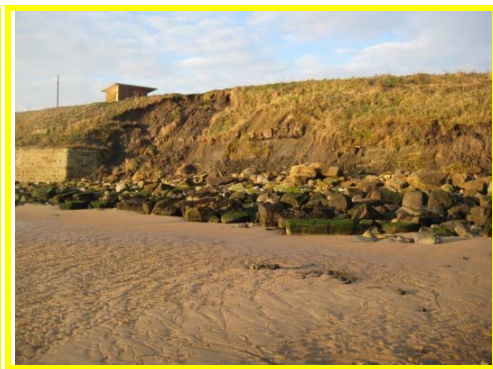
*Recent slumping to southern section cliff face.*

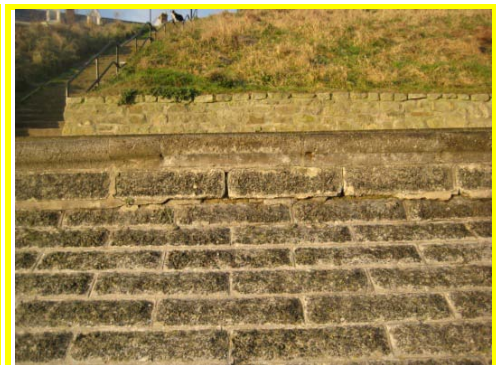
*Localised damage to crest of masonry revetment with gaps in joints leading to cracking.*

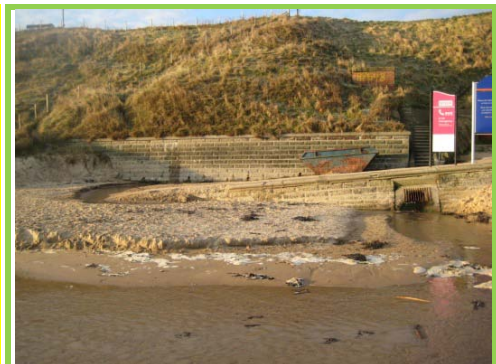
*Concrete block work wall in good condition.*

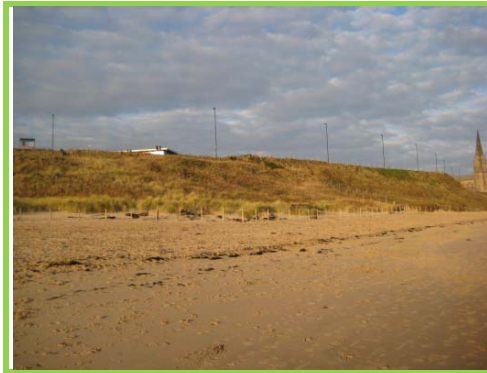
*Well vegetated dune system.*

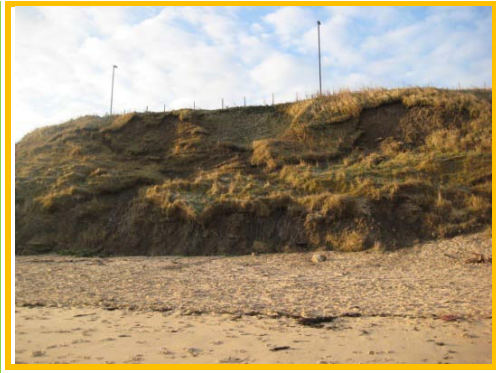
*Localised slumping in need of further risk assessment.*

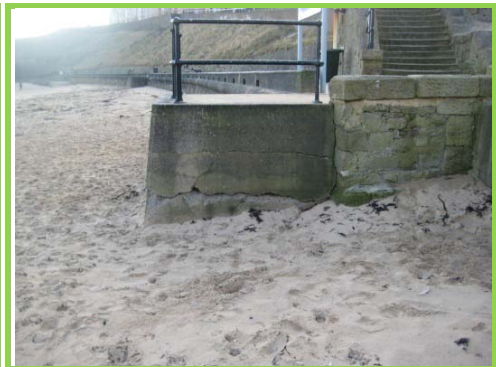
*Cracking to concrete access steps*

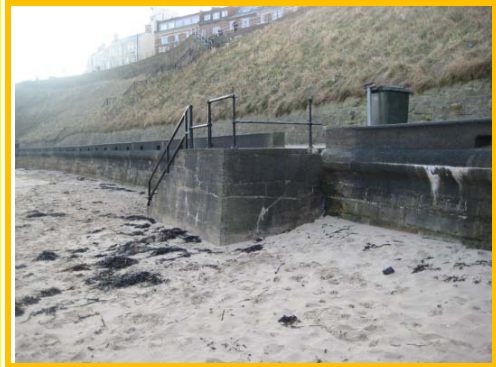
*Handrailing missing to access steps.*

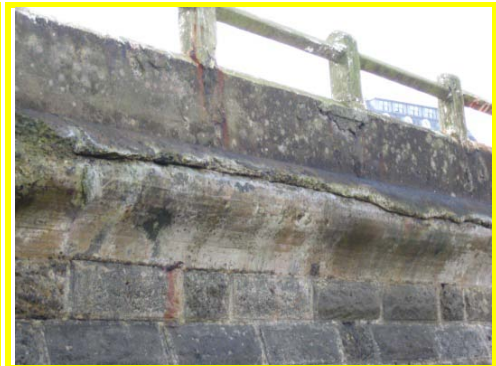
*Abrasion and spalling to wave return wall.*

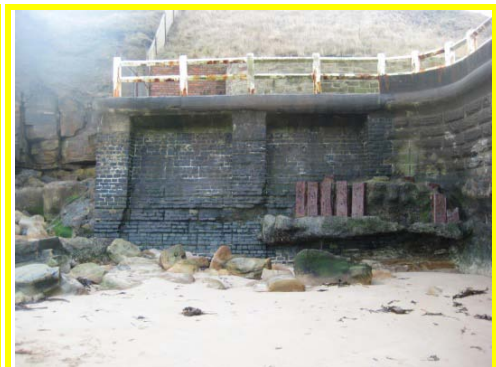
*Wall at southern landward tie-in of Tyne Pool with apron undermined.*

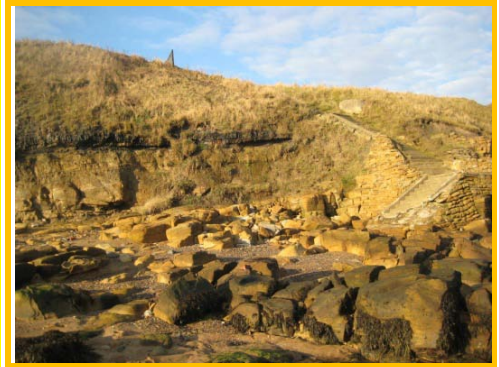
*Heavily abraded access steps.*

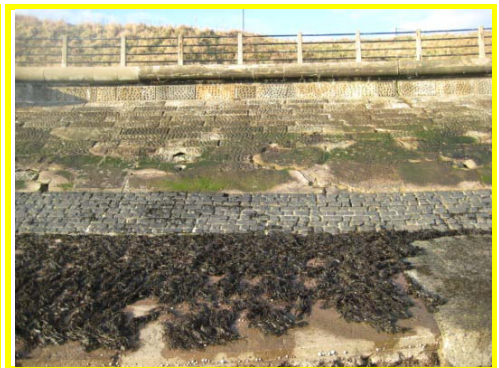
*Sloping revetment with occasional cracks and mortar gaps*

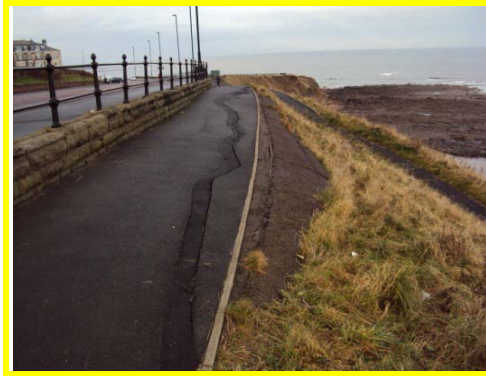
*Cracking in upper slope.*

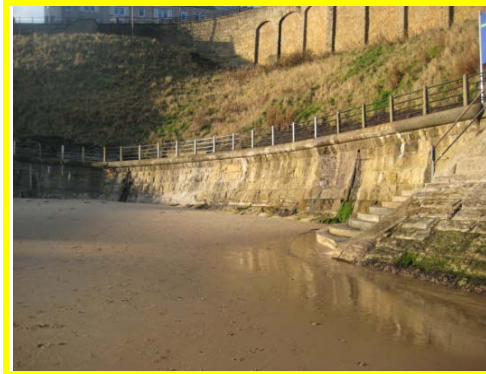
*Curved sea wall in Kind Edwards Bay in fair condition.*

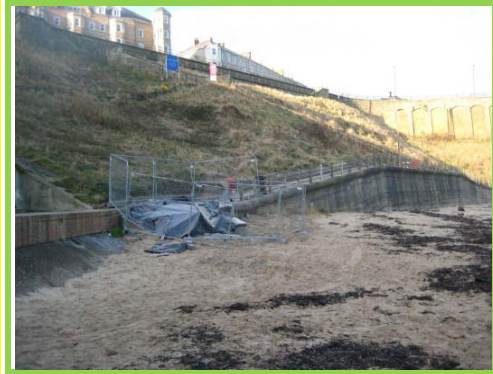
*Repair works underway to access*

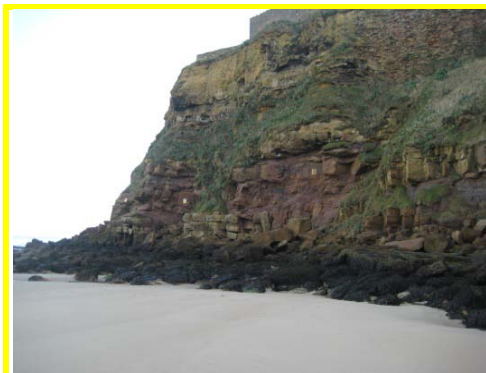
*Fractured rock structure at Tynemouth Headland with rockfall on foreshore*

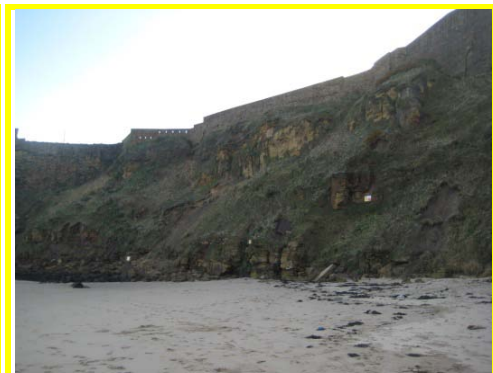
*Signs of movement and slippage in vegetated cliff.*

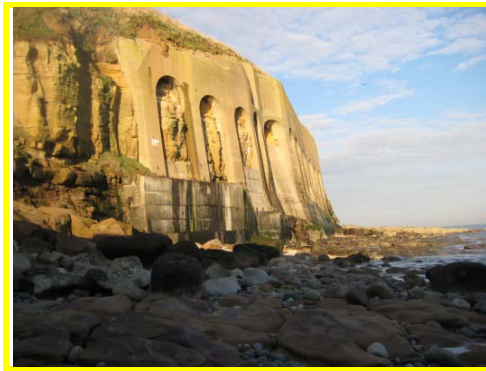
*High arched retaining wall north of the North Pier in fair condition.*

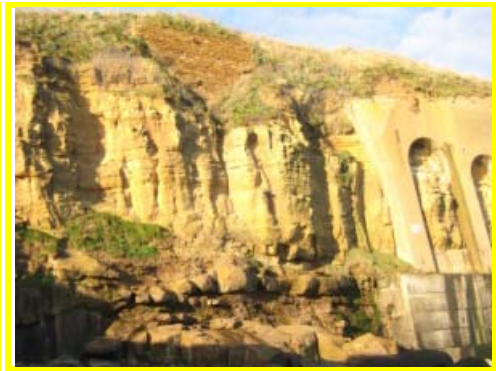
*Some signs of slippage in the upper vegetated cliffs.*

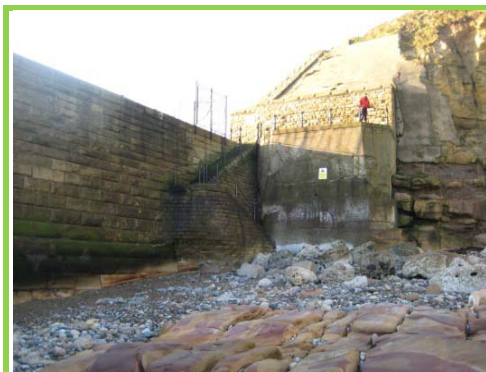
*Northern pier wall with minor cracking*

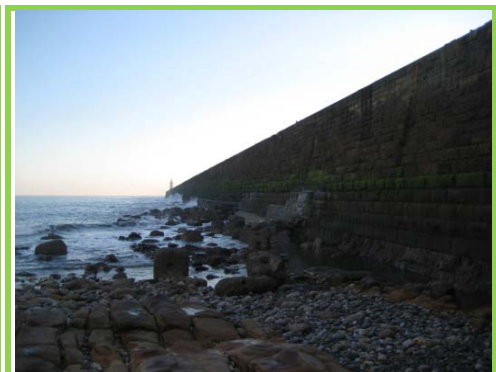
*Northern pier seaward side*

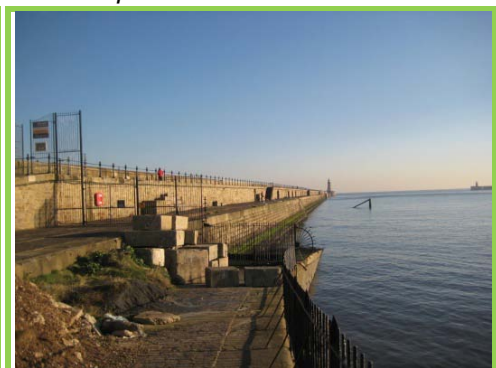
*Northern pier leeward side*

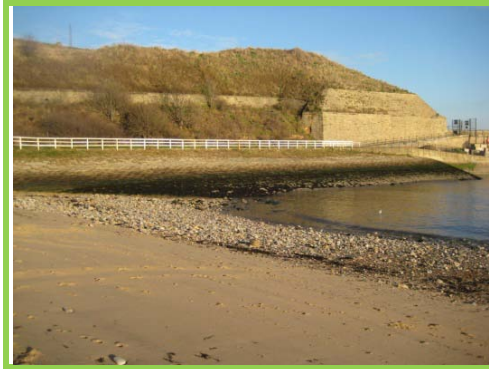
*Masonry revetment at Prior's Haven in good condition*

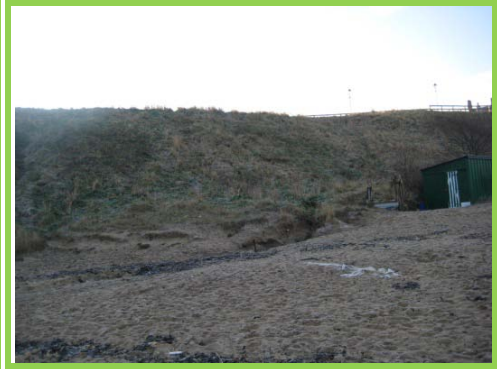
*Coastal slope in good condition*

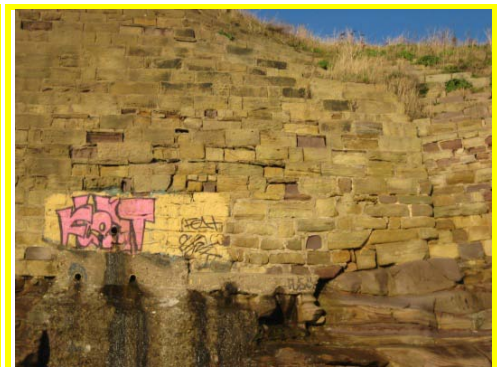
*Gaps and cracks in mortar joints*

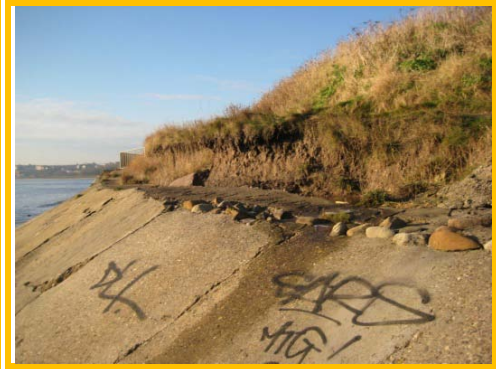
*Erosion to upper slope*

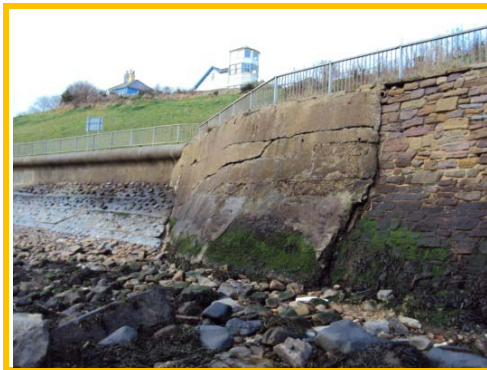
*Spalling concrete render to masonry wall at Sandy Goit.*

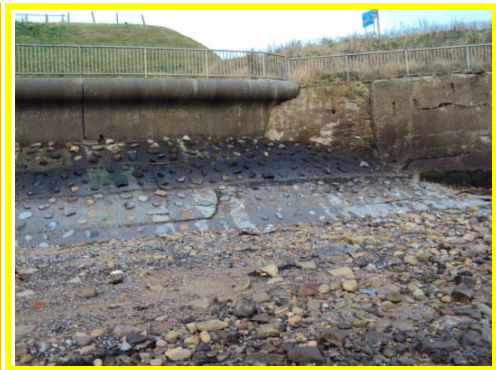
*Cracking in pitched stone revetment*

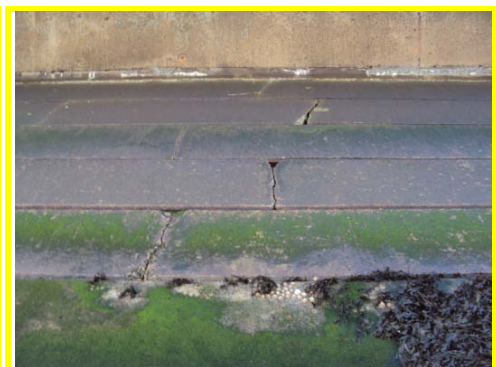
*Cracking in panels and gaps at joints evident throughout*

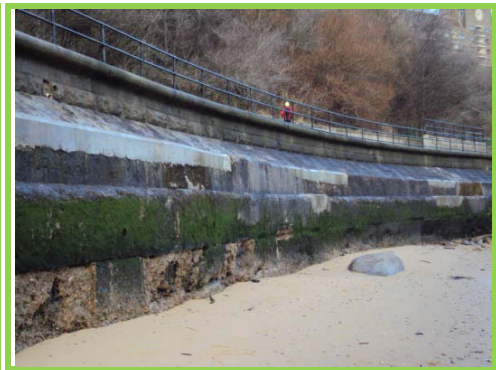
*Very recent patch repairs evident throughout this section*

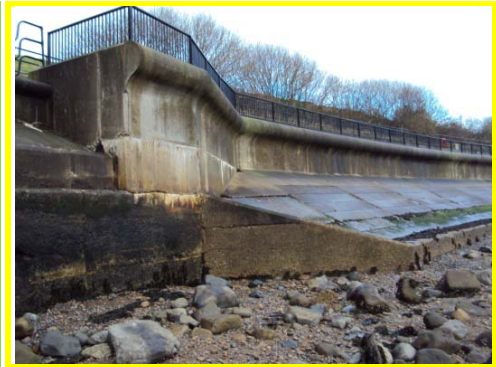
*Exposed concrete toe*

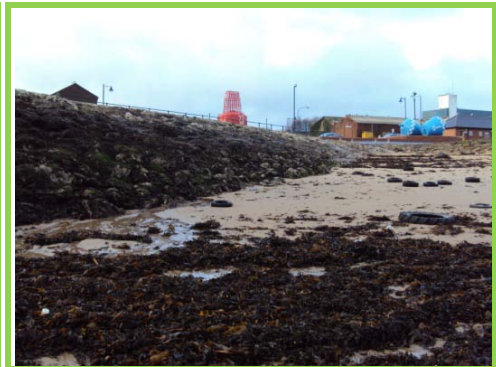
*Pitched stone revetment to jetty*
