**Cell 1 Regional Coastal Monitoring Programme:  
Walk-over Visual Inspections of Assets**

**North Tyneside Council  
Final Report**

**August 2014**

## Walkover Inspection Survey

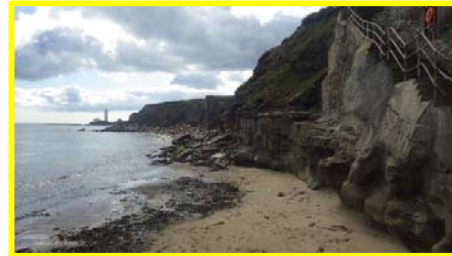
Evidence of minor rock falls and slips between Hartley Cove and Curry's Point (/4401c23).

The undefended cliffs between Hartley Cove and Curry's Point have been subject to historic rock falls and slippages in the overlying softer material. There is evidence of recent rock falls and slippage between the steps and causeway to St. Mary's Island.

This cliff top recession continues to narrow the footpath in sections necessitating the need to move the footpath inland. At Curry's Point erosion of the soft earth slopes continues initiating outflanking of the north end of the rock revetment, which is in good condition, and cutting back to the access road to St. Mary's Island.

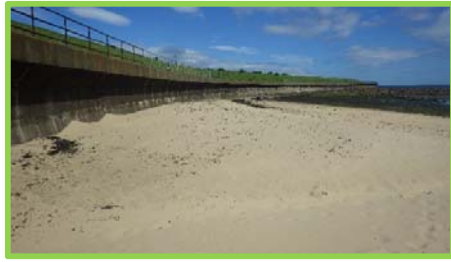
Trinity Road seawall in good condition, sand level good (/4501c04).

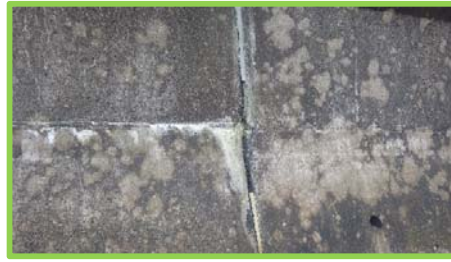
Trinity Road sea wall spalling of some joints (/4501c04).

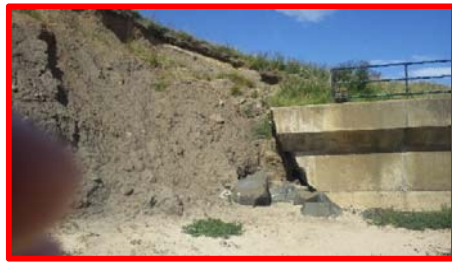
As reported during previous inspections, the undefended sea cliffs at the northern end of Whitley Sands are actively slumping, despite the presence of a relatively high boulder beach and sandy foreshore along their toe. As this erosion continues the cliffs release material, including boulders, to the foreshore. This process also cuts the cliff top back through successive slumping failures, closer to the footpath, in time, this process will start to affect the seaward edge of Briardene Car Park and the municipal mini golf course. Some sections of the undefended cliff are prone to imminent slumping since the soft material is extensively cracked. Work began in October 2014 to build a concrete blockwork wall along this frontage.

Outflanking at south end of wall similar to 2012 (/4501c05).

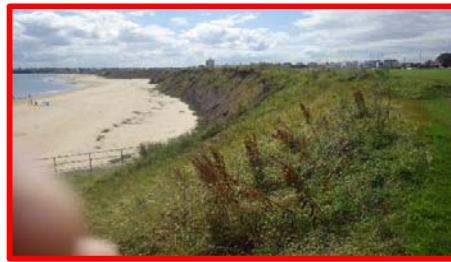
Slumping of cliffs at end of Whitley Sands adjacent to golf course (/4501c05).

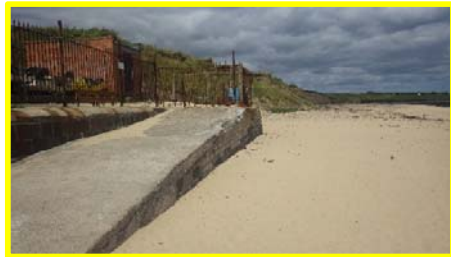
Concrete ramp boathouse in reasonable condition minor spalling (/4501c05).

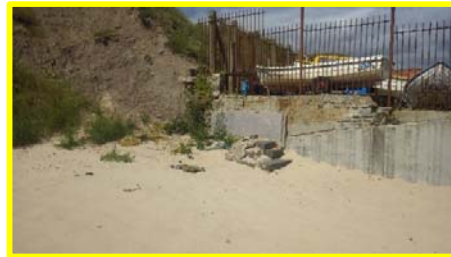
Repairs to south end of boatyard in good condition, high sand levels (/4501c05).

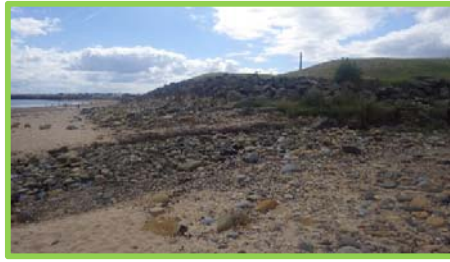
Revetment Briardene in good condition (/4501c06).

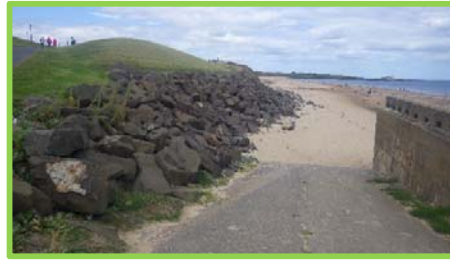
Revetment Briardene in good condition, sand levels good (/4501c06).

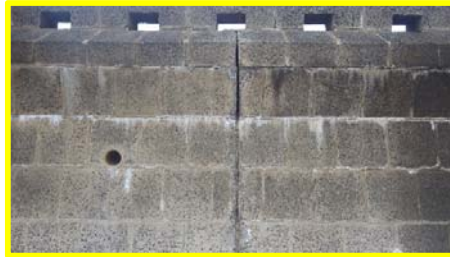
Further repairs to joints required in Whitley Links sea wall (/4501c07).

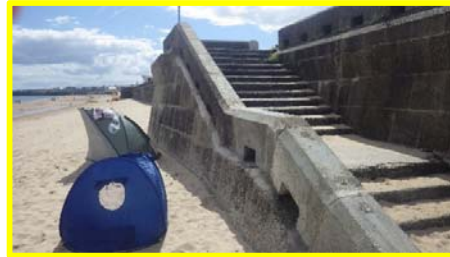
Steps in good condition, repairs carried out to joints (/4501c07).

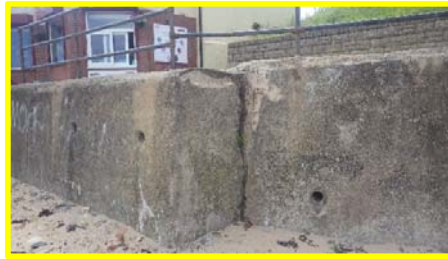
Wall south of Boardwalk Cafe, spalling and exposed reinforcement mesh (/4501c09).

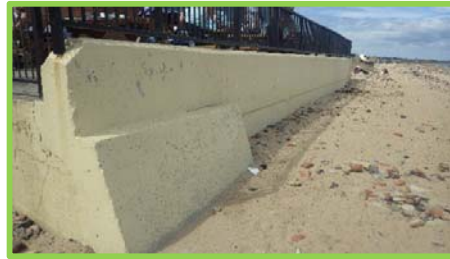
Concrete wall fronting Boardwalk Cafe in good condition (/4501c09).

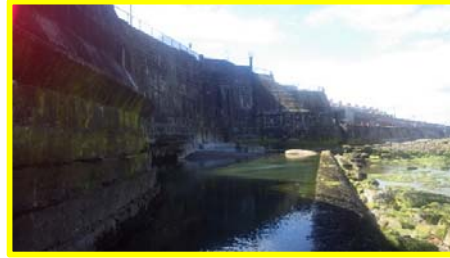
Hand railings appear in good condition (/4601c04).

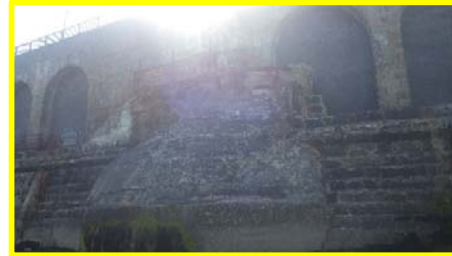
Localised repairs (/4601c08).

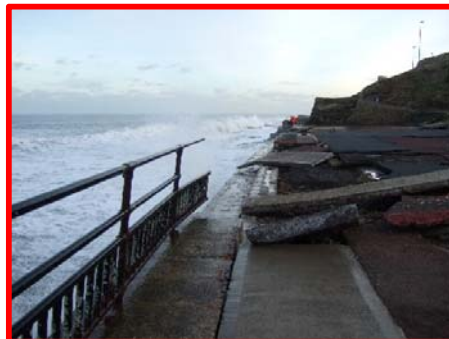
To the south, the lower masonry blockwork fronts the Southern Lower Promenade. This section of wall was damaged during the severe weather in December 2013. The coping blocks were removed by the storms resulting in damage to the adjacent surfacing and concrete bays constructed after 2010 inspection. Other sections of asphalt surfacing and kerbing along the centre section remain damaged. The hand railing in the area damaged was lost and the remaining hand railing along the whole wall is badly corroded. The beach access steps are heavily abraded but are now redundant since they have been closed off. The area of damaged wall was fenced off for safety and the inspection was undertaken at low water. However the toe along the southern section remained below water and was therefore not observed. Plans are in place to carry out repair works to the damaged area during 2014/15.

Severe damage to promenade and loss of coping stones, surfacing and railings at south end (/4601c08).

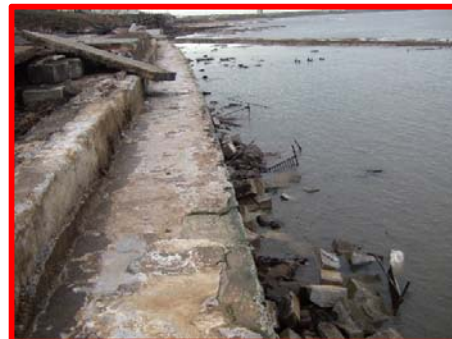
Severe damage to promenade and loss of coping stones, surfacing and railings at south end (/4601c08).

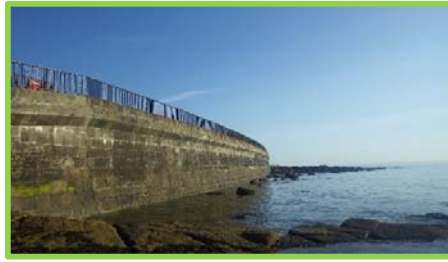
Brown's Bay has two separate sections of sea wall. In the northern part of the bay the wall is generally in good condition, although the cracks, joint gaps and abrasion around joint gaps increase in frequency to the south. The ramp to the beach area is locally in poor condition and repairs are required.

Cracks, joint gaps and abrasion around joint gaps increasing at south end (/4601c10).

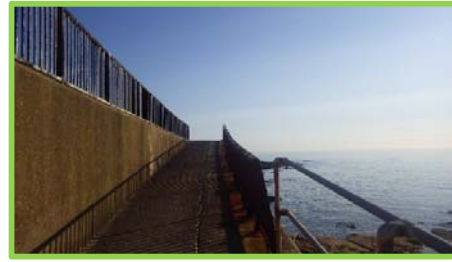
Access ramp cracking and hand railings damage (/4601c10).

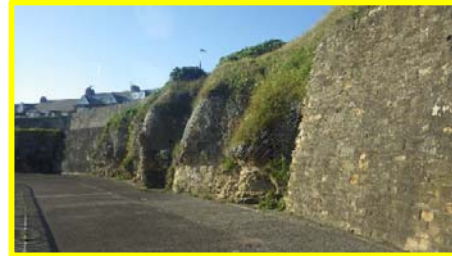
Rear wall well maintained, rock bolts and meshing (/4701c01).

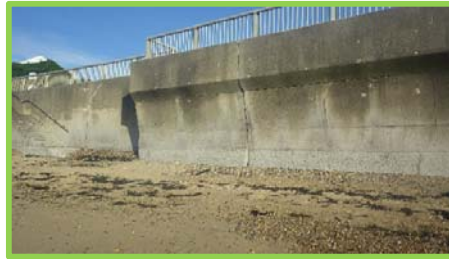
Concrete wall in good condition, abrasion to lower section of wall (/4701c01).

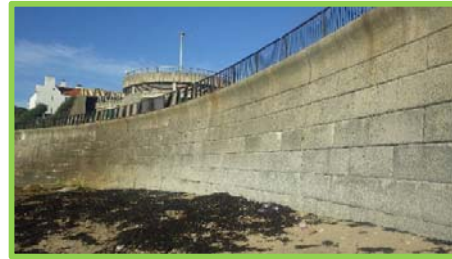
Wall in good condition, minor joint repairs required (/4701c05).

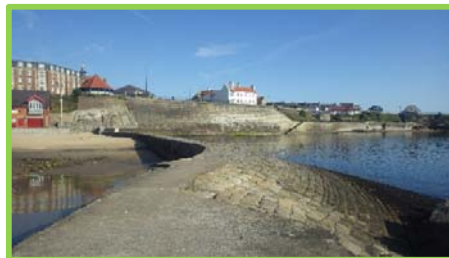
Cullercoats North Pier in good condition following repair works (/4701c07).

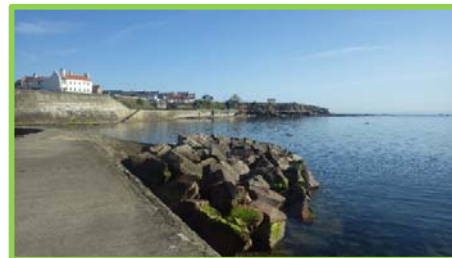
Stone protection in good condition North Pier (/4701c07).

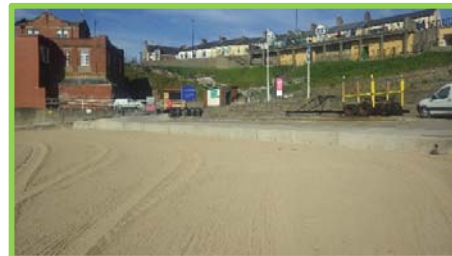
Concrete protection to steps in good condition. Sand level good (/4701c08).

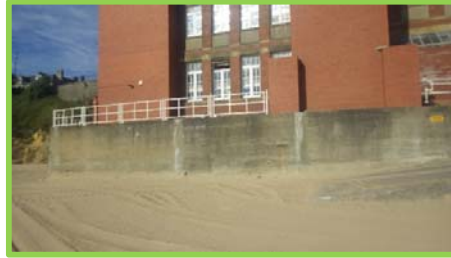
Concrete protection to Dove Marine Laboratory in good condition. Joint repairs carried out (/4701c09).

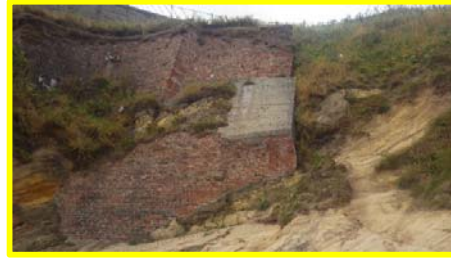
Missing mortar and gaps in upper wall (/4701c10).

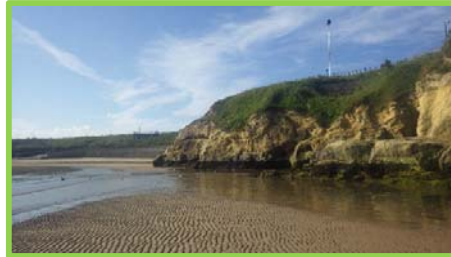
Cliffs centre of Cullercoats Bay in good condition, no evidence of rock falls (/4701c11).

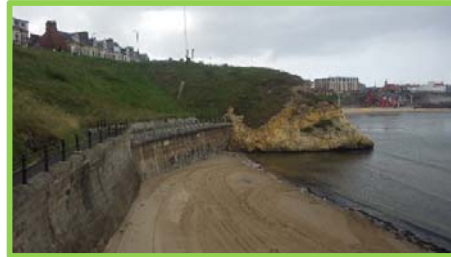
Cliffs centre of Cullercoats Bay in good condition, no evidence of rock falls (/4701c11).

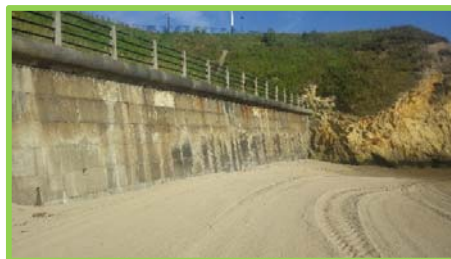
Walls in the southern section of the bay in good condition and level of sand good (/4701c12).

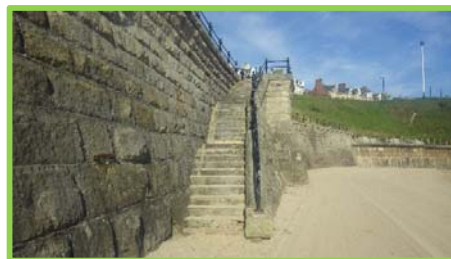
Concrete repairs required at base of the steps in bay (/4701c13).

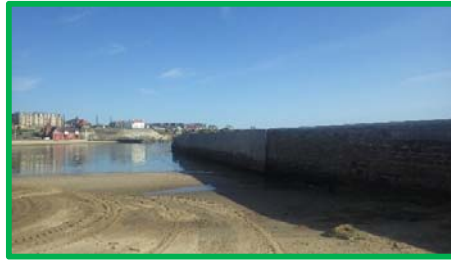
South Pier in very good condition following reconstruction. Beach levels good (/4701c15).

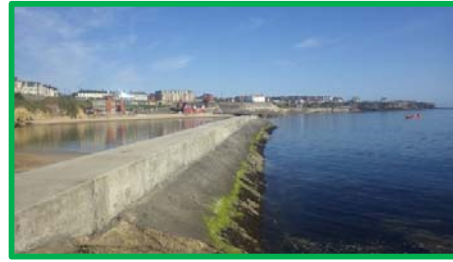
South Pier in very good condition following reconstruction, seaward side (/4701c15).

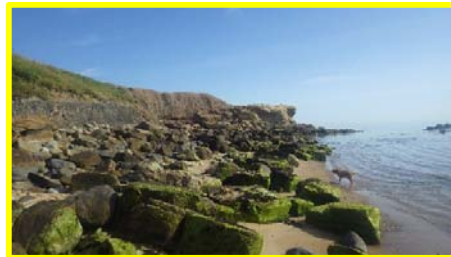
Minor slumping of cliffs at Tynemouth North Point but no major change (/4701c16).

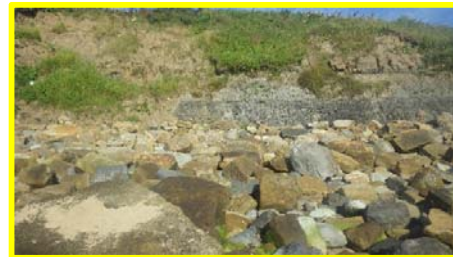
Evidence of slumping (/4701c16).

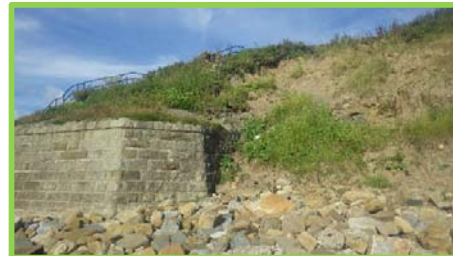
Evidence of vegetation on area identified as slumping in 2012, slightly improved (/4701c17).

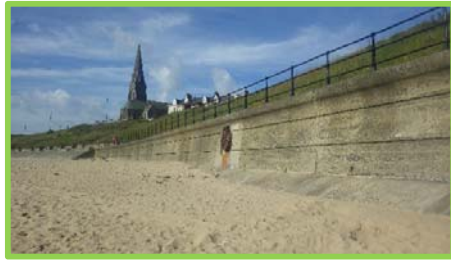
Concrete wall in good condition (/4701c17).

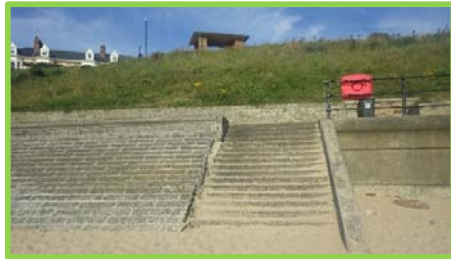
Localised damage to steps and crest of masonry revetment with gaps in joints leading to cracking (/4701c019).

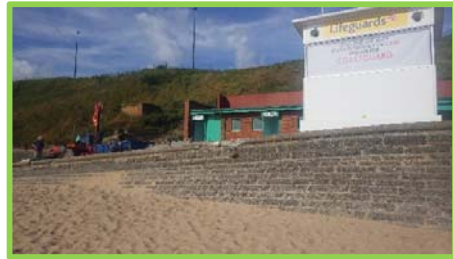
Damage to coping stones (/4701c018).

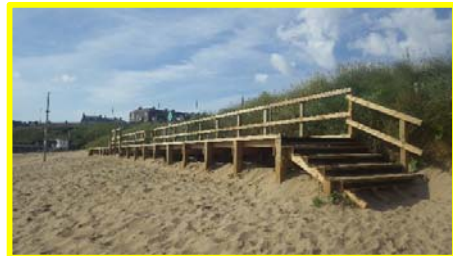
New boardwalk to improve management of pedestrian movement on the dunes (/4701c21).

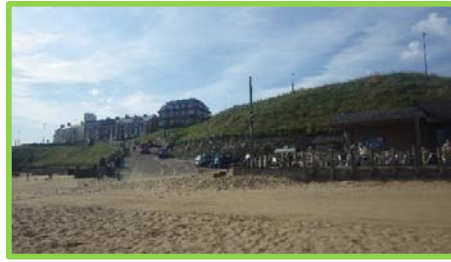
Timber and concrete protection to Crusoes Café (/4701c22).

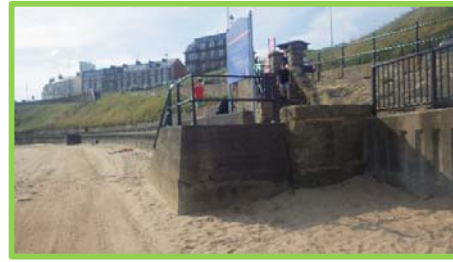
Cracking to access steps similar to 2012 (/4701c22).

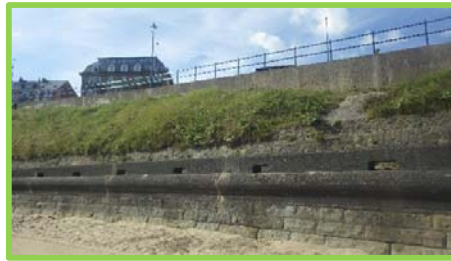
Missing mortar to joints and coping stones (/4701c23).

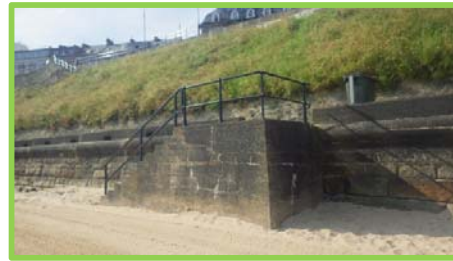
Cracking to concrete on access steps, handrails repaired (/4701c23).

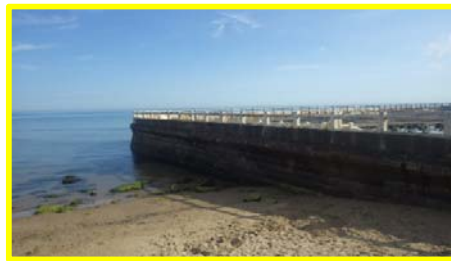
Tynemouth Pool abrasion and spalling on wave return wall (/4701c24).

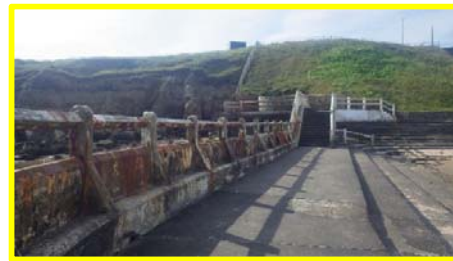
Interior of top wall spalling and staining (/4701c24).

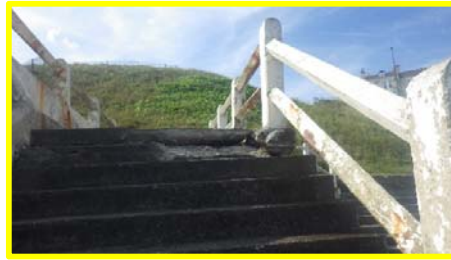
Damage to interior steps in pool (/4701c24).

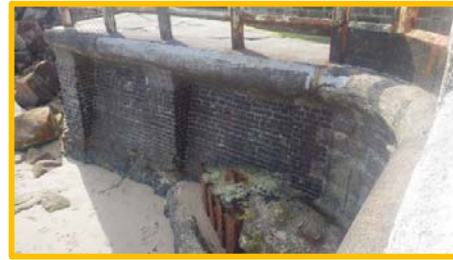
Wall at southern landward tie in of pool with apron undermined (/4701c25).

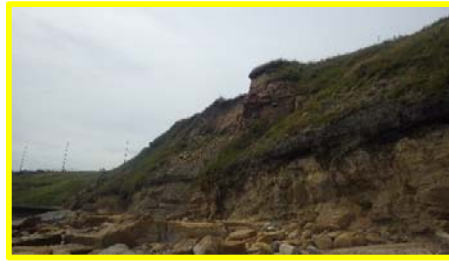
Evidence of slippage and rock fall around Sharpness Point (/4701c26).

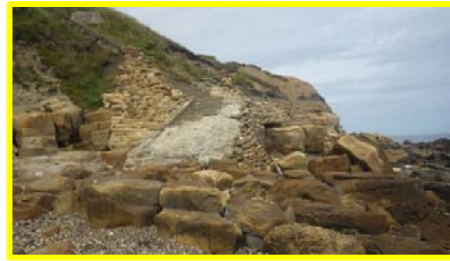
Considerable abrasion and damage to steps (/4701c26).

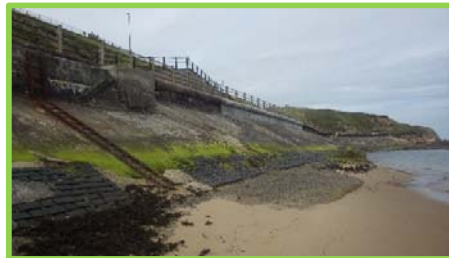
Major spalling and cracking, abrasion and exposure of reinforcement at toe. New section of coping stone (/4701c27).

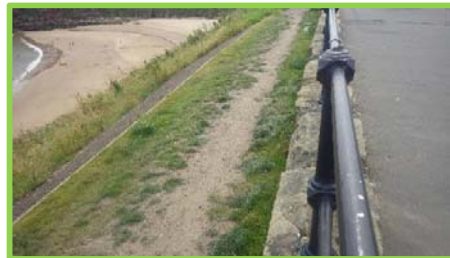
Section of upper slope top soiled and seeded since 2012 when cracking was visible in bitmac footpath (/4701c27).

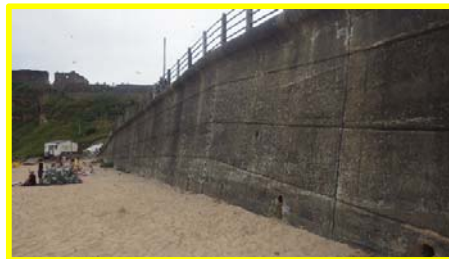
Concrete wall in King Edward's Bay in good condition, also railings (/4701c28).

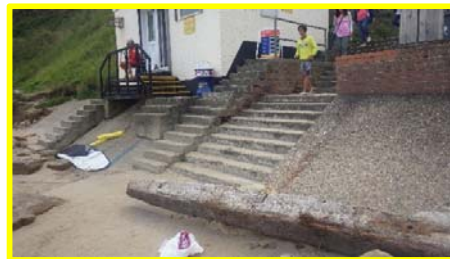
Undermining of steps to Lifeguard Centre King Edward's Bay (/4701c28).

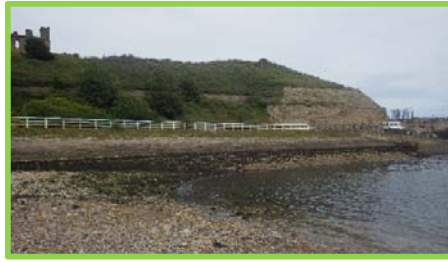
Revetment in Priors Haven in good condition, vegetation at top of wall (/4801c02).

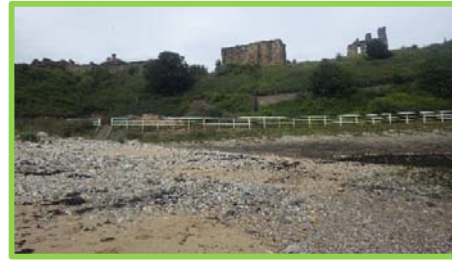
Masonry revetment in good condition, vegetation at the top of wall (/4801c02).

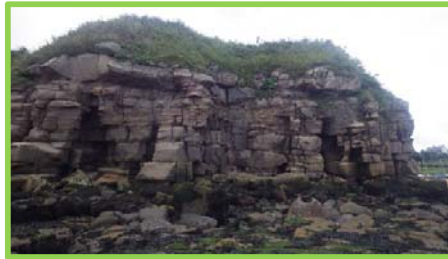
Fractured rock at Freestone Point (/4801c11).

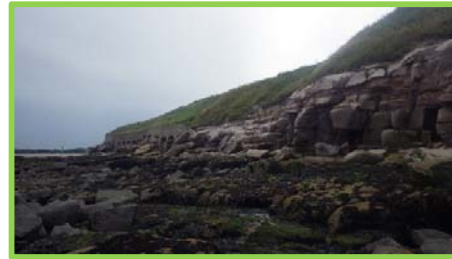
Fractured rock at Freestone Point (/4801c11).

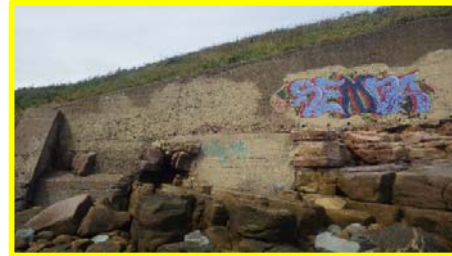
Joint of concrete wall and stone wall, fair condition (/4801c04).

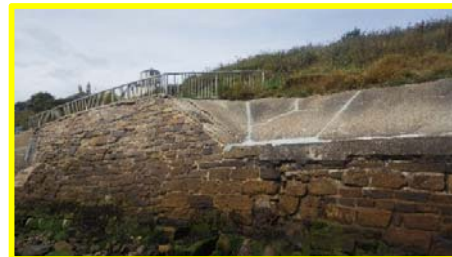
Concrete repairs, gaps in joints of stone wall (/4801c05).

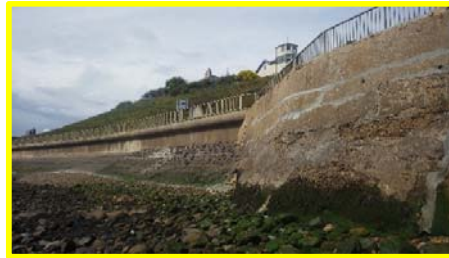
Repairs to concrete cracks (/4801c06).

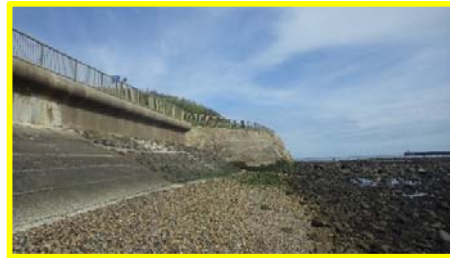
Masonry wall with concrete render adjacent to pitched stone revetment (/4801c06).

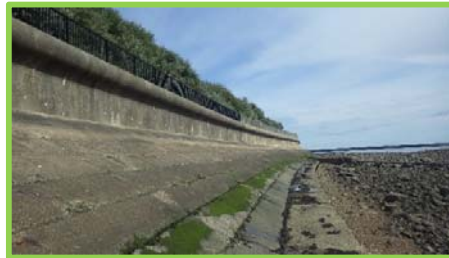
Abrasion to concrete toe of concrete recurved wall (/4801c07).

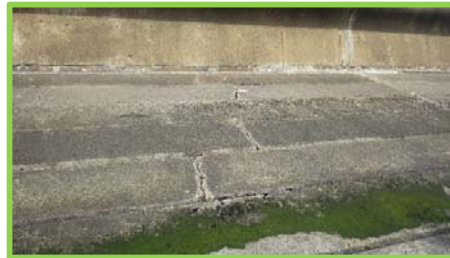
Cracks in revetment and gaps between panels (/4801c07).

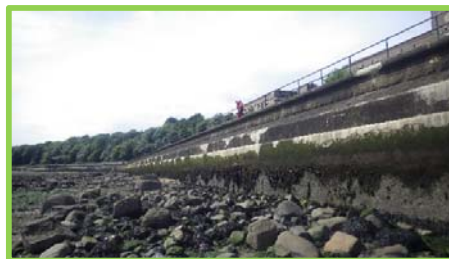
Previous patch repairs to vertical seawall in good condition (/4801c08).

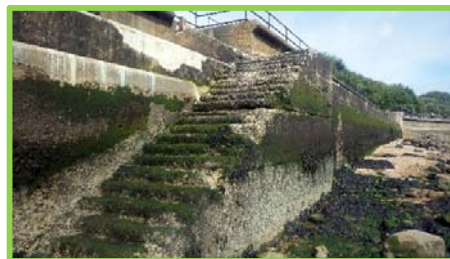
Abrasion to steps (/4801c08).

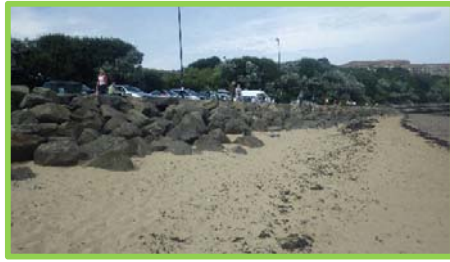
Stone protection in good condition (/4801c09).

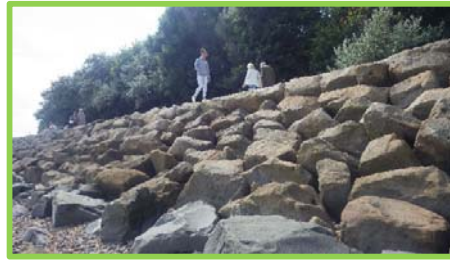
Stone protection in good condition (/4801c09).

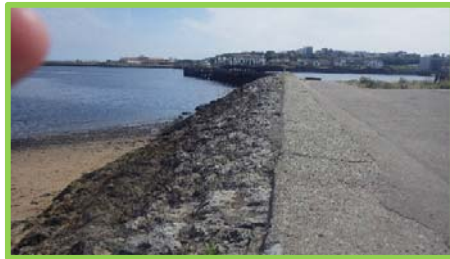
Pitched stone to jetty in good condition (/4801c10).

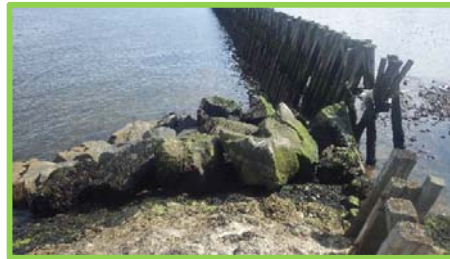
Stone protection at end of jetty in good condition (/4801c10).
