Cell 1 Regional Coastal Monitoring Programme Walkover Inspection Surveys 2016

North Tyneside Council

September 2016

Walkover Inspection Surveys 2016

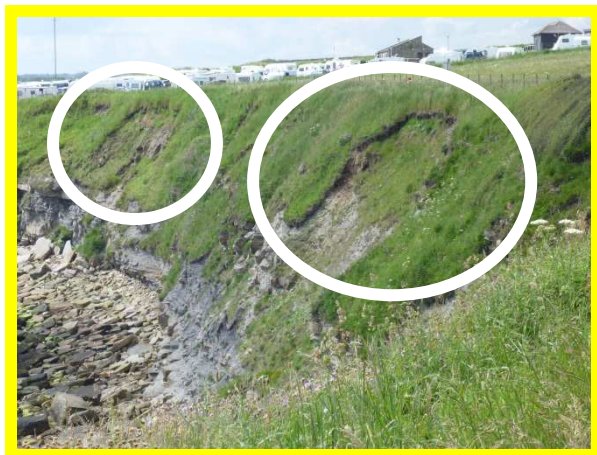
The undefended cliffs between Hartley Cove and Curry's Point have been subject to historic rock falls and slippages in the overlying softer material. There is also evidence of recent rock falls and slippage especially between the access steps at Hartley Cove and the causeway to St. Mary's Island. This cliff top recession continues to narrow the footpath in sections necessitating the need to realign the footpath inland.

Slippages in soft material along upper cliffs (/4401C22)

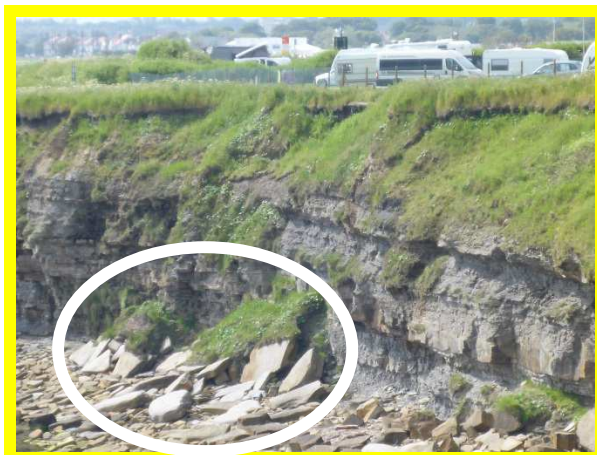
Rock falls in hard material along lower cliffs (/4401C22)

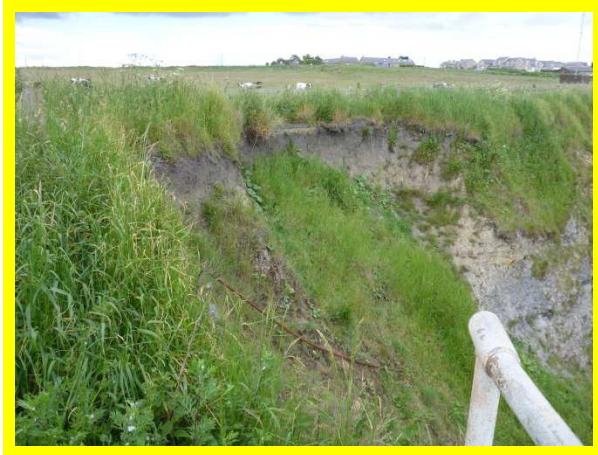
One local slump in particular occurred in soft material immediately adjacent to foreshore access steps at Hartley Cove in 2009 and at this time the cliff top fencing was relocated. This cliff section does not appear to have worsened since the original slippage. The access steps are in fair condition with no significant signs of damage. As in the previous inspections, repairs to grouting between blocks and upper masonry remain good and the hand railings are in good condition

Slippages in soft material adjacent to Hartley Cove access steps (/4401C23)

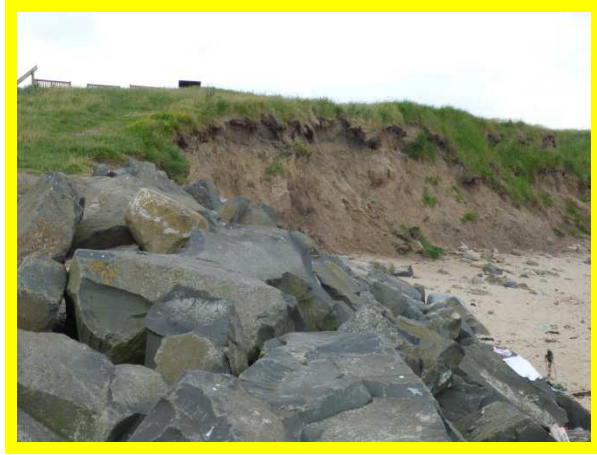
At Curry's Point, erosion of the soft earth slopes continues initiating outflanking of the north end of the rock revetment, which is in good condition.

Erosion adjacent to rock revetment by St Mary's Island causeway (/4401C24)

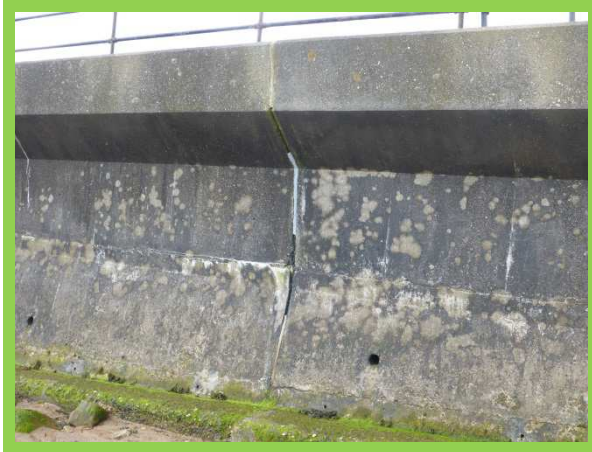
The Trinity Road seawall is generally well founded on the rock foreshore and in good condition with no signs of movement. There is clear evidence that previous repairs have been undertaken and these mostly remain effective, although a small number of previously sealed joints need re-sealing. There are some areas of wall where minor abrasion or spalling has occurred to the concrete face and some cold joints (cracks at construction joints) are apparent, but these do not deter from the overall effectiveness of the structure. The access ladders, promenade surfacing and shallow grass earth embankment behind the wall are in good condition.

Trinity Road seawall in good overall condition, but with some minor maintenance required (/4501C04)

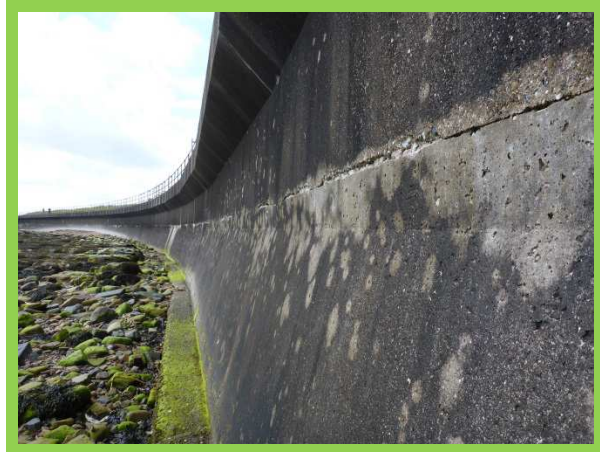
Trinity Road seawall in good overall condition, note the construction joints (/4501C04)

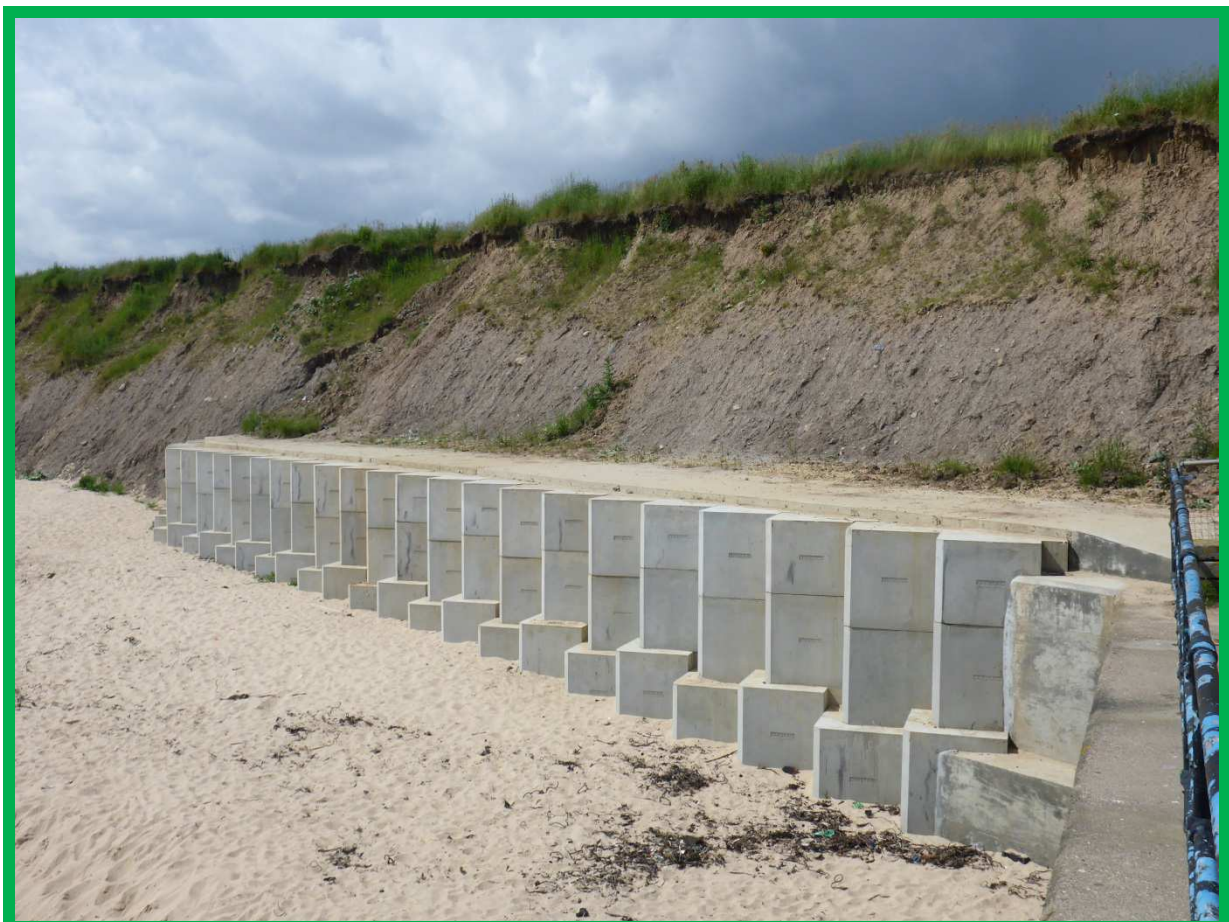
A long-standing problem of erosion, potentially leading to outflanking of the Trinity Road seawall at its southern end, has been addressed since the previous inspections by the construction of a short T-Block wall installed in late 2014. The T-Block units were fabricated by Lafarge Tarmac and installed by North Tyneside Council's framework partner ESH Group. The T-Block wall remains in 'as built' condition but future inspections should check for signs of erosion at their southern end and slippage in the cliffs above the units. .

New T-Block units (constructed in 2014) prevent outflanking at the southern end of Trinity Road seawall (/4501C04)

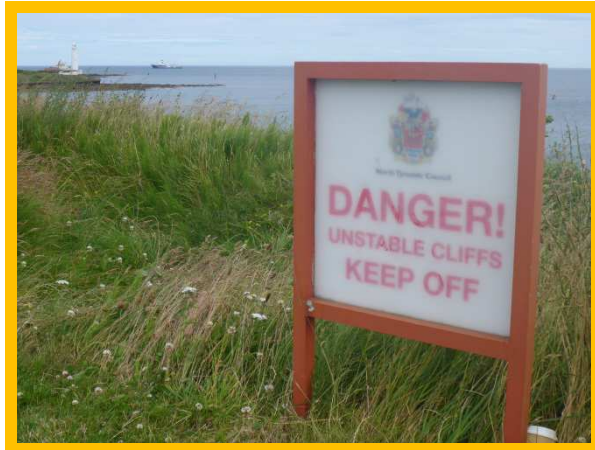
Warning signs along cliff top at municipal golf course (/4501C05)

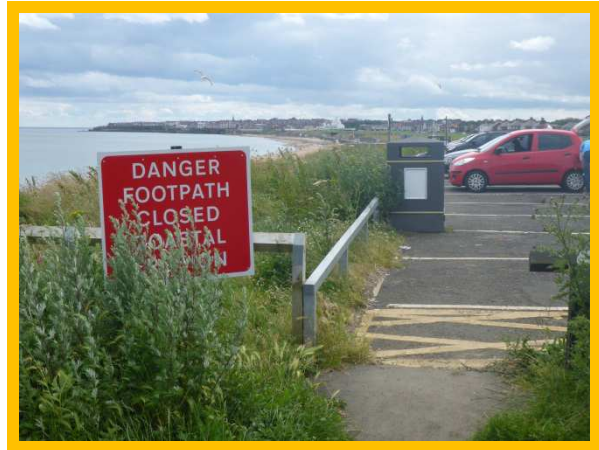
Closed cliff top footpath at Briardene car park (/4501C05)

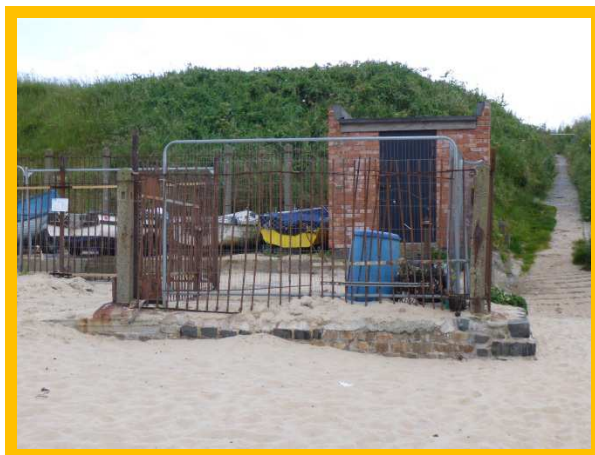
At the boatyard at the north end of Whitley Sands, the sand levels were high, covering much of the wall but the visible sections were relatively poor in condition. The access ramp shows signs of abrasion and is only in fair condition. The concrete repairs to the south end of the boatyard were largely buried by sand due to high beach levels, but as with previous inspections there is evidence of terminal erosion of the cliffs at the southern end of the boatyard.

High beach levels at boatyard (/4501C05)

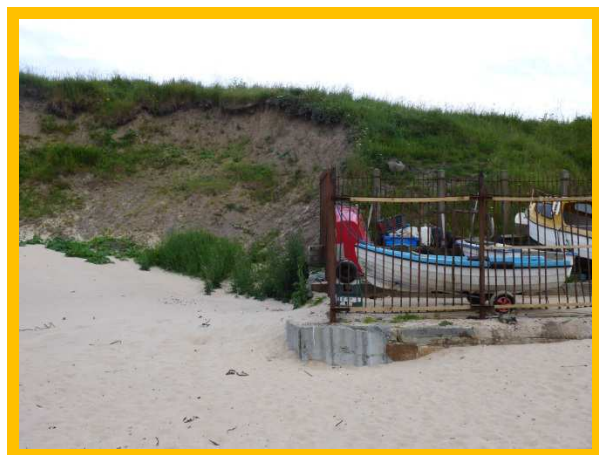
Erosion of the cliffs immediately south of the boatyard (/4501C05)

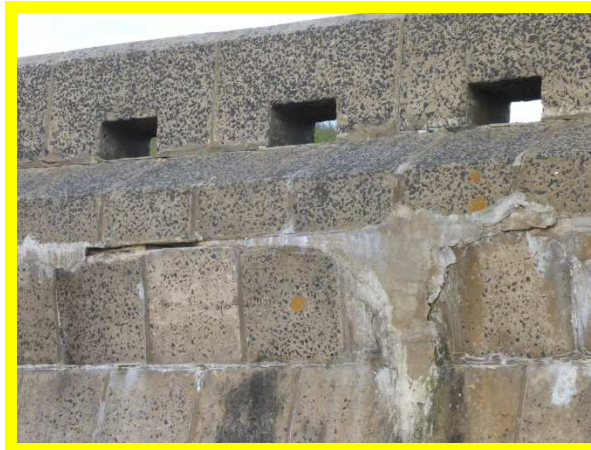
The Whitley Links sea wall extends in front of the Northern Promenade. The access ramp at the northern end has a few cracks and areas of spalling in the deck which would benefit from minor maintenance. The sea wall itself is in fair overall condition and several past repairs are notable. A small number of previous joint seals are re-opening and would benefit from maintenance. There is also occasional spalling or cracking in the coping wall with drainage holes which sits at the crest of the main wall. Along almost the entire length there are small open joints between the main wall and its coping wall.

Previous repairs and local open joints which would benefit from maintenance (/4501C07)

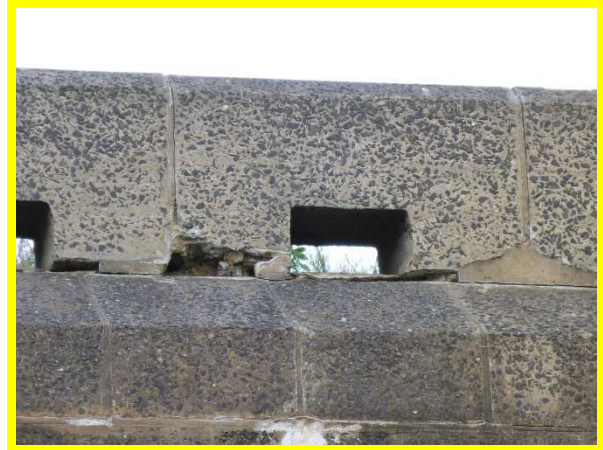
Cracked coping unit (/4501C07)

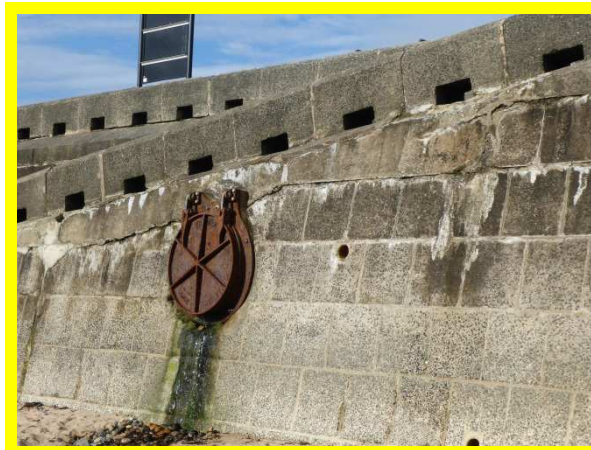
There are several sets of access steps within the wall, and in many of these locations previous repairs are holding well. However there are some access steps where cracking to the wing walls has occurred and maintenance should be undertaken. This is especially prevalent towards the south of the asset length and the single worst area is around an outfall in the wall. Around this location there are remnants of a concrete outfall across the foreshore where the concrete is heavily abraded. The main sea wall also starts to exhibit increased evidence of cracking with progression south and the entirety of this wall would benefit from maintenance.

Previous repairs and local open joints which would benefit from maintenance (/4501C07)

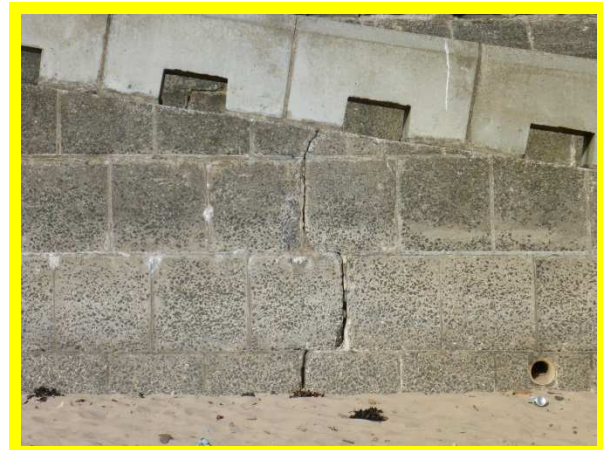
Cracked blocks in wing wall to access steps (/4501C07)

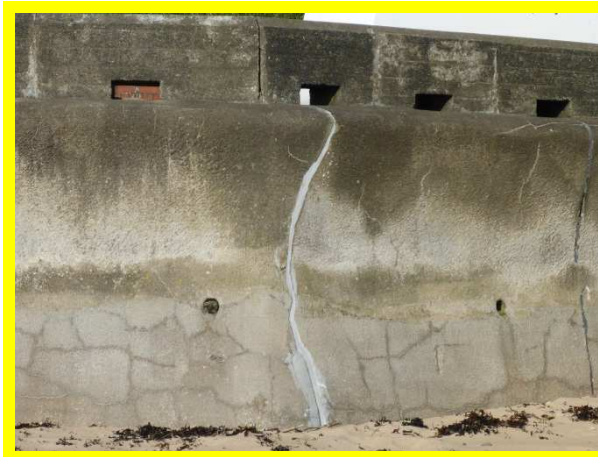
The rendered sections of the sea wall along the Panama Gardens frontage are in fair condition. In some locations there is clear evidence of previous repairs which are holding well, especially in terms of replaced coping units and filled cracks and joints. The wall has several shallow horizontal cracks (construction joints) but structurally appears sound. Next to this, the yellow painted concrete wall at the site of the former Boardwalk Cafe is in good condition. The exposed timber piles and undermining identified in previous inspections were not observed due to high beach levels. The entire area of promenade behind these two sea wall sections was closed off at the time

Previous repairs to rendered sea wall (/4501C08)

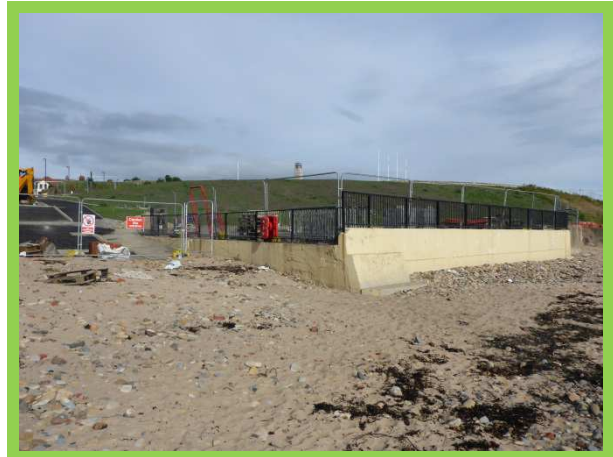
Yellow painted sea wall at site of former Boardwalk Cafe (/4501C09)

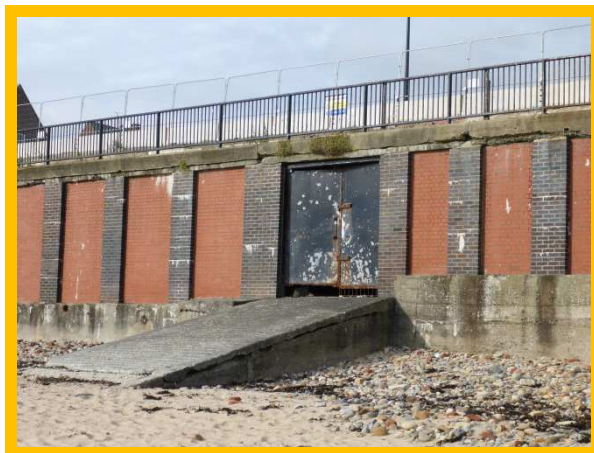
The lower section of the Central Promenade is protected by various sections of sea wall. The first section comprises brickwork above a concrete base and with a concrete coping. There is extensive abrasion damage to the concrete, especially along the toe and the coping. The two short lower access ramps remain extensively abraded and cracked on both sides and at risk of becoming voided and collapsing. The concrete surfacing to the main full height access ramp is also cracking in places. The spalling, abrasion and cracking damage appears to be worst at a set of access steps from the promenade to the beach and this whole section should be rebuilt as part of future capital works associated with the Whitley Bay Seafront Master Plan. In fact, the entire area of promenade behind the sea wall was closed off at the time of the inspection, with construction activity planned by Owen Pugh to deliver part of the Master Plan.

Cracking to boat ramp (/4601C02)

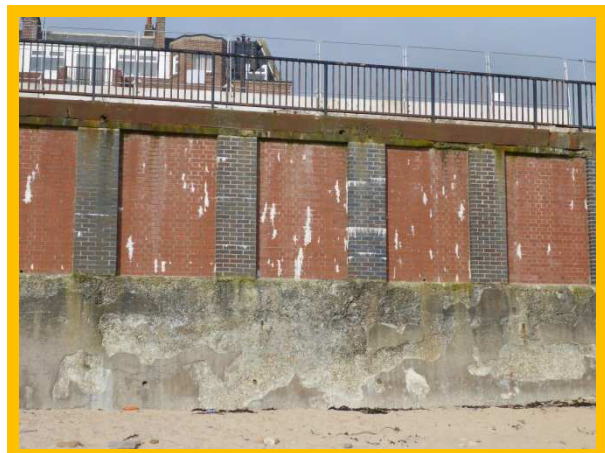
Abrasion damage to wall toe and cope (/4601C02)

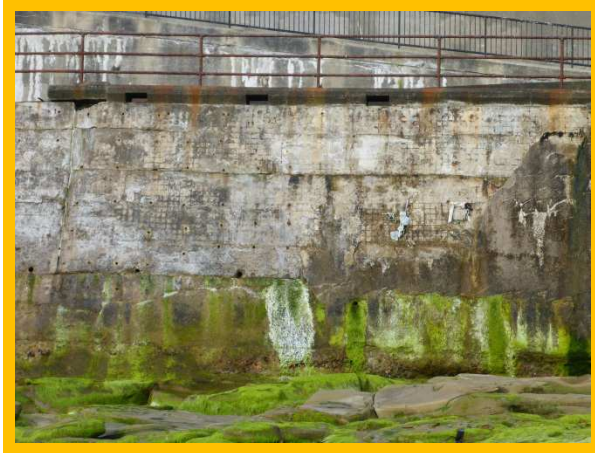
The final section of straight concrete sea wall at the south end of Whitley Sands is generally in fair to poor condition with no signs of movement or undermining. There is, however, continued loss of the concrete render along much of the face of the wall exposing the reinforcement mesh which has corroded and been lost in many places. There is also one section of missing coping. The hand railing at the access steps is in very poor (corroded) condition or is missing and at the time of inspection a pool of water was retained at the toe of the structure.

Loss of render and exposed reinforcement mesh (/4601C03)

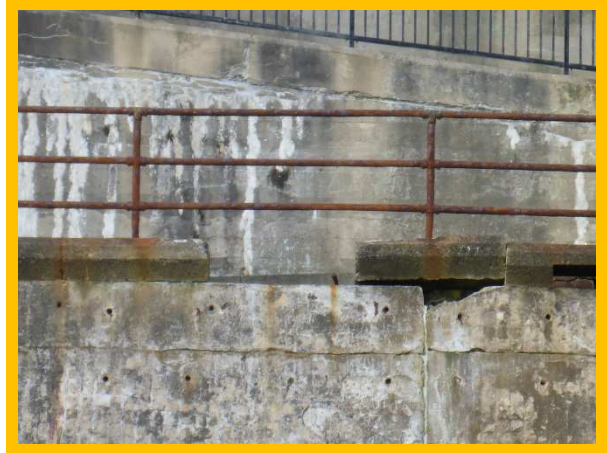
Missing section of cope (/4601C03)

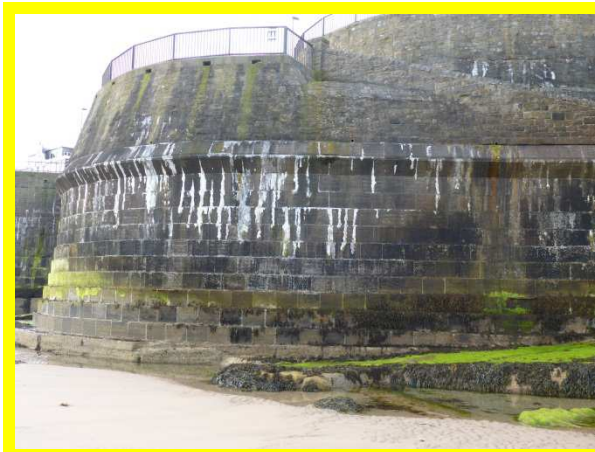
The high curved masonry blockwork sea wall 'bullnose' adjacent to South Parade Road is in fair condition, although there is evidence of heavy staining to the face. At one location at the northern end there was a gap between the main blockwork sea wall and the upper masonry brickwork section which would benefit from sealing.

Blockwork sea wall at first 'bullnose' (/4601C04)

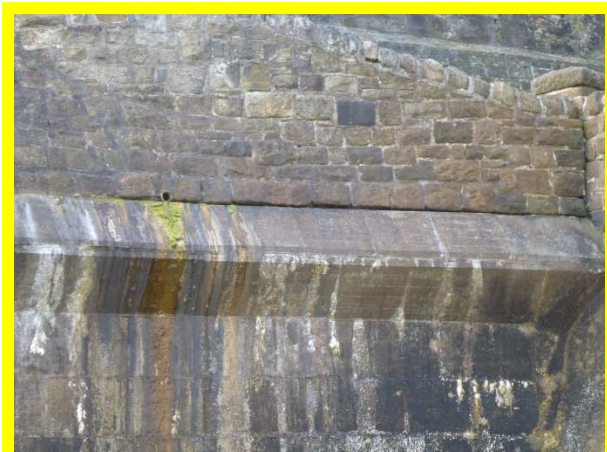
Gap between blockwork and masonry walls (/4601C04)

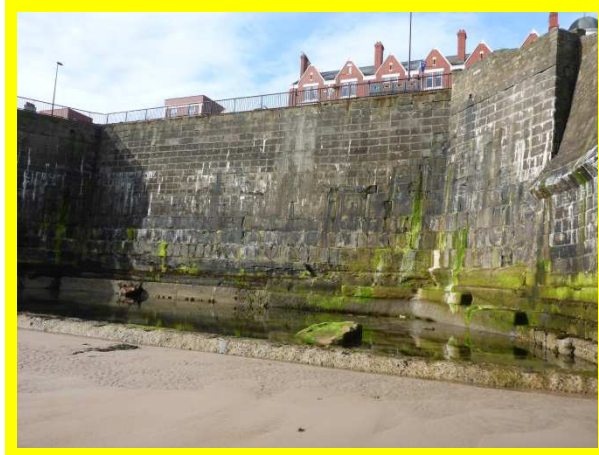
The straight section of high masonry seawall to the south is also in fair condition with no signs of movement or undermining. However, there is noticeable abrasion at the toe and lower to mid sections of the face and also noticeable horizontal gaps in the upper brickwork below the crest, as identified in the previous inspections.

High blockwork sea wall (/4601C05)

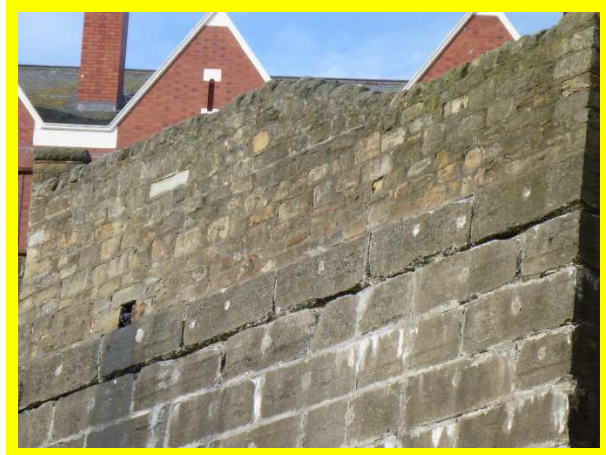
Gap between blockwork in upper section of wall (/4601C05)

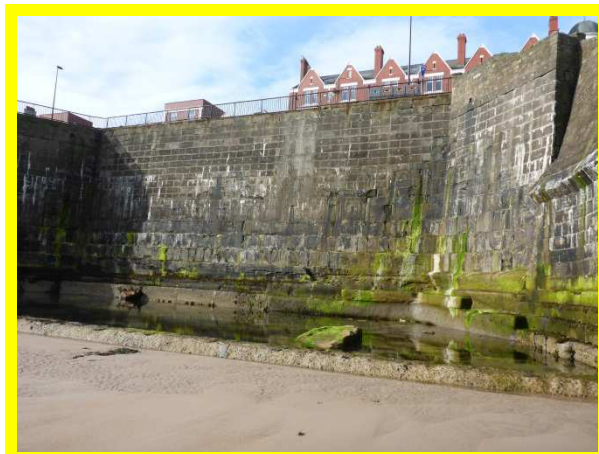
To the south, the curved masonry blockwork wall 'bullnose' and upper sloping brickwork is generally in fair condition with no gaps observed in the lower concrete blocks. There remain two sections of missing brickwork at the south of the upper wall, although these do not appear to have significantly worsened since first identified in 2012.

Blockwork sea wall at second 'bullnose' (/4601C06)

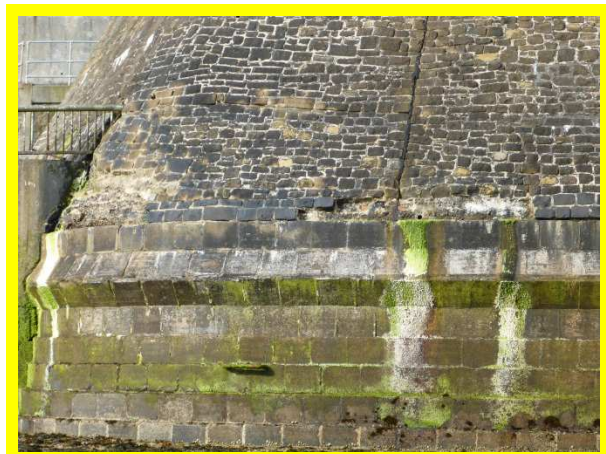
Two sections of missing brickwork (/4601C06)

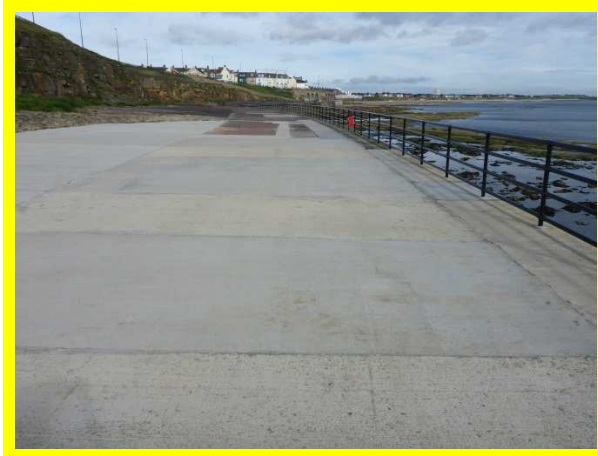
To the south, a masonry blockwork fronts the lower Southern Promenade. This section of wall was damaged during the severe weather in December 2013. The coping blocks were removed by the storms resulting in damage to the adjacent surfacing and concrete bays constructed after the 2010 inspection. Other sections of asphalt surfacing and kerbing along the center section were damaged and some hand railing in the area was lost. At the time of the previous inspections, the area of damaged wall and promenade was fenced off for safety reasons. At the time of the present inspections, the repair works to the damaged area had been completed and were holding well. However, the beach access steps remain heavily abraded and are now redundant since they were closed off a few years ago.

Repaired deck following storm damage in 2013 (/4601C08)

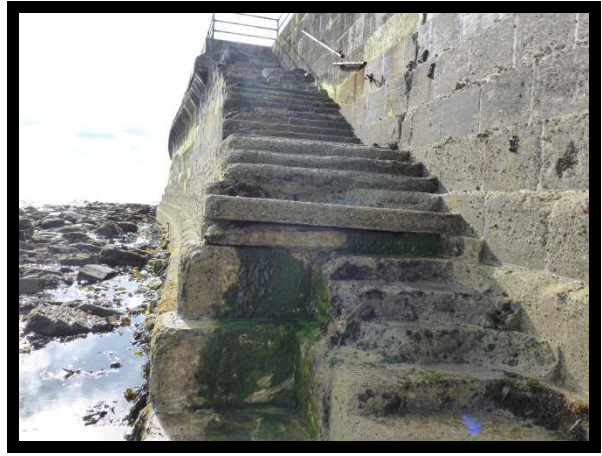
Heavily abraded access steps – now redundant (/4601C08)

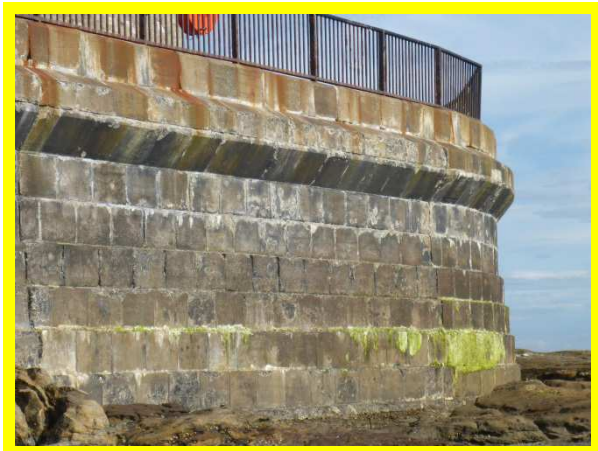
Brown's Bay has two separate sections of sea wall. In the northern part of the bay the wall is generally in fair condition, although there are some gaps between the main wall and its coping, especially at the access ramp. The ramp to the beach area is locally in poor condition and has missing hand railing. The promenade behind the northern section of sea wall has cracked deck at its northern end.

Brown's Bay northern sea wall in generally fair condition (/4601C10) (/4601C10)

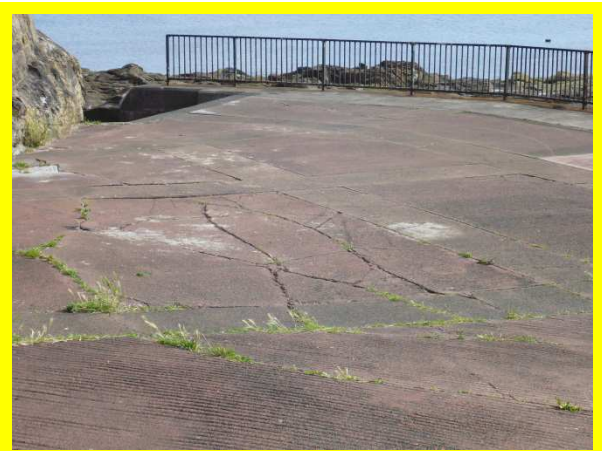
Cracked promenade deck at northern end (/4601C10)

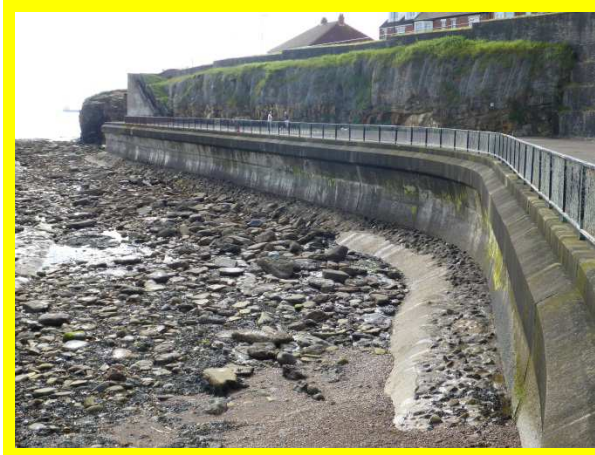
The southern wall is generally in fair condition. The hand railing along the top of the wall is in good condition. The rear wall between the Promenade and road is generally in a fair/good condition it has been well maintained with rock bolts and wire meshing. There is cracking to the access ramp and damage to hand railing.

Brown's Bay southern sea wall in generally fair condition (/4701C01)

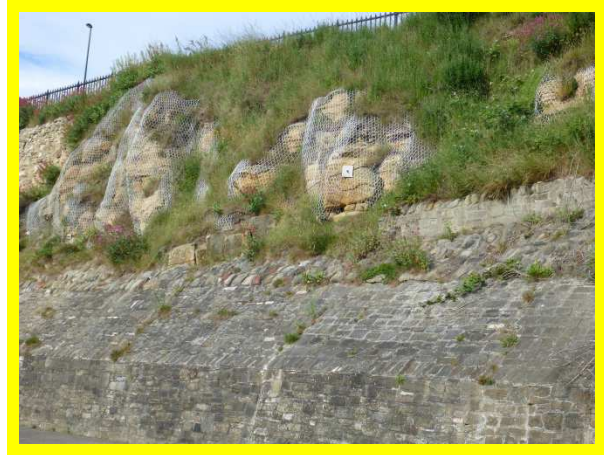
Rock bolts and netting on slopes to rear of promenade (/4701C01)

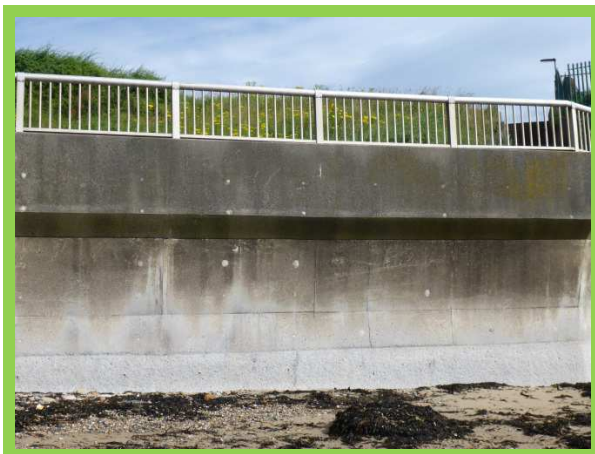
First section of sea wall in generally good condition (/4701C04)

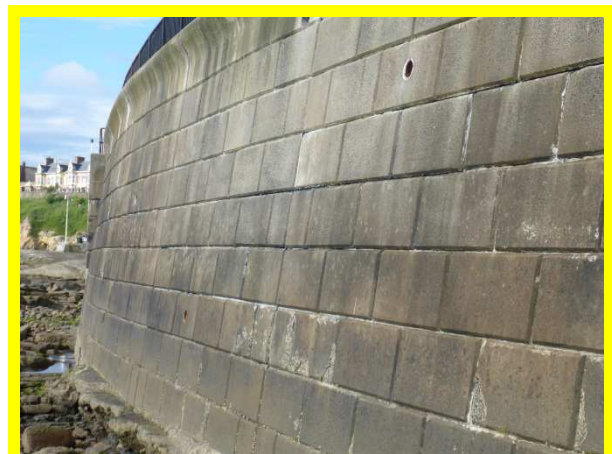
Middle section of sea wall in generally fair condition but with face abrasion (/4701C05)

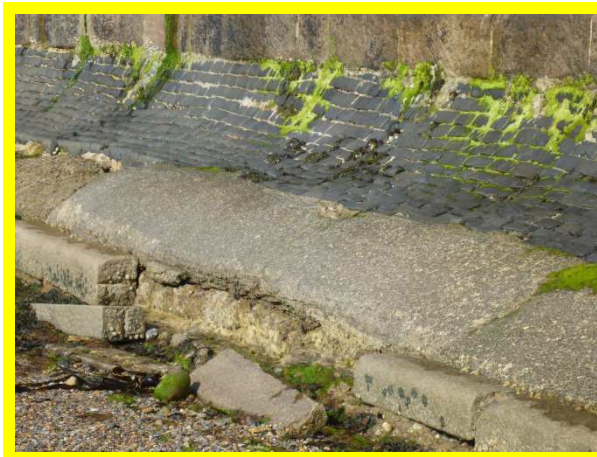
The final section of sea wall, extending to meet the Cullercoats North Pier, is comprised of stepped blockwork lower and sloping blockwork upper wall, with an upper wave return. A concrete apron at the toe makes way to a charcoal-coloured small 'brickwork' revetment toe with a concrete base. The concrete base has broken away from the wall in one area and in one further area there is some undercutting of the toe apron, requiring remedial works. Where this wall ties-in to the pier, the blockwork main wall makes way to a short rendered section of wall. The render is breaking away and where underlying cracks are exposed there is considerable vegetation growth in the wall.

Final section of sea wall in generally fair condition, but with some defects at the toe requiring remedial attention (/4701C06)

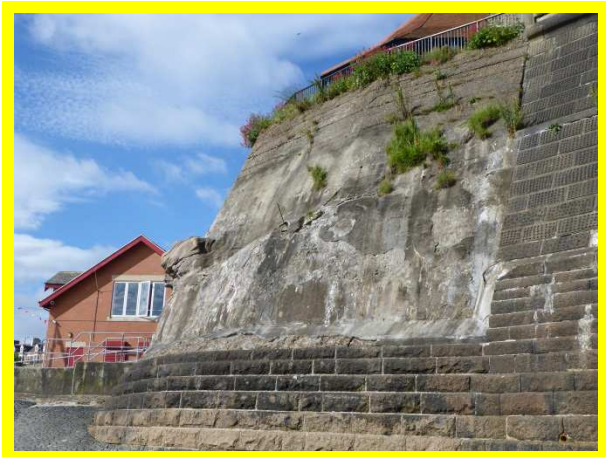
Final section of sea wall in generally fair condition, but with some defects at the tie-in requiring remedial attention (/4701C06)

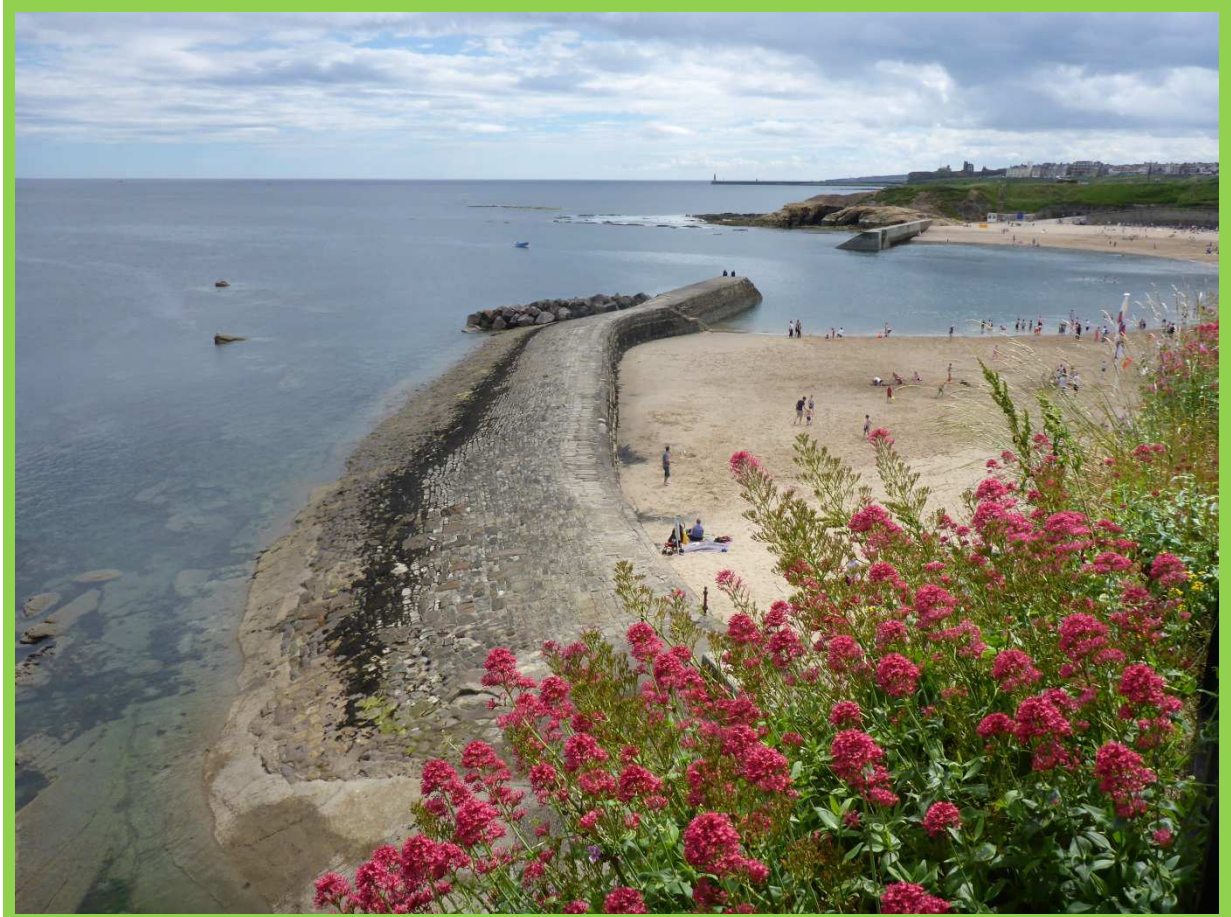
Sections of Cullercoats North Pier have been repaired within the past few years and the repairs are holding well. The outer face of the pier has one or two slightly 'sunken' areas of revetment blocks towards the landward end but otherwise appears in good condition. The rock armour that was used to plug a breach which occurred several years ago is also in good condition. The deck has one notable area of concrete spalling but is otherwise fine and the inner face and terminal end are generally sound despite heavy abrasion and a small number of open joints.

Cullercoats North Pier in good condition following repair works (J4701C07)

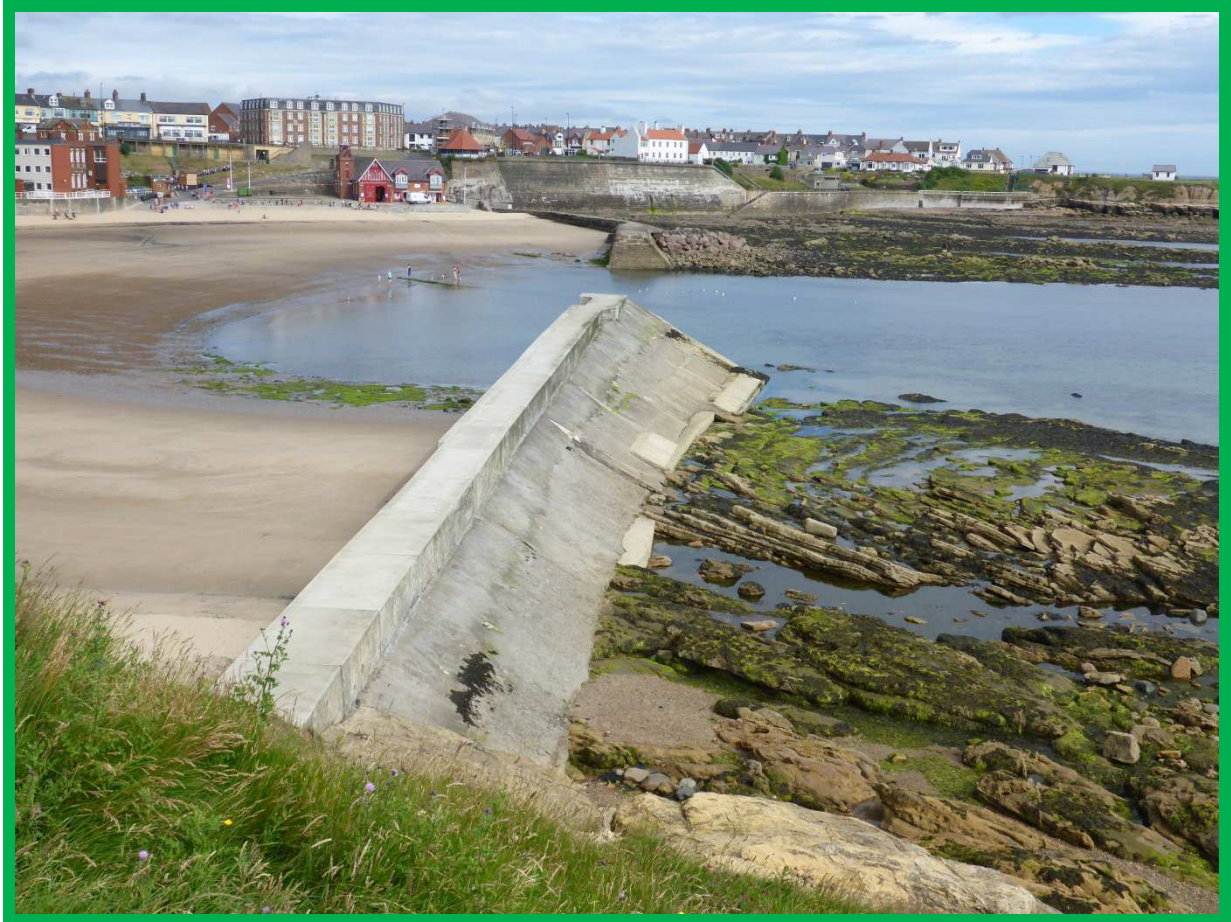
The South Pier at Cullercoats Bay has recently been extensively reconstructed and is in very good condition. There are no open joints or problems at the toe of the structure. A short blockwork section of inner face at the landward end was not encased in concrete by the works and this section remains heavily abraded but appears structurally sound.

Cullercoats South Pier in very good condition following refurbishment works (I4701C15)

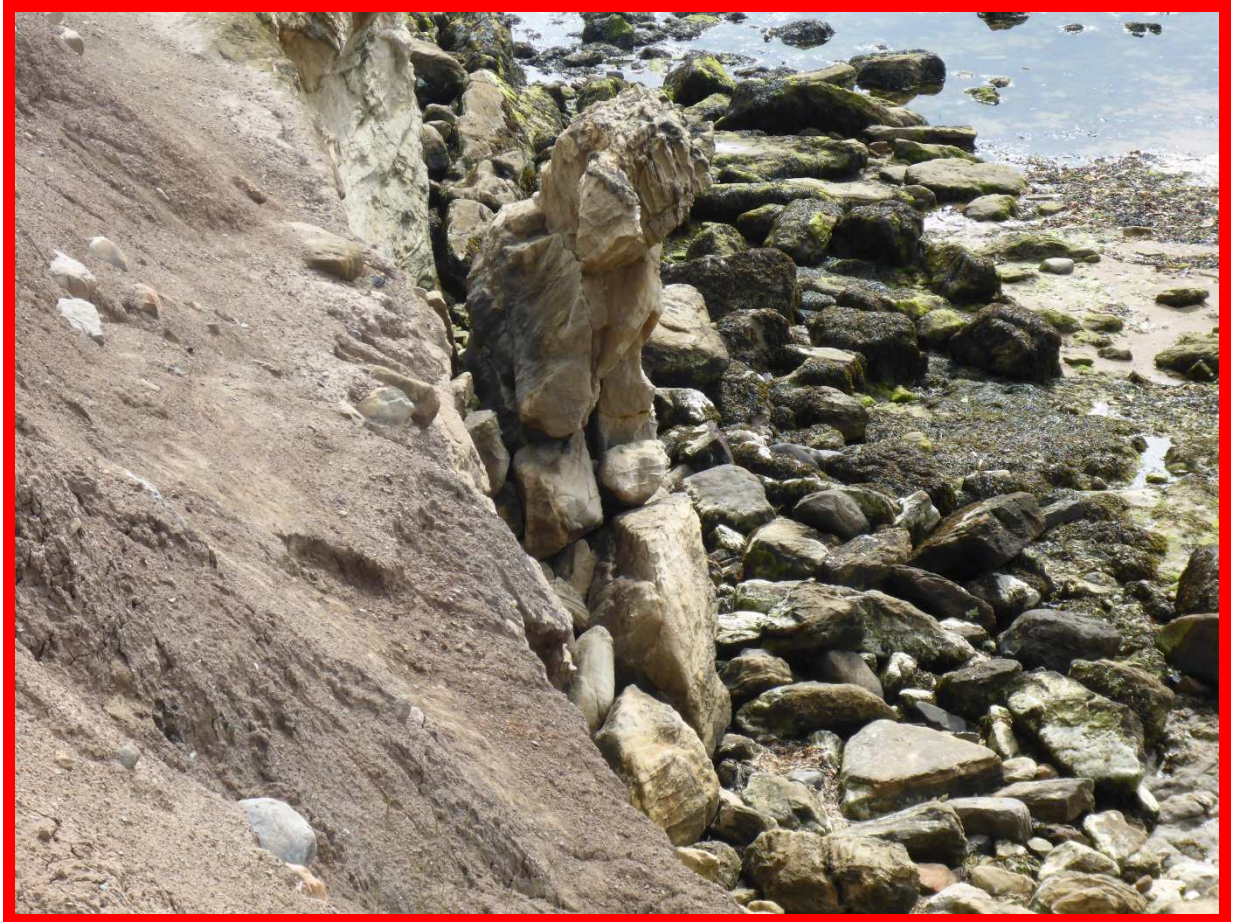
The cliffs around Tynemouth North Point have arches and caves at their base in the lower rock sections, with evidence of slippages in the upper softer section of cliff. On the south side of the headland, at the very northern end of Long Sands, there is one rock stack which is precariously balanced and likely to topple imminently. This beach is used widely by the public and the present state of the stack presents a safety risk.

Rock stack near Tynemouth North Point that has the potential to topple imminently (/4701C16)

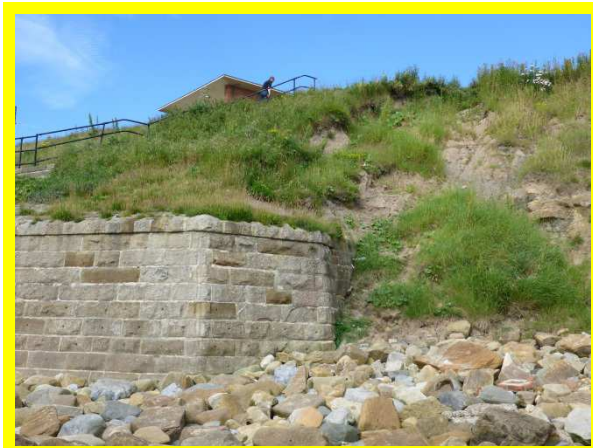
The masonry wall at the north of Tynemouth Longsands is in fair overall condition but future inspections will need to pay attention to the risk of slumping and outflanking at the northern end. Also, the concrete toe is abraded and one block is undercut, requiring repair, whilst small gaps are beginning to open at the crest, where the slope becomes concreted-over.

Slumping in cliffs near northern end of masonry wall (/4701C17)

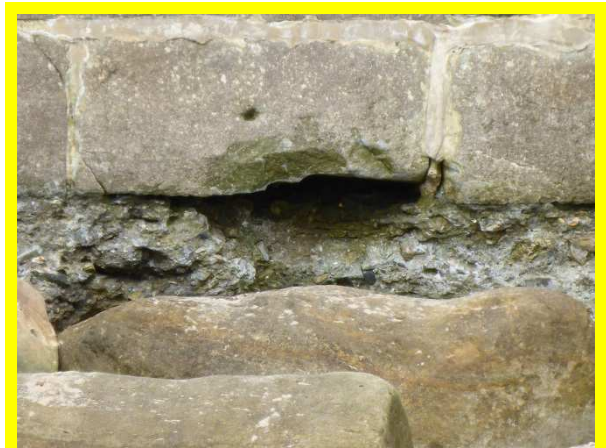
Undercutting at toe of wall (/4701C17)

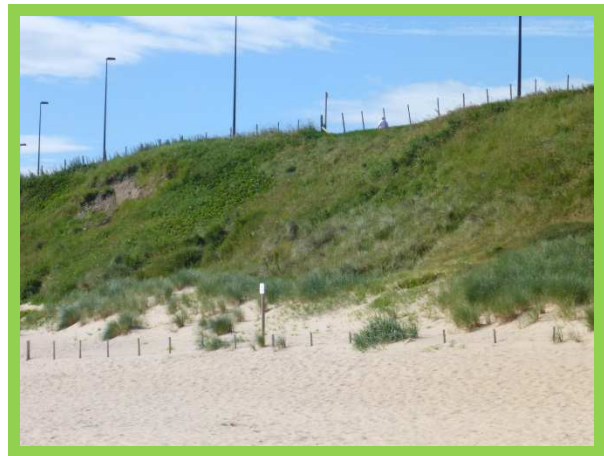
The undefended dunes along the Long Sands appear to be benefiting from a programme of fencing and planting to restore the dunes. It is clear that a management strategy is in place with the construction of a new boardwalk and improved signage to manage the dunes and pedestrian movements. There is notable sand accretion at the toe of the dunes and in several places this is accompanied by embryonic vegetation growth.

Dunes being restored along Long Sands (/4701C20)

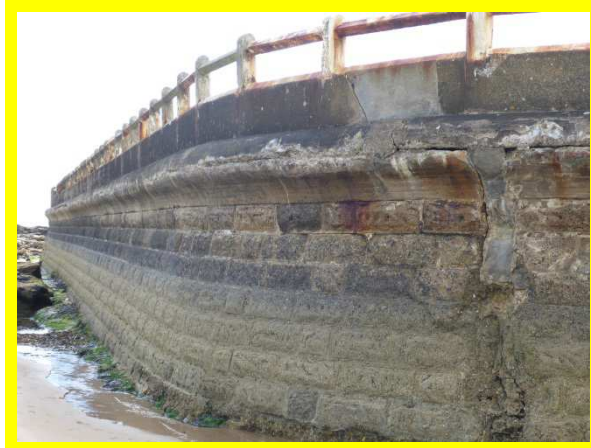
Around Tynemouth Pool the wall is generally fair apart from in one areas of previous repairs to a vertical crack, which needs re-sealing. The wave return wall is very heavily abraded and cracked. The short section of wall at the southern landward tie-in is in relatively poor condition, being abraded and spalling, with extensive corrosion to the steel sheet piles.

Further repairs to an area of previous repair at the Outdoor Pool (/4701C24)

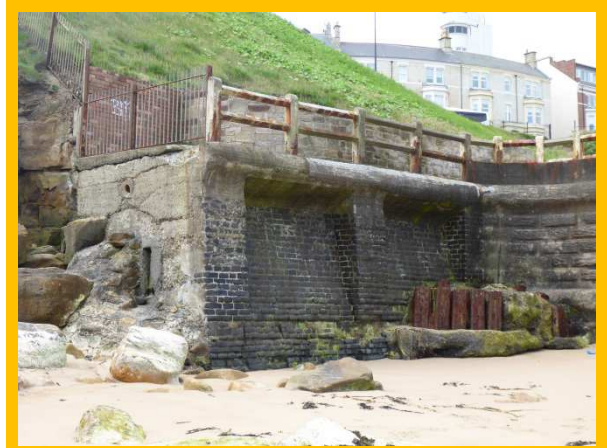
Tie-in wall between Outdoor Pool and undefended rock cliffs (/4701C25)

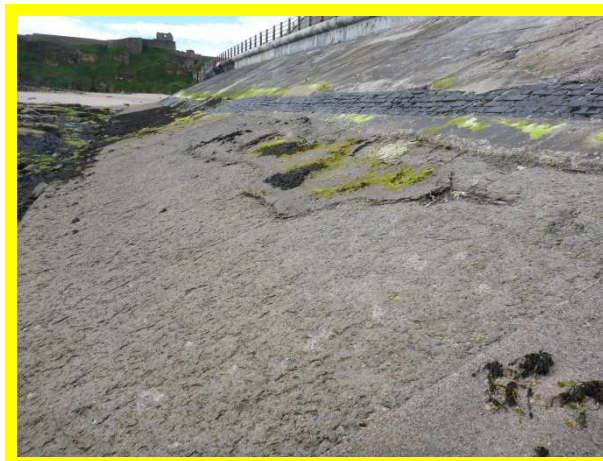
The sea wall that protects the Lower Promenade in King Edward's Bay has at its northern end a concrete apron tie in to the cliffs at Sharpness Point. This apron has been repaired in recent years. The main body of the wall and the revetment are generally in fair condition although there is one small void at the apron's toe and loss of revetment blocks in one area. There are still considerable areas of abrasion at the toe and on the sloping revetment face, in places exposing the reinforcement bars. In some areas, previous render repairs to these defects are breaking-up, requiring further maintenance.

Sea wall in fair condition with abrasion of the apron leading to exposed rebar (/4701C27)

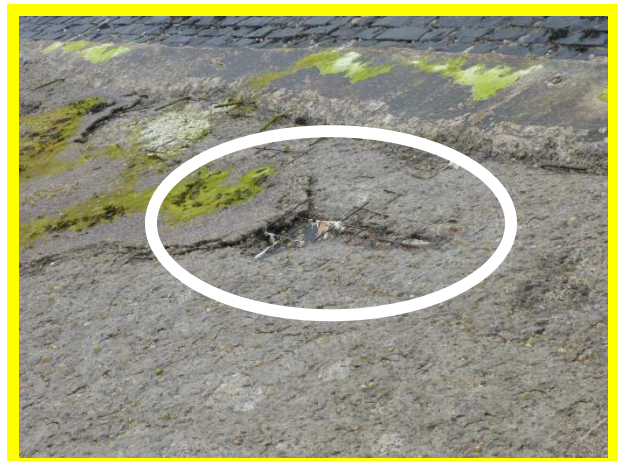
Exposed rebar (/4701C27)

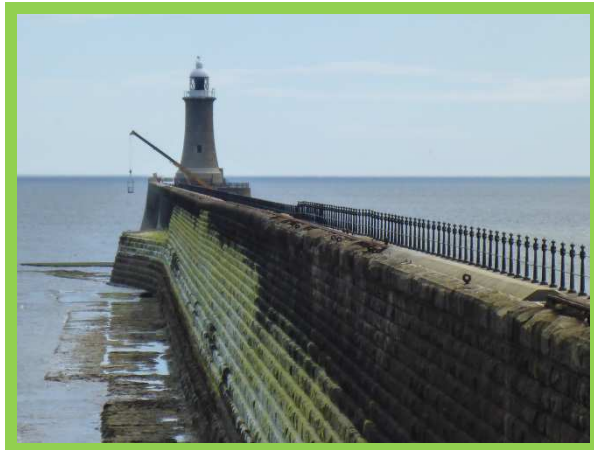
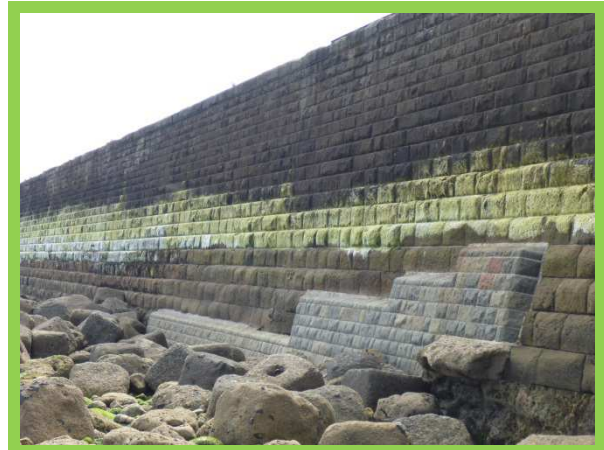
The North Pier was only inspected from a distance because at the time of the inspections the access cut was closed, preventing access to the pier by members of the public, because maintenance work by the Port of Tyne was ongoing. It appears in generally good condition, except for notable abrasion on the crest wall, and is pro-actively maintained. The presence of a fair number of masonry blocks stored on the ramp and deck of the pier and a large crane suggests that the maintenance activity towards the seaward end of the pier involved replacement of damaged blocks.

North Pier appears in good overall condition and is well maintained (/4801C01) Areas of previous repairs at toe (/4801C01)

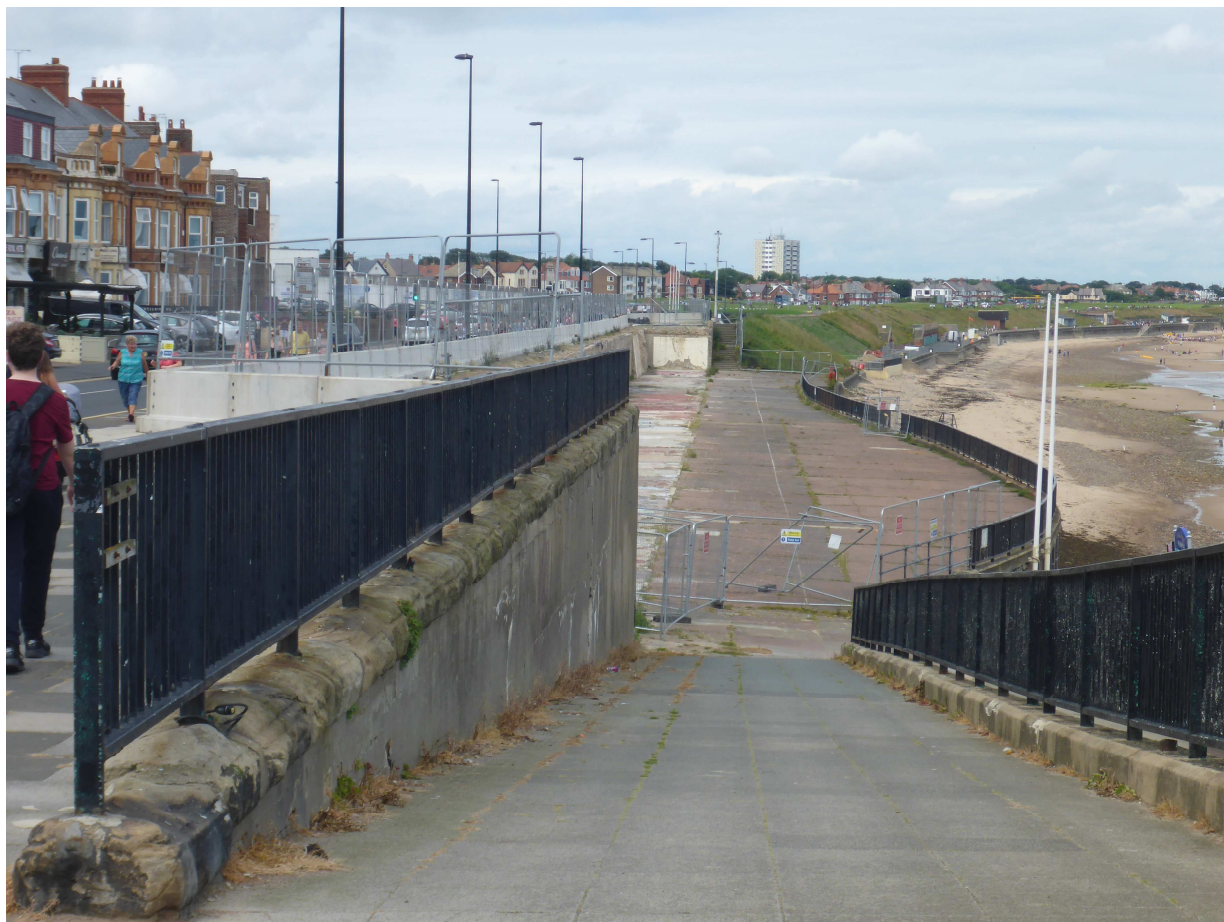
Area of Whitley Bay lower promenade closed-off awaiting redevelopment as part of Seafront Master Plan

Several areas of promenade are currently undergoing construction works as part of the Whitley Bay Seafront Master Plan. As part of these works, opportunities should be taken to maintain or improve the sea walls and in some areas access steps to the beach at the same time.
