**Cell 1 Regional Coastal Monitoring Programme
Walk-over Visual Inspections of Assets**

**Durham County Council
Final Report**

July 2014

Walk-over Visual Inspections of Assets

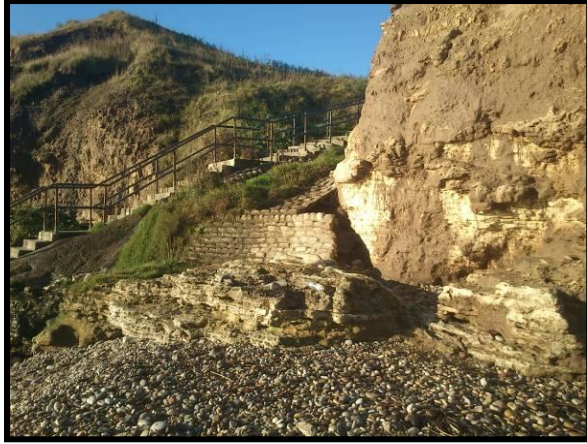
Photo from 2012 report. (Asset ref. No. 121AB901B0804C01)

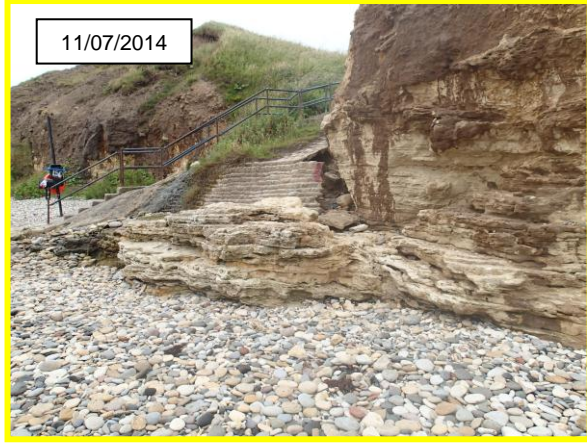
11/07/2014
Outflanking at north of steps unchanged from 2012. (Asset ref. No. 121AB901B0804C01)

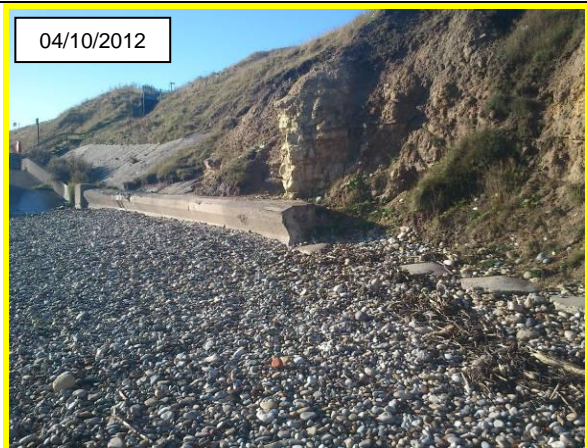
04/10/2012
Wall at north end of Seaham.
Photo from 2012 report.

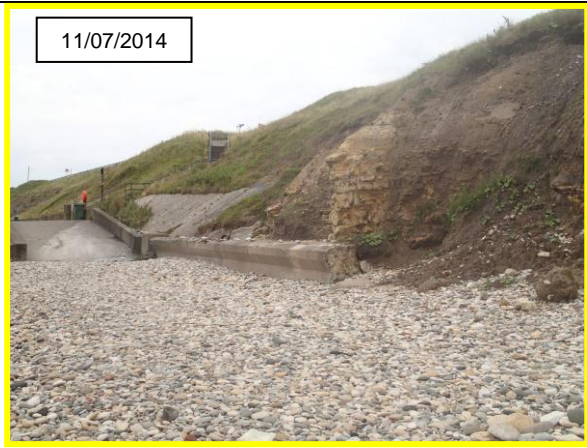
11/07/2014
Slightly lower beach levels, but little change since 2012.
(Asset ref. No. 121AB901B0804C01)

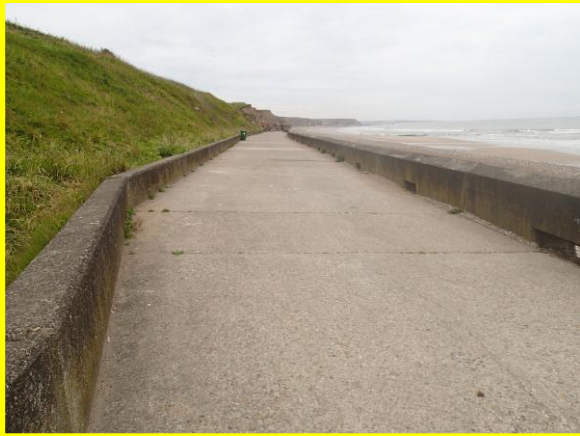
Cracks to promenade with vegetation growth.
Well vegetated cliff to rear.
(Asset ref. No. 121AC901C0102C01)

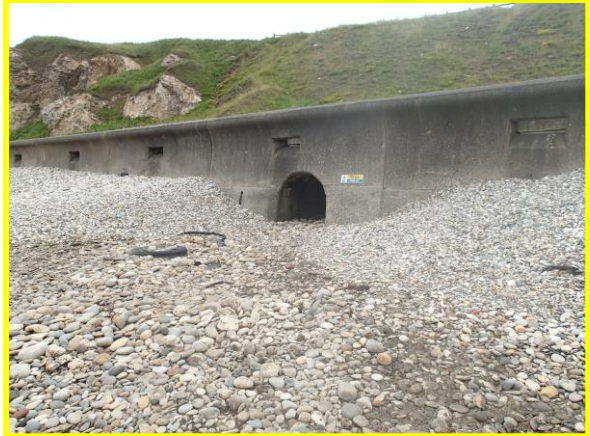
Scour channel at outfall from Seaham Dene.
(Asset ref. No. 121AC901C0102C01)

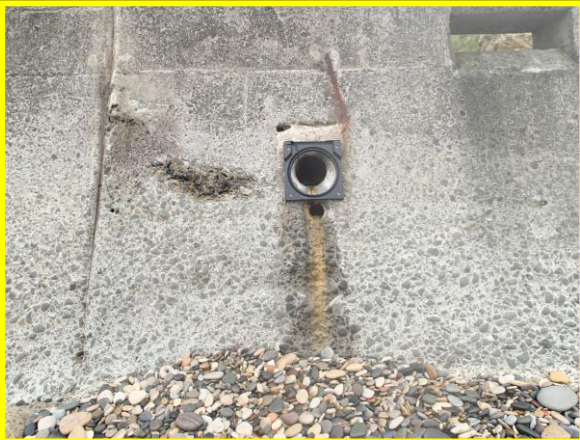
Minor abrasion damage to lower wall and
example of broken flap valve.
(Asset ref. No. 121AC901C0102C01)

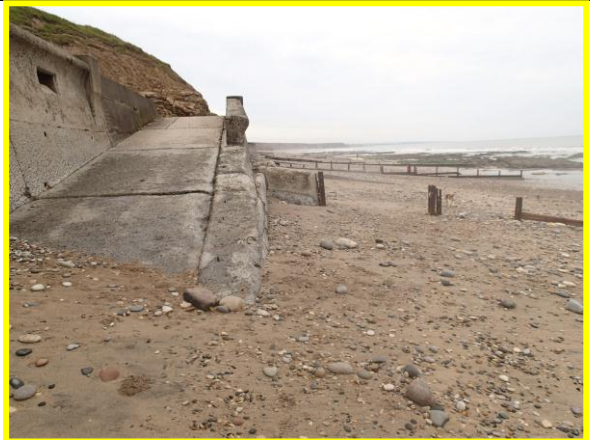
Damaged / derelict groynes on beach at south
end. Recommended to confirm redundant and
remove to reduce H&S risks or replace / repair.
(Asset ref. No. 121AC901C0102C01)

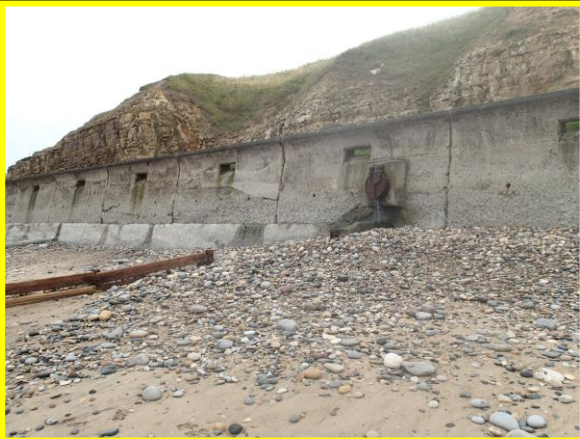
Low beach levels exposing toe of wall and
damaged groynes.
(Asset ref. No. 121AC901C0102C01)

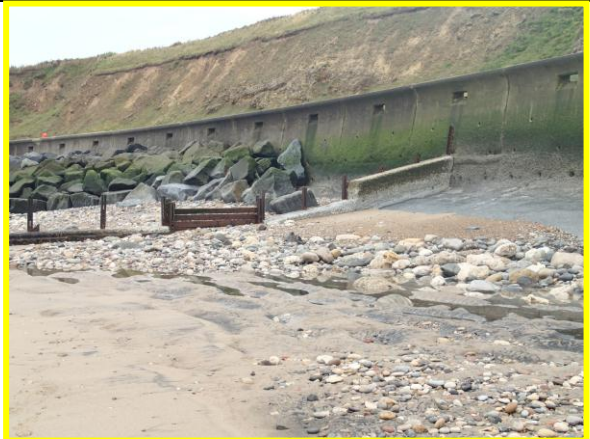
Exposed concrete toe apron adjacent to start
of rock armour at south of defence.
(Asset ref. No. 121AC901C0102C01)

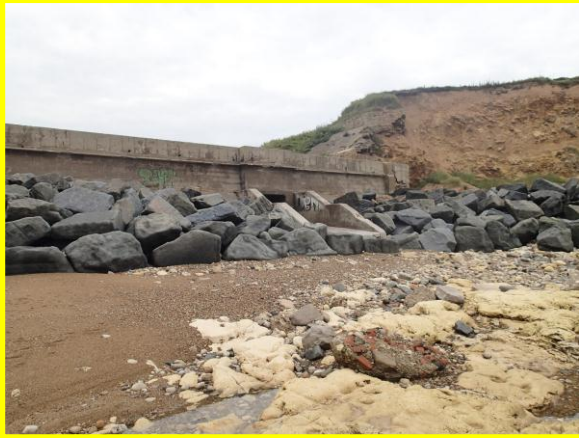
Culverted outfall from Dawdon Dene.
(Asset Ref. No. 121AC901C0103C04)

121AC901C0103C04	CPSE-220/6805/03	680503 Gunned rock toe to wall. Rock protection scheme under study.	Apron	NZ43004984, NZ42994986	22.6	11/07/2014	Rock armour protecting short length of wall with large outfall. Wall in fair condition, armour good. Damage to wall at S corner where returns toward eroding rock outcrop. Large cracks in wall face at N end.	3	3	11 - 20	Monitor for outflanking. Repair cracks in crest wall.	routine
121AC901C0103C05	CPSE-220/6808/01	680801 Slipping cliff. To path and police station.	Cliff / Scarp	NZ43114957, NZ43204952	103.9	11/07/2014	As previous survey. High levels of pebble beach berm protecting cliff toe. Upper beach remains high but has steepened. Large slip in the cliff between steps and start of rock armour.	2	2	>20		no repairs
121AC901C0103C06	CPSE-220/6807	undefended	Cliff / Scarp. Limestone	NZ43114957, NZ43024978	223.3	11/07/2014	As 2012. Partly undefended, but is a 'transition zone' from rock armour to north to undefended bay. Cliffs in south well vegetated, but with signs of continued slumping. Erosion and slumping continue in north, with sheds / fence close to edge.	3	4	>20	Public safety needs monitoring - access to cliff top controlled by fencing.	routine

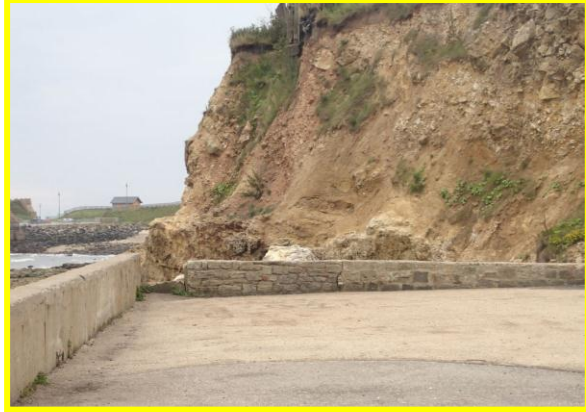
Damage to masonry at south corner of wall.
(Asset Ref. No. 121AC901C0103C04)

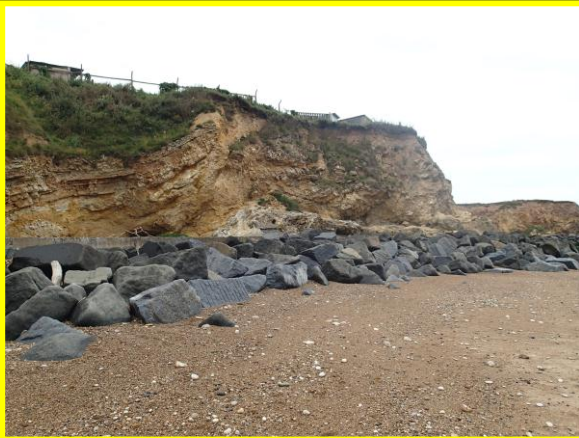
Rock armour protecting cliff toe, property sheds close to edge.
(Asset Ref. No. 121AC901C0103C02)

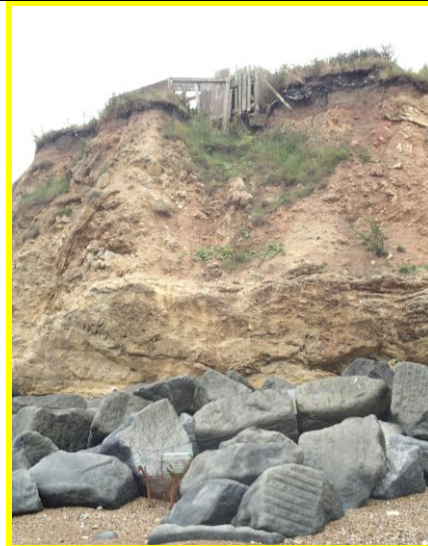
Ongoing erosion of cliff behind rock armour.
(Asset Ref. No. 121AC901C0103C02)

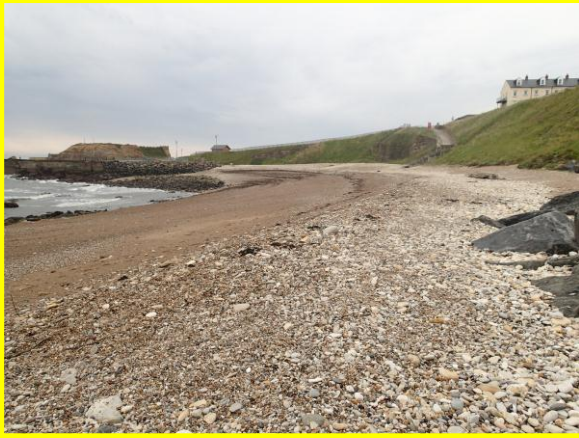
Beach remains high at cliff toe but has steepened since 2012.
(Asset Ref. No. 121AC901C0103C06)

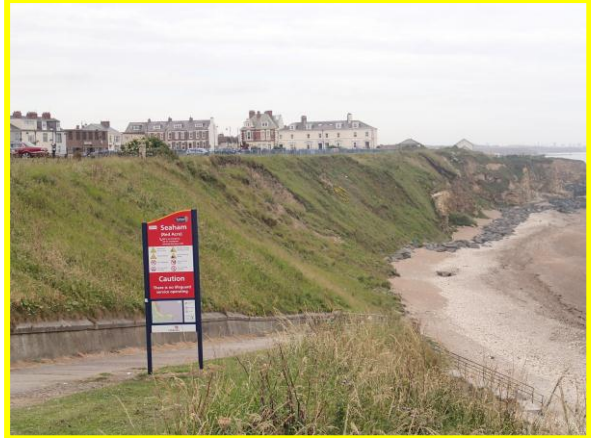
Slumping in cliff between end of rock armour and beach access steps.
(Asset Ref. No. 121AC901C0103C06)

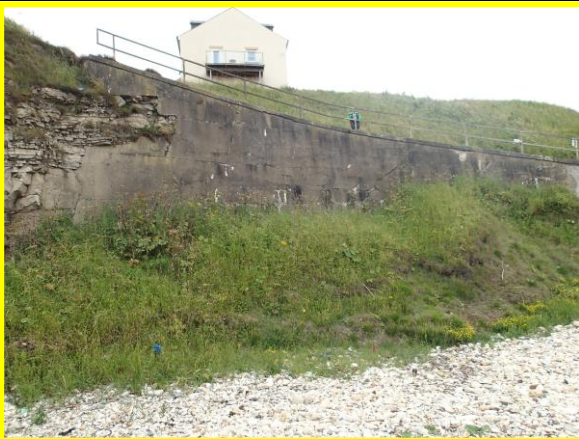
The beach access ramp and steps are supported by a vertical concrete retaining wall, below left that has a large diagonal crack through the full height. The crack is also present on the photographs from 2010 and 2012 so the situation does not seem to have significantly worsened. There was also minor cracking to retaining wall at toe of slope to rear of ramp, below lower left.

Cracking in the retaining wall to the beach access ramp.
(Asset Ref. No. 121AC901C0103C07)

121AC901C0103C07	CPSE-220/6808/01	680801 Slipping cliff. To path and police station.	Cliff / Scarp	NZ43134950, NZ43094957	84.1	11/07/2014	Diagonal cracking to seaward face of wall retaining access ramp/steps. Beach levels high. Minor cracking to retaining wall at toe of slope to rear of ramp. However, minimal change since 2012.	3	4	11 - 20	Repairs to cracks.	routine
121AC901C0104C01	CPSE-220/6812/02	681202 Recurved splash wall set back from main wall. Protection against overtopping into South dock.	Splash Wall	NZ43414885, NZ43424897	190.7	11/07/2014	Only viewed from cliff due to access restrictions to port. Rock armour revetment appears to still be in good condition.	2	2	>20	2-yearly inspections.	routine
121AC901C0104C02	CPSE-220/6809/01	680901 Rock armour slope to rear of harbour area reclaiming land.	Armour	NZ43204952, NZ43234958	80.7	11/07/2014	Again no change from prev surveys. Substantial rock armour sizes and stable profile of works. Some erosion of land at root, but not worsened since 2008.	2	2	>20	Monitor.	no repairs

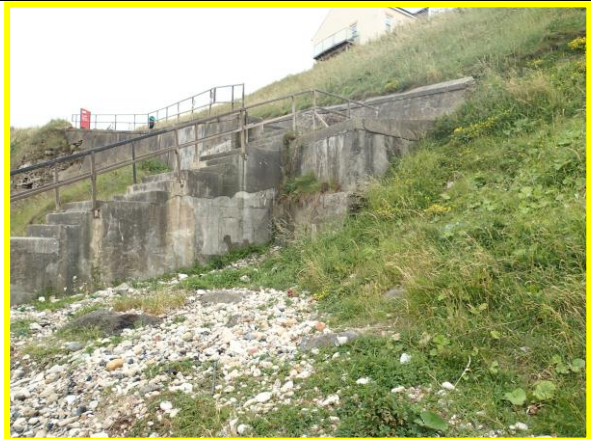
Beach access ramp and steps.
(Asset Ref. No. 121AC901C0103C07)

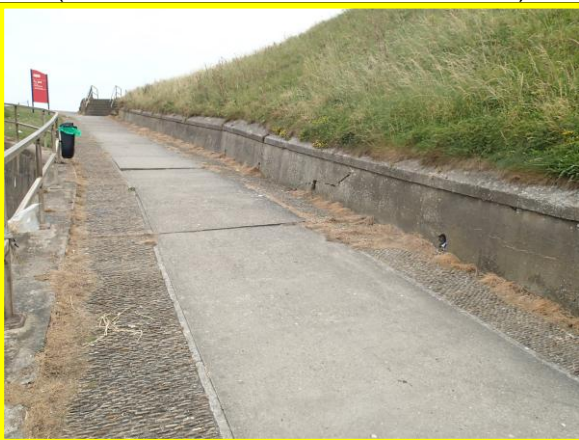
Cracking in the retaining wall to rear of beach access ramp.
(Asset Ref. No. 121AC901C0103C07)

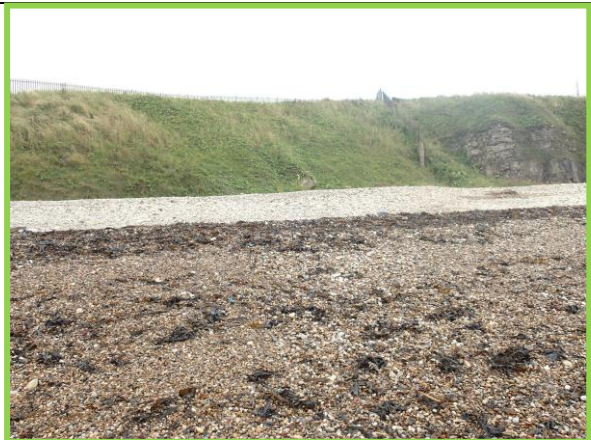
Undefended length south of beach ramp.
(Asset Ref. No. 121AC901C0103C05)

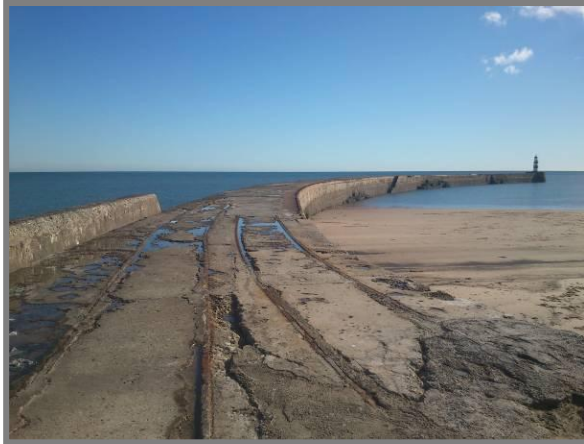
View of North Pier in 2012.
(Asset Ref. No. 121AC901C0104C03)

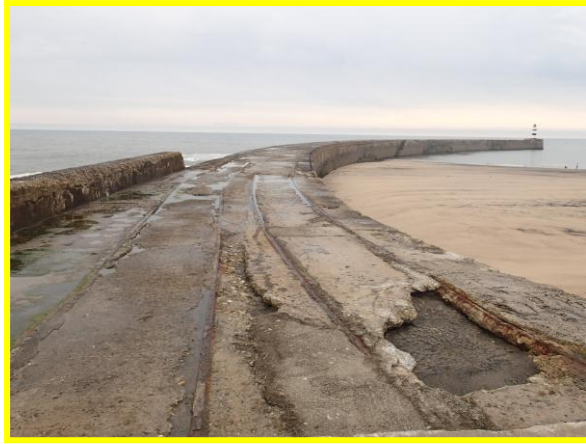
Access to the North Pier is restricted by a locked access gate at the landward end and the photographs below left and right are taken through the gate. The concrete deck shows significant damage and weathering and has worsened since 2012, compare photos below, although the massive structure still clearly provides an effective coast protection function and is therefore assumed to be in fair overall condition. The inner face was inspected from the beach at low tide, see below lower photos.

View of North Pier in 2014 showing increased damage to deck.
(Asset Ref. No. 121AC901C0104C03)

121AC901C0104C03	CPSE-220/6810/02	681002 Crest wall to river end of North Pier. Overtopping protection to pier and reclaimed land.	Wall	NZ43234958, NZ43724939	986.3	11/07/2014	Seaward face and crest not accessible. Inner face fair, evidence of repairs, which are holding. Some missing mortar and voids between masonry blocks. Structure is heavily overtopped at high tide.	3	3	>20	Detailed inspection	routine
121AC901C0104C04	CPSE-220/6817/02	681702 Masonry toe on seaward side only.	Apron	NZ43464938, NZ43454949	231	11/07/2014	Only viewed from Marina side due to access restrictions. Appears fair overall. Some missing mortar between masonry blocks.	3	4	>20	Detailed inspection	routine

It is recommended that, if not already in place, more detailed inspections, including vessel based and underwater inspection are undertaken by the Dock Company and if not already in progress a maintenance programme should be put in place.

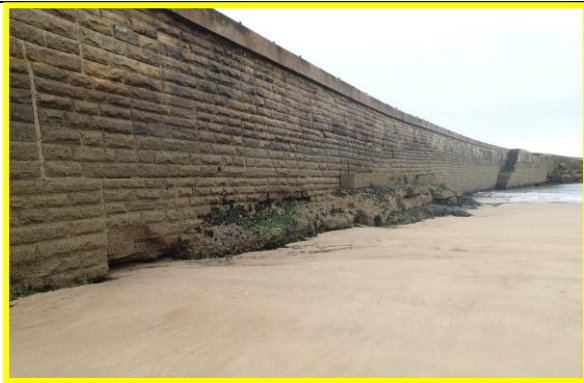
Toe erosion damage where North Pier ties into rock outcrops.
(Asset Ref. No. 121AC901C0104C03)

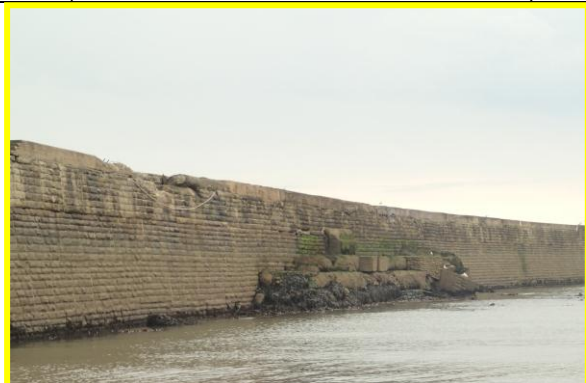
Missing section of inner coping to North Pier.
(Asset Ref. No. 121AC901C0104C03)

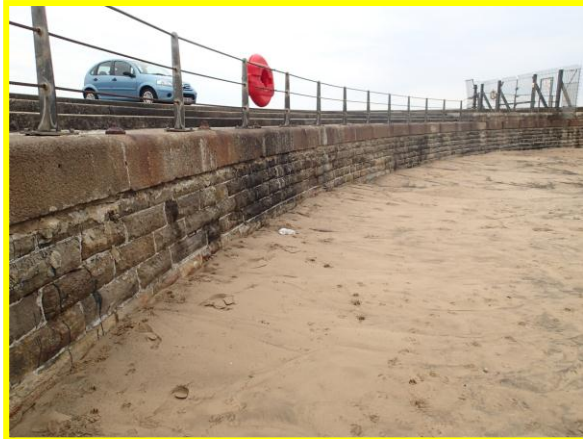
Low masonry wall at back of beach.
(Asset Ref. No. 121AC901C0104C05)

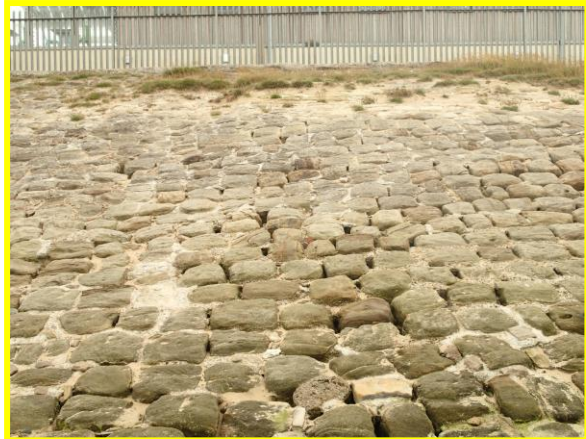
The wall at the back of the beach in the outer harbour, asset 121AC901C0104C05 consists of two parts, the first being a vertical wall at the car park, which ties into North Pier, and the second a dressed masonry sloping revetment that ties into the breakwater to the south of the beach. Both parts appeared to be in fair condition see below left and right, but there was missing mortar and open joints in both sections that need repairing before the damage worsens.

Gaps and missing grout in masonry revetment adjacent to new marina building.
(Asset Ref. No. 121AC901C0104C05)

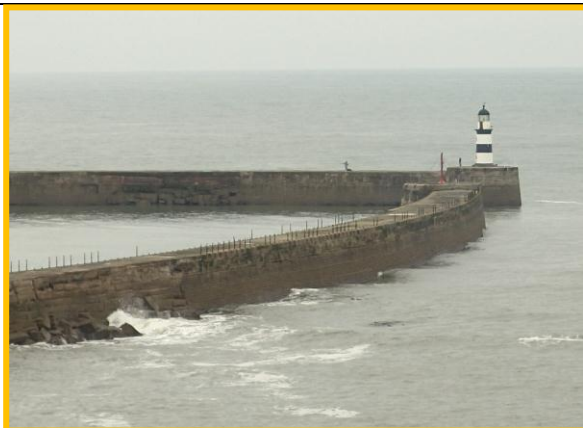
The South Pier was only inspected from a distance as it is within the port operational area, see photos below. The main pier appeared to have significant damage to sections of the crest, and outer face, see photos below left and right. At the root of the pier rock armour has been placed at the tie in to the coast, below right as part of a previous phase of regeneration. There is an area of tipped rubble in front of the rock armour, see below, lower left. The armour continues to the south protecting the port access road and appeared to be in good condition.

View of South Pier showing damaged crest.
(Asset Ref. No. 121AC901C0104C17)

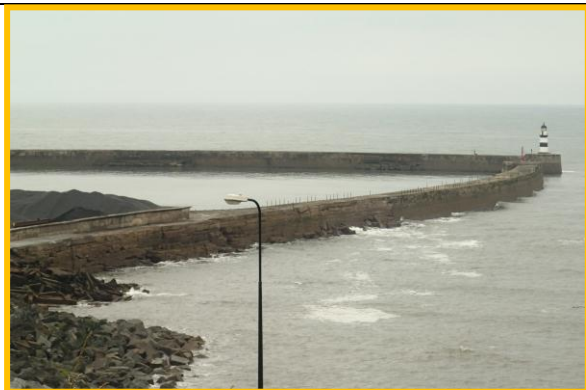
General view of South Pier.
(Asset Ref. No. 121AC901C0104C17)

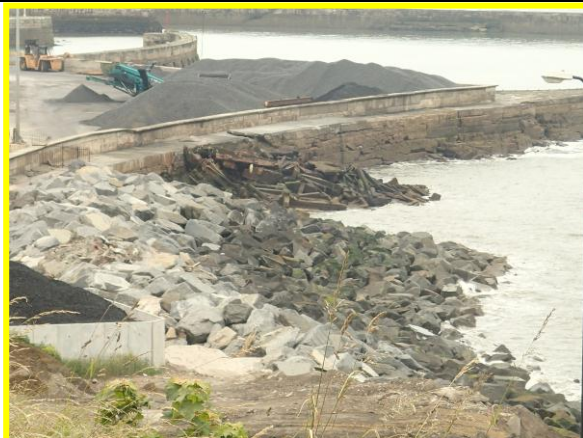
Rock armour at root of South Pier.
(Asset Ref. No. 121AC901C0104C01)

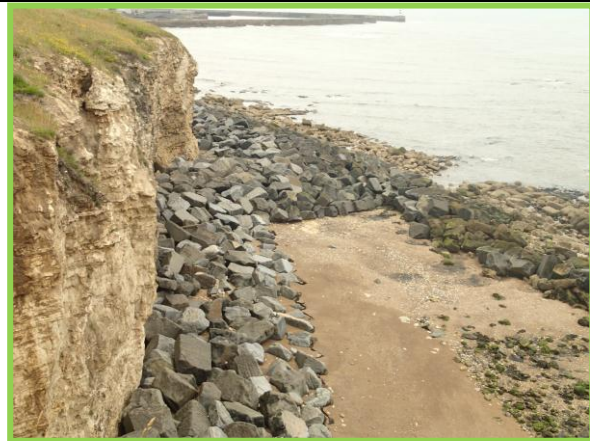
Rock armour south of port.
(Asset Ref. No. 121AC901C0105C01)

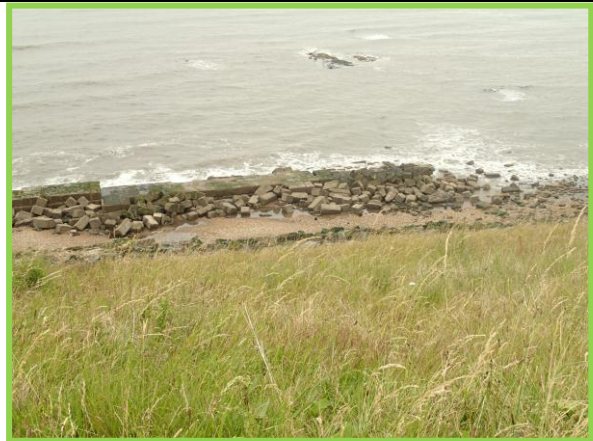
Rock armour bund seaward of cliff.
(Asset Ref. No. 121AC901C0105C01)

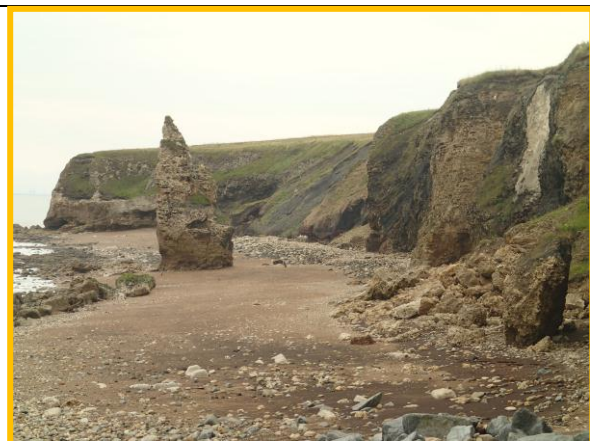
Colliery spoil has been eroded from Chemical Beach.
(Asset Ref. No. 121AC901C0106C01)

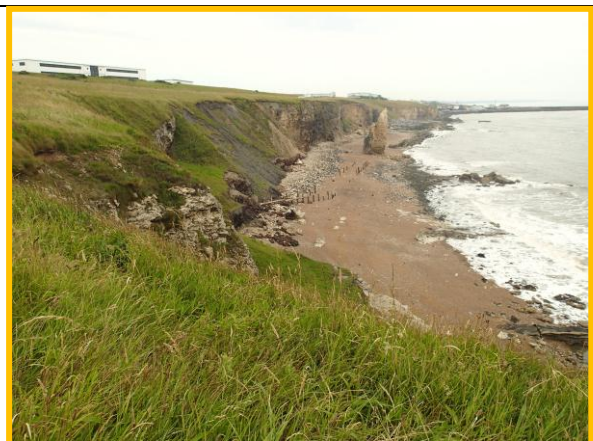
View north from Noses Point.
(Asset Ref. No. 121AC901C0106C01)

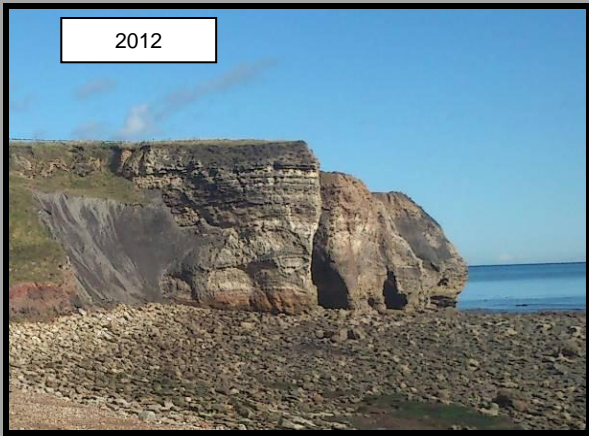
Caves and arches at Nose's Point from 2012 report. (Asset Ref. No. 121AC901C0107C01)

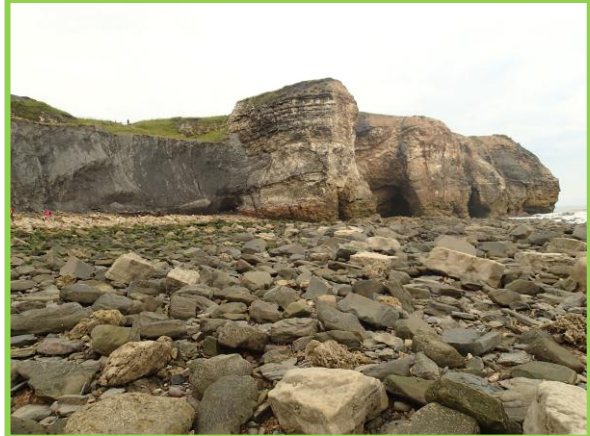
Cliffs with caves at Nose's Point. (Asset Ref. No. 121AC901C0107C01)

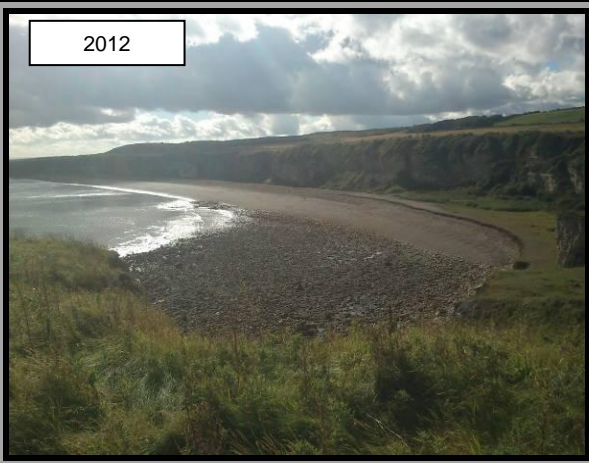
Photo of Blast beach from 2012 report. (Asset Ref. No. 121AC901C0107C01)

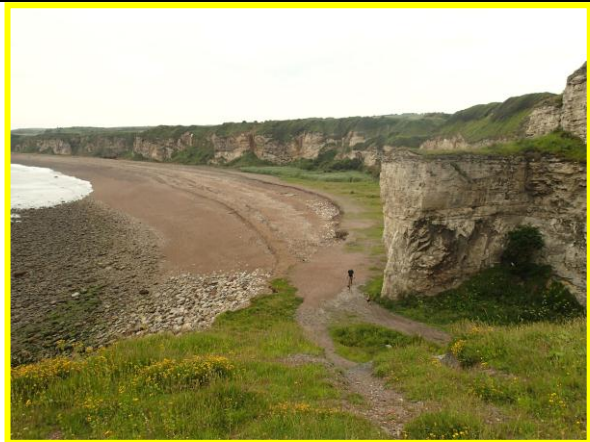
Eroding colliery Spoil at Blast beach. (Asset Ref. No. 121AC901C0107C01)

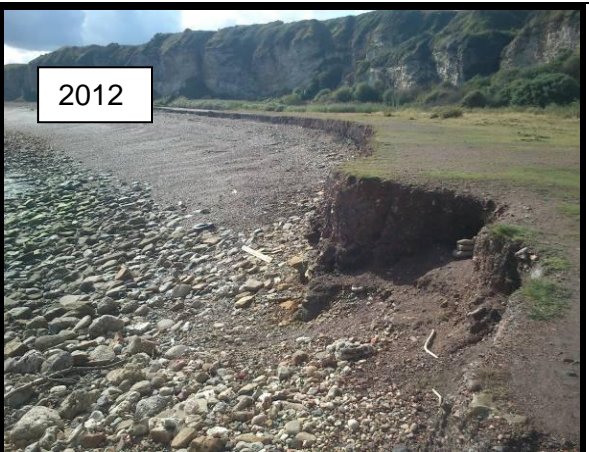
Eroding spoil at north end of Blast beach. Photo from 2012 report

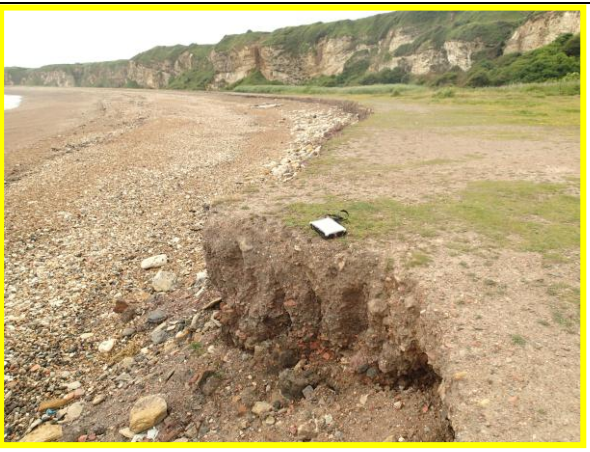
Eroding spoil at north end of Blast beach. (Asset Ref. No. 121AC901C0107C01)

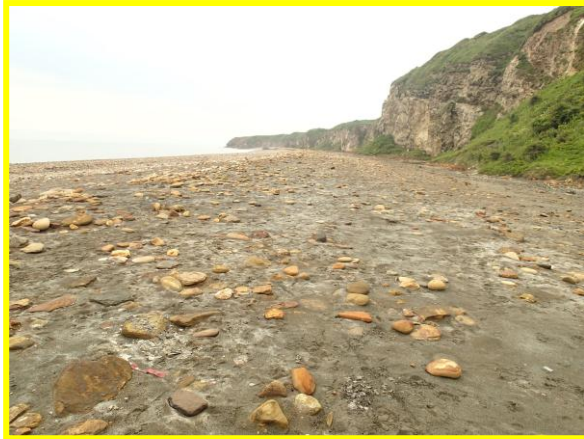
Eroding spoil at north end of Blast beach.
(Asset Ref. No. 121AC901C0107C01)

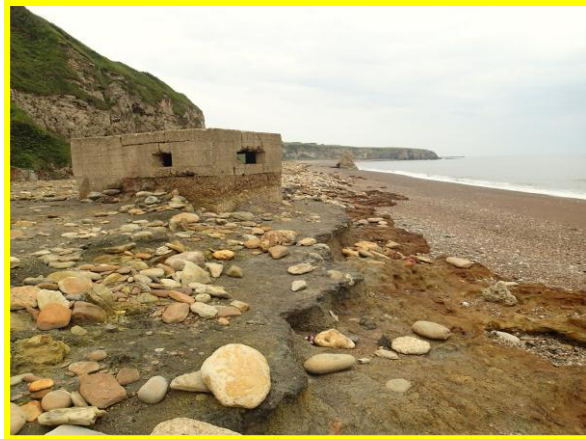
Eroding spoil beach adjacent to pill box located south of the footpath steps down to the beach.
(Asset Ref. No. 121AC901C0107C01)

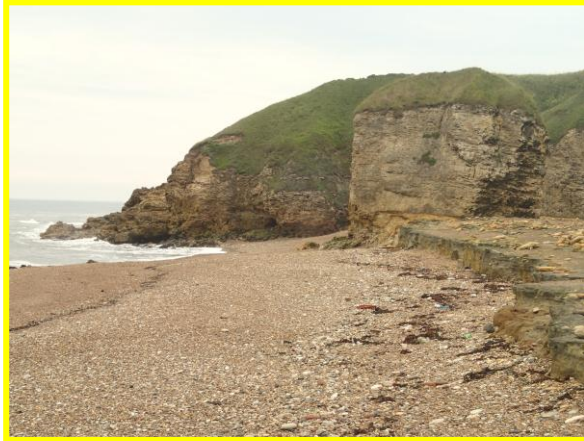
View of Chourdon Point looking south from Blast Beach.
(Asset Ref. No. 121AC901C107C02)

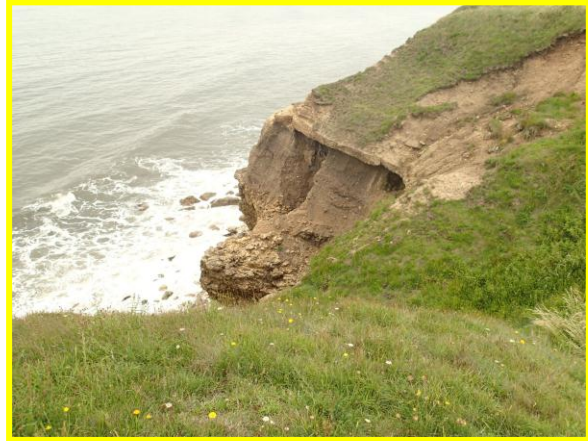
Eroding till mantle above limestone cliffs at Chourdon Point.
(Asset Ref. No. 121AC901C0107C02)

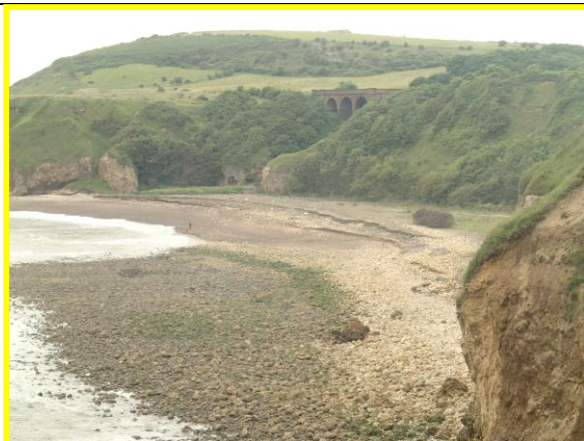
Eroding spoil beach in Hawthorne Hive Bay.
(Asset Ref. No. 121AC901C0201C01)

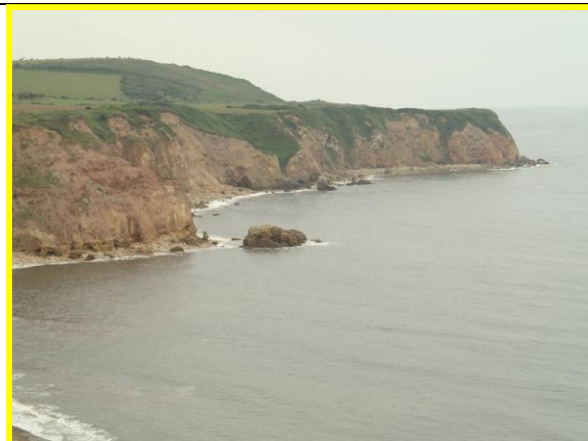
View of cliffs at Easington Colliery, looking north from Fox Holes.
(Asset Ref. No. 121AC901C0201C01)

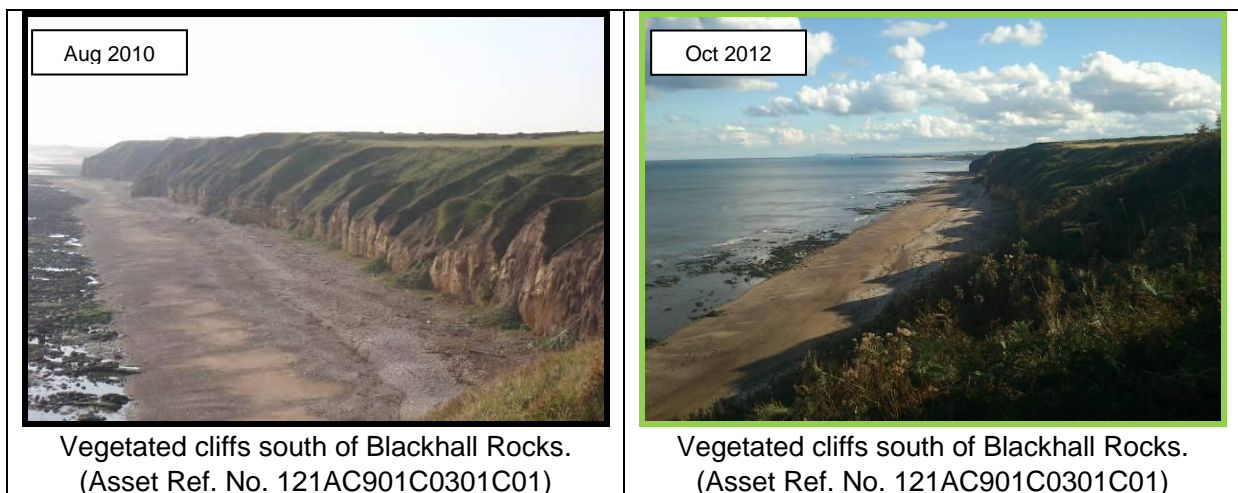
<p>July 2014</p> <p>Vegetated cliffs south of Blackhall Rocks. (Asset Ref. No. 121AC901C0301C01)</p>	  <p>Slumping in cliffs to north of caravan park. (Asset Ref. No. 121AC901C0301C01)</p>
  <p>Caravan park access steps closed due to cliff falls. (Asset Ref. No. 121AC901C0301C01)</p>	  <p>Vegetated cliff slopes adjacent to caravan park. (Asset Ref. No. 121AC901C0301C01)</p>

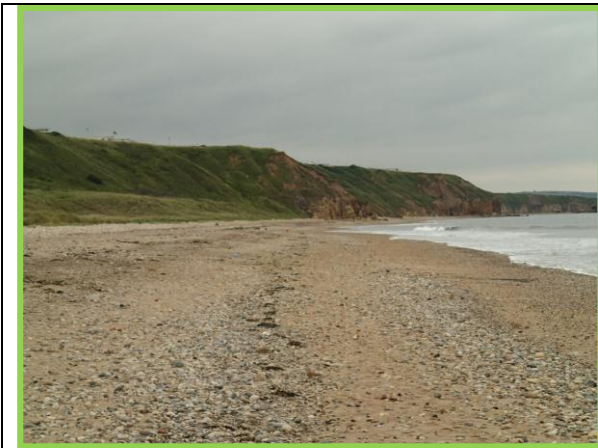
North end of dune system near caravan park.
(Asset Ref. No. 121AC901C0301C02)

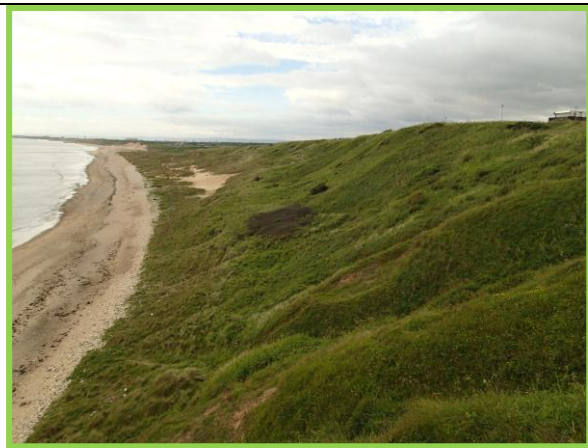
View of dune system looking south from caravan park. Paths through dunes in distance.
(Asset Ref. No. 121AC901C0301C02)

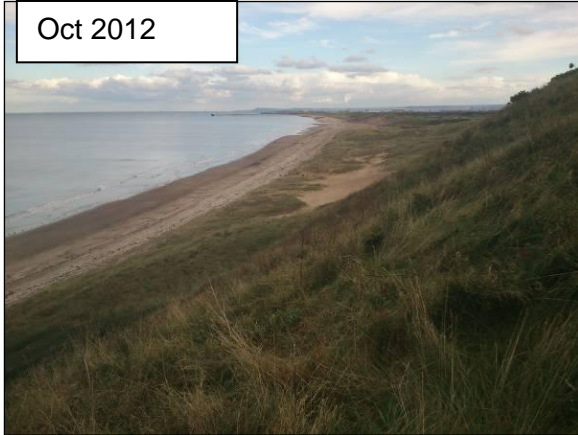
Oct 2012

Sand dunes north of Crimdon Beck.
(Asset Ref. No. 121AC901C0301C02)

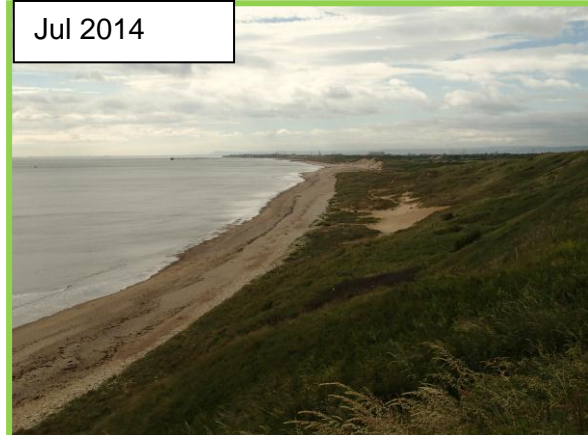
Jul 2014

Sand dunes at Crimdon Beck (Asset Ref. No. 121AC901C0301C02)

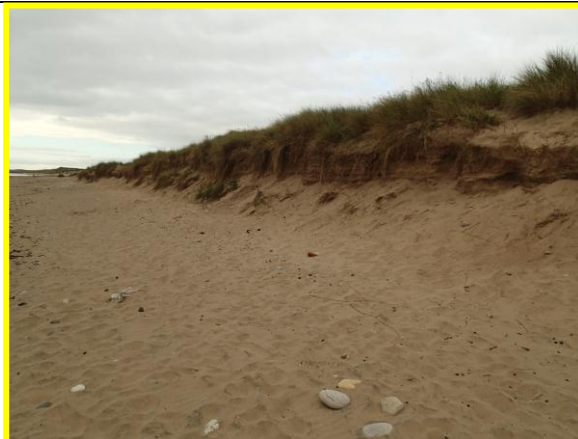
Evidence of erosion of front face of dunes.
(Asset Ref. No. 121AC901C0301C02)

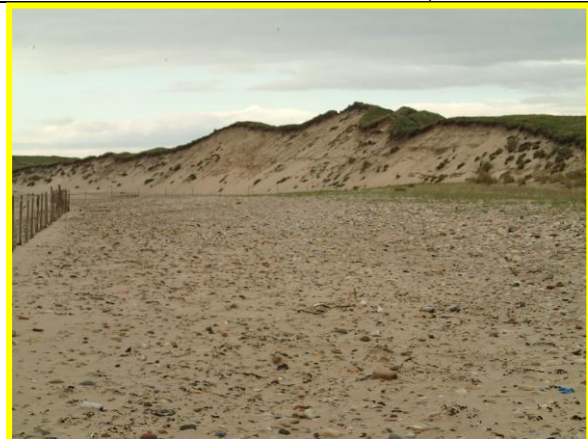
Erosion of dune face immediately south of Crimdon Beck.
(Asset Ref. No. 121AC901C0301C02)
