**Cell 1 Regional Coastal Monitoring Programme  
Walkover Inspection Surveys 2016**

**Durham County Council**

**September 2016**

## Walkover Inspection Surveys 2016

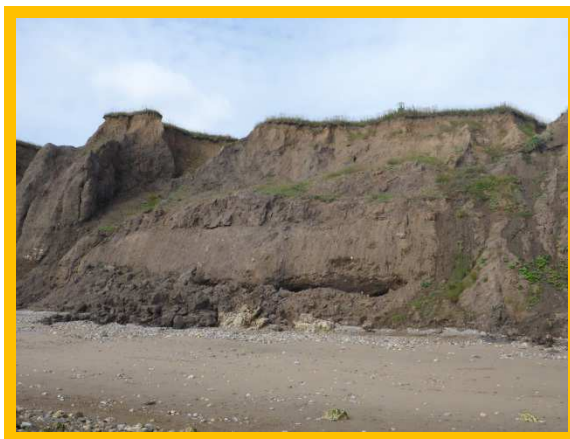
The most northern asset length (/B0804C01) within Durham County Council's jurisdiction extends along undefended sea cliffs from Ryhope Dene to the picnic site located at the north of Seaham, near Seaham Hall. The cliffs comprise a glacial till and are slumping along almost the entire length. At one location there is a relatively large 'bench' type failure involving a substantial volume of material.

*'Bench' type failure in glacial till sea cliffs  
(/0804C01)*

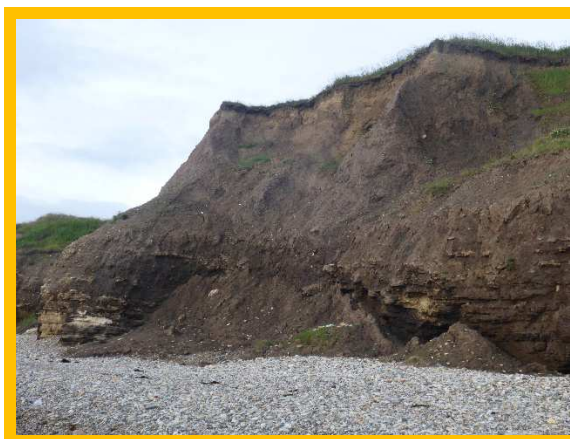
Further towards the southern end of the frontage length, the till sits on top of a harder Magnesian Limestone base. At these locations, there is evidence of recent local slumping in the upper till cliff. There are also frequent caves and arches formed in the limestone rock at the base of the cliffs caused by differential erosion by waves.

*Localised slumping of upper till within the cliffs  
(/0804C01)*

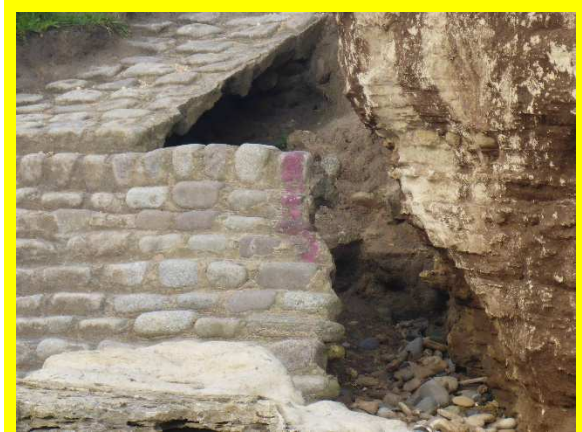
Within this asset length is a set of access steps from the picnic site car park near Seaham Hall with a small stream discharging to the foreshore over an adjacent stone revetment. There was little flow in the stream at the time of the inspection, but the previously identified outflanking of the revetment appears unchanged since 2010. There is also a small diameter pipe encased on concrete running alongside the steps. This was not discharging at the time of the inspection and the outlet was partially blocked by large cobbles.

*Outflanking of revetment (/0804C01)*

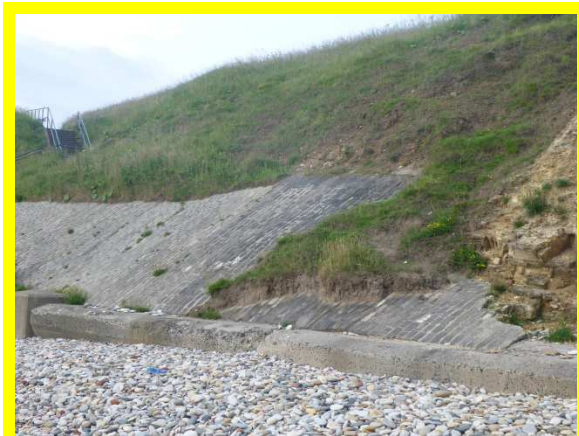
Backing the southern end of the low-level tie-in wall, and continuing behind the very northern end of the Seaham sea wall is a blockwork revetment on the backing slope which remains in fair condition despite a little outflanking at its northern end. There are small slippages in the slope above the revetment. The access ramp at the northern end to the main Seaham promenade has small cracks in the deck.

*Minor outflanking of blockwork revetment (/0102C01)*

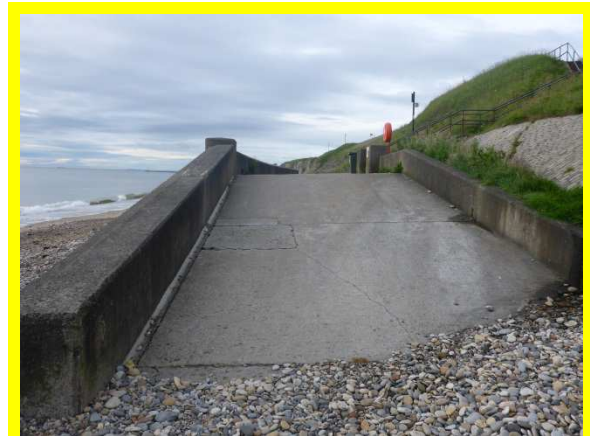
*Cracks in deck of access ramp at northern end of promenade (/0102C01)*

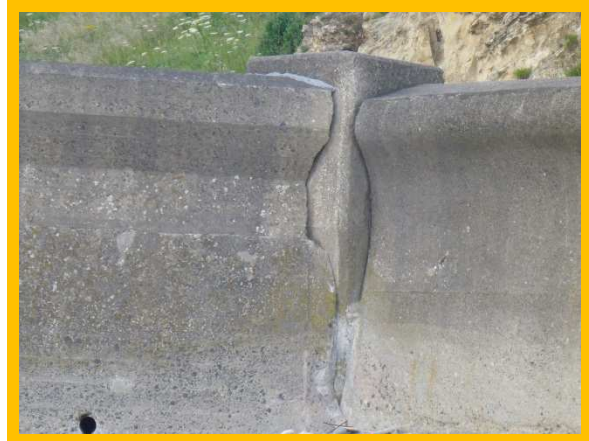
The main Seaham sea wall is fronted by a high shingle beach. The wall and promenade are both in fair condition, although at every junction with a set of access steps a crack exists between the main sea wall and the wing-wall of the steps. Joints in the main sea wall are mostly intact but a few areas would benefit from re-sealing. There is some vegetation growth in construction joints and cracks in the promenade, which should be removed and the joints sealed.

*Cracks at junction between sea wall and access steps (/0102C01)*

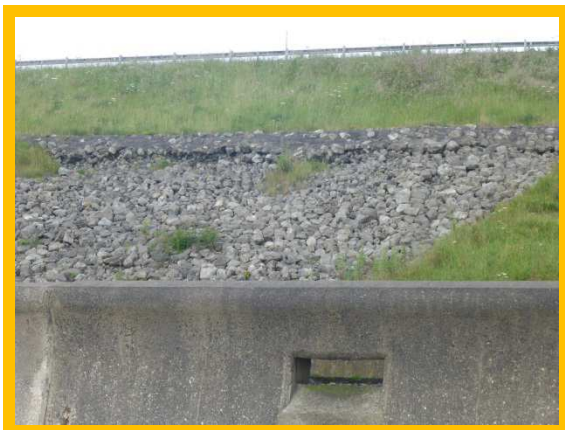
To the rear of the sea wall and promenade there is a blockwork revetment at the interface between the coastal slopes and the steeper cliffs. This revetment appears 'sunken' into the slope and remedial works are recommended.

*Remedial works needed to 'sunken' area of blockwork revetment (/0102C01)*

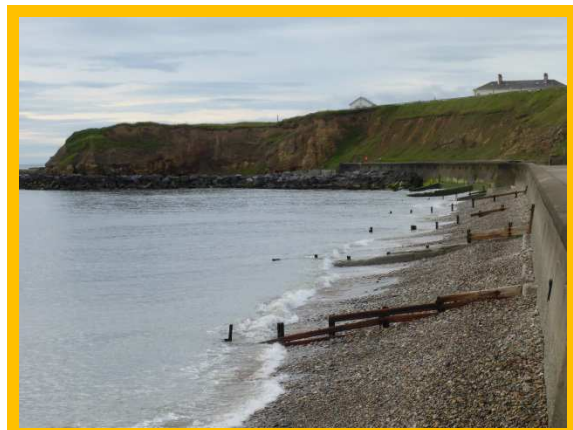
Towards the southern end, the sea wall is fronted by remnants of groynes which have a concrete base and timber boards fixed to vertical steel piles. In many places there is no longer timber boarding present and the steel piles remain upstanding and exposed.

*Remnants of groynes (/0102C01)*

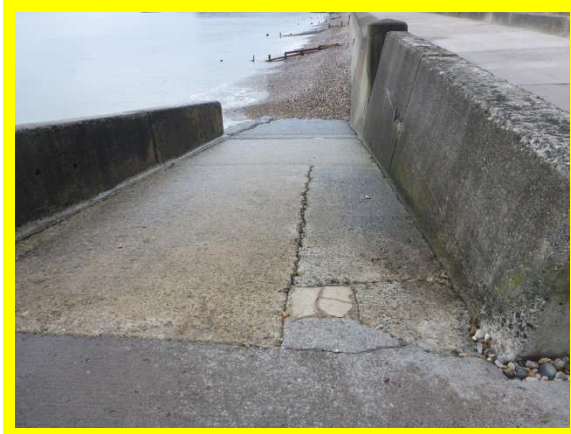
At the southern end of the sea wall, the access ramp is heavily abraded and its deck is cracked. The ramp is protected by rock armour. Also around this location, the cliffs behind the promenade are steeper and past episodes of slippage have left a headscarp visible, although no 'fresh' slippages were noted during the inspection.

*Cracks in deck of access ramp at southern end of promenade (/0102C01) (/0102C01)*

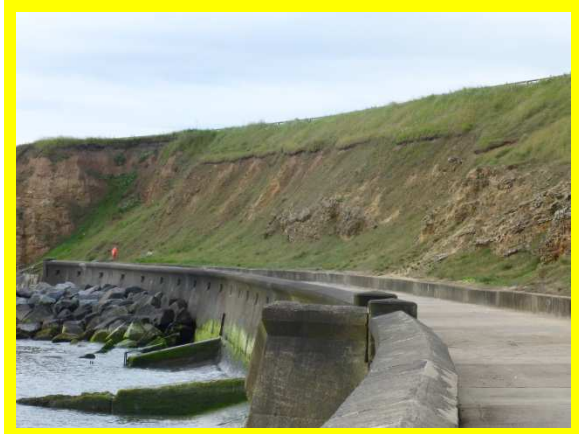
*Headscarp in backing cliffs formed by previous slippages (/0102C01)*

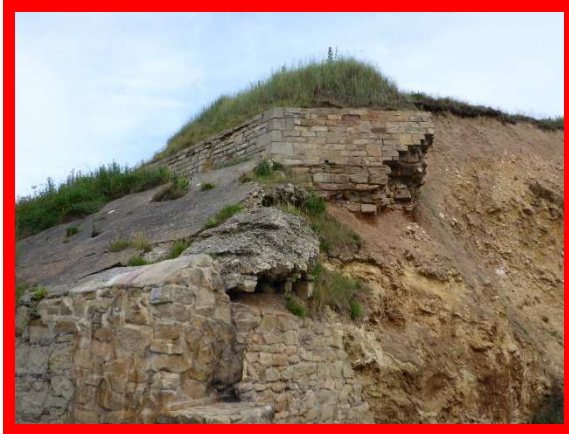
At the tie-in of the outfall's concrete platform to the cliffs to the north, a section of masonry wall above a sloping poured concrete revetment is actively breaking up. In addition, a short length of low masonry wall around the southern edge of the outfall's concrete platform has previously been reported as being damaged but remains unrepaired. Immediately south of the outfall's concrete platform cliff recession continues to affect fence line in the vicinity of the Coastguard Station.

*Masonry wall and concrete revetment at tie-in to cliffs breaking-up (/0103C01)*

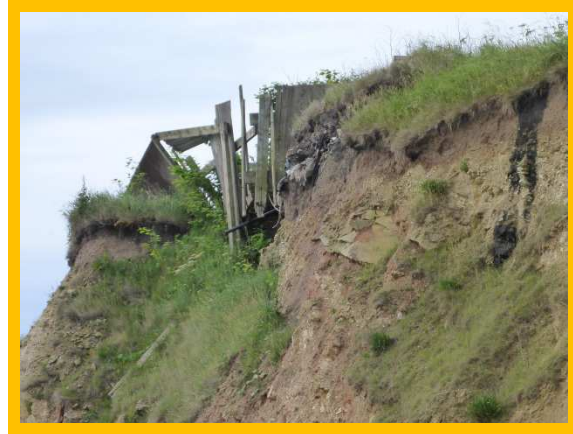
*Erosion affecting fence line of properties to south of Dawdon Dene outfall (/0103C01)*

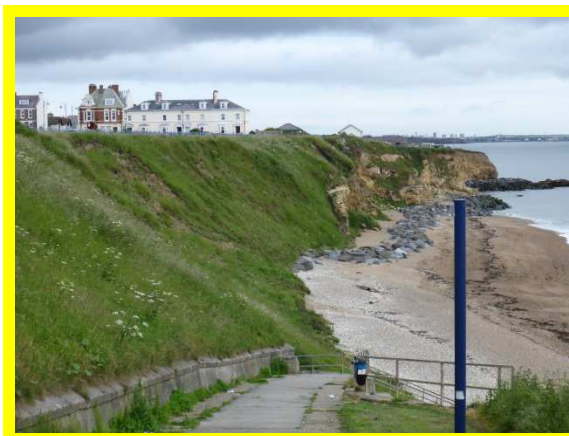
*Local slumps in cliffs (/0103C06)*

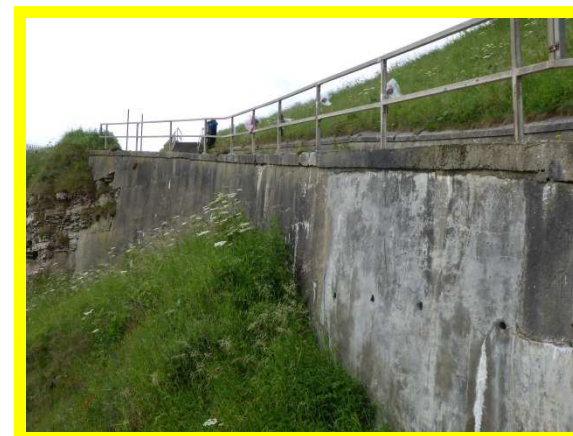
*Cracking in retaining wall to access steps and ramp (/0103C07)*

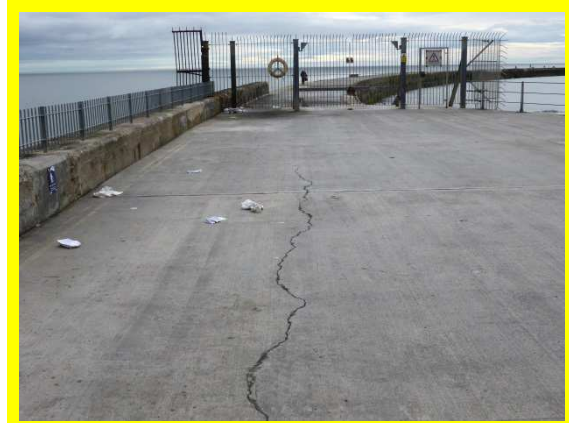
Access to the North Pier is restricted by a locked access gate at the landward end. The concrete deck shows cracking on the accessible sections, although the massive structure still clearly provides an effective coast protection function and is therefore assumed to be in fair overall condition. Recent repairs to previously-reported defects to the deck and both coping and upper

sections of the inner face were noted beyond the access gate, but these could not be inspected in detail. The inner face was inspected from the beach at low tide and appears in fair condition. It is recommended that, if not already in place, more detailed vessel-based and underwater inspections are undertaken by the Dock Company and if not already in progress a maintenance programme should be put in place.

*Deck of Seaham Harbour North Pier (/0104C03)*

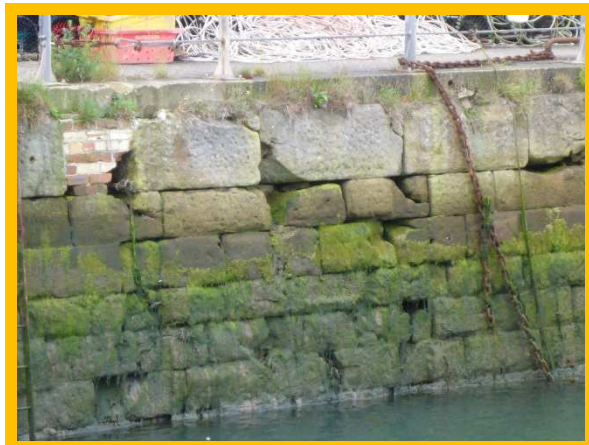
The wall at the back of the beach in the outer harbour (0104C05) consists of two parts, the first being a vertical wall at the car park, which ties into North Pier, and the second a dressed masonry sloping revetment that ties into the breakwater to the south of the beach. Both parts appeared to be in fair condition, although there is vegetation growth on open joints which should receive attention. Generally speaking, the walls around North Dock are in fair condition, but all have some open joints between masonry blocks in their faces and these would undoubtedly benefit from a routine maintenance programme involving re-pointing. Assets 0104C04, 0104C06, 0104C11 and 0104C14 require only localised re-pointing, but assets 0104C09 and 0104C13 are in need of slightly more attention. The asset which needs the greatest attention in this regard, however, is 0104C12.

*Gaps between blocks at Seaham North Dock (/0104C12)*

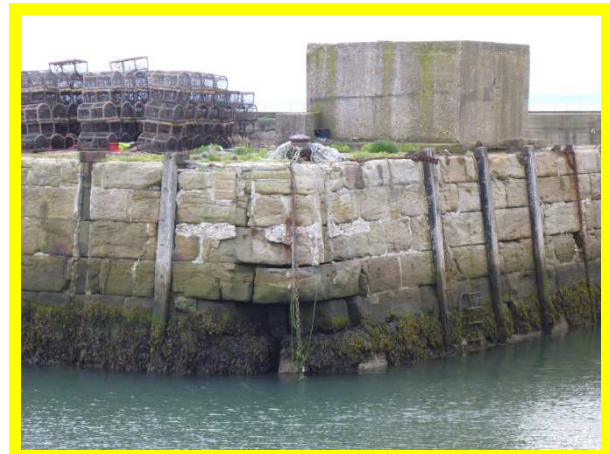
*Gaps between blocks at Seaham North Dock (/0104C09)*

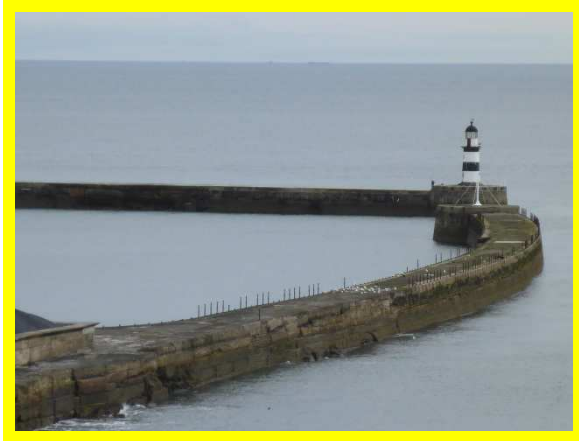
Access to South Pier and South Dock is prohibited due to port-related activity and the structures were only inspected from a distance. The South Pier appeared from afar to have significant damage to sections of the crest and outer face. At the root of the pier, rock armour has been placed at the tie in to the coast as part of a previous phase of regeneration. There is an area of tipped rubble in front of the rock armour. The armour continues to the south protecting the port access road and appeared to be in good condition.

*Seaham Harbour South Pier (/0104C17)*

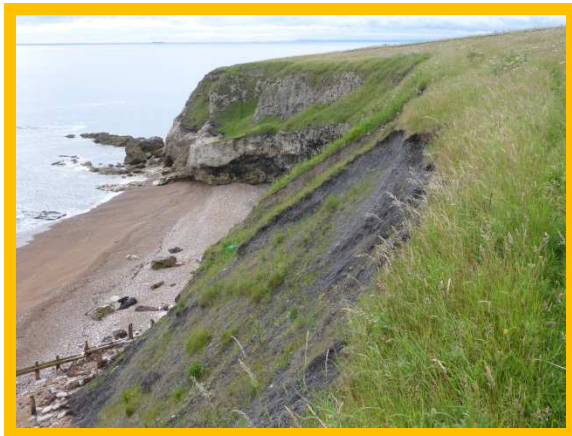
South of the revetment between Seaham Fleet Rock and Nose's Point, the unprotected cliffs were previously fronted by a colliery spoil beach (known as Chemical Beach) but this has now been virtually completely eroded and there are an increasing number of local slumps in the backing cliffs, some of which consists of colliery waste. Debris exposed by the eroding beach should be removed routinely. The erosion appears greatest towards the south of Chemical Beach, just to the north of Nose's Point.

*Slippage in cliff at Chemical Beach (/0106C01)*

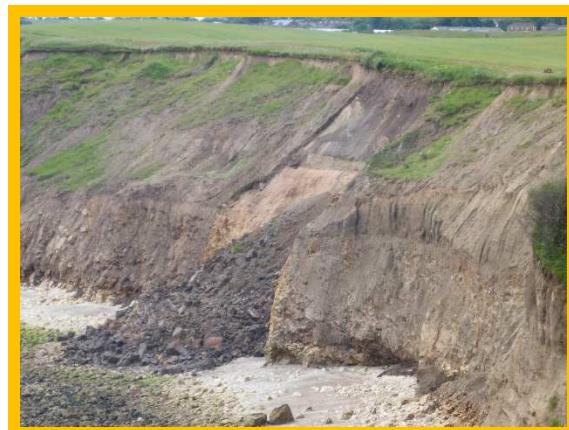
*Rockfall to north of Horden Point (/0201C01)*

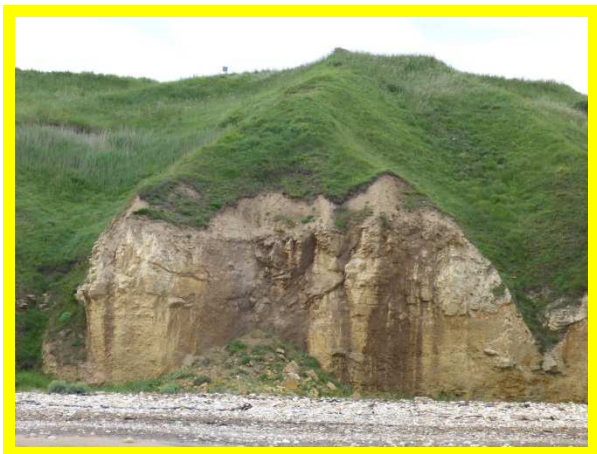
*Local rock fall in cliffs (/0301C01)*
