**Cell 1 Regional Coastal Monitoring Programme
Walkover Inspection Surveys 2018**

Durham County Council

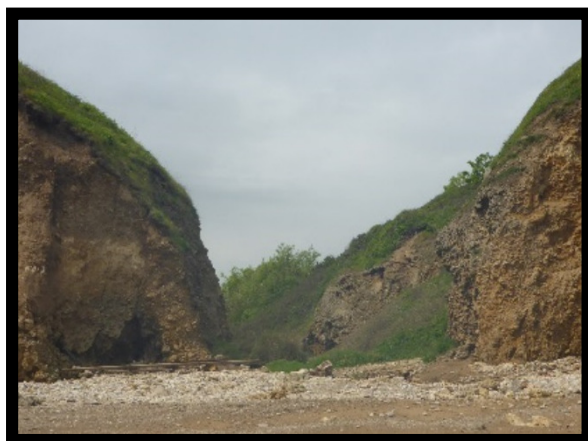
*Ryhope Dene
(northern boundary of /0804C01)*

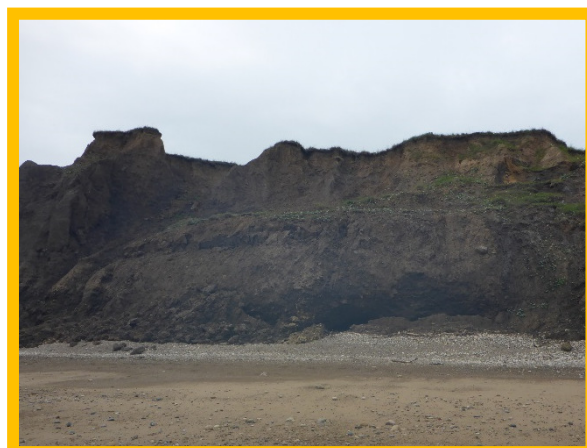
*'Bench' type failure in glacial till sea cliffs
(/0804C01)*

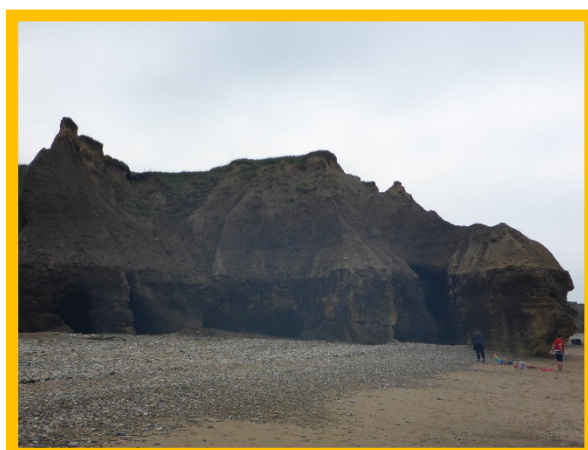
*Undefended sea cliffs with till sitting on
limestone (/0804C01)*

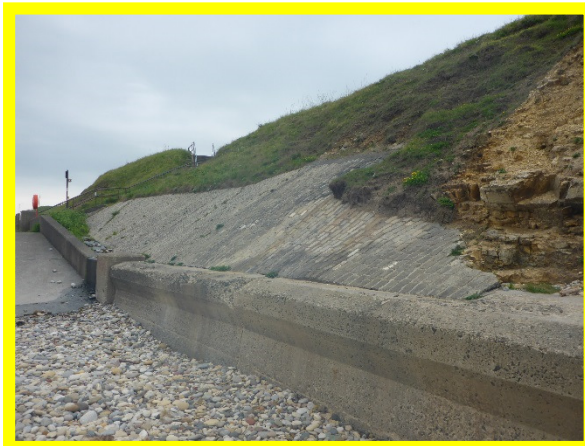
Minor outflanking of blockwork revetment (/0102C01)

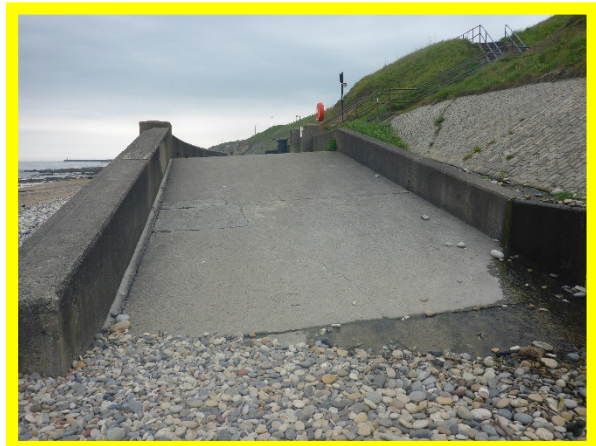
Cracks in deck of access ramp at northern end of promenade (/0102C01)

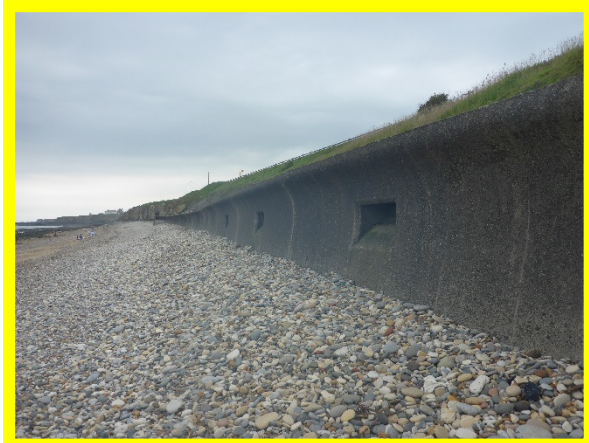
Seaham sea wall (/0102C01)

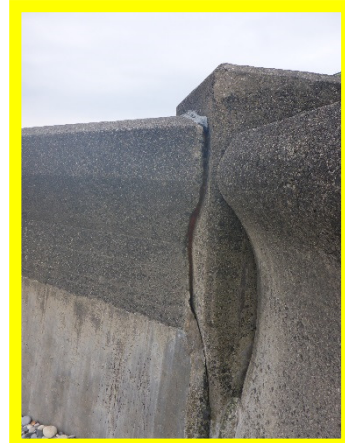
Sealant missing at joint between sea wall and access steps (/0102C01)

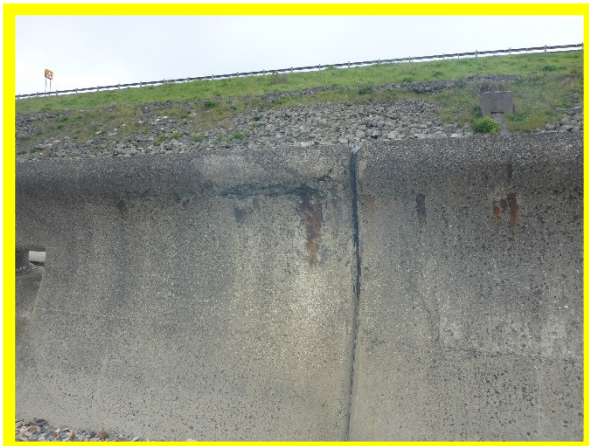
Spalling of bullnose on sea wall (/0102C01)

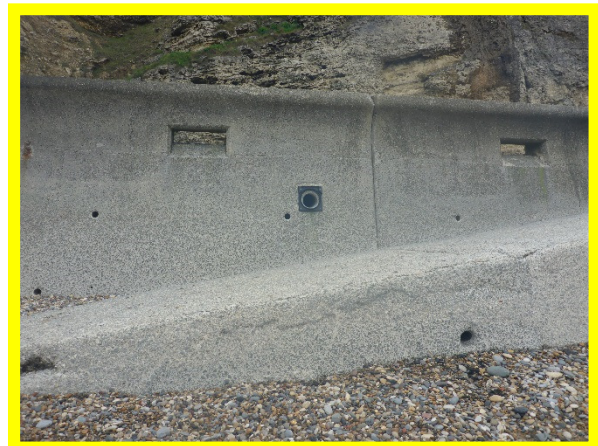
Missing flap valve at access ramp (/0102C01)

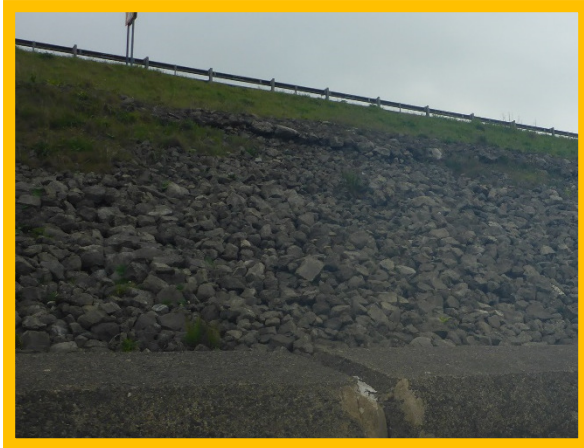
Remedial works needed to 'sunken' area of stone infill (/0102C01)

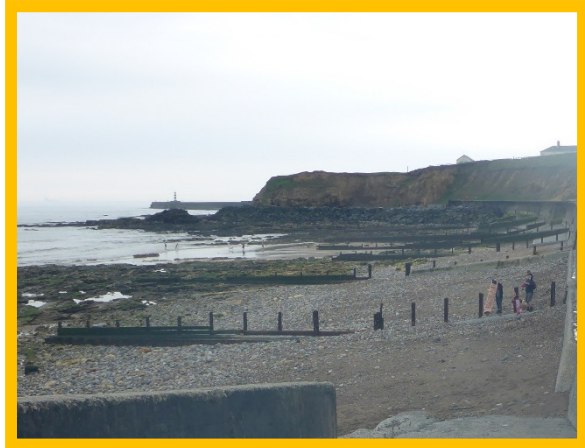
Remnants of groynes (/0102C01)

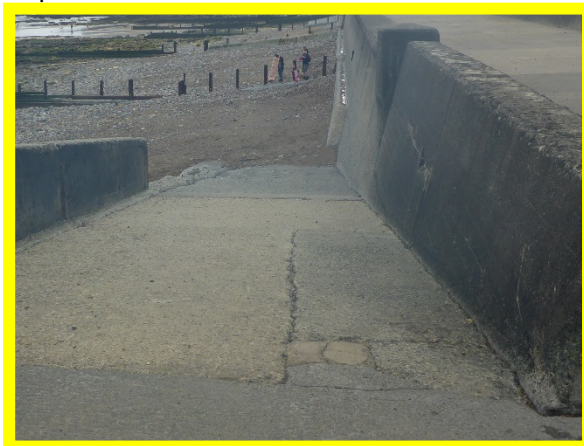
Cracks in deck of access ramp at southern end of promenade (/0102C01)

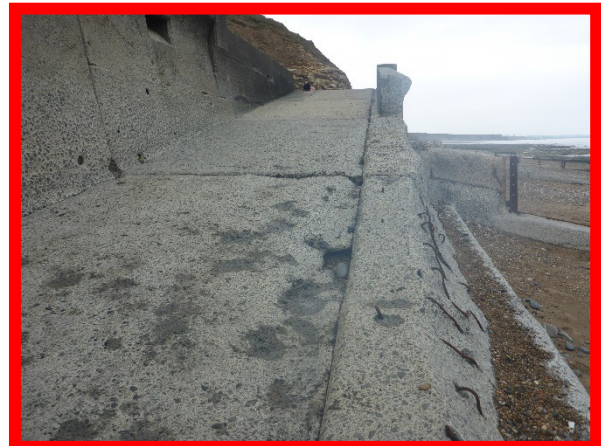
Hole in deck of ramp, exposed reinforcement (/0102C01)

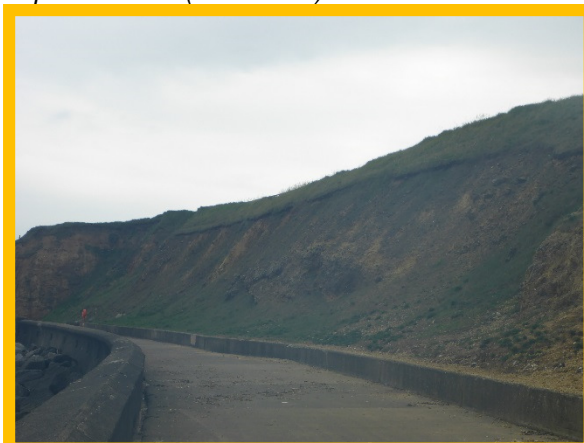
Headscarp in backing cliffs formed by previous slippages (/0102C01)

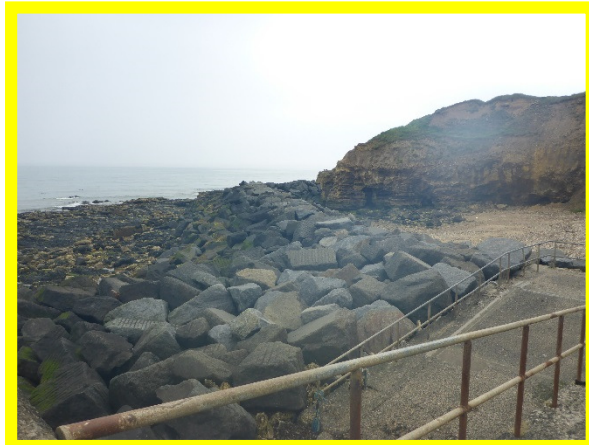
Rock berm around Featherbed Rocks headland (/0103C01)

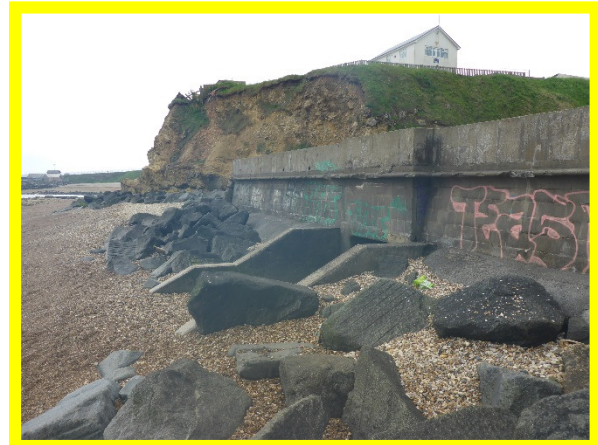
Rock berm around Dawdon Dene culvert and further south (/0103C04)

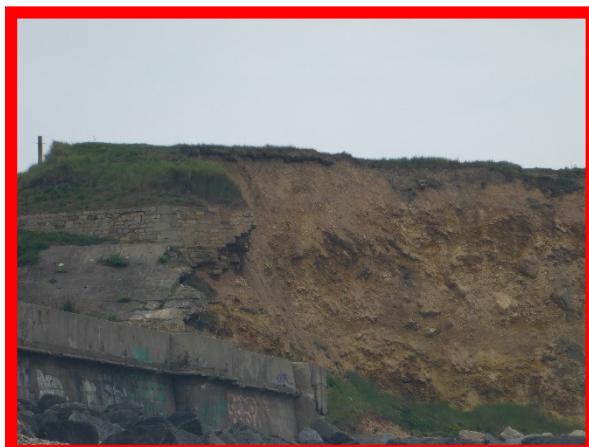
Masonry wall and concrete revetment at tie-in to cliffs breaking-up (/0103C04)

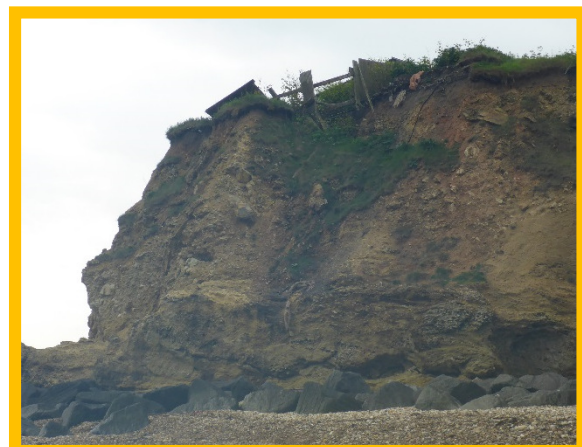
Erosion affecting fence line of properties to south of Dawdon Dene outfall (/0103C02)

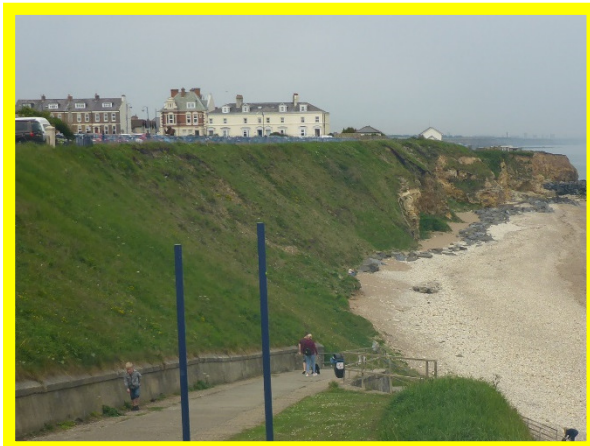
Local slumps in cliffs (/0103C06)

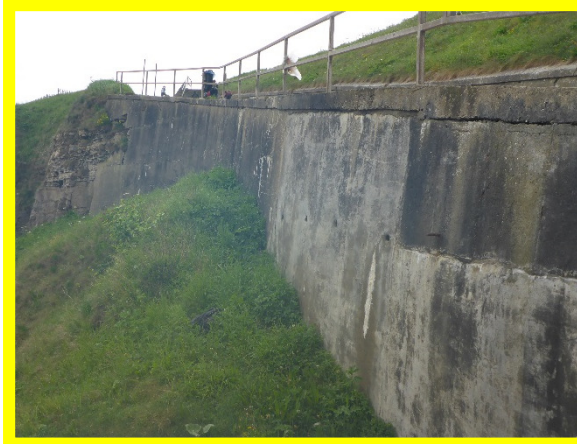
Cracking in retaining wall to access steps and ramp (/0103C07)

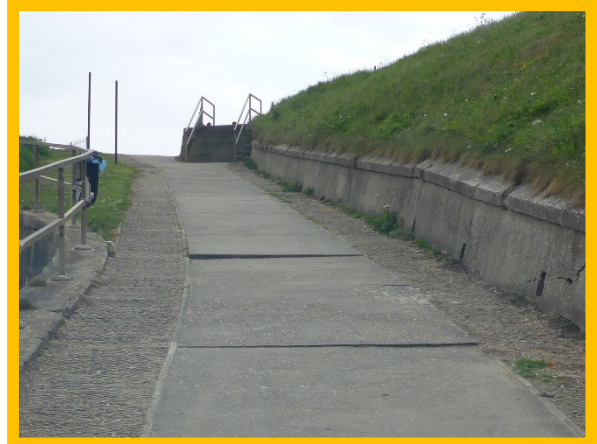
Movement of deck slabs in access ramp (/0103C07)

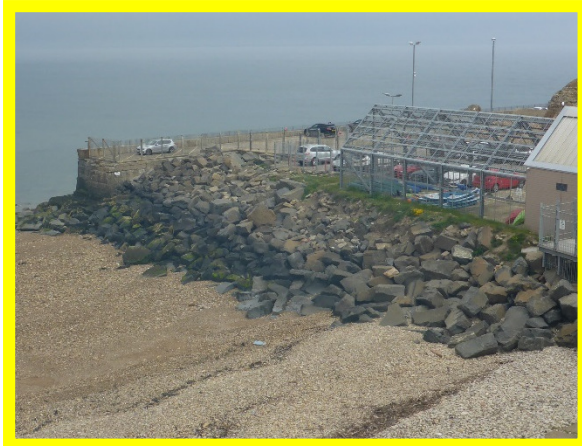
Low spot in revetment causing erosion to bank (/0103C07)

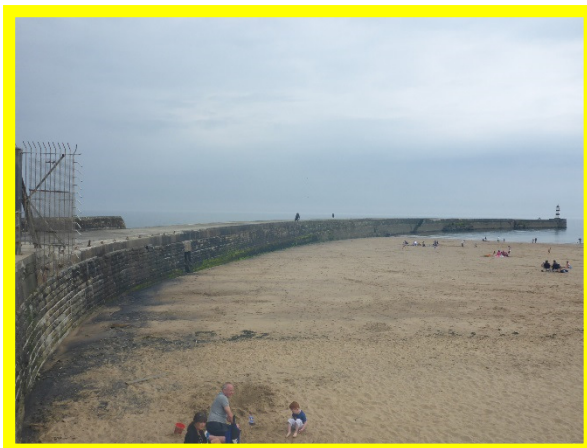
Seaham Harbour North Pier (/0104C03)

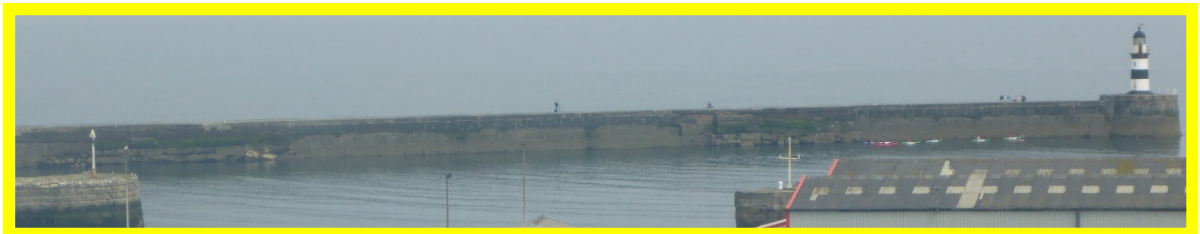
Seaham Harbour North Pier Inner Face (/0104C03)

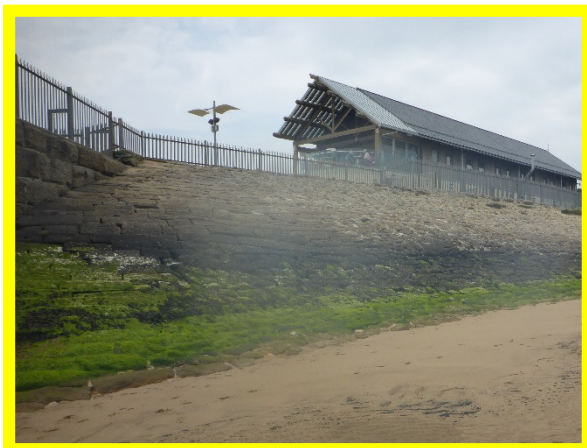
Open joints and vegetation growth on masonry revetment (/0104C05)

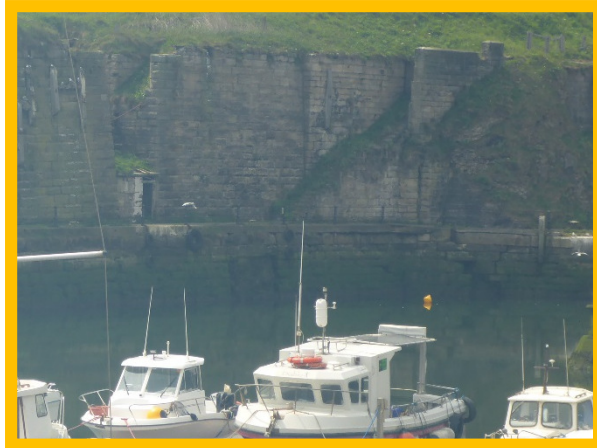
Gaps between blocks at Seaham North Dock (/0104C12)

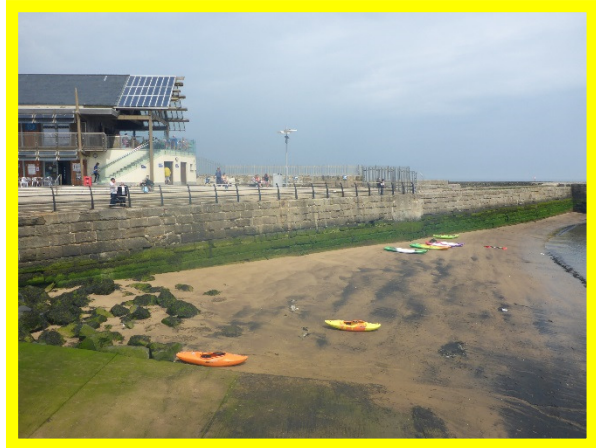
Several damaged/chipped blocks (/0104C06)

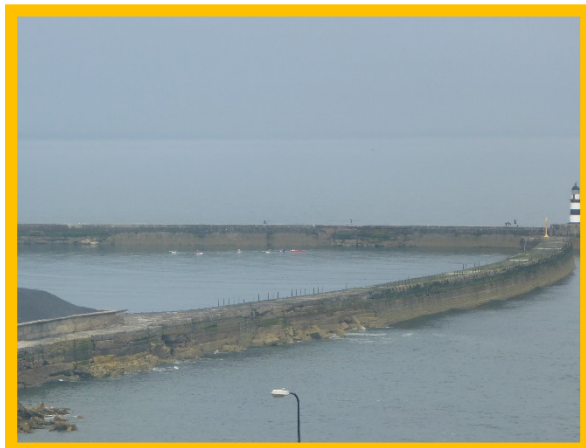
Seaham Harbour South Pier (/0104C17)

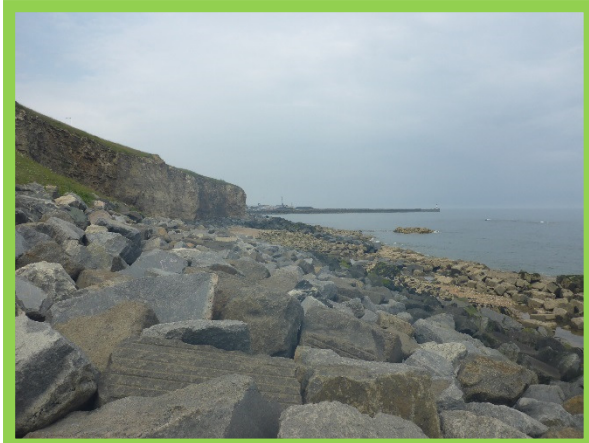
Rock revetment from South Pier to Chemical Beach (/0105C01)

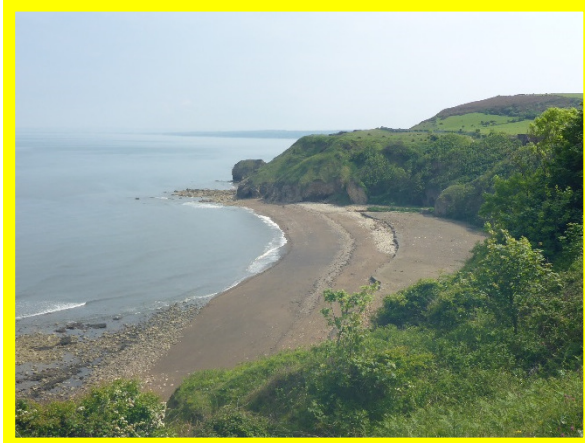
Residual spoil beach at Hawthorne Hive (/0201C01)

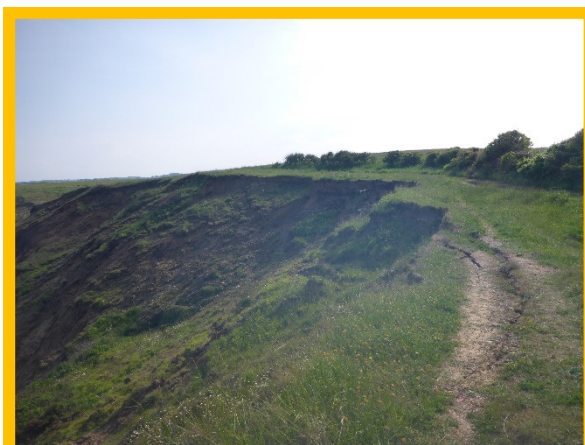
Tension cracks in path at cliff top (/0201C01)

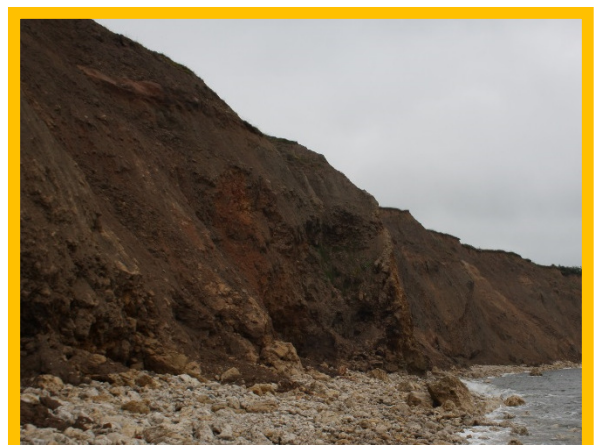
Exposed slopes to north of Horden Point (/0201C01)

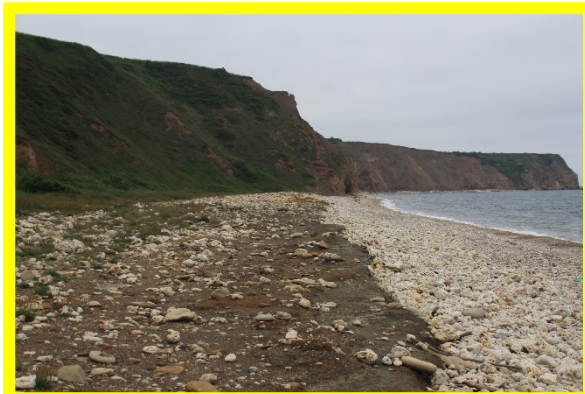
Looking northwards from Warren House Gill (/0201C01)

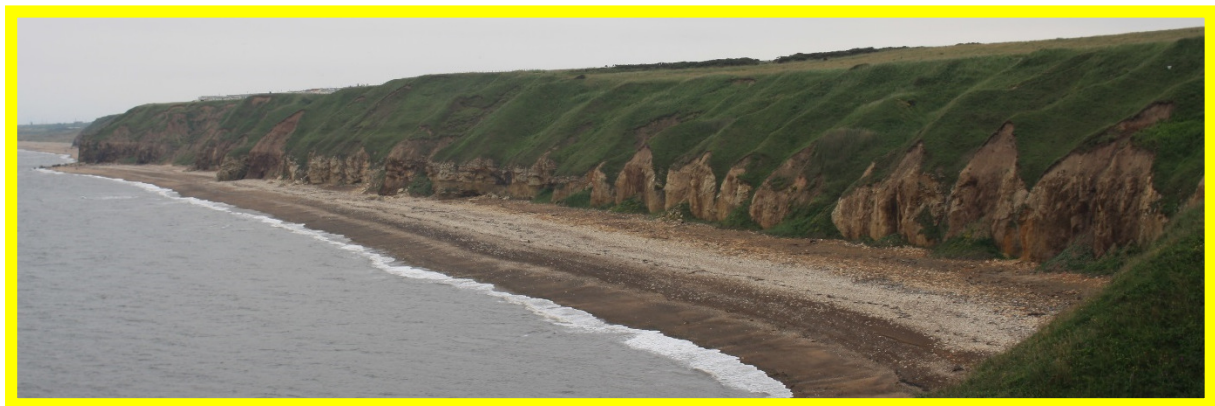
View south from Blackhall Rocks (/0301C01)
