Cell 1 Regional Coastal Monitoring Programme Walkover Inspection Surveys 2020

Durham County Council

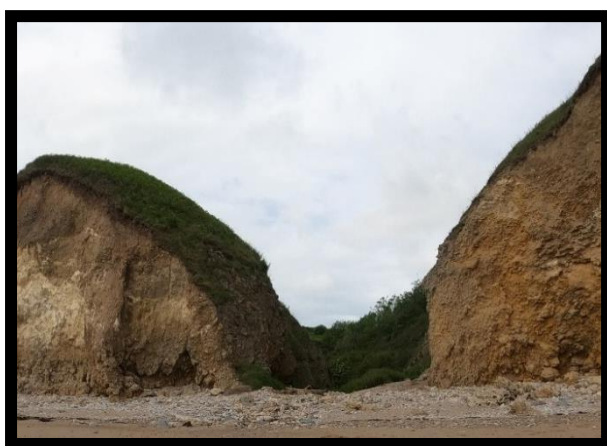
*Ryhope Dene
(northern boundary of /0804C01)*

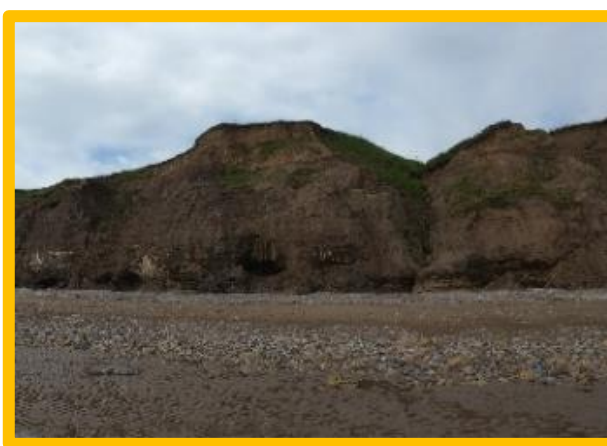
Glacial Till slumping along the majority of the frontage (/0804C01)

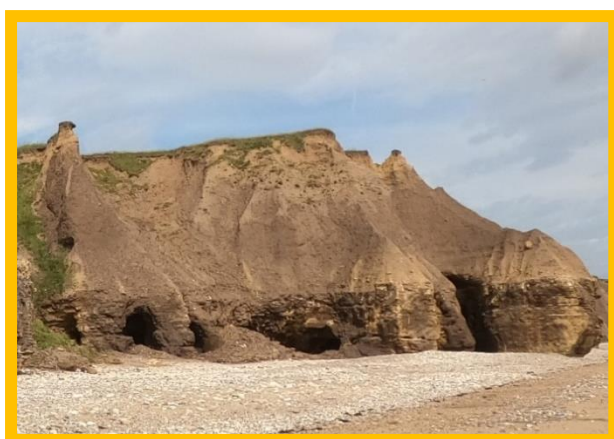
Undefended sea cliffs with till sitting on limestone (/0804C01)

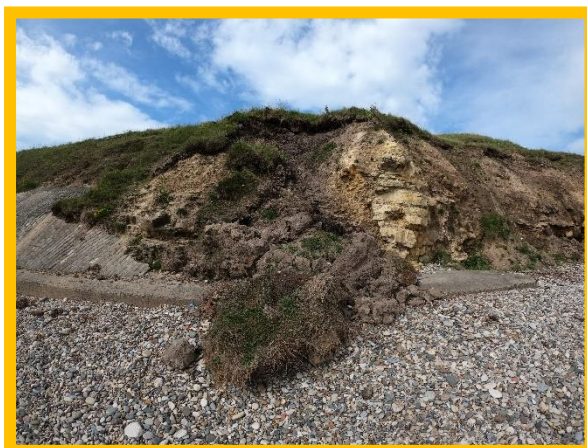
Minor outflanking of blockwork revetment and slippage at south end of seawall (/0102C01)

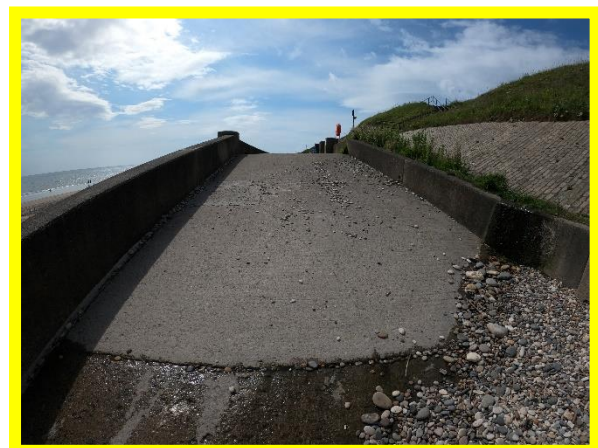
Cracks in deck of access ramp at northern end of promenade (/0102C01)

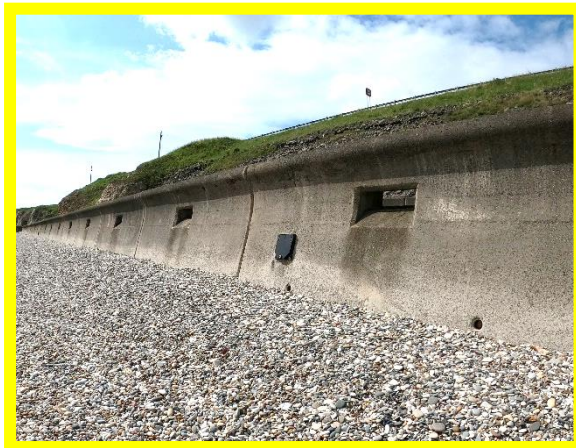
Seaham sea wall (/0102C01)

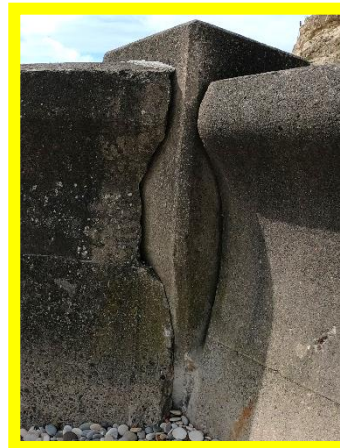
Sealant missing at joint between sea wall and access steps (/0102C01)

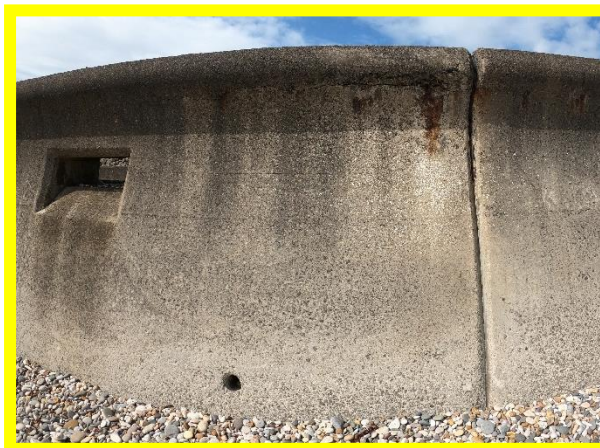
Spalling of bullnose on sea wall (/0102C01)

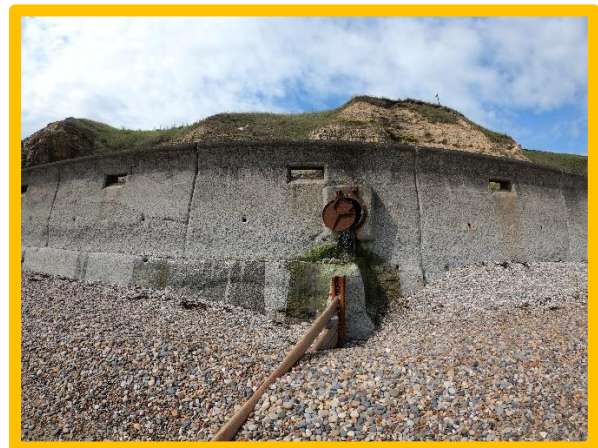
failed cast iron flap valve (/0102C01)

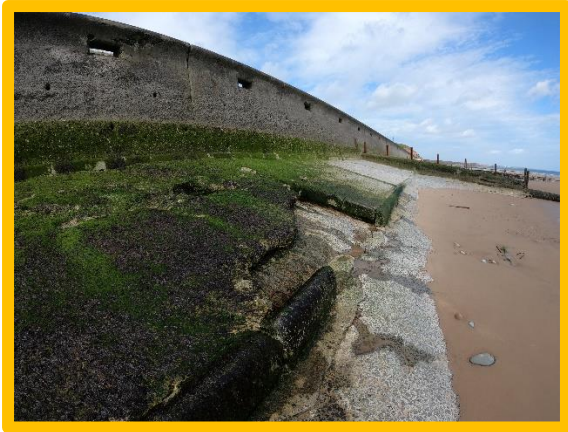
Failed section of concrete apron (/0102C01)

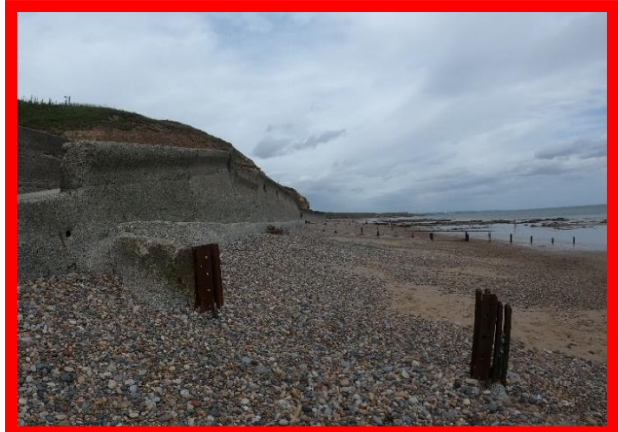
Remnants of groyne (/0102C01)

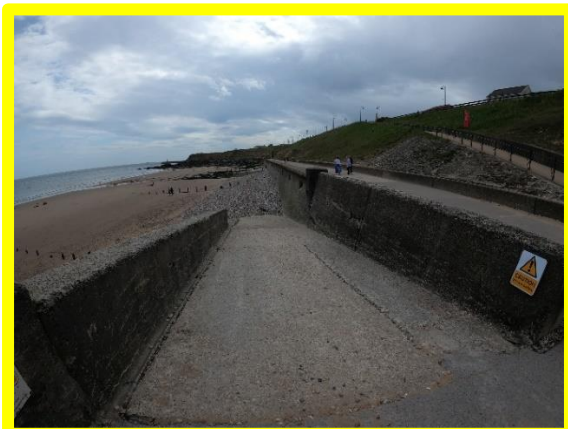
Cracks in deck of access ramp at southern end of promenade (/0102C01)

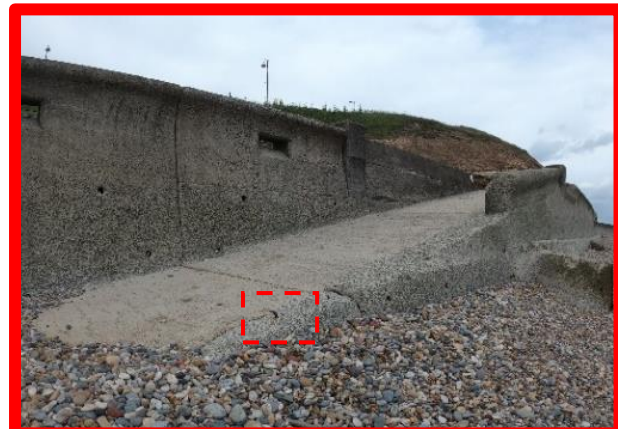
Hole in deck of ramp and exposed reinforcement (/0102C01)

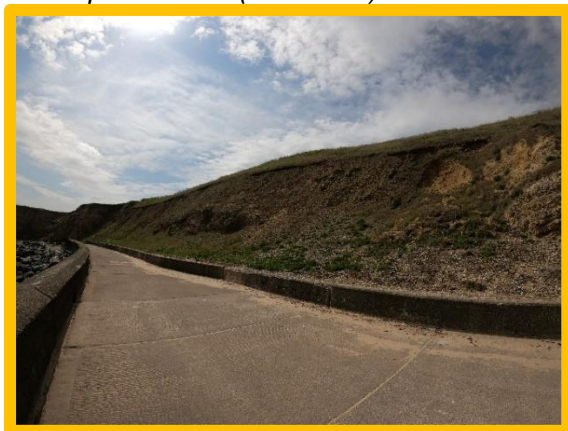
Headscarp in backing cliffs formed by previous slippages (/0102C01)

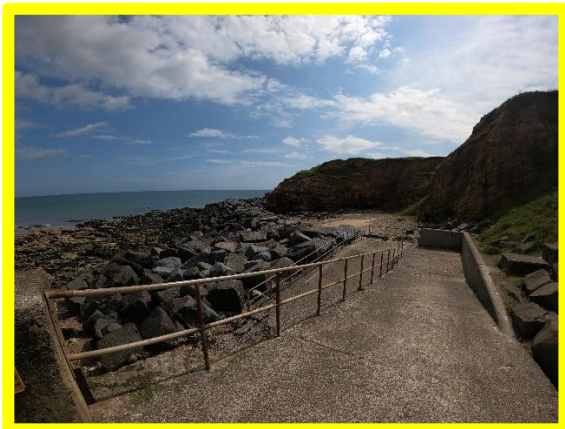
Rock berm around Featherbed Rocks headland (/0103C01)

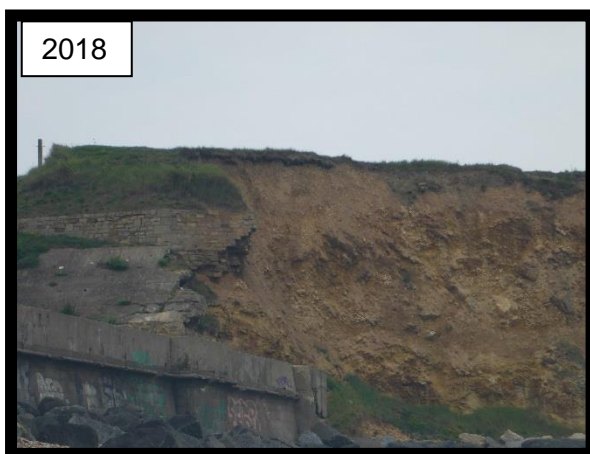
Masonry wall and concrete revetment at tie-in to cliffs breaking-up (/0103C04)

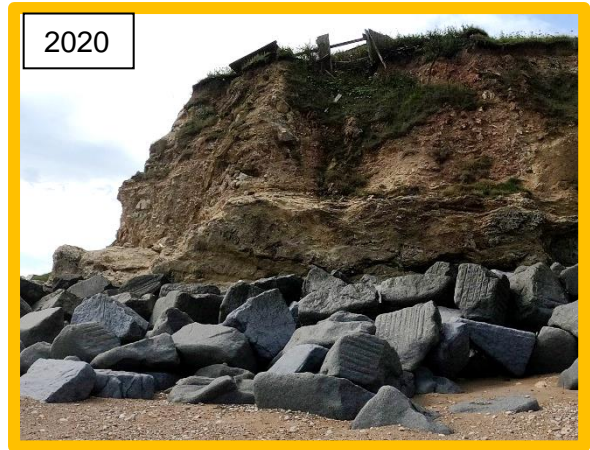
Erosion affecting fence line of properties to south Dawdon Dene Outfall - 2020 (/0103C02)

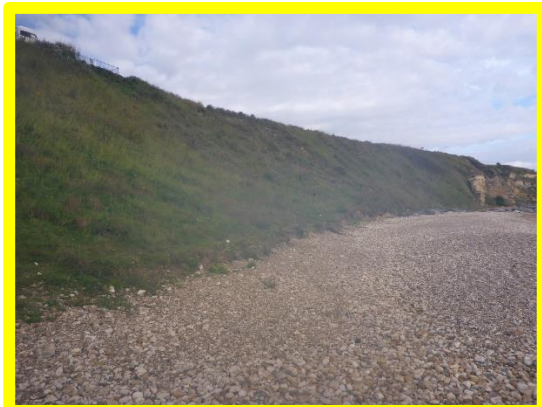
Local slumps in cliffs (/0103C06)

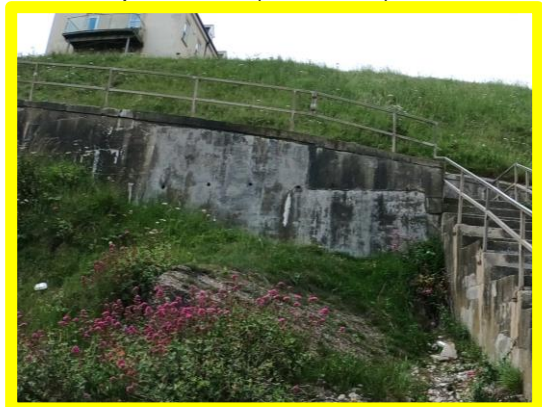
Cracking in retaining wall to access steps and ramp (/0103C07)

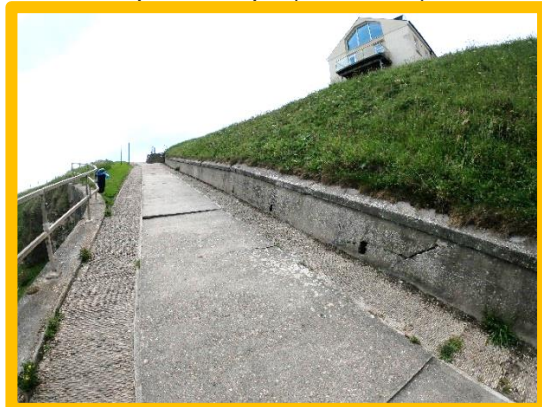
Movement of deck slabs in access ramp (/0103C07)

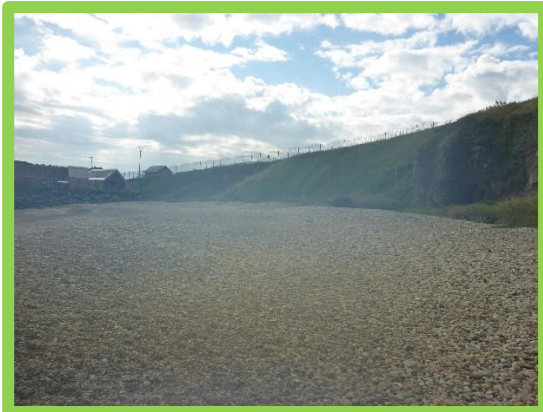
Stable cliff fronted by healthy cobble beach (/0103105)

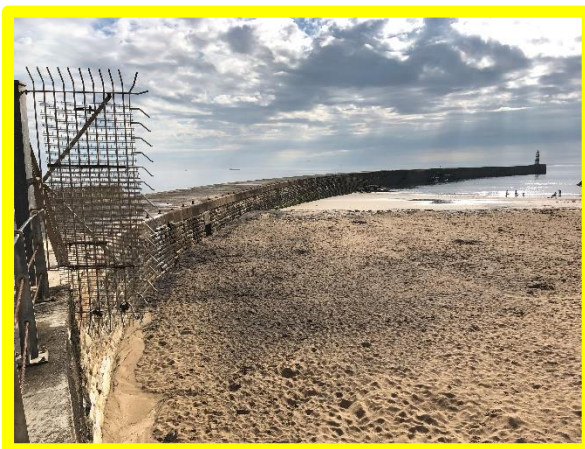
Seaham Harbour North Pier Inner Face (0104C03)

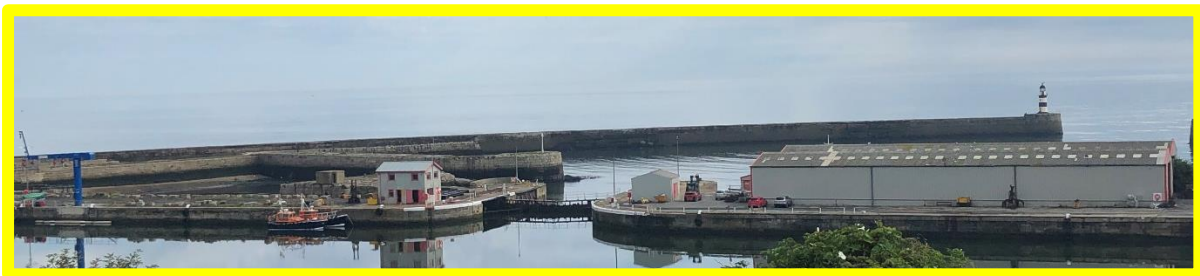
Seaham Harbour North Pier Inner Face (0104C03)

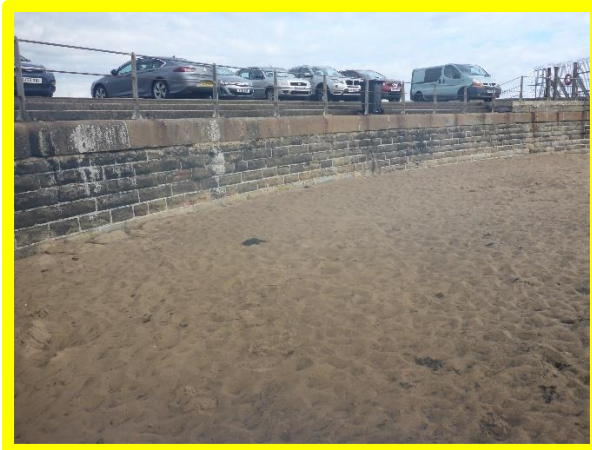
Vertical rear wall recently repointed (circa pre 2018) (/0104C05)

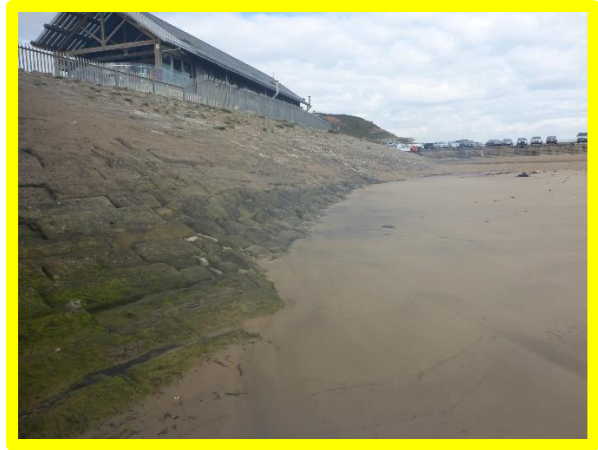
Open joints and vegetation growth on masonry revetment. High sediment levels (/0104C05)

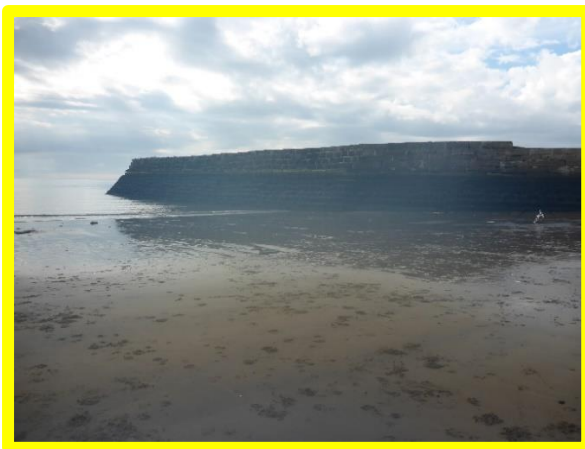
Inner Pier north face largely obscured by marine growth (/0104C06)

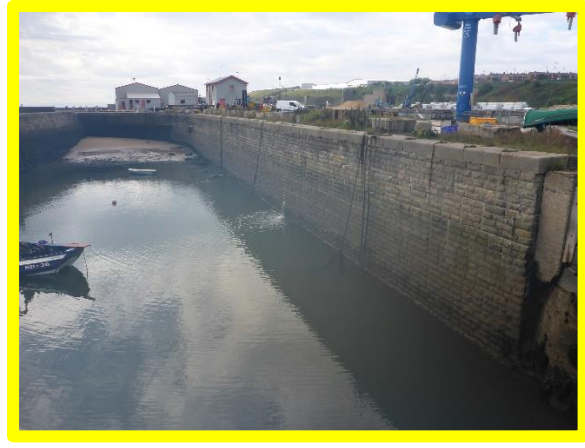
Inner face appeared in good to fair condition (/0104C10)

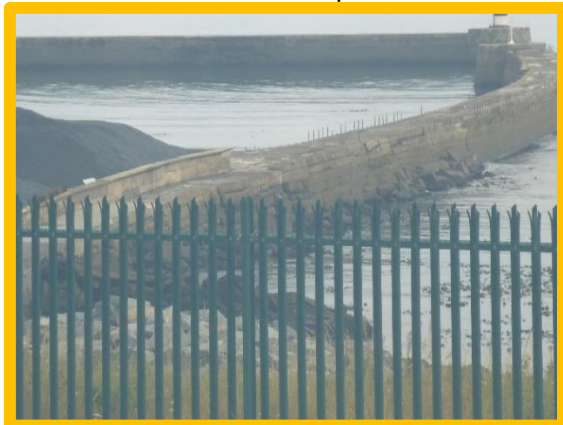
Seaham Harbour South Pier (/0104C17)

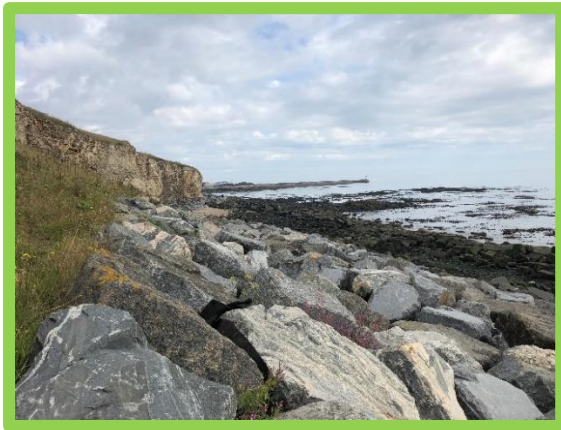
Rock revetment from South Pier to Chemical Beach (/0105C01)

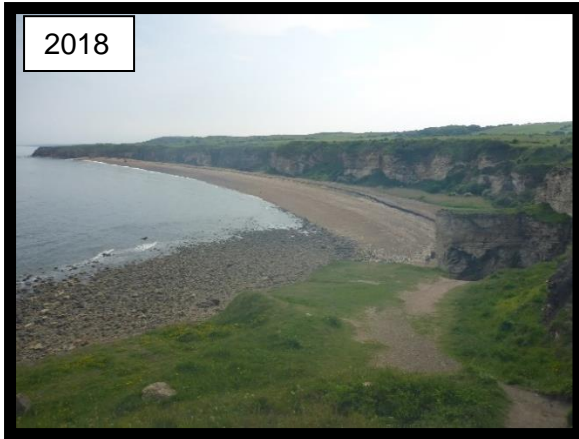
*Blast Beach – view looking south - 2018
(/0103C07)*

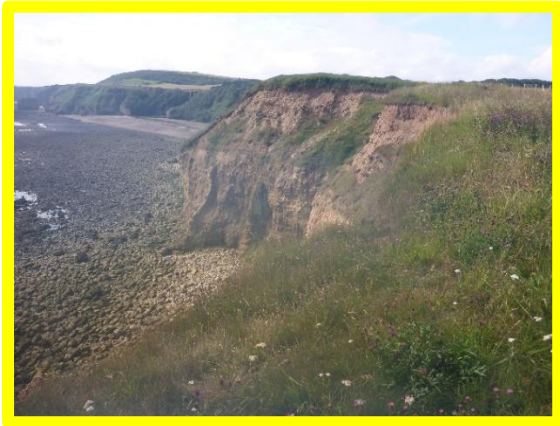
South side of Chourdon Point (/0201C01)

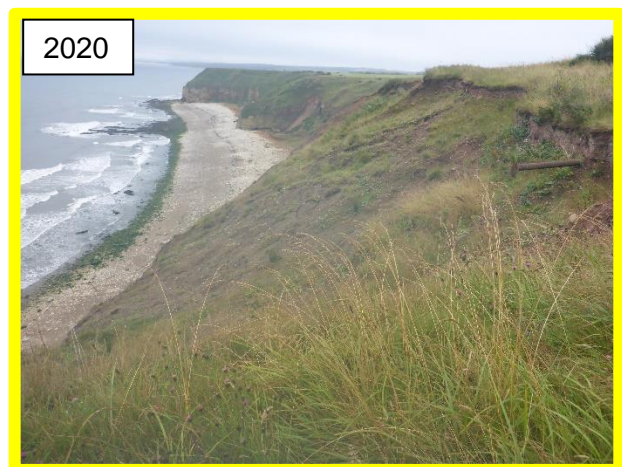
*Unnamed Bay fronting Easington Colliery -
2020 (/0201C01)*

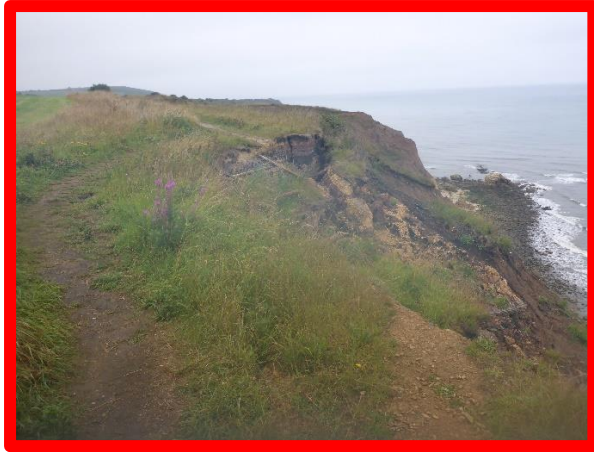
Cliff failure through coastal footpath (/0201C01)

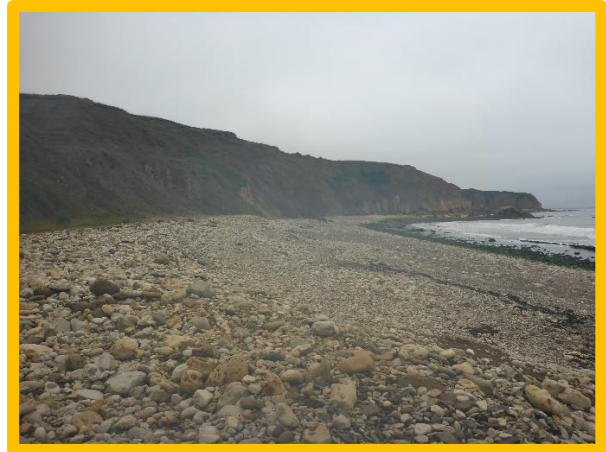
Actively eroding section of cliff in between shot Rock and Loom. (/C0201C01)

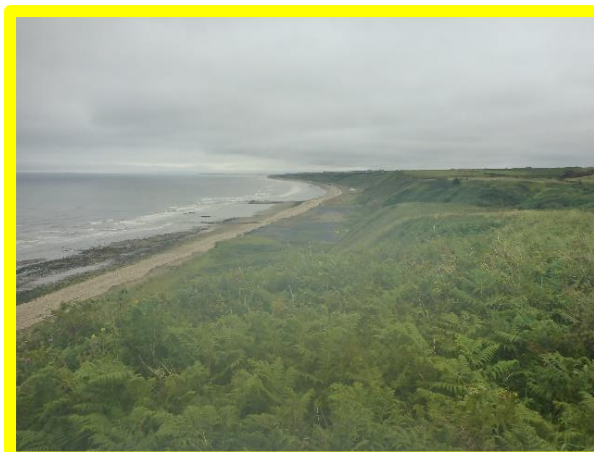
Looking southwards from Horden Point (/0201C02)

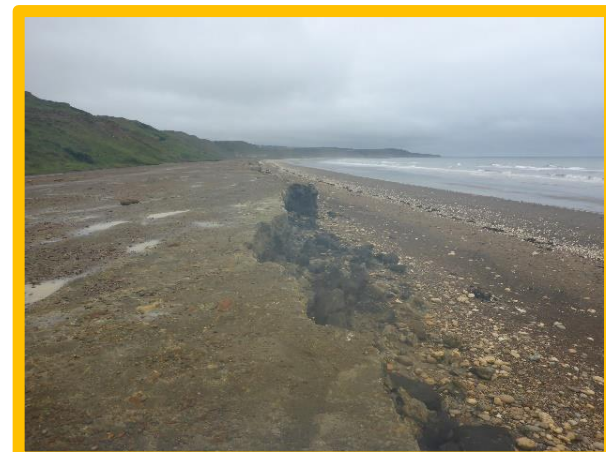
Significant ongoing erosion to the colliery spoil to the North of the bay. Note – tension cracks and debris piles (/0201C02)

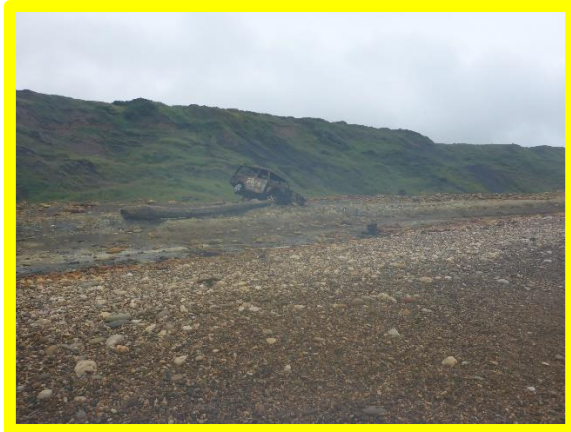
Northwards from Castle Eden Dene (/0201C02)

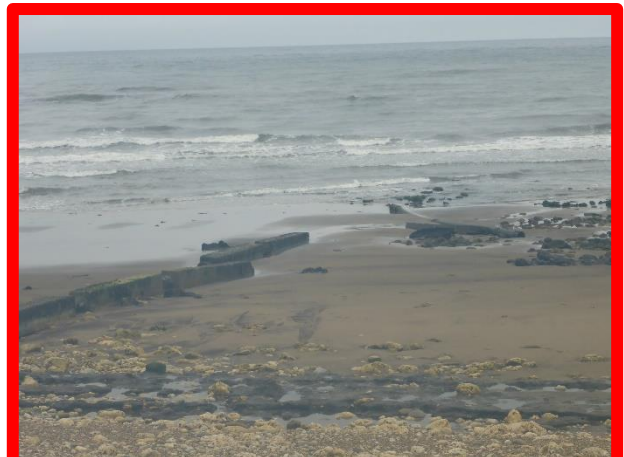
Failed section of concrete-encased outfall structure (/0201C01)

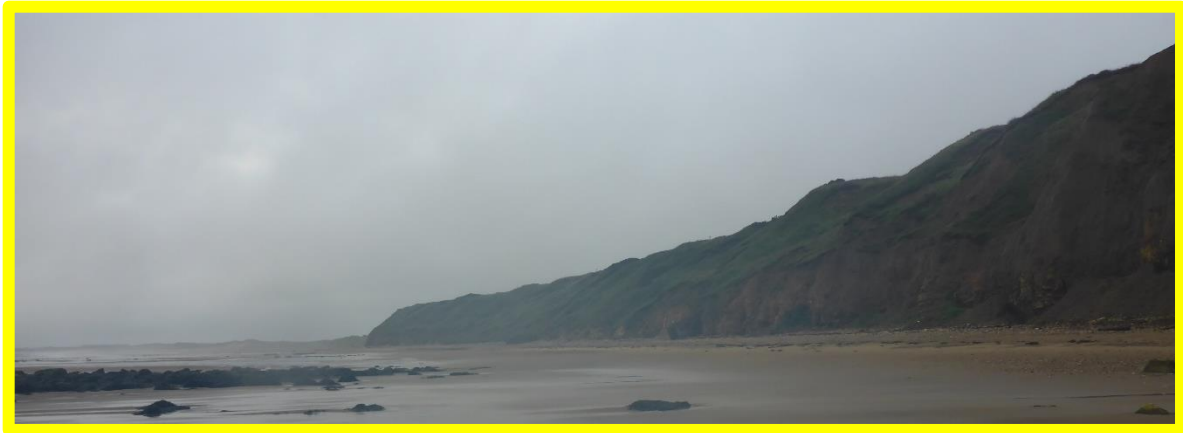
View south from Blackhall Rocks (/0301C01)

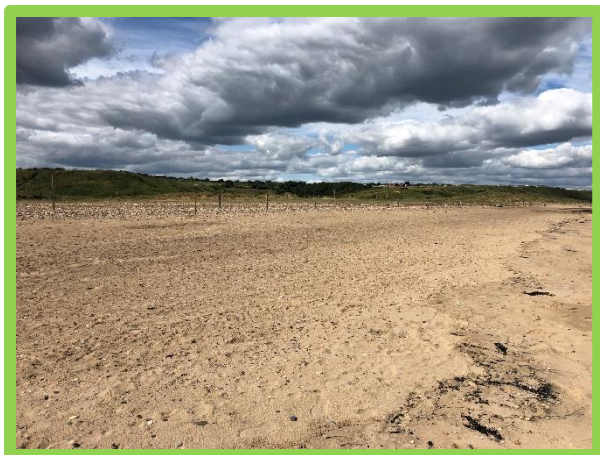
Stable dunes at Crimdon – nesting Little Terns in on the upper foreshore (/0301C02)
