## **Cell 1 Regional Coastal Monitoring Programme Walkover Inspection Surveys 2022**

# Hartlepool Borough Council

## Walkover Inspection Surveys 2022

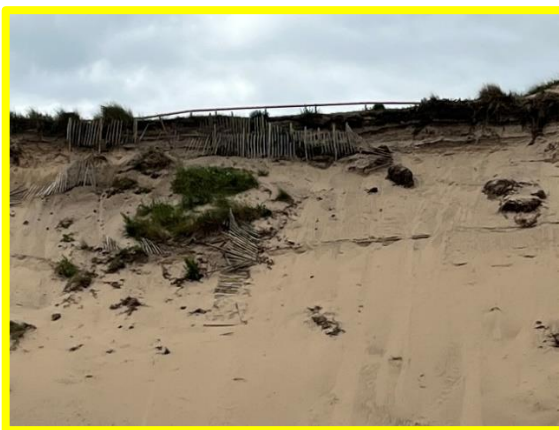
The first ~500m length of dunes, adjacent to Crimdon Beck, are high and steep with an unvegetated foredune. Minor cliffing is noted at the crest. The dunes here have again showed signs of local erosion. The wooden sand fence once at the crest of the dune has been bypassed and is now on the face of the dune.

*High, steep, unvegetated dune with eroding crest adjacent to Crimdon Beck (/C0301C01)*

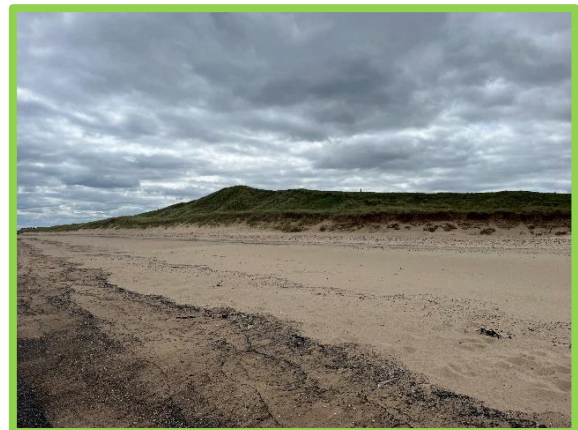
*Healthy well vegetated dunes fronting Hartlepool golf course (/C0301C01)*

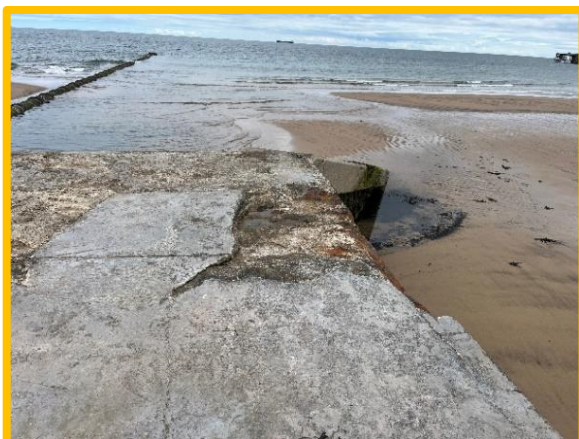
The two piled outfall structures to the north of Steetley Pier are in fair to poor condition. The sheet piles are heavily corroded, and the concrete capping beam and slab are cracked and abraded. Despite the notable defects, the structures appear stable. The structures were again noted to be retaining sediment, albeit not to the same extent as in 2020.

*Cracking / spalling to piled outfall structure deck (/C0302C01)*

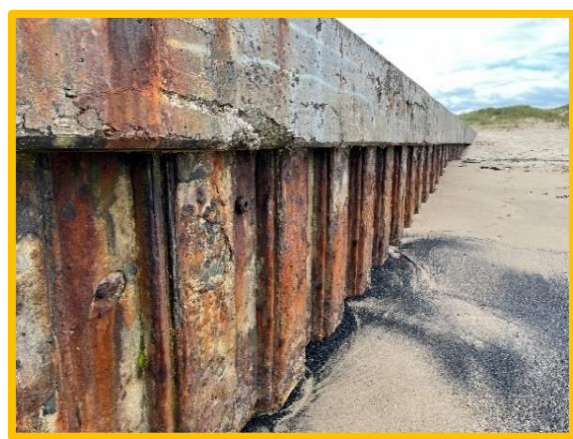
*Heavily corroded piled outfall structure (/C0302C01)*

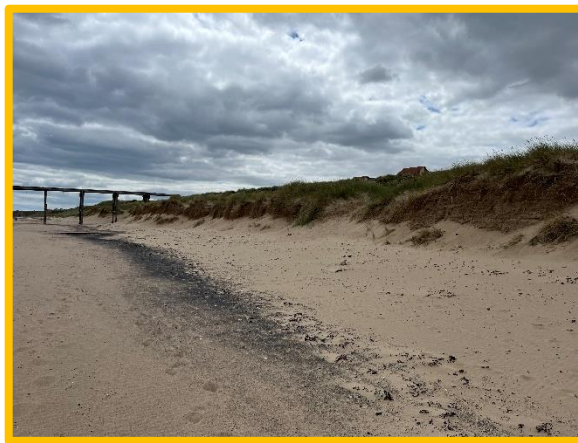
Continued property development has occurred behind the dunes adjacent to Steetley Pier since 2020, sprawling north towards the golf club. The dunes fronting the development are overall in fair condition with local sections in poor condition. The worse condition dunes are those either side of Steetley Pier itself where the foredune is showing significant cliffing. Heavy footfall in the area has also resulted in swathes of unvegetated dunes.

The deterioration of the dune locally may be as a result of the particularly stormy winter, where several named storms occurred. Non worse than Storm Arwen in November 2021, where record wave heights were recorded at all buoys along the Cell 1 coast during the event. The dunes should be monitored for signs of potential recovery.

*Dunes locally poor adjacent to Steetly Pier  
(/C0302C01)*

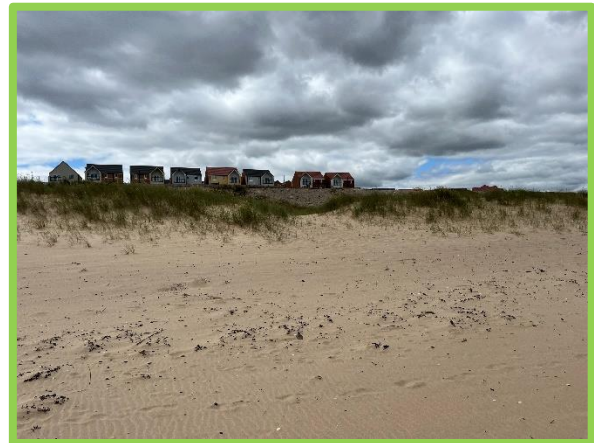
*Embryonic dune growth on the foredune  
(/C0302C01)*

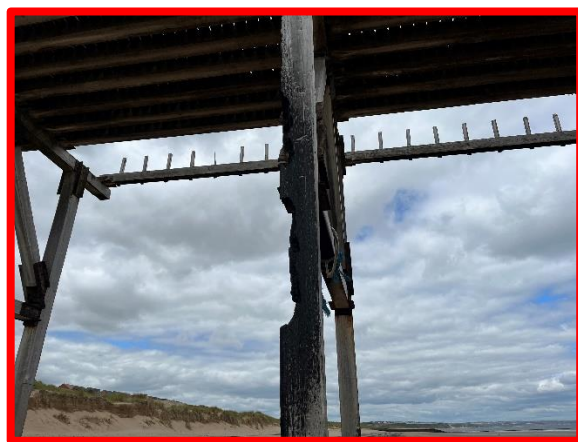
As reported previously, several timber columns supporting the historic Steetley Pier structure have significant loss of section, likely due to fire damage. Children were observed on the deck of the structure during the 2020 inspection and so if not done already, it is recommended that any informal access routes onto the pier should be reviewed urgently.

*Loss of section to timber support columns of historic pier structure, likely due to fire damage  
(/C0302C01)*

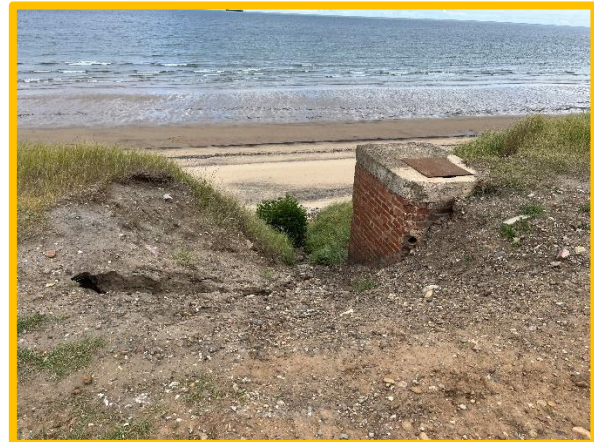
*Manhole chamber at risk due to ongoing erosion  
(/C0302C01)*

North of the Pier, on the southern boundary of the cemetery, a brick manhole chamber is a focal point for erosion and is at risk of collapsing onto the foreshore. It is recommended that the chamber is decommissioned.

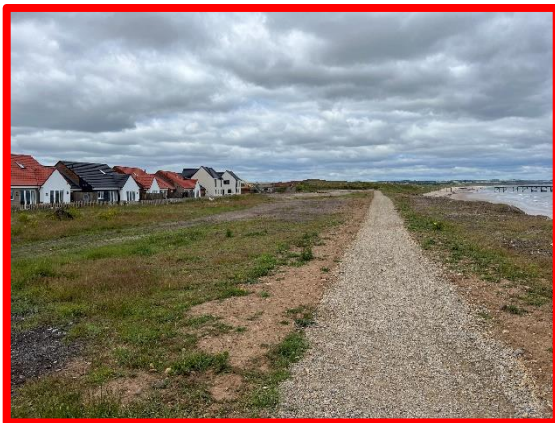
Property development on former industrial site, fronted by collapsed gabion structure (/C0302C02)

In light of the property development in the vicinity, it is recommended a formal coastal defence is considered in this area.

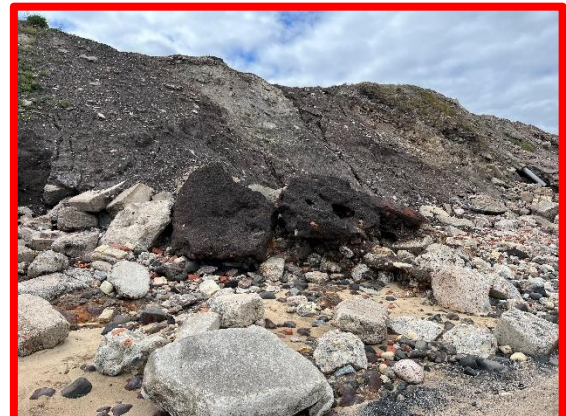
Erosion of made ground slope in 2022 (/C0302C02)

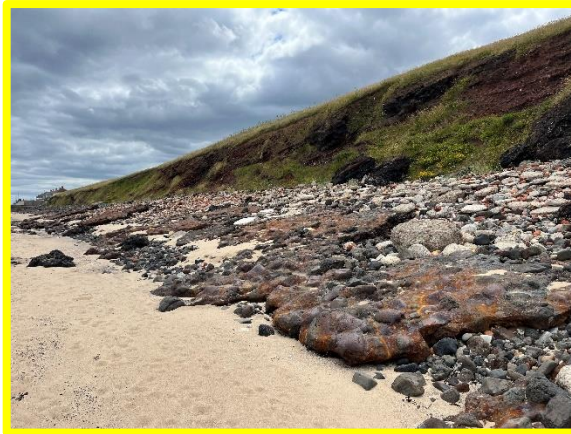
Large pieces of slag material previously poured to form a protective apron had continued to break up although the material is likely to remain *in situ*. Rock armour revetment (also incorporating several concrete tank blocks) at the interface with Marine Drive sea wall appeared in fair condition.

*Deteriorating slag-poured apron (/C0302C03)*

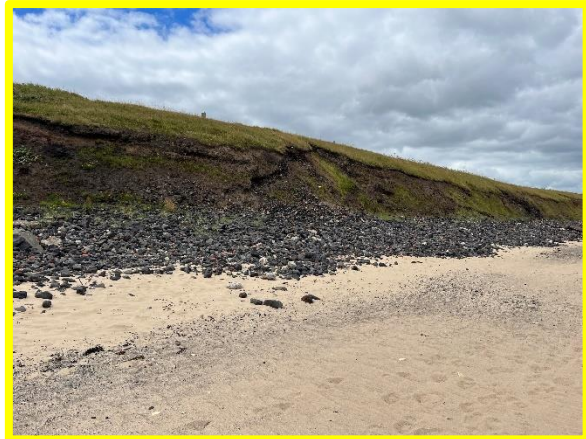
*Historic slipping in coastal slope (/C0302C03)*

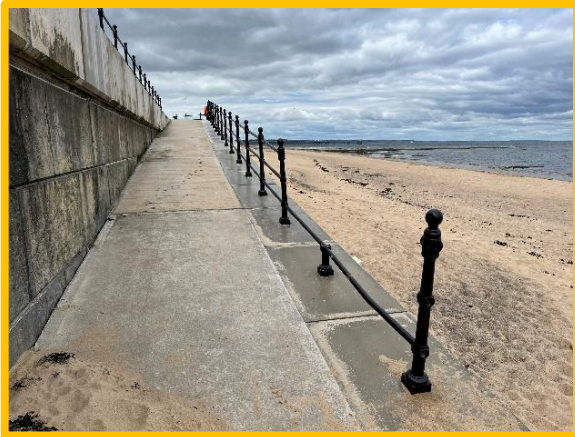
*Damaged handrail on access ramp at Vane Street (/C0303C01)*

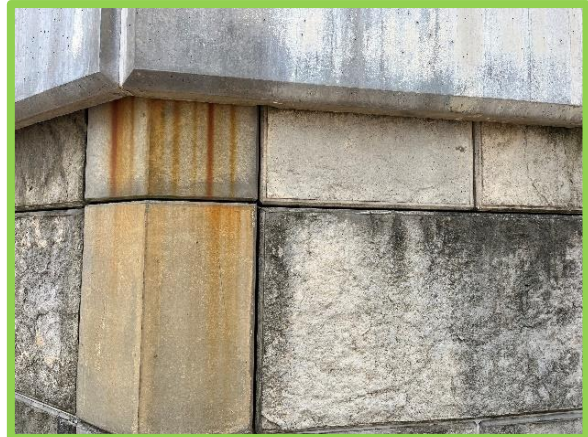
In 2022, the structure generally remained in 'as built' condition with the exception of the sealant which, as reported in 2020, is being washed out from between the precast units and precast copestones. It is estimated that up to 40% of the sealant has been washed out. It is recommended that this should be replaced as part of the routine maintenance. A section of the handrail on the access ramp adjacent to Vane Street has also been damaged.

*Sealant being washed out between precast units (/C0303C01)*

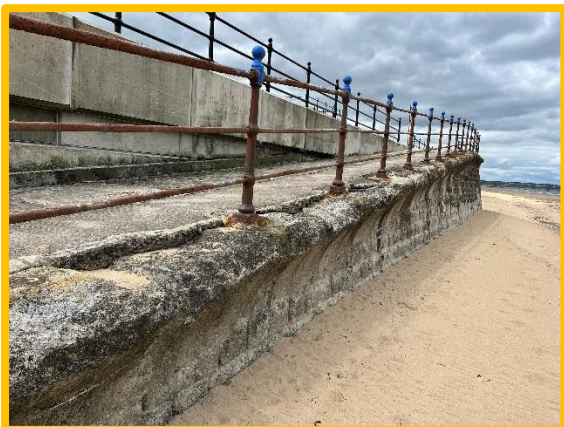
*Damaged cope to Thorpe Street access ramp (/C0303C01)*

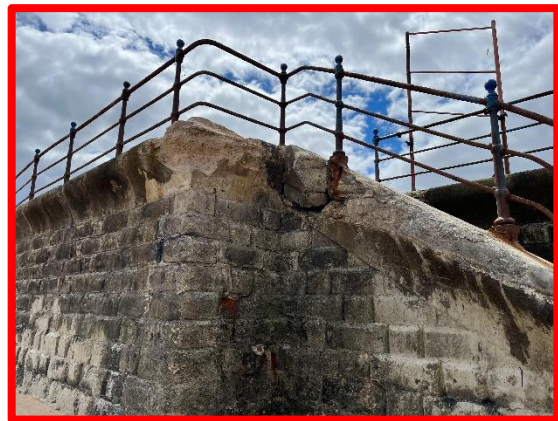
*Local damage to coping/handrails at Thorpe Street access steps (/C0303C01)*

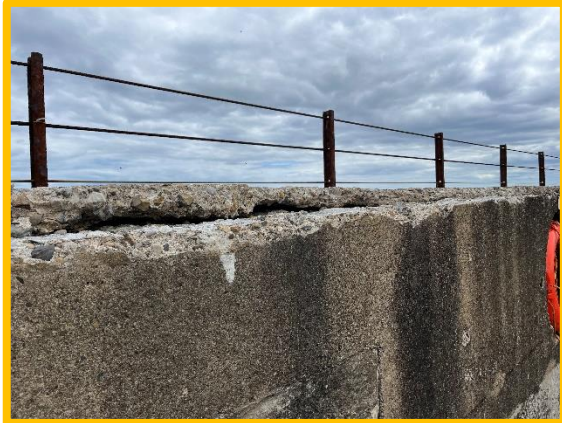
Spalling of concrete (/C0401C01)

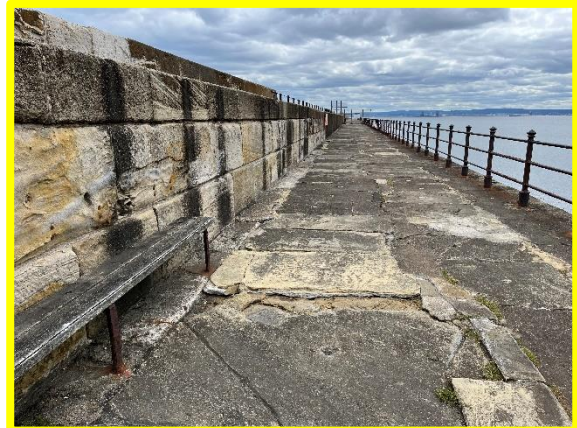
Cracking to the deck slab (/C0401C01)

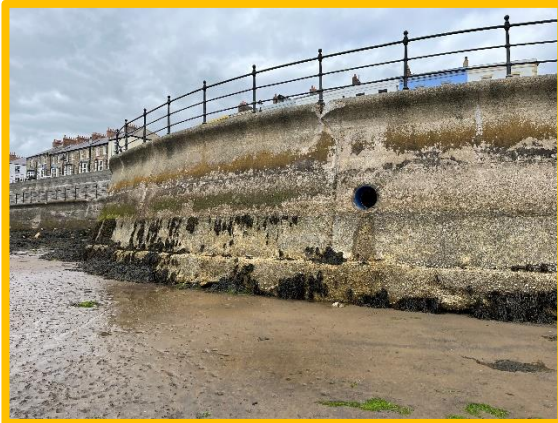
*Damaged cope around handrailing fixing (/C0401C04)*

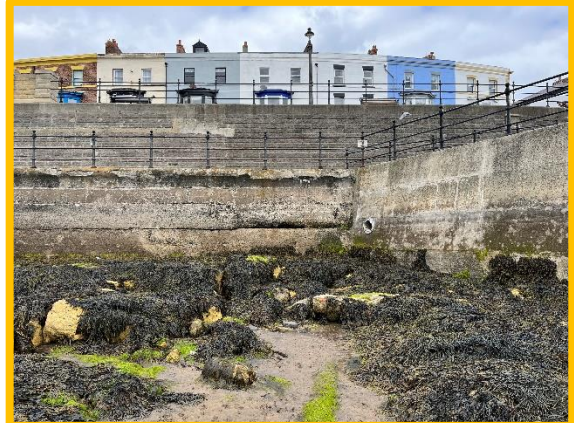
Numerous outfalls are present at the interface between assets /C0401C04 and /C0401C05. It was noted of the five outfalls, three have no protection, one has a WaStop non-return valve which appeared in working condition and the final outfall has a failed flap valve. It is recommended that the protection to these outfalls is reviewed and the flap valve replaced if necessary.

*Broken Flap Valve (/C0401C04)*

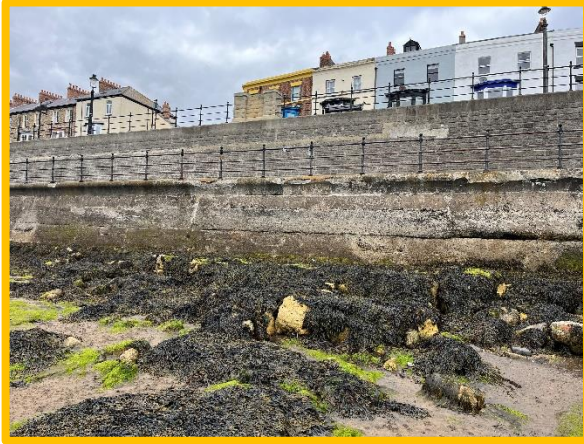
*Damaged recurve cope (/C0401C05)*

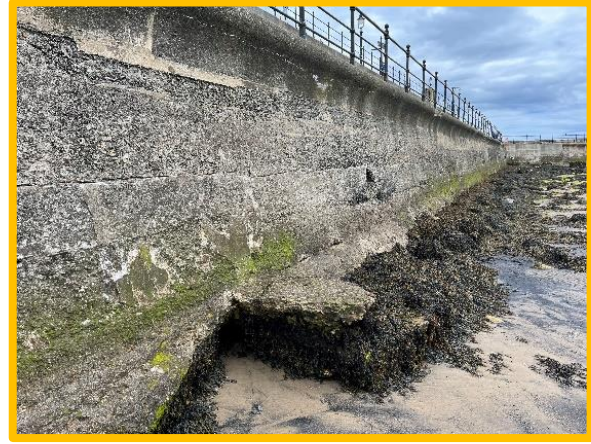
*Voiding at toe of wall (/C0401C05)*

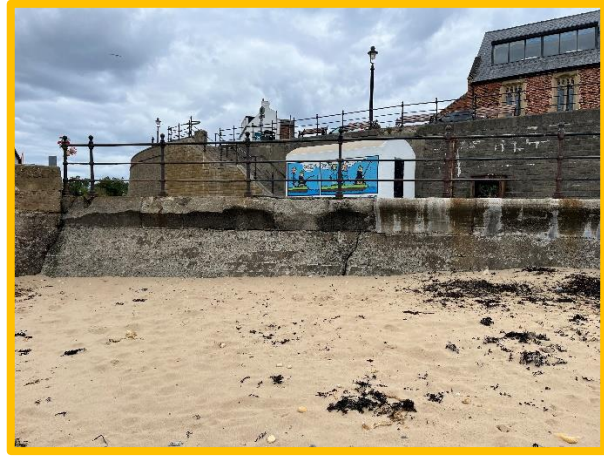
At the interface with the Old Pier the wall had sustained damage to the concrete recurve. A large crack extended the full height of the wall, potentially suggesting a global movement of the structure; however no distress was evident in the promenade immediately above this section of wall. Undercutting was identified at the interface with Old Pier in 2016, however has not been visible since due to high beach levels. This location should be monitored with consideration given to infilling/repairing the existing undercutting/voids.

*Spalling damage to recurve wall, significant crack suggesting settlement. Old Pier to left of image (/C0401C05)*

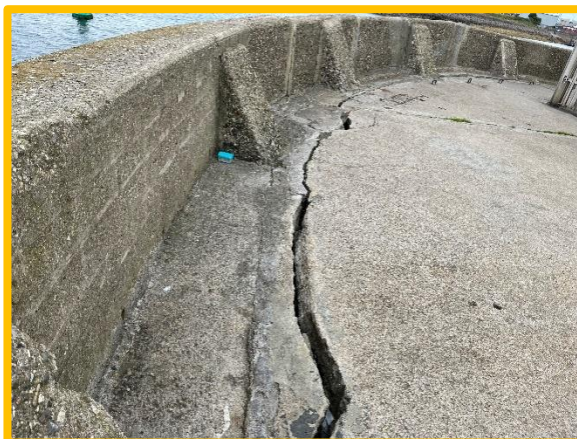
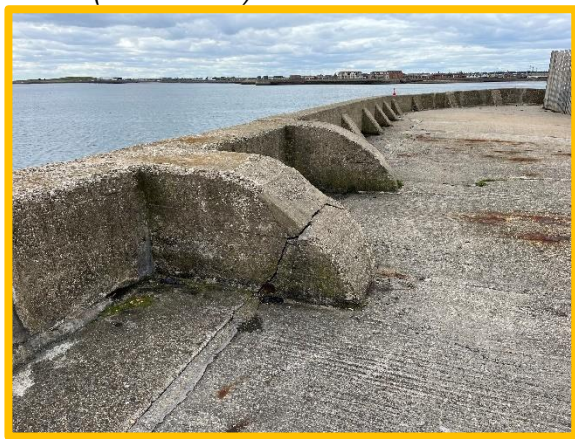
As recorded in previous inspections, an approximately 30m crack is present between the concrete parapet wall and main slab around the roundhead. This cracking may indicate settlement of the structure or seaward rotation of the parapet rather than local damage. These defects have been present since the 2014 survey, although appear to have worsened since the previous inspection. It was noted in the 2018 inspection that strain gauges were installed on the lighthouse structure which suggests monitoring of the structure is ongoing.

*Cracking in parapet wall and deck  
(/C0401C34)*

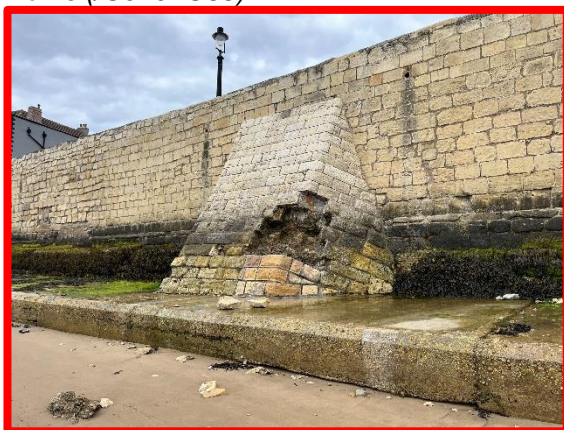
A significant defect was noted to the most easterly stone abutment where several blocks were missing. It was unclear whether this was a previous repair that had unravelled or whether the repair was in progress and this is being checked by Hartlepool Borough Council (as the works are being undertaken by PD Teesport).

*Significant defect to masonry abutment (/C0401C35)*

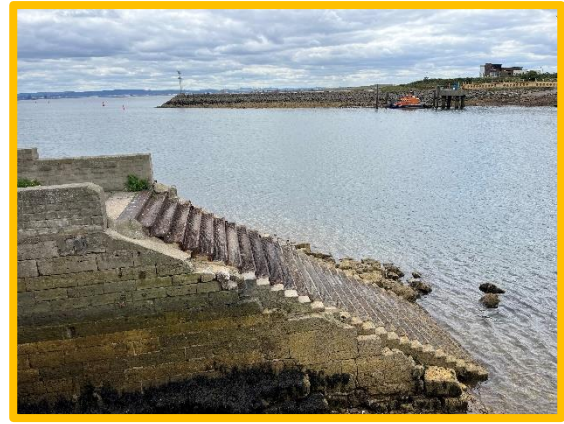
The steps at the former passenger ferry landing marking the southern extent of the asset remain in poor condition with loose and displaced masonry and heavily corroded steel ties. Public access to this structure, from the road, is prevented by a masonry wall and signage.

*Damage to steps at former passenger ferry landing (/C0401C35)*

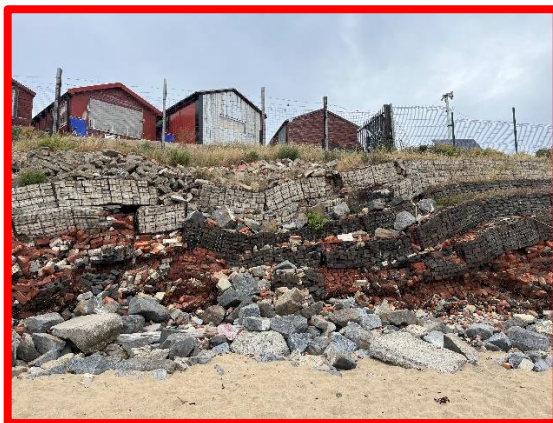
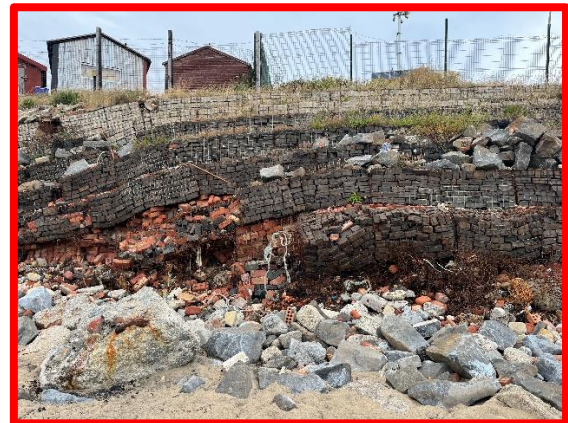
As reported in 2020, the southern section of the stacked gabion wall to the south of Middleton Jetty has failed. Local settlement of the wall is evident, numerous gabion baskets have burst and others are heavily corroded. The failing structure is posing a health and safety risk to the sheds at the crest of the slope. It is recommended that the existing larger rock armor revetment to the south, that remains in good condition, is extended to provide protection to this section.

*Stacked gabion wall in very poor condition especially to the south (/C0401C17)*

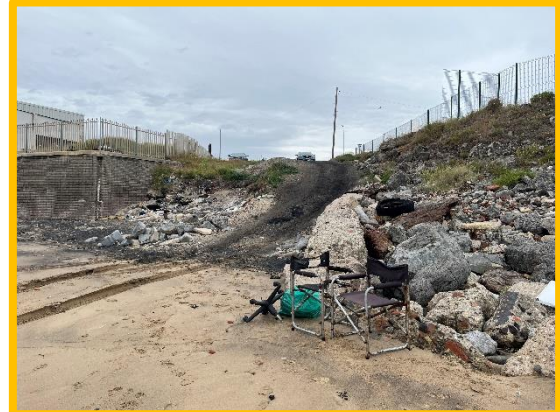
The short length of undefended frontage comprises an informal beach access ramp. Erosion has started to outflank the adjacent seawall causing the retreat of the southern section of the ramp. It is likely that the ramp will become unusable if erosion continues. As a result the need for the ramp should be reviewed. Evidence of fly-tipping was again observed in this location, but not to the same extent as in 2020.

*Erosion outflanking seawall at Informal access ramp (/C0401C18)*

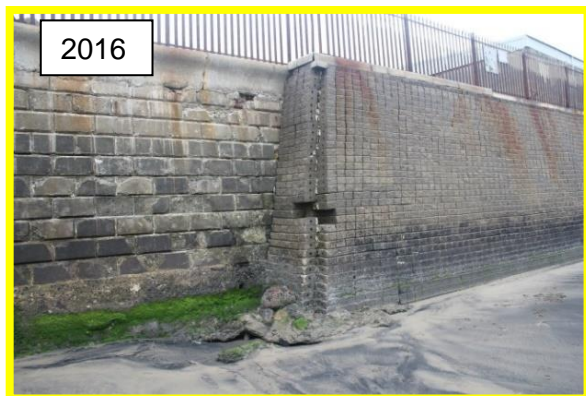
The missing blocks at the interface between the two walls has been progressively failing since 2016, however no further block loss in this location was observed since the previous inspection. High beach levels again concealed the minor scour observed in previous surveys. It is recommended that a detailed structural survey is carried out of the retaining blockwork wall.

*Missing blocks at interface between two walls. Local scour at toe (2016) (/C0401C19)*

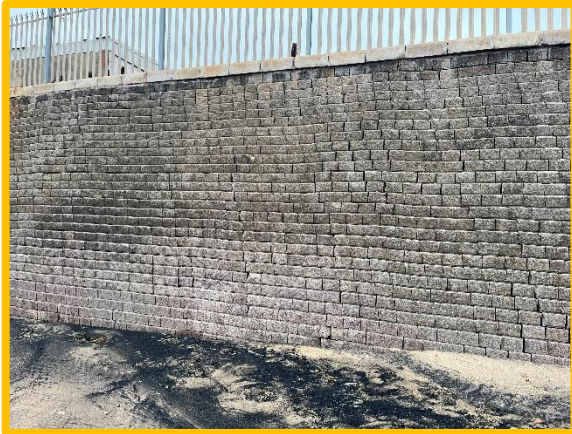
The concrete blockwork wall, fronting a derelict industrial site, is in poor condition. The profile of the wall is not consistent, with bulges of various sizes visible along the full length. The majority of concrete coping units were missing. Opening joints were evident, suggesting global movement of the structure. An additional missing block was observed in the face of the wall in 2022 which should be monitored closely to prevent unravelling of the wall as per further south.

*Inconsistent profile, missing copes, open joints  
(/C0401C19)*

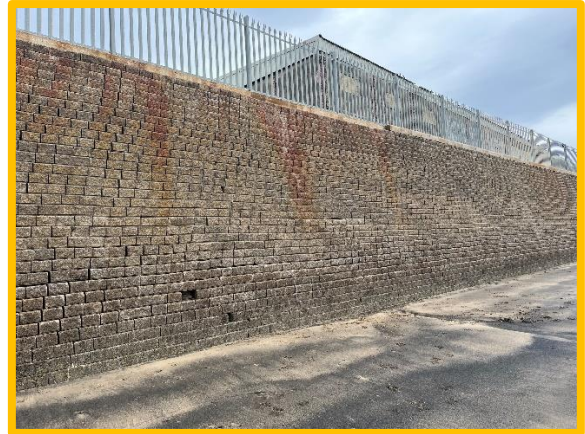
*additional block loss (/C0401C19)*

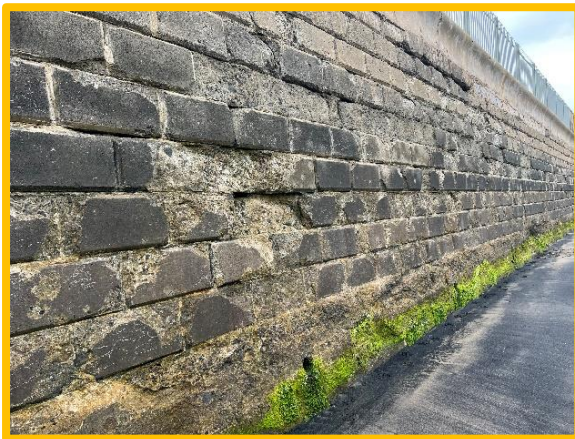
The large blockwork wall was significantly spalled with abrasion to the lower courses especially at the seaward bend cracking to the concrete coping. Several cracks extended through the parapet wall and through the full height of the seawall. These should be monitored. The Middleton Beach access structure is in fair condition with areas of concrete is showing signs of abrasion. The short section concrete toe beam to the splash wall remains in good condition. The blockwork parapet wall is insubstantial and is not believed to offer an additional protection.

*Spalling/abrasion of concrete blocks  
(/C0401C19)*

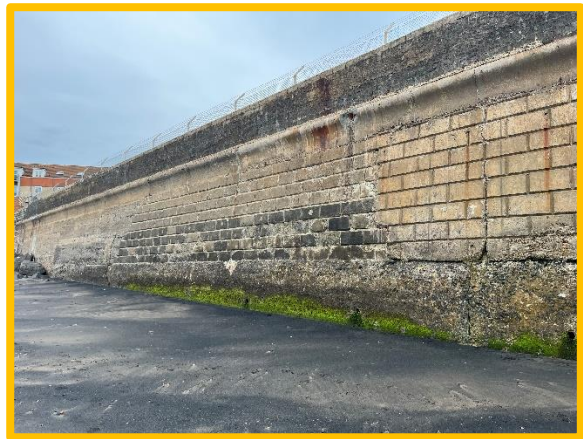
*Vertical crack through parapet and seawall  
(/C0401C20)*

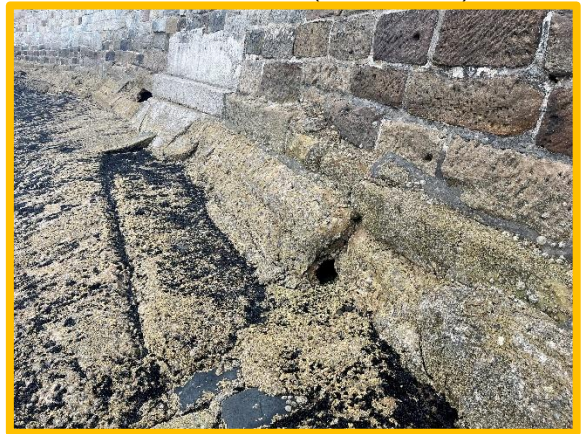
The landward end of the structure was viewed from the foreshore. As identified in previous surveys, the masonry structure appeared in fair to poor condition. Locally lower beach levels exposed timber piles and a masonry apron with open jointing and local voiding. As reported previously, the voiding should be addressed urgently to prevent further deterioration.

Voids observed in toe of north face of North Pier(/C0401C22)

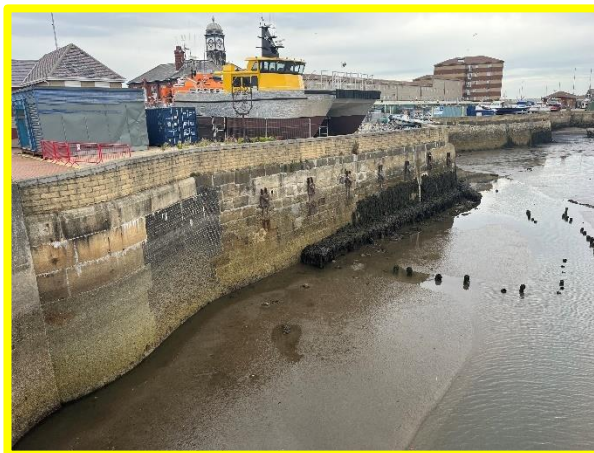
*Local repairs to masonry seawall to north of harbour entrance (/C0401C24)*

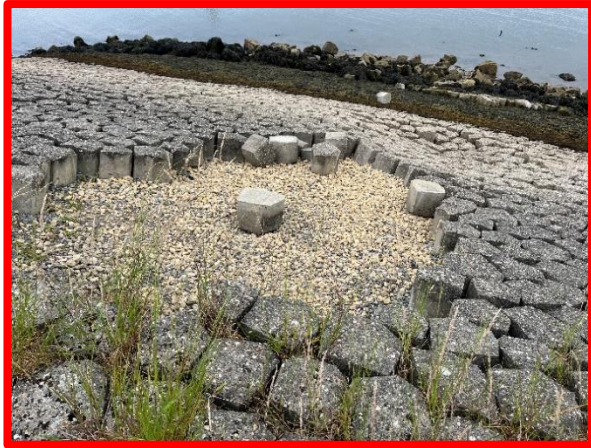
The concrete blockwork revetment to the south is generally in fair condition. However, since 2008 it has been reported that an area of concrete blocks approximately 10m from the northern corner of the revetment has been showing signs of settlement. This defect has continued to unravel with displaced blocks starting to pile up at the toe of the revetment. An approximately 4m by 2m area of gravel subbase is now exposed. It is strongly recommended that a repair solution is found immediately, as further loss of either fill material or concrete blocks could lead to extensive damage to the corner of the revetment, and properties at its rear. The toe of the southern section of the revetment appears to be steeper than elsewhere causing the joints between the blocks to be larger. This should continue to be monitored to ensure a similar defect does not occur.

*Unravelling of concrete blockwork revetment (/C0401C26)*

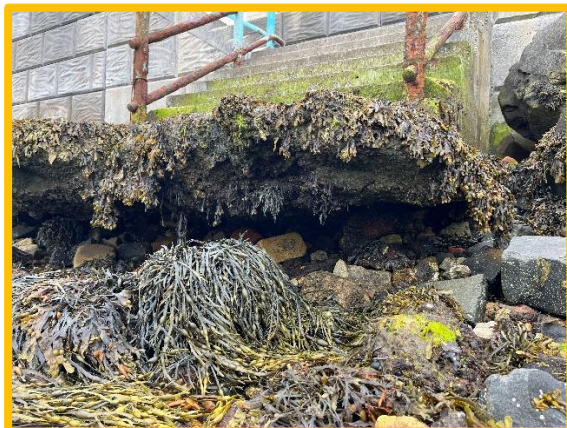
*Undercutting of access steps (/C0401C27)*

As was recommended in previous inspection, the voids should be repaired locally and additional rock armour placed to avoid further scour damage, particularly to the west of the asset where undercutting to the toe beam is exposed.

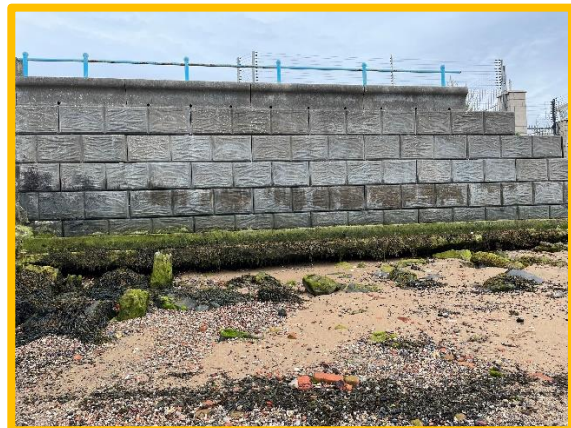
*Low beach levels exposing undercutting of concrete toe to the west. (/C0401C27)*

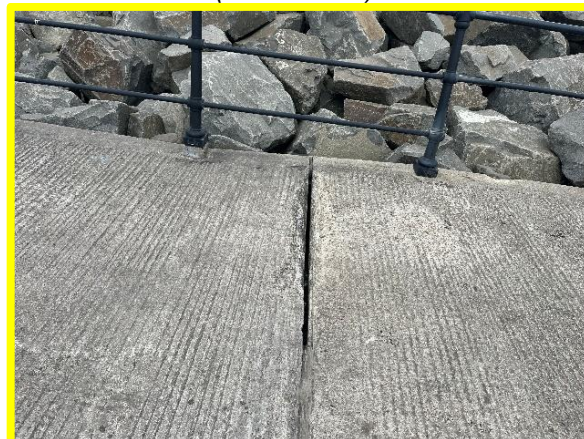
Other noticeable defects included hardened and missing flexible sealant in construction joints of the concrete seawall, minor local spalling and cracking of the concrete access steps and corroded handrails on access steps. Despite this, the seawall and various access steps remain generally in fair to good condition. Surface water drainage holes on the landward side of the seawall were generally found to be clear and working effectively.

*Loss of flexible joint sealant in northern access ramp, potential trip hazard (/C0401C33)*

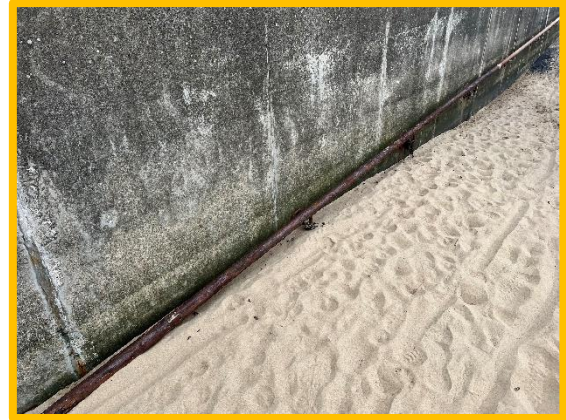
berm). Cracks were observed in the concrete seawall at the access ramp remained. They appear to be associated with the fixings for the handrail, and do not appear to have worsened. Local repairs should be undertaken and monitored to ensure this does not become a more significant issue. The handrail on the lower ramp is heavily corroded.

*Heavily corroded handrail on lower section of ramp (/C0401C33)*

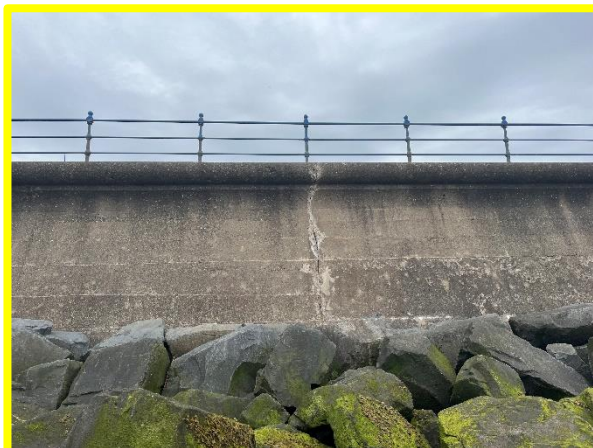
Minor defects were observed along the asset, these will require attention, and consisted of localized cracking and spalling of the cope and face of the wall and missing or damaged joint sealant. Several large vertical cracks were noted to be running the full height of the structure. There was evidence of historic repairs, including grouting / filling of spalled sections and cracks. Some of these repairs appeared to be in poor condition and should be revisited.

*Vertical cracking through cope and wall (/C0501C05)*

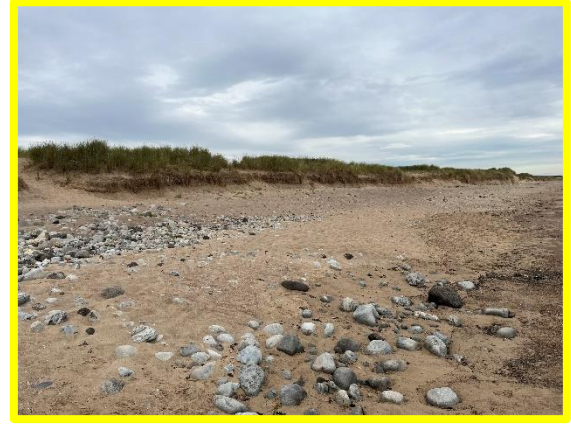
*Cliffing of foredune deteriorating since 2020  
(/C0502C01)*

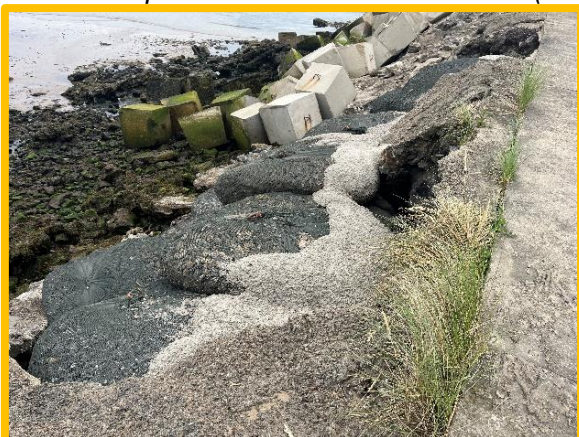
- **North Gare** – Further repairs works have been carried out since the previous inspection including the placement of concrete blocks and bagwork on northern face towards the landward end to fill a large void..

Concrete blocks and bagwork repairs to voiding.(/C0503C01)
