**Walk-over Visual Inspections of Selected Assets  
following Storm Surge of  
5<sup>th</sup> December 2013**

**Scarborough Borough Council  
Supplementary Report**

**December 2013**

### Walk-over Visual Inspections of Selected Assets following Storm Surge of 5th December 2013

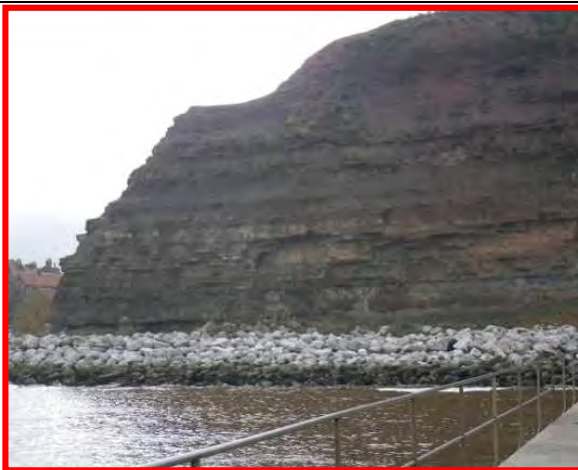
**MU4/1a** - Exposed and active end of Cowbar Nab, the southern half (Totally Active).  
Photo from Sept 2012

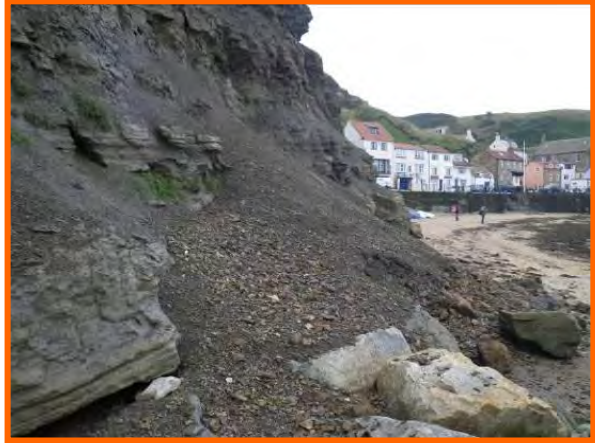
**MU4/2** – There have been a number of recent failures in this management unit, which is now classed as Partly Active. Photo from Sept 2012

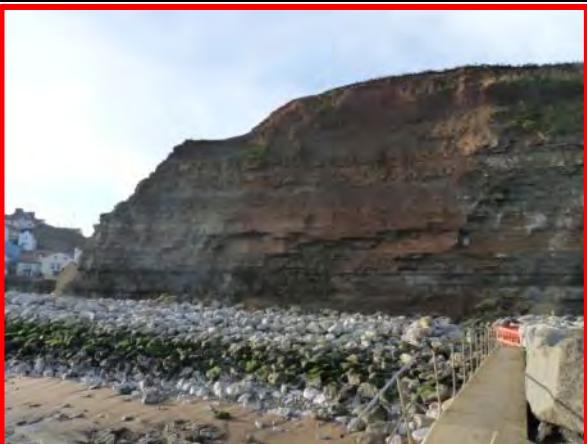
**MU4/1a** The southern part of Cowbar Nab after the December 2013 surge – note fresh scarring in cliff face (Totally Active)

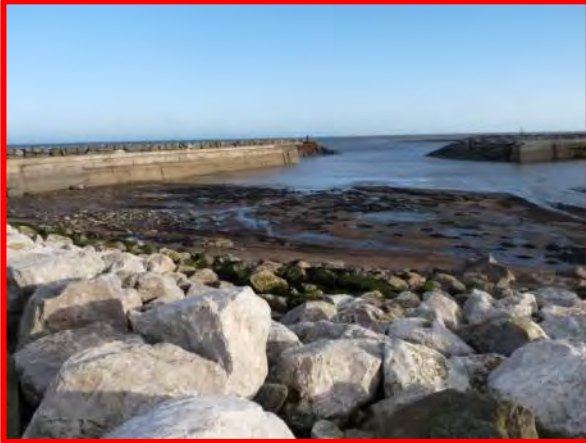
**MU4/1a Beach condition after the December 2013 storm surge. (Totally Active)**

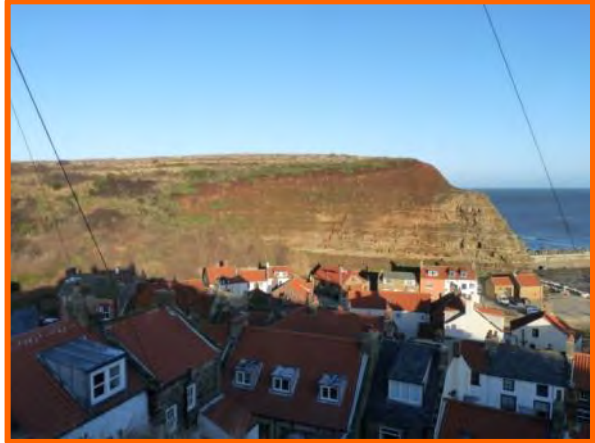
**MU4/1b – No noticeable change in activity status following the surge. (Partly Active)**

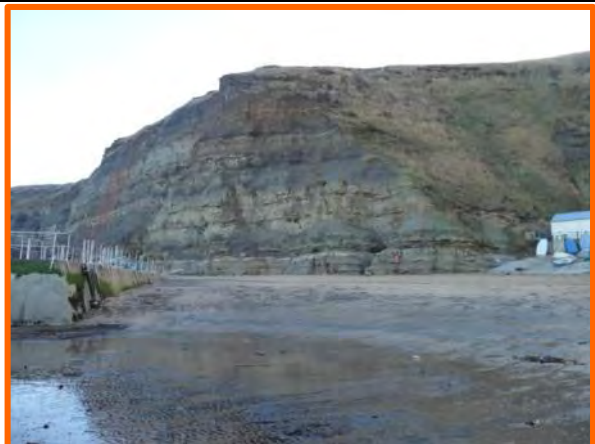
**MU4/2 Beach condition post December 2013 storm surge. Note absence of talus at base of cliff. (Partly Active)**

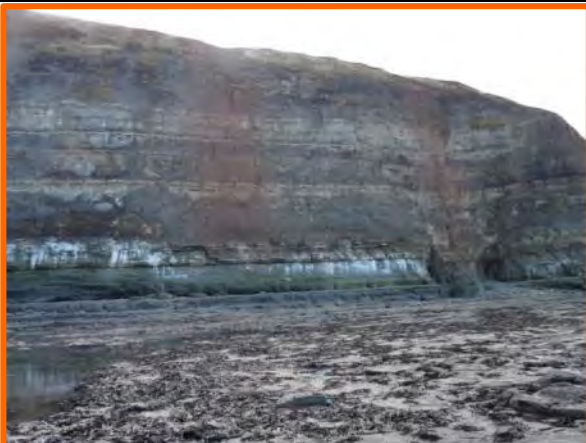
**MU4/3 – Undefended cliff east of Staithes Harbour. Note red-brown ‘streaking’ on cliffs from failures in till.**

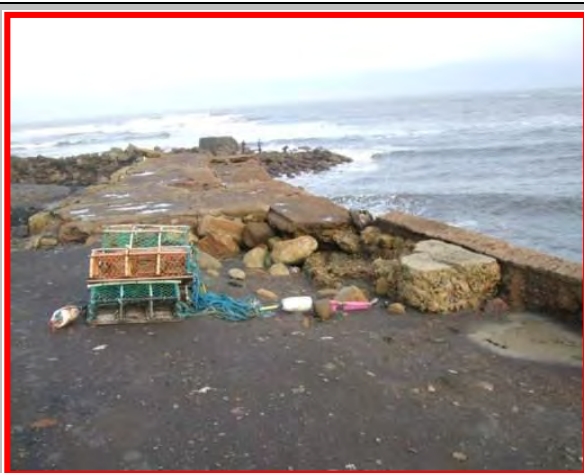
Looking at the end of the breakwater with evidence of erosion and failure in 2009 (Asset Ref. 1221D901D0502C01)

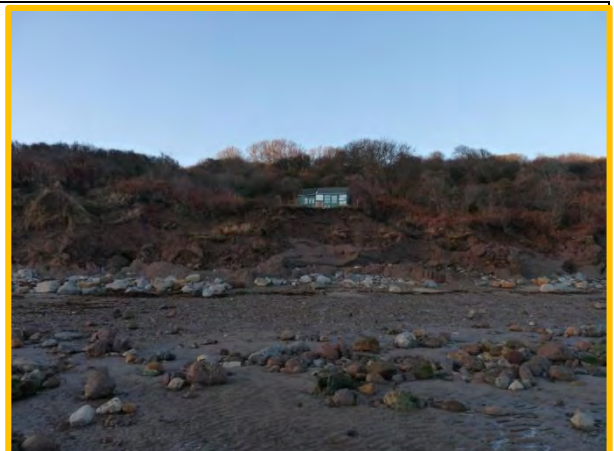
**MU7/3 Widespread toe erosion and significant failure at the toe of the cliff post December 2013 surge. Also note exposure of coarse material on the beach. (Partly Active)**

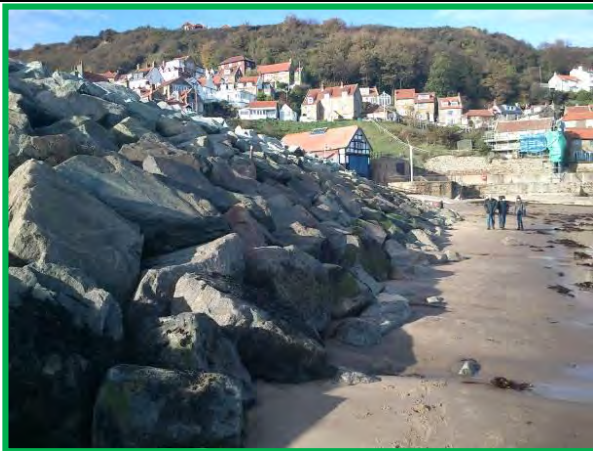
The rock armour defences (Asset ref: 1221D901D0602C01) remain in very good condition, with the rocks tightly packed with good coverage and no evidence of significant deformation. The associated slipway towards the south from the end of the road and boat park is also in good condition. Beach levels appeared relatively high at the time of the inspection, so the toe was not visible. There is ongoing erosion of the undefended cliff at the southern end of the defence and some of the locally sourced smaller rock used at the tie in has been scattered, see below right, however this is not a cause for concern at present.

Runswick Bay village rock armour defences, Oct 2012. (Asset Ref. 1221D901D0602C01)

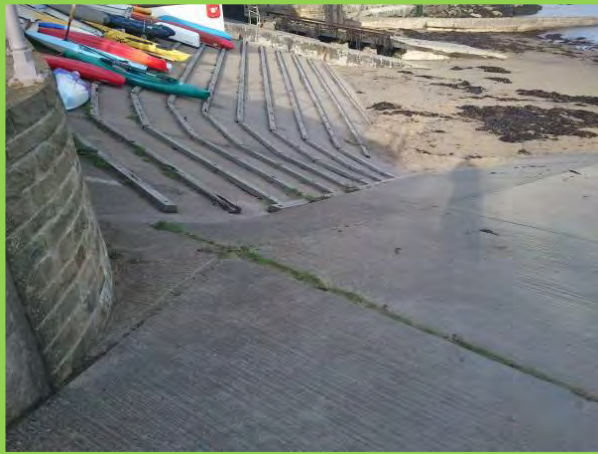
At the northern end of the rock armour, the slipway adjacent to the RNLI building was reported to be in good overall condition in October 2012, although the timber strips to support the small boats were rotting in many places and will need replacing and joints between slabs need resealing, below left. The seawall around the pumping station to the north of the RNLI building was also in very good condition, below right, although the standards for all of the handrails were showing corrosion and needed cleaning and repainting.

Northern slipway adjacent to the RNLI, Oct 2012.  
(Asset Ref. 1221D901D0601C04)

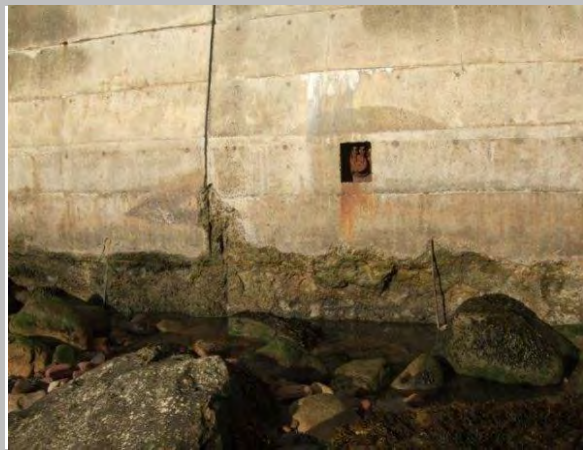
Undercutting of the northern coastal sea wall (Photo taken from 2009 report)

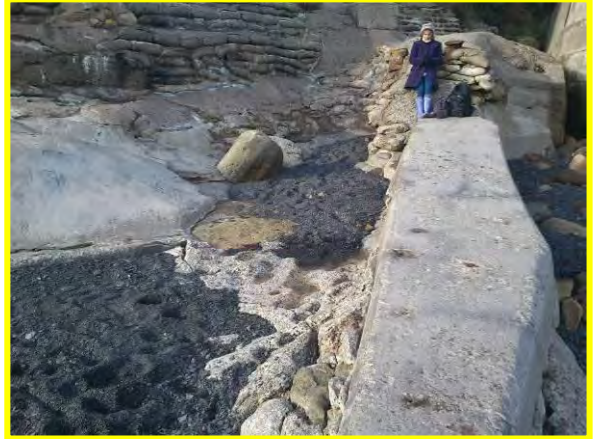
View of northern end of wall with cracked concrete bagwork, Oct 2012.  
(Asset Ref. 1221D901D0601C06)

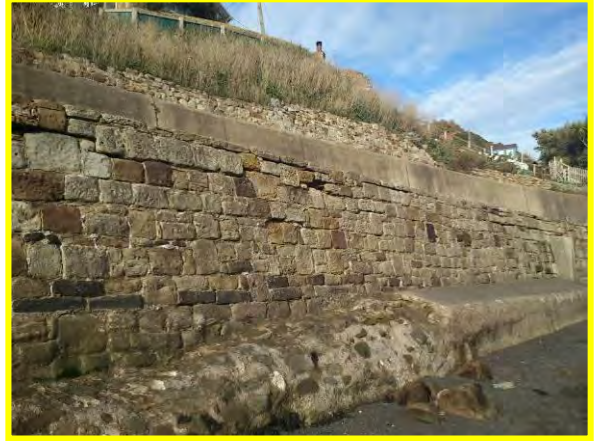
Gaps at joints and missing blocks, Oct 2012.  
(Asset Ref. 1221D901D0601C03)

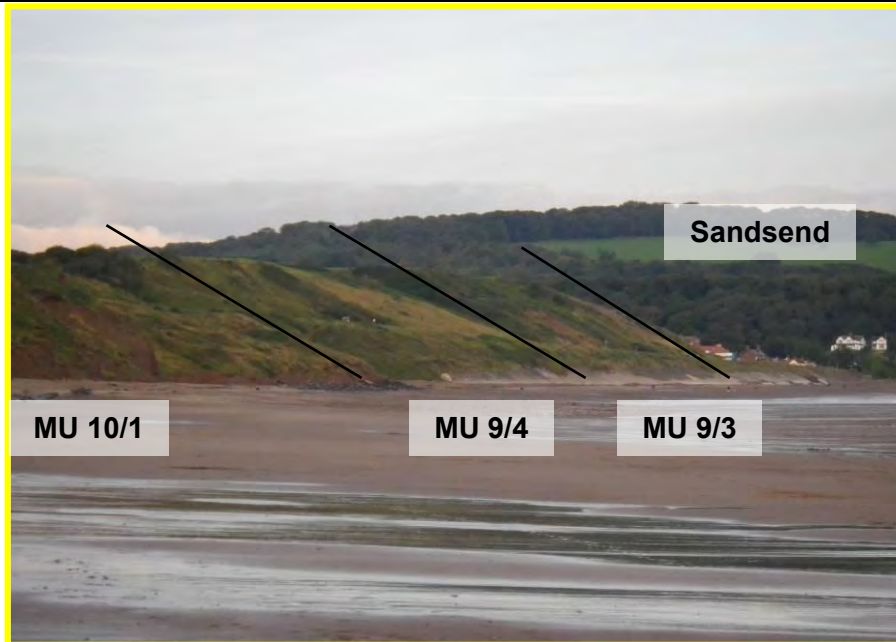
**MU9/3 and MU 9/4** The slope overall is stable with erosion apparent at the shore where the defence has become degraded (Locally Active). October 2012

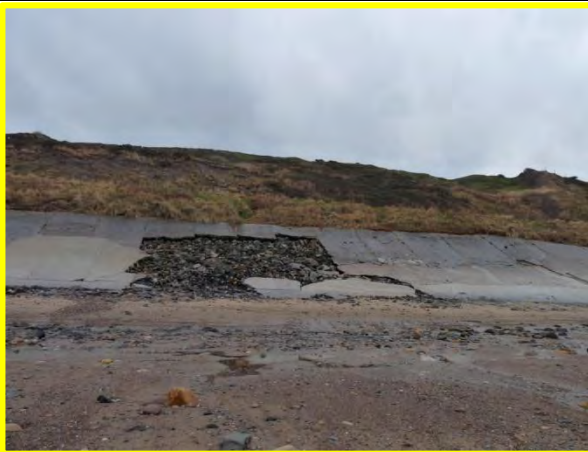
**MU9/3 – Note erosive features in the upper slope as well as failure of toe defence. December 2013**

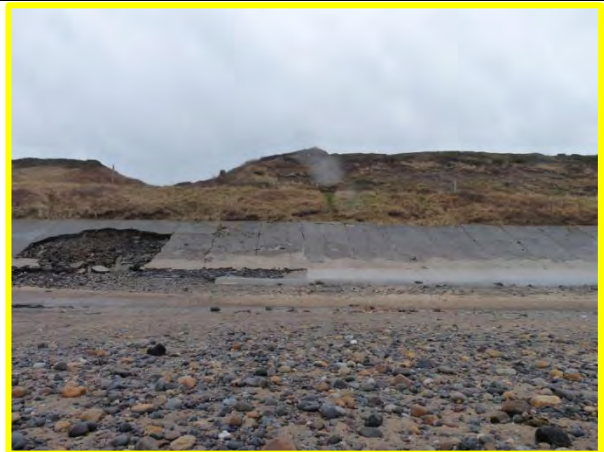
**MU9/3 Note erosive features in upper slope and failure of defence at the toe. December 2013**

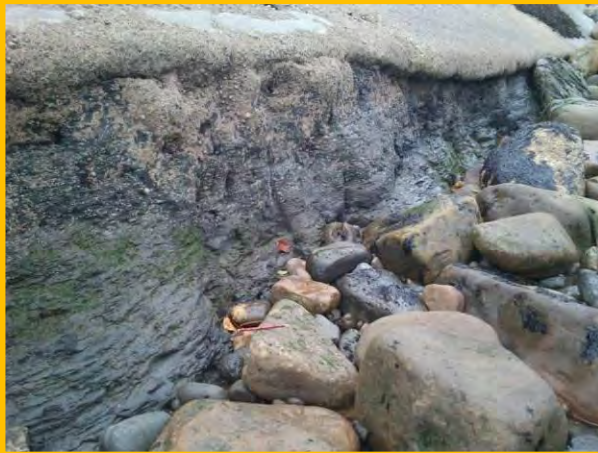
Displaced toe armour, undercutting to concrete revetment and abrasion damage to revetment, Oct 2012. (Asset Ref No.1221D901D0701C02)

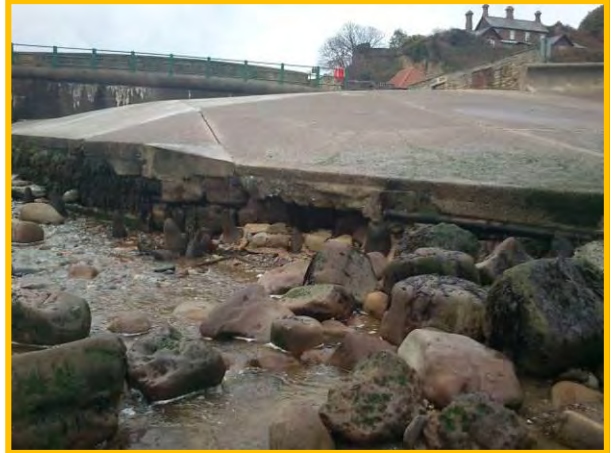
Void under slipway at the north of Sandsend, Oct 2012. (Asset Ref No.1221D901D0701C02)

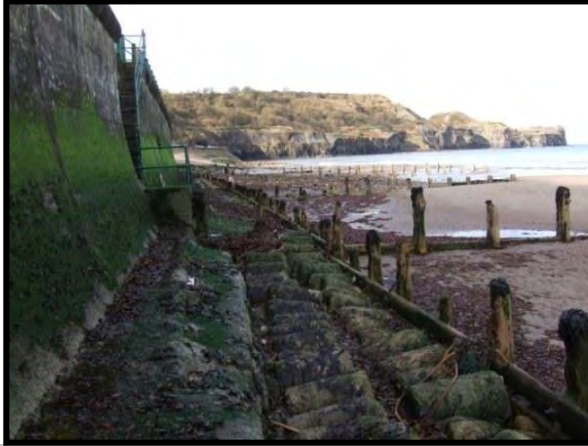
Timber toe of sea wall in a poor state - photo from 2009 (Asset Ref. 1221D901D0702C01)

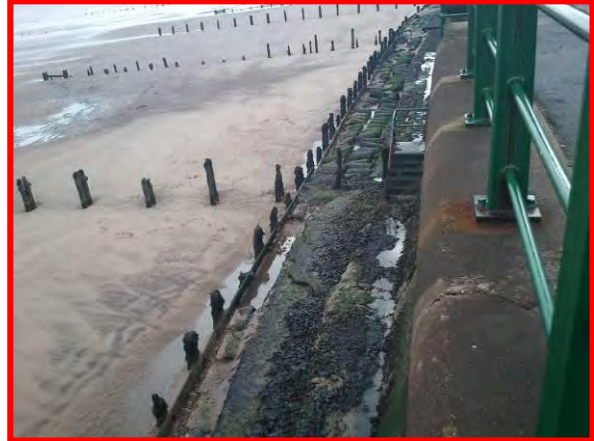
Failed timber groynes and timber breastwork at toe of wall in front of Sandsend, Oct 2012. (Asset Ref. 1221D901D0702C01)

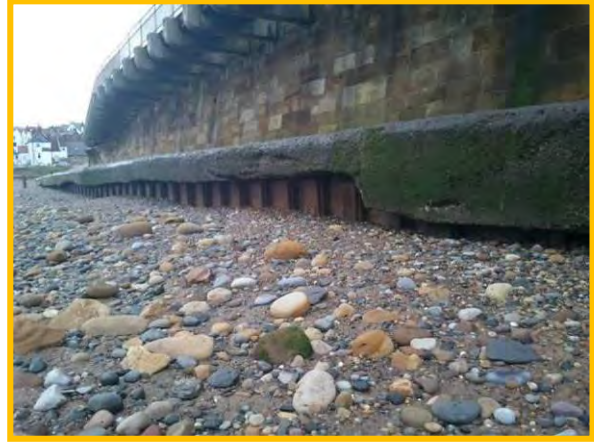
Exposure of toe piling below masonry wall, Oct 2012. (Asset Ref. 1221D901D0702C04)

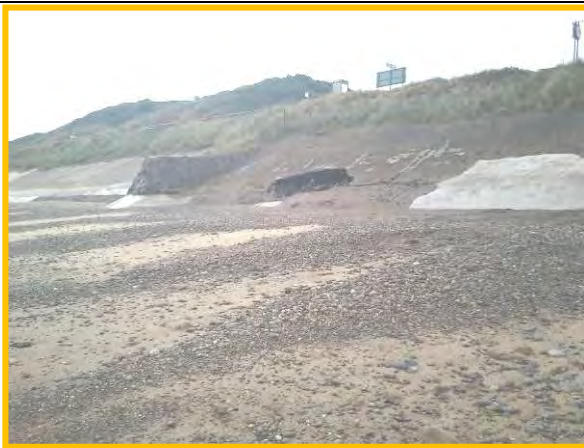
Large void in revetment adjacent to recent patch repair, Oct 2012. (Asset Ref. 1221D901D0702C02)

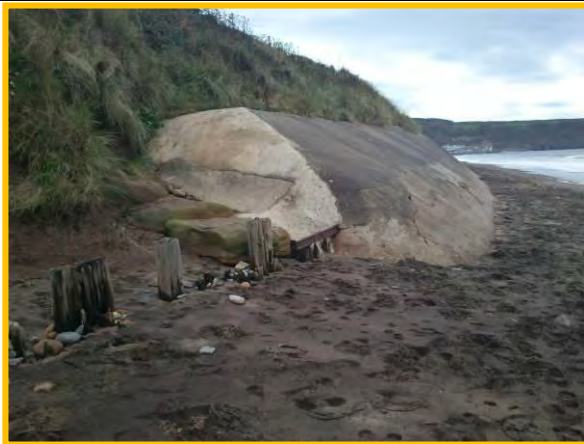
Repair at east end of the concrete revetment since 2009 inspection, Oct 2012. (Asset Ref. 1221D901D0702C02)

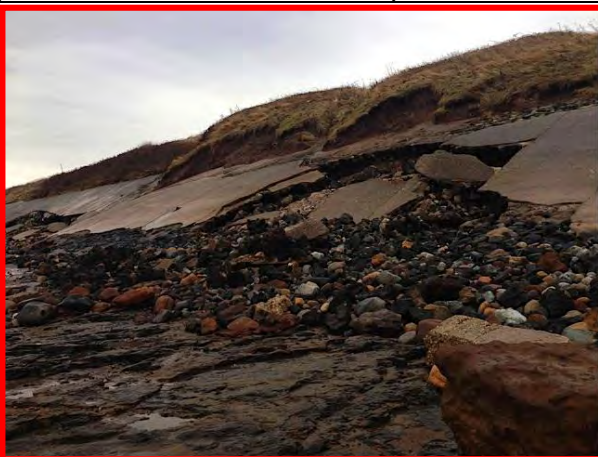
Significant further damage to the asset was evident following the storm surge of 5<sup>th</sup> December 2013. North Yorkshire County Council (NYCC) carried out a visual inspection on 8<sup>th</sup> December 2013 as the defence fronts the A174 carriageway. Notable during this inspection was the loss of beach material on the foreshore exposing clay. Some sand recovery is however evident during the inspection of 17<sup>th</sup> December. Various elements of the sloping concrete defences south of Sandsend have been broken out and scoured by the sea during the storm surge. The voids have been temporarily refilled with rock debris rescued from the beach area (ongoing operation on 17<sup>th</sup> Dec 2013) but the whole wall needs urgent attention.

Extensive damage to revetment and cliff material above revetment. Note also the scoured beach with no sand in front of the revetment, 8<sup>th</sup> December 2013, NYCC inspection.  
(Asset Ref. 1221D901D0702C02)

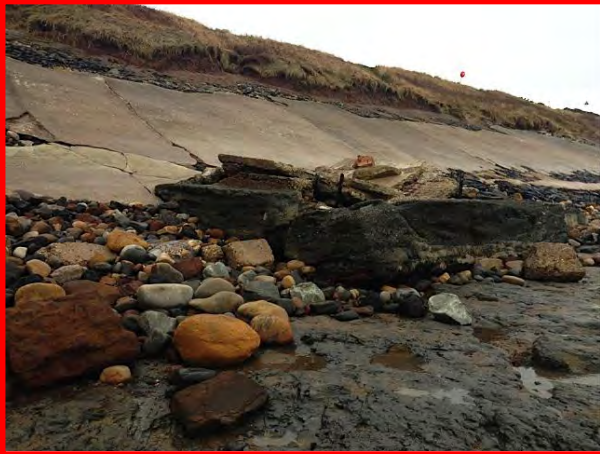
Extensive damage to revetment and the scoured beach with no sand in front of the revetment, 8<sup>th</sup> December 2013, NYCC inspection. (Asset Ref. 1221D901D0702C02)

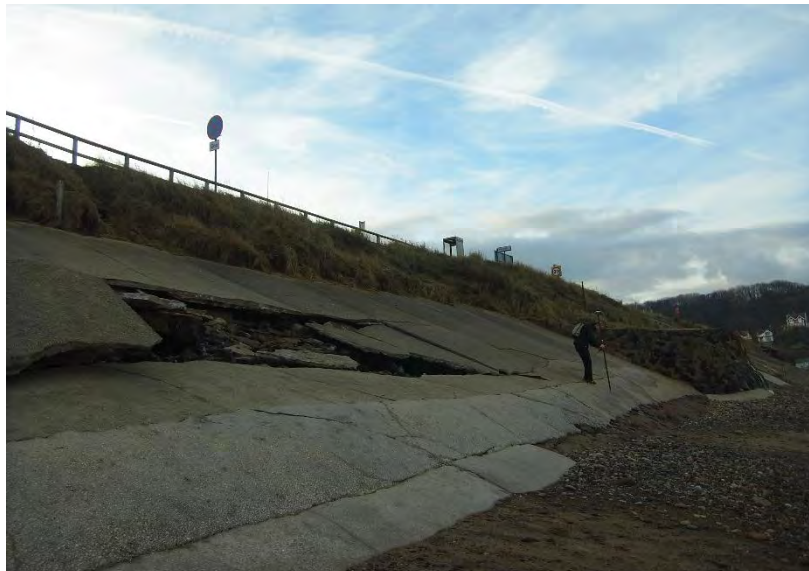
**Damage to the defence close to Profile 1dWB1. Photo taken on 9th December 2013**

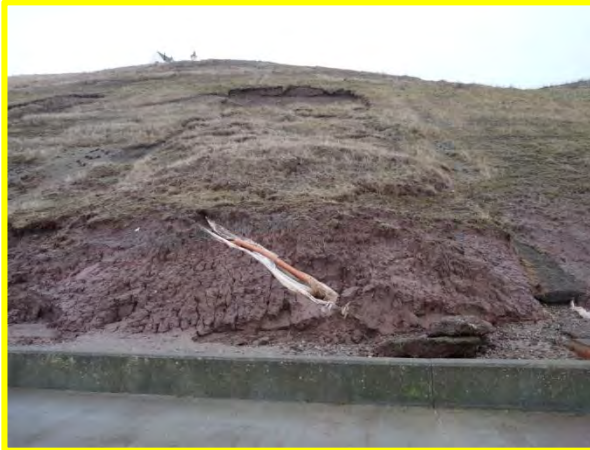
**MU11/1** – Reactivation of significant failure in lower slope. Note toe erosion exposing drainage pipe and recently exposed scar. December 2013. (Locally Active)

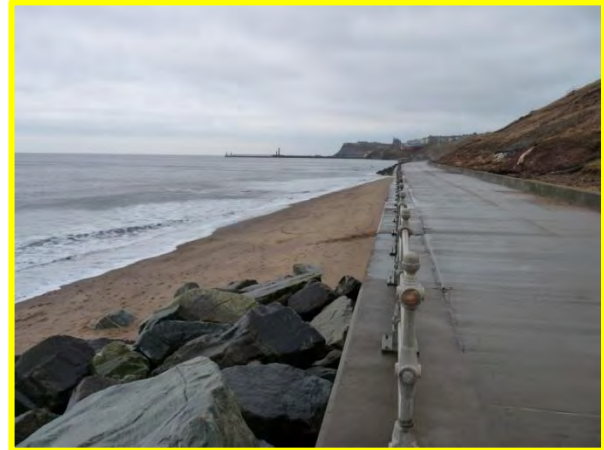
**MU11/1** – Gap in rock armour beneath active lower slope December 2013. (Locally Active).

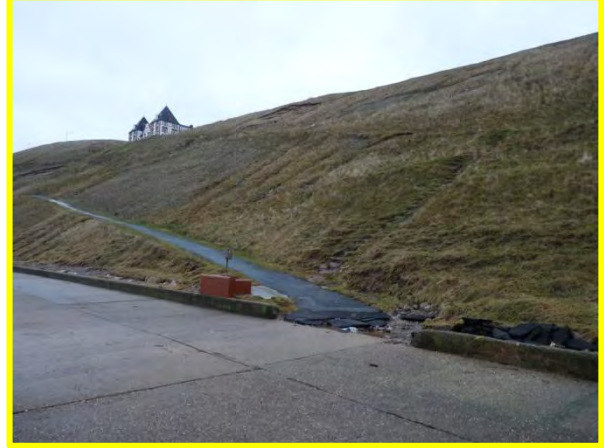
**MU11/2 – Failures in upper to midslope. December 2013. (Locally Active).**

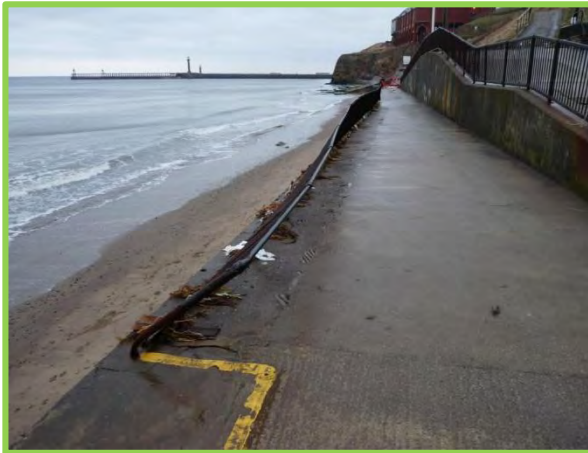
**MU11/13 – Damage to fence following December 2013 storm surge. (Inactive)**

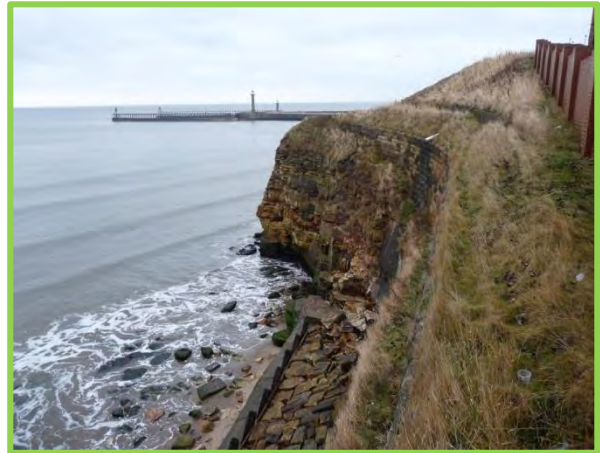
**MU11/13 – Small rockfall (centre photo) observed during the post-December 2013 storm surge inspection. (Inactive)**

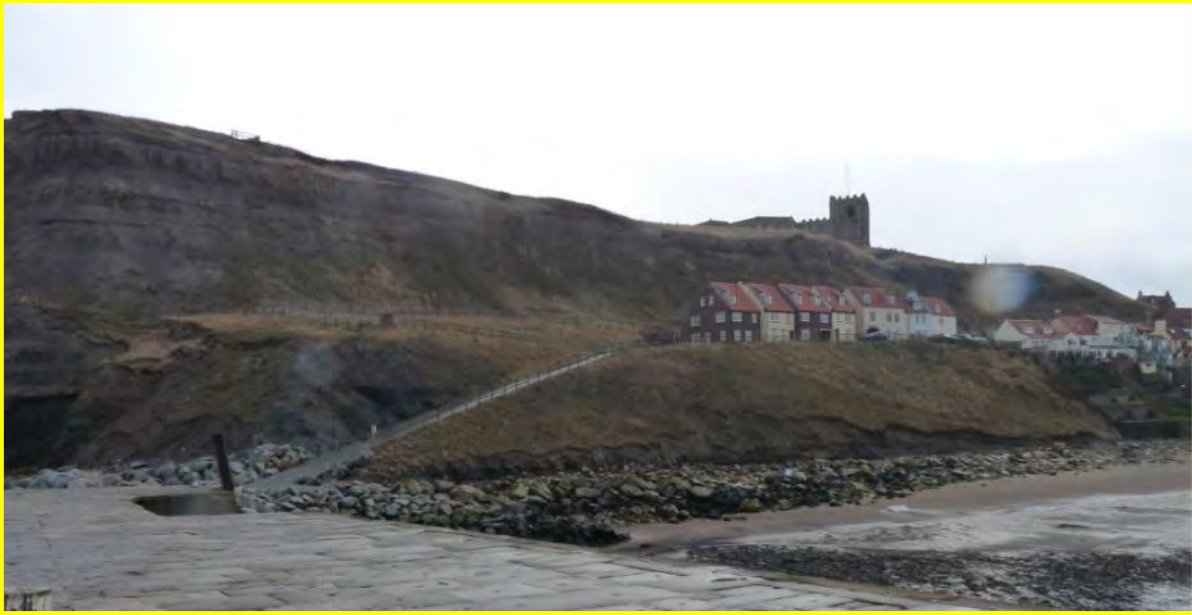
**MU12/1 Note toe erosion above rock armour along full length of the slope. December 2013**

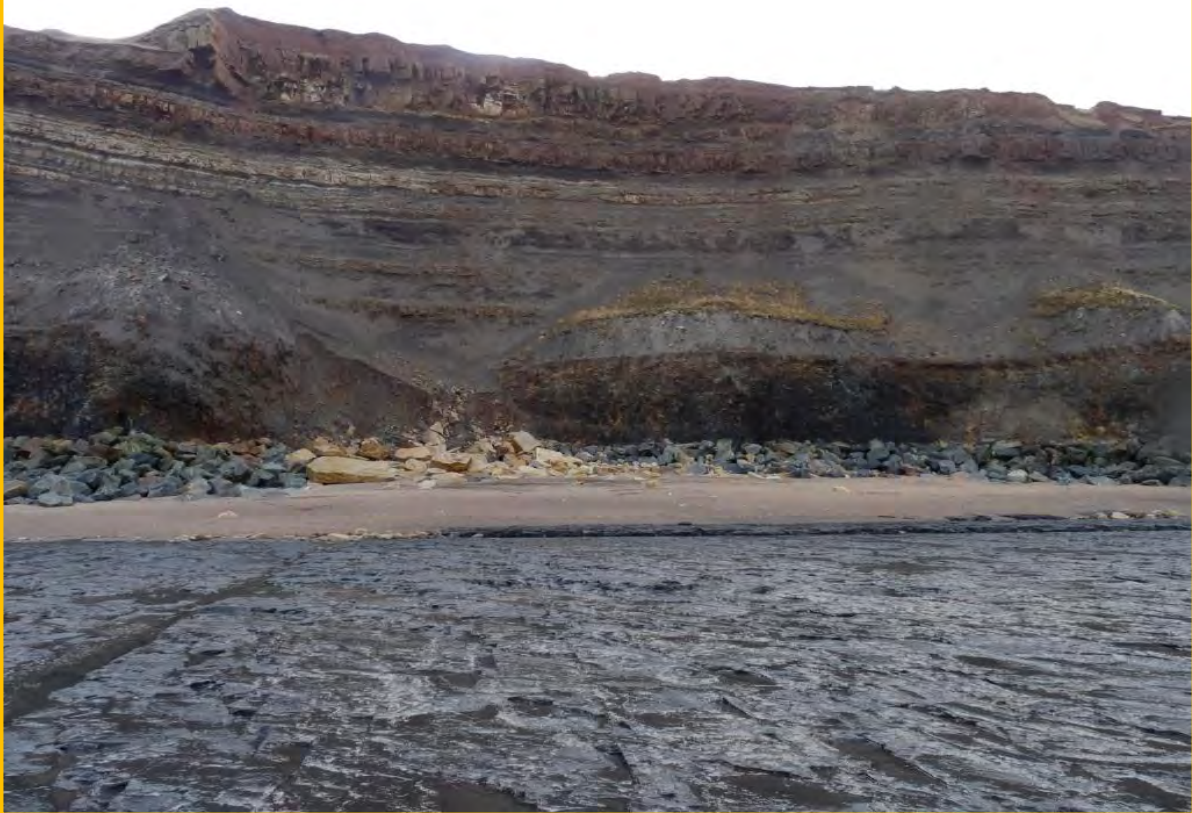
**MU12/2 – Major recent rockfall and failure of lower slope/toe erosion indicating ‘Partly Active’ status is still appropriate. December 2013.**

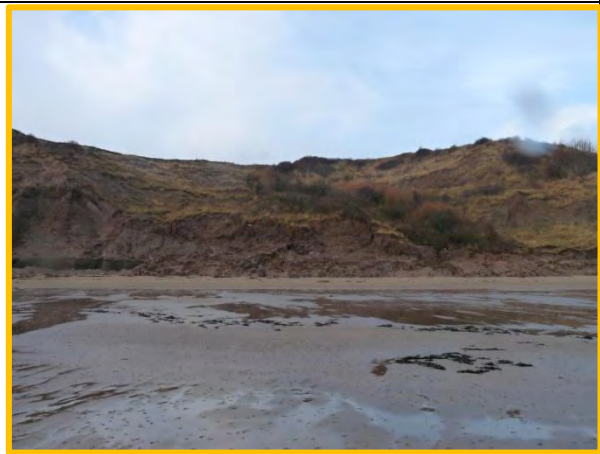
**MU17/3** Recent toe erosion and failure at toe, December 2013 (Partly Active).

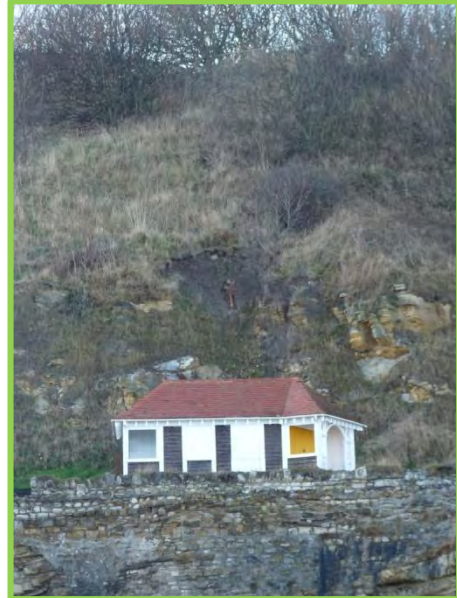
**MU22/5 – Small midslope failure (centre photo, above building). December 2013. (Inactive)**

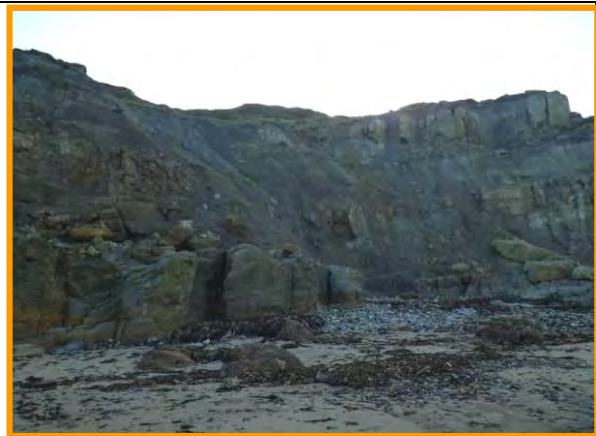
**MU23/B** Recent failure of the cliff (Partly Active)  
Sept 2012

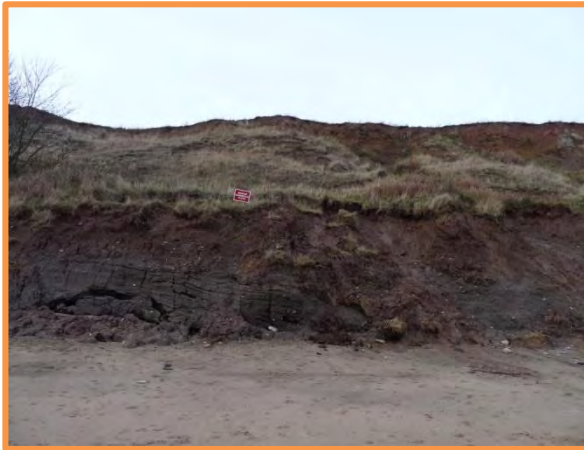
**MU27/W – Toe erosion and scarp failure evident throughout unit. December 2013 (Partly Active).**

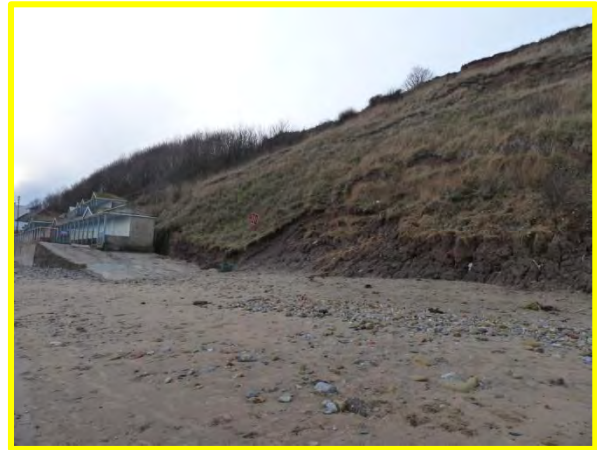
**MU27/X – Some toe erosion occurring at undefended northern end of unit (closest in photo) and movement on slope (Note angle of red sign). December 2013 (Locally Active).**

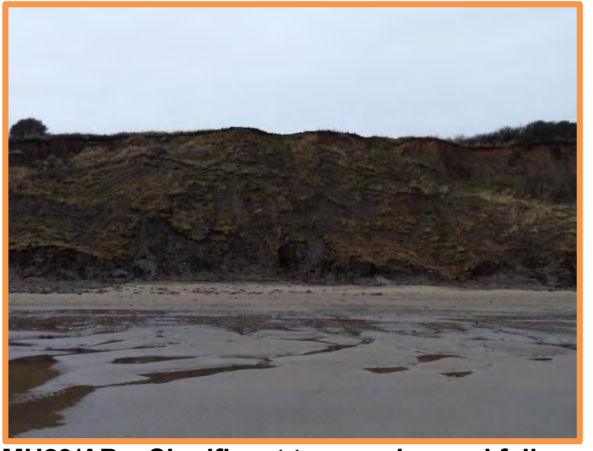
**MU29/AB** – Significant toe erosion and failure of lower cliff. December 2013 (Partly Active).

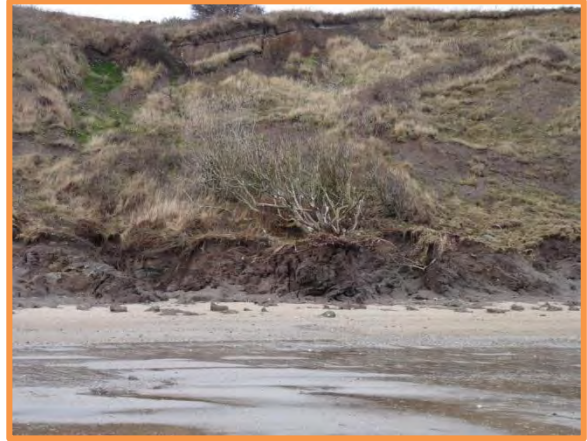
**MU29/AC** – Further failure of toe. December 2013 (Partly Active).

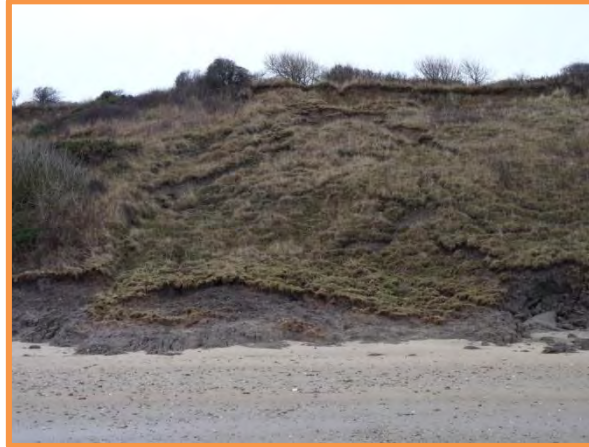
**MU29/AH Failure affecting near whole slope. December 2013 (Partly Active)**

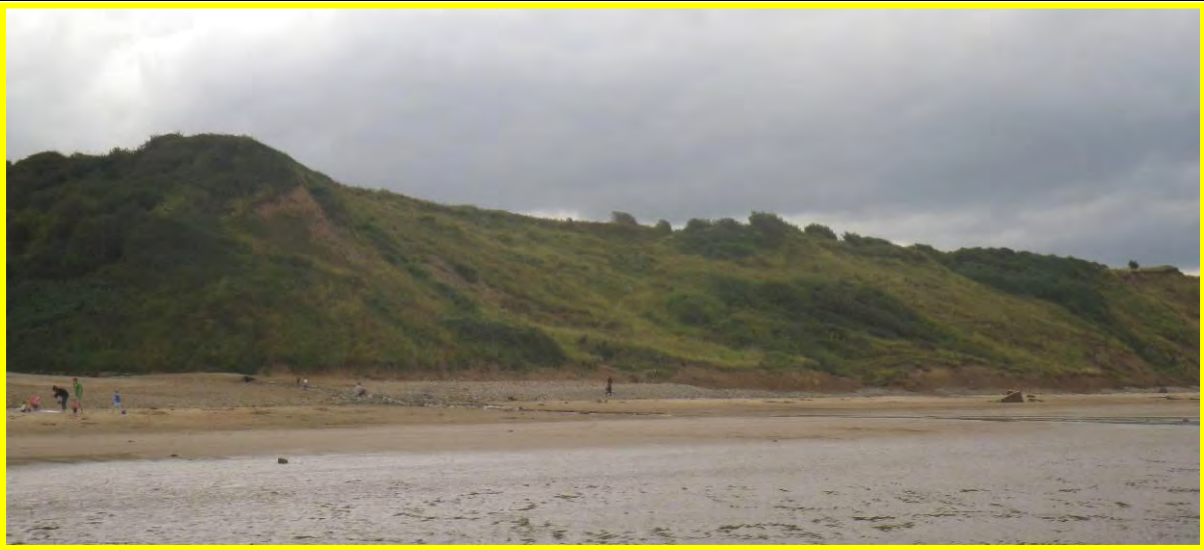
**MU29/AI Locally steep, exposed unit toe (Locally Active) Sept 2012**

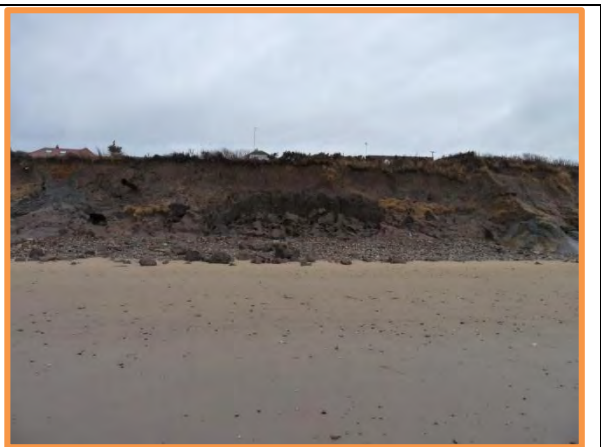
**MU29/AS** – Severe toe erosion including failure blocks. Note protruding pipe. December 2013 (Partly Active)
