Ongoing Analysis and Interpretation of Coastal Monitoring Data

Second Review of Full Suite Monitoring

Geotechnical Interpretative Report

Document Ref. No. 721229/002/GIR/007/Final

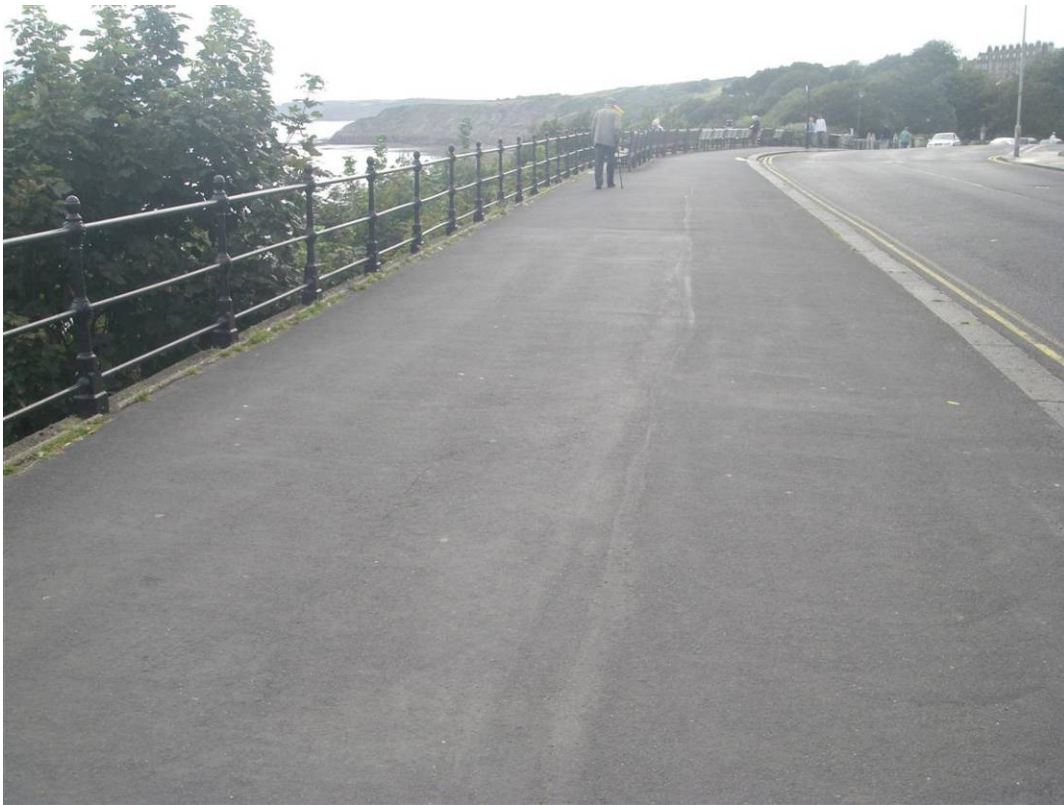
Plate 69 Scarborough South Cliff Promenade showing signs of subsidence.

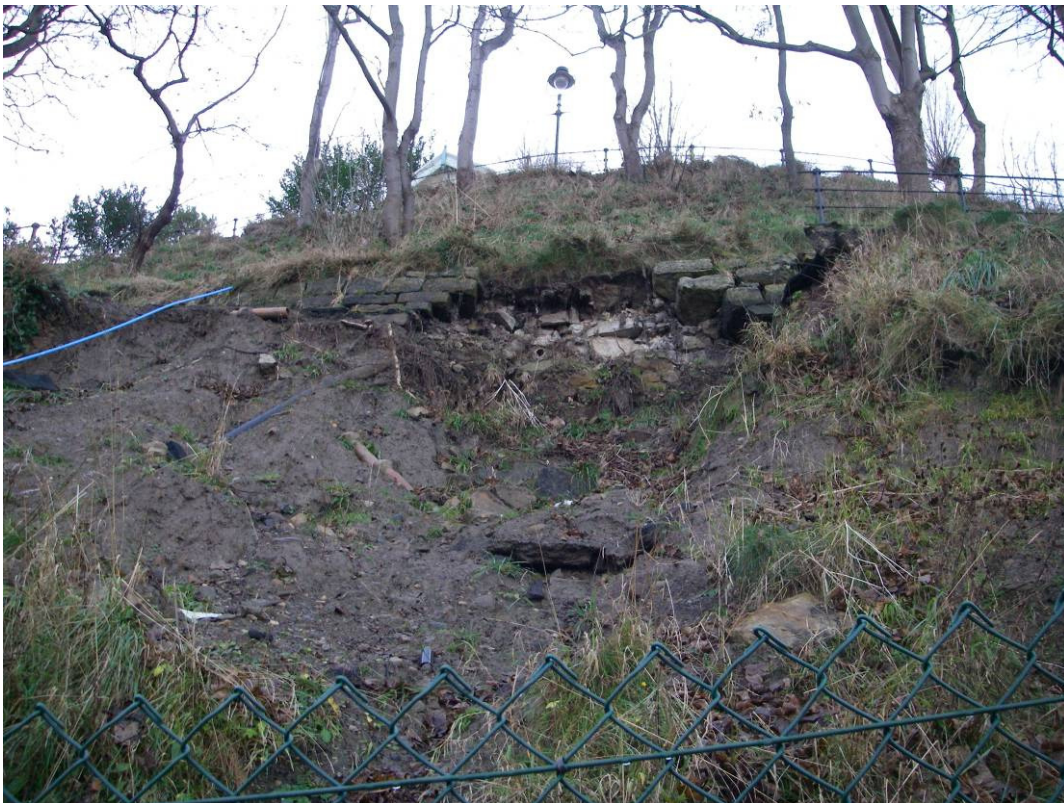
Plate 30 Site view of retaining wall and slope failure behind The Spa on Spa Cliff.

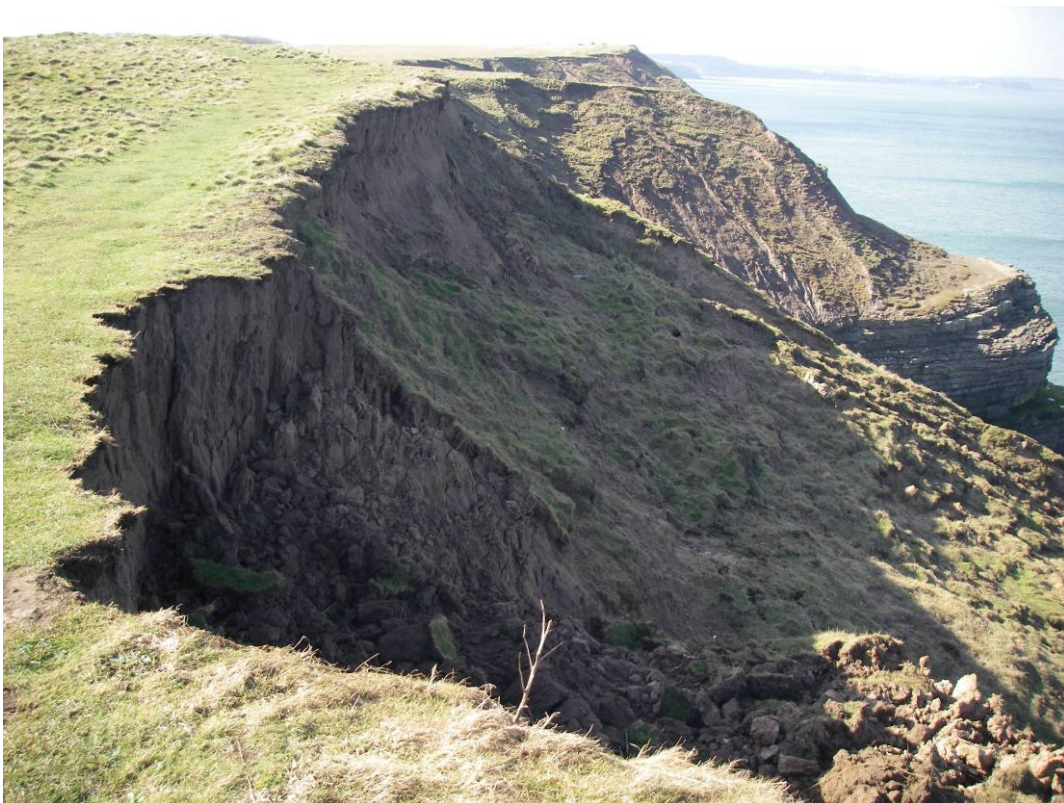
Plate 39 Site view looking east at slumped glacial tills at Filey Brigg.

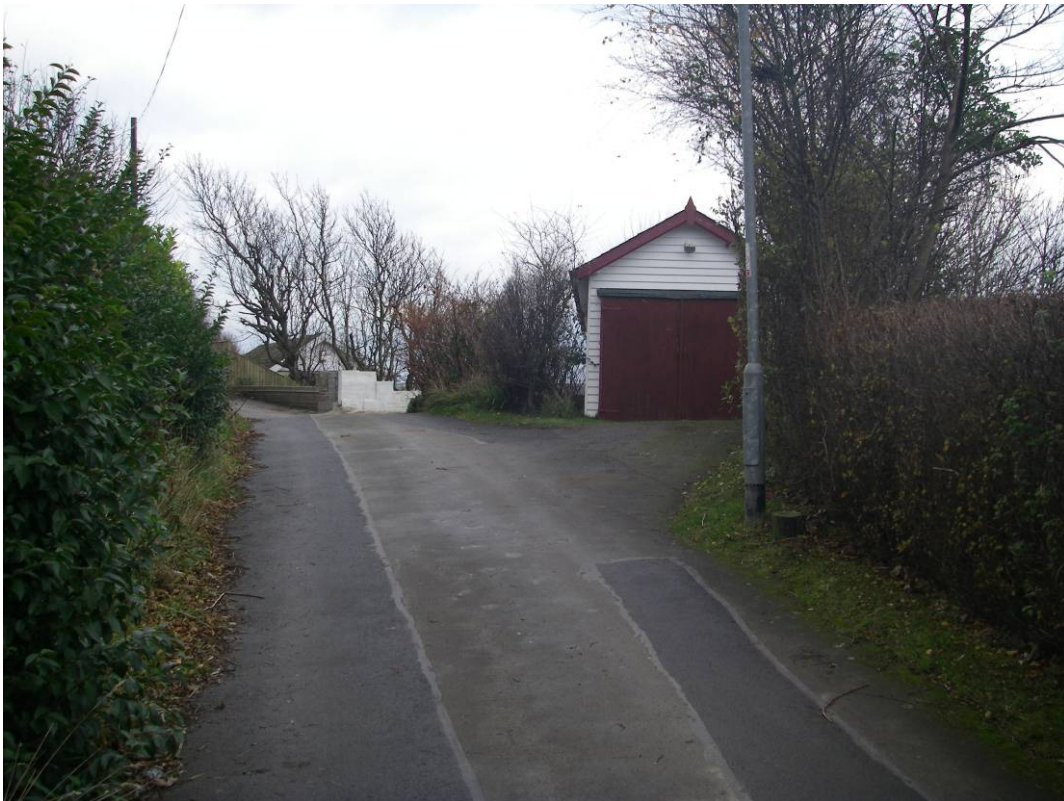
Plate 43 Site view of leaning timber garage at No. 5 Flat Cliffs; seaward of coastal slopes.
