# Interpretation Report 11: June 2018 to November 2018

*Prepared for*  
Scarborough  
Borough Council

February 2019

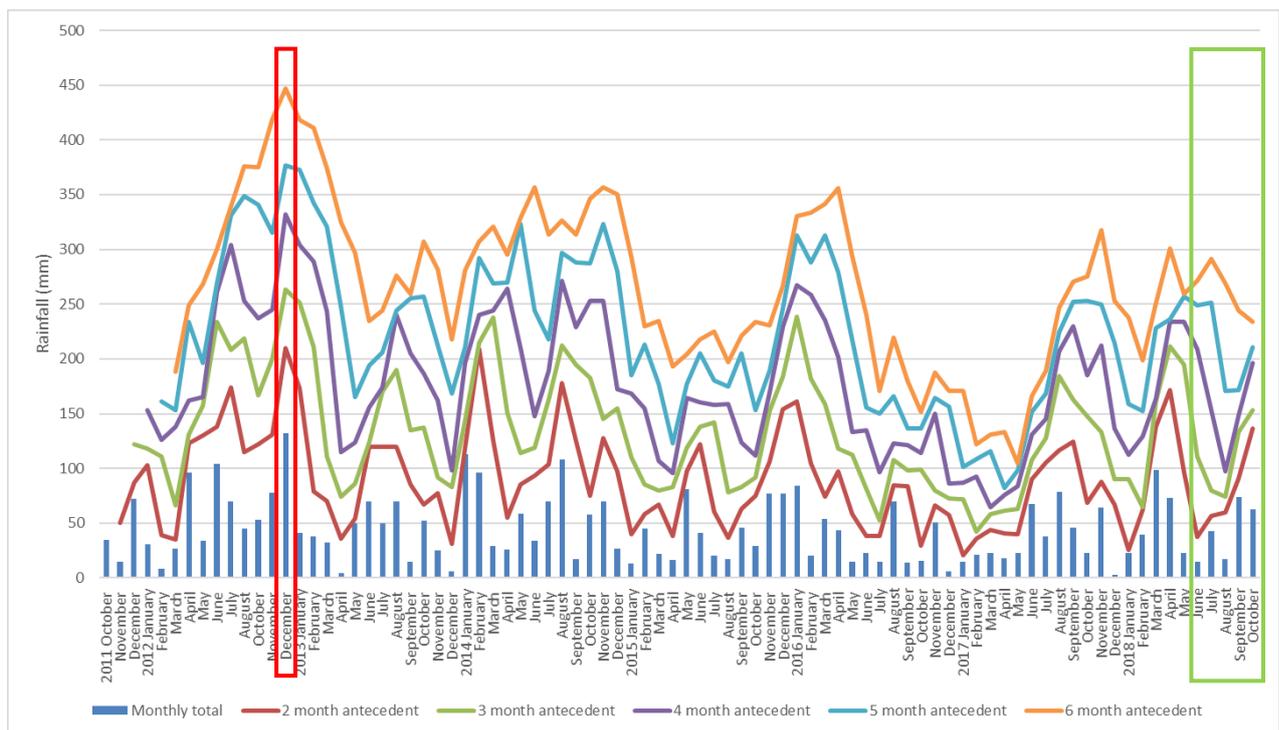
Antecedent rainfall over the current June-November monitoring period show peaks that are lower than that seen in December 2012, however a rapidly decreasing trend in antecedent rainfall over the monitoring period is evident, unlike the pattern to the previous June to November monitoring period which shows antecedent rainfall rises after June. Instead, antecedent rainfall increases in September. Antecedent rainfall totals do not reach those seen in December 2012 and it is therefore concluded there is a low likelihood of rainfall-induced landslides occurring in the monitoring period. However, the antecedent rainfall levels at the end of this monitoring period are increasing, which means if the winter of 2018/19 is wet, there may be an increased likelihood of ground movement in the next monitoring period.

Figure 2.6. Monthly rainfall and two to six month antecedent totals (2011 to 2018). Ground movements were recorded at Scalby Mills during December 2012 (red box). Current monitoring period shown by green box.

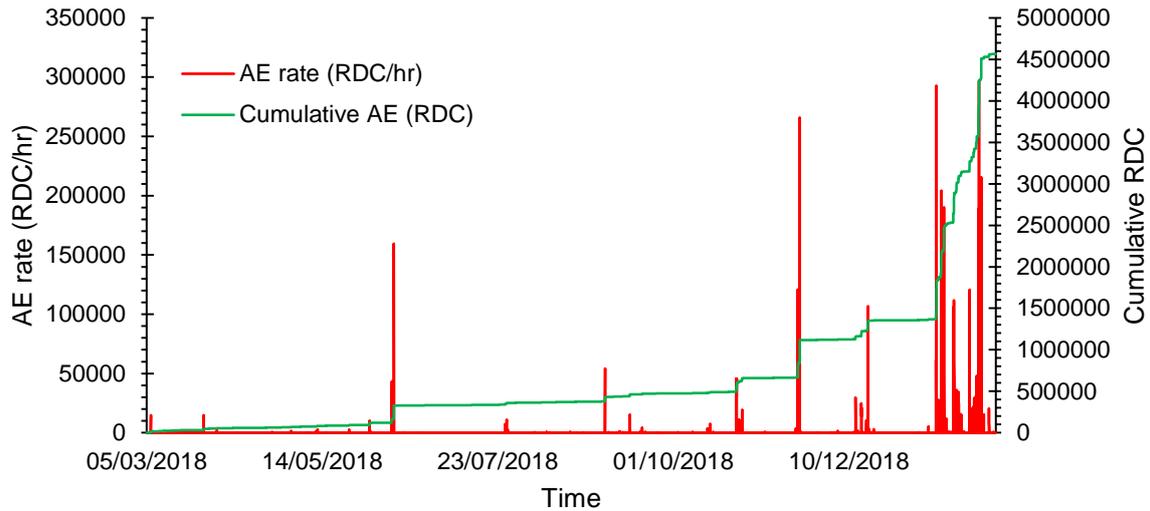
Figure 9.2. Cumulative AE (RDC) and AE rate (RDC/hr) time series at Scarborough Spa for the period March 2018 to January 2019.

- Acoustic emissions (AE) detected are negligible and do not suggest slope movement. Fluctuations in the data represent the specific hydrogeological conditions at this site (i.e. time dependent seepage conditions following rainfall events). This is supported by the inclinometer measurements at BH105, which show negligible movement. (Figure 9.2 and 9.3). It is also possible that extraneous noise generated at Scarborough could be due to ongoing construction activities to stabilise the slope.

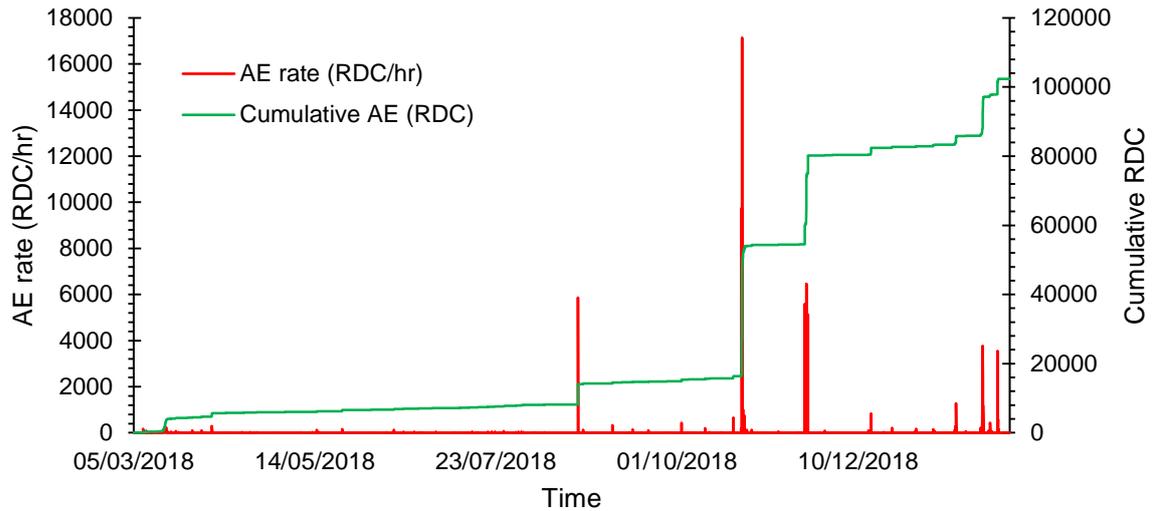
Figure 11.2 Cumulative AE (RDC) and AE rate (RDC/hr) time series at Flat Cliffs, Filey for the March 2018 to January 2019.

- No evidence for ground movements is shown by inclinometers, with the exception of minor movement in borehole A2 within mudstone.
- AE measurements between June and November 2018 do not show significant slope movements. The periods of elevated AE activity, which are shown by periods of increased gradient of the cumulative RDC record, could be indicative of deformations but of a very slow rate and small magnitude. However, it is more likely that this increased AE activity was caused by extraneous noise (e.g. interference with the surface cover).
- Groundwater data show levels have risen in borehole B1, however remain within the historical range.
- No data collected at piezometer in borehole C4a, A3 and D1, requires readings to be retaken.
