LOCAL COASTAL SLOPE MONITORING ANALYSIS

# Interpretation Report 15: August 2020 to December 2020

*Prepared for*  
Scarborough  
Borough Council

February 2021

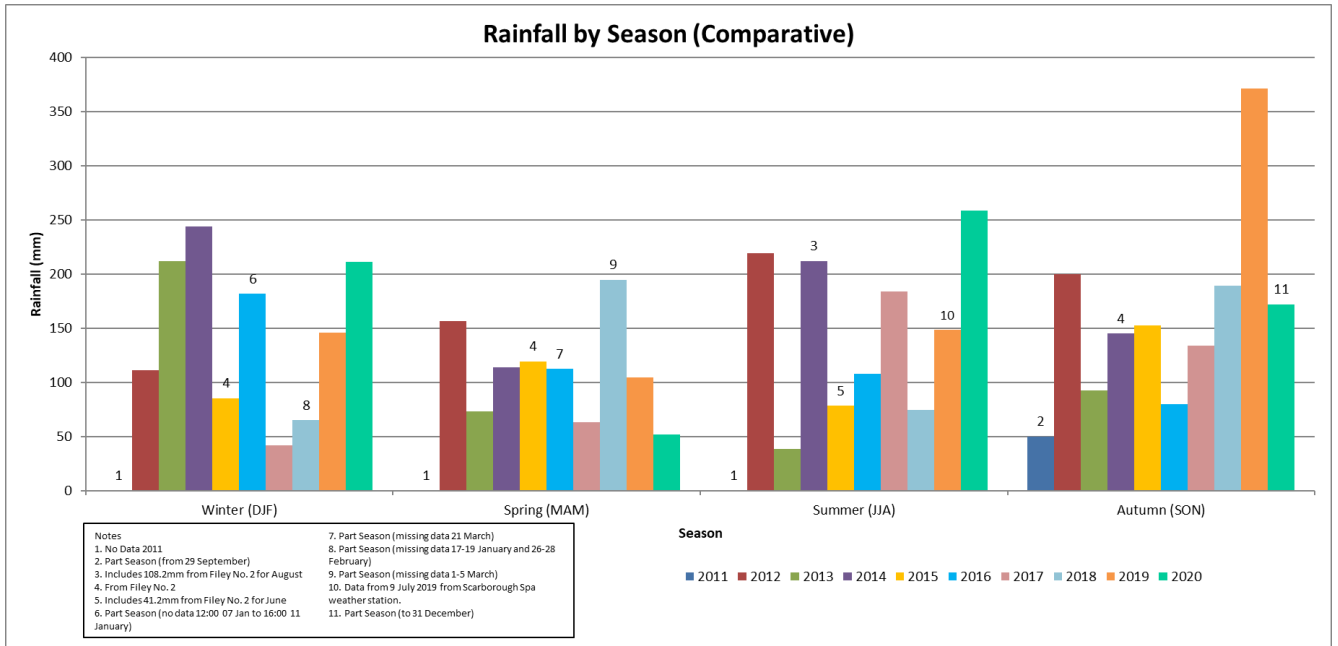
Figure 2.3 Seasonal rainfall comparison (2011-2020)

Seasonal totals are shown in Figure 2.3, which shows that the wettest season tends to be autumn, and that the spring is the driest. The wettest season on record was autumn of 2019 (i.e. September, October and November) that received a total of 371mm rainfall, which is exceptional when compared to previous years. The next wettest season is the summer of 2020 (June, July and August), with 258mm of rainfall. The winter of 2016/17 and summer 2013 were the driest on record.

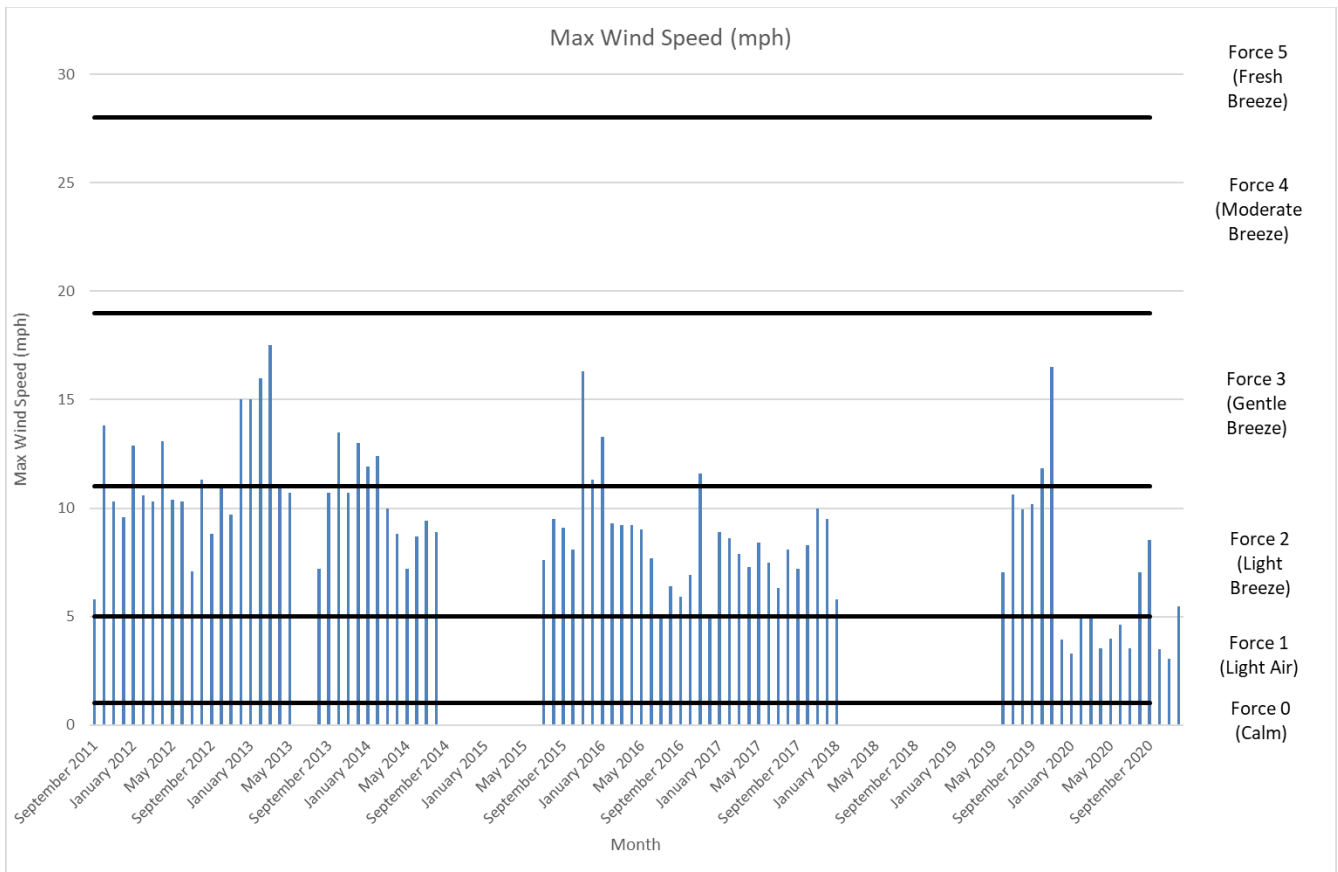
Figure 2.4 Maximum daily wind speed (2011 to 2020).

Wind speed and air temperature records are presented in Figures 2.4 and 2.5. In both cases, the failure of the Scarborough Spa met station means there are no data for some of the previous monitoring periods.

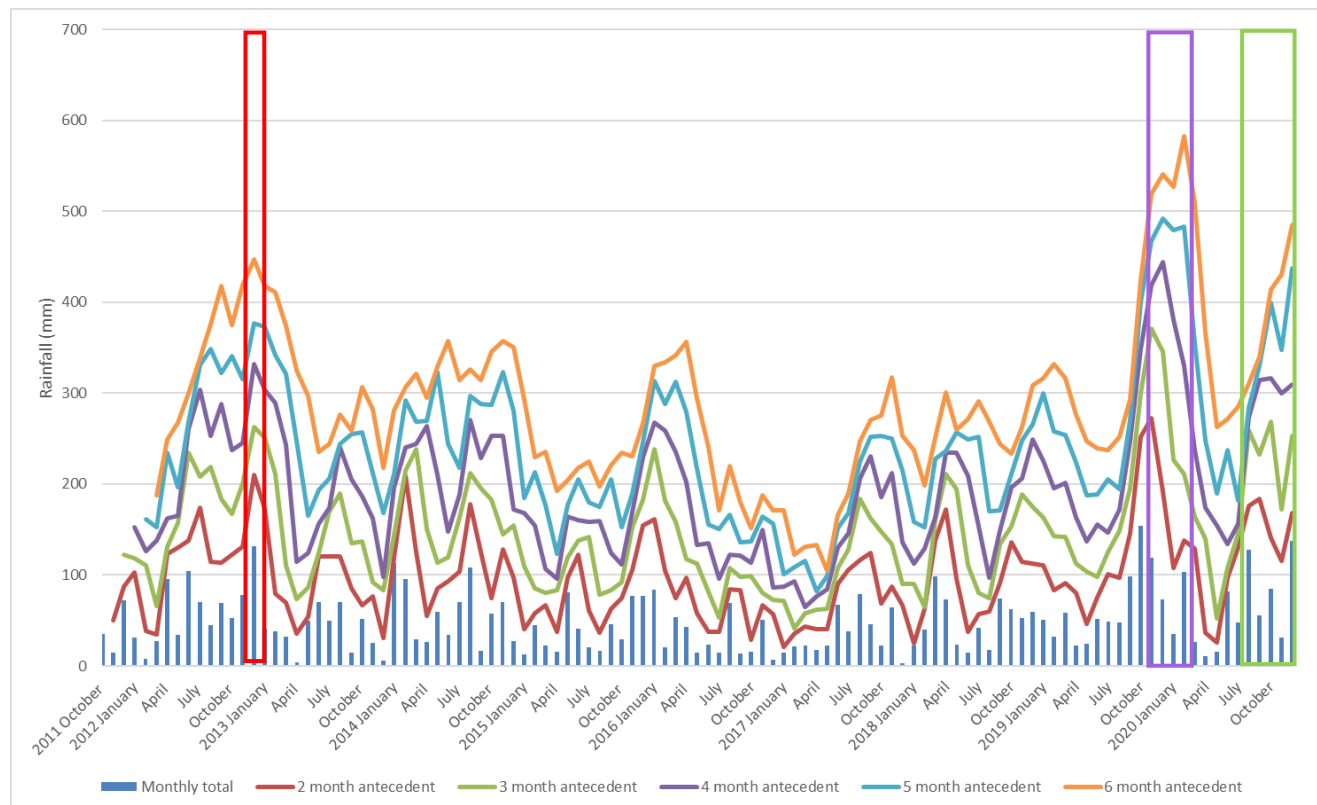
Antecedent conditions prior to the current monitoring over the winter of 2019/20 show peaks higher than those seen in 2012, meaning ground movements could be expected. However, no ground movements were recorded by in situ monitoring. After a fall in rainfall over the summer of 2020, levels began to rise in the autumn and exceeded the peak recorded in 2012. If the winter of 2020/21 continues to be wet, the peak of 2019/20 may be reached, and the likelihood of ground movement in the next monitoring period will also be high.

Figure 2.6. Monthly rainfall and two to six-month antecedent totals (2011 to 2020). Ground movements were recorded at Scalby Mills during December 2012 (red box), but not during the rainfall peak in winter 2019/20 (purple box). Current monitoring period shown by green box.

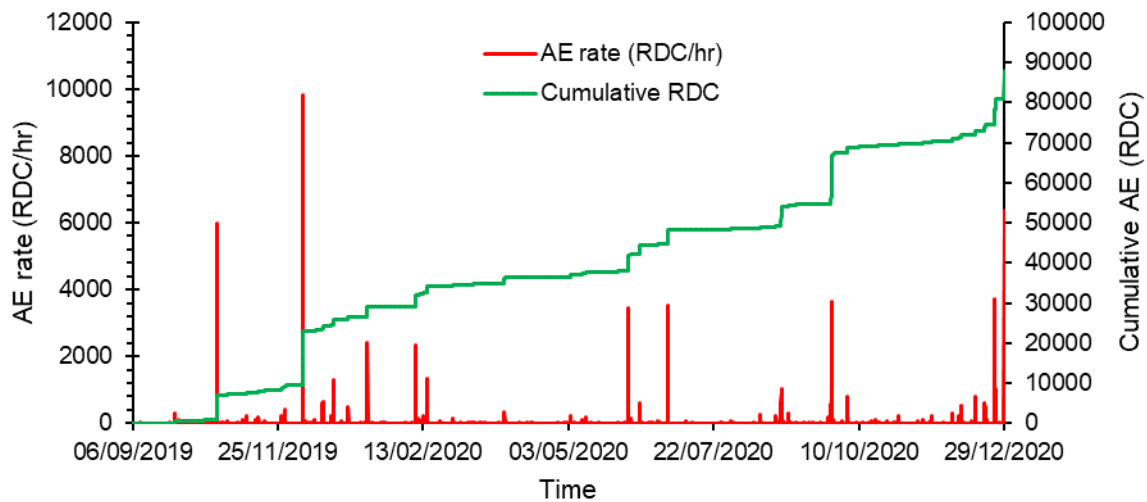
Figure 11.2 Cumulative AE (RDC) and AE rate (RDC/hr) time series at Flat Cliffs, Filey for the period September 2019 to December 2020.

- No data collected at piezometer in borehole C4a, A3 and D1, requires readings to be retaken.
- AE measurements collected to December 2020 do not show significant slope movements. The periods of elevated AE activity, which are shown by periods of increased gradient of the cumulative ring down count (RDC) record, could be indicative of deformations at a very slow rate and small magnitude. However, given no evidence for ground movement has been observed in the wider area or recorded in adjacent inclinometers, it is more likely that this increased AE activity was caused by extraneous noise (e.g. interference with the surface cover). The EA equipment has now been decommissioned following completion of the successful research and development project.
