Coastal Slope Monitoring Analysis Interpretation Report 17: July 2021 to November 2021

Document no: 11/2021
Revision no: 1

Scarborough Borough Council

Local Coastal Slope Monitoring Analysis
7 December 2021

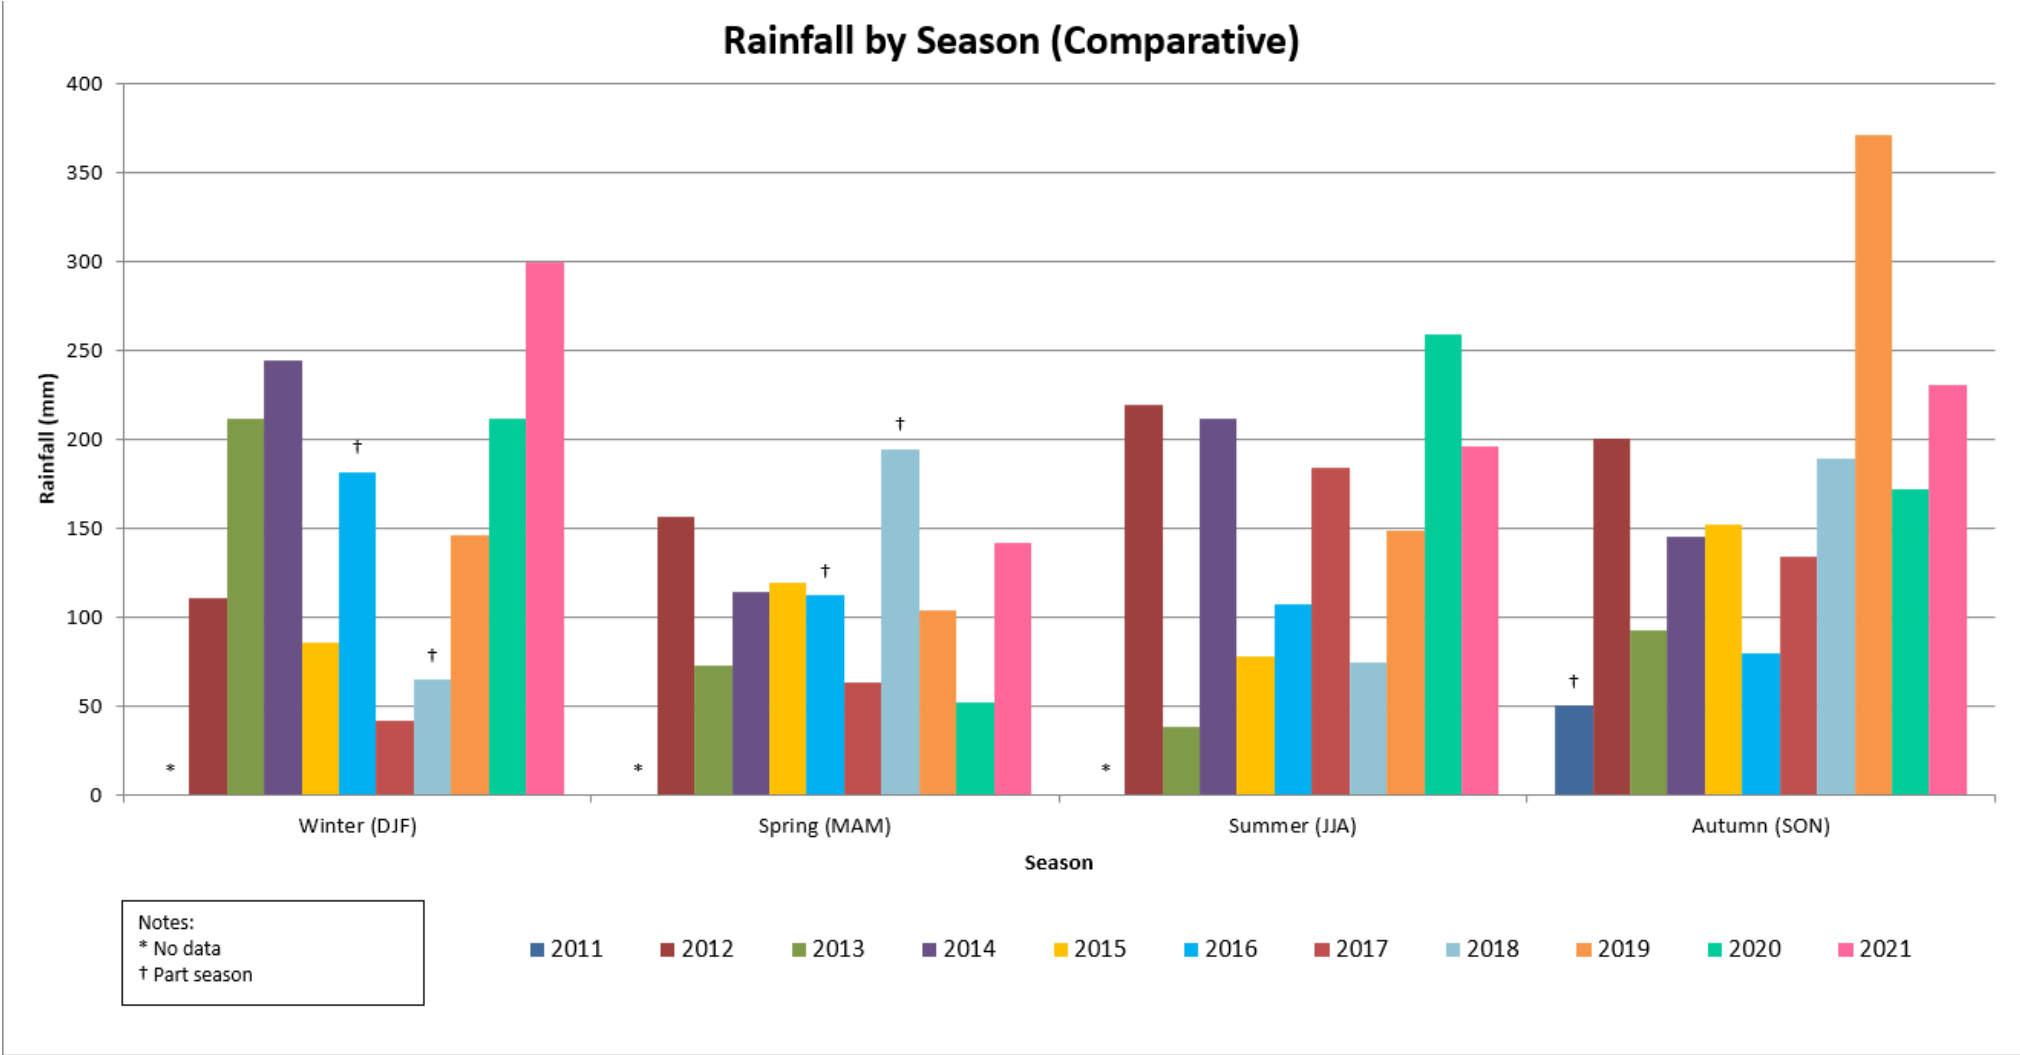
Figure 2-3 Seasonal rainfall comparison (2011 to 2021).

Seasonal totals are shown in Figure 2-3, highlighting that the wettest season tends to be winter, though this is closely followed by autumn. The spring season tends to be the driest, though data from this season is partially missing. The wettest season on record was the autumn of 2019 (i.e. September, October and

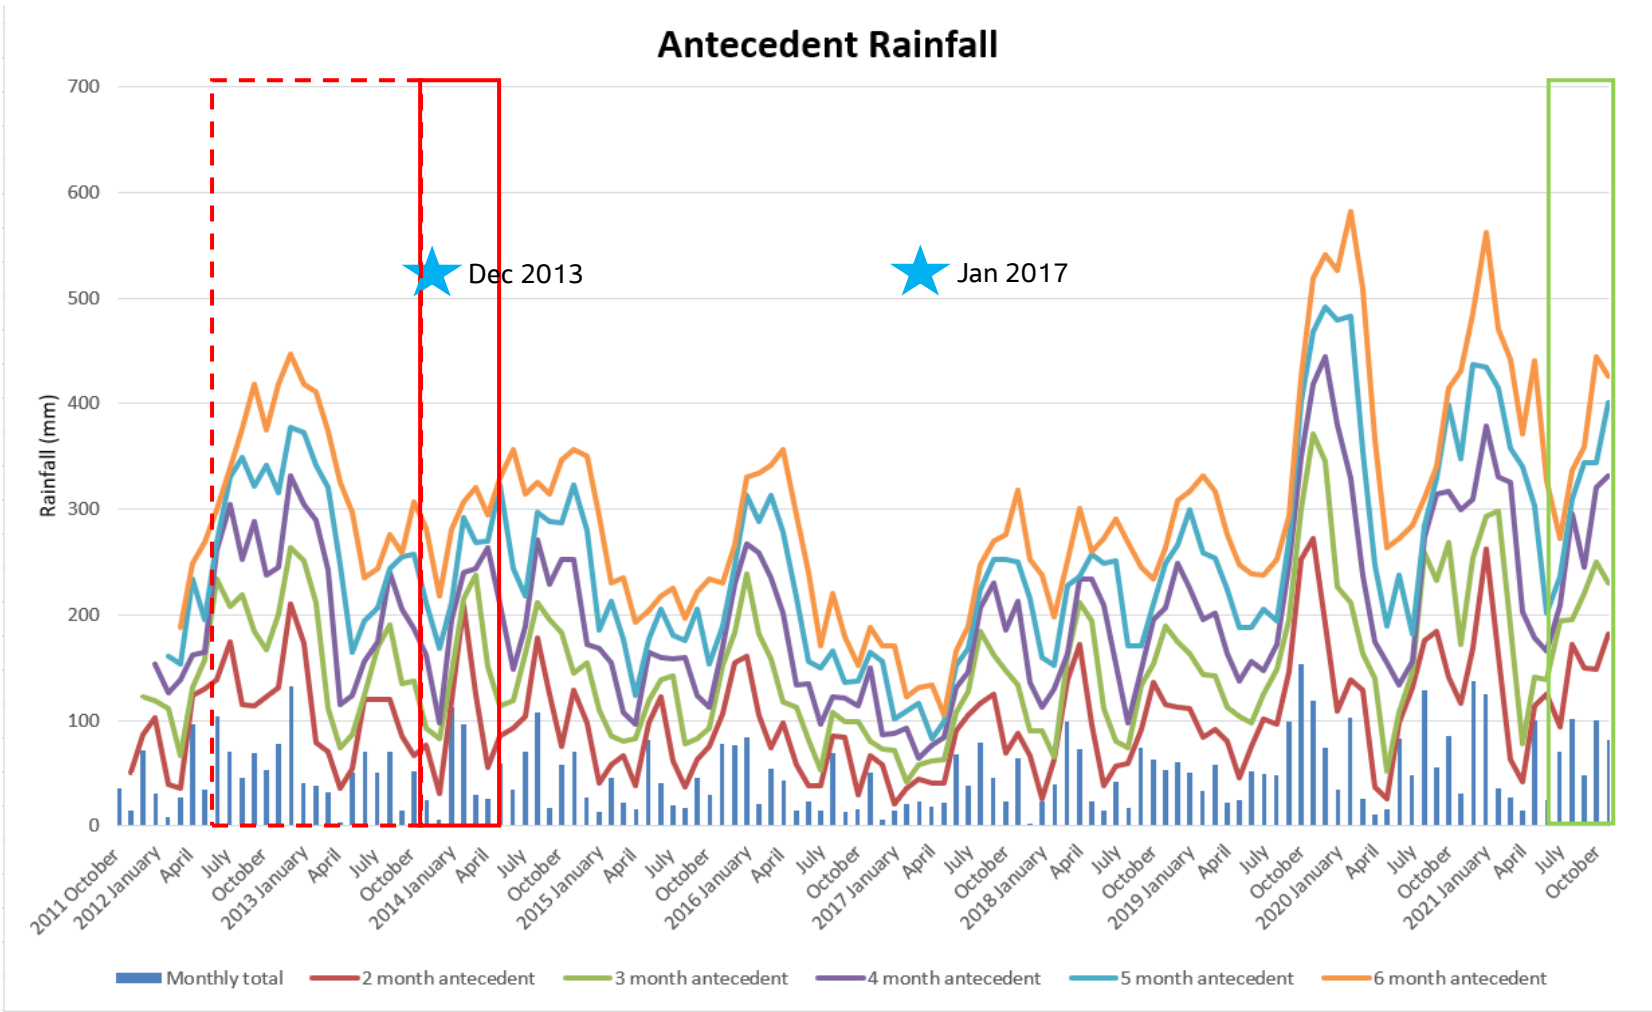
Figure 2-6 Monthly rainfall, two to six-month antecedent totals (2011 to 2021) and notable storm surges.

Ground movements were recorded at Scalby Mills during June–Dec 2010 and Feb–June 2011 at times of high groundwater levels. Slight movement was recorded during June 2012–Nov 2013 (red dashed box) with significant movements between November 2013 and May 2014 (solid red box). Current monitoring period shown by green box. Storm surges shown by blue stars.

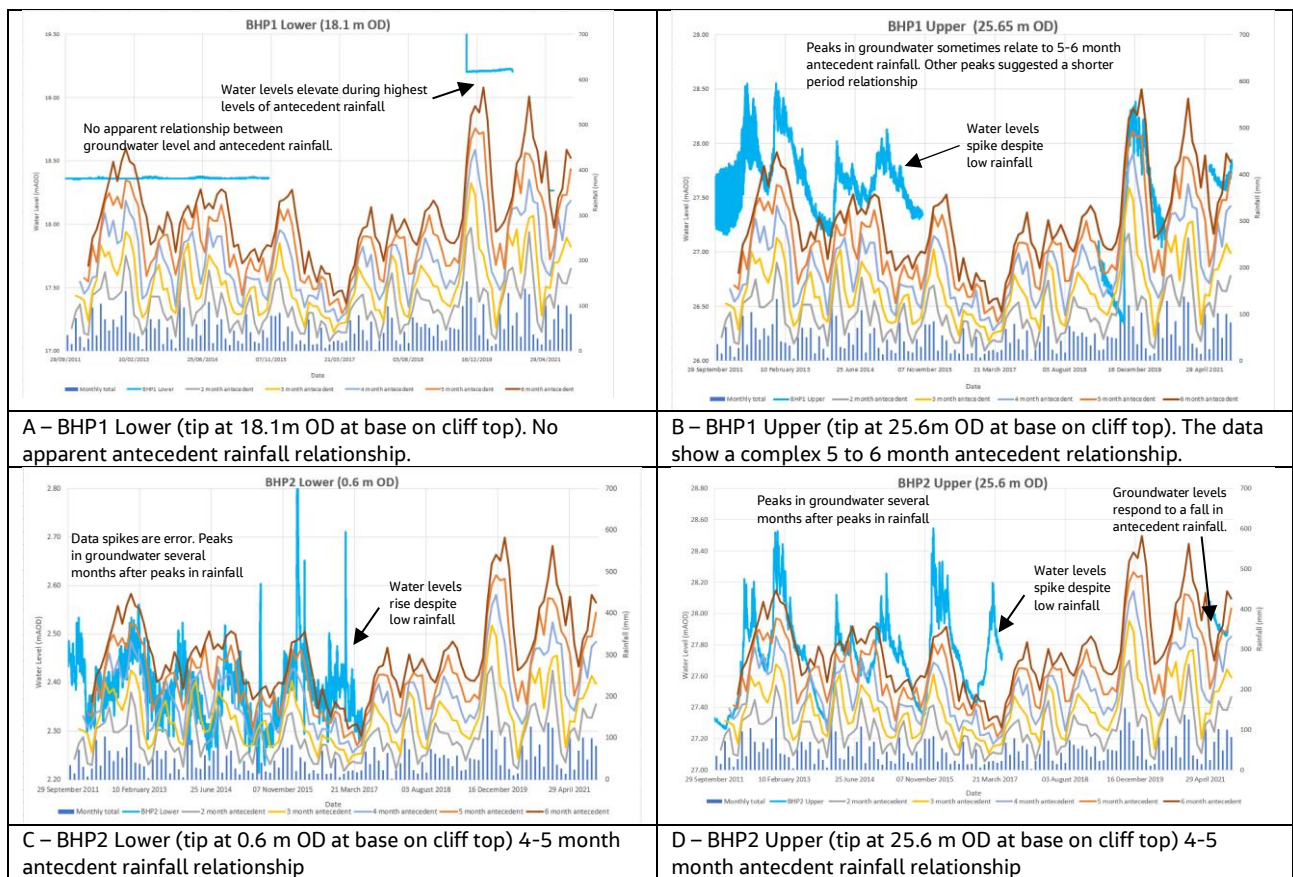
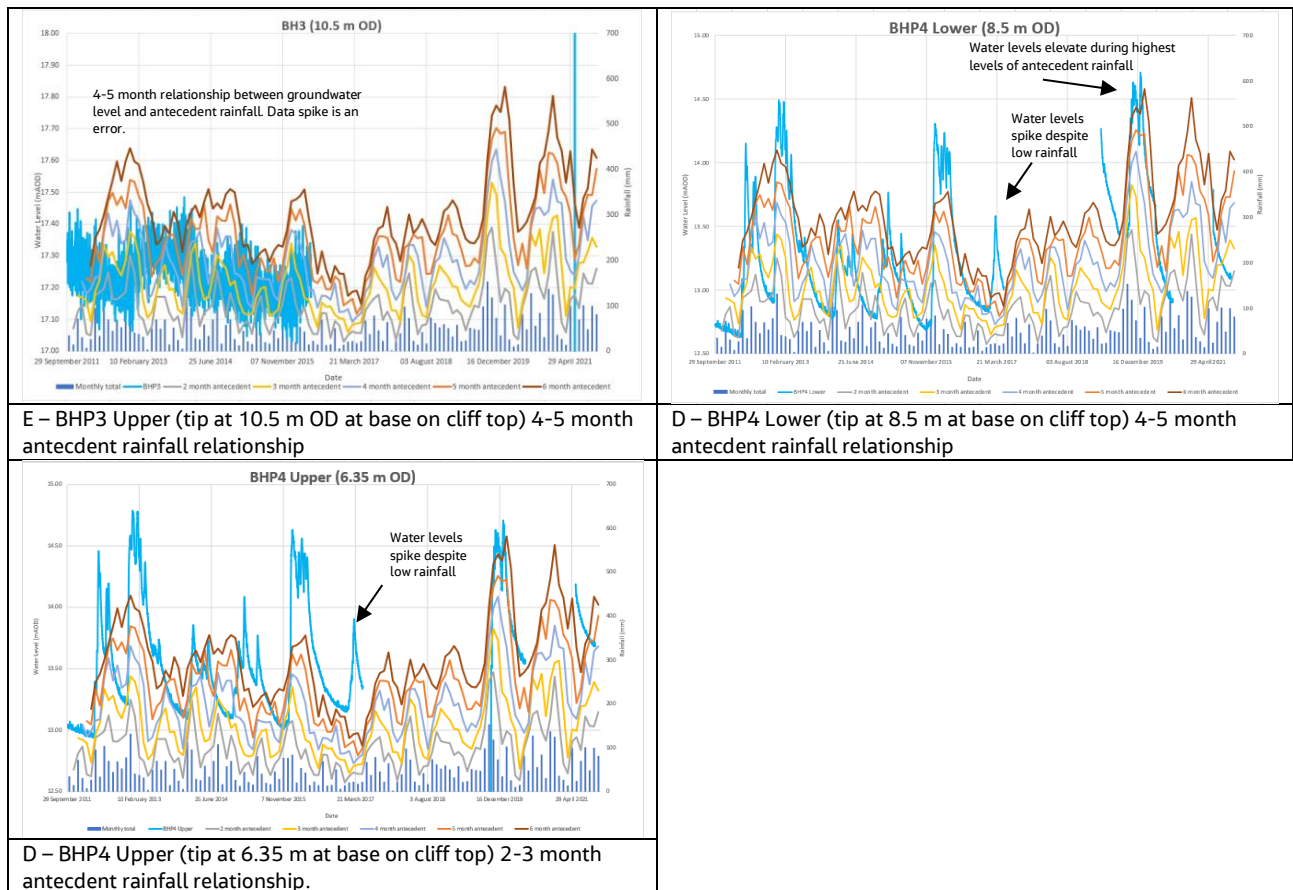
Figure 6-2 Relationship between groundwater levels and antecedent rainfall.

These data confirm that deeper piezometers take longer to respond to rainfall than shallower piezometers and suggests a 4 to 5 month antecedent rainfall relationship at depth, and a 2-3 month relationship for shallower piezometers. These long response times reflect the impermeable nature of the glacial sediments.

Multiple piezometers record a spike in groundwater levels in March 2017, during a period of low antecedent rainfall. This is likely due to a very intense local rainfall event at Scalby Ness that was not recorded at the meteorological station at Scarborough Spa.

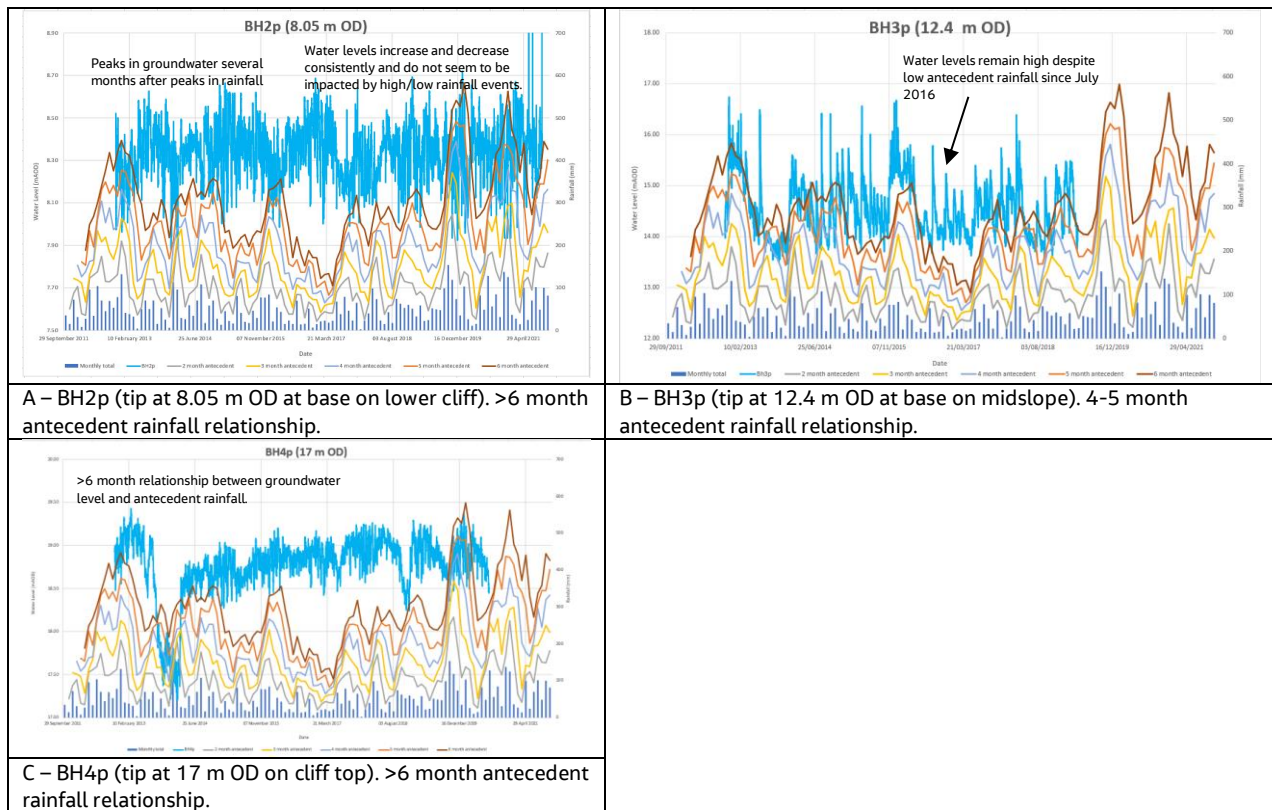
Figure 7-2 Relationship between groundwater levels and antecedent rainfall at Oasis Café.

Figure 7-2 presents the groundwater levels at Oasis Café recorded by each piezometer (with data logger) and antecedent rainfall. The relationships to different antecedent rainfall periods have been assessed visually.

BH3p, located mid-way down the cliff, has a 4-5 month antecedent rainfall relationships. In contrast BH2p and BH4p, at the base and top of the cliff respectively, appear to have an antecedent rainfall relationship greater than 6 months. These complex spatial relationships probably reflect variation in the glacial sediments that are typically low permeability clays, but locally high permeability sands.

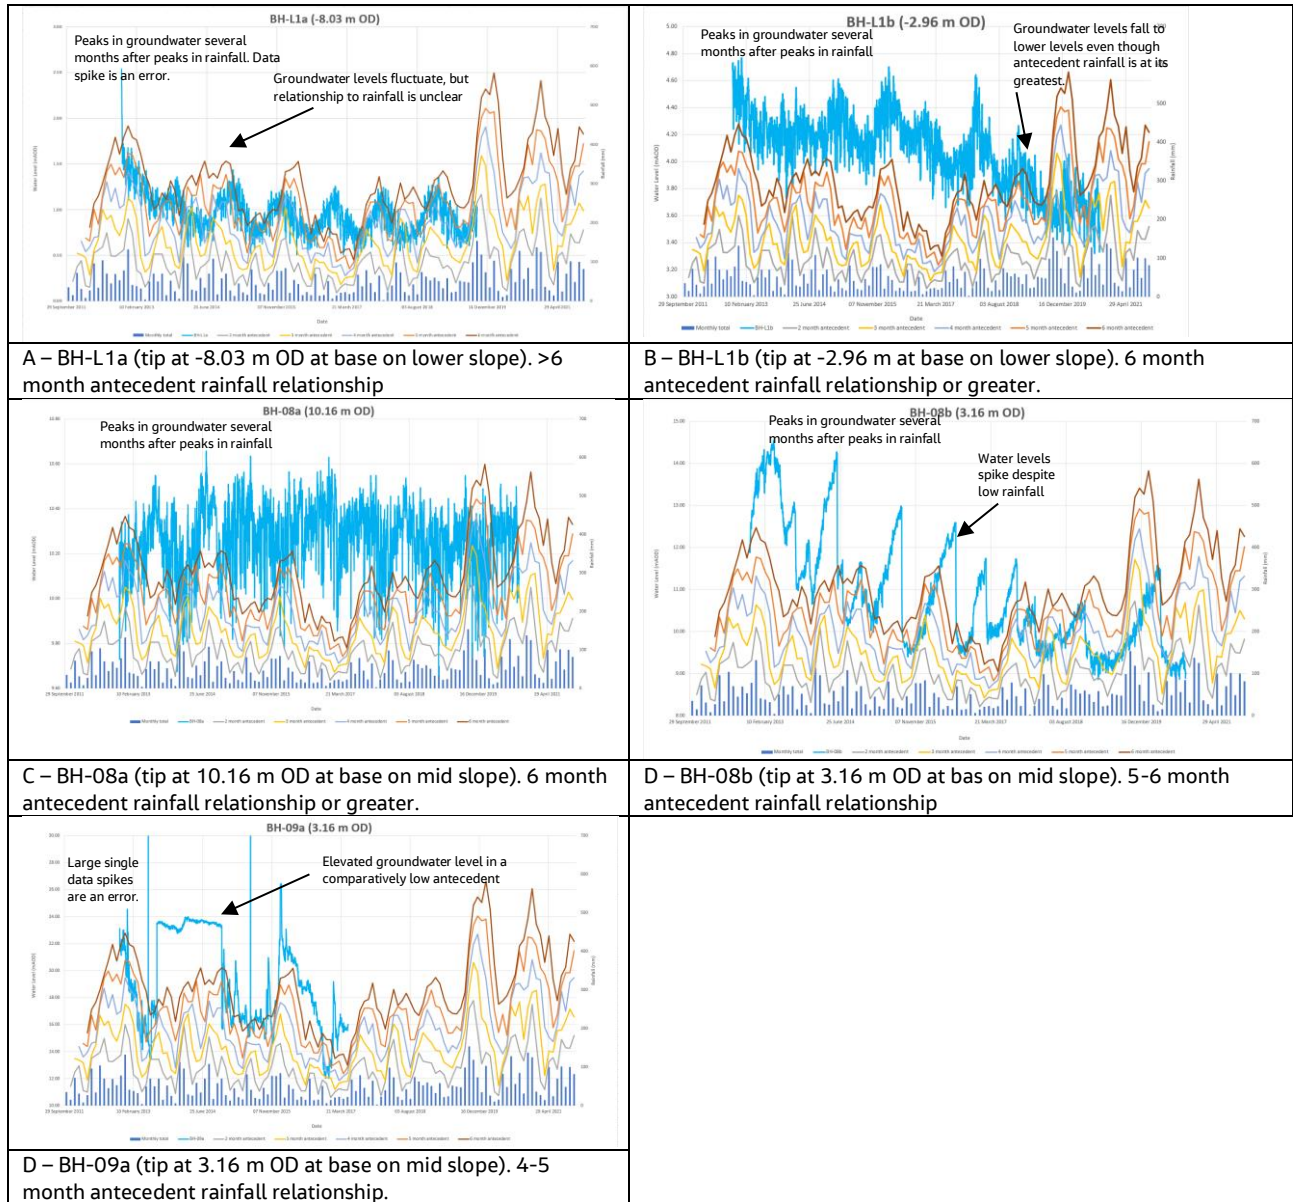
Figure 8-2 Relationship between groundwater levels and antecedent rainfall at the Holmes

The piezometers at The Holms show a lagged response to above average rainfall conditions, with only BH8a showing a rapid response. Groundwater levels in BH8a responded rapidly to higher than average rainfall in May 2015, March and November 2016. Levels fell during winter 2016/2017 following months of dry conditions then stabilised following a wet summer in 2017. Levels increased again over the drier than average winter 2017/18 and have stabilised at average levels following this. Other boreholes show a continuation of past fluctuating or steady levels of groundwater, suggesting they respond to several months' antecedent rainfall. Over the whole record, BH8b shows a different pattern of gradual highs followed by sharp falls, however, movements are not shown in the inclinometer upslope at BH10A. There is no clear response in any of the boreholes to the extreme rainfall events experienced on 23 August 2017, 20 September 2018 or during autumn. During this monitoring period, the response to the wetter than average conditions in summer are not clear at the functioning piezometers. The steady and falling groundwater levels recorded may be representative of 3-month antecedent rainfall conditions.

Figure 8-2 presents the groundwater levels at the Holms recorded by each piezometer (with a data logger) with enough continuous data and highlights the best relationship to antecedent rainfall, which has been assessed visually by plotting various antecedent rainfall totals against the piezometer records. BH-L1a, BH-L1b and BH-08a all have an observed antecedent rainfall relationship of greater than 6-months, whereas BH-08b and BH-09a have 5-6 month and 4-5 month antecedent rainfall relationships respectively. A groundwater level spike at BH-08b in late 2016 does not coincide with antecedent rainfall levels, which probably reflects a very localised rainfall event at The Holms.

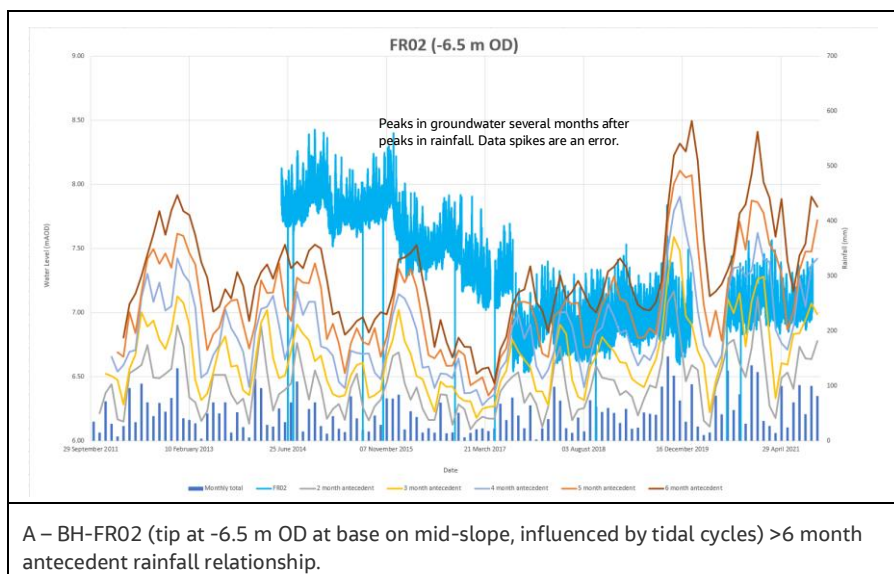
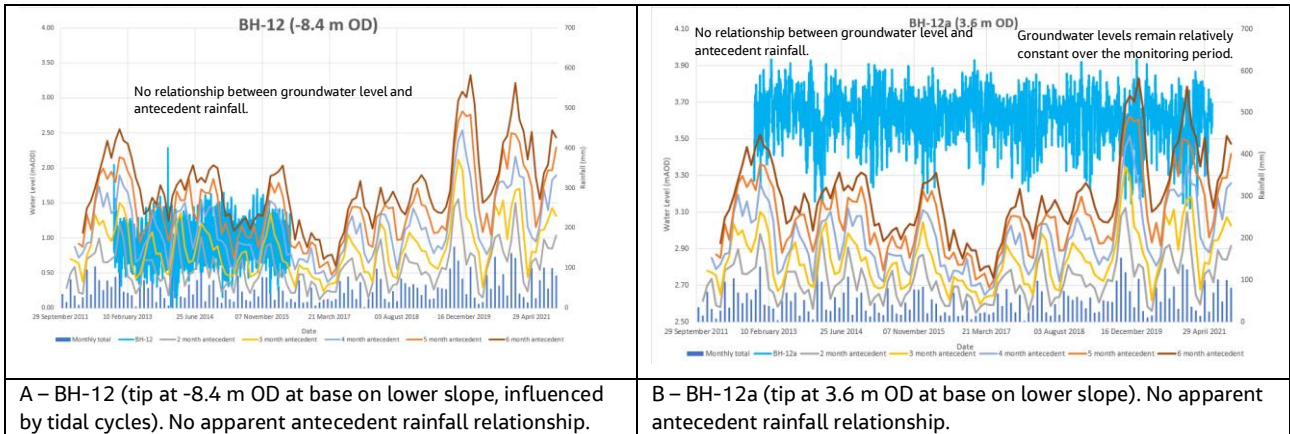
At St Nicholas cliff (Figure 9-2) BH-FR02 shows an antecedent rainfall relationship that appears greater than 6 months. At Spa Chalet (Figure 9-3), antecedent rainfall relationships are unclear, with responses often appearing following 6 months antecedent rainfall and greater. The picture is similar at the Spa (Figure 9-4), where BH-01a Spa and BH-01 Prom also show responses of greater than 6 months. In contrast BH-H5, which is at the base of the slope behind the Spa building, suggests an antecedent rainfall relationship of 4 months. All other automated piezometers at the Spa do not have an apparent antecedent rainfall relationship. At South Cliff Gardens (Figure 9-5), the antecedent rainfall relationship is greater than 6 months at BH-D2a, BH-E2a and BH-E2b. Relationships at other automated piezometers at the South Cliff Gardens remain complex.

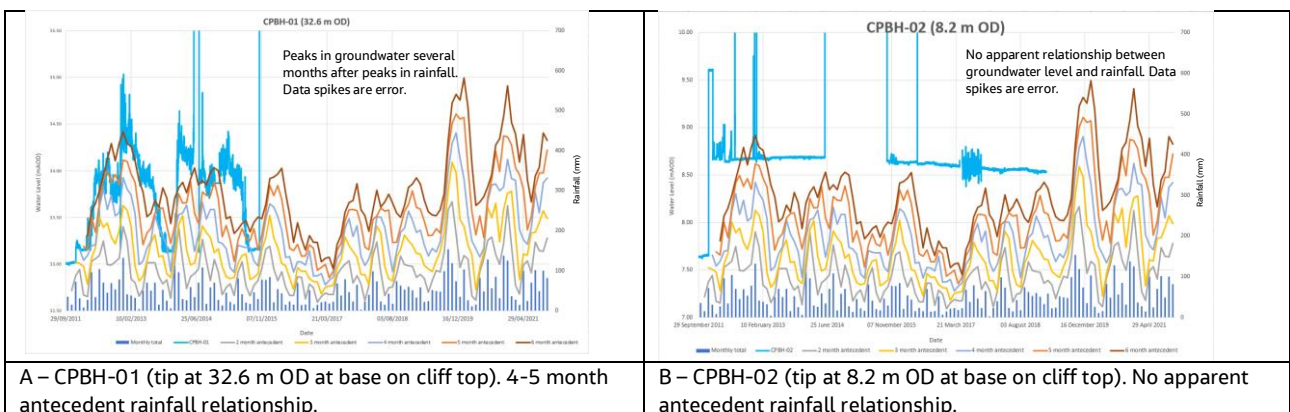
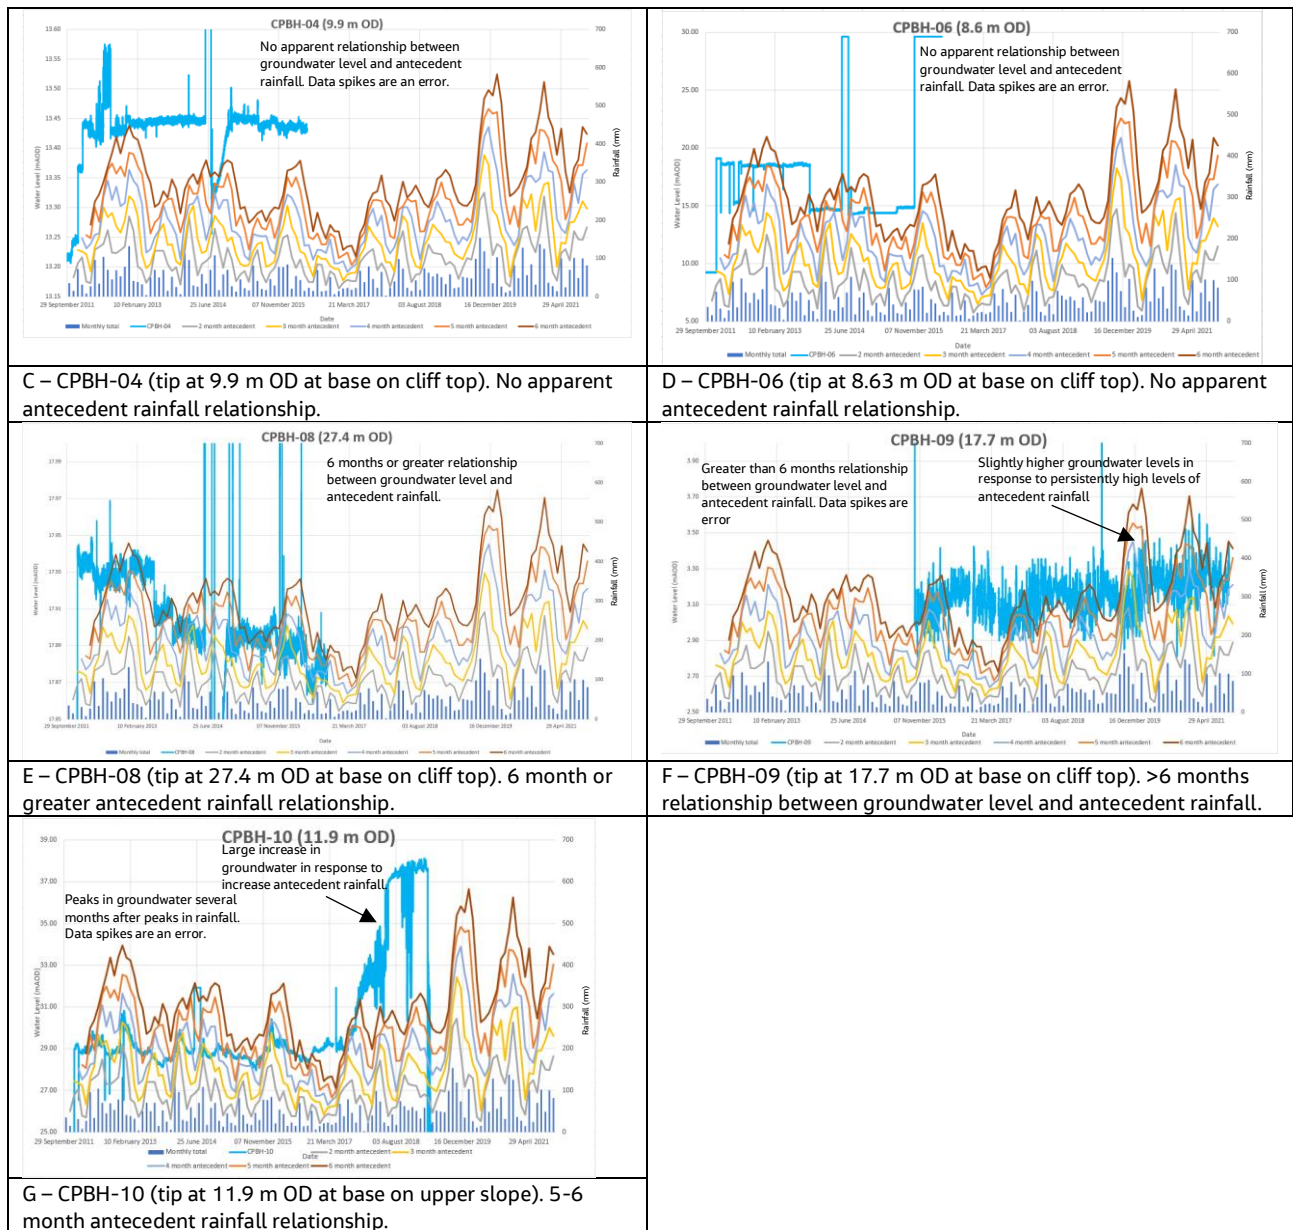
Figure 10-2 Relationship between groundwater levels and antecedent rainfall at Filey Town.

Figure 10-2 presents the groundwater levels at Filey town recorded by each piezometer (with a data logger) to highlight the relationships to antecedent rainfall. CPBH-01, CPBH-09 and CPBH-10 have antecedent rainfall relationships of 4-5 months, greater than 6 months and 5-6 months, respectively. Other automated piezometers at Filey Town have an unclear antecedent rainfall relationship.

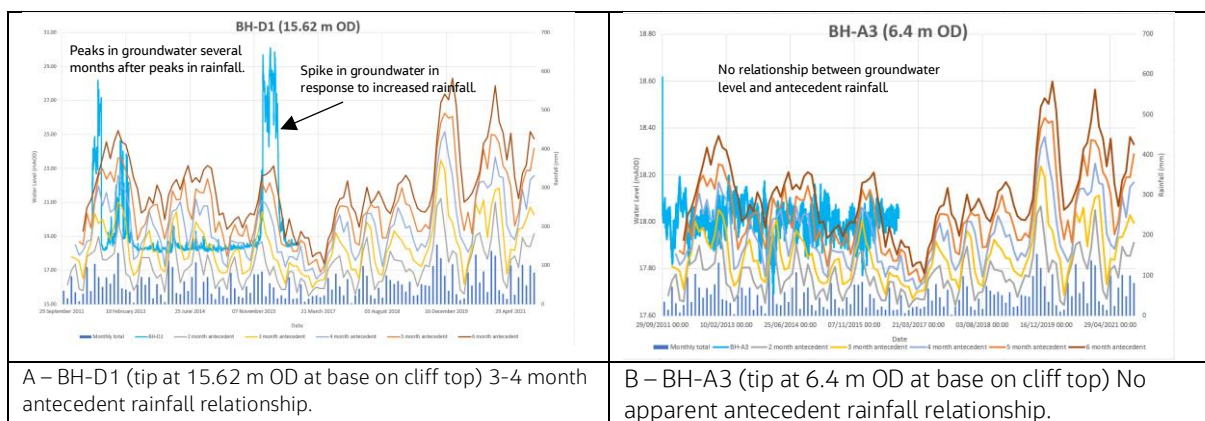
Figure 11-2 Relationship between groundwater levels and antecedent rainfall at Filey Flat Cliffs.

Figure 11-2 presents the groundwater levels at Filey Flat Cliffs recorded by each piezometer (with a data logger) to highlight the relationships to antecedent rainfall. BH-D1 has an antecedent rainfall relationship of 3-4 months. BH-A3 has an unclear antecedent rainfall relationship.
