# Interpretation Report 4: December 2014 to June 2015

*Prepared for*

Scarborough  
Borough Council

August 2015

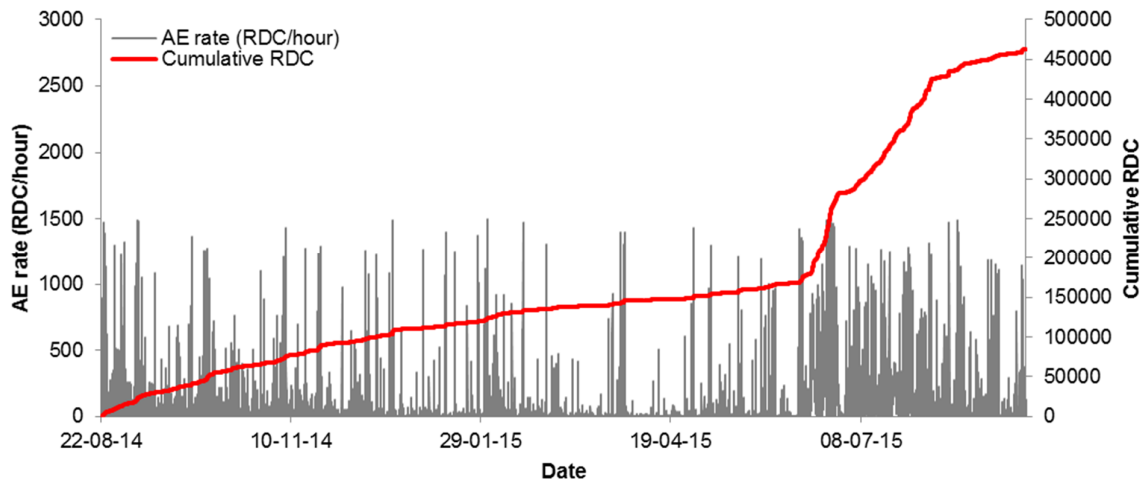
Figure 9.2. AE rate- and cumulative AE-time series measurements at Scarborough Spa for the period August 2014 to September 2015.

- Acoustic emissions (AE) detected subtle and do not suggest slope movement. Fluctuations in the data represent rainfall-induced groundwater flows interacting with the wave guide. (Figure 9.2)

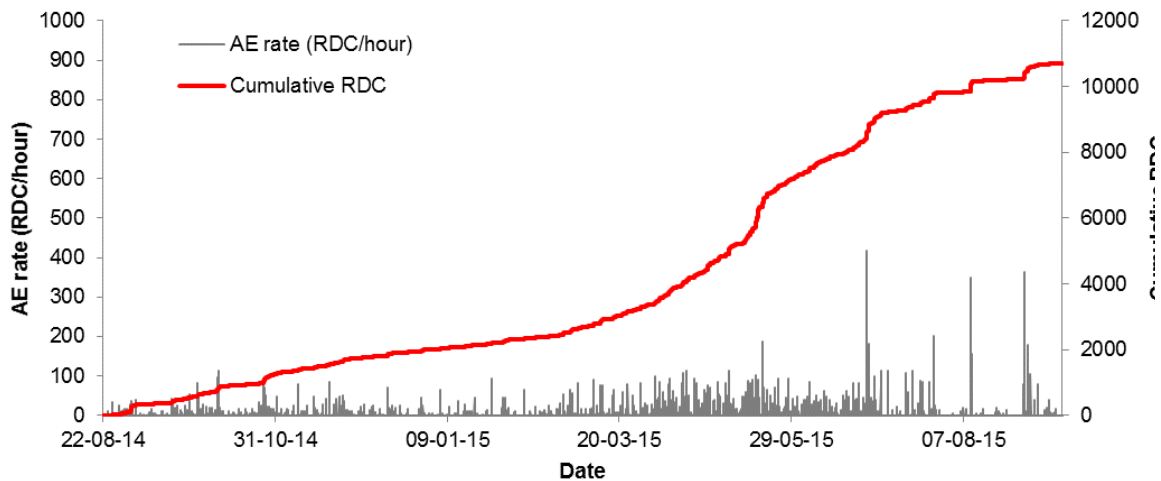
Figure 11.2 Acoustic emission (AE) rate- and cumulative AE time series measurements at Flat Cliffs for the period August 2014 to September 2015

- No evidence for ground movements is shown by inclinometers.
- Acoustic inclinometer data for the period August 2014 to September 2015 do not show any significant slope movement (Figure 11.2). Fluctuations in the data represent rainfall-induced groundwater flows interacting with the wave guide.
- Groundwater data show no significant change.
