Interpretation Report 7: June 2016 to November 2016

Prepared for
Scarborough
Borough Council

January 2017

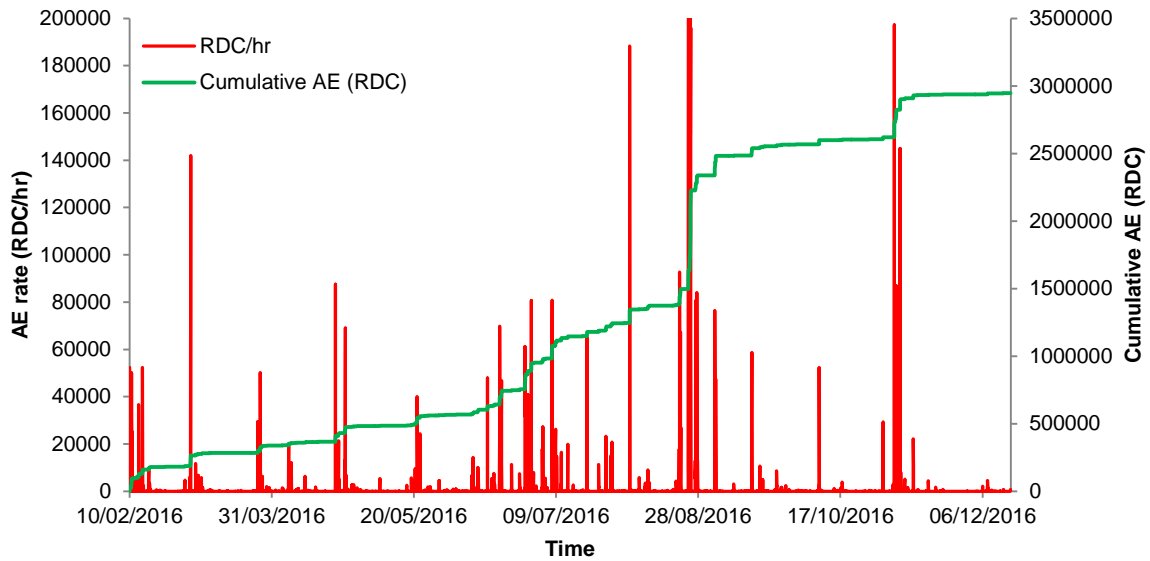
Figure 9.2. Cumulative AE (RDC) and AE rate (RDC/hr) time series at Scarborough Spa for the period February 2016 to December 2016.

- Acoustic emissions (AE) detected are negligible and do not suggest slope movement. Fluctuations in the data represent the specific hydrogeological conditions at this site (i.e. time dependent seepage conditions following rainfall events). This is supported by the inclinometer measurements at BH105, which show negligible movement. (Figure 9.2 and 9.3)

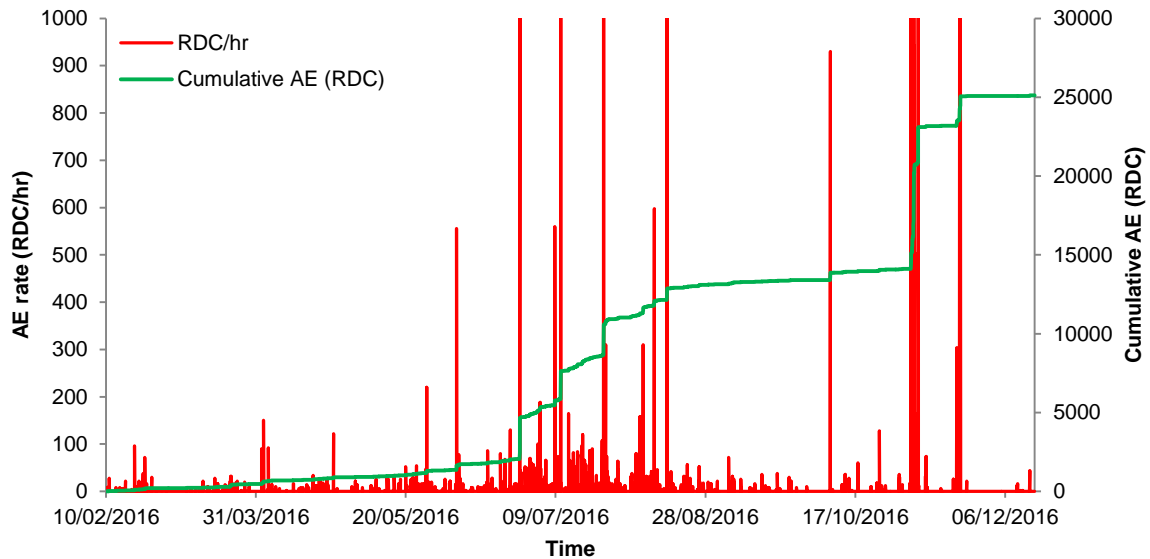
Figure 11.2 Cumulative AE (RDC) and AE rate (RDC/hr) time series at Flat Cliffs, Filey for the period February 2016 to December 2016.

- No evidence for ground movements is shown by inclinometers.
- AE measurements between February 2016 and August 2016 do not show significant slope movements. The period of elevated AE activity after June 2016 could be indicative of minor deformations of a very slow rate and magnitude. It is likely that this is a function of the deterioration of the cover lid generating spurious AE. The cover lid has been replaced. Bursts of high activity in November are thought to be a result of interference with the equipment by the public.
- Groundwater data show no significant change except for Borehole D1 near the top of the slope adjacent to the main access road. Here, water levels have decreased significantly since Winter 2015/16.
- No data collected at piezometer in borehole C4a, and requires readings to be retaken.
