# Interpretation Report 8: December 2016 to May 2017

*Prepared for*  
Scarborough  
Borough Council

October 2017

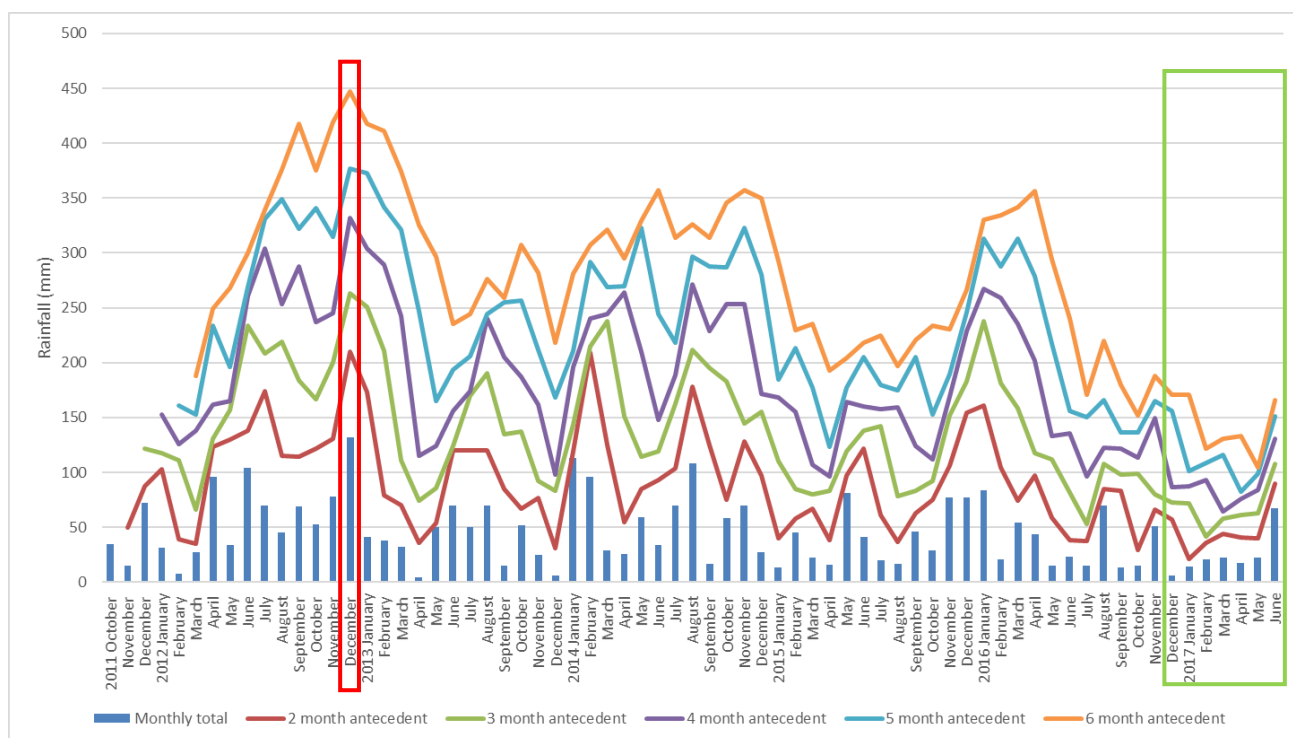
Antecedent rainfall over the current December-May monitoring period show peaks that are significantly lower than that seen in December 2012 and with a similar pattern to the previous June to November monitoring period. It is therefore concluded there is a low likelihood of rainfall-induced landslides occurring in the monitoring period.

Figure 2.6. Monthly rainfall and two to six month antecedent totals (2011 to 2017). Ground movements were recorded at Scalby Mills during December 2012 (red box). Current monitoring period shown by green box.

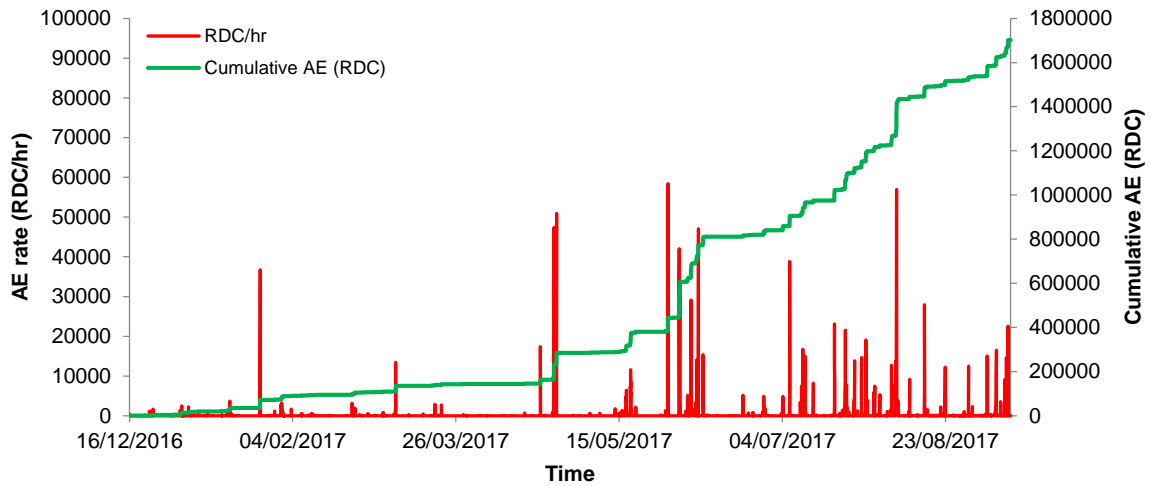
- Acoustic emissions (AE) detected are negligible and do not suggest slope movement. Fluctuations in the data represent the specific hydrogeological conditions at this site (i.e. time dependent seepage conditions following rainfall events). This is supported by the inclinometer measurements at BH105, which show negligible movement. (Figure 9.2 and 9.3)

Figure 9.2. Cumulative AE (RDC) and AE rate (RDC/hr) time series at Scarborough Spa for the period December 2016 to September 2017.

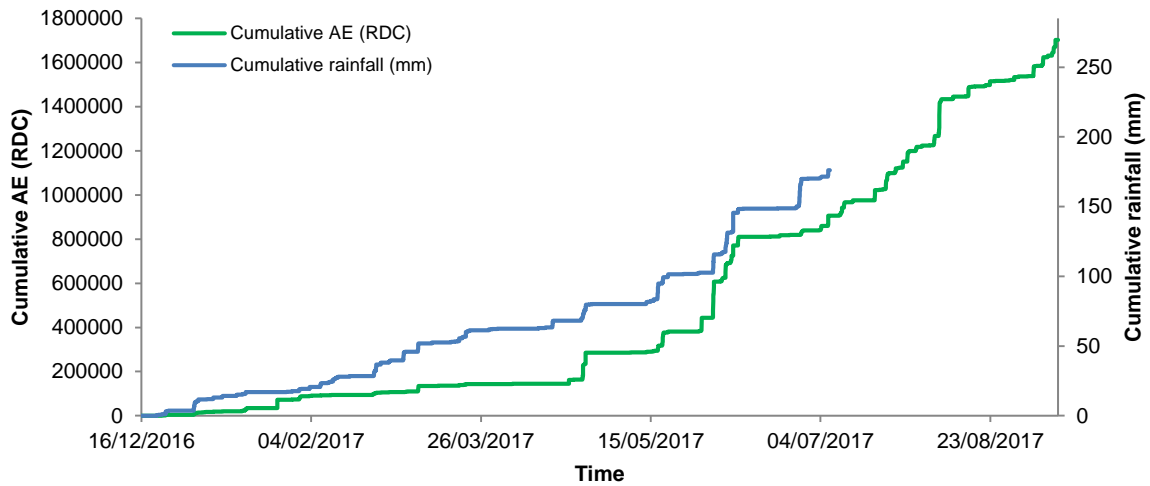
Figure 9.3. Cumulative AE (RDC) and cumulative rainfall time series at Scarborough Spa for the period December 2016 to September 2017.

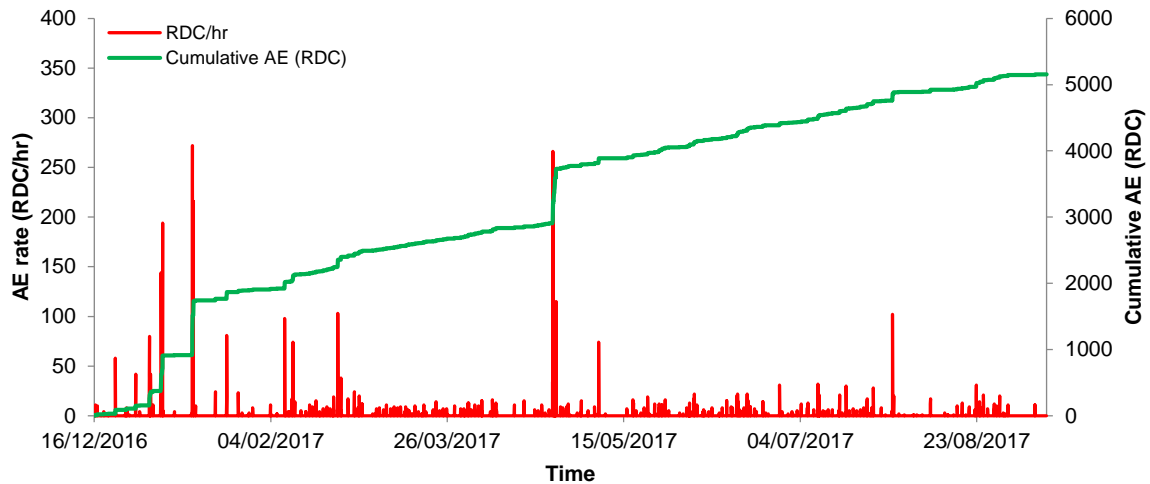
- No evidence for ground movements is shown by inclinometers.
- AE measurements between December 2016 and September 2017 do not show significant slope movements. The periods of elevated AE activity, which are shown by periods of increased gradient of the cumulative RDC record, could be indicative of deformations but of a very slow rate and small magnitude. However, it is more likely that this increased AE activity was caused by extraneous noise (e.g. interference with the surface cover).
- Groundwater data show no significant change. At borehole D1 near the top of the slope adjacent to the main access road water levels remain steady after decreasing significantly since winter 2015/16.
- No data collected at piezometer in borehole C4a, and requires readings to be retaken.

Figure 11.2 Cumulative AE (RDC) and AE rate (RDC/hr) time series at Flat Cliffs, Filey for the December 2016 to September 2017.

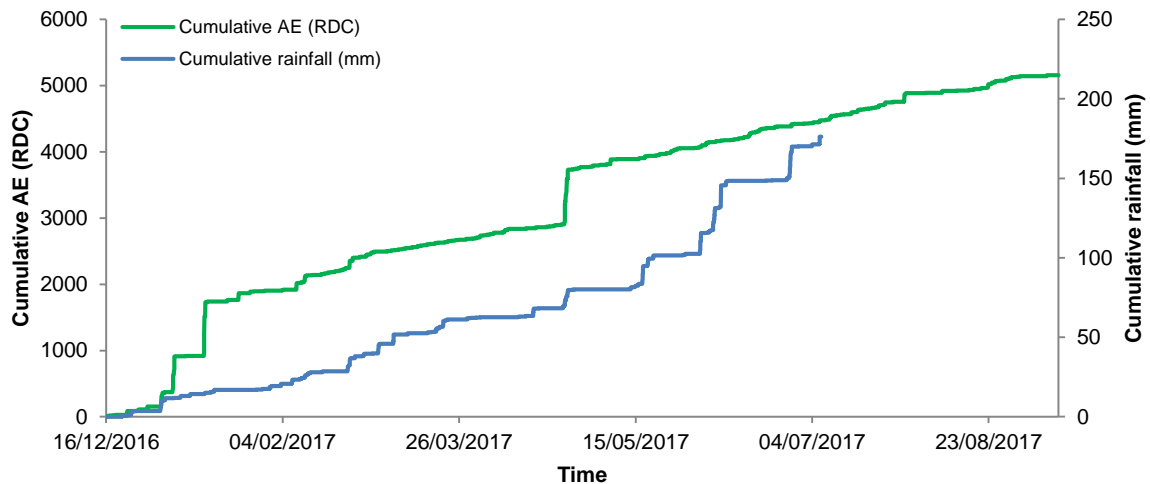
Figure 11.3 Cumulative AE (RDC) and cumulative rainfall time series at Flat Cliffs, Filey for the period December 2016 to September 2017.
