# Interpretation Report 9: June 2017 to November 2017

*Prepared for*  
Scarborough  
Borough Council

February 2018

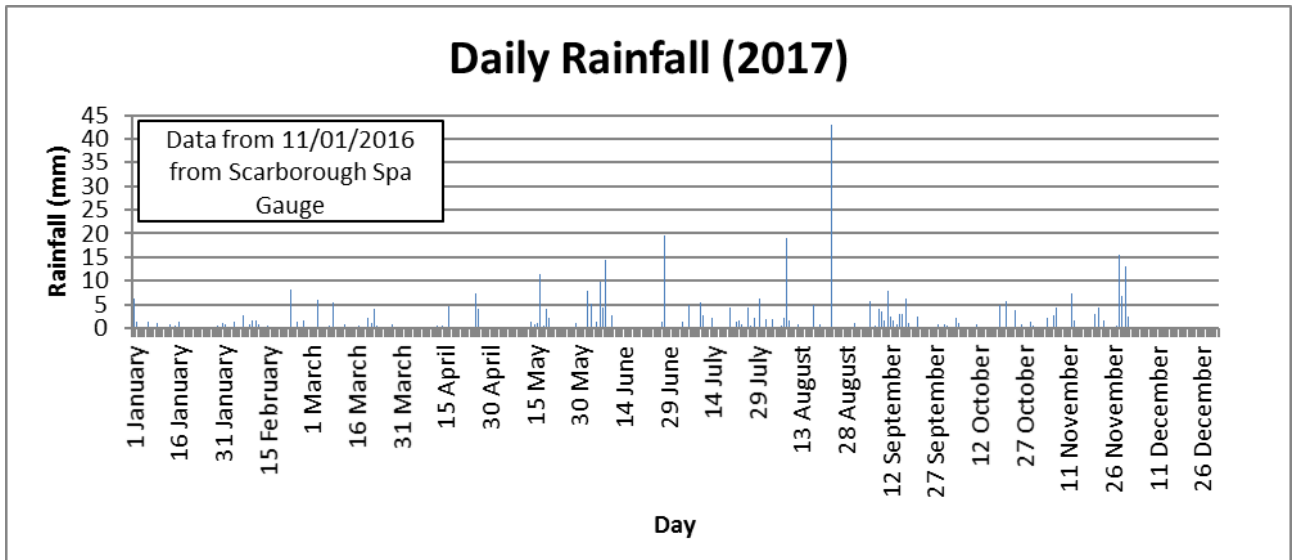
Figure 2.2 Daily rainfall recorded at Scarborough Spa during 2017. Note the exceptional rainfall on 23 August, which was recorded across the Yorkshire region on this day.

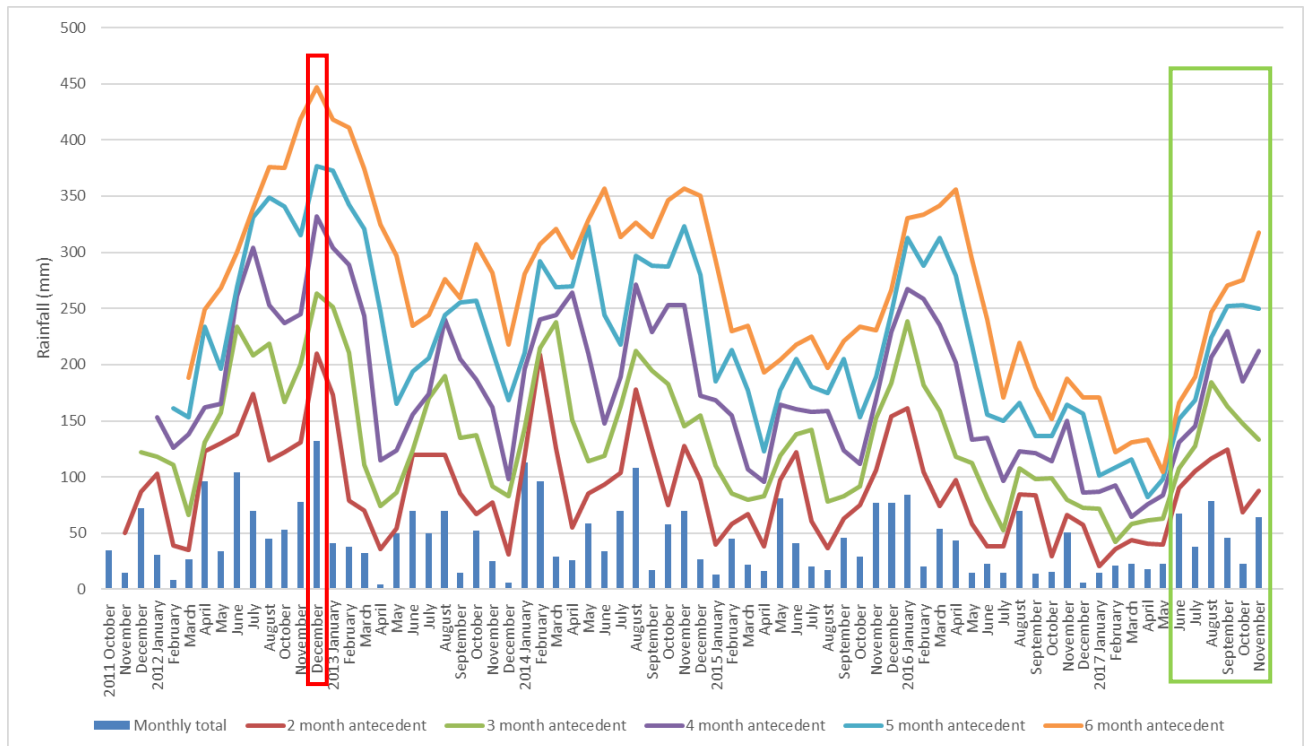
Antecedent rainfall over the current June-November monitoring period show peaks that are lower than that seen in December 2012, despite the exceptional event of 23 August, however a rapidly increasing trend in antecedent rainfall over the monitoring period is evident, unlike the pattern to the previous June to November monitoring period which saw a falling trend. Antecedent rainfall totals do not reach those seen in December 2012 and it is therefore concluded there is a low likelihood of rainfall-induced landslides occurring in the monitoring period. However, the antecedent

rainfall at the end of this monitoring period is relatively high, meaning if the winter of 2017/8 is wet, there would be an increased likelihood of ground movement in the next monitoring period.

Figure 2.6. Monthly rainfall and two to six month antecedent totals (2011 to 2017). Ground movements were recorded at Scalby Mills during December 2012 (red box). Current monitoring period shown by green box.

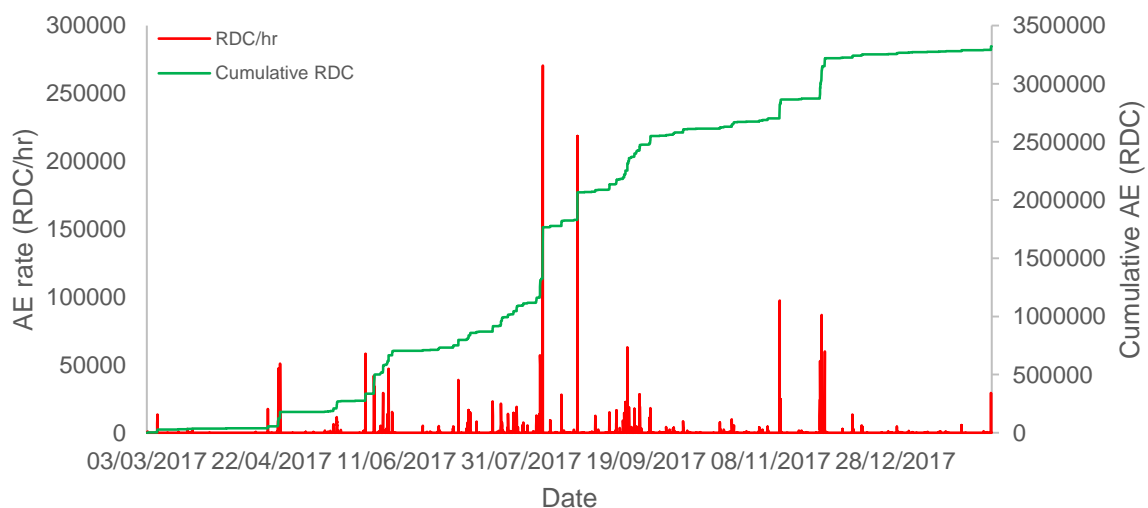
- Boreholes BH102a and BH102b have been filled with tarmac and the piezometers are no longer functional.
- Acoustic emissions (AE) detected are negligible and do not suggest slope movement. Fluctuations in the data represent the specific hydrogeological conditions at this site (i.e. time dependent seepage conditions following rainfall events). This is supported by the inclinometer measurements at BH105, which show negligible movement. (Figure 9.2 and 9.3)

Figure 9.2. Cumulative AE (RDC) and AE rate (RDC/hr) time series at Scarborough Spa for the period March 2017 to February 2018.

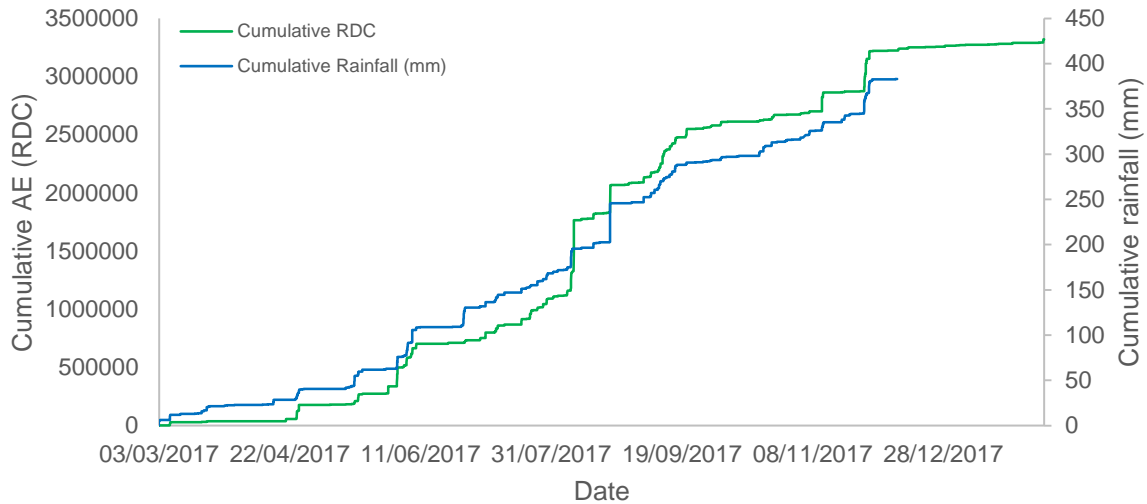
Figure 9.3. Cumulative AE (RDC) and cumulative rainfall time series at Scarborough Spa for the period March 2017 to February 2018.

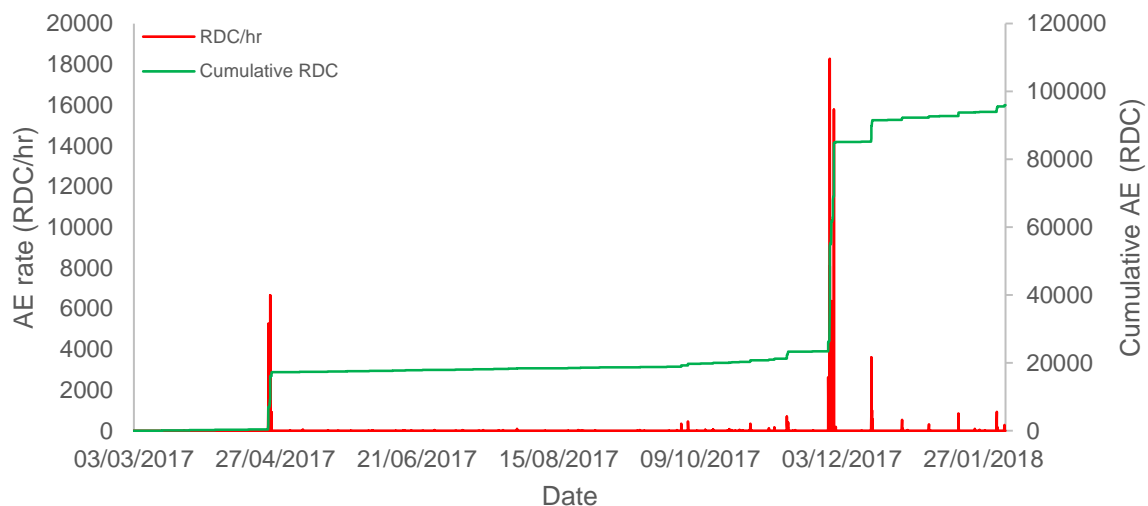
Figure 11.2 Cumulative AE (RDC) and AE rate (RDC/hr) time series at Flat Cliffs, Filey for the March 2017 to February 2018.

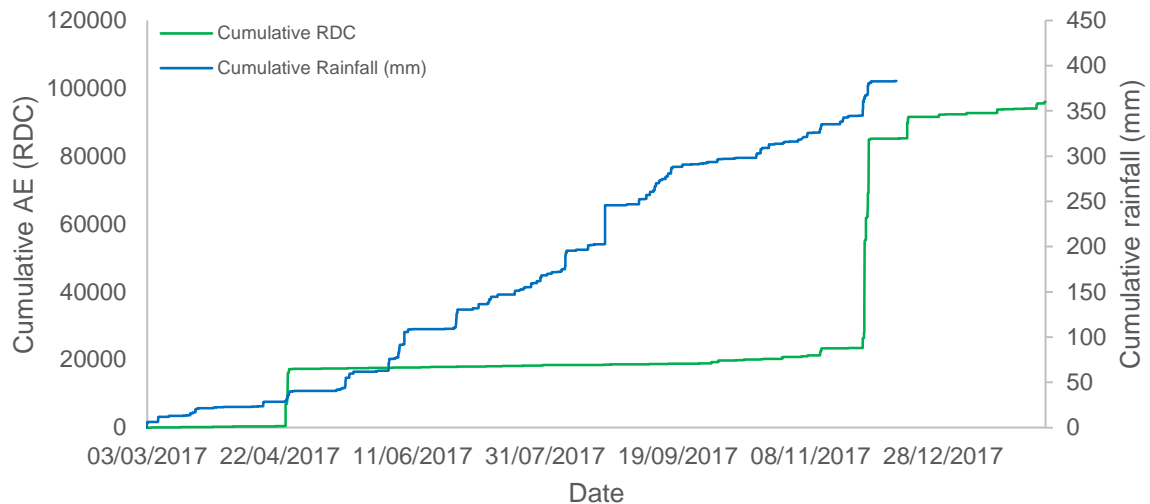
Figure 11.3 Cumulative AE (RDC) and cumulative rainfall time series at Flat Cliffs, Filey for the period March 2017 to February 2018.
