Scarborough Borough Council
Cayton Bay Cliff Stability Assessment
Ground Investigation and Appraisal of
Engineering Stabilisation Options

April 2009

Halcrow Group Limited

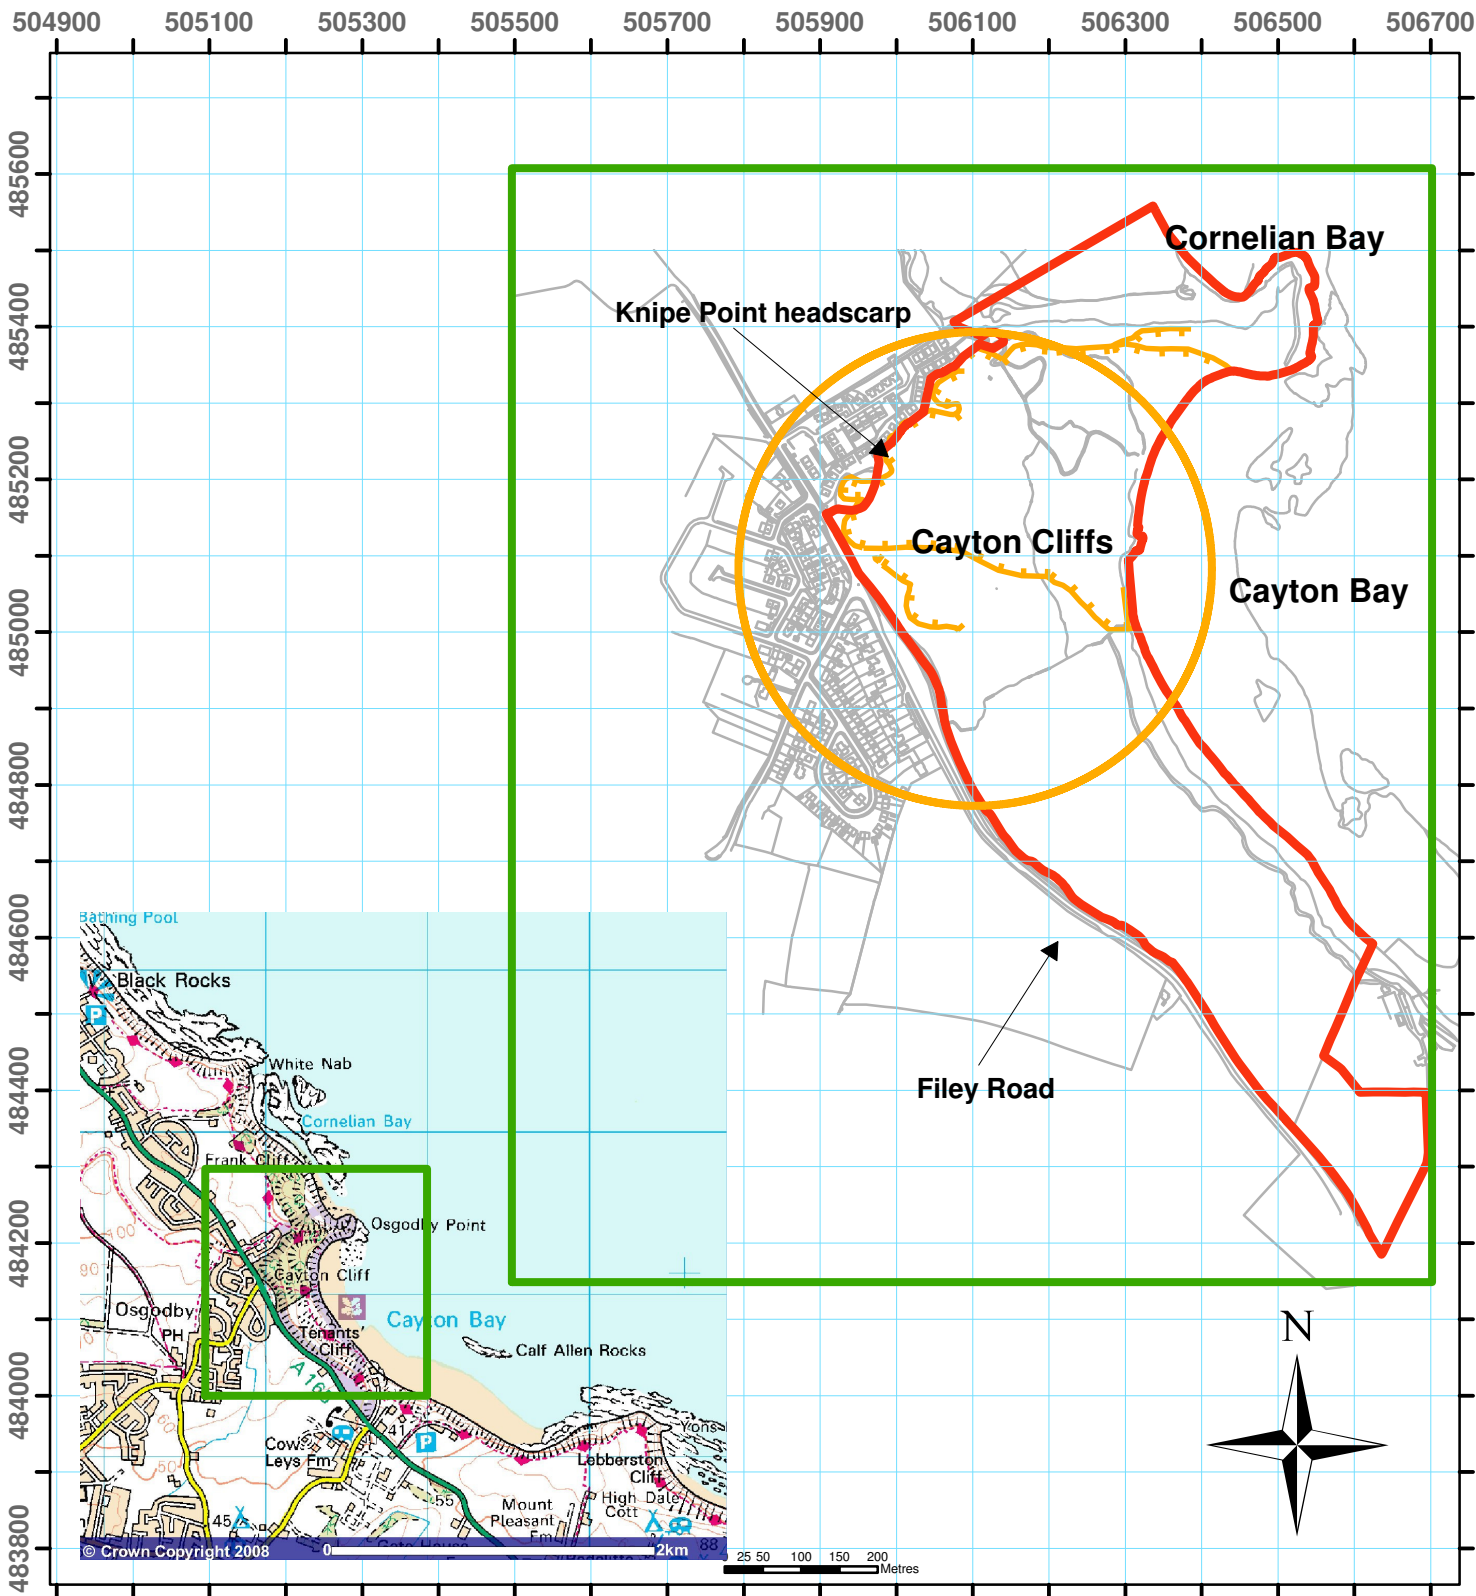
Figure 3. Geomorphological map

A geomorphological interpretation is presented in *Figure 3* based on the surface morphology and limited published geological information. Results suggest that an ancient deep-seated translational failure has developed at Cayton Cliffs as depicted by the steep distinct 'block and scarp' morphology which is apparent throughout the site. This morphology has subsequently been degraded by glacial till deposits which have led to the development of large mudslides which are active in the shallow soils.

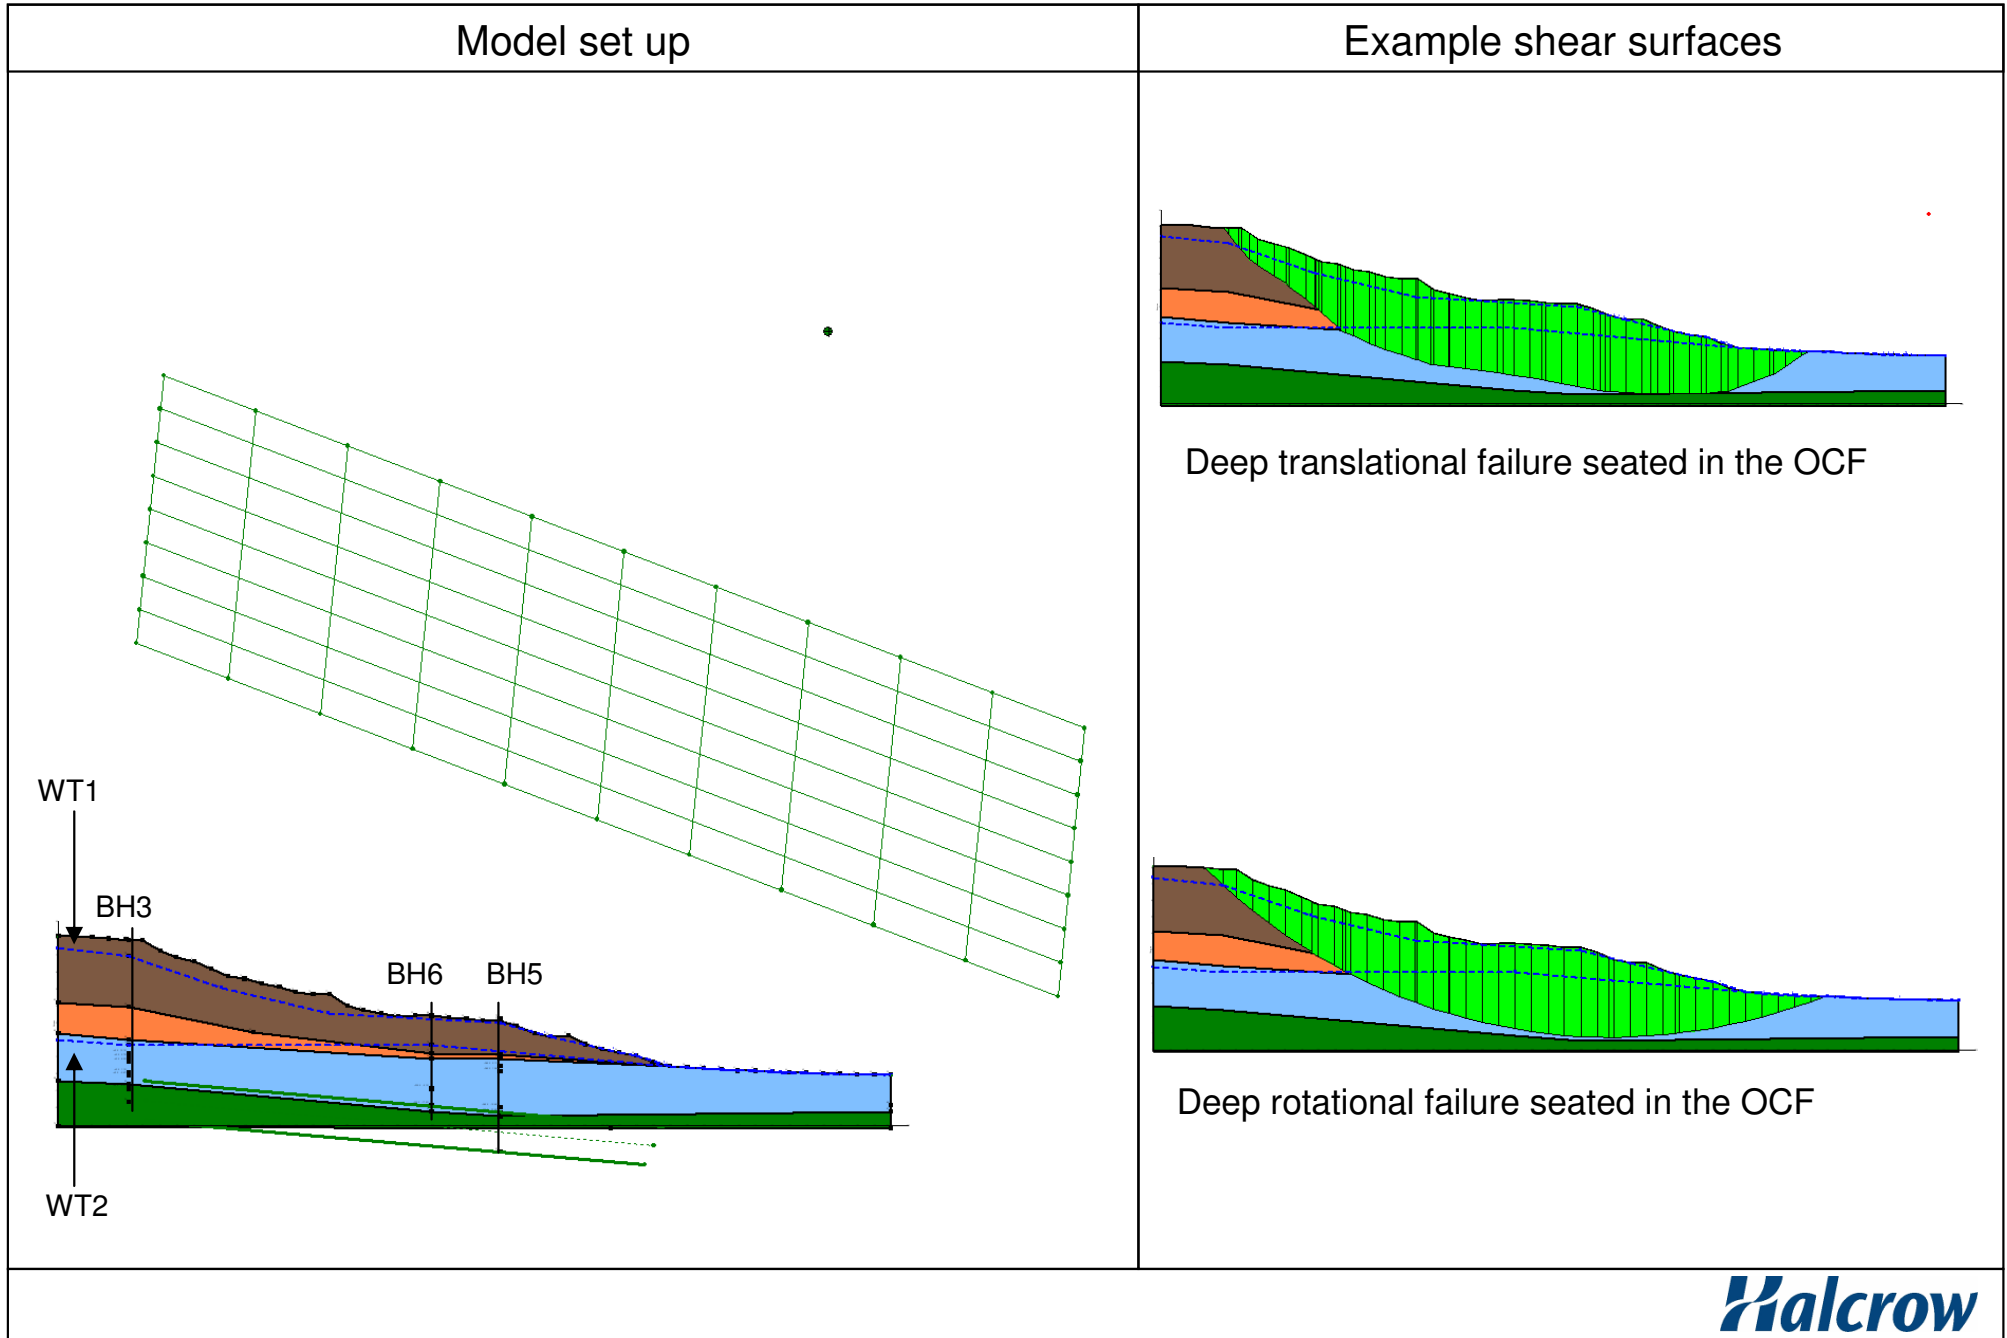
Figure 9. Slope stability modelling of landslide mechanisms

- ***Mechanism 1*** – a deep translational failure along the base of the OCF extending from the headscarp of Knipe Point to beneath Cayton beach.
- ***Mechanism 2*** – a deep translational failure along the base of the OCF extending from the centre of the existing landslide complex in Cayton Cliffs to Cayton beach.
- ***Mechanism 3*** – a shallow mudslide within the superficial glacial deposits extending from the headscarp at Knipe Point to the base of the existing sea cliff at Cayton Bay.

Sensitivity analysis of the three potential landslide mechanisms demonstrates that minor alterations in the residual ϕ' value may cause a significant reduction in the FoS for both deep translational landslide mechanism and shallow mudslide failure mechanism. Site records from the ground investigation, site monitoring and previous mapping studies confirm that the existing landslide complex is only marginally stable in its current condition. Back analysis of the current condition would therefore suggest an operational residual ϕ' value of 12.5 degrees for the OCF and an operational residual ϕ' value of 20 for the FF.

Retrogression of a deep-seated translational landslide (mechanism 1), however, is currently marginally stable under the measured groundwater conditions (FoS = 1.12). Elevated groundwater level scenarios are less effective in reducing the FoS to a critical point of failure. The potential for a deep-seated retrogressive failure at the landslide headscarp could therefore be considered to be relatively low compared with the shallow mudslide mechanism; this is supported by observations since early 2008 of relatively small localised collapses, mudslides and mudflows on the headscarp.
