Flat Cliffs stability assessment and management plan

Ground investigation and monitoring report

Scarborough Borough Council

31 May 2012

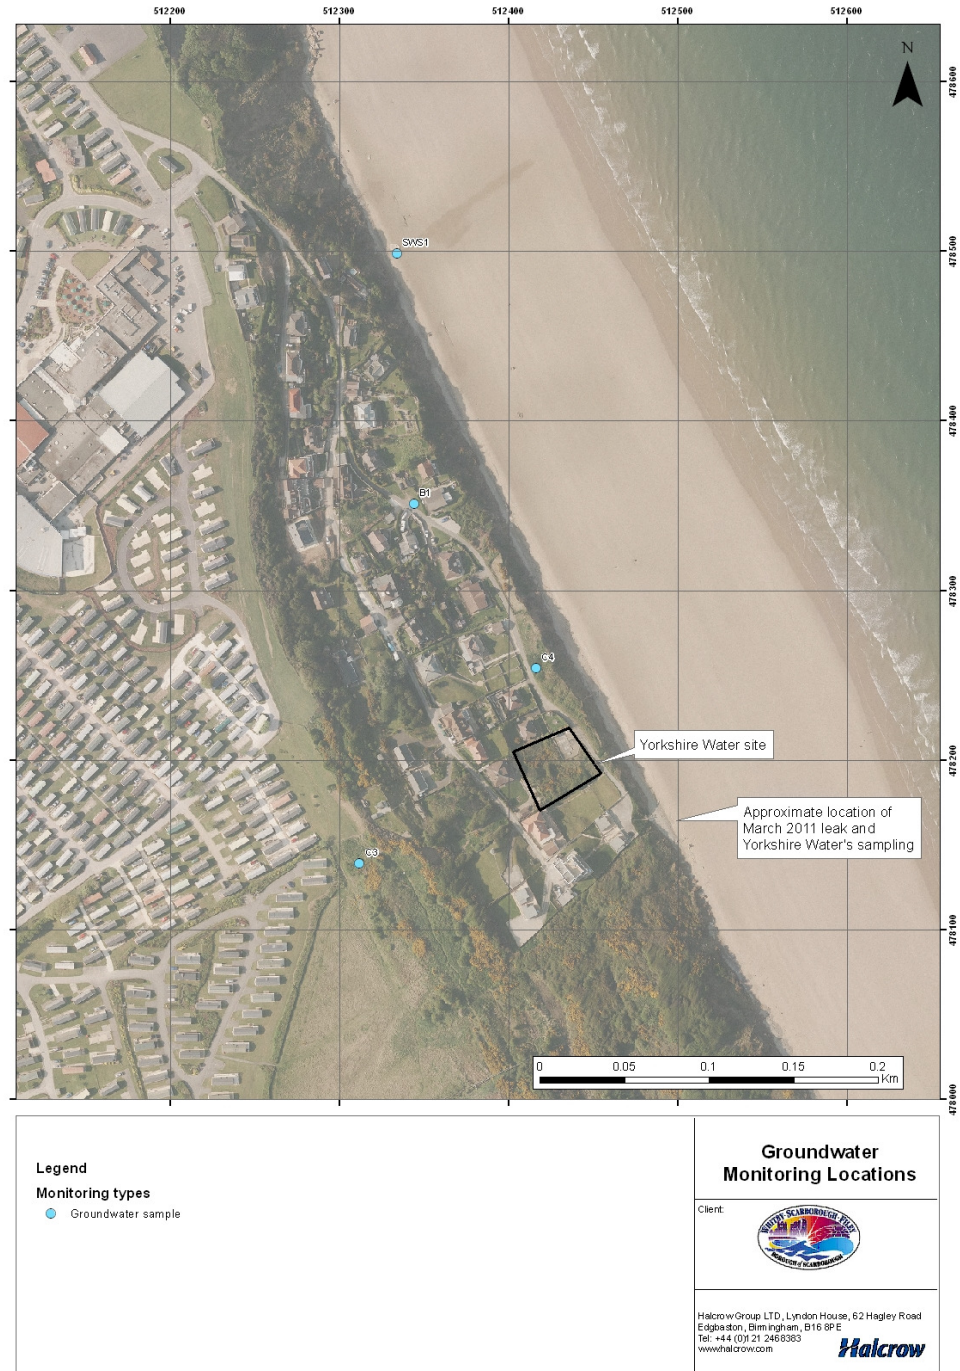
Figure 2. Groundwater sample locations and wastewater infrastructure

In general the level of contamination encountered in the groundwater is not considered to be significant, the only exceptions being the coliform count in three of the five samples tested. Exploratory holes C3 (shallow and deep) and C4 recorded over 8000 coliform counts per 100ml, which is indicative of sewage contamination.

C3 and C4 are in close proximity to the Yorkshire Water pipeline and pumping station located at the southern part of Flat Cliffs. A leak in the Yorkshire Water wastewater pipeline above Flat Cliffs was reported on 26th March 2011 when untreated waste was observed issuing to the beach near the Whitehouse access steps to the south of Flat Cliffs. Yorkshire Water immediately investigated the site and subsequently repaired a blockage in a private sewer originating from the holiday camp. This sewer has now been adopted into the Yorkshire Water network. Water quality samples taken by Yorkshire Water in March 2011 highlighted elevated levels

The repair works were underway to remedy the leak before the ground investigation and collection of groundwater samples for testing in September 2011. The results recorded during this study may represent a residual contamination from the leakage and repair works. However, the source of present contamination is not proven and could originate from ongoing septic tank discharges from private properties. Consequently it is not possible to link these results to a specific cause or point source.

In order to resolve outstanding uncertainty over sources of contamination, it is recommended that re-sampling and testing is undertaken at all locations.

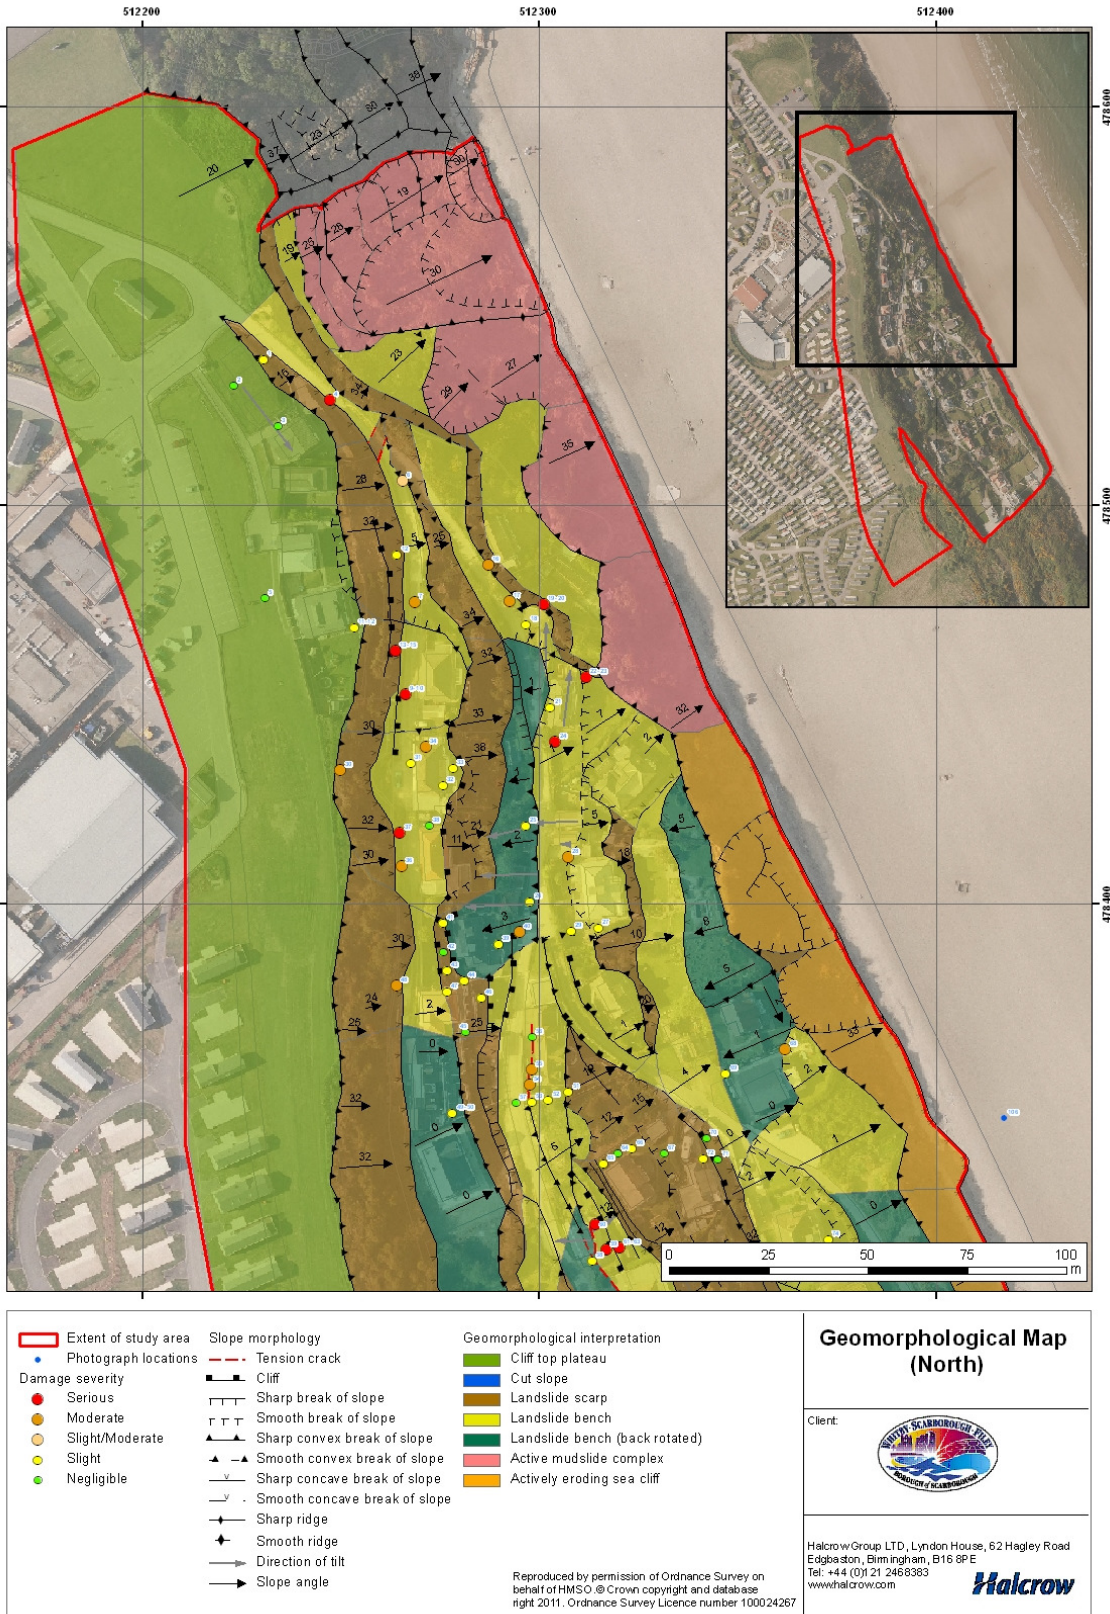
Figure 3 Geomorphological map and damage survey (Flat Cliffs north)

The benches and scarps within the undercliff complex are generally laterally continuous. The large upper bench in the south of Flat Cliffs has a long and continuous tension crack that follows the access road. The undercliff complex is separated from the flat slopes that characterise the inland area by a continuous, steep back scarp of around 30 degrees. The toe of the undercliff complex forms a steep sea-cliff that is typically over 30 degrees and locally up to 45 degrees. In the north of the site, this sea cliff slope is much wider and a series of mudslides have developed that extend almost to the main back scarp. No uncontrolled drainage was observed during field work, however it should be noted that the field survey was undertaken in the summer when the antecedent weather conditions were dry.

A landslide damage survey was undertaken at the same time as the geomorphological mapping exercise. Such surveys provide vital clues about ground behaviour and can be used with the geomorphology to confirm landslide extents, morphology and displacement rates, as well as inform assessment of hazards and risk. Damage points were mapped and classified according to a standard five-point scale ranging from serious to negligible. The results are shown in Figures 3 and 4 and full details are provided in Appendix B. The general standard of building and slope modification work at Flat Cliffs is such that observed landslip damage may in part be related to structural failures as much as it is ground movement. However, the data suggest that areas of greatest damage (serious and moderate) are associated with the steeper scarp slopes towards the back of the landslide system and the full extent of the undercliff forming the northern part of Flat Cliffs.

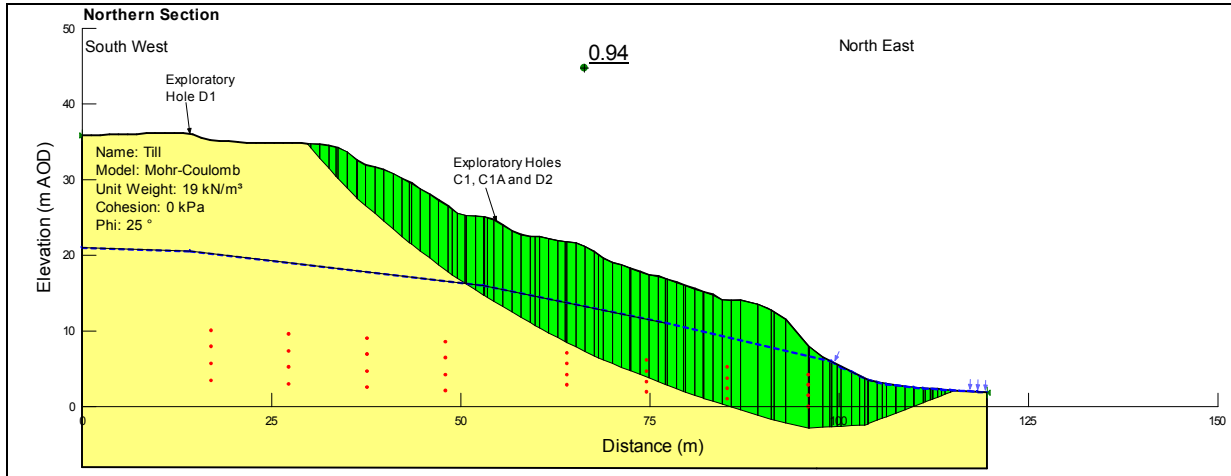
Figure 8. Northern Section; Long term stability of the existing slope profile

The long term global factor of stability was computed as 0.94 and is presented in Figure 8. Despite this model showing a value less than unity and therefore a failed state, in reality it shows that the slope has marginal instability. The stability of the toe is shown on Figure 9 and this shows that with a FoS of 0.86 the toe is in the process of failing or has a low margin of stability.

Increasing the internal friction value to 31° for the global stability condition has the effect of increasing the overall FoS to 1.22 demonstrating that the frictional properties of materials along this section are a critical factor in determining FoS.

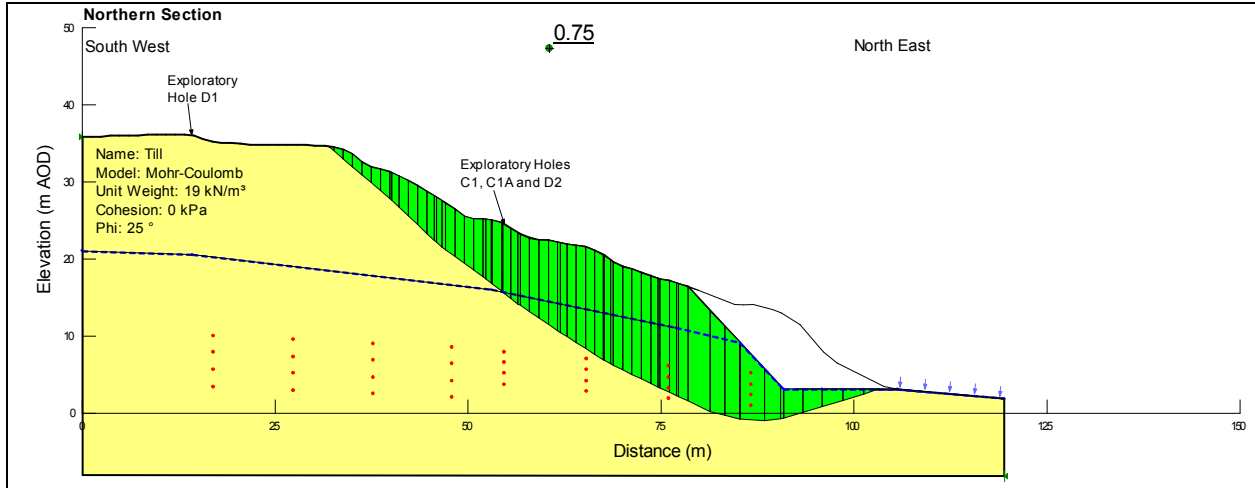
Figure 10. Northern Section; Long term stability with 10m toe erosion

Table 16 shows that the stability of the slope is very sensitive to the erosion of the slope toe and that any change will cause a reduction in the stability of the slope. These figures demonstrate very low FoS and demonstrate how toe erosion affects the stability of the slope. Table 16 presents the results of this sensitivity analyses.

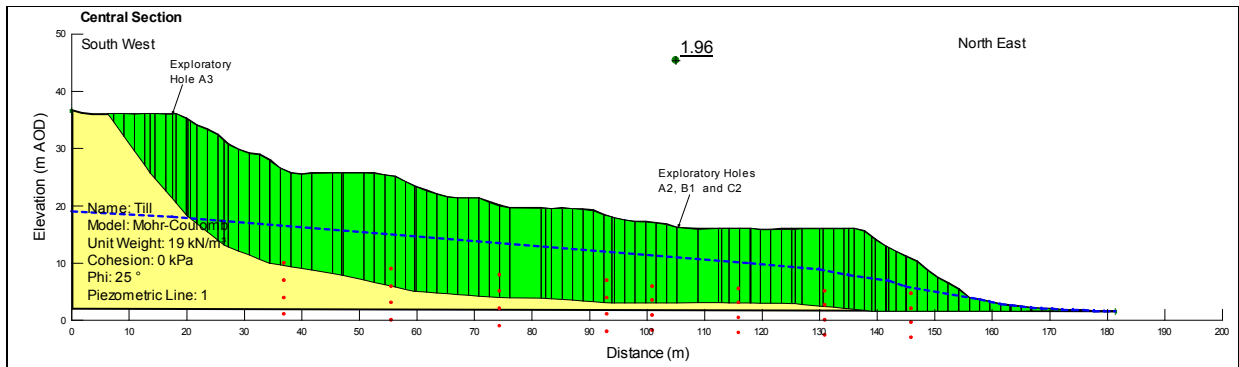
Figure 13. Central Section; Long term stability of the existing slope profile

The exploratory holes relevant to the central section are: C2 (AEG 2011 investigation) and A2, A3 and B1 (Figure 1). The long term global stability of this section shows a FoS of 1.96 (Figure 13) and the stability of the toe shown on Figure 14 has a FoS of 1.12. Both of these conditions are shown to be stable in the long term with their current ground surface and 'average' groundwater profile modelled.

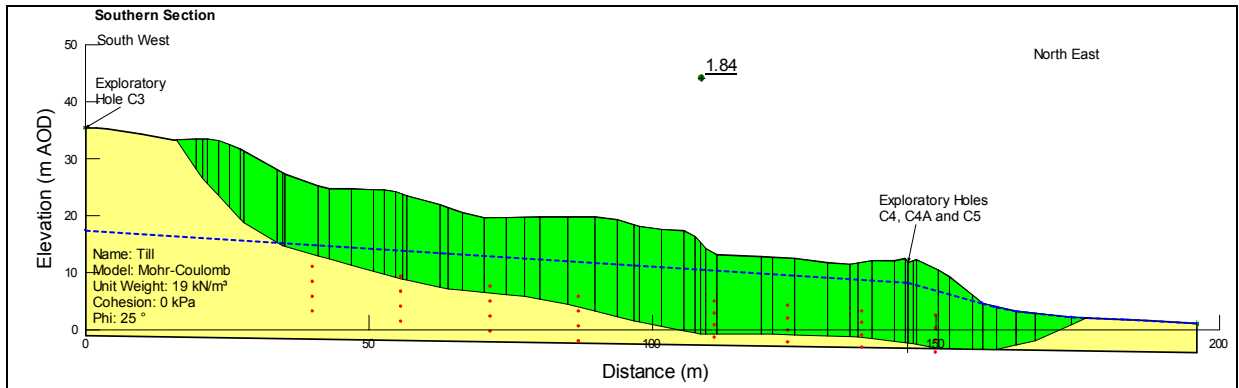
Figure 15. Southern Section; Long term stability of the existing slope profile

The exploratory holes relevant to the southern section are: C3, C4, C4A and C5 (Figure 1). As with the central section, the southern section also exhibits stability in the long term, with the global FoS shown on Figure 15 of 1.84 and the toe stability shown on Figure 16 of 1.14.
