**Robin Hood's Bay Seawall,
North Yorkshire**

CONCRETE CONDITION SURVEY

20H/01363

for Restek UK Ltd

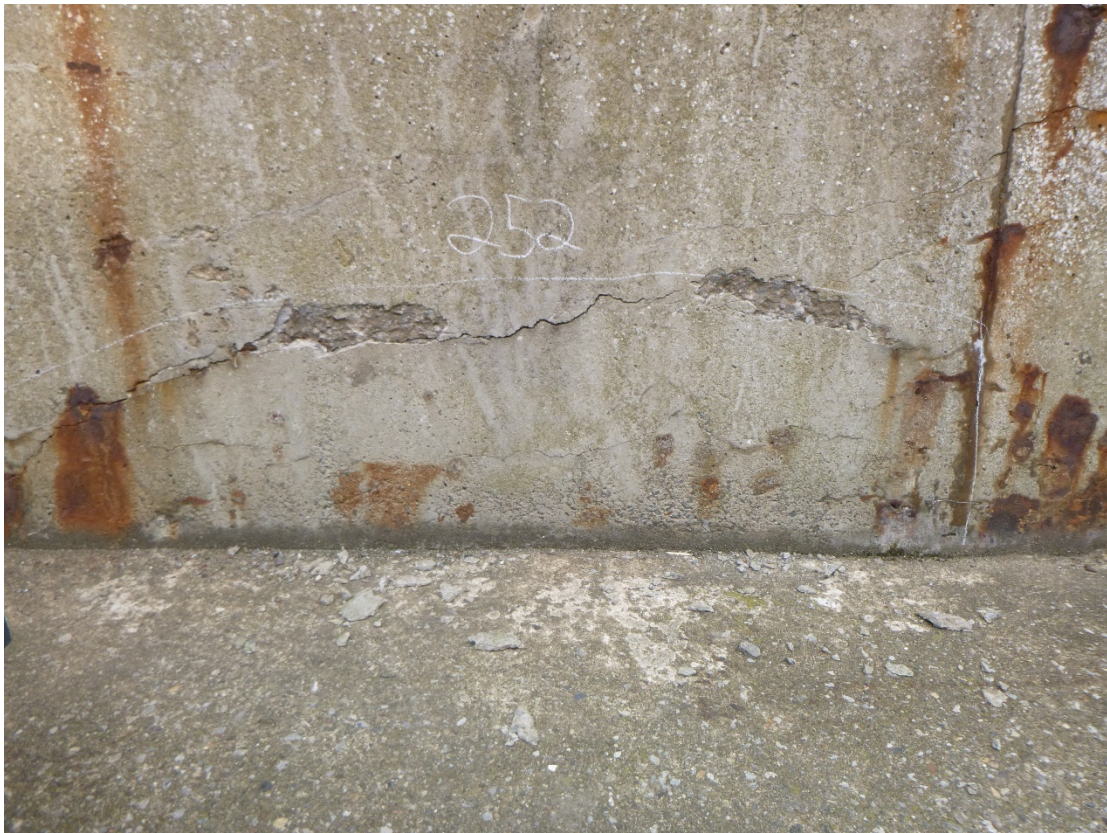
Photograph 3 – Defect 4-13 corrosion damage to parapet wall

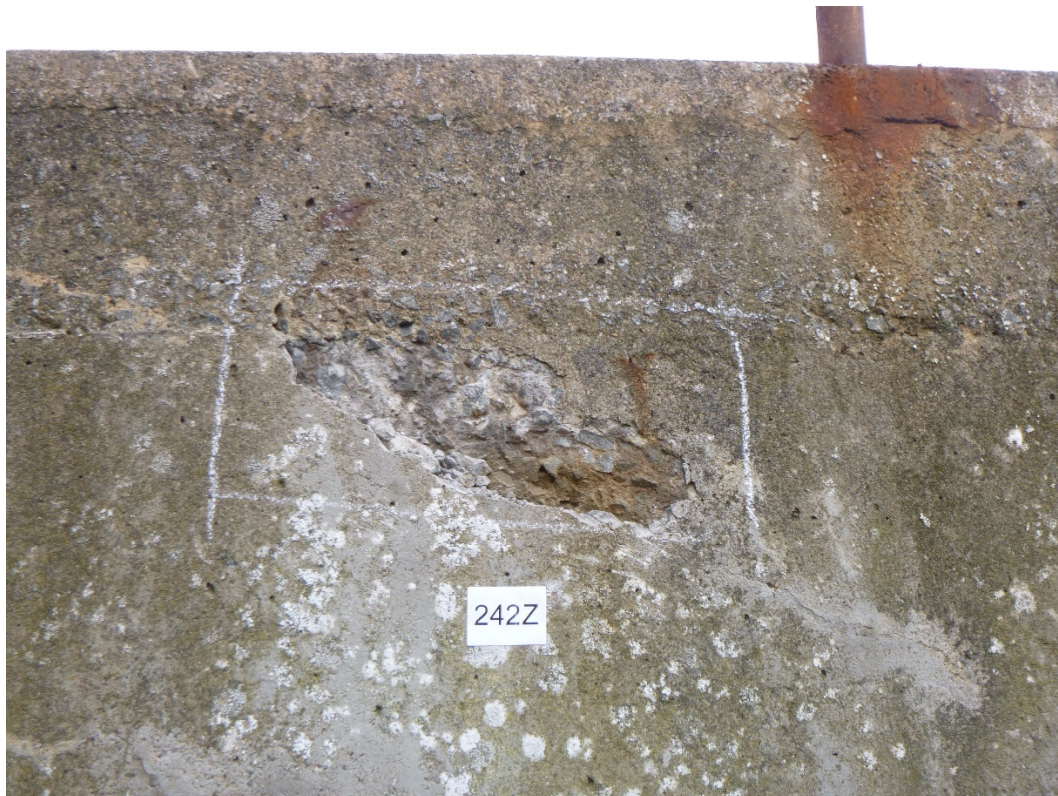
Photograph 4 – Defect 10-11 spalling parapet wall

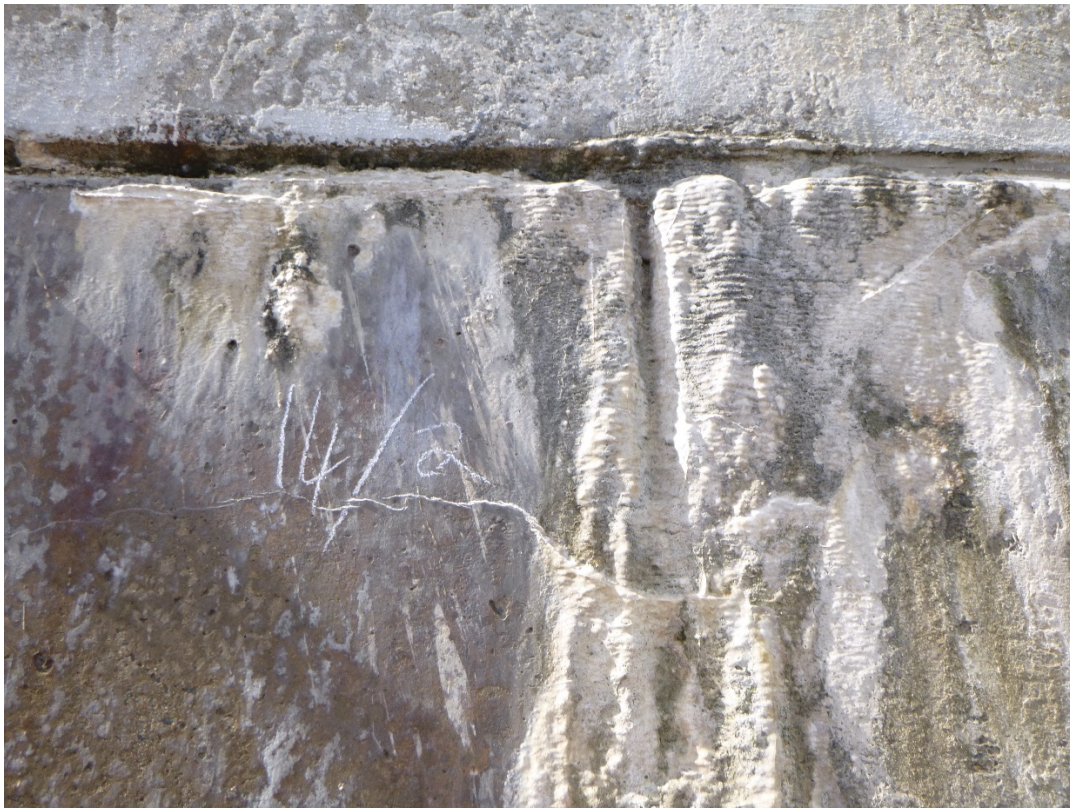
Photograph 5 – Defect 14-2 leakage through wall forming calcite dripstone

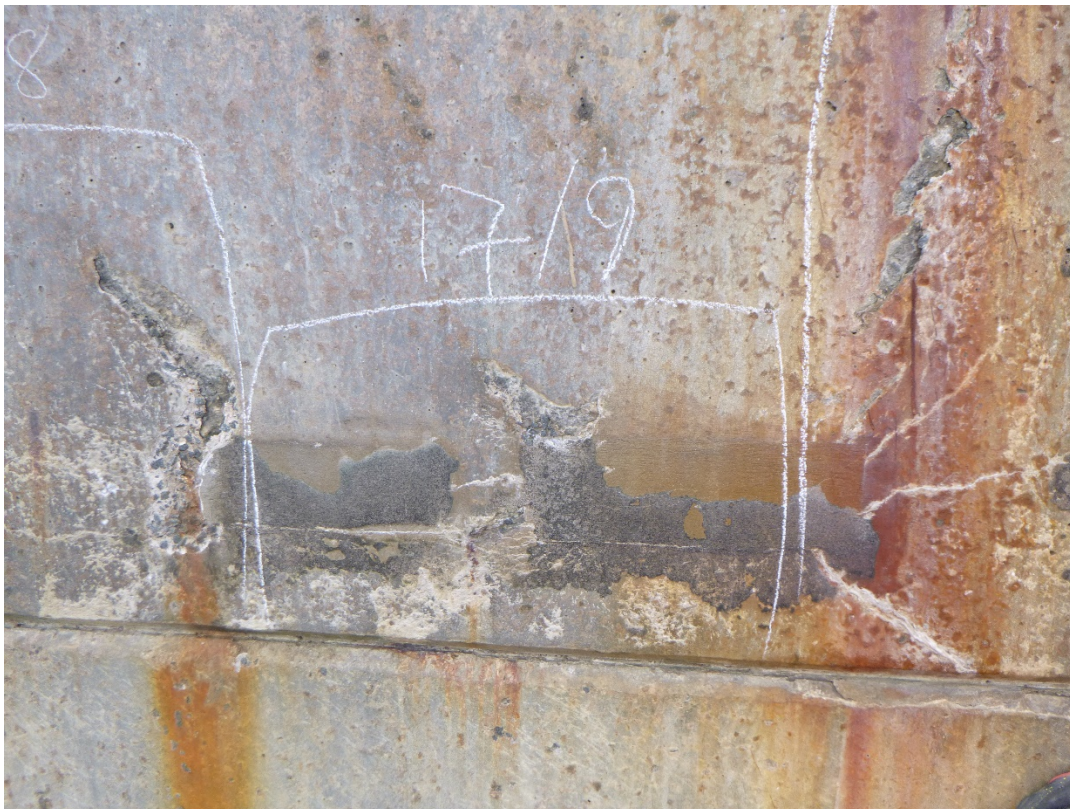
Photograph 6 – Defect 17-9 area of delamination and corrosion staining

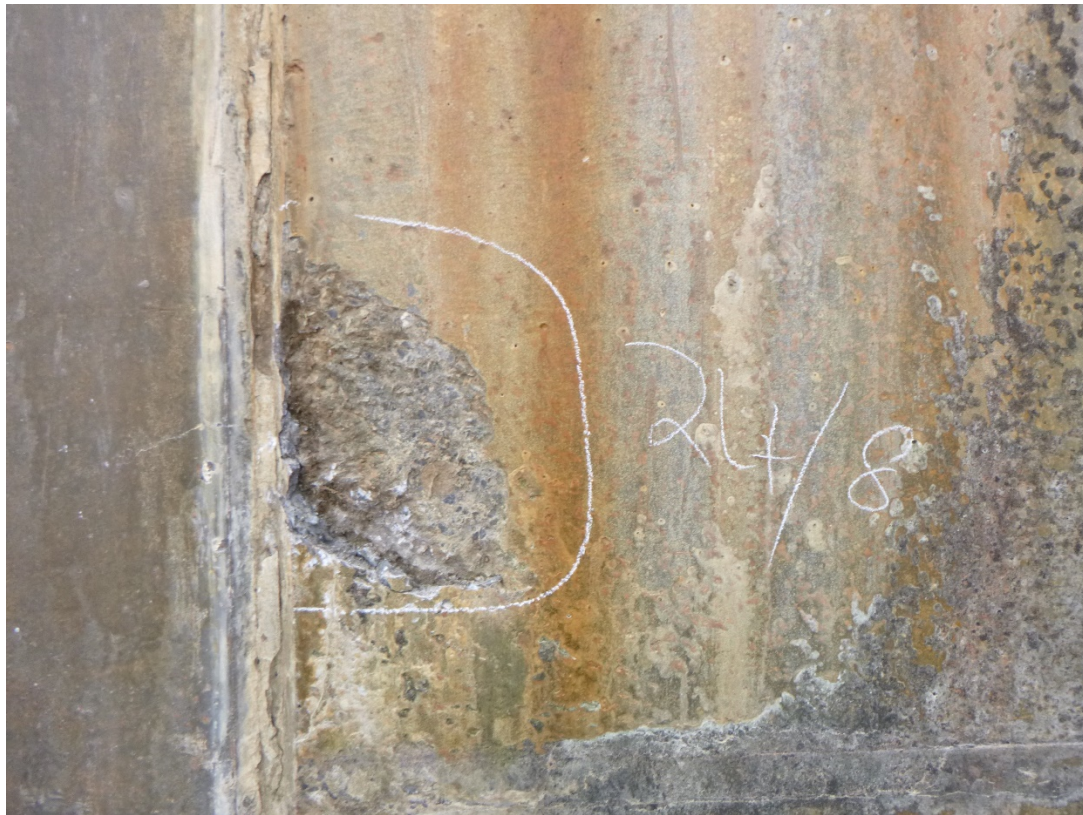
Photograph 7 – Defect 24-8 spalling

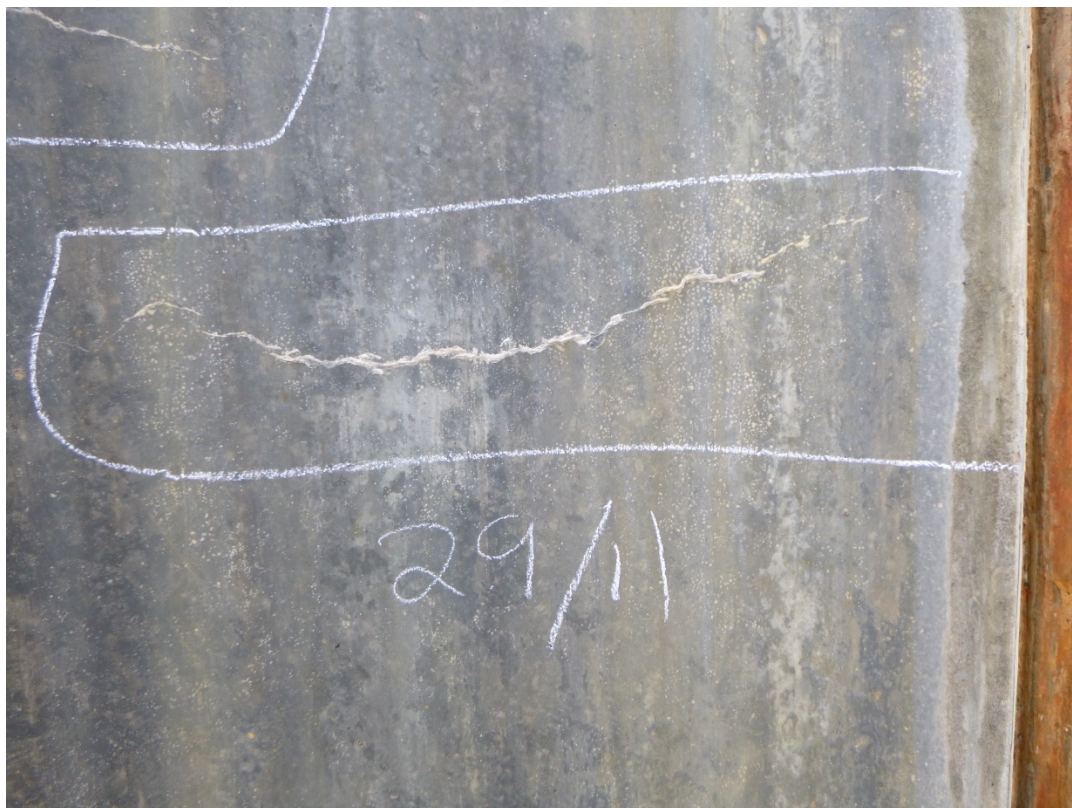
Photograph 8 – Defect 29/11 calcite filled cracks

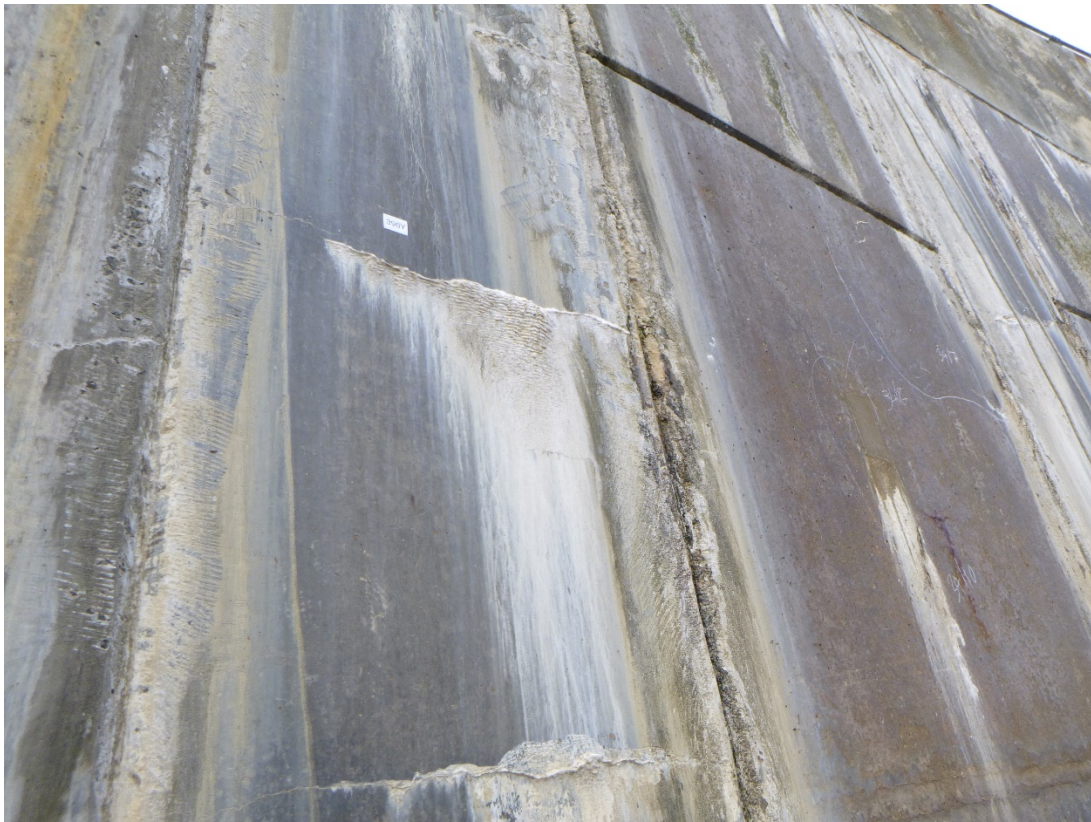
Photograph 9 – Defect 33-8 cracking and calcite staining

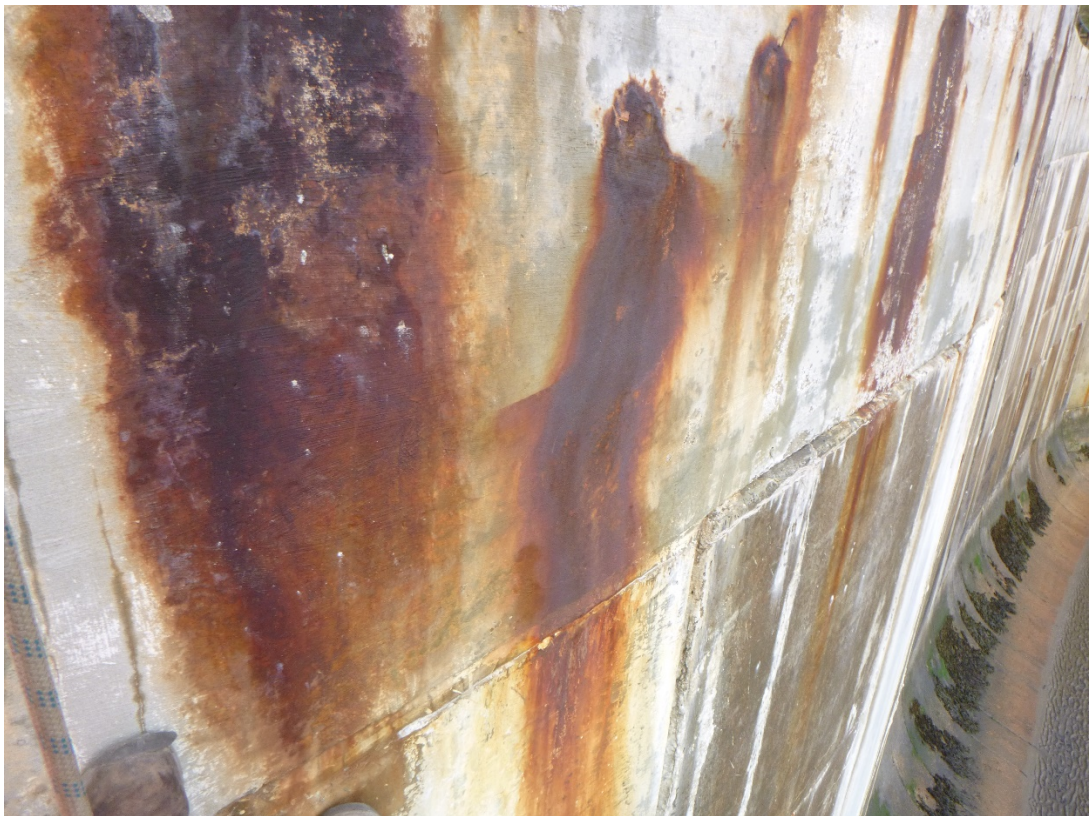
Photograph 10 – Defect 42-3 corrosion staining to panel

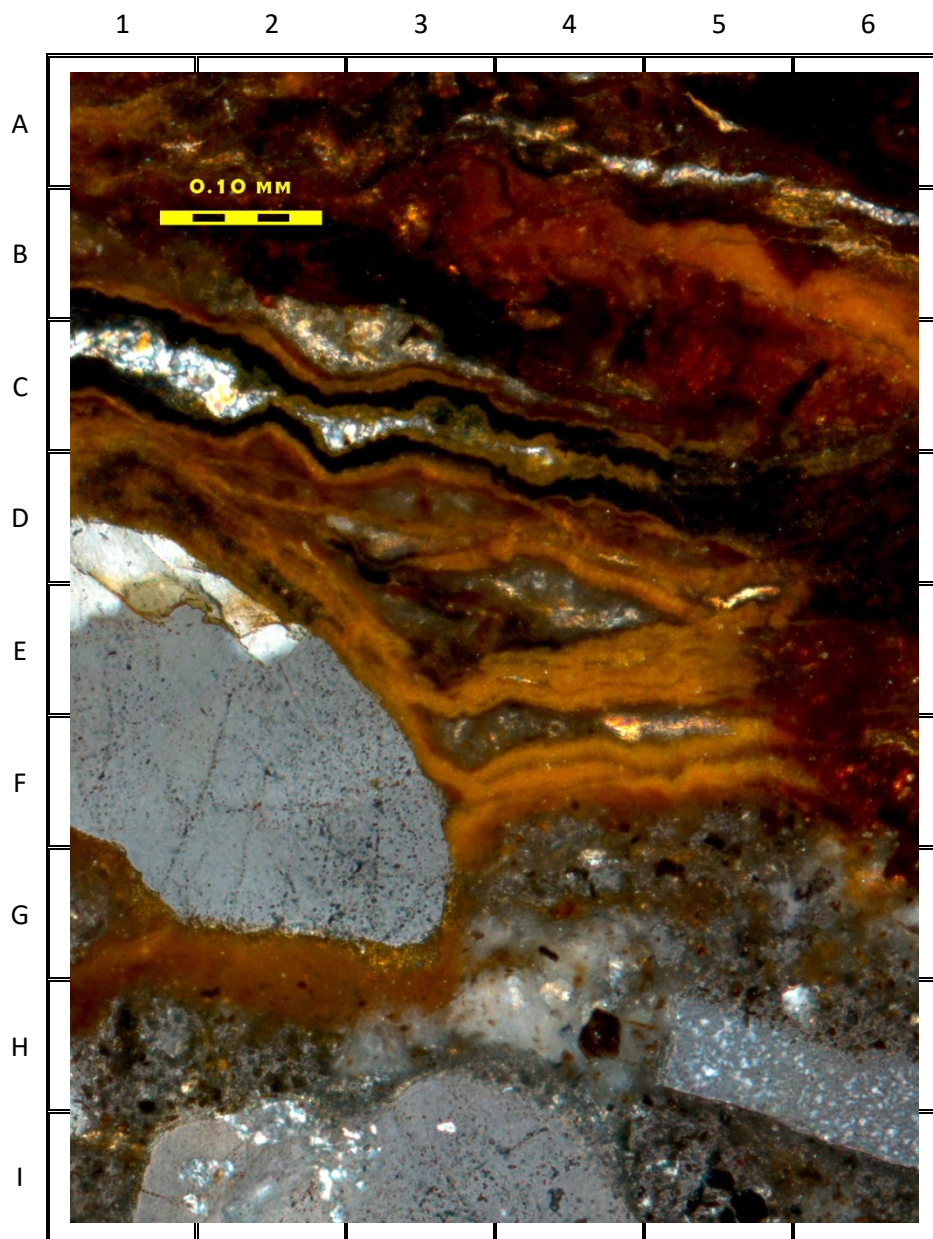
Figure C3

- a) Core 2, from a column within the tidal zone showed a bar a 50mm depth which had severely corroded. At bar depth, there are an abundance of sub-surface parallel cracks.

Thin section, crossed polars, reflected light: View showing the severely corroded reinforcement with abundant cracks infilled with corrosion products visible for example from C/D1 to E/F6. Small areas of uncarbonated paste are visible for example in G/H6 and I5. Quartz particles occur in E1 and I3. A small flint fragment occurs in H/16.

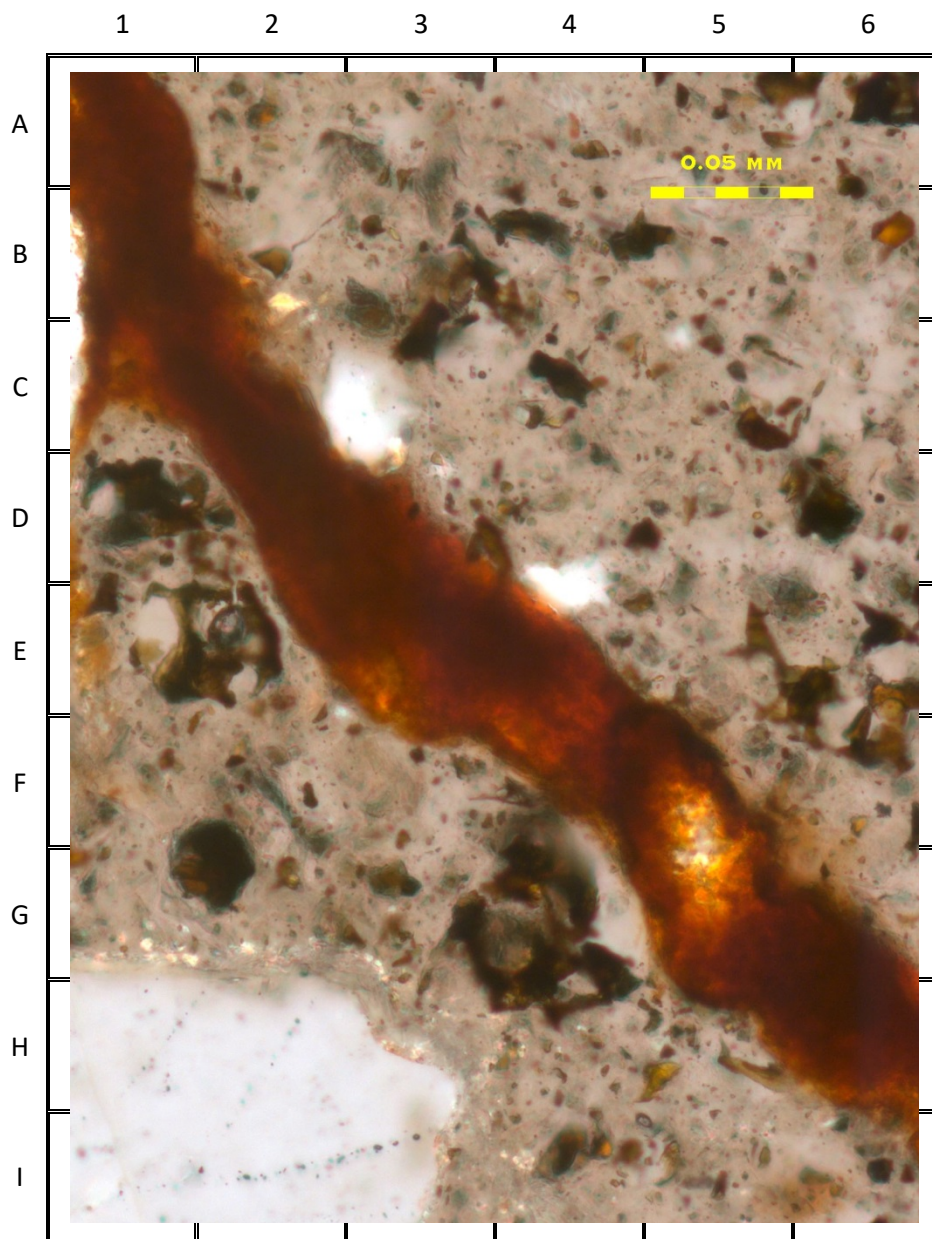
Figure C4

Thin section, oblique polars: A fine crack infilled with corrosion products runs diagonally through the field of view from A1 to H6. The crack is surrounded by portlandite-depleted paste with pseudomorphically hydrated Portland cement grains visible in E/F6 and G/H4. A quartz particle occurs in I1/2.

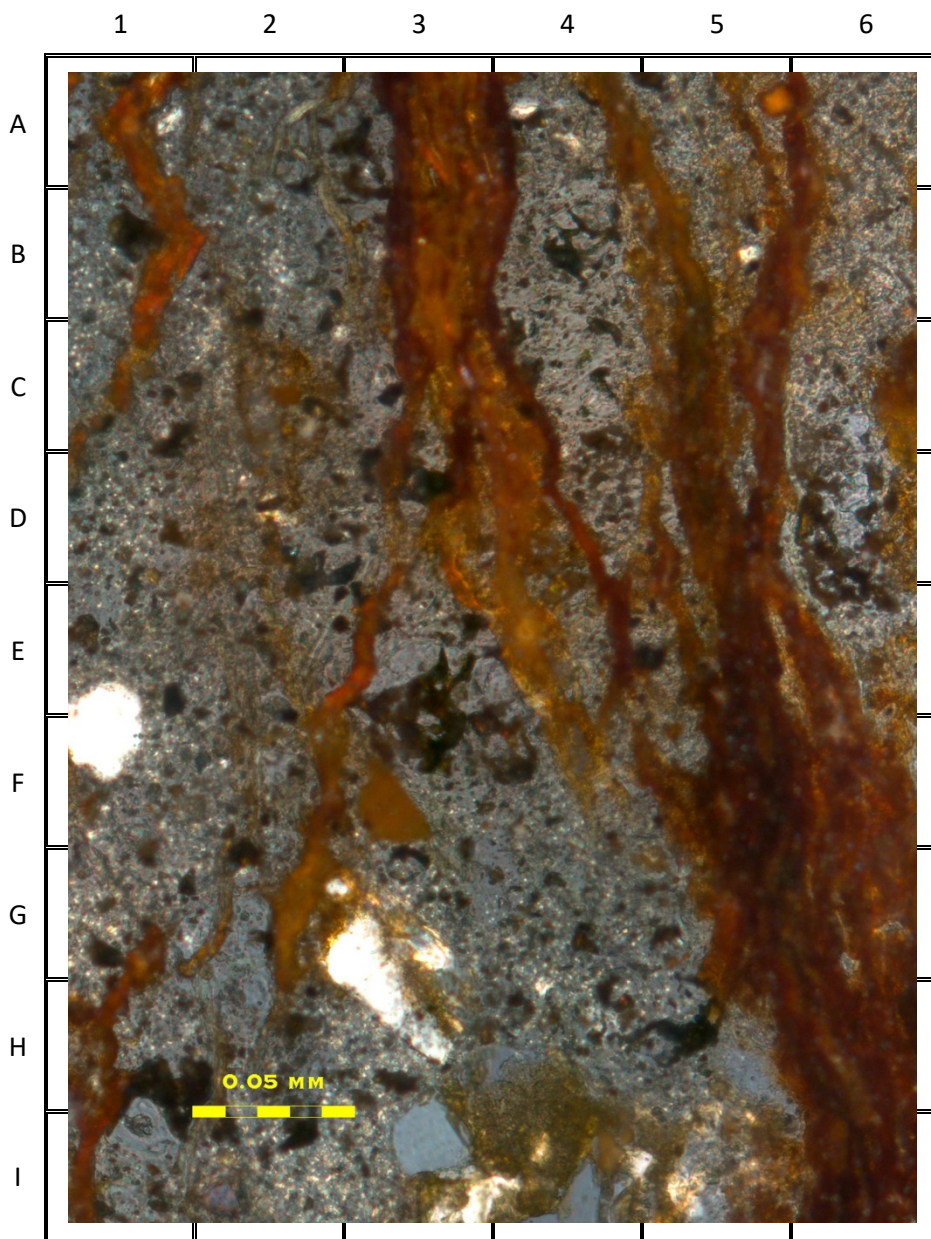
Figure C7

- b) Core 3, from a panel at high level showed a bar present at a depth of 81mm which showed surface corrosion and minimal loss of section.
 - c) Core 4, removed from a panel within the tidal zone, shows reinforcement at 97mm depth, which has suffered severe corrosion and loss of section. There are sub-surface parallel cracks at the bar depth, filled with corrosion product.

Thin section, crossed polars, reflected light: View showing abundant fine cracks infilled with corrosion products close to the corroded reinforcement. The cracks are visible from A3 – A5 to G/H6. Much of the field of view is occupied by uncarbonated paste visible for example in A2 and G4. A pseudomorphically hydrated Portland cement grain can be seen in E/F3.

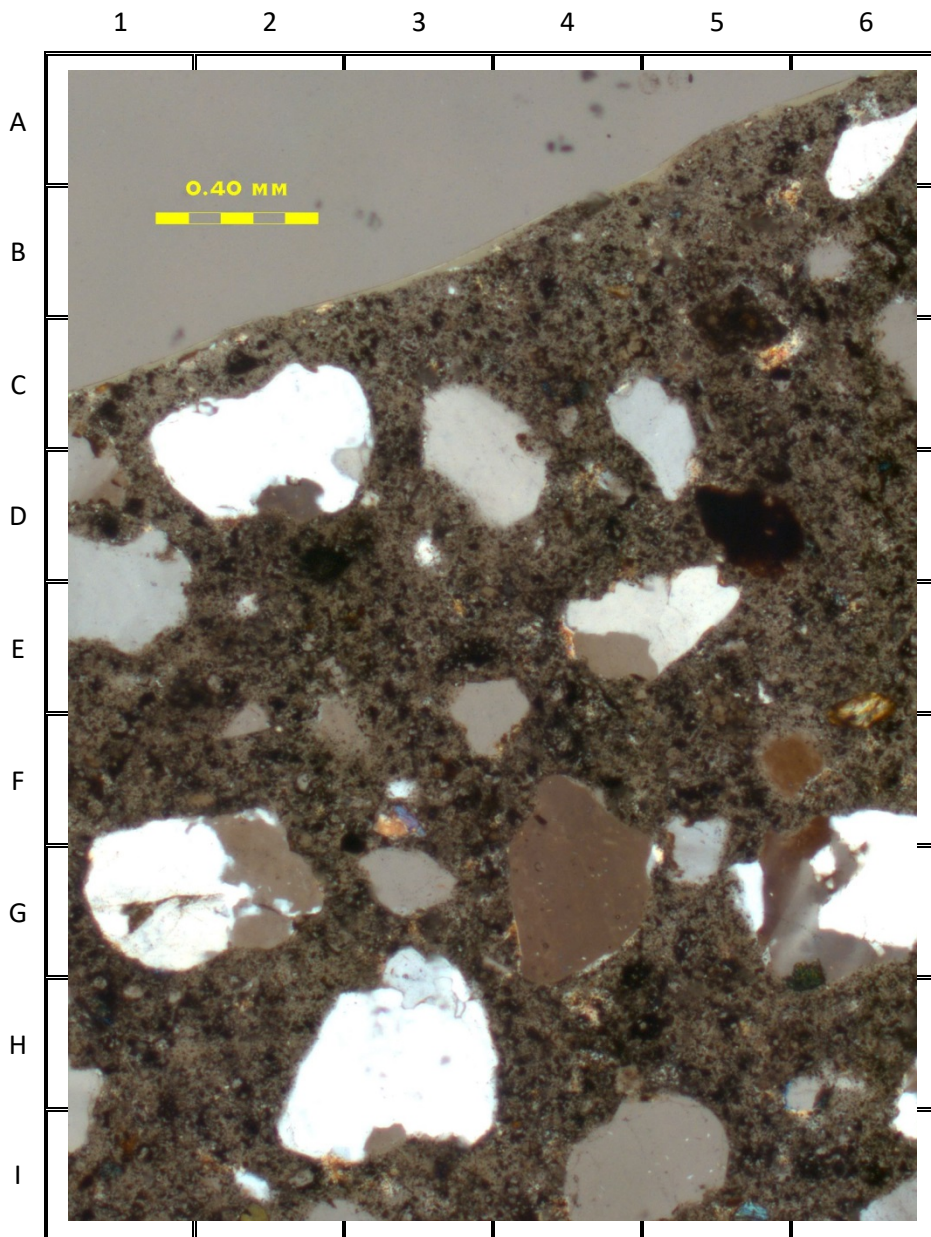
Figure C9

Thin section, oblique polars: Low magnification view showing the imprint of the reinforcement. The reinforcement surface runs from C1 to C6. Note the lack of corrosion products. Much of the field of view is occupied by uncarbonated, predominantly low porosity paste appearing dark grey for example in E2/3. Quartz particles appear various shades of grey and are visible throughout the field of view.
