JMS DRAIN SOLUTIONS LTD

Site address: Robin Hoods Bay

Date: 24/02/15

Please find below the report for the cctv drain survey which was carried out at Robin Hoods Bay by ourselves.

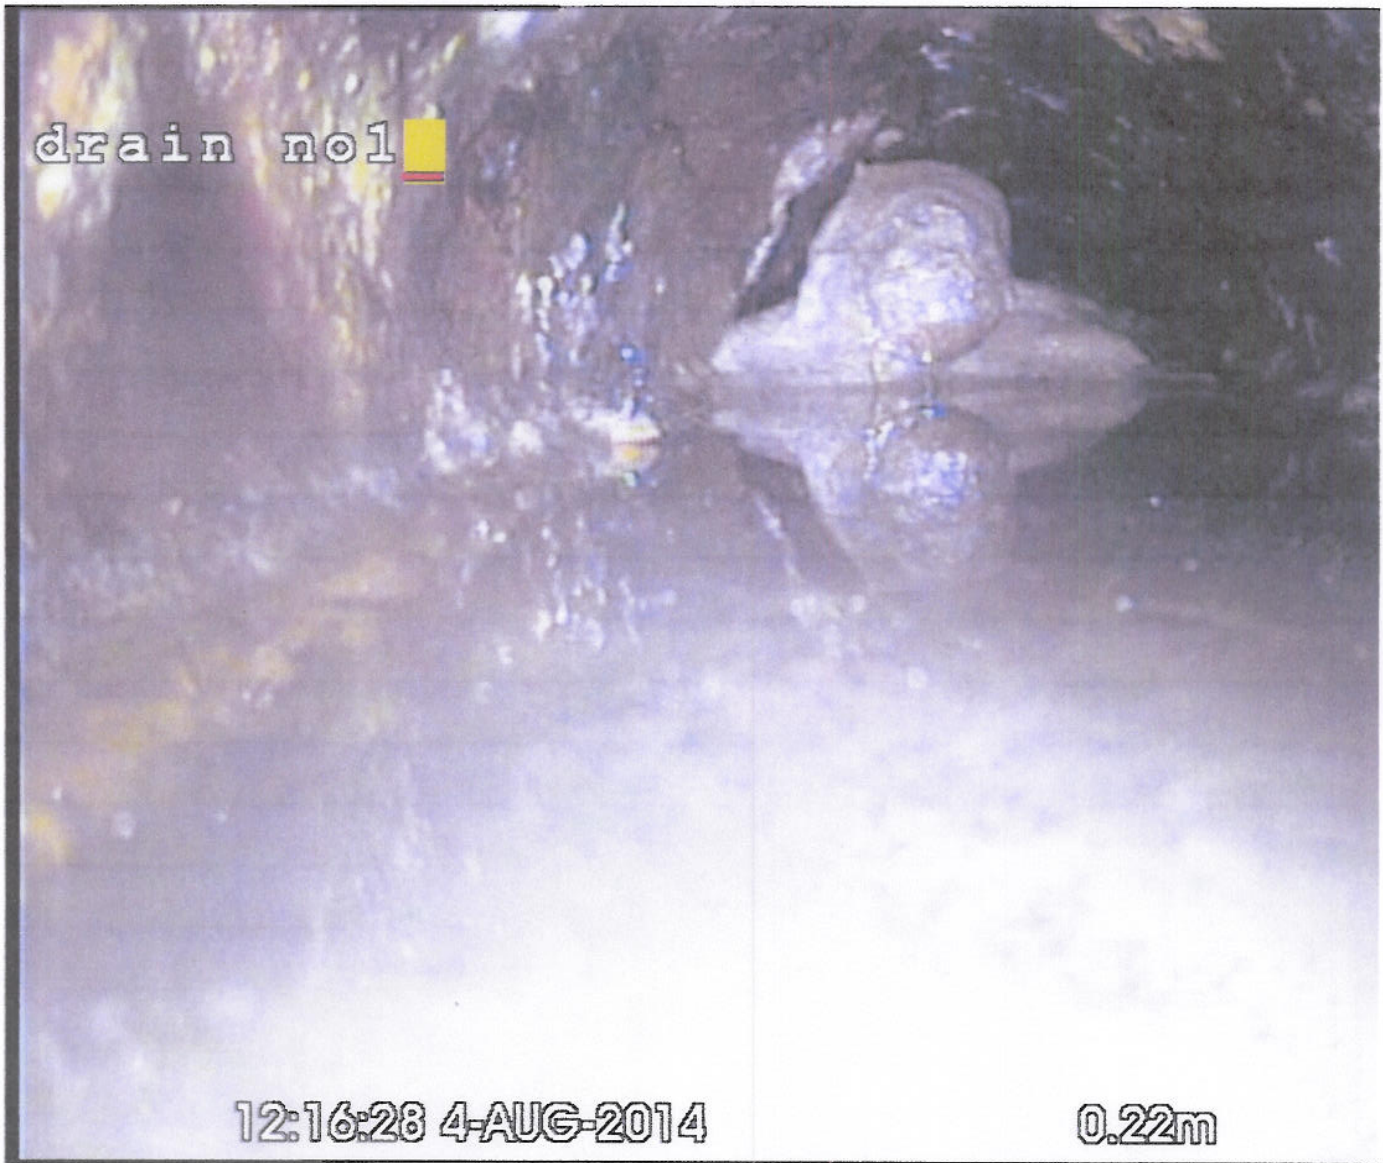
drain no1

At the toe of the sea wall at the southside.

As you can see from the photograph, there is approximately 0.5 metres blocked with debris.

A large amount of time was spent jetting the drains out, but there were so many large rocks and debris that it was running away with cost with little benefit to yourselves.

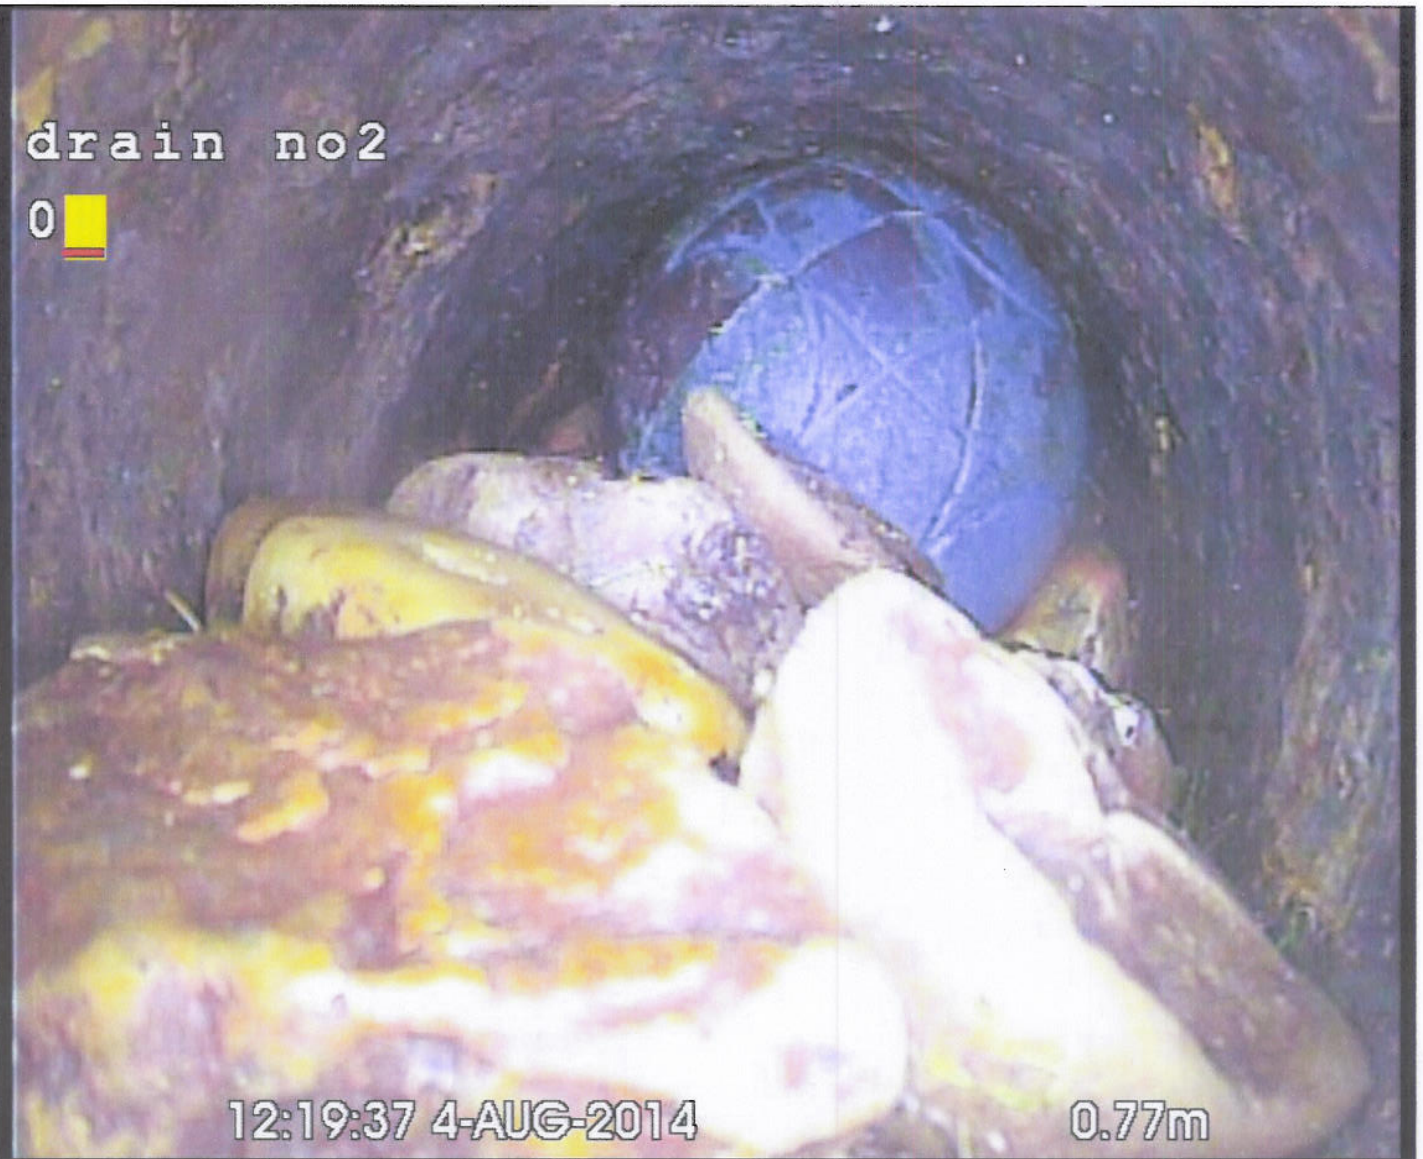
drain no2

Blocked with rock, sand and football.

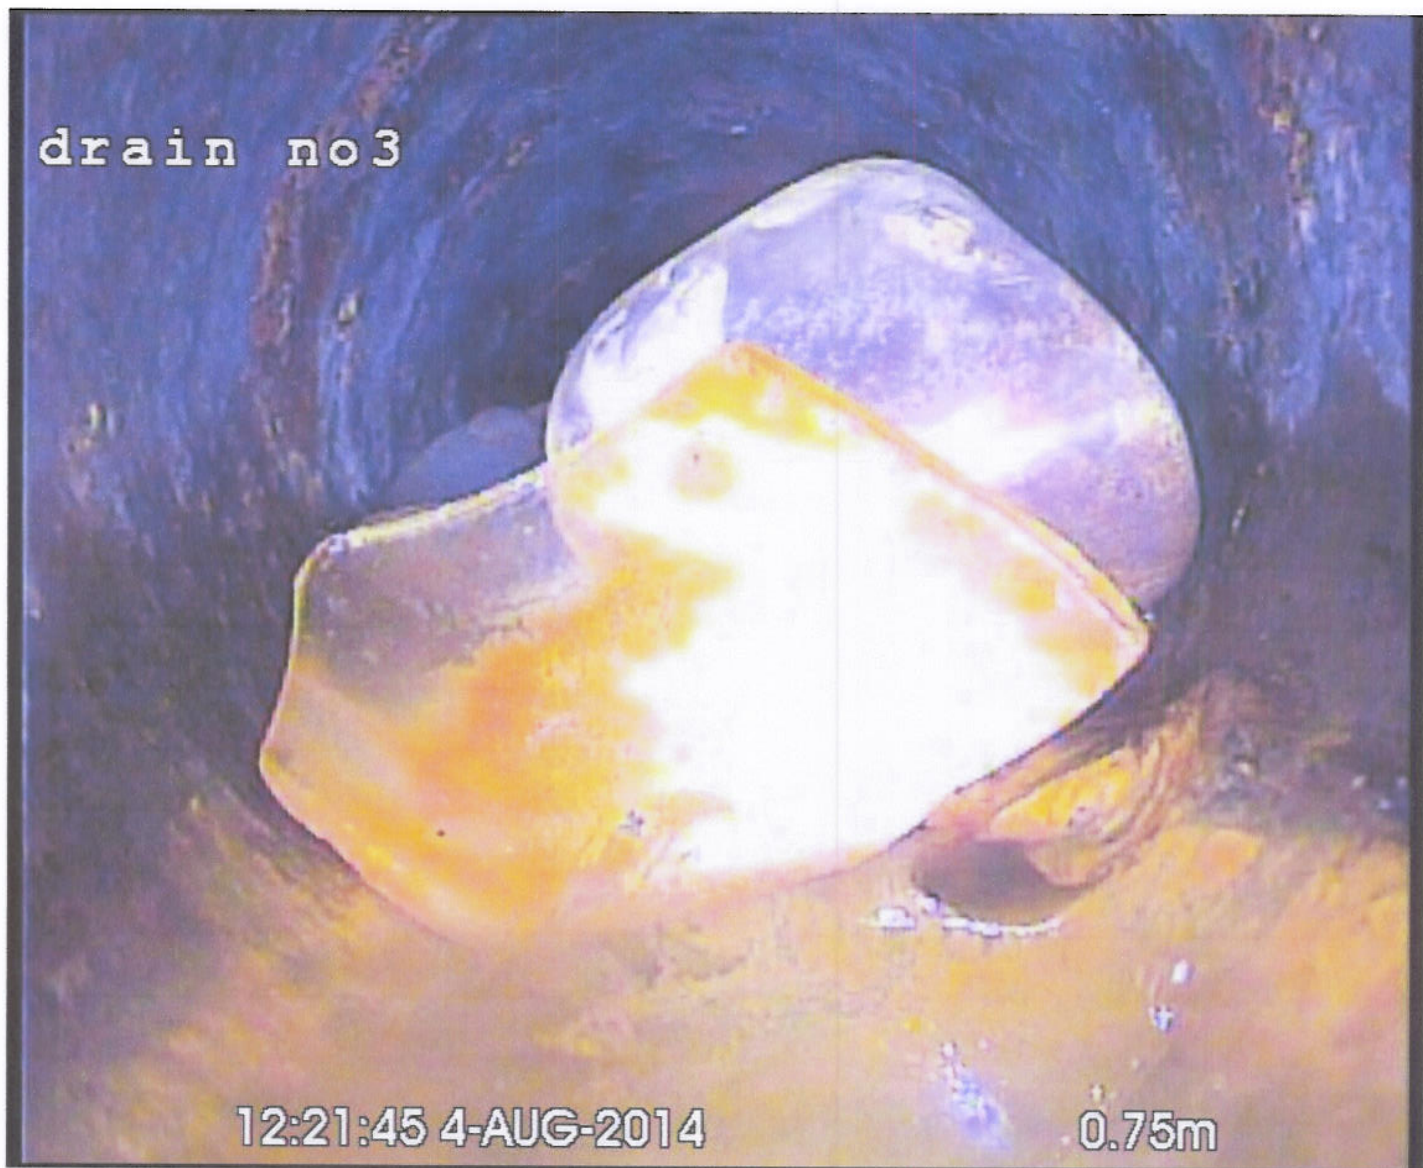
drain no3

Blocked with rocks, sand and silt.

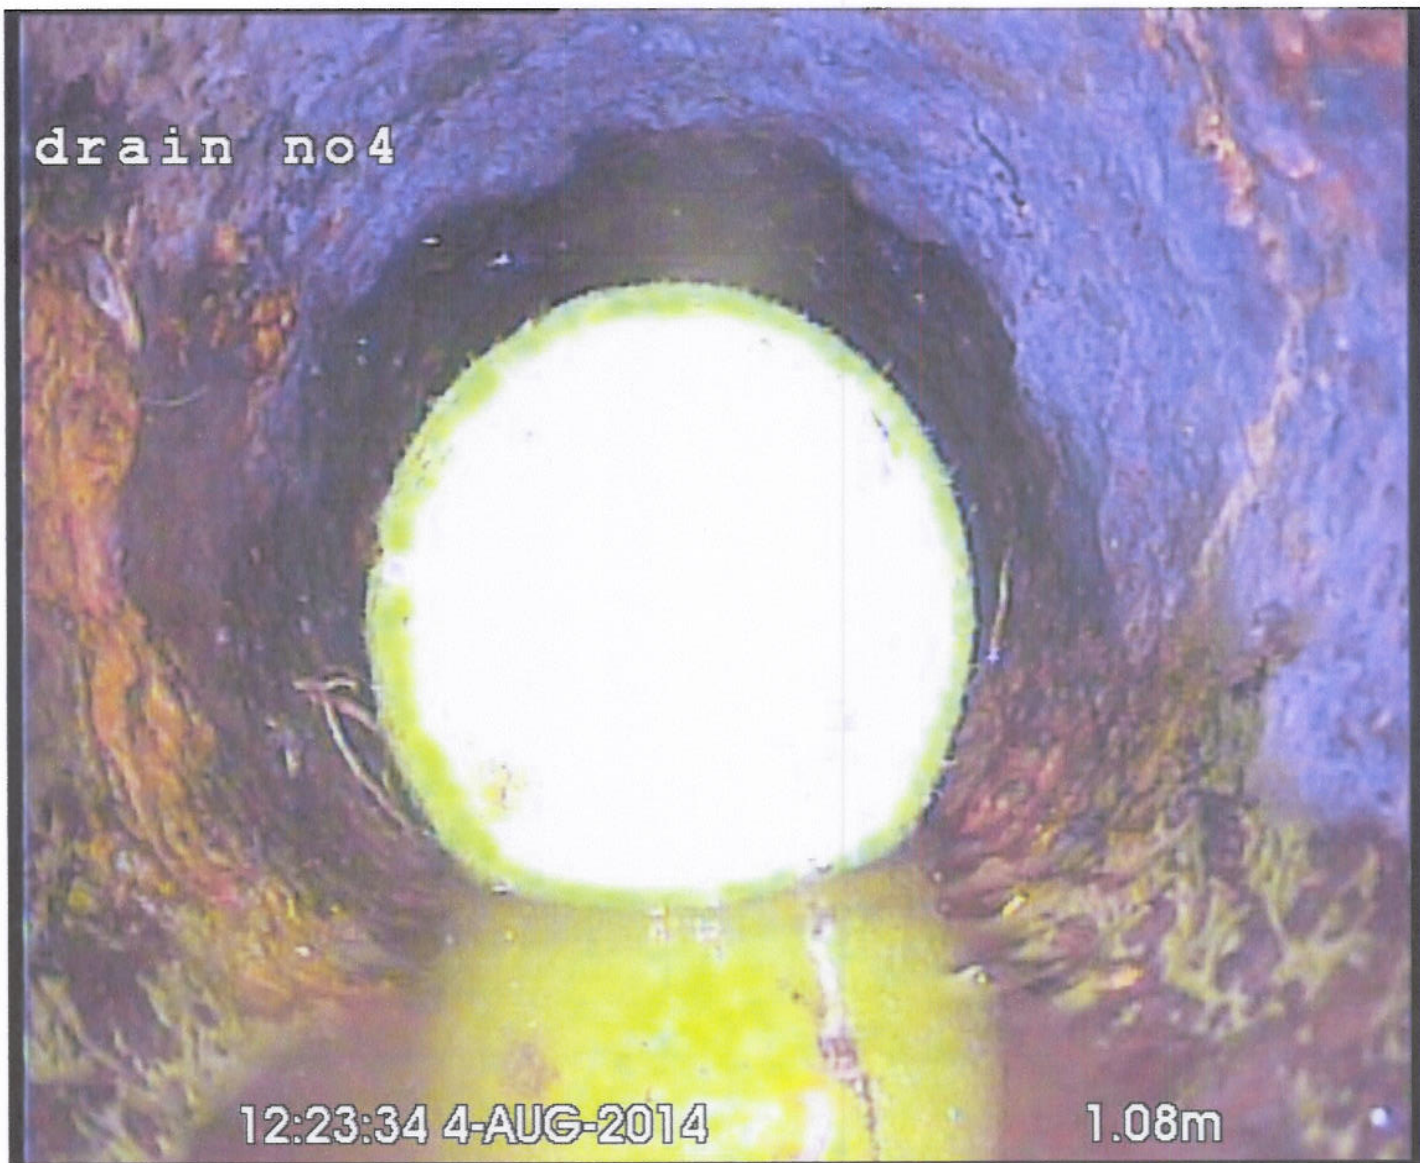
drain no4

Blocked with sand, silt and a tennis ball.

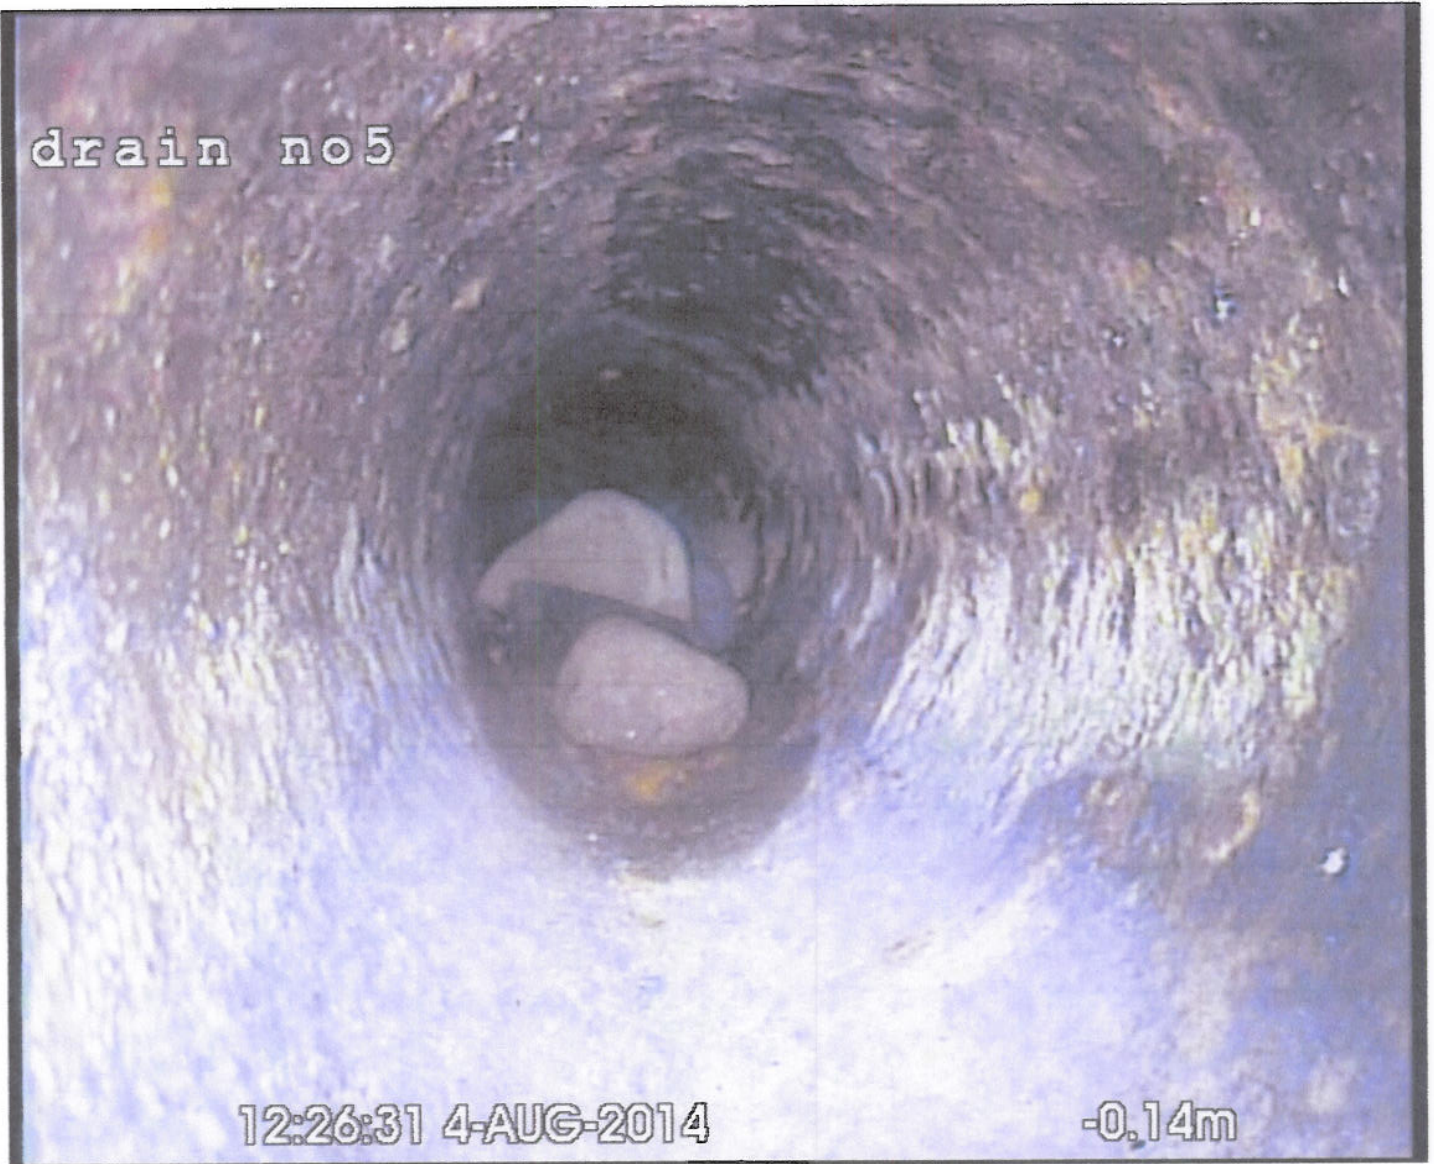
drain no5

Blocked with rocks.

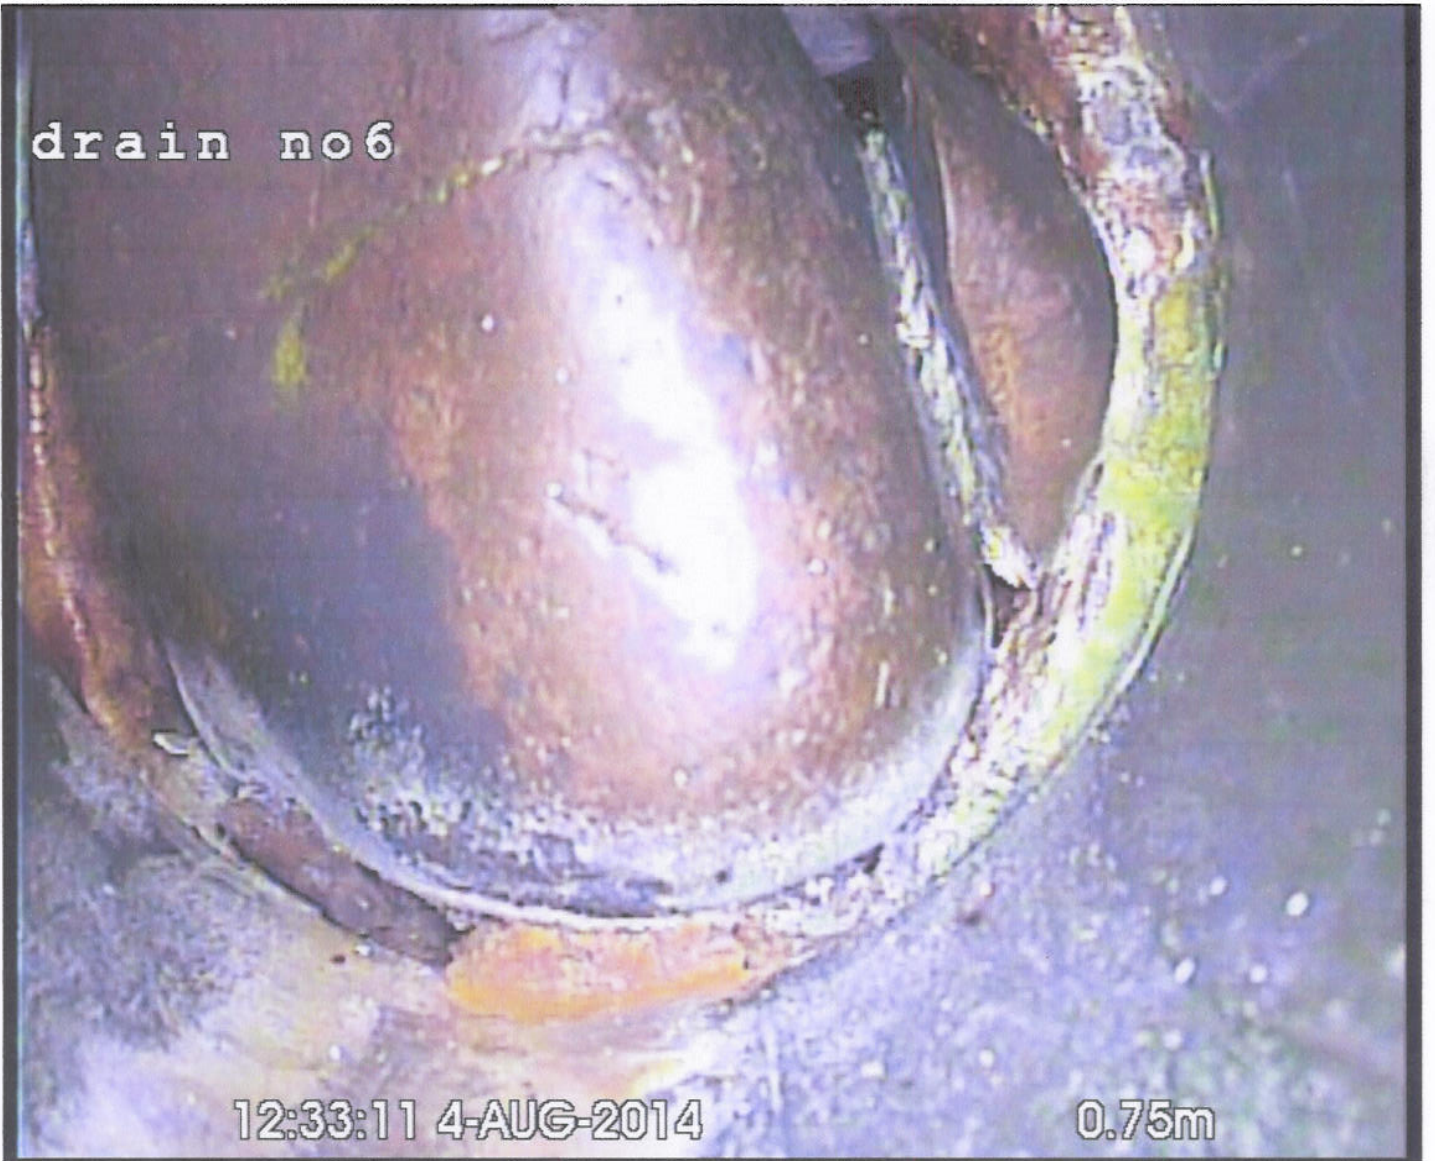
drain no6

Blocked with rocks.

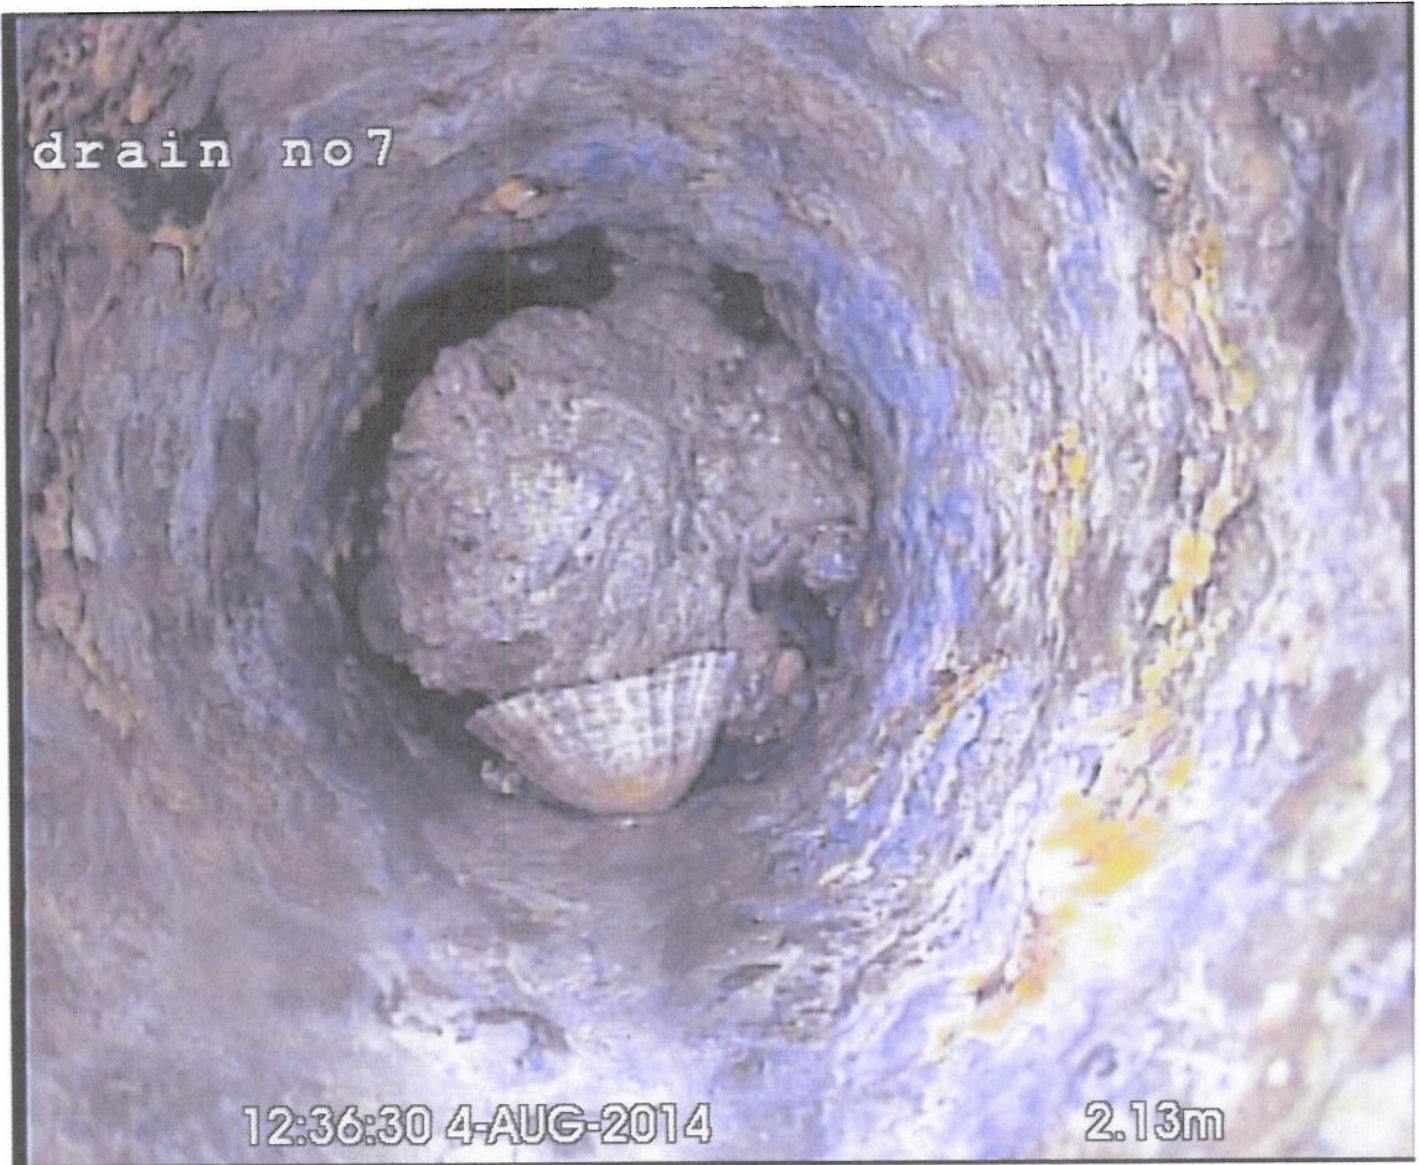
drain no7

Blocked with sand and silt.

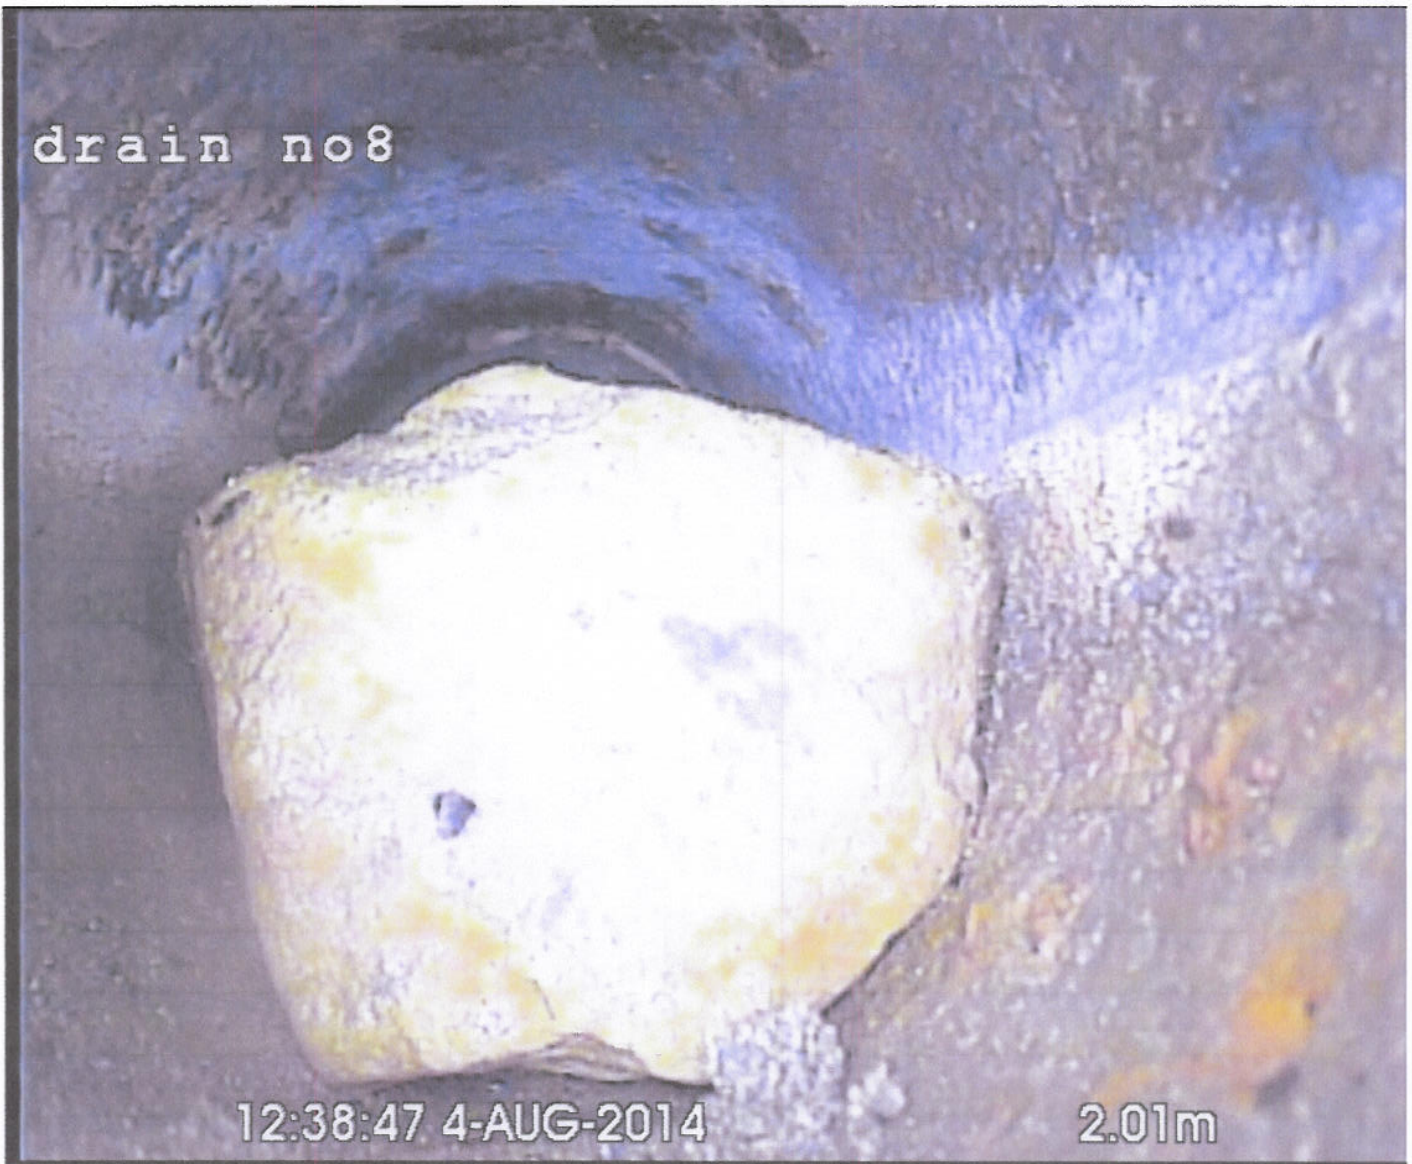
drain no8

Blocked with rocks.

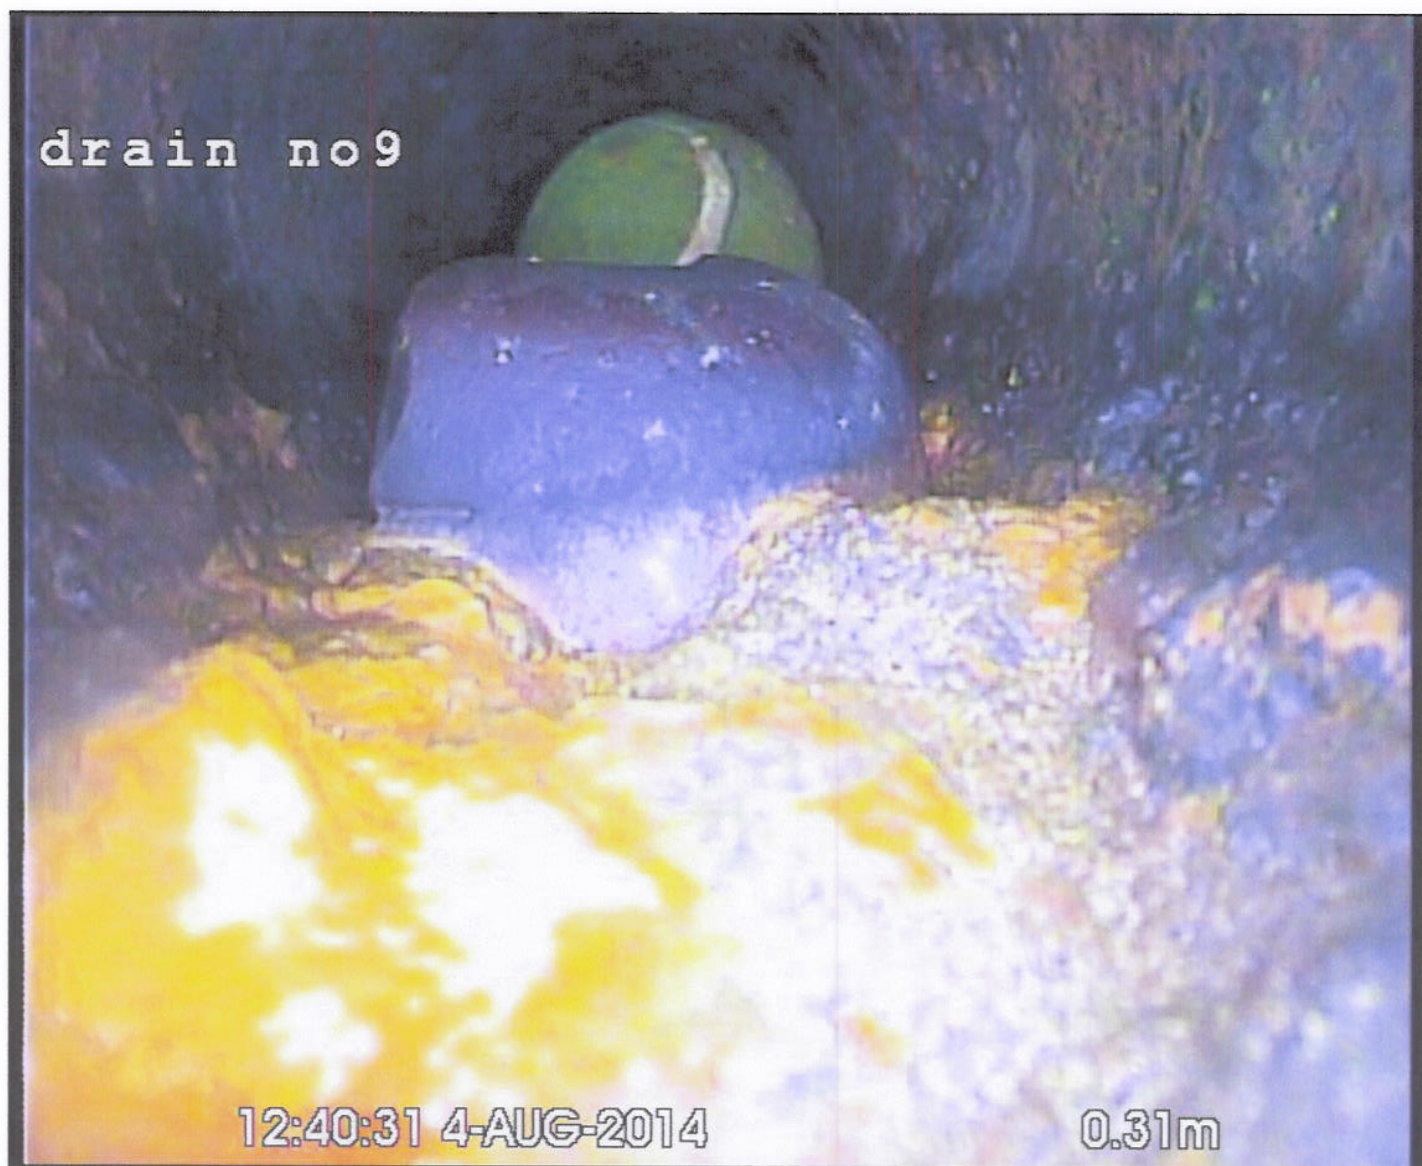
drain no9

Blocked with tennis ball, rocks, silt and sand.

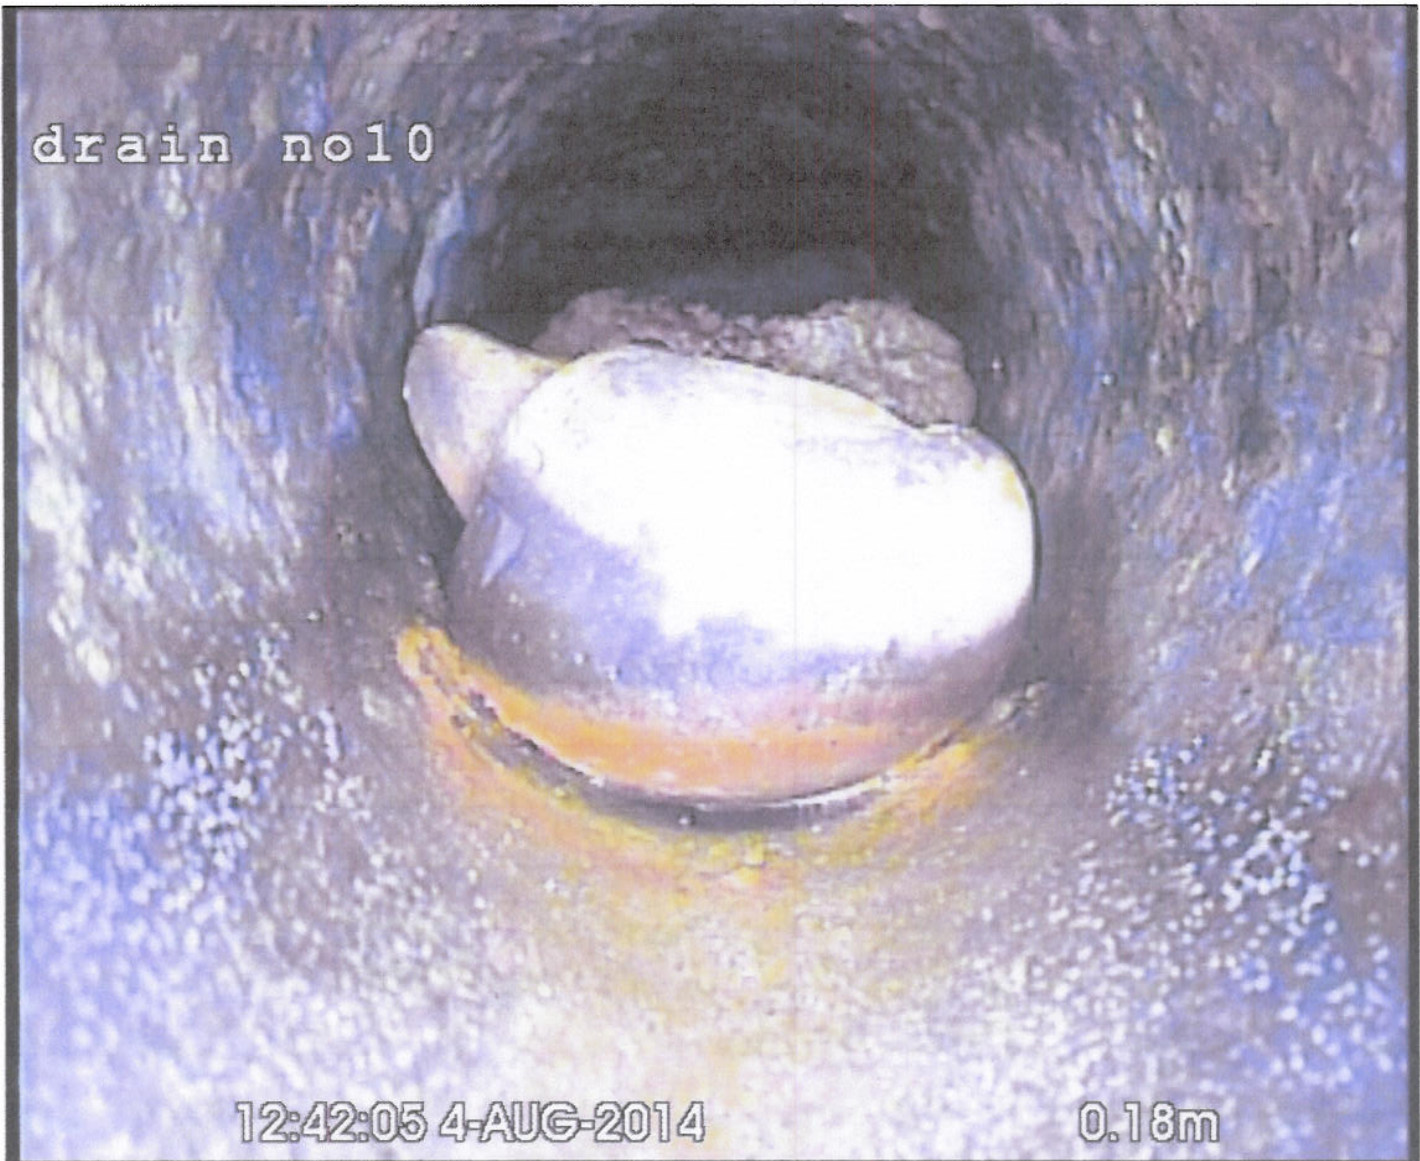
drain no10

Blocked with rocks.

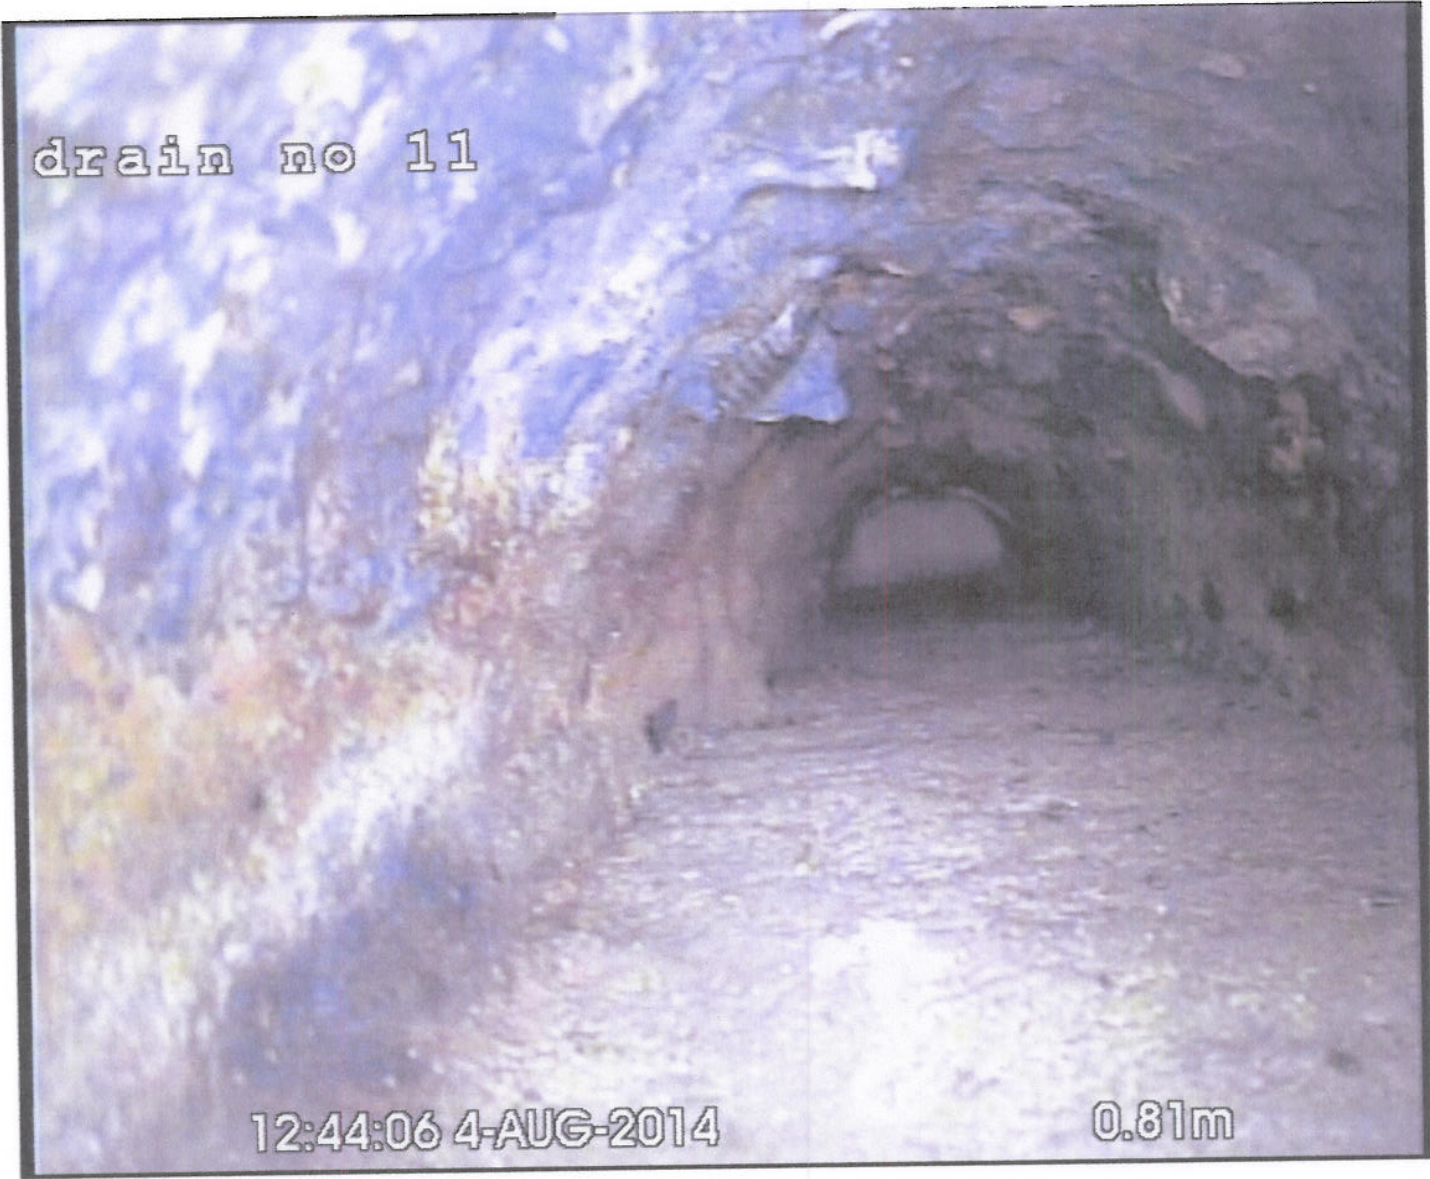
drain no 11

Blocked with rocks, silt and sand.

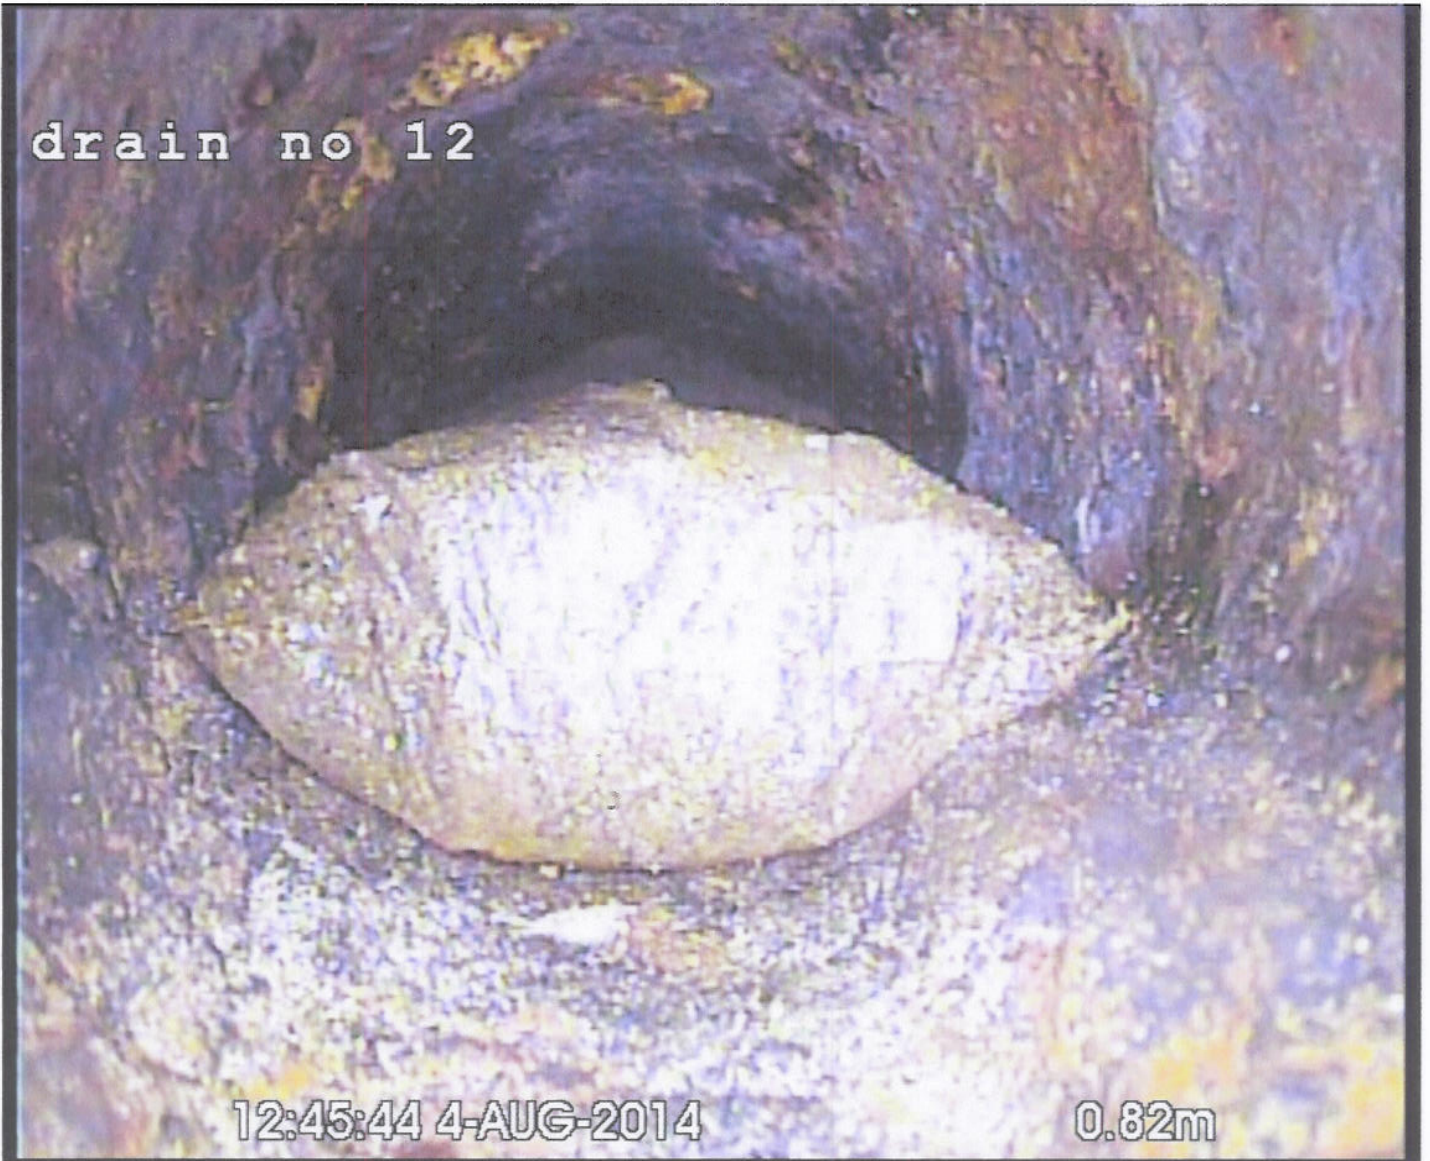
drain no 12

Blocked with rocks, silt and sand.
