**HaskoningDHV UK Ltd.
Water**

Subject: Cell 1 Coastal Asset Condition Summary_v2

1 Introduction

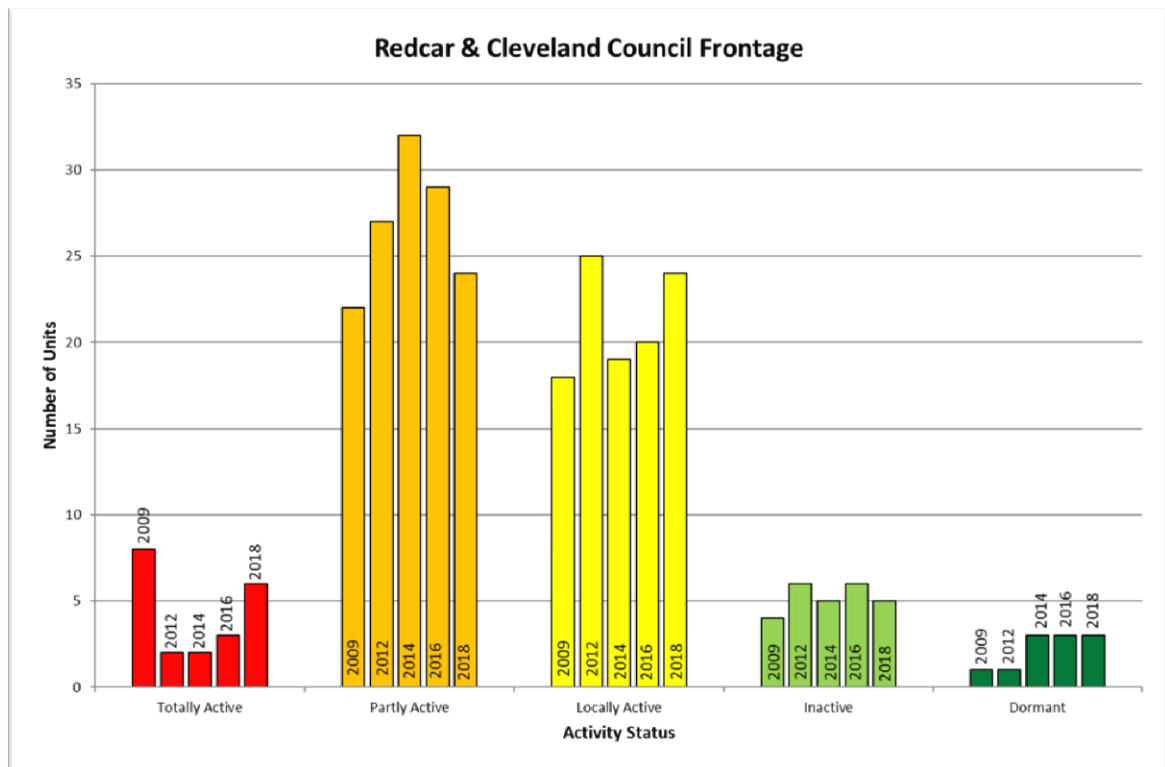
Figure 1 - Frequency of cliff activity along the Redcar & Cleveland frontage 2010 to 2018

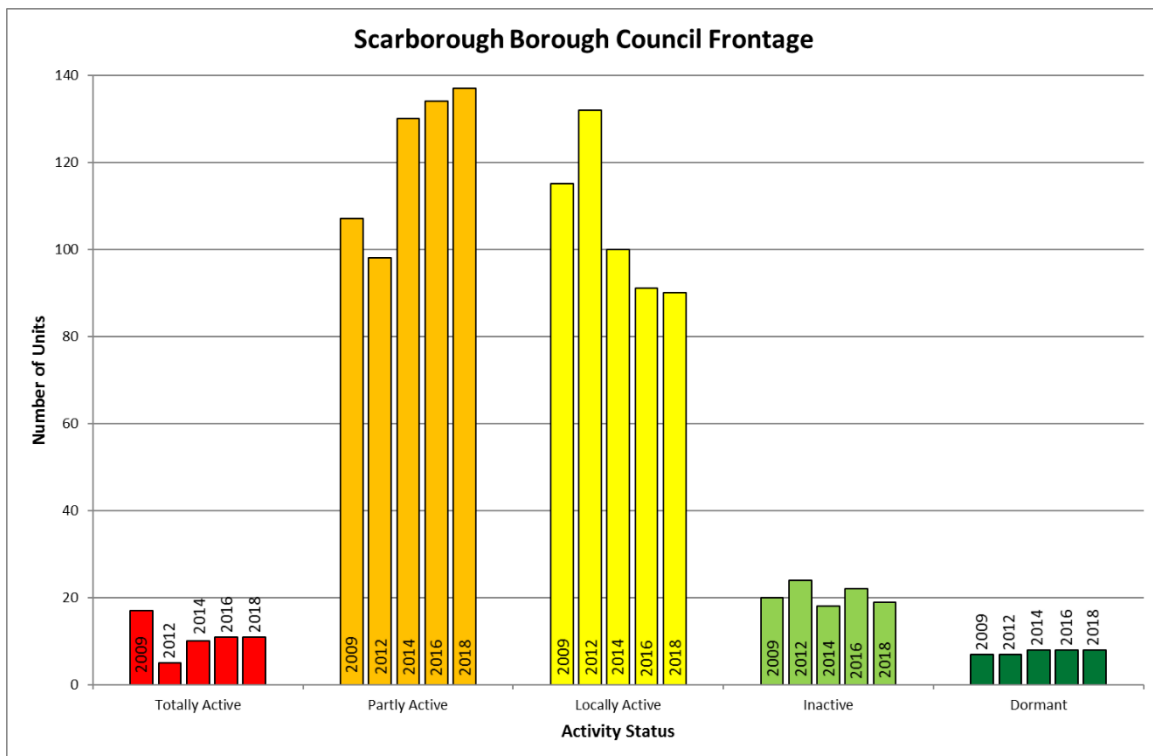
Figure 2 - Frequency of cliff activity along the Scarborough BC frontage 2009 – 2018
