**Note / Memo**

**HaskoningDHV UK Ltd.  
Water**

**Subject: Cell 1 Coastal Asset Condition Summary\_v2**

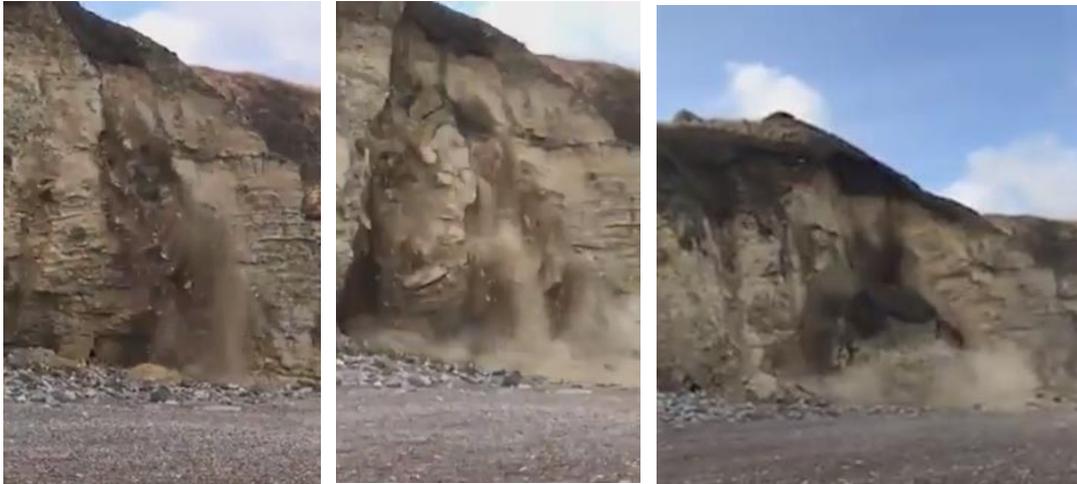
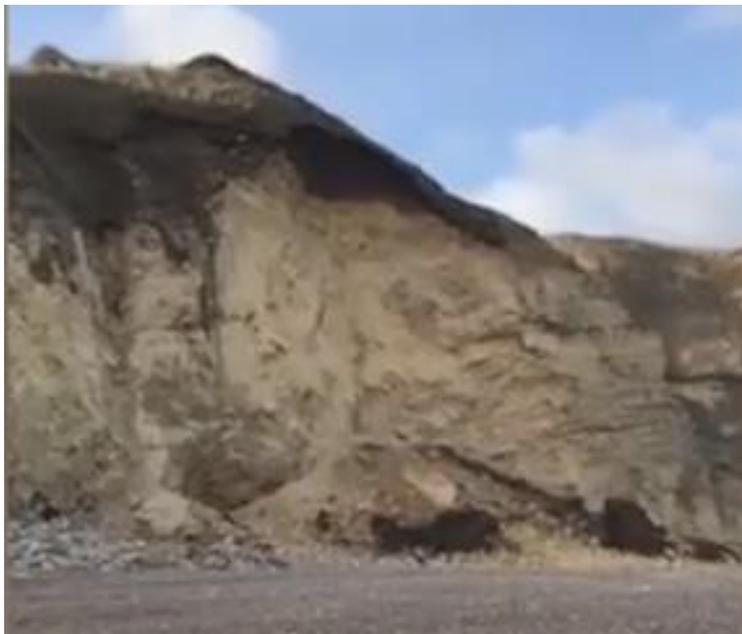
[In late January 2021, a local rock fall occurred in Marsden Bay, to the south of the Redwell Steps, following a period of prolonged intense rainfall and cycles of freeze-thaw due to severe weather

conditions. It is estimated that the rockfall resulted in a slip of 310.9m<sup>3</sup> of material with a maximum depth of cliff loss of 3.6m].

**Local rock fall at Marsden Bay, January 2021**

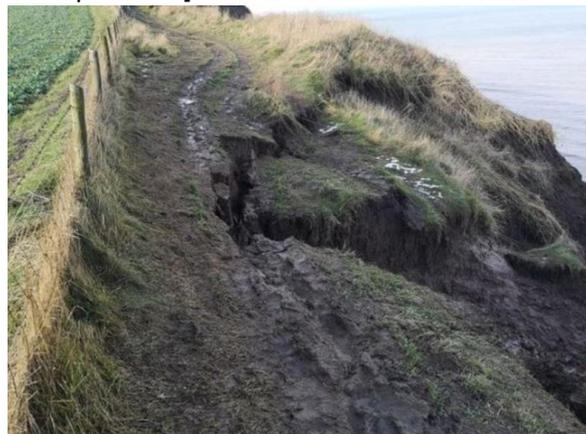
[In late January 2021, a local landslip occurred at Huntcliff (below). This was following a period of prolonged intense rainfall and cycles of freeze-thaw due to severe weather conditions. The slip caused a section of the Cleveland Way to become impassable].

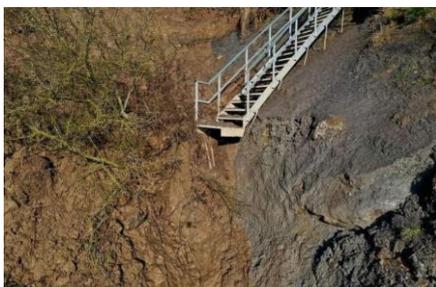
[In late January 2021, landslips occurred at Port Mulgrave (below, left) and Runswick Bay (below, right), following a period of intense rainfall and cycles of freeze-thaw due to severe weather conditions].
