Cell 1 Coastal Landfills Study

February 2019

Scarborough Borough Council

Cell 1 Regional Coastal Monitoring Programme Coastal Landfills Study

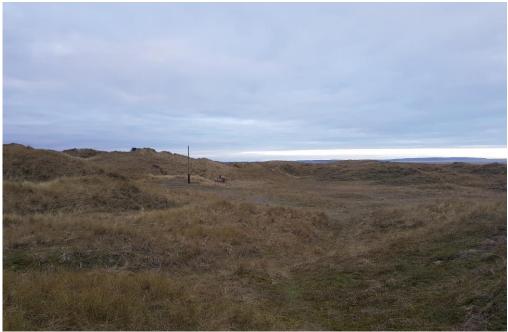
The inspection commenced along the Snook, where the dune frontage is high and well vegetated with some lower dipping dunes allowing easy access to the historic landfill site at Reference 1. The wrack line was along the toe of the dunes, indicating the extent of high spring tides. There are some areas of blowouts and dune fencing visible in the dunes adjacent to Reference 1, which was in a shallow, panned area approximately 40 m inland from the causeway (**Figure 3**).

Figure 3 Site of Reference 1 located in shallow, panned area of dunes along The Snook, Holy Island

It is recommended that Reference 1 contamination potential is lowered to 1 and erosion potential is lowered to 1, downgrading the overall risk ranking to 4, 'Very Low'.

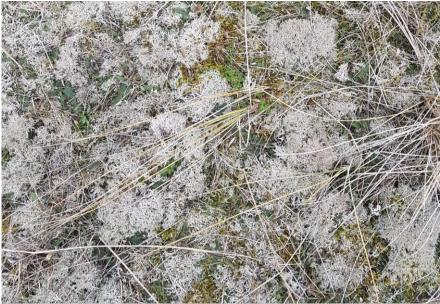
Vegetation in the area was noticeably different to surrounding areas and was predominantly covered in a grey lichen (**Figure 4**). It is believed to be *Cladonia portentosa*, a lichen which favours acidic, sandy heaths and dunes and is common in lowland areas (Silverside, 2016). There is no landfill exposed at the site. To the west of the site, there is a small brickwork feature and flag pole (**Figure 5**), which has been visible since the earliest Google Earth imagery from 2003. The seaward side of the Snook is gently sloping and well vegetated.

Figure 4 Grey lichen Cladonia portentosa covering site Reference 1, Holy Island

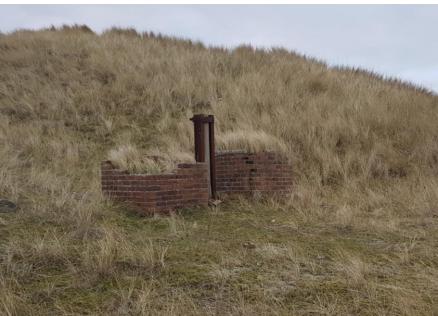
Figure 5 Brickwork feature present on the western side of site Reference 1, Holy Island

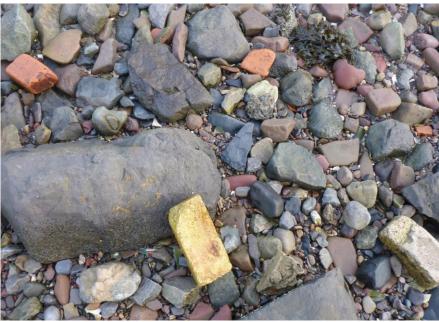
The inspection continued along the west of Holy Island to the foreshore of the Basin. No landfill is exposed on the intertidal flats at Reference 2, however, bricks, concrete, ceramics and glass are strewn on the upper beach close to the site (**Figure 6**). It is thought that this material was discarded on the lower beach at Reference 2 and over time has washed onshore, eroding landfill to boulder and cobble sized bricks and ceramics.

Figure 6 Inert landfill comprising bricks, concrete and glass strewn on the upper beach at site Reference 2

It is recommended that Reference 2 contamination potential is lowered to 1 and erosion potential is lowered to 1, downgrading the overall risk ranking to 4, 'Very Low'.

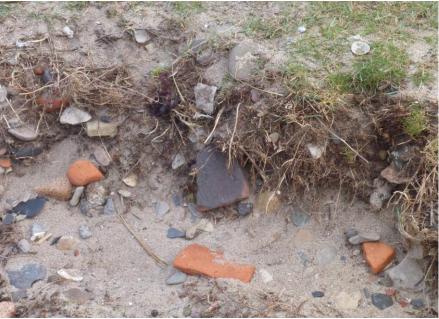
The low cliffs backing the upper beach contain partially eroded out bricks and ceramics (Figure 7).

Figure 7 Bricks and ceramics partially eroded out of low lying cliffs backing the beach at site Reference 2

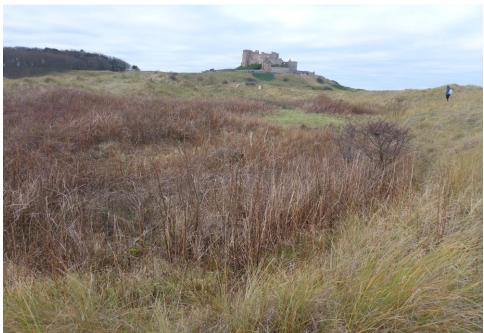
The inspection commenced on the foreshore and proceeded through the high dunes to Reference 3, located approximately 97 m inland. The dune system contains large hummocks with low-lying marsh and damp hollows (**Figure 9**).

Figure 9 The Dune Tip (Reference 3) overgrown with bramble

It is recommended that Reference 3 contamination potential is lowered to 1 and erosion potential is lowered to 1, downgrading the overall risk ranking to 4, 'Very Low'.

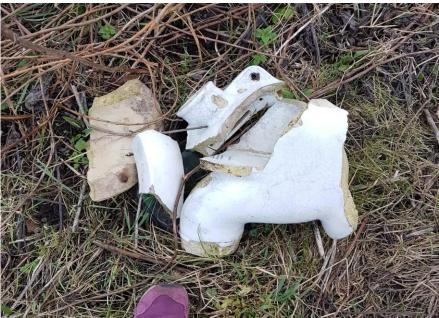
Similar to Reference 1, grey lichen *Cladonia* is present at Reference 3 and large parts of the site are overgrown with bramble. General household waste is exposed across the site, including bricks, ceramics and glass and other large household items (**Figure 10** and **Figure 11**). The site appears to be capped with topsoil / sand. No metalwork waste was visible during the site visit.

Figure 10 Household waste present at site Reference 3 amongst bramble

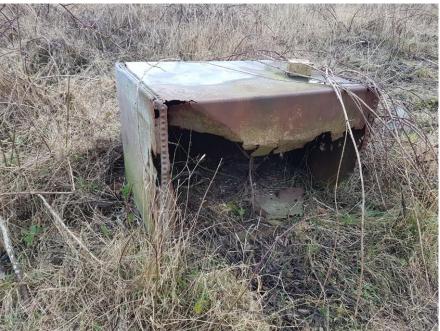
Figure 11 Large item present at site Reference 3

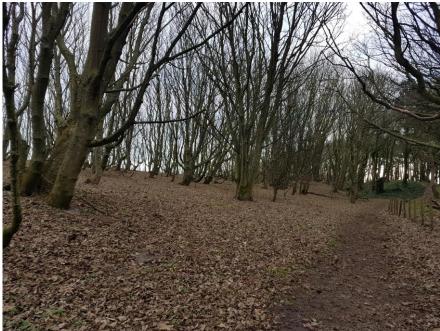
Reference 6 is located approximately 200 m inland of Reference 3 and was accessed via the wooded area along the Links Road (**Figure 12**). The site is well vegetated with trees and capped with a sandy topsoil. There is no landfill exposed, however, isolated plastic eroding from the topsoil is visible on the seaward facing edge of the site (**Figure 13**).

Figure 12 Path to site Reference 6, accessed via Links Road

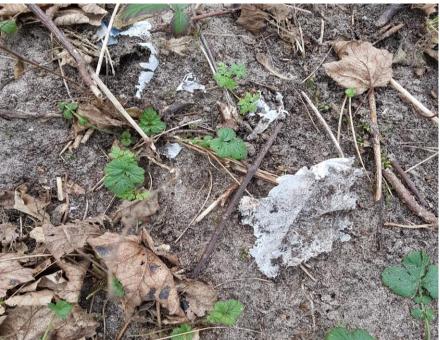
Figure 13 Plastic visible eroding out of sandy topsoil at site Reference 6

It is recommended that Reference 6 contamination potential is lowered to 1 and erosion potential is lowered to 1, downgrading the overall risk ranking to 4, 'Very Low'.

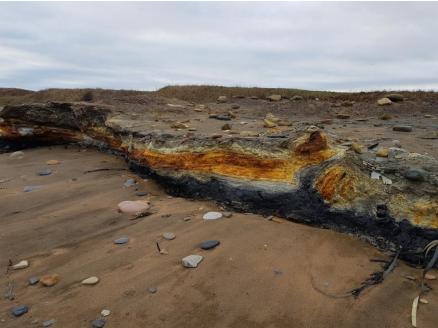
Figure 15 Deposition of colliery spoil along the foreshore at Lynemouth, creating an artificially advanced beach front

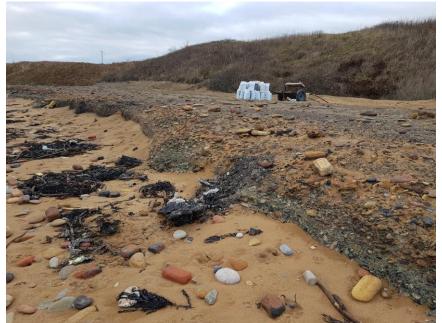
Reference 7 is a continuation of the colliery spoil historic landfill present along Lynemouth Bay, which has been actively eroding into the sea for decades. Bricks, coal, glass, rubber tubing and other industrial waste are exposed along the extent of the spoil (**Figure 17** and **Figure 18**) and coal deposits are strewn along the middle to upper beach. The spoil is backed by high, well vegetated dunes.

Figure 17 Landfill seen visibly eroding out of colliery spoil beach at site Reference 7

It is recommended that Reference 7 contamination potential remains at 4 and erosion potential remains at 5, ensuring the overall Risk Ranking of 80, 'Very High' remains in place.

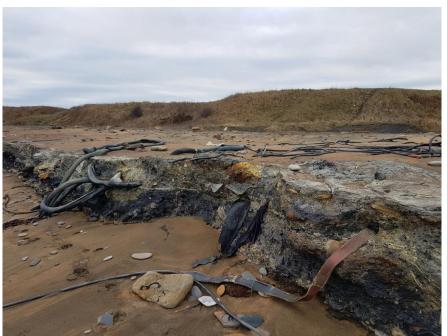
Figure 18 Rubber tubing and other industrial waste eroding from colliery spoil at site Reference 7

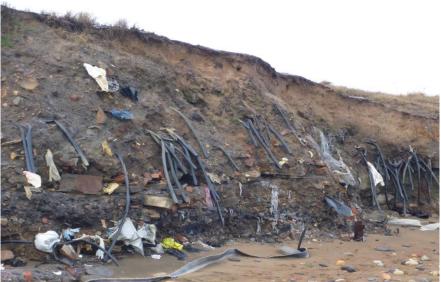
During the second site inspection, undertaken on Thursday 24th January 2019, landfill, including rubber tubing, bricks, concrete and ceramics is visibly eroding from the colliery spoil cliffs at a section of open coastline north of the River Lyne and at another section inside the river mouth (**Figure 19** and **Figure 20**).

Figure 19 Landfill eroding from colliery spoil cliffs along open coastline north of the River Lyne

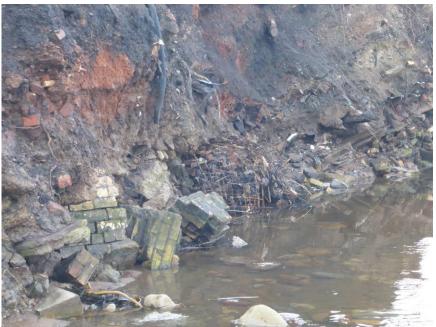
Figure 20 Landfill such as bricks and metalwork eroding out of the spoil cliffs along the banks of the mouth of the River Lyne

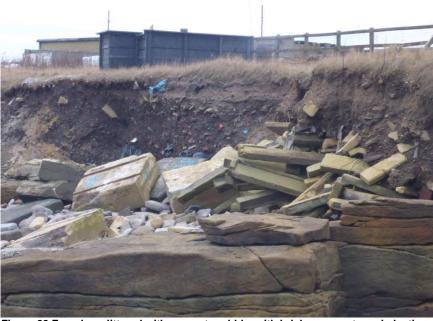
Figure 22 Foreshore littered with concrete rubble, with bricks, concrete and plastic eroding from Made Ground Cliffs along coastline of site Reference 4

Given the proximity of Reference 4 to the coastline, there is a potential coastal erosion risk to the site. However, given the placement of toppled Sandstone and concrete rubble at the base of the cliffs, coupled with the minor erosion rates found in HTA, the erosion risk to Reference 4 is low. Additionally, landfill is predominantly composed of inert concrete rubble at the seaward margin and presents no contamination risk (although other materials may be buried further inland).

It is noted that in the previous study, the receptor potential score was only rated as 4, which realistically should have been 5 for consistency with Reference 8, so this has been updated. Also, it is recommended that Reference 4 contamination potential is lowered to 3 and erosion potential is lowered to 3, downgrading the overall risk ranking to 36, 'Low'.

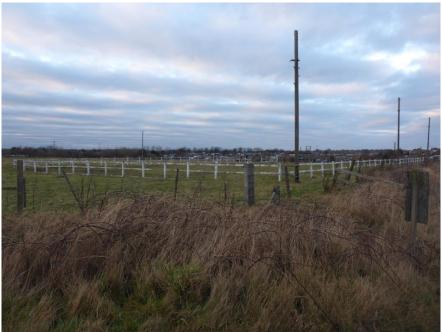
Figure 23 Site Reference 4 inaccessible during site visit

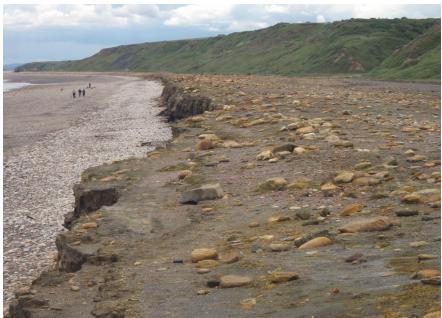
Figure 26 Colliery waste dumped on foreshore at Horden, Co. Durham

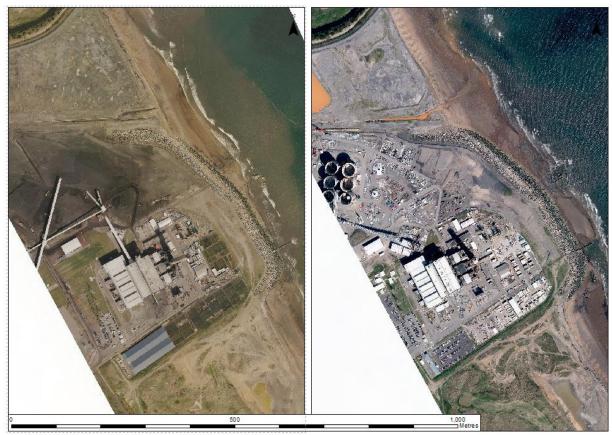
By 2017 there has been further erosion of the slag cliff north (c.10 m) and south (c.20 m) of Lynemouth Power Station (**Figure 31** and **Figure 32**), corroborated by the Coastal Inspection Report (2016) which describes "continuous erosion of the spoil cliff between the Power Station and Beacon Point".

Figure 31 Colliery spoil erosion north of the power station in 2010 (left) and 2017 (right)

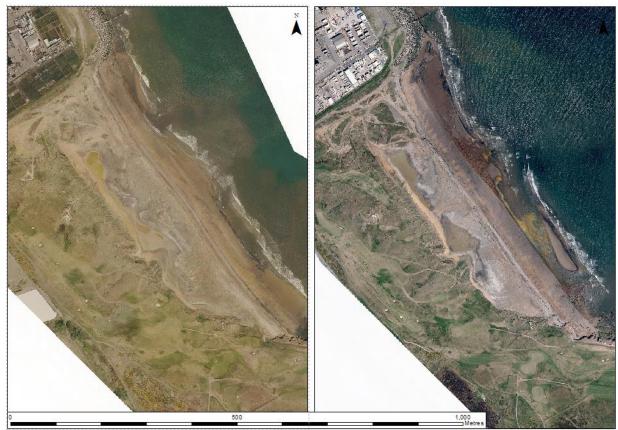
Figure 32 Colliery spoil erosion south of the power station in 2010 (left) and 2017 (right)
