# Cell 1 Regional Coastal Monitoring Programme Update Report 3: 'Partial Measures' Survey 2011

Northumberland County Council

July 2011

<sup>(\*)</sup> The present report is **Update Report 3** and provides an analysis of the 2011 Partial Measures survey for Northumberland County Council's frontage. It is intended as a brief update of the key findings from this survey to maintain an understanding of ongoing changes.

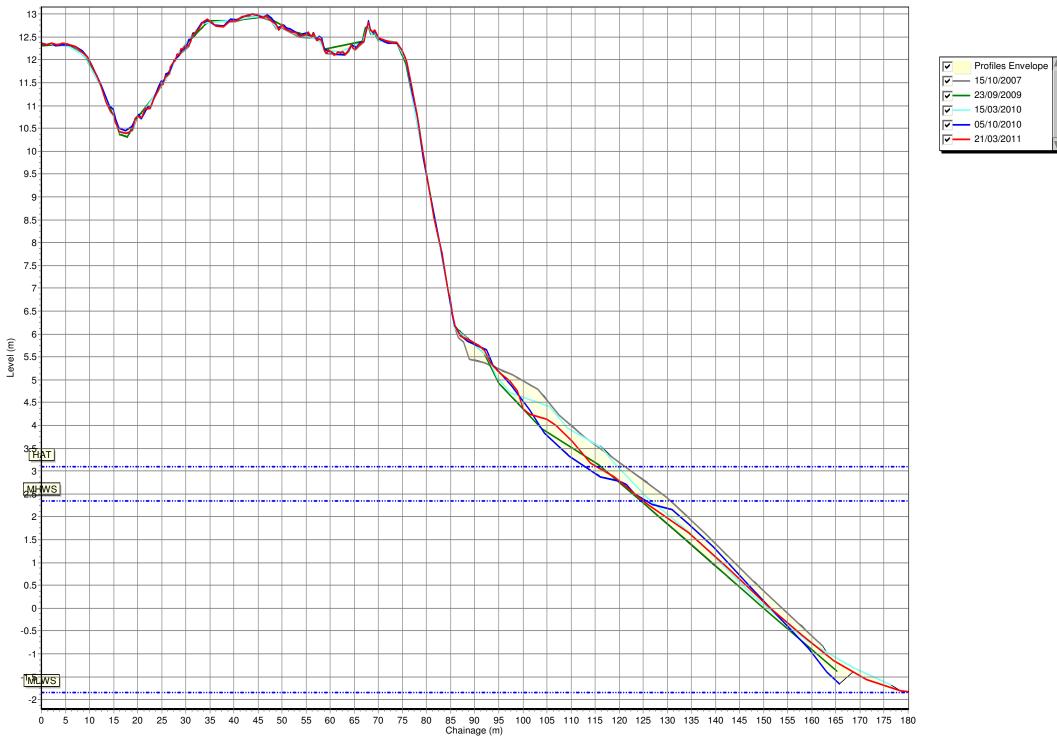
#### Beach Profiles: 1aCMBC03A

Survey Date	Description of Changes Since Last Survey	Interpretation
03-2011	<ul> <li>Beach Profiles:</li> <li>Lynemouth is covered by two beach profile lines during the Partial Measures survey (Appendix A), namely profiles CMBC03A and CMBC03B, which were both added to the programme in October 2007.</li> <li>Along CMBC03A the position of the slag bank at the rear of the foreshore has remained stable, whilst the foreshore has shown some minor variations since October 2010. Previous surveys have shown some progressive cut-back of the foreshore, but this appears to have stabilised in the March 2011 survey.</li> <li>Significant erosion of the foreshore has been reported over the past several years along CMBC03B, leading to significant slag bank erosion. In the March 2011 survey, the slag bank appears to have been re-graded back to a shallower angle. This is confirmed by the surveyor's notes, which record this was achieved through use of mechanical plant. This process has resulted in some material being deposited from the slag bank onto the foreshore, raising levels by a minimum value of around 0.5m.</li> </ul>	The profiles along CMBC03A and CMBC03B have been experience ongoing change since the surveys were introduced here in October 2007. Whilst the foreshore cut back appears to have stabilised between October 2010 and March 2011 along CMBC03A, there still remains only a very narrow beach width before slag bank erosion will commence. Along CMBC03B, the rate of erosion of the slag bank (some 17m in the three years between October 2007 and October 2010) appears to have prompted management intervention by Rio-Tinto Alcan, the owners of the Lynemouth Power Station. The combined effect of re- grading of the slope to a shallower angle together with the foreshore accretion should slow or arrest the rate of recession. This will be confirmed through analysis on ongoing surveys in future reports.
