Cell 1 Regional Coastal Monitoring Programme Update Report 2: 'Partial Measures' Survey 2010

South Tyneside Council

South Tyneside Council Final Report

May 2010

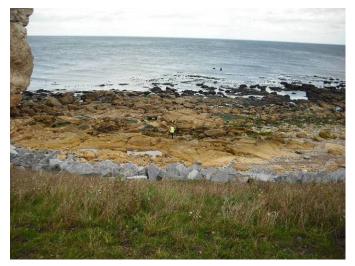
Surveys of foreshore areas that are covered by inter-tidal rock outcrops present some problems to our surveyors. It is logistically difficult for staff to access across the foreshore but more importantly it is very difficult to ensure that identical rock features are re-surveyed on each occasion. Due to the fragmented, creviced and 'rocky' nature of the foreshore it is extremely likely that different features will be recorded on successive surveys due to this.

We would expect that the rock foreshore would not experience significant down-weathering over short timescales and therefore any apparent changes between successive surveys are likely to be due to surveying different features rather than erosion.

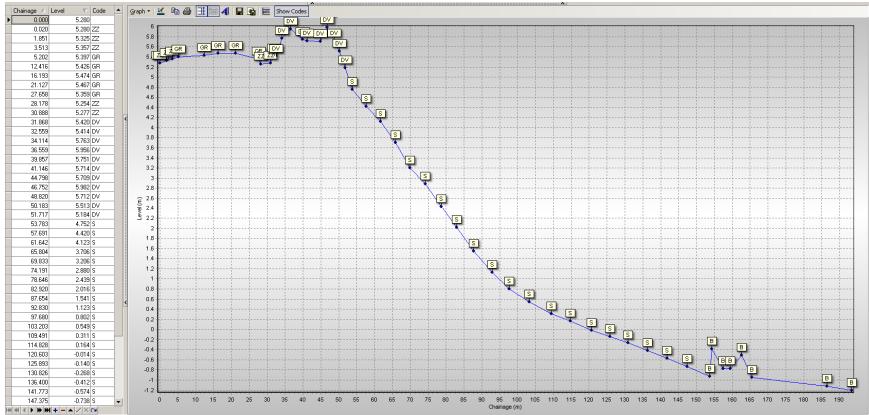
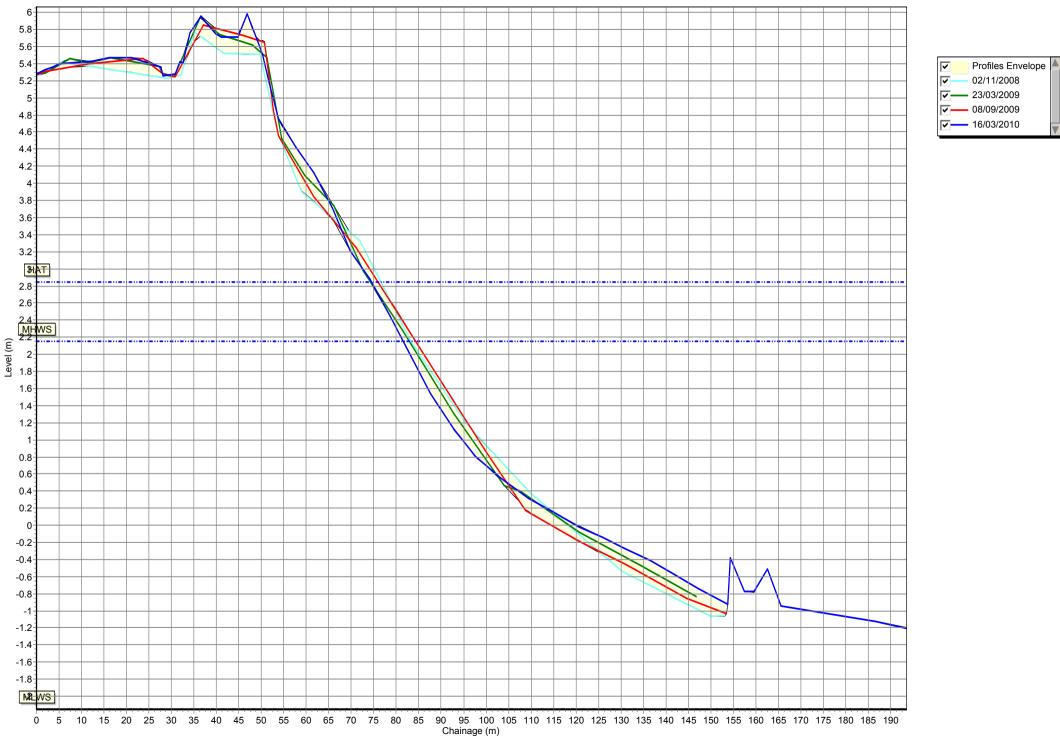
1bSS1 - 16/03/2010

Survey Date	Description of Changes Since Last Survey	Interpretation
03-2010	 Beach Profiles: Littlehaven Beach is covered by two beach profile lines during the Partial Measures survey (Appendix A). SS1 shows some redistribution of material from the mid and upper beach, where the lowest levels were recorded since surveys began in November 2008, to both the lower beach and the toe and crest of the dunes, where in all of these zones the highest levels to date were recorded. The particularly low tides at the time of the survey revealed boulders along the lower foreshore, at a chainage of around 155m to 165m. Note: This survey was completed before the highest tides of the spring equinox and these did cause notable changes in dune position and foreshore levels elsewhere across the north east on a quite widespread basis. 	SS1 demonstrated a greater degree of redistribution of sediment from the mid beach to the upper and lower sections than previously recorded, although these are considered to be seasonal trends particularly affected over winter 2009/10 by easterlies and a number of storm events. This shows natural variability that is expected to continue to be observed along this profile. General ongoing accretion of the dune toe and crest means they remain healthy in this area, and the boulders along the lower foreshore will assist in protecting this frontage to a degree.

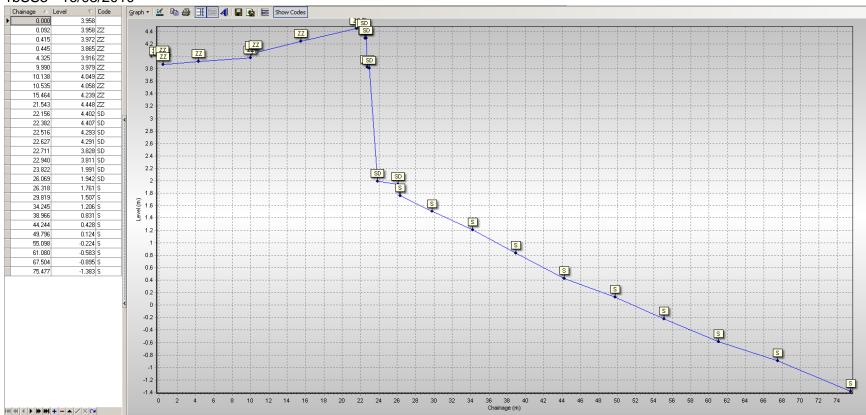
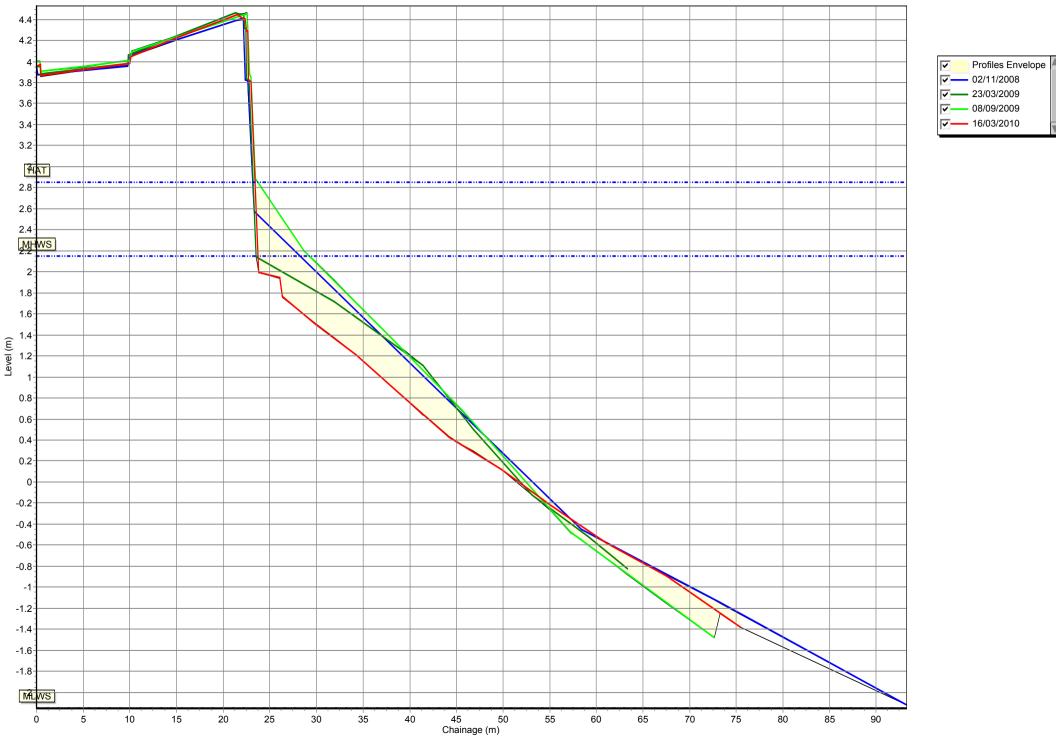
1bSS3 - 16/03/2010

SS3 exhibited the lowest foreshore levels recorded to date along its length. The foundations at the toe of the sea wall were exposed to a depth of 1.7mODN and beach levels along the foreshore were typically some 0.4m lower than the previous survey which already was recording low values.	The already very low levels at the toe of the sea wall dropped further, exposing the foundation of the wall and leaving it vulnerable to direct wave attack, overtopping and failure due to undermining. This is an area of ongoing concern.

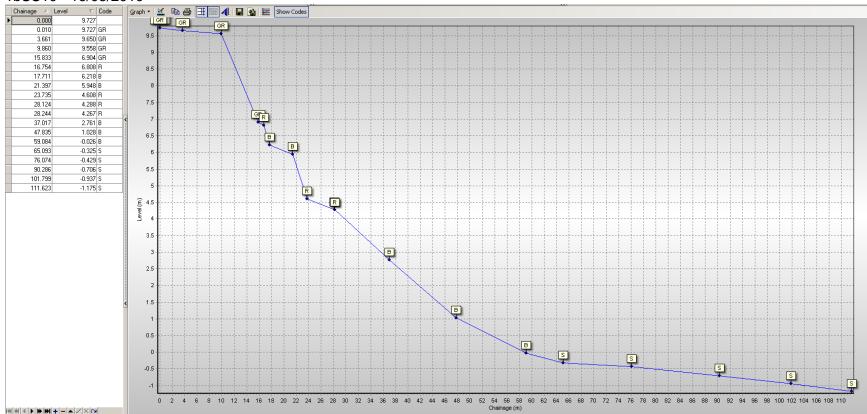
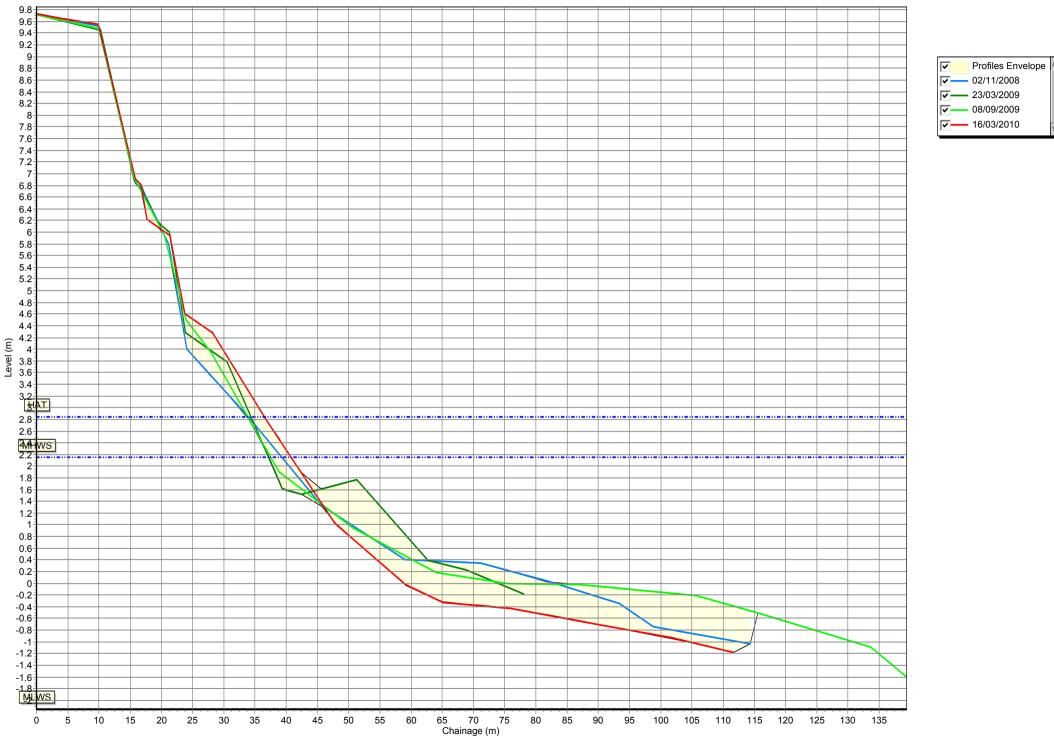
1bSS10 - 16/03/2010

Survey Date	Description of Changes Since Last Survey	Interpretation
03-2010	 Beach Profiles: Trow Quarry is covered by four beach profile lines during the Partial Measures survey (Appendix A), two in Graham's Sand and two in Southern Bay. SS10 demonstrates good stability in the coastal slope and revetment that were constructed along Graham's Sand during 2008, although one point along the revetment appears more landward than in previous surveys. Seaward of the revetment foreshore changes continue, with material eroded from the lower profile being deposited on the foreshore between around MHWN and the toe of the revetment. SS11, also in Graham's Sand, shows similar stability in the coastal slope and revetment but the sand veneer has been stripped off the foreshore, exposing the underlying bedrock along much of the lower profile length. SS12 and SS13 are both located in Southern Bay and both show stability in the coastal slope and rock revetment, In both cases, the thin sand veneer observed in places along each profile during the 	The coastal slope and rock revetment constructed as part of the coastal defence scheme in 2008 are showing good stability, and although the slight difference in one survey point along SS10 may be indicative of local displacement of rock armourstone, this will be further checked during the forthcoming 2010 visual walk-over inspections. There continues to be natural variability in the thickness and location of the sand veneer covering the rocky foreshore at Trow Quarry.

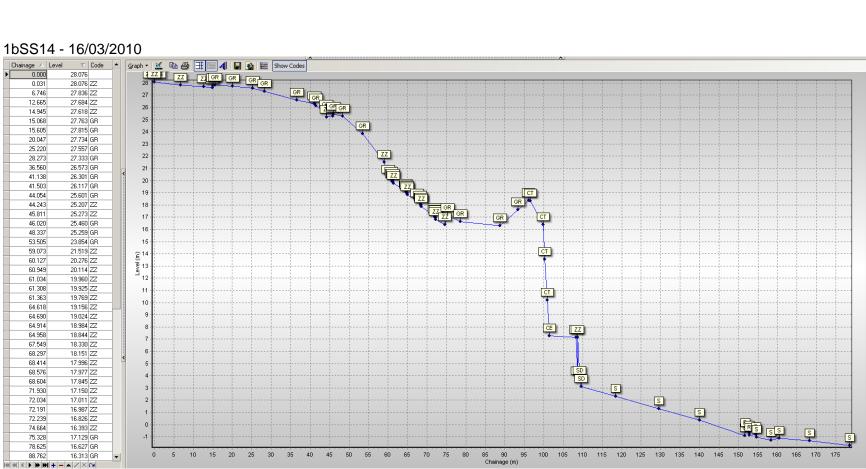
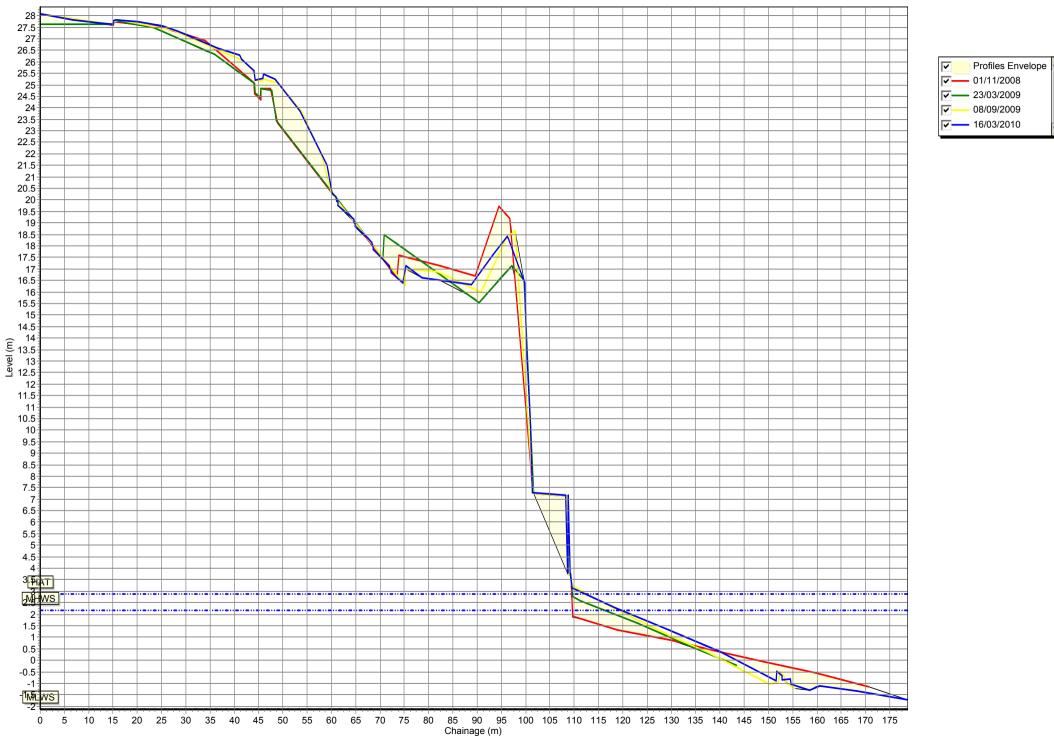
1bSS14 - 16/03/2010

Beach Profile SS14 is located at the northern end of Marsden Bay, close to the Redwell Steps. Surveys of the beach and the concrete platform and steps at the base of the cliffs are accurately undertaken on each survey. Due to this, it has become clear that the changes in the cliff form above the structure are 'apparent' changes caused by survey difficulties on this steeply bevelled cliff face. In particular, the rock that outcrops at the seaward face of the cliff is showing apparent signs of change (see Appendix A - Beach Profile 1bSS14).

A slight change in alignment of the profile across the cliff section can result in an apparently large change in form simply due to different rock features being picked up on each survey.
