Cell 1 Regional Coastal Monitoring Programme Update Report 2: 'Partial Measures' Survey 2010

Sunderland City Council Final Report

June 2010

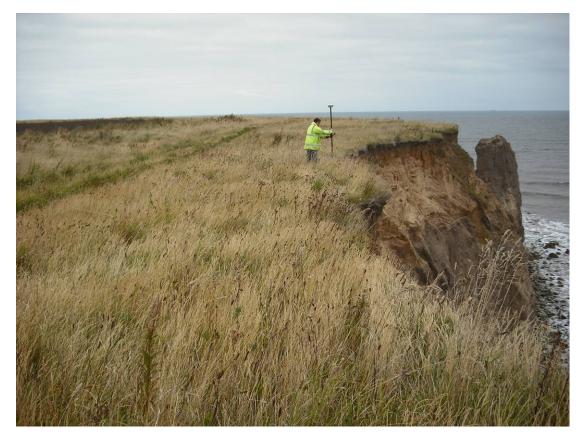
Plate 1 – Cliff Top Surveying

Surveying any cliff top is difficult due to the Health and Safety risks posed to surveyors, especially during adverse weather, and the 'apparent' changes that can arise due to surveyors interpreting different points as the cliff edge on successive surveys (Plate 1). This has previously been identified as affecting most of the cliff top surveys.

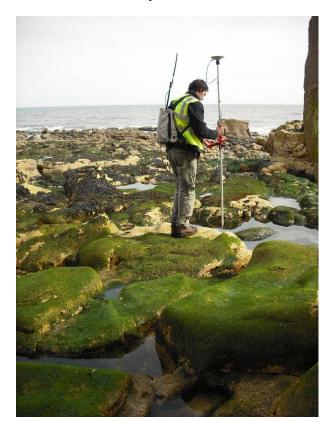
Plate 2 - Survey of Rock Foreshore

Surveys of foreshore areas that are covered by inter-tidal rock outcrops present some problems to our surveyors (Plate 2). It is logistically difficult for staff to access across the foreshore but more importantly it is very difficult to ensure that identical rock features are resurveyed on each occasion. Due to the fragmented, creviced and 'rocky' nature of the foreshore it is extremely likely that different features will be recorded on successive surveys due to this. We would expect that the rock foreshore would not experience significant downweathering over short timescales and therefore any apparent changes between successive surveys are likely to be due to surveying different features rather than erosion.

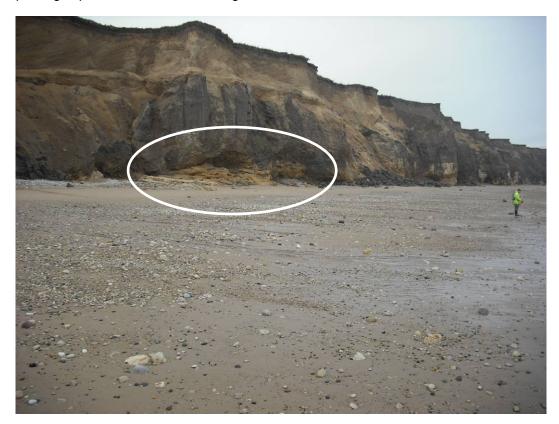
Plate 3 – Cliff Undercutting

- The sections of undefended cliff appear to be eroding quite rapidly, especially along Halliwell Banks, with several metres of cliff top recession recorded between March 2009 and March 2010.
- The mechanism for failure is initiated by undercutting at the base of the cliffs (Plate 3) by wave action. This has occurred on a quite widespread basis across the frontage during the winter of 2009/2010 because the weather conditions were severe, coinciding with a prolonged period of easterlies and high sea states.

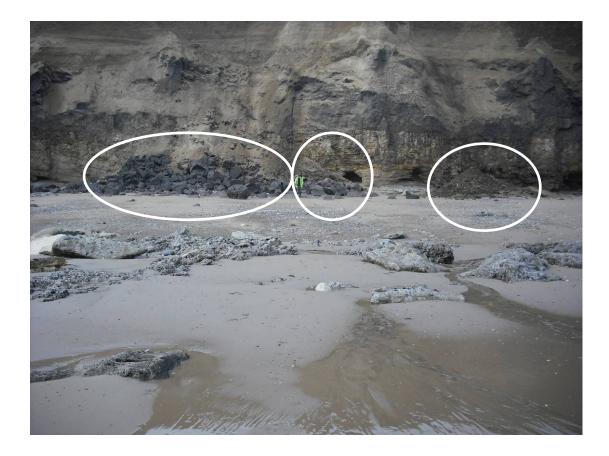
Plate 4 – Debris at the Cliff Toe

- Once such conditions have been created at the base of the cliffs, cliff failures can more readily be triggered by waves, rainfall, freeze-thaw cycles or additional loading (such as heavy snow during the winter of 2009/2010).
- Such failures generally take the form of material falling from the cliff face with the debris becoming deposited on the foreshore at the toe of the cliff (Plate 4). Here, the debris will provide some protection until it is removed by marine action and the process starts again.

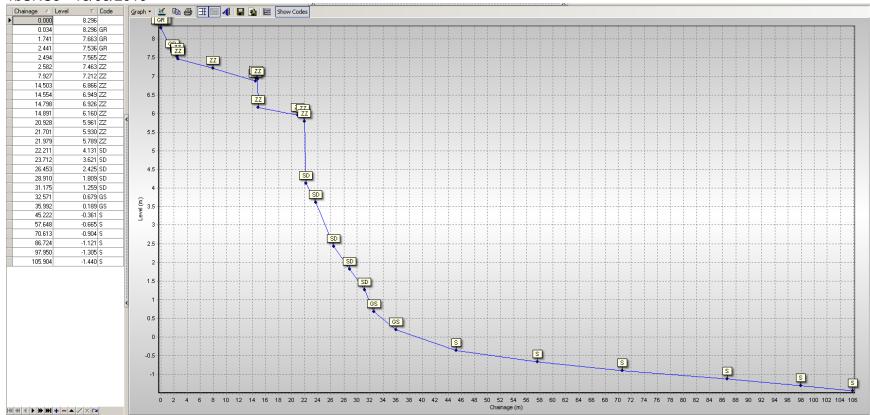
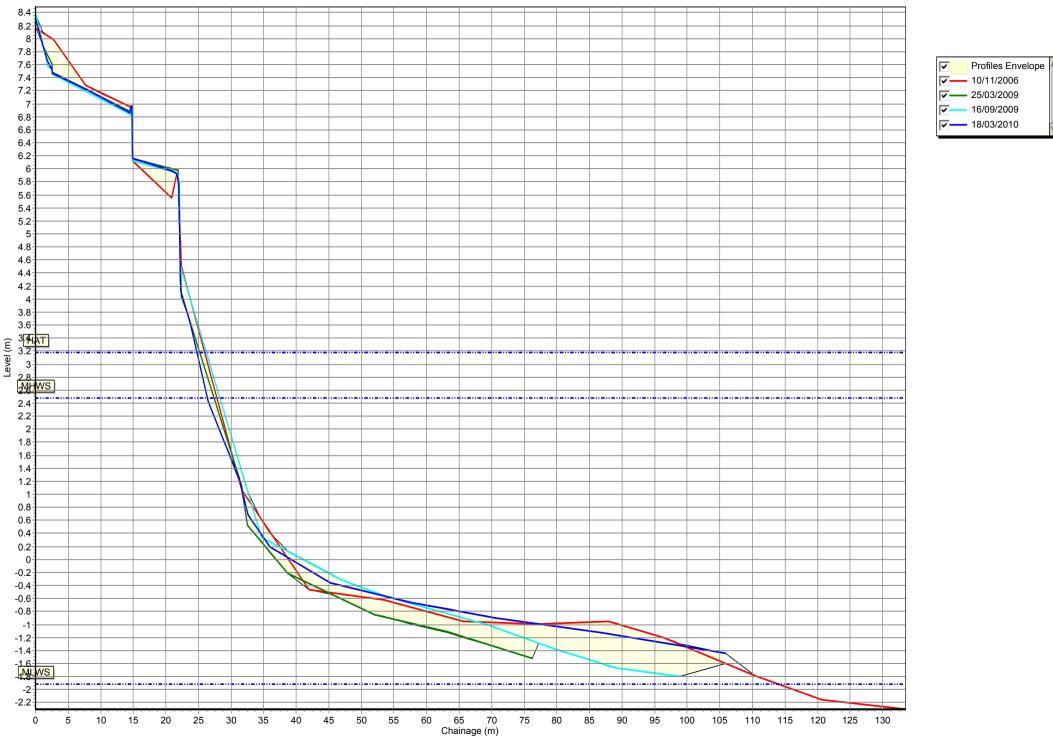
1bSNS8 - 18/03/2010

02 2040	SNS8 and SNS11 both start at the coastal slope/cliff backing the Hendon Sea Wall and extend across the wall and fronting rock armour before reaching sand levels and then extending down to low water. SNS8 experienced lowering of the beach profile between the toe of the revetment and a chainage of around 55m. The lower foreshore, seaward of a chainage of 55m, experienced accretion by around 0.4m.	There appears to have been no consistent trend in profile response along the southern end of the Hendon Seawall, although some of the material liberated
03-2010	SNS11 experienced accretion between September 2009 and March 2010 along the upper section of the narrow foreshore zone that extends seawards from the toe of the rock revetment.	from SNS8 may have become deposited along SNS11.
	SNS20 is located at Shirley Banks. The profile extends across the cliff top, which is at an elevation in excess of 25mODN, and drops over 21m in height down the steeply-sloping cliff face to the toe. The profile then extends across the foreshore down to low water, with some rock outcrops captured towards the landward end. Whilst there was no significant change in position of the cliff top along this profile, the toe of the cliff did experience cut-back of some 2.5m at the toe of the cliff. This has resulted in a steeper cliff profile which will lead to subsequent cliff failures and recession of the cliff top position.	The profiles measured along the undefended cliffs of Shirley Banks and Halliwell Banks have generally experienced erosion at the toe of the cliffs, resulting in undercutting. This has resulted in a steeper cliff profile which in
