Cell 1 Regional Coastal Monitoring Programme Update Report 10: 'Partial Measures' Survey 2018

Scarborough Borough Council June 2018

^(*) The present report is **Update Report 10** and provides an analysis of the 2018 Partial Measures survey for Scarborough Council's frontage.

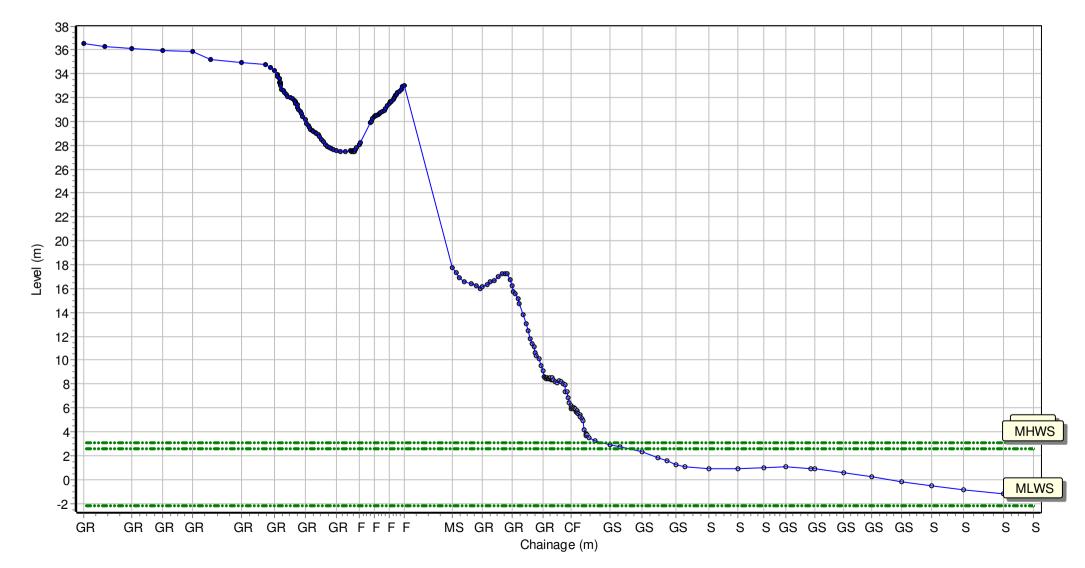
Location: 1dWB2

At Whitby two areas of profile 1dWB2 were not measured due to dense vegetation on an area of the cliff face.

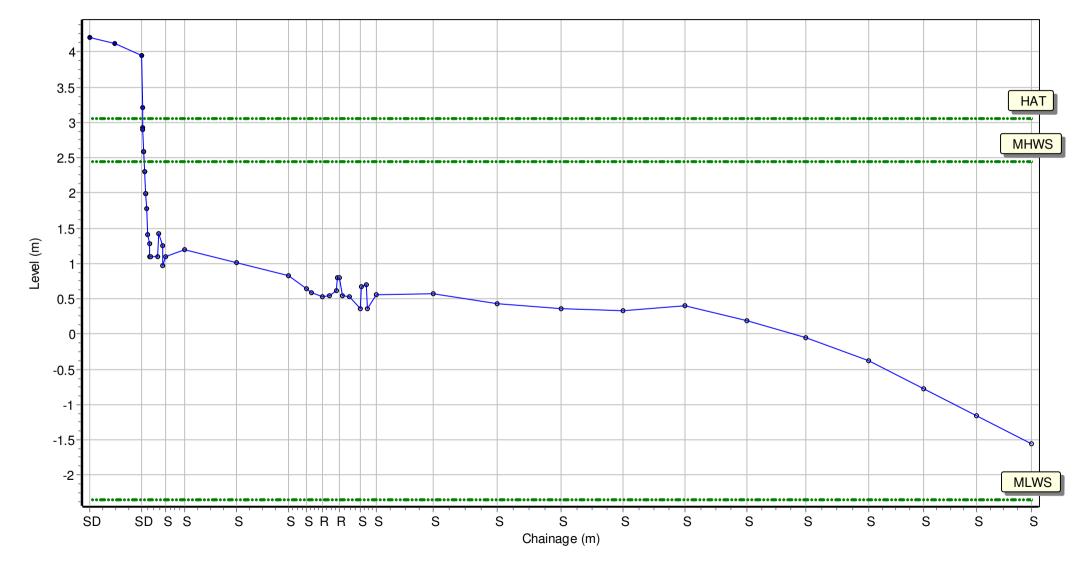
Location: 1dSBN2

21 st March 2018	Profile 1dSBN2 is located close to the former chair lift. There has been erosion across the upper beach, with 1.4m at the toe of the seawall tapering to 0.2m by chainage 75m. Seawards of chainage 75m there has been accretion of up to 1.0m, covering some of the rock exposures. The upper beach is at lowest recorded level, whilst the lower beach is at a relatively high level compared to the range recorded from previous surveys.	seasonal drawdown and recovery.
	Profile 1dSBN3 is located near Royal Albert Drive. There has been erosion of up to 0.7m across the majority of the profile, with the exception of the toe of the beach seawards of chainage 135m where there has been accretion of 0.2m. Overall the beach is at a medium level compared to the range recorded from previous surveys.	
	Profile 1dSBN4 is located at the northern end of Clarence Gardens. The profile is dominated by erosion, with up to 1.1m between the seawall and the exposed rock at chainage 35m. Seawards of the rock exposure there has been erosion of up to 1.3m, but more typically 0.4m. The length of rock exposed has increased by around 18m. Beach levels are at a relatively low level compared to the range recorded from previous surveys.

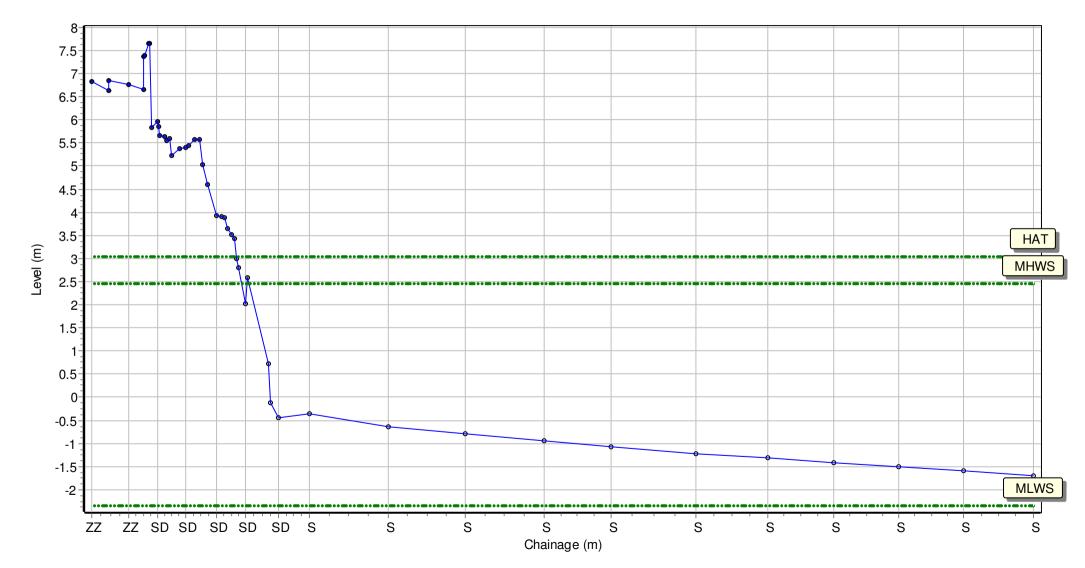
Location: 1dSBN5

Profile 1dSBN5 is located southern of Clarence Gardens. There has been erosion across the whole profile of up to 0.6m. Overall the profile is at a relatively low level compared to the range recorded from previous surveys.

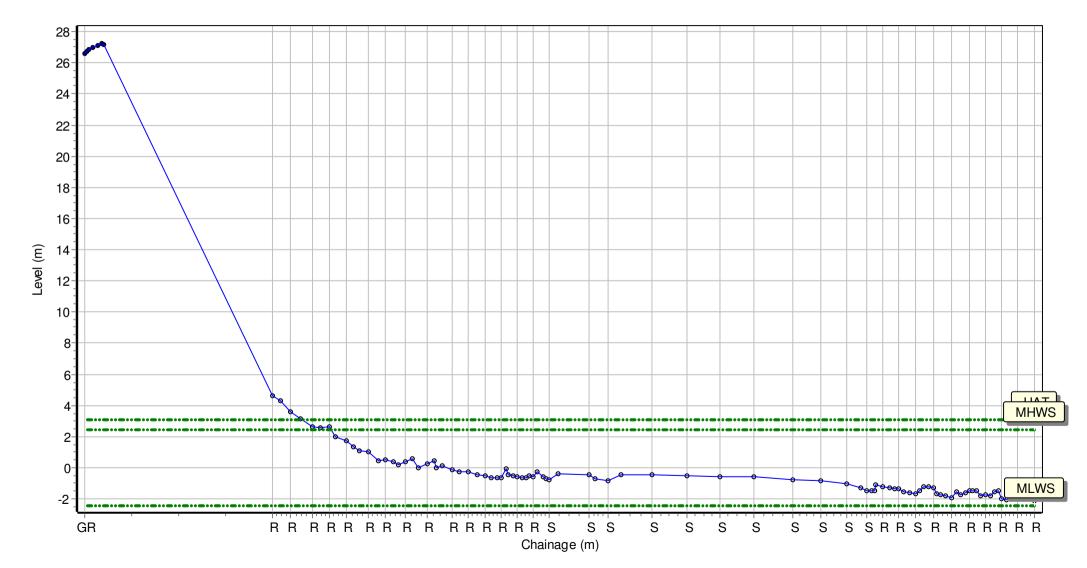
Location: 1dCY1

- the top of profile 1dCY1 cannot be measured due to dense vegetation;
- The middle of profile 1dCY2 could not be measured due to the ground make-up, soft mud flows, and unstable grass;
- The middle of profile 1dCY3 could not be measured due to the ground make-up, soft mud flows, unstable grass, and landslips;
- Profile 1dCY3 was measured to cliff edge on top and as close to the cliff face at the bottom as possible.

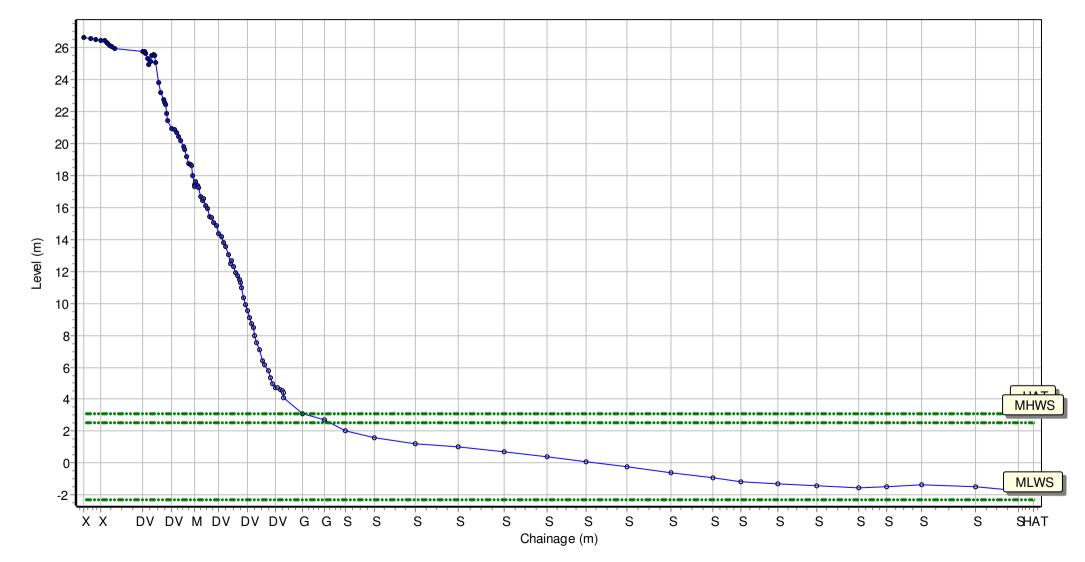
Location: 1dFB2

- The surveyor was unable to measure the middle of section 1dFB2 between chainage 12m and 20m due to dense vegetation.
- The middle of profile 5 was unable to be measured from chainage 65m to c. 204m, due to undergrowth and bushes.

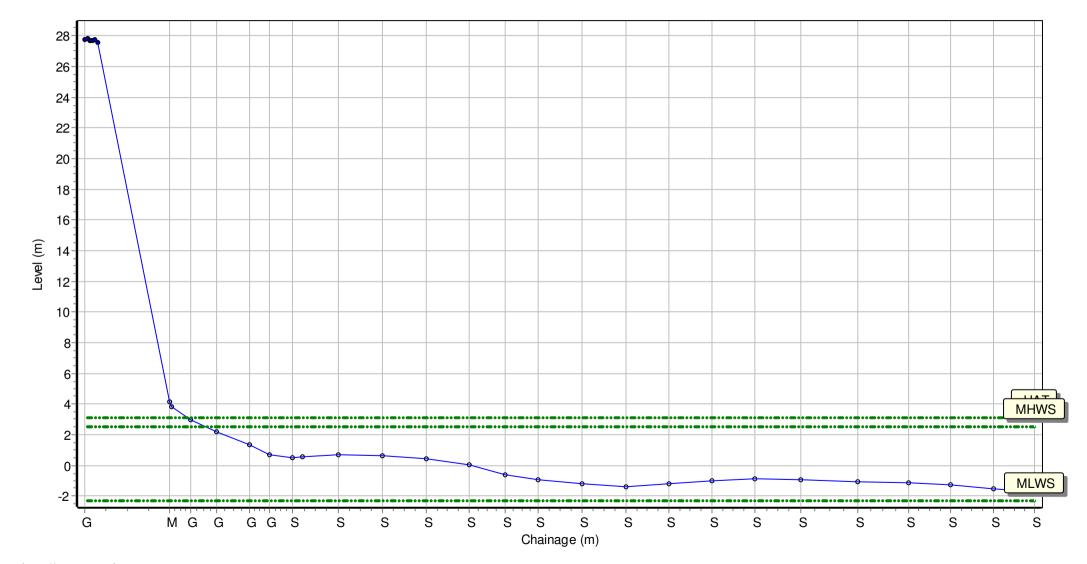
Location: 1dFB4

Profile 1dFB4 is located near Humanby Gap. There has been variable erosion of 0.1m to 2.2m between chainages 30m and 195m. This has created a stepped profile with the upper beach berm previously recorded at chainage 130m moving landwards by around 50m and dropping in height. In addition, a lower beach berm has formed at chainage 200m. There has been accretion between chainage 195m and 265m of up to 0.3m. The upper beach is at a low level compared to the range recorded from previous surveys, whilst the lower beach is at a relatively high level.

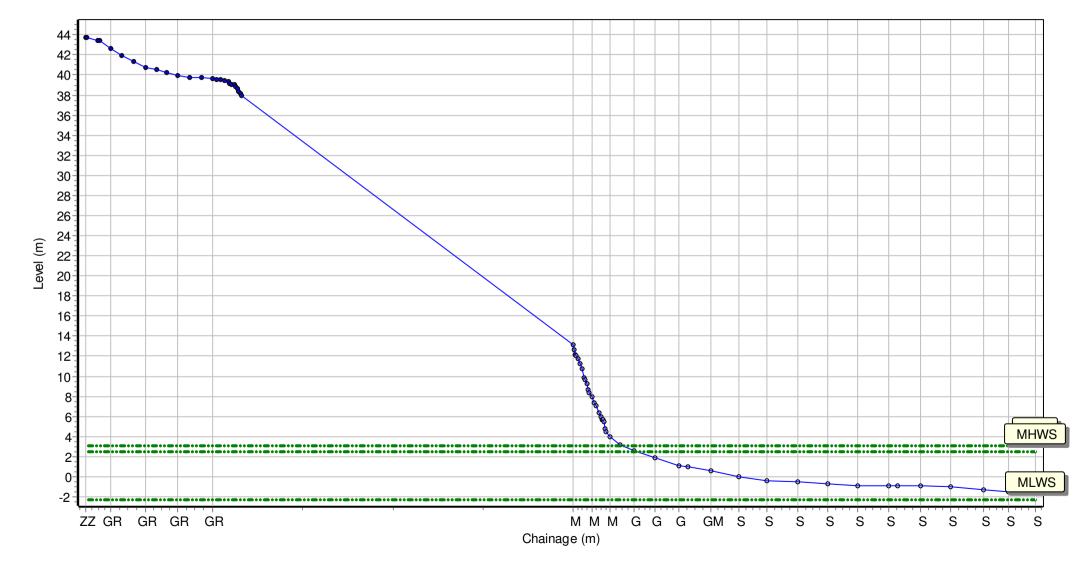
Location: 1dFB5

Survey Date	Description of Changes Since Last Survey	Interpretation
	Profile 1dFB5 is located close to Reighton Gap. The surveyor noted that the middle of profile 1dFB5 was unable to be measured from 65m to c. 204m chainage due to vegetation. There has been erosion across the whole beach profile of up to 1.0m. Overall the profile is at a relatively low level compared to the range recorded from previous surveys, with the section between chainage 245m and 290m the lowest on record.	
March 2018	Topographic Survey: Data from the most recent topographic survey (Partial Measures, Spring 2018) have been used to create a digital ground model (DGM) (Appendix B – Map 5a) using a Geographical Information System (GIS). The topographic plot shows the gently sloping shore parallel bathymetry in front of Filey town. A difference plot has also been produced using the DGM (Appendix B – Map 5b) comparing the last topographic survey (Full Measures, Autumn 2017) to the present survey. The difference plot is dominated by a wide band of erosion across the majority of the beach. There is however, a very narrow band of accretion at the base of the seawall. The toe of the beach shows a narrow band of very little change.	The erosion at the top of the beach next to the sea wall was observed in the previous partial measures report. The erosion of this part of the beach is probably due to the refection of wave energy on the hard defences through the winter. Overall the beach has flattened with some of the material lost on the upper beach being held on the lower beach close to the extent of the survey. Longer term trends: The erosion of the upper beach, close to the sea wall is observed over the winter of 2014/15, 2015/16, and 2016/17 does not reflect the long-term trend between Autumn 2008 and Autumn 2016 that shows with accretion on the upper beach and erosion on the lower beach. The atypical pattern seen in recent years probably reflects changes in wave climate.

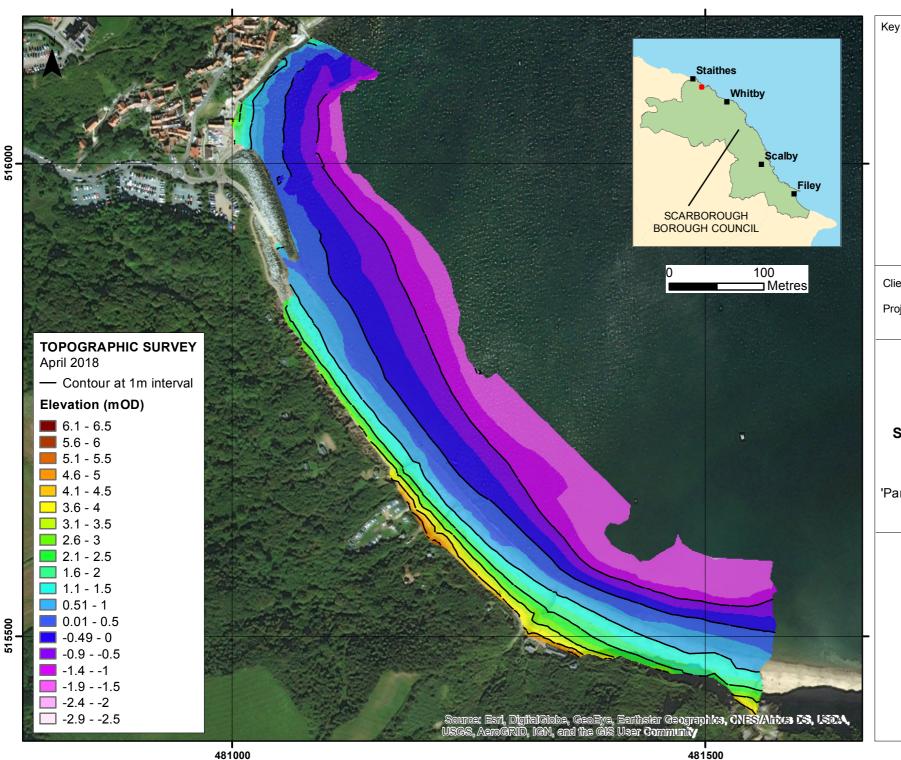
Appendix B - Map 1

Survey Date	Description of Changes Since Last Survey	Interpretation
1 st May 2018	Topographic Survey: Runswick Bay is covered by a 6-monthly topographic survey. A consistently applied GIS processing routine has been used to create a digital ground model (DGM) (Appendix B - Map 1a) and to calculate the differences between the current topographic survey (Spring 2018) and the previous survey (Autumn 2017) to highlight areas and amounts of erosion and deposition. In all cases, a 5m resolution raster grid has been used to identify areas of erosion and accretion. (Appendix B – Map 1b). Appendix B - Map 1b shows changes that are primarily shore-parallel, with erosion dominating on the upper beach and accretion on the lower beach. There is a narrow discontinuous band of accretion at the very top of the beach in the middle of the bay near the sailing club. The entire beach at the northern end of the bay, in front of the village, is dominated by erosion. The greatest magnitude of change is at the southern end of the survey area.	Material appears to have been moved from the top of the beach to the bottom of the beach. The pattern indicates seasonal draw down, with material moving down the beach and temporary stored below MLW. Longer term trends: The data collected since 2008 indicate a general pattern of winter drawdown and spring recovery with no net change. The trends from this survey are comparable with observations since 2013.

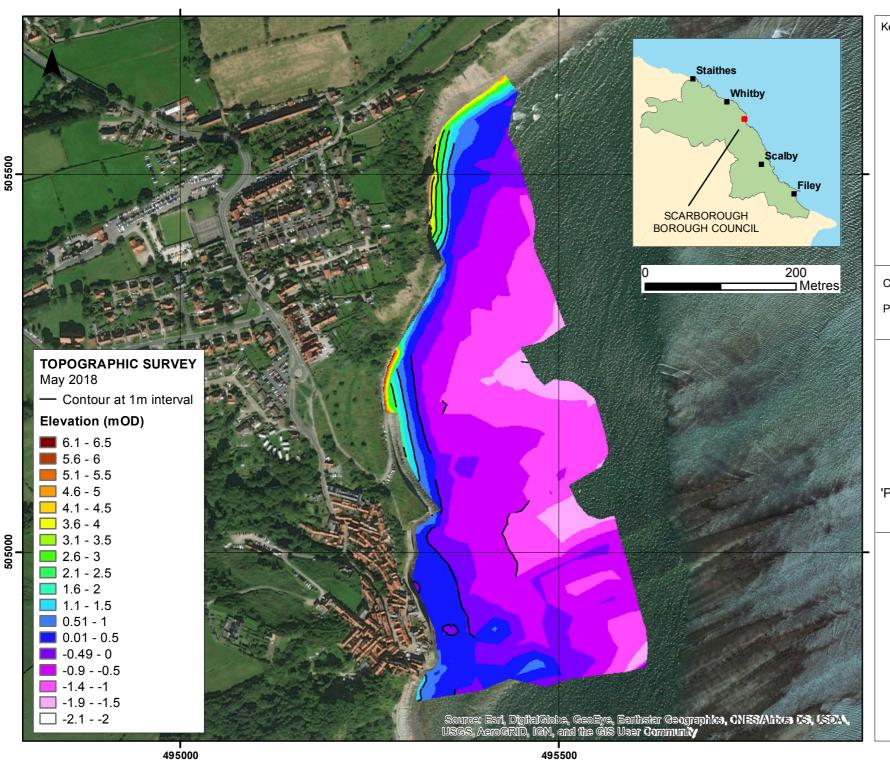
Appendix B - Map 2

Survey Date	Description of Changes Since Last Survey	Interpretation
1 st May 2018	Topographic Survey: Data from the most recent topographic survey (Partial Measures, Spring 2017) have been used to create a digital ground model (DGM) (Appendix B – Map 2a) using a Geographical Information System (GIS). A difference plot has also been produced using the DGM (Appendix B – Map 2b) from the last topographic survey (Full Measures, Autumn 2017) and the present survey. The difference plot shows changes in level between Autumn 2017 and Spring 2018 and highlights a patchy distribution of erosion and accretion. The majority of the bay has seen very little change (±0.25m) over the winter of 2017/18, associated with rocky outcrops that run perpendicular to the shore. The main patches of erosion are on the upper beach.	The distribution of change is very patchy. There has been little change over the rock promontories in the bay, although there has been localised erosion and accretion. The loss of 1m of material at the bottom of the cliff is likely to be due to erosion of debris from earlier cliff failures Longer term trends: The difference plots show a continuation of the trend of patchy distribution of erosion and accretion. Overall, the observed changes are of limited magnitude and within the range of changes previously seen. The long term difference between Autumn 2008 and Autumn 2016 shows stability with accretion limited to the defended part of the frontage.
