Cell 1 Regional Coastal Monitoring Programme Update Report 11: 'Partial Measures' Survey 2019

Scarborough Borough Council July 2019

^(*) The present report is **Update Report 11** and provides an analysis of the 2019 Partial Measures survey for Scarborough Council's frontage.

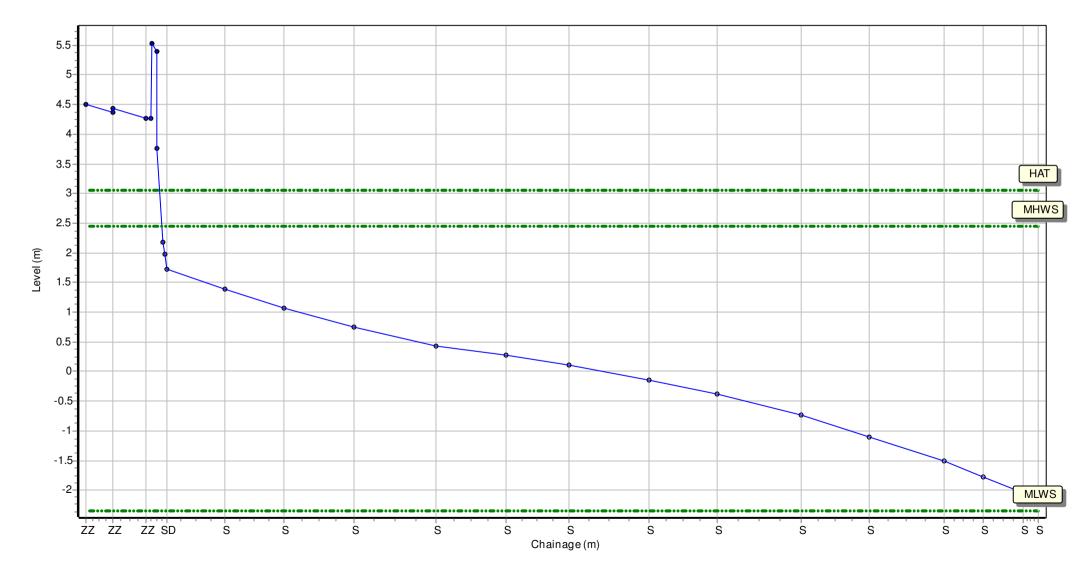
Location: 1dSBN4

Profile 1dSBN4 is located at the northern end of Clarence Gardens. The upper beach has generally experienced accretion of up to 0.4m between the toe of the seawall and the rocky outcrops at chainage 35m. There has been some accretion between the outcrops at chainage 40m to 50m of up to 0.6m. Seawards of the rock exposure there has been erosion of up to 0.8m, but more typically 0.3m. The length of rock exposed has not increased. On the lower beach, seawards of chainage 160m until the

Survey Date	Description of Changes Since Last Survey	Interpretation
	end of the survey at chainage 195m there has been between 0.1m and 0.2m of accretion. Beach levels are at a relatively low level compared to the range recorded from previous surveys, with the section from chainage 103m-135m being the lowest on record.	
	Profile 1dSBN5 is located southern of Clarence Gardens. There has been accretion across the upper and mid beach of up to 0.6m, infilling a depression noted in the previous survey. Across the lower beach from chainage 100m to 175m there has been a small, consistent level of erosion of up to 0.1m. Overall the profile is at a medium level compared to the range recorded from previous surveys.

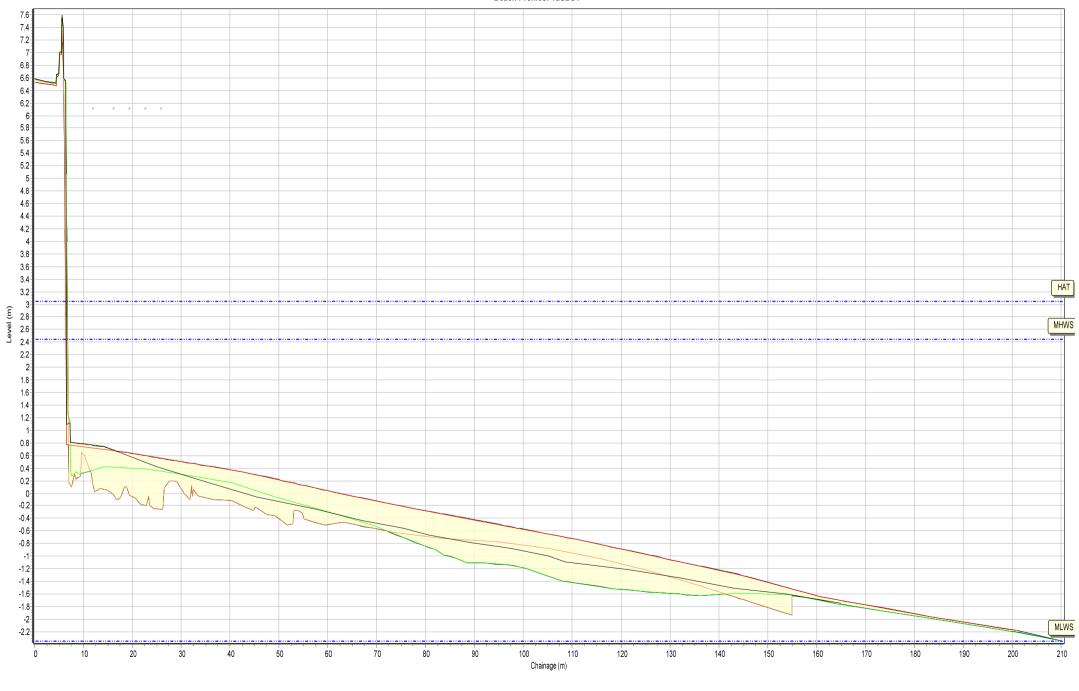
Beach Profiles: 1dCY1

- the top of profile 1dCY1 cannot be measured due to dense vegetation;
- The middle of profile 1dCY2 could not be measured due to the ground make-up, soft mud flows, and unstable grass;
- The middle of profile 1dCY3 could not be measured due to the ground make-up, soft mud flows, unstable grass, and landslips;
- Profile 1dCY3 was measured to cliff edge on top and as close to the cliff face at the bottom as possible.

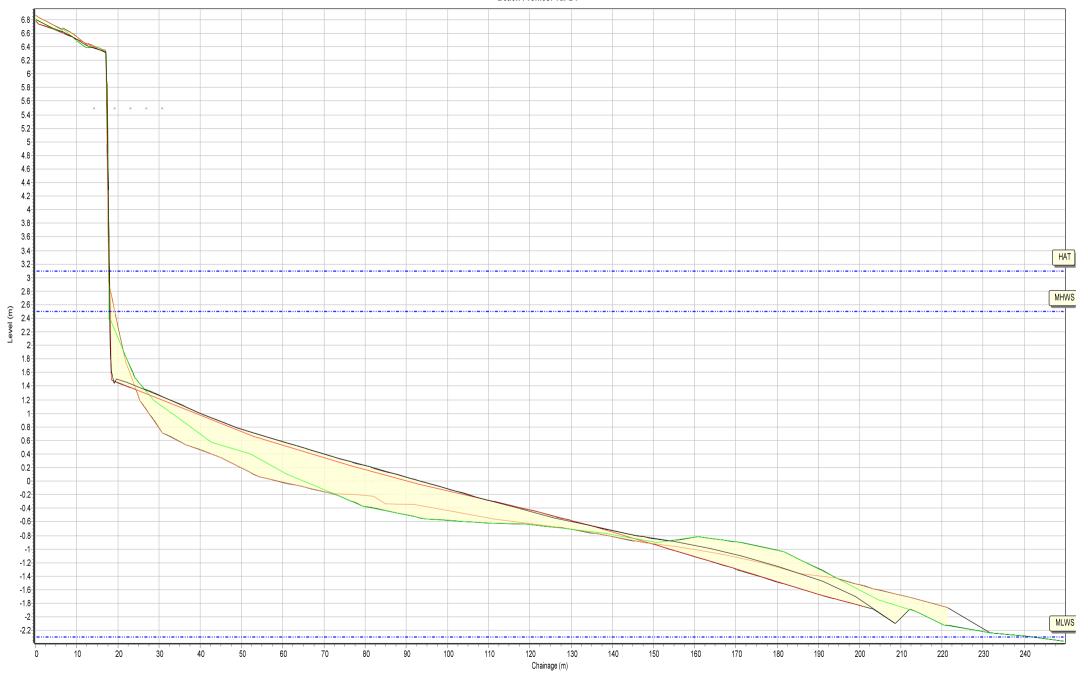
Beach Profiles: 1dFB2

- The surveyor was unable to measure the middle of section 1dFB2 between chainage 12m and 20m due to dense vegetation.
- The middle of section 4 is unable to be measured from chainage 4m to approx 24m, due to the cliff face being unsafe.
- The middle of profile 5 was unable to be measured from chainage 65m to c. 204m, due to undergrowth and bushes.
