**Cell 1 Regional Coastal Monitoring Programme
Lynemouth Bay Post Storm Walkover Inspection
Survey 2023**

Northumberland County Council

Lynemouth Bay Post Storm Walkover Inspection Surveys 2023

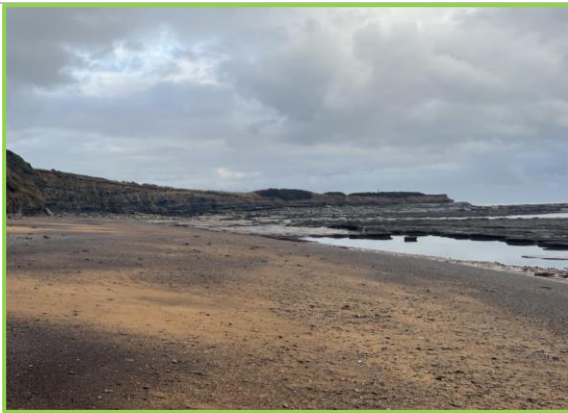
The northern section of Lynemouth Bay is encased within a rocky and sandy foreshore bay topped with a rocky cliff and protected in the north by Snab Point, transitioning southwards into a low rock cliff base overlain with softer material (/3301C02). The soft material is covered by considerable vegetation.

Rocky cliff extending from Snab Point (/3301C02)

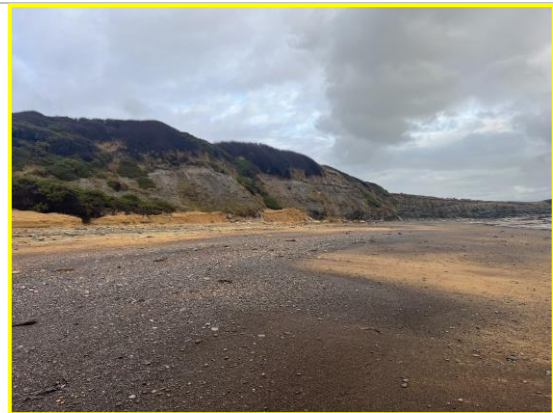
It appears this section of the frontage has been less affected by the recent storms, although some localised rock falls were observed at the base of the cliff. Clinging was also observed in the localised deposits of finer beach material, likely caused by the drawdown of material during stormy conditions.

Localised rock falls in harder cliffs to the north. Clinging in the finer beach material in foreground (/3301C02)

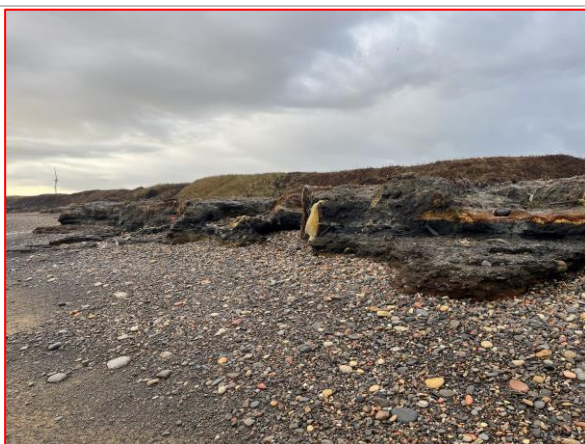
Progressing southwards, the colliery spoil has formed a small cliff above the natural sandy beach, and in front of a densely vegetated sand dune, of approximately 1m height at around the highwater mark (/3401C01). The spoil has been subject to continuous erosion both through marine processes and surface water runoff. It is clear the recent storms have accelerated this erosion, retreating the seaward face and exposing more refuse. At the southern extents, the spoil platform has all but been eroded, resulting in the erosion of the toe of the dunes previously sheltered by the spoil.

Eroding colliery spoil platform (/3401C01)

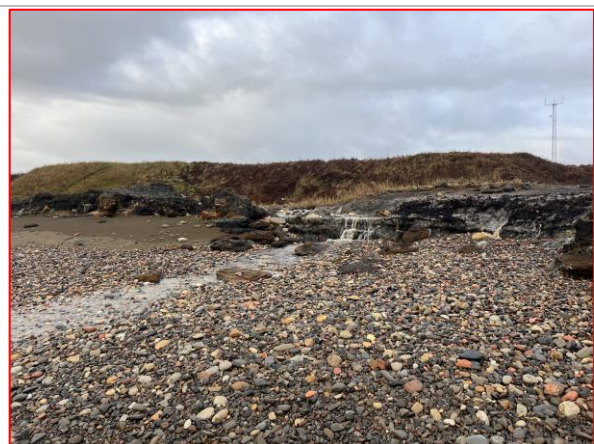
Accelerated erosion at surface water run off locations (/3401C01)

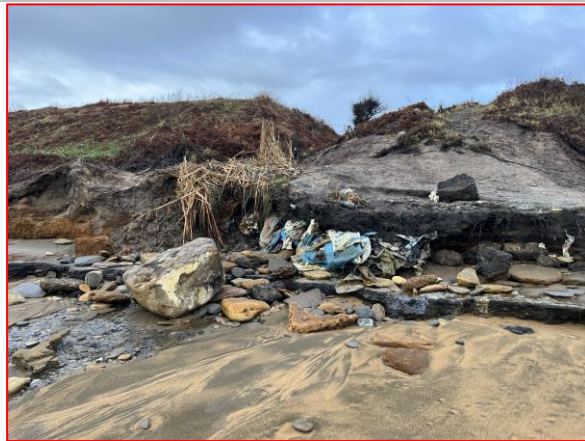
Plastic refuse exposed during recent storms (/3401C01)

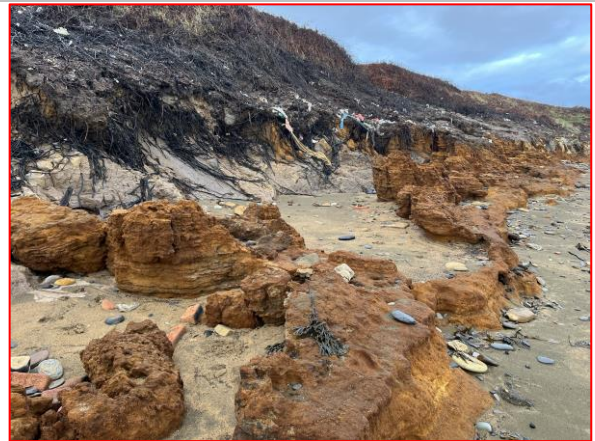
Erosion of the dunes previously protected by colliery spoil (/3401C01)

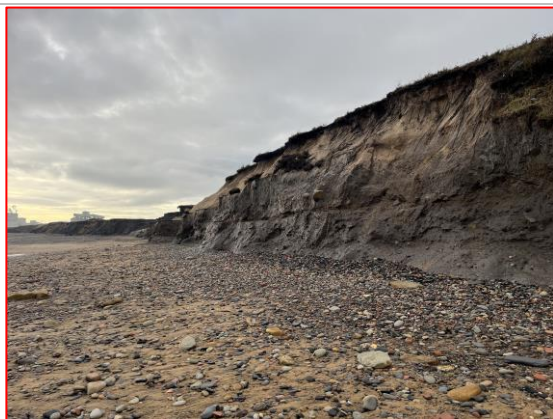
The southern end of asset (/3401C01) also appears to have experienced accelerated erosion as a result of the recent stormy weather. Slumping is evident within the softer sand material mantled on the colliery spoil platform. Large swathes of this material are also deposited across the foreshore. The informal beach access adjacent to Lyneburn Cottages travellers' site is now inaccessible due to erosion. There is less refuse in the cliffs in this area.

Accelerated erosion of the softer sand mantled on the colliery spoil platform (/3401C01)

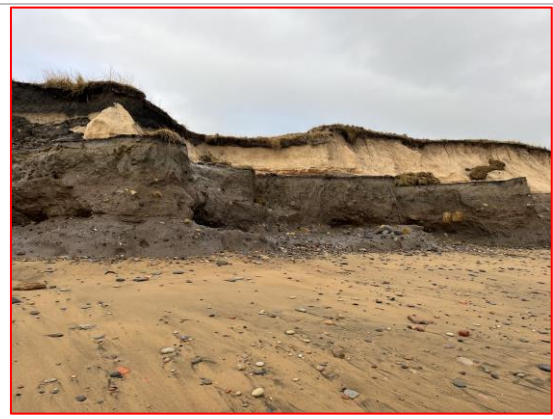
Accelerated erosion of the softer sand mantled on the colliery spoil platform (/3401C01)

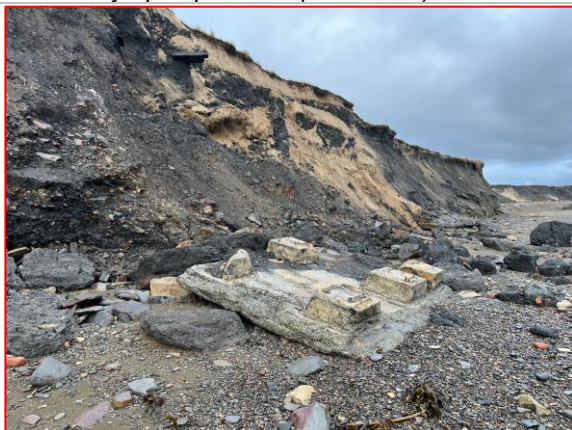
Concrete slab displaced due to recent erosion (/3401C01)

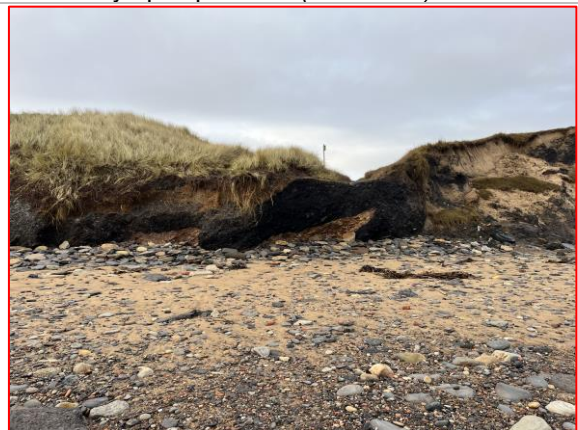
Beach access path, adjacent to Lyneburn Cottages travellers' site, inaccessible due to erosion (/3401C01)

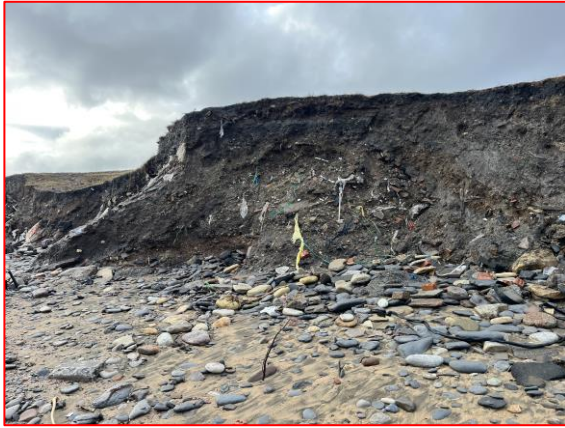
The next section (/3401C05), shoreline fronting Lynn Hill, from the centre of Lynemouth Bay to the River Lyne, is less well protected by the rapidly receding (or in places absent) spoil beach. The man-made (spoil) cliffs are actively eroding, releasing spoil and significant volumes of refuse to the foreshore. The cliff appears to have retreated notably since the previous survey; it is thought in part due to the recent stormy weather. The cliffs in this section had previously been benched (mitigation to prevent sand martins nesting) ahead of mobilisation for the upcoming remediation works in 2024. The cliffs have retreated such that this benching is no longer present in places.

Erosion of backing man-made cliffs, releasing colliery spoil and refuse to the foreshore (/3401C05)

121AA901A3401C05	Man-made cliff of tipped colliery waste. Beach comprised of colliery waste.	Cliff - Lynemouth	NZ30379105	NZ30509080	591050	283.8	45246	Royal HaskoningDHV	Plenty of discarded refuse exposed by the rapid erosion of the spoil cliff on top of the sandy beach. The cliff appears to have retreated notably since the previous survey; it is thought in part due to the recent stormy weather. The cliffs in this section had previously been benched (mitigation to prevent sand martins nesting) ahead of mobilisation for the upcoming remediation works in 2024. The cliffs have retreated such that this benching is no longer present in places.	5	>20	Capital waste management scheme planned for 2024. Some of the waste visible within the eroding spoil cliffs (exposed during recent storms) is outside of the 'work areas' that will be addressed by the 2024 capital waste management scheme in parts of Lynemouth Bay. Given this, it is recommended that Northumberland County Council considers how this may be addressed, both from a practical perspective and from a public perception perspective.	routine

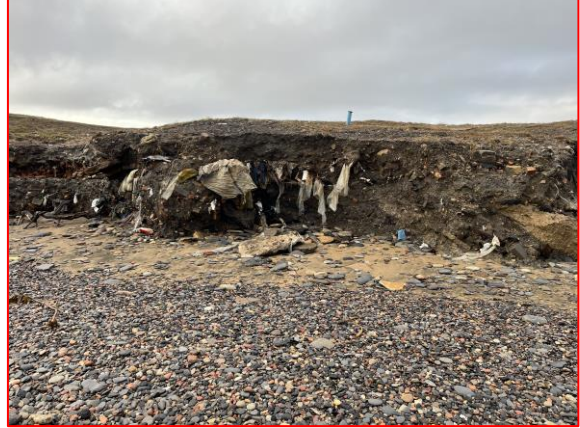
Erosion of backing man-made cliffs, releasing colliery spoil and refuse to the foreshore (/3401C05)

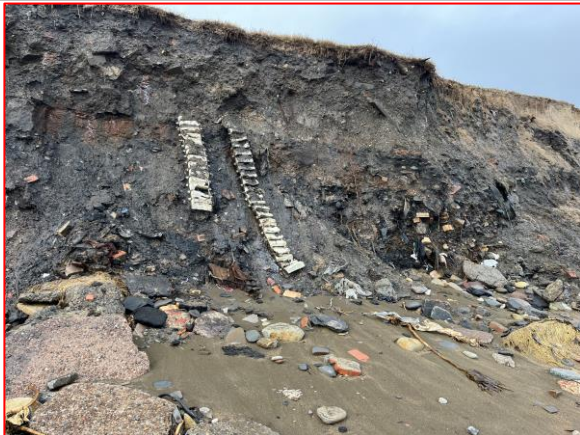
Erosion of backing man-made cliffs, releasing colliery spoil and refuse to the foreshore (/3401C05)

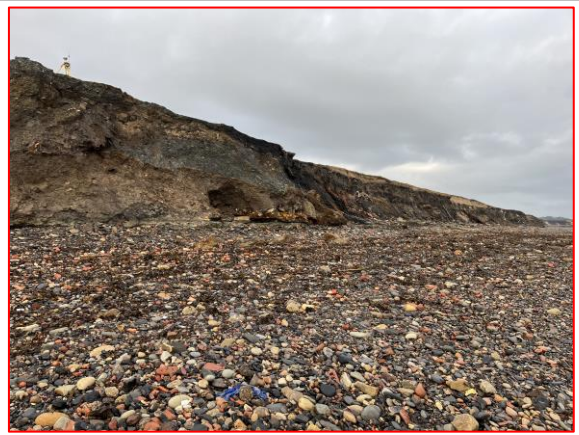
Erosion of backing man-made cliffs, releasing colliery spoil and refuse to the foreshore (/3401C05)

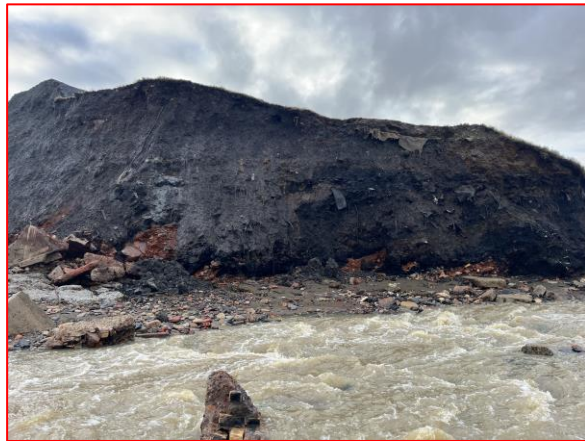
This erosion is also evident along the south bank of the river Lyne and, albeit less frequently, along the open coast south of the River Lyne to the Power Station (3401C06). At the mouth of the river Lyne, there is notable storm deposits present.

Erosion of backing man-made cliffs at the mouth of the river Lyne (/3401C06)

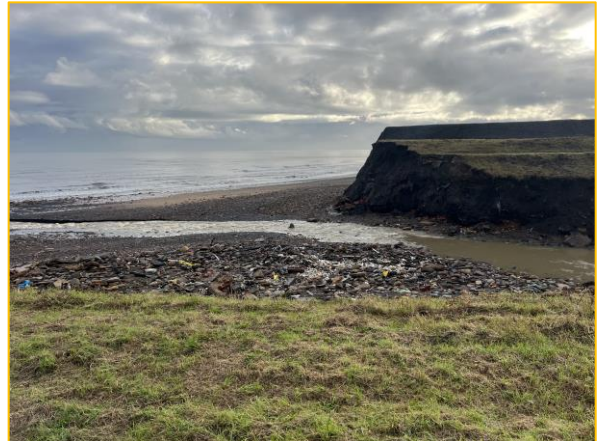
Storm deposits at the mouth of the river Lyne (/3401C06)

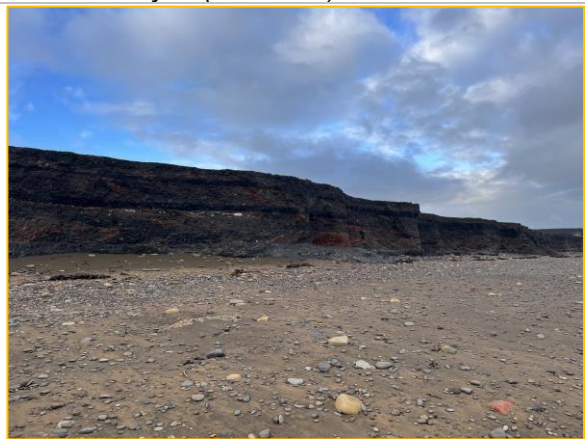
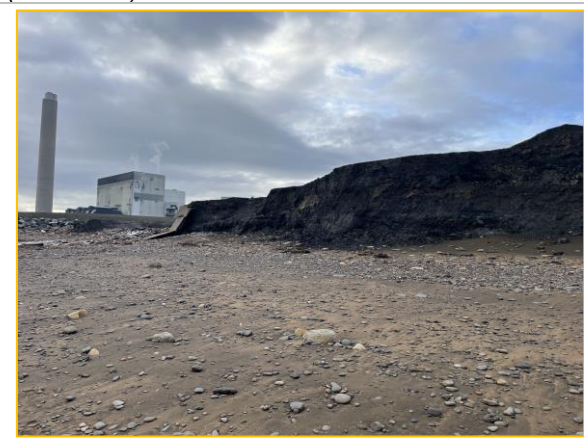
River Lyne to the Power Station (/3401C06)

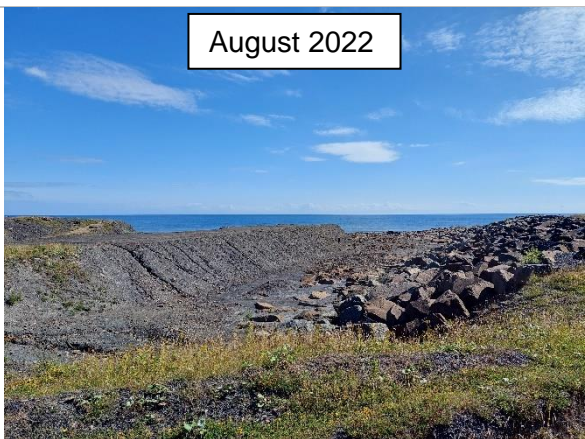
The large rock armour berm revetment constructed in front of the Power Station in 1995 (/3401C08) and subsequently extended around the coal stocking yard in 2005 (/3401C07) remains in good condition. Rock armour is angular and well packed with no displaced stones or movement at the toe. Minor erosion was observed behind the crest. No visible damage was observed as a result of the recent storms however a significant volume of storm deposits was noted within the outfall channel,

North Rock Revetment end and outfall channel (/3401C07)

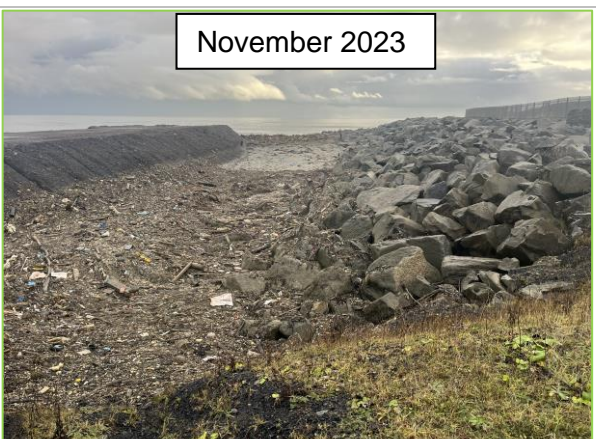
Significant volumes of storm deposits within outfall channel (/3401C07)

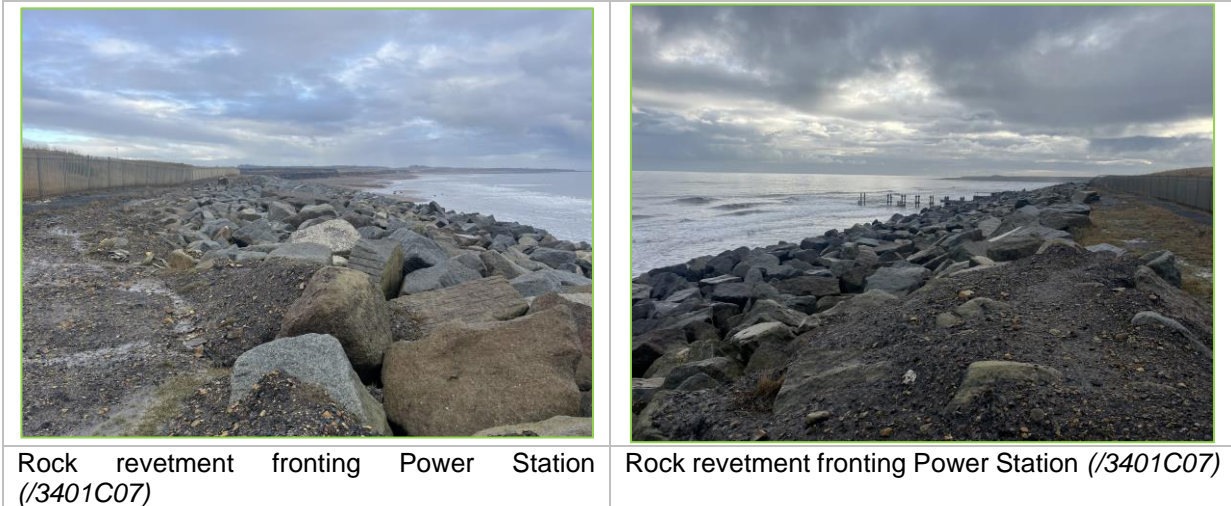
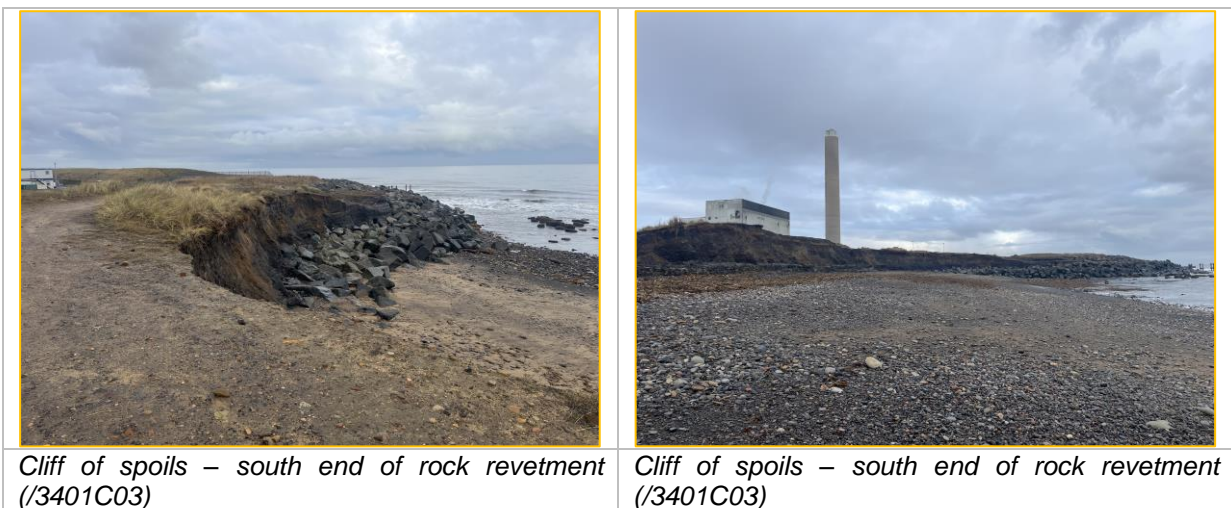
At the southern end of the revetment (/3401C03), rapid erosion of the spoil beach was previously observed over the 2017/18 winter, exposing the buried tie-in of the revetment and initially causing some concern. However, the tie-in extends some distance landward (currently largely remaining buried). Although, as discussed further below, the shoreline parallel section of spoil cliffs appears to have retreated since the previous survey, the section of cliffs at the rock armour tie in appears to have undergone less change.

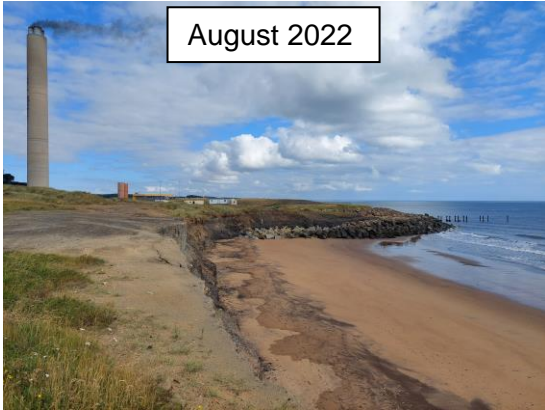
Between the Power Station and Beacon Point the shoreline again comprises colliery spoil. Further erosion of the high spoil cliff in the north has occurred since August 2022, with the tension cracks observed on the cliff top in that survey having now failed. The retreating cliff top is now beginning to impede on the England Coast Path, with a local realignment required in the near future.

Eroding cliff to the north in August 2022. Tension cracks visible along the cliff top (3501/C01)

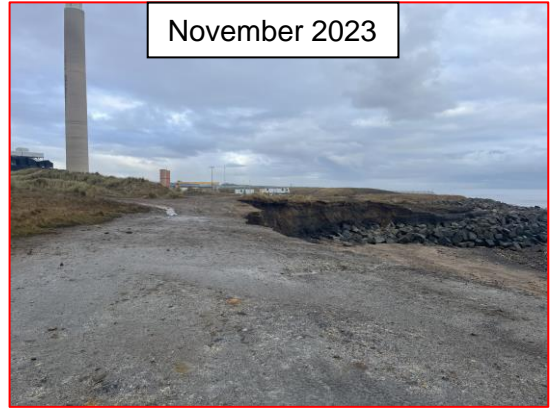
Eroding cliff to the north in November 2023 (3501/C01)

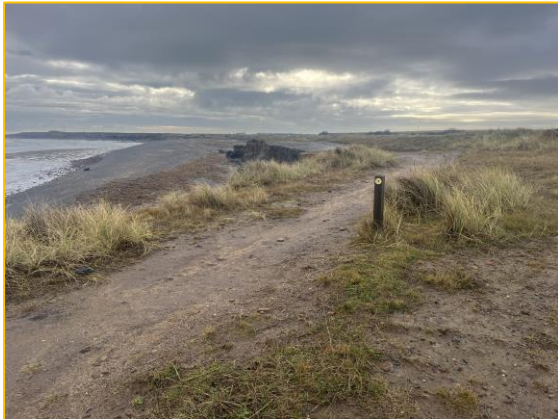
Eroding cliff to the north starting to impede the England Coast Path (3501/C01)

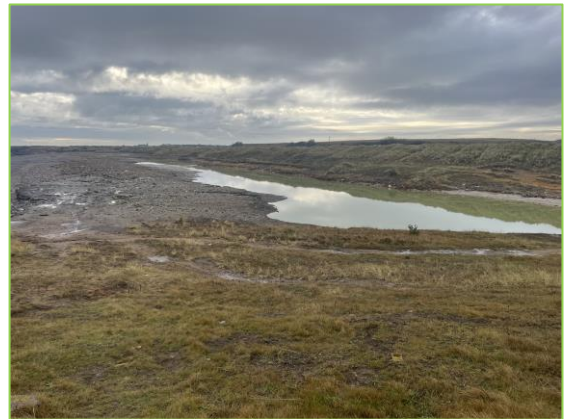
Water accumulation between the spoil's berm and the rear soft natural dunes (3501/C01)

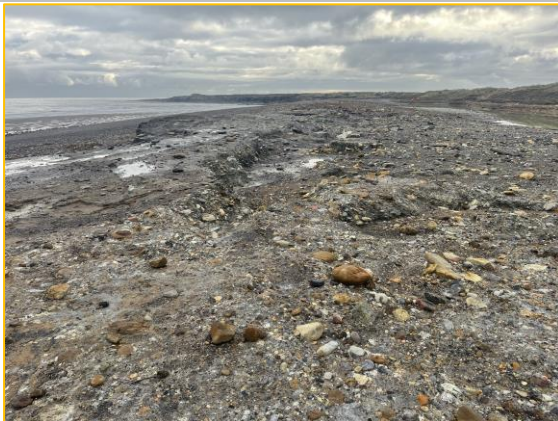
The central and southern sections of this southern bay are quite stable with lower sandy cliffs tapering to a low cobble and boulder berm fronting colliery spoil and wide backing natural dunes. It is apparent the recent storms overtopped the colliery platform, with significant erosion observed along the crest and rear of the platform. Vast volumes of storm deposits were also noted on the colliery spoil including both seaweed and household wastes. The setback rear dune systems appear to have been largely unaffected by the recent storms.

Recent overtopping damage to colliery spoil platform (3501/C01)

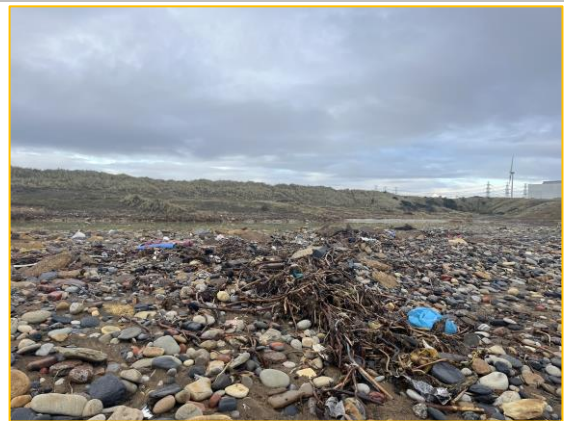
Significant storm deposits along colliery spoil platform (3501/C01)
