**Cell 1 Regional Coastal Monitoring Programme
Newbiggin-by-the-Sea Post Storm Walkover
Inspection Surveys 2023**

Northumberland County Council

Post Storm Walkover Inspection Surveys 2023

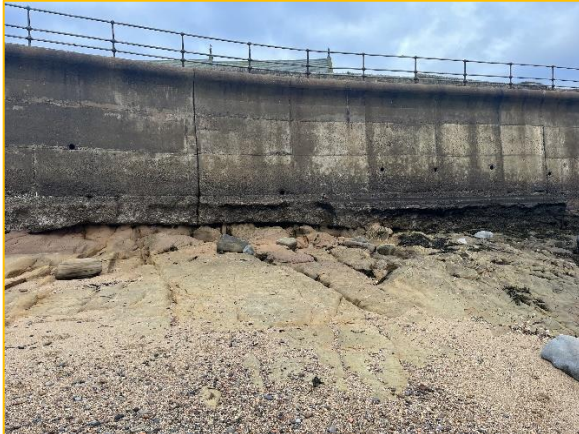
The vertical concrete seawall at Church Point remains in overall fair condition. However, as noted previously there is a reasonable amount of abrasion at the toe and crest as well as signs of local undermining between the toe and rock slab, this does not appear to have worsened significantly as a result of the recent storms. The recurved section of seawall to the west of Church Point is well founded on the rock foreshore and generally in good condition. However, the concrete apron has deteriorated since the previous survey with sections of the slab now broken up. Areas of undermining also remain.

Church Point seawall in fair overall condition with localised undermining of toe protection (/3601C12)

Asset Name	Description/comment	Type/desc	Start	End	Sort by N	Length	Inspection Date	Inspector	Comments	Overall Condition	Residual Life	Recommendations	Urgency
121AA901A3601C12	Vertical concrete seawall with re-curved crest and narrow promenade behind. Short lengths of concrete toe projection works at interface with rock foreshore. Low exposed earth cliff at rear of promenade.	Sea Wall - Little Bay	NZ31788791	NZ31718791	587910	72.6	16/11/2023	Royal HaskoningDHV	No significant changes since last inspection. Abrasion along most of seawall toe with localised undermining. Abrasion and cracks opening at construction joints. No movement apparent. Loss of joint sealant. Minor erosion along most of upper earth bank. Hand rail rusty (vertical upstand). Locally in poor condition at areas of undermining.	3	>20	Repair undermining. Repair cracks. Replace joint sealant.	routine
121AA901A3601C13	Recurved concrete seawall and integrated promenade backed by low earth cliff. Founded on rock foreshore	Sea Wall - Church Point	NZ31718791	NZ31688795	587910	48.6	16/11/2023	Royal HaskoningDHV	No significant changes since last inspection. Wall well founded on rock foreshore. No settlement or cracks. Localised minor undermining/ breakup of additional toe apron. Replaced sealant in good condition. Some minor rusting to hand railing. No erosion to upper grass crest. Handrailing corroded.	3	>20	Repair concrete apron Repair handrailing	routine

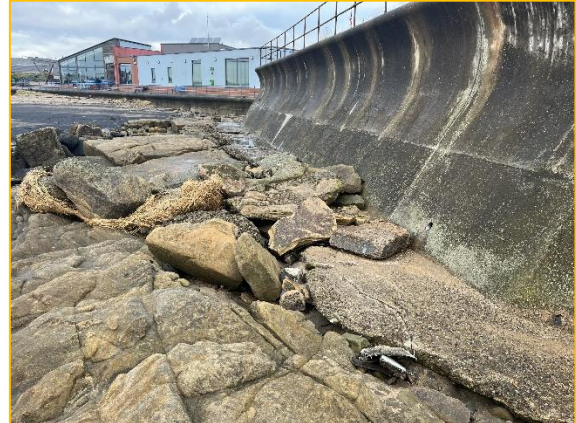
Concrete apron of recurved wall in poor condition (/3601C13)

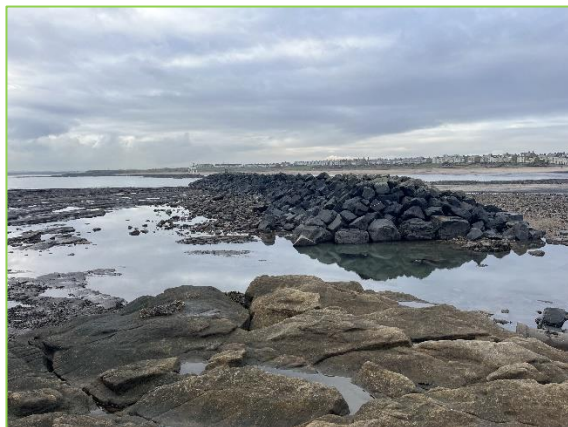
The start of Newbiggin Bay is marked by a rock armour breakwater, built along the edge of Hully Rocks and extending from just offshore of Church Point. This structure is in good condition though there are some smaller rocks displaced across the foreshore on both the seaward and landward aspect. The profile and crest level along the structure appears stable with no signs of settlement. Build of sediment in the lee of the breakwater has concealed the outfall crossing and possibly masks the true extent of rock displacement.

North breakwater in Newbiggin Bay in overall good condition (/3601C14)

121AA901A3601C14	Linear rock armour breakwater. Atlee sewage outfall crossing underneath the breakwater.	Breakwater - Hully Rocks	NZ31688795	NZ31508789	587950	189.9	16/11/2023	Royal HaskoningDHV	Angular rocks well interlocked and stable. No damage to either trunk or roundhead. Small, Locally displaced rocks visible on foreshore.	2	>20	Monitor settlement of crest and loss of filter/core.	no repairs
121AA901A3601C15	Recurved concrete seawall with a short rock revetment at the toe.	Revetment - Newbiggin	NZ31688795	NZ31698797	587950	21	16/11/2023	Royal HaskoningDHV	No significant changes since last inspection. Some concrete spalling and cracks not affecting performance of asset. Rubble mound not visible. Undermining / break up of concrete apron.	3	>20	None.	routine
121AA901A3601C16	Detached rubble mound breakwater at the center of Newbiggin bay, with the iconic "The Couple" sculpture, creating a sand tombolo from the beach. The breakwater core lies on a geotextile layer and the armour layer is comprised of 3.9m ³ Core-Loc units. Beach replenishment and offshore breakwater completed 2007.	Detached Breakwater - Newbiggin				210	16/11/2023	Royal HaskoningDHV	No apparent damage to the Core loc armour layer. Few rocks of the armour toe possibly displaced at the south roundhead, but not affecting performance or survival of the breakwater. Sand tombolo growing.	2	>20	Undertake a boat inspection to check the seaward face of the breakwater	routine

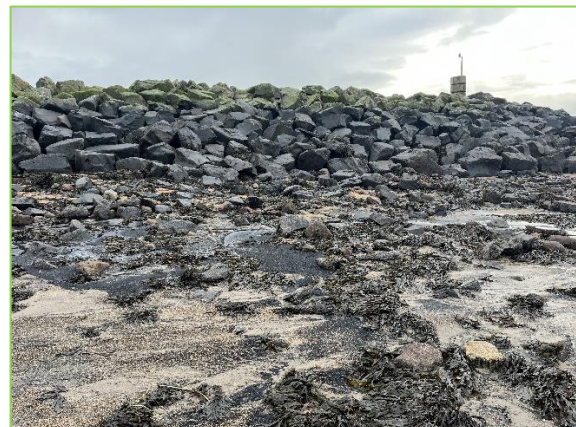
Smaller rocks displaced across the foreshore on both the seaward and landward aspect (/3601C14)

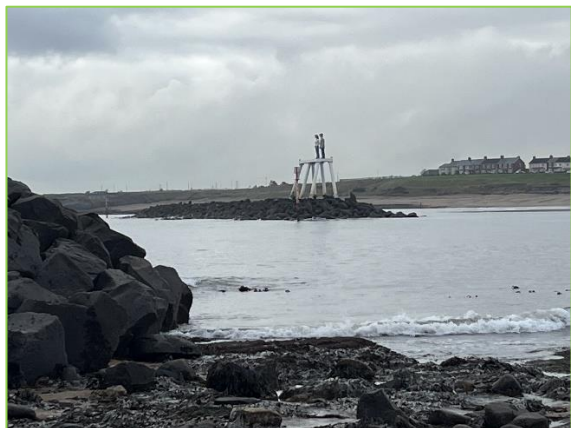
The offshore breakwater in the centre of the bay was constructed in 2007 and comprises inter-locking Core-loc concrete armour units. At the centre of the bay the salient / tombolo in the lee of the breakwater has been progressively growing and will soon connect the breakwater to the beach at low tide. The recent storms appear to have slowed down this process with Hunkleton Stone appearing now to be located seaward of the beach crest. The structure could only be inspected from the beach tombolo end, it appears in good condition with a uniform crest and no signs of displaced units or settlement.

Detached breakwater in central Newbiggin Bay remains in good condition (/3601C16)

There is no access to the seaward aspect of the offshore breakwater, it is recommended a boat survey is commissioned to inspect this. The seaward aspect was inspected from the foreshore only.

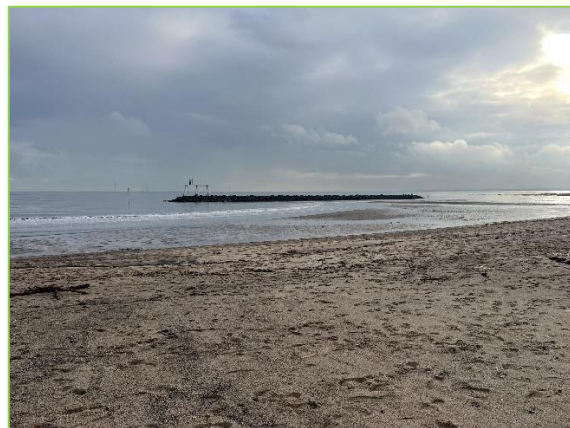
Salient/tombolo developed in lee side of the detached breakwater (/3601C16)

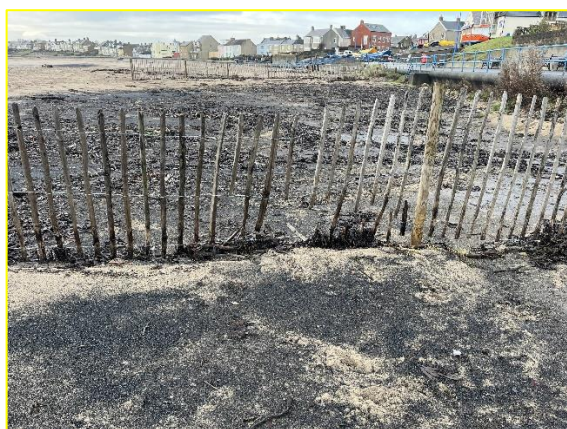
In Newbiggin Bay the Maritime Centre at the north end of the bay was opened in 2012. The sea walls along this stretch are protected by healthy beach levels following replenishment operations in 2007 and subsequent net accretion of sand in the lee of the detached breakwater. Picket fencing has been installed against the seawall to further encourage the build-up of sediment and vegetation growth. The fencing appears to have only received minor damage as a result of the recent storms. A concrete slipway fronting the RNLI lifeboat station was constructed in 2022. It remains in good to very good condition, with the exception of the loss of sealant at the joint with the existing structure. At the old slipway, adjacent to Church Point car park, a length of geotextile has been exposed likely due to surface water run-off from the promenade.

Minor damage to picket fencing but overall, in good condition (/3601C06)

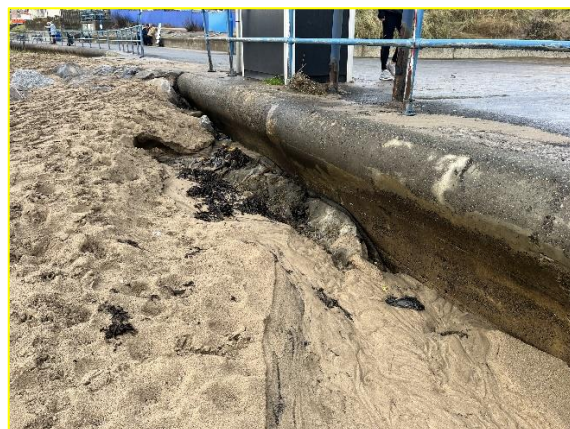
Exposed geotextile adjacent to slipway (/3601C06)

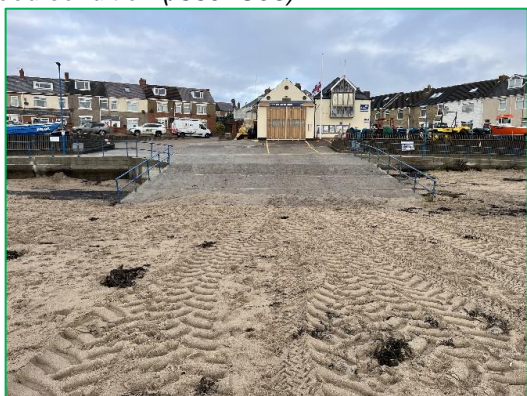
New concrete access ramp constructed 2022 (/3601C06)

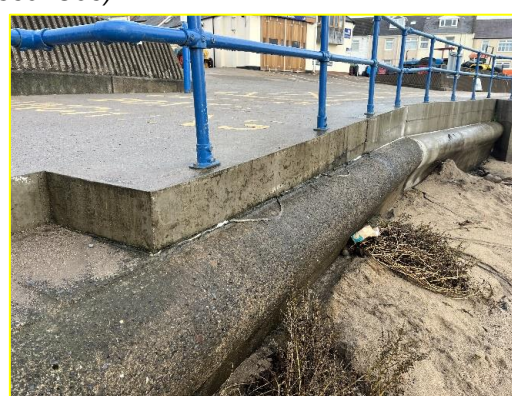
Loss of sealant at joint with existing seawall (/3601C06)

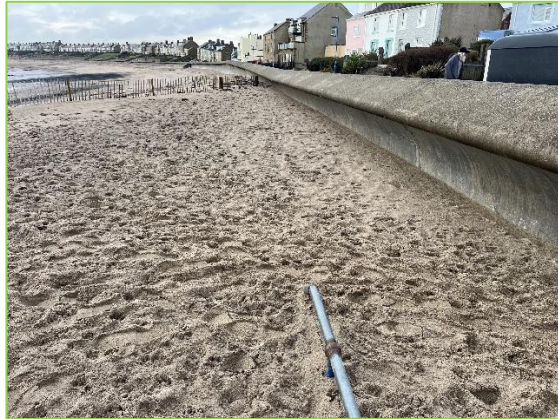
The high recurved seawall and promenade at the centre of the bay are in good condition. In the November 2023 post storm inspection, the beach levels varied along its length. At the north and south extents of the wall, beach levels were very high. In the north, beach levels had almost entirely submerged a length of picket fencing, as well as the hand railing and access ramp. To the south the high levels were preventing the promenade from draining efficiently creating puddles at the access point. Vegetation growth was noted at the seawall to the south indicating stability in beach levels. In the centre of the bay, it appears the recent storms have drawn down material, exposing the outline of the previously submerged stepped apron fronting the wall. Despite this, the wall remained in good condition.

High Beach level to the north of the recurved wall partially submerging picket fencing (/3601C07)

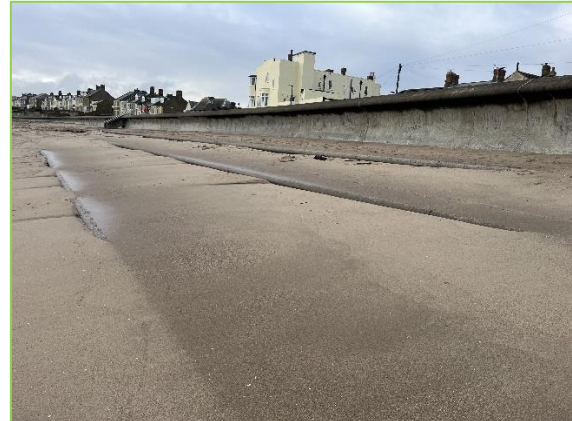
Lower beach levels in the centre of the bay exposing stepped apron (/3601C07)

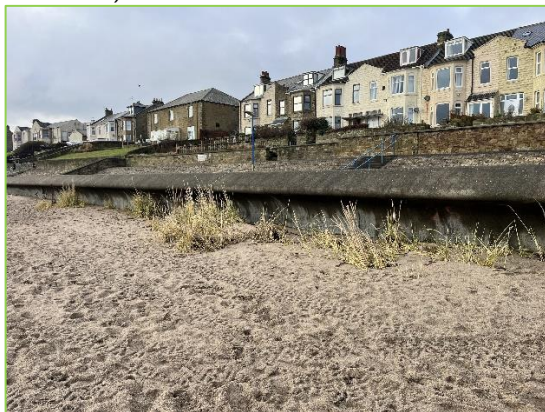
High Beach level to the south of the recurved wall, dune formation fronting the seawall (/3601C07)

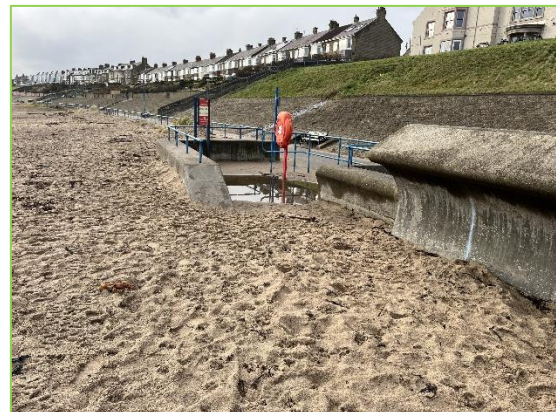
High beach levels preventing surface water drainage from the promenade (/3601C07)

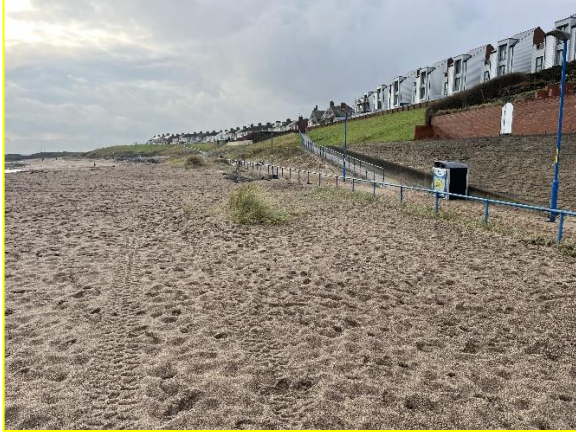
At the south end of the bay the vertical section of seawall is protected by a rock revetment. This revetment is part of the defences that were in poor condition prior to the 2007 scheme, but is now almost completely buried by high beach levels. Where visible, this rock revetment continues to appear in good condition although some displacement of lower rocks is notable. The high beach levels have blocked the drainage scuppers resulting in pooling of water on the promenade. Handrailing and some ancillary elements present high levels of corrosion. At the very southern extent, large amounts of beach sediment have washed onto the promenade, likely in part due to the recent storms. This is corroborated by larger deposits such as drift wood pushed against the promenade handrailing.

Rock armour, in parts, entirely buried by high beach levels (/3601C08)

121AA901A3601C08	Shallow sloping rock armour revetment backed by capping beam and seafront promenade backed by masonry sloped revetment. Beach replenishment and offshore breakwaters completed 2007.	Revetment - Newbiggin Bay	NZ31028756	NZ30988722	587560	346.3	16/11/2023	Royal HaskoningDHV	No significant changes since last inspection. High beach levels over-spilling onto prom. Rock mostly buried, some vegetation growth at south end. Hand railing with localised corrosion in fair to very poor condition. Some locally displaced rocks were rock armour visible. Significant beach deposits on the promenade likely due to recent storms.	3	>20	Repair handrailing	routine

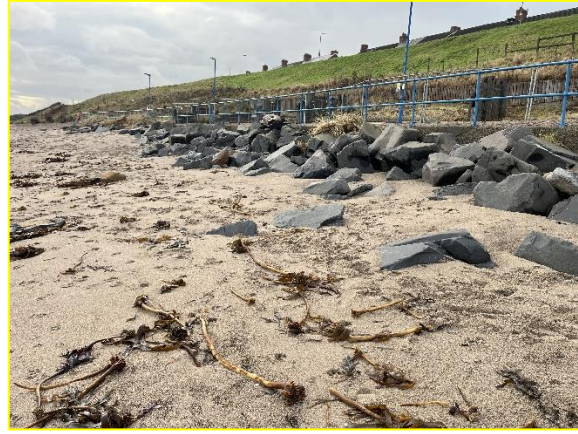
Some localised rock displacement but generally in good condition (/3601C08)

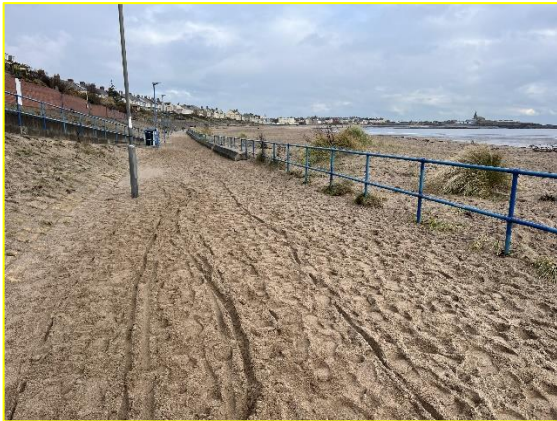
Large volumes of deposits on the promenade to the south of the bay likely due to the recent stormy weather (/3601C08)

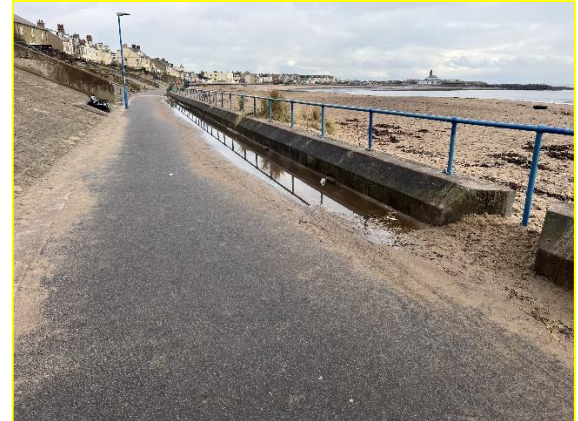
Block promenade drainage scuppers (/3601C08)

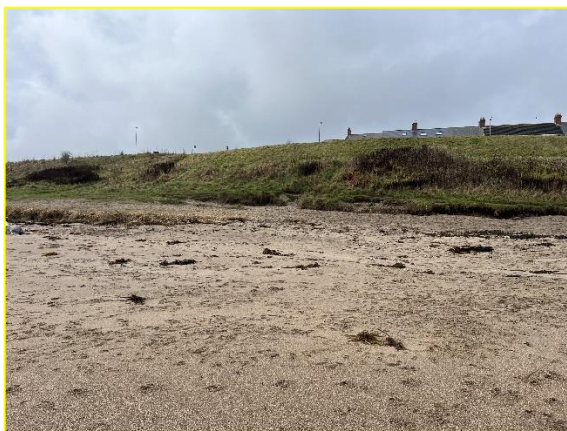
At the south end of Newbiggin Bay the soft earth slopes are largely stable and protected by a wide beach. The previous inspection had noted new dune vegetation growth on the foreshore, however it appears the recent storms have largely halted this growth.

New dune growth stunted by recent storms (/3601C08)

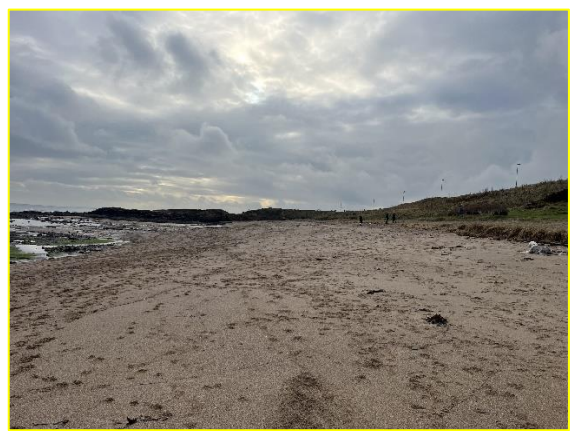
Spital Point (/3601C08)

At Spital Point there is no evidence of new rock falls or slips in the overlying softer material since the previous inspection, but the path along the thin ridge has been fenced off.
