**Cell 1 Regional Coastal Monitoring Programme:
Walk-over Visual Inspections of Assets**

Northumberland County Council

Walkover Visual Inspection of Assets

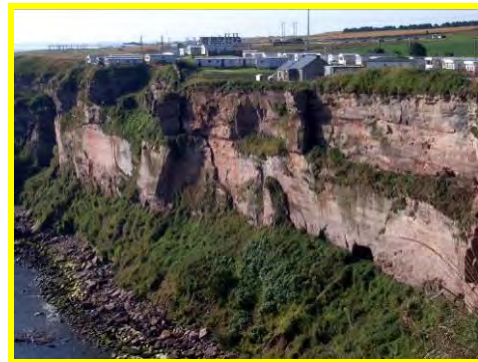
Fractures in cliffs at south end of Marshall Meadows Bay (/601c03).

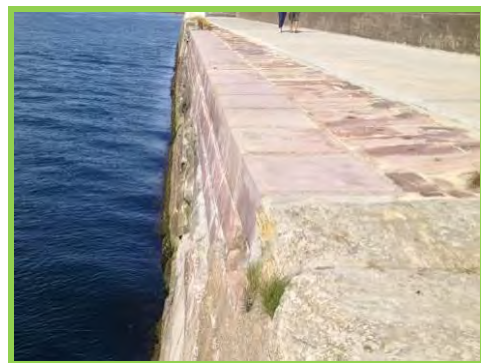
Replacement of masonry blocks and new concrete deck slab (/701c15).

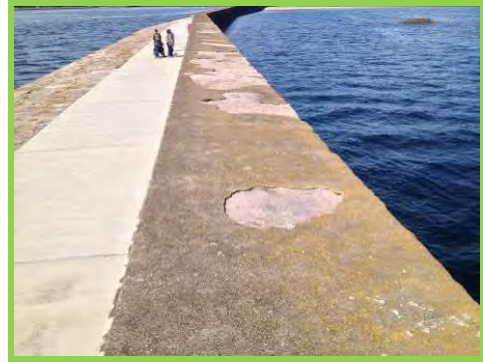
Spalling of concrete render on wave wall (/701c14).

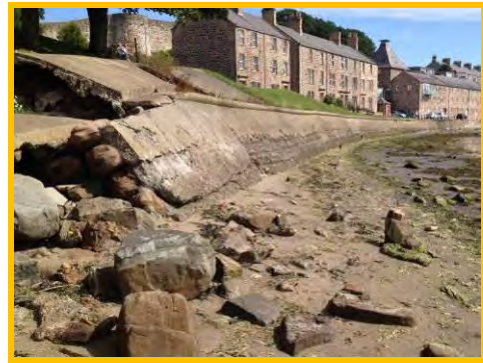
Outflanking and collapse at the south end of seawall (/801c07).

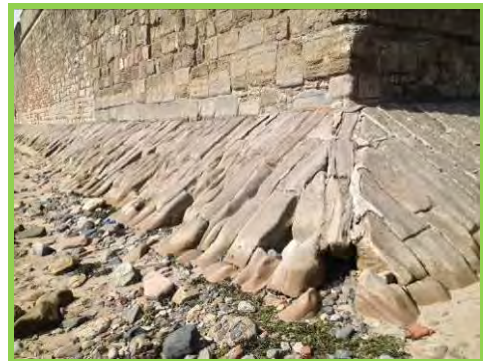
Historic abrasion to footing of seawall (/801c06).

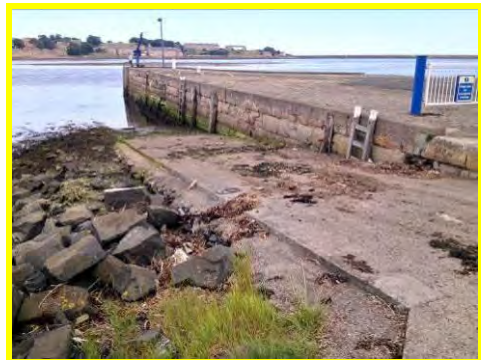
Abrasion and cracking of masonry blocks on west face of Spittal Pier (/901C06).

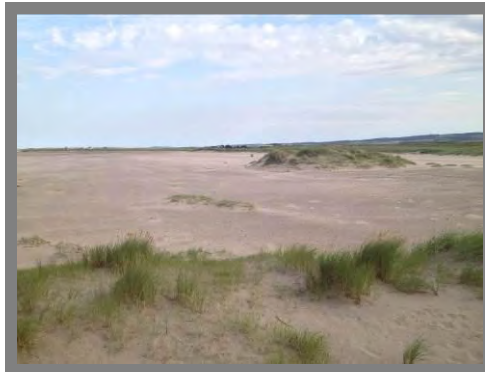
Dunes at Cheswick Sands in 2012.

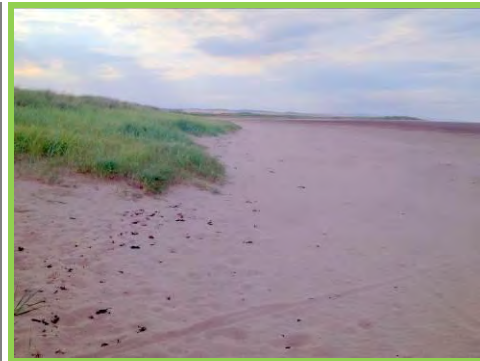
Dunes at Cheswick Sands in 2014 (1201c03).

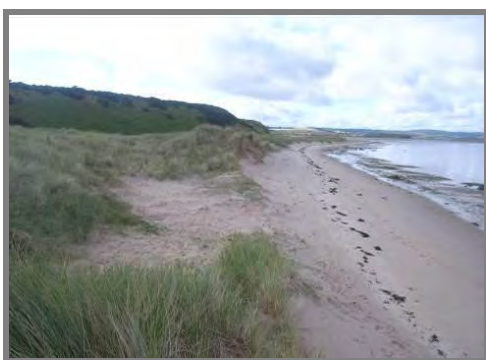
Erosion at toe of dunes fronting Heather Cottages in 2012.

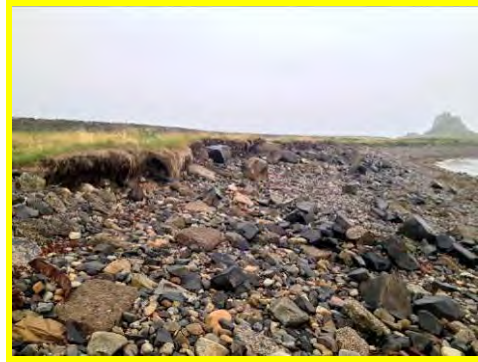
Active erosion and cliffing of earth slopes around the north side of the bay (4901c11).

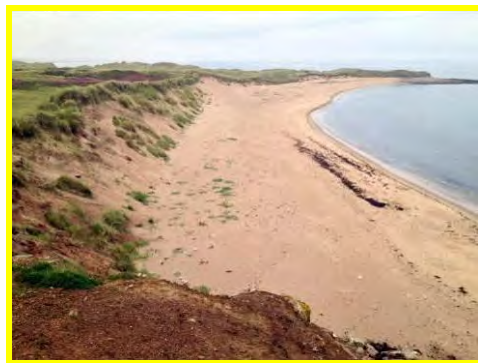
Loss of vegetation on the face of the dune ridge in Coves Haven (/5001c08).

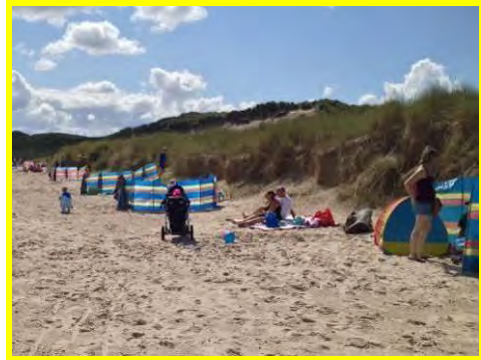
Erosion and cliffing along much of the dune toe (/1601c02).

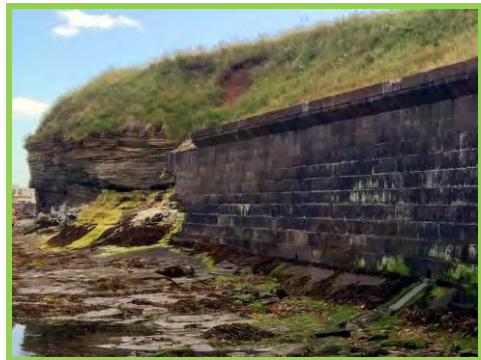
Erosion of upper earth cliff at east end of seawall.

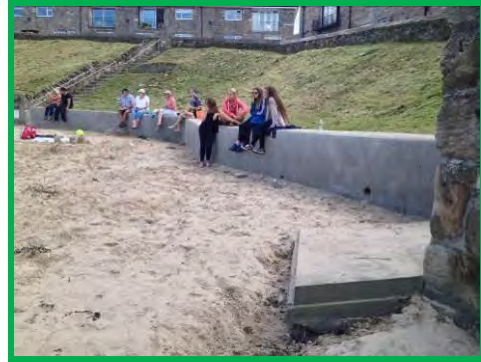
Onset of undermining of bottom landing of steps at low concrete seawall (/1701c16).

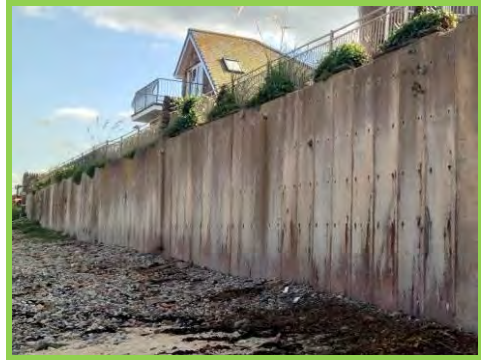
Minor signs of cracking and rust staining to concrete seawall (/1701c31).

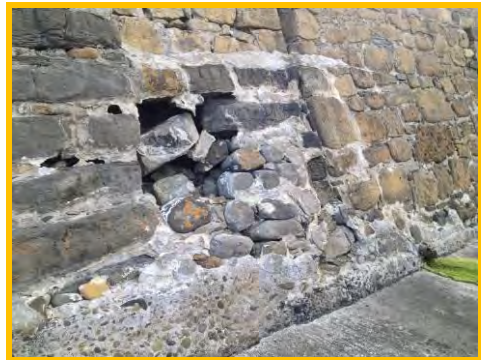
Missing blocks resulting in a deep hole and void behind (/1701c36).

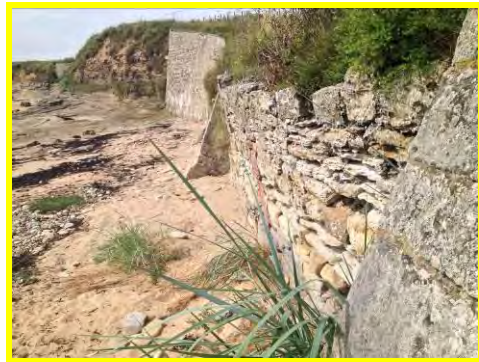
Weathering of blocks, missing mortar and seaward rotation of masonry retaining walls at Howick Haven (2501c01).

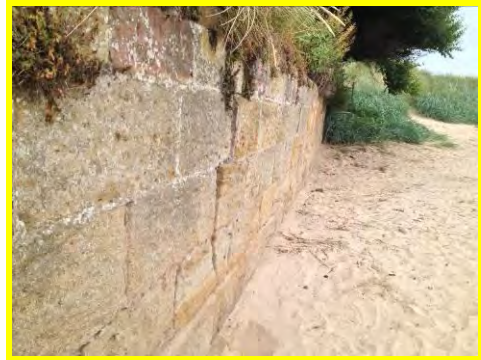
The masonry wall immediately south of the River Aln road continues to show signs of settlement and cracking along the central section with gaps in the blockwork.

Vertical crack and some rotation in central section of wall (/2801c02).

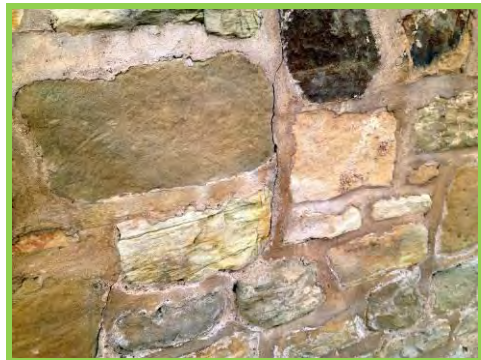
Minor cracks visible in masonry wall fronting the boat club (/2801c03).

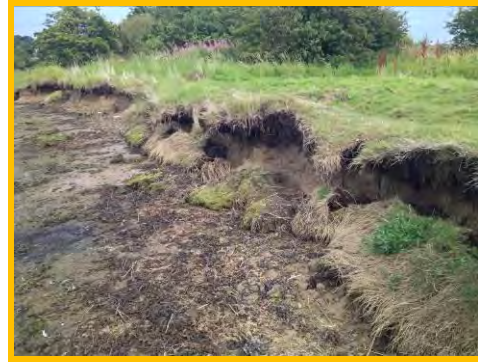
Total erosion and undermining of earth bank on upstream face of spit (2801c09).

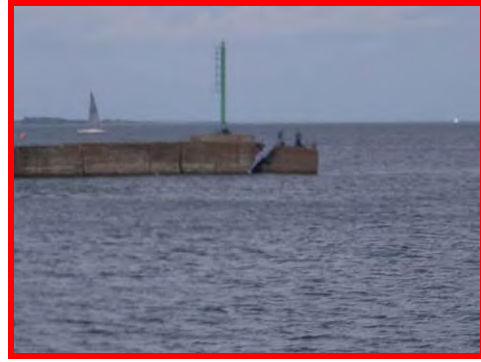
Significant damage of the seaward end of the North Pier at Warkworth Harbour remains with a full height vertical crack and rotation of the seaward tip. However, photographs since 2002 indicates no significant recent change.

Large crack and rotation of tip of North Pier.

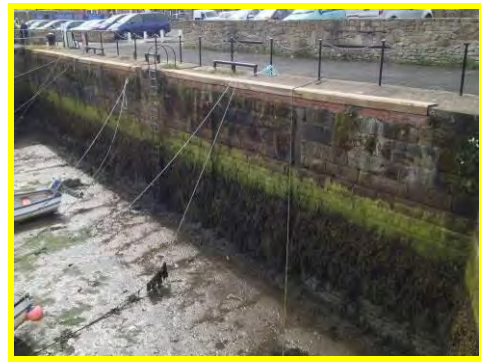
Some gaps between masonry blocks, timber edging protecting the cope (/3001c06).

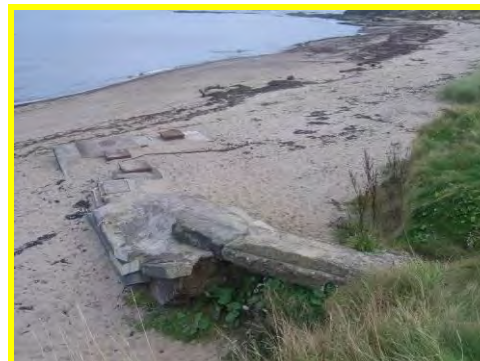
Dilapidated outfall requiring removal or repair (/3101c09).

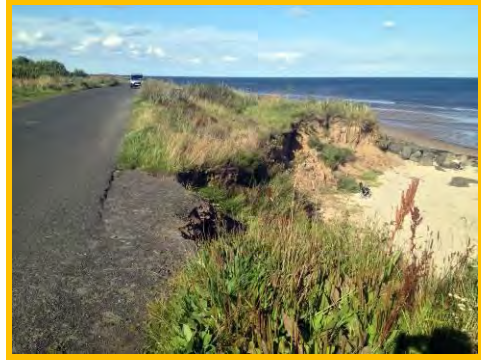
Cut back of the low earth cliffs close to the road at Hadston Scaurs slipway (/3201c14).

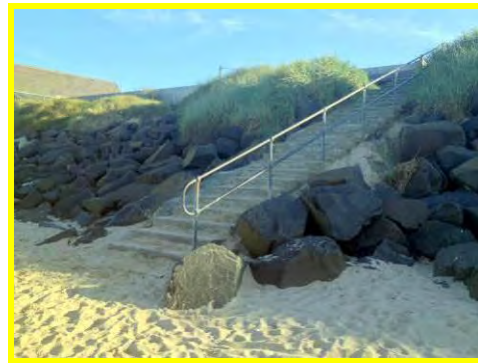
Lower beach levels at access steps north of Cresswell (/3201c17).

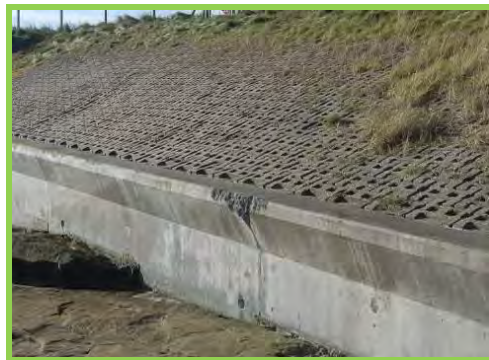
Minor abrasion to low concrete wall at south end of Cresswell (/3201c19).

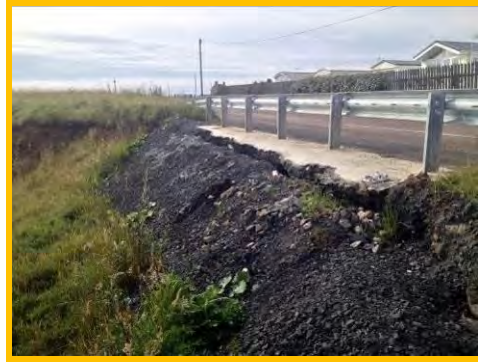
Slope showing recent signs of movement below the new barrier (3201c22).

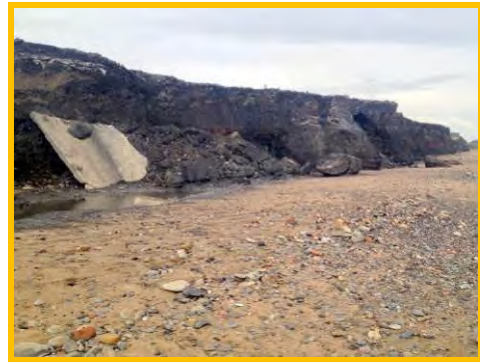
Slumps in colliery spoil cliff releasing construction waste onto the foreshore (/3401c06).

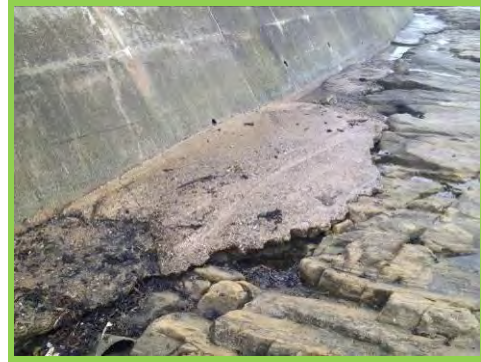
New sealant to joints in recurved seawall (/3601c13).

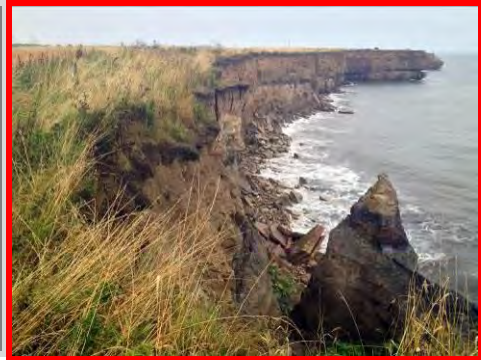
Partially collapsed cliff and closed footpath at Hawk Cliffs in 2014 (/3701c02).

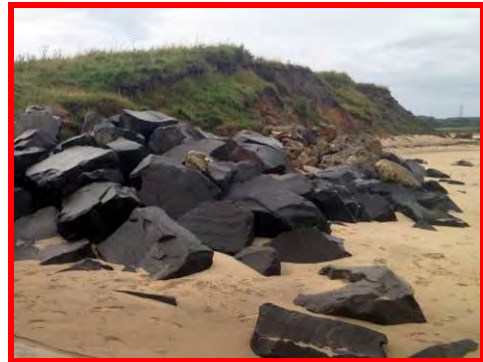
Rock armour and dumped concrete rubble partially stabilising cliff at slipway (/3901c01).

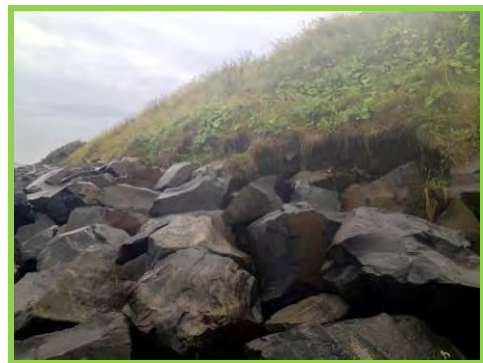
Minor erosion and cliffing of earth cliffs behind crest at north end (/3901c05).

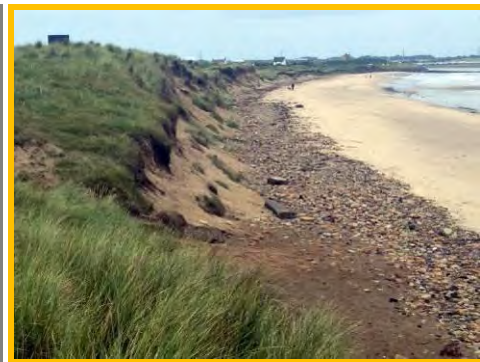
Low beach levels exposing cobble toe, erosion and collapse of dunes in 2014 (/3901c03).

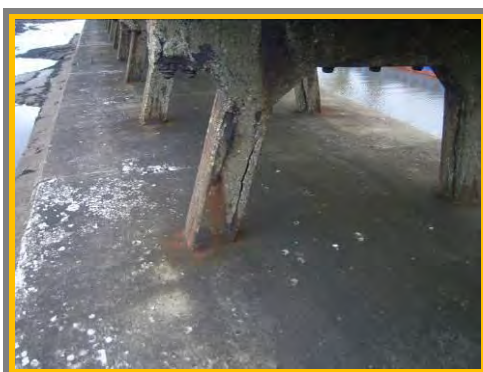
The Blyth East Pier was not accessible but the previous inspection noted rust staining, spalling and cracking to the majority of the trestle legs. In addition the timber deck was worn with the onset of rot around fixings and a number of boards and a section of handrailing missing.

Corrosion and spalling to trestle legs along Blyth East Pier in 2012.

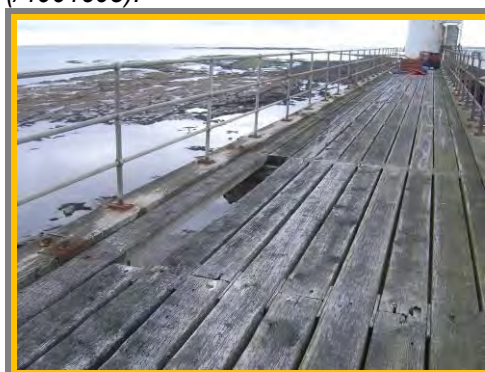
Missing sections of timber decking and rot at some fixings in 2012.

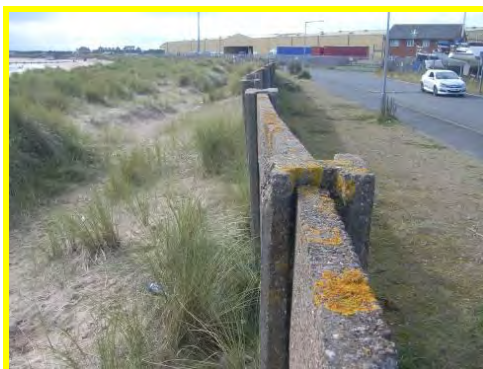
Some rotation of concrete post and plank wall at back of dunes (/4201c11).

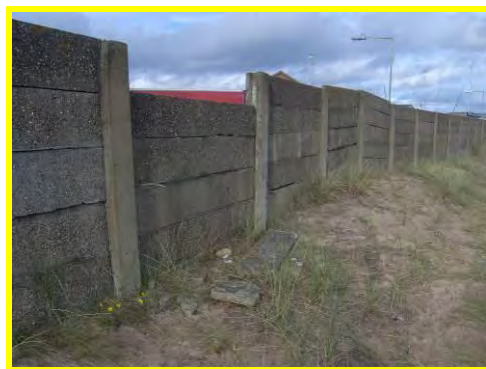
Some broken and missing planks along wall at back of dunes (/4201c11).

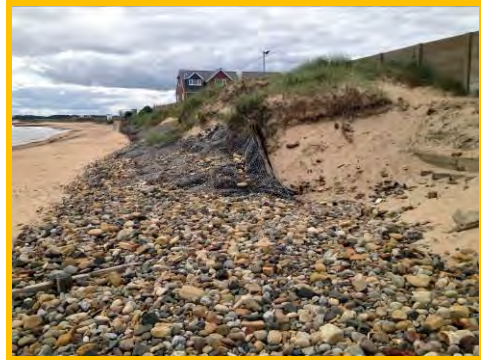
Along Blyth South Beach erosion at the toe of the narrow band of dunes continues with unravelling of the gabion baskets exposing of the foundation of the crest wall.

Outflanking of gabions at north end, erosion of dunes and exposure of wall foundations (/4201c03).

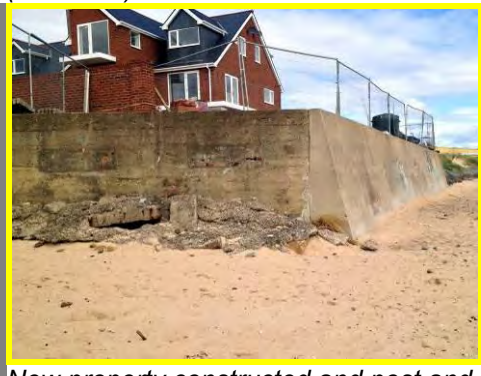
High beach levels at the concrete seawall north of the promenade have re-buried the toe of the structure. The wall along the crest of this structure has been removed which could increase the risk of overtopping damage to the property behind.

New property constructed and post and plank crest wall removed in 2014 (/4201c04).

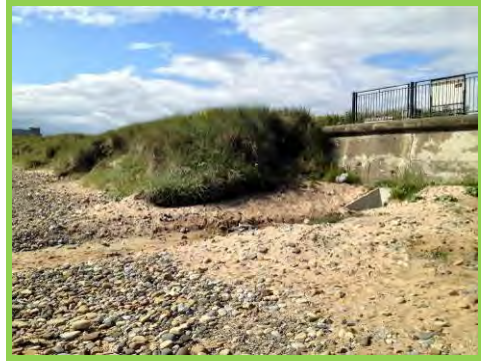
Localised erosion to the dune edge from the outfall constructed in 2009/10 (/4201c05).

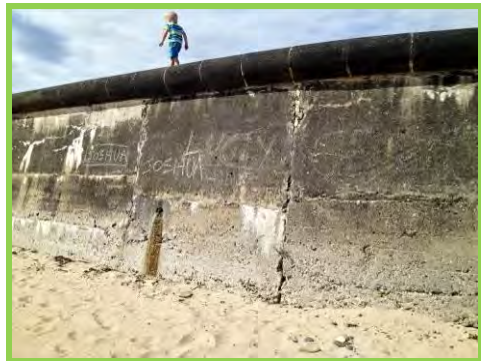
Cracks and staining in the seawall adjacent to the Dave Stephens Centre (/4201c06).

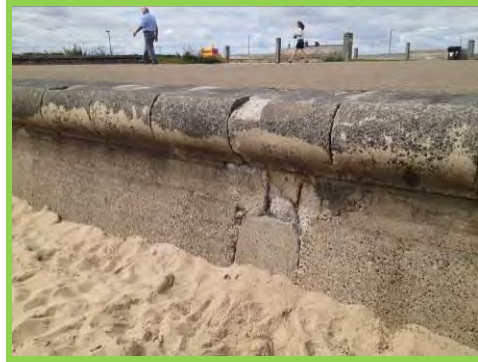
High beach levels, minor cracks and gaps at construction joints (/4201c07).

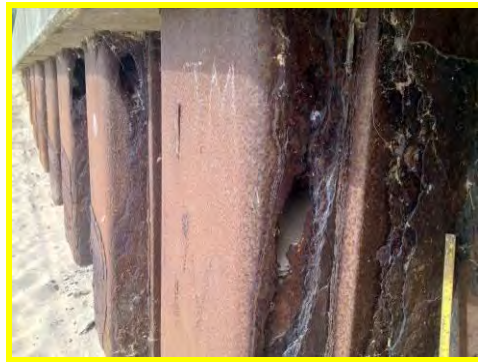
Corrosion of steel piles resulting in loss of section thickness and holes in the web (/4201c08).

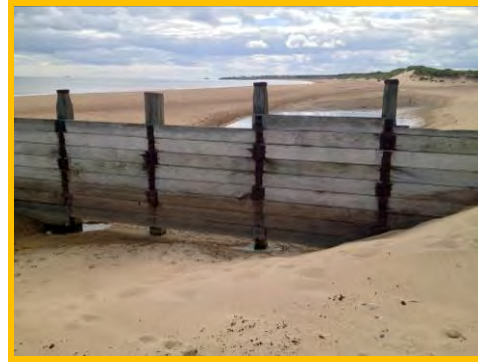
The groynes fronting the seawall at the centre of the bay continue to be largely ineffective with missing timber planks, arson damage and many sizable gaps. The groyne at the south end adjacent to Seaton Sluice Harbour is also in a similar condition.

Scour beneath southern groyne due to re-alignment of Meggie's Burn (/4301c01).

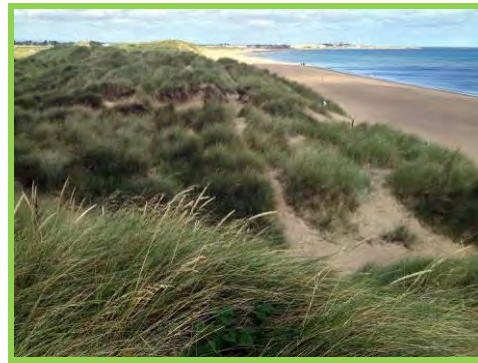
Erosion of dune crest due by walkers due to numerous uncontrolled access points (/4301c02).

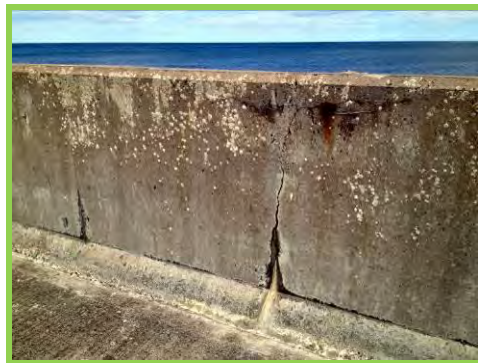
Minor cracking and missing joint sealant (/4401c10).

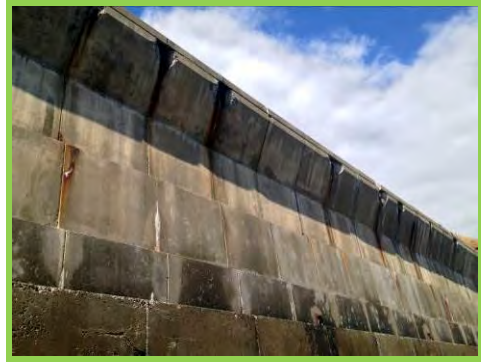
Spalling of concrete along upper section of seawall at north end of Collywell Bay (/4401c14).

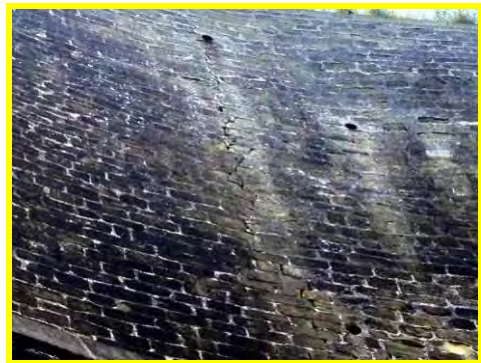
Full height gaps in the brickwork in the upper wall (/4401c15).

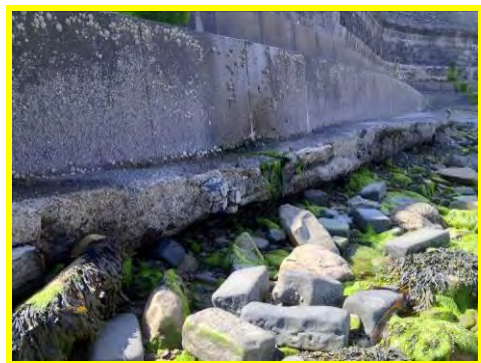
Abrasion, rotting timber wailing and undercutting at toe of seawall (/4401c16).

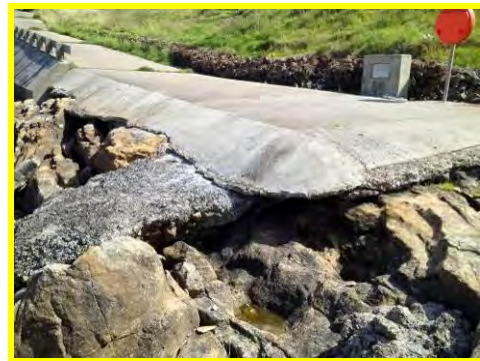
Undermining of concrete access ramp (/4401c19).
