Cell 1 Regional Coastal Monitoring Programme Walkover Inspection Surveys 2016

Northumberland County Council

Walkover Inspection Surveys 2016

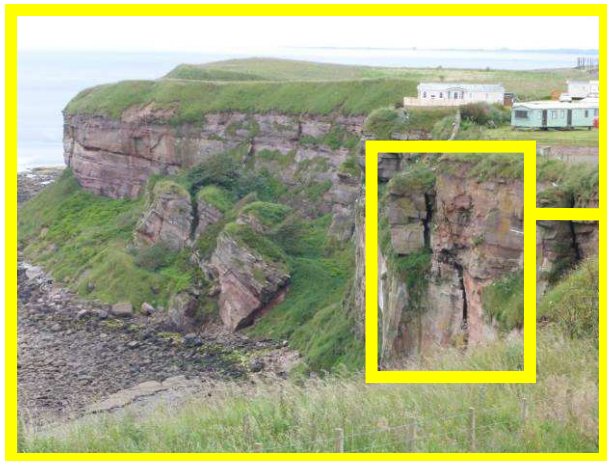
The cliffs at Marshall Meadows Bay are fractured in places adjacent to the caravan park but have been in this condition for some time. At the time of the inspections, no recent movement was observed in terms of either rock falls in the harder rock base or slumping in the overlying softer material, although both processes remain the characteristic behaviour of these cliffs.

Fractured cliffs at Marshall Meadows Bay (/0601C02)

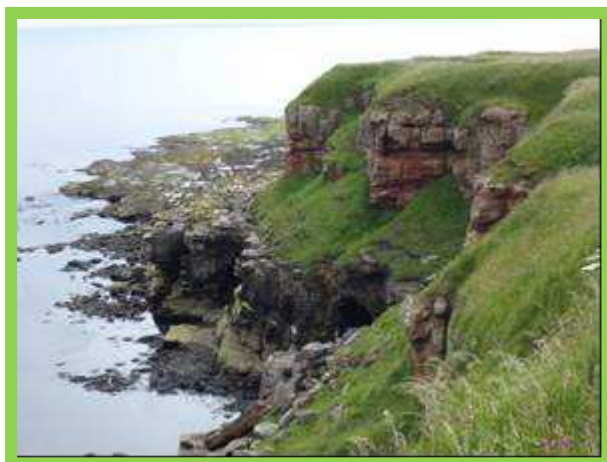
Stable cliffs at St. John's Haven (/0601C04)

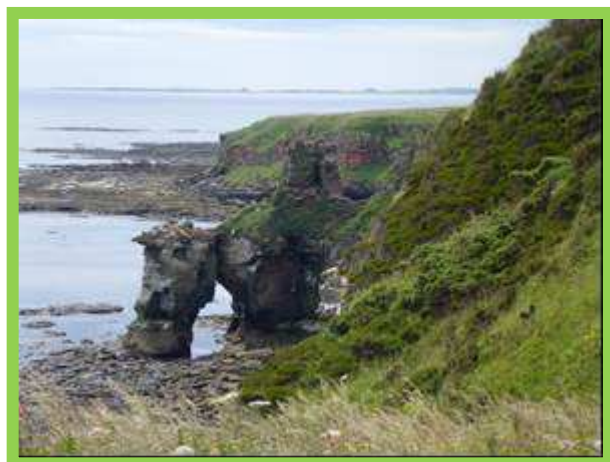
Needle's Eye (/0601C05)

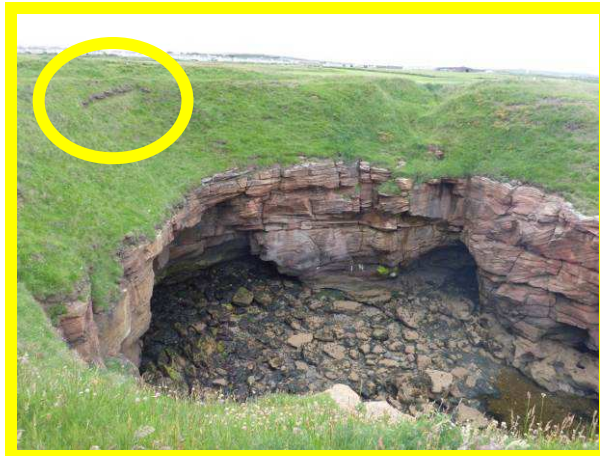
The cliffs at the northern section of Magdalene Fields continue to be susceptible to local and occasional slumping in the upper soft material, which was particularly observed at Brotherston's Hole. Previous slumps have cut the cliff top back to the footpath in places at the Golf Course. In the harder rock base there are numerous caves, fissures and rock overhangs.

Localised slumping at Brotherston's Hole (/0701C01)

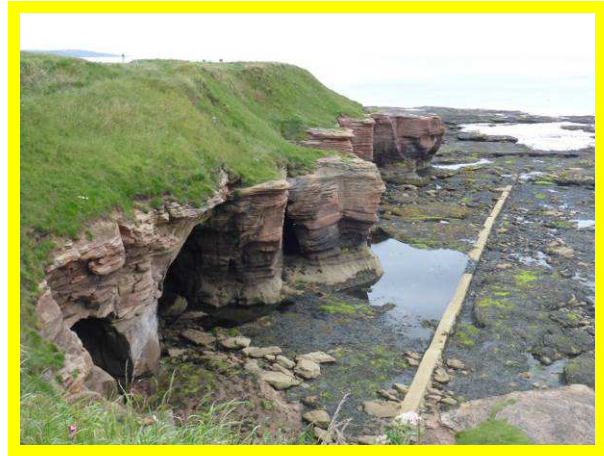
Caves at base of cliffs (/0701C01)

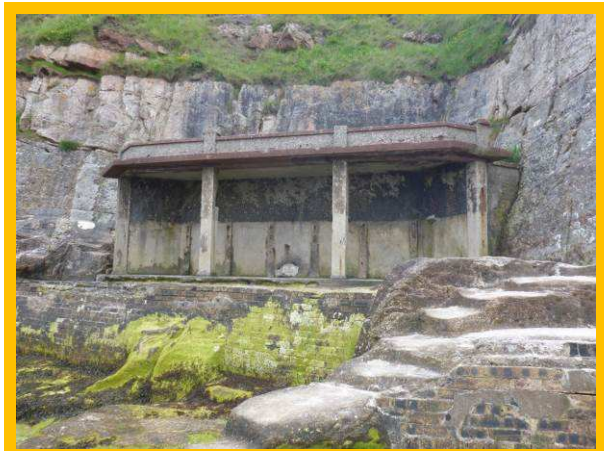
Concrete pavilion structure in fair/poor condition (/0701C02)

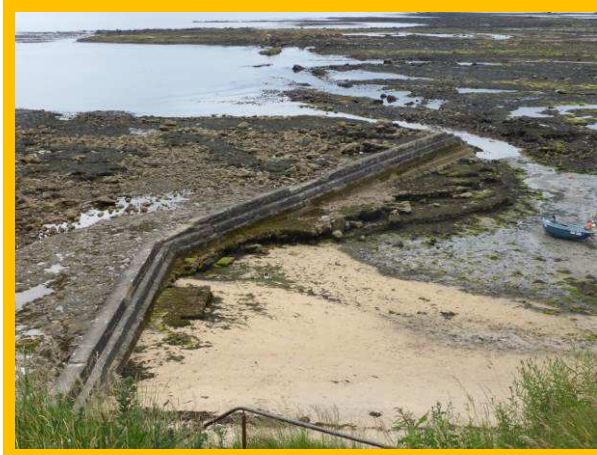
Green's Haven (also known as Fisherman's Haven) Breakwater remains in poor condition but there has been no significant further deterioration since the previous survey. The structure continues to show signs of heavy abrasion along most of its length with loss of the upper section of crest at two locations. Ongoing horizontal cracking and spalling along much of the rest of its length is likely to lead to further damage of the crest. Whilst the structure is well founded on rock, this is being undercut. Although the structure is in poor condition it is still performing the function of retaining sand within the bay.

Green's Haven Breakwater remains in poor condition but still retains beach sand (/0701C04)

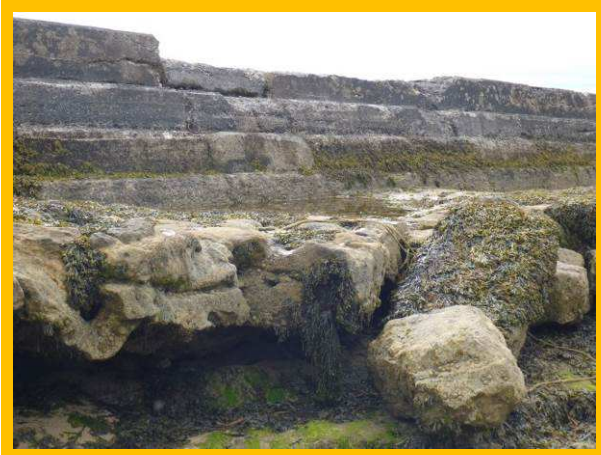
Abrasion, damage and rock undercutting along the breakwater (/0701C04)

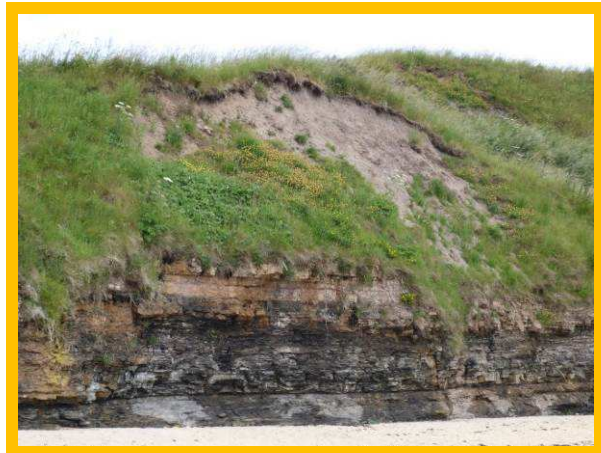
Slumping in cliffs at Greens' Haven (/0701C08)

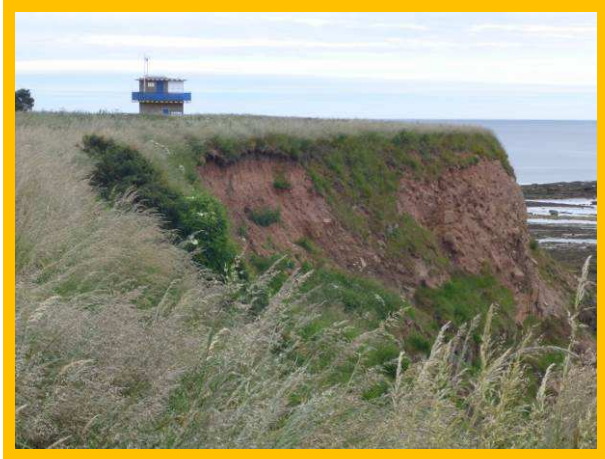
The cliffs along the southern part of Magdalene Fields are actively slumping and the fence and footpath have been moved in response.

Slumping cliffs along Magdalene Fields Golf Course (/0701C12)

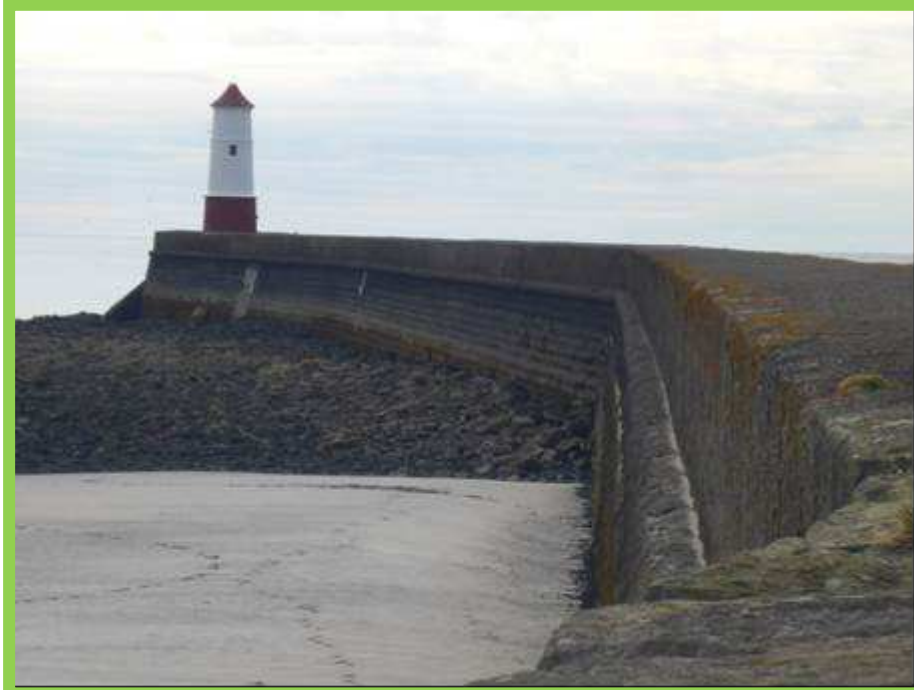
The Berwick Pier underwent substantial refurbishment during 2012/13, including repair of a significant void midway along the leeward face and replacement of the concrete deck.

Berwick Pier in good overall condition following refurbishment in 2012/13 (/0701C14 & C15)

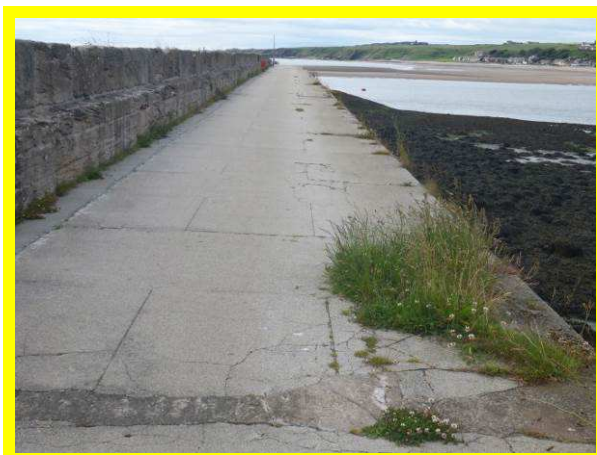
The new repairs remain in good condition, but some minor cracking, which does not seem to have worsened since the previous inspections, is evident in the older (inland section) deck. Vegetation growth is occurring in some of these cracks. In addition, some of the concrete render on the crest of the outer wave wall is spalling along the seaward sections and the older, inner section of this wave wall is heavily abraded on its landward face.

Older (inland) sections of cracked deck and abraded wave wall on Berwick Pier (/0701C14)

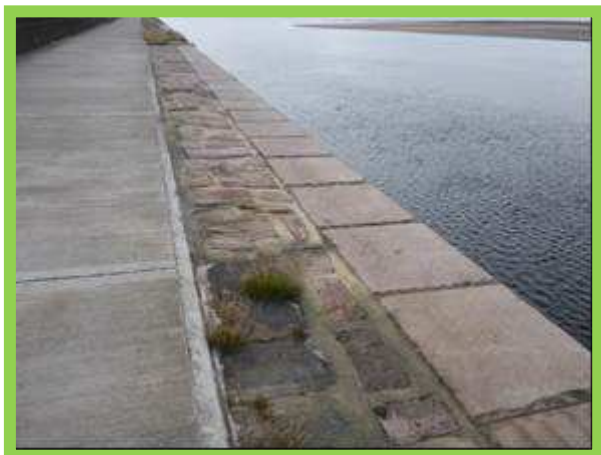
Repairs to deck and southern face of Berwick Pier (/0701C15)

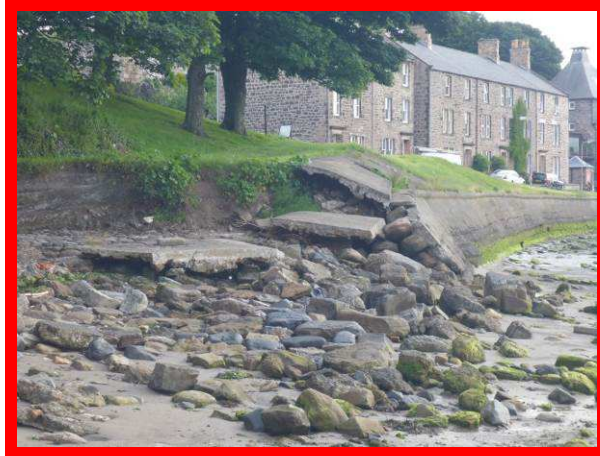
The masonry seawall along Pier Road remains in fair condition overall, with occasional minor cracking and spalling of the concrete coping. However, as previously reported, there is outflanking and localised collapse of the wall at its western end, although this does not appear to have worsened since the previous inspection and appears to have changed little since 2004. An old cobble slipway which crosses an outfall pipe midway along the wall continues to deteriorate with blocks continuing to be displaced across the foreshore. The nearshore section of the outfall is encased in concrete which has cracked notably.

Local failed section of river slope revetment/wall (/0801C07)

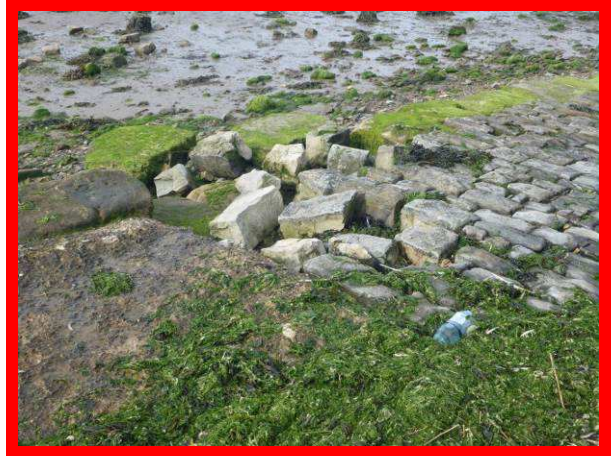
Local failed section of slipway over foreshore outfall (/0801C07)

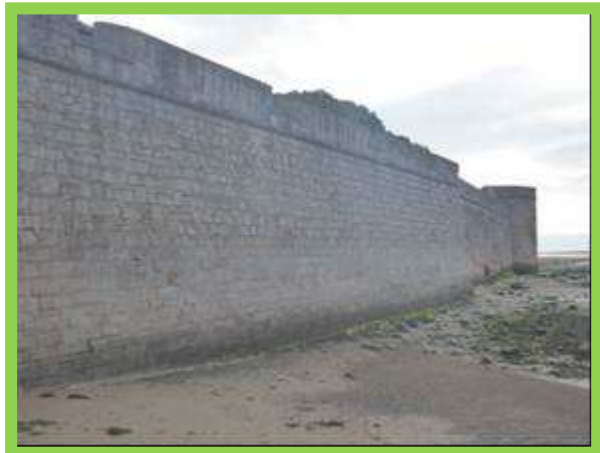
The historic masonry wall of Fisher's Fort remains in relatively good condition although some local areas would benefit from re-pointing. Previous repairs have been made at the junction of the wall and the roundhead. Where the wall has a toe apron several of the blocks in the apron are heavily abraded.

Berwick's historic town walls in good overall condition (/0801C06)

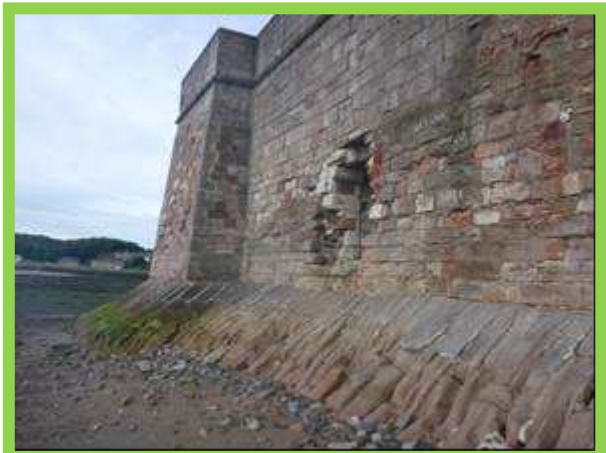
Abrasion to toe apron where present (/0801C06)

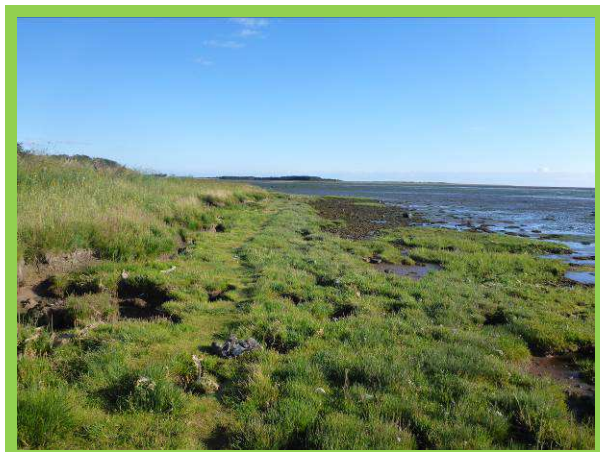
Along the Chesterhill Slakes in Budle Bay the salt marsh remains generally in a healthy condition, with salt pans evident in several locations, with little change evident since the previous inspection. Whilst marsh edge erosion was reported in the 2012 inspections, it has not been evident since then with a healthy marsh edge. In some places there is Chord Grass (*Spartina*) growth on the foreshore.

1401C21 – Salt marsh in healthy condition in Budle Bay

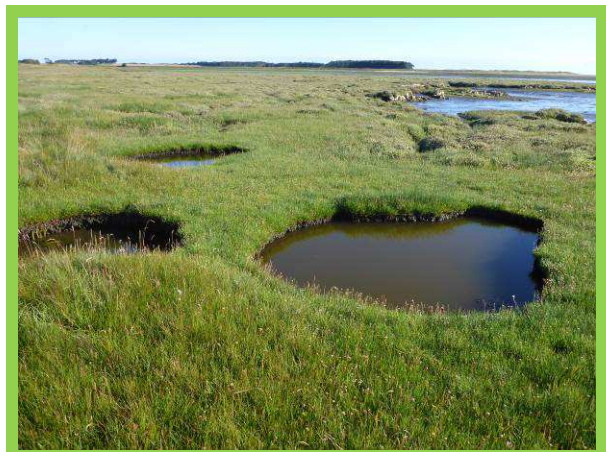
1401C21 – Salt pans within the salt marsh in Budle Bay

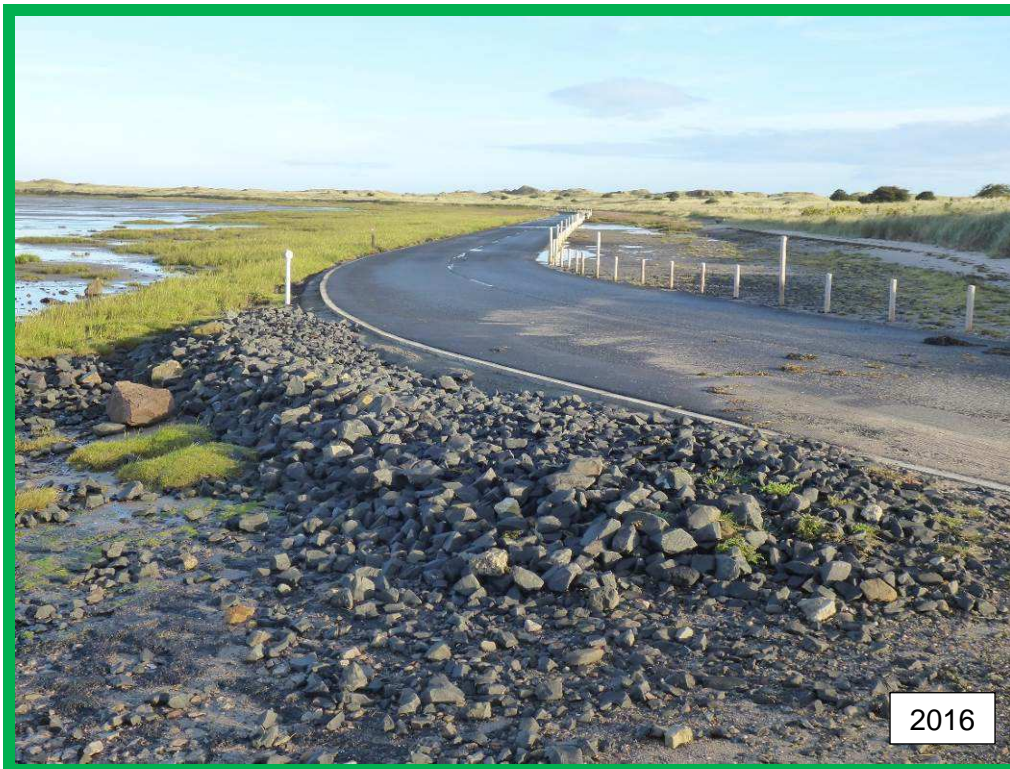
Repaired road surface and kerb at Chare Ends in 2016 (4901c01)

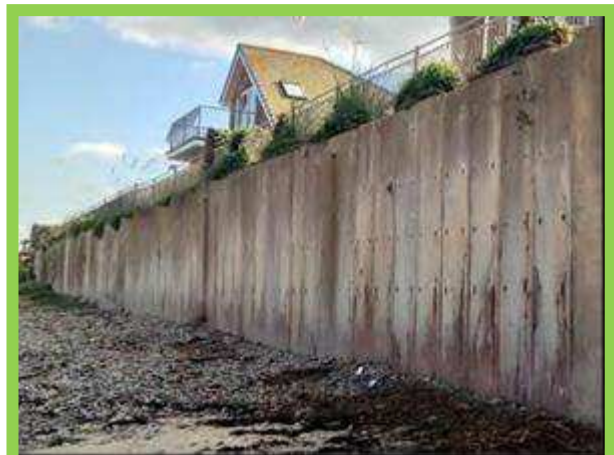
Good condition seawall (/1701C31)

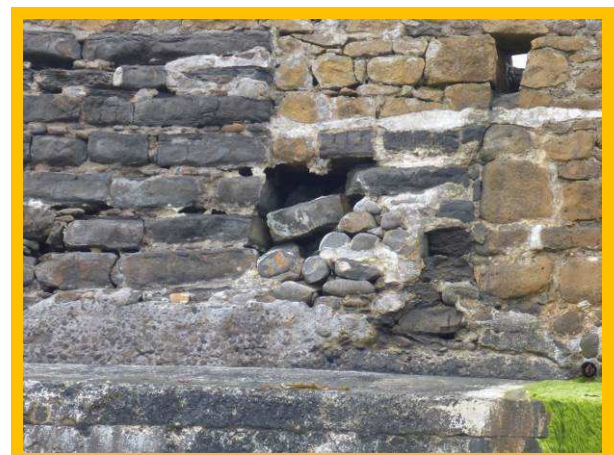
Voiding within seawall at Beadnell North (Nacker's Hole) (/1701C36)

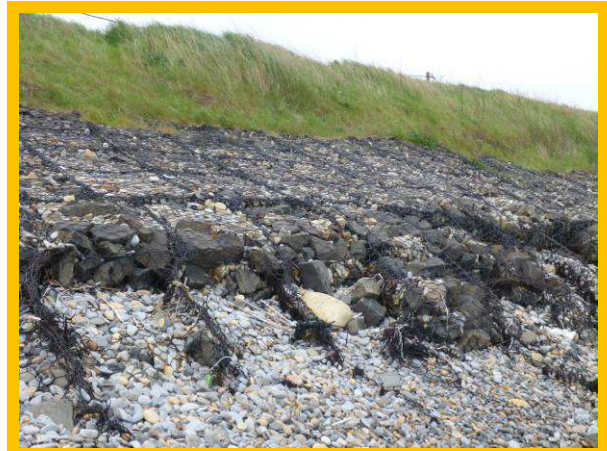
Failing mattresses at Beadnell North (Lady's Hole) (/1701C40)

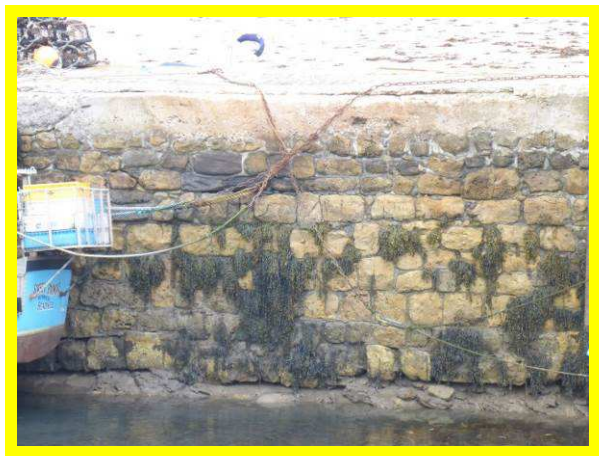
Undermining of Beadnell Harbour wall (inner face of northern wall) (/1701C51)

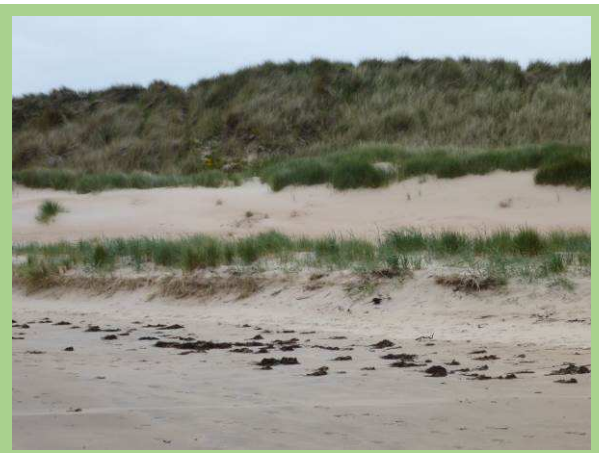
Sand accretion and embryonic vegetation growth at toe of dunes in Beadnell Bay (/1801C01)

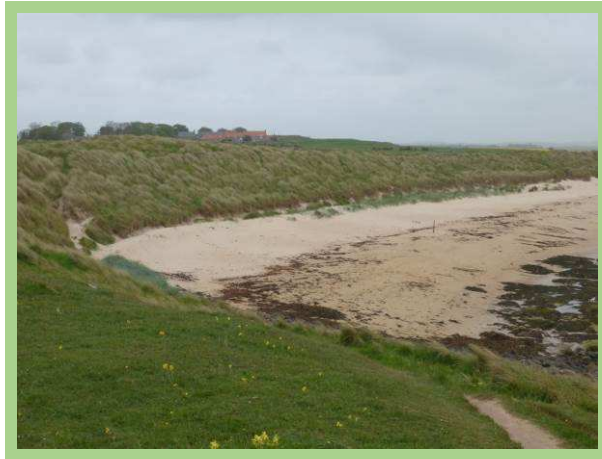
The vegetated dunes in Football Hole are in good condition, with only very small areas of localised slumping and generally sand accretion and embryonic vegetation growth at the toe. There has been some localised erosion in the coastal slope at Newton Point headland, however, with the National Trust fencing off a small area adjacent to a fence line. This now requires relocation of the fencing inland. The wall at Low Newton-by-the-Sea remains in fair condition.

Stable dunes in Football Hole (/1901C02)

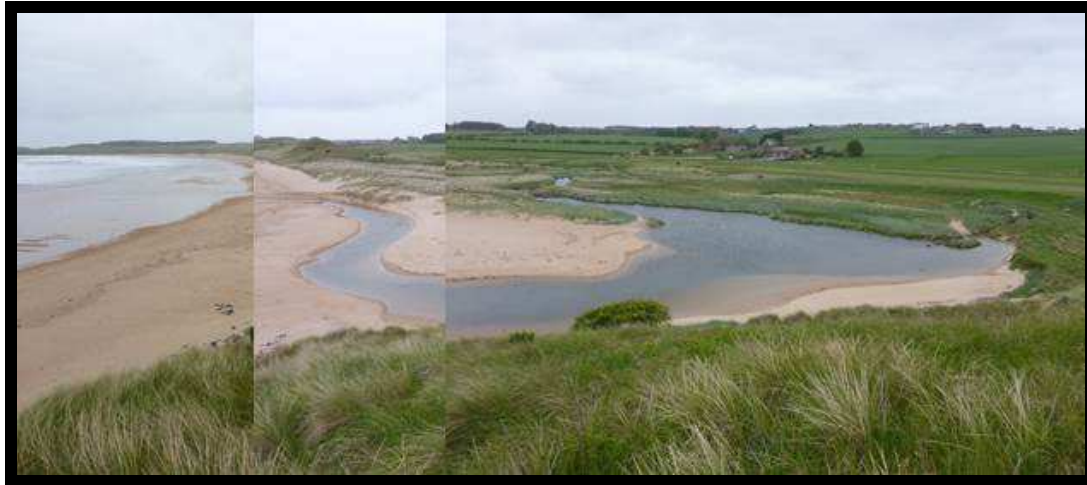
There have been interesting changes in Embleton Bay at the outflow of the Embleton Burn. The channel has changed its route as it flows to sea, running to the south very close to the toe of the dunes before flowing across the inter-tidal towards low water. This has resulted in localised erosion to those dunes, but this does not present any risk to assets. Otherwise, the dunes are relatively stable and in good condition, especially at the southern end where protected by a beach composed of large cobbles.

Change in course of Embleton Burn as it discharges to sea (/2001C04)

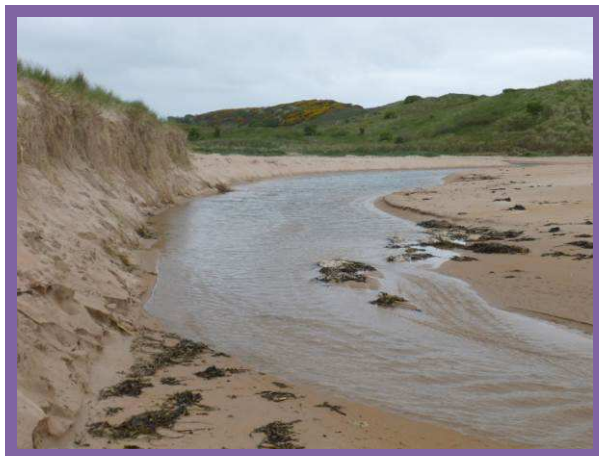
Localised dune erosion adjacent to channel of Embleton Burn (/2001C04)

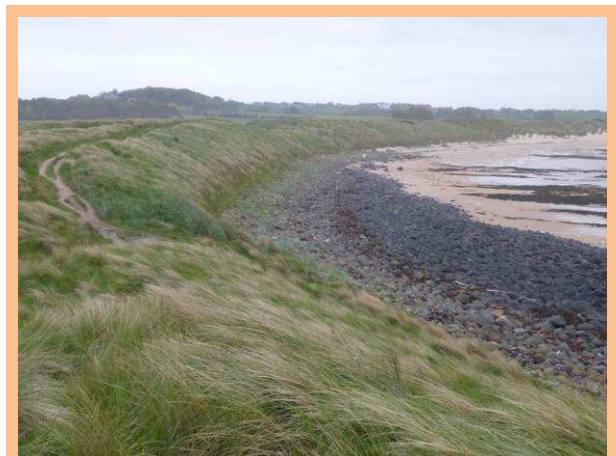
Stable dunes in Embleton Bay (/2001C04)

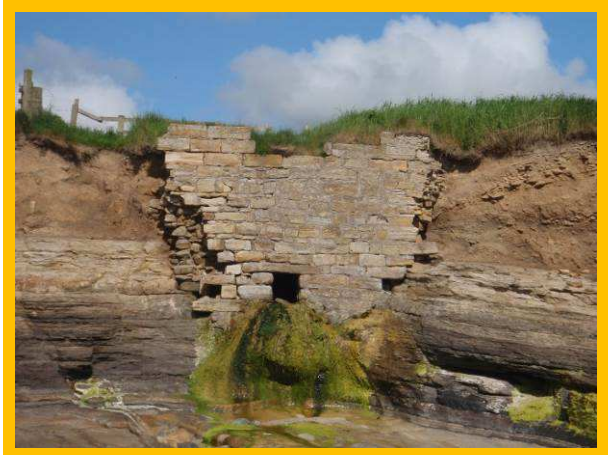
Poor condition retaining wall (/2501C01)

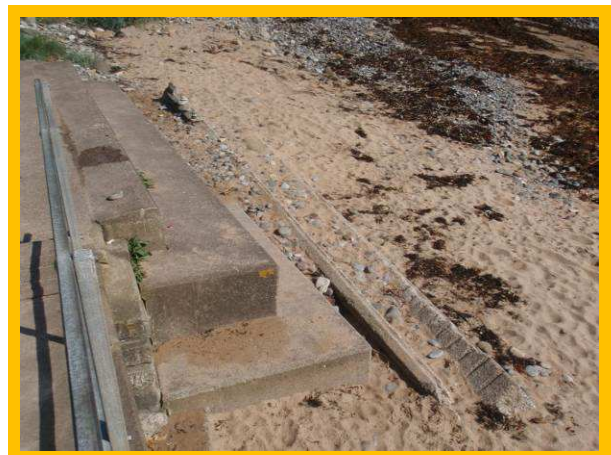
Detached toe beam at northern bridge abutment (/2501C01)

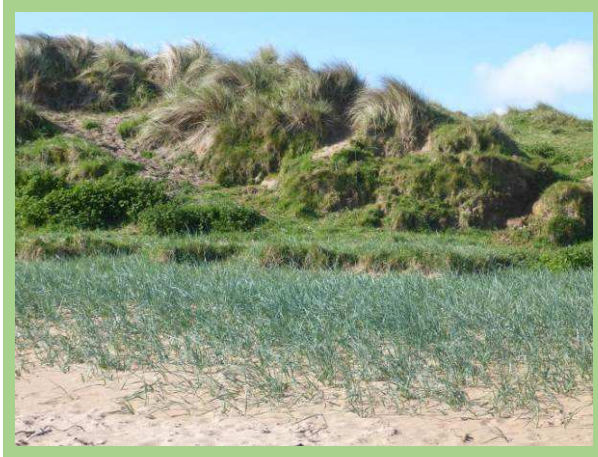
The bays of Sugar Sands and Howdiemont Sands comprise healthy sandy beaches backed by stable dunes, with mature and embryonic vegetation. The only sign of (minor) erosion is in a highly localised patch immediately south of the footbridge across the small burn which discharges at the southern end of Howdiemont Sands. This erosion is affecting the fence line which is in need of repositioning.

Stable dunes with mature and embryonic vegetation growth (/2501C01)

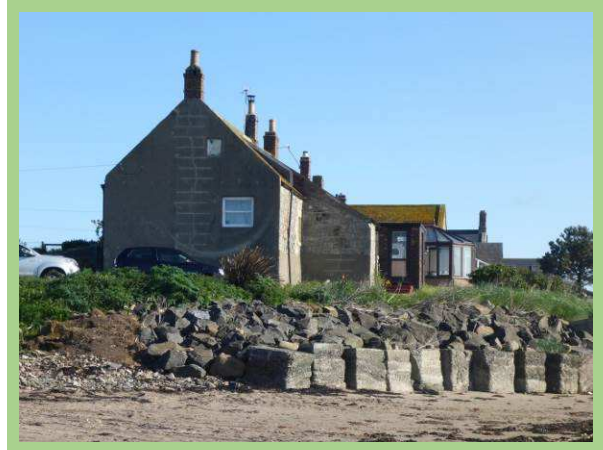
Stacked concrete blocks (original scheme) and rock revetment (emergency scheme) at southern end of Boulmer village (/2601C05)

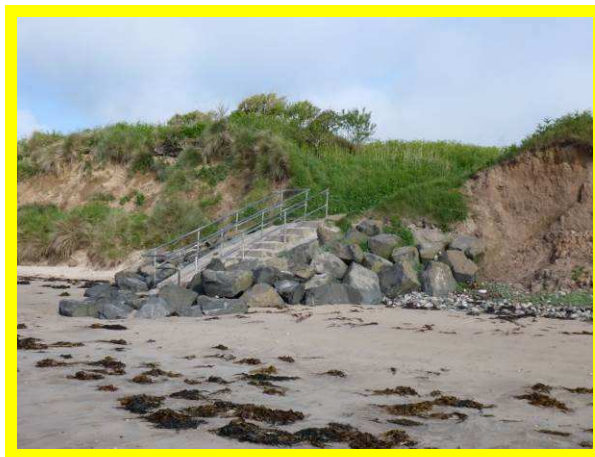
The access steps towards the northern end of Foxtton Bay are protected by rock armour but erosion of the cliffs either side continues. Just to the south of the access steps, the eroding cliffs are largely bare of vegetation on their face and sand martins are nesting in the upper sections of cliff. The ongoing erosion has caused the fence to become lost in places.

*Rock armour around access steps in north of
Foxtton Bay (/2601C09)*

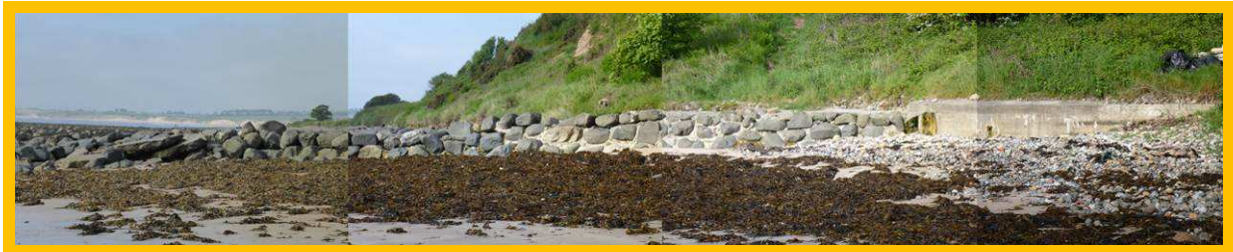
At the footpath access to the beach, there is a small 'breakwater' wall coming around the headland and extending seaward. The landward section is concrete and in fair condition. The adjacent stone section is also in fair condition, but the seaward end is comprised of loose boulders and in poor condition.

Breakwater wall at Marden Rocks headland in fair to poor condition (/2701C03)

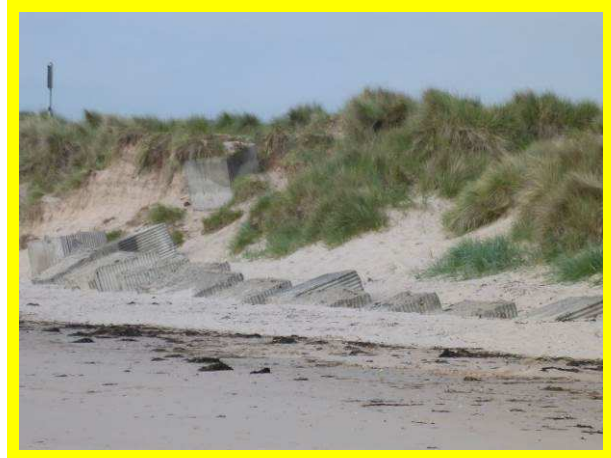
Minor slumping in dunes protected by concrete blocks by Alnmouth Golf Clubhouse (/2701C08)

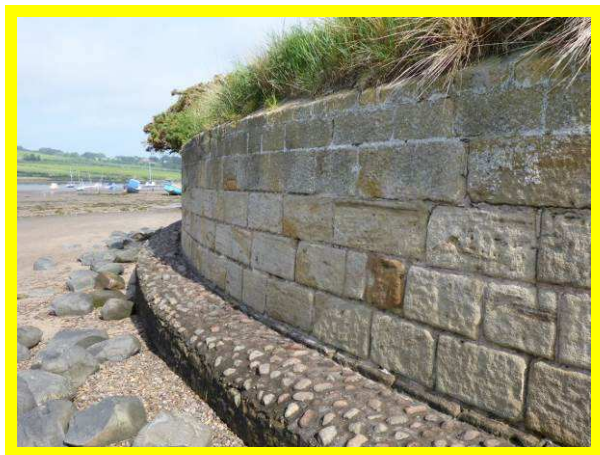
A masonry wall that extends into the estuary appears stable but appears to bow at its seaward and should be monitored for future signs of rotational displacement. The concrete and cobble toe apron of the wall is initially buried but, with progression into the estuary, becomes higher and eventually merges into a low masonry stone wall at the River Aln Boat Club which extends along Peases Park. This wall remains in good condition and is fronted by salt marsh offering addition surface roughness against incoming tidal energy.

Masonry wall with concrete and cobble toe apron (/2801C02)

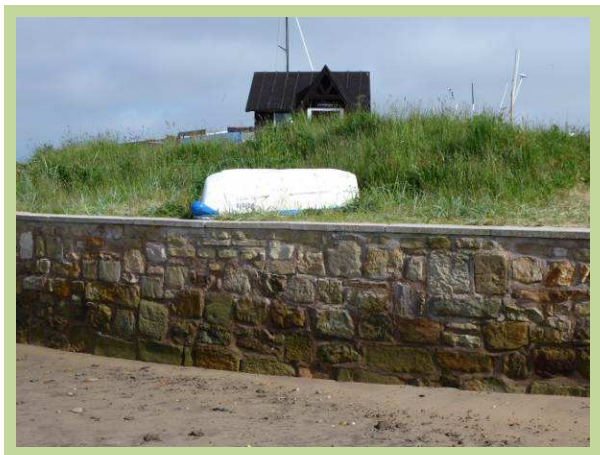
Masonry wall at Boat Club (/2801C03)

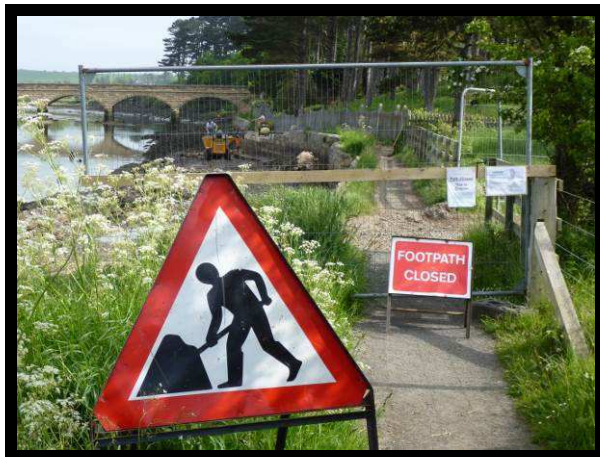
Between the spit of land and the B1338 road bridge over the River Aln, the riverbank footpath was closed at the time of the inspections because an eroded section of bank and collapsed section of wall was being repaired. These works should restore the masonry wall to good condition when complete.

Footpath closure for repairs (/2801C10)

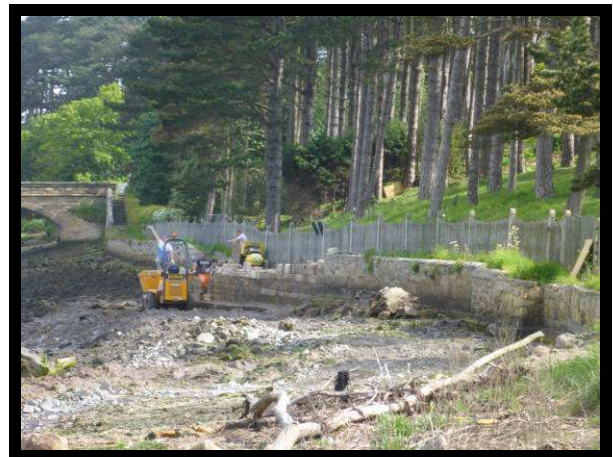
Repair of masonry riverbank wall (/2801C10)

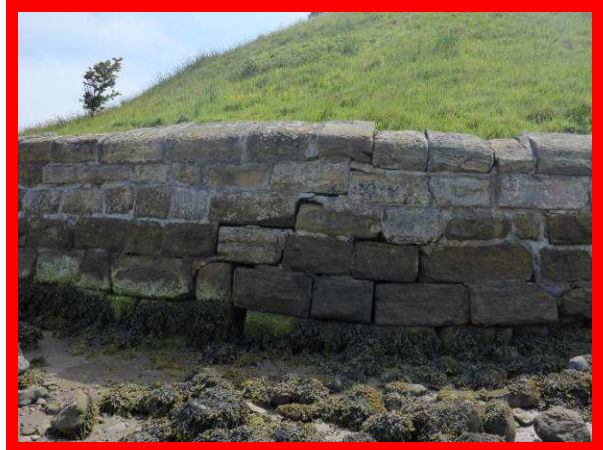
Defective section of masonry wall adjacent to collapsed section (/2801C13)

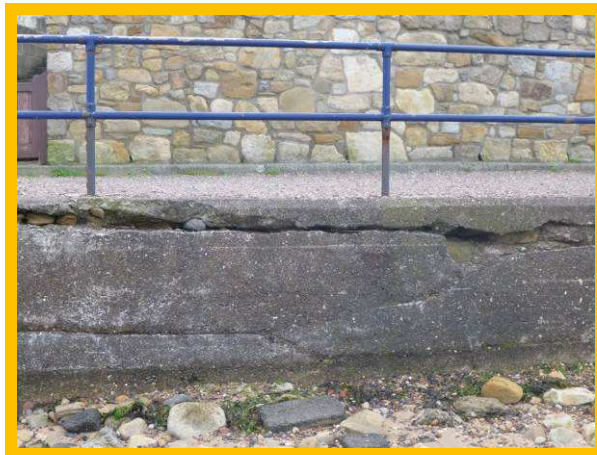
The poor condition of the concrete seawall along Bay View road (/3001C10) continues to worsen, with horizontal cold joints and vertical cracking, toe undermining, missing sections of coping, corroded hand railing and voids in the access ramp. Safety issues should be addressed urgently and capital improvement works should follow when funding is secured.

Sea wall along Bay View in poor overall condition (/3001C10)

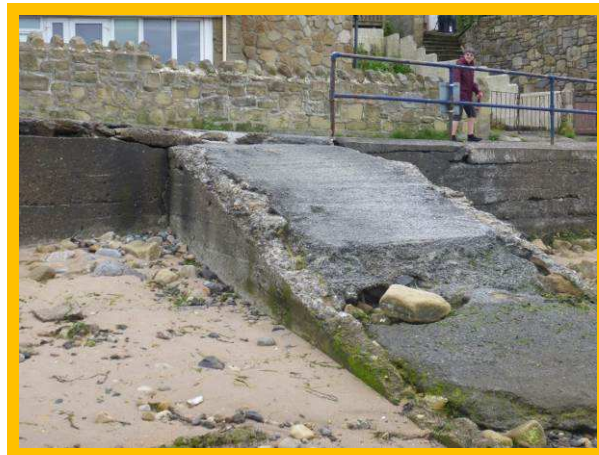
Access ramp to Little Shore Wave Basin in poor condition (/3001C10)

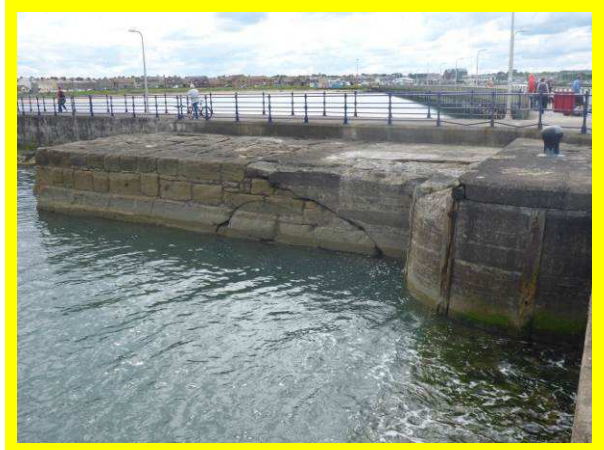
Poor condition at junction of South Pier and South Jetty (seaward face) (/3101C01)

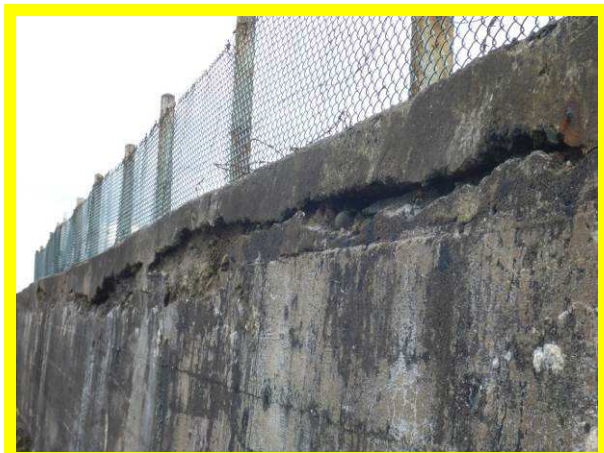
Cracks in private seawall around Pan Point (/3101C04)

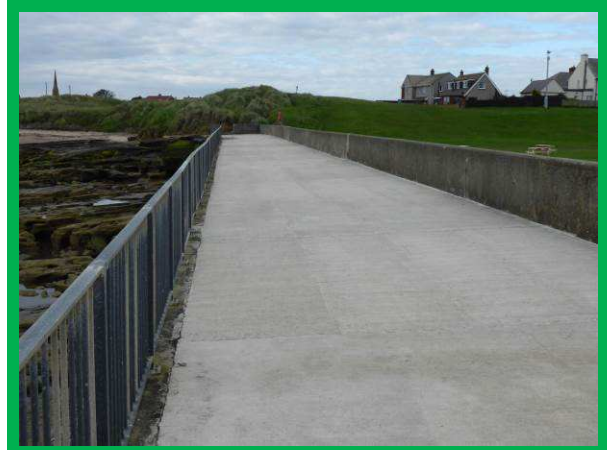
Promenade deck remains in very good condition following previous repairs (/3101C05)

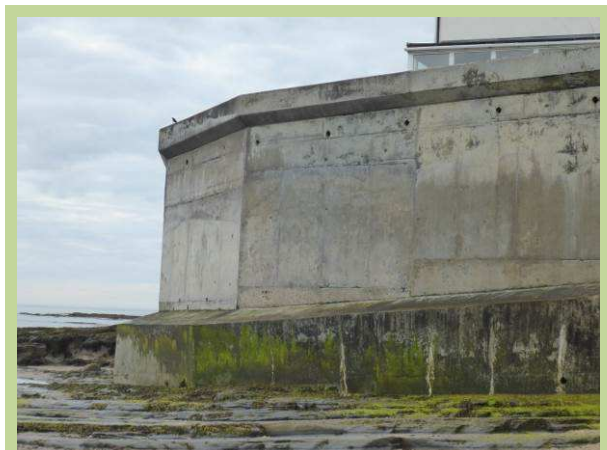
Substantial seawall in overall good condition (/3101C07)

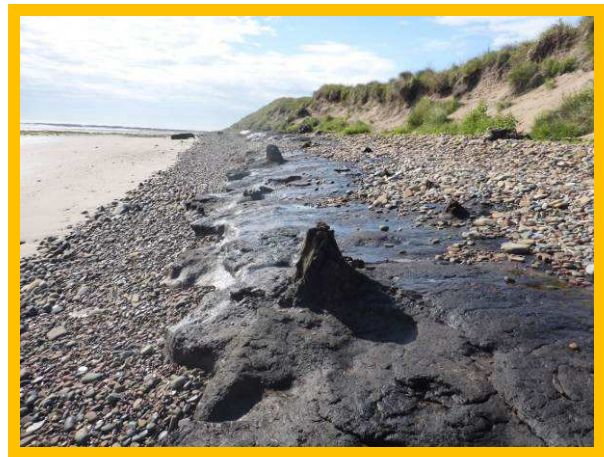
Exposed peat layer at base of dunes (/3101C12)

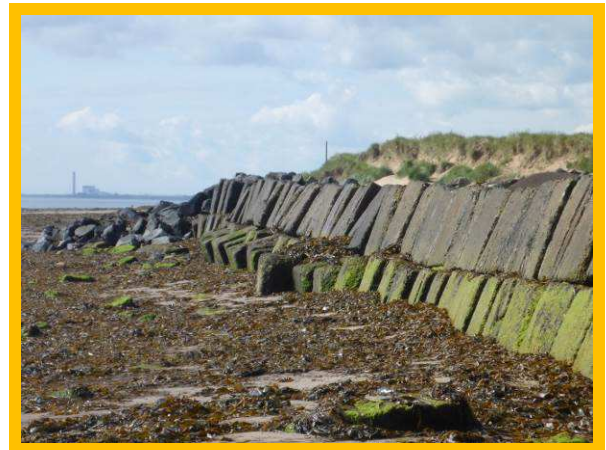
Rotational displacement at southern end of concrete block revetment (/3201C04)

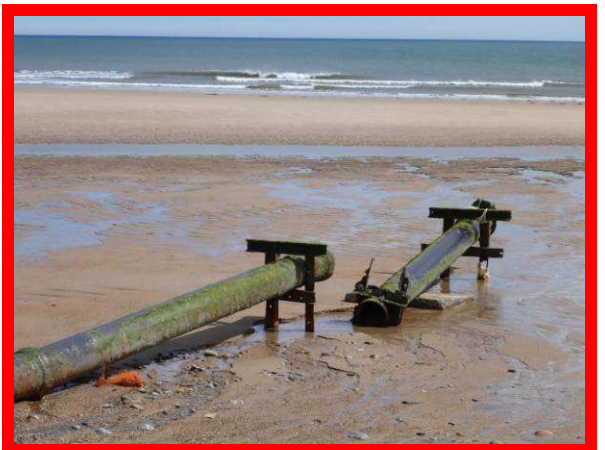
Collapsed section of outfall pipe in southern end of Druridge Bay (/3201C16)

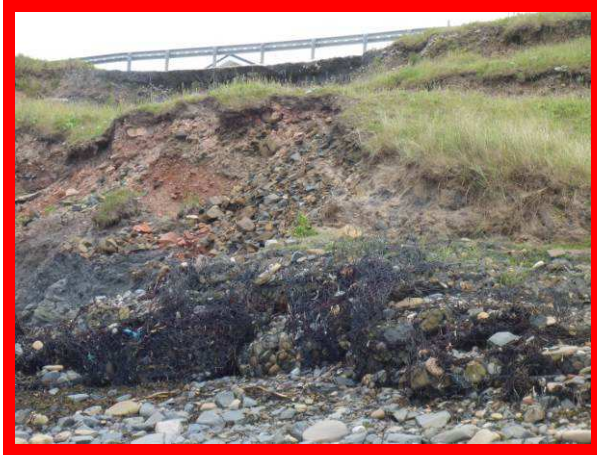
Further south still, fronting the Golden Sands Holiday Park just north of Snab Point, the cliffs become more active once again, where the cobble berm at the toe is sparser. There is one area where a slippage has previously occurred, cutting the cliff top right back to the coast road. At this location, the gabions are now almost entirely obsolete. The entire slope was saturated at the time of the inspections, suggesting a lot of groundwater build up in the failed cliff section. It is likely that further recession at this point will occur, thus affecting the coast road.

*Failed section of cliff adjacent to coast road
(/3201C22)*

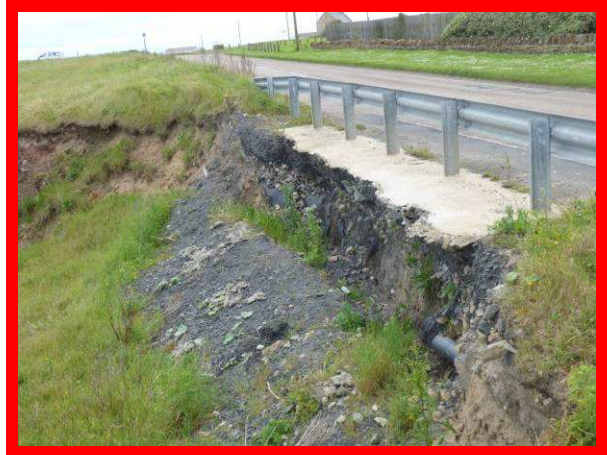
*Failed section of cliff adjacent to coast road
(/3201C22)*

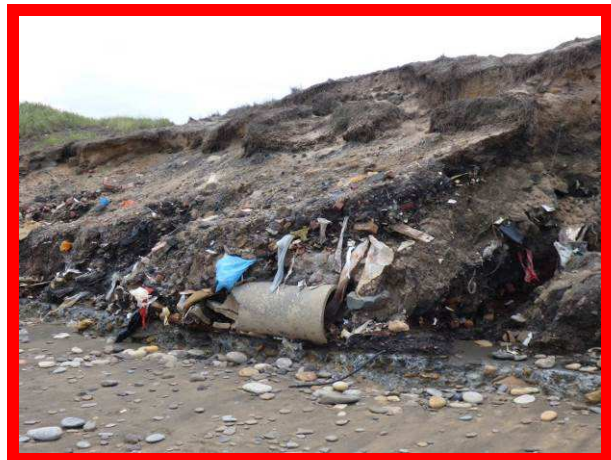
Actively eroding spoil cliff (/3401C05)

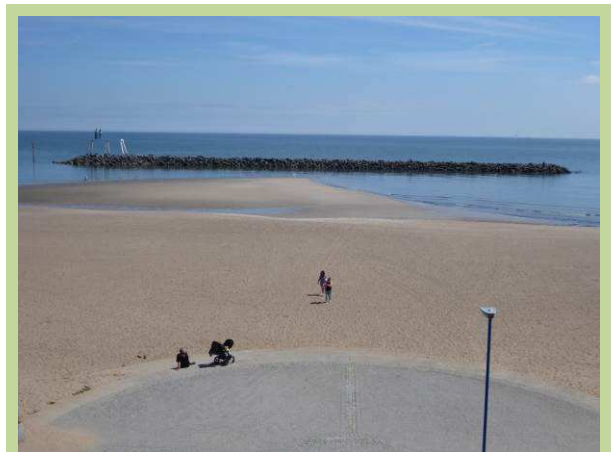
Detached breakwater in central Newbiggin Bay remains in very good condition with salient/tombolo developed in lee (/3601C13)

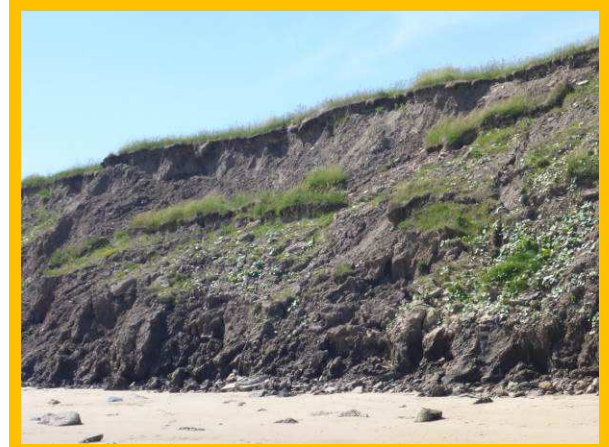
Eroding cliffs south of Cambois House (/3901C01)

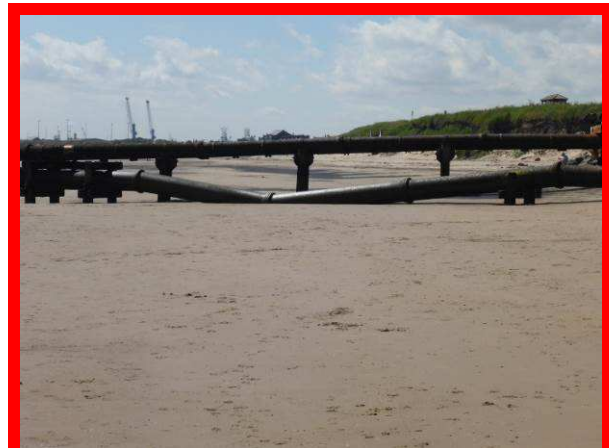
Failed section of outfall pipe (/3901C05)

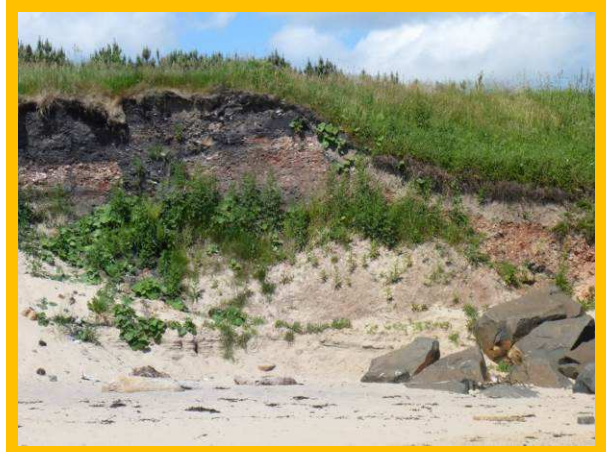
Erosion of cliffs at terminal end of rock revetment (/3901C03)

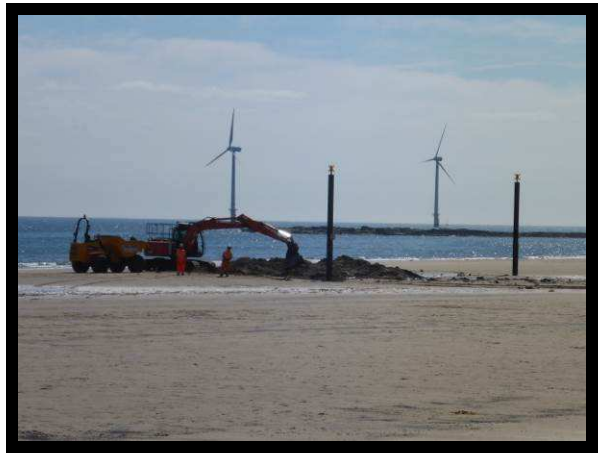
Repair works to outfall on foreshore (/3901C04)

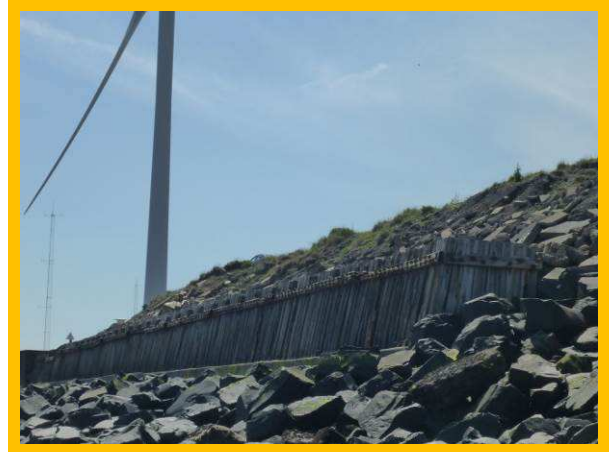
Composite defence with timber breastwork (/4001C03)

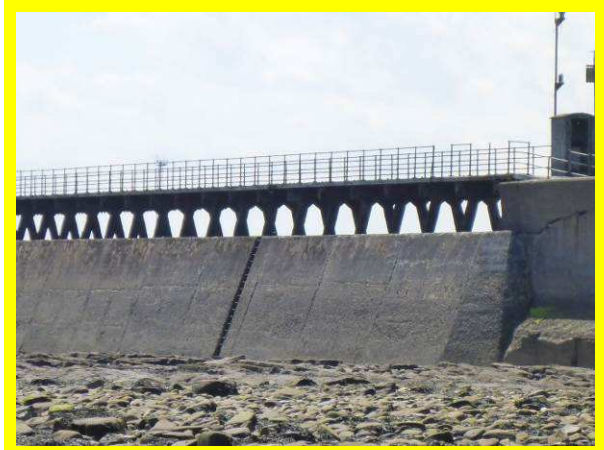
Generally fair condition of main Blyth East Pier substructure (although superstructure in poorer condition) (/4001C05)

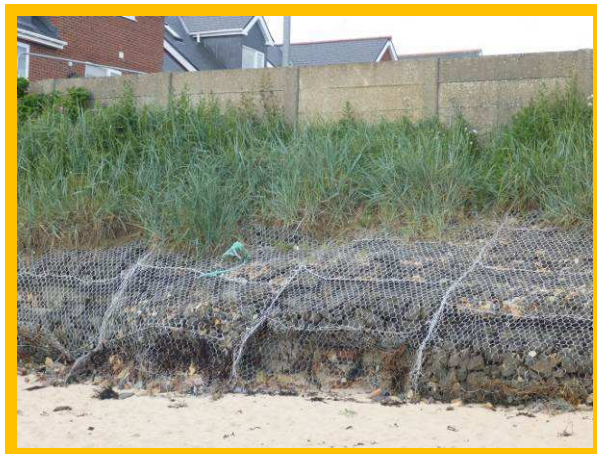
Failing gabions protecting very narrow strip of dunes (/4201C03)

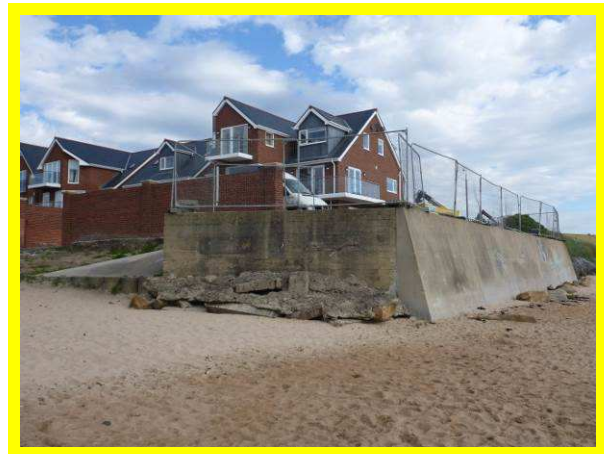
Existing sea wall protecting new properties (/4201C04)

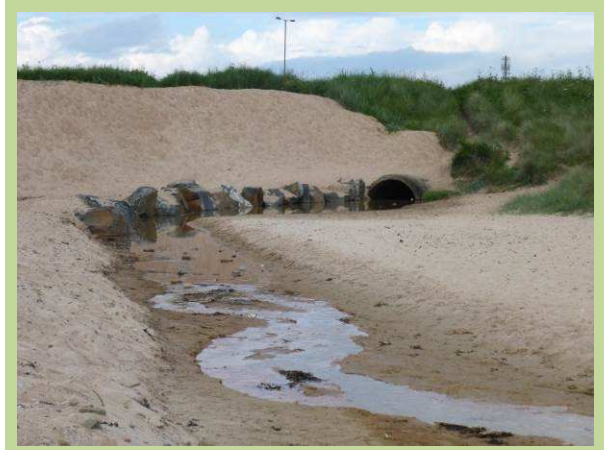
Rock armourstone placed in 2016 to train course of Meggie's Burn away from dune toe (/4301C01)

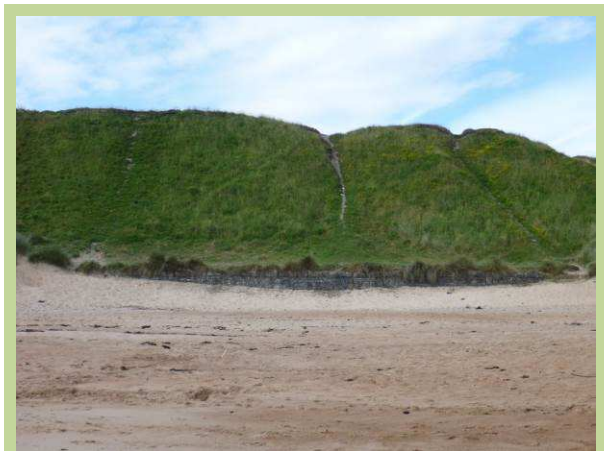
Stable dunes and good condition low wall at Sandy Island (/4401C01)

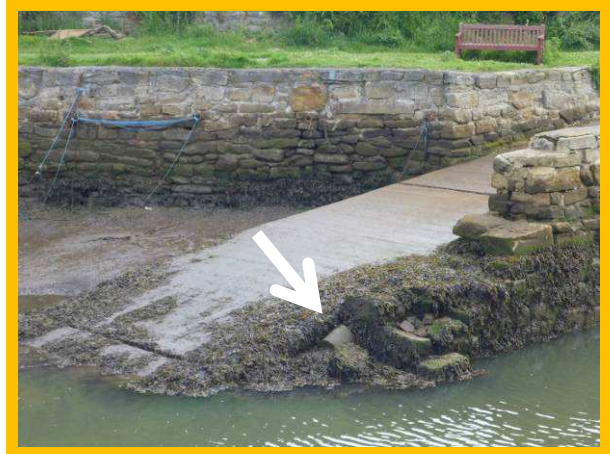
*Collapsed wall on outer face of boat ramp
(/4401C05)*

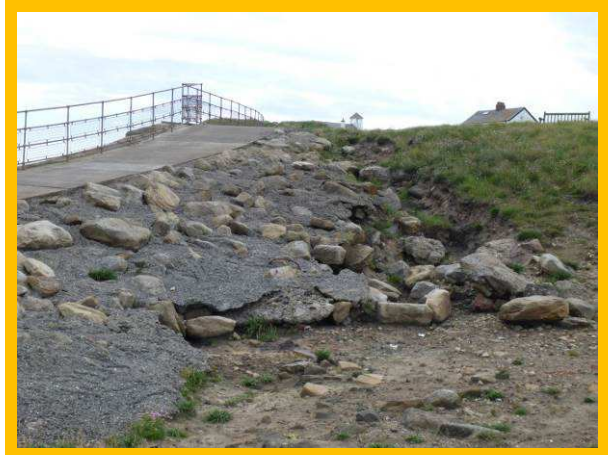
Break-up of poured concrete slurry and erosion of slope (/4401C11)

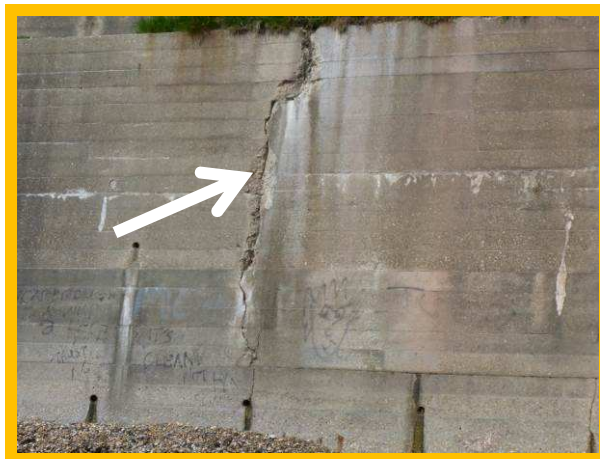
One of three notable vertical cracks in the sea wall (/4401C17)
