Cell 1 Regional Coastal Monitoring Programme Walkover Inspection Surveys 2016

Northumberland County Council

Walkover Inspection Surveys 2016

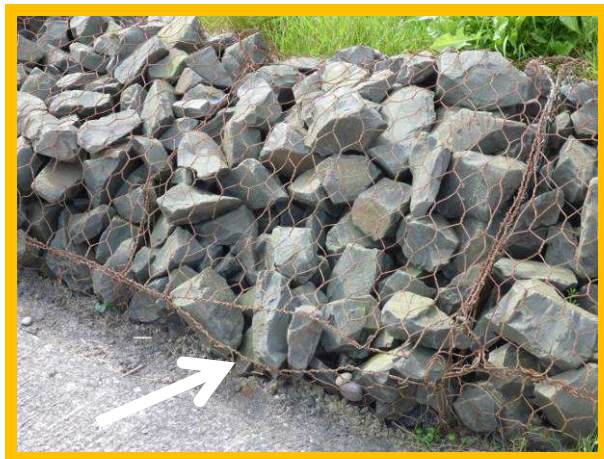
Break-up of gabion baskets (/4401C19)
