## **Cell 1 Regional Coastal Monitoring Programme Walkover Inspection Surveys 2018**

**Northumberland County Council**

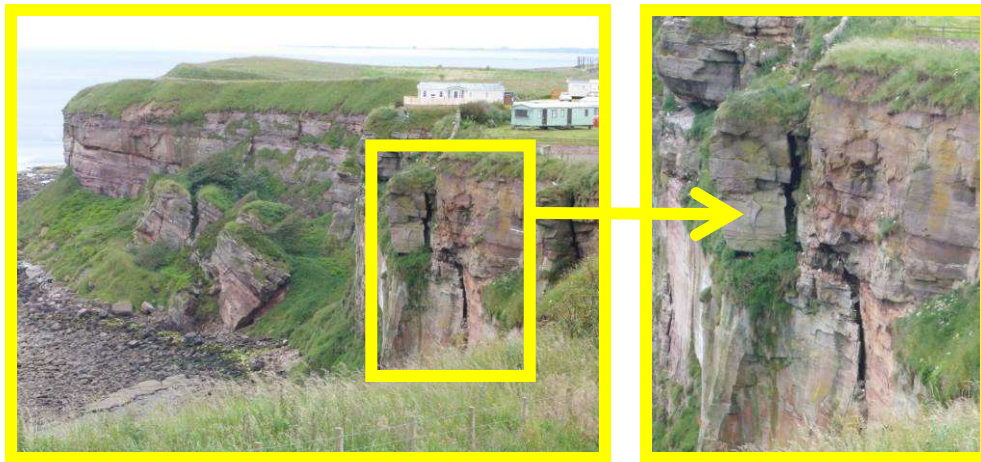
*Fractured cliffs at Marshall Meadows Bay (/0601C02) - photo from 2016 due to sea fret in 2018*

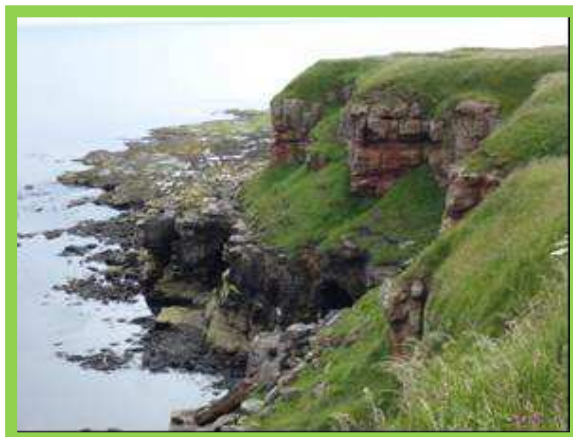
*Stable cliffs at St. John's Haven (/0601C04) - photo from 2016 due to sea fret in 2018*

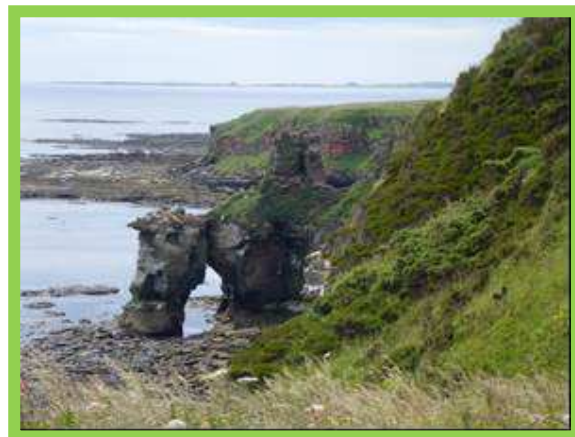
*Needle's Eye (/0601C05) - photo from 2016 due to sea fret in 2018*

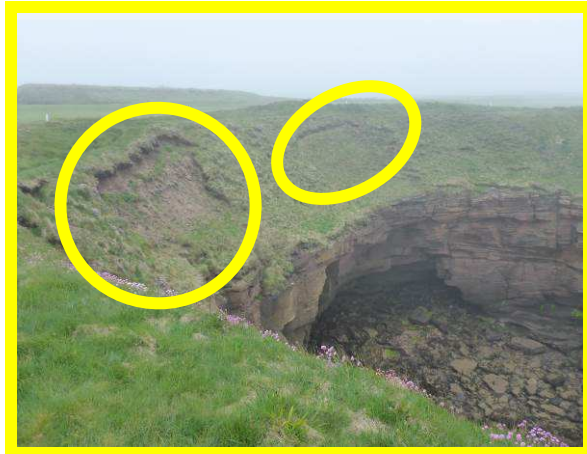
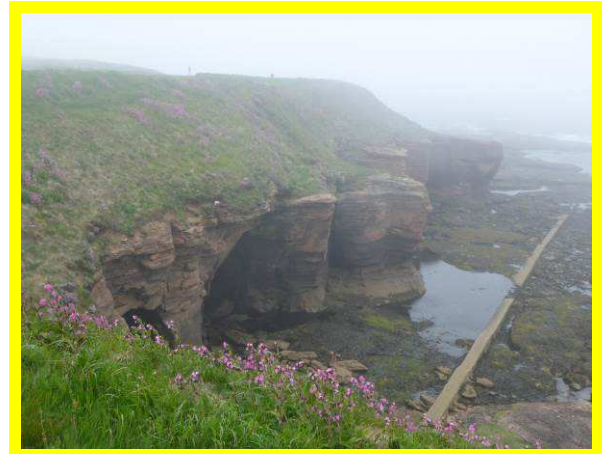
*Localised slumping at Brotherston's Hole (0701C01)*      *Caves at base of cliffs (0701C01)*

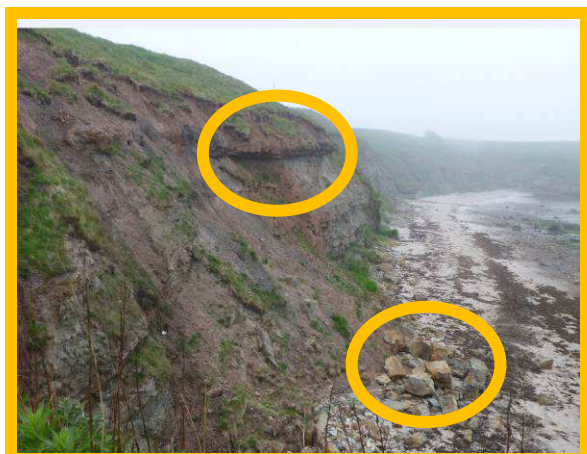
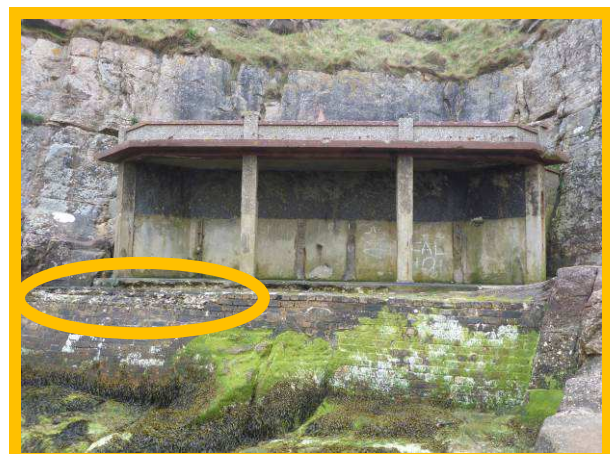
*Rock fall and residual overhang (0701C02)*      *Concrete pavilion structure in fair/poor condition, missing brickwork from fronting wall (0701C02)*

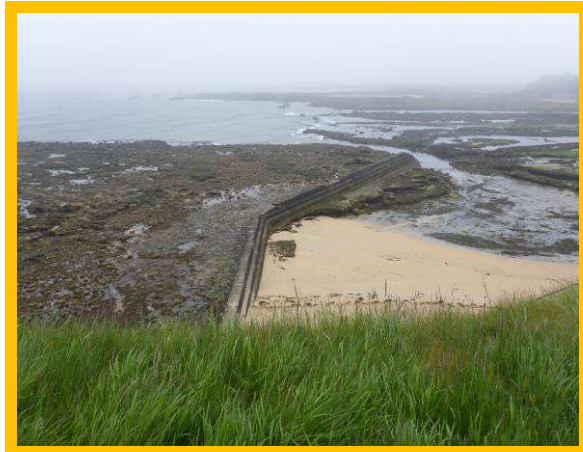
*Green's Haven Breakwater remains in poor condition but still retains beach sand (/0701C04)*

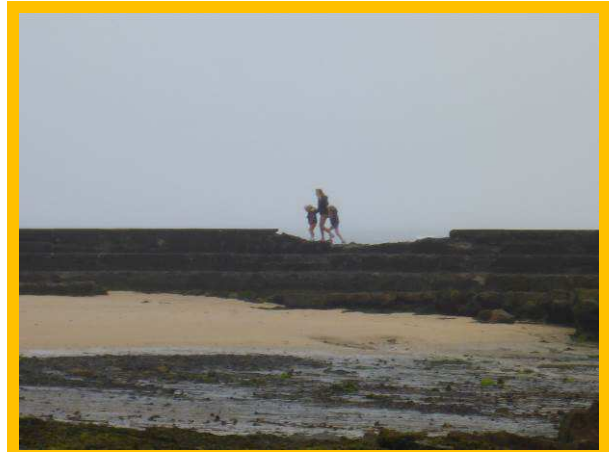
*Adult and two children on breakwater crest in damaged section (/0701C04)*

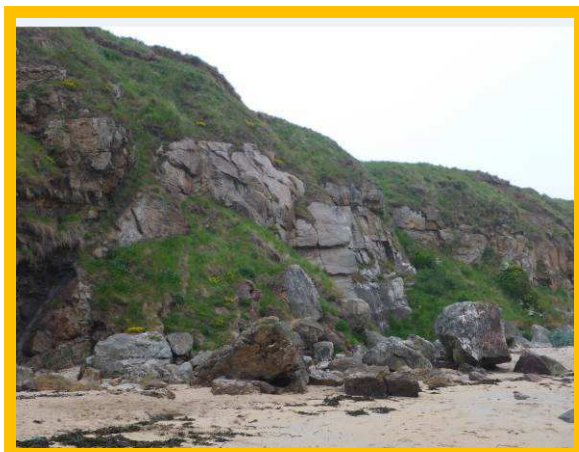
*Past rock fall in cliffs at Green's Haven (/0701C05)*

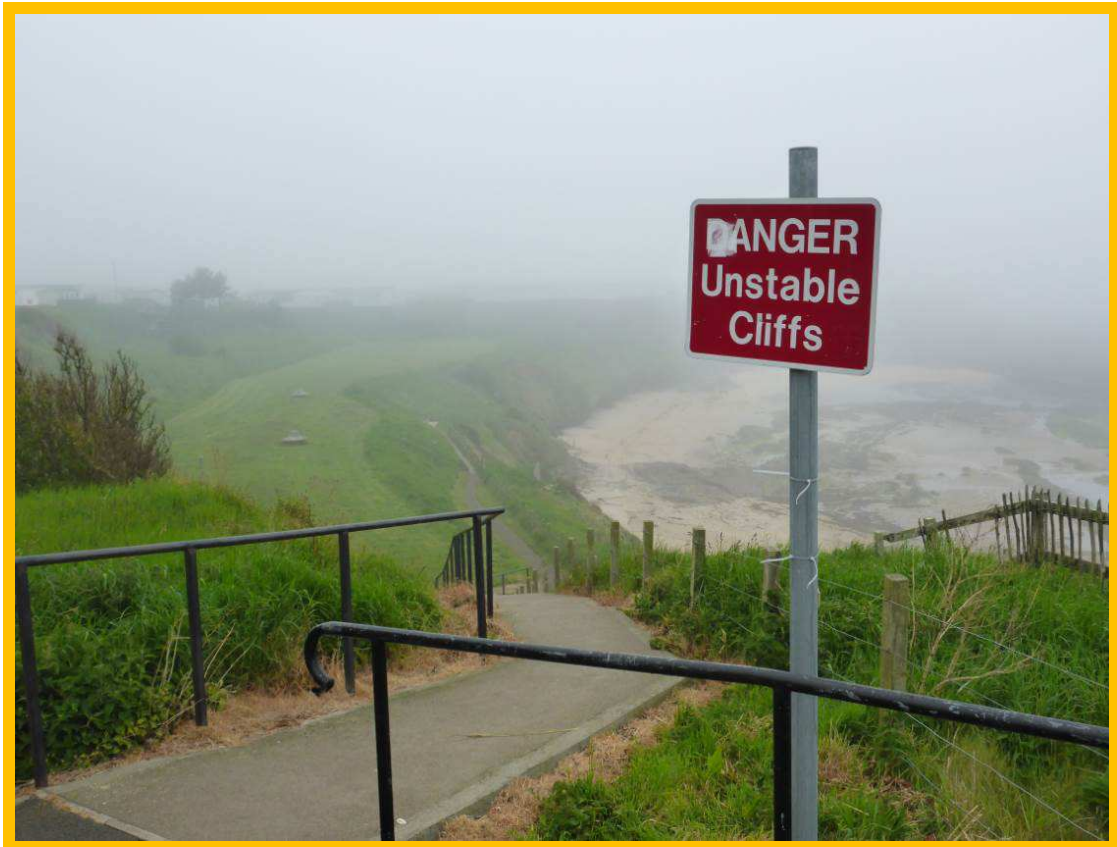
*Public warning signs on cliff top in Greens Bay*

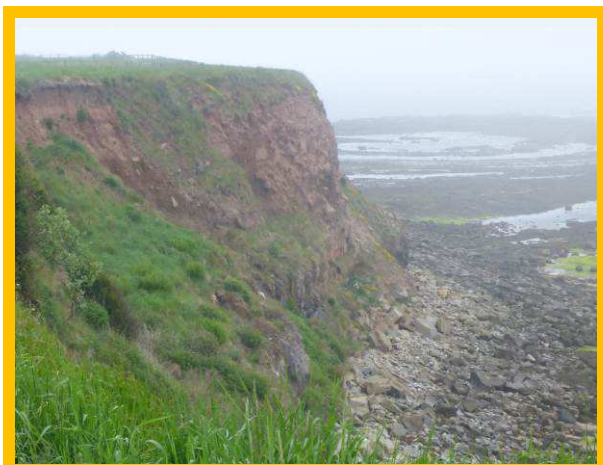
*Slumping cliffs along Magdalene Fields Golf Course (/0701C12)*

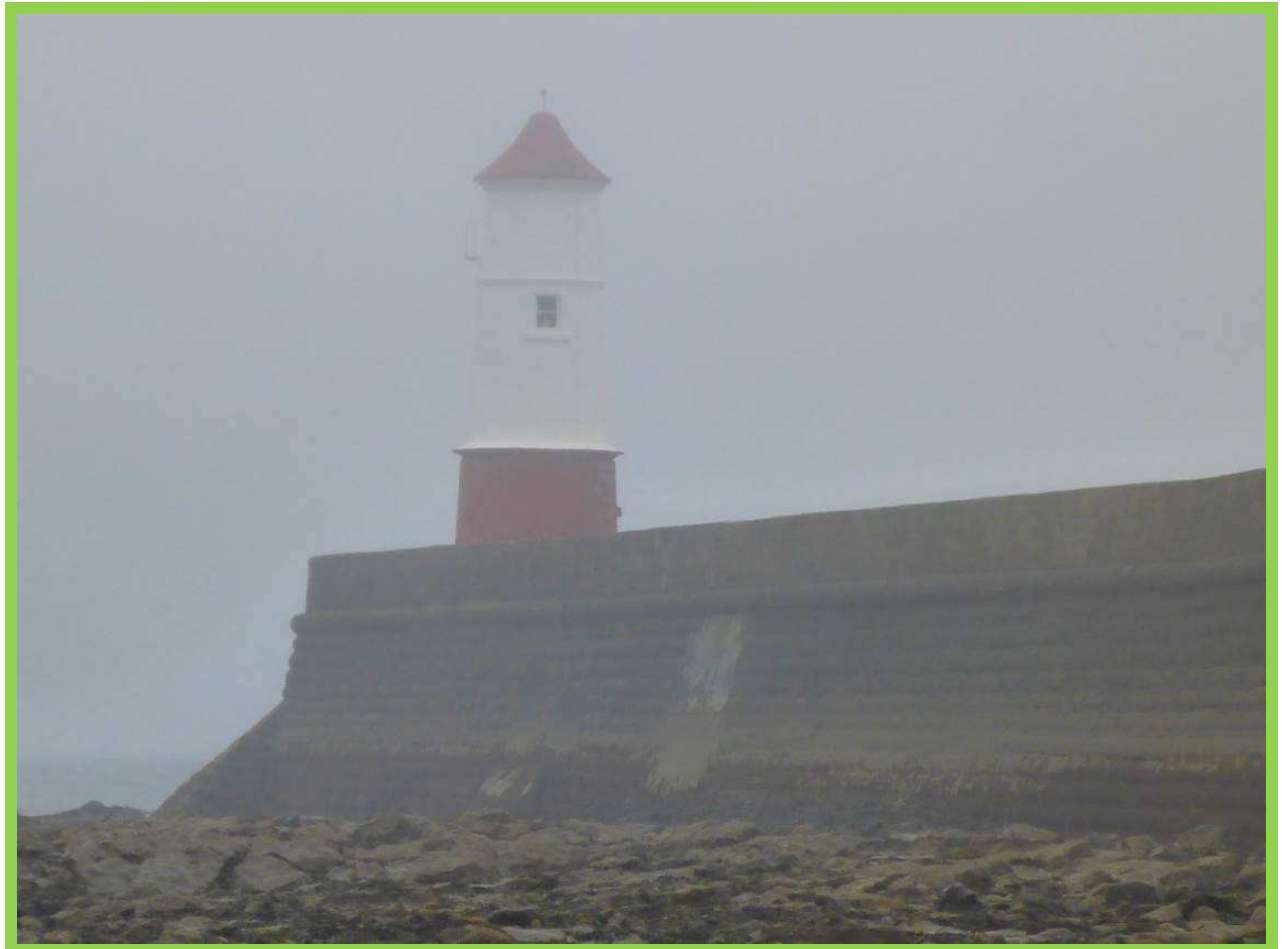
*Berwick Pier in good overall condition following refurbishment in 2012/13 (/0701C14 & C15)*

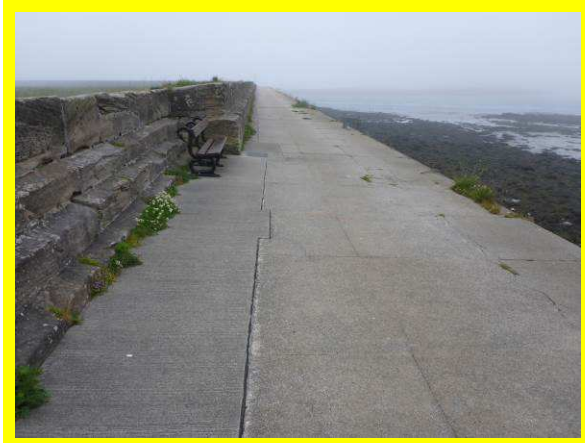
*Older (inland) sections of cracked deck and abraded wave wall on Berwick Pier (/0701C14)*

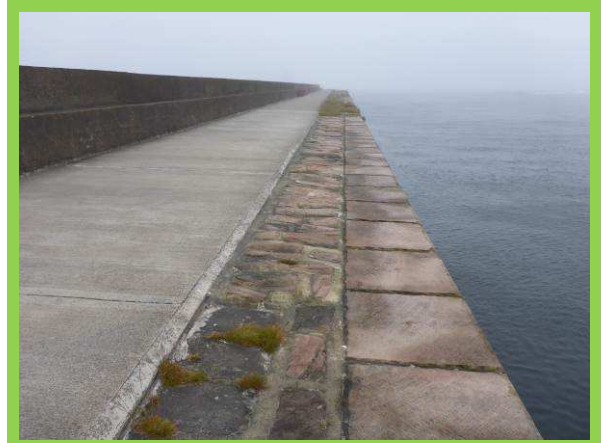
*Repairs to deck and southern face of Berwick Pier (/0701C15)*

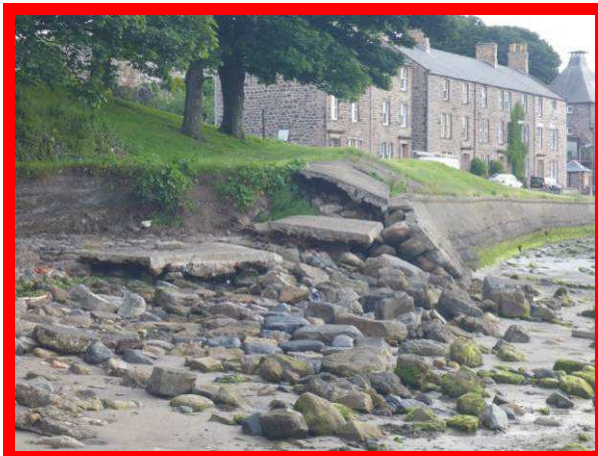
*Local failed section of river slope revetment/wall (/0801C07)*

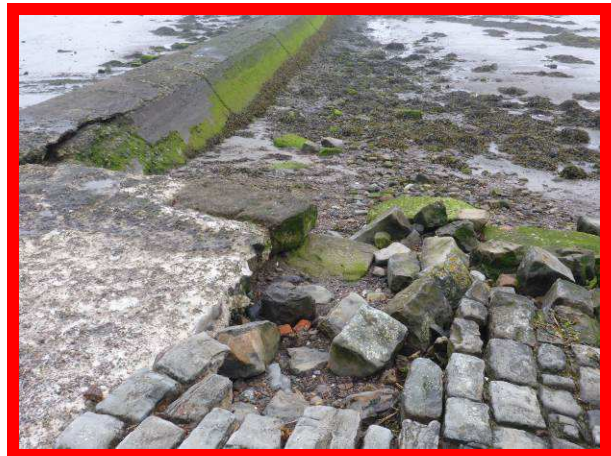
*Local failed section of slipway over foreshore outfall (/0801C07)*

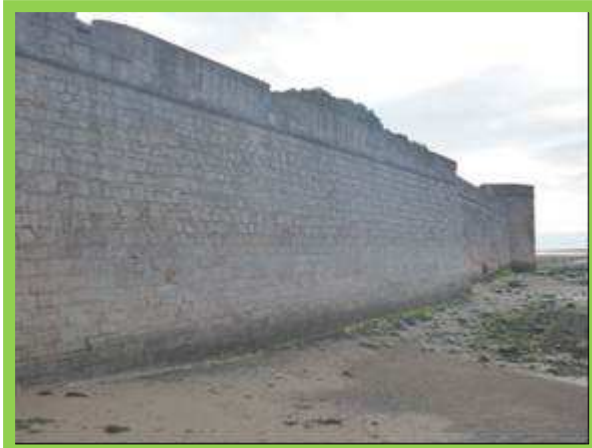
*Berwick's historic town walls in good overall condition (/0801C06)*

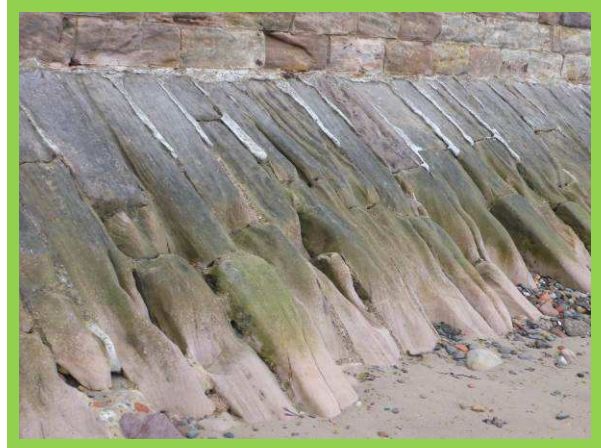
*Abrasion to toe apron where present (/0801C06)*

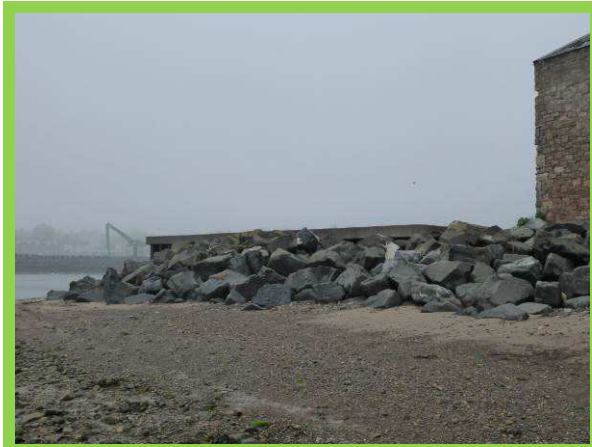
*Rock revetment in good overall condition (/0801C04)*

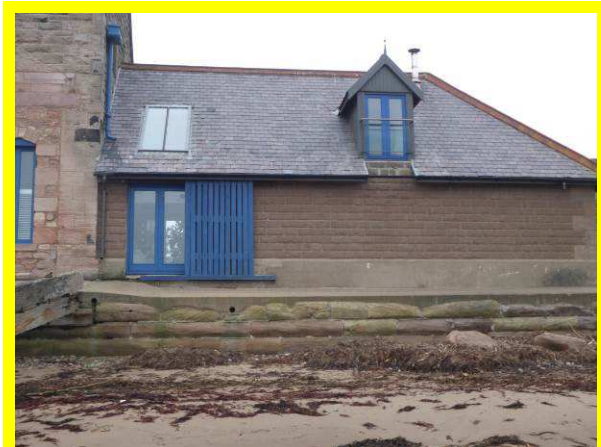
*Wall in fair overall condition (/0801C05)*

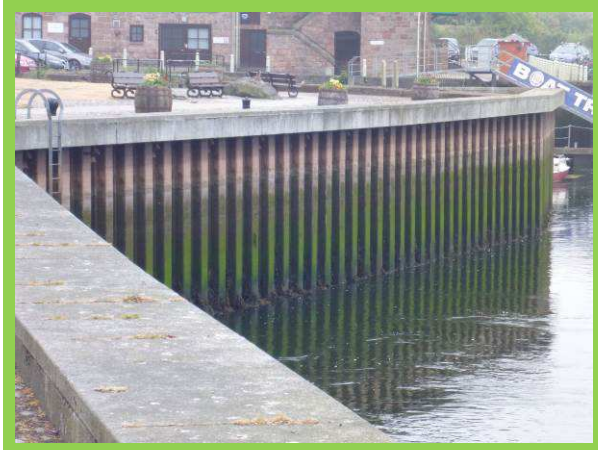
*Steel sheet piled quay walls in good overall condition (/0801C03)*

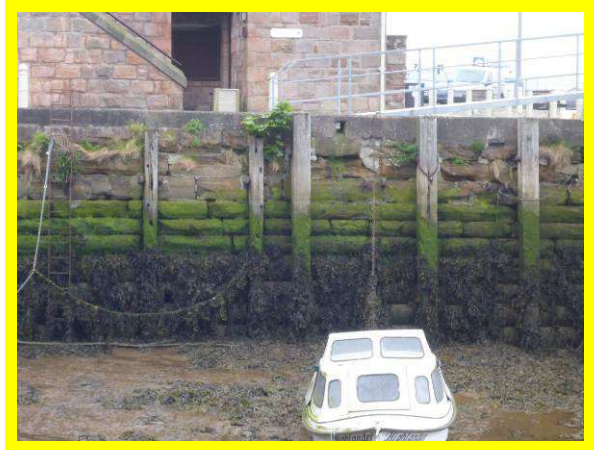
*Masonry quay walls in dock area in fair overall condition with some open joints, cracks and abrasion (/0801C03)*

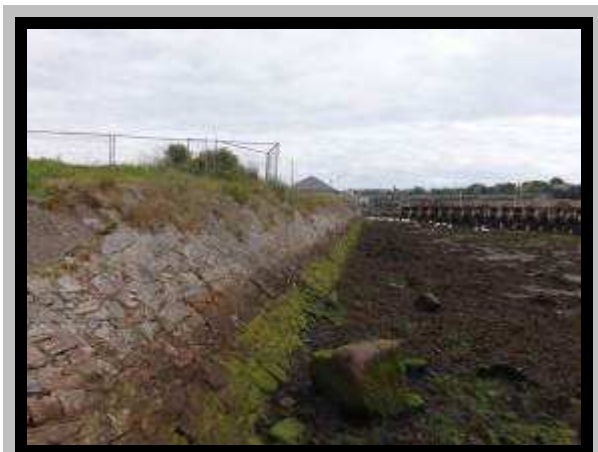
*Masonry revetment 901c04 at northern end -2016.*

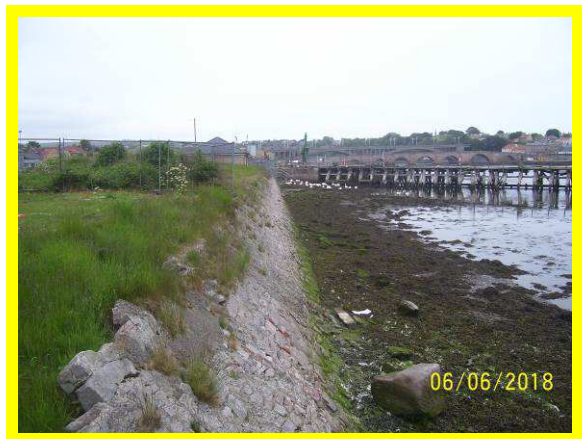
*No deterioration 2018*

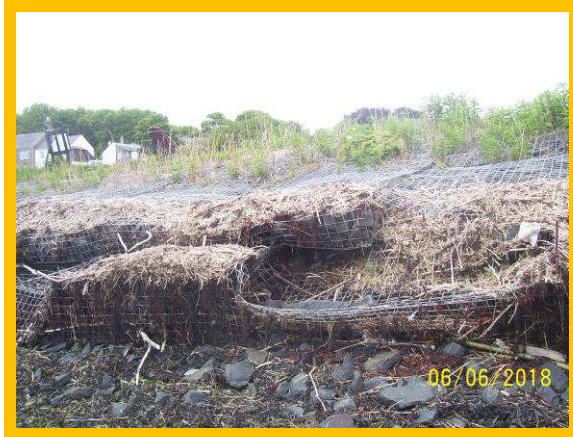
901c04 severe damage 2018.

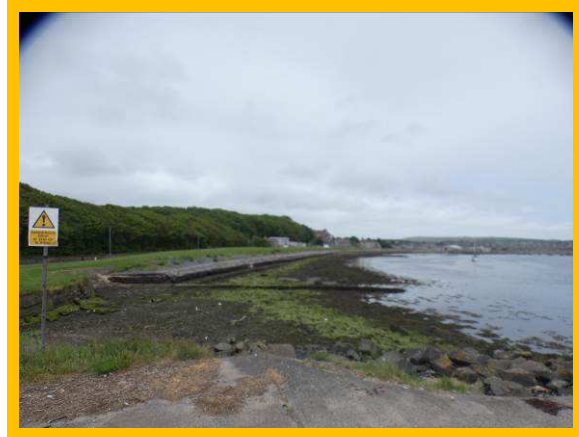
General view of 901c04 -2018.

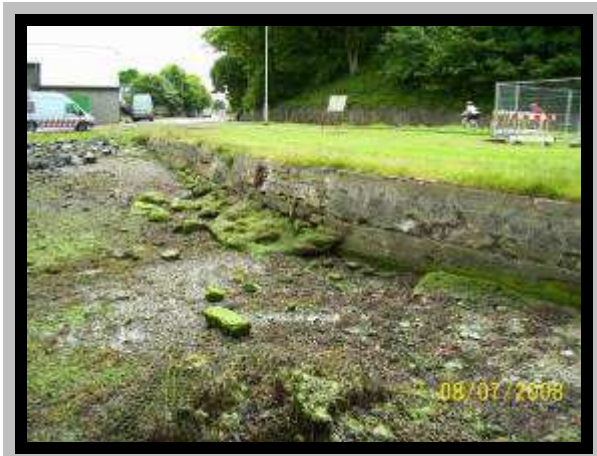
901c05/06 in 2008 showing toe level and condition of masonry.

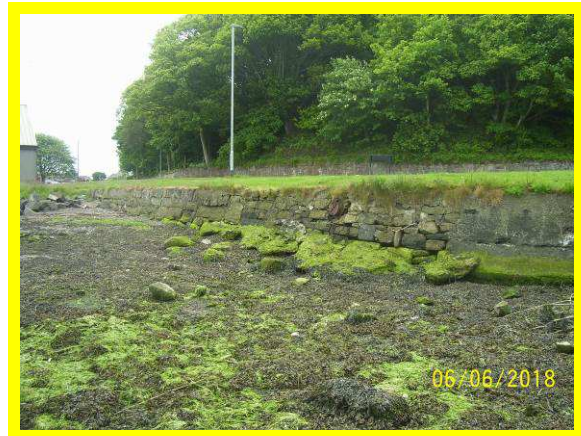
901c05/06 in 2018 showing some possible erosion but little overall change from 2008.

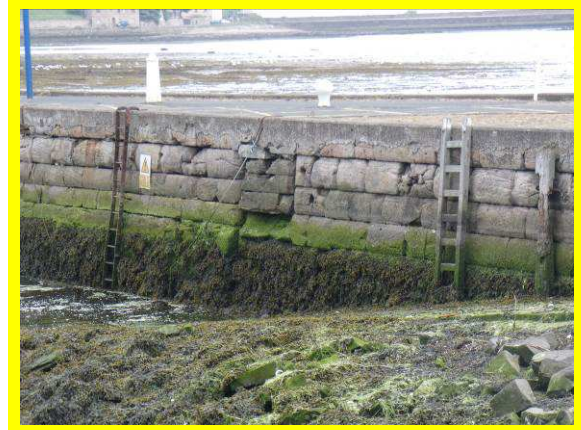
901c06 - 2016. Little change since 2008

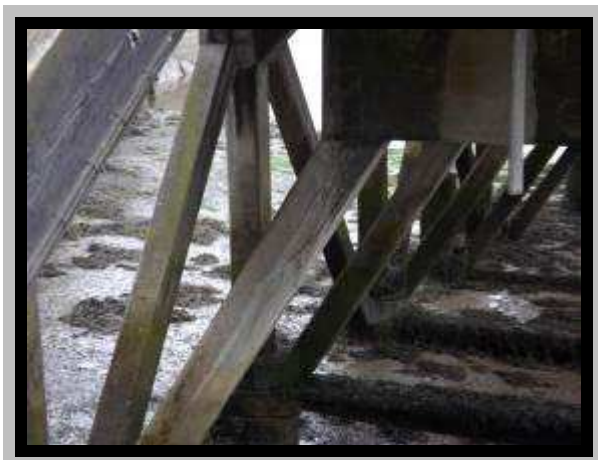
901c07 - 2016 spalling and repairs to RNLI .

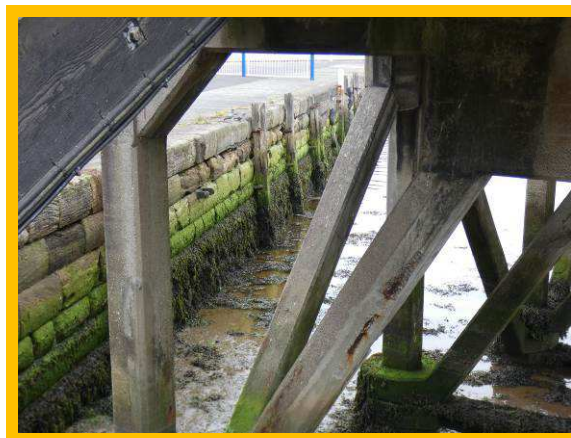
901c07 – further spalling 2018.

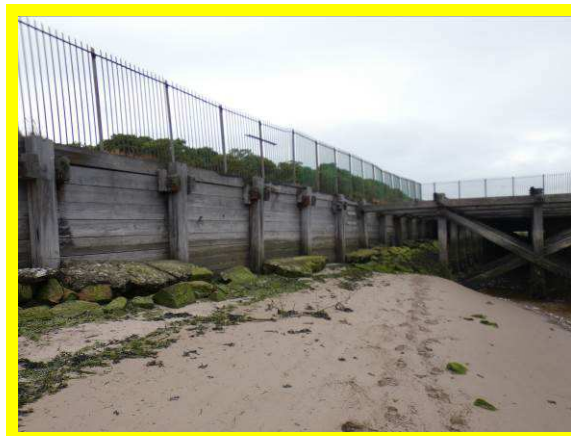
901c07 – reduced beach levels 2018, exposing support to structure.

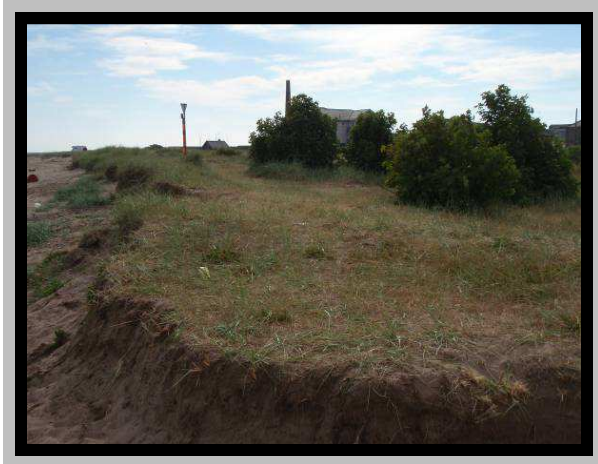
901c08 - erosion in 2012.

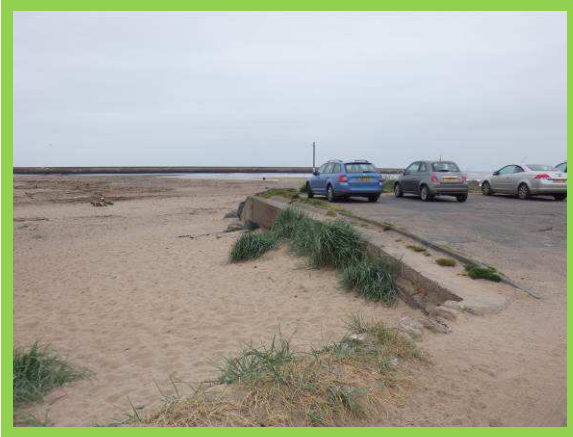
*901c09 – high beach levels 2018.*

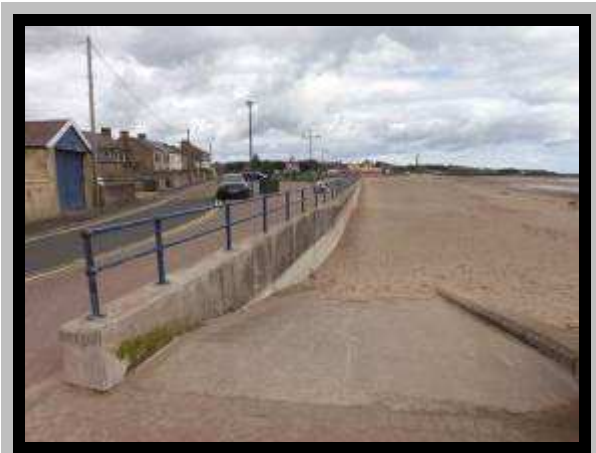
*1001 c02 – high beach levels with good crest width 2016.*

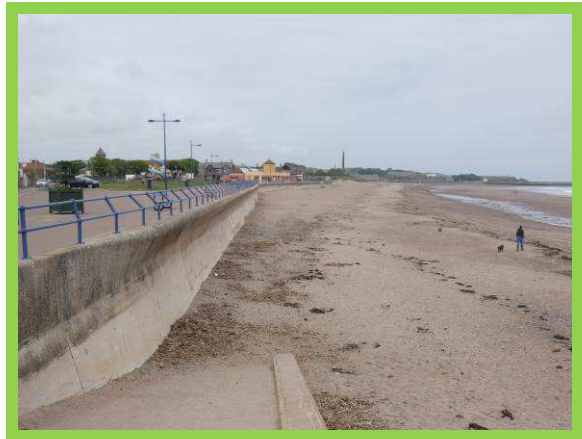
*1001 c02 – some reduction in beach levels with realignment of beach shape 2018.*

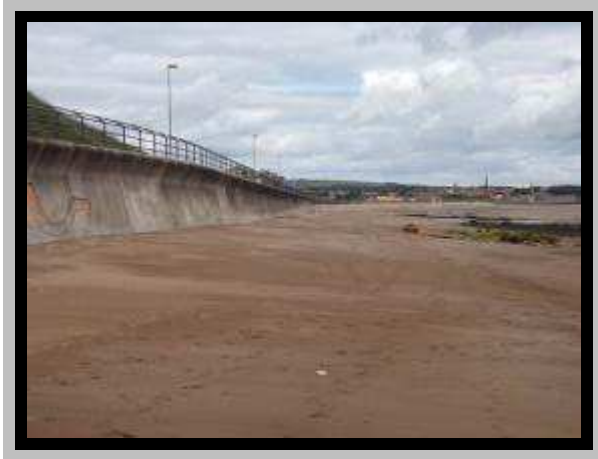
1001 c03 – relatively high beach levels 2016.

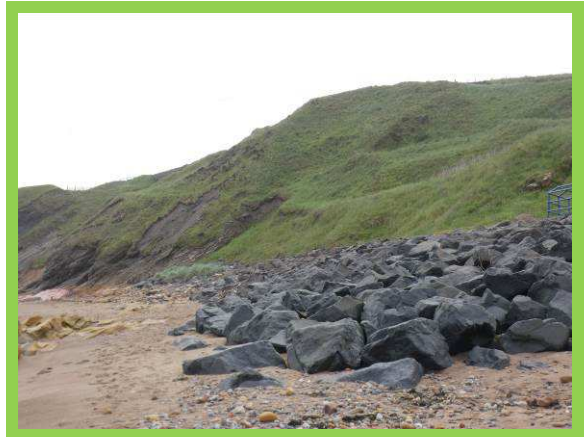
1001 c04/ 05 – higher beach levels 2018.

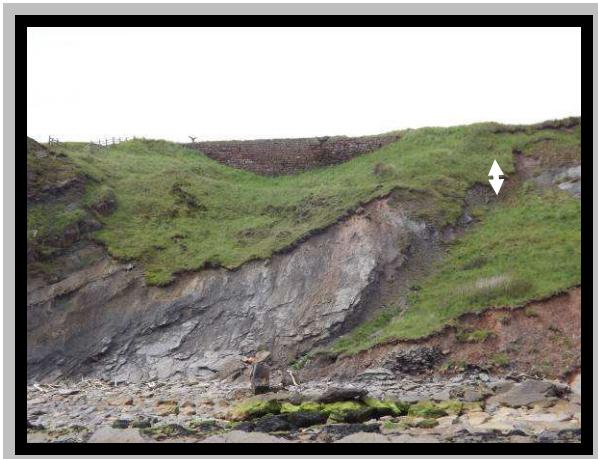
1001 c05 – coastal slope 2016.

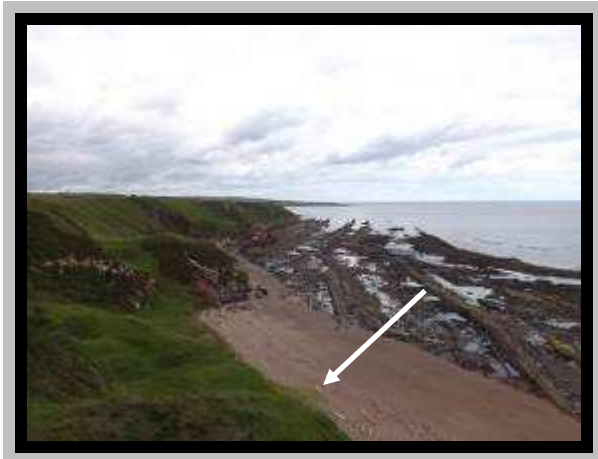
1101/c01 general view of cliffs and beach to north of Sea House 2016.

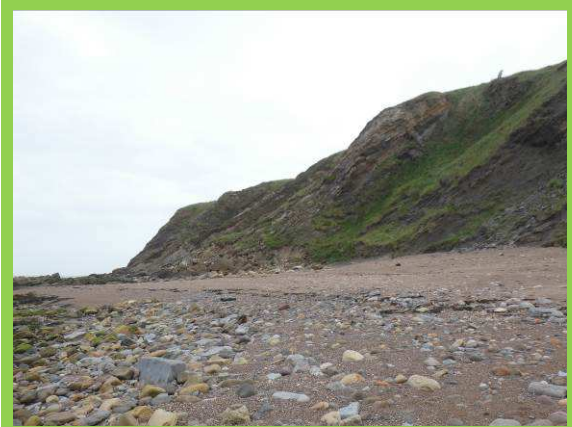
1101/c03 coastal slope

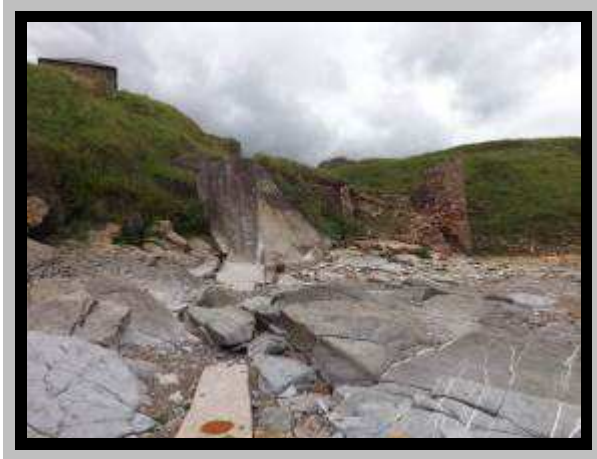
*1101/c04 Outfall and concrete slope protection, cracked and weeping water 2016.*

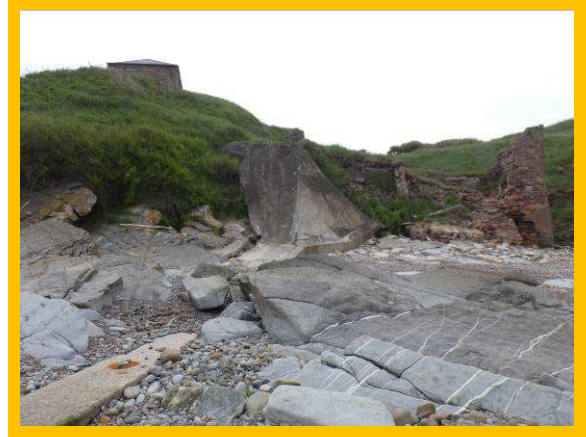
*1101/c04 Outfall and concrete slope protection, cracked and weeping water 2018.*

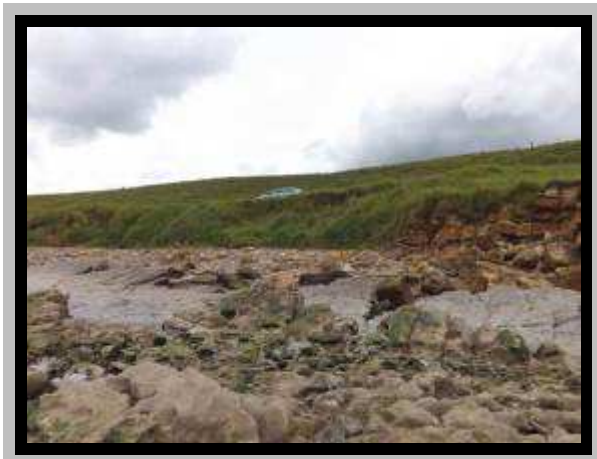
*1101/c05 Critical section of frontage closest to road 2016*

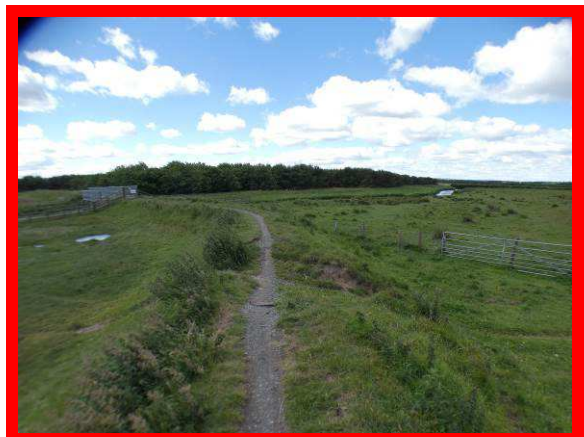
1401/ C31, Bank failure to area of South Low.

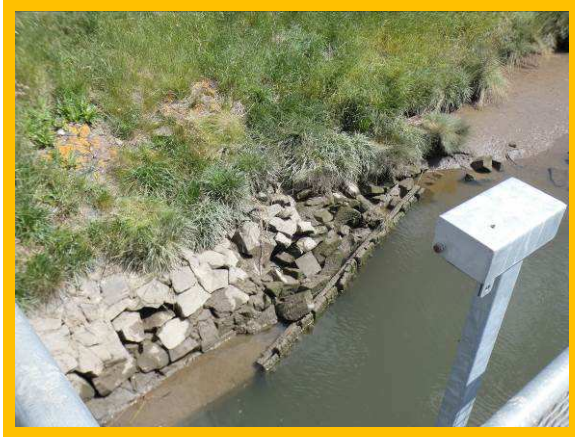
1401/C01 – undermining of edge protection.

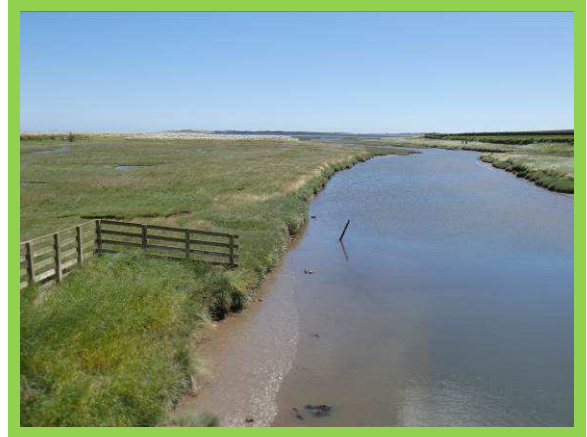
1401/ C01, general view of entrance channel. .

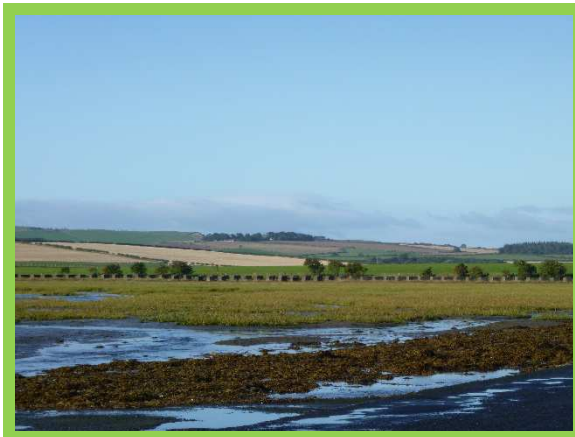
1401/C23 – wide vegetation looking from causeway.

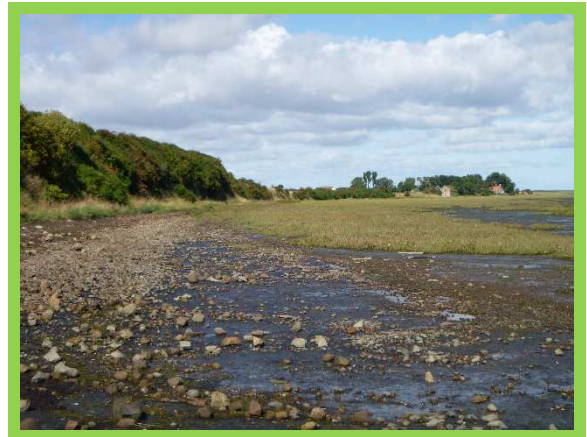
1401/ C23, sparsely vegetated rocky foreshore looking north towards Fenham Mill.

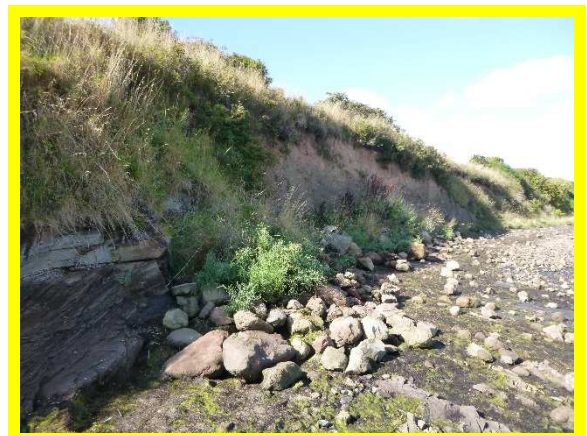
1401/ C23 Actively eroding sandstone escarpment along Common Slap

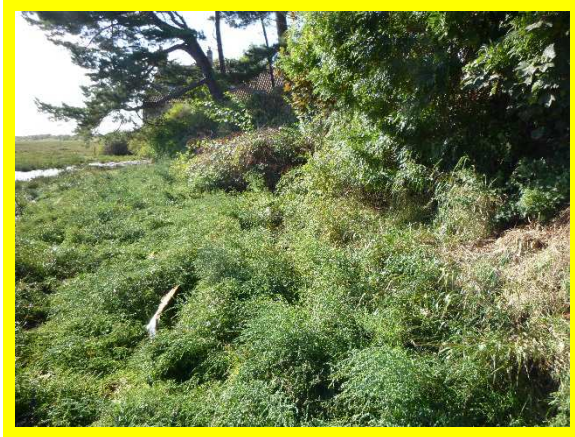
*1401/C23 – dense vegetation covering the local timber defence.*

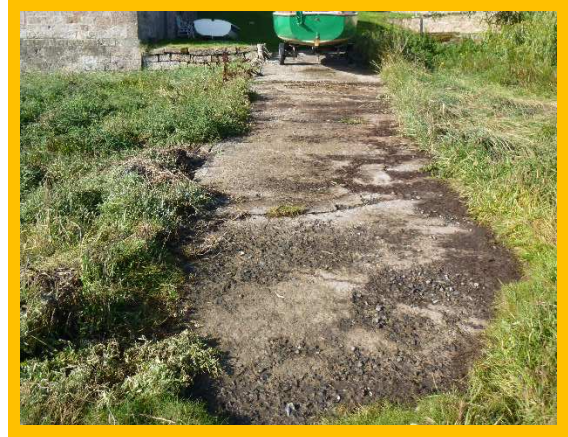
*1401/ C23, Slipway in poor condition.*

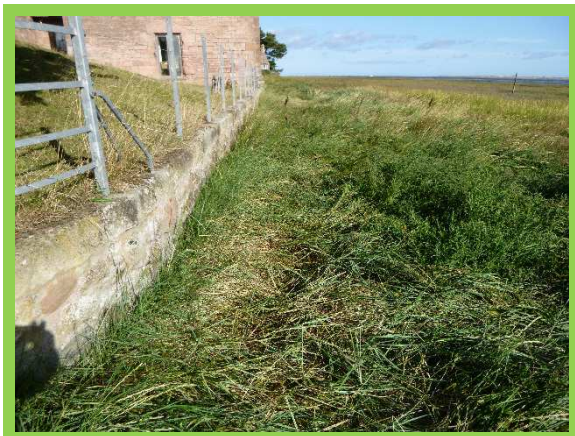
*1401/C23 – local defence north of slipway.*

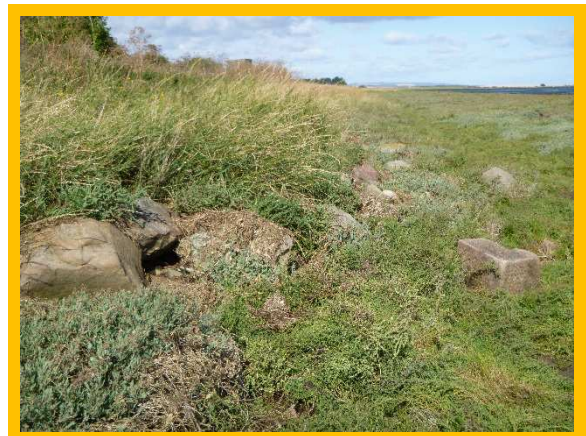
*1401/ C23, vegetation covering localised rock defence*

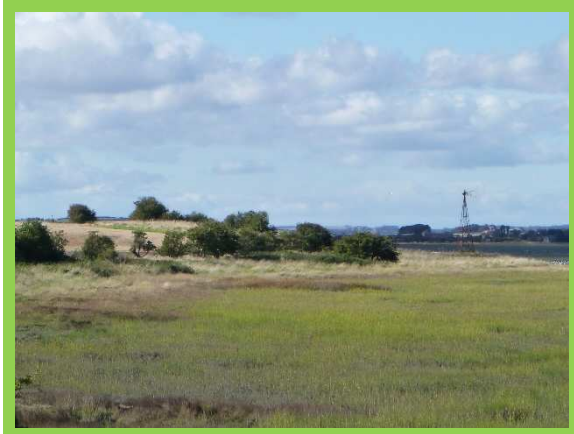
1401/ C24 narrowing of marshland around Whitelee Letch

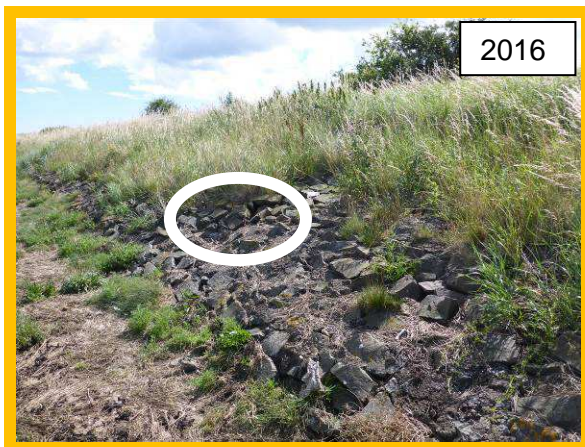
1401C98 – generally fair but locally poor stone-revetted embankment.

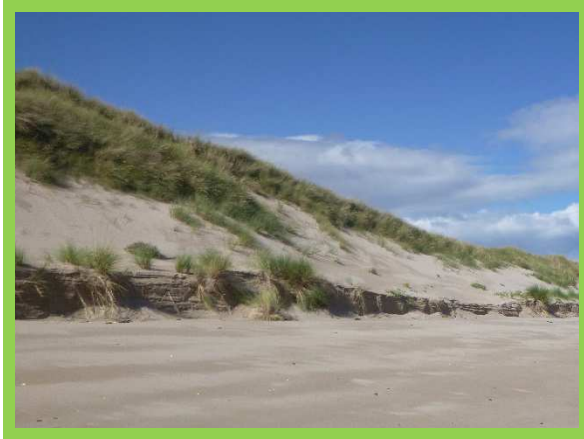
1401C99 – Some evidence of erosion to dune toe

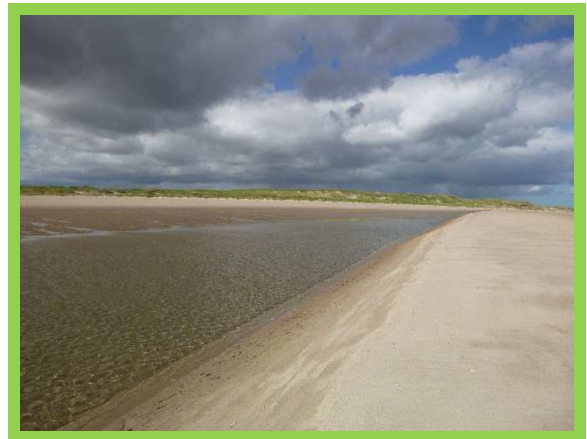
1401C06 – Embryo dunes exist among much of the asset length.

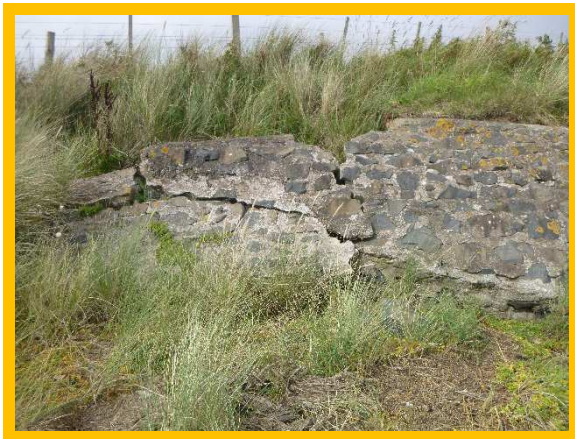
1401C29 – Extensive damage to western end of revetment.

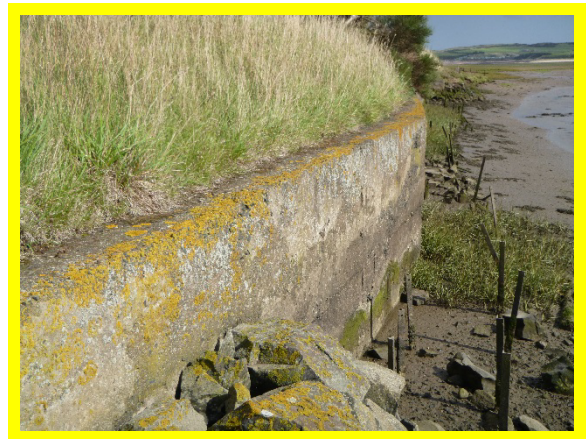
1401C14 – Concrete wall in fair condition. Timber toe erosion protection in poor condition.

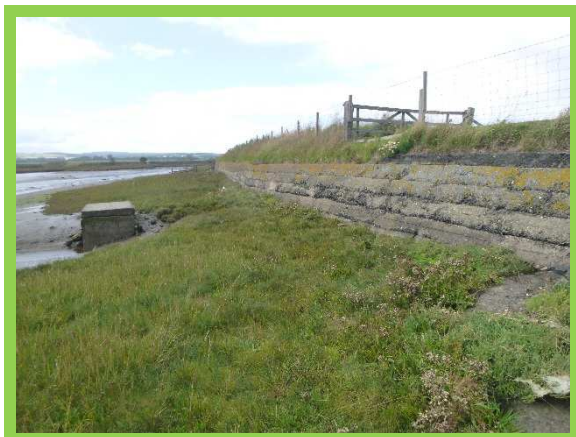
1401C14 – Concrete block revetment and outfall in good condition

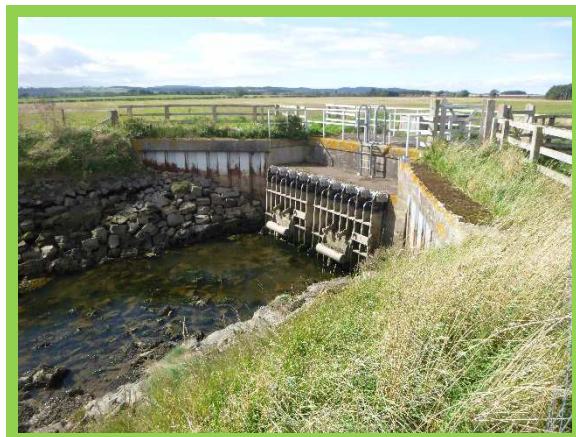
1401C16 – Good condition sluice at Ross Low channel

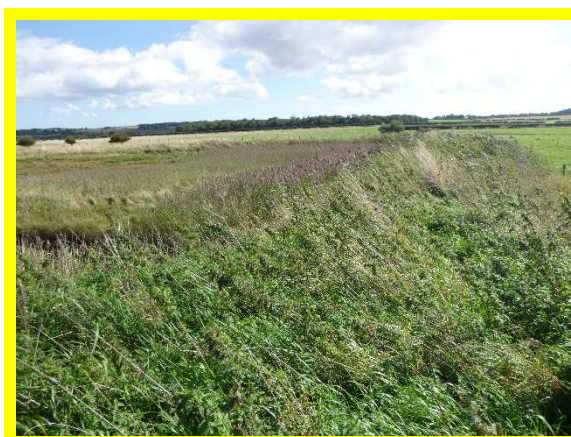
1401C21 – Heavily overgrown embankment to rear of saltmarsh

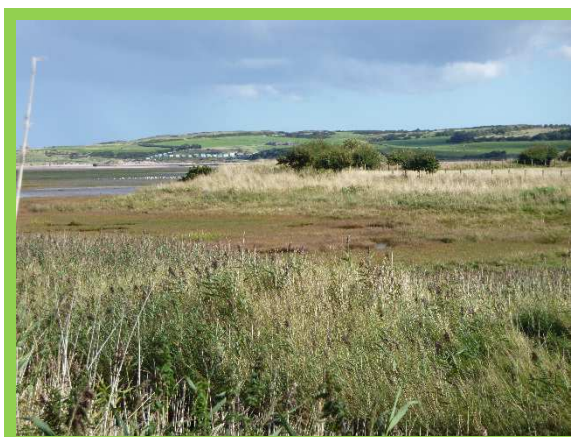
1401C21 – Salt marsh in healthy condition in Budle Bay

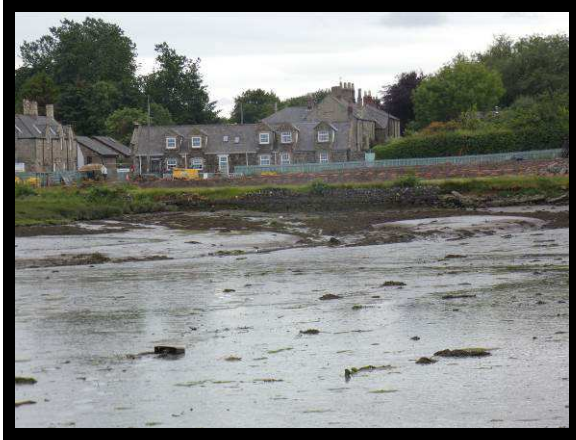
1501/C02 – poor condition of masonry wall but development occurring behind.

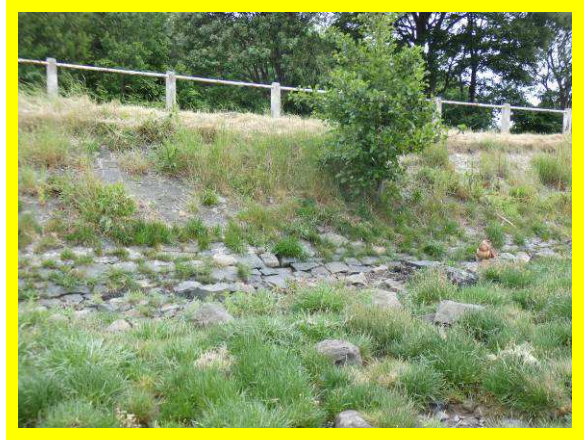
1501/C04 – gaps and local movement of stone to revetment.

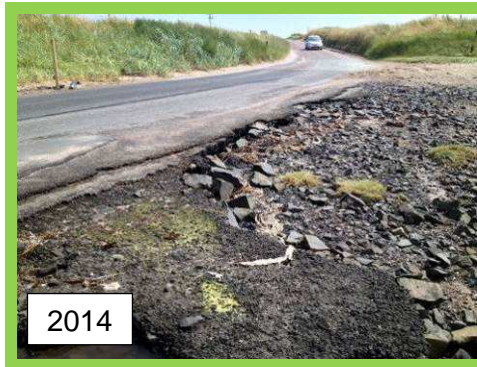
*Localised erosion damage to road at Chare Ends in 2014 (4901c01)*

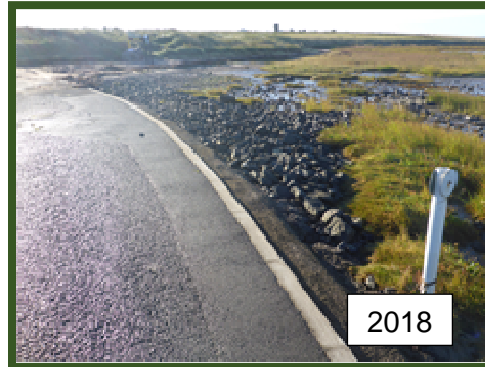
*Repaired road surface and kerb at Chare Ends in 2016 (4901c01)*

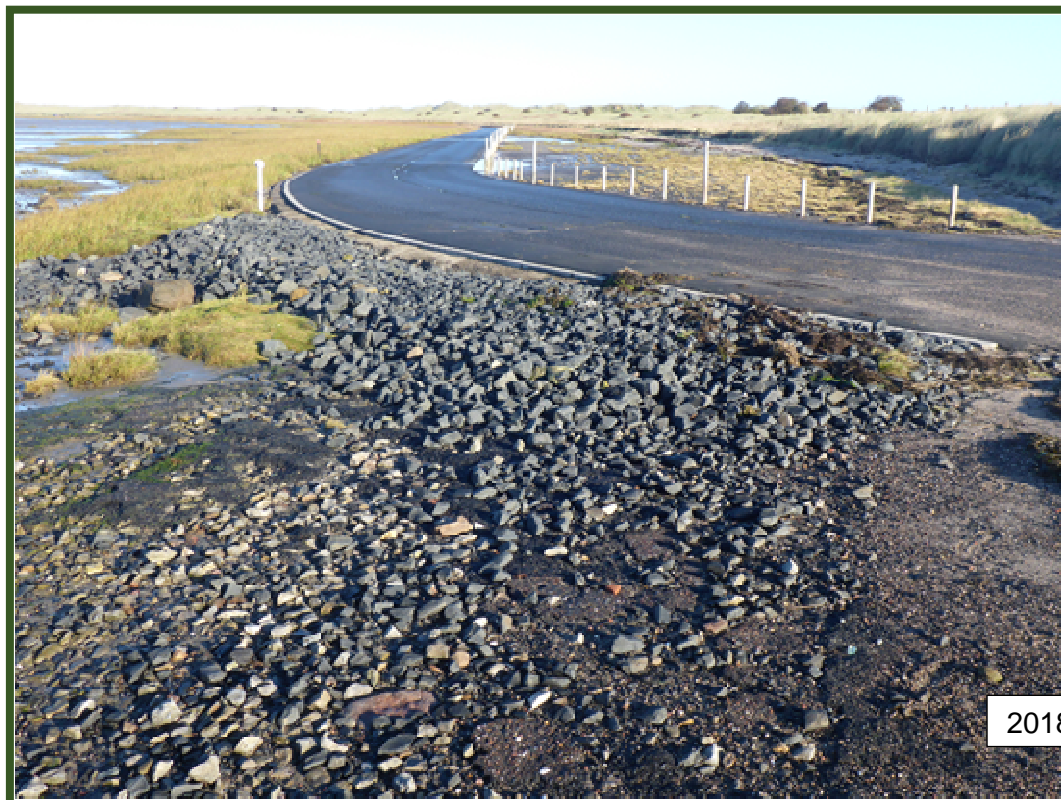
*Repaired road surface and kerb at Chare Ends in 2016 (4901c01)*

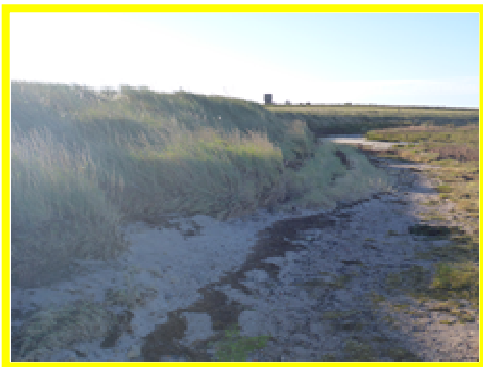
*Stable dunes approaching The Basin (/4901c03).*

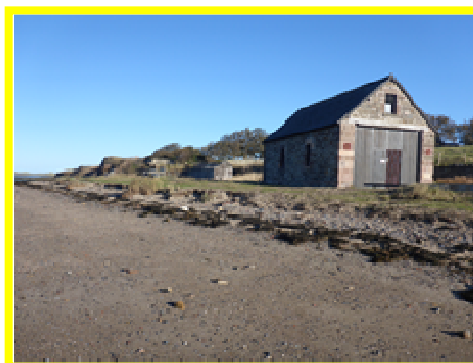
*Beach in shelter of St. Cuthbert's Isle (/4901c04).*

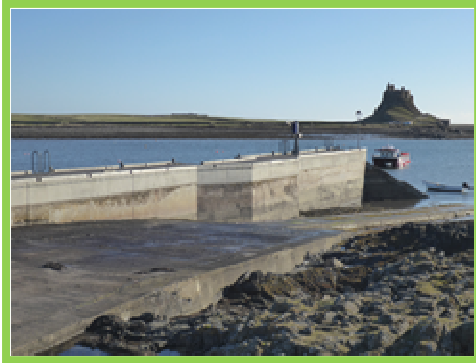
*Improvement works to harbour pier (/4901c09)*

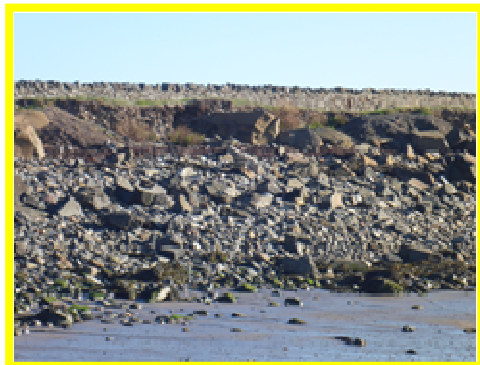
*Slopes around the north side of the bay (/4901c11).*

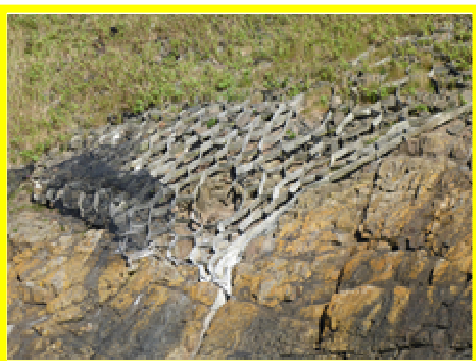
*Hexagonal erosion control matting below castle in fair condition but locally with absent rocks (/4901c12).*

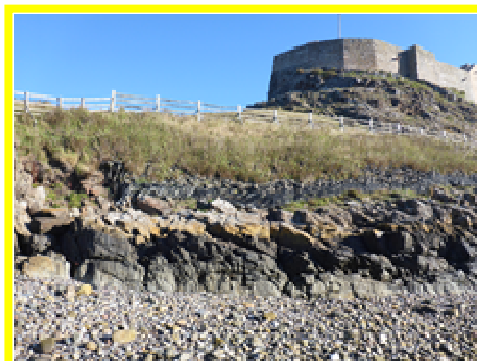
*Cliff below castle east of erosion matting (/4901c12).*

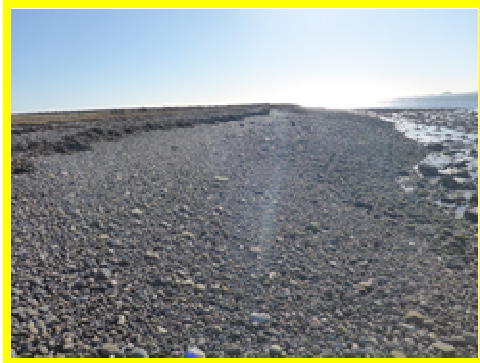
*Shingle ness at Castle Point remains in a healthy condition (/4901c014)*

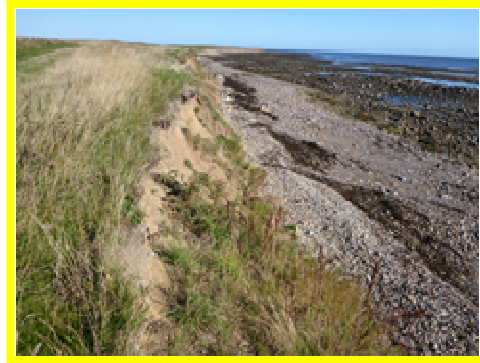
*Erosion and undermining of grassed shingle on north side of ness (4901c14).*
