## **Cell 1 Regional Coastal Monitoring Programme Walkover Inspection Surveys 2018**

**Northumberland County Council**

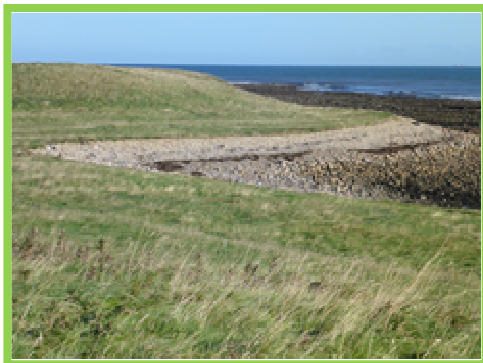
*Relatively stable shingle bay near Sheldrake Pool with washover fans (/5001c03)*

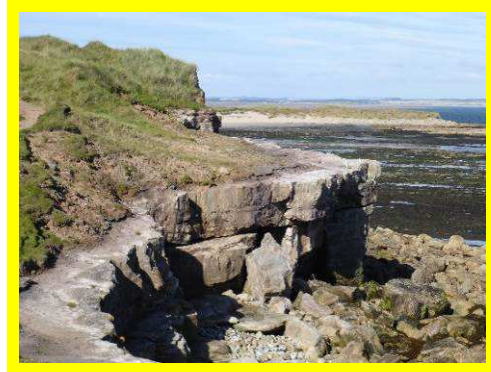
*Locally active cliffs at Nessend (/5001c07).*

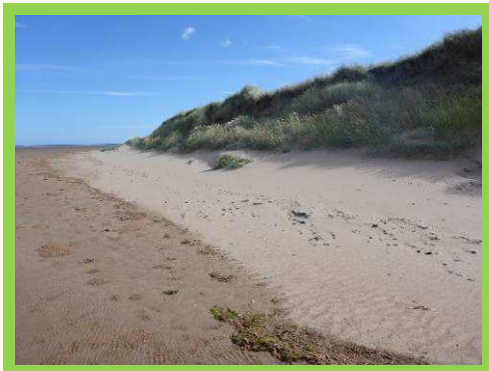
*Well vegetated dunes at Snook Point (/5001c10).*

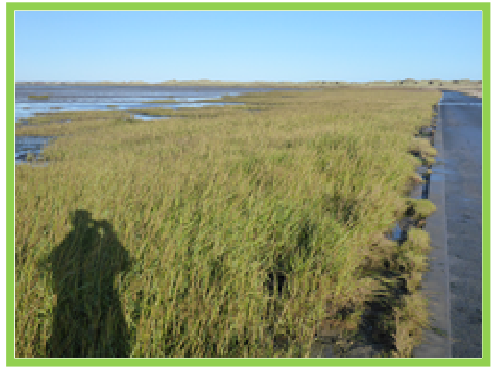
*Causeway road and salt marsh (/5001c011).*

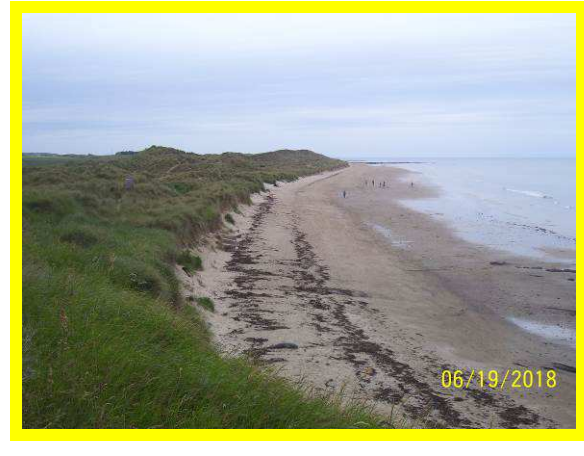
*Continued minor erosion 1601/C04. 2018*

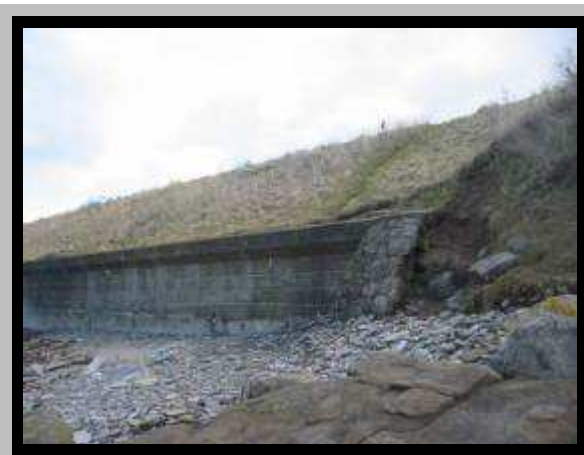
*Outflanking of northern end of wall 1701/C54 - 2006*

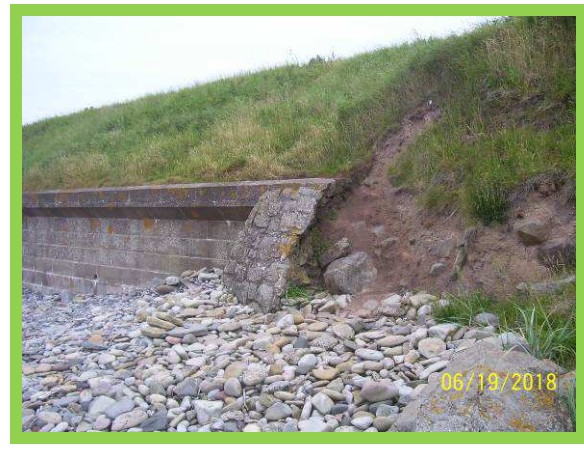
*Outflanking of northern end of wall 1701/C54 - 2018*

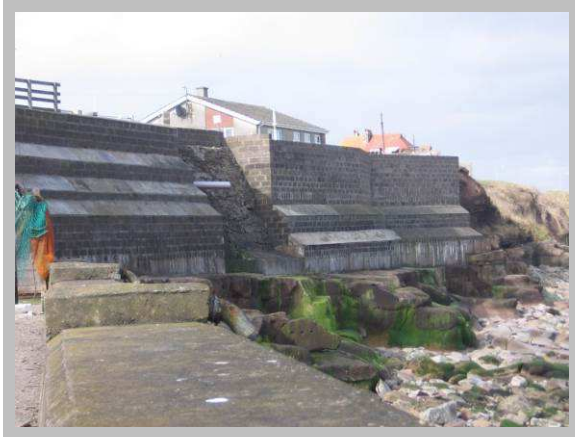
1701/C02 to 04 - 2006

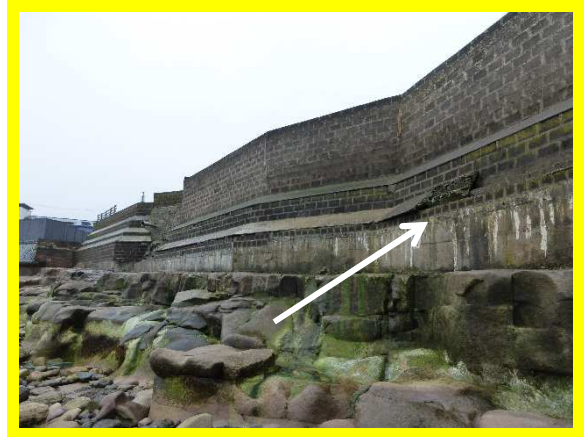
Damage of lower coping 2018 (1701/C02)

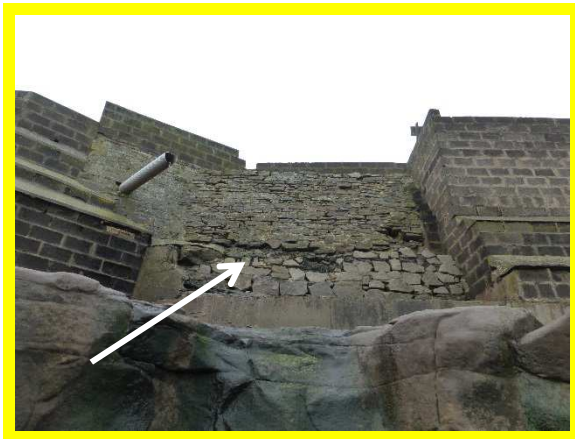
1701/C03, requires repointing.

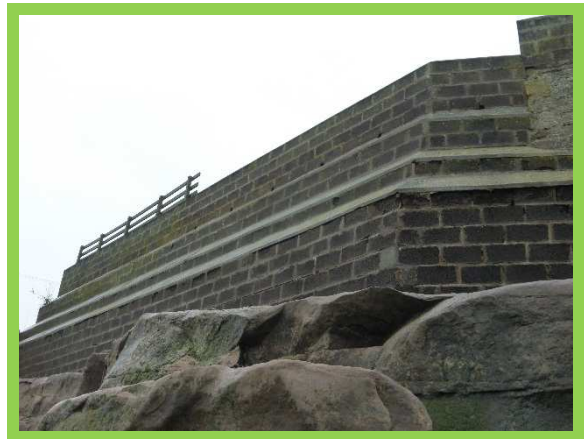
No significant damage (1701/C04)

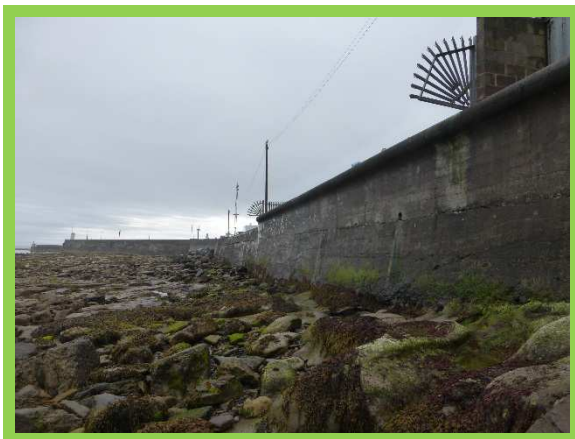
Harbour wall in good condition 1701/C05.

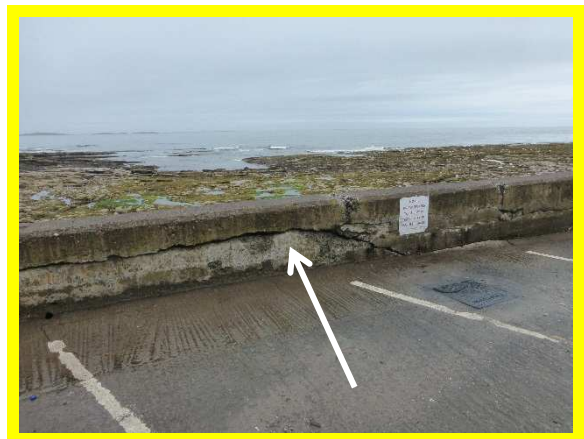
Old crack not noticeably worse 1701/C06

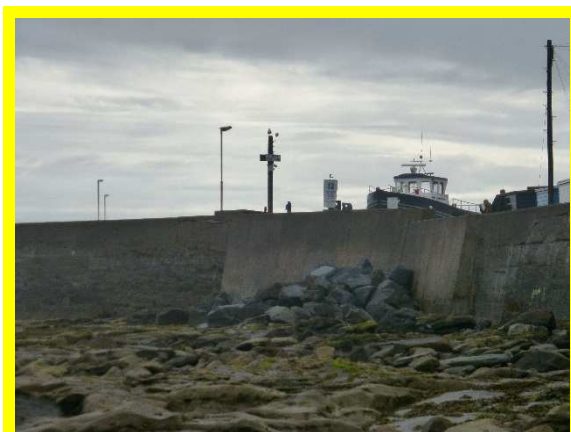
*Rock armour wave reduction 1701/C06 – C07*

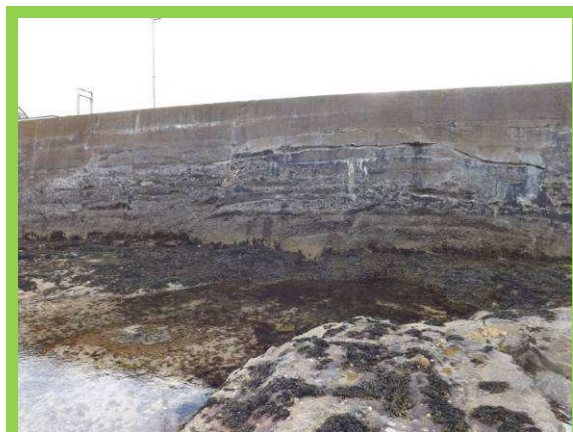
*Old crack not noticeably worse 1701/C07*

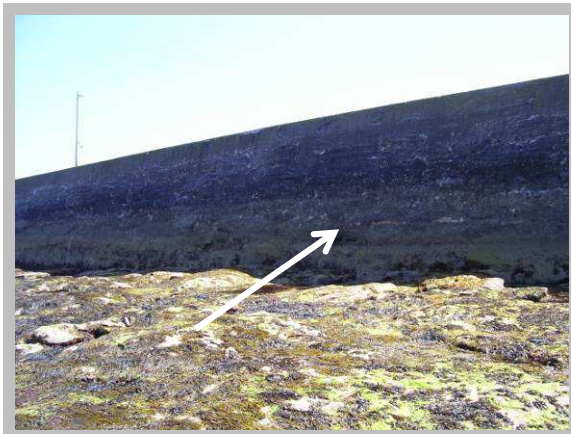
*Developing abrasion hole 1701/C07 2010*

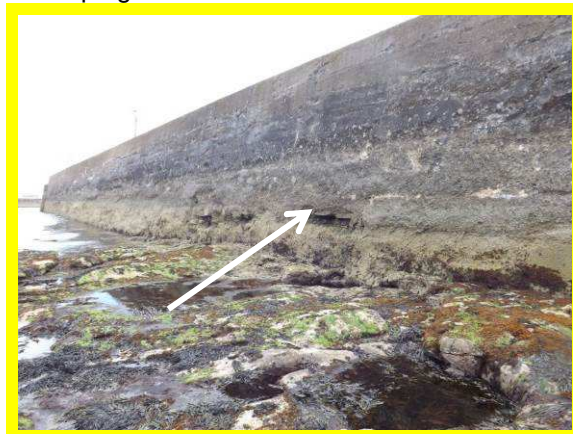
*Increased depth of abrasion hole 1701/C07 2016*

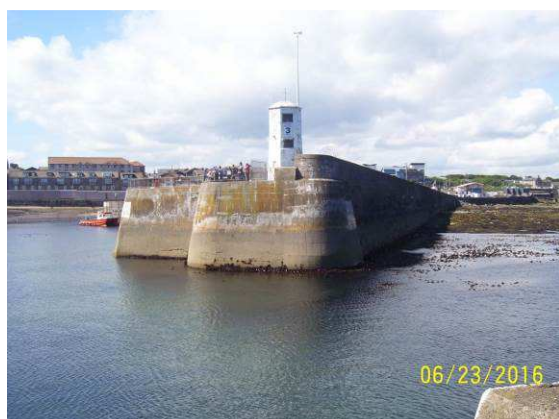
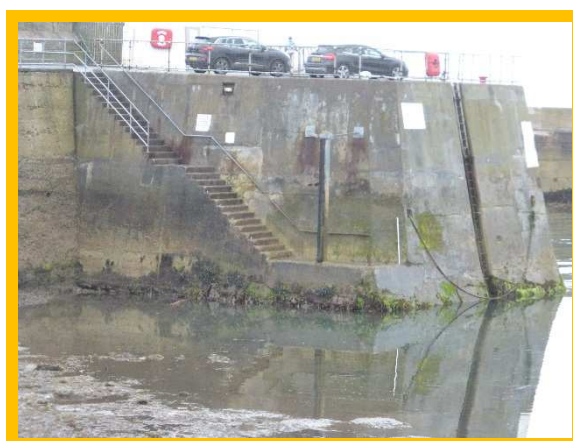
Pier head 1701/C08 (taken 2016)

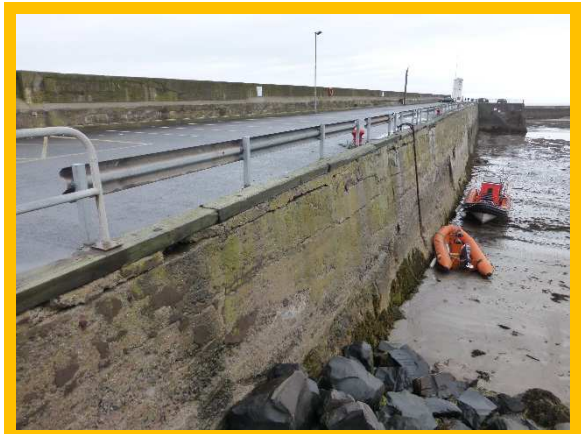
Damage to coping at western end of pier 1701/C09

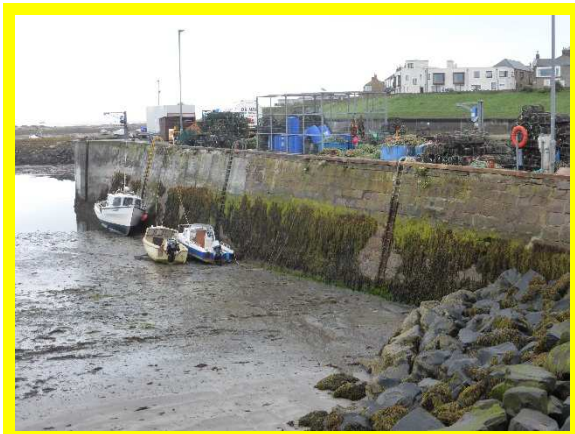
Inner face of the Inner Pier 1701/C10

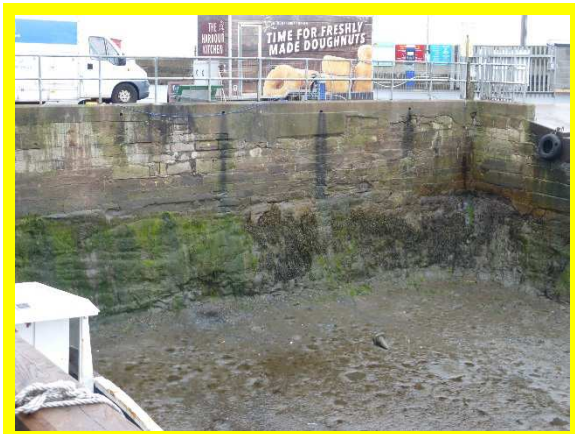
No signs of deterioration 1701/C12

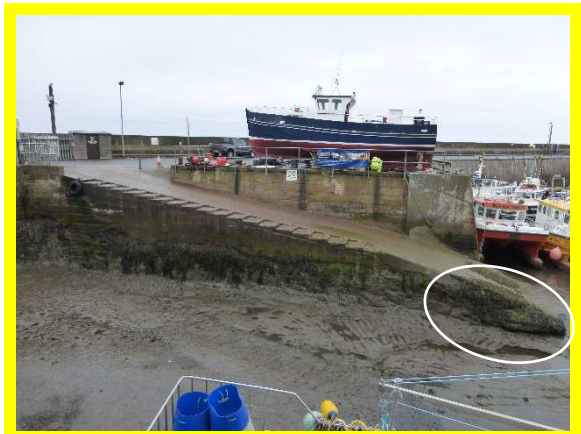
Undercutting of slipway 1701/C12

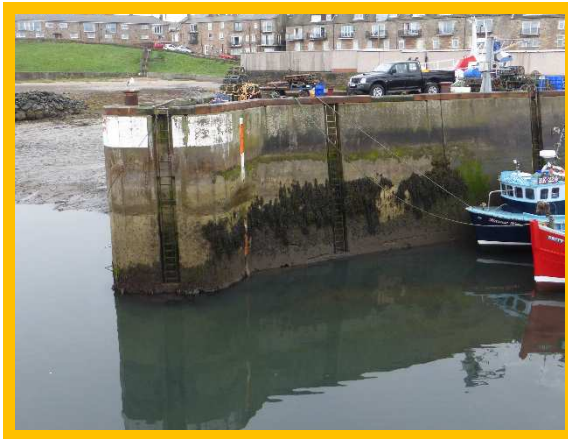
*Scour holes and possible undermining around low water mark 1701/C14*

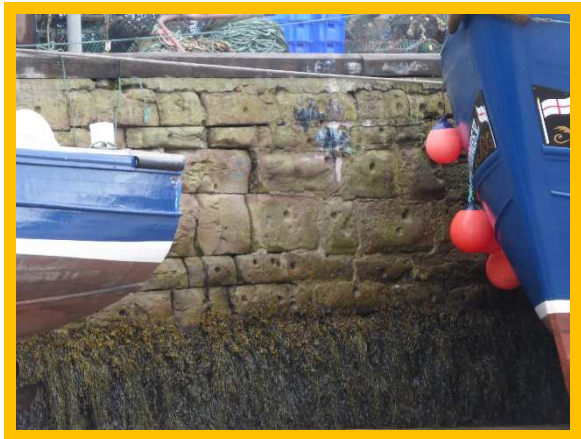
*Full height cracking and loss of mortar to outer face 1701/C14*

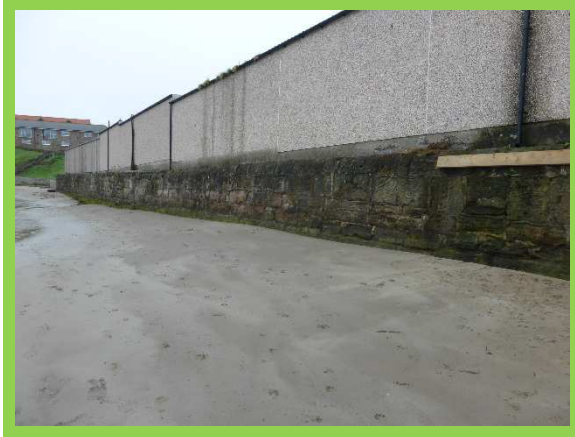
1701/C15 Good condition

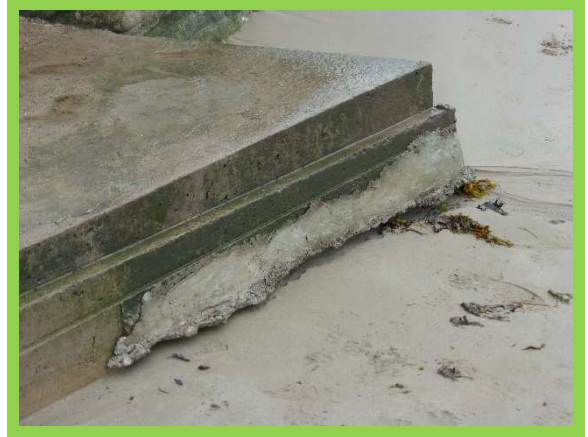
1701/C16 Low beach levels have exposed toe of steps, wall remains in good condition,

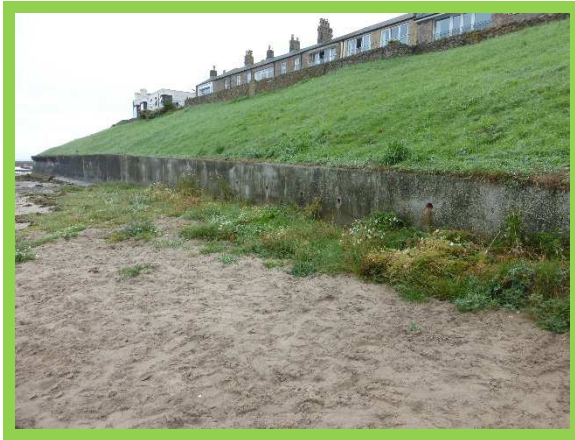
1701/C17 Good condition

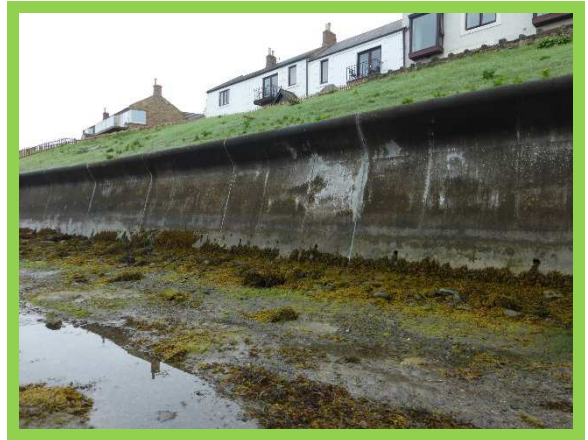
1701/C18 Wall and slope in good condition

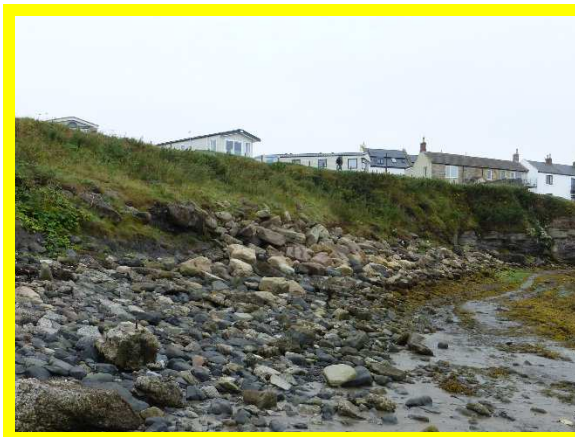
1701/C19 minor erosion above rock

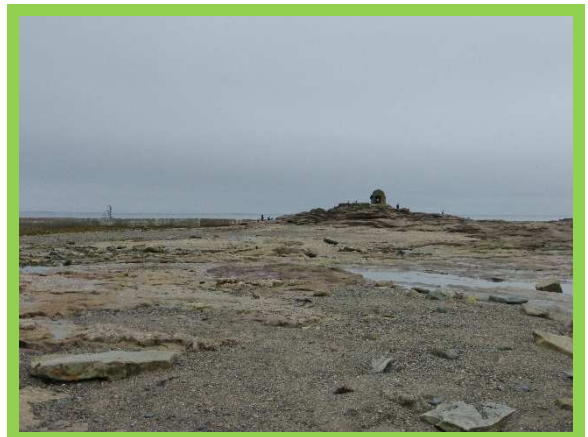
1701/C19 ridge to back of harbour.

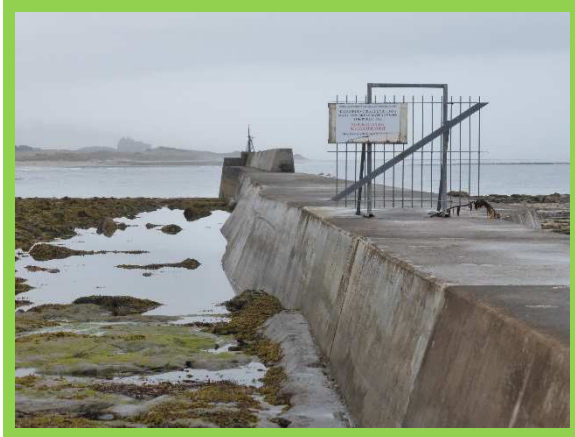
1701/C20 No signs of damage

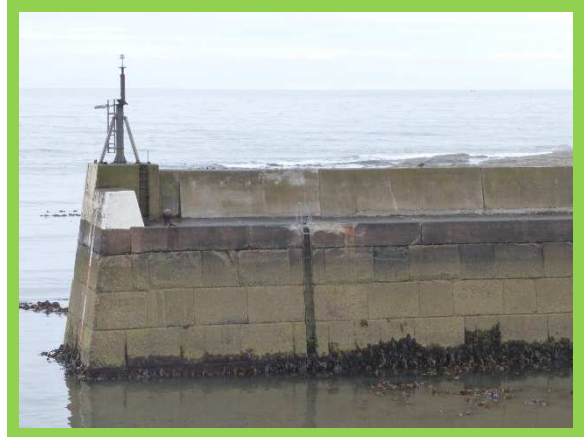
1701/C21 Good condition, some cracking and loss of mortar in original deck - no significant damage.

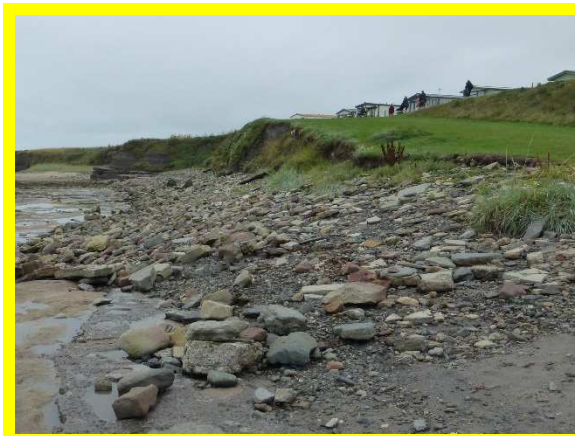
Erosion to access ramp 1701/ C22

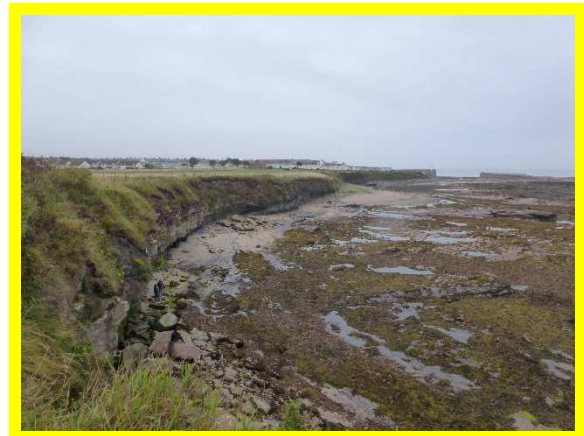
Embryo dunes within bay with slow erosion to cliffs to the south 1701/ C22

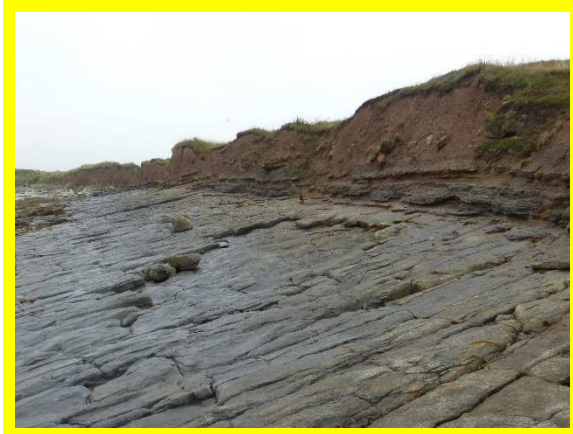
*1701/C23 Narrowing and retreat of ridge*

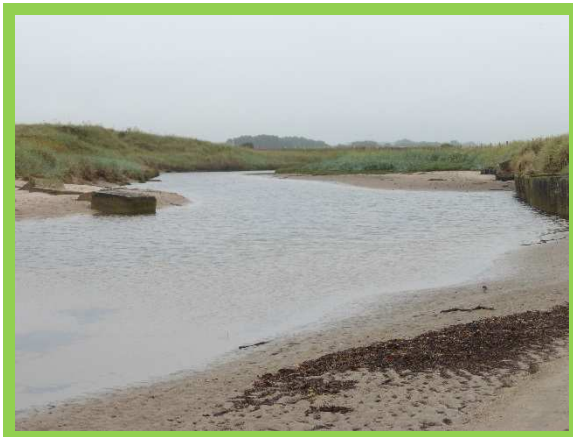
*Minor areas of erosion and some areas of toe dune development to Annstaed Burn.*

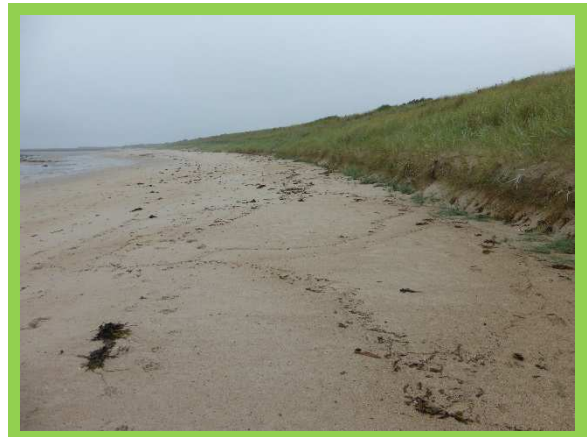
*1701/C23 Stable fully vegetated dunes to the south of Annstaed Burn.*

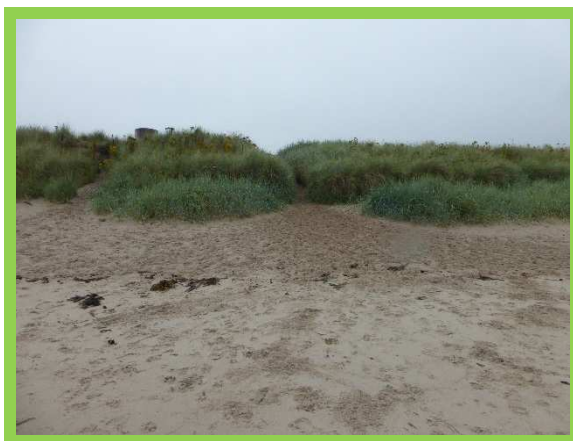
*1701/C23 localised evidence of erosion at beach access points.*

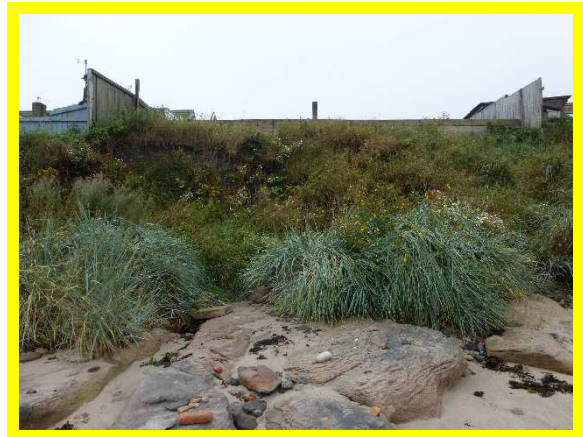
*Retreat of slope, risk of out-flanking adjacent defences. (/1701C24)*

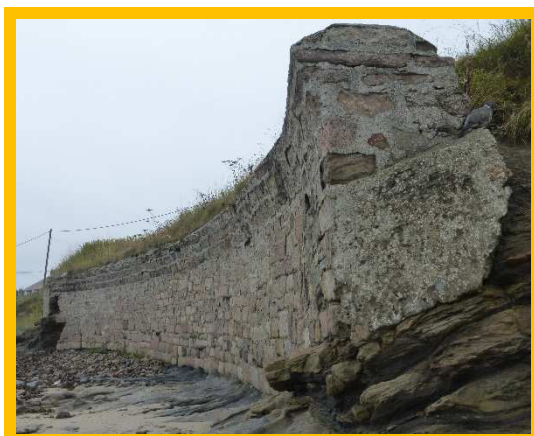
*Masonry blockwork wall in poor condition. (/1701C25)*

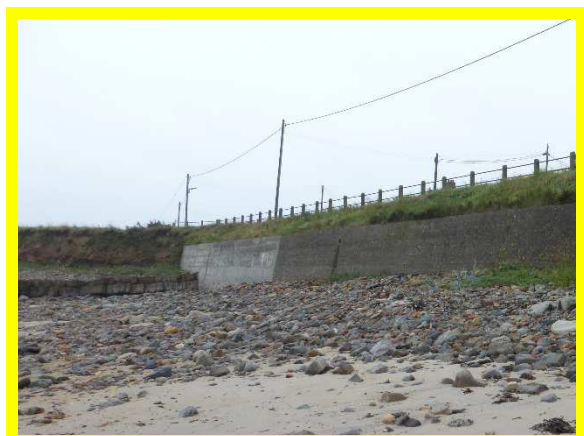
*Fair classification of wall north of Dell Point, minor outflanking at southern end (/1701C27)*

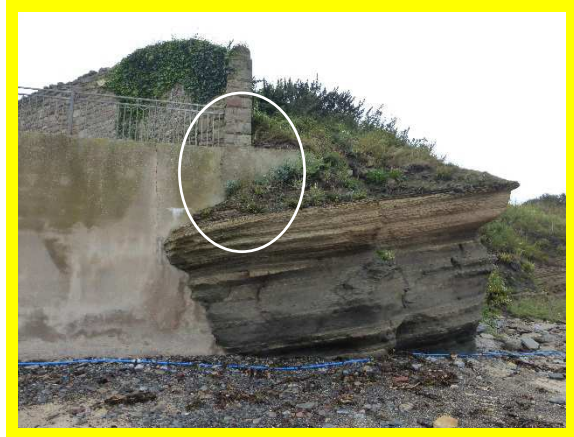
*Cracking of seawall at transition with undefended frontage (/1701C31)*

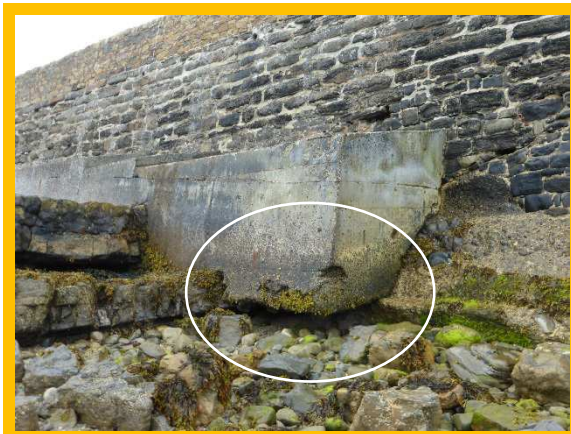
*Undermining of seawall at Beadnell North (Nacker's Hole) (/1701C36)*

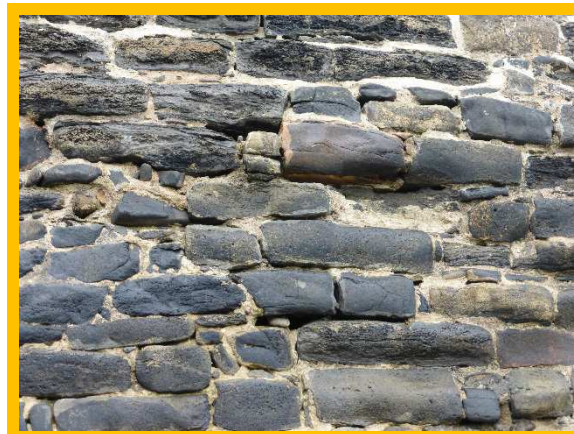
*Loss of mortar and damage to blockwork of seawall at Beadnell North (Nacker's Hole) (/1701C36)*

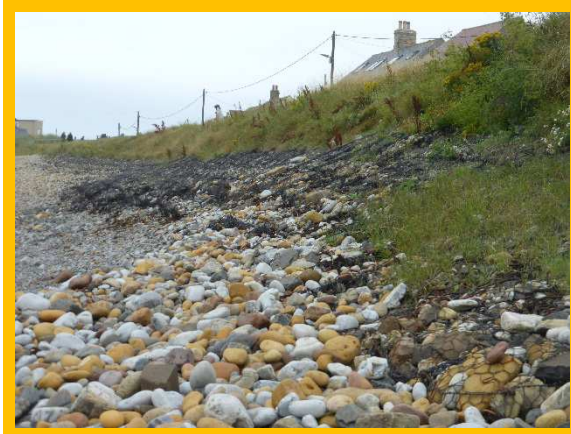
*Failing mattresses at Beadnell North (Lady's Hole) (/1701C39)*

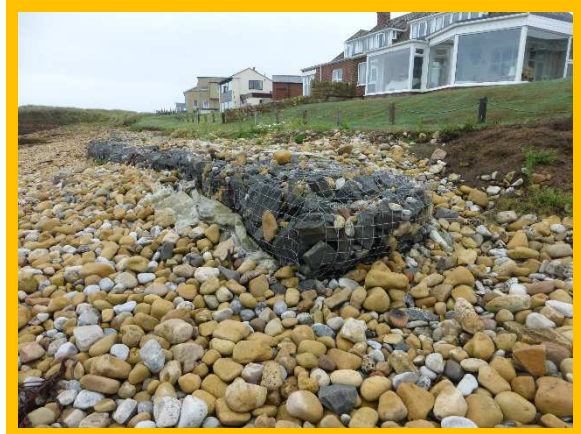
*Damage to gabion basket wall at (Lady's Hole) gabion wall (/1701C40)*

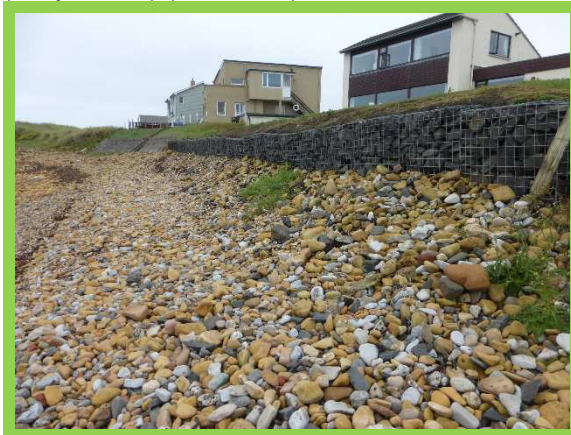
*New gabion basket wall in good condition. (/1701C41)*

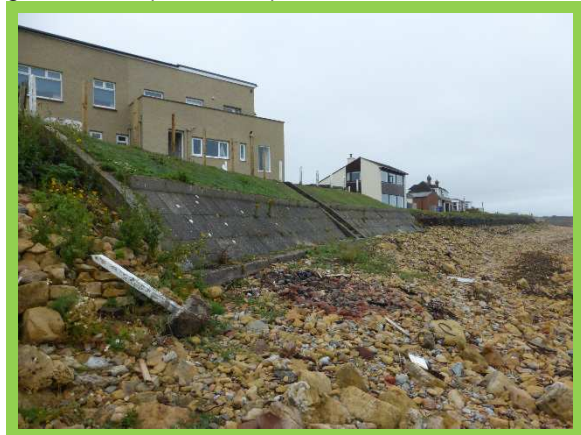
*Concrete revetment in good condition, evidence of grout repairs at southern end (/1701C42)*

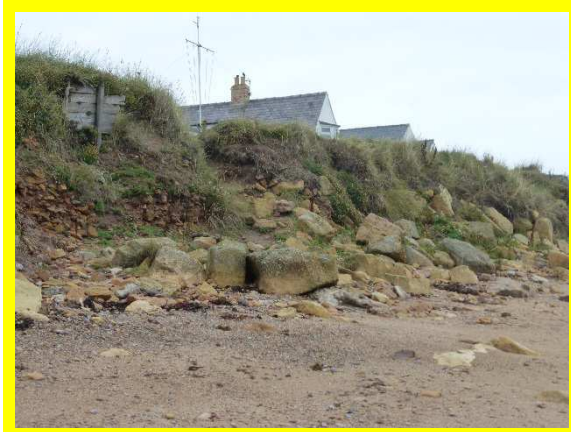
*Ongoing erosion to slopes fronting properties (/1701C44)*

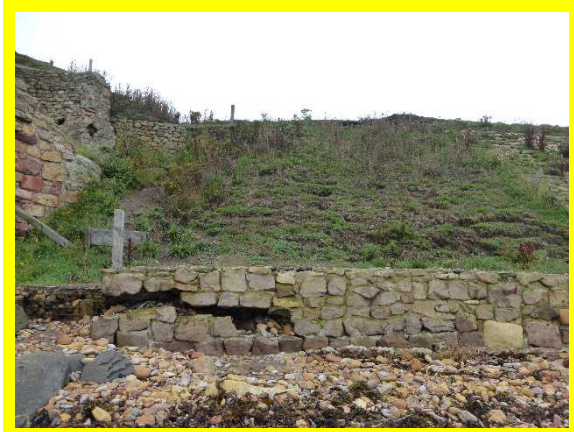
*Damage to retaining wall adjacent lime kiln. Possible slumping of slope to rear (/1701C44)*

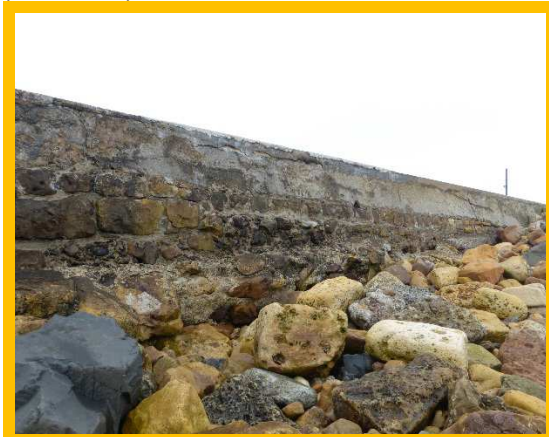
*Abrasion and undermining of Beadnell Harbour wall (outer face of eastern wall) (1701C47)*

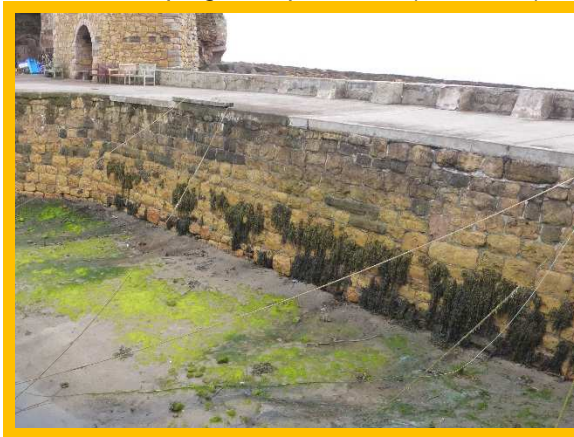
*Open joints between blocks on Beadnell Harbour wall (inner face of eastern wall) (1701C51)*

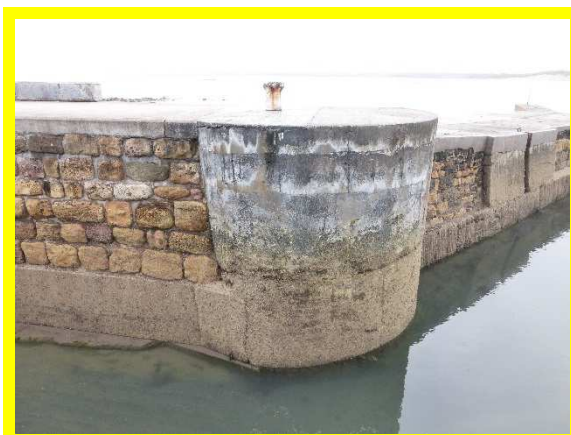
*Undermining of Beadnell Harbour wall (inner face of southern wall) (1701C51)*

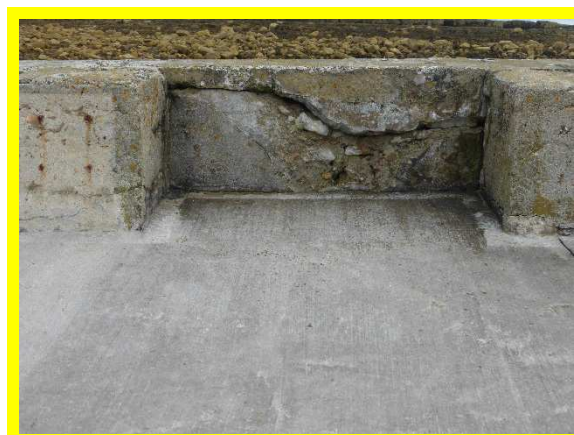
*Damage to splash wall (1701C51)*

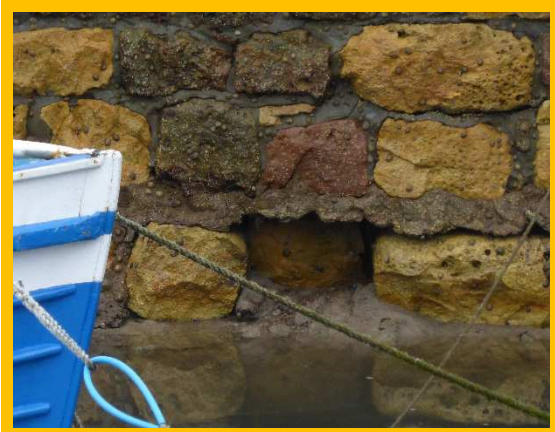
*Missing block at toe of Beadnell Harbour wall (inner face of northern wall) (/1701C52)*

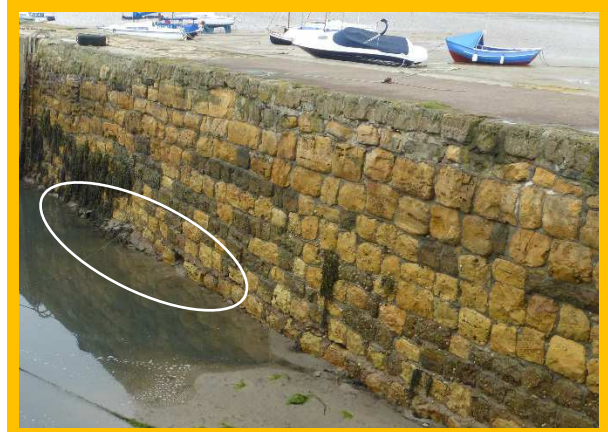
*Undermining of Beadnell Harbour wall (inner face of northern wall) (/1701C52)*

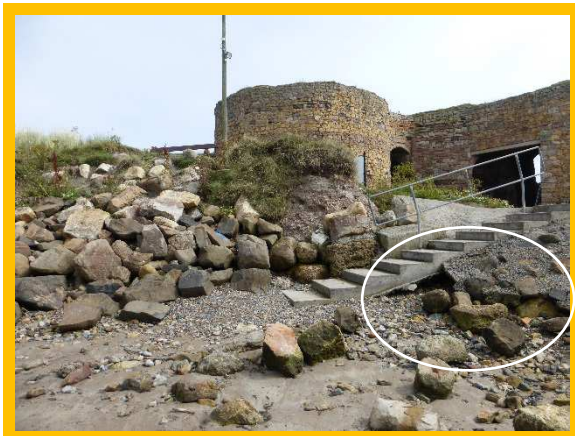
*Undermining and partial collapse of grouted stone revetment adjacent access steps. (/1701C53)*

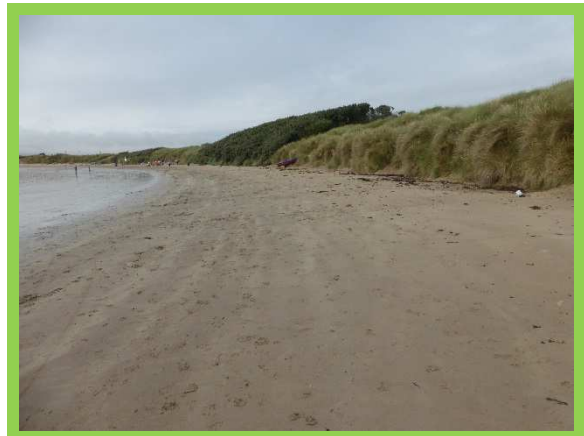
*Sand accretion and embryonic vegetation growth at toe of dunes in Beadnell Bay (/1701C53)*

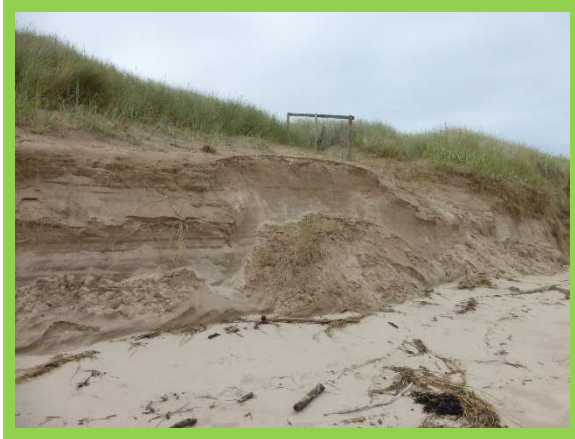
*Ongoing erosion of the dunes to the north of Brunton Burn / Long Nanny (1801C01)*

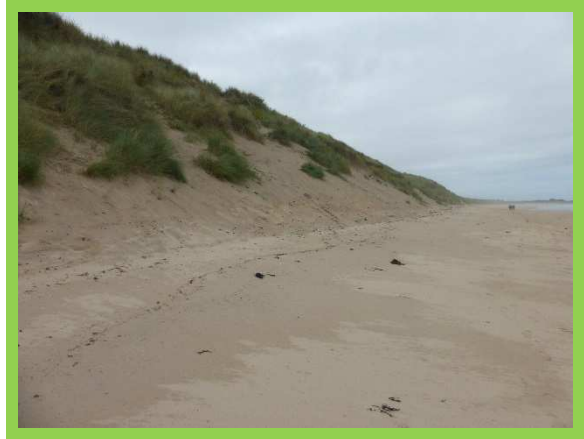
*Larger dunes to the south of Brunton Burn / Long Nanny (1901C01)*

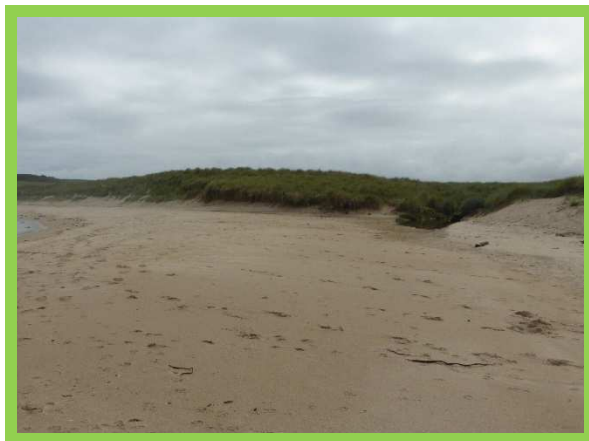
*Stable dunes in Football Hole (/1901C02)*

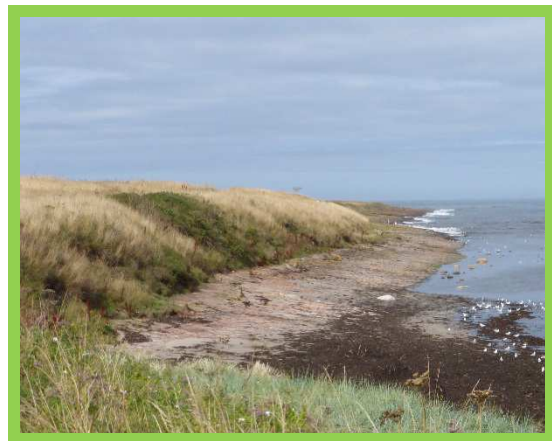
*Vegetated slopes to the south west of Newton Point headland (2001C01)*

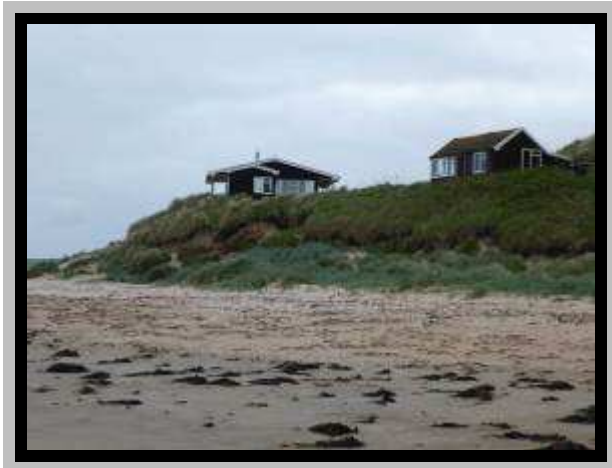
*Previous dune damage followed by recovery at Newton Haven (/2001C03) 2016*

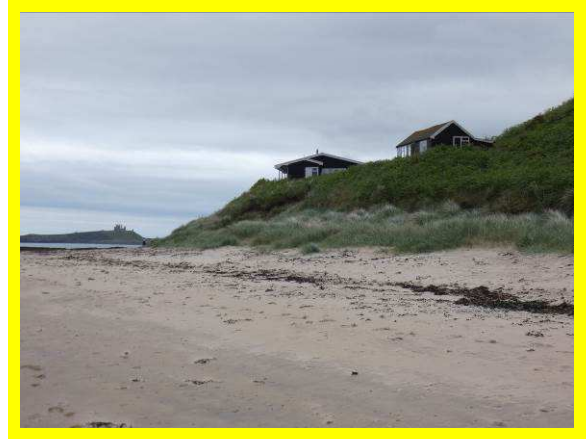
*Continued improvement at Newton Haven (/2001C03) 2018*

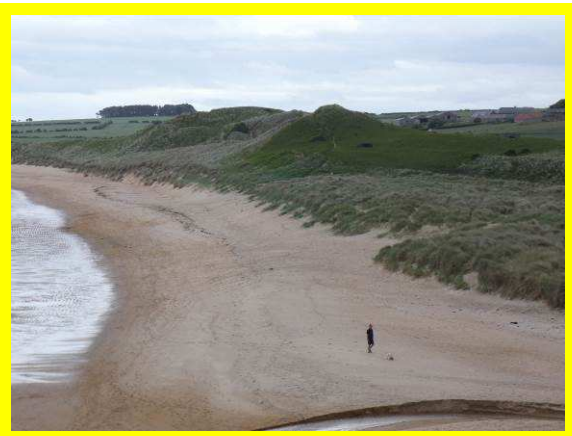
*Intermittent erosion and dune growth (/2001C03) 2018 (note change in position of Embleton Burn entrance).*

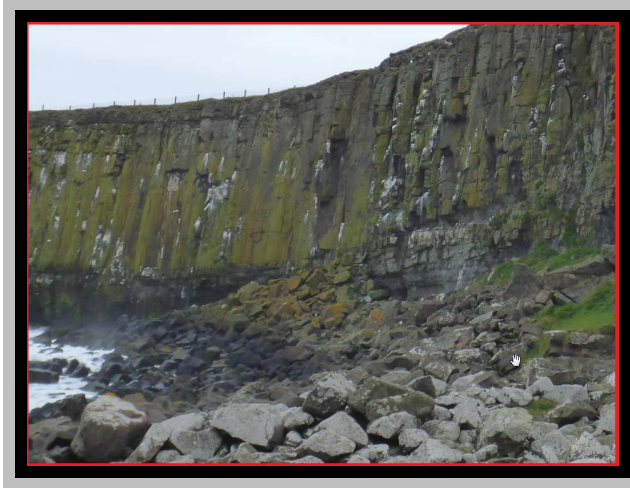
*Localised rock fall at Castle Point (/2001C05) 2016*

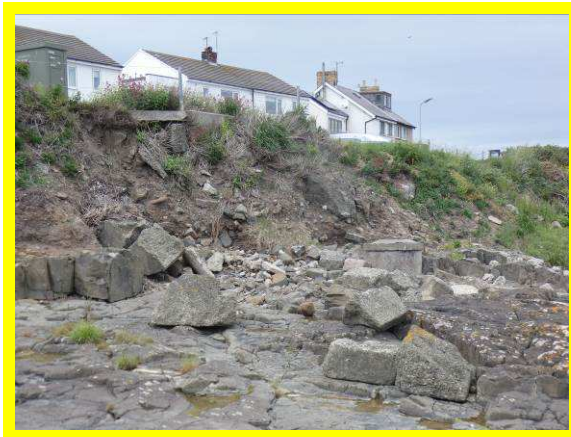
*Slight erosion around outfall (/2201C02)*

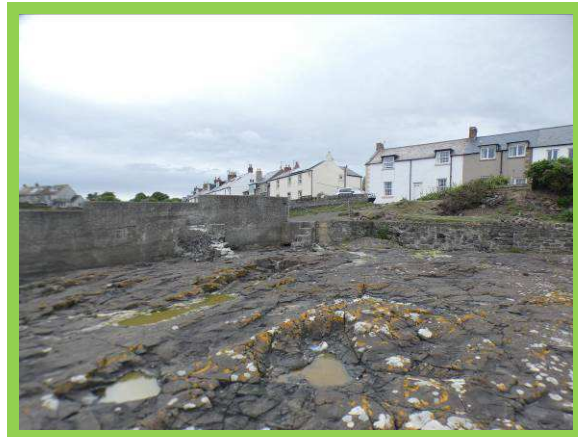
*Wall and start of Pier (/2201C02 / C03)*

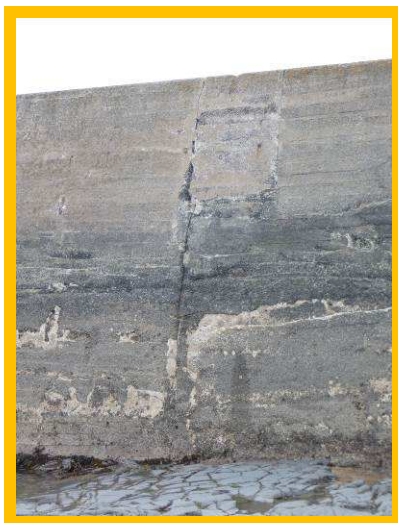
*Crack in north pier (/2201C03)*

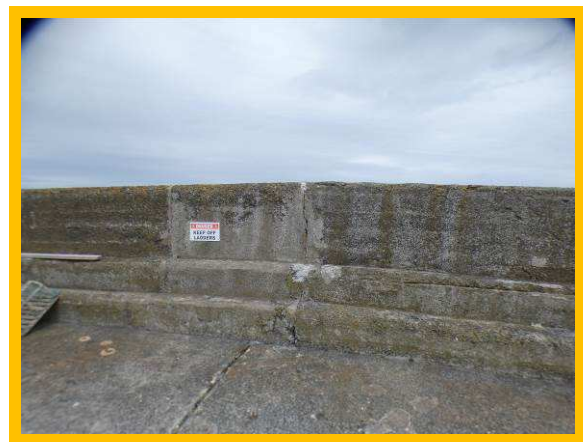
*Inside face (crest wall) at crack (/2201C03)*

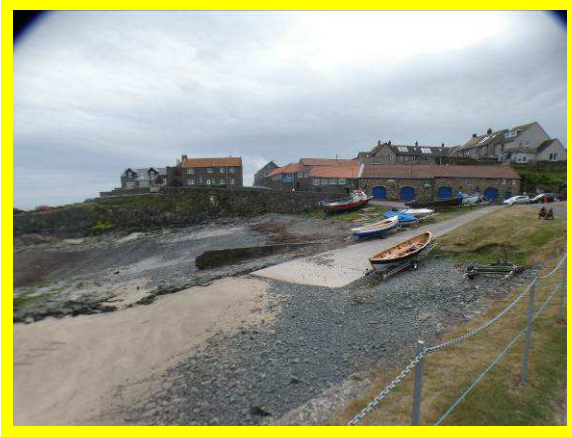
*Slipway with slight voiding at toe (/2201/C06)*

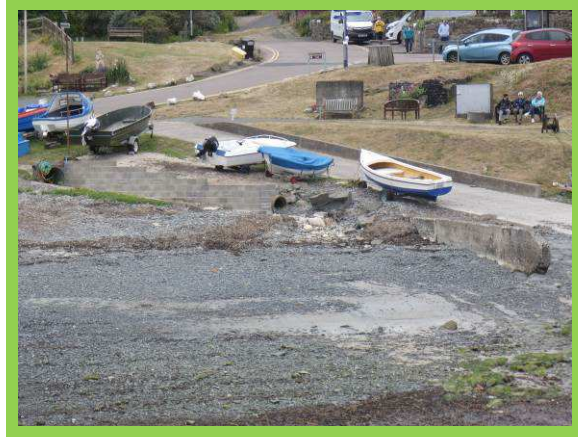
*New blockwork wall (/2201C06)*

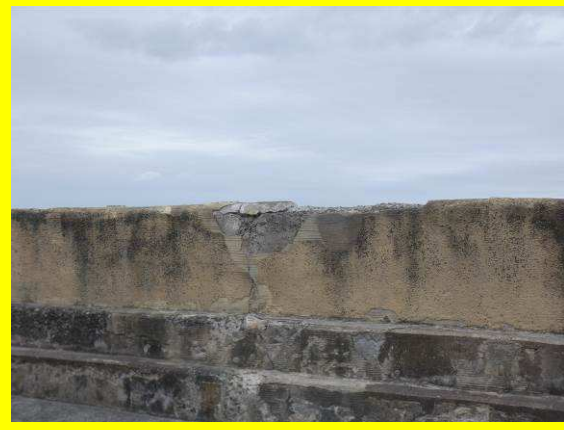
*Continued spalling of repairs (/2201/C11)*

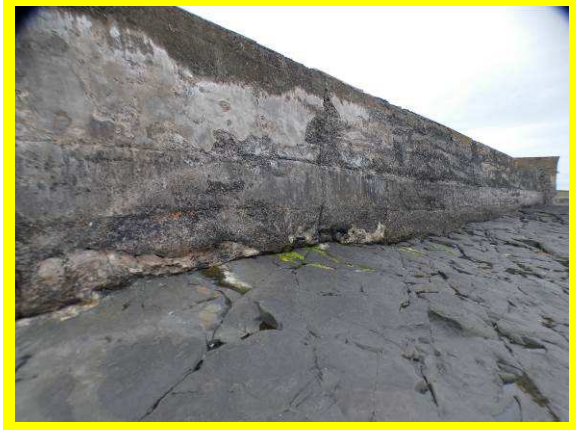
*Front face of Pier (/2201C11)*

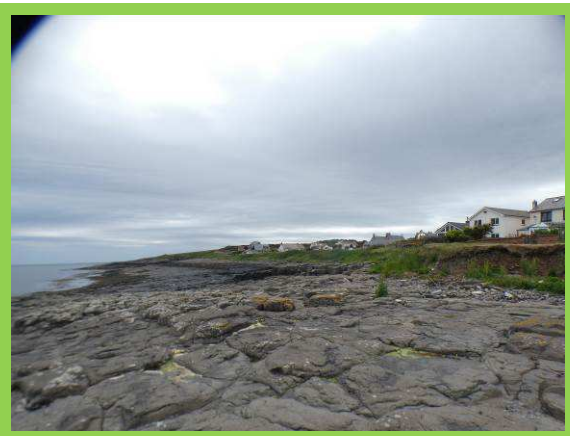
*Slight cliffing within (/2201C14) but well vegetated slope to (/2201 C15)*

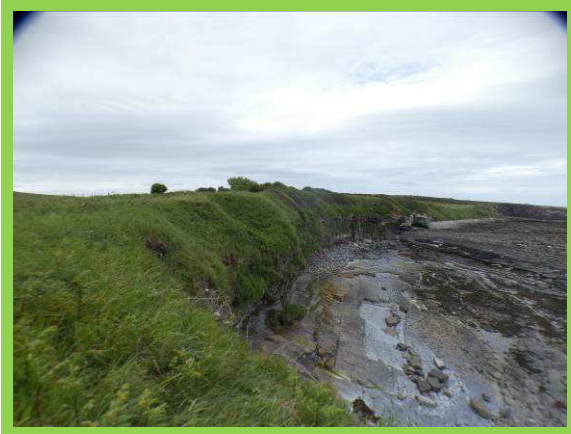
*Slow undercutting (/2401C01)*

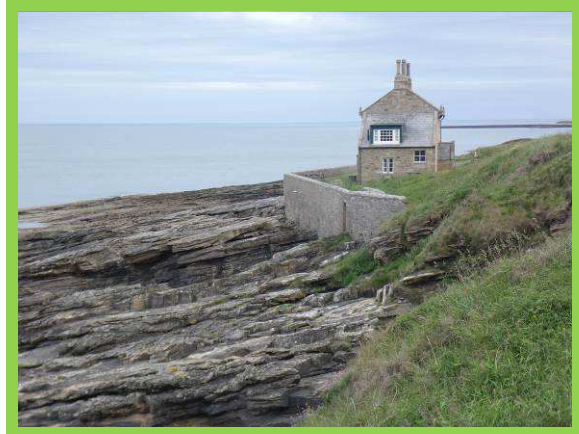
*Masonry wall at The Bathing House in good condition (/2401C02)*

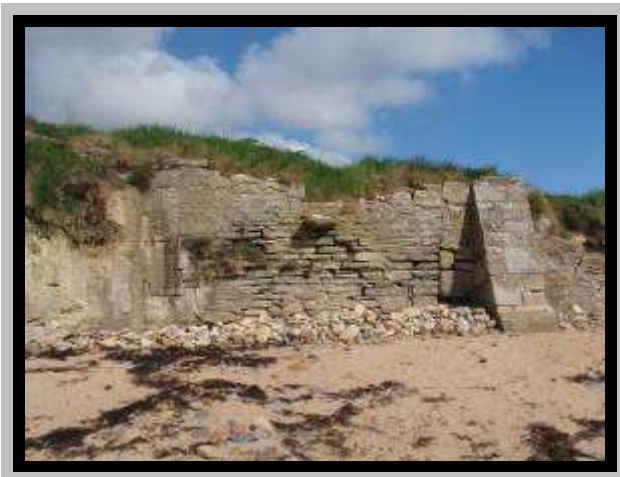
*Poor condition retaining wall (/2501C01) 2016*

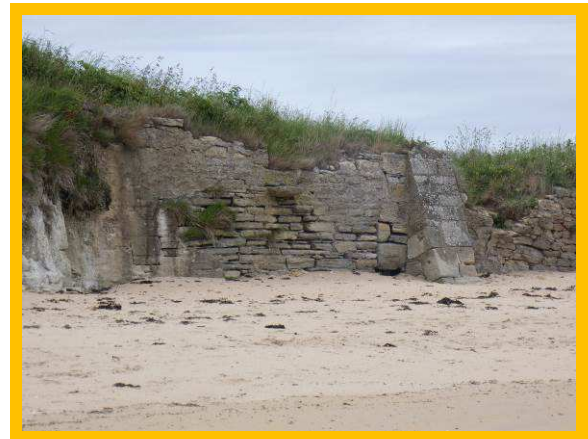
*Poor condition retaining wall (/2501C01) 2018*

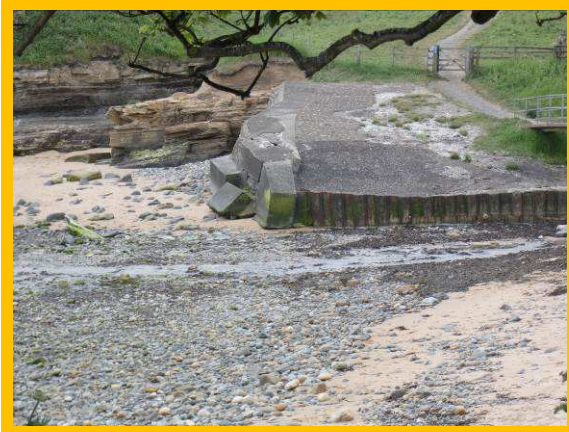
*Undermining and voiding in concrete at southern bridge abutment (/2501C01). Low beach levels*

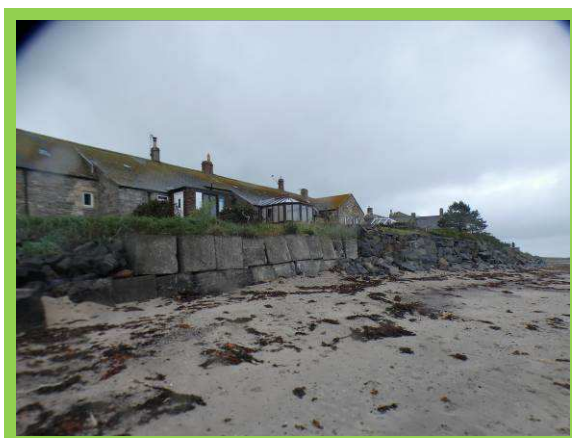
*Stacked concrete blocks (original scheme) and rock revetment (emergency scheme) at southern end of Boulmer village (/2601C05)*

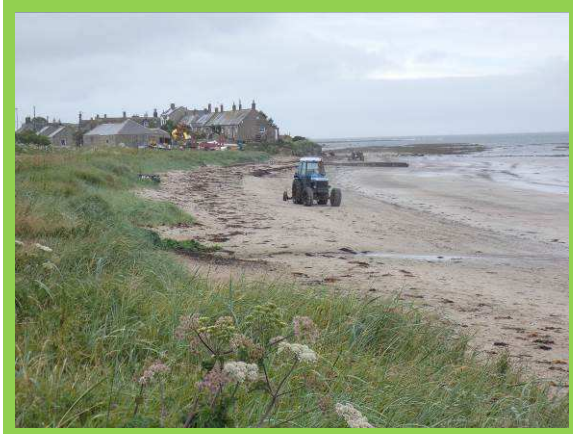
*Stable dunes around Boulmer Haven  
(/2601C06)*

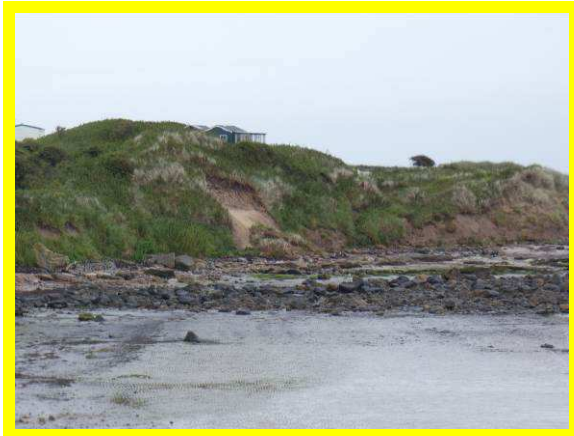
*Front face dune failure (/2601C07)*

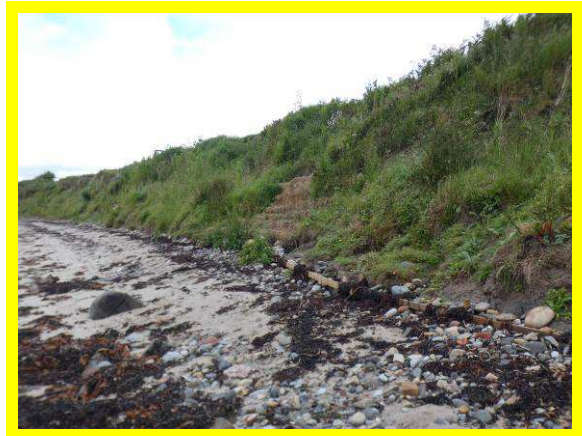
*Local defence at toe of eroding cliffs (/2601C08)*

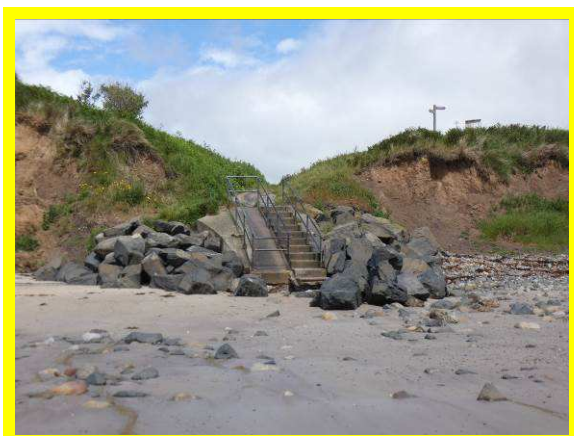
*Rock armour around access steps in north of Foxtan Bay (/2601C09)*

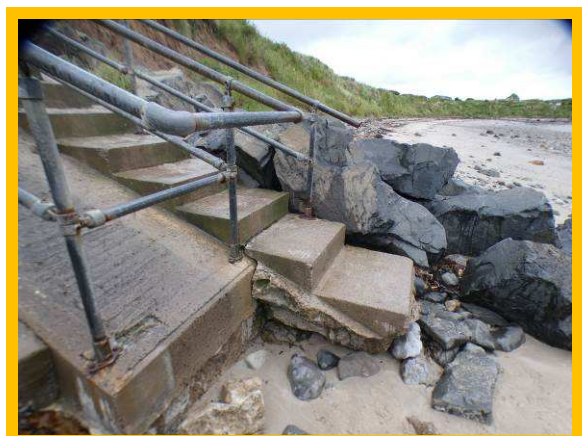
*Lower beach levels exposing additional toe. (/2601C09)*
