## **Cell 1 Regional Coastal Monitoring Programme Walkover Inspection Surveys 2018**

**Northumberland County Council**

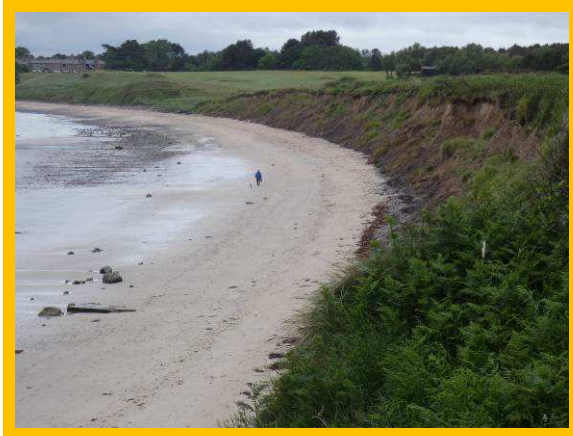
*Eroding cliff to golf course(/2701C01)*

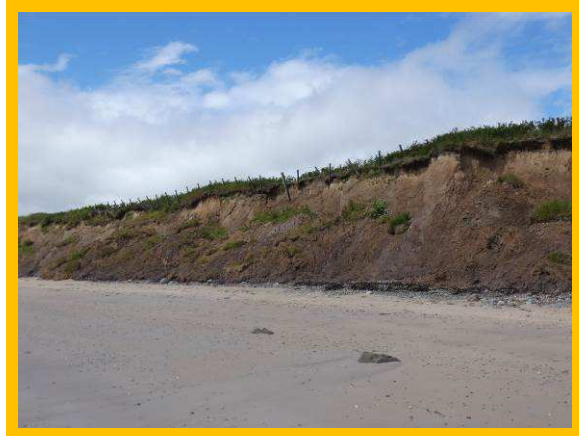
*Cliff failure affecting a long section of fencing (/2701C01)*

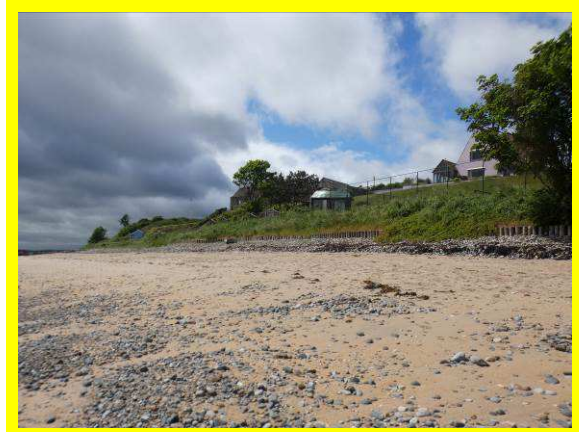
*Timber breastwork fronting property (/2701C02)*

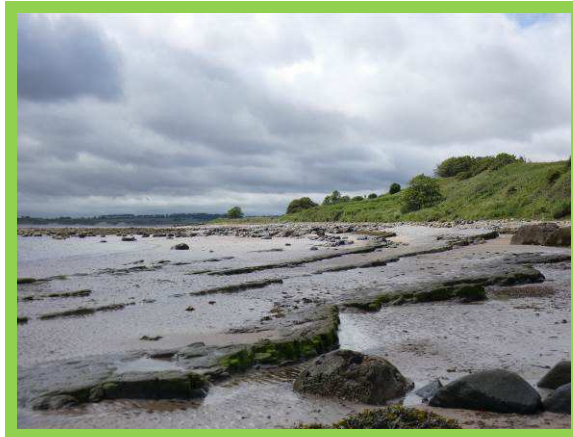
Generally stable slope protected by rocky shore platform (/2701C04)

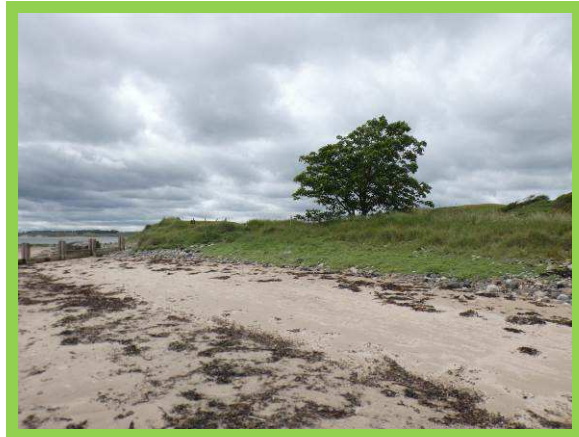
Isolated timber groyne (/2701C04)

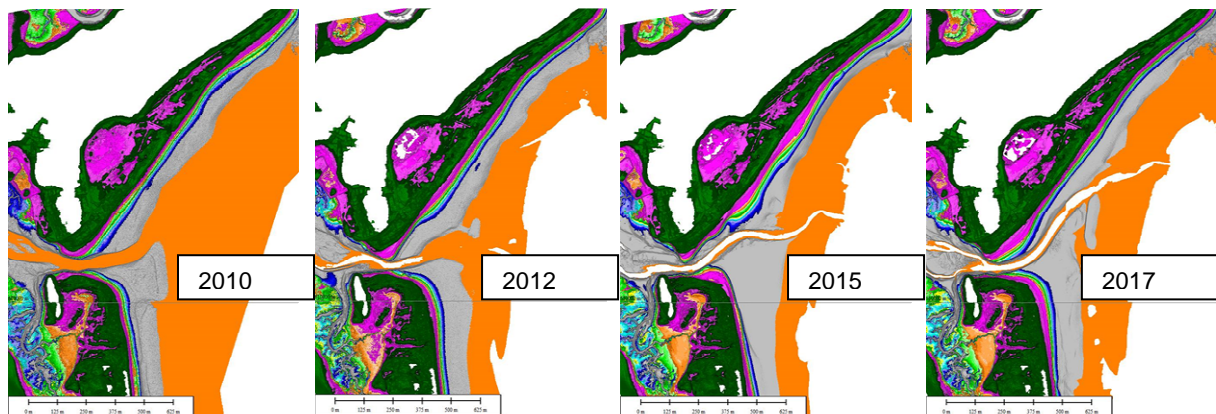
Change in beach shape over the whole frontage.

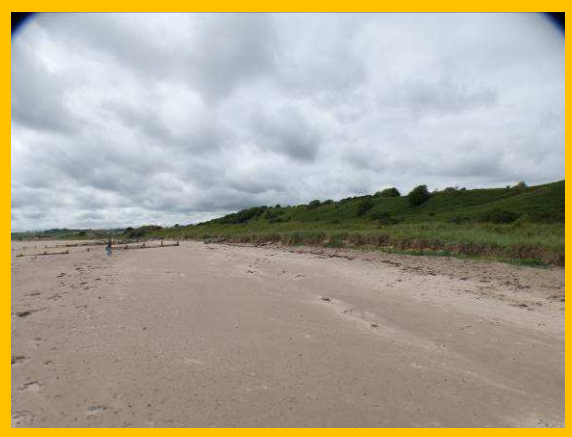
*General erosion of back face with some evidence of local rebuilding by time of inspection 2018 (/2701C05)*

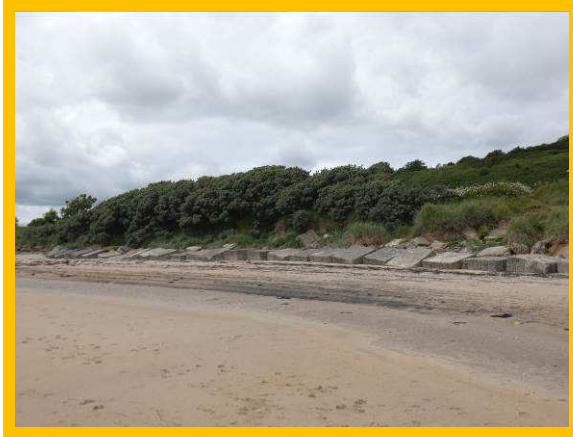
*Relatively stable dunes but with some erosion. (/2701C06)*

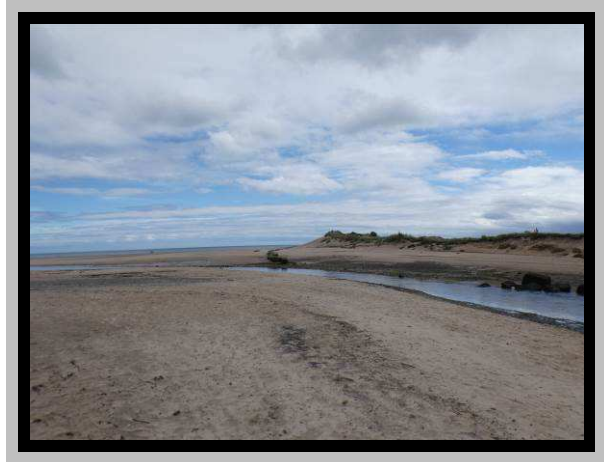
*Deepening of the estuary channel and impact to the south (/2901C01)*

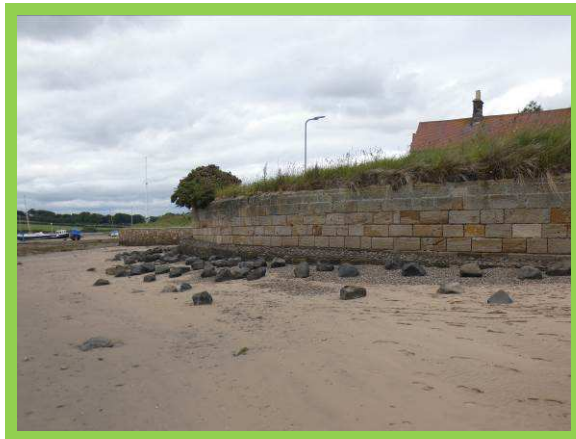
*Masonry wall with concrete and cobble toe apron (/2801C02)*

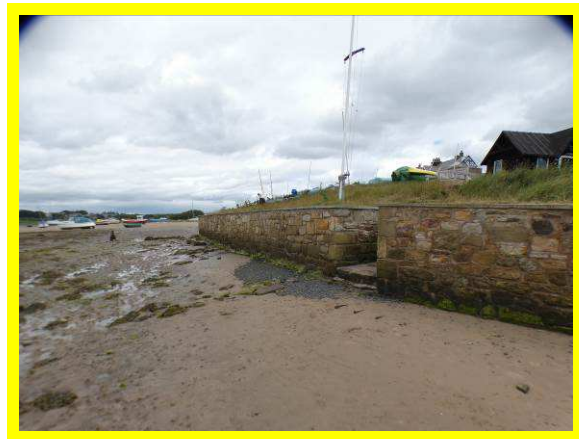
*Masonry wall at Boat Club with some signs of loss of pointing. (/2801C03)*

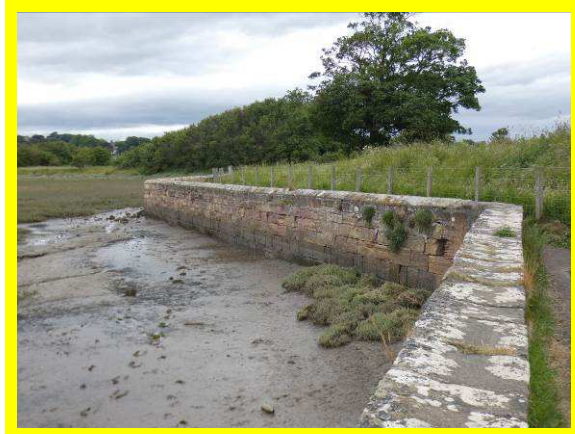
*Masonry wall fronted by salt marsh (/2801C06)*

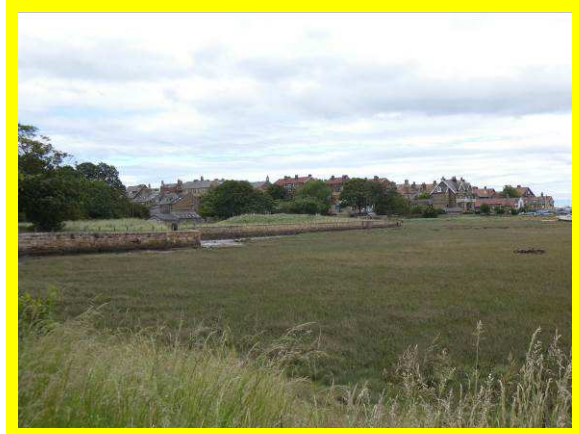
*Salt marsh (/2801C06)*

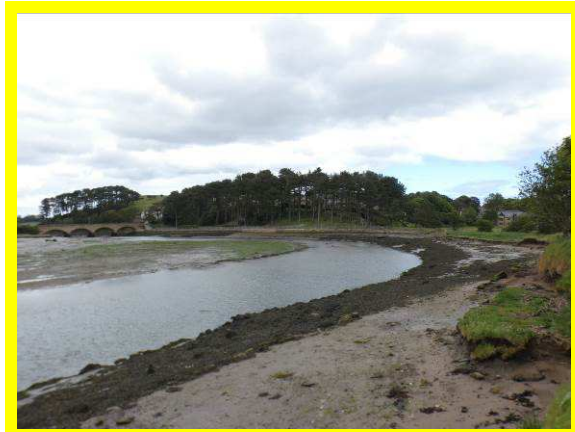
*Eroding face of raised area (/2801C09)*

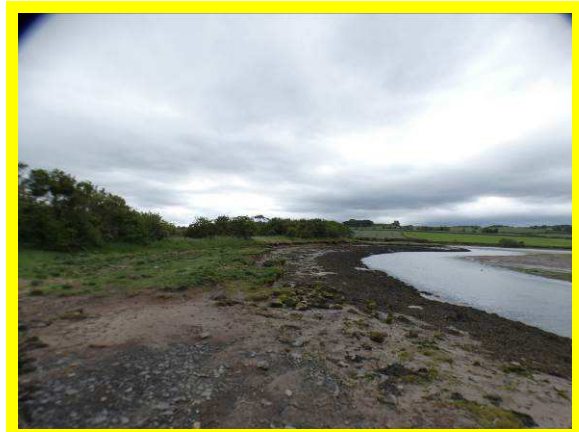
*Eroding face of raised area (/2801C09)*

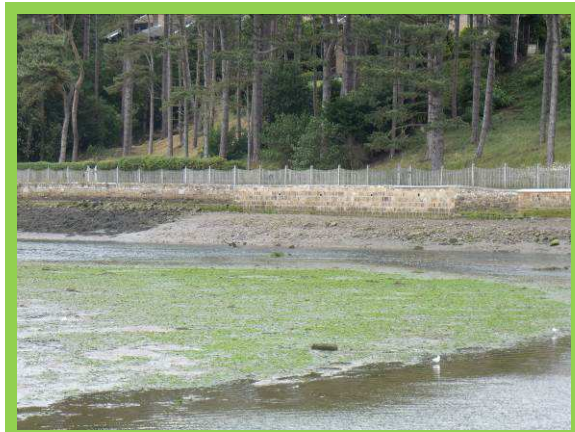
*Footpath repaired wall (/2801C10)*

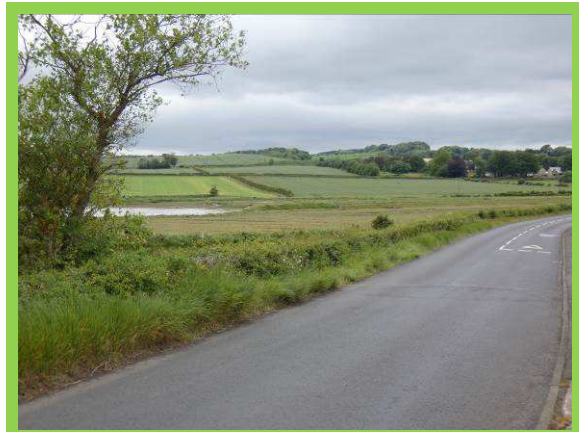
*Area of realignment (/2801C11)*

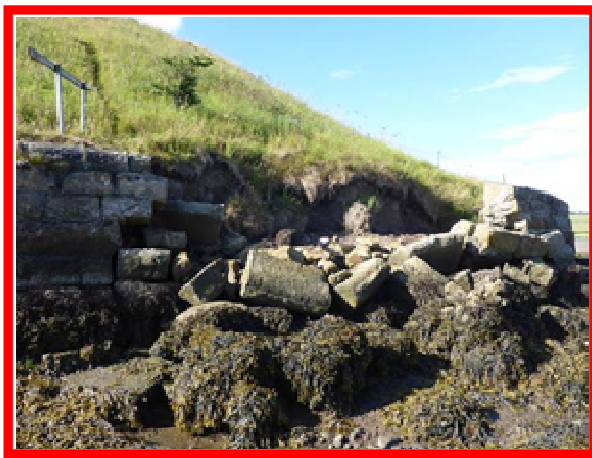
*Collapsed section of wall at Church Hill now with erosion of the land behind (/2801C13)*

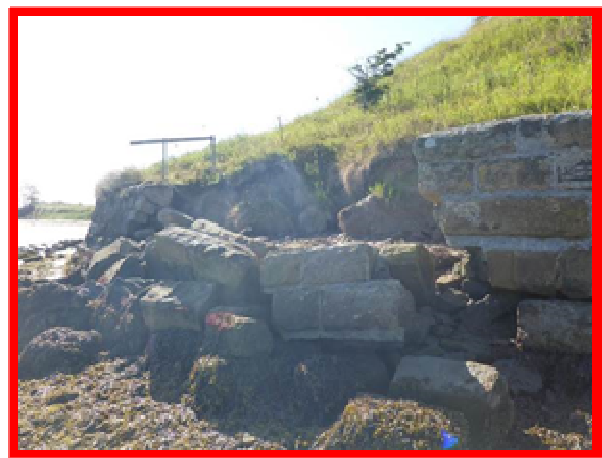
*Defective section of masonry wall adjacent to collapsed section (/2801C13)*

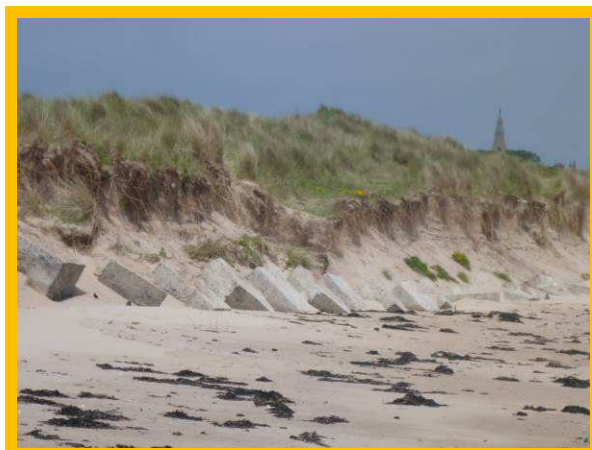
*Eroding dunes at northern end of Birling Carrs frontage (/2901C01)*

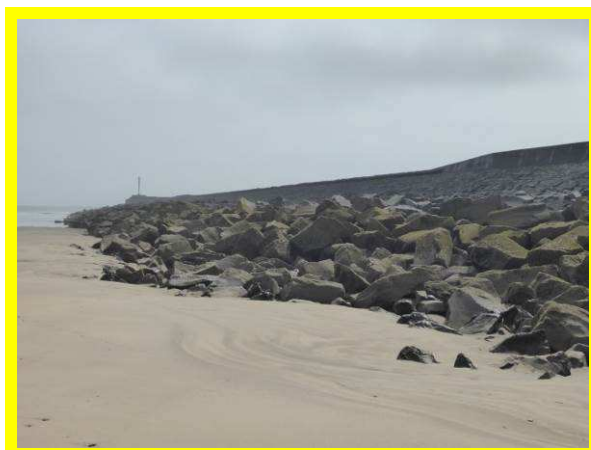
*Rock armourstones on north face of North Pier (/3001C01)*

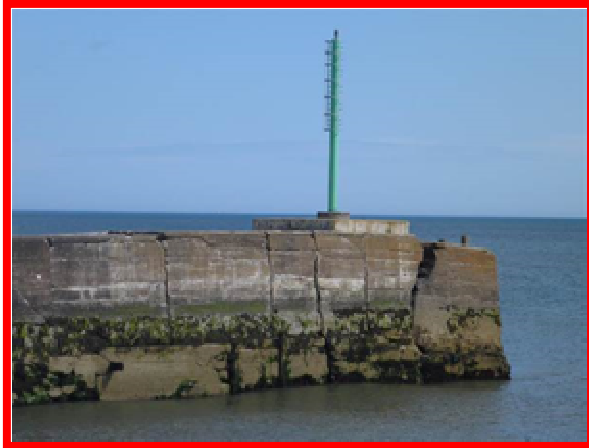
*Seaward end of North Pier in very poor condition (/3001C02)*

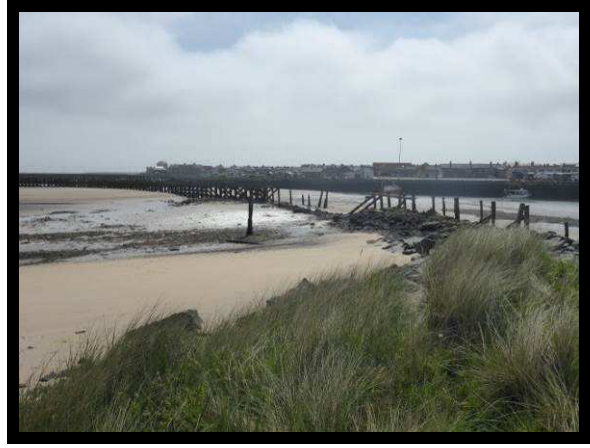
*Dilapidated North Jetty (no asset reference)*

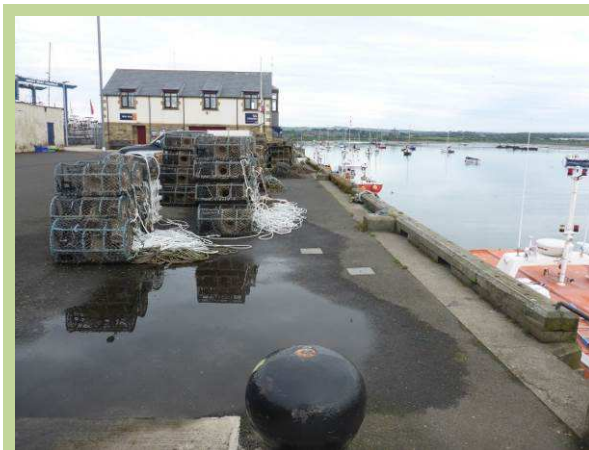
*Quay wall in good overall condition (/3001C05)*

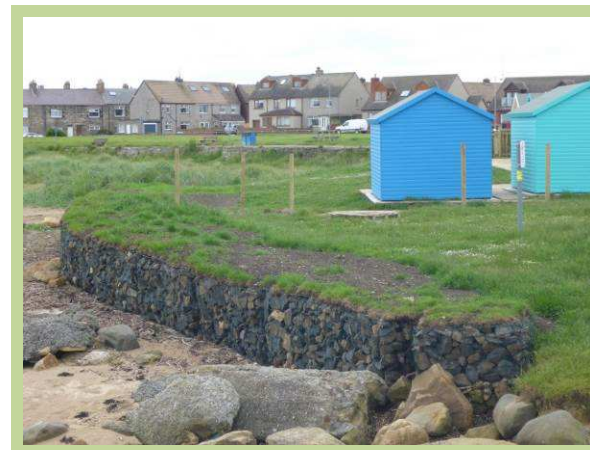
*New gabions and beach huts (/3001C07)*

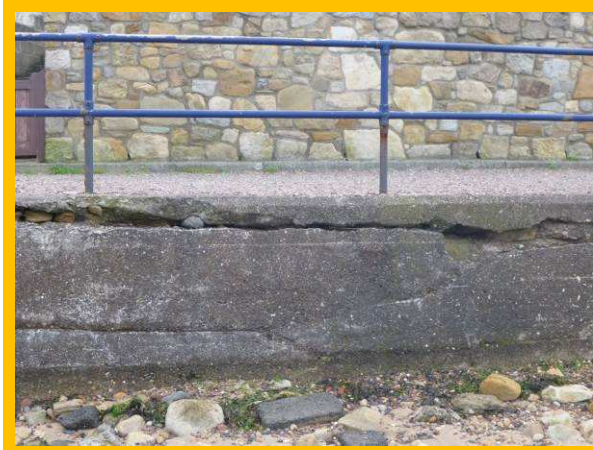
*Sea wall along Bay View in poor overall condition (/3001C10)*

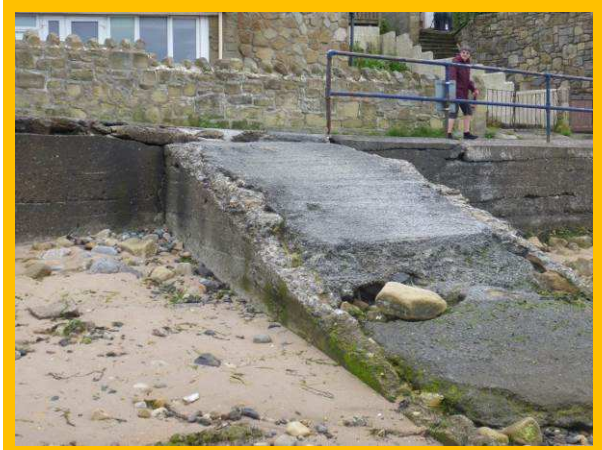
*Access ramp to Little Shore Wave Basin in poor condition (/3001C10)*

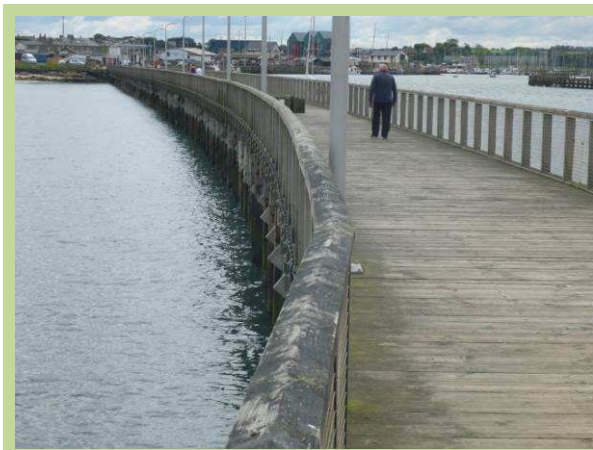
*South Jetty in good overall condition (/3001C11)*

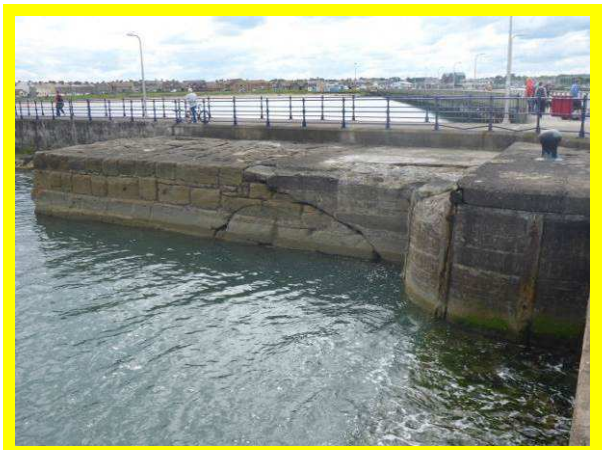
*Poor condition at junction of South Pier and South Jetty (seaward face) (/3101C01)*

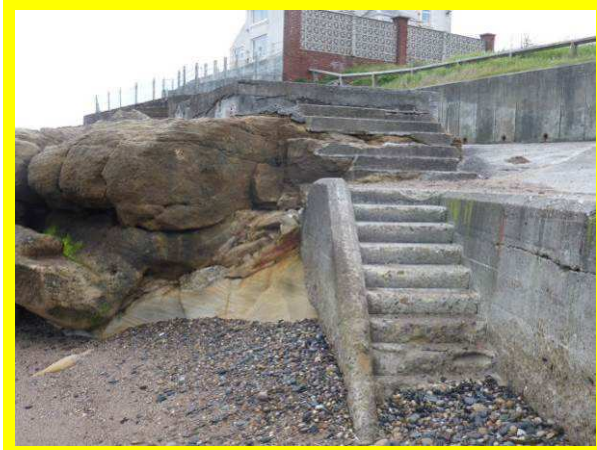
*Heavily abraded access steps to foreshore (/3101C02)*

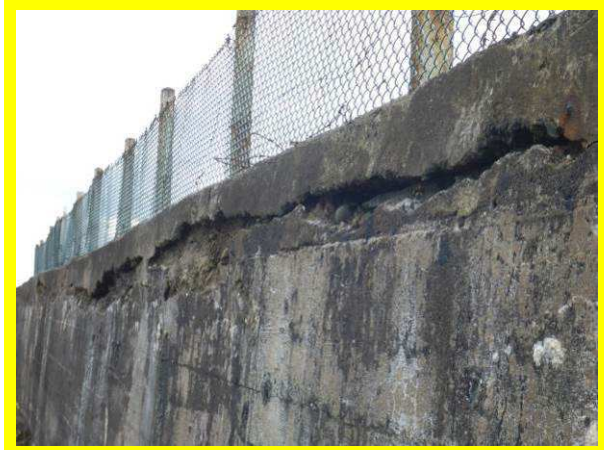
*Cracks in private seawall around Pan Point (/3101C04)*

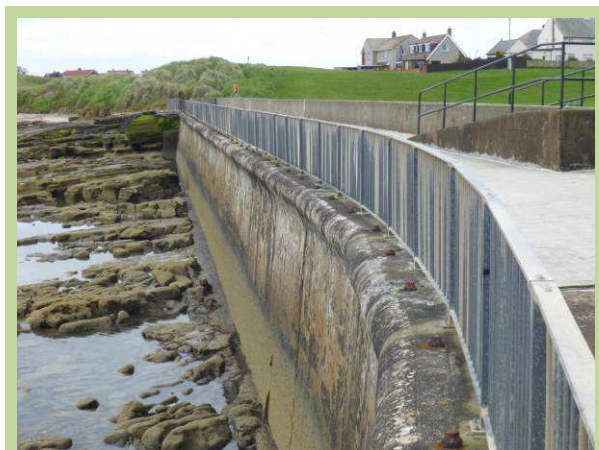
*Seawall in good condition despite rust-staining (/3101C05)*

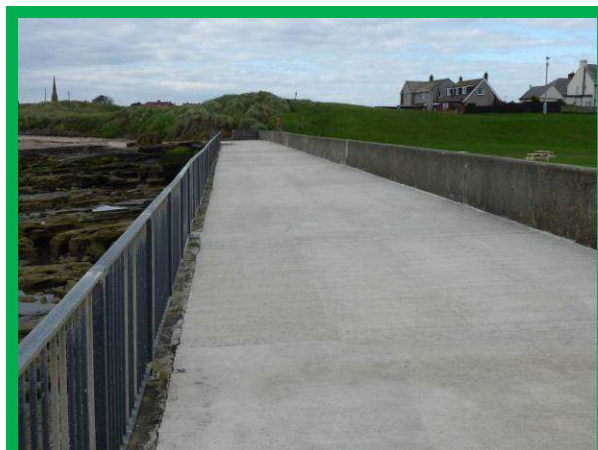
*Promenade deck remains in very good condition following previous repairs (/3101C05)*

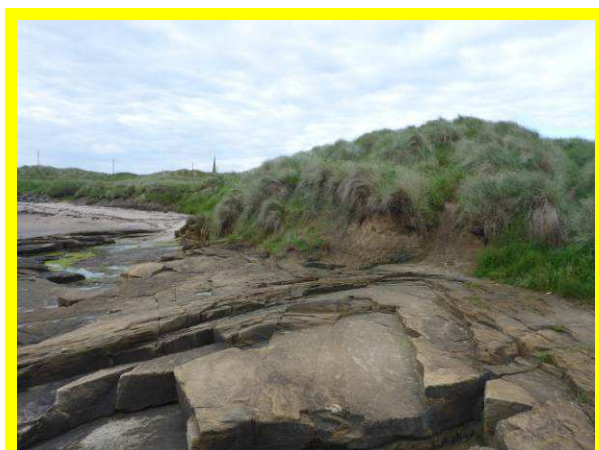
*Dunes and low slopes above rock ledge (/3101C06)*

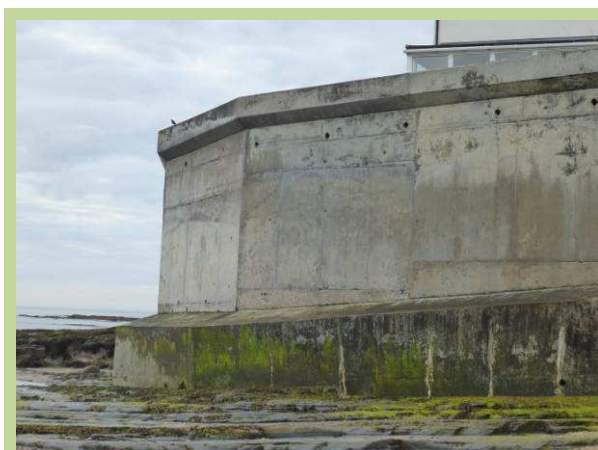
*Substantial seawall in overall good condition (/3101C07)*

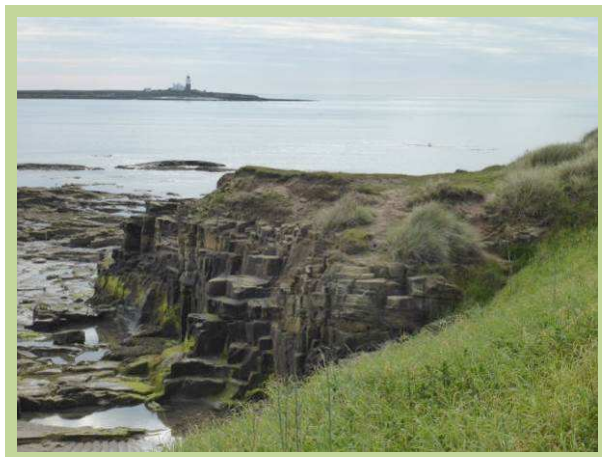
*Cliffed headland around Wellhaugh Point (/3101C11)*

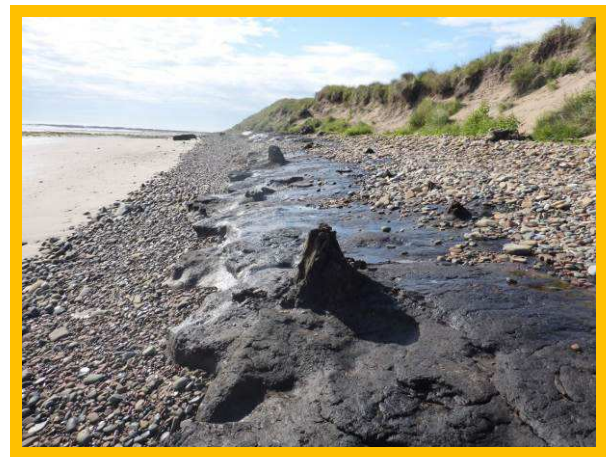
*Exposed peat layer at base of dunes (/3101C12)*

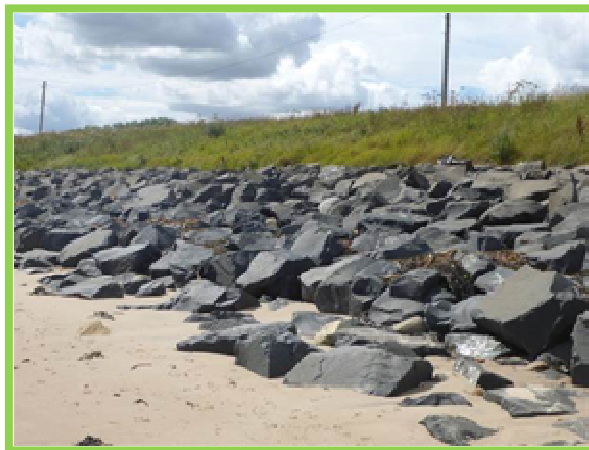
Wide rock revetment in good condition (/3201C03)

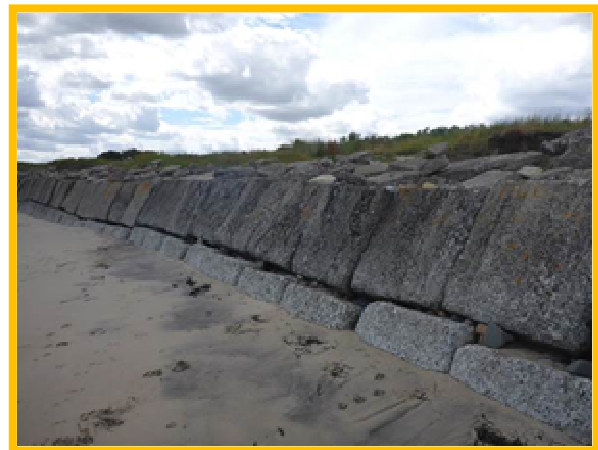
Rotational displacement at southern end of concrete block revetment (/3201C04)

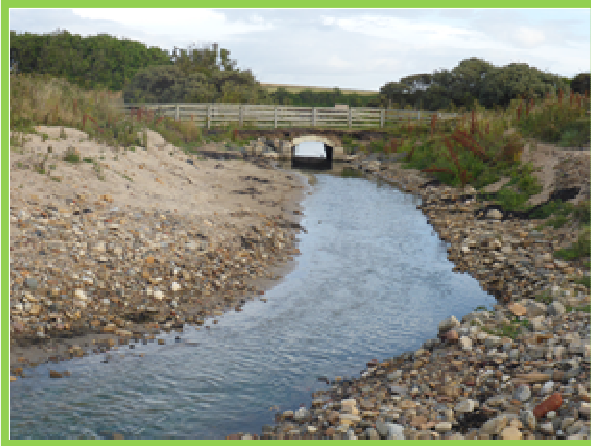
*Landward view of newly 'daylighted' open channel section of outfall from Hauxley Nature Reserve (/3201C09)*

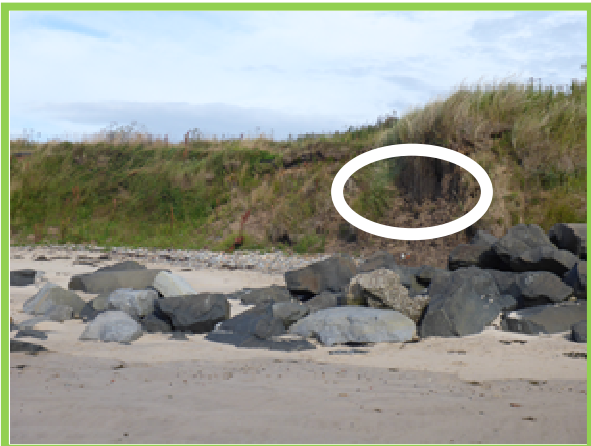
*Erosion of low cliffs (/3201C14) at terminal end of rock revetment*

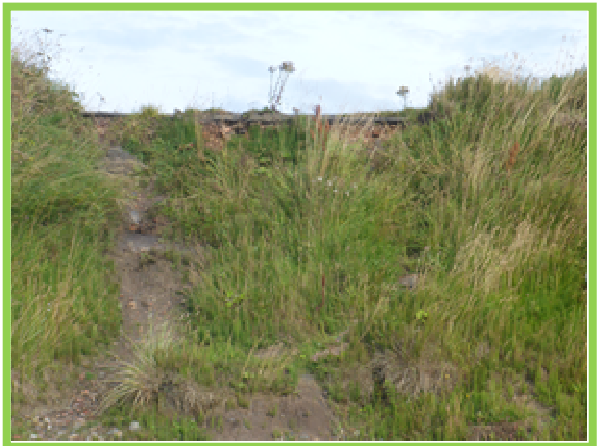
*Erosion of low cliffs exposing carriageway of access road (/3201C14)*

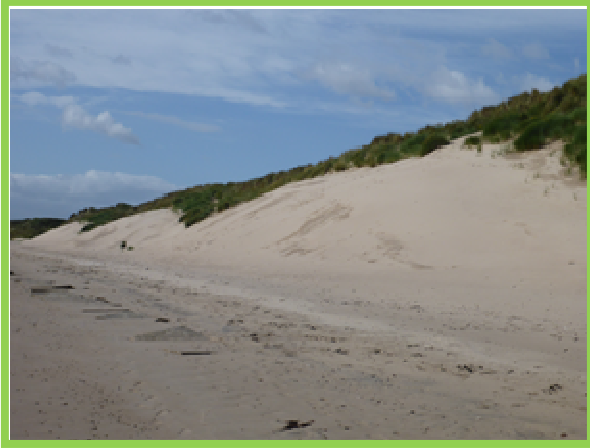
*Healthy dunes in Druridge Bay  
(/3201C15 & C16)*

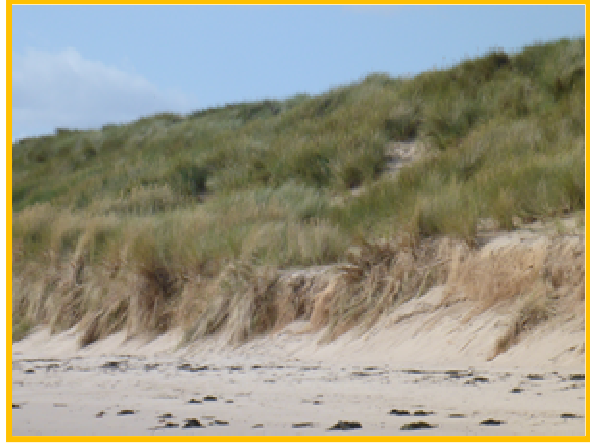
*Previous dune toe erosion now recovering  
Druridge Bay (/3201C16)*

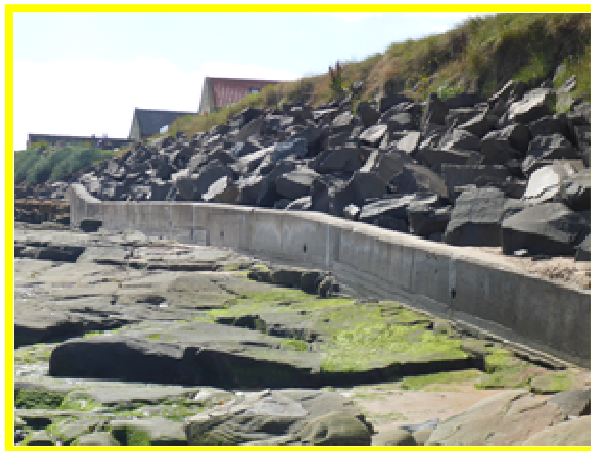
*Low concrete wall and rock revetment at Cresswell (/3201C18)*

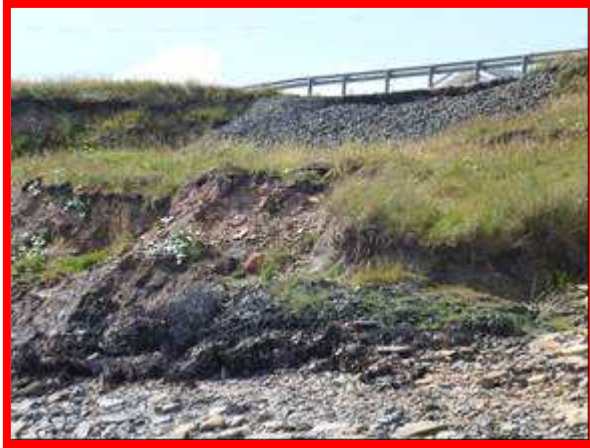
*Failed section of cliff adjacent to coast road (/3201C22)*

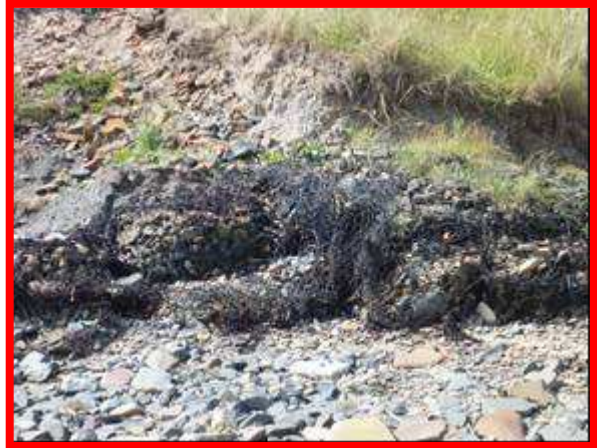
*Failed section of gabion (/3201C22)*

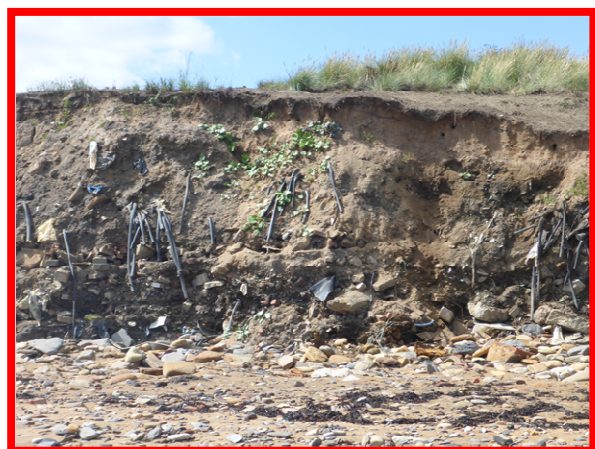
*Actively eroding spoil cliff (/3401C05)*

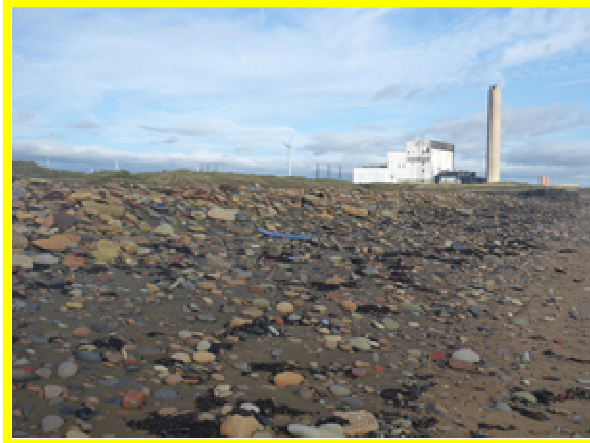
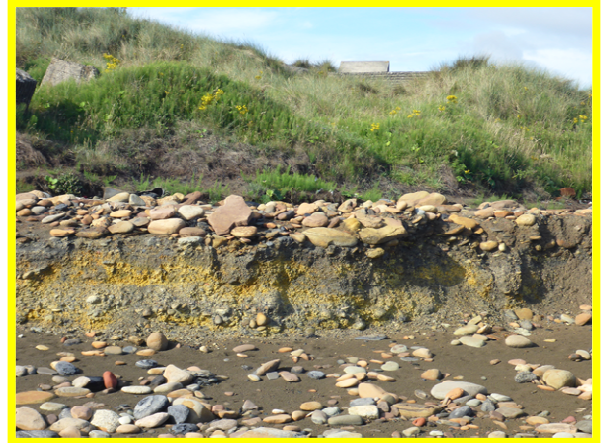
*Eroding colliery spoil in southern Lynemouth Bay*

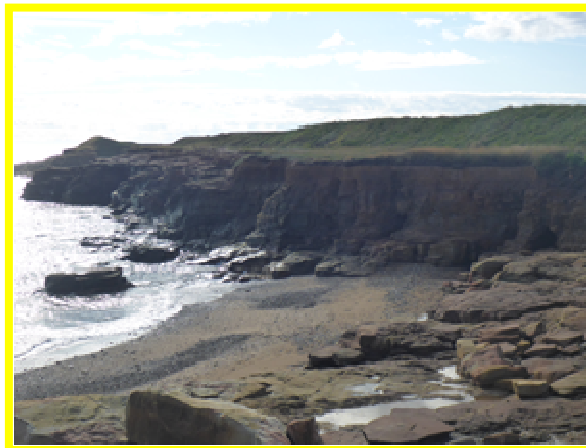
*Currently relatively stable cliffs around Beacon Point (/3501C03)*

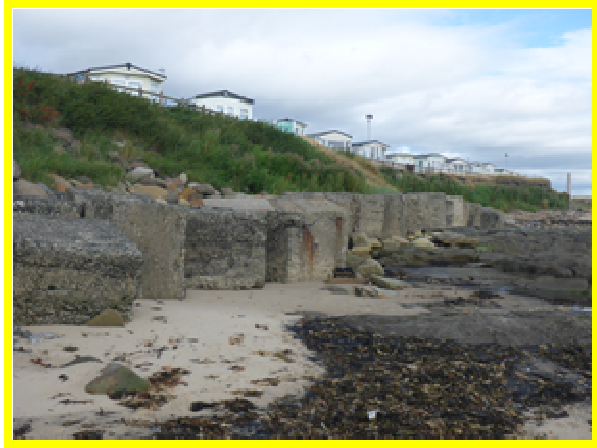
*More stable central section fronting caravan park (/3501C06)*

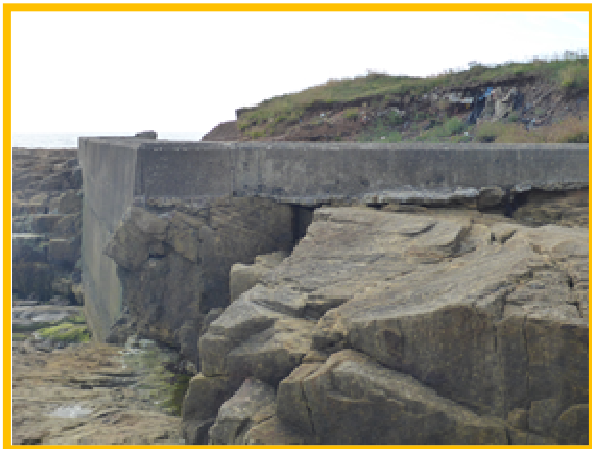
*Seawall with undermining and outflanking (/3501C08)*

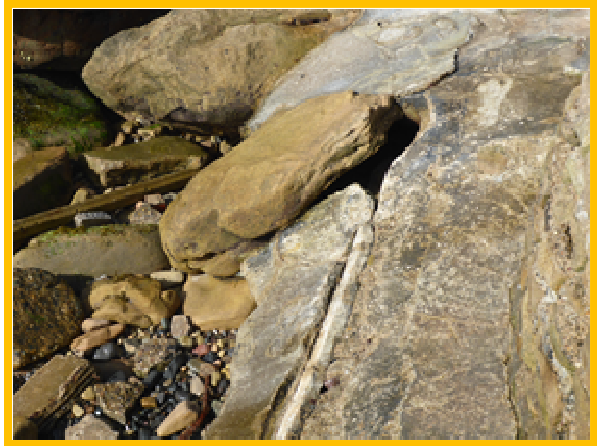
*Undermining at toe of small wall*

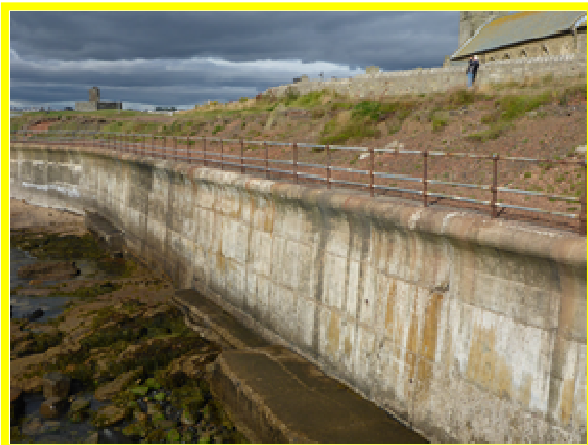
*Church Point seawall in fair overall condition (/3601C12)*

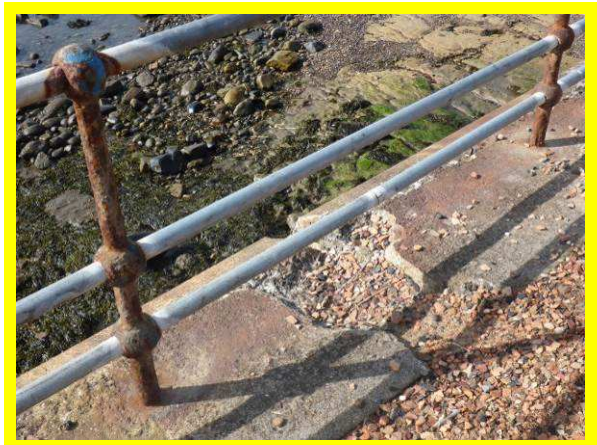
*Local crest damage to Church Point seawall (/3601C12)*

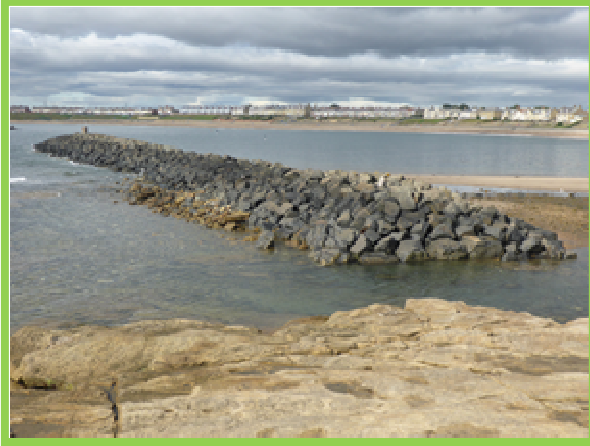
*North breakwater in Newbiggin Bay in overall good condition (/3601C13)*

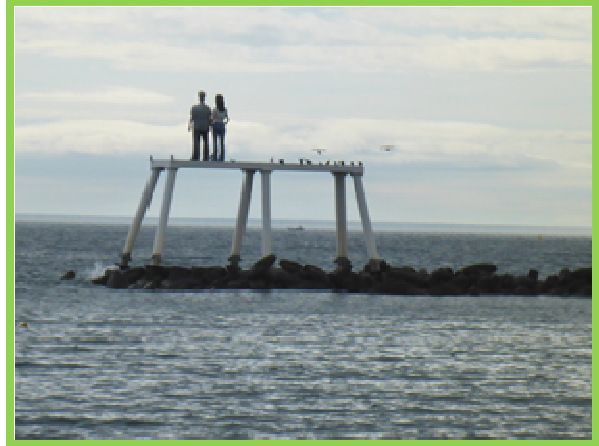
*Detached breakwater in central Newbiggin Bay remains in very good condition with salient/tombolo developed in lee (/3601C13)*

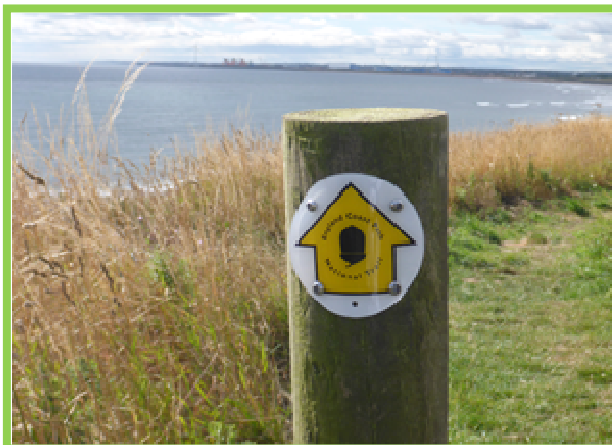
*England Coast Path sign*

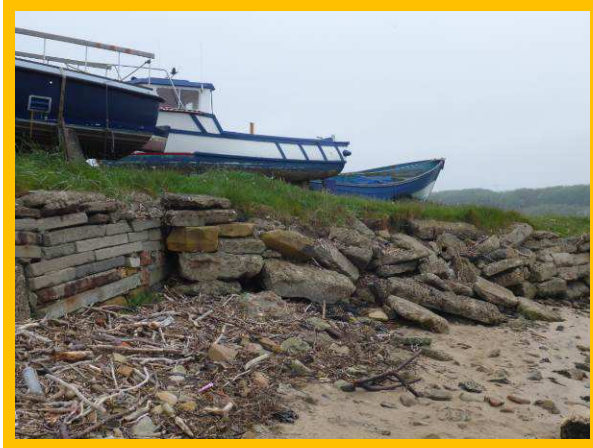
*Failed section of Wansbeck Boat Club retaining wall (/3801C02)*

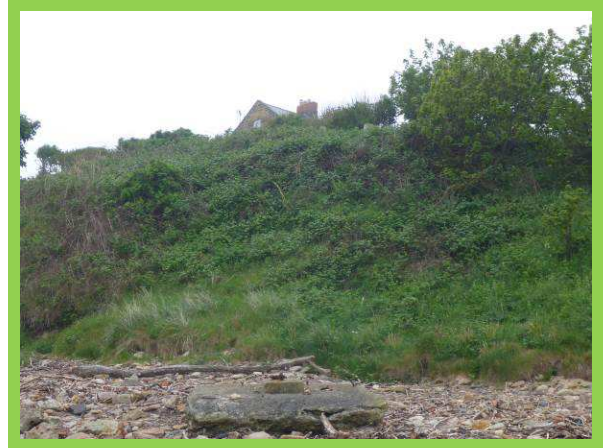
*Relatively stable cliffs on inner estuary (/3801C01)*

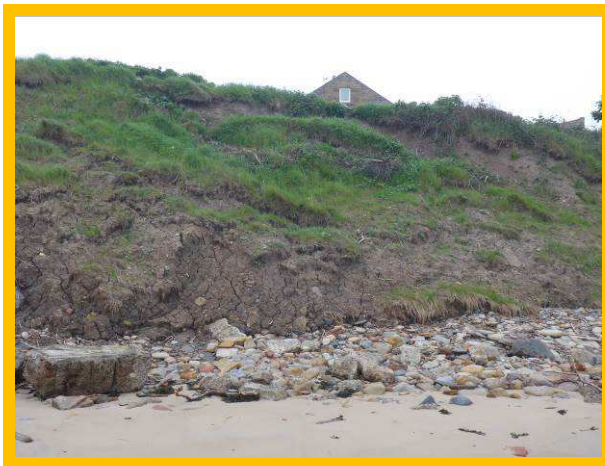
*Eroding cliffs south of Cambois House (/3901C01)*

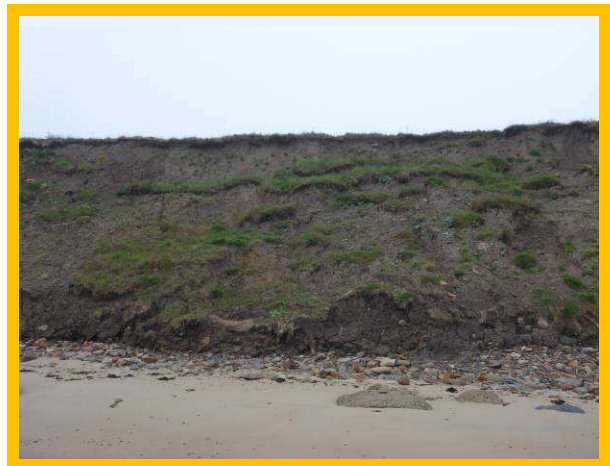
*Eroding cliffs south of Cambois House (/3901C01)*

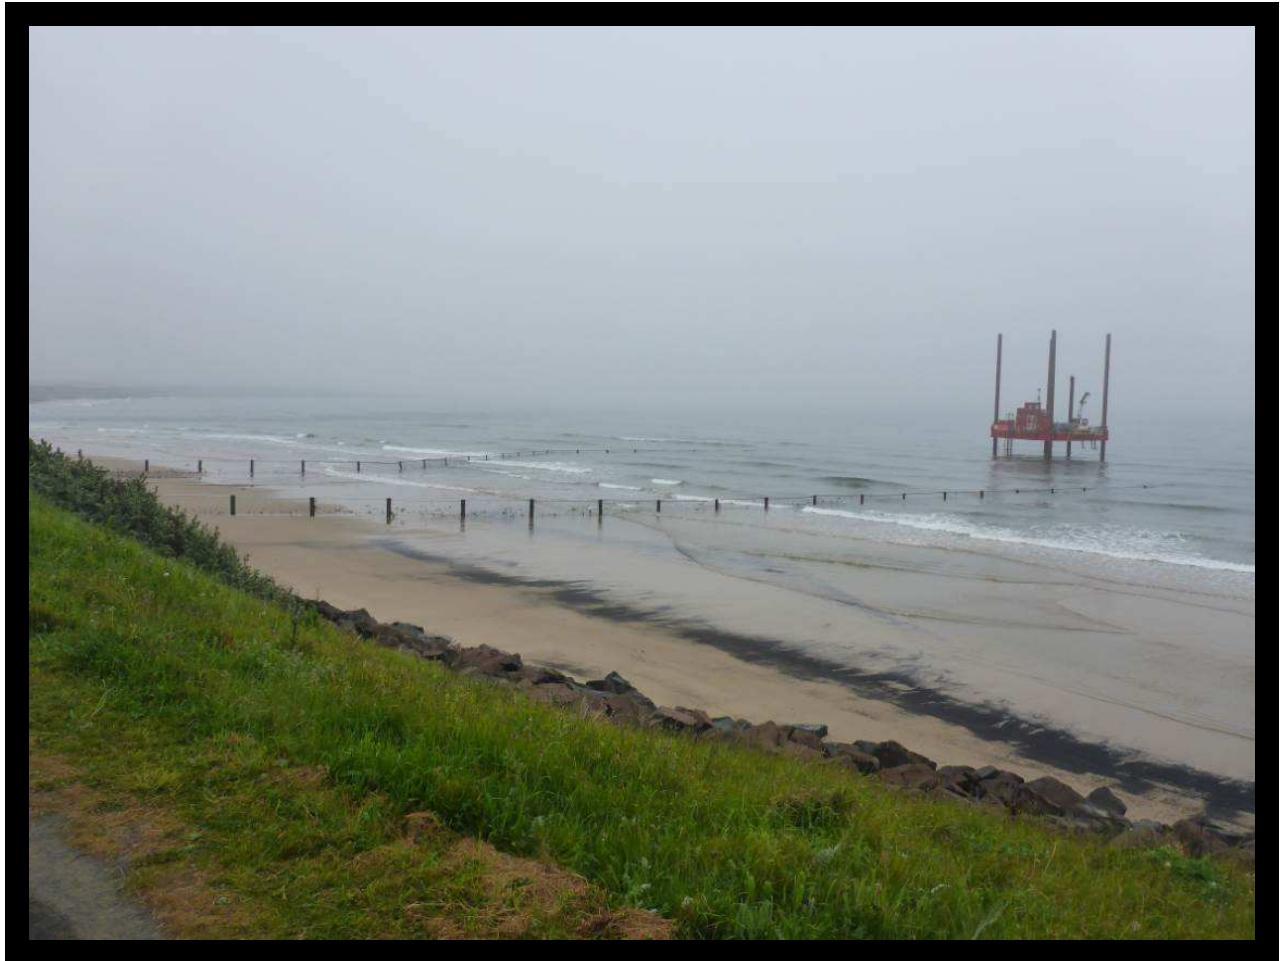
*Cable landfall works for North Sea Interconnection (/3901C05)*

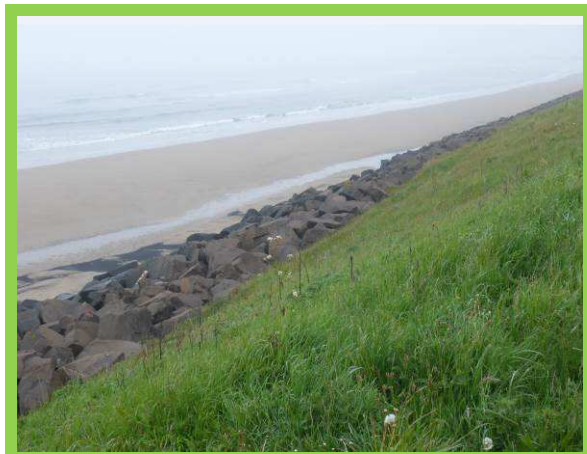
*Rock revetment protecting former foundry site (/3901C05)*

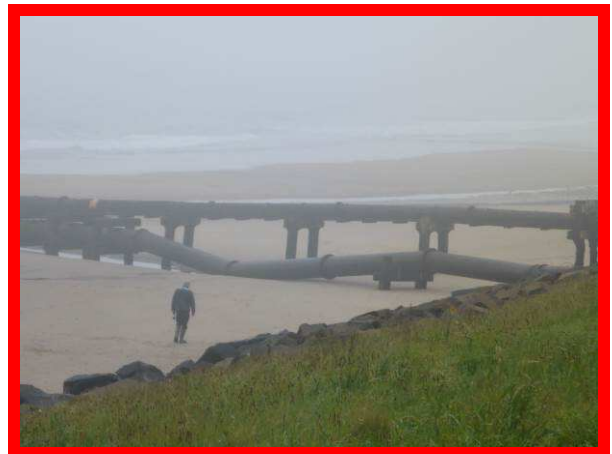
*Failed section of outfall pipe (/3901C05)*

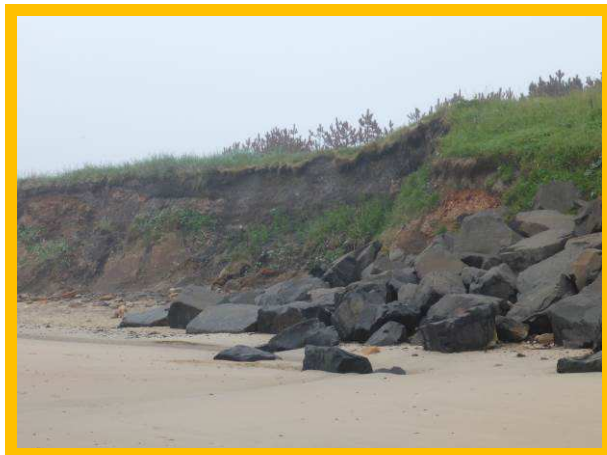
*Erosion of cliffs at terminal end of rock revetment (/3901C03)*

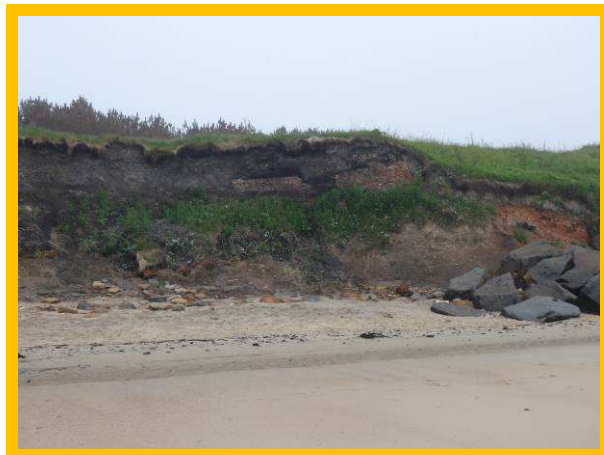
*Erosion of cliffs at terminal end of rock revetment (/3901C03)*

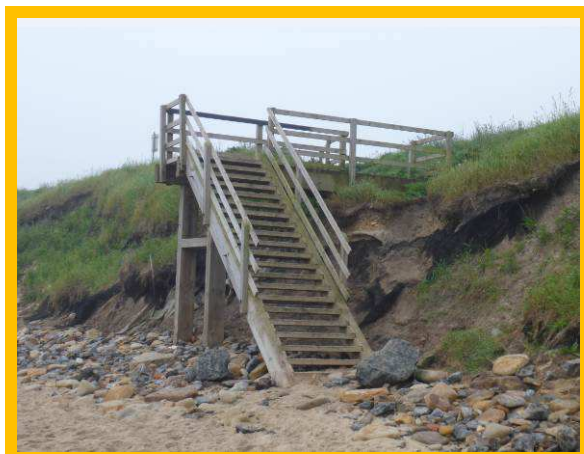
*Erosion of cliffs near recently-installed access steps (/3901C03)*

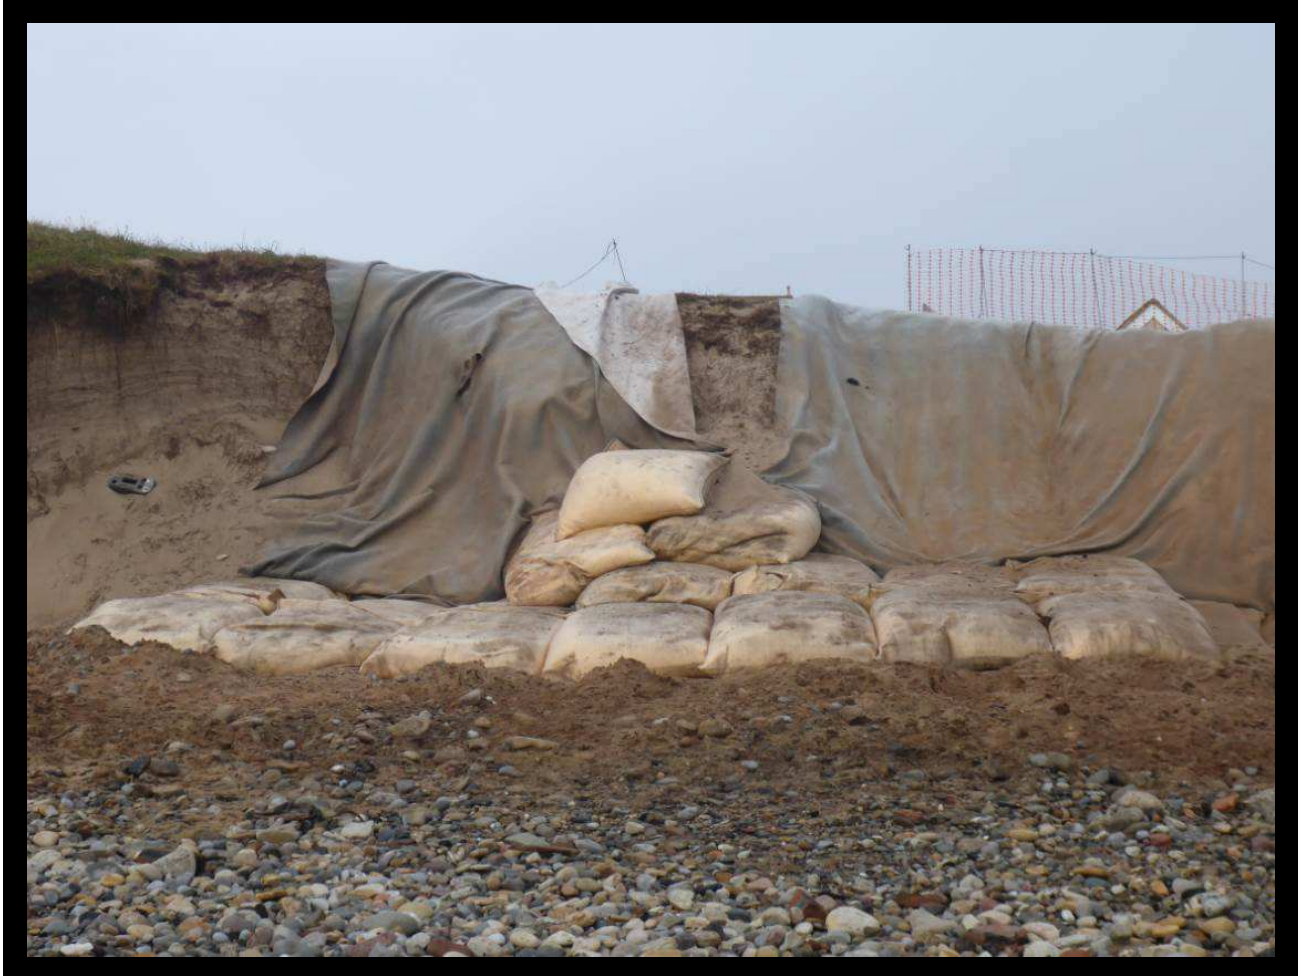
*Dune stabilisation works at landfall of Blyth Offshore Demonstrator Windfarm export cable (/3901C04)*

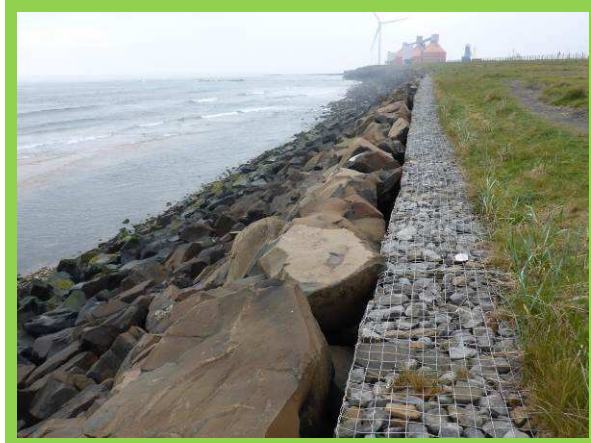
*Rock revetment and gabion baskets (/4001C01)*

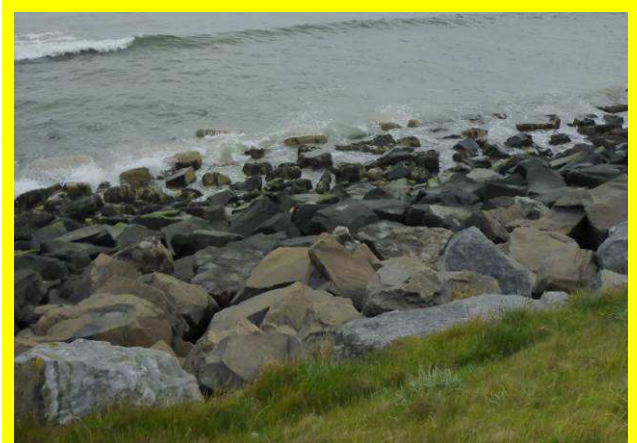
*Composite defence with timber breastwork (/4001C02)*

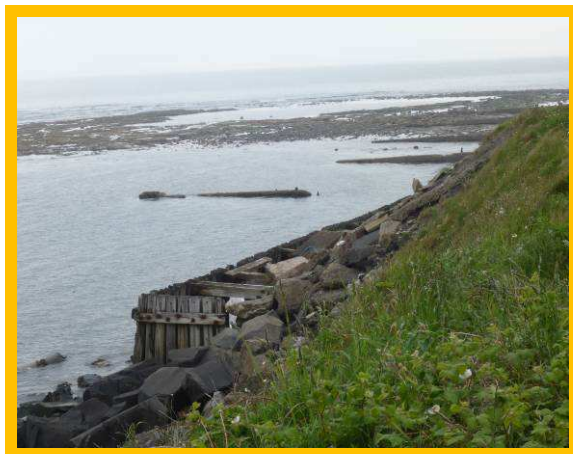
*Composite defence with timber breastwork (/4001C03)*

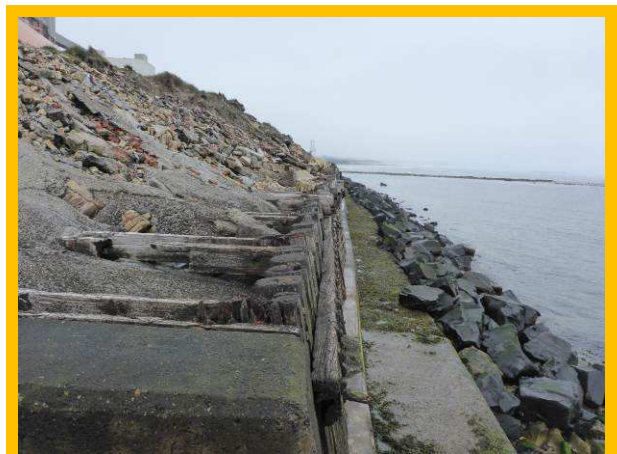
*Composite defence with timber breastwork (/4001C03)*
