## **Cell 1 Regional Coastal Monitoring Programme Walkover Inspection Surveys 2018**

**Northumberland County Council**

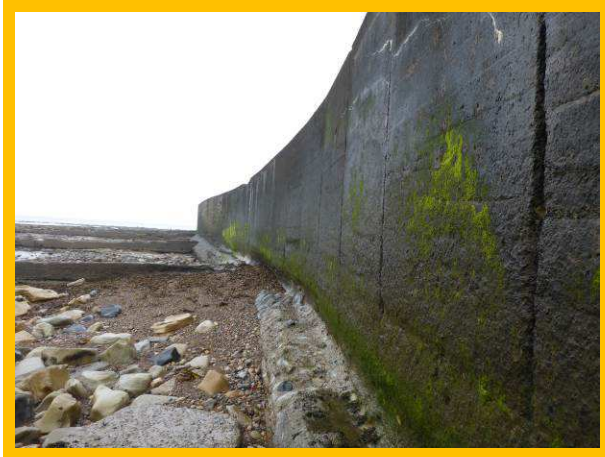
*Landward section of Blyth East Pier (4001C04)*

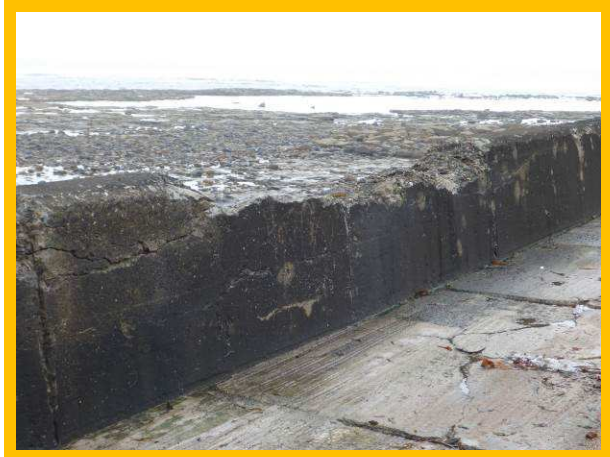
*Damaged wall crest to landward section of Blyth East Pier (4001C04)*

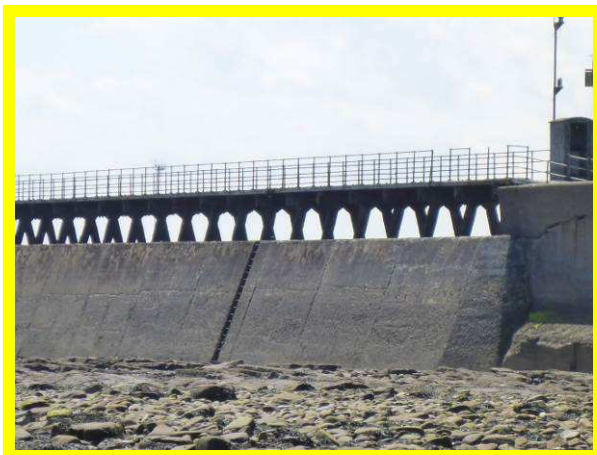
*Generally fair condition of main Blyth East Pier substructure (although superstructure in poorer condition) (4001C05)*

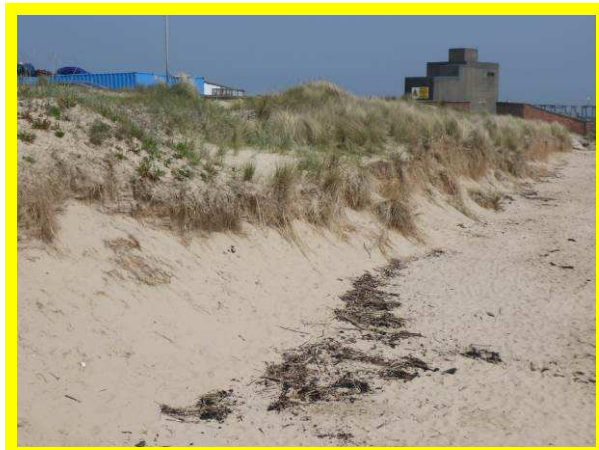
*Storm damage to usually stable dunes (/4201C10)*

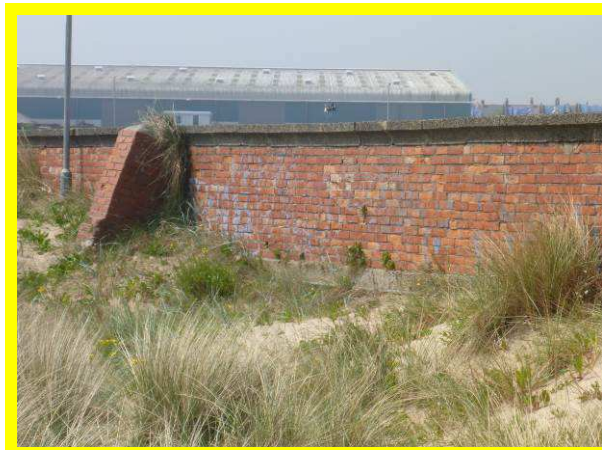
*Masonry wall to rear of dunes (/4201C10)*

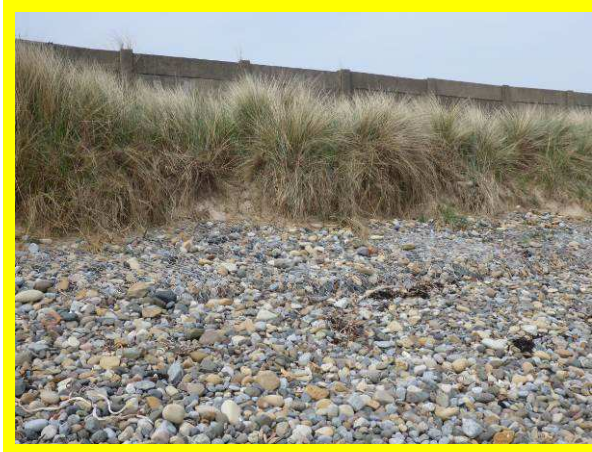
*Cobble berm at toe of dunes with concrete plank wall to rear (/4201C11)*

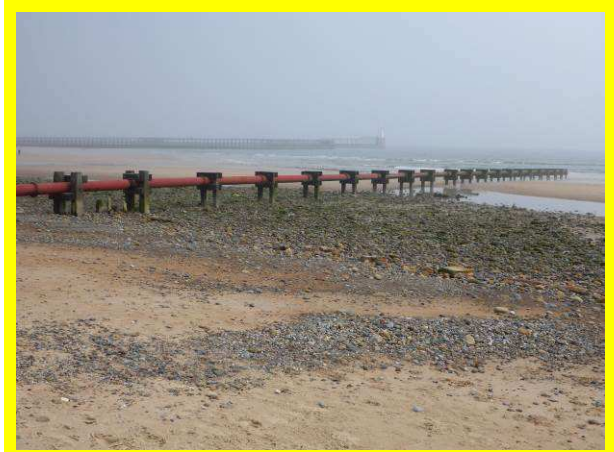
*Cobble lag on mid beach by outfall (/4201C11)*

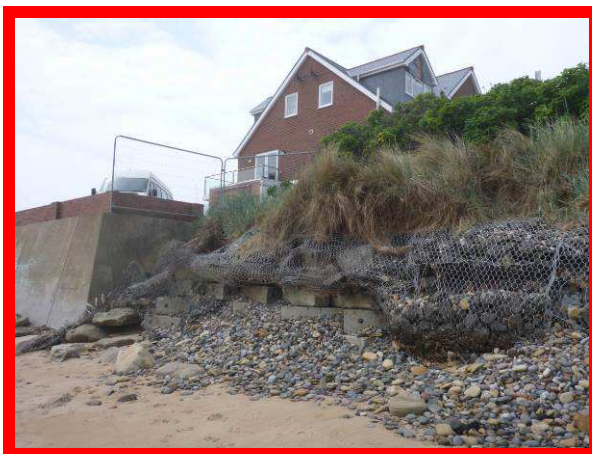
*Failing gabions protecting very narrow strip of dunes (/4201C03)*

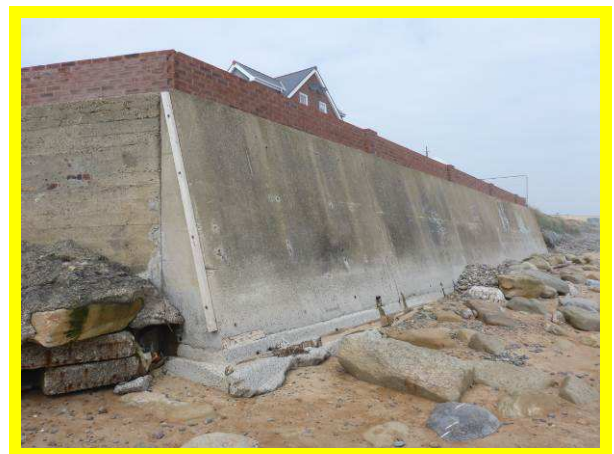
*Existing sea wall protecting new properties (/4201C04)*

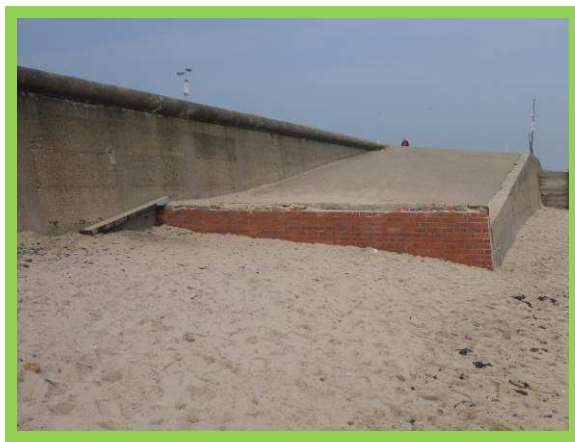
*Low beach levels at ramp new end of promenade (4201C07)*

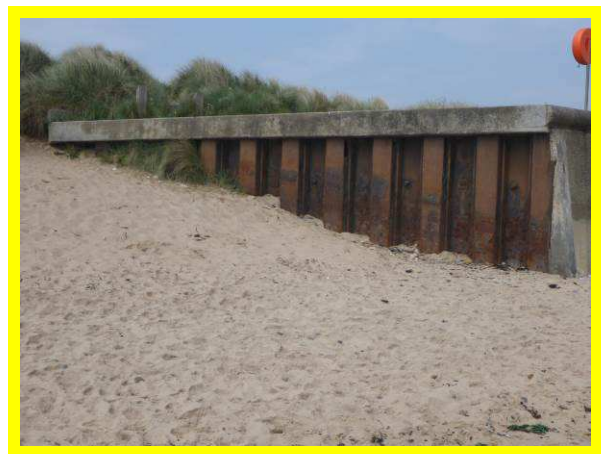
*Steel sheet pile end to promenade (4201C08)*

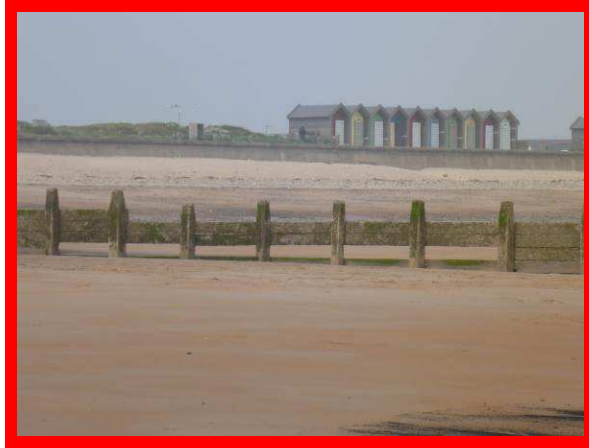
*Missing boards from northern groyne (/4301C01)*

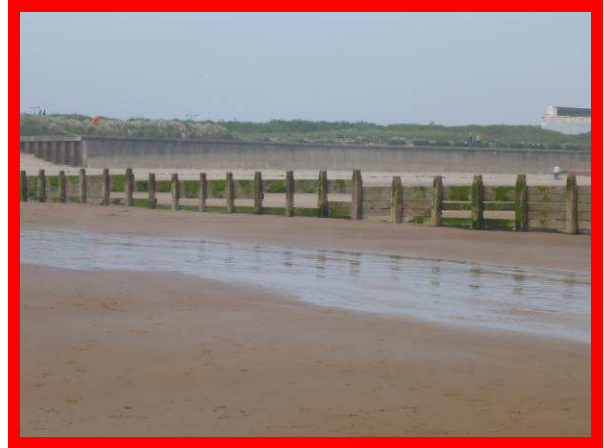
*Missing boards from central groyne (/4301C01)*

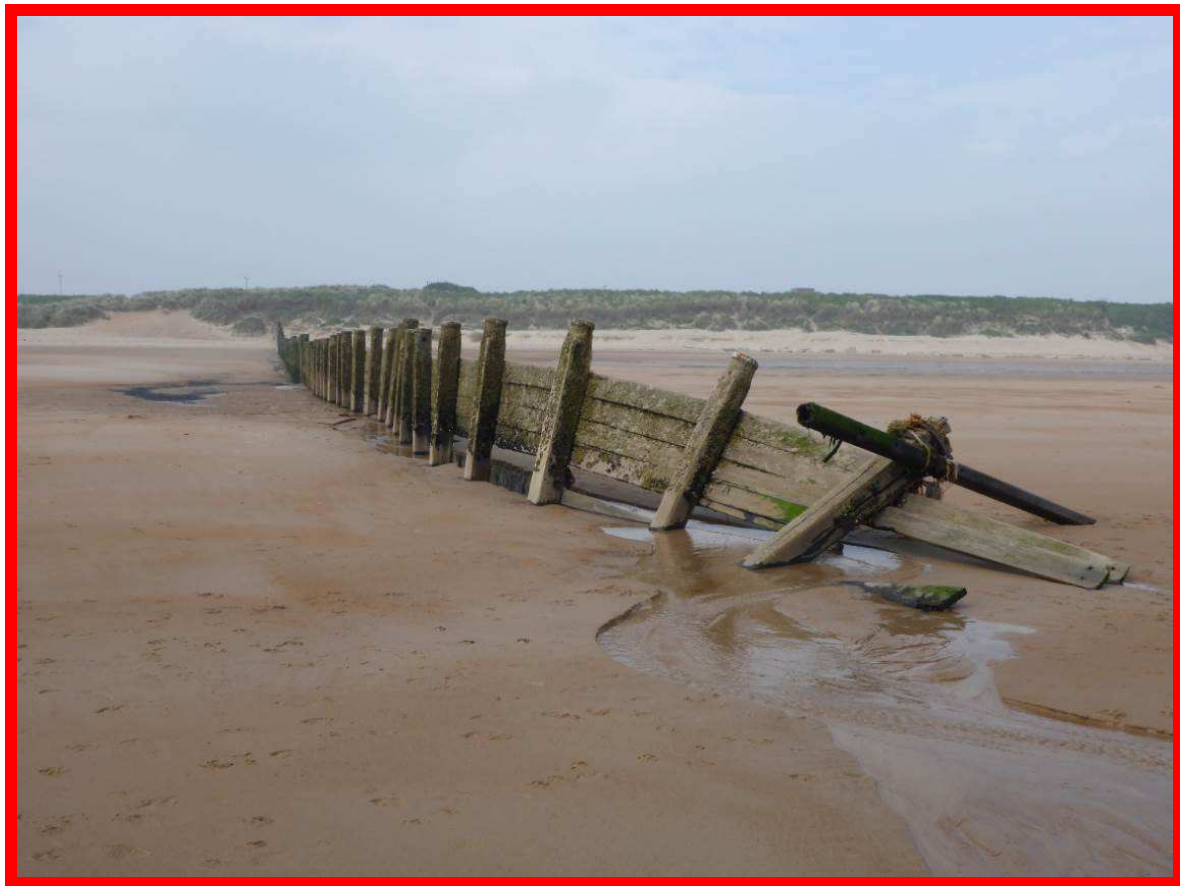
*Failed seaward end of southern groyne (/4301C01)*

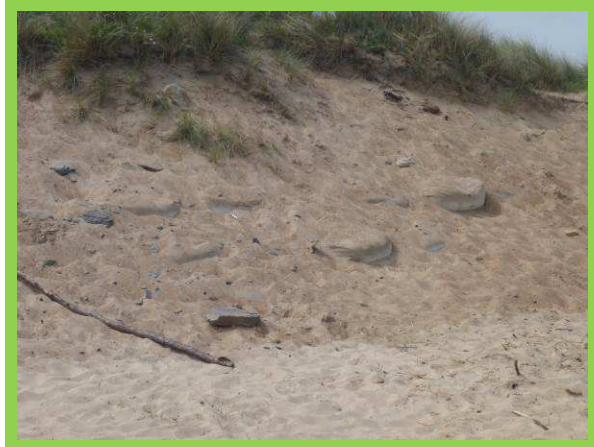
*Exposure of sand bags on dunes near Meggie's Burn (/4301C01)*

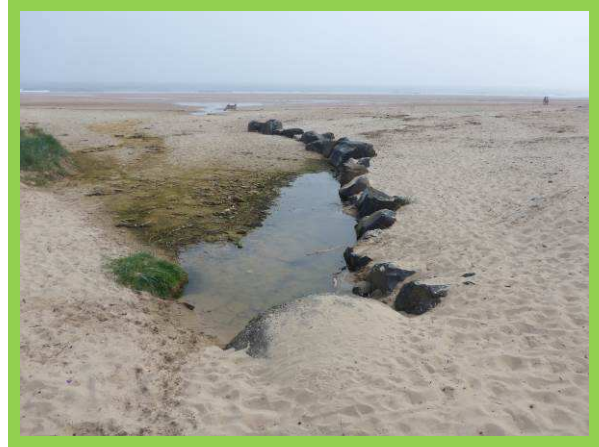
*Rock armourstone placed in 2016 to train course of Meggie's Burn away from dune toe (/4301C01)*

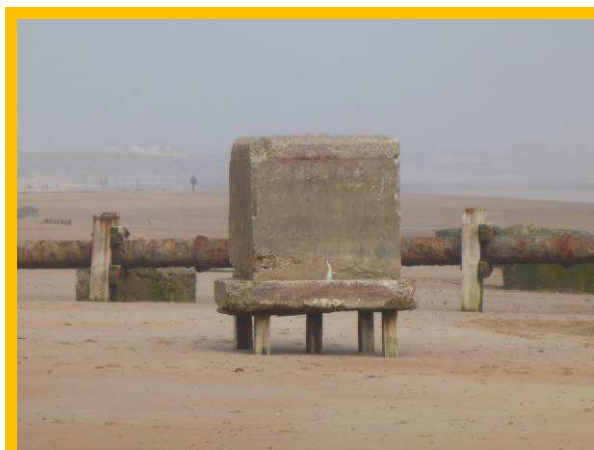
*Exposure of anti-tank block in central South Bay (/4301C02)*

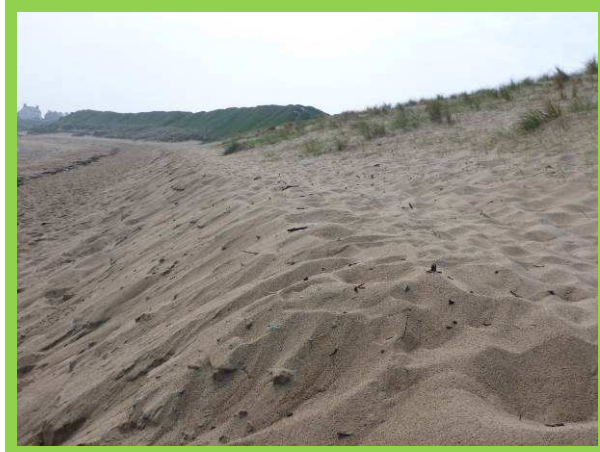
*High sand berm at toe of dunes in south of South Beach (/4301C02)*

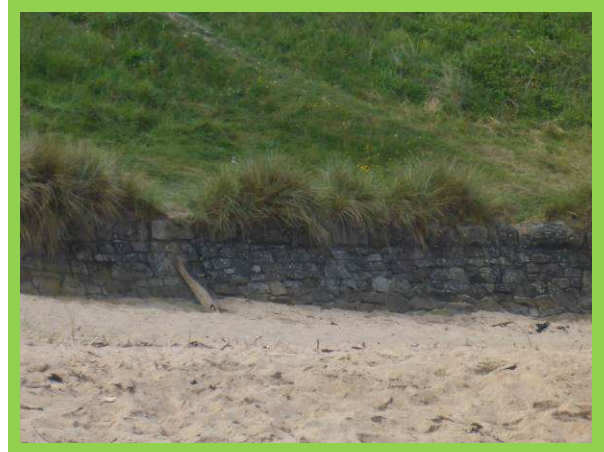
*Stable dunes and good condition low wall at Sandy Island (/4401C01)*

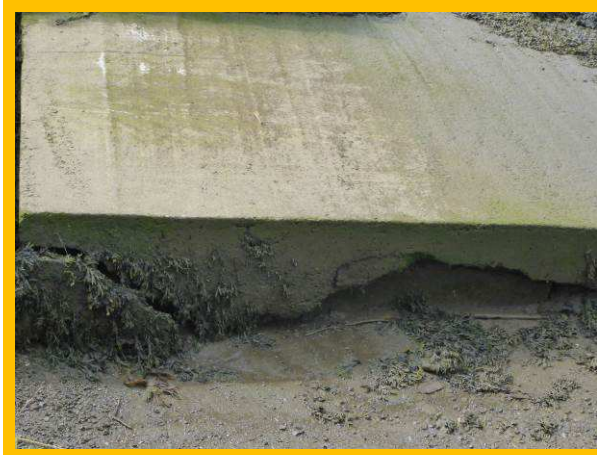
*Undermining at toe on inner face of boat ramp (/4401C05)*

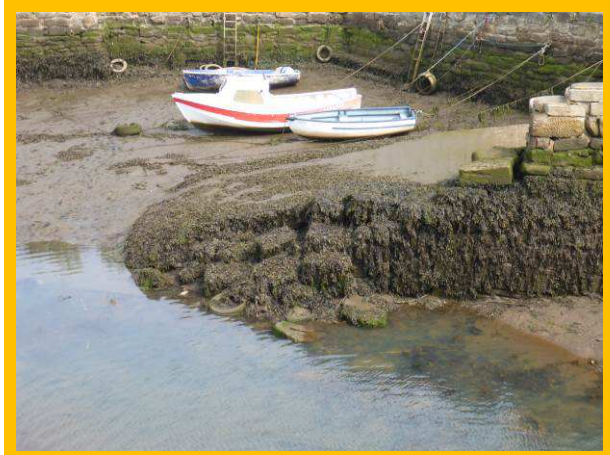
*Collapsed wall on outer face of boat ramp (/4401C05)*

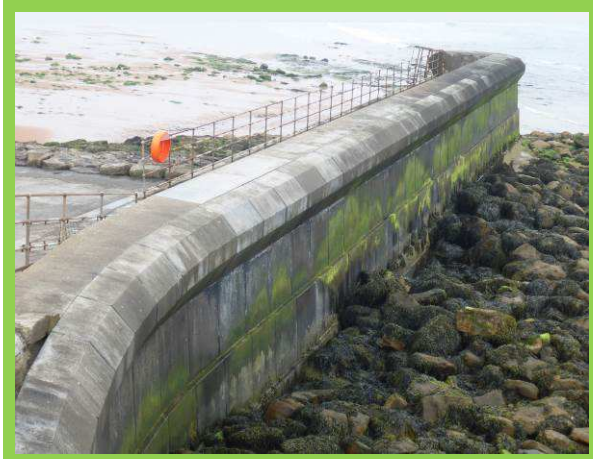
*Pier wall (/4401C10)*

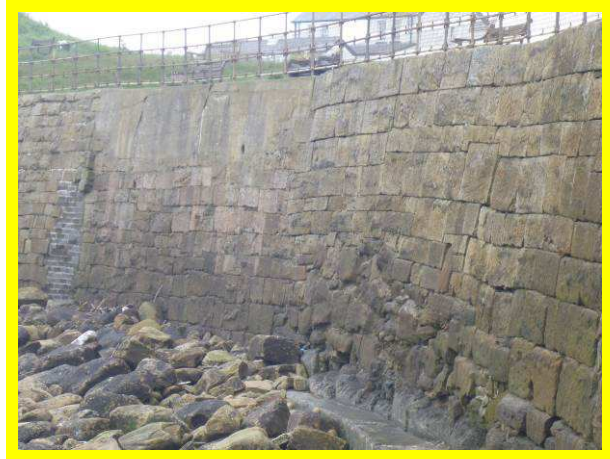
*High masonry wall (/4401C11)*

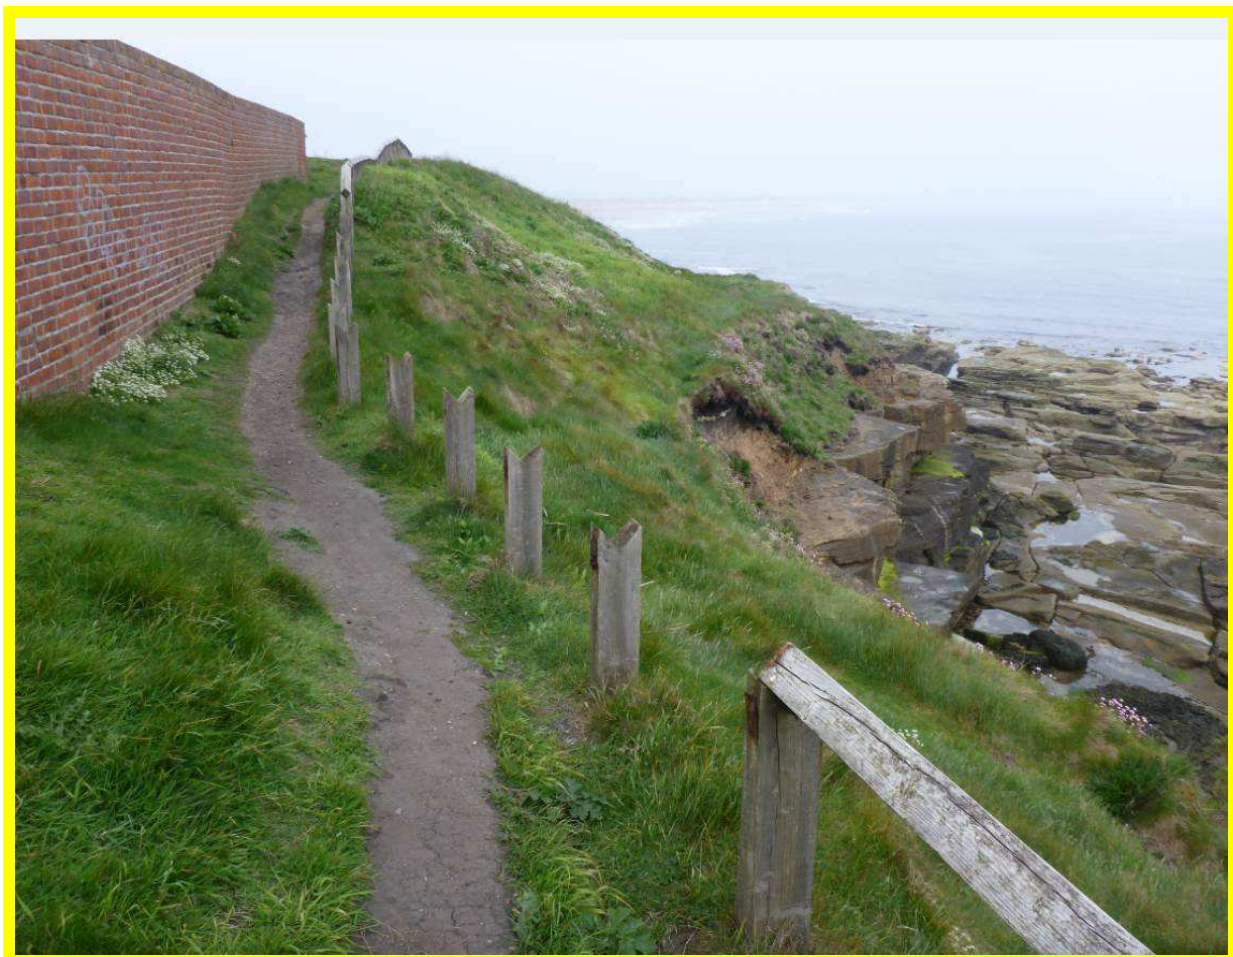
*Cliffs at Rocky Island – note missing low fencing (/4401C12)*

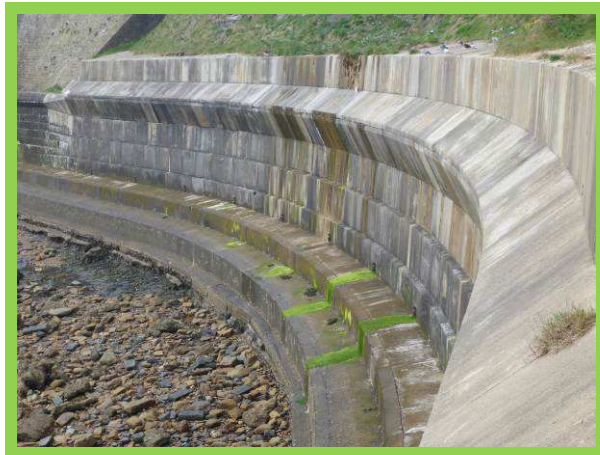
*Near-vertical seawall (/4401C14)*

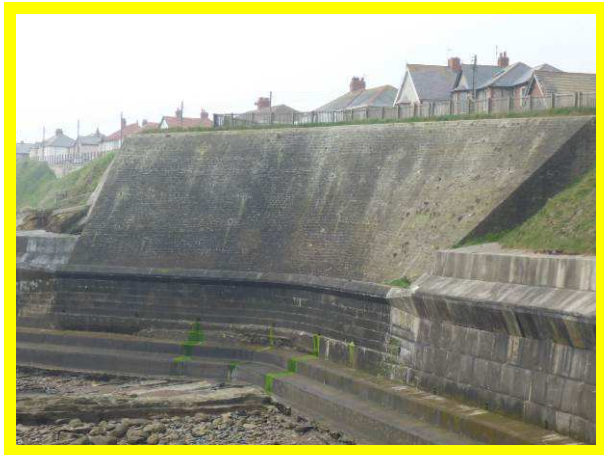
*Seawall with upper brickwork retaining wall (/4401C15)*

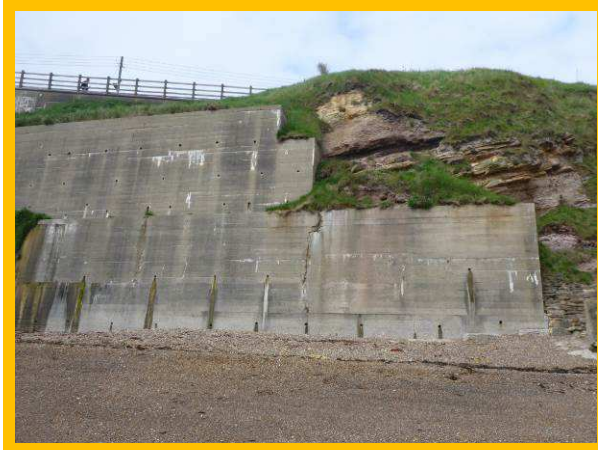
One of three notable vertical cracks in the sea wall (/4401C17)

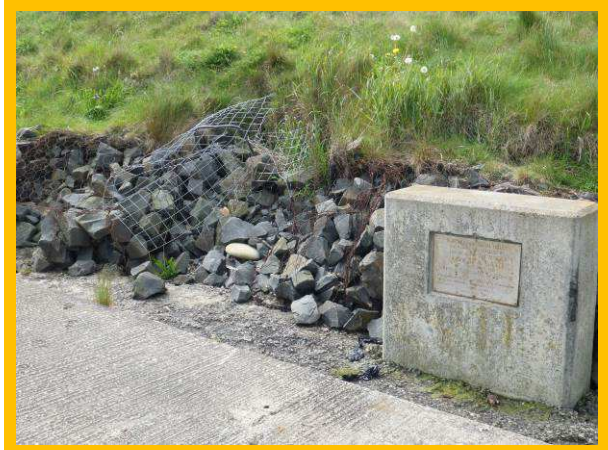
Break-up of gabion baskets (/4401C19)
