## **Cell 1 Regional Coastal Monitoring Programme Walkover Inspection Surveys 2020**

**Northumberland County  
Council**

## Walkover Inspection Surveys 2020

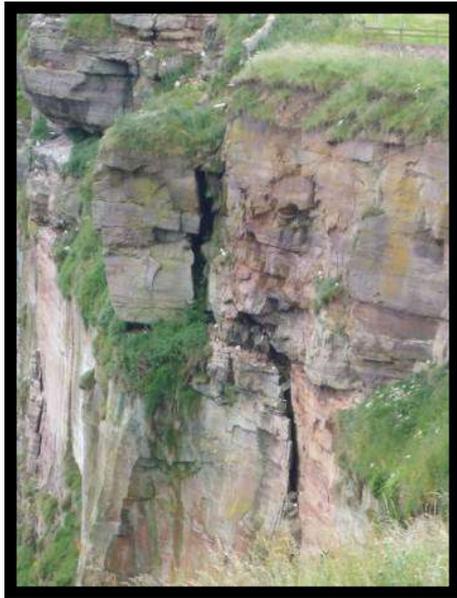
The cliffs at Marshall Meadows Bay are fractured in places adjacent to the caravan park but have been in this condition for some time with no apparent signs of collapse between subsequent inspections. At the time of the inspections, no recent movement was observed in terms of either rock falls in the harder rock base or slumping in the overlying softer material, although both processes remain the characteristic behaviour of these cliffs. There is one area of large overhang, but this has not collapsed for some time.

*Fractured cliffs at Marshall Meadows Bay (/0601C02) - 2016*

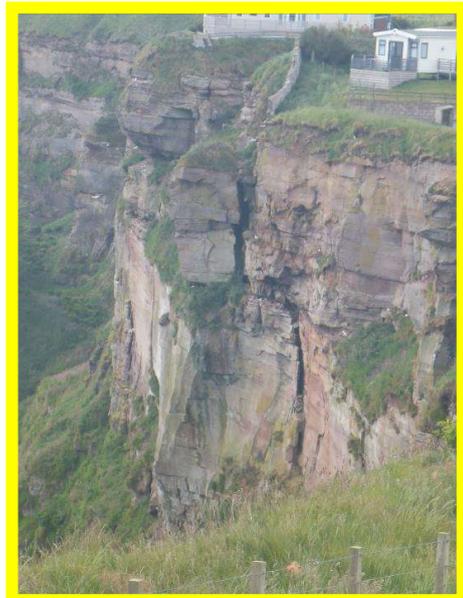
*Fractured cliffs at Marshall Meadows Bay (/0601C02) - 2020 (no change)*

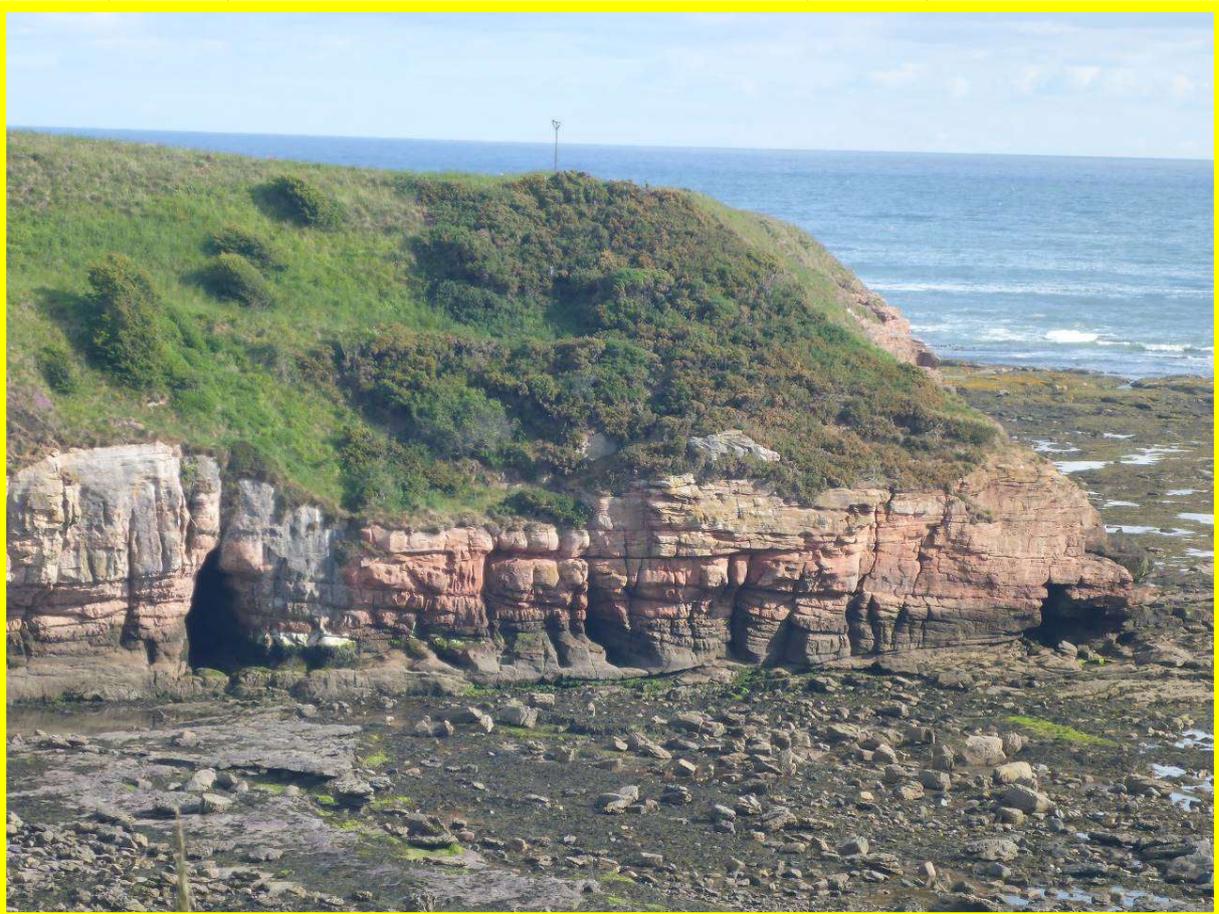
*Caves at base of cliffs (/0701C02)*

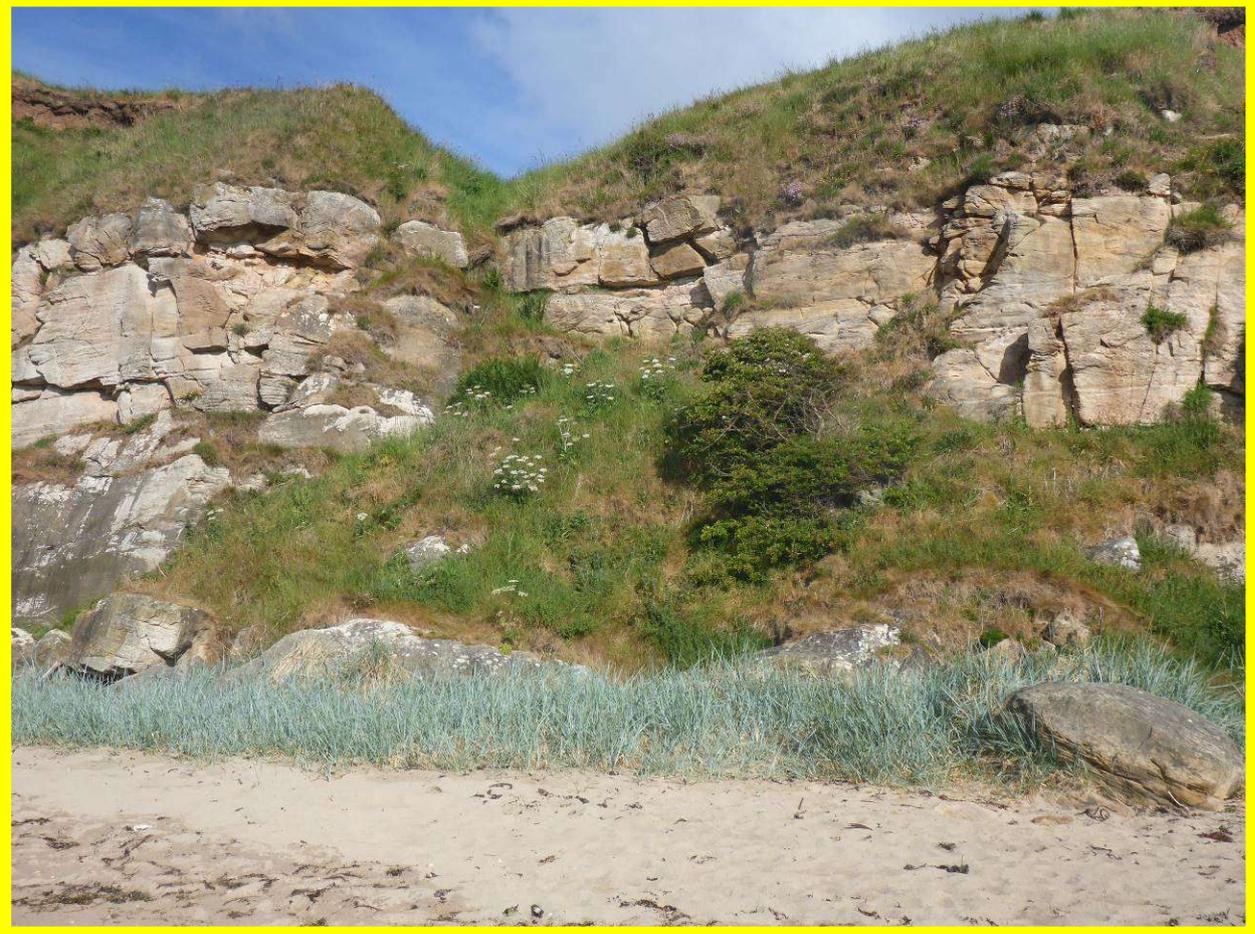
*Sand accumulation and embryo dune growth at toe of cliffs in lee of Breakwater (/0701C05)*

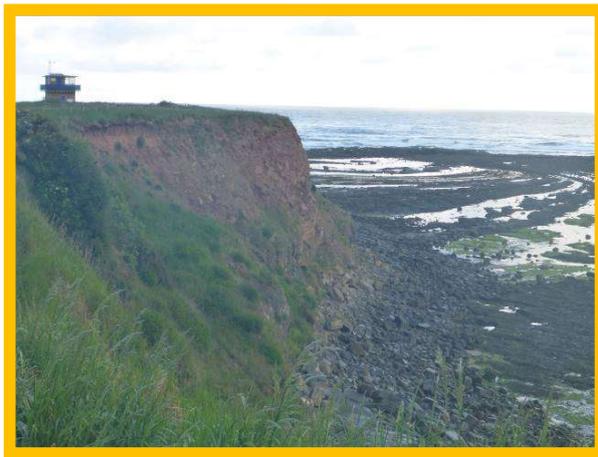
The cliffs along the southern part of Magdalene Fields are actively slumping and the fence and footpath have been moved away from the edge in response. There are signs of tension cracks in the cliff top path, suggesting the slumping remains ongoing. The foreshore is characterised by impressive rock platform.

*Slumping cliffs along Magdalene Fields Golf Course (/0701C12)*

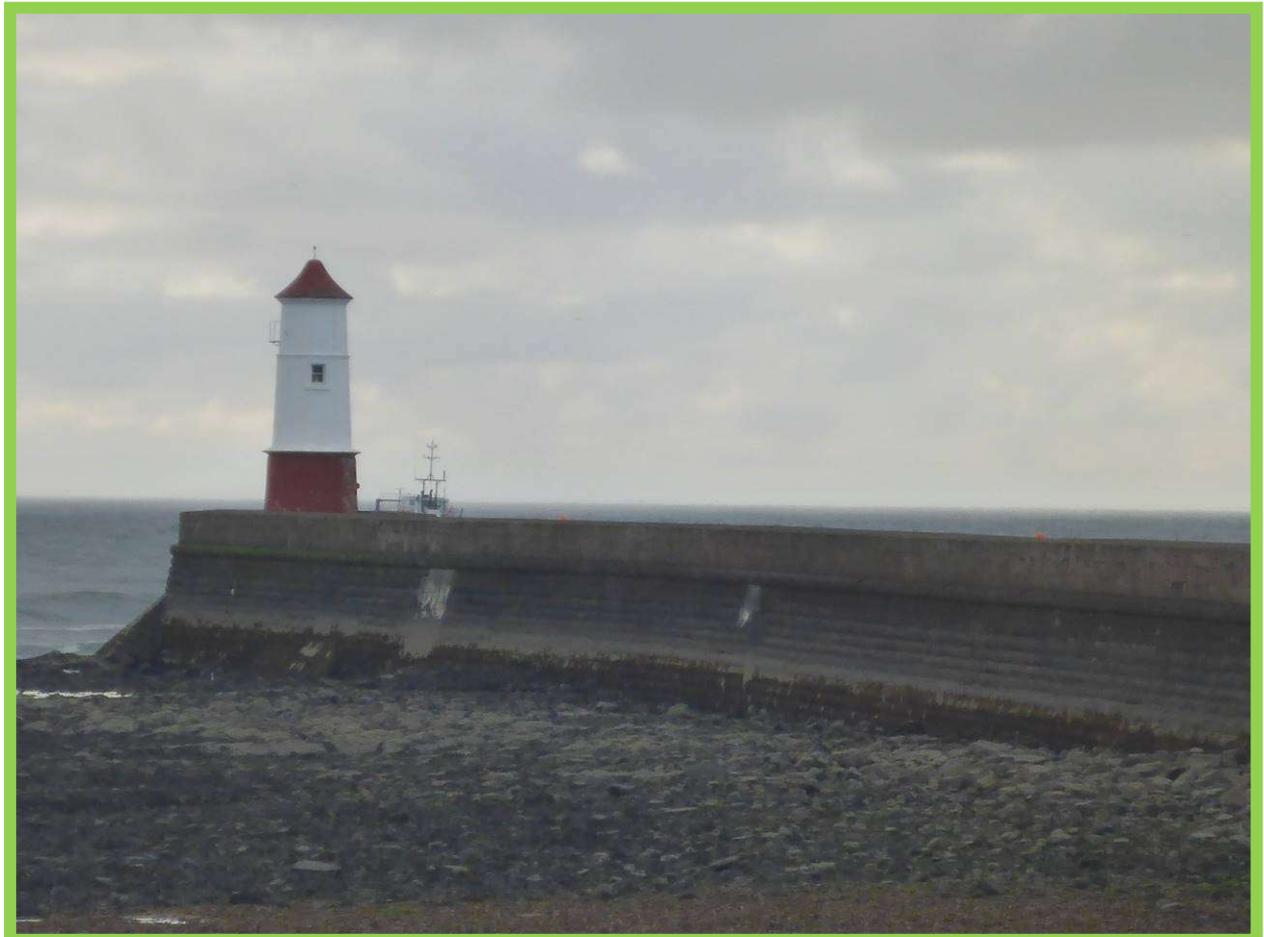
The Berwick Pier underwent substantial refurbishment during 2012/13, including repair of a significant void midway along the leeward face and replacement of the concrete deck.

*Berwick Pier in good overall condition following refurbishment in 2012/13 (/0701C14 & C15)*

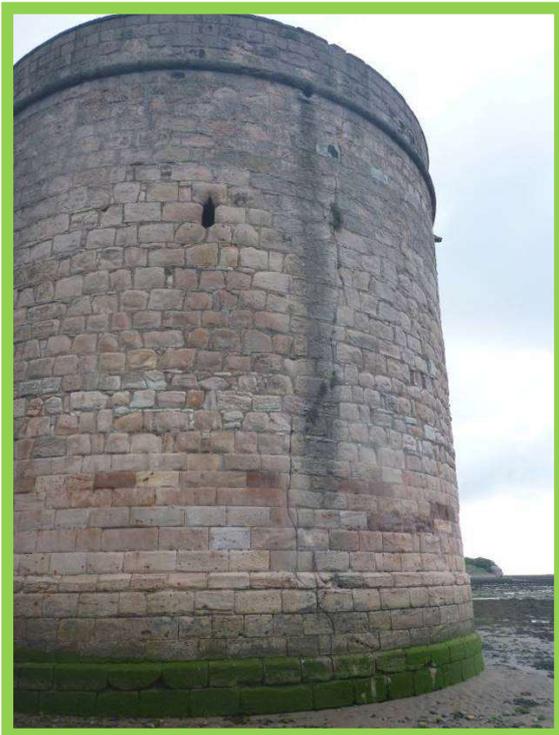
*Vertical crack in wall at roundhead (/0801C06)*

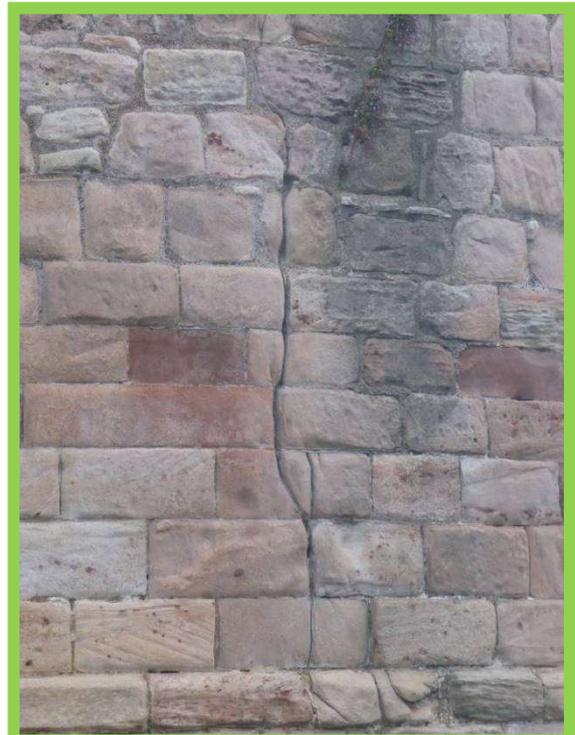
*Vertical crack in wall at roundhead (/0801C06)*

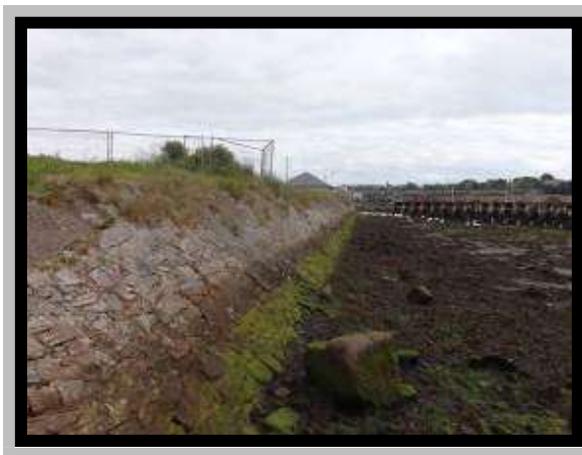
*Masonry revetment 901c04 at northern end -2016.*

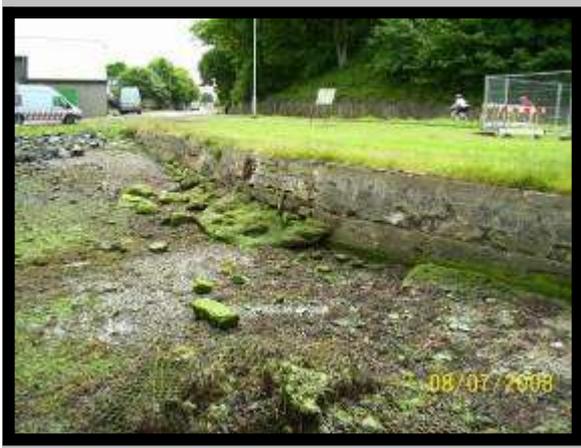
In both cases there has been little change and while both structures show significant gaps and cracking, in 2020 neither structure appears to have deteriorated further.

901c05/06 in 2008 showing toe level and condition of masonry.

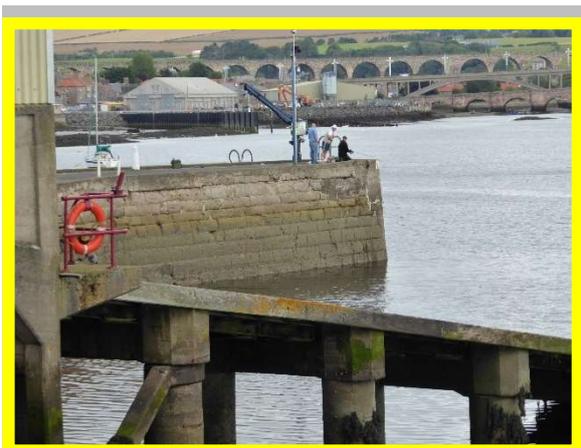
The open piled timber jetty remains in a dilapidated condition. The section behind the RNLI section is in fair condition. Despite some repairs spalling of the concrete support structure to the RNLI Station continues.

901c06 - 2020 general view of Spital Pier .

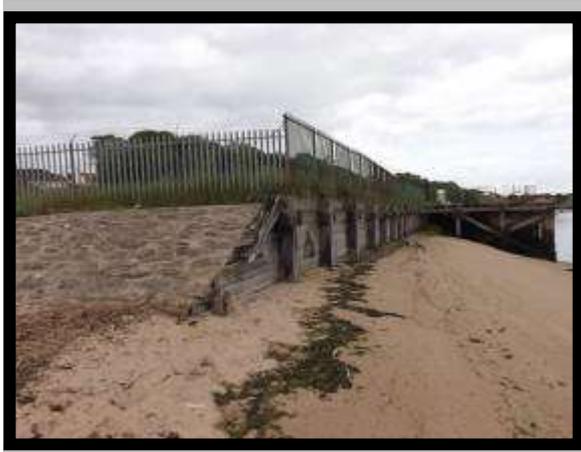
*901c07 high sand levels 2016.*

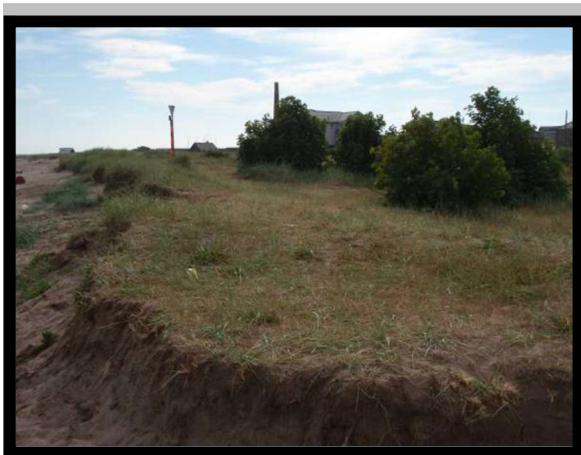
*901c08 - erosion in 2012.*

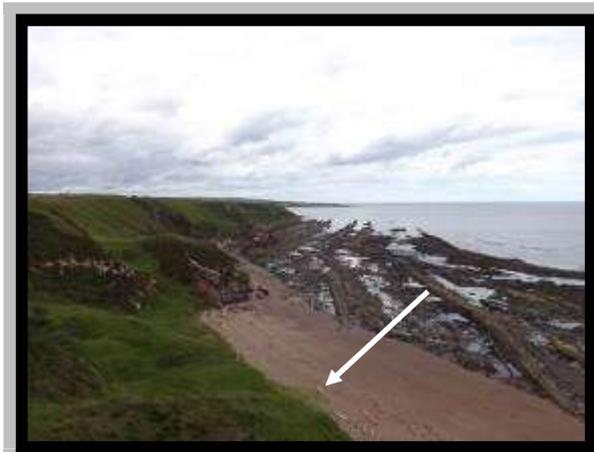
1101/c01 general view of cliffs and beach to north of Sea House 2016.

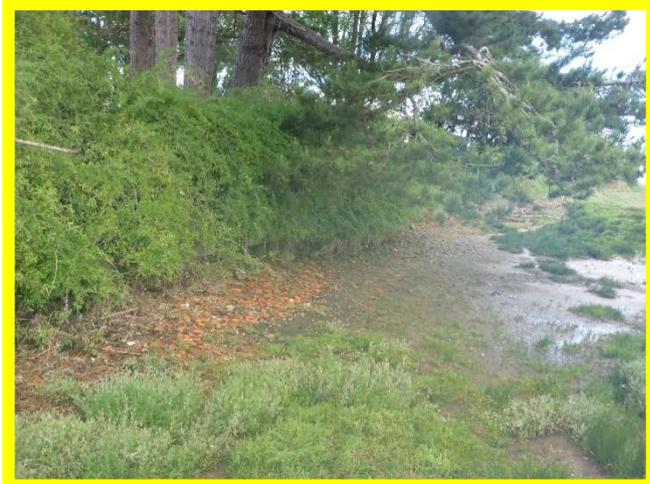
*1401/C23 – dense vegetation covering the local timber defence.*

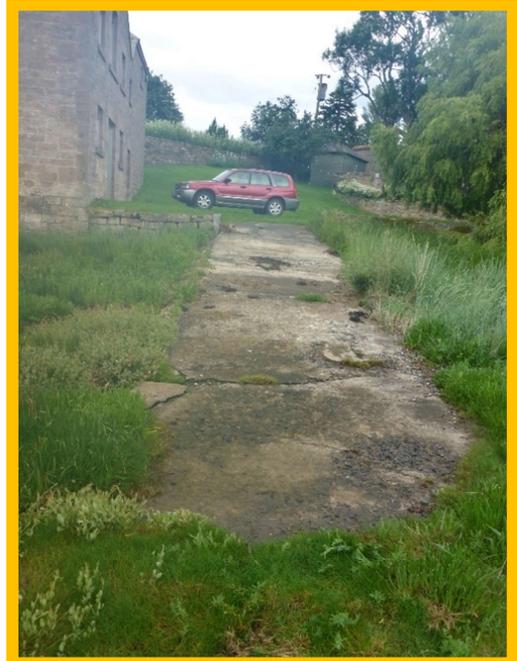
*1401/ C23, Slipway in poor condition.*

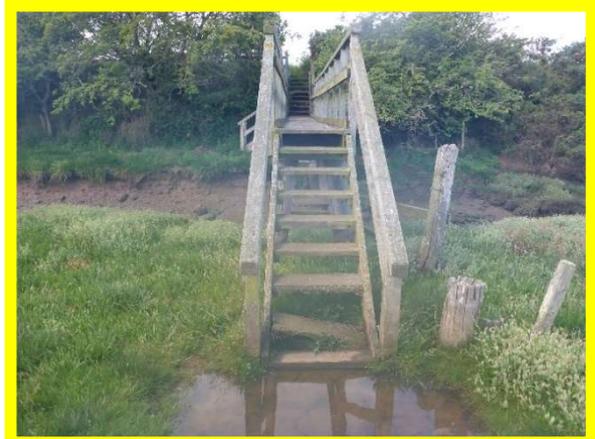
*1401/C24 displaced tread on wooden bridge across the Fenham burn.*

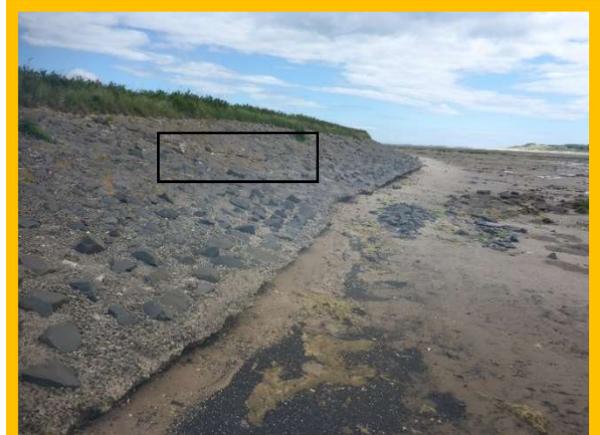
1401C29 – Depleted beach levels believed to be causing washout of material resulting large cracks opening.

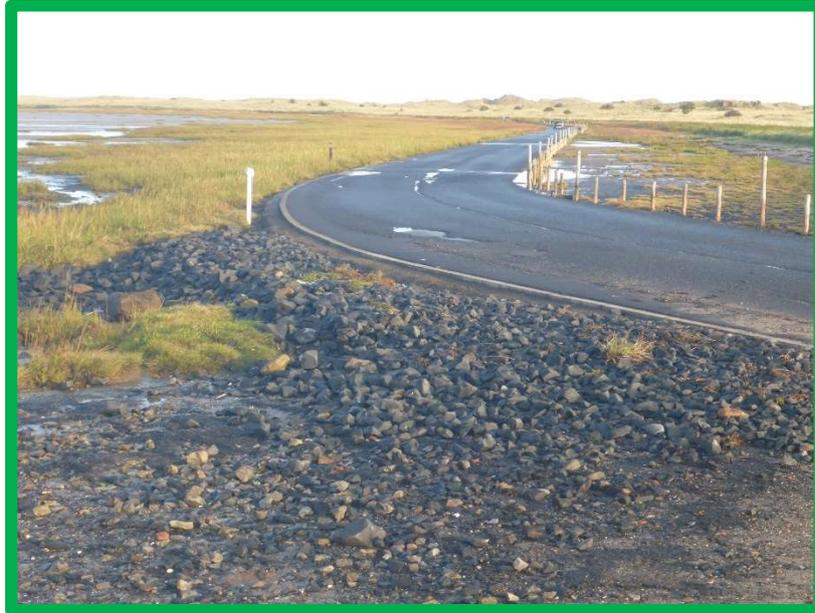
The damage to the causeway road at Chare Ends reported during the 2012 and 2014 inspections was repaired and resurfaced prior to the 2016 inspections. The repairs are holding well.

*Repaired road surface and kerb at Chare Ends in 2016 (4901c01)*

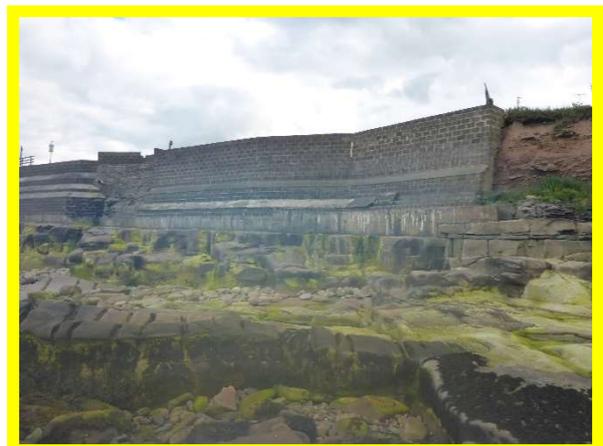
Damage of lower coping 2020 (1701/C02)

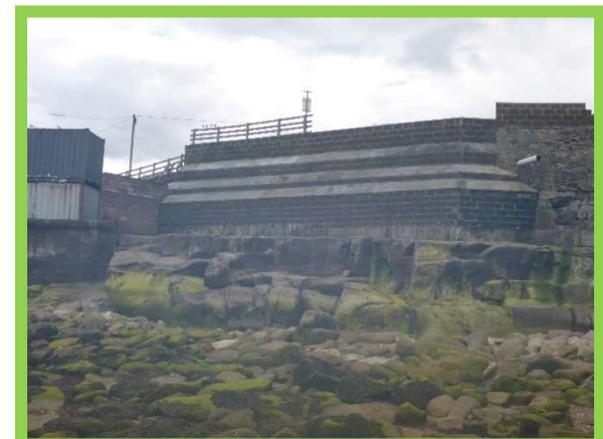
No significant damage - minor abrasion noted to the concrete toe (170104)

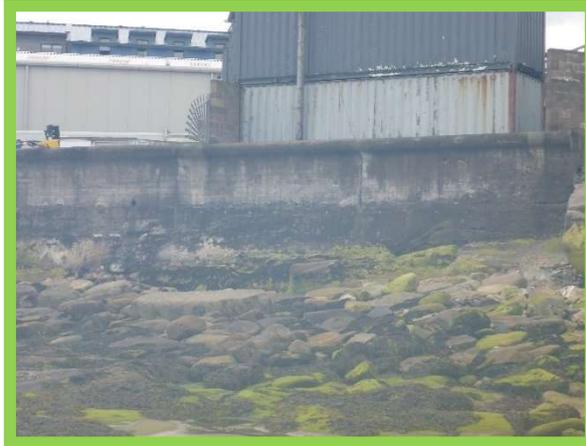
*Harbour wall in good condition 1701/C05.*

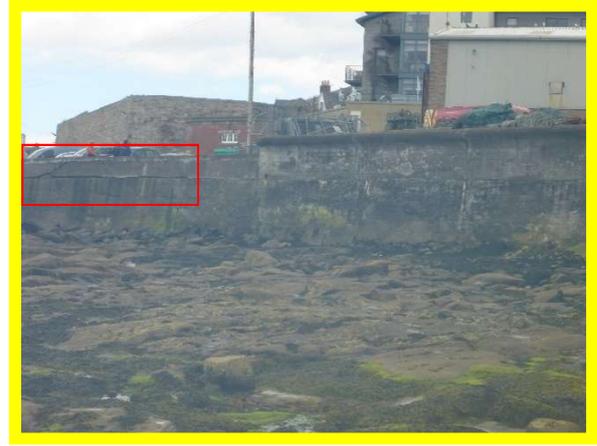
*Old crack not noticeably worse 1701C05-6*

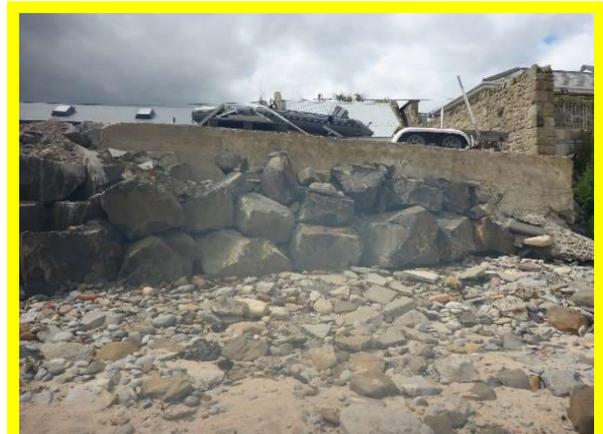
*Concrete cast onto the crest of the revetment to provide flat storage area (/1701/C32)*

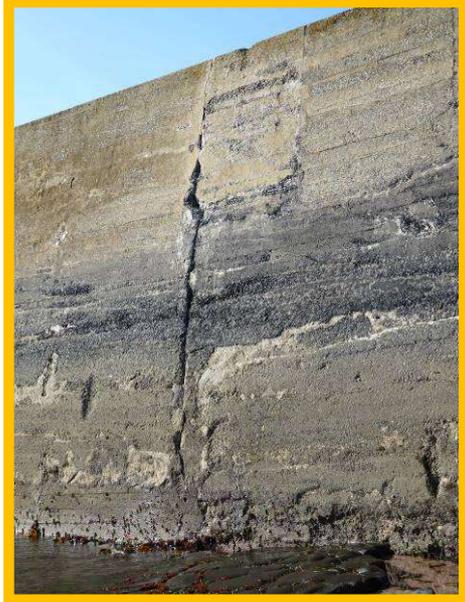
There is some indication of spalling local to the crack towards the end of the Northern Pier but no fundamental change.

2201C03 Crack in north pier. Minor spalling

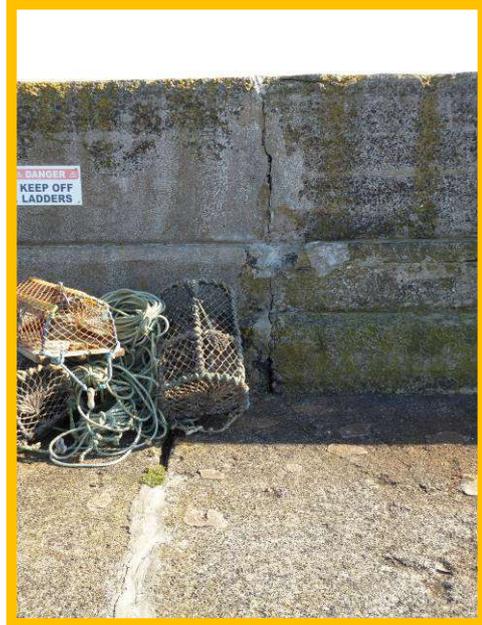
2201C03 Inside face (crest wall) at crack

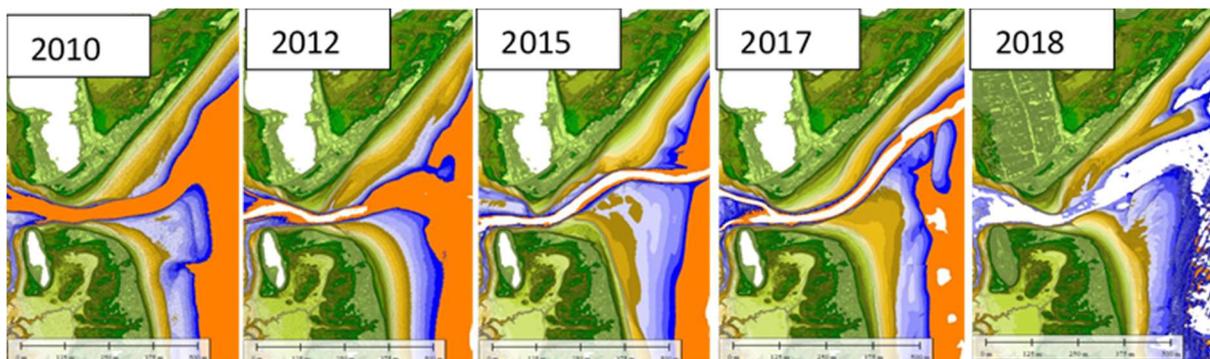
However, as shown particularly in the 2018 image, the influence of change in the channel can be seen to effect the northern length of the beach, with quite specific sections of differential accretion and erosion. While more recent Lidar surveys are not yet available, the variation along the frontage is highlighted in the discussion below.

*Change in beach shape over the whole frontage.*

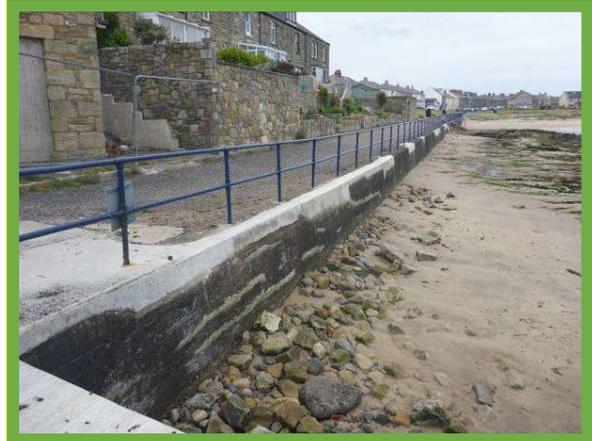
*Seawall at Little Shore Wave Basin repaired to good condition in 2020 (/3001C10)*

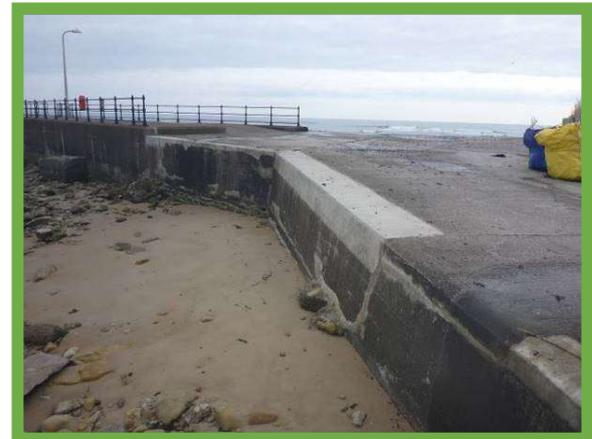
*Repairs return sea wall along Bay View to good overall condition in 2020 (/3001C10)*

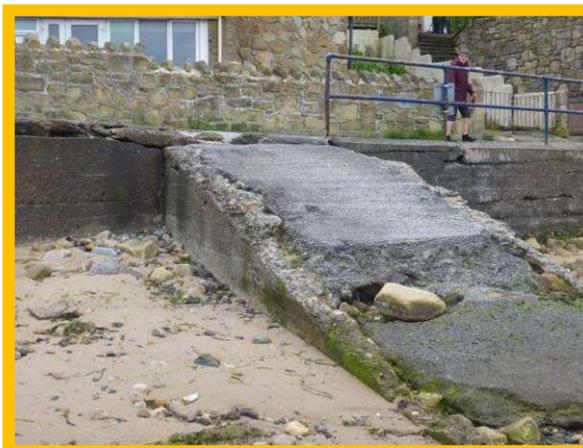
*Access ramp to Little Shore Wave Basin in poor condition in 2018 (/3001C10)*

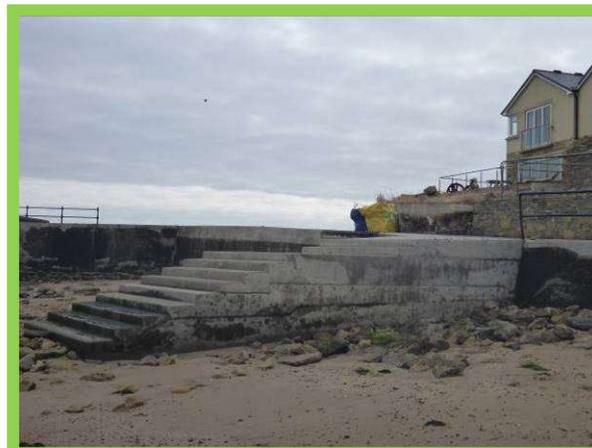
*New access steps to Little Shore Wave Basin in good condition in 2020 (/3001C10)*

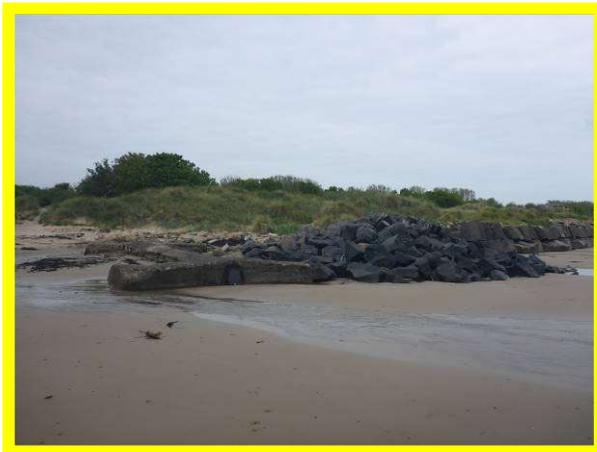
Immediately south of this revetment is an outfall in poor (but draining) condition. It is clearly evident that terminal erosion extends around 100m south of the end of the defended section, cutting the dunes back.

*Rock revetment in fair condition (/3201C05) around poor but functional outfall*

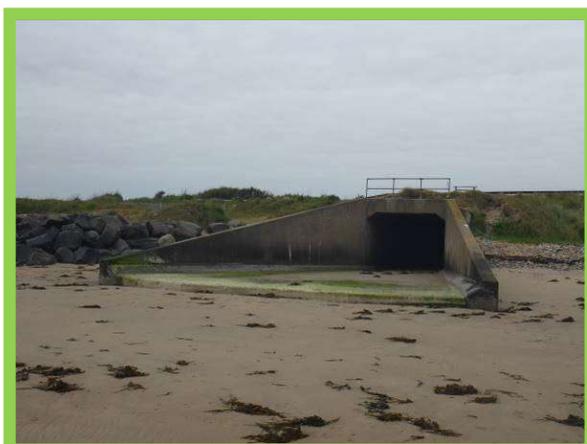
The large structure at the outfall to Ladyburn Lake remains in good condition. The adjacent slipway belonging to the Hadston Scaurs Boat Club remains in fair condition, as does its protective rock revetment. However, the revetment continues to be actively outflanked at the southern end resulting in unravelling of the structure with some rocks displaced across the foreshore and severe cut-back terminal erosion of the low vegetated earth cliffs to the south. These cliffs are in poor condition with recent erosion impinging on the flanks of the road carriageway.

*Concrete outfall and adjacent rock revetment (/3201C12)*

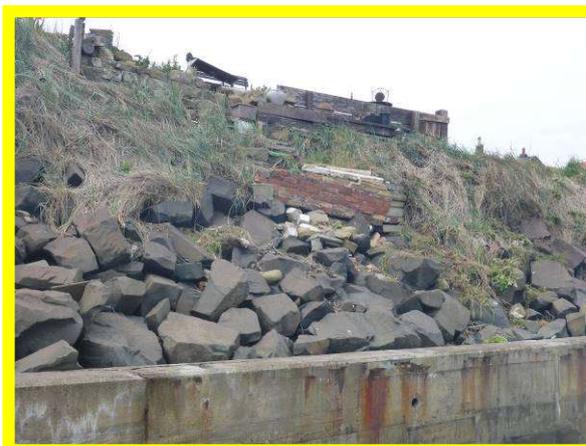
To the south of Cresswell the low concrete wall and interlocking concrete unit revetment is largely in good condition and the area of apparent settlement towards its southern end has not worsened since it was first observed.

*Low concrete wall and rock revetment at Cresswell (/3201C18)*

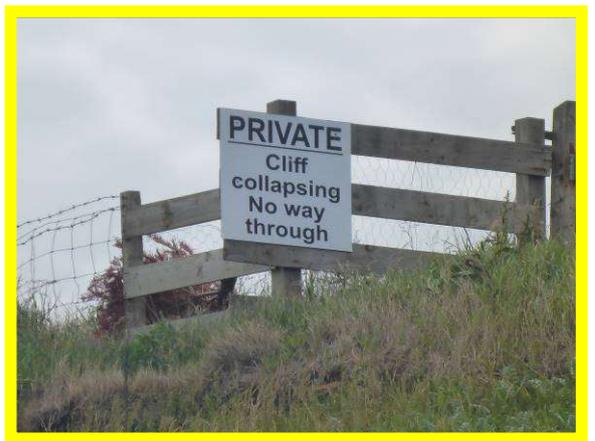
*Low earth cliffs backing Stank Letch Rocks (/3201C20)*

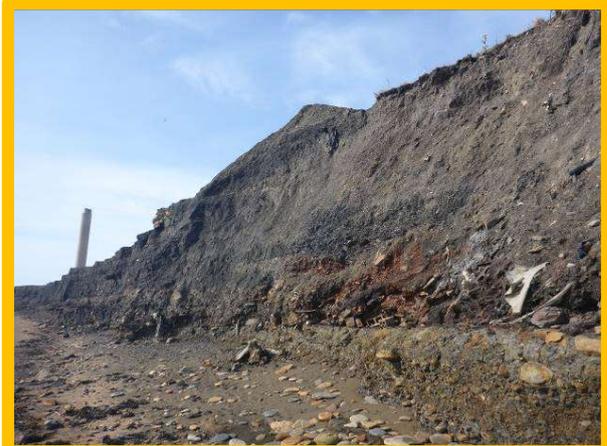
*Rapidly eroding colliery spoil beach south of River Lyne leading to erosion of backing man-made cliffs, releasing colliery spoil (and by the river mouth, refuse) to the foreshore (/3401C05)*

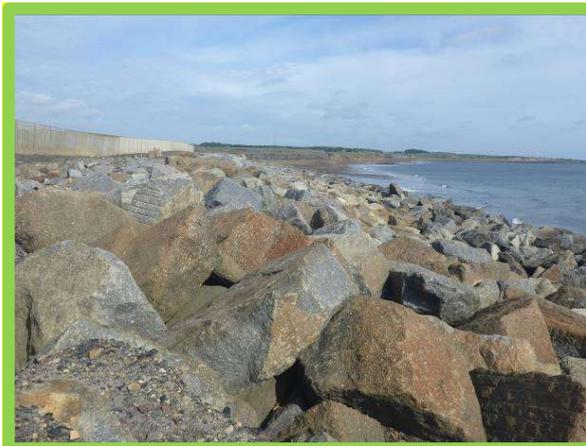
The large rock armour revetment constructed in front of the Power Station in 1995 and subsequently extended around the coal stocking yard in 2005 remains in good condition. Rock armour is angular and well packed with no displaced stones or movement at the toe. Minor erosion was observed behind the crest. A lot of waste cables and cable covering was discarded on the revetment crest.

*Substantial rock revetment (/3401C07)*

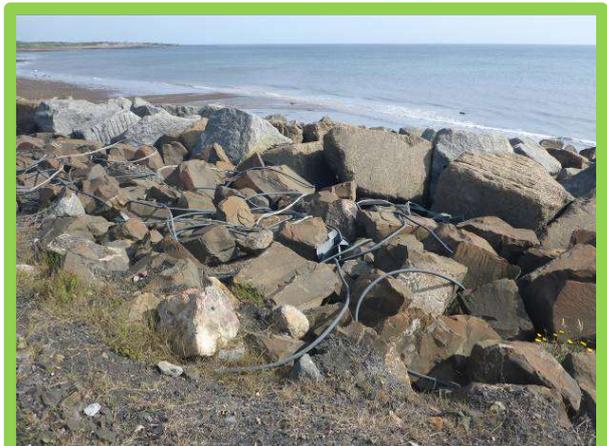
*Note cabling discarded on revetment crest (/3401C07)*

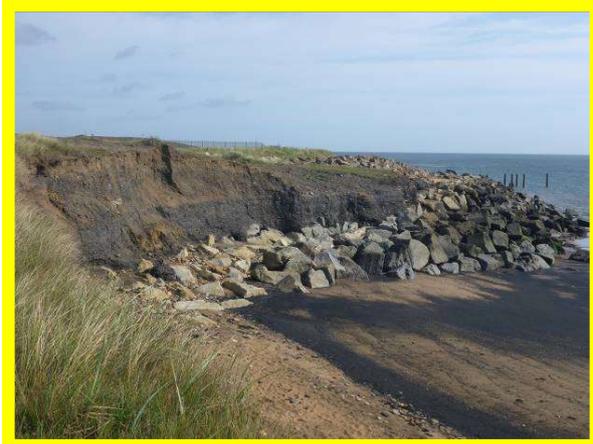
At the southern end of the revetment, rapid erosion of the spoil beach was previously observed over the 2017/18 winter, exposing the buried tie-in of the revetment and initially causing some concern. However the tie-in extends some distance landward (currently largely remaining buried) and the rapid erosion has reduced. Between the Power Station and Beacon Point the shoreline again comprises colliery spoil with erosion of the high spoil cliff in the north continuing. The central and southern sections of this bay become more stable with lower sandy cliffs tapering to a low cobble and boulder berm fronting colliery spoil and wide backing natural dunes.

*Revetment tie-in at southern end of Power Station largely buried by spoil cliffs / land (/3401C08)*

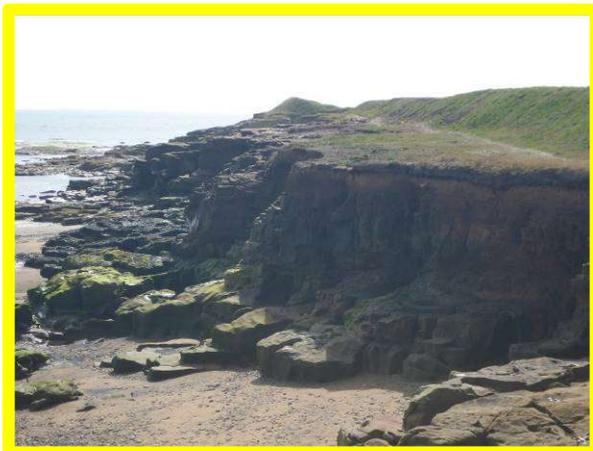
*Currently relatively stable cliffs around Beacon Point (/3501C11)*

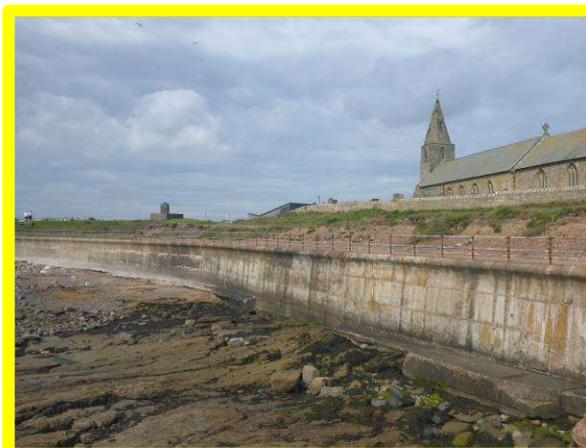
The vertical concrete seawall at Church Point remains in overall fair condition. However, there is a reasonable amount of abrasion at the toe and crest as well as signs of local undermining between the toe and rock slab. The recurved section of seawall to the west of Church Point is well founded on the rock foreshore and generally in good condition. Slight undermining of the concrete apron nearer its western end remains although this is unlikely to affect the stability of the structure.

*Church Point seawall in fair overall condition (/3601C12)*

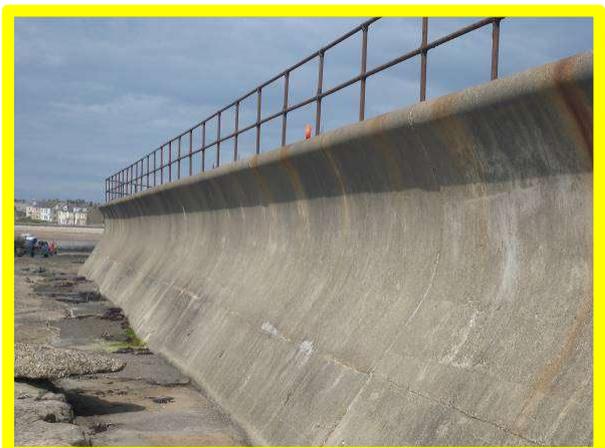
*Recurved section of Church Point seawall (/3601C13)*

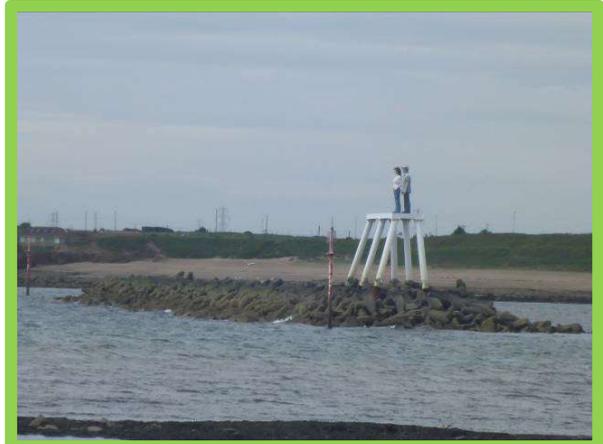
*Detached breakwater in central Newbiggin Bay remains in very good condition with salient/tombolo developed in lee (/3601C15)*

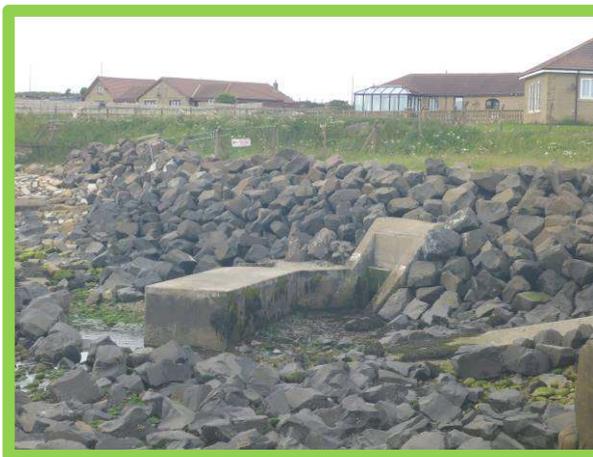
*Rock revetment around sewage outfall (/3601C11)*

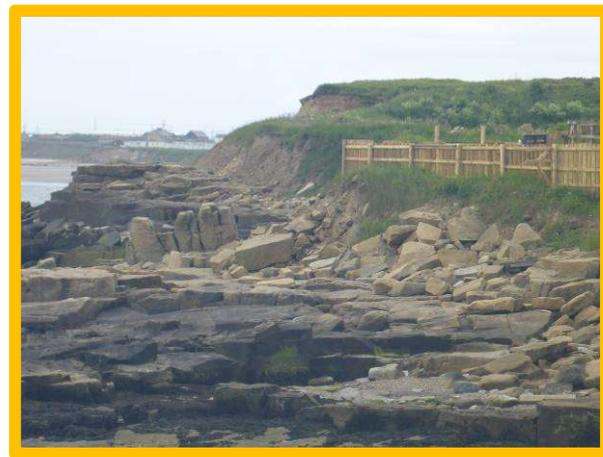
South of the outfall, there is a short section of cliffs fronting Links Quarry which are in poor condition, with significant erosion and cliffing along most of the length. Large quantities of rubble and quarry waste have been tipped down its seaward face. However, slumping in the soft material continues, releasing waste and debris onto the foreshore.

*Cliffs fronting Links Quarry expiring notching at base and rockfalls, leading to slumping in softer material (/3701C01)*

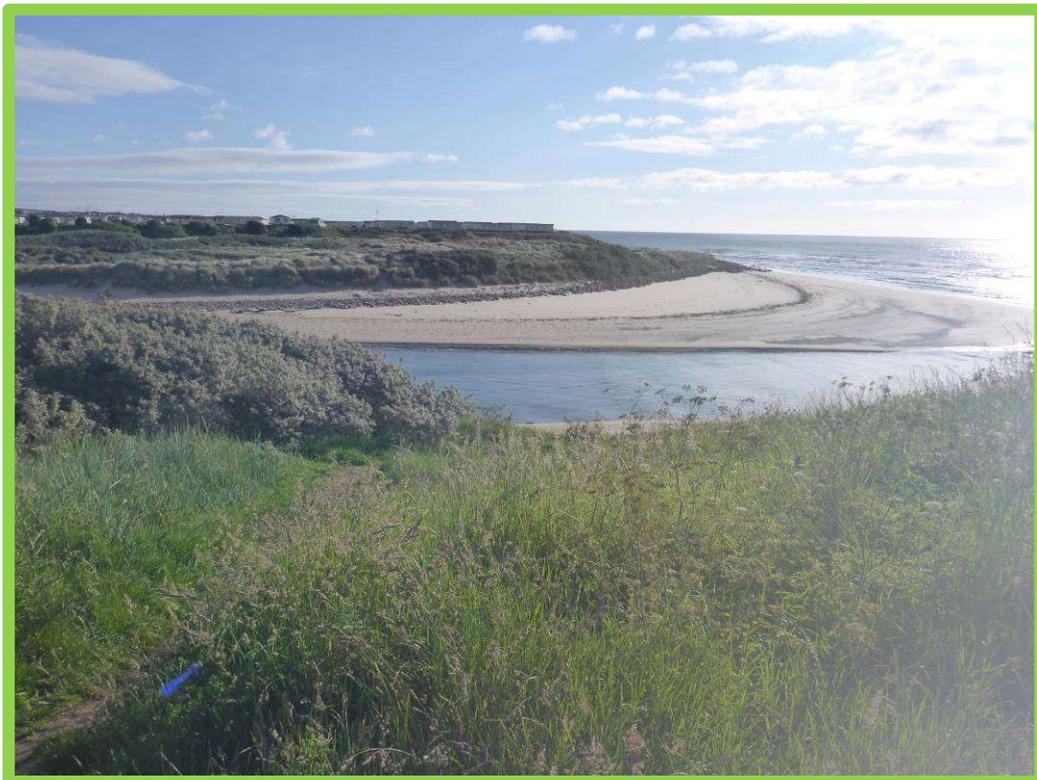
*View towards north bank of River Wansbeck mouth (/3801C01)*

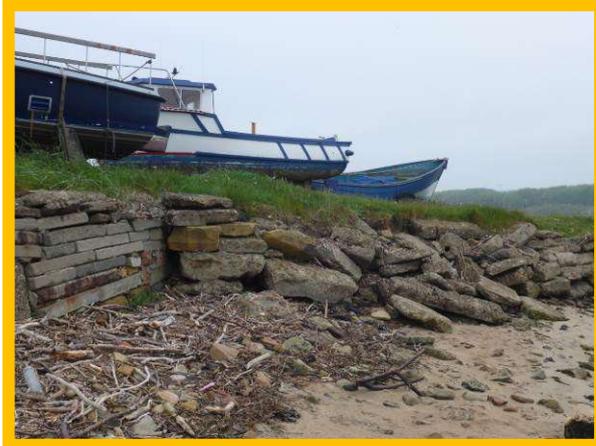
*Partially collapsed section of Wansbeck Boat Club retaining wall (/3801C02)*

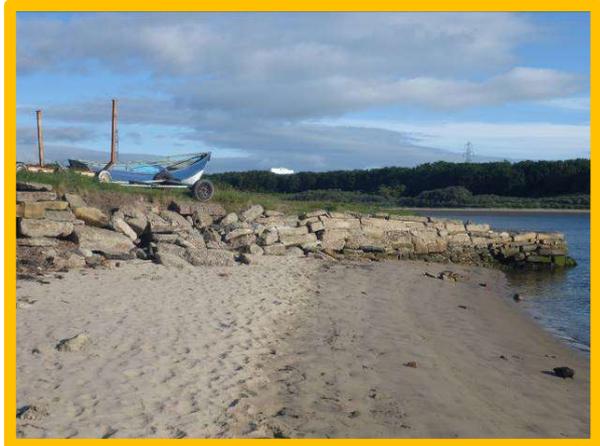
*Repaired section of Wansbeck Boat Club retaining wall (/3801C02)*

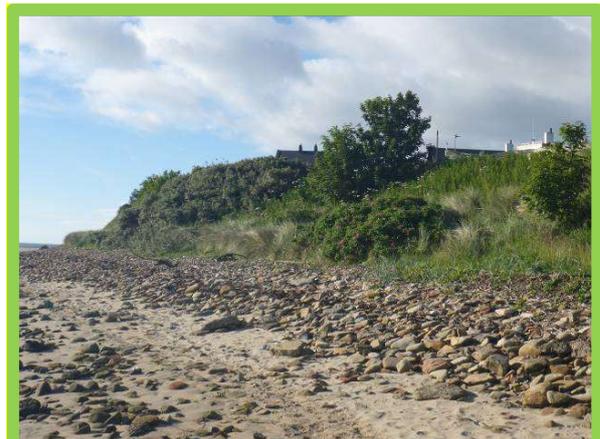
*Relatively stable cliffs on inner estuary protected by sandy beach and boulder berm (/3801C02)*

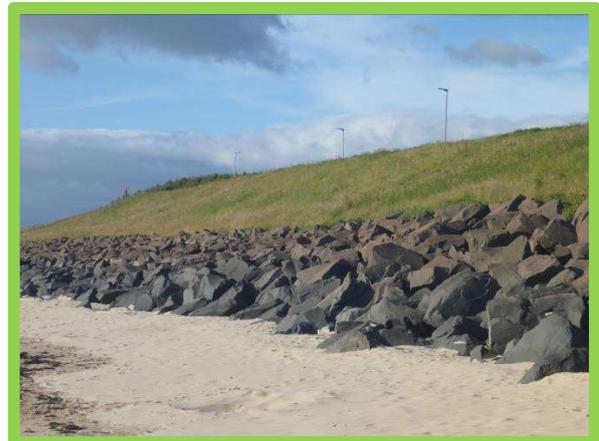
*Rock revetment protecting former foundry site (/3901C05)*

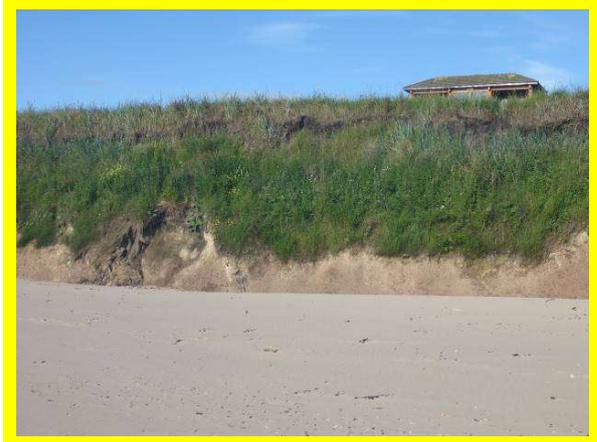
*Cliffs protected by relatively wide and high beach (/3901C03)*

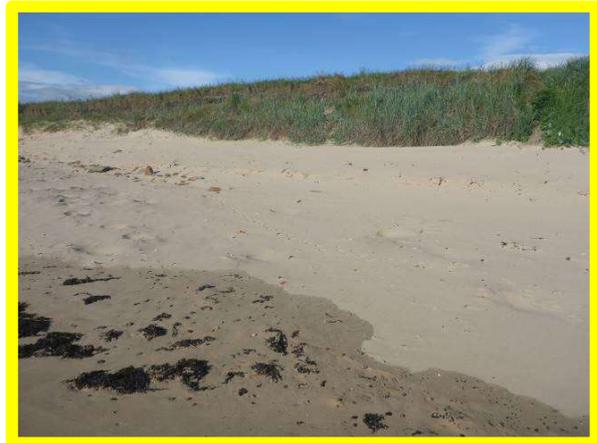
*Stable and healthy dunes (whereas they are often recorded as actively eroding) (/3901C04)*

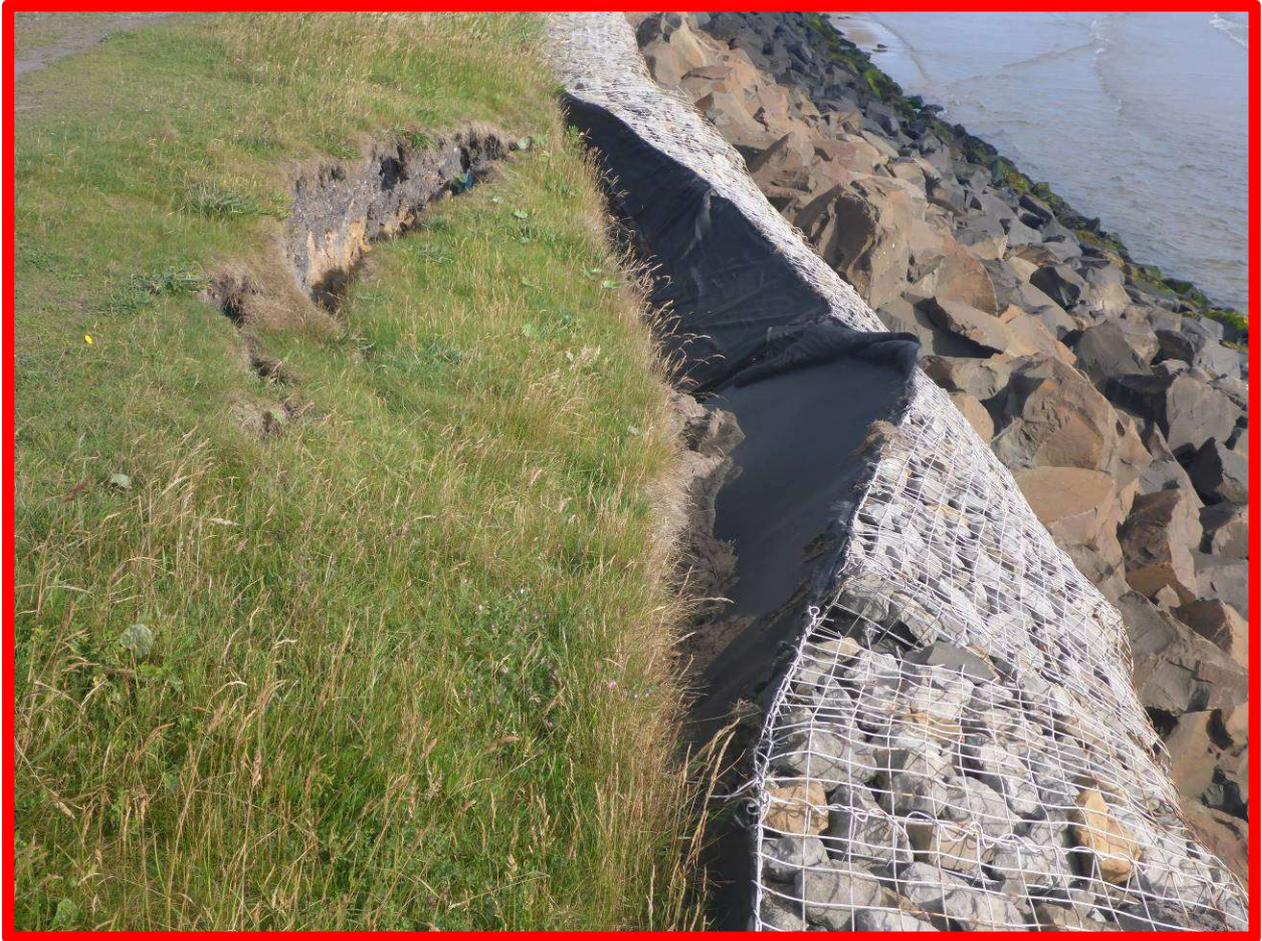
*Rotational failure of one section of gabion basket caused by cliff slumping – requires maintenance (/4001C01) – locally very poor*

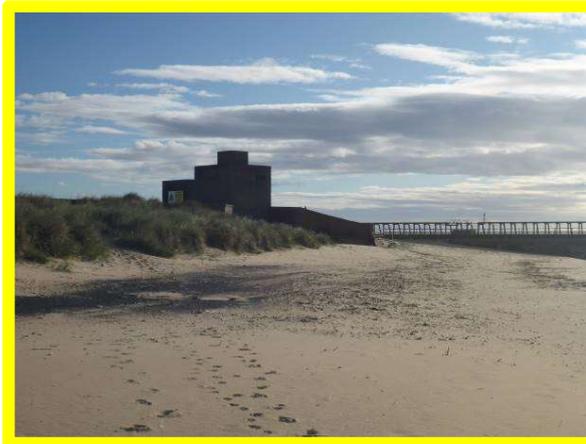
*Recovered dunes (/4201C10)*

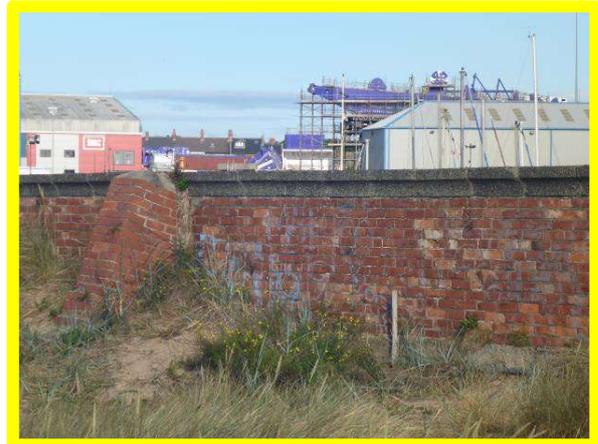
*Masonry wall to rear of dunes (/4201C10)*

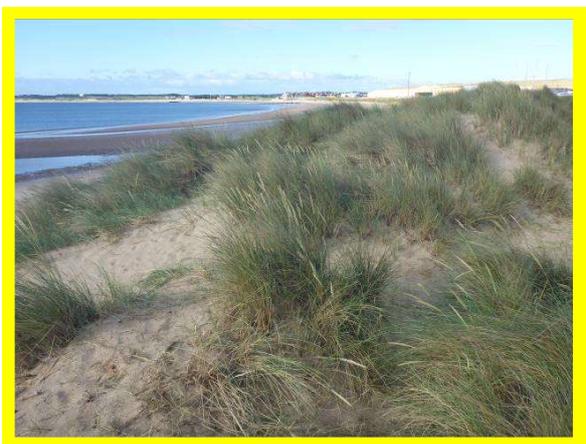
*Dunes in healthy condition (/4201C11)*

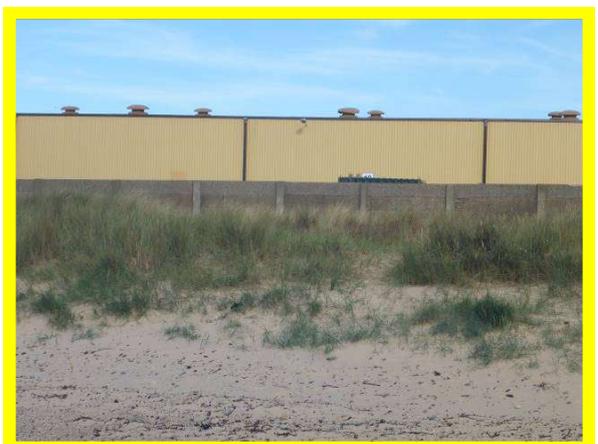
*Dunes with concrete plank wall to rear (/4201C11)*

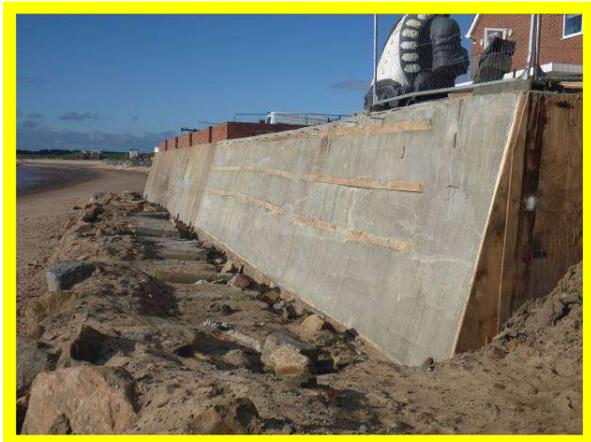
*Existing sea wall protecting new properties (/4201C04)*
