## **Cell 1 Regional Coastal Monitoring Programme Walkover Inspection Surveys 2020**

**Northumberland County  
Council**

## Walkover Inspection Surveys 2020

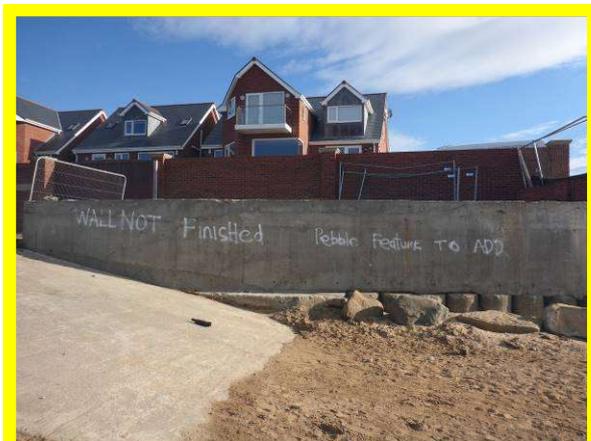
*"Wall not finished" (/4201C04)*

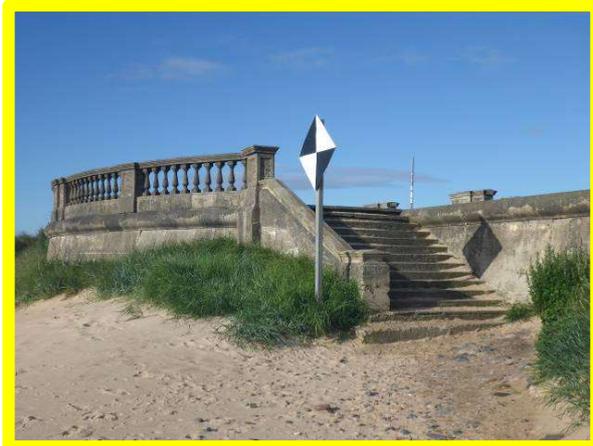
*Seawall and access steps (/4201C05)*

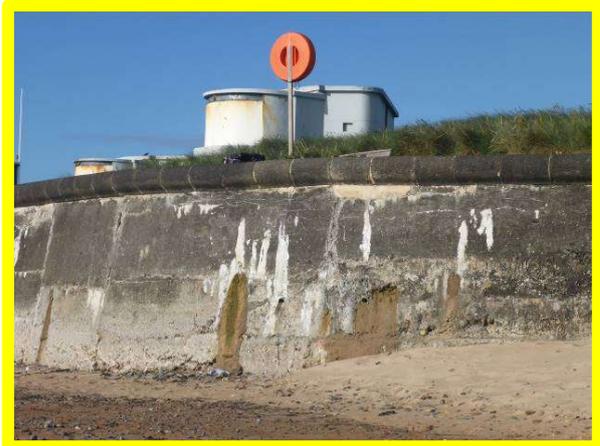
*Abrasion and staining to seawall (/4201C06)*

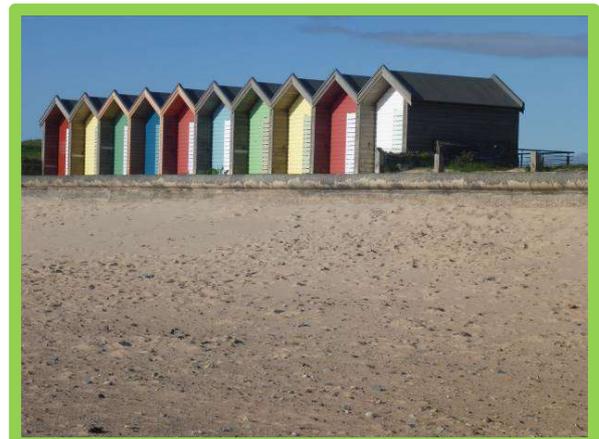
*High beach levels fronting sea wall (/4201C07)*

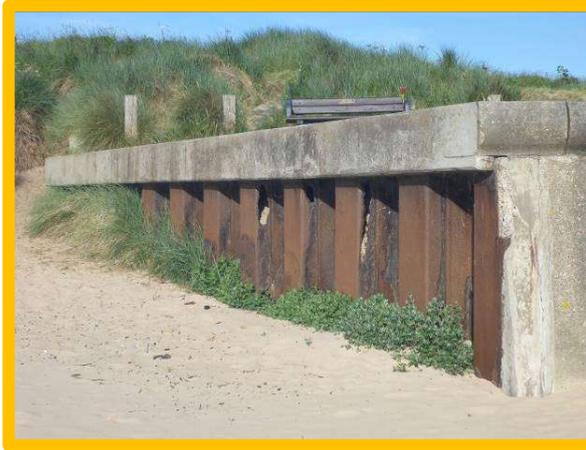
*Steel sheet pile end to promenade (/4201C08)*

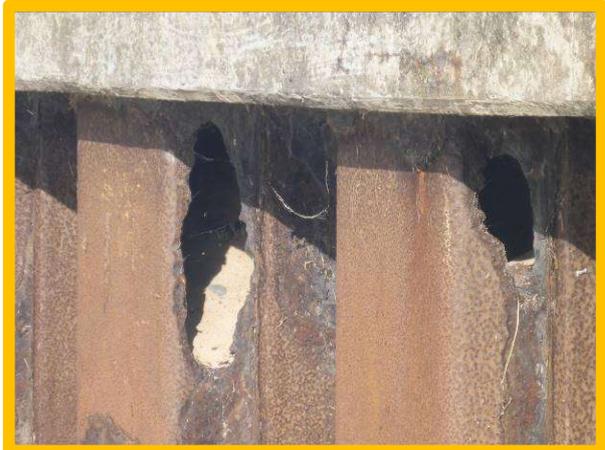
*Voids in steel sheet pile end to promenade (/4201C08)*

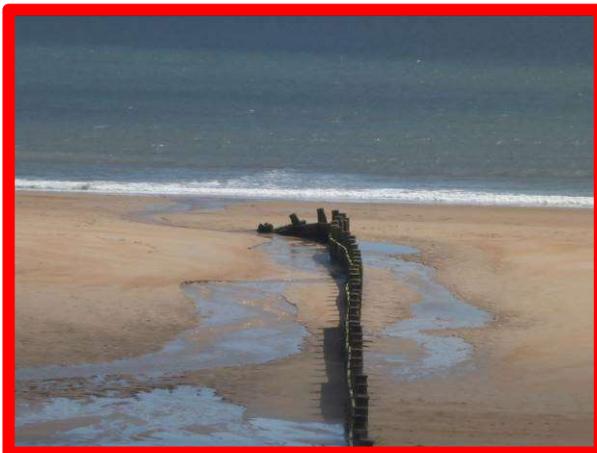
*Collapsed end of southern groyne (/4301C01) – locally very poor*

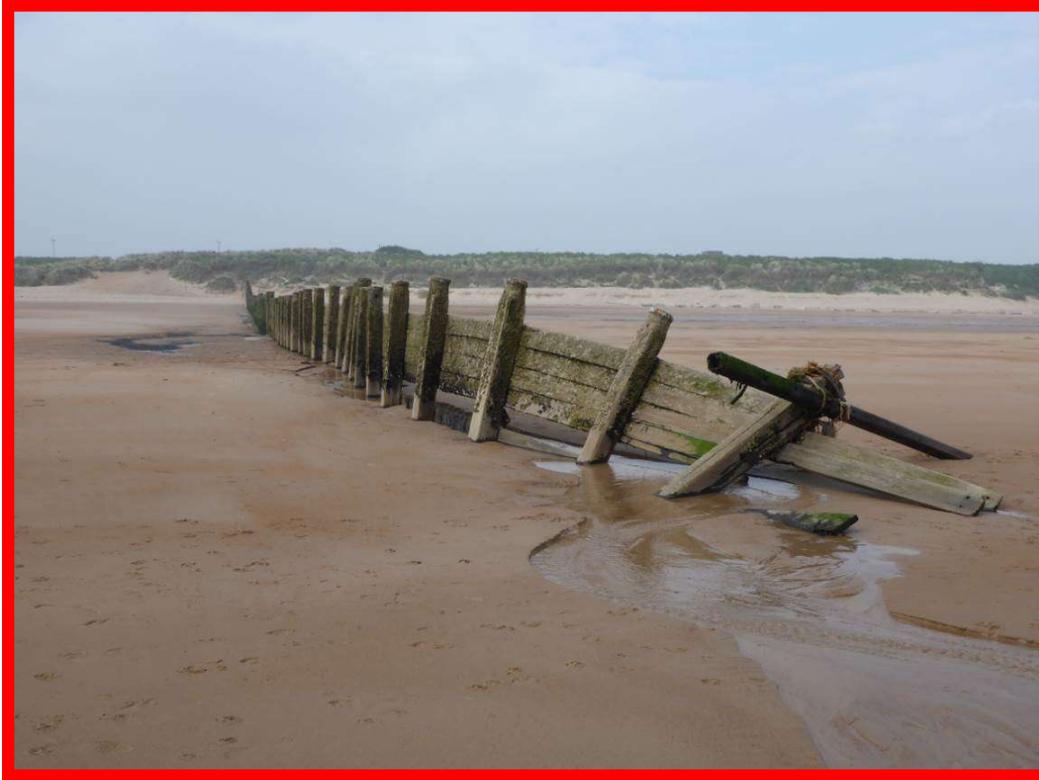
*Failed seaward end of southern groyne in 2018 when beach levels were low (/4301C01) – not so visible in 2020 due to high beach levels partly burying the collapsed section – locally very poor*

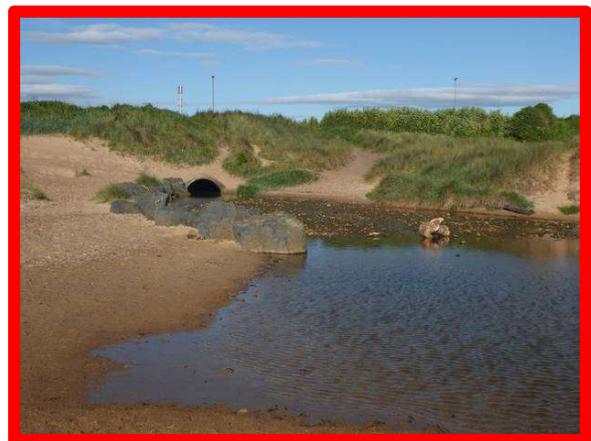
*Rock armourstone placed in 2016 to train course of Meggie's Burn away from dune toe (/4301C01)*

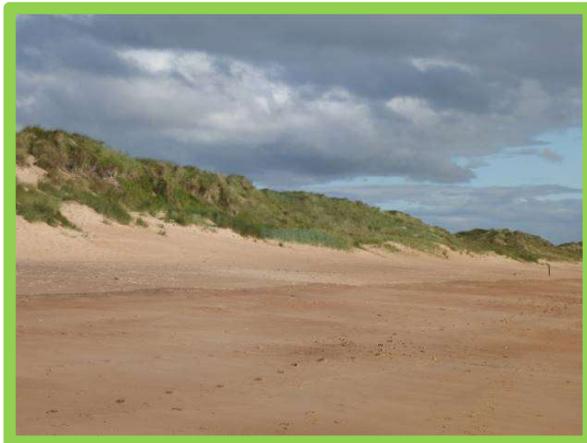
*Recovered dunes in central South Bay (/4301C02)*

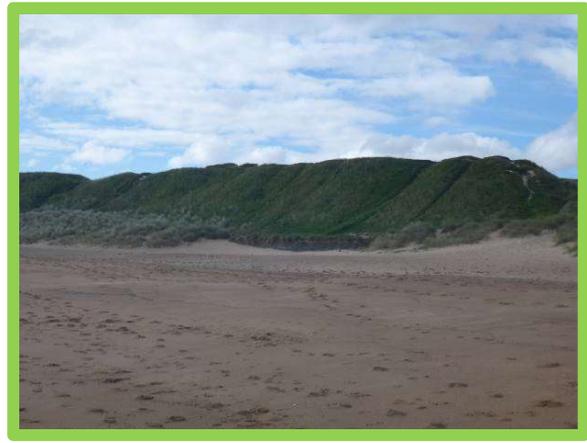
*Stable dunes and good condition low wall at Sandy Island (/4401C01)*

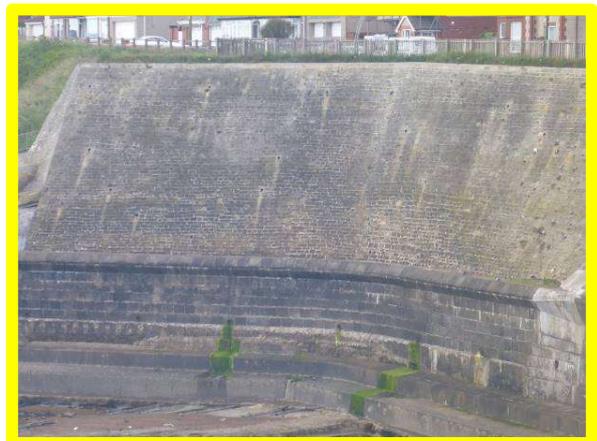
*Seawall with upper brickwork retaining wall (/4401C15)*
