**Cell 1 Regional Coastal Monitoring Programme
Coastal Walkover Inspections 2010**

**North Tyneside Council
Final Report**

October 2010

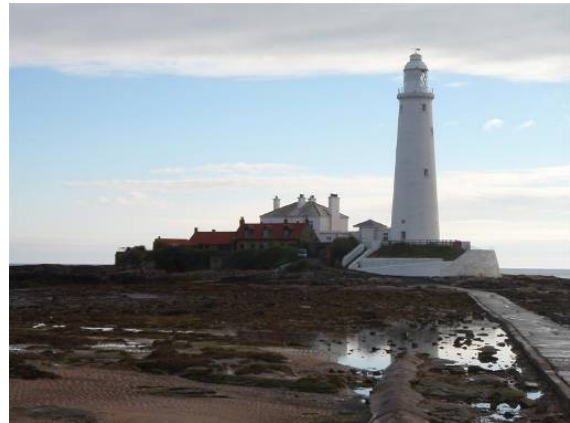
St. Mary's Island is accessed by a causeway at low water (right).

An old concrete outfall structure runs parallel with the causeway on the northern side for part of its length.

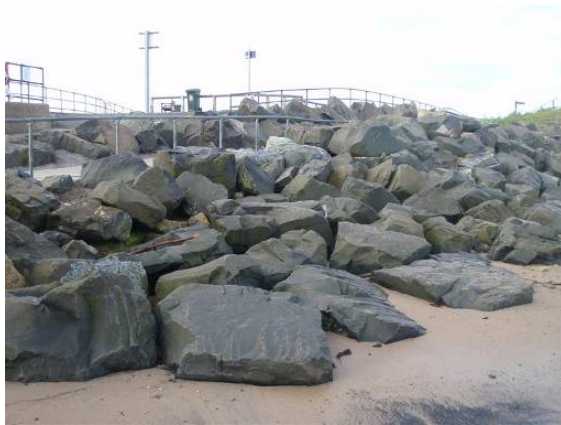
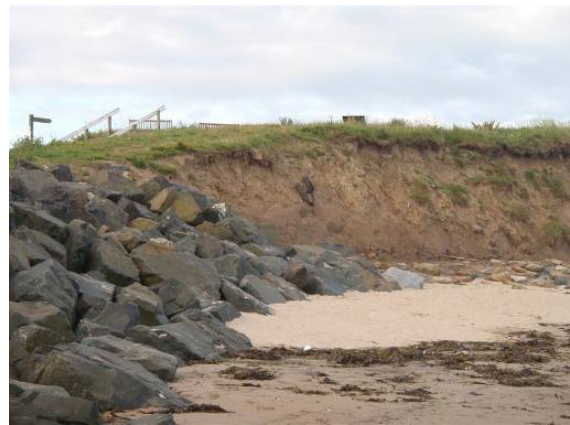
At the landward end of the access ramp to the causeway, on its northern side, rock armour protection works were constructed in 2006 (below left). Erosion of the undefended cliffs to the immediate north of the rock armour is continuing (below right) but at present outflanking of the defence is not occurring.

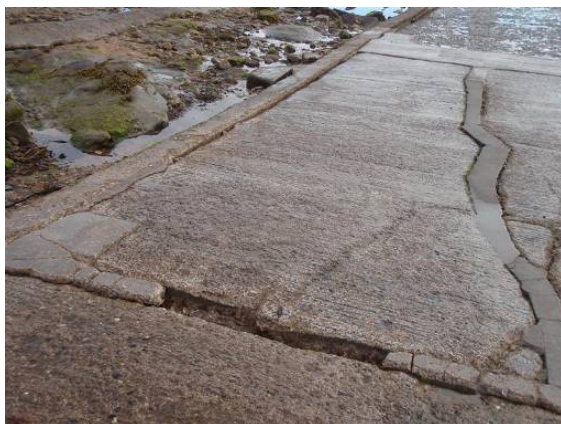
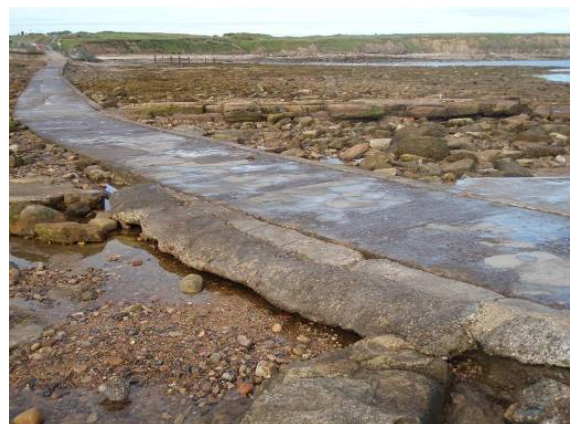
The causeway to St. Mary's Island is generally in a poor condition despite previous patch repairs (below left), with numerous areas of cracking, voiding, displaced edge-coping, abrasion and, in some places, undermining (below right). The causeway would benefit from some relatively minor maintenance to address these defects.

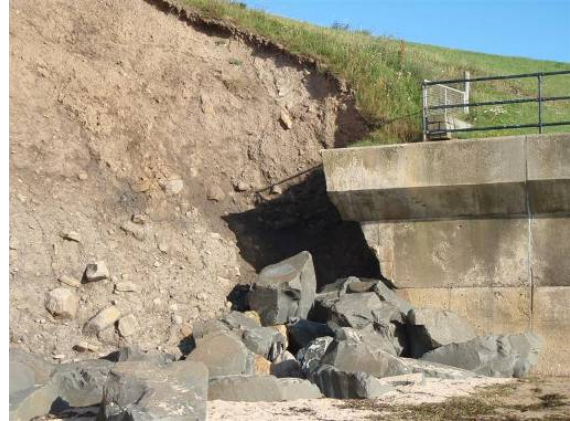
There remains some minor ongoing abrasion, especially where joint sealant has been washed-out (below left), which would benefit from ongoing routine maintenance which presently would only need to be of a minor nature. The main issue with the Trinity Road Sea Wall, however, is the continued outflanking at its southern end (below right). If the undefended cliffs to the immediate south of the wall continue to cut back behind the rock armour and seawall structure, there could be more major problems caused by outflanking and therefore a more immediate remedy to this ongoing problem is recommended.

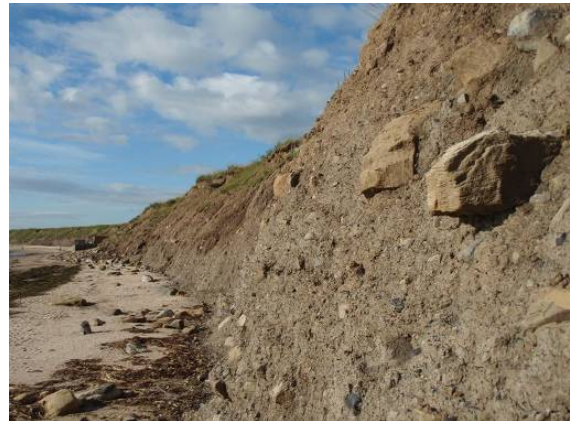
The undefended sea cliffs at the northern end of Whitley Sands are actively slumping (below left) despite the presence of a relatively high boulder beach at their toe which sits on top of the sandy foreshore. As this erosion continues, the cliffs release material, including boulders, to the foreshore (below right). This process also cuts the cliff top back, through successive slumping failures, closer to the footpath. In time, this process will start to affect the seaward edge of the Briardene Car Park and the municipal golf course. Some sections of the undefended cliff are prone to imminent slumping since the soft material is extensively cracked.

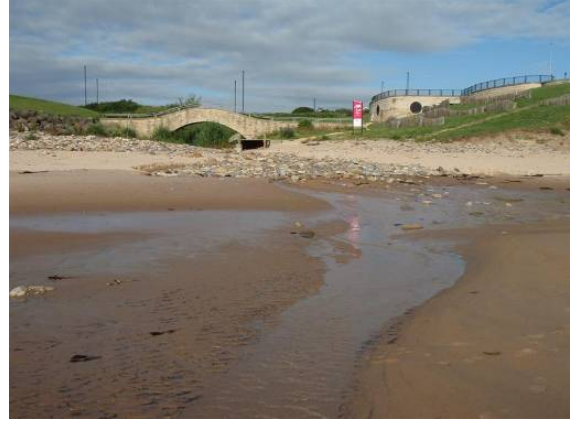
The stone blockwork wall fronting the boatyard along the otherwise undefended cliffs has received some repairs at its southern end since the last inspections in the form of concrete fill, using steel sheet piles as temporary works, following a large failure of this section (below left). Some minor unravelling of the structure continues at the southern end. In contrast to the 2008 inspections, which occurred after an intense rainfall event, the Briardene Burn was barely discharging across the foreshore at its mouth (below right). The rainfall-induced damage previously reported to the access path down the northern bank of the burn has been satisfactorily repaired, as has the previously-reported damage to the timber boardwalk.

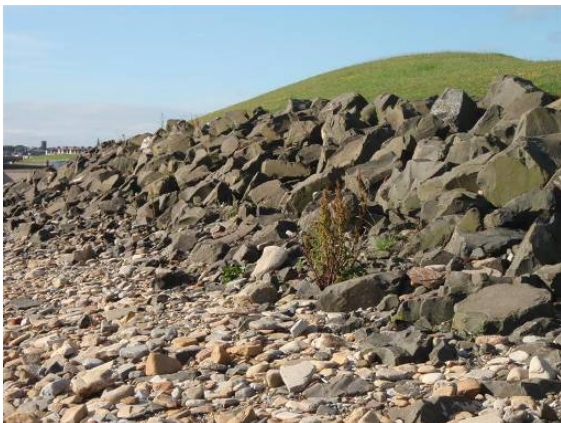
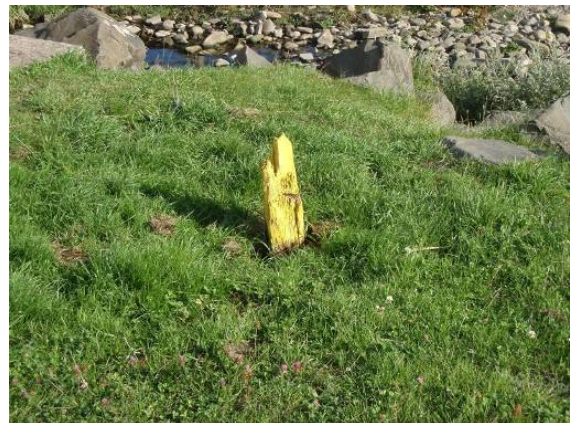
The rock revetment (below left) to the immediate south of Briardene Burn remains in good condition and the previously-reported sink hole in the slope behind has now been infilled (below right).

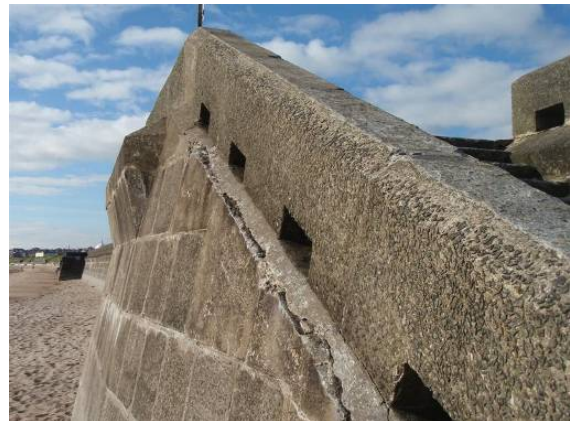
The worst affected areas are generally where there are access steps or access ramps from the promenade to the foreshore. Many of these structures have been repaired since the 2008 inspections but in some areas those repairs are now damaged (below left) and several other areas are in need of attention otherwise further failures of the coping will occur (below right).

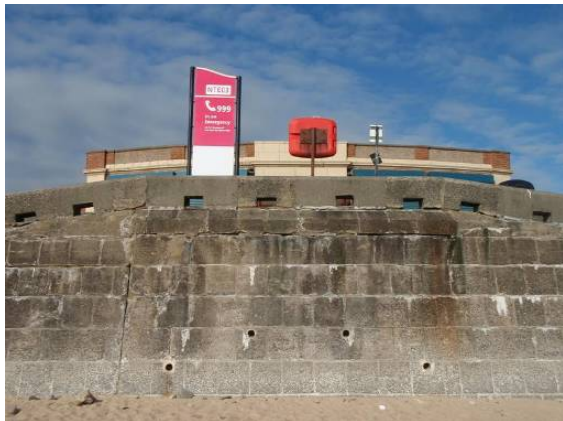
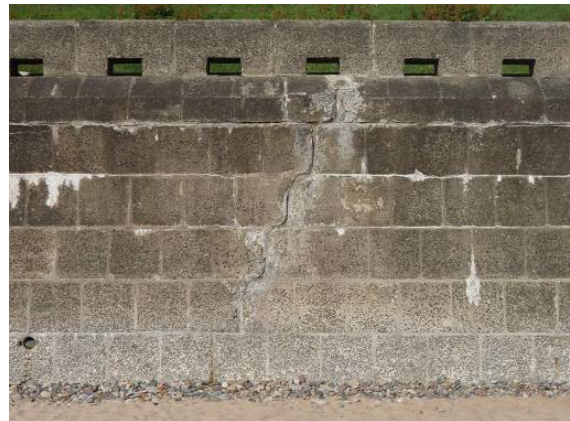
The access steps in front of the Rendezvous Café are particularly in need of attention (below left) and the sea wall between the Café and the Panama Swimming Club has several areas where cracks have proliferated diagonally down the wall following the gaps between adjacent blocks (below right).

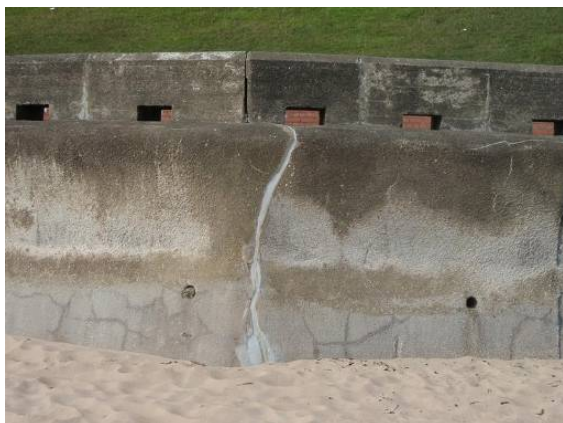
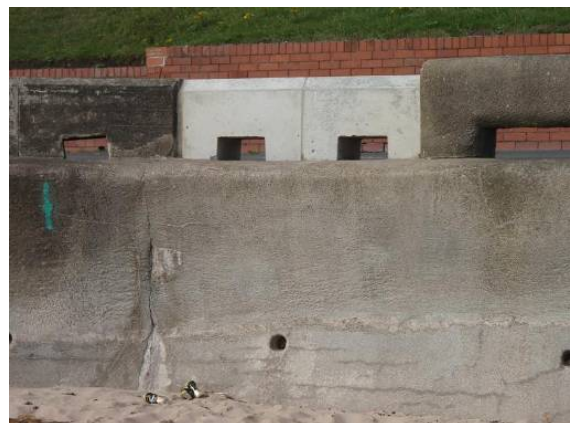
The Panama Gardens Sea Wall appears to have received some maintenance repairs since the 2008 inspections, including infilling of the most notable cracks and gaps between construction joints, which have improved its overall condition (below left). Most repairs are holding well, although some infilling of the construction joints is just starting to come away in some areas and usefully could be re-filled. The maintenance repairs also include the replacement of some previously collapsed coping with water-return holes (below right), but there remain some that are blocked or where the joint between the coping and the wall has cracked and needs infilling.

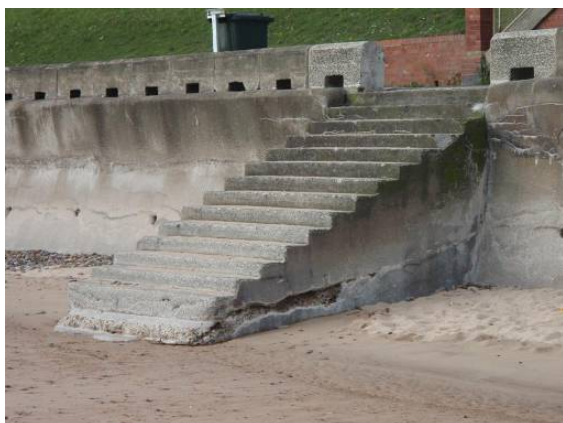
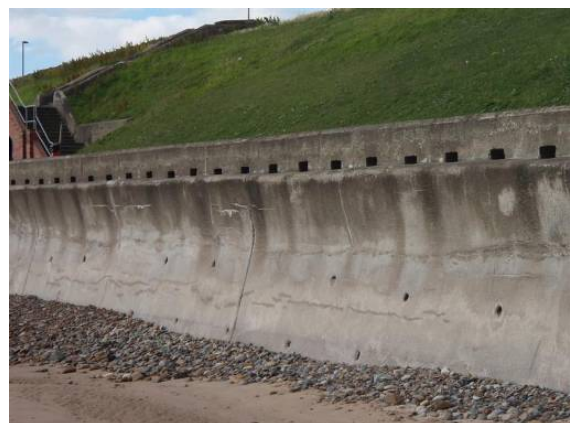
The beach access steps from the sea wall remain badly damaged in places (below left), but elsewhere the wall is in fair condition overall (below right).

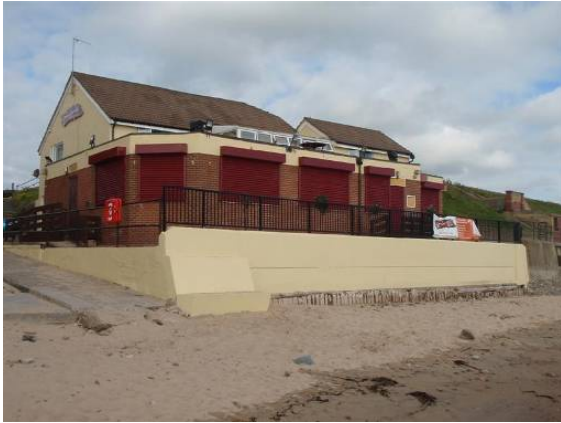
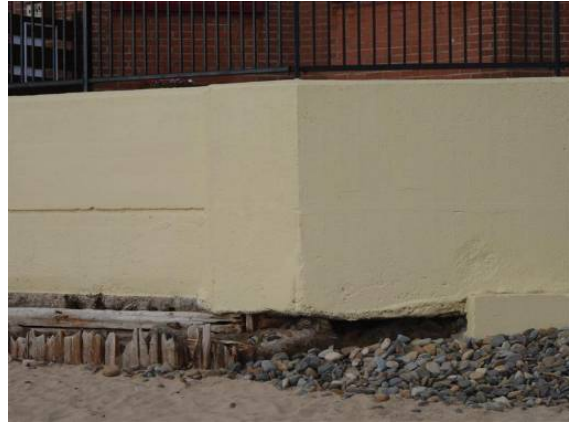
The yellow-painted wall fronting the Boardwalk Café has its timber piles exposed at the toe (below left) and is being undermined towards its northern end (below right).

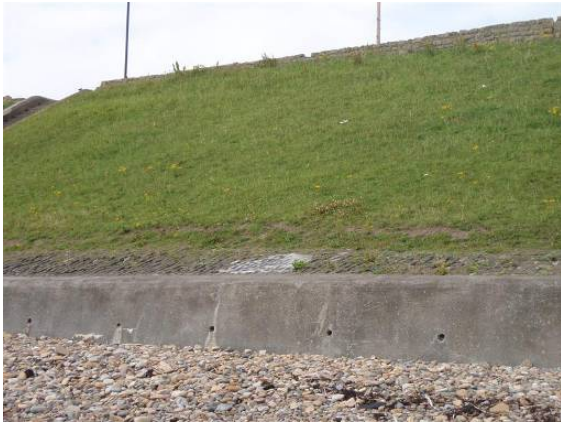
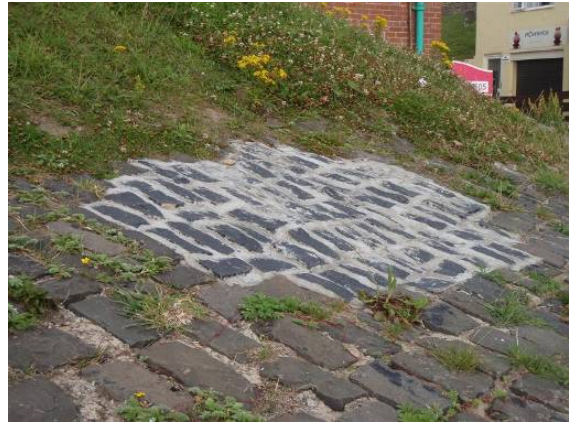
Fronting Spanish City is a steep vegetated slope protected by a blockwork revetment and concrete wall (below left). The previously-reported missing blockwork has been repaired (below right) and the overall defence system is in fair condition.

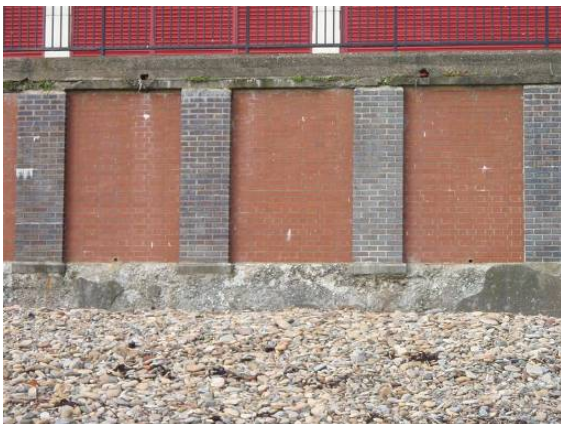
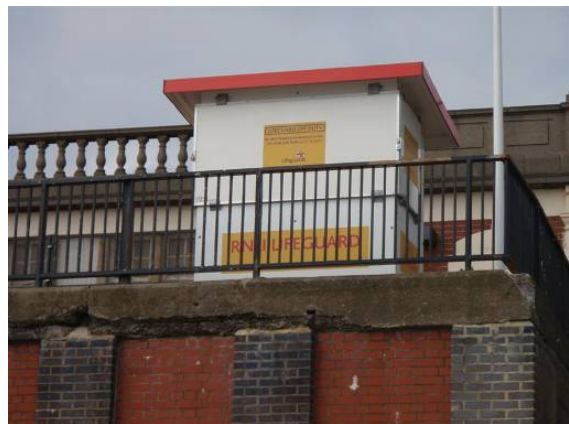
The Central Lower Promenade is protected by various sections of sea wall. Beach levels at the toe of the walls were high at the time of the inspections, mainly with sand but locally with cobbles. The visible sections of the concrete and brickwork wall have extensive abrasion damage to the concrete at both the toe and the coping, although the brickwork appears fair (below left). The old red lifeguard box on the promenade, which was extensively cracked, has been replaced with a modern, mobile, lifeguard box (below right).

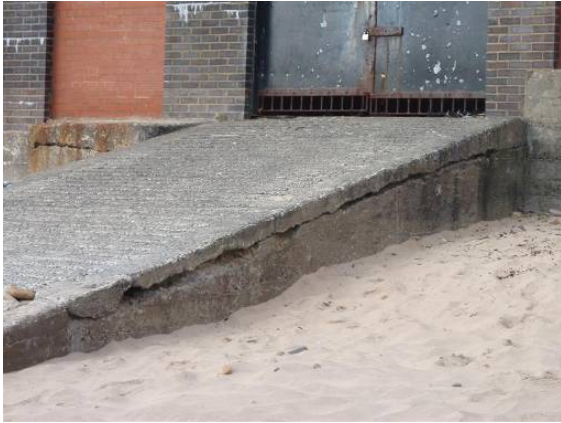
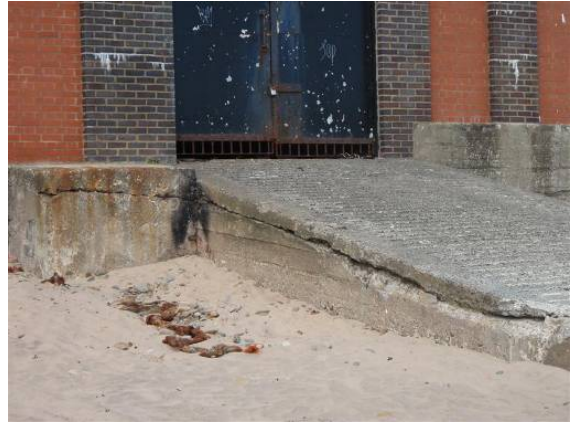
The access ramp remains extensively abraded and cracked on both its northern (below left) and southern (below right) sides and is in danger of becoming voided and collapsing.

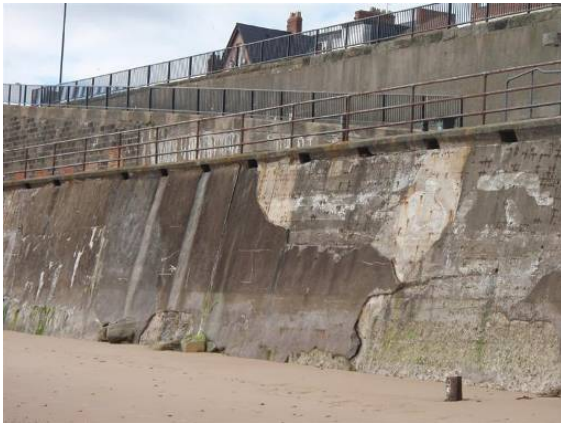
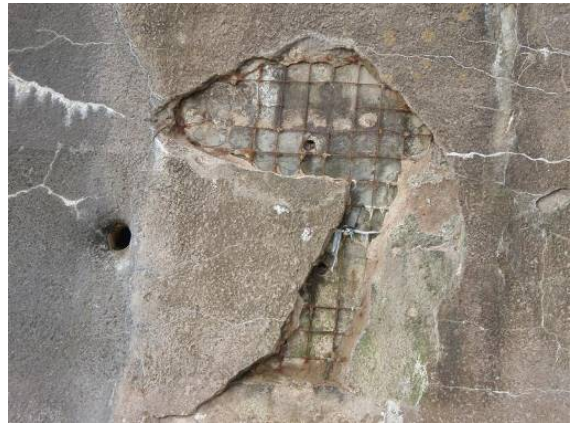
The next section of sea wall has experienced continued loss of render from its face (below left), resulting in more exposed reinforcement bars (below right).

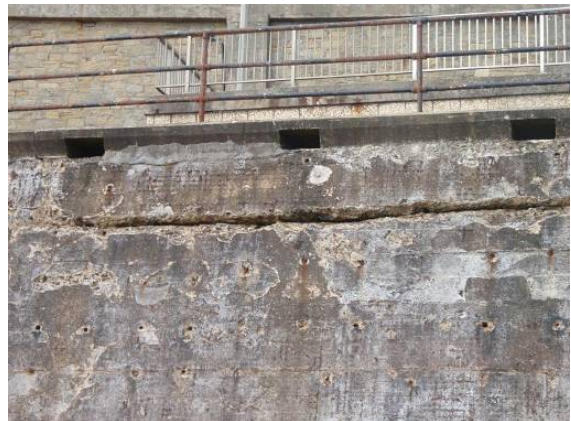
The access steps down this wall have missing handrailing (below left), and the wall crest has, in places, notable cracking (below right).

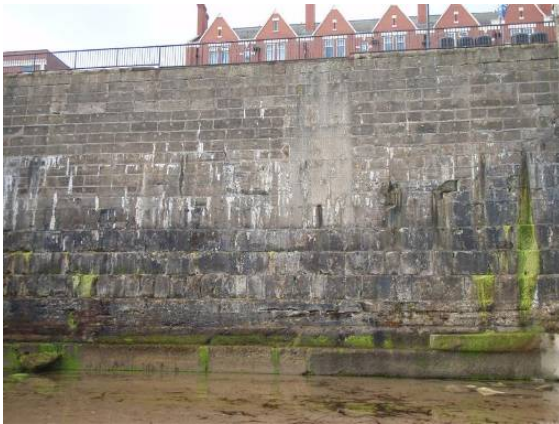
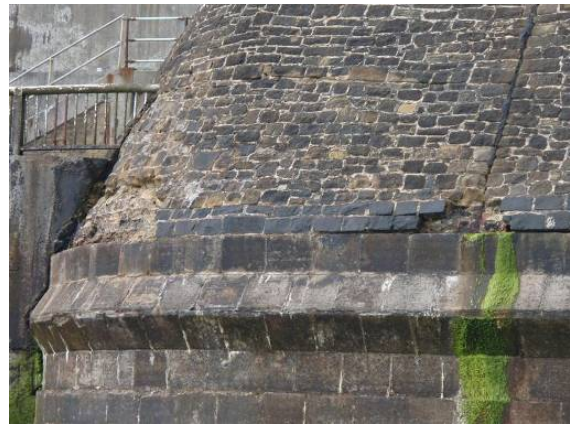
The masonry wall further south is in overall fair structural condition, although heavily stained. Maintenance should be undertaken to infill gaps between joints along the central, linear, section of this wall (below left) and replace the missing blockwork at the southern end of the southerly 'roundhead' (below right).

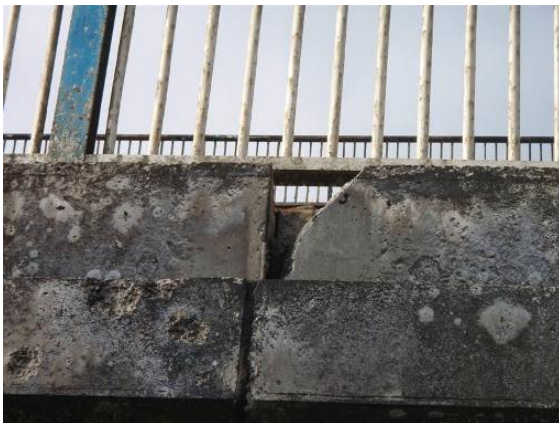
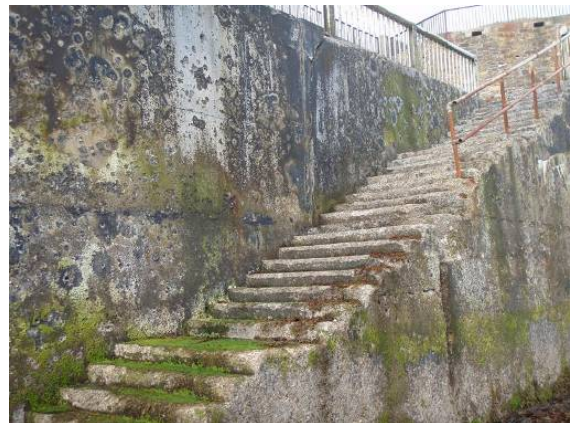
The short section of 'connecting' wall between the southern roundhead and the larger arched concrete blockwork and masonry wall has overall fair condition, but there are three sections where concrete is missing from the wall crest at construction joints (below left) and one vertical joint where the 'Expandite' sealant is exposed. The access steps are in a highly abraded condition (below right).

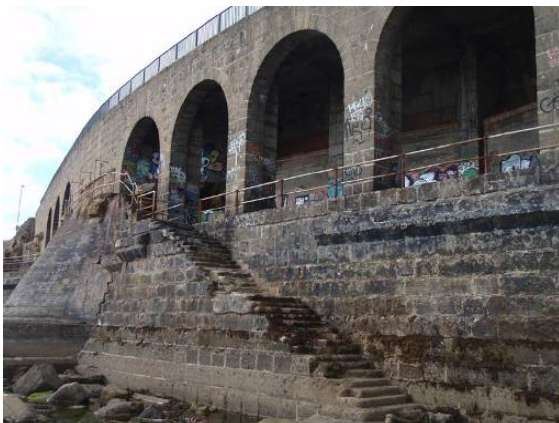
The concrete blockwork and masonry wall initially is arched (below left), with abrasion at the toe at the northern end. The bullnose is becoming undermined (below right) and the disused access steps are in a very poor condition and now fenced-off to the public.

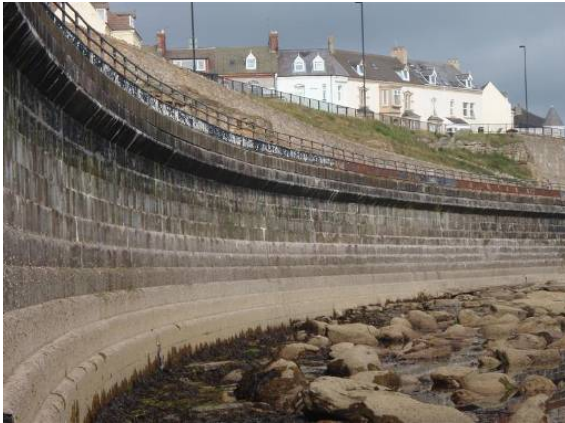
As the wall fronts the Southern Lower Promenade it is generally in fair condition (below left), although the incidences of gaps between the wall and the promenade deck increase to the southern end (below right). There are also cracks and small voids in the promenade deck, areas of damaged or missing kerbing, and one area where only temporary fencing is installed to fill a gap left by missing handrailing.

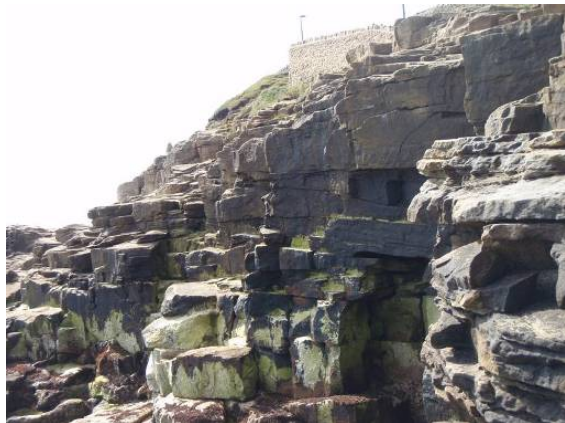
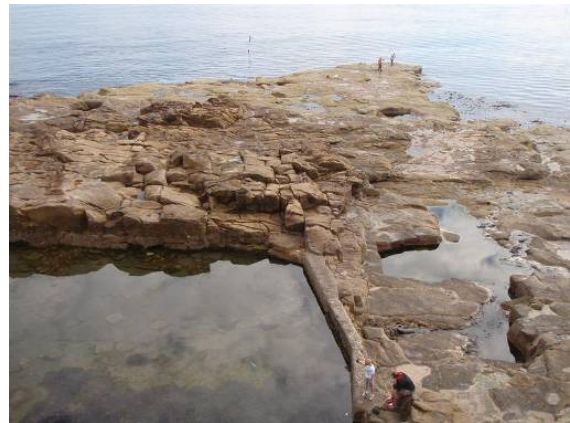
The northern end of Brown's Bay is marked by cliffs (below left) which appear totally unchanged since the 2008 inspections due to the protection afforded by the extensive fronting rock platform of Table Rocks (below right).

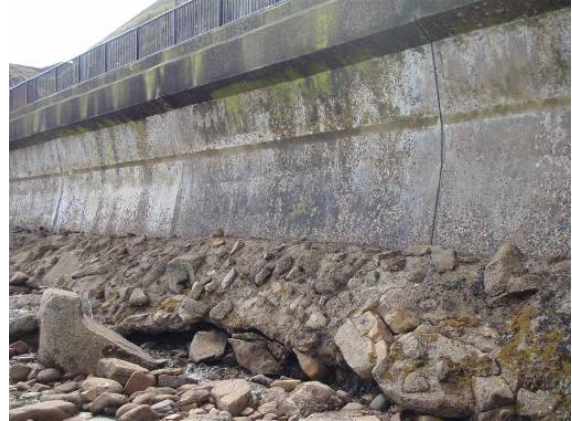
Brown's Bay has two separate sections of seawall. In the northern part of the bay, the wall is generally in fair condition (below left), although the cracks, joint gaps and abrasion around joint gaps increase in frequency to the south. The high beach levels at the time of the survey meant that the abrasion previously reported to the access steps at the southern end of this wall could not be observed. The southern wall is also generally in fair condition, although there is one area of toe undermining towards the southern end (below right). The rock netting to the cliffs behind the wall remains in good condition.

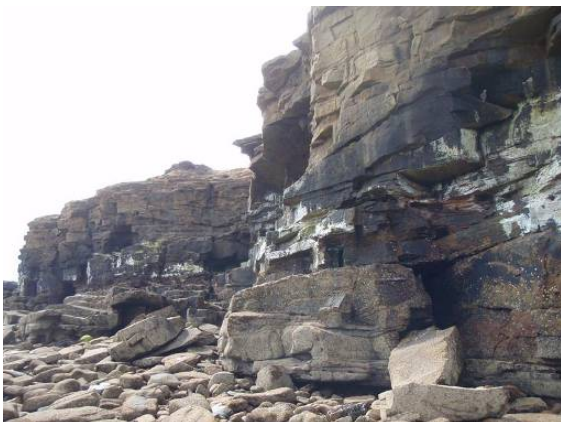
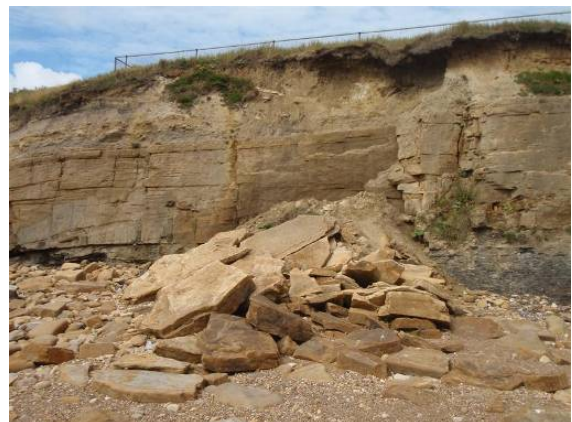
The cliffs at Brown's Point initially are composed of hard rock with a small capping of softer till. The hard rock is quite highly fractured and there is evidence of several local rock falls on the foreshore, with overhangs left in the hard rock above (below left), and some cave formation at the base of the cliffs. South of Brown's Point the hard rock dips, leaving a greater thickness of capping softer material. Three areas of rockfall have led to slippage in the overlying till, including one area close to a cliff-top property. There are three other areas where large individual rocks have fallen (below right).

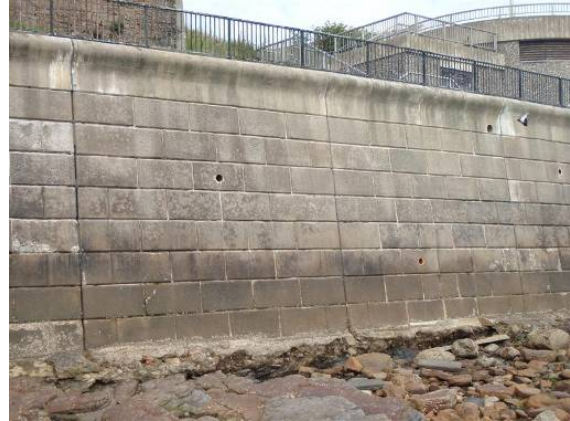
There are three sections of sea wall extending southwards to meet the North Pier of Cullercoats Bay. The first section is a concrete recurve wall in good condition (below left), although there is abrasion at the toe of the access steps. The mid section is a concrete blockwork wall which again is in overall good condition, but the poured concrete apron is being undermined in places (below right). There has been some deterioration in condition since the 2008 inspections since the toe apron is now in places breaking up, with concrete debris remaining on the foreshore and medium urgency maintenance would be beneficial.

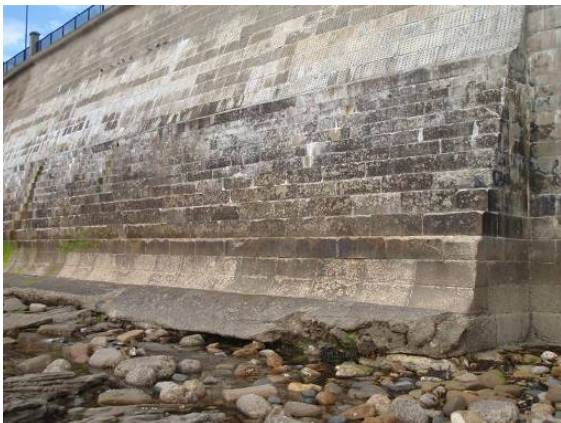
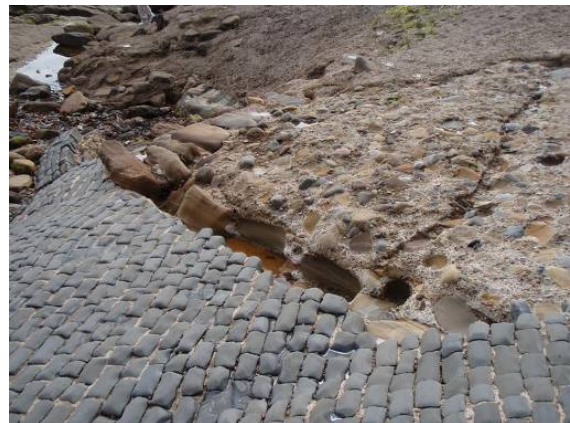
The final section, extending to the North Pier, is also experiencing undermining of the concrete apron, requiring medium urgency maintenance action (below left). This includes the blockwork 'tie-in' to the North Pier, where some large masonry has been removed from the concrete apron to the pier, leaving the adjacent smaller blockwork at risk of unravelling (below right).

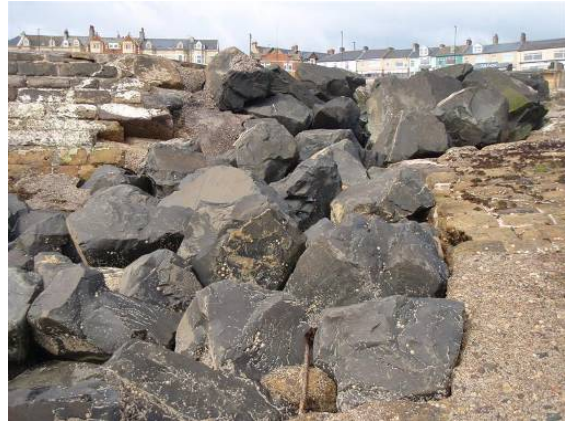
The North Pier has previously been breached during a storm, and the breach was subsequently infilled with rock armour (below left). The pier can significantly be over-washed during high spring tides that combine with storms. The concrete apron at the seaward toe is being undermined and there are several missing or settled blocks, and gaps between blocks, on the seaward face. There may be the onset of voiding adjacent to the previous rock armour repairs, part-way up the face to the northern side of the seaward-facing repair (below right). The leeward face is in better condition, although suffering from abrasion, especially around the head.

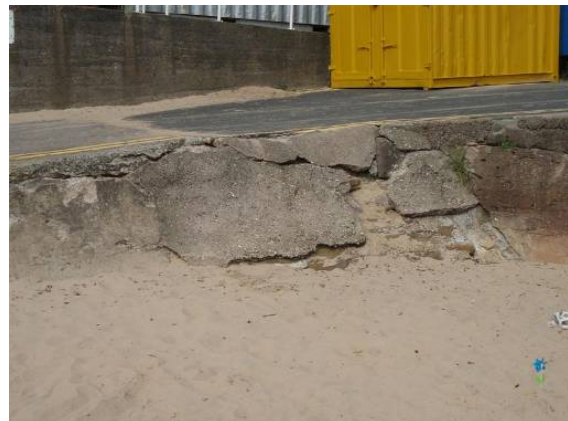
The wall fronting the lifeguard station in the north of the bay is in fair condition, but the lifeboat access ramp is starting to become abraded at the edges. The low wall fronting the sloping concrete area (below left) and the seaward end of the main pedestrian/vehicle access ramp to the bay (below right) are cracked and voided and in need of fairly urgent repair due to their continued heavy use.

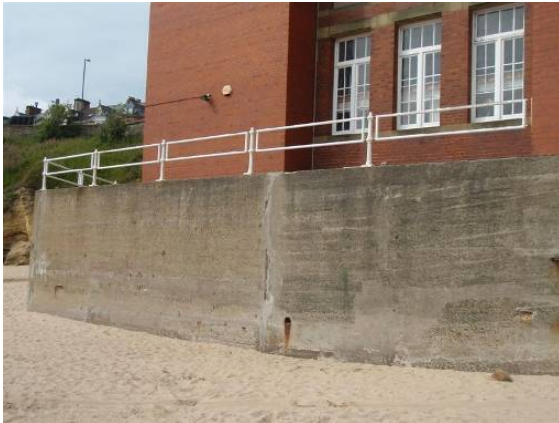
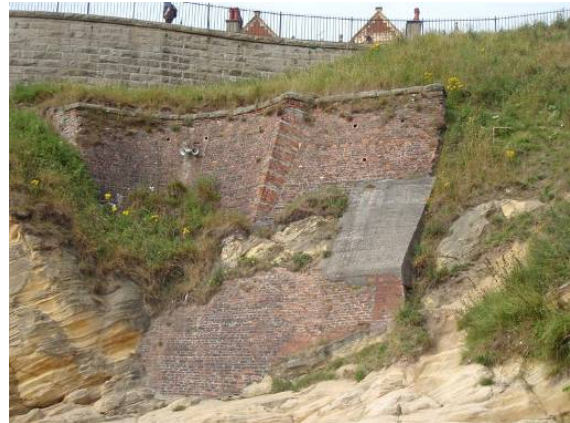
The wall fronting the Dove Marine Laboratory has several minor cracks that have been infilled (below left) and will probably need re-filling before the next inspections in 2012. The brick wall and cliffs to the south of the Dove Marine Laboratory appear in fair condition (below right).

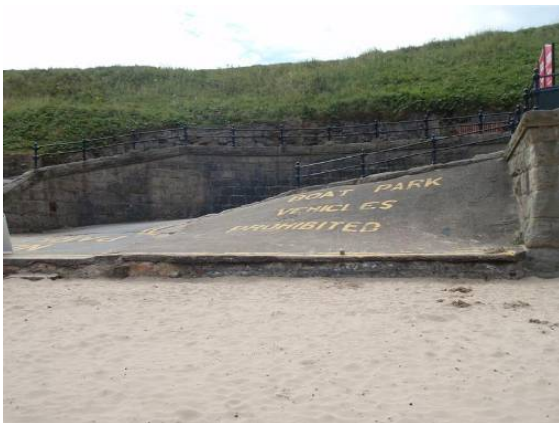
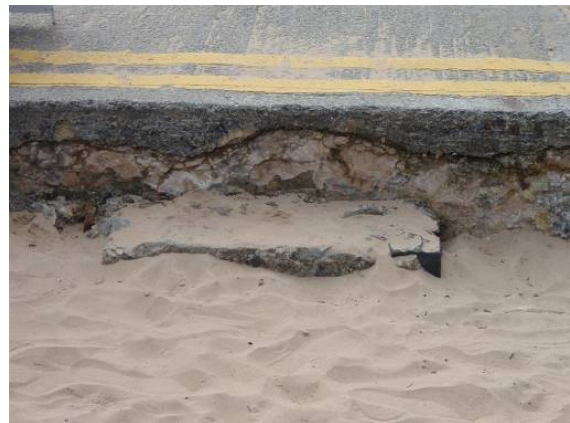
The cliffs in the centre of the bay appear stable, although there are extensive caves formed at the base. The two separate sea walls south of the cliffs also appear in fair condition with no notable defects. The defects previously recorded at the sloping concrete apron (below left) that leads to the South Pier were not observed due to high beach levels, although abrasion above the steps was still noted (below right).

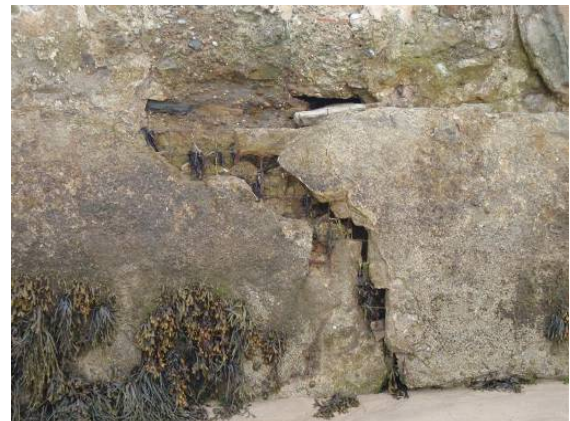
The South Pier remains in poor condition, with render breaking off the leeward face of the structure and laying on the foreshore as debris (below left). Other sections have the render 'bowing' away from the wall. In areas where the render is no longer present, the reinforcement bars are often exposed, and in one area a void has opened in the face (below right).

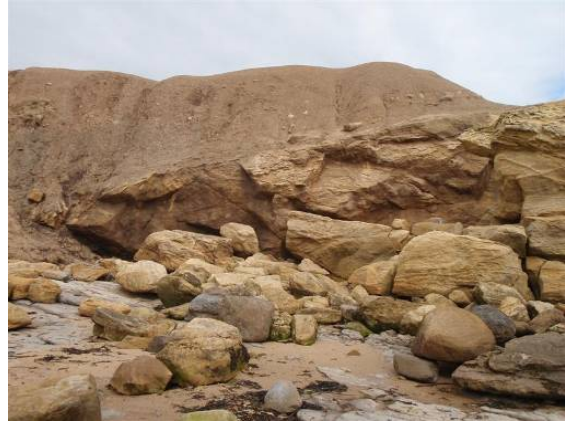
The cliffs around Tynemouth North Point have arches and caves at their base (below left). There is one area near the landward root of the headland on the southern side where there has been a minor rockfall (below right), otherwise there have been the characteristic occasional local slumps in the overlying softer material.

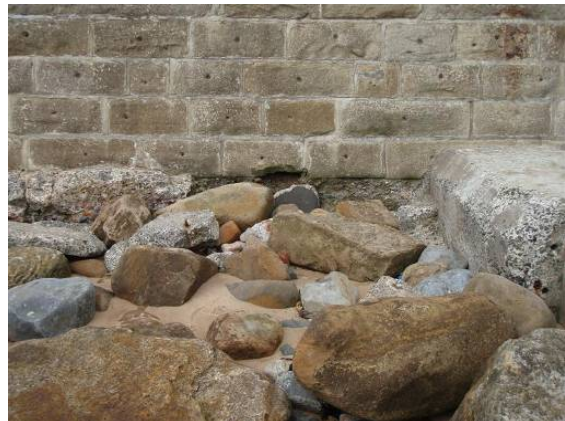
The large gap previously identified at the northern end of the masonry wall in the north of Tynemouth Longsands has been repaired (below left). There is one area, however, where part of the concrete toe apron has now broken away (below right).

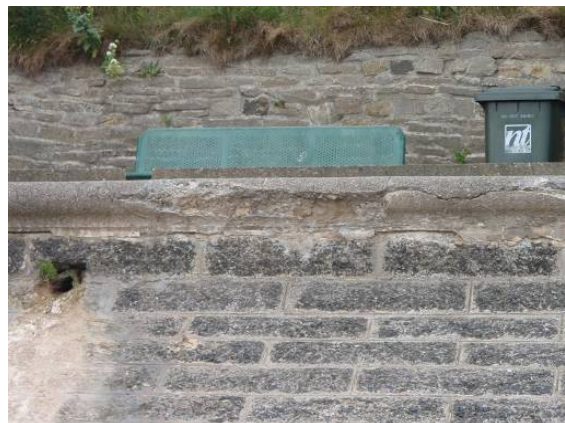
The sea wall protecting the promenade and vegetated coastal slope remains in fair condition despite some abrasion (below left). Along the neighbouring sloping blockwork revetment, there is some damage to the crest of the splash wall, although the structure overall remains in fair condition (below right).

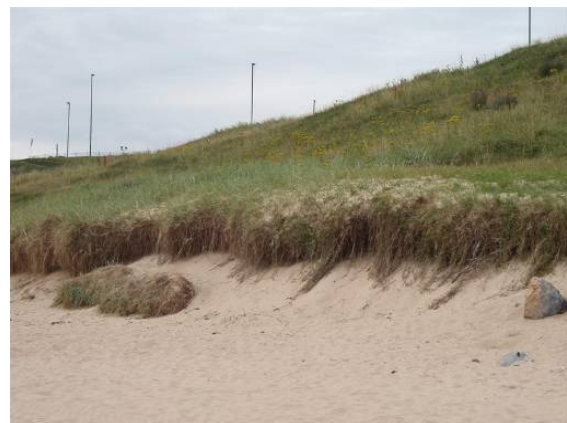
During the 2010 inspections, beach levels at the toe of the dunes were high which has helped the dunes to stabilise (below left) or recover, although in the worst affected area slumps in the face of the dune remain visible and just south of there a distinct 'clifflet' remains at the toe of the dunes (below right). The erosion that was recorded, and the subsequent general recovery, is characteristic of the interactions that occur between beaches and dunes during different seasons and is within the bounds of usual behaviour, although the erosion was particularly notable because of the severity of the winter 2009/10 storms.

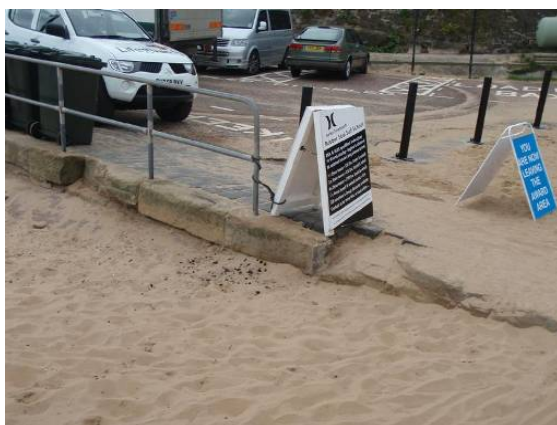
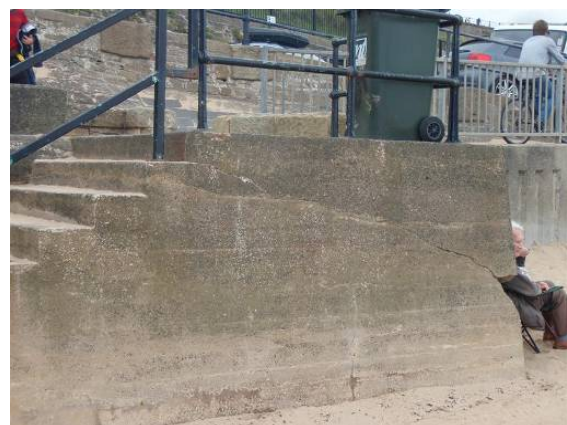
The access ramp at the foot of the Spa Car Park has one coping stone still missing but now another has broken away and some blocks from the ramp deck have become washed out (below left). The concrete access steps south of the newer concrete platform have cracked, with some concrete breaking away (below right). The wall extending to the Tynemouth Pool is generally in fair condition, although there are many gaps between the blocks which could usefully be infilled.

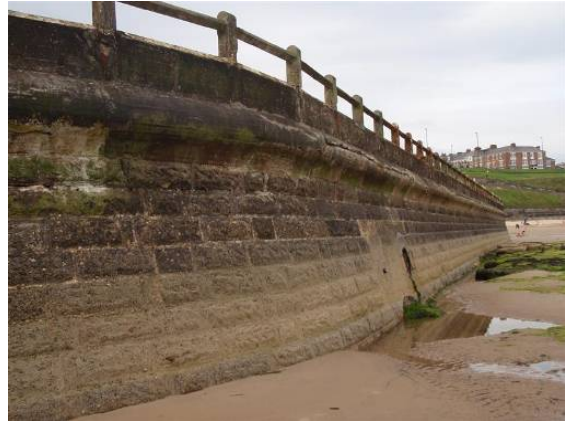
Around Tynemouth Pool, the wall on the northern-facing side has cracks and some previous repairs are now coming away. The eastern- and southern-facing walls mainly suffer from abrasion and cracks at the join between the masonry wall and the concrete wave return wall.

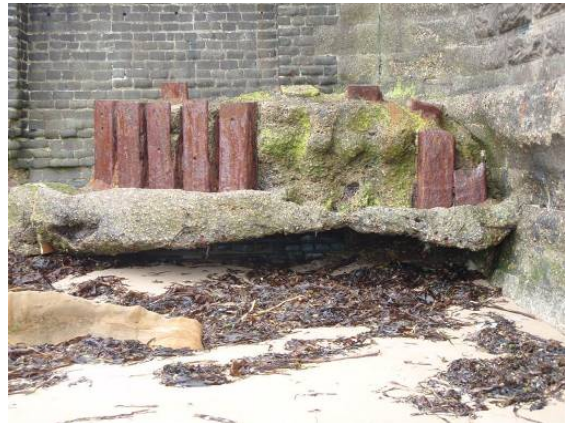
The short section of wall at the southern landward tie-in has its concrete apron cantilevered off the foreshore (below), although the wall behind appears sound.

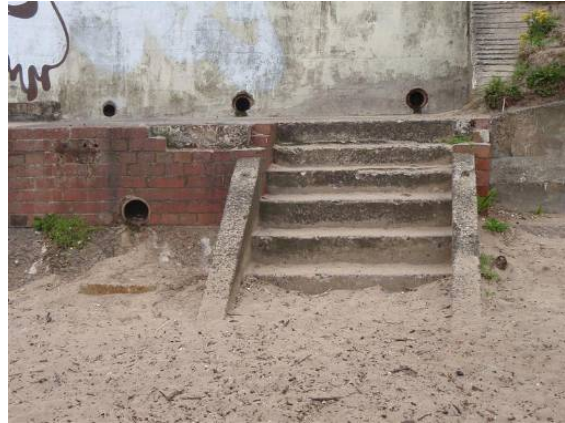
There is a longitudinal crack in the wall at the rear of the access slope near the lifeguard station (below left), and missing bricks at the short set of access steps (below right).

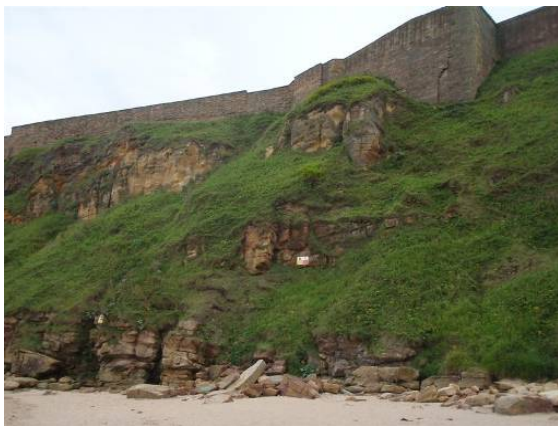
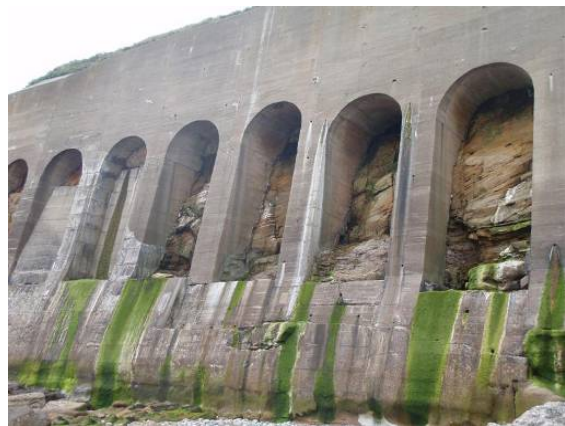
The cliffs at Tynemouth headland have a highly fractured rock structure and there are several areas with rockfalls on the foreshore (below left). In places this has left overhangs in the cliff face, with boundary walls of the Tynemouth Priory close to the cliff edge. The high arched retaining walls which extend along a short length close to the northern side of the landward end of the North Pier remain in fair condition (below right).

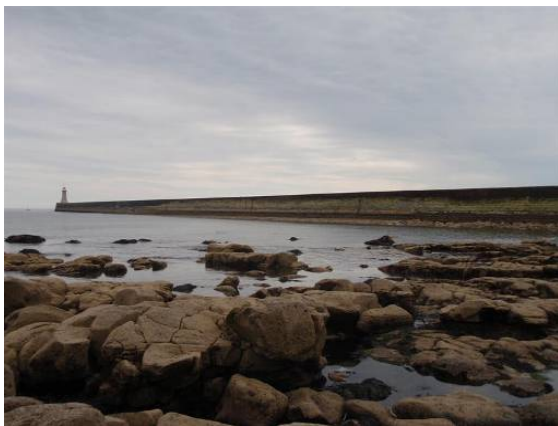
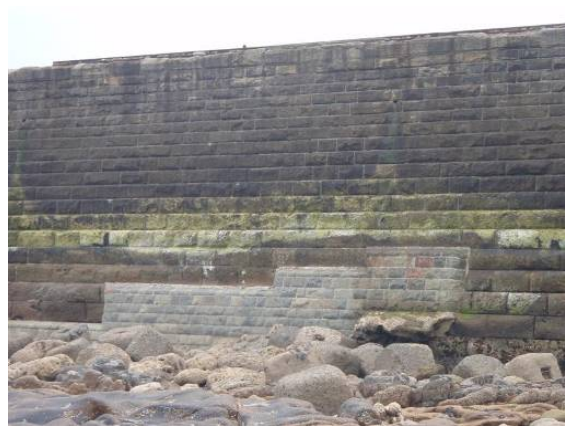
The North Pier (below left) appears well maintained, despite the apparent cosmetic defects on its deck, which shows considerable cracking. There are clearly areas on the outer face where maintenance has been undertaken (below right). It is anticipated that the Port of Tyne undertakes its own vessel-based inspections of the structure and plans maintenance work accordingly.

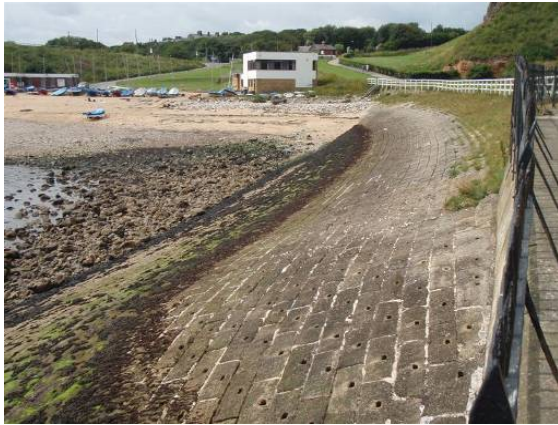
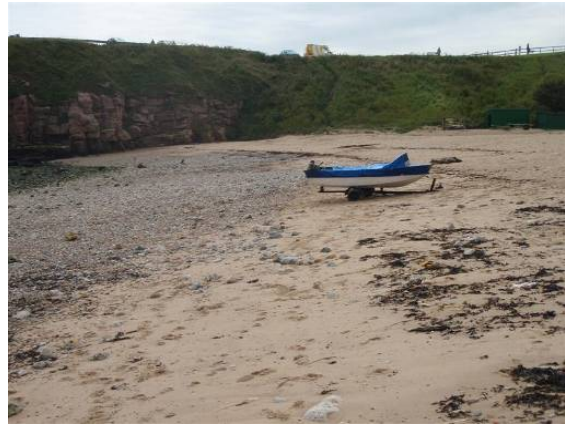
The revetment at Prior's Haven (below left) and the sandy bay backed with a coastal slope (below right) remain in good condition.

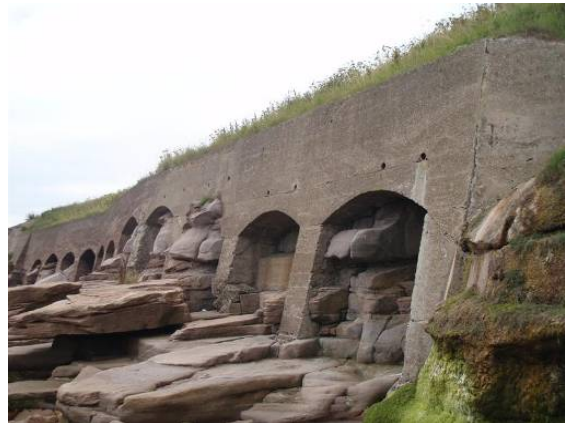
The rock headland Freestone Point is highly fractured but only experiencing occasional very local rock falls (below left). The arched retaining wall is in fair structural condition, although there is some abrasion and flaking of render (below right).

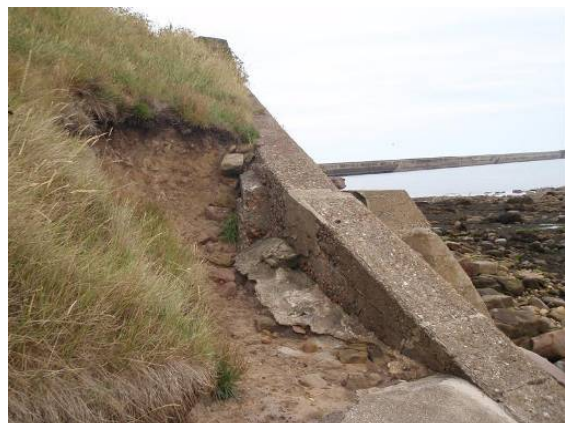
The adjacent masonry wall, however, has blocks missing from the toe (below left) and outflanking at its southern end (below right), leaving it in poor overall condition.

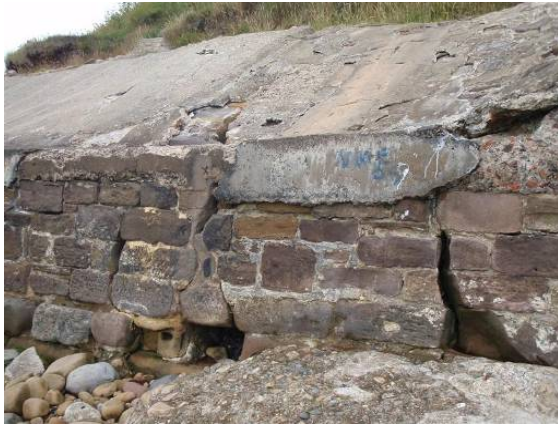
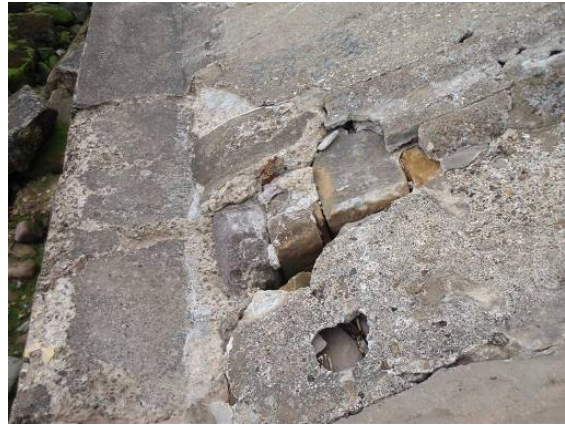
The masonry wall with a sloping concrete revetment at Sandy Goit is in very poor condition, with voids in both the wall and revetment (below), and erosion of the slope above the revetment. The structure is actively failing.

There is also an urgent need for maintenance to repair the failing structures at Sandy Goit, and the damaged structures in King Edward's Bay.

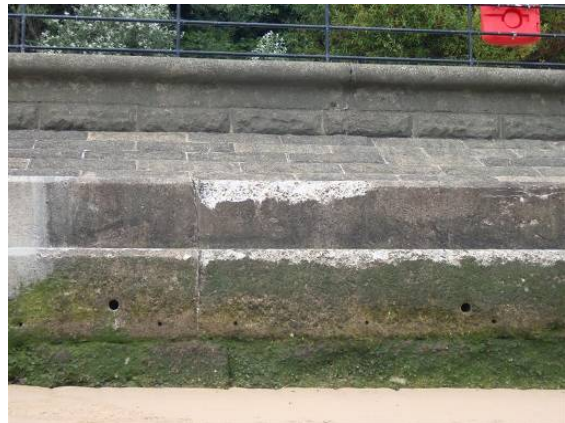
The concrete sloping revetment with a concrete toe wall (below left) that runs along the riverside towards The Flats is generally in a fair condition, although there are gaps between revetment panels along the eastern section of defence, and then increasing incidences of abrasion damage to the toe wall in particular (below right) but also the crest of the structure with progression upstream along the western section of defence.

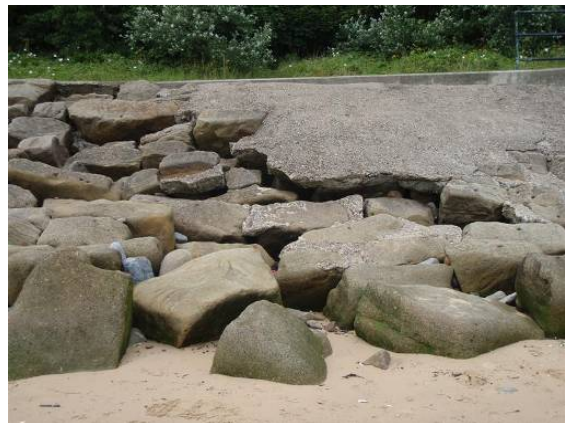
The rock revetment (below left) extending to the jetty downstream of the Fish Quay suffers from settlement of rock and in places the concrete slurry that has been poured to address this is now being undermined and in places breaking up (below right).

121AA901 A4801C10	Low Lights	Revetment	routine	2012	improve condition through maintenance	Maintenance/repairs to revetment.
