**Cell 1 Regional Coastal Monitoring Programme
Walkover Inspection Surveys 2018**

North Tyneside Council

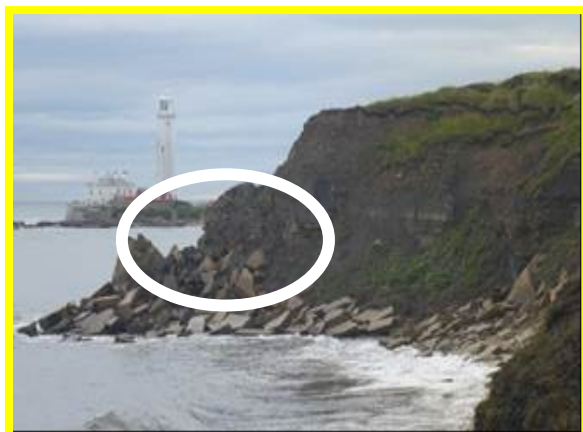
Slippages in soft material along upper cliffs and rock fall at base (/4401C24)

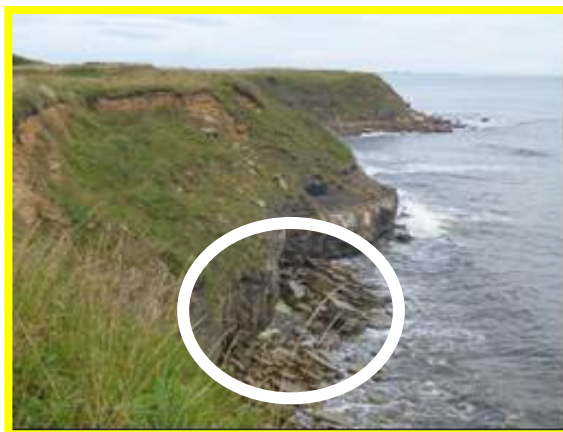
Rock falls in hard material along lower cliffs (/4401C24)

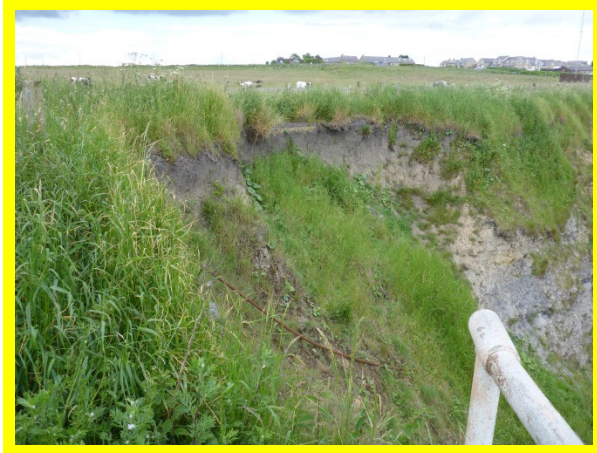
Slippages in soft material adjacent to Hartley Cove access steps (/4401C23)

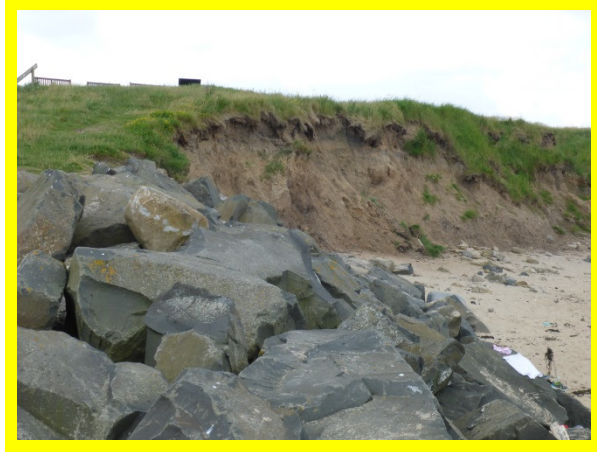
Erosion adjacent to rock revetment by St Mary's Island causeway (/4401C24)

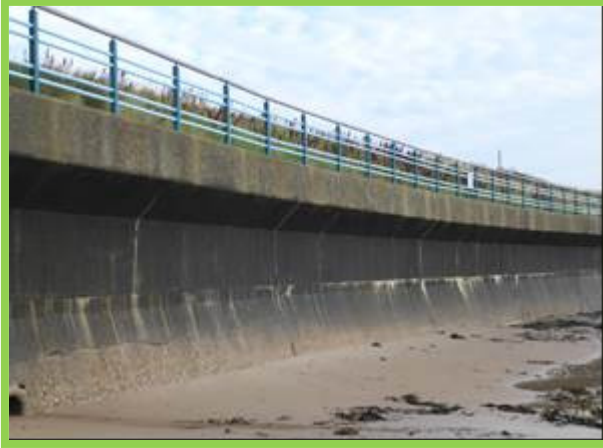
Trinity Road seawall in good overall condition, but with some minor maintenance required (/4501C04)

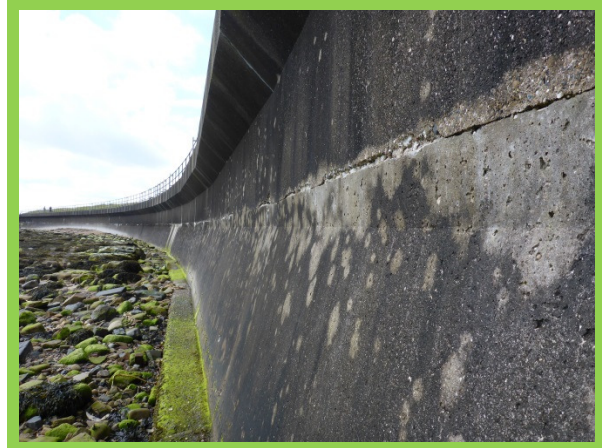
Trinity Road seawall in good overall condition, note the construction joints (/4501C04)

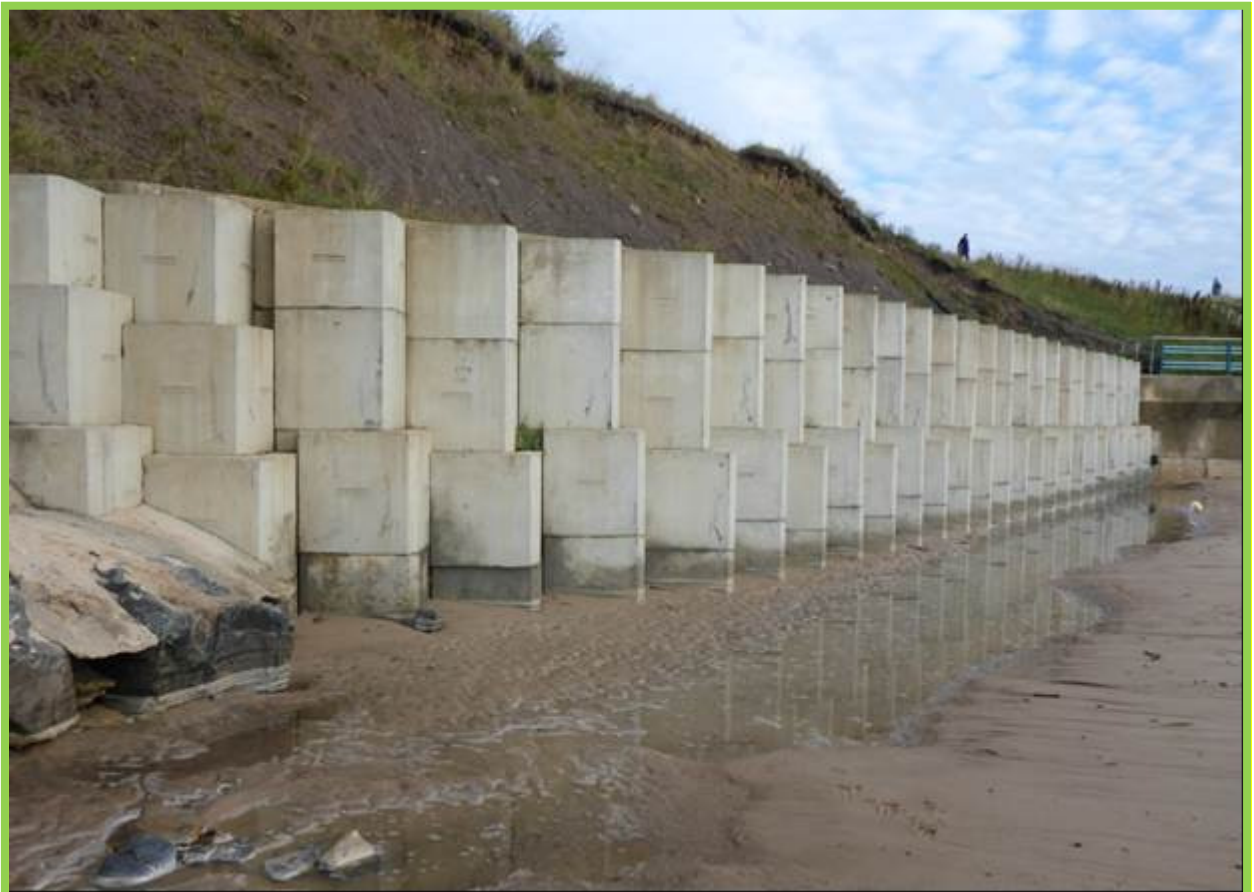
New T-Block units (constructed in 2014) prevent outflanking at the southern end of Trinity Road seawall (/4501C04)

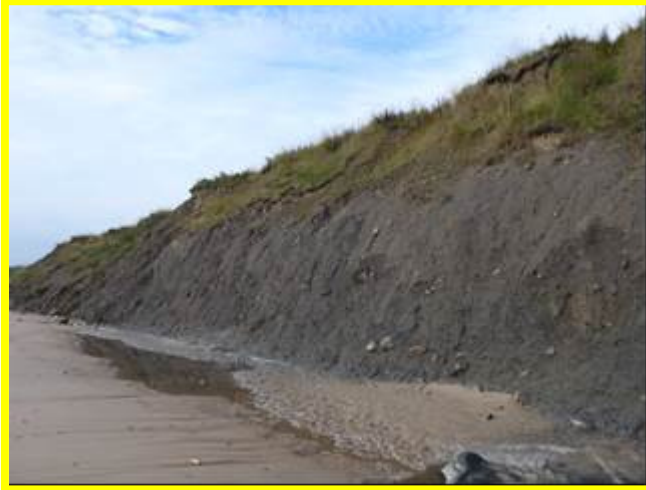
Slumping cliffs (/4501C05)

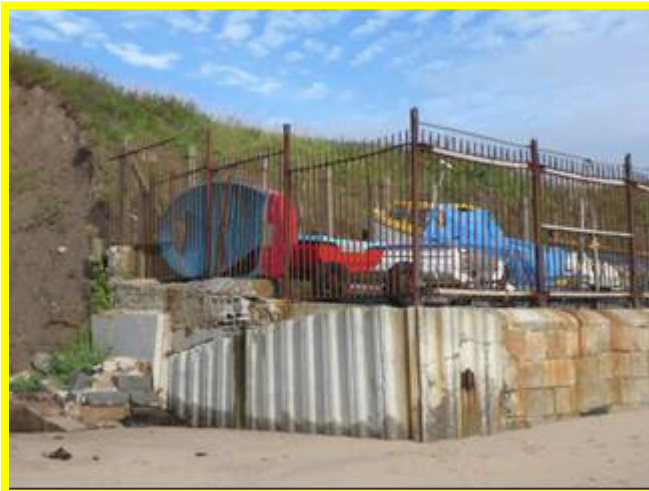
Wall at boatyard (/4501C05)

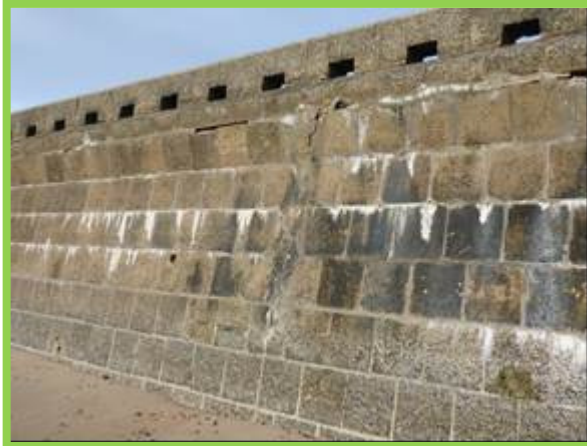
Previous repairs and local open joints which would benefit from maintenance (/4501C07)

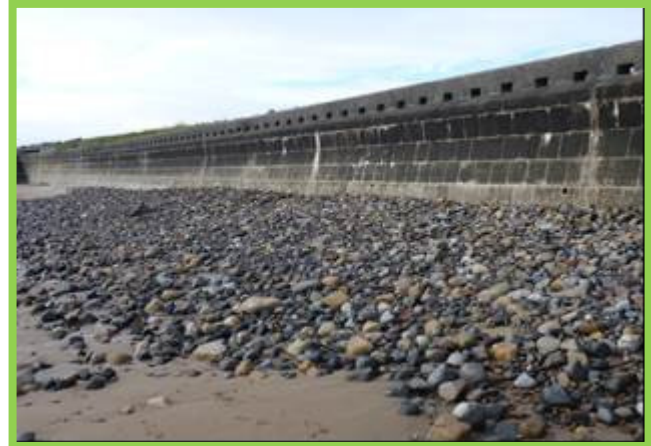
Cobble berm at toe (/4501C07)

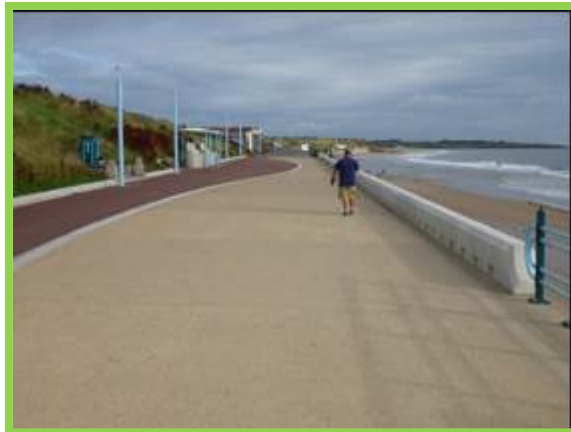
Refurbished Central Promenade (/4501C07)

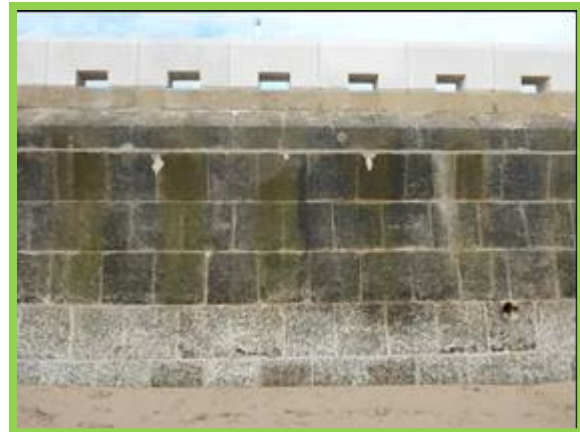
New coping on seawall (/4501C07)

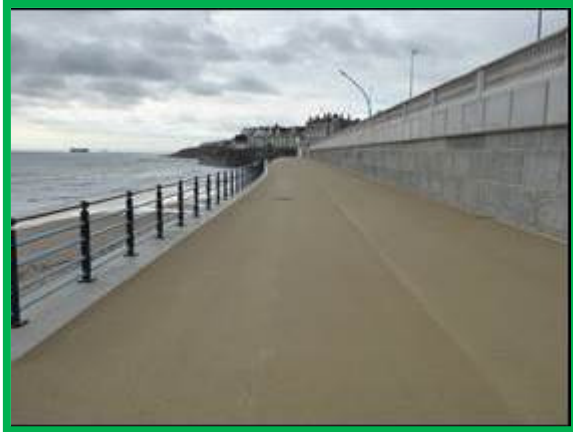
Refurbished promenade (/4601C03)

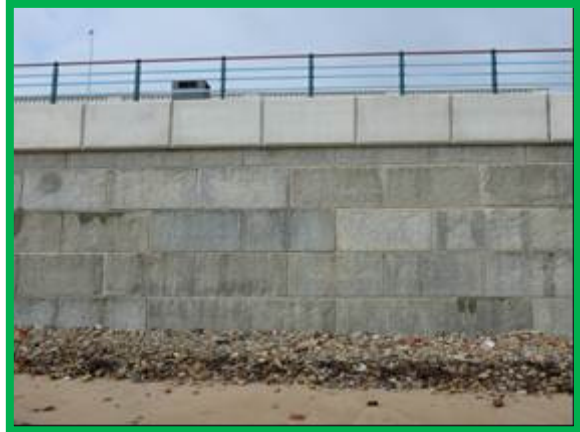
Refurbished sea wall (/4601C03)

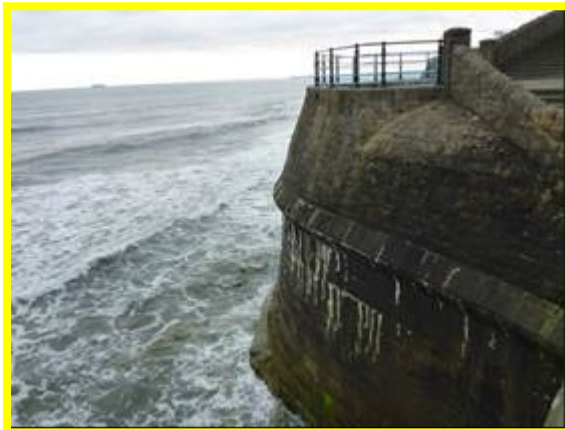
Blockwork sea wall at first 'bullnose' (/4601C04)

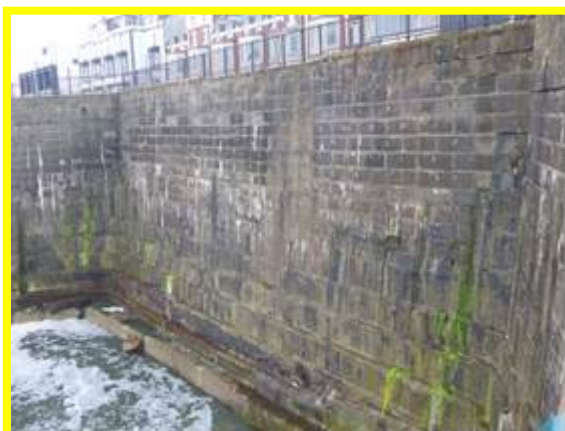
High blockwork sea wall (/4601C05)

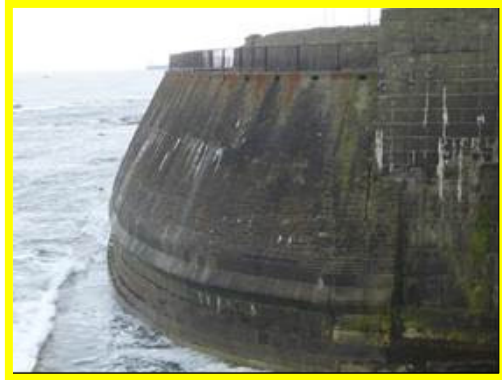
High blockwork sea wall (/4601C06)

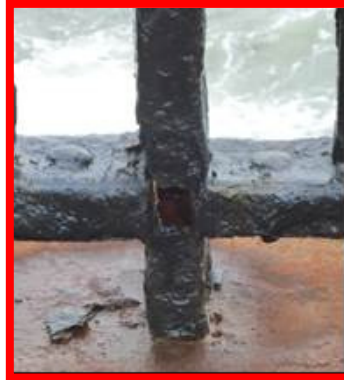
Broken handrailing (/4601C06)

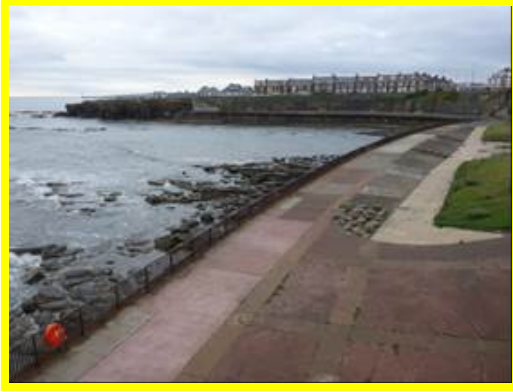
Brown's Bay northern sea wall in generally fair condition (/4601C10)

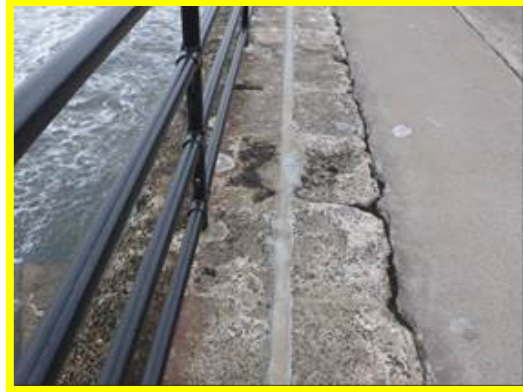
Gaps in promenade deck at northern end (/4601C10)

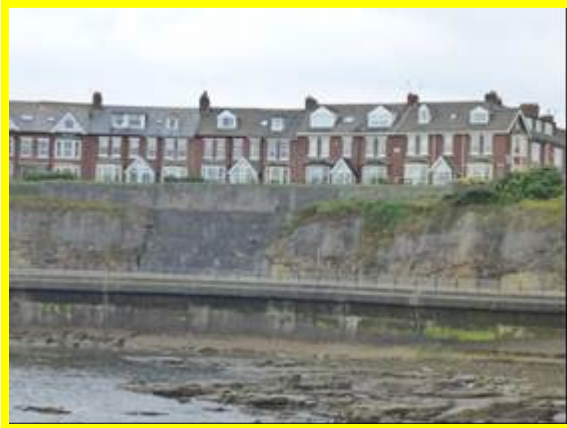
Brown's Bay southern sea wall in generally fair condition (/4701C01)

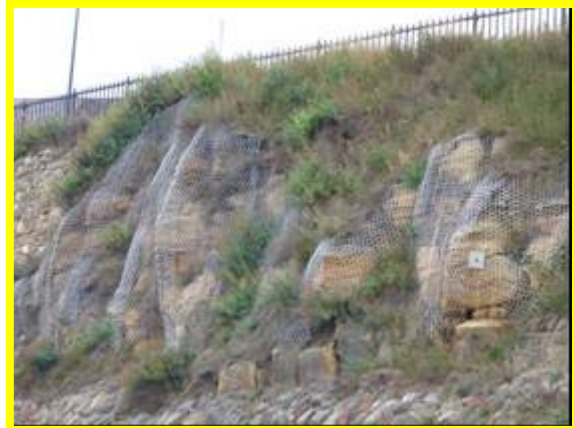
Rock bolts and netting on slopes to rear of promenade (/4701C01)

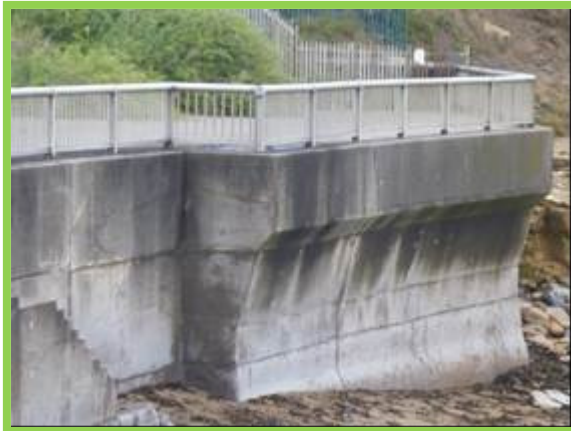
First section of sea wall in generally good condition (/4701C04)

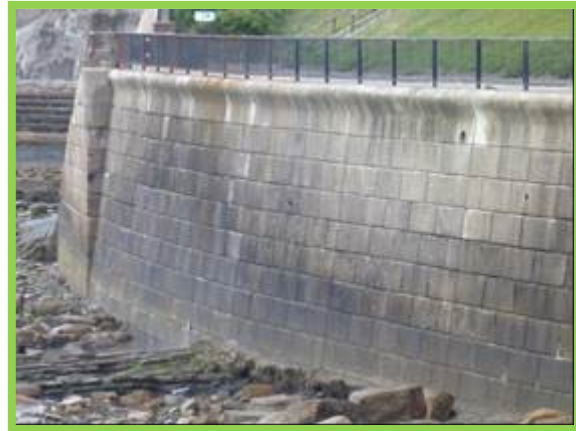
Middle section of sea wall in generally good condition but with face abrasion (/4701C05)

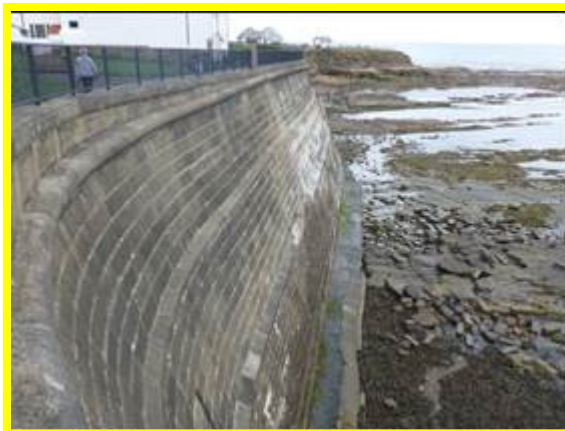
Final section of sea wall in generally fair condition, but with some defects at the toe requiring remedial attention (/4701C06)

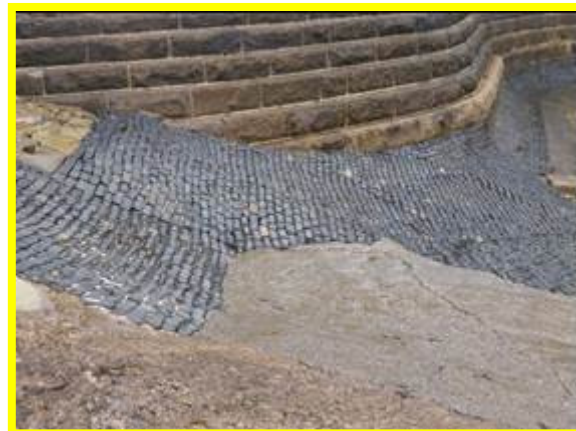
Final section of sea wall in generally fair condition, but with some defects at the tie-in requiring remedial attention (/4701C06)

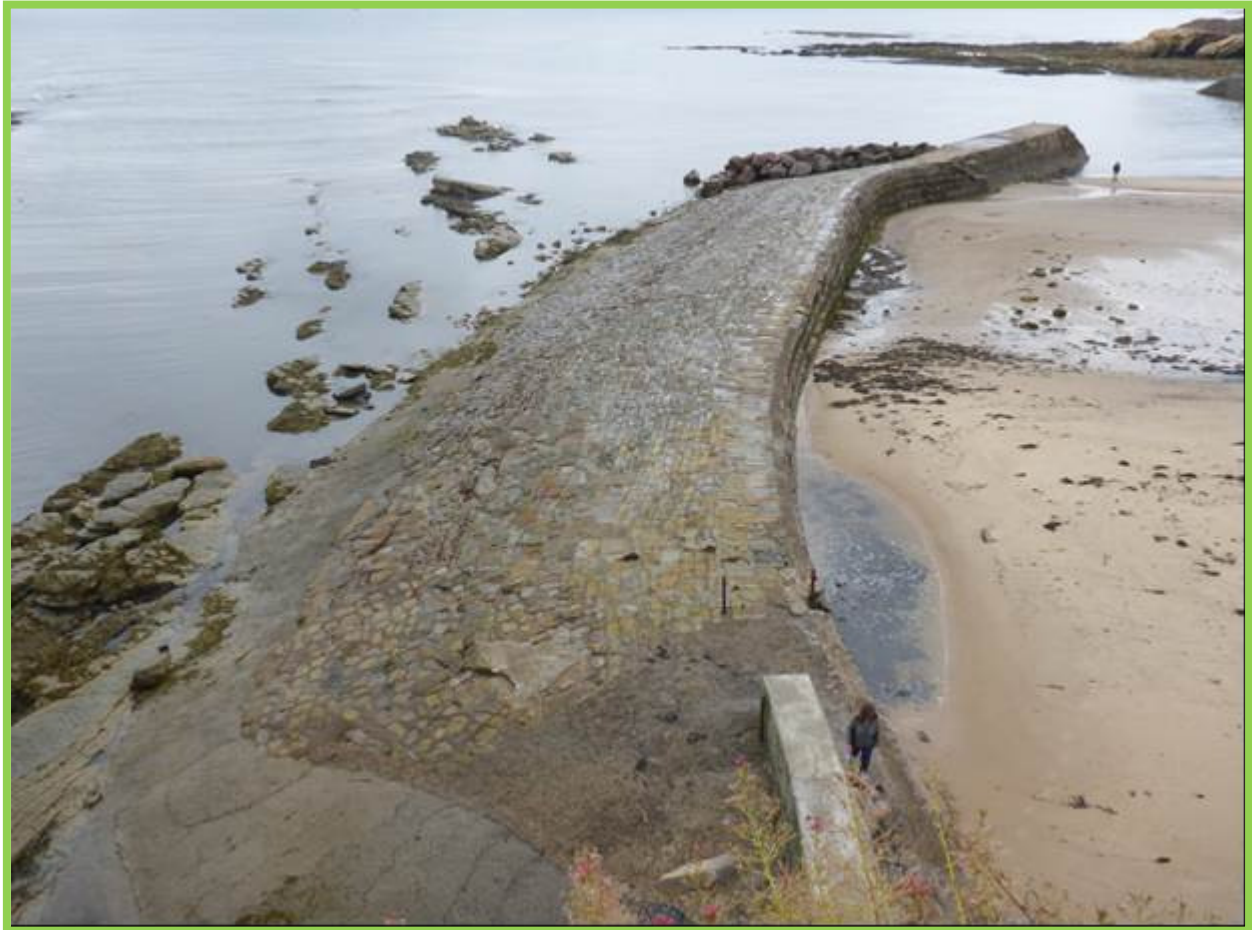
Cullercoats North Pier in good condition following repair works (I4701C07)

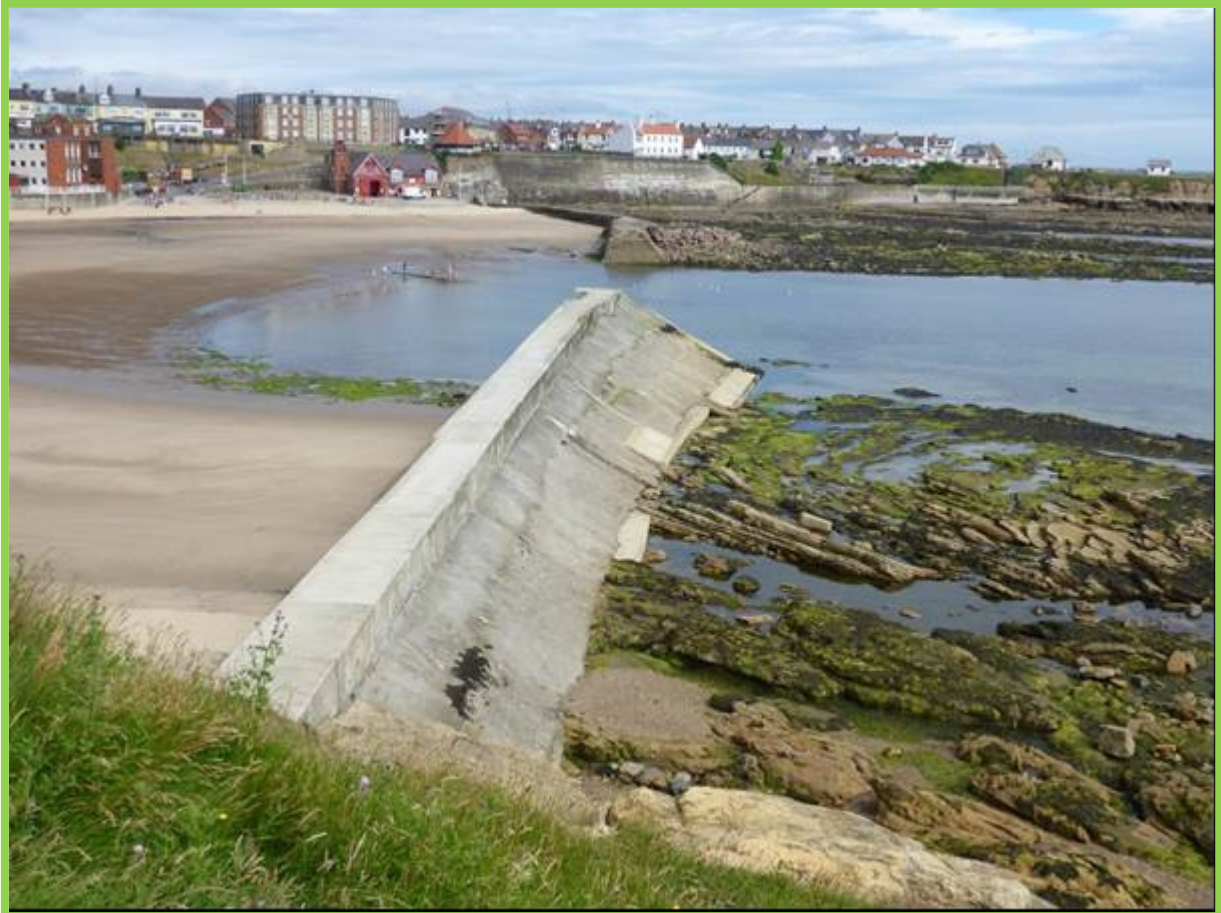
Cullercoats South Pier in very good condition following refurbishment works (/4701C15)

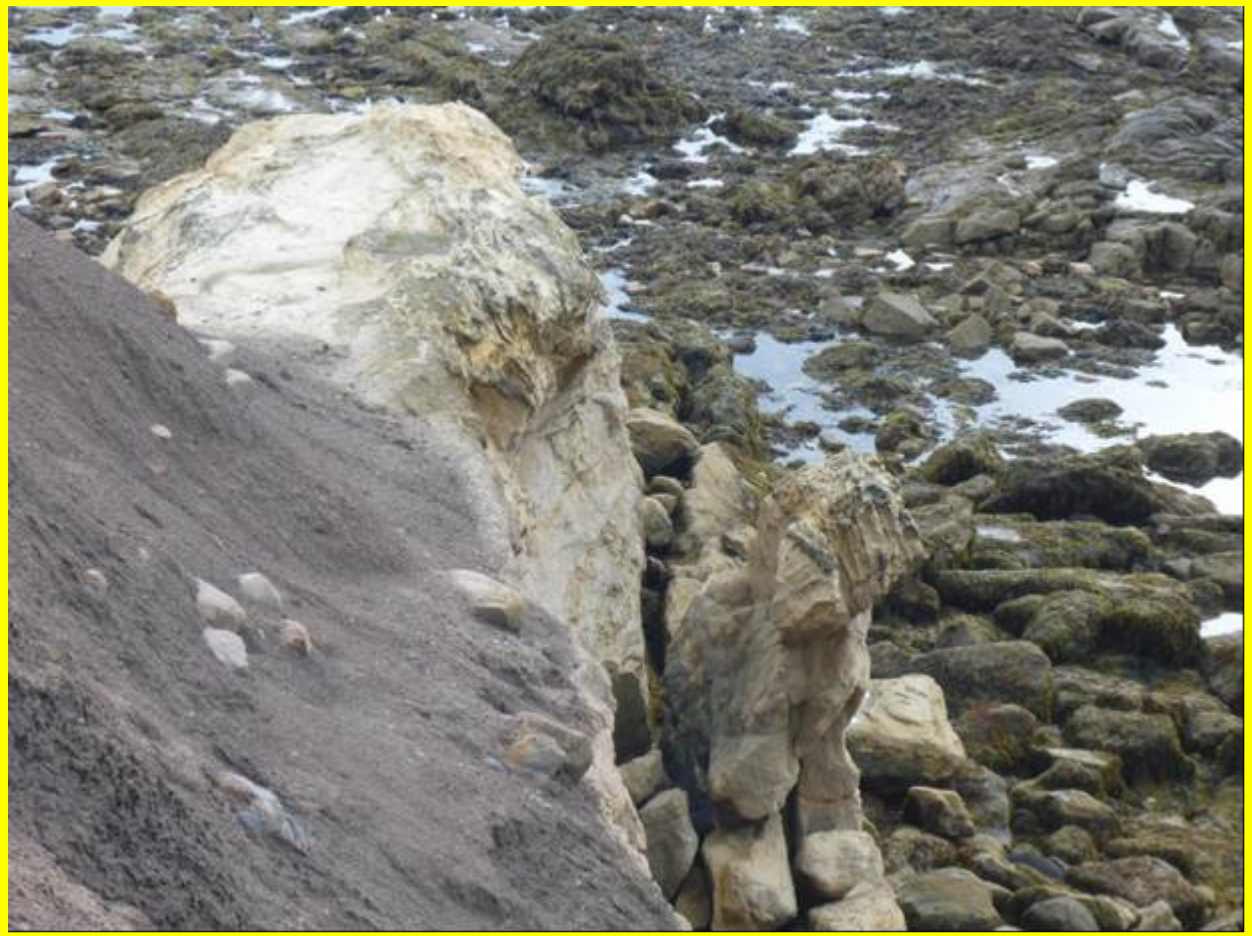
Rock stack near Tynemouth North Point that has the potential to topple imminently (/4701C16)

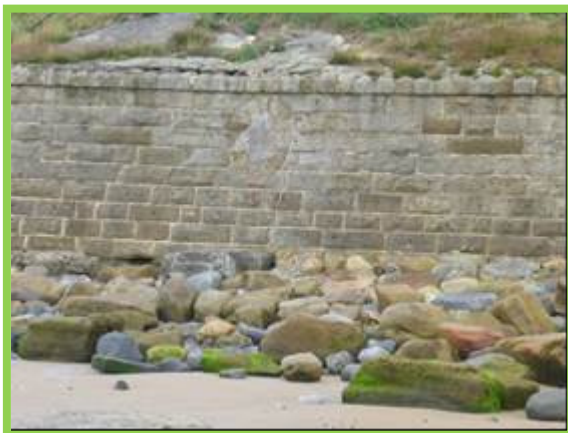
Slumping in cliffs near northern end of masonry wall (/4701C17)

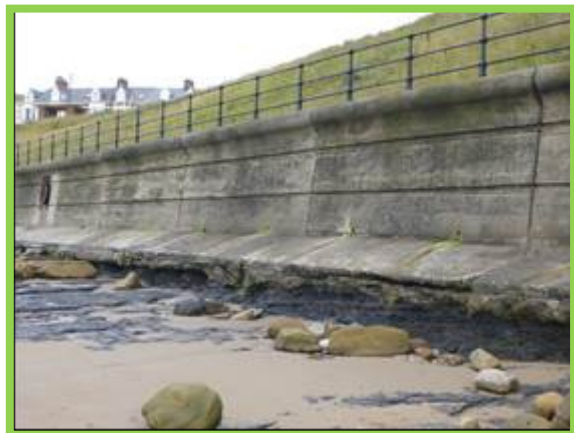
Undercutting and exposure of coal at toe of wall (/4701C18)

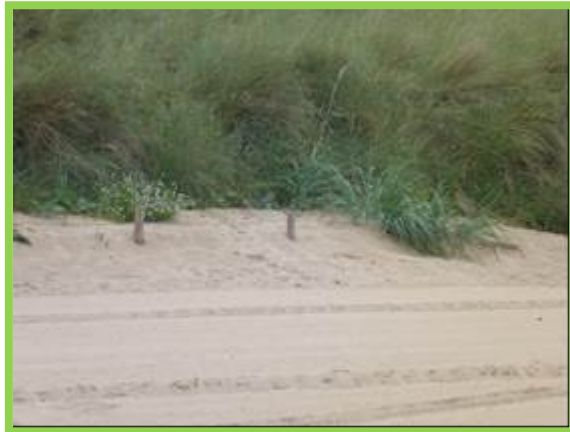
Dunes showing some recovery (/4701C19)

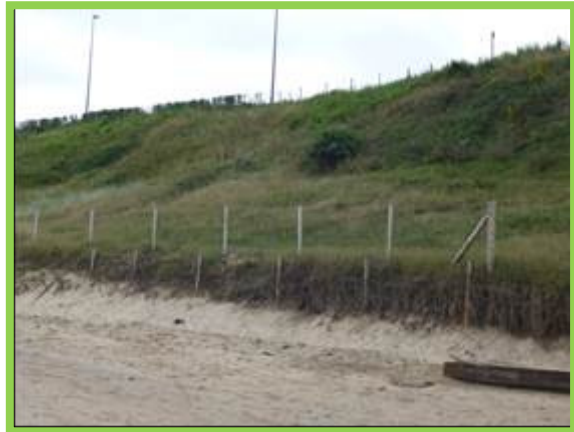
Dunes showing post erosion along Long Sands (/4701C21)

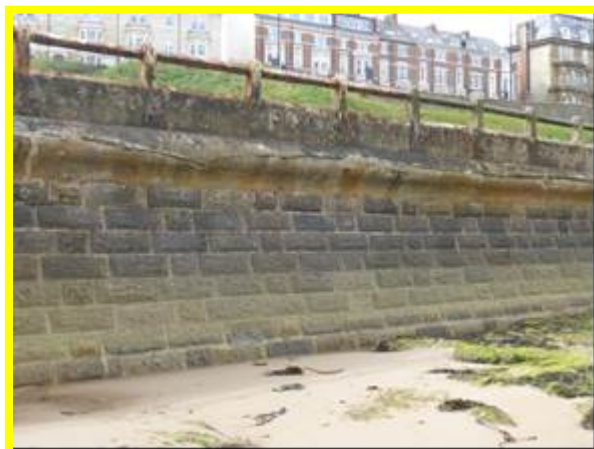
Further repairs to an area of previous repair at the Outdoor Pool (/4701C24)

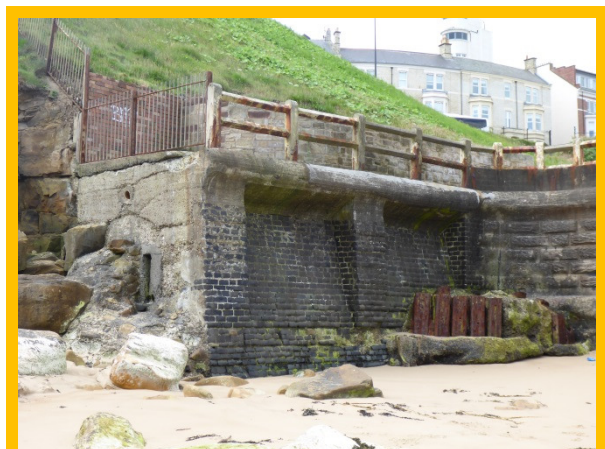
Tie-in wall between Outdoor Pool and undefended rock cliffs (/4701C25)

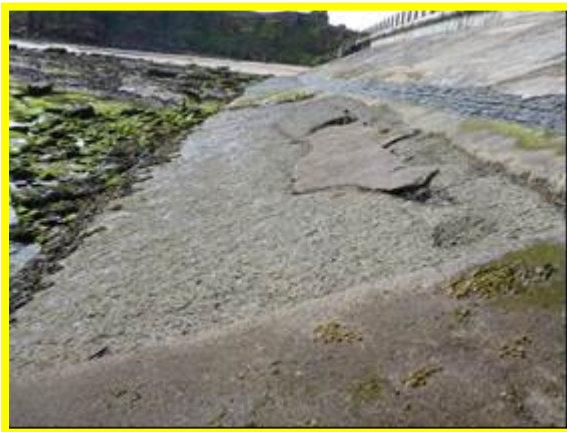
Sea wall in fair condition with abrasion of the apron leading to exposed rebar (/4701C27)

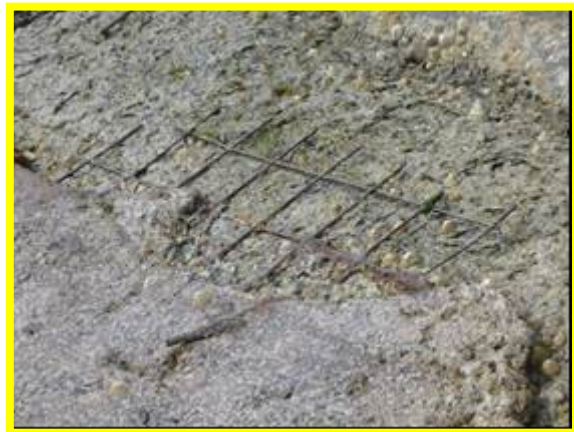
Exposed rebar (/4701C27)

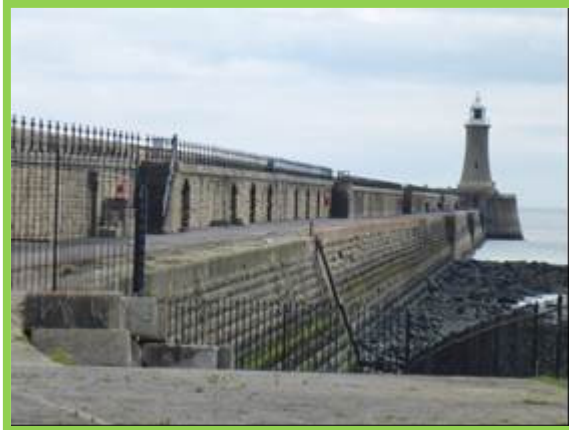
North Pier appears in good overall condition and is well maintained (/4801C01)

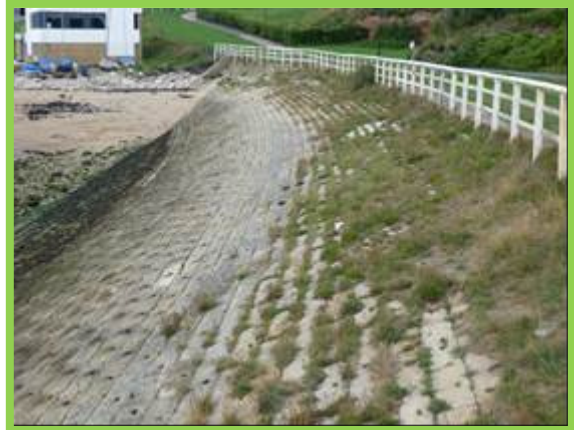
Masonry revetment (/4801C02)
